APPENDIX 2

Building Assessment Sheets (Inventory Sheets)

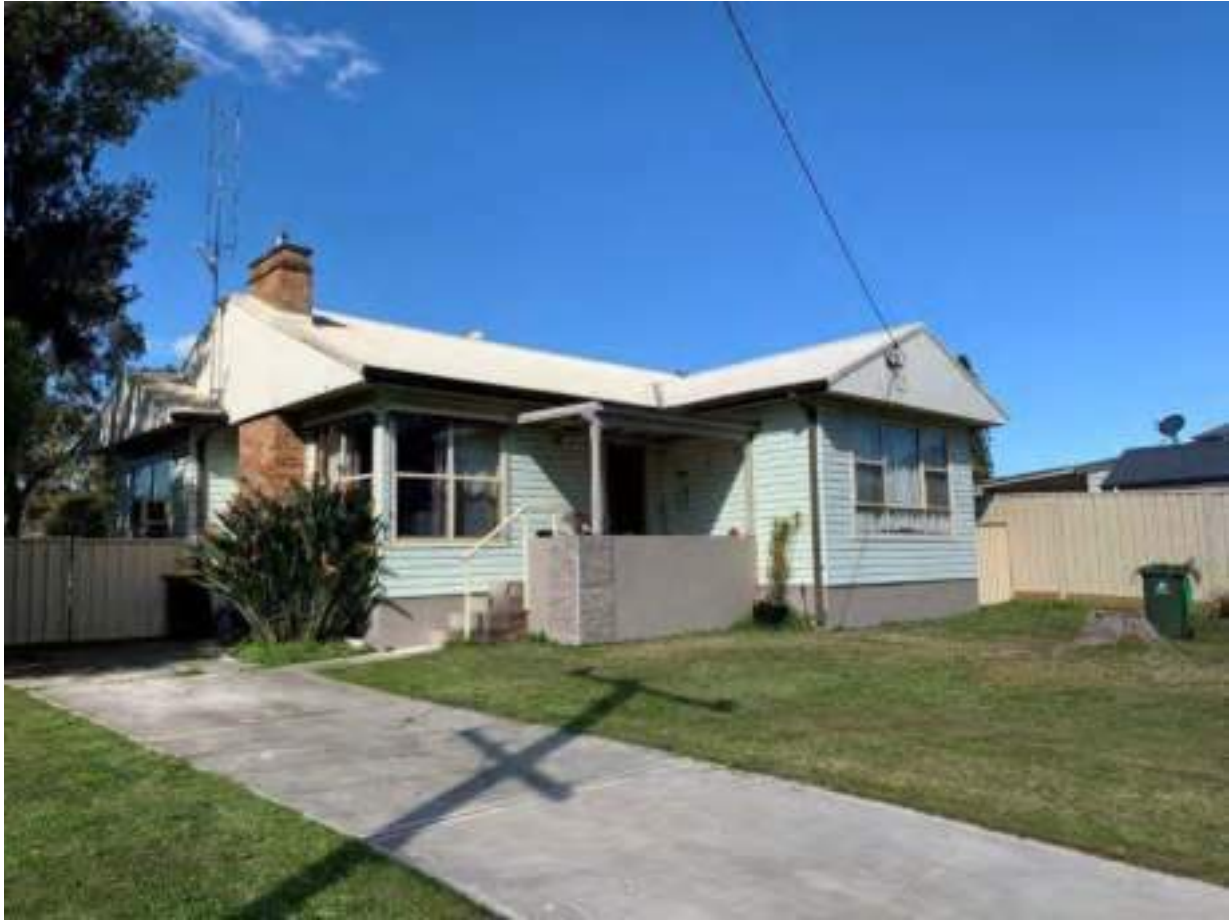
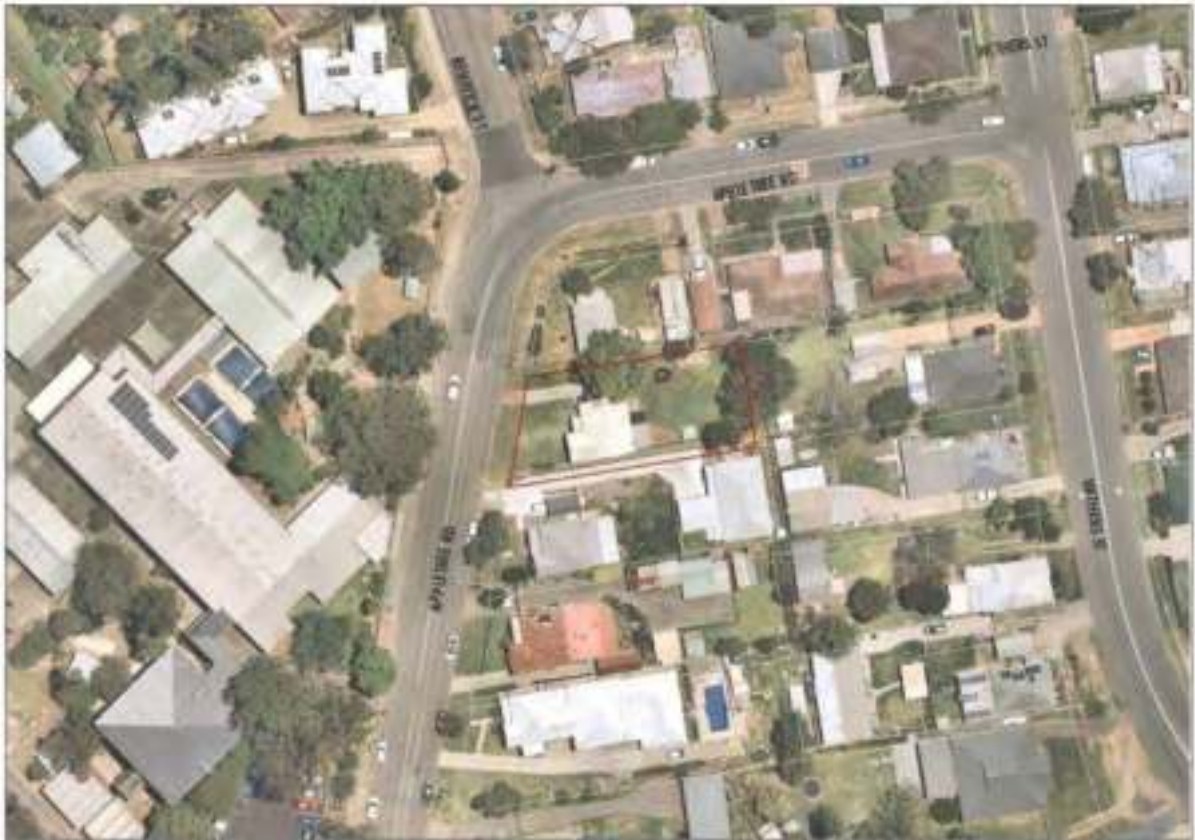
5 APPLETREE ROAD, WEST WALLSEND 2286

Conservation Area Contribution Level	Est. Construction Date	Previous studies and/or community input
Contributory 2	Early to late 20 th century (broad range)	No prior heritage assessments or research undertaken.
Assessment Text		Observed Modifications
<p>The scale (single-storey) and general style of the dwelling is consistent with that of the streetscape and wider HCA. Dwelling contributes positively to the streetscape and wider HCA, particularly in comparison to Non-Contributory buildings.</p> <p>The dwelling features appropriately proportioned and positioned fenestrations, an appropriate roof form (gabled or hipped) and other features consistent with the architectural character of the area (e.g. front verandah with timber or brick posts, timber detailing, corrugated metal roofing, etc). The contributory value of the dwelling is limited however by either:</p> <ul style="list-style-type: none"> • External modifications that have in some way obscured the style, scale or design intent of the building and have resulted in less physical integrity than Contributory 1 buildings. • Being a later dwelling constructed in an appropriate referential style, but comprising little to no fabric of intrinsic heritage significance. 		<p>The veranda wall has been rendered with additional masonry detailing.</p>

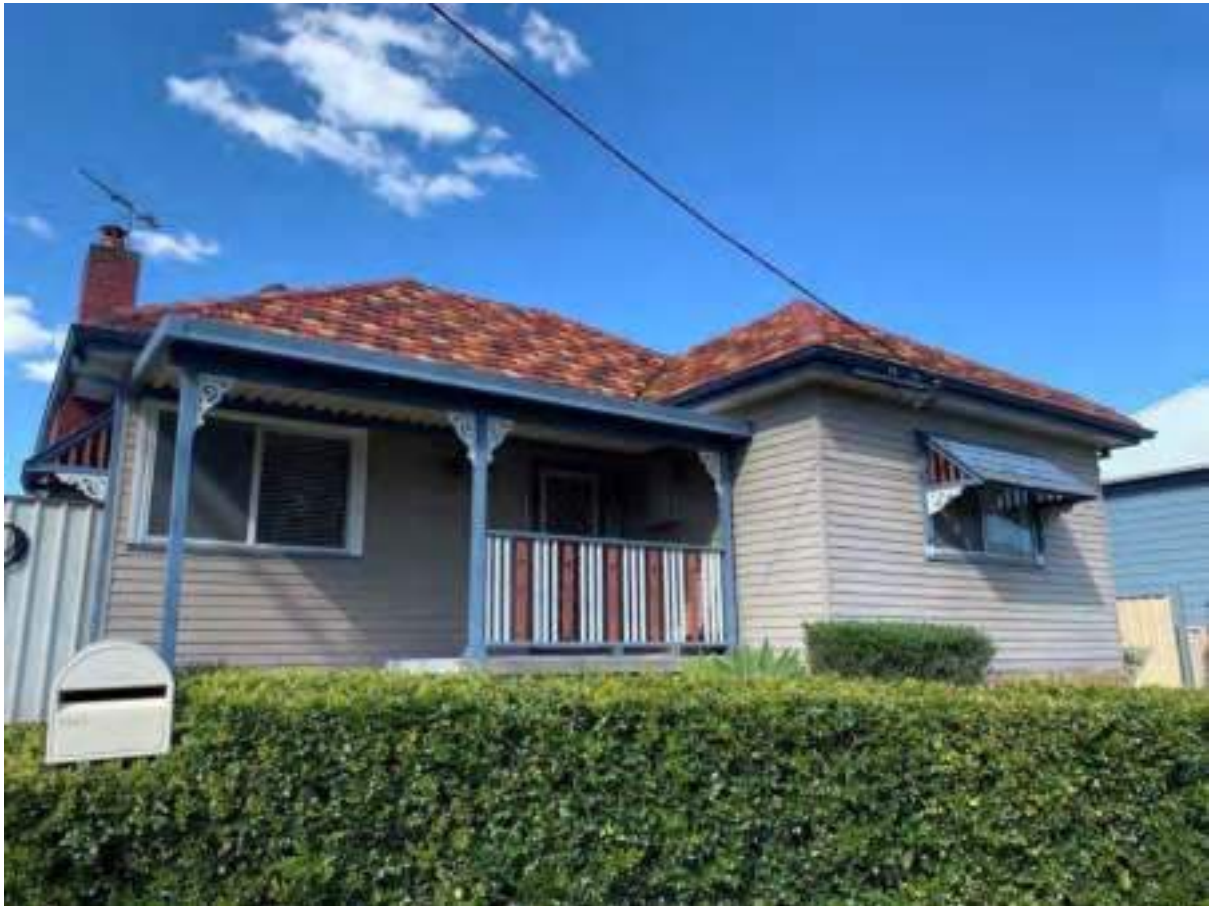
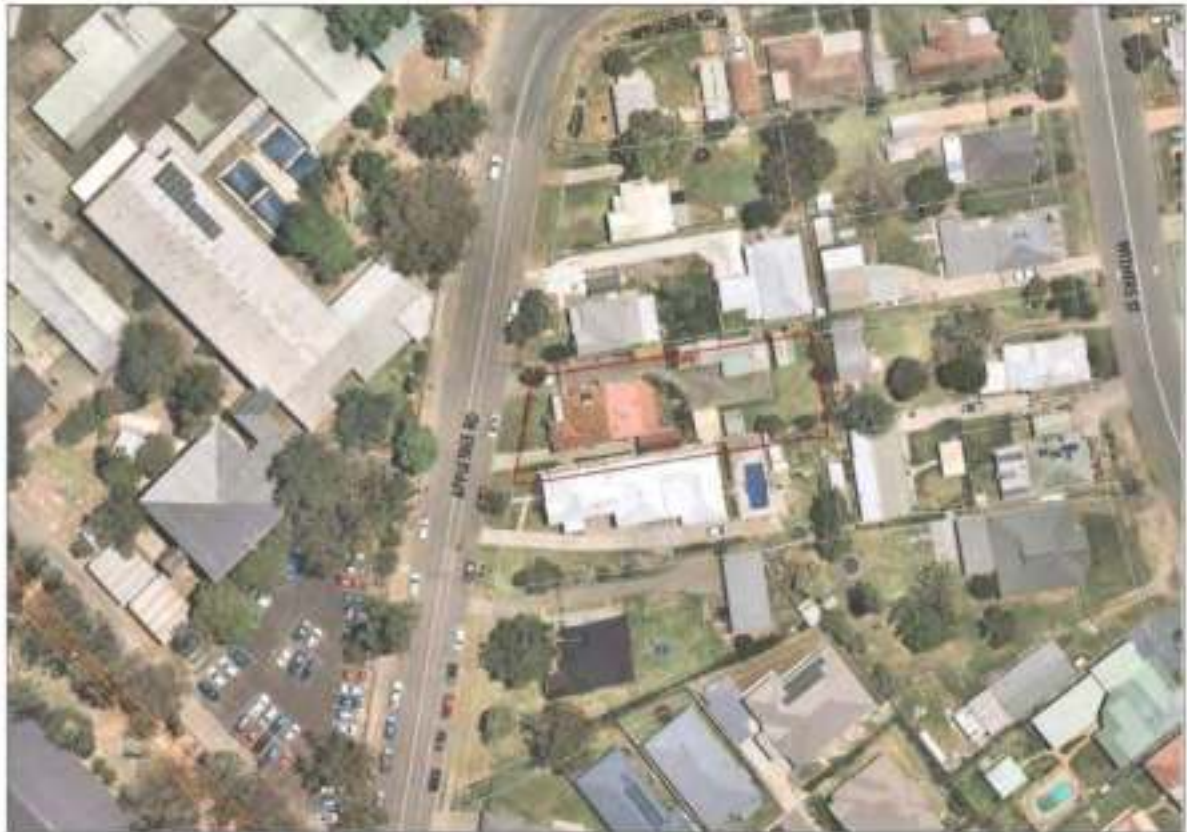
9 APPLETREE ROAD, WEST WALLSEND 2286

Conservation Area Contribution Level	Est. Construction Date	Previous studies and/or community input
Contributory 2	Early to late 20 th century (broad range)	No prior heritage assessments or research undertaken.
Assessment Text		Observed Modifications
<p>The scale (single-storey) and general style of the dwelling is consistent with that of the streetscape and wider HCA. Dwelling contributes positively to the streetscape and wider HCA, particularly in comparison to Non-Contributory buildings.</p> <p>The dwelling features appropriately proportioned and positioned fenestrations, an appropriate roof form (gabled or hipped) and other features consistent with the architectural character of the area (e.g. front verandah with timber or brick posts, timber detailing, corrugated metal roofing, etc). The contributory value of the dwelling is limited however by either:</p> <ul style="list-style-type: none"> • External modifications that have in some way obscured the style, scale or design intent of the building and have resulted in less physical integrity than Contributory 1 buildings. • Being a later dwelling constructed in an appropriate referential style, but comprising little to no fabric of intrinsic heritage significance. 		<p>The decorative detailing of the façade, including the ornate bracketing, awnings and timber balustrade, are a contemporary addition. This has been constructed in a sympathetic manner and to a heritage style. It does not detract from the heritage streetscape.</p>

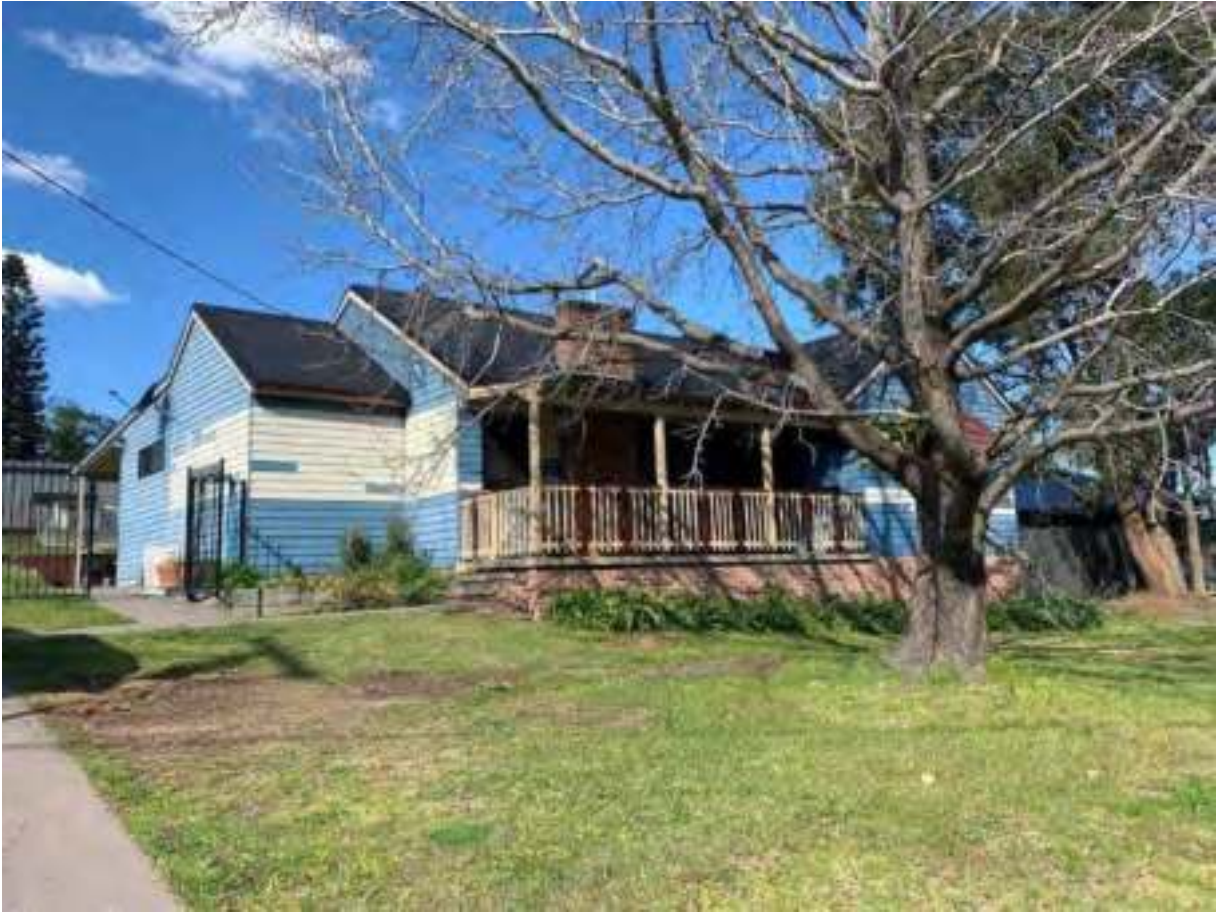
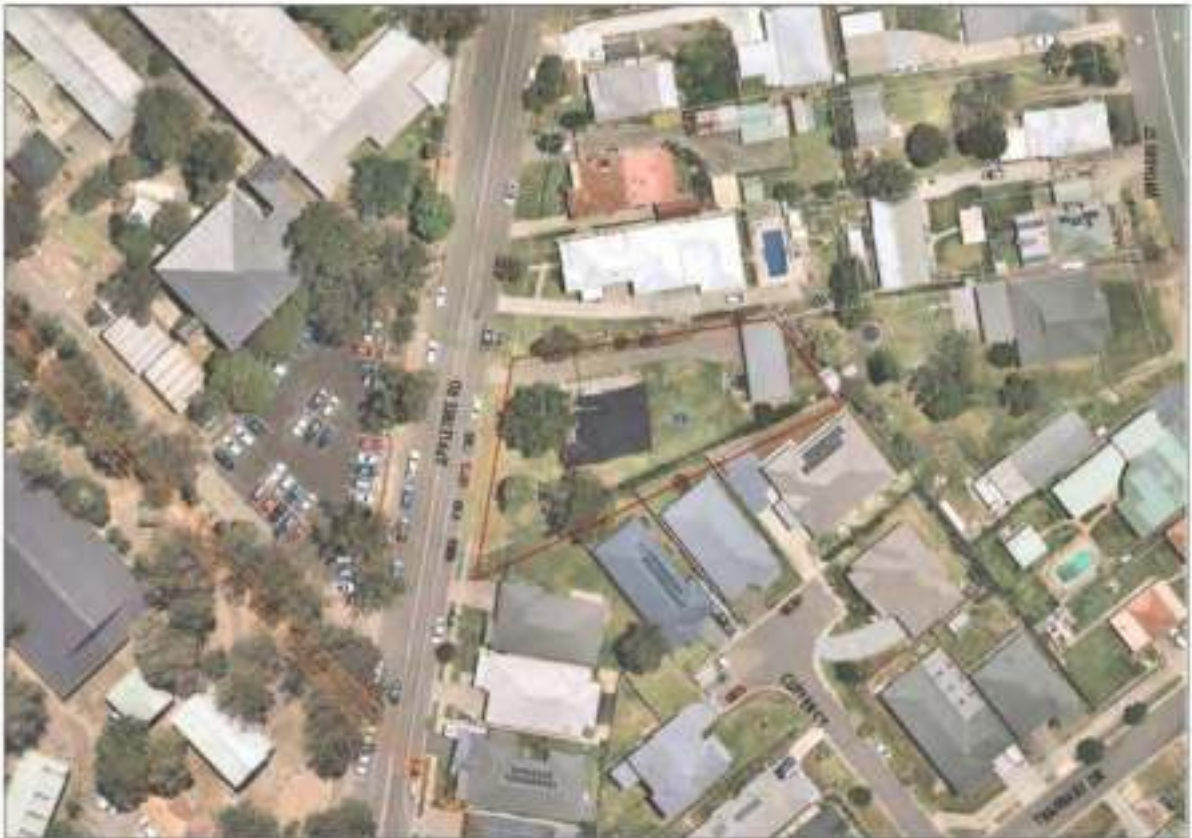
13 APPLETREE ROAD, WEST WALLSEND 2286

Conservation Area Contribution Level	Est. Construction Date	Previous studies and/or community input
Contributory 2	Early to late 20 th century (broad range)	No prior heritage assessments or research undertaken.
Assessment Text		Observed Modifications
<p>The scale (single-storey) and general style of the dwelling is consistent with that of the streetscape and wider HCA. Dwelling contributes positively to the streetscape and wider HCA, particularly in comparison to Non-Contributory buildings.</p> <p>The dwelling features appropriately proportioned and positioned fenestrations, an appropriate roof form (gabled or hipped) and other features consistent with the architectural character of the area (e.g. front verandah with timber or brick posts, timber detailing, corrugated metal roofing, etc). The contributory value of the dwelling is limited however by either:</p> <ul style="list-style-type: none"> • External modifications that have in some way obscured the style, scale or design intent of the building and have resulted in less physical integrity than Contributory 1 buildings. • Being a later dwelling constructed in an appropriate referential style, but comprising little to no fabric of intrinsic heritage significance. 		<p>The timber balustrade enclosing the veranda is a contemporary addition, likely replicating an original timber design.</p> <p>An extension has been constructed onto the northern side of the dwelling.</p>

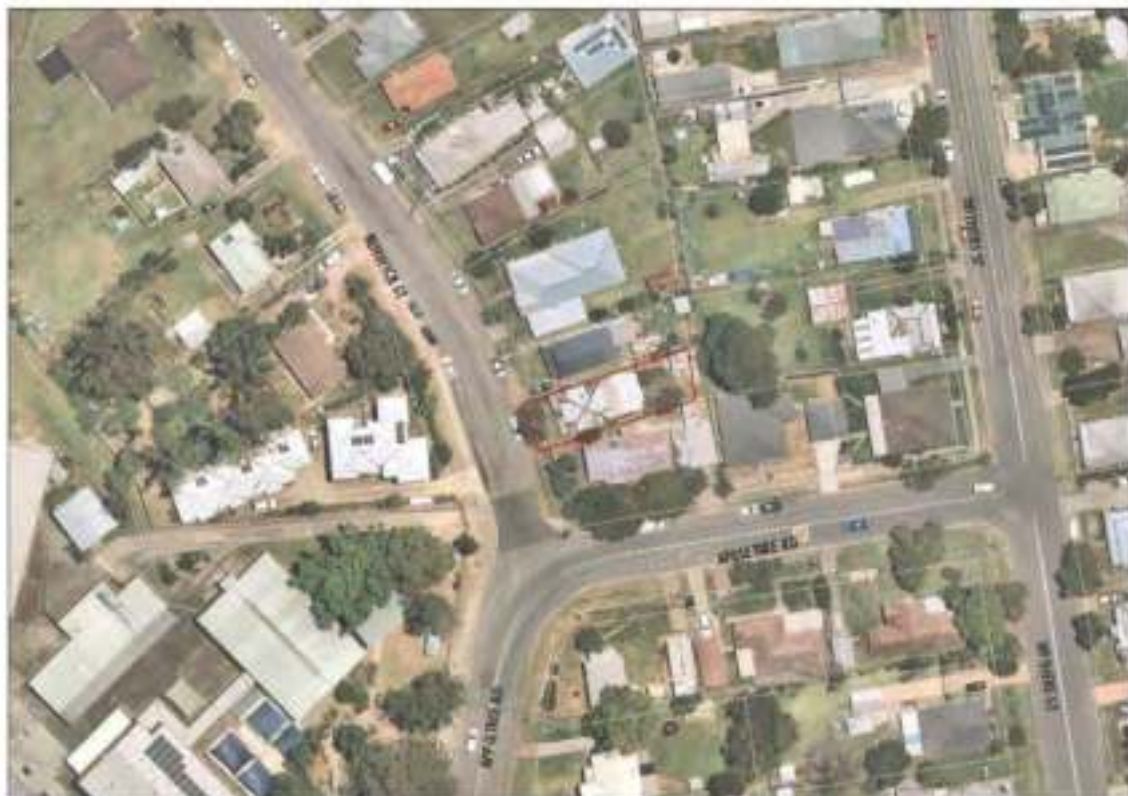
19 RENWICK STREET, WEST WALLSEND 2286

Conservation Area Contribution Level	Est. Construction Date	Previous studies and/or community input
Contributory 2	1910–1930	No prior heritage assessments or research undertaken.
Assessment Text		Observed Modifications
<p>The scale (single-storey) and general style of the dwelling is consistent with that of the streetscape and wider HCA. Dwelling contributes positively to the streetscape and wider HCA, particularly in comparison to Non-Contributory buildings.</p> <p>The dwelling features appropriately proportioned and positioned fenestrations, an appropriate roof form (gabled or hipped) and other features consistent with the architectural character of the area (e.g. front verandah with timber or brick posts, timber detailing, corrugated metal roofing, etc). The contributory value of the dwelling is limited however by either:</p> <ul style="list-style-type: none"> External modifications that have in some way obscured the style, scale or design intent of the building and have resulted in less physical integrity than Contributory 1 buildings. Being a later dwelling constructed in an appropriate referential style, but comprising little to no fabric of intrinsic heritage significance. 		<p>The visible windows are contemporary designs.</p> <p>The faux European pillars are a contemporary addition.</p> <p>The timber fencing enclosing the veranda/front garden space is a recent addition.</p>

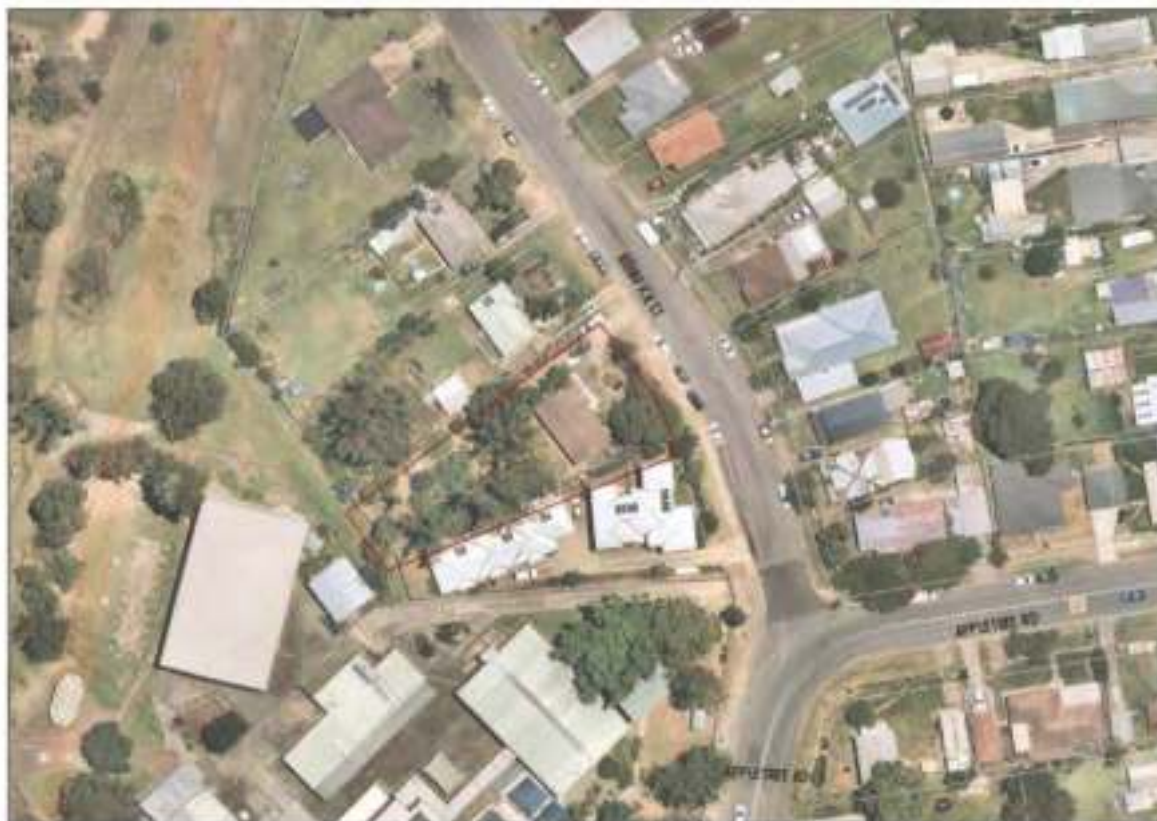
10 RENWICK STREET, WEST WALLSEND 2286

Conservation Area Contribution Level	Est. Construction Date	Previous studies and/or community input
Contributory 2	Early to late 20 th century (broad range)	No prior heritage assessments or research undertaken.
Assessment Text		Observed Modifications
<p>The scale (single-storey) and general style of the dwelling is consistent with that of the streetscape and wider HCA. Dwelling contributes positively to the streetscape and wider HCA, particularly in comparison to Non-Contributory buildings.</p> <p>The dwelling features appropriately proportioned and positioned fenestrations, an appropriate roof form (gabled or hipped) and other features consistent with the architectural character of the area (e.g. front verandah with timber or brick posts, timber detailing, corrugated metal roofing, etc). The contributory value of the dwelling is limited however by either:</p> <ul style="list-style-type: none"> • External modifications that have in some way obscured the style, scale or design intent of the building and have resulted in less physical integrity than Contributory 1 buildings. • Being a later dwelling constructed in an appropriate referential style, but comprising little to no fabric of intrinsic heritage significance. 		No modifications observed.

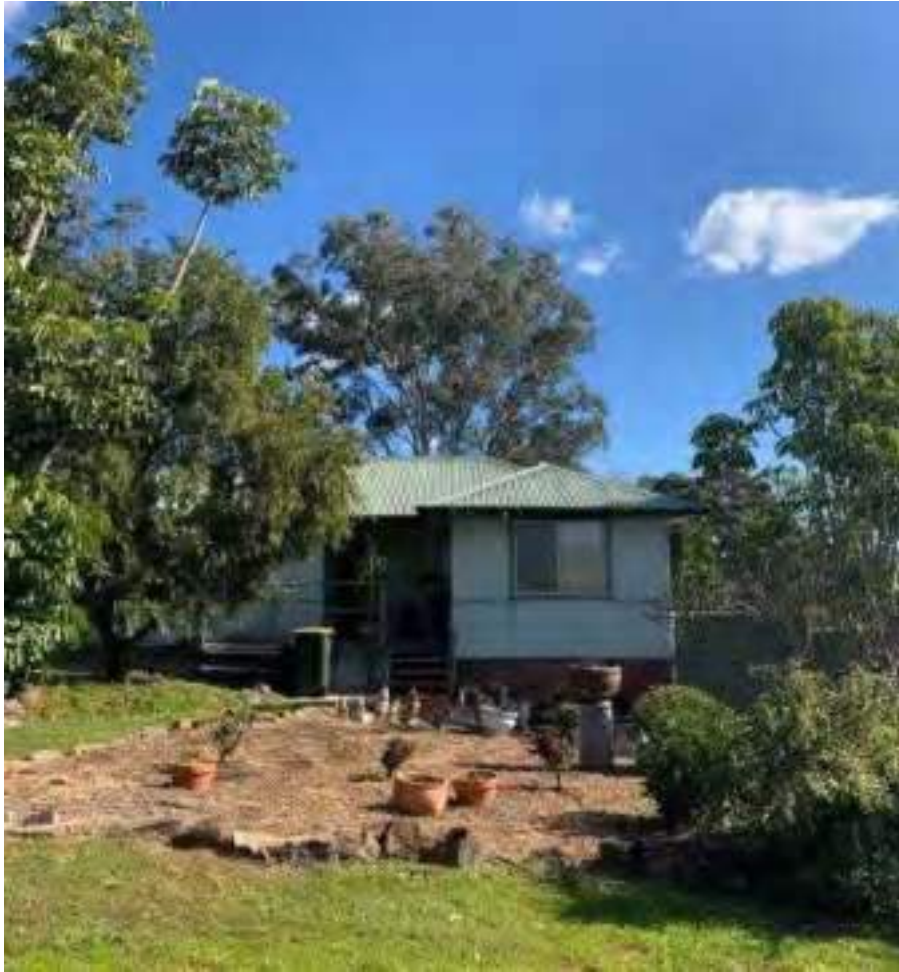
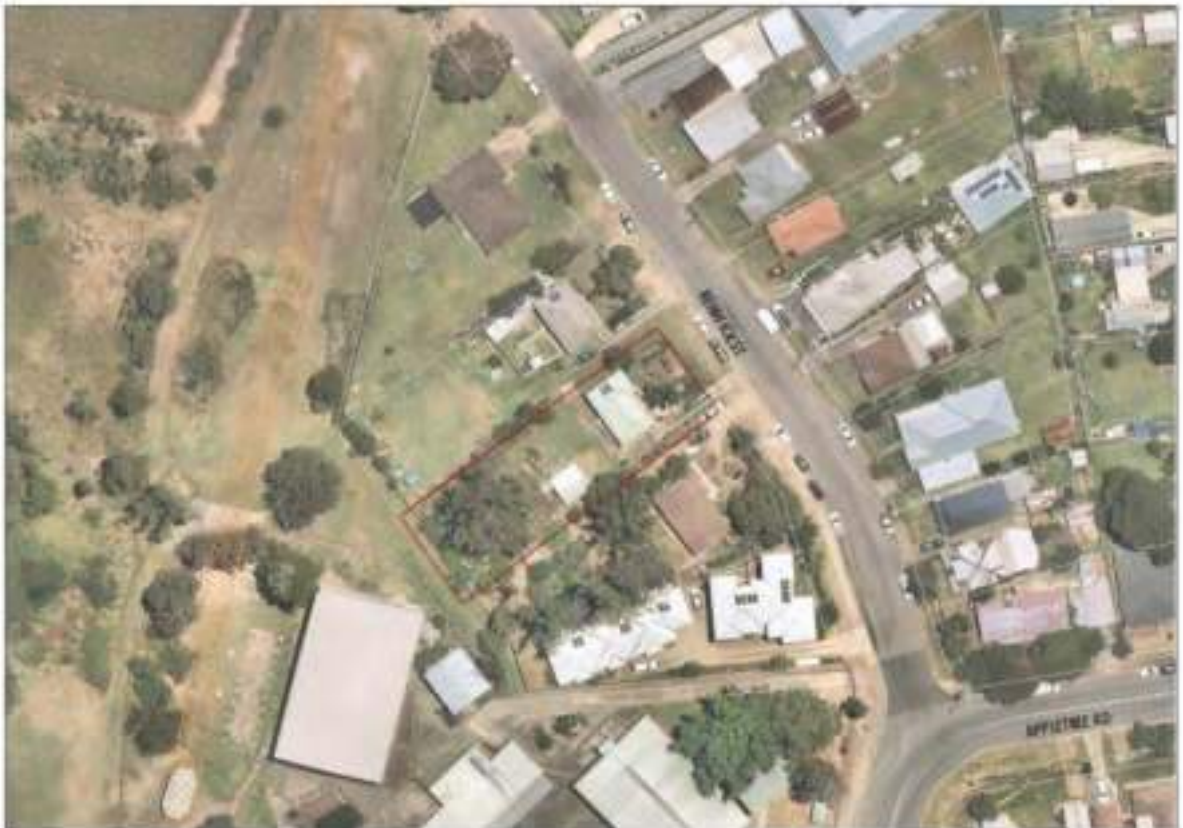
8 RENWICK STREET, WEST WALLSEND 2286

Conservation Area Contribution Level	Est. Construction Date	Previous studies and/or community input
Contributory 2	Early to late 20 th century (broad range)	No prior heritage assessments or research undertaken.
Assessment Text		Observed Modifications
<p>The scale (single-storey) and general style of the dwelling is consistent with that of the streetscape and wider HCA. Dwelling contributes positively to the streetscape and wider HCA, particularly in comparison to Non-Contributory buildings.</p> <p>The dwelling features appropriately proportioned and positioned fenestrations, an appropriate roof form (gabled or hipped) and other features consistent with the architectural character of the area (e.g. front verandah with timber or brick posts, timber detailing, corrugated metal roofing, etc). The contributory value of the dwelling is limited however by either:</p> <ul style="list-style-type: none"> • External modifications that have in some way obscured the style, scale or design intent of the building and have resulted in less physical integrity than Contributory 1 buildings. • Being a later dwelling constructed in an appropriate referential style, but comprising little to no fabric of intrinsic heritage significance. 		No modifications observed.

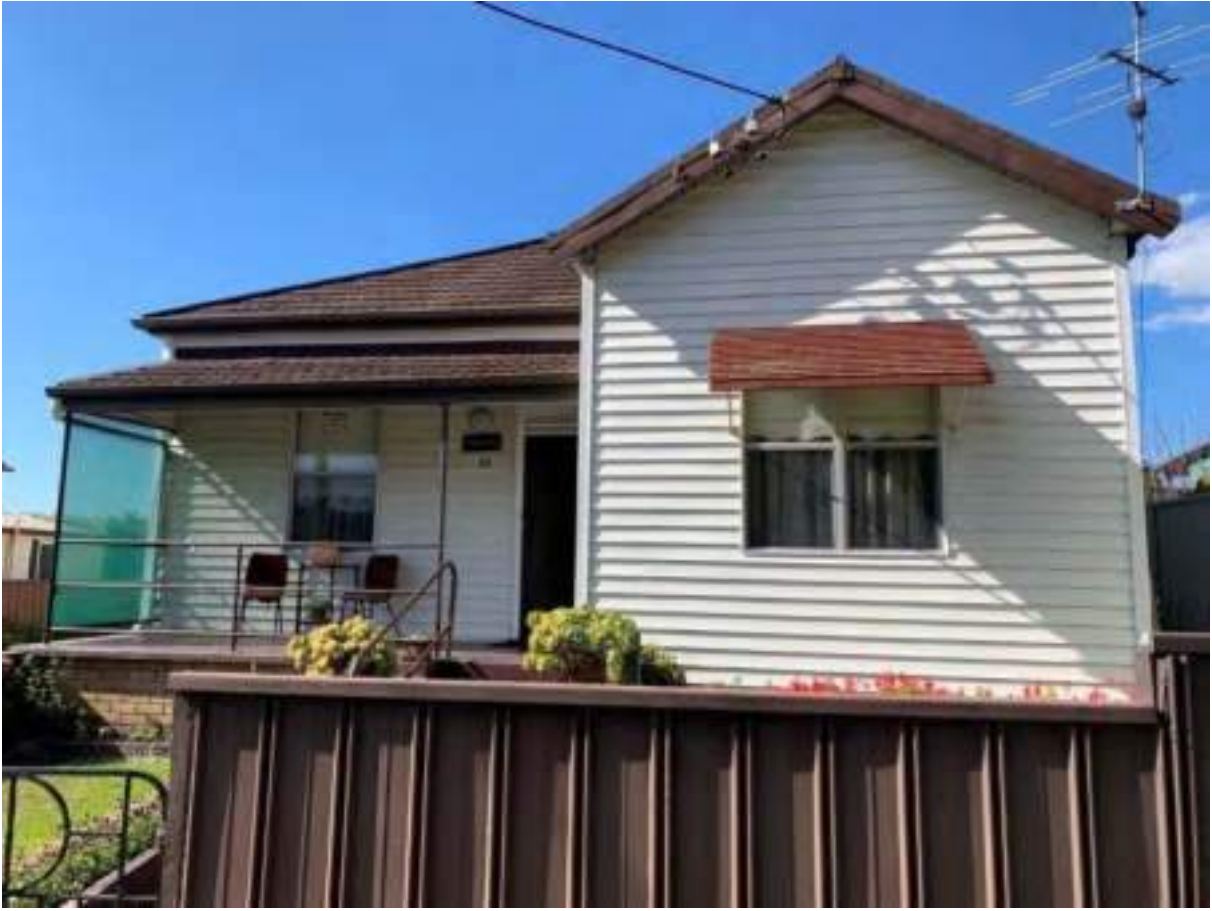
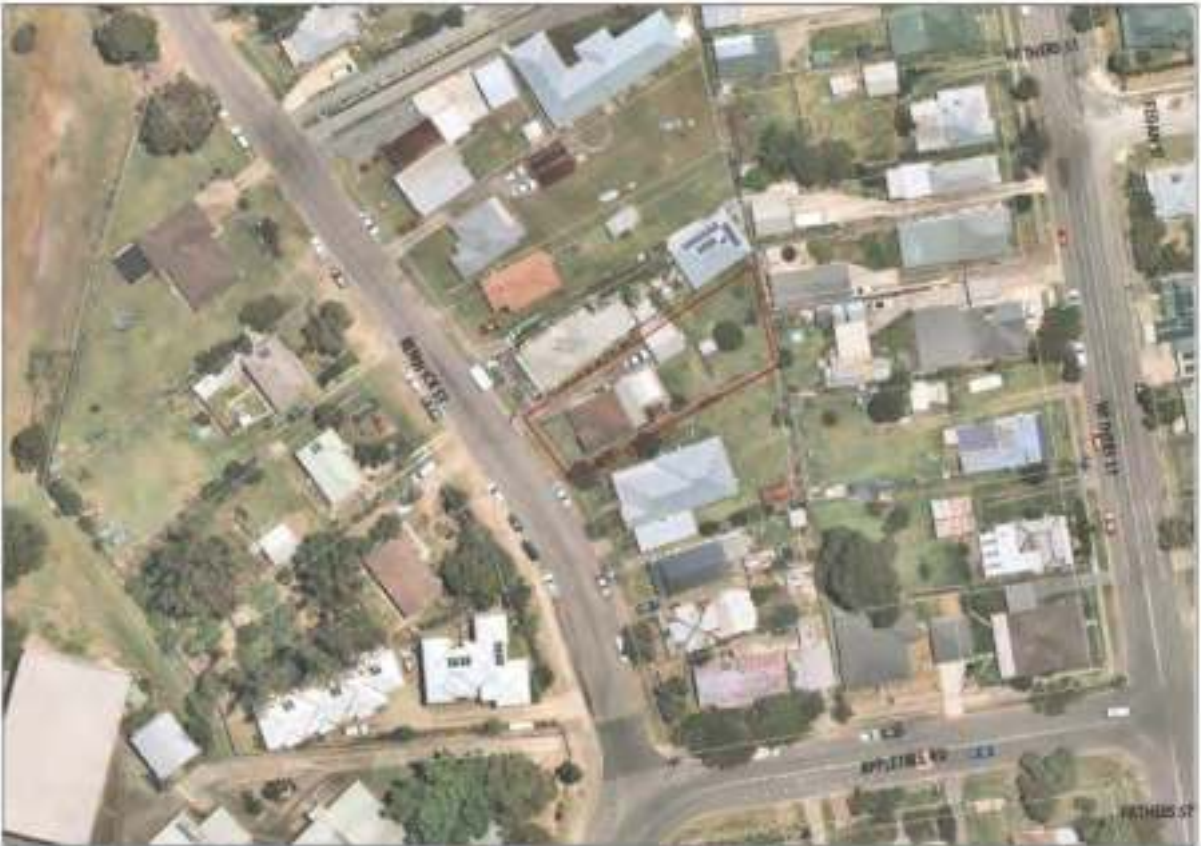
13 RENWICK STREET, WEST WALLSEND 2286

Conservation Area Contribution Level	Est. Construction Date	Previous studies and/or community input
Contributory 2	Early to late 20 th century (broad range)	No prior heritage assessments or research undertaken.
Assessment Text		Observed Modifications
<p>The scale (single-storey) and general style of the dwelling is consistent with that of the streetscape and wider HCA. Dwelling contributes positively to the streetscape and wider HCA, particularly in comparison to Non-Contributory buildings.</p> <p>The dwelling features appropriately proportioned and positioned fenestrations, an appropriate roof form (gabled or hipped) and other features consistent with the architectural character of the area (e.g. front verandah with timber or brick posts, timber detailing, corrugated metal roofing, etc). The contributory value of the dwelling is limited however by either:</p> <ul style="list-style-type: none"> • External modifications that have in some way obscured the style, scale or design intent of the building and have resulted in less physical integrity than Contributory 1 buildings. • Being a later dwelling constructed in an appropriate referential style, but comprising little to no fabric of intrinsic heritage significance. 		<p>The metal balustrade partially enclosing the veranda is a dated modification, likely being installed shortly after the dwellings construction.</p> <p>The green mesh screen enclosing the veranda space is a contemporary addition.</p>

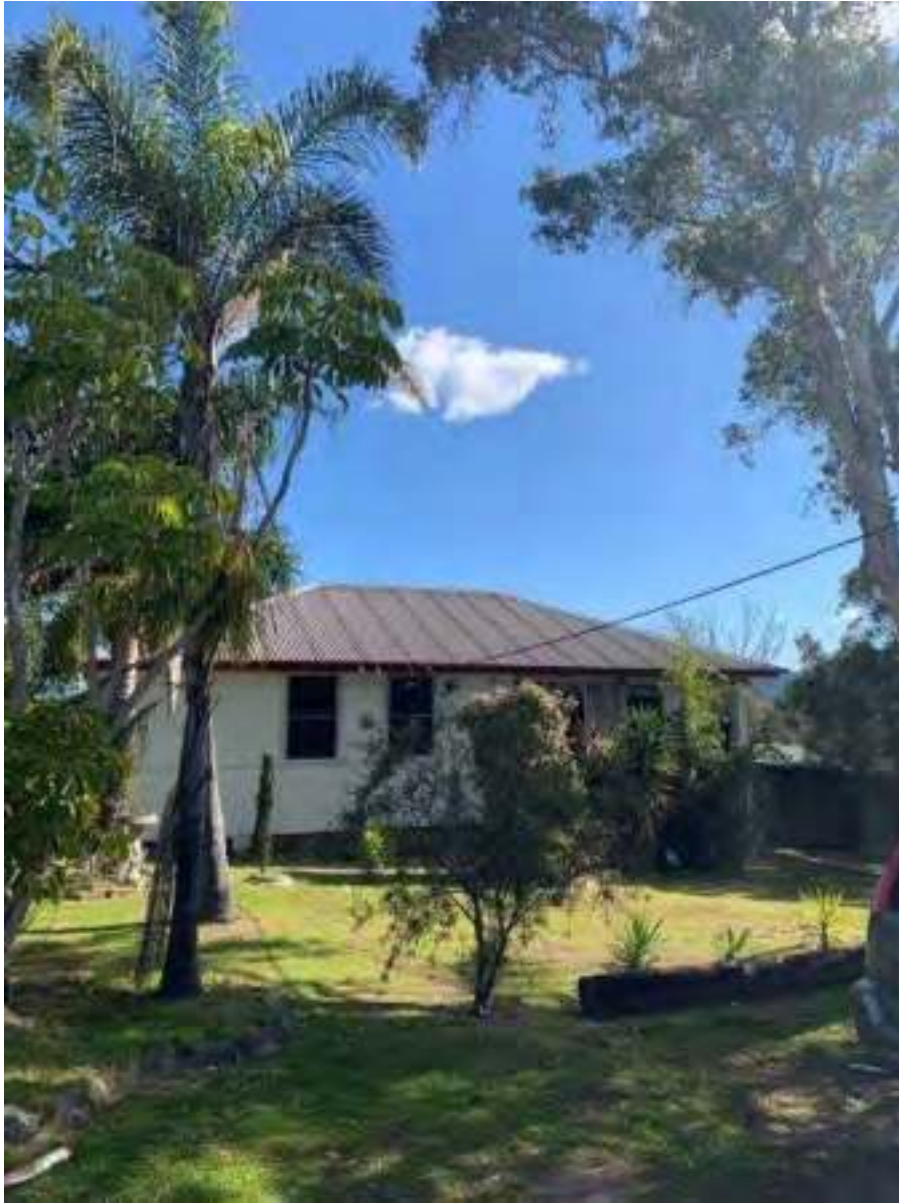
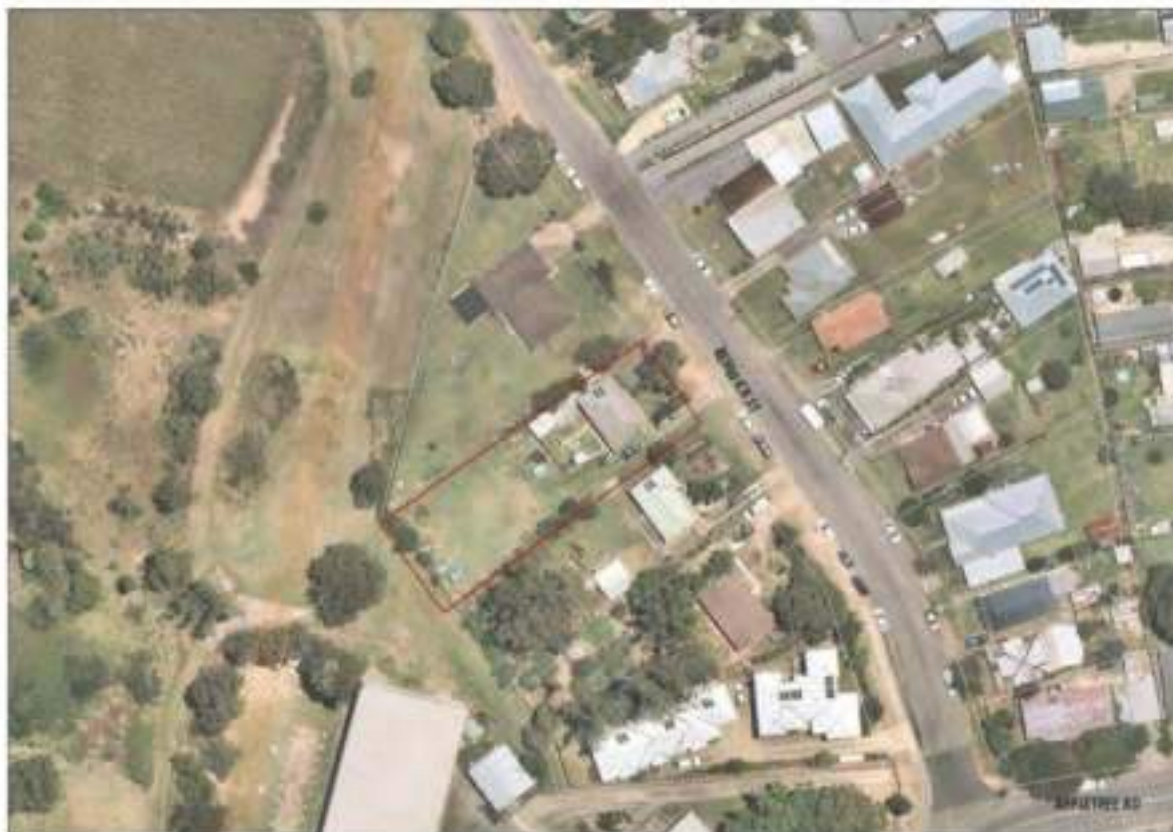
6 RENWICK STREET, WEST WALLSEND 2286

Conservation Area Contribution Level	Est. Construction Date	Previous studies and/or community input
Contributory 2	Early to late 20 th century (broad range)	No prior heritage assessments or research undertaken.
Assessment Text		Observed Modifications
<p>The scale (single-storey) and general style of the dwelling is consistent with that of the streetscape and wider HCA. Dwelling contributes positively to the streetscape and wider HCA, particularly in comparison to Non-Contributory buildings.</p> <p>The dwelling features appropriately proportioned and positioned fenestrations, an appropriate roof form (gabled or hipped) and other features consistent with the architectural character of the area (e.g. front verandah with timber or brick posts, timber detailing, corrugated metal roofing, etc). The contributory value of the dwelling is limited however by either:</p> <ul style="list-style-type: none"> • External modifications that have in some way obscured the style, scale or design intent of the building and have resulted in less physical integrity than Contributory 1 buildings. • Being a later dwelling constructed in an appropriate referential style, but comprising little to no fabric of intrinsic heritage significance. 		No modifications observed.

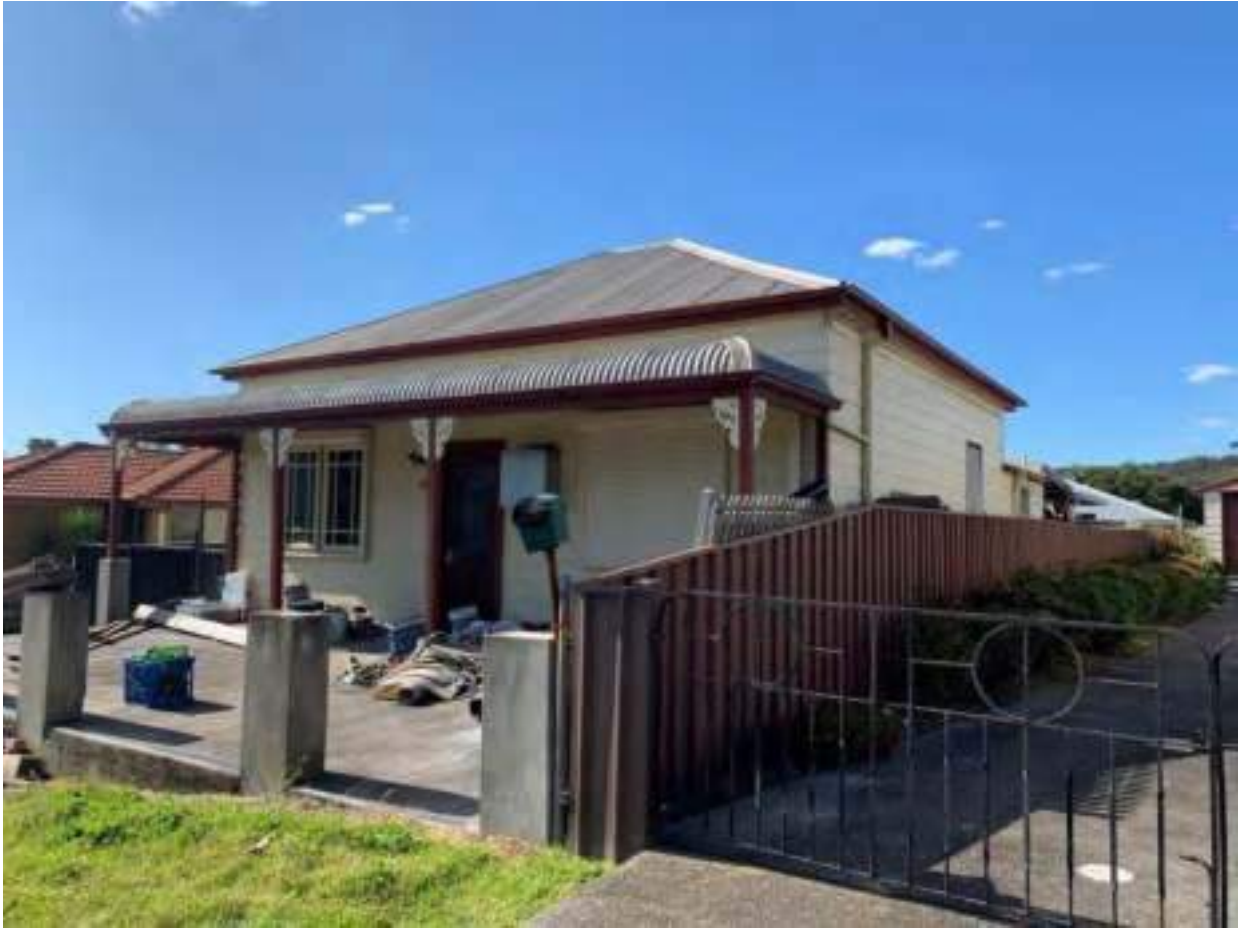
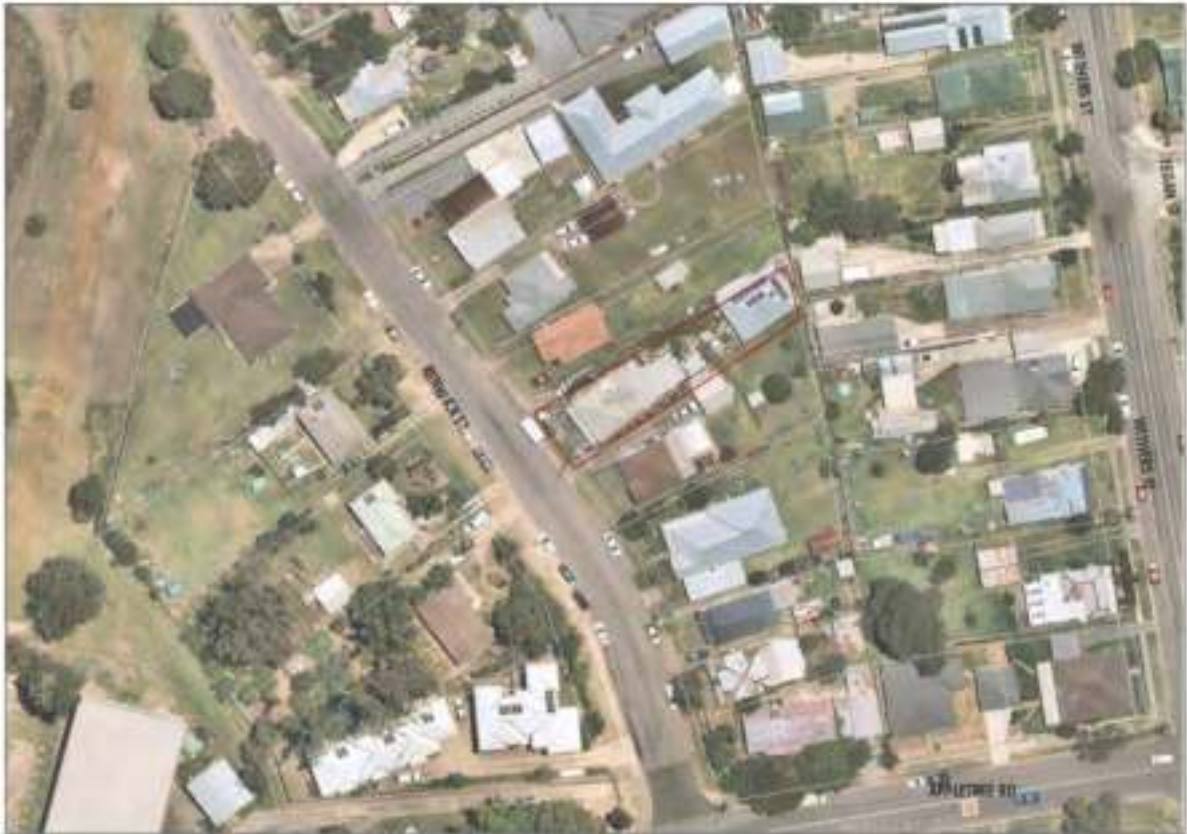
11 RENWICK STREET, WEST WALLSEND 2286

Conservation Area Contribution Level	Est. Construction Date	Previous studies and/or community input
Contributory 2	1900–1930	No prior heritage assessments or research undertaken.
Assessment Text		Observed Modifications
<p>The scale (single-storey) and general style of the dwelling is consistent with that of the streetscape and wider HCA. Dwelling contributes positively to the streetscape and wider HCA, particularly in comparison to Non-Contributory buildings.</p> <p>The dwelling features appropriately proportioned and positioned fenestrations, an appropriate roof form (gabled or hipped) and other features consistent with the architectural character of the area (e.g. front verandah with timber or brick posts, timber detailing, corrugated metal roofing, etc). The contributory value of the dwelling is limited however by either:</p> <ul style="list-style-type: none"> • External modifications that have in some way obscured the style, scale or design intent of the building and have resulted in less physical integrity than Contributory 1 buildings. • Being a later dwelling constructed in an appropriate referential style, but comprising little to no fabric of intrinsic heritage significance. 		<p>A concrete fore-garden veranda has been constructed, juxtaposing with the heritage features of the dwelling.</p> <p>The decorative details, including the bracketing and leadlight windows are likely a contemporary replication of an original design.</p> <p>Metal roller shutters have been installed a top the façade windows.</p>

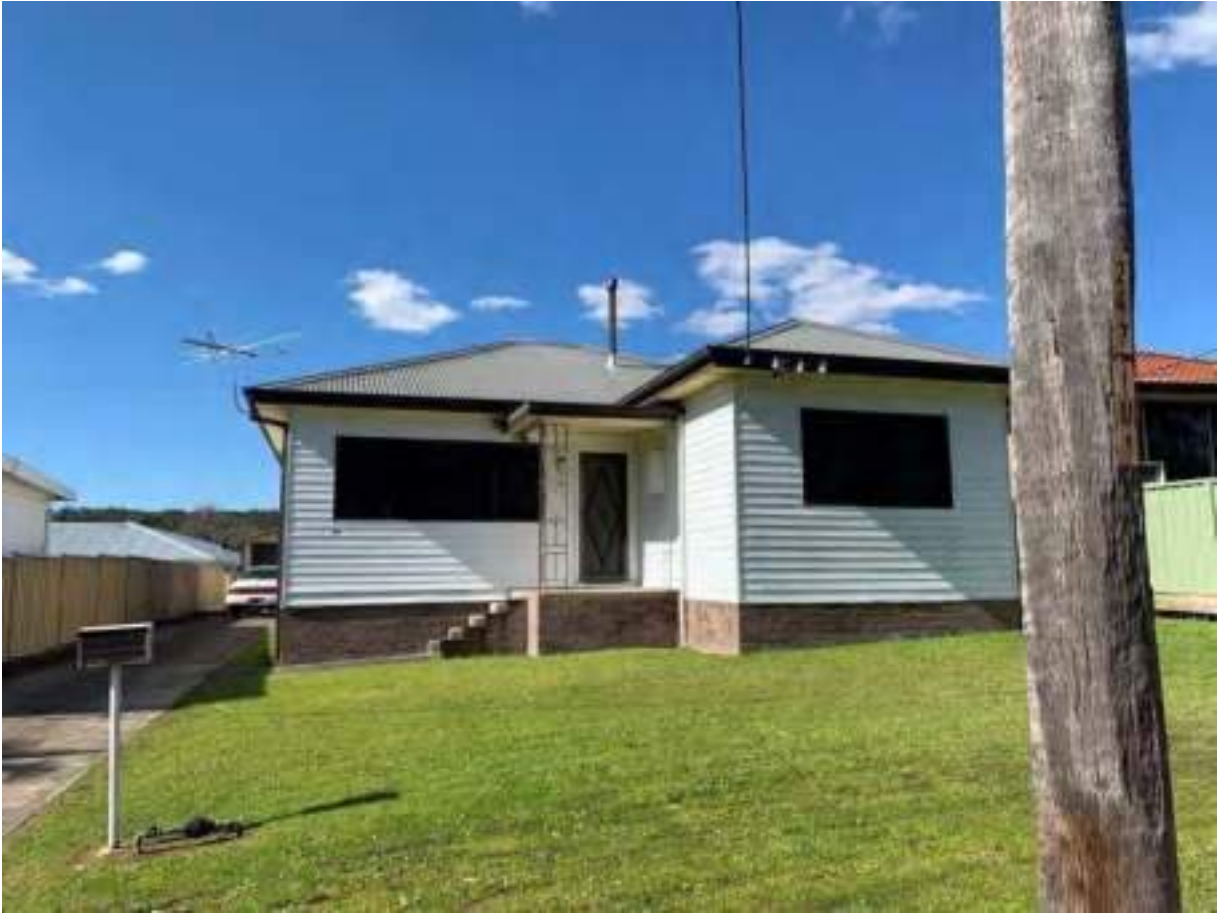
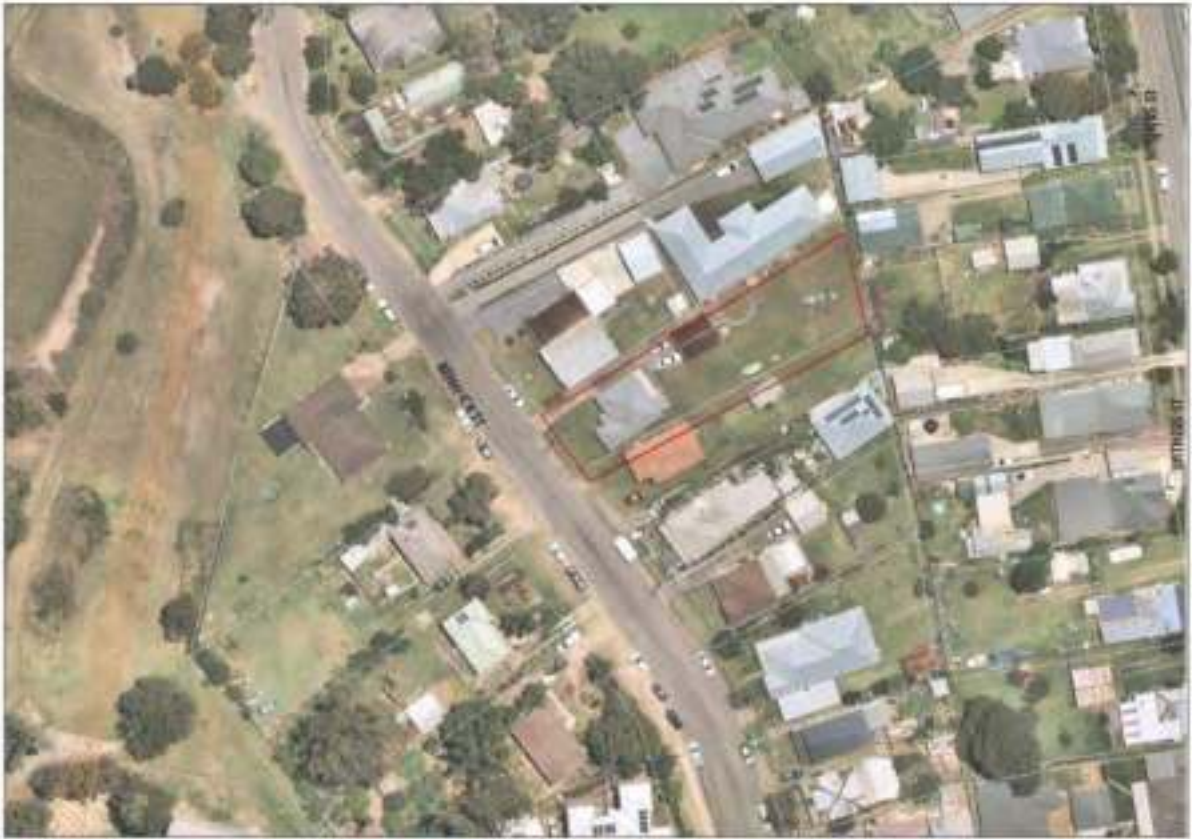
9 RENWICK STREET, WEST WALLSEND 2286

Conservation Area Contribution Level	Est. Construction Date	Previous studies and/or community input
Contributory 2	Early to late 20 th century (broad range)	No prior heritage assessments or research undertaken.
Assessment Text		Observed Modifications
<p>The scale (single-storey) and general style of the dwelling is consistent with that of the streetscape and wider HCA. Dwelling contributes positively to the streetscape and wider HCA, particularly in comparison to Non-Contributory buildings.</p> <p>The dwelling features appropriately proportioned and positioned fenestrations, an appropriate roof form (gabled or hipped) and other features consistent with the architectural character of the area (e.g. front verandah with timber or brick posts, timber detailing, corrugated metal roofing, etc). The contributory value of the dwelling is limited however by either:</p> <ul style="list-style-type: none"> • External modifications that have in some way obscured the style, scale or design intent of the building and have resulted in less physical integrity than Contributory 1 buildings. • Being a later dwelling constructed in an appropriate referential style, but comprising little to no fabric of intrinsic heritage significance. 		No modifications observed.
