APPENDIX 2

Building Assessment Sheets (Inventory Sheets)

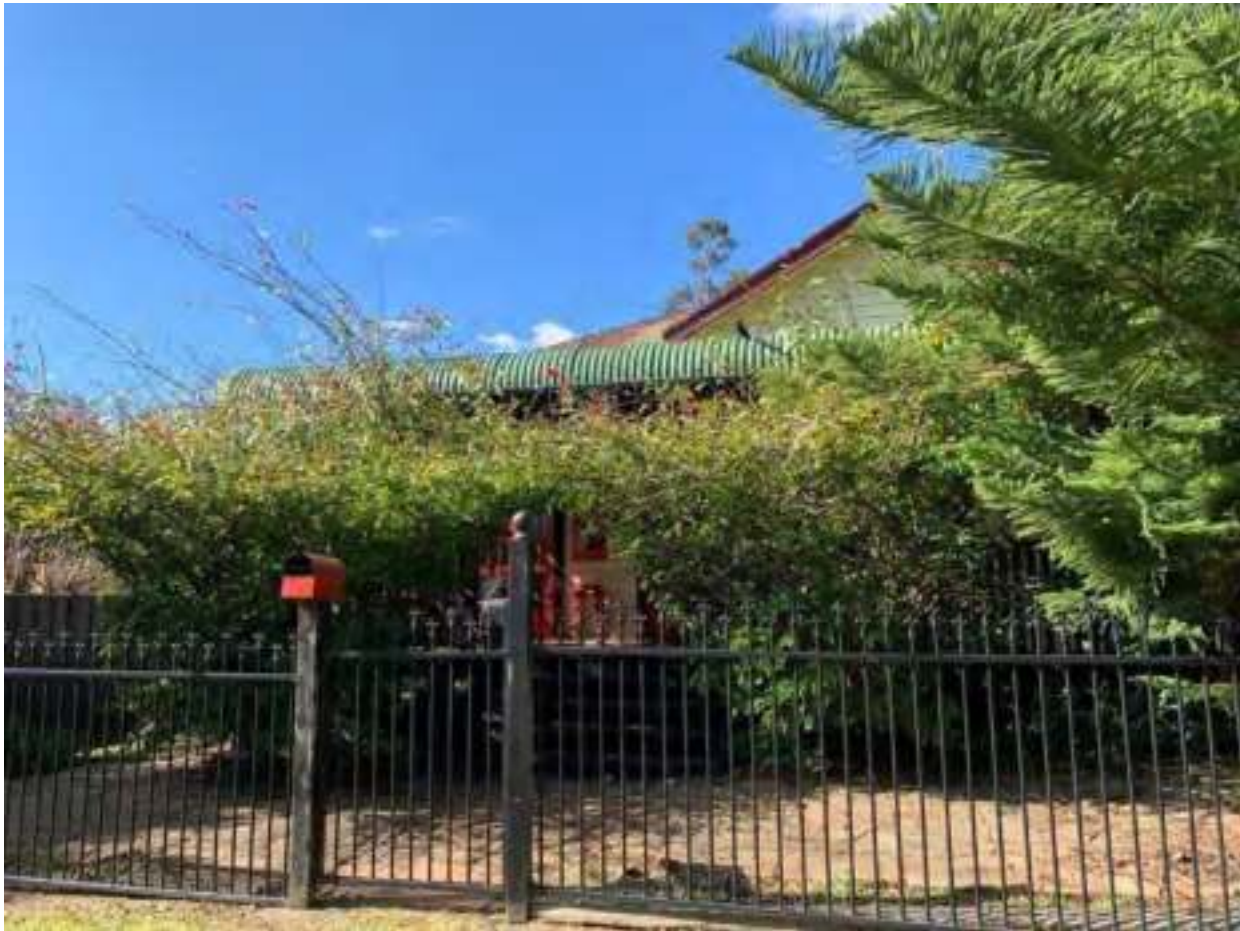
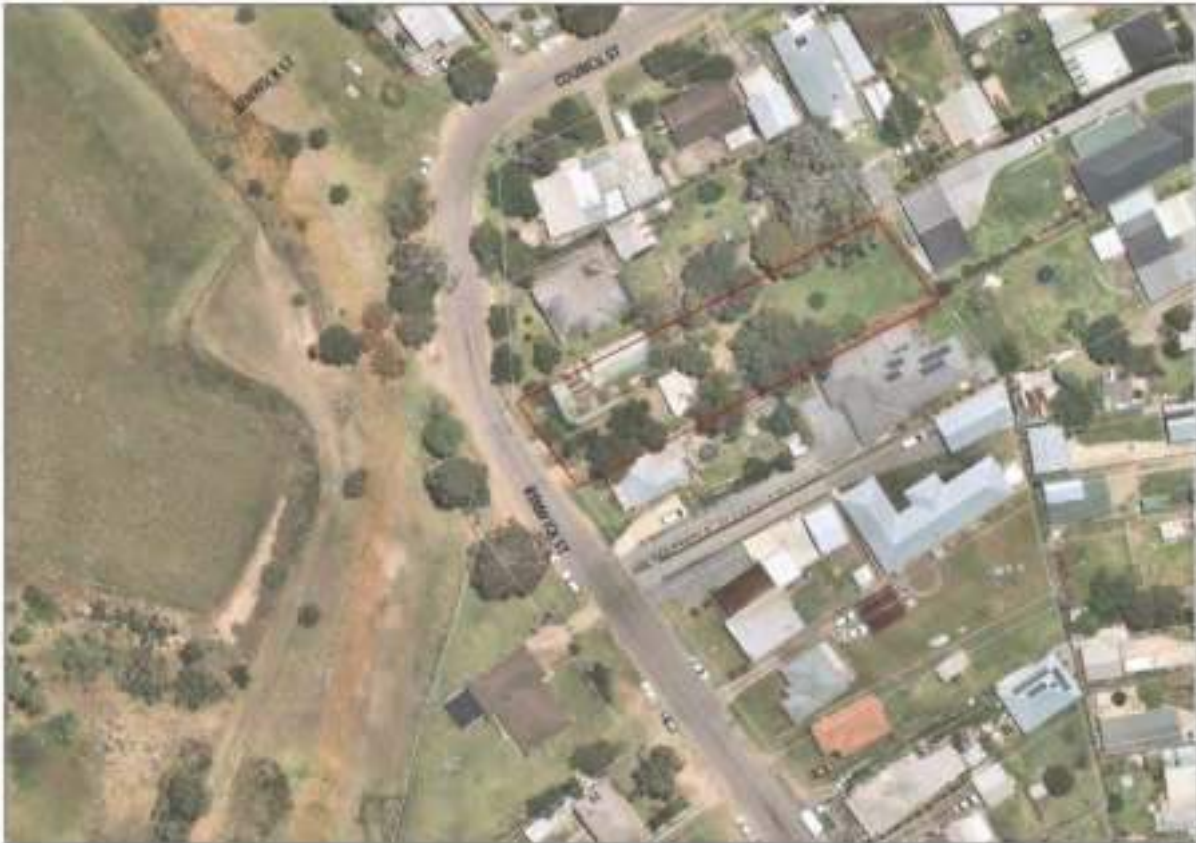
3 RENWICK STREET, WEST WALLSEND 2286

Conservation Area Contribution Level	Est. Construction Date	Previous studies and/or community input
Contributory 2	Early to late 20 th century (broad range)	No prior heritage assessments or research undertaken.
Assessment Text		Observed Modifications
<p>The scale (single-storey) and general style of the dwelling is consistent with that of the streetscape and wider HCA. Dwelling contributes positively to the streetscape and wider HCA, particularly in comparison to Non-Contributory buildings.</p> <p>The dwelling features appropriately proportioned and positioned fenestrations, an appropriate roof form (gabled or hipped) and other features consistent with the architectural character of the area (e.g. front verandah with timber or brick posts, timber detailing, corrugated metal roofing, etc). The contributory value of the dwelling is limited however by either:</p> <ul style="list-style-type: none"> • External modifications that have in some way obscured the style, scale or design intent of the building and have resulted in less physical integrity than Contributory 1 buildings. • Being a later dwelling constructed in an appropriate referential style, but comprising little to no fabric of intrinsic heritage significance. 		<p>The veranda has been partially enclosed by canvas/mesh screens.</p> <p>The property is partially obscured by vegetation.</p>

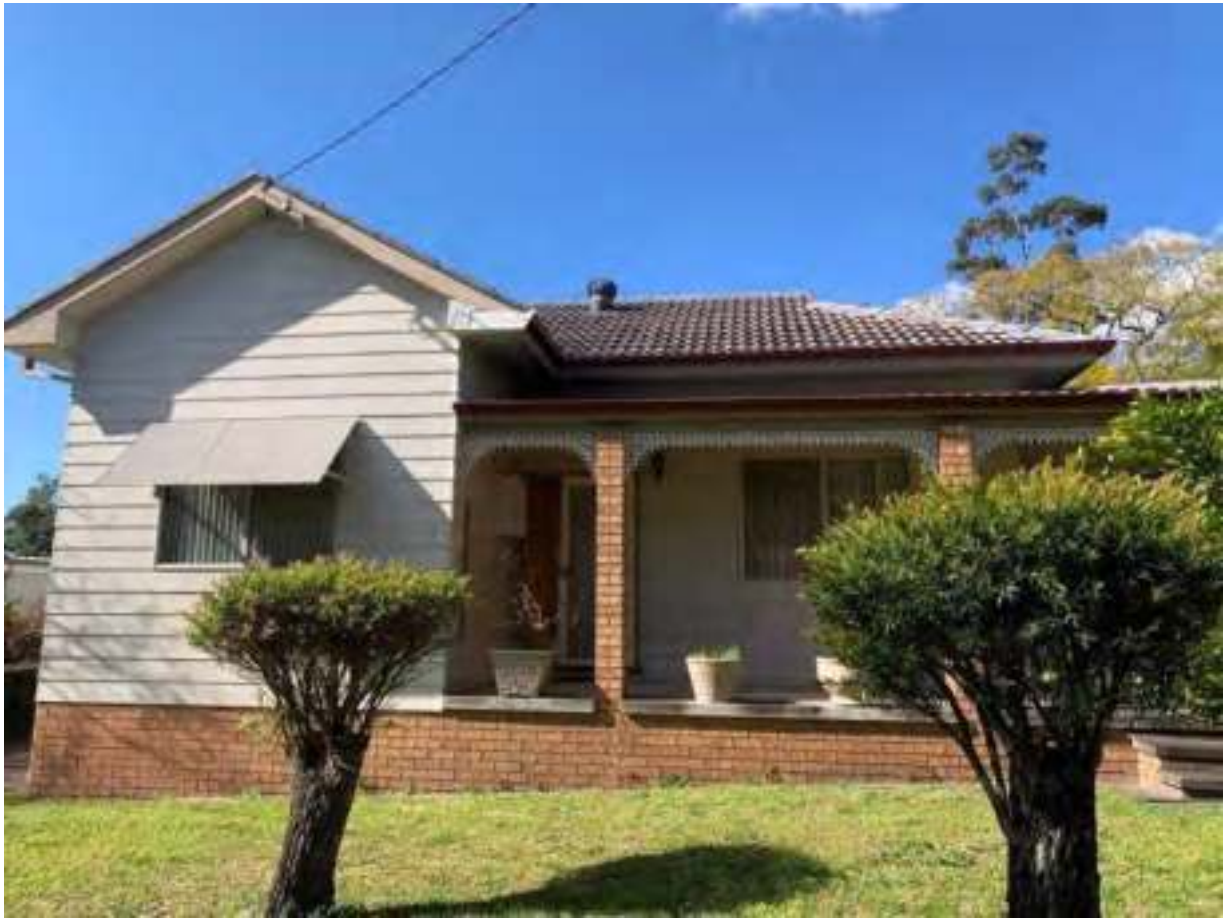
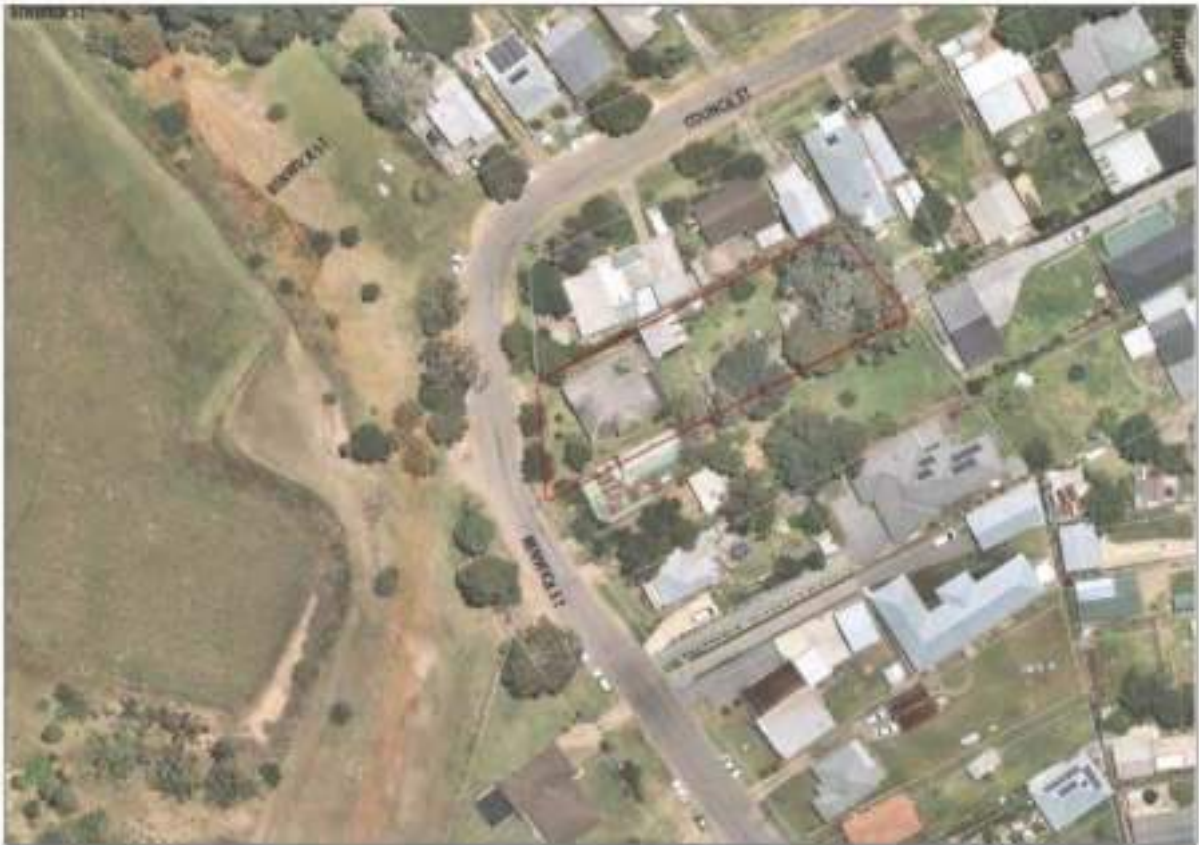
1 RENWICK STREET, WEST WALLSEND 2286

Conservation Area Contribution Level	Est. Construction Date	Previous studies and/or community input
Contributory 2	1900-1930	No prior heritage assessments or research undertaken.
Assessment Text		Observed Modifications
<p>The scale (single-storey) and general style of the dwelling is consistent with that of the streetscape and wider HCA. Dwelling contributes positively to the streetscape and wider HCA, particularly in comparison to Non-Contributory buildings.</p> <p>The dwelling features appropriately proportioned and positioned fenestrations, an appropriate roof form (gabled or hipped) and other features consistent with the architectural character of the area (e.g. front verandah with timber or brick posts, timber detailing, corrugated metal roofing, etc). The contributory value of the dwelling is limited however by either:</p> <ul style="list-style-type: none"> • External modifications that have in some way obscured the style, scale or design intent of the building and have resulted in less physical integrity than Contributory 1 buildings. • Being a later dwelling constructed in an appropriate referential style, but comprising little to no fabric of intrinsic heritage significance. 		<p>The decorative cast iron valance is a contemporary addition, likely replicating an original design.</p> <p>The brickwork pillars are a contemporary addition, likely replacing an original timber design.</p> <p>The concrete tiled roof likely replaced an original Colourbond/iron roof.</p>

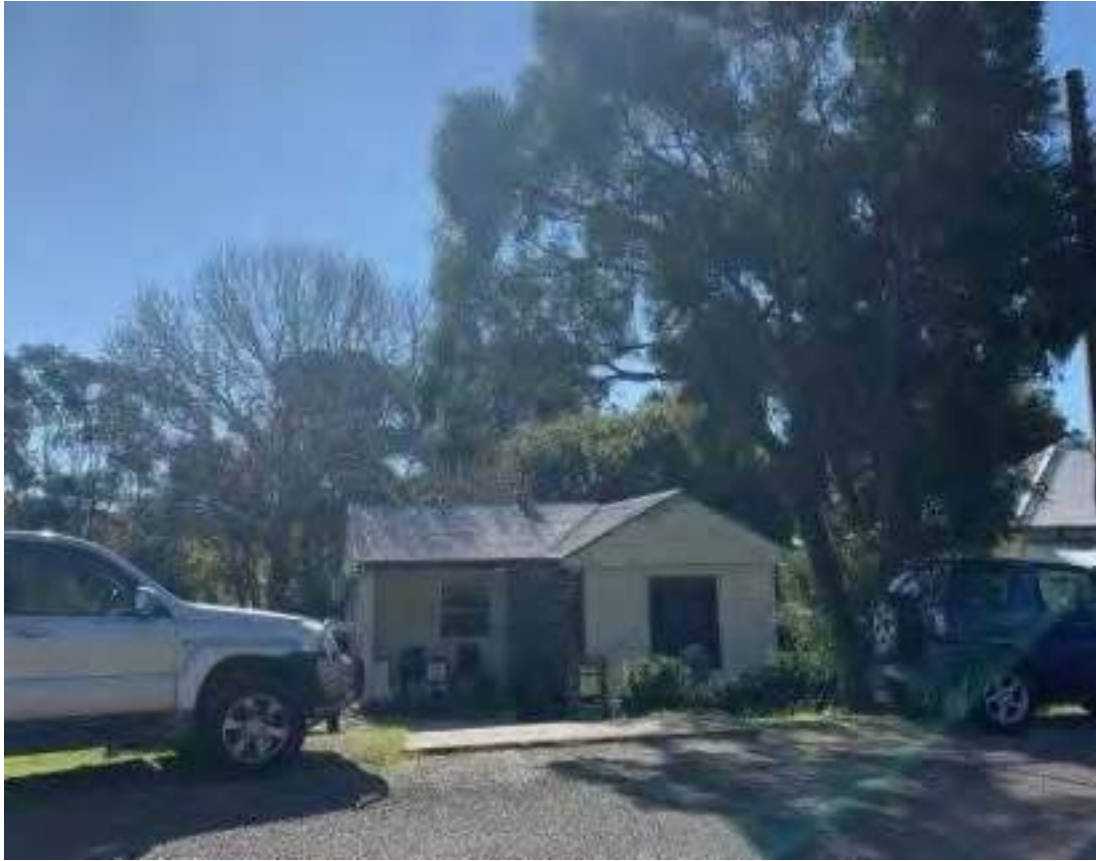
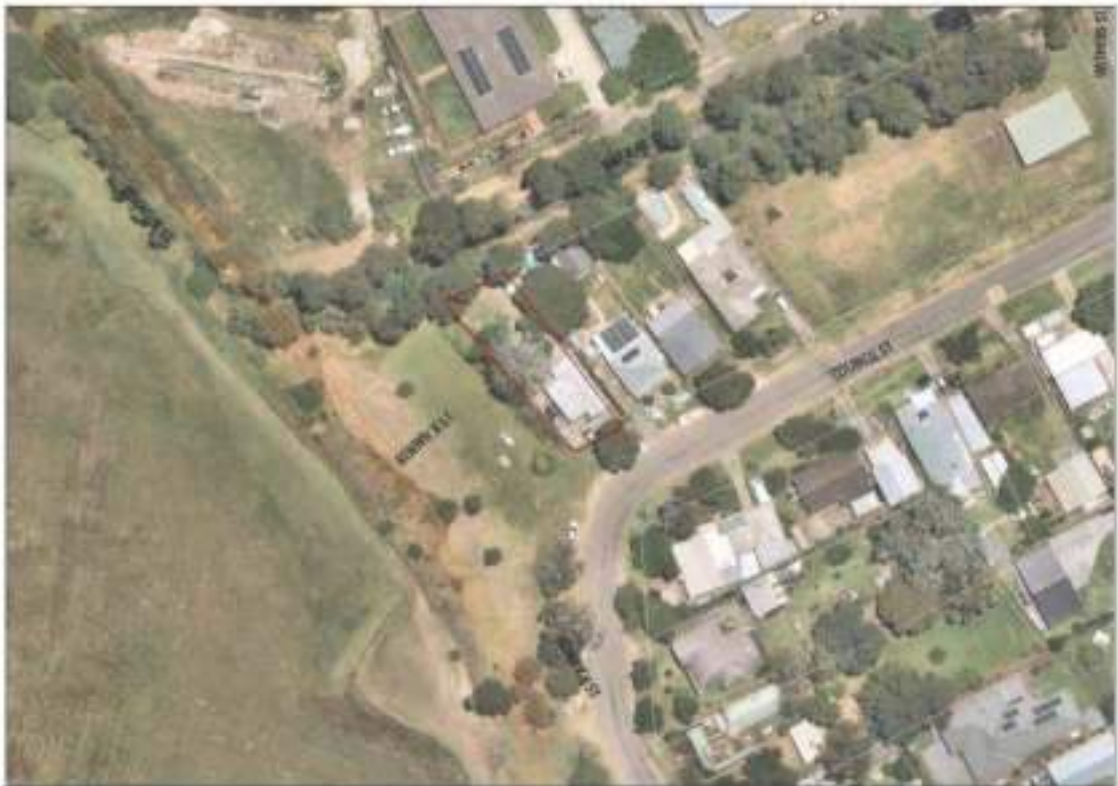
7 COUNCIL STREET, WEST WALLSEND 2286

Conservation Area Contribution Level	Est. Construction Date	Previous studies and/or community input
Contributory 2	Early to late 20 th century (broad range)	No prior heritage assessments or research undertaken.
Assessment Text		Observed Modifications
<p>The scale (single-storey) and general style of the dwelling is consistent with that of the streetscape and wider HCA. Dwelling contributes positively to the streetscape and wider HCA, particularly in comparison to Non-Contributory buildings.</p> <p>The dwelling features appropriately proportioned and positioned fenestrations, an appropriate roof form (gabled or hipped) and other features consistent with the architectural character of the area (e.g. front verandah with timber or brick posts, timber detailing, corrugated metal roofing, etc). The contributory value of the dwelling is limited however by either:</p> <ul style="list-style-type: none"> • External modifications that have in some way obscured the style, scale or design intent of the building and have resulted in less physical integrity than Contributory 1 buildings. • Being a later dwelling constructed in an appropriate referential style, but comprising little to no fabric of intrinsic heritage significance. 		No modifications observed.

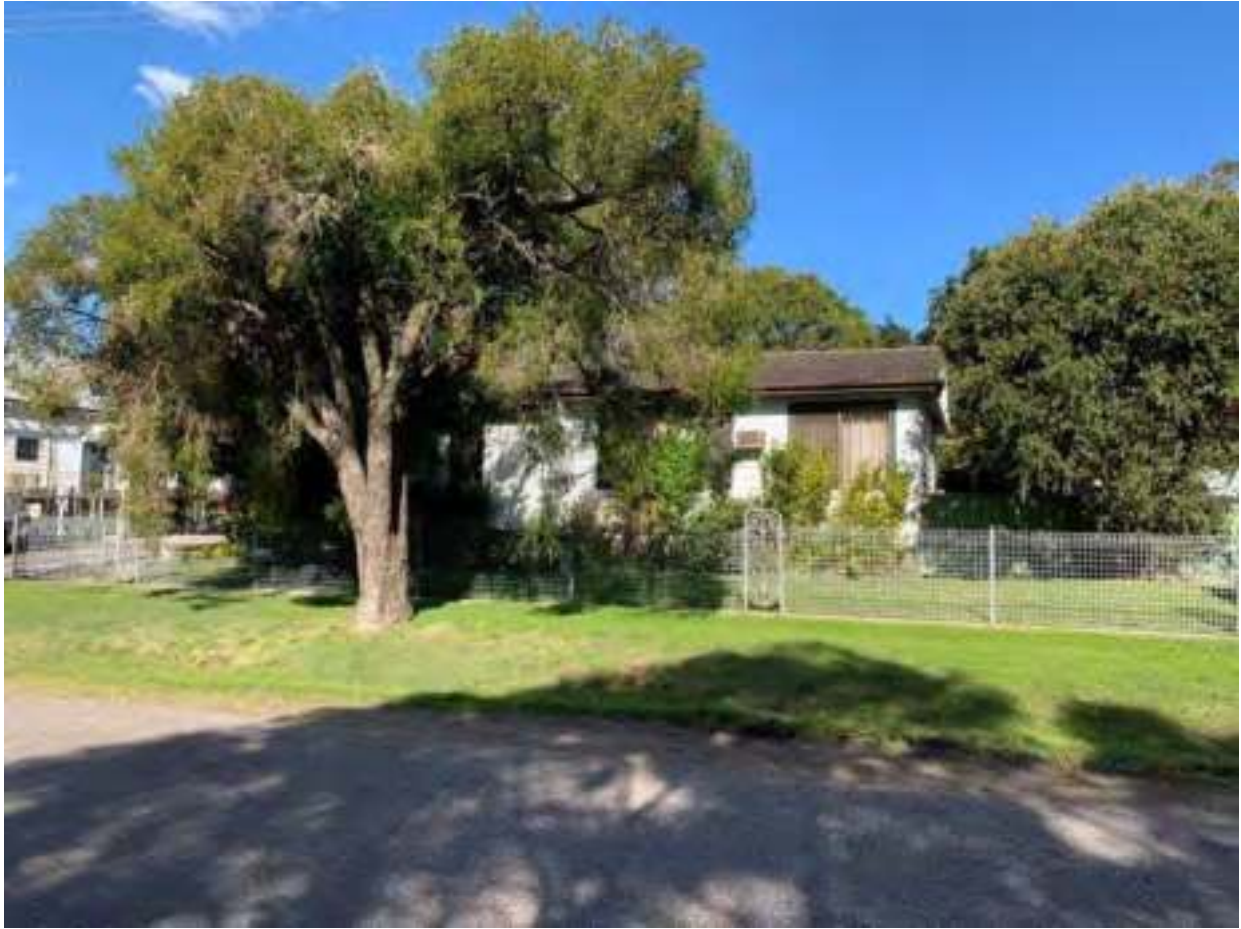
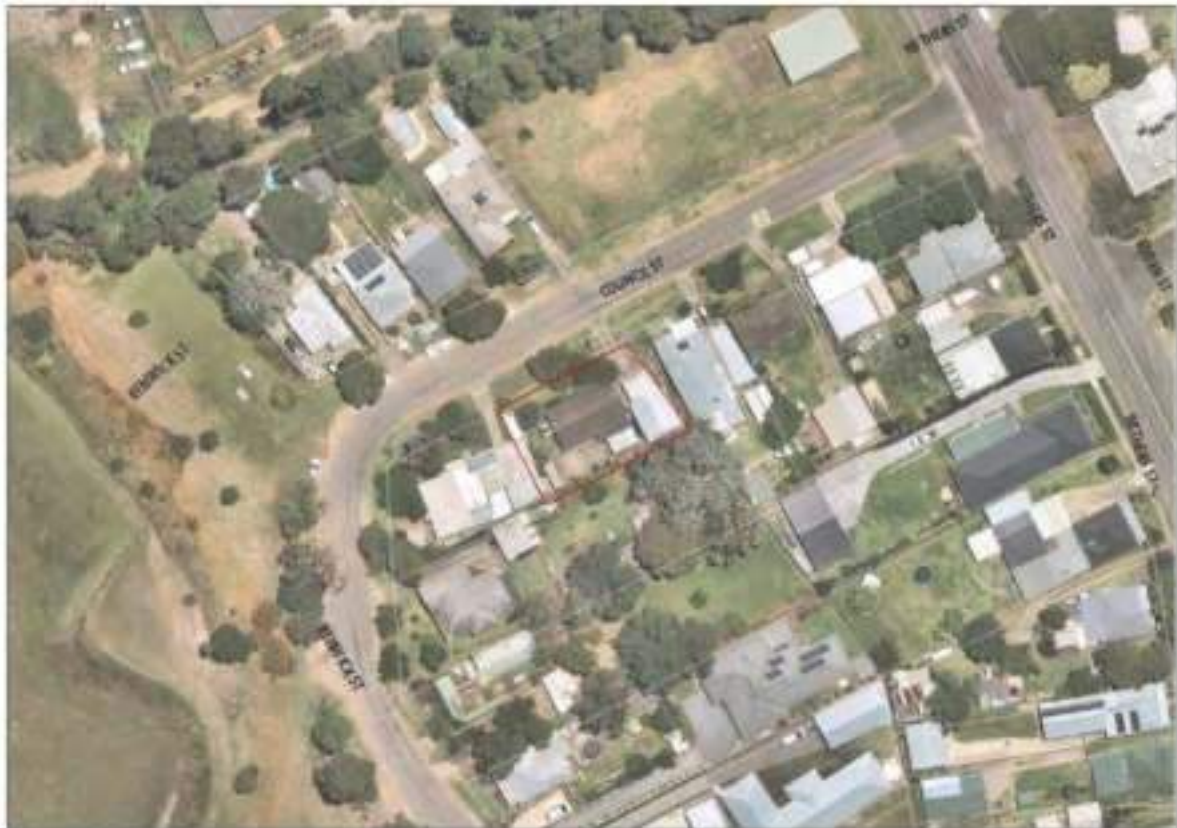
4 COUNCIL STREET, WEST WALLSEND 2286

Conservation Area Contribution Level	Est. Construction Date	Previous studies and/or community input
Contributory 2	Early to late 20 th century (broad range)	No prior heritage assessments or research undertaken.
Assessment Text		Observed Modifications
<p>The scale (single-storey) and general style of the dwelling is consistent with that of the streetscape and wider HCA. Dwelling contributes positively to the streetscape and wider HCA, particularly in comparison to Non-Contributory buildings.</p> <p>The dwelling features appropriately proportioned and positioned fenestrations, an appropriate roof form (gabled or hipped) and other features consistent with the architectural character of the area (e.g. front verandah with timber or brick posts, timber detailing, corrugated metal roofing, etc). The contributory value of the dwelling is limited however by either:</p> <ul style="list-style-type: none"> • External modifications that have in some way obscured the style, scale or design intent of the building and have resulted in less physical integrity than Contributory 1 buildings. • Being a later dwelling constructed in an appropriate referential style, but comprising little to no fabric of intrinsic heritage significance. 		No modifications observed.

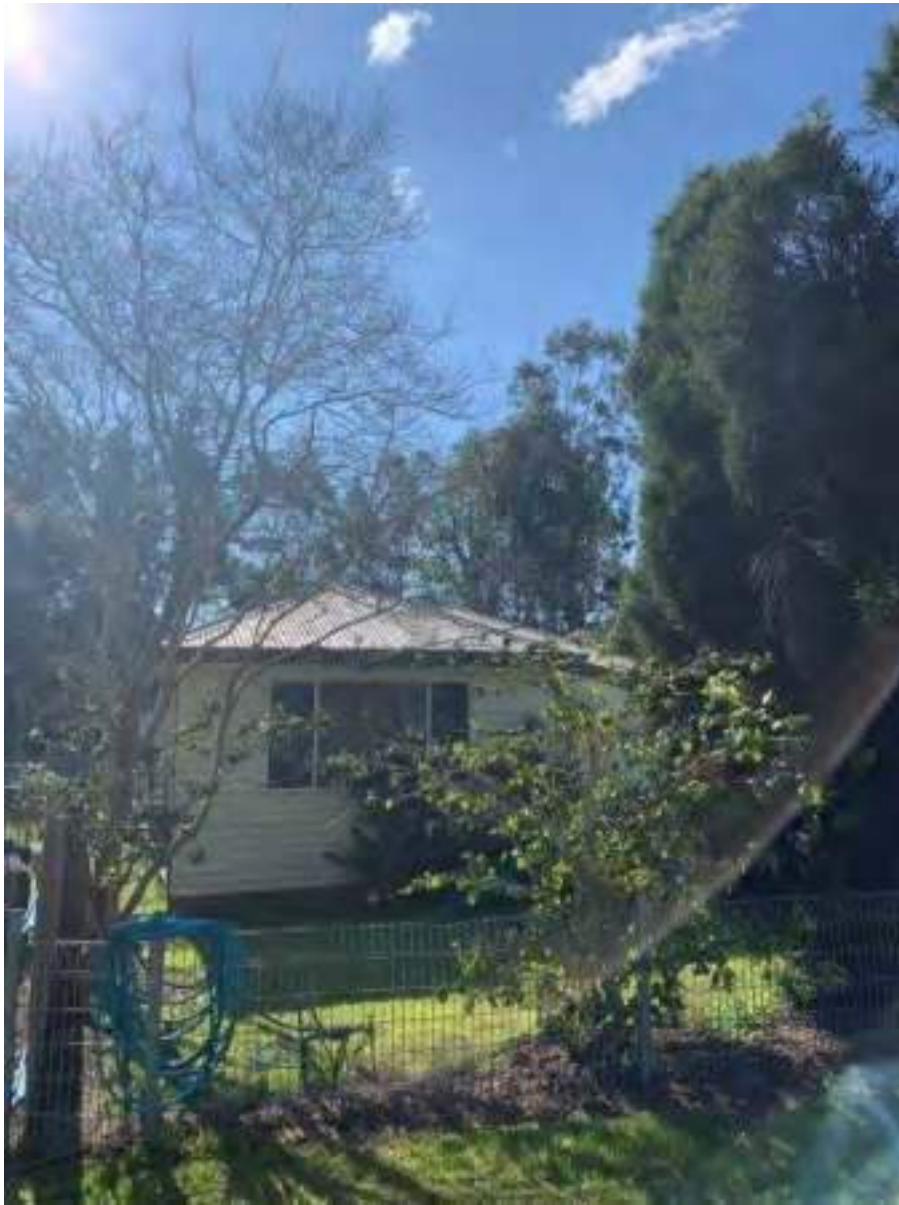
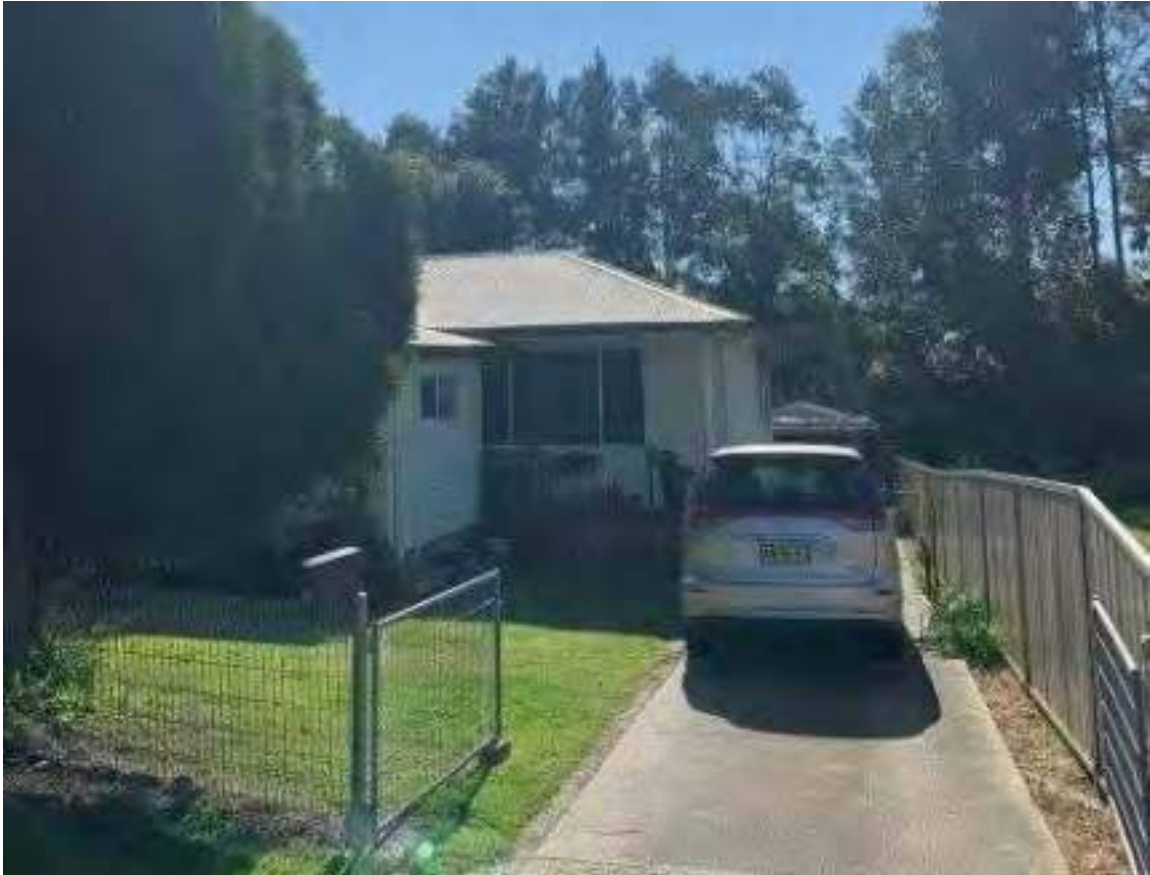
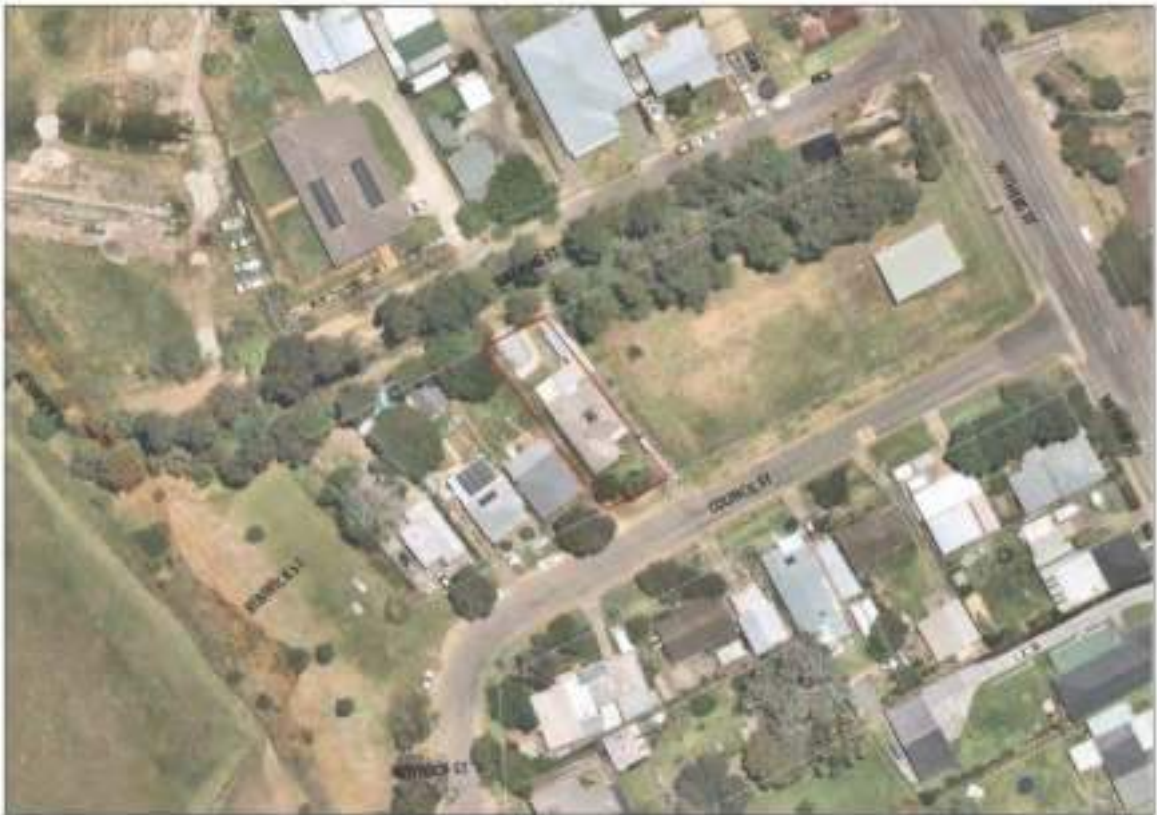
1 COUNCIL STREET, WEST WALLSEND 2286

Conservation Area Contribution Level	Est. Construction Date	Previous studies and/or community input
Contributory 2	Early to late 20 th century (broad range)	No prior heritage assessments or research undertaken.
Assessment Text		Observed Modifications
<p>The scale (single-storey) and general style of the dwelling is consistent with that of the streetscape and wider HCA. Dwelling contributes positively to the streetscape and wider HCA, particularly in comparison to Non-Contributory buildings.</p> <p>The dwelling features appropriately proportioned and positioned fenestrations, an appropriate roof form (gabled or hipped) and other features consistent with the architectural character of the area (e.g. front verandah with timber or brick posts, timber detailing, corrugated metal roofing, etc). The contributory value of the dwelling is limited however by either:</p> <ul style="list-style-type: none"> • External modifications that have in some way obscured the style, scale or design intent of the building and have resulted in less physical integrity than Contributory 1 buildings. • Being a later dwelling constructed in an appropriate referential style, but comprising little to no fabric of intrinsic heritage significance. 		No modifications observed.

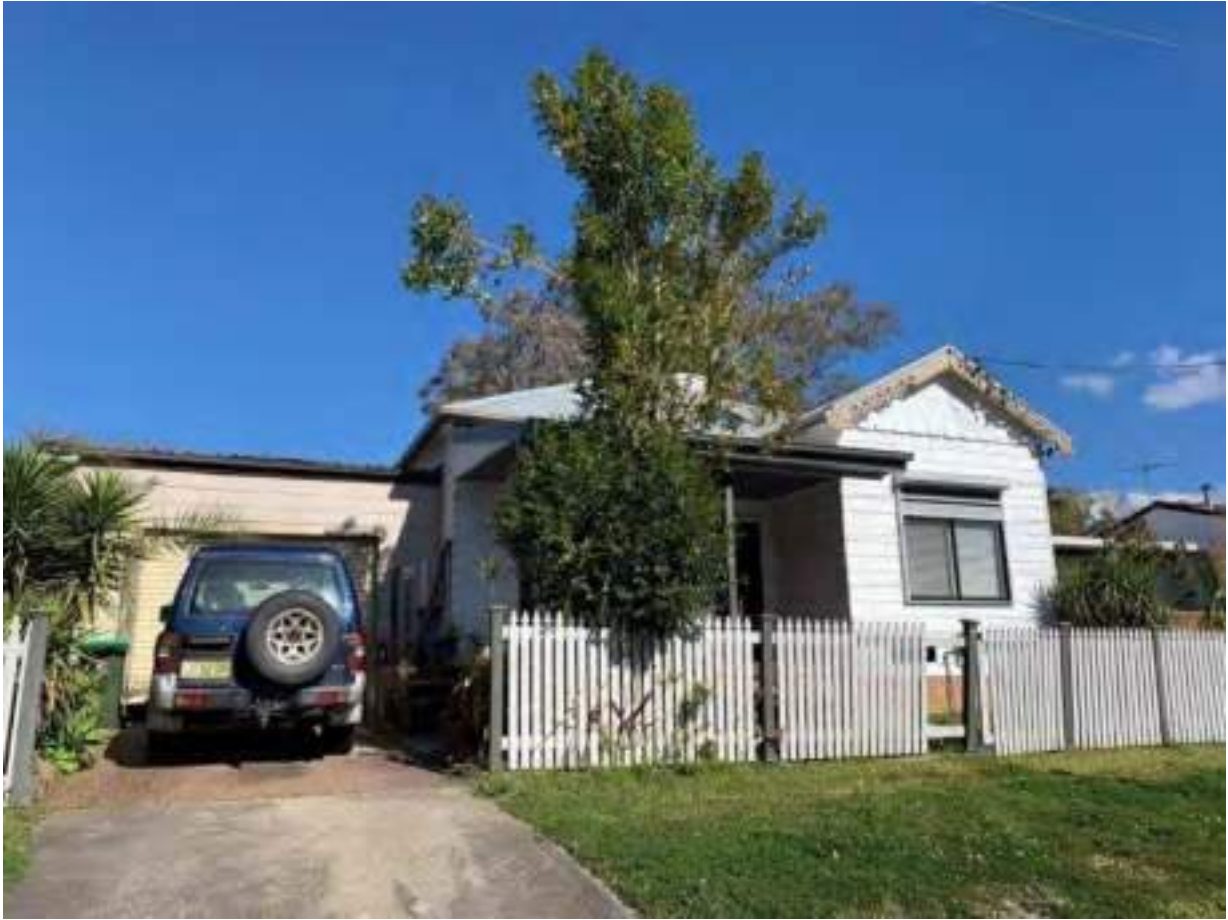
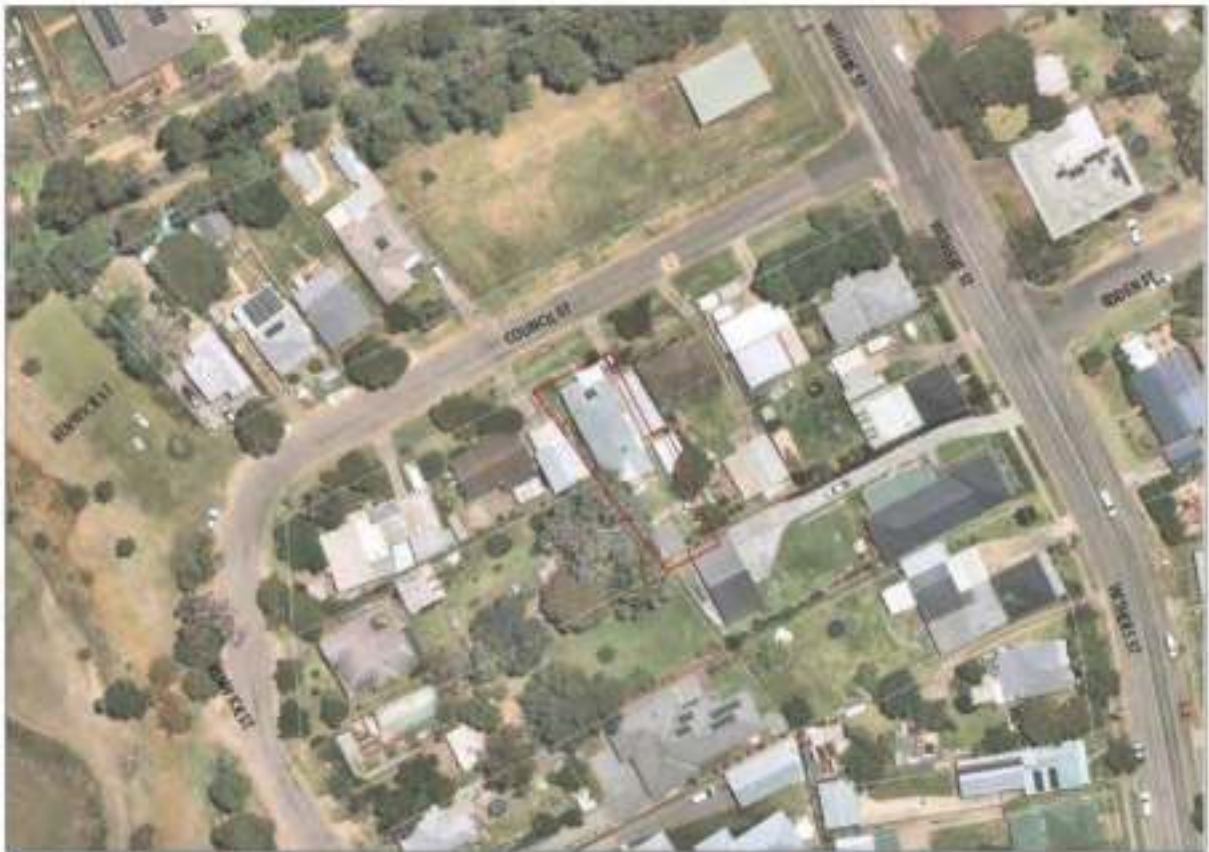
2 COUNCIL STREET, WEST WALLSEND 2286

Conservation Area Contribution Level	Est. Construction Date	Previous studies and/or community input
Contributory 2	Early to late 20th century (broad range)	No prior heritage assessments or research undertaken.
Assessment Text		Observed Modifications
<p>The scale (single-storey) and general style of the dwelling is consistent with that of the streetscape and wider HCA. Dwelling contributes positively to the streetscape and wider HCA, particularly in comparison to Non-Contributory buildings.</p> <p>The dwelling features appropriately proportioned and positioned fenestrations, an appropriate roof form (gabled or hipped) and other features consistent with the architectural character of the area (e.g. front verandah with timber or brick posts, timber detailing, corrugated metal roofing, etc). The contributory value of the dwelling is limited however by either:</p> <ul style="list-style-type: none"> • External modifications that have in some way obscured the style, scale or design intent of the building and have resulted in less physical integrity than Contributory 1 buildings. • Being a later dwelling constructed in an appropriate referential style, but comprising little to no fabric of intrinsic heritage significance. 		<p>The visible windows are contemporary designs, with metal roller shutters being installed a top.</p> <p>The decorative barge board is likely a contemporary replication of an original heritage design.</p> <p>A garage has been built onto the eastern side of the dwelling.</p>

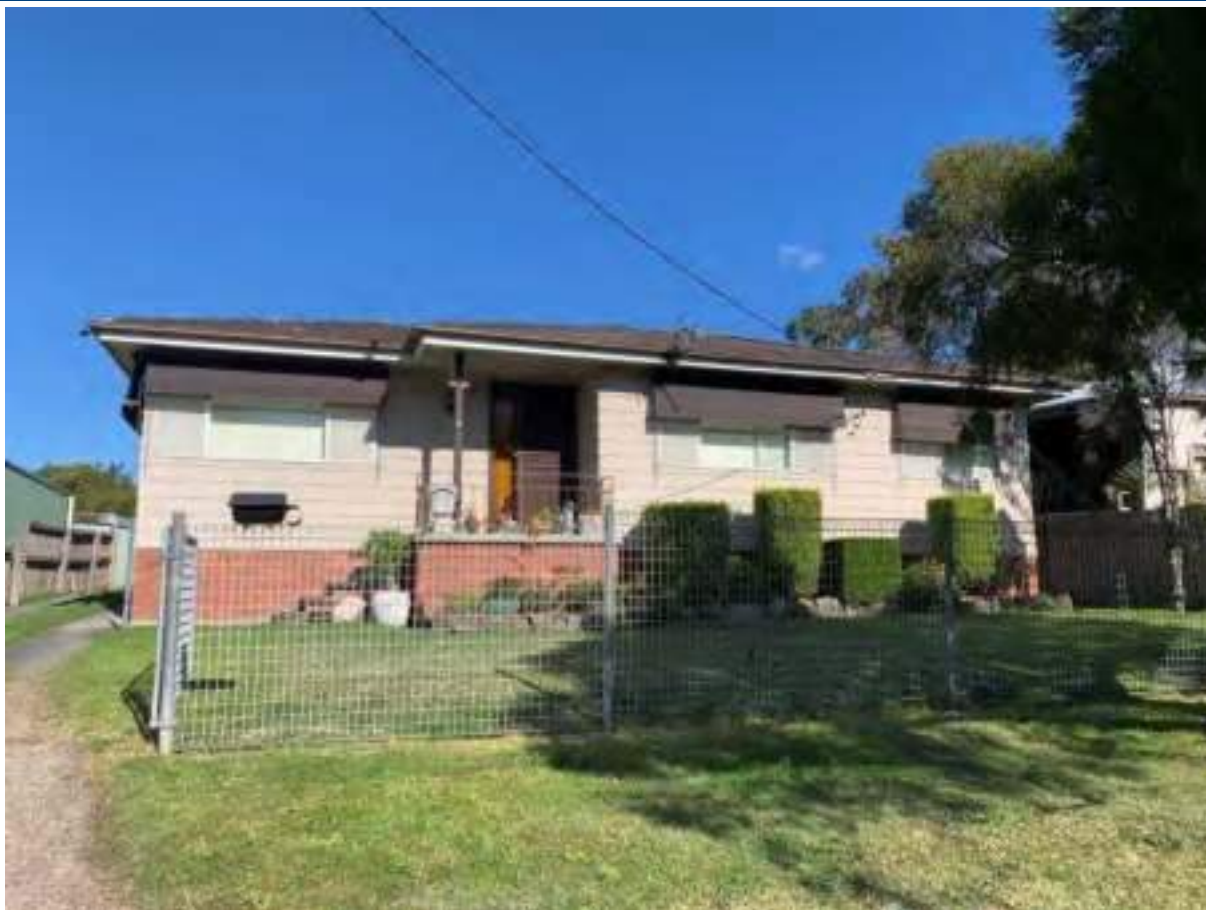
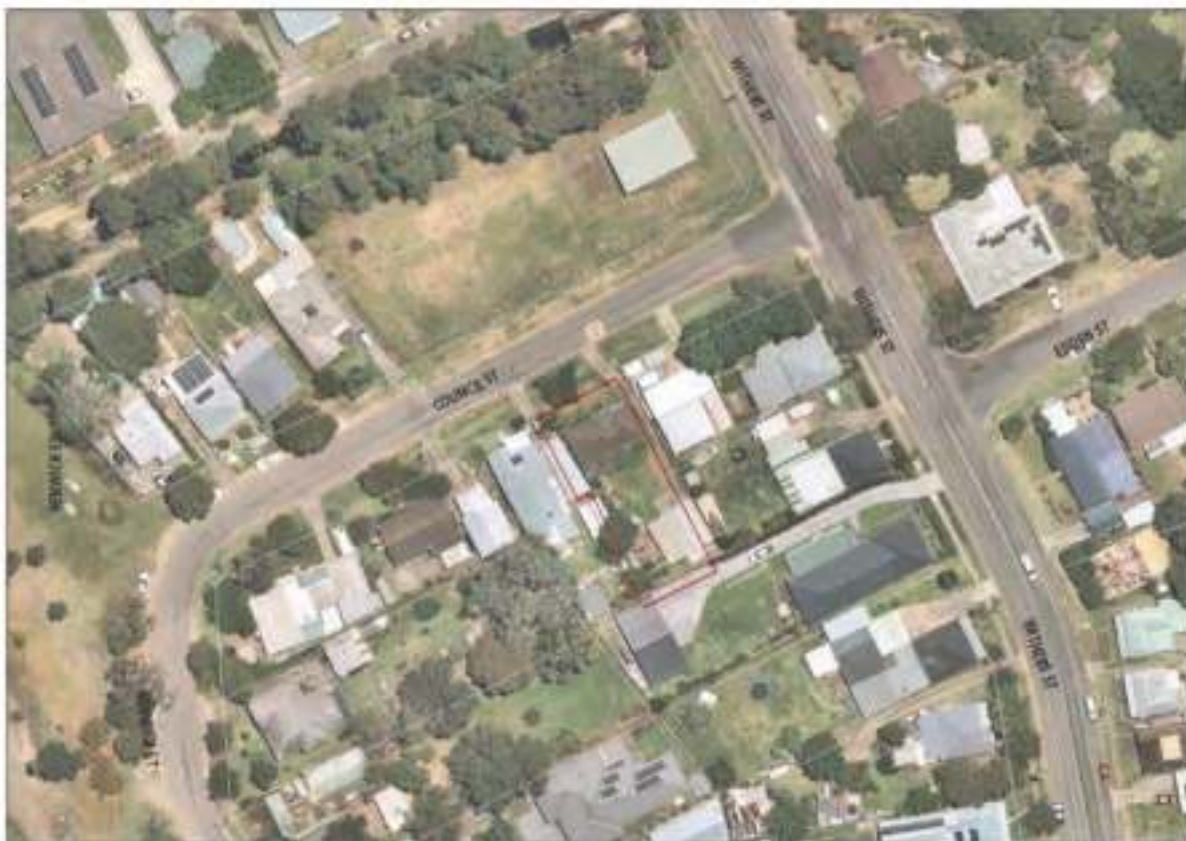
2A COUNCIL STREET, WEST WALLEND 2286

Conservation Area Contribution Level	Est. Construction Date	Previous studies and/or community input
Contributory 2	Early to late 20 th century (broad range)	No prior heritage assessments or research undertaken.
Assessment Text		Observed Modifications
<p>The scale (single-storey) and general style of the dwelling is consistent with that of the streetscape and wider HCA. Dwelling contributes positively to the streetscape and wider HCA, particularly in comparison to Non-Contributory buildings.</p> <p>The dwelling features appropriately proportioned and positioned fenestrations, an appropriate roof form (gabled or hipped) and other features consistent with the architectural character of the area (e.g. front verandah with timber or brick posts, timber detailing, corrugated metal roofing, etc). The contributory value of the dwelling is limited however by either:</p> <ul style="list-style-type: none"> • External modifications that have in some way obscured the style, scale or design intent of the building and have resulted in less physical integrity than Contributory 1 buildings. • Being a later dwelling constructed in an appropriate referential style, but comprising little to no fabric of intrinsic heritage significance. 		No modifications observed.

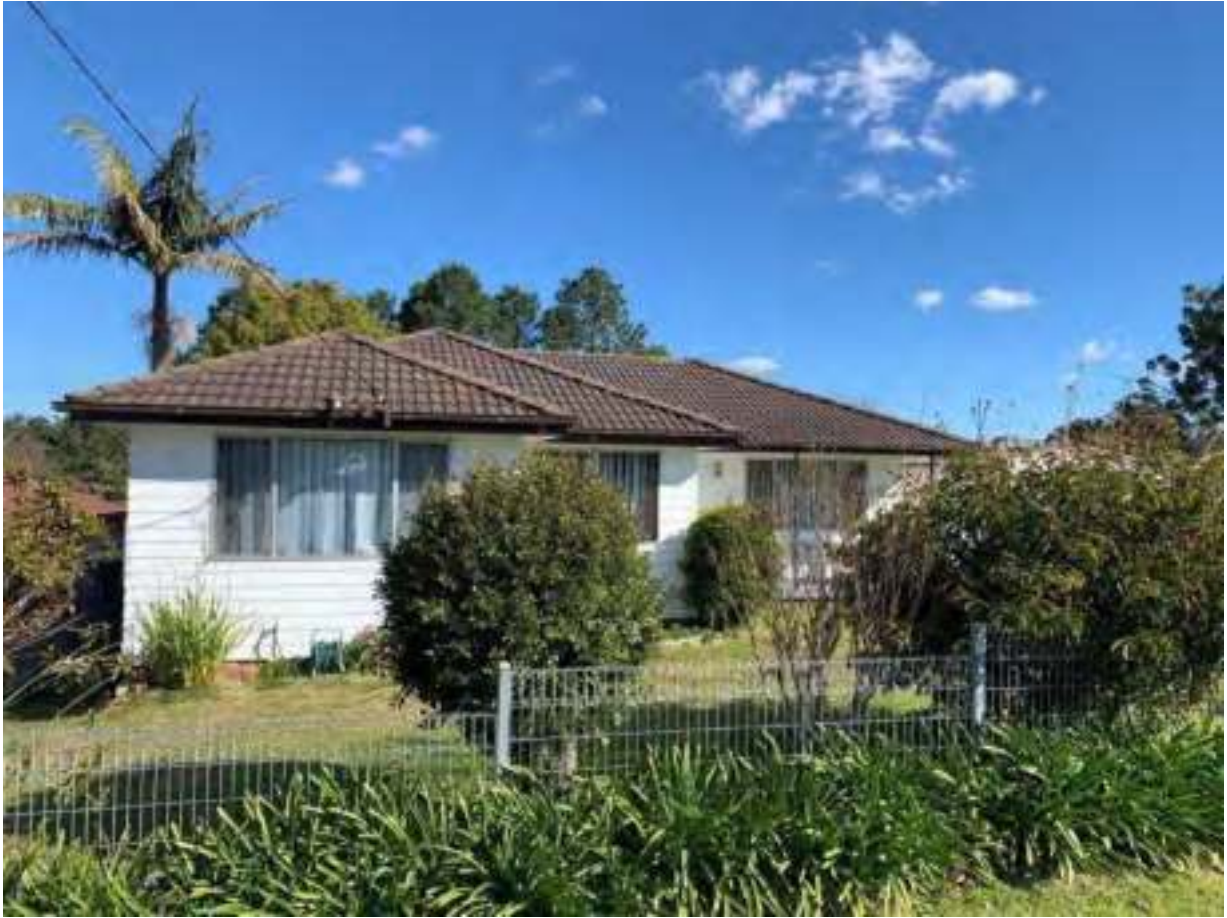
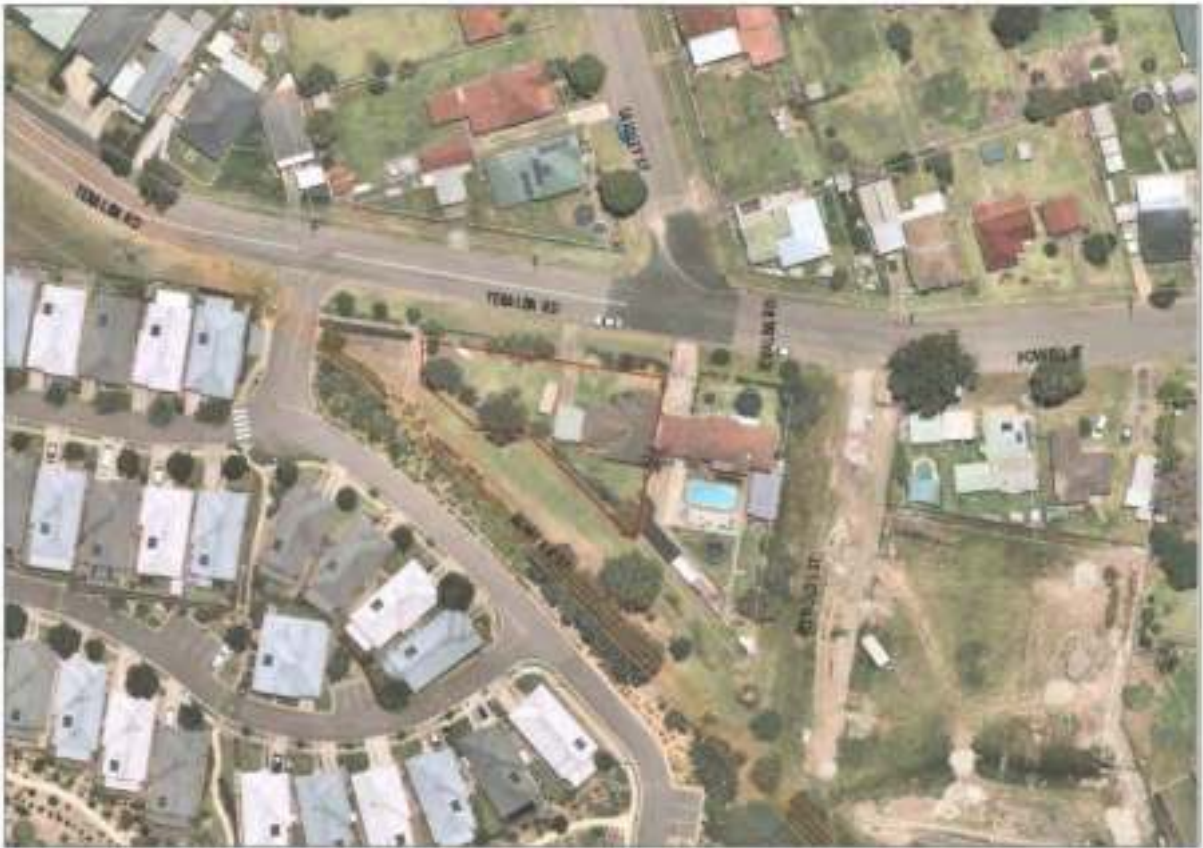
12A POWELL STREET, WEST WALLSEND 2286

Conservation Area Contribution Level	Est. Construction Date	Previous studies and/or community input
Contributory 2	Early to late 20 th century (broad range)	No prior heritage assessments or research undertaken.
Assessment Text		Observed Modifications
<p>The scale (single-storey) and general style of the dwelling is consistent with that of the streetscape and wider HCA. Dwelling contributes positively to the streetscape and wider HCA, particularly in comparison to Non-Contributory buildings.</p> <p>The dwelling features appropriately proportioned and positioned fenestrations, an appropriate roof form (gabled or hipped) and other features consistent with the architectural character of the area (e.g. front verandah with timber or brick posts, timber detailing, corrugated metal roofing, etc). The contributory value of the dwelling is limited however by either:</p> <ul style="list-style-type: none"> • External modifications that have in some way obscured the style, scale or design intent of the building and have resulted in less physical integrity than Contributory 1 buildings. • Being a later dwelling constructed in an appropriate referential style, but comprising little to no fabric of intrinsic heritage significance. 		No modifications observed.
