APPENDIX 2

Building Assessment Sheets (Inventory Sheets)

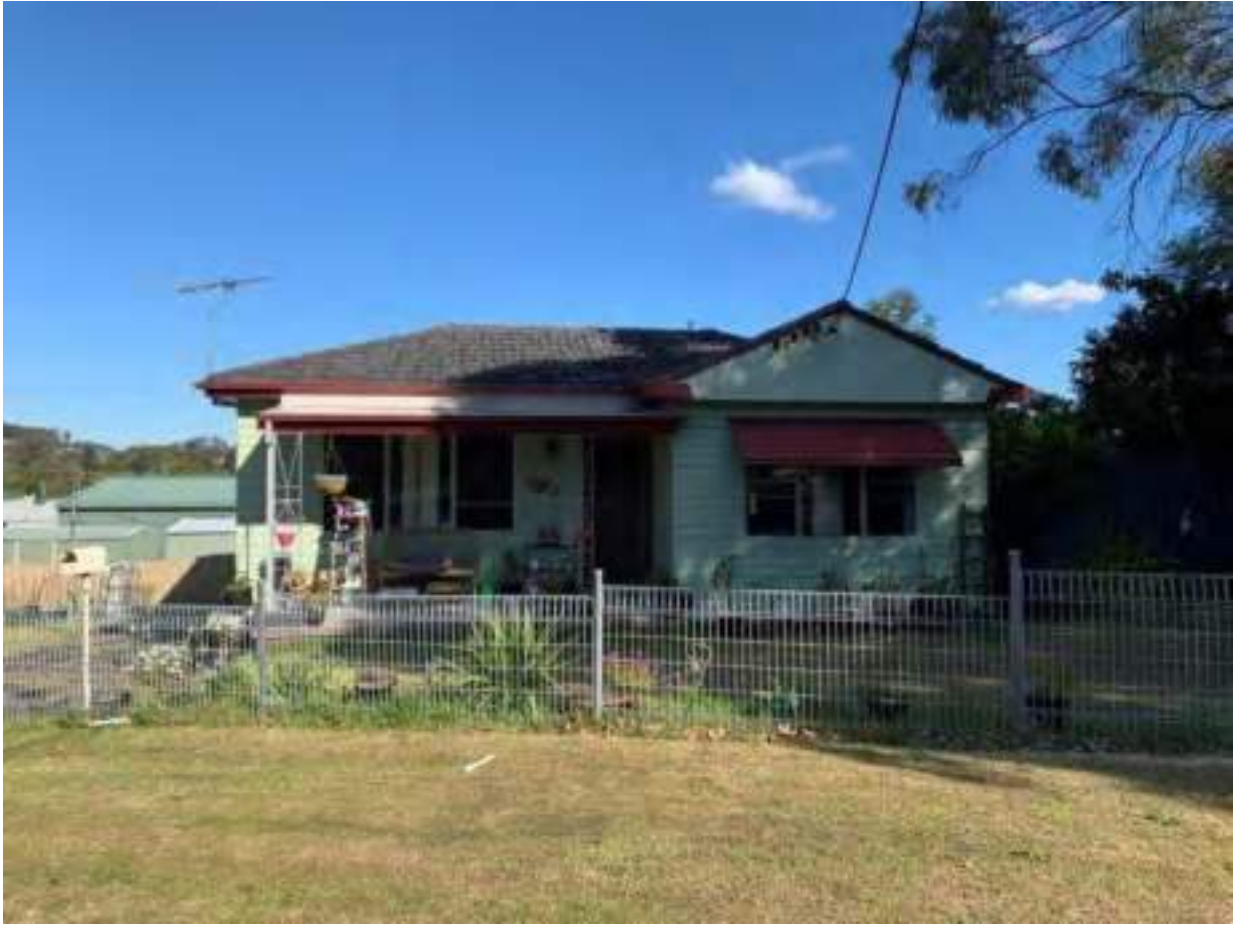
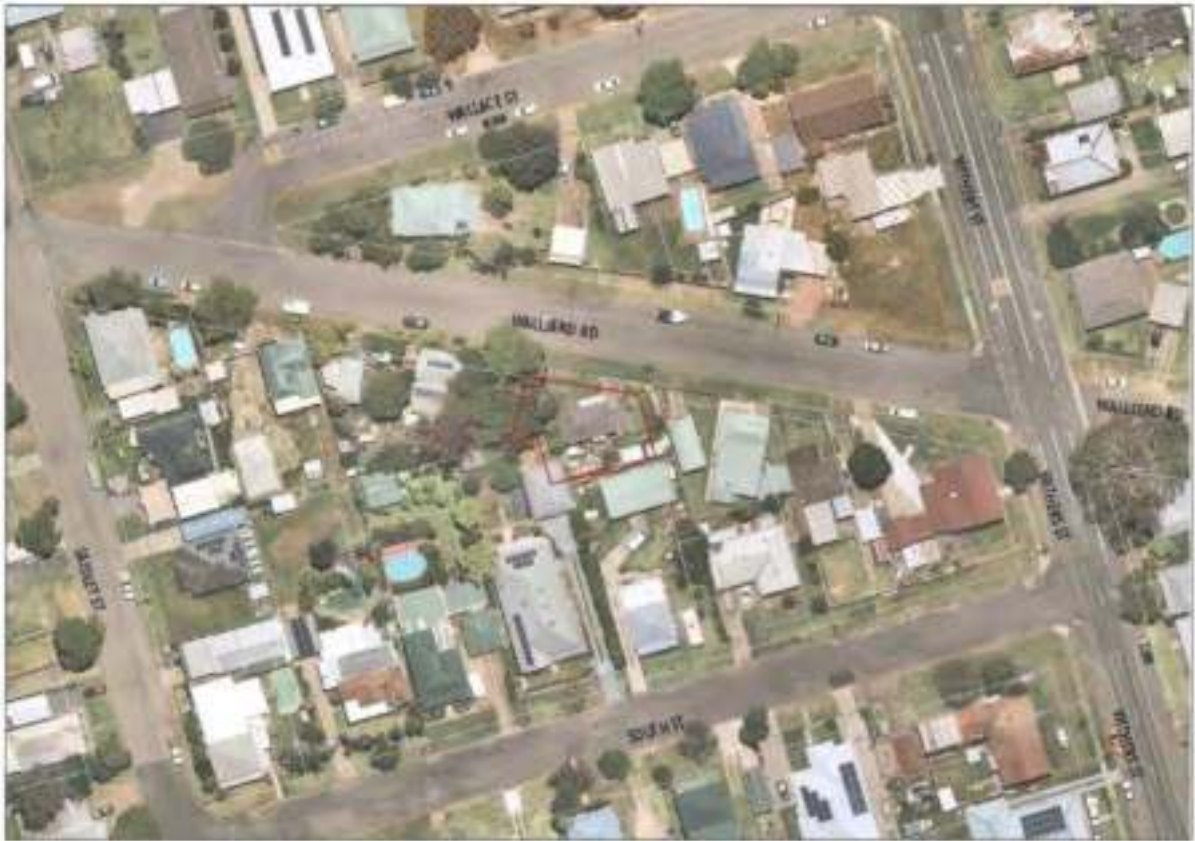
12 WALLSEND ROAD, WEST WALLSEND 2286

Conservation Area Contribution Level	Est. Construction Date	Previous studies and/or community input
Contributory 2	Early to late 20 th century (broad range)	No prior heritage assessments or research undertaken.
Assessment Text		Observed Modifications
<p>The scale (single-storey) and general style of the dwelling is consistent with that of the streetscape and wider HCA. Dwelling contributes positively to the streetscape and wider HCA, particularly in comparison to Non-Contributory buildings.</p> <p>The dwelling features appropriately proportioned and positioned fenestrations, an appropriate roof form (gabled or hipped) and other features consistent with the architectural character of the area (e.g. front verandah with timber or brick posts, timber detailing, corrugated metal roofing, etc). The contributory value of the dwelling is limited however by either:</p> <ul style="list-style-type: none"> • External modifications that have in some way obscured the style, scale or design intent of the building and have resulted in less physical integrity than Contributory 1 buildings. • Being a later dwelling constructed in an appropriate referential style, but comprising little to no fabric of intrinsic heritage significance. 		<p>Ornate metal pillars have been installed along the veranda, likely a contemporary addition.</p> <p>A flat roof veranda extension has been constructed.</p>

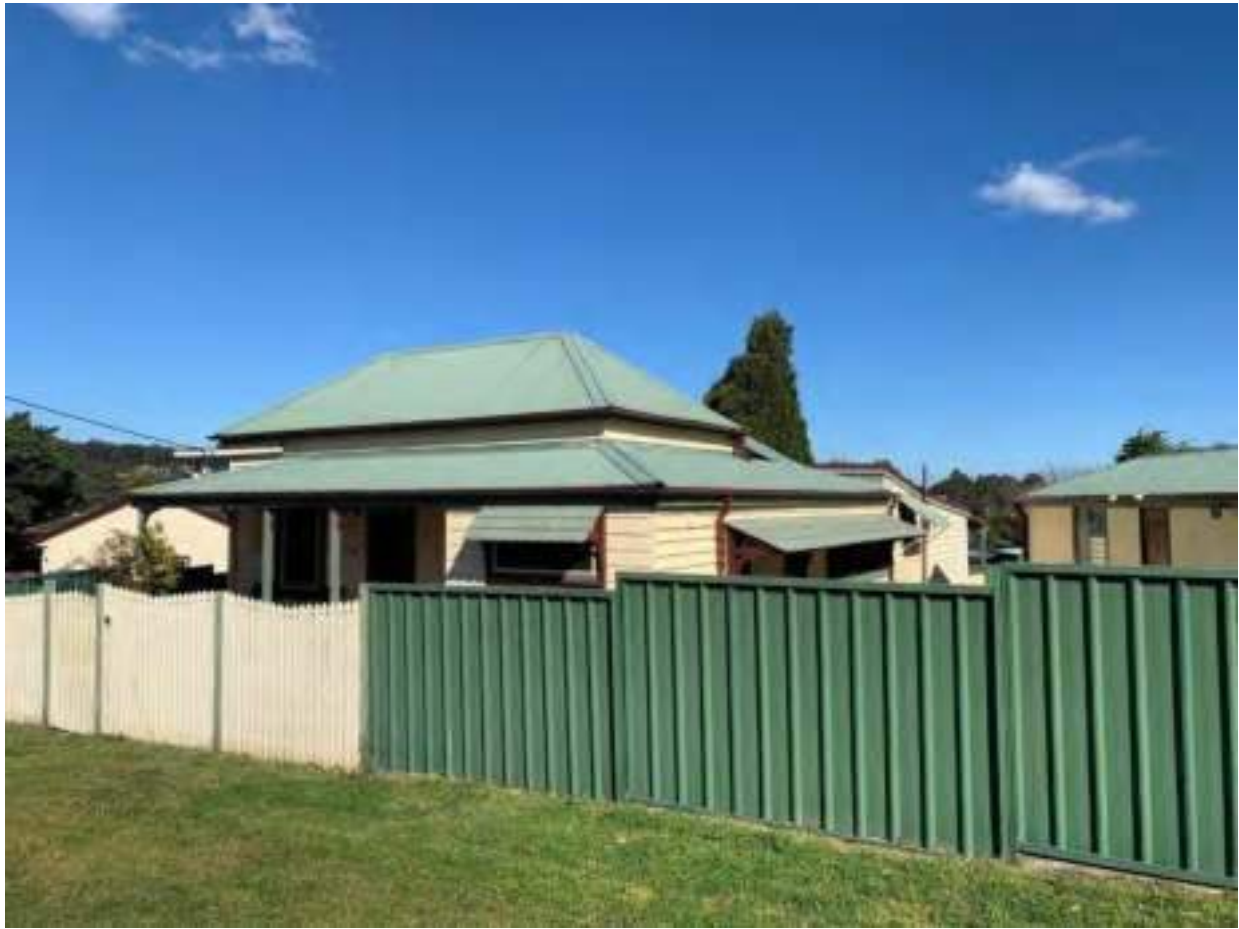
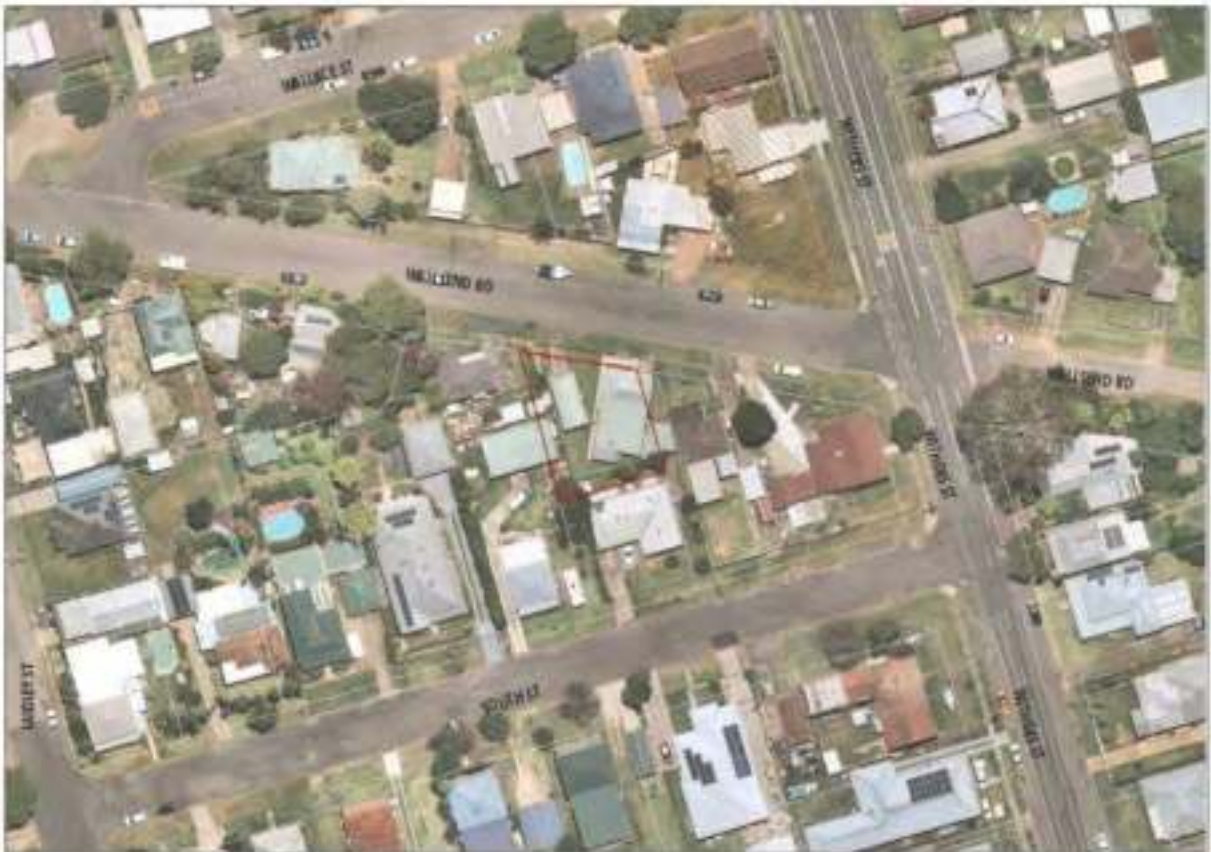
10 WALLSEND ROAD, WEST WALLSEND 2286

Conservation Area Contribution Level	Est. Construction Date	Previous studies and/or community input
Contributory 2	1900–1930	No prior heritage assessments or research undertaken.
Assessment Text		Observed Modifications
<p>The scale (single-storey) and general style of the dwelling is consistent with that of the streetscape and wider HCA. Dwelling contributes positively to the streetscape and wider HCA, particularly in comparison to Non-Contributory buildings.</p> <p>The dwelling features appropriately proportioned and positioned fenestrations, an appropriate roof form (gabled or hipped) and other features consistent with the architectural character of the area (e.g. front verandah with timber or brick posts, timber detailing, corrugated metal roofing, etc). The contributory value of the dwelling is limited however by either:</p> <ul style="list-style-type: none"> • External modifications that have in some way obscured the style, scale or design intent of the building and have resulted in less physical integrity than Contributory 1 buildings. • Being a later dwelling constructed in an appropriate referential style, but comprising little to no fabric of intrinsic heritage significance. 		<p>A north western extension has been constructed, creating an additional living area. This has been done in a sympathetic style and does not detract from the heritage streetscape.</p> <p>The timber shingle awnings are likely a contemporary replication of an original heritage design.</p>

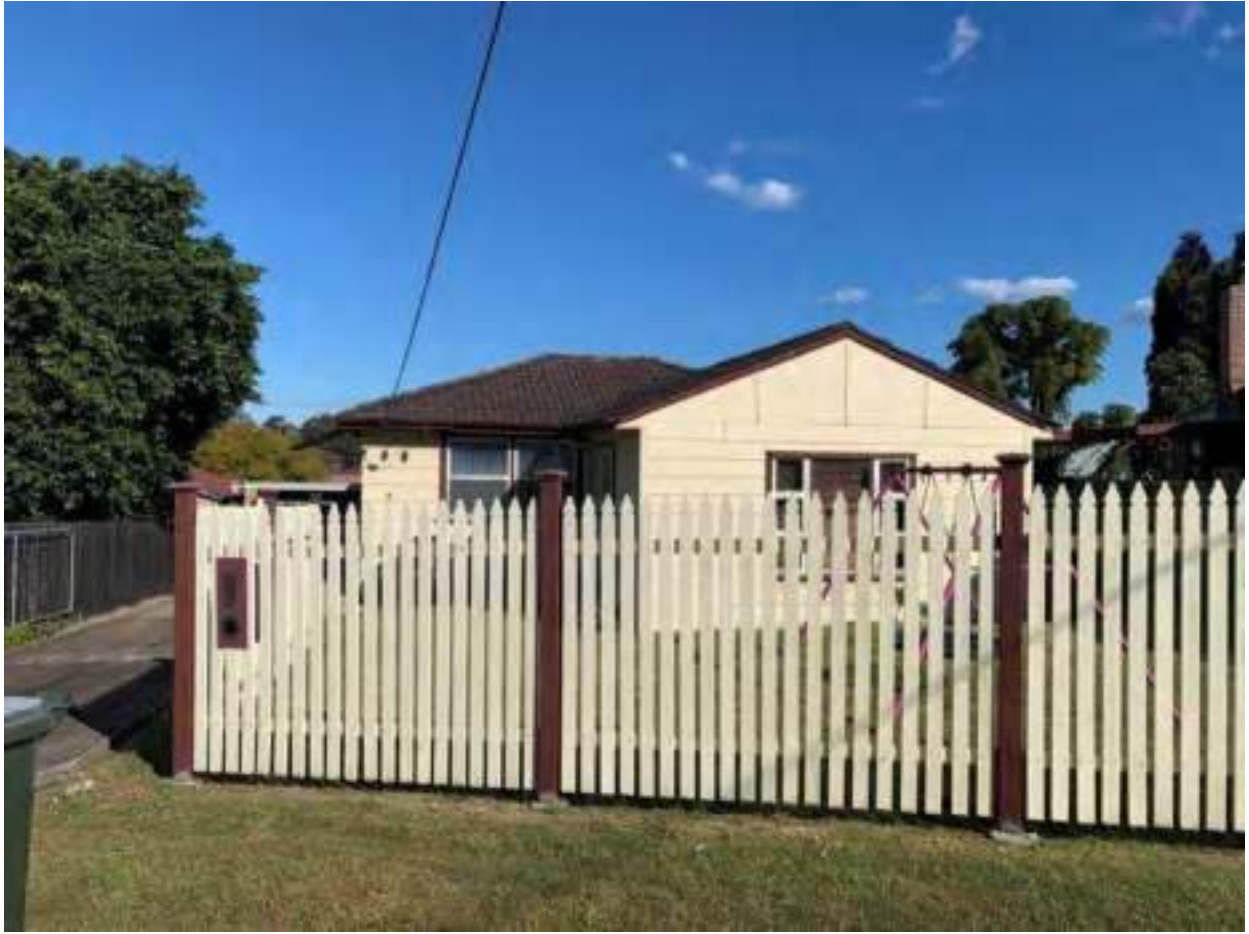
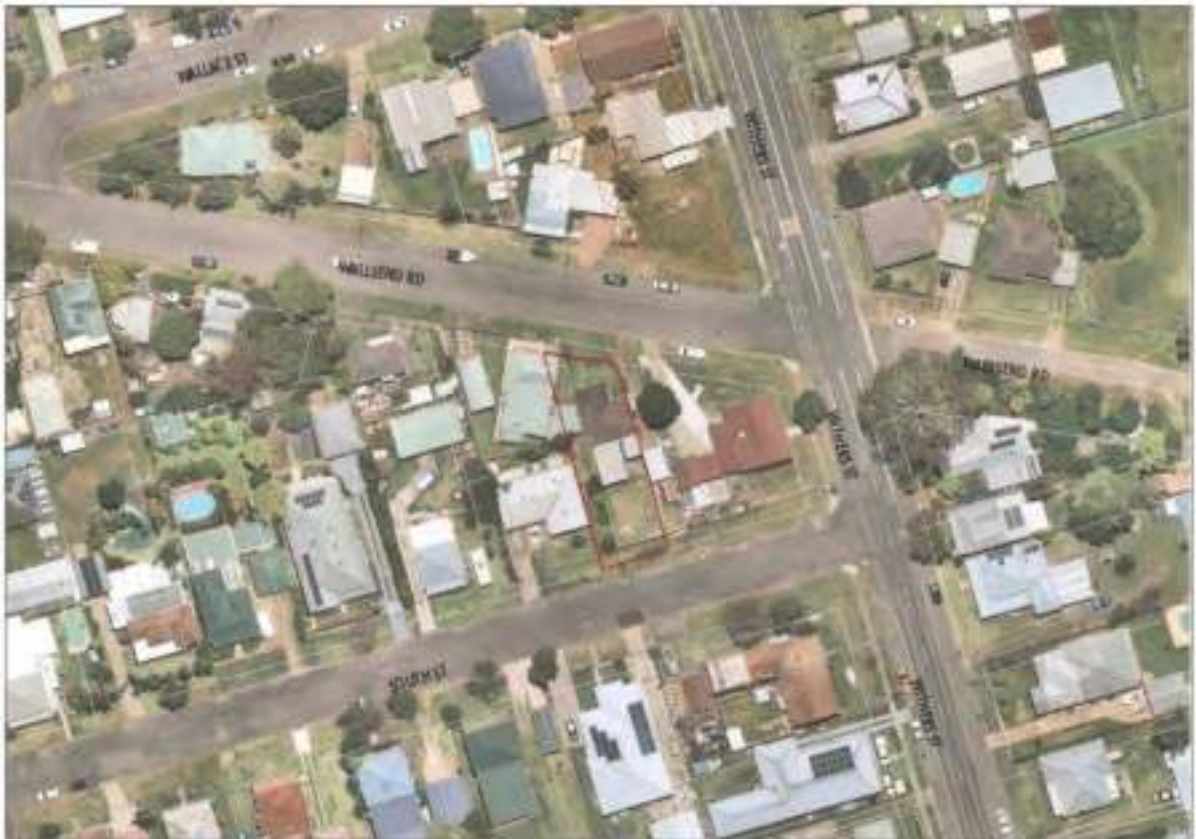
8 WALLSEND ROAD, WEST WALLSEND 2286

Conservation Area Contribution Level	Est. Construction Date	Previous studies and/or community input
Contributory 2	Early to late 20 th century (broad range)	No prior heritage assessments or research undertaken.
Assessment Text		Observed Modifications
<p>The scale (single-storey) and general style of the dwelling is consistent with that of the streetscape and wider HCA. Dwelling contributes positively to the streetscape and wider HCA, particularly in comparison to Non-Contributory buildings.</p> <p>The dwelling features appropriately proportioned and positioned fenestrations, an appropriate roof form (gabled or hipped) and other features consistent with the architectural character of the area (e.g. front verandah with timber or brick posts, timber detailing, corrugated metal roofing, etc). The contributory value of the dwelling is limited however by either:</p> <ul style="list-style-type: none"> • External modifications that have in some way obscured the style, scale or design intent of the building and have resulted in less physical integrity than Contributory 1 buildings. • Being a later dwelling constructed in an appropriate referential style, but comprising little to no fabric of intrinsic heritage significance. 		No modifications observed.

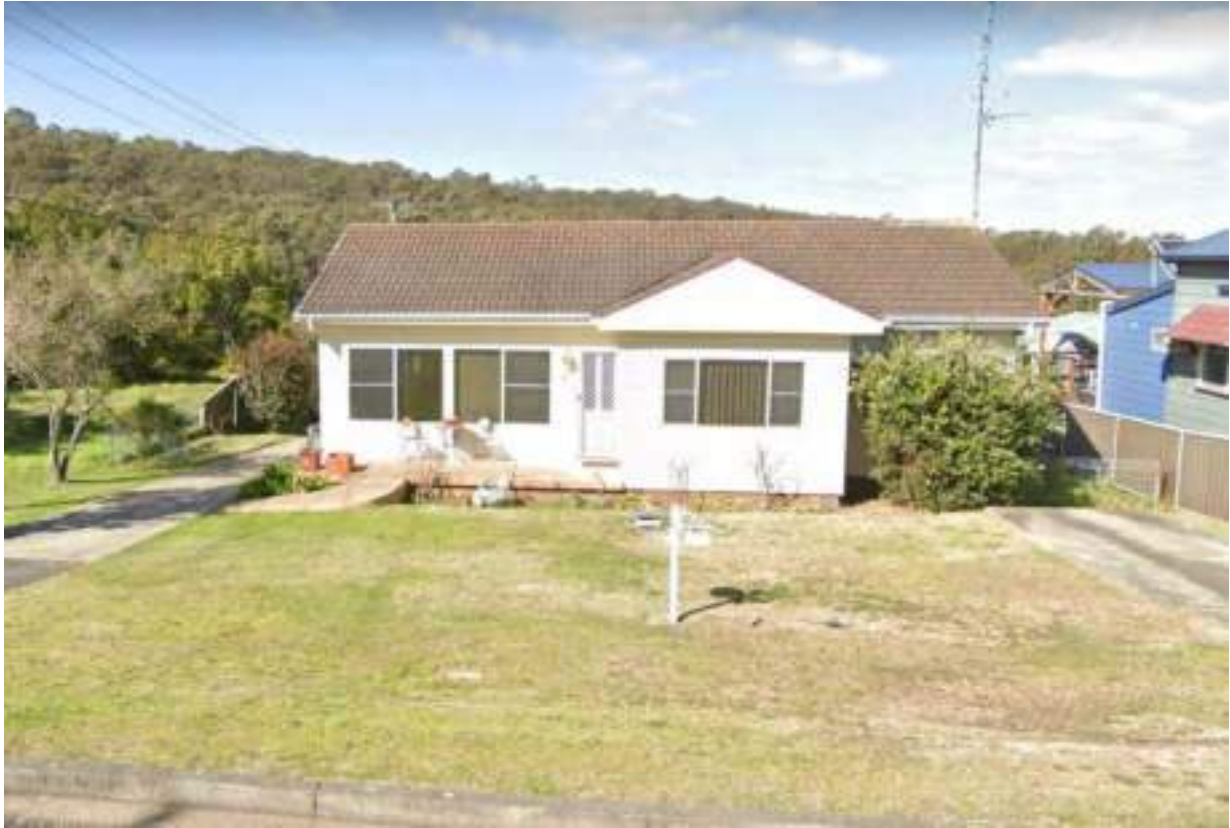
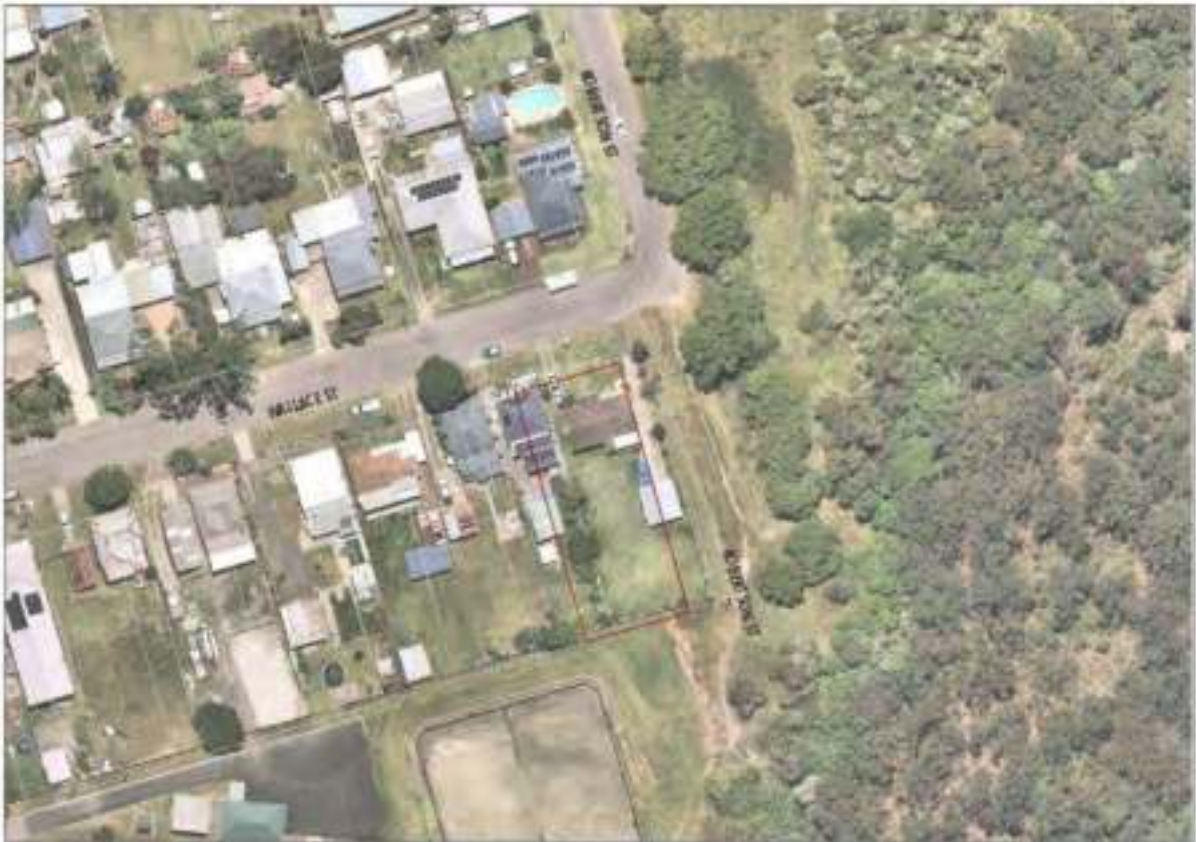
2 WALLACE STREET, WEST WALLSEND 2286

Conservation Area Contribution Level	Est. Construction Date	Previous studies and/or community input
Contributory 2	Early to late 20 th century (broad range)	No prior heritage assessments or research undertaken.
Assessment Text		Observed Modifications
<p>The scale (single-storey) and general style of the dwelling is consistent with that of the streetscape and wider HCA. Dwelling contributes positively to the streetscape and wider HCA, particularly in comparison to Non-Contributory buildings.</p> <p>The dwelling features appropriately proportioned and positioned fenestrations, an appropriate roof form (gabled or hipped) and other features consistent with the architectural character of the area (e.g. front verandah with timber or brick posts, timber detailing, corrugated metal roofing, etc). The contributory value of the dwelling is limited however by either:</p> <ul style="list-style-type: none"> • External modifications that have in some way obscured the style, scale or design intent of the building and have resulted in less physical integrity than Contributory 1 buildings. • Being a later dwelling constructed in an appropriate referential style, but comprising little to no fabric of intrinsic heritage significance. 		No modifications observed.

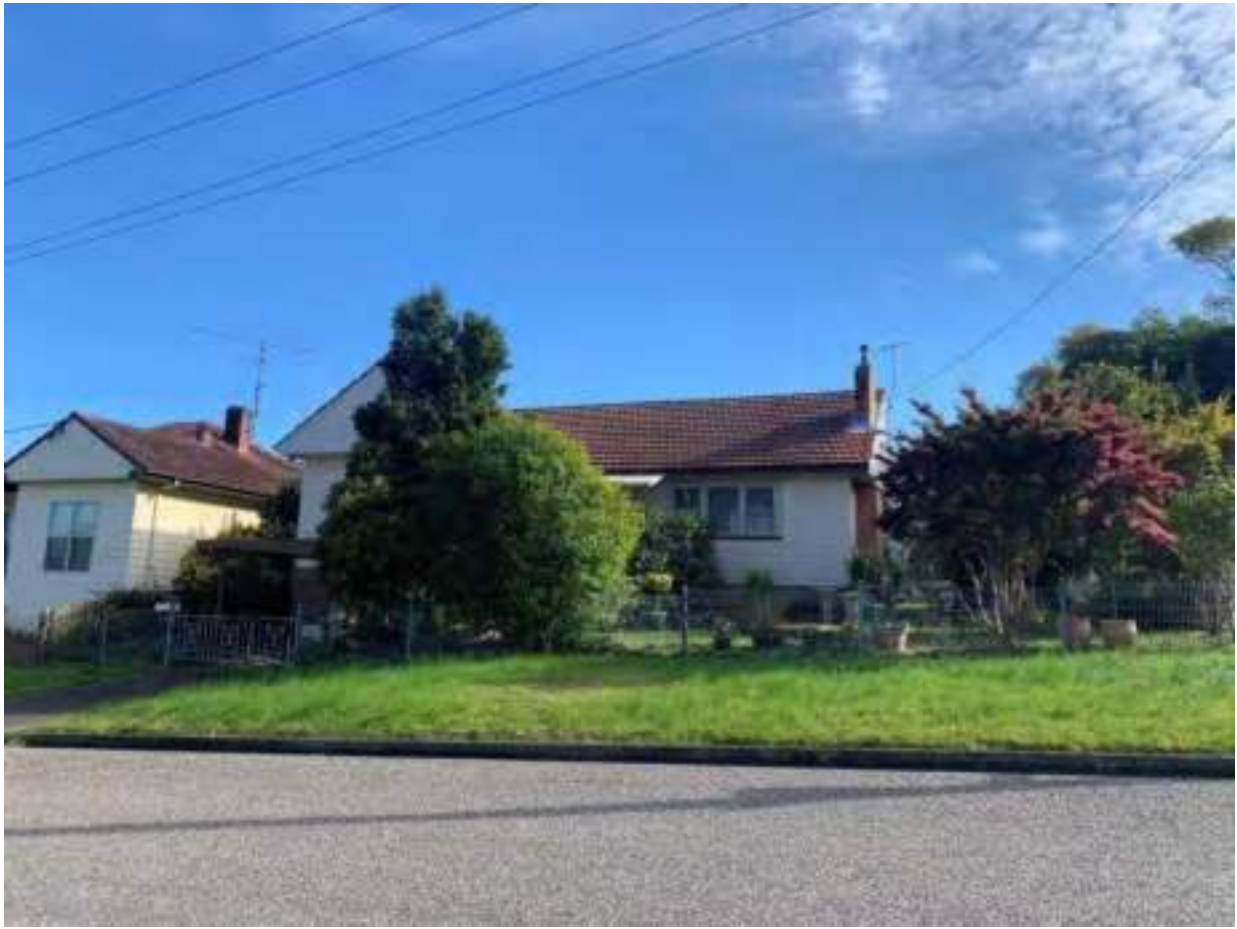
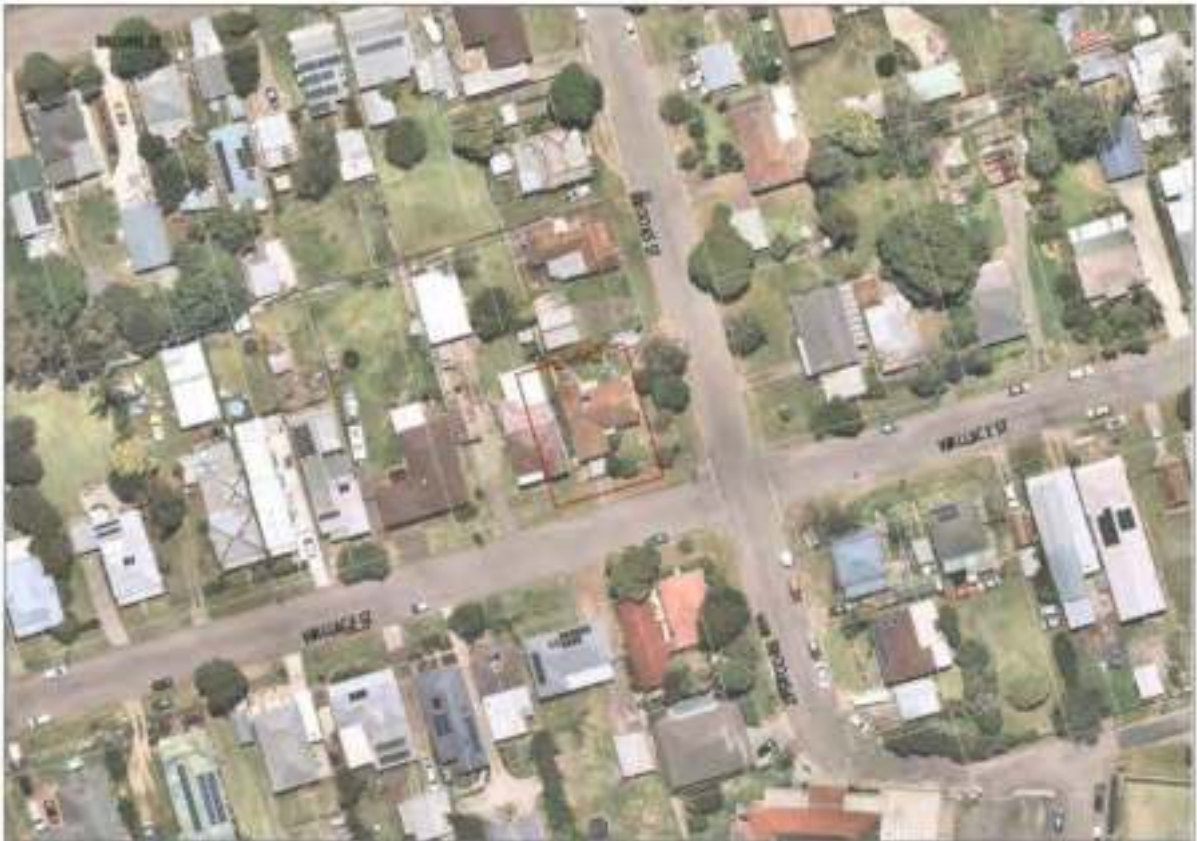
19 WALLACE STREET, WEST WALLSEND 2286

Conservation Area Contribution Level	Est. Construction Date	Previous studies and/or community input
Contributory 2	Early to late 20 th century (broad range)	No prior heritage assessments or research undertaken.
Assessment Text		Observed Modifications
<p>The scale (single-storey) and general style of the dwelling is consistent with that of the streetscape and wider HCA. Dwelling contributes positively to the streetscape and wider HCA, particularly in comparison to Non-Contributory buildings.</p> <p>The dwelling features appropriately proportioned and positioned fenestrations, an appropriate roof form (gabled or hipped) and other features consistent with the architectural character of the area (e.g. front verandah with timber or brick posts, timber detailing, corrugated metal roofing, etc). The contributory value of the dwelling is limited however by either:</p> <ul style="list-style-type: none"> • External modifications that have in some way obscured the style, scale or design intent of the building and have resulted in less physical integrity than Contributory 1 buildings. • Being a later dwelling constructed in an appropriate referential style, but comprising little to no fabric of intrinsic heritage significance. 		No modifications observed.

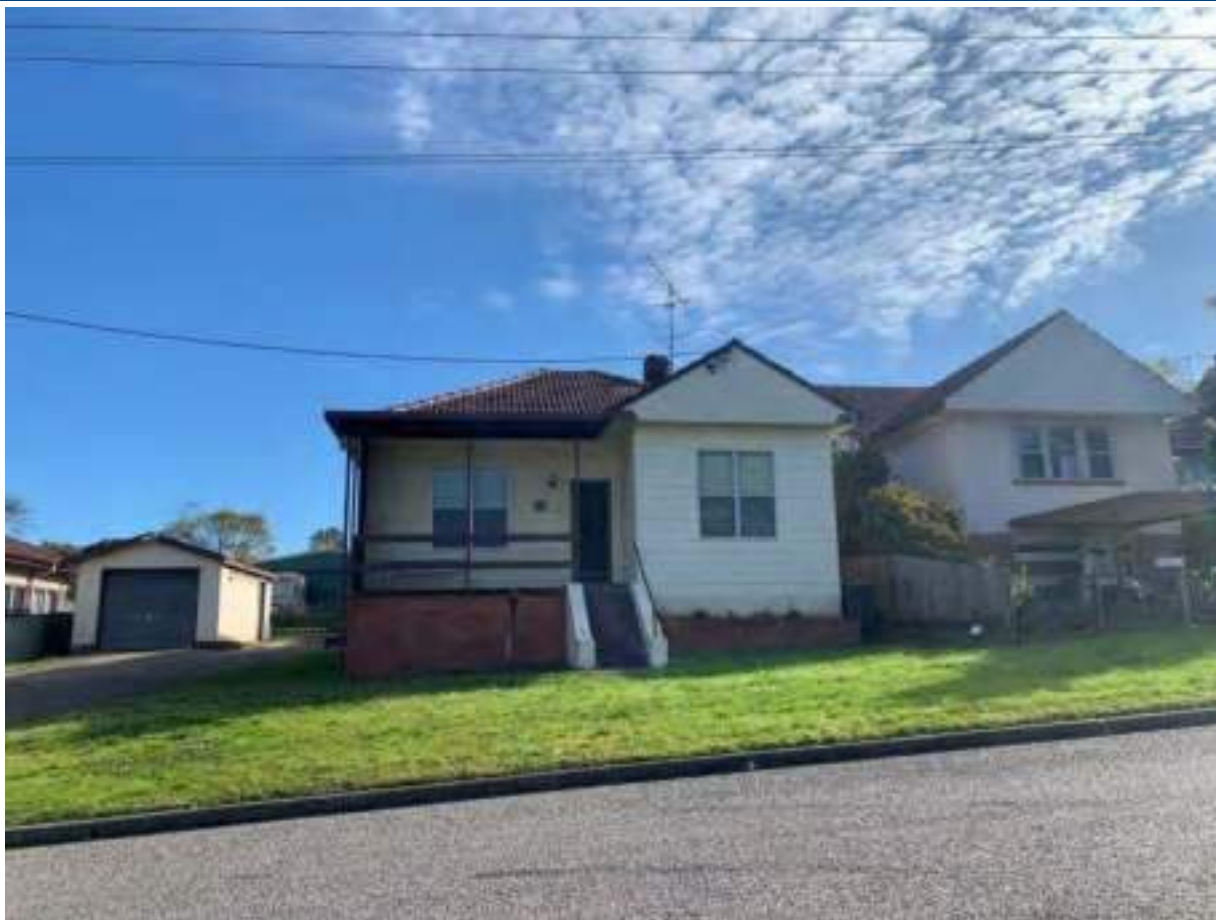
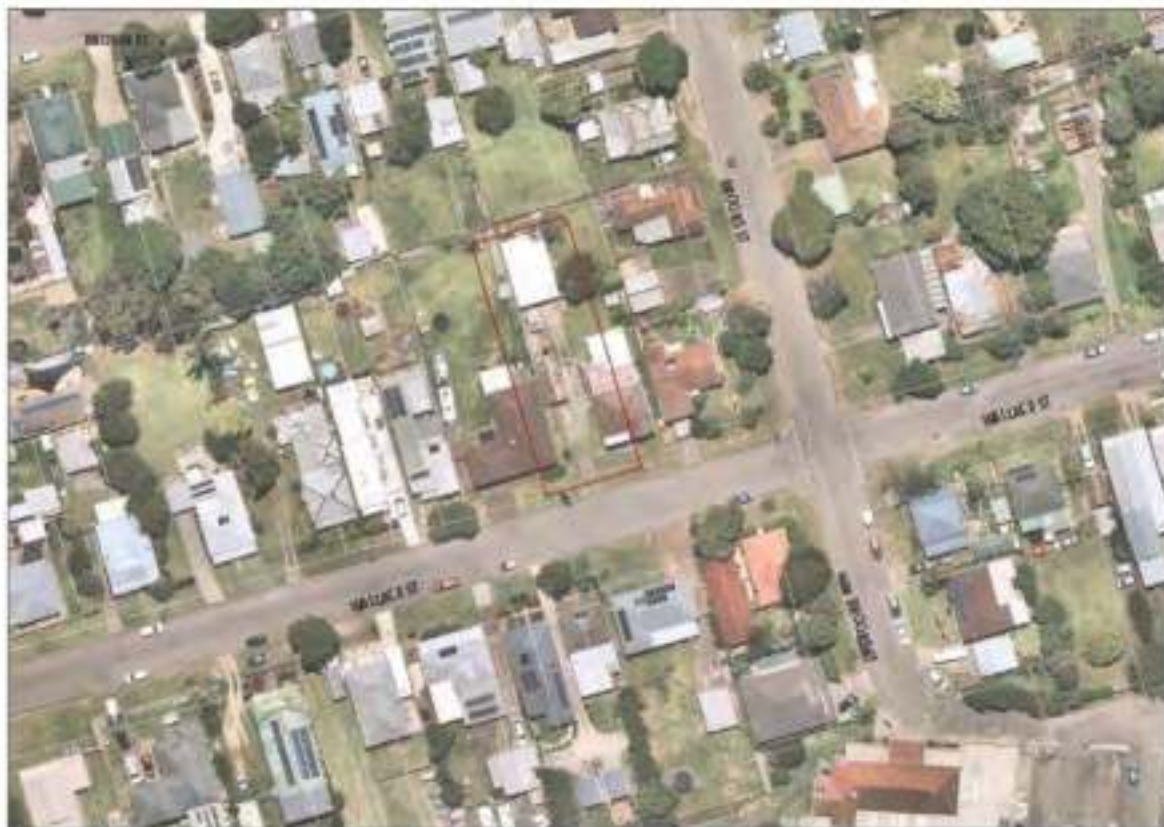
21 WALLACE STREET, WEST WALLSEND 2286

Conservation Area Contribution Level	Est. Construction Date	Previous studies and/or community input
Contributory 2	Early to late 20 th century (broad range)	No prior heritage assessments or research undertaken.
Assessment Text		Observed Modifications
<p>The scale (single-storey) and general style of the dwelling is consistent with that of the streetscape and wider HCA. Dwelling contributes positively to the streetscape and wider HCA, particularly in comparison to Non-Contributory buildings.</p> <p>The dwelling features appropriately proportioned and positioned fenestrations, an appropriate roof form (gabled or hipped) and other features consistent with the architectural character of the area (e.g. front verandah with timber or brick posts, timber detailing, corrugated metal roofing, etc). The contributory value of the dwelling is limited however by either:</p> <ul style="list-style-type: none"> • External modifications that have in some way obscured the style, scale or design intent of the building and have resulted in less physical integrity than Contributory 1 buildings. • Being a later dwelling constructed in an appropriate referential style, but comprising little to no fabric of intrinsic heritage significance. 		<p>The timber balustrade enclosing the veranda is likely a contemporary addition, replacing an original design.</p>

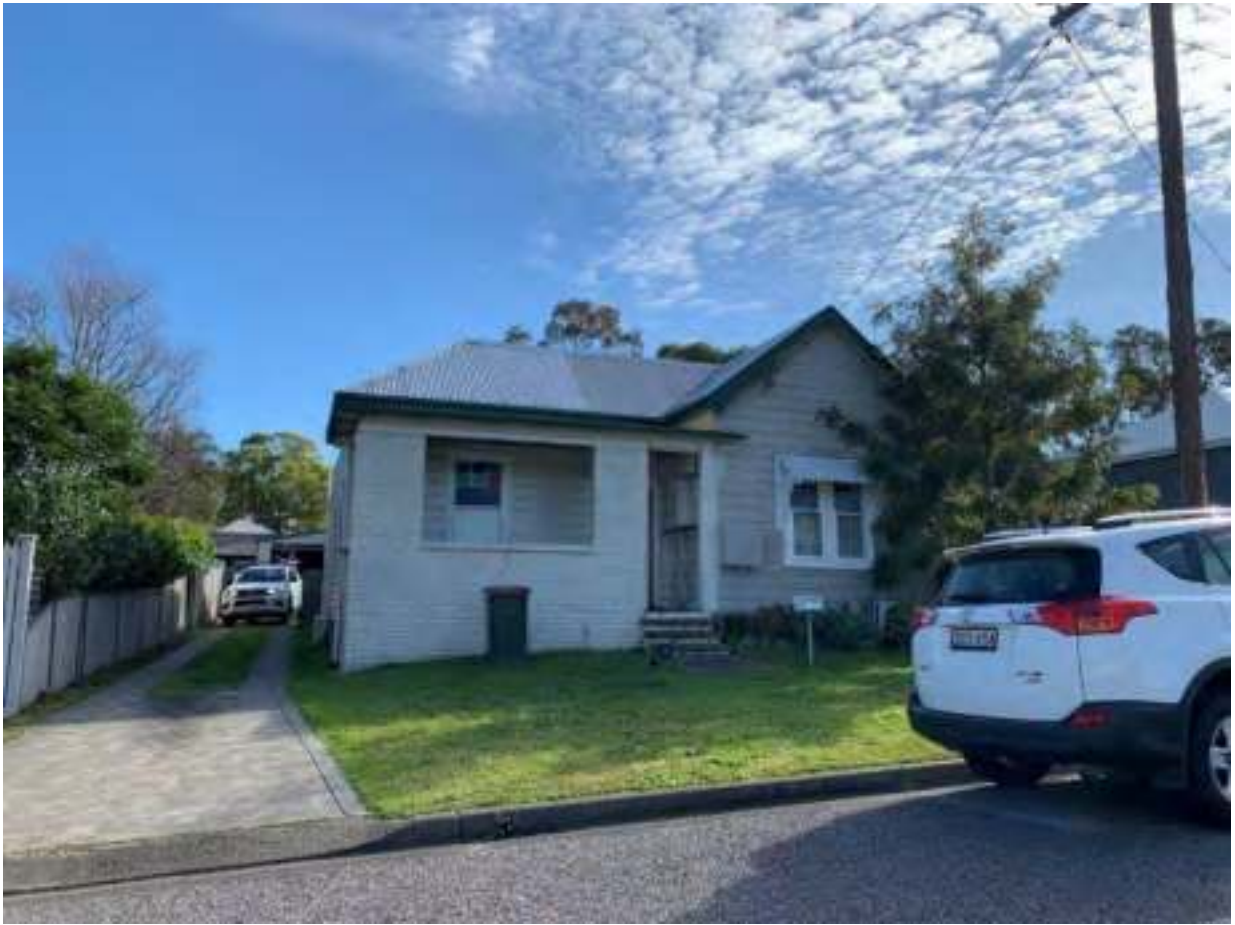
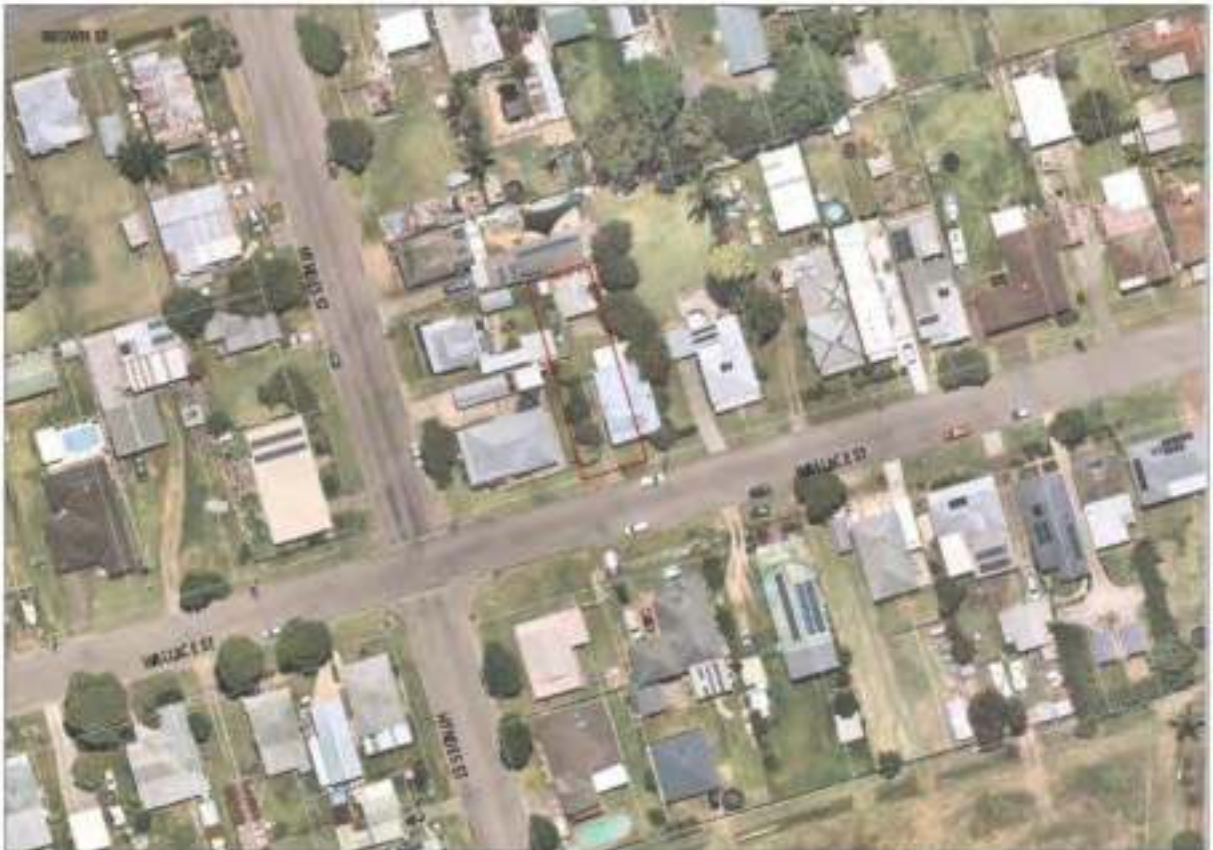
33 WALLACE STREET, WEST WALLSEND 2286

Conservation Area Contribution Level	Est. Construction Date	Previous studies and/or community input
Contributory 2	Early to late 20 th century (broad range)	No prior heritage assessments or research undertaken.
Assessment Text		Observed Modifications
<p>The scale (single-storey) and general style of the dwelling is consistent with that of the streetscape and wider HCA. Dwelling contributes positively to the streetscape and wider HCA, particularly in comparison to Non-Contributory buildings.</p> <p>The dwelling features appropriately proportioned and positioned fenestrations, an appropriate roof form (gabled or hipped) and other features consistent with the architectural character of the area (e.g. front verandah with timber or brick posts, timber detailing, corrugated metal roofing, etc). The contributory value of the dwelling is limited however by either:</p> <ul style="list-style-type: none"> • External modifications that have in some way obscured the style, scale or design intent of the building and have resulted in less physical integrity than Contributory 1 buildings. • Being a later dwelling constructed in an appropriate referential style, but comprising little to no fabric of intrinsic heritage significance. 		<p>The rendered brick veranda wall is a contemporary addition, likely replacing an original timber design.</p>

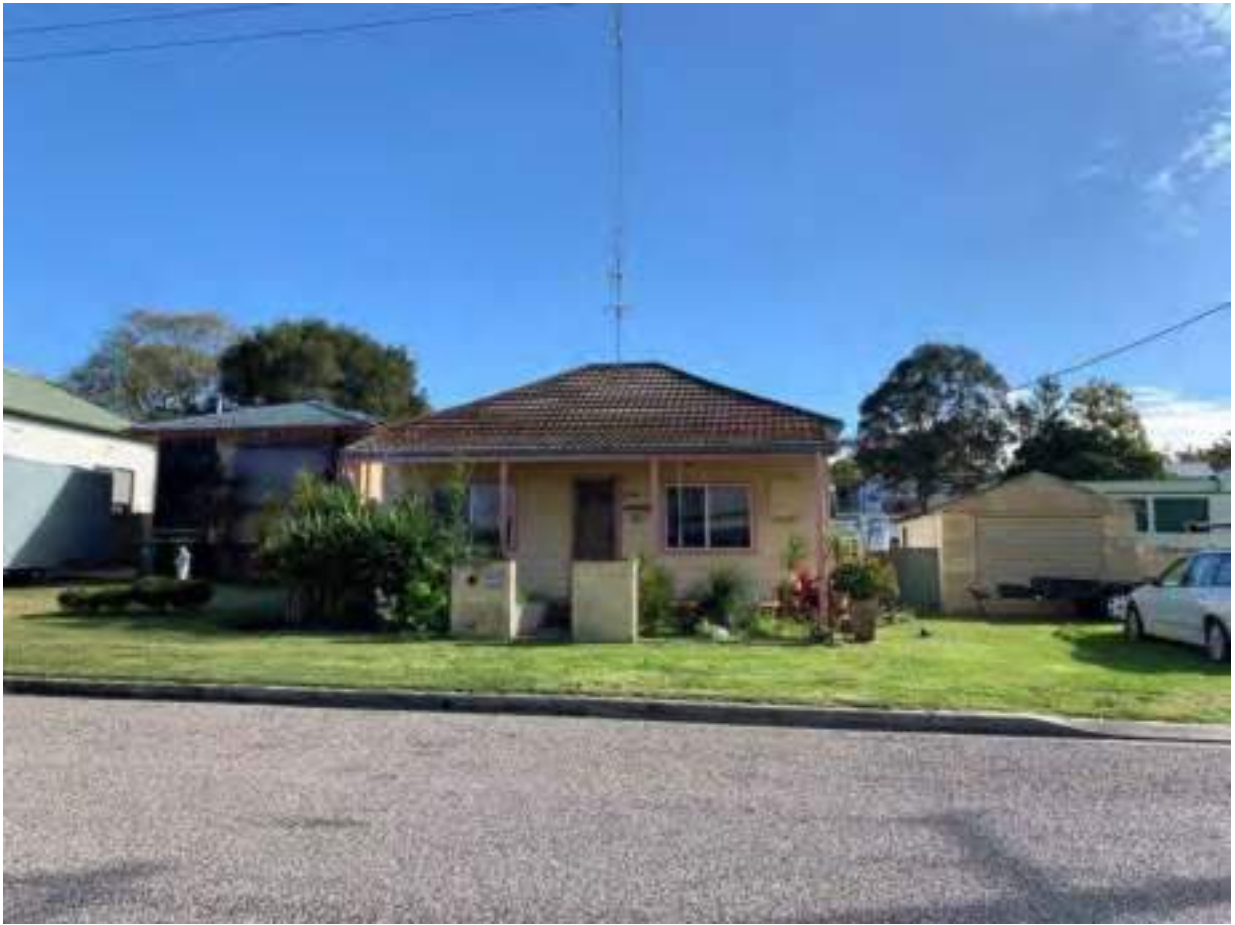
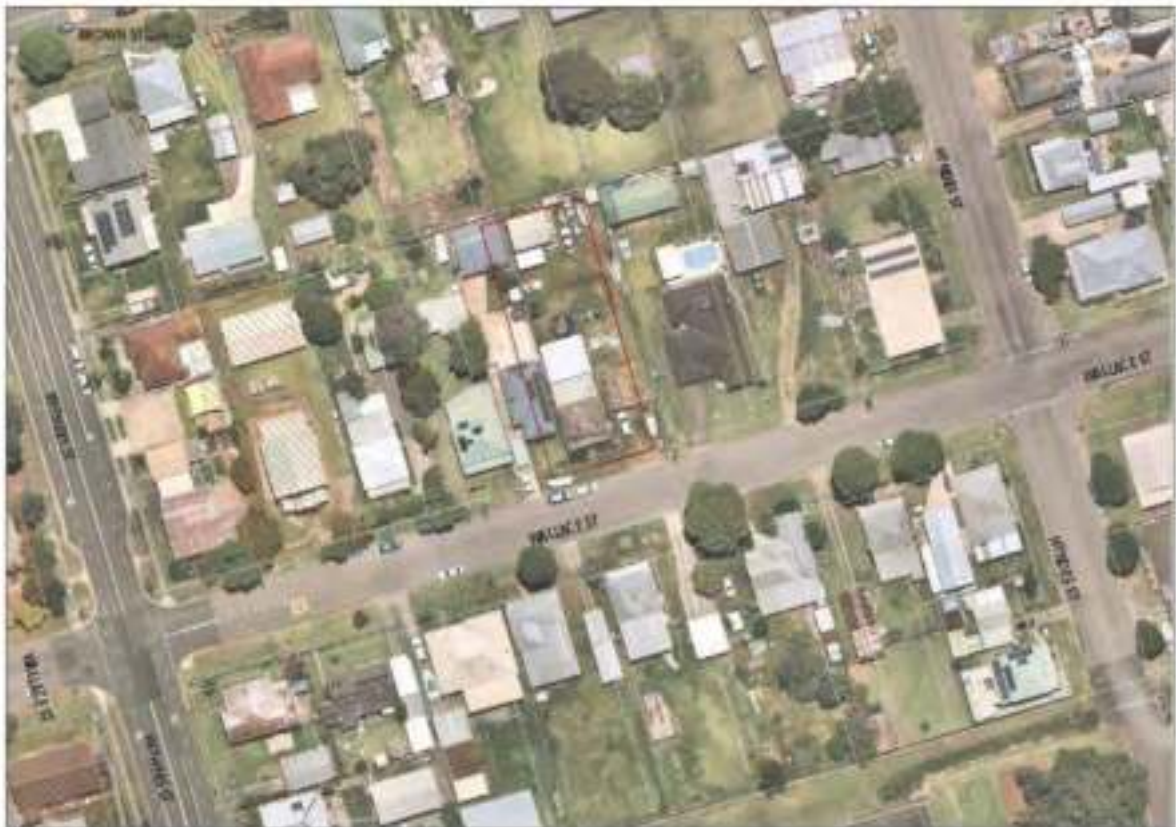
41 WALLACE STREET, WEST WALLESEND 2286

Conservation Area Contribution Level	Est. Construction Date	Previous studies and/or community input
Contributory 2	Early to late 20 th century (broad range)	No prior heritage assessments or research undertaken.
Assessment Text		Observed Modifications
<p>The scale (single-storey) and general style of the dwelling is consistent with that of the streetscape and wider HCA. Dwelling contributes positively to the streetscape and wider HCA, particularly in comparison to Non-Contributory buildings.</p> <p>The dwelling features appropriately proportioned and positioned fenestrations, an appropriate roof form (gabled or hipped) and other features consistent with the architectural character of the area (e.g. front verandah with timber or brick posts, timber detailing, corrugated metal roofing, etc). The contributory value of the dwelling is limited however by either:</p> <ul style="list-style-type: none"> External modifications that have in some way obscured the style, scale or design intent of the building and have resulted in less physical integrity than Contributory 1 buildings. Being a later dwelling constructed in an appropriate referential style, but comprising little to no fabric of intrinsic heritage significance. 		<p>All visible windows are contemporary designs.</p> <p>The tiled roof is a contemporary modification, likely replacing a Colourbond or iron sheeting. The skillion veranda roof is similarly contemporary, replacing an original bull nosed design.</p> <p>Two masonry/rendered cement pillars frame the entrance to the dwelling, both being a recent addition to the dwelling.</p>

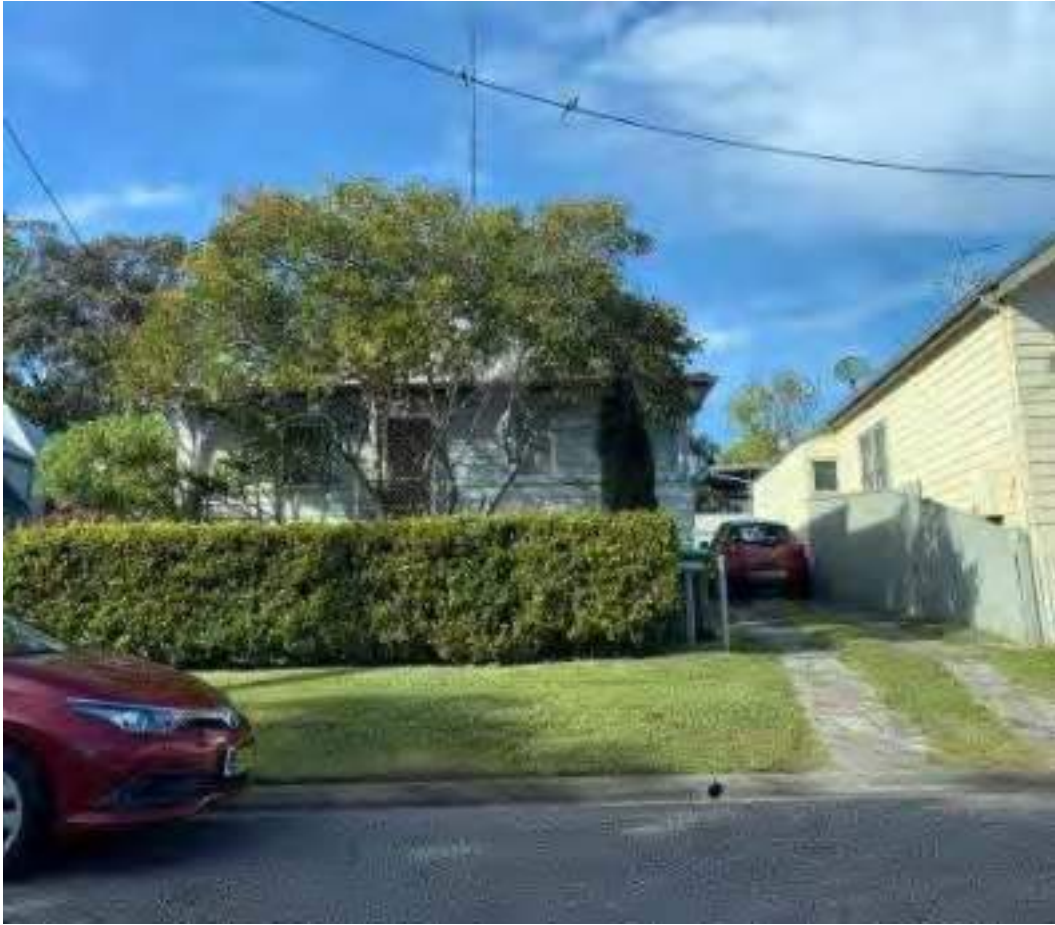
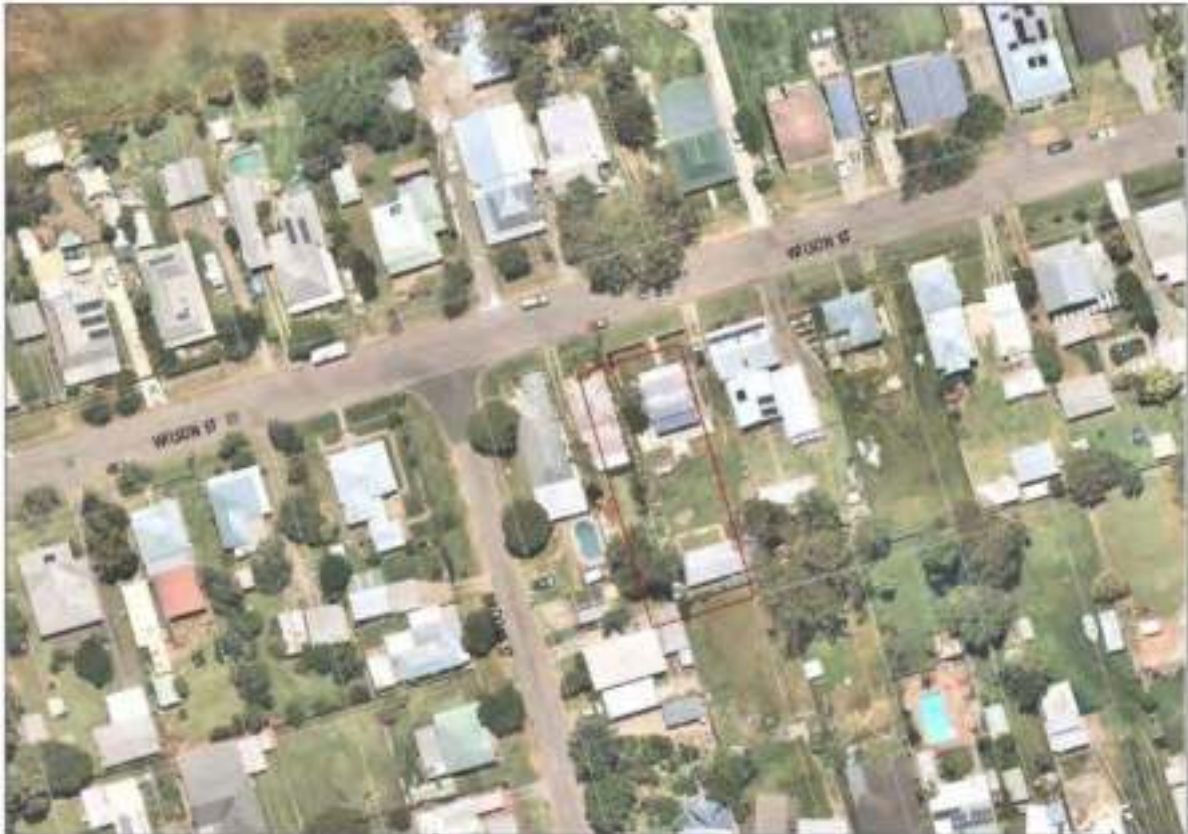
18 WILSON STREET, WEST WALLSEND 2286

Conservation Area Contribution Level	Est. Construction Date	Previous studies and/or community input
Contributory 2	Early to late 20 th century (broad range)	No prior heritage assessments or research undertaken.
Assessment Text		Observed Modifications
<p>The scale (single-storey) and general style of the dwelling is consistent with that of the streetscape and wider HCA. Dwelling contributes positively to the streetscape and wider HCA, particularly in comparison to Non-Contributory buildings.</p> <p>The dwelling features appropriately proportioned and positioned fenestrations, an appropriate roof form (gabled or hipped) and other features consistent with the architectural character of the area (e.g. front verandah with timber or brick posts, timber detailing, corrugated metal roofing, etc). The contributory value of the dwelling is limited however by either:</p> <ul style="list-style-type: none"> • External modifications that have in some way obscured the style, scale or design intent of the building and have resulted in less physical integrity than Contributory 1 buildings. • Being a later dwelling constructed in an appropriate referential style, but comprising little to no fabric of intrinsic heritage significance. 		<p>The veranda has been fully enclosed to create an additional living area. This is a common modification for the area.</p> <p>All visible windows are contemporary designs.</p> <p>The dwelling is partially obscured by vegetation.</p>
