APPENDIX 2

Building Assessment Sheets (Inventory Sheets)

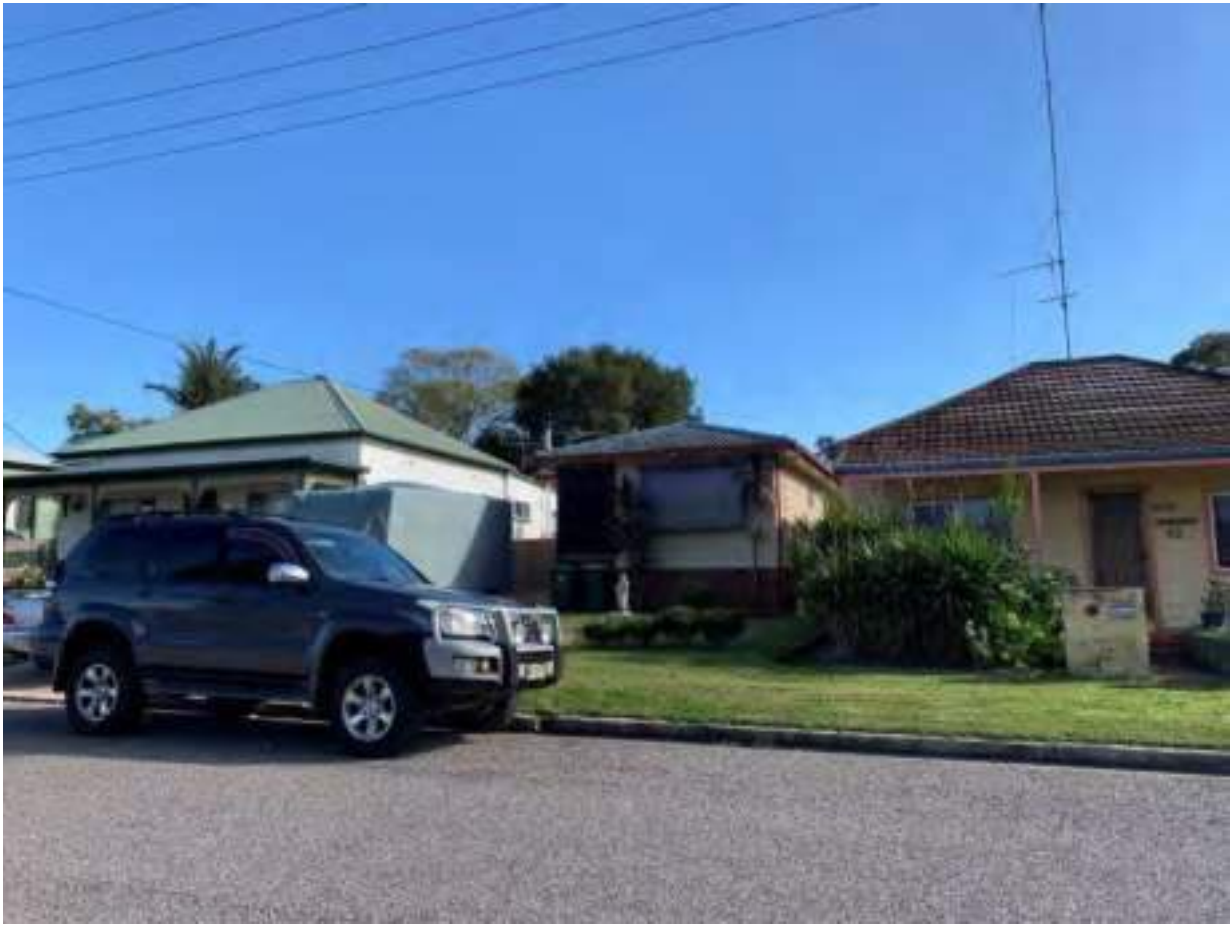
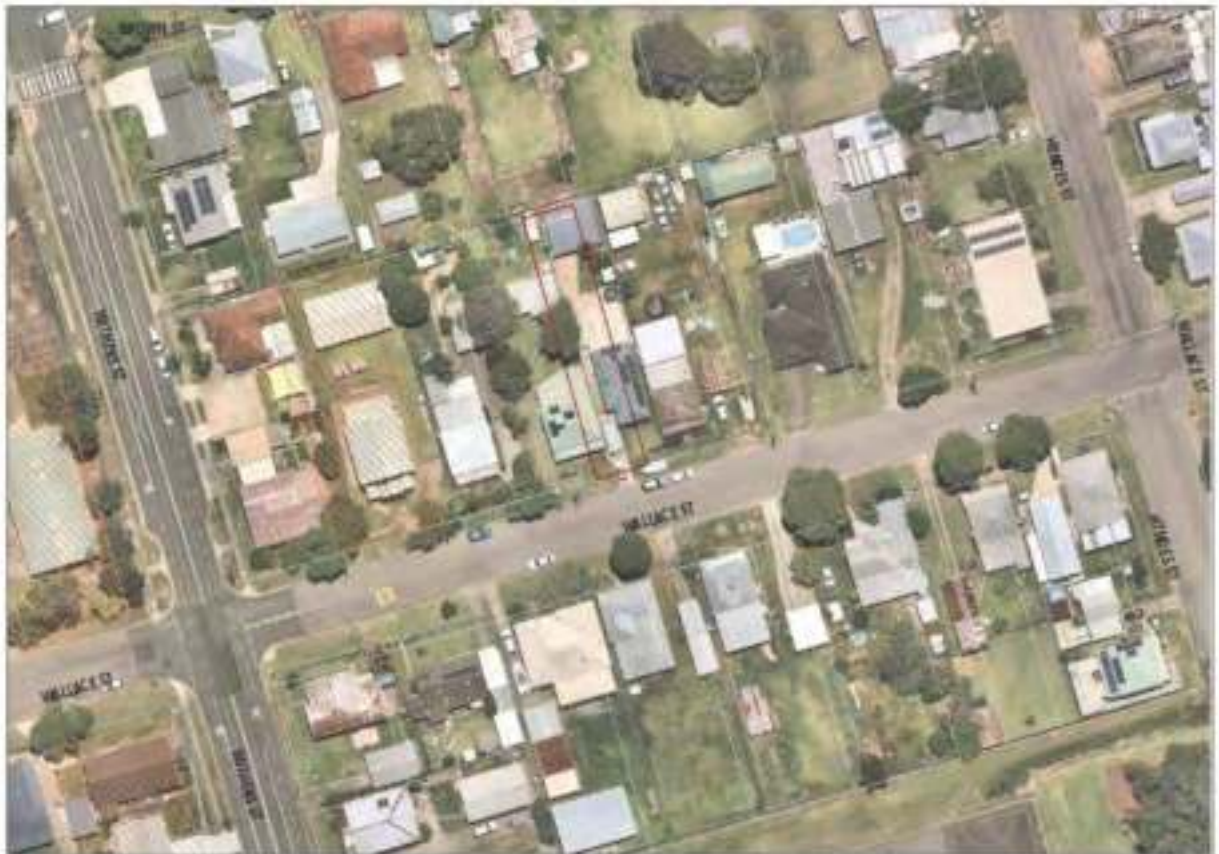
43 WALLACE STREET, WEST WALLSEND 2286

Conservation Area Contribution Level	Est. Construction Date	Previous studies and/or community input
Contributory 2	Early to late 20 th century (broad range)	No prior heritage assessments or research undertaken.
Assessment Text		Observed Modifications
<p>The scale (single-storey) and general style of the dwelling is consistent with that of the streetscape and wider HCA. Dwelling contributes positively to the streetscape and wider HCA, particularly in comparison to Non-Contributory buildings.</p> <p>The dwelling features appropriately proportioned and positioned fenestrations, an appropriate roof form (gabled or hipped) and other features consistent with the architectural character of the area (e.g. front verandah with timber or brick posts, timber detailing, corrugated metal roofing, etc). The contributory value of the dwelling is limited however by either:</p> <ul style="list-style-type: none"> • External modifications that have in some way obscured the style, scale or design intent of the building and have resulted in less physical integrity than Contributory 1 buildings. • Being a later dwelling constructed in an appropriate referential style, but comprising little to no fabric of intrinsic heritage significance. 		<p>A canvas/mesh screen has been installed to obscure the veranda space.</p> <p>A large canvas blind has been installed on the southern side of the dwelling, dominating the front façade.</p>

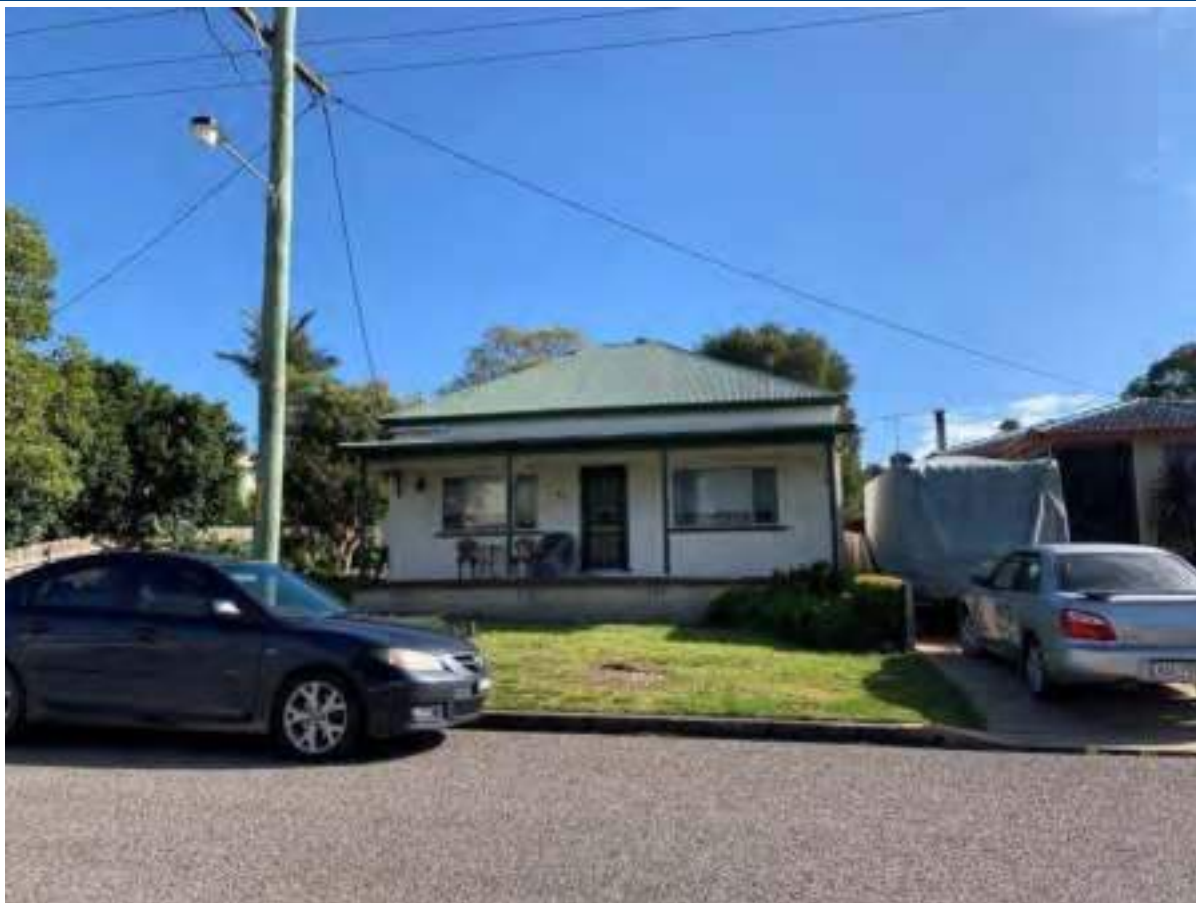
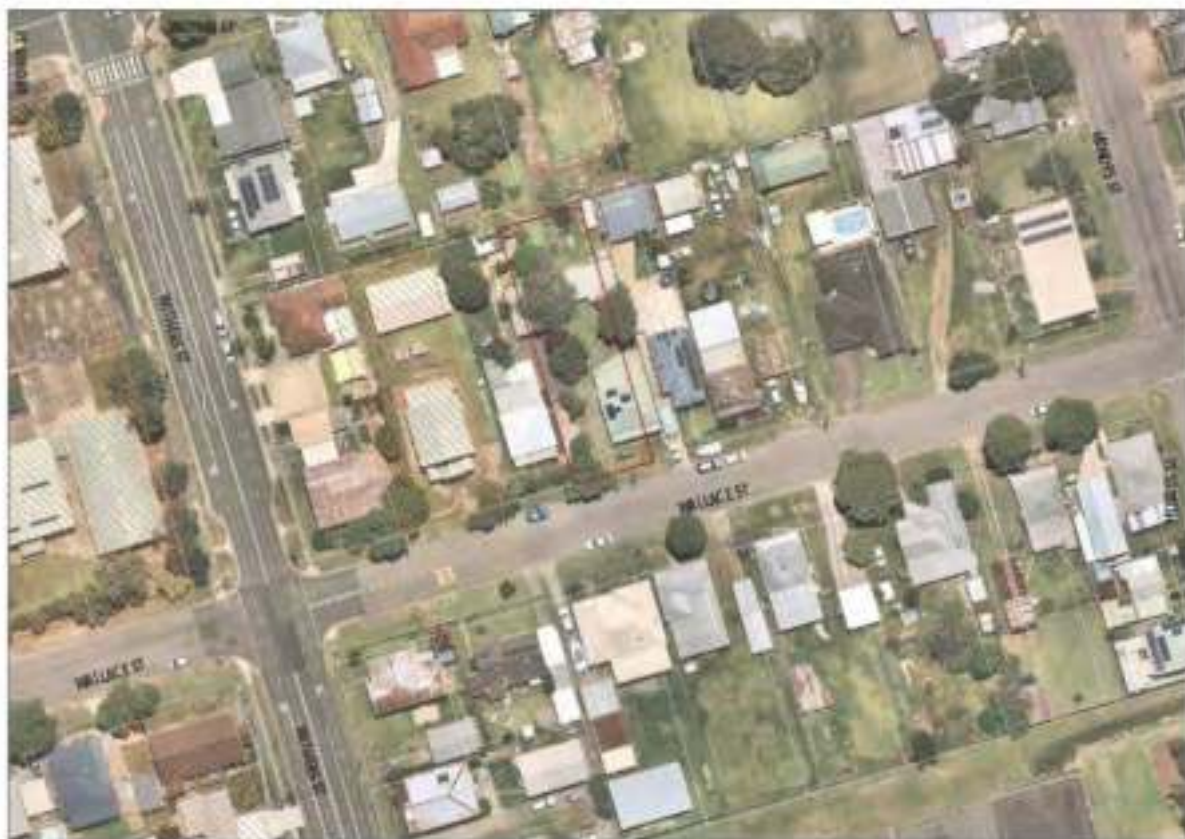
45 WALLACE STREET, WEST WALLSEND 2286

Conservation Area Contribution Level	Est. Construction Date	Previous studies and/or community input
Contributory 2	Early to late 20 th century (broad range)	No prior heritage assessments or research undertaken.
Assessment Text		Observed Modifications
<p>The scale (single-storey) and general style of the dwelling is consistent with that of the streetscape and wider HCA. Dwelling contributes positively to the streetscape and wider HCA, particularly in comparison to Non-Contributory buildings. The dwelling features appropriately proportioned and positioned fenestrations, an appropriate roof form (gabled or hipped) and other features consistent with the architectural character of the area (e.g. front verandah with timber or brick posts, timber detailing, corrugated metal roofing, etc). The contributory value of the dwelling is limited however by either:</p> <ul style="list-style-type: none"> • External modifications that have in some way obscured the style, scale or design intent of the building and have resulted in less physical integrity than Contributory 1 buildings. • Being a later dwelling constructed in an appropriate referential style, but comprising little to no fabric of intrinsic heritage significance. 		<p>The visible windows are contemporary in design.</p> <p>The skillion veranda roof is a replacement of an original bull nosed or hipped design.</p> <p>The cast iron valance is likely a contemporary addition, replicating an original heritage design.</p>

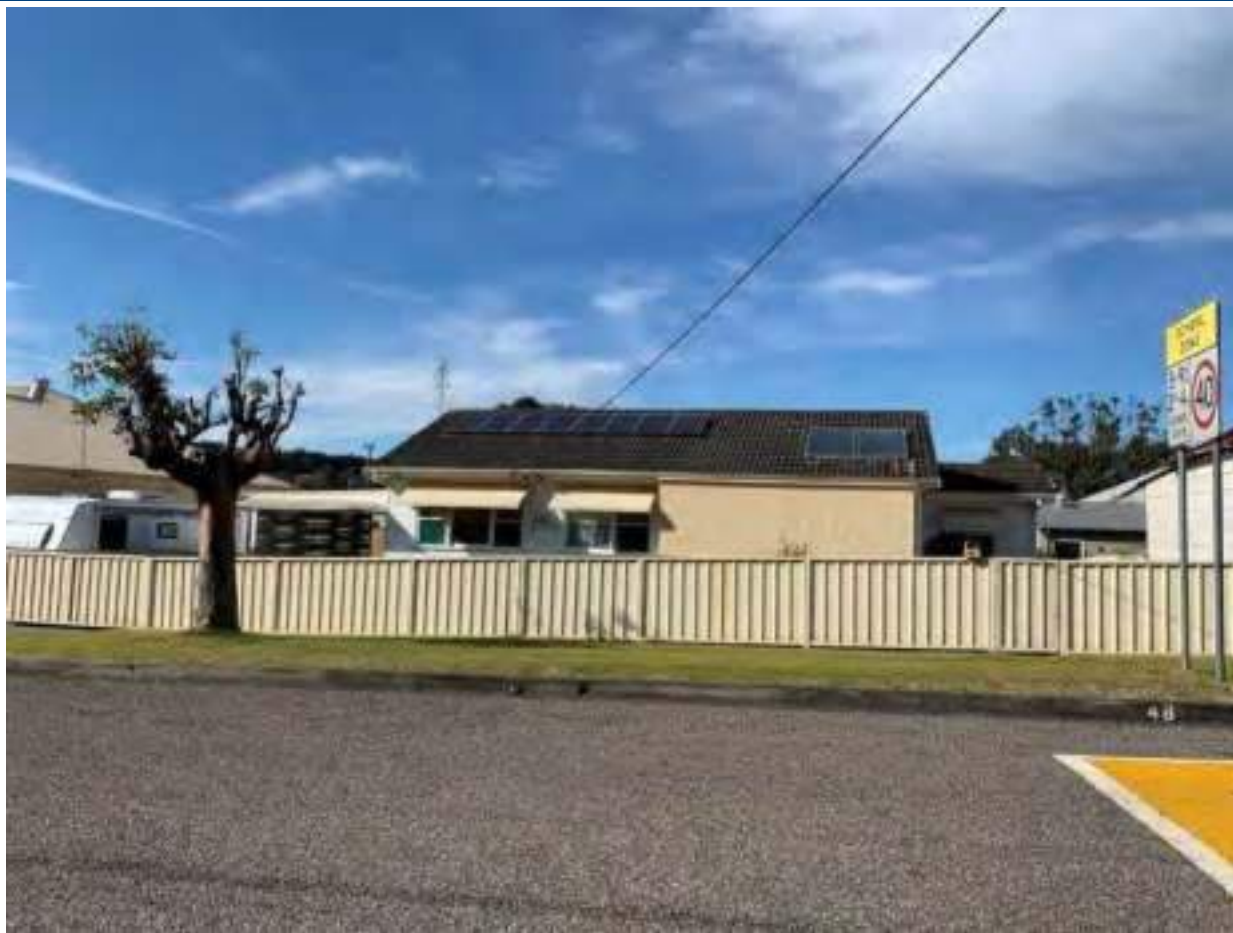
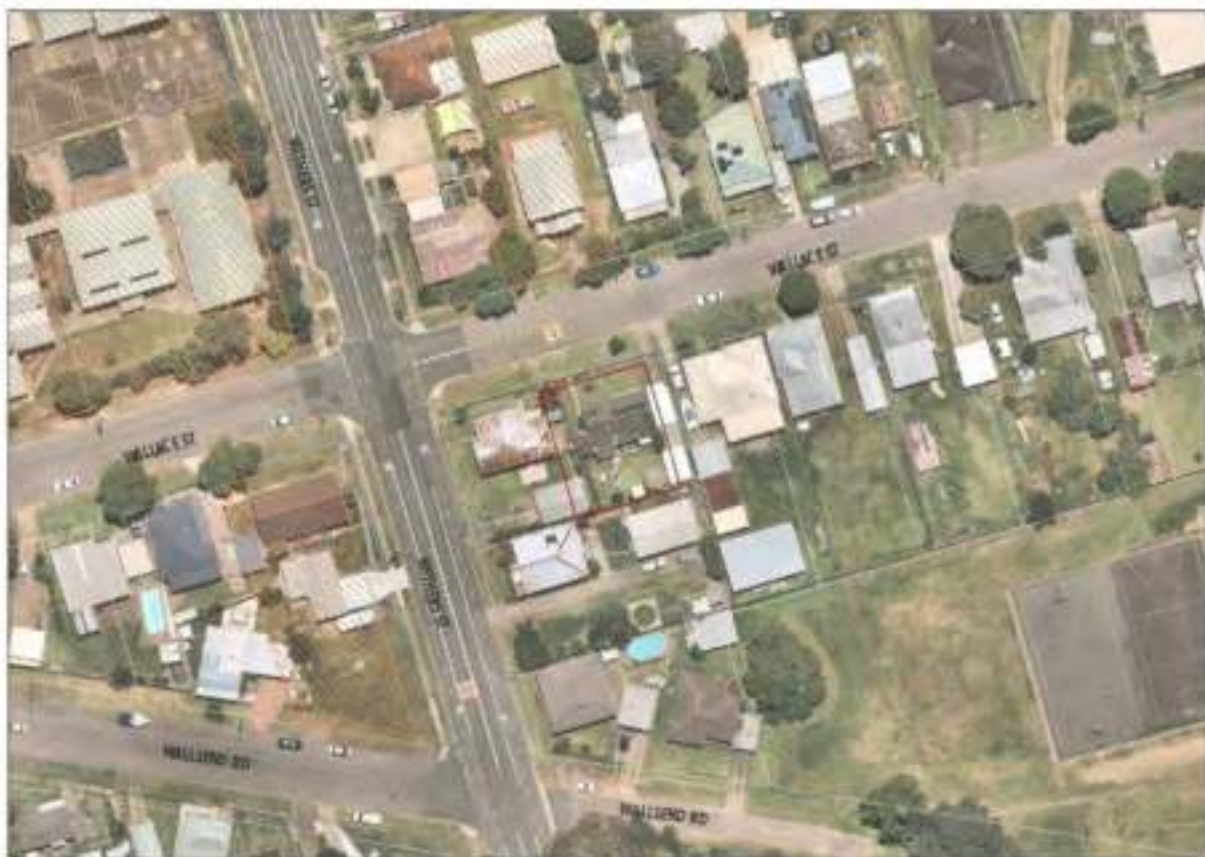
48 WALLACE STREET, WEST WALLSEND 2286

Conservation Area Contribution Level	Est. Construction Date	Previous studies and/or community input
Contributory 2	Early to late 20 th century (broad range)	No prior heritage assessments or research undertaken.
Assessment Text		Observed Modifications
<p>The scale (single-storey) and general style of the dwelling is consistent with that of the streetscape and wider HCA. Dwelling contributes positively to the streetscape and wider HCA, particularly in comparison to Non-Contributory buildings.</p> <p>The dwelling features appropriately proportioned and positioned fenestrations, an appropriate roof form (gabled or hipped) and other features consistent with the architectural character of the area (e.g. front verandah with timber or brick posts, timber detailing, corrugated metal roofing, etc). The contributory value of the dwelling is limited however by either:</p> <ul style="list-style-type: none"> • External modifications that have in some way obscured the style, scale or design intent of the building and have resulted in less physical integrity than Contributory 1 buildings. • Being a later dwelling constructed in an appropriate referential style, but comprising little to no fabric of intrinsic heritage significance. 		<p>Solar panels are visible along the northern portion of the roof.</p> <p>A large canvas blind has been installed, obscuring the dwellings façade.</p>

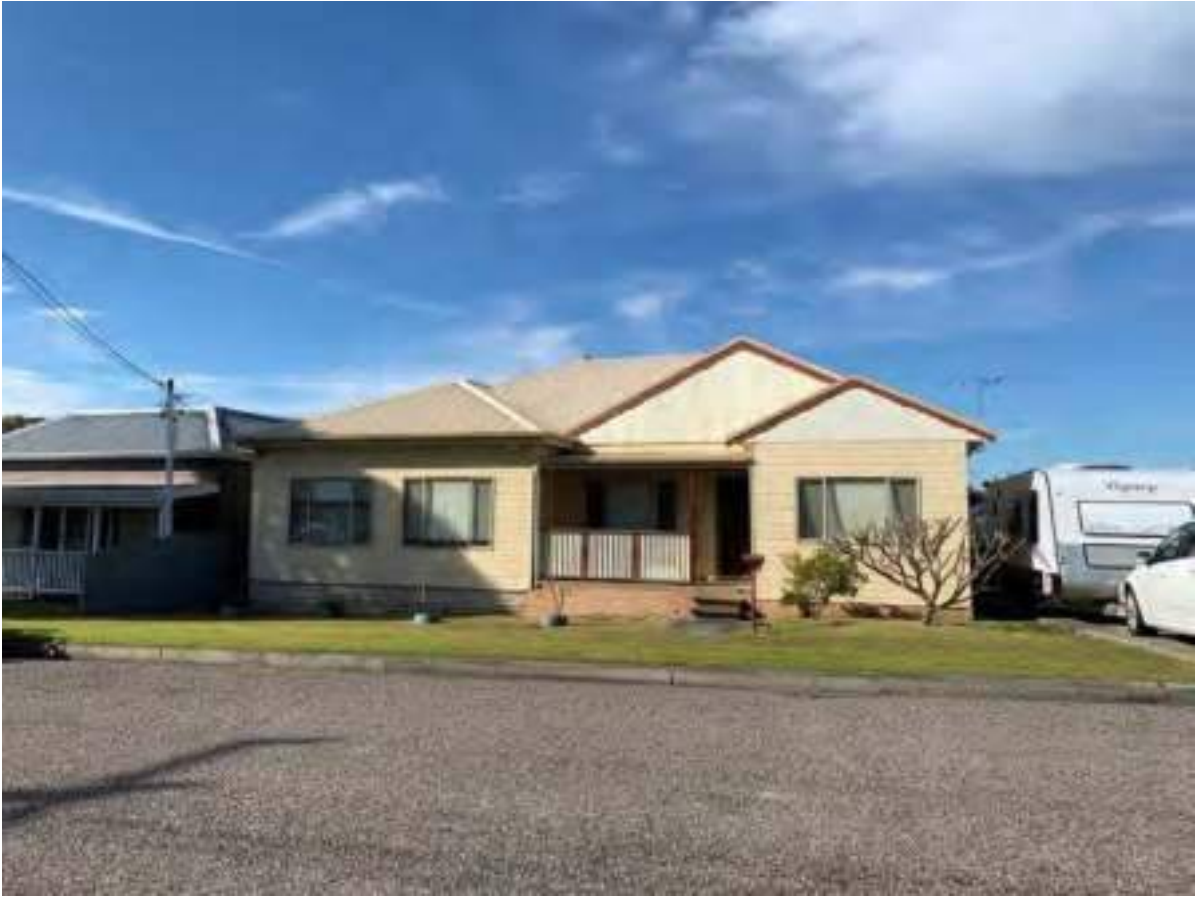
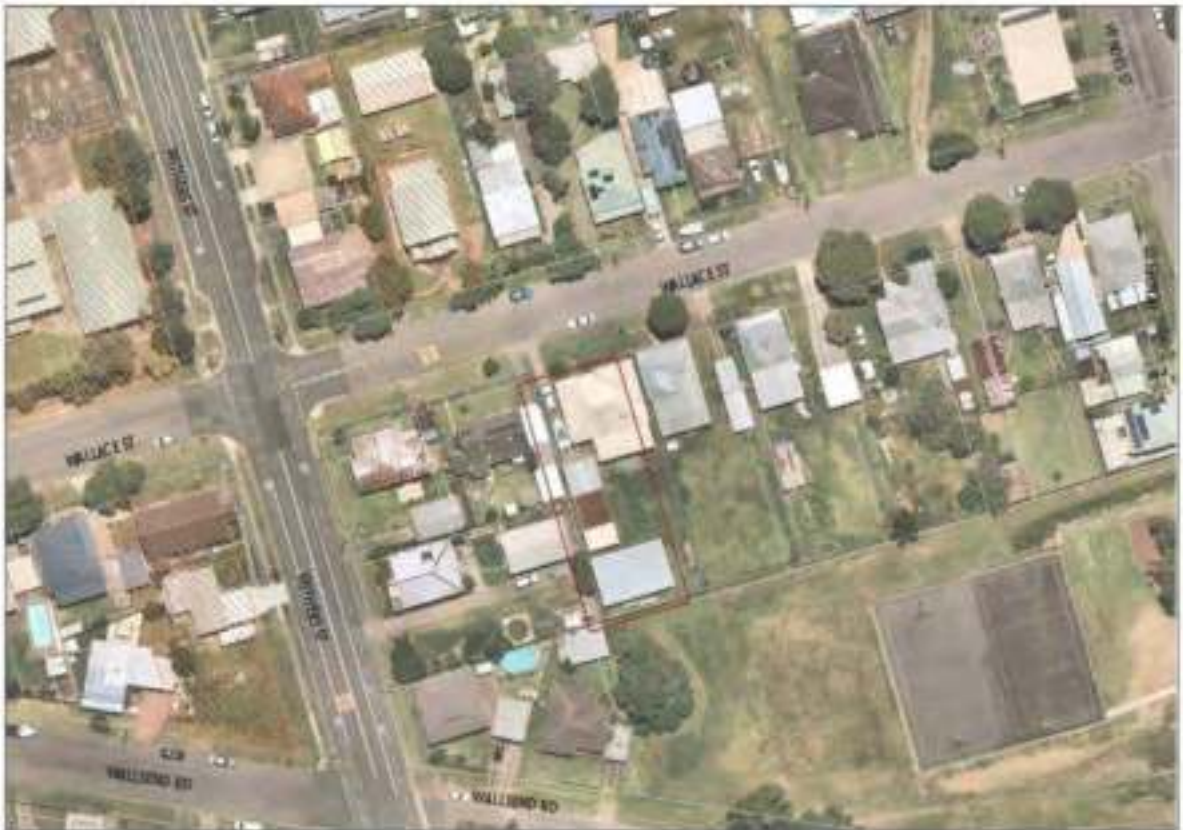
46 WALLACE STREET, WEST WALLSEND 2286

Conservation Area Contribution Level	Est. Construction Date	Previous studies and/or community input
Contributory 2	Early to late 20 th century (broad range)	No prior heritage assessments or research undertaken.
Assessment Text		Observed Modifications
<p>The scale (single-storey) and general style of the dwelling is consistent with that of the streetscape and wider HCA. Dwelling contributes positively to the streetscape and wider HCA, particularly in comparison to Non-Contributory buildings.</p> <p>The dwelling features appropriately proportioned and positioned fenestrations, an appropriate roof form (gabled or hipped) and other features consistent with the architectural character of the area (e.g. front verandah with timber or brick posts, timber detailing, corrugated metal roofing, etc). The contributory value of the dwelling is limited however by either:</p> <ul style="list-style-type: none"> • External modifications that have in some way obscured the style, scale or design intent of the building and have resulted in less physical integrity than Contributory 1 buildings. • Being a later dwelling constructed in an appropriate referential style, but comprising little to no fabric of intrinsic heritage significance. 		<p>A large eastern extension has been constructed onto the dwelling. this has been done in a sympathetic manner, however is highly visible and detracts from the heritage streetscape.</p> <p>All visible windows are contemporary in design.</p>

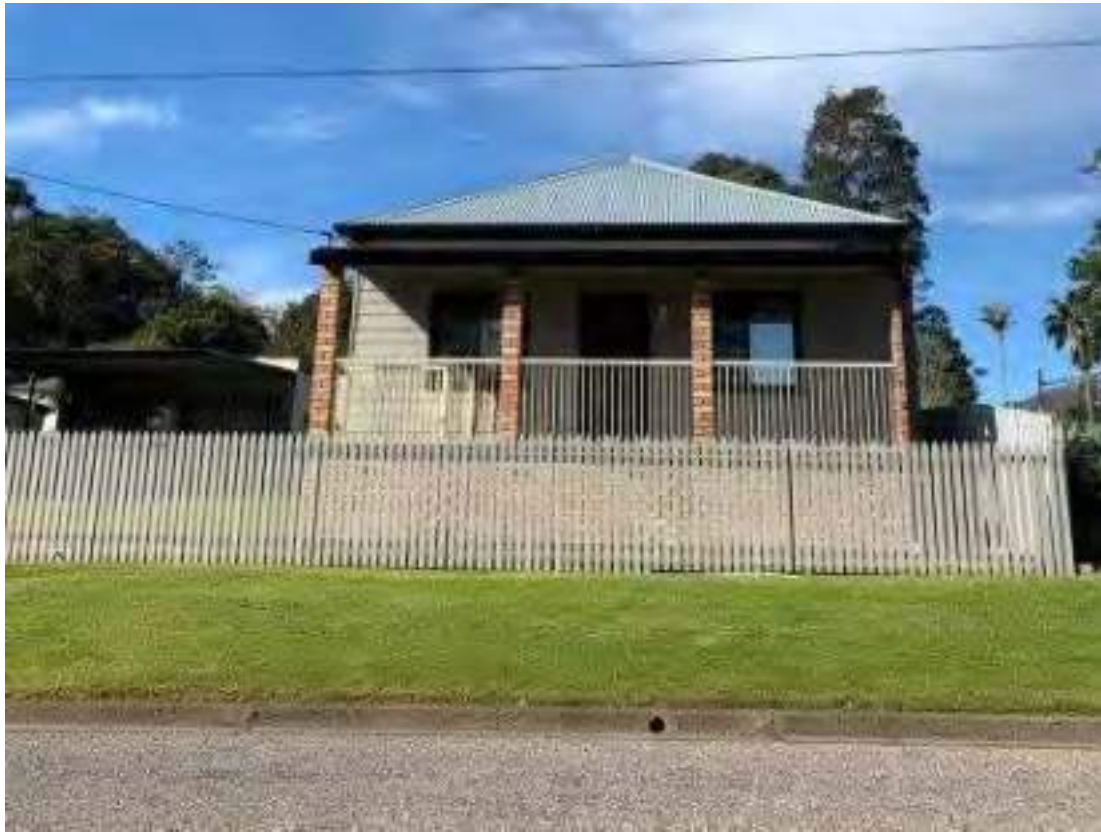
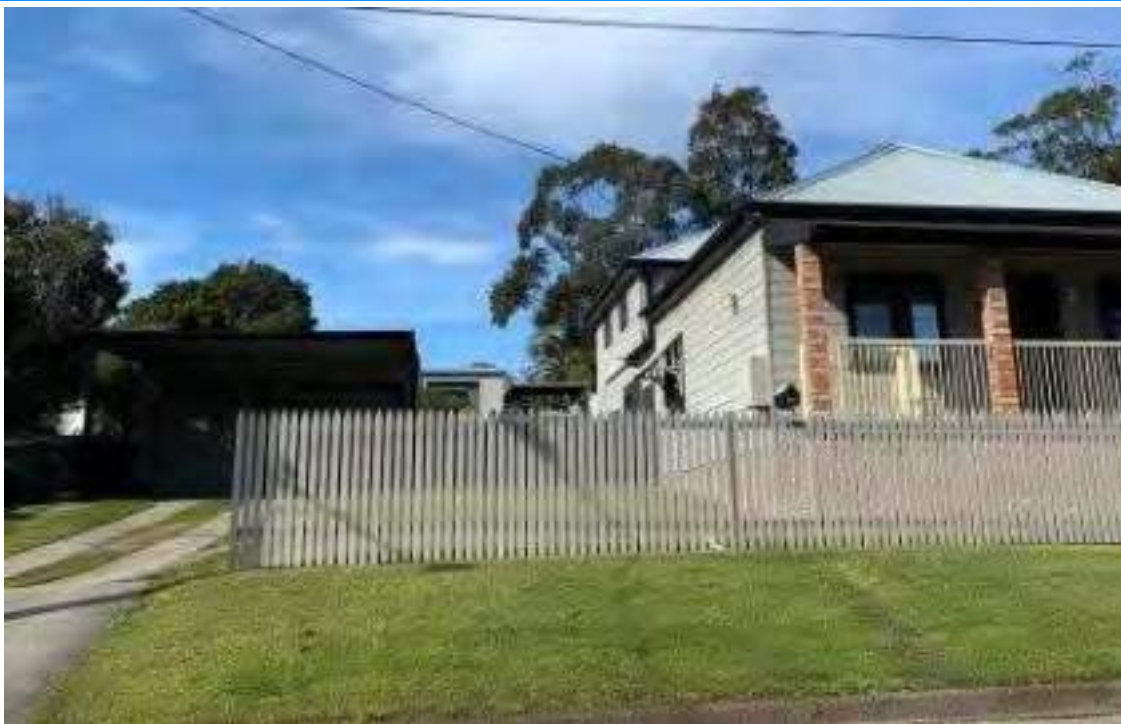
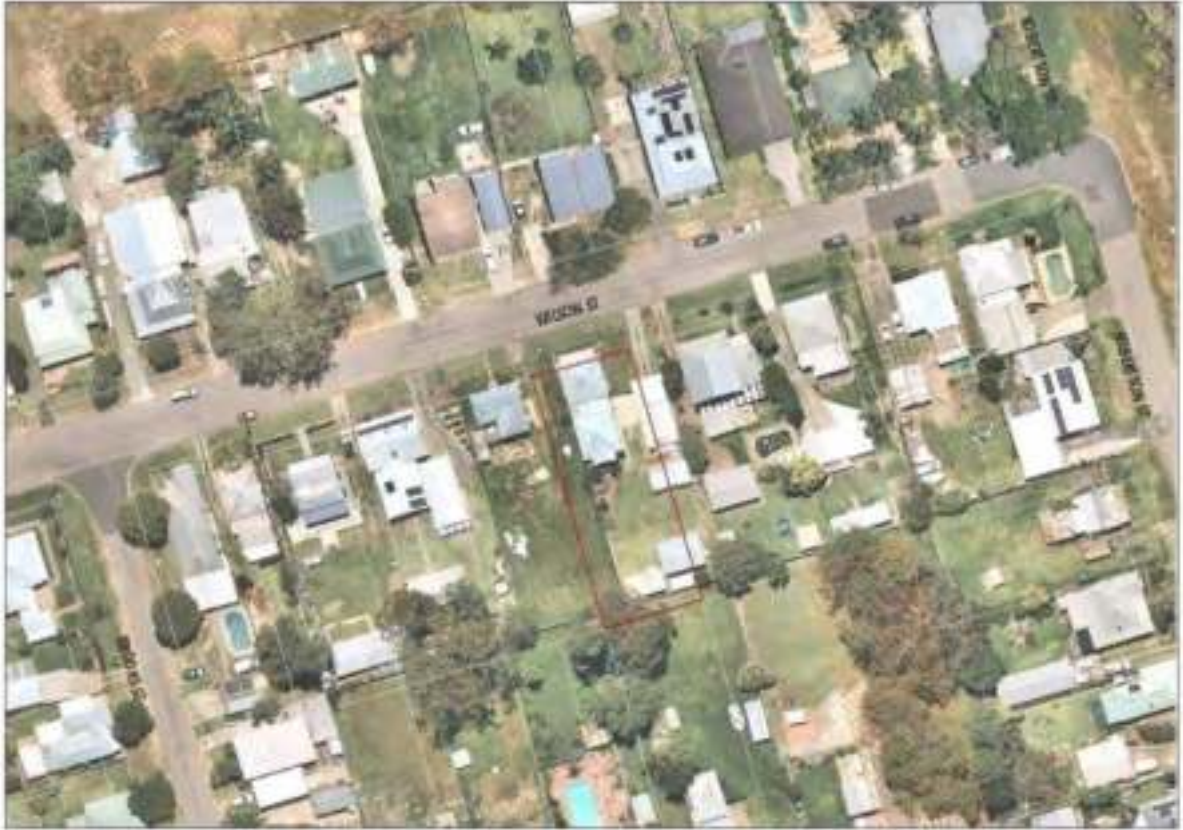
10 WILSON STREET, WEST WALLSEND 2286

Conservation Area Contribution Level	Est. Construction Date	Previous studies and/or community input
Contributory 2	Early to late 20 th century (broad range)	No prior heritage assessments or research undertaken.
Assessment Text		Observed Modifications
<p>The scale (single-storey) and general style of the dwelling is consistent with that of the streetscape and wider HCA. Dwelling contributes positively to the streetscape and wider HCA, particularly in comparison to Non-Contributory buildings.</p> <p>The dwelling features appropriately proportioned and positioned fenestrations, an appropriate roof form (gabled or hipped) and other features consistent with the architectural character of the area (e.g. front verandah with timber or brick posts, timber detailing, corrugated metal roofing, etc). The contributory value of the dwelling is limited however by either:</p> <ul style="list-style-type: none"> External modifications that have in some way obscured the style, scale or design intent of the building and have resulted in less physical integrity than Contributory 1 buildings. Being a later dwelling constructed in an appropriate referential style, but comprising little to no fabric of intrinsic heritage significance. 		<p>The veranda roof has been modified to a skillion design, likely originally being hipped or bull nosed.</p> <p>The brick work veranda pillars are a recent addition, as is the metal balustrade partially enclosing the verandah space. Neither are sympathetic to the heritage streetscape and detract from the original heritage features of the dwelling.</p> <p>The visible windows are contemporary in style.</p>

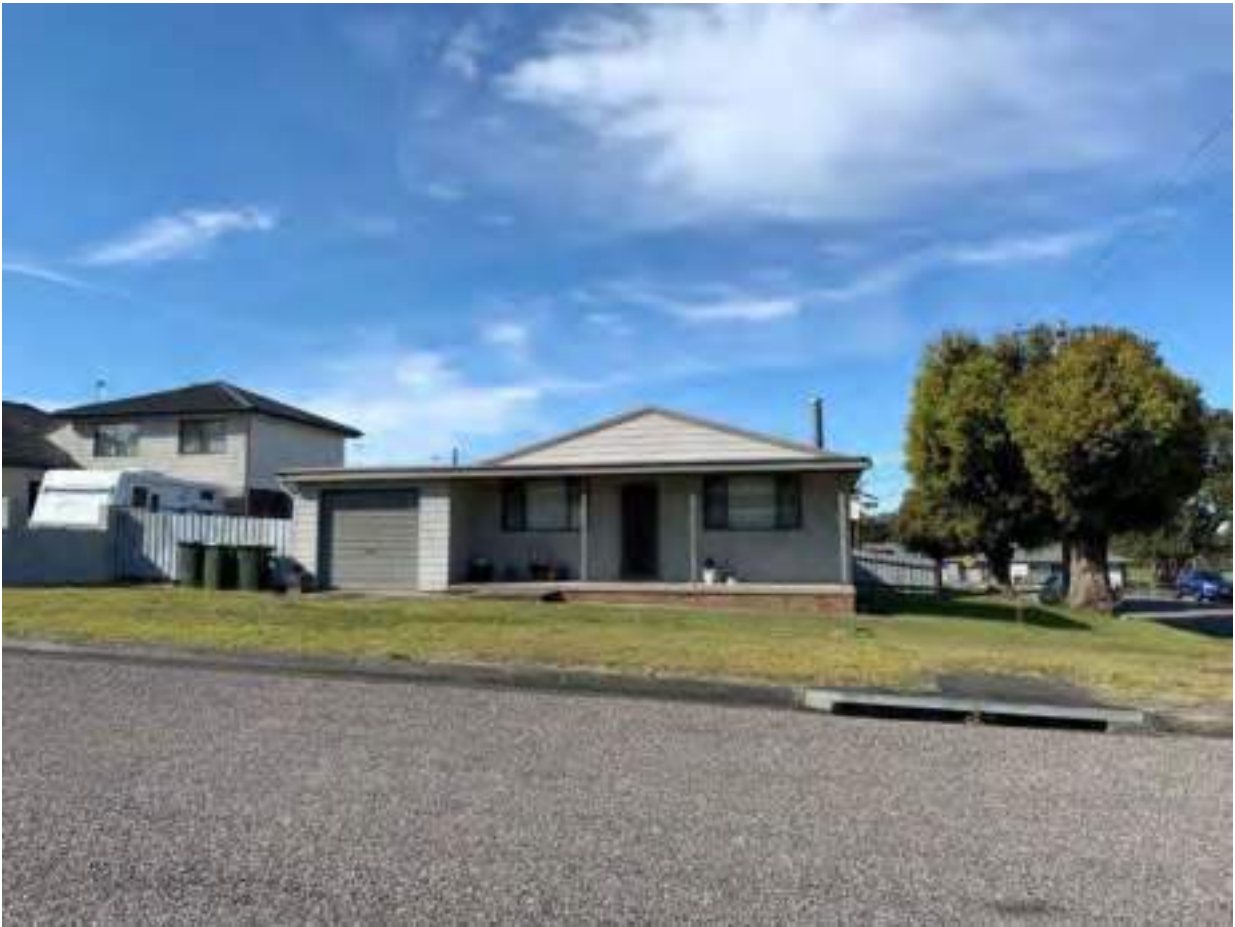
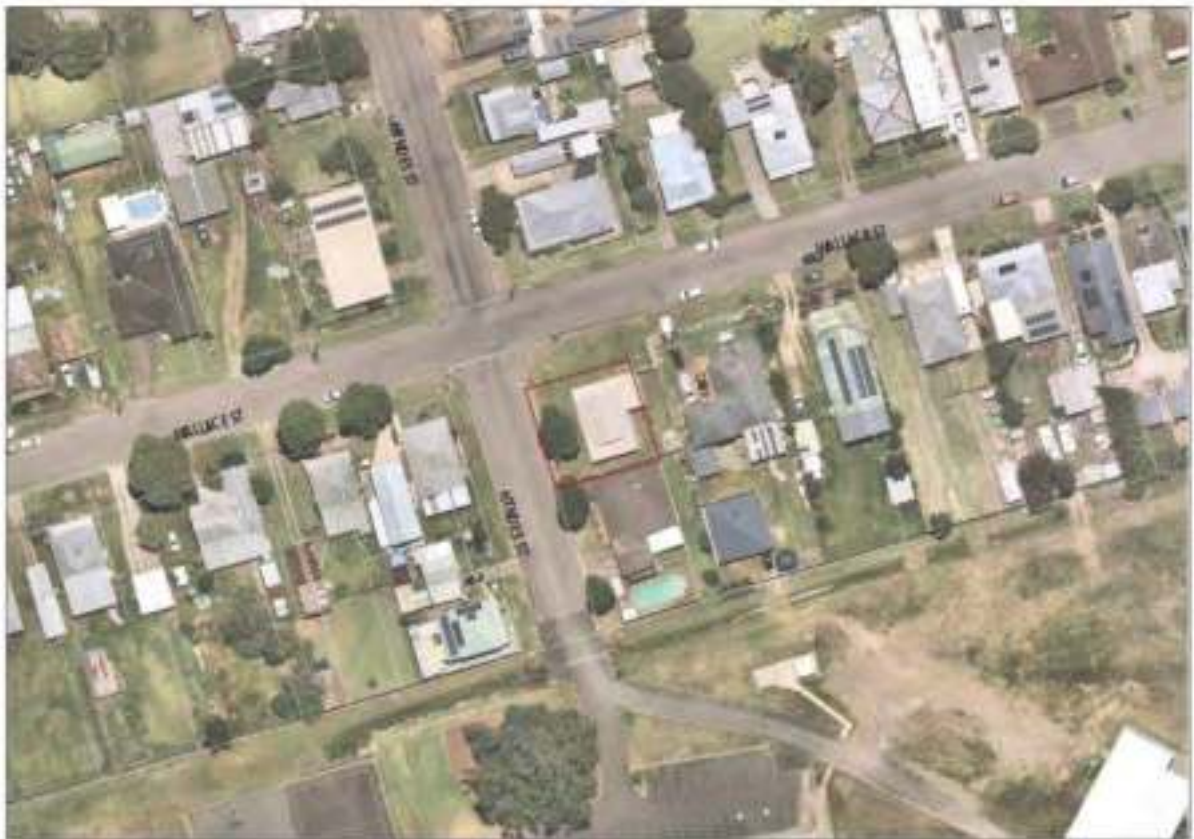
15 HYNES STREET, WEST WALLSEND 2286

Conservation Area Contribution Level	Est. Construction Date	Previous studies and/or community input
Contributory 2	Early to late 20 th century (broad range)	No prior heritage assessments or research undertaken.
Assessment Text		Observed Modifications
<p>The scale (single-storey) and general style of the dwelling is consistent with that of the streetscape and wider HCA. Dwelling contributes positively to the streetscape and wider HCA, particularly in comparison to Non-Contributory buildings.</p> <p>The dwelling features appropriately proportioned and positioned fenestrations, an appropriate roof form (gabled or hipped) and other features consistent with the architectural character of the area (e.g. front verandah with timber or brick posts, timber detailing, corrugated metal roofing, etc). The contributory value of the dwelling is limited however by either:</p> <ul style="list-style-type: none"> • External modifications that have in some way obscured the style, scale or design intent of the building and have resulted in less physical integrity than Contributory 1 buildings. • Being a later dwelling constructed in an appropriate referential style, but comprising little to no fabric of intrinsic heritage significance. 		<p>The garage located to the east of the dwelling is likely a contemporary addition to the dwelling.</p> <p>The visible windows are contemporary in style.</p>

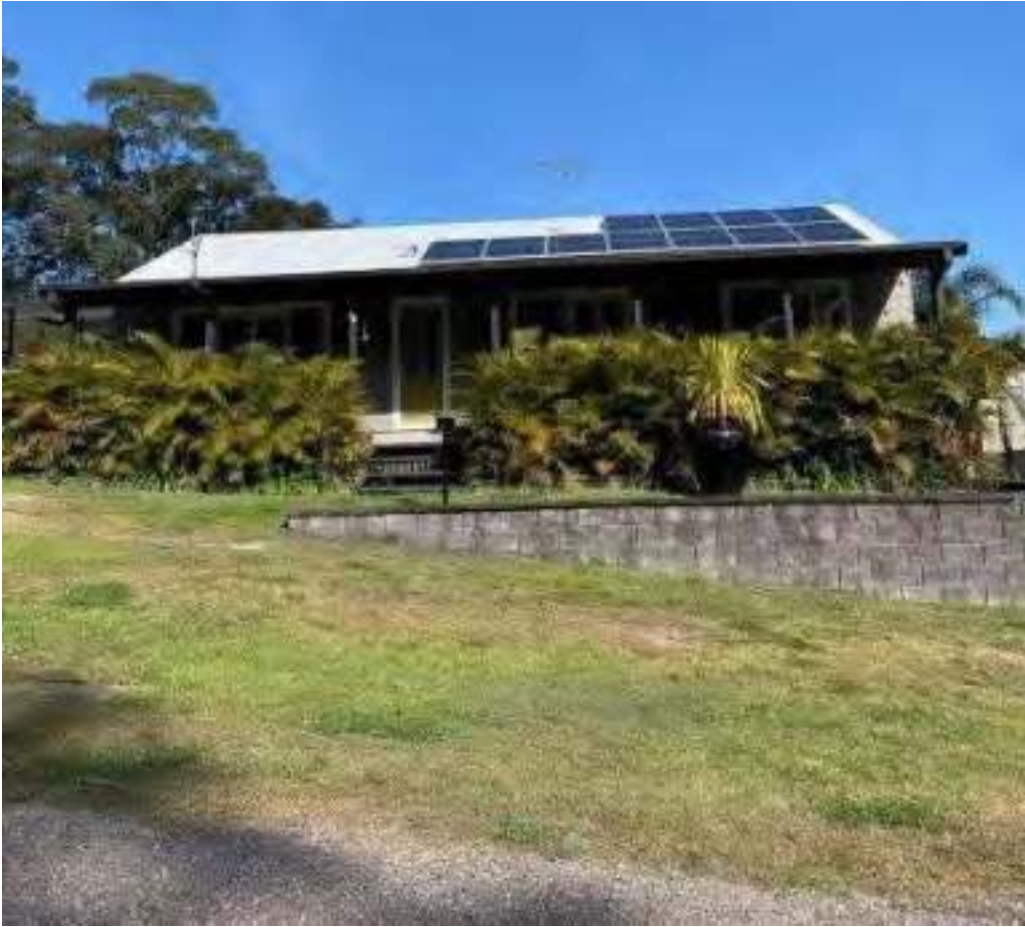
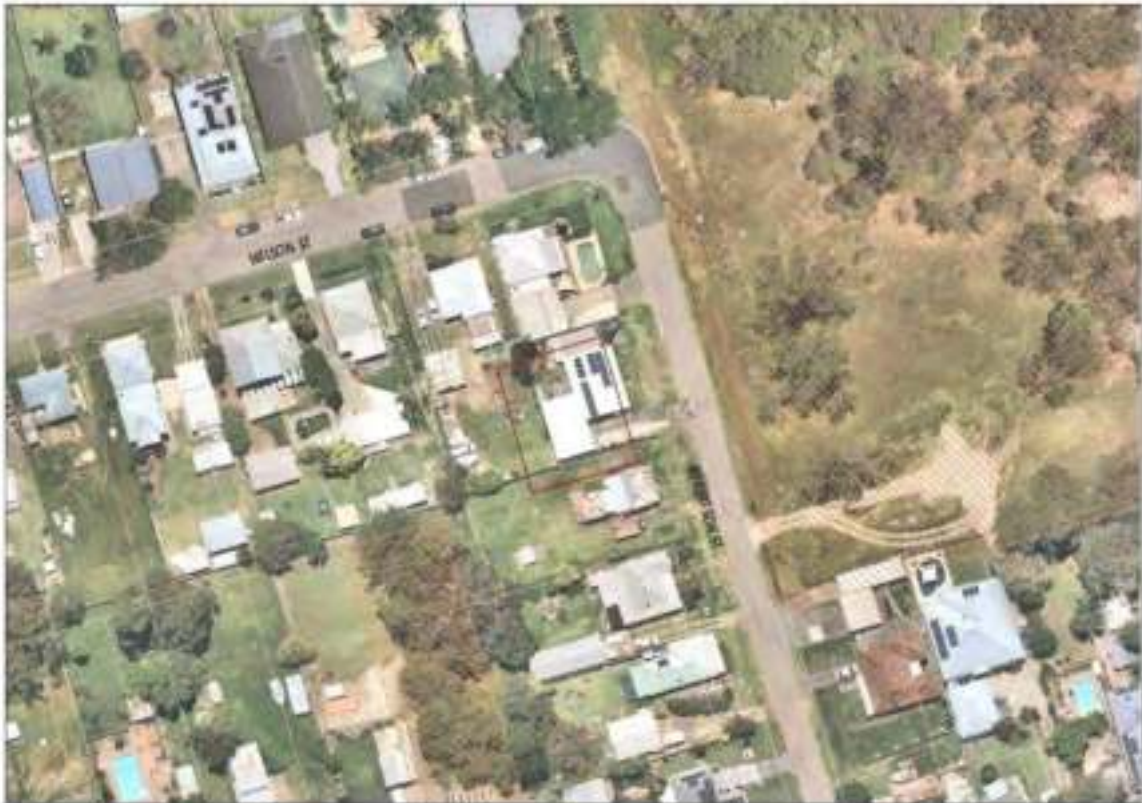
2A ROBERTSON STREET, WEST WALLSEND 2286

Conservation Area Contribution Level	Est. Construction Date	Previous studies and/or community input
Contributory 2	Early to late 20 th century (broad range)	No prior heritage assessments or research undertaken.
Assessment Text		Observed Modifications
<p>The scale (single-storey) and general style of the dwelling is consistent with that of the streetscape and wider HCA. Dwelling contributes positively to the streetscape and wider HCA, particularly in comparison to Non-Contributory buildings.</p> <p>The dwelling features appropriately proportioned and positioned fenestrations, an appropriate roof form (gabled or hipped) and other features consistent with the architectural character of the area (e.g. front verandah with timber or brick posts, timber detailing, corrugated metal roofing, etc). The contributory value of the dwelling is limited however by either:</p> <ul style="list-style-type: none"> • External modifications that have in some way obscured the style, scale or design intent of the building and have resulted in less physical integrity than Contributory 1 buildings. • Being a later dwelling constructed in an appropriate referential style, but comprising little to no fabric of intrinsic heritage significance. 		Solar panels are highly visible along the eastern portion of the roof.

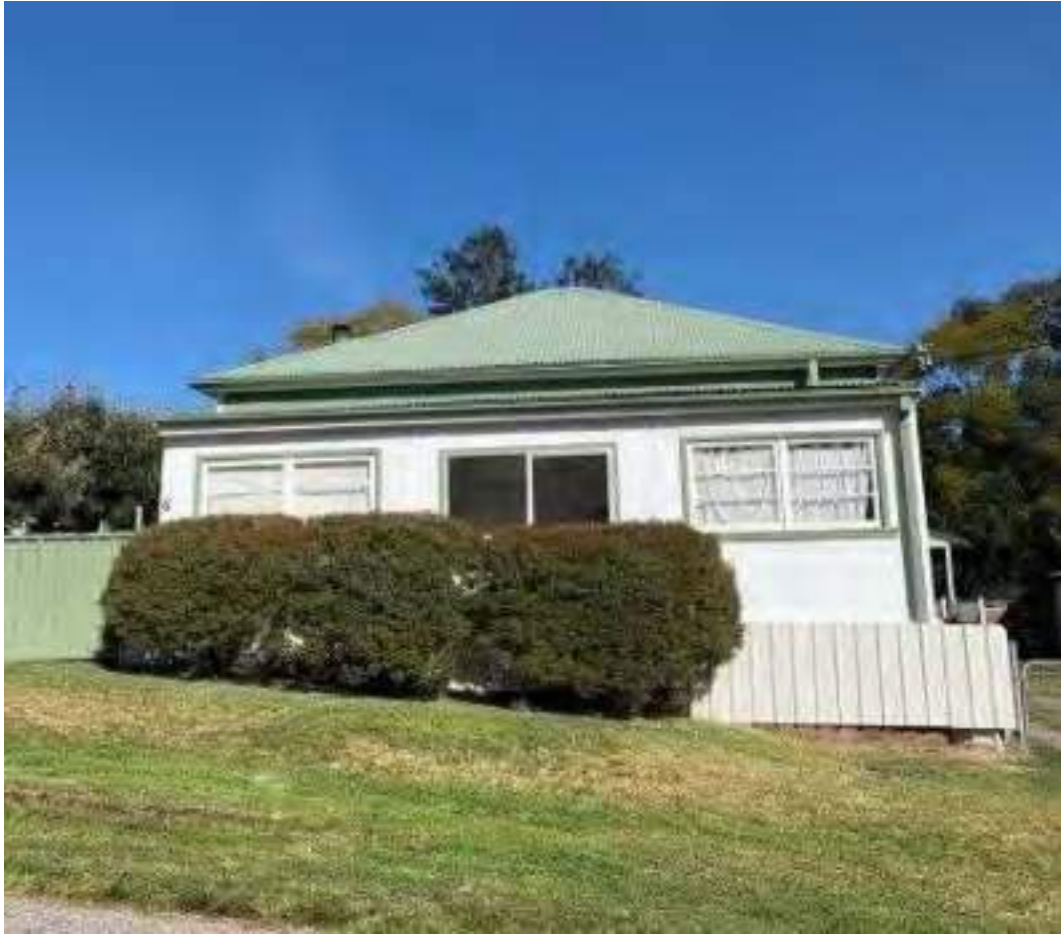
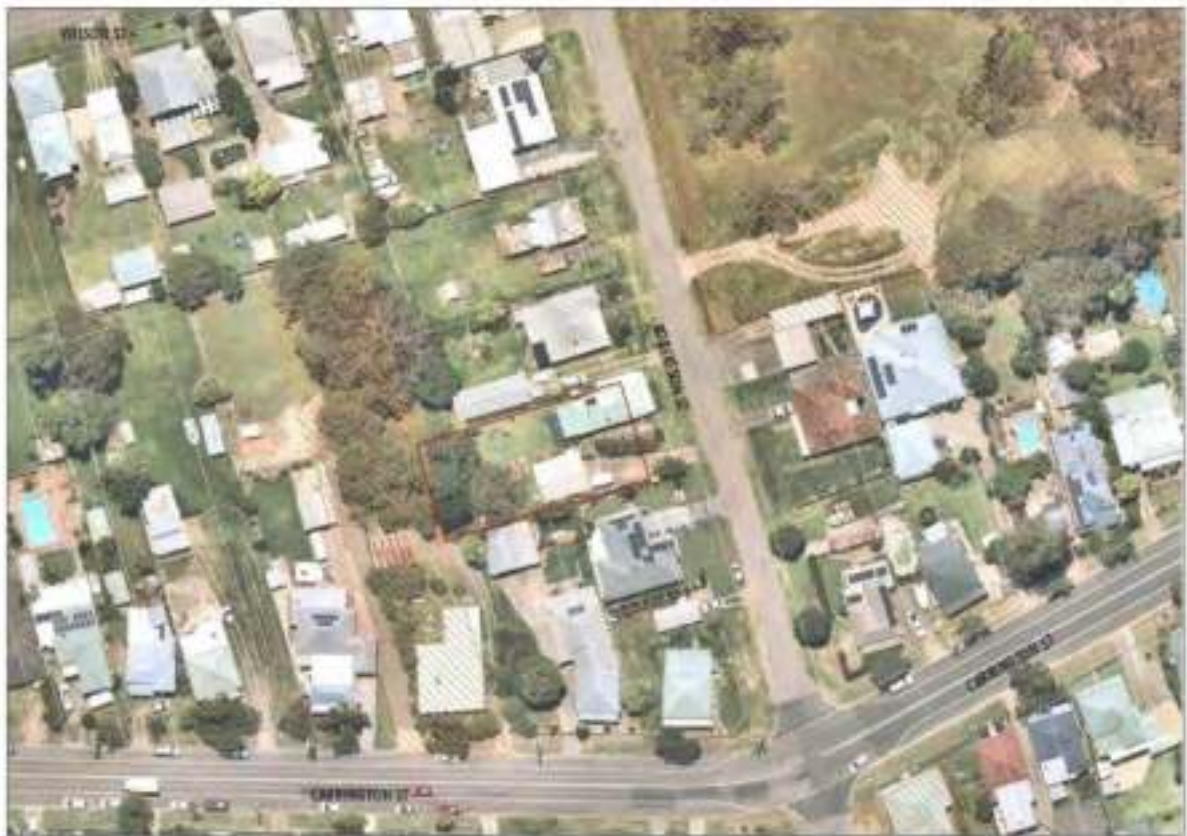
6 ROBERTSON STREET, WEST WALLSEND 2286

Conservation Area Contribution Level	Est. Construction Date	Previous studies and/or community input
Contributory 2	Circa 1900	No prior heritage assessments or research undertaken.
Assessment Text		Observed Modifications
<p>The scale (single-storey) and general style of the dwelling is consistent with that of the streetscape and wider HCA. Dwelling contributes positively to the streetscape and wider HCA, particularly in comparison to Non-Contributory buildings.</p> <p>The dwelling features appropriately proportioned and positioned fenestrations, an appropriate roof form (gabled or hipped) and other features consistent with the architectural character of the area (e.g. front verandah with timber or brick posts, timber detailing, corrugated metal roofing, etc). The contributory value of the dwelling is limited however by either:</p> <ul style="list-style-type: none"> • External modifications that have in some way obscured the style, scale or design intent of the building and have resulted in less physical integrity than Contributory 1 buildings. • Being a later dwelling constructed in an appropriate referential style, but comprising little to no fabric of intrinsic heritage significance. 		<p>The veranda has been built in to construct an additional living area.</p> <p>The visible windows and door are contemporary in style.</p> <p>A rear extension has been constructed, however is not visible from the street.</p>
