APPENDIX 2

Building Assessment Sheets (Inventory Sheets)

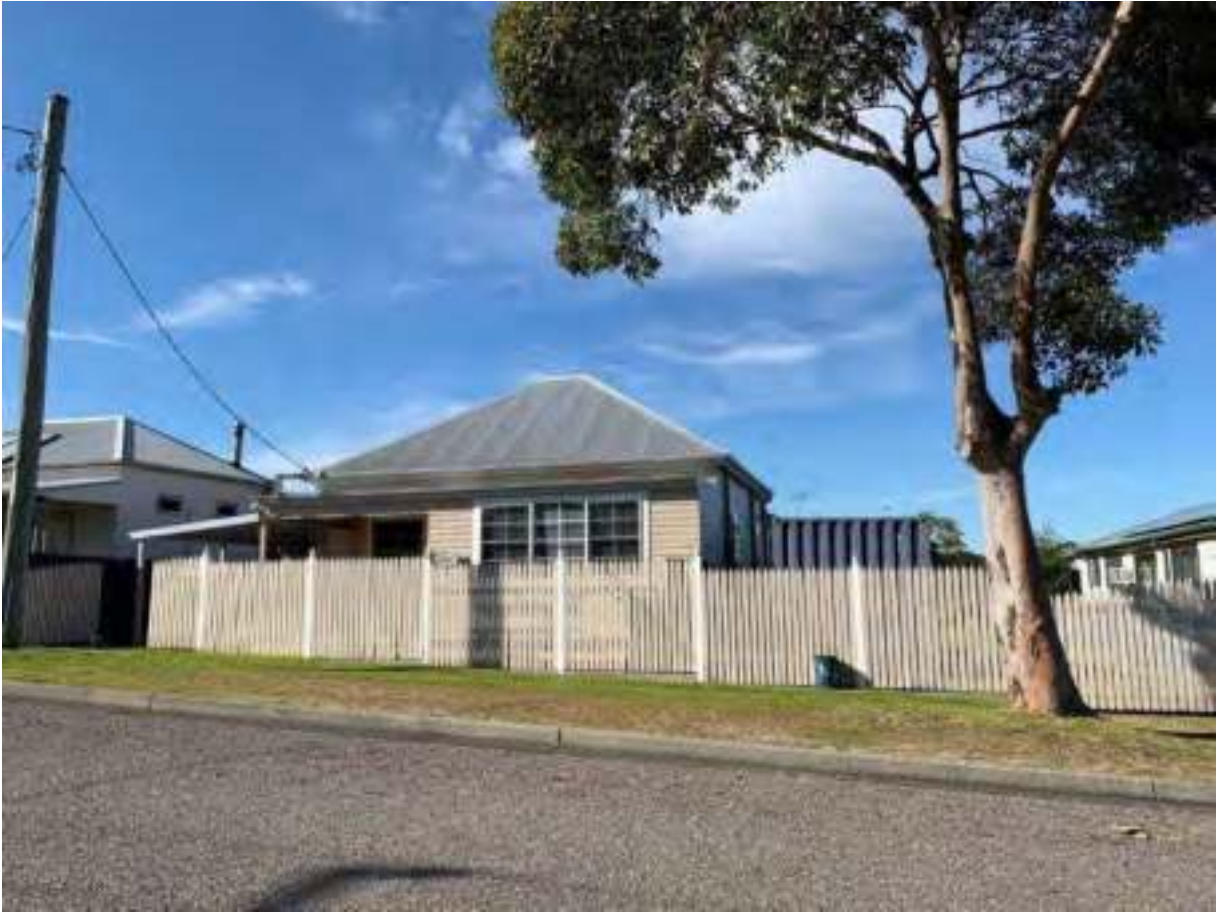
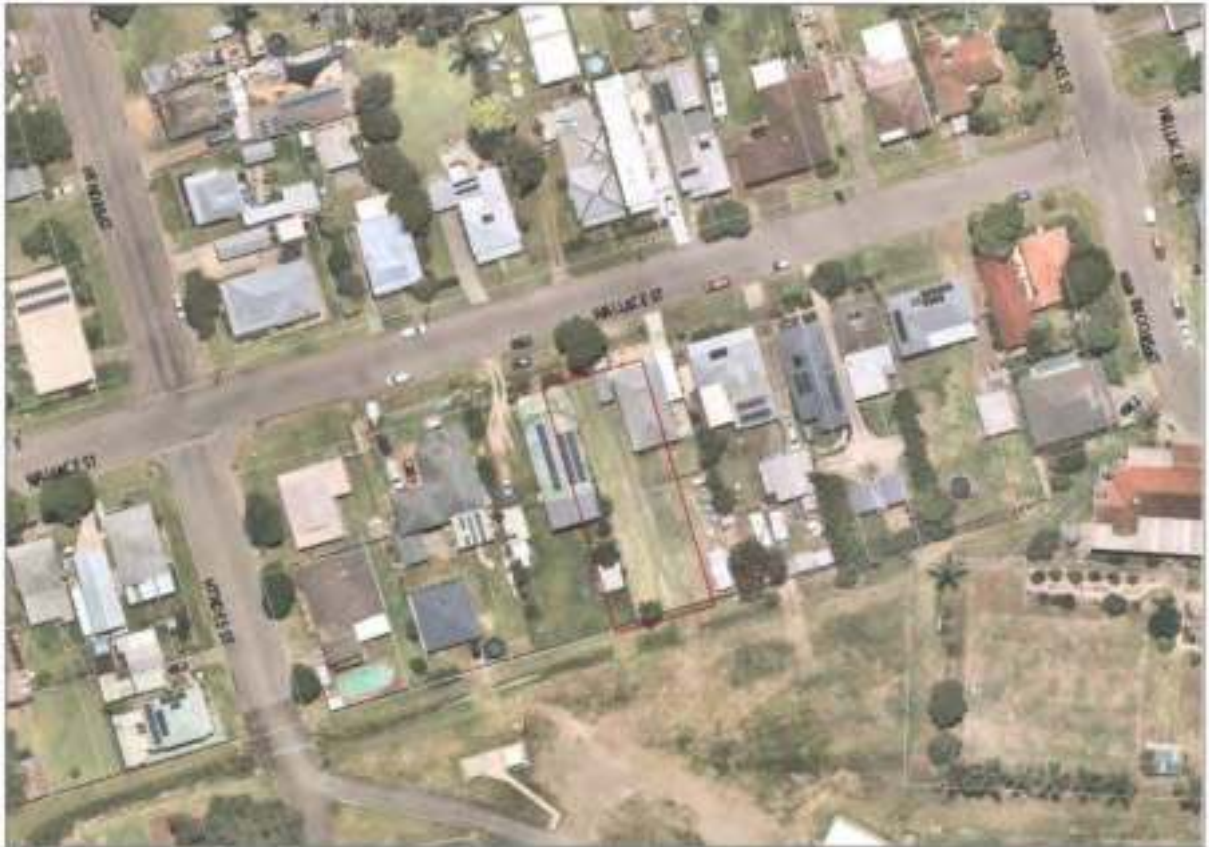
30 WALLACE STREET, WEST WALLSEND 2286

Conservation Area Contribution Level	Est. Construction Date	Previous studies and/or community input
Contributory 2	Early to late 20 th century (broad range)	No prior heritage assessments or research undertaken.
Assessment Text		Observed Modifications
<p>The scale (single-storey) and general style of the dwelling is consistent with that of the streetscape and wider HCA. Dwelling contributes positively to the streetscape and wider HCA, particularly in comparison to Non-Contributory buildings.</p> <p>The dwelling features appropriately proportioned and positioned fenestrations, an appropriate roof form (gabled or hipped) and other features consistent with the architectural character of the area (e.g. front verandah with timber or brick posts, timber detailing, corrugated metal roofing, etc). The contributory value of the dwelling is limited however by either:</p> <ul style="list-style-type: none"> External modifications that have in some way obscured the style, scale or design intent of the building and have resulted in less physical integrity than Contributory 1 buildings. Being a later dwelling constructed in an appropriate referential style, but comprising little to no fabric of intrinsic heritage significance. 		<p>The visible windows are contemporary in style.</p> <p>The western portion of the veranda has been built in to construct an additional living area.</p> <p>A carport has been built onto the eastern side of the dwelling.</p>

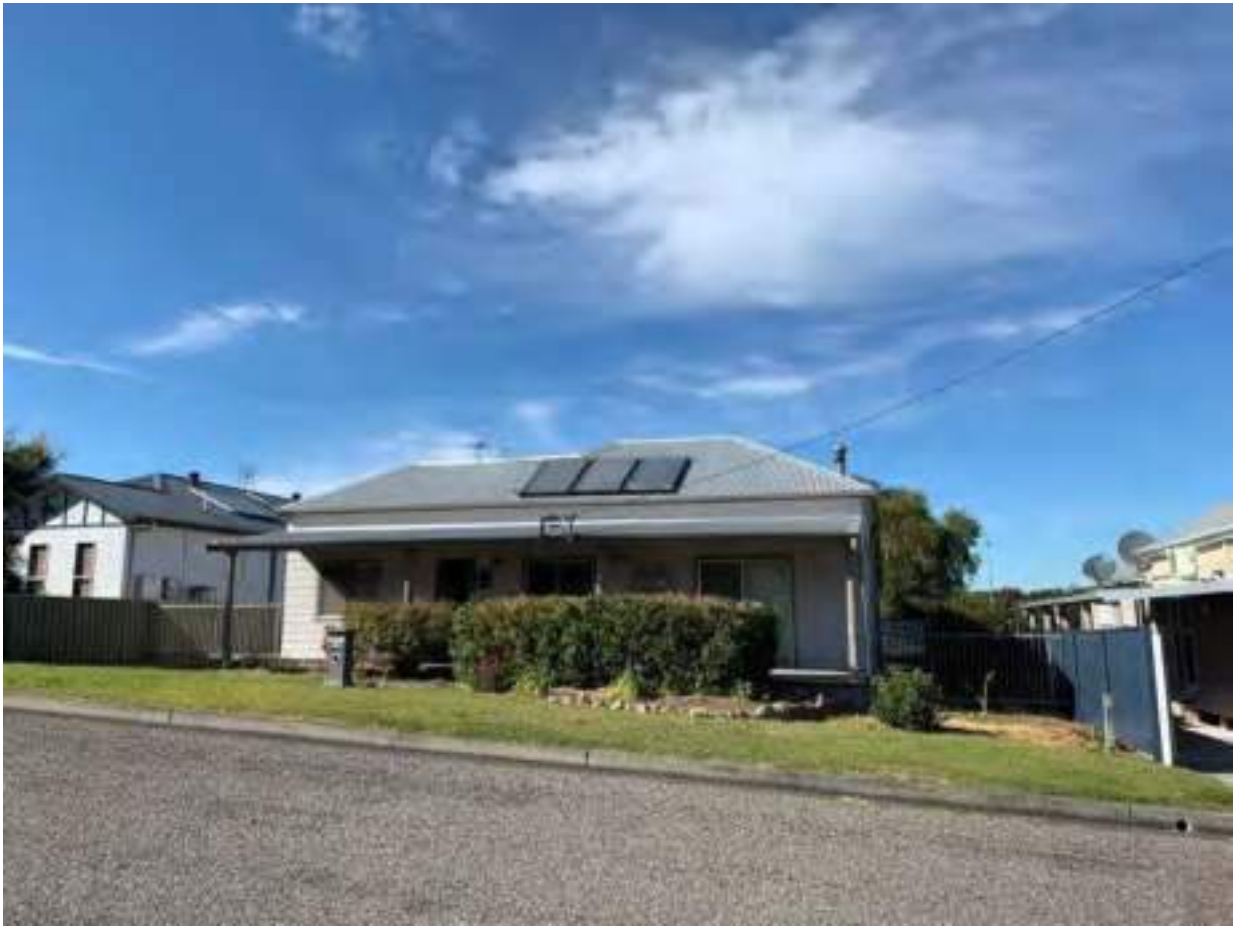
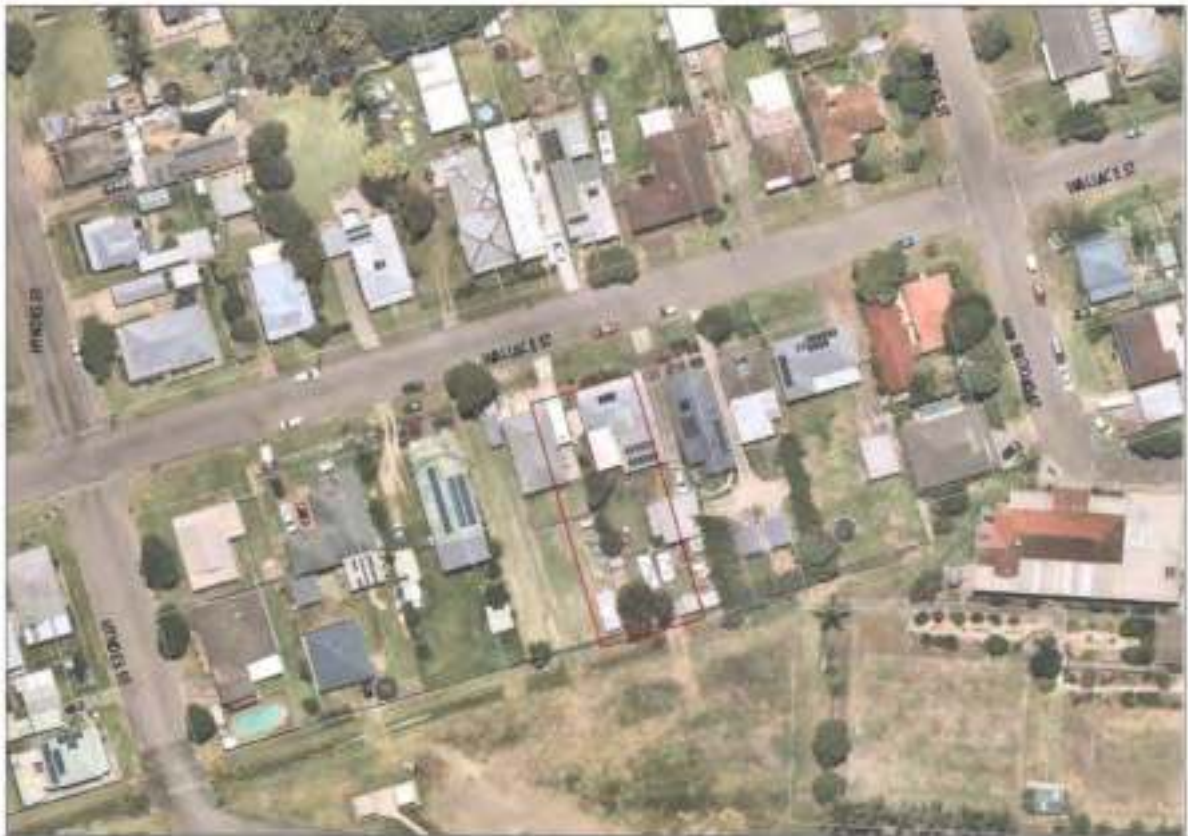
28 WALLACE STREET, WEST WALLSEND 2286

Conservation Area Contribution Level	Est. Construction Date	Previous studies and/or community input
Contributory 2	Early to late 20 th century (broad range)	No prior heritage assessments or research undertaken.
Assessment Text		Observed Modifications
<p>The scale (single-storey) and general style of the dwelling is consistent with that of the streetscape and wider HCA. Dwelling contributes positively to the streetscape and wider HCA, particularly in comparison to Non-Contributory buildings.</p> <p>The dwelling features appropriately proportioned and positioned fenestrations, an appropriate roof form (gabled or hipped) and other features consistent with the architectural character of the area (e.g. front verandah with timber or brick posts, timber detailing, corrugated metal roofing, etc). The contributory value of the dwelling is limited however by either:</p> <ul style="list-style-type: none"> • External modifications that have in some way obscured the style, scale or design intent of the building and have resulted in less physical integrity than Contributory 1 buildings. • Being a later dwelling constructed in an appropriate referential style, but comprising little to no fabric of intrinsic heritage significance. 		<p>Solar panels/heating components are highly visible along the northern portion of the dwelling.</p> <p>The western portion of the dwelling is a contemporary extension, with the original dwelling consisting of a boxed vernacular mining cottage.</p> <p>The visible windows are contemporary in style.</p>

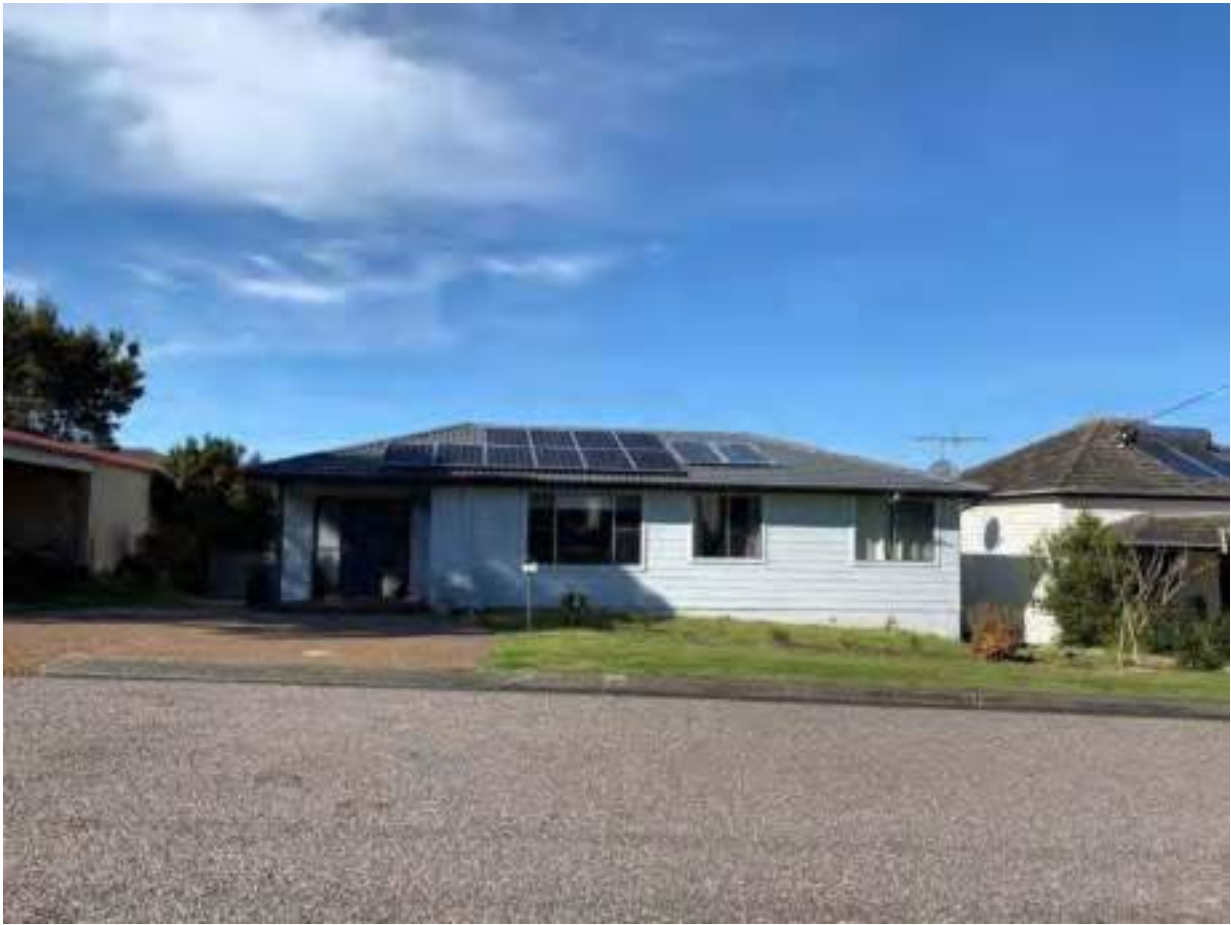
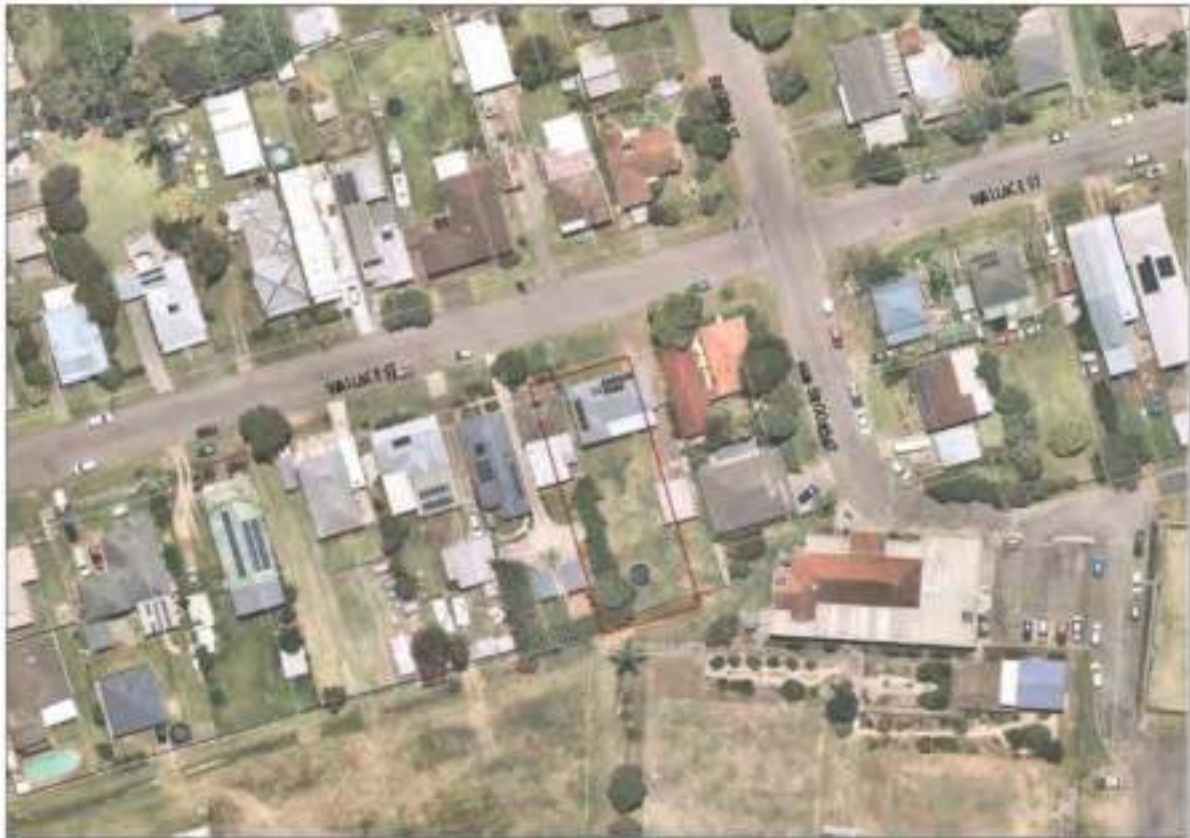
24 WALLACE STREET, WEST WALLSEND 2286

Conservation Area Contribution Level	Est. Construction Date	Previous studies and/or community input
Contributory 2	Early to late 20 th century (broad range)	No prior heritage assessments or research undertaken.
Assessment Text		Observed Modifications
<p>The scale (single-storey) and general style of the dwelling is consistent with that of the streetscape and wider HCA. Dwelling contributes positively to the streetscape and wider HCA, particularly in comparison to Non-Contributory buildings.</p> <p>The dwelling features appropriately proportioned and positioned fenestrations, an appropriate roof form (gabled or hipped) and other features consistent with the architectural character of the area (e.g. front verandah with timber or brick posts, timber detailing, corrugated metal roofing, etc). The contributory value of the dwelling is limited however by either:</p> <ul style="list-style-type: none"> • External modifications that have in some way obscured the style, scale or design intent of the building and have resulted in less physical integrity than Contributory 1 buildings. • Being a later dwelling constructed in an appropriate referential style, but comprising little to no fabric of intrinsic heritage significance. 		<p>Solar panels are highly visible along the northern portion of the roof.</p> <p>The visible windows are contemporary in style.</p>

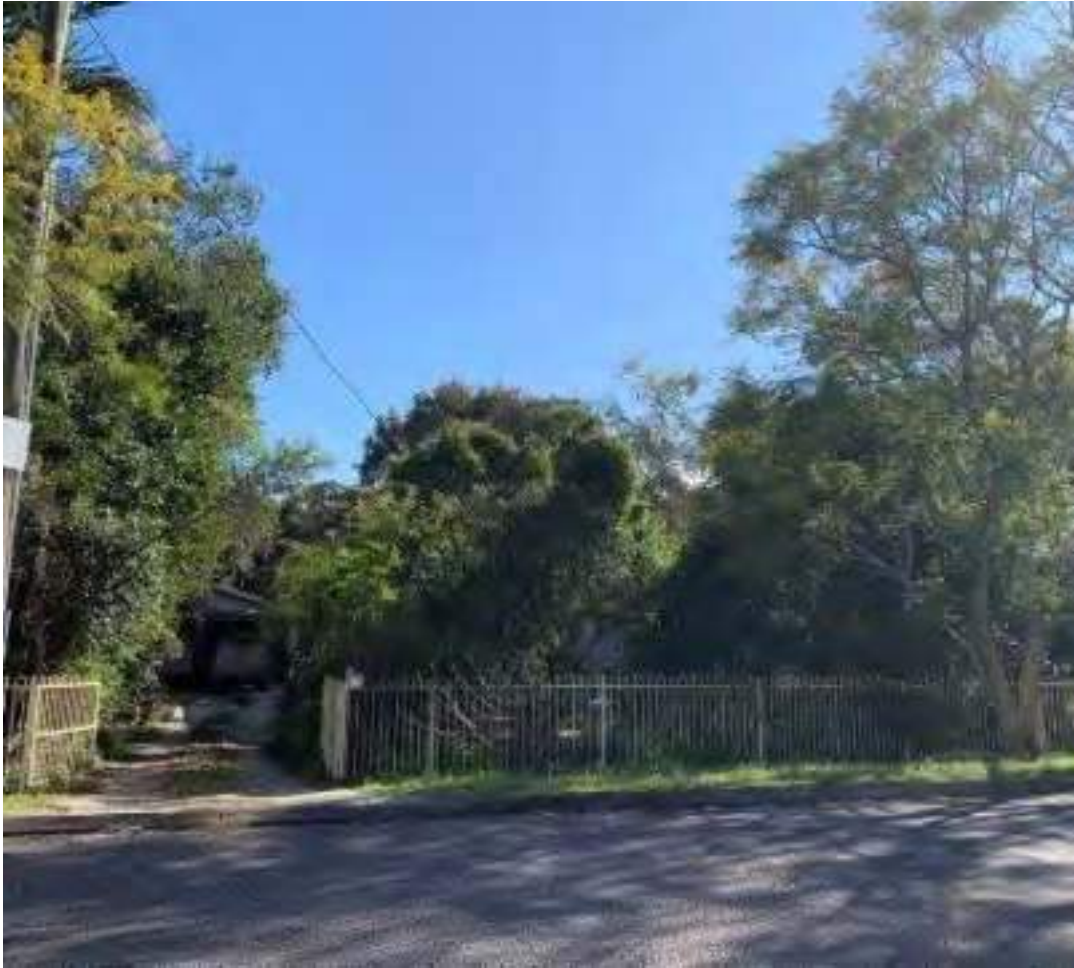
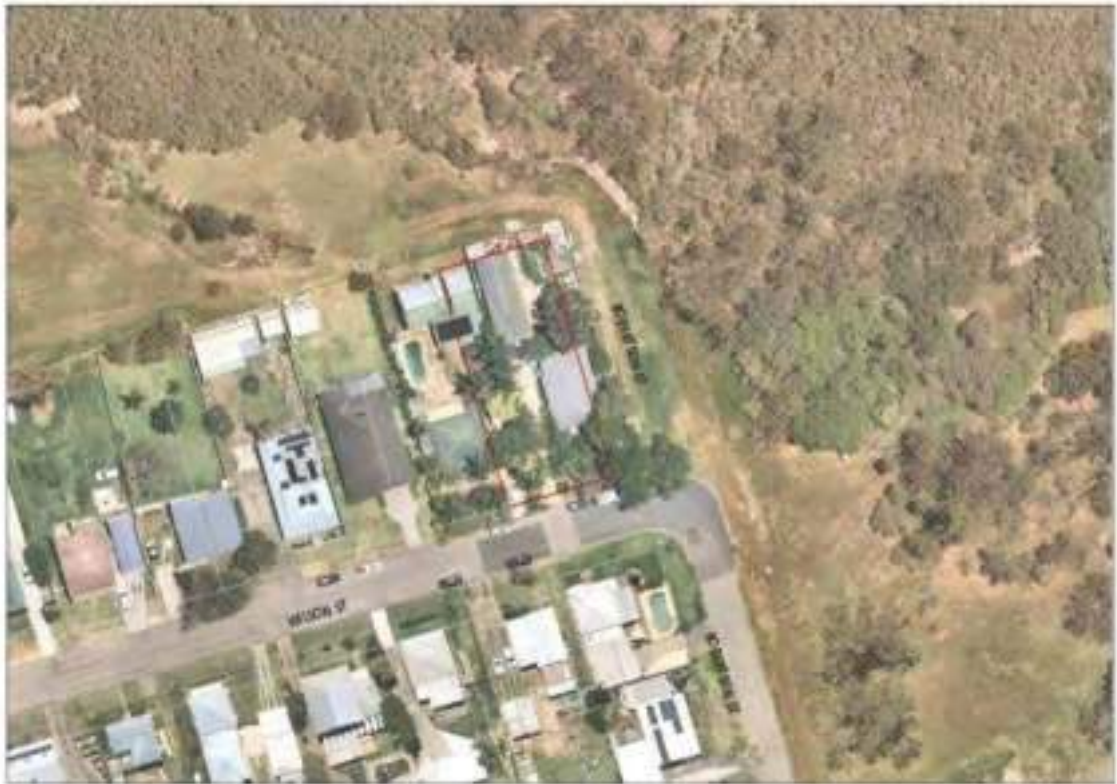
1 WILSON STREET, WEST WALLSEND 2286		
Conservation Area Contribution Level	Est. Construction Date	Previous studies and/or community input
Contributory 2	Early to late 20 th century (broad range)	No prior heritage assessments or research undertaken.
Assessment Text		Observed Modifications
<p>The scale (single-storey) and general style of the dwelling is consistent with that of the streetscape and wider HCA. Dwelling contributes positively to the streetscape and wider HCA, particularly in comparison to Non-Contributory buildings.</p> <p>The dwelling features appropriately proportioned and positioned fenestrations, an appropriate roof form (gabled or hipped) and other features consistent with the architectural character of the area (e.g. front verandah with timber or brick posts, timber detailing, corrugated metal roofing, etc). The contributory value of the dwelling is limited however by either:</p> <ul style="list-style-type: none"> • External modifications that have in some way obscured the style, scale or design intent of the building and have resulted in less physical integrity than Contributory 1 buildings. • Being a later dwelling constructed in an appropriate referential style, but comprising little to no fabric of intrinsic heritage significance. 		<p>The dwelling is obscured by mature vegetation growth. No modifications observed.</p>

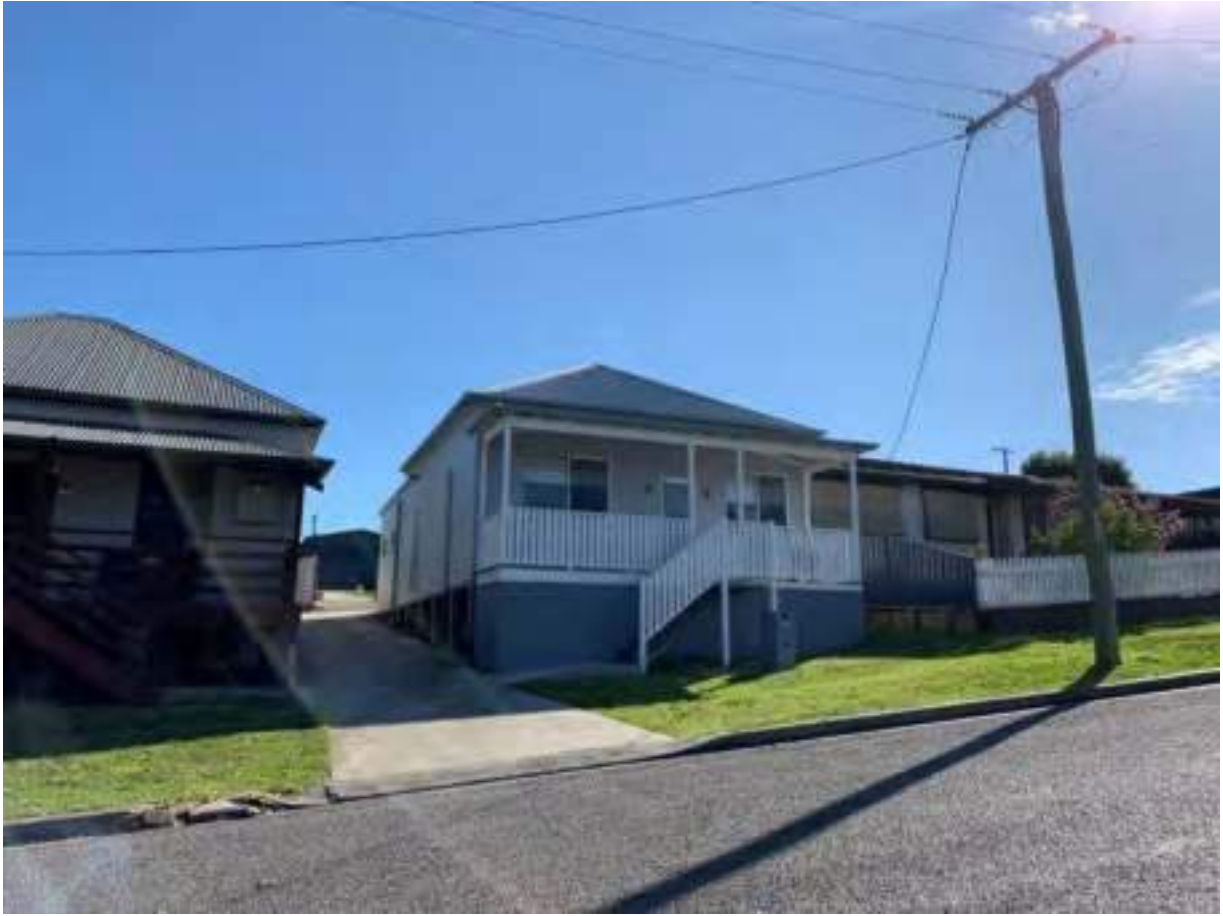
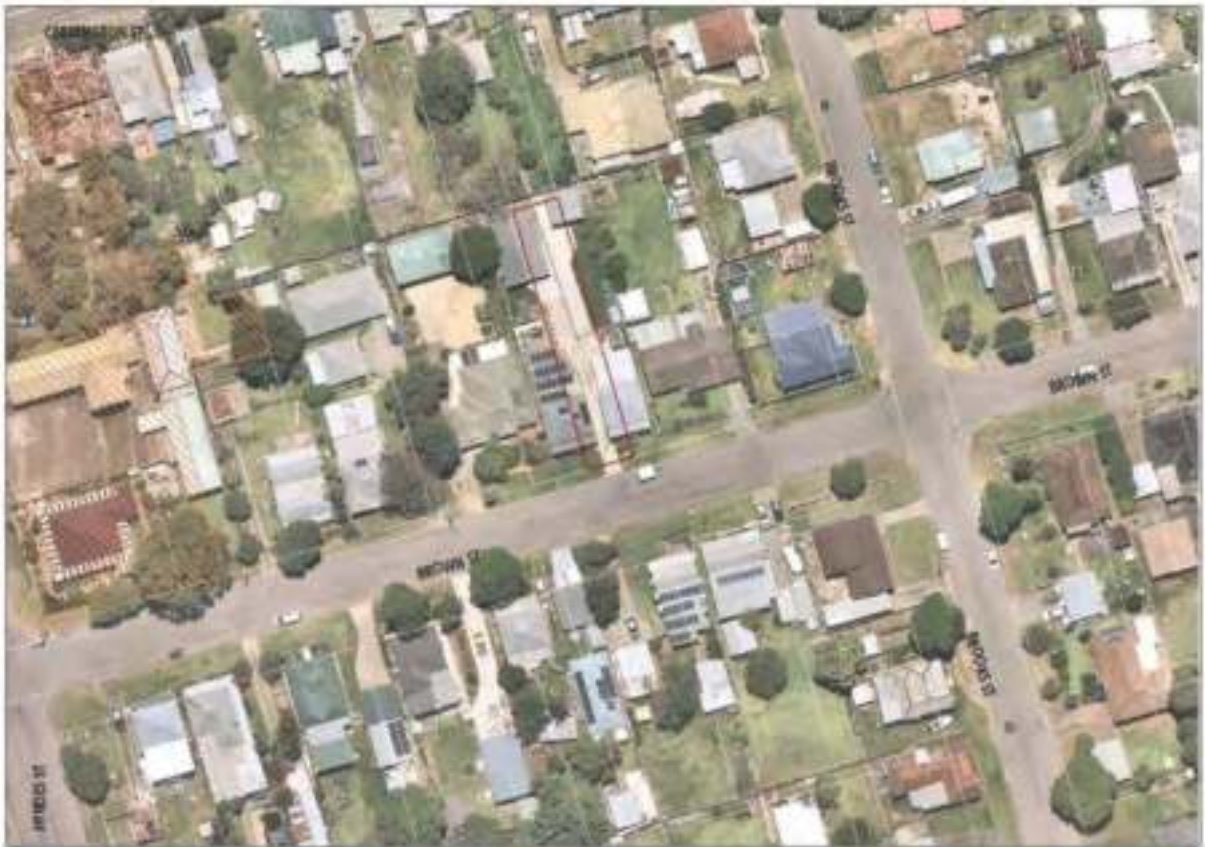
19 BROWN STREET, WEST WALLSEND 2286

Conservation Area Contribution Level	Est. Construction Date	Previous studies and/or community input
Contributory 2	Early to late 20 th century (broad range)	No prior heritage assessments or research undertaken.
Assessment Text		Observed Modifications
<p>The scale (single-storey) and general style of the dwelling is consistent with that of the streetscape and wider HCA. Dwelling contributes positively to the streetscape and wider HCA, particularly in comparison to Non-Contributory buildings.</p> <p>The dwelling features appropriately proportioned and positioned fenestrations, an appropriate roof form (gabled or hipped) and other features consistent with the architectural character of the area (e.g. front verandah with timber or brick posts, timber detailing, corrugated metal roofing, etc). The contributory value of the dwelling is limited however by either:</p> <ul style="list-style-type: none"> • External modifications that have in some way obscured the style, scale or design intent of the building and have resulted in less physical integrity than Contributory 1 buildings. • Being a later dwelling constructed in an appropriate referential style, but comprising little to no fabric of intrinsic heritage significance. 		<p>The timber balustrade and stair railing is a recent addition, however is sympathetic in style.</p> <p>The metal frame stairs leading onto the veranda are not original, likely a dated modification, replacing an original brick or timber staircase.</p> <p>The dwelling has undergone extensive modifications, with the entire external façade being revitalised during recent renovation works. This has all been undertaken in a sympathetic manner and does not detract from the heritage streetscape.</p>

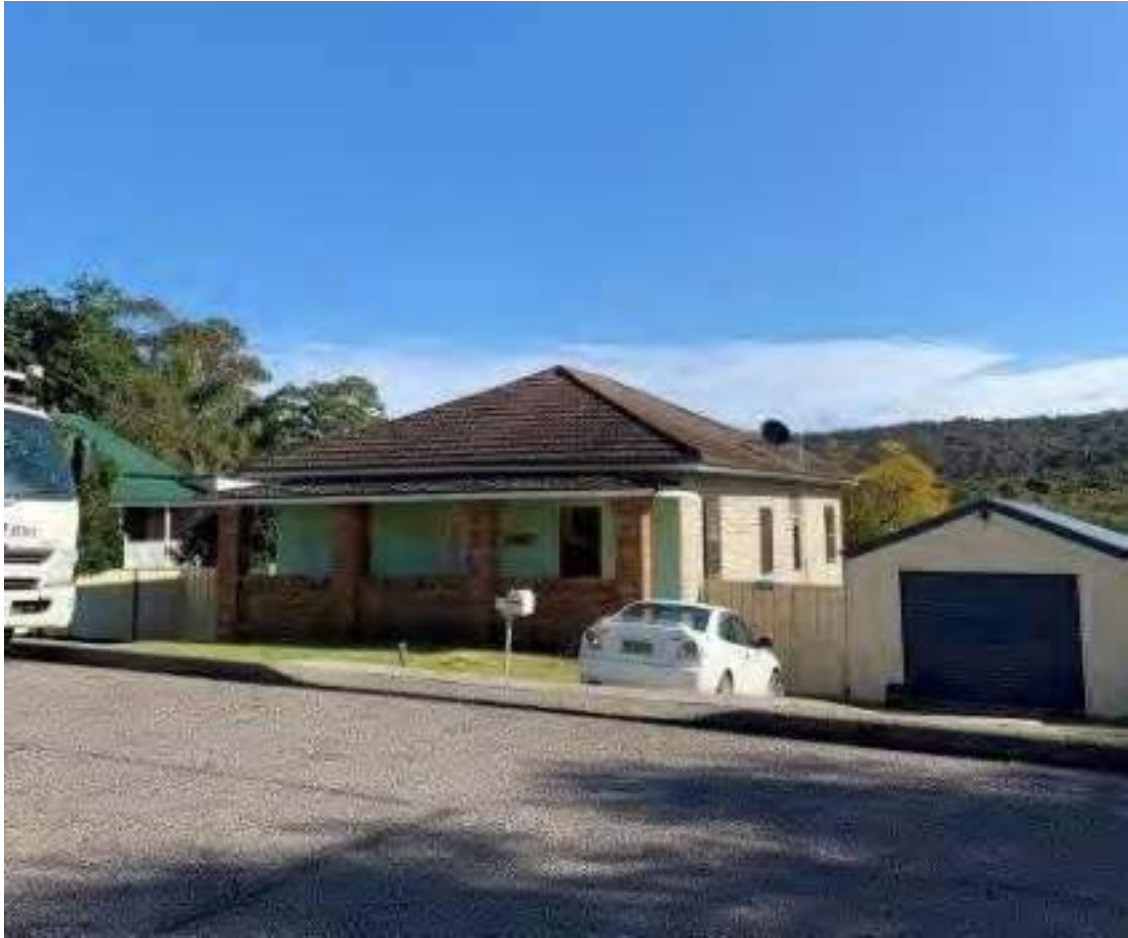
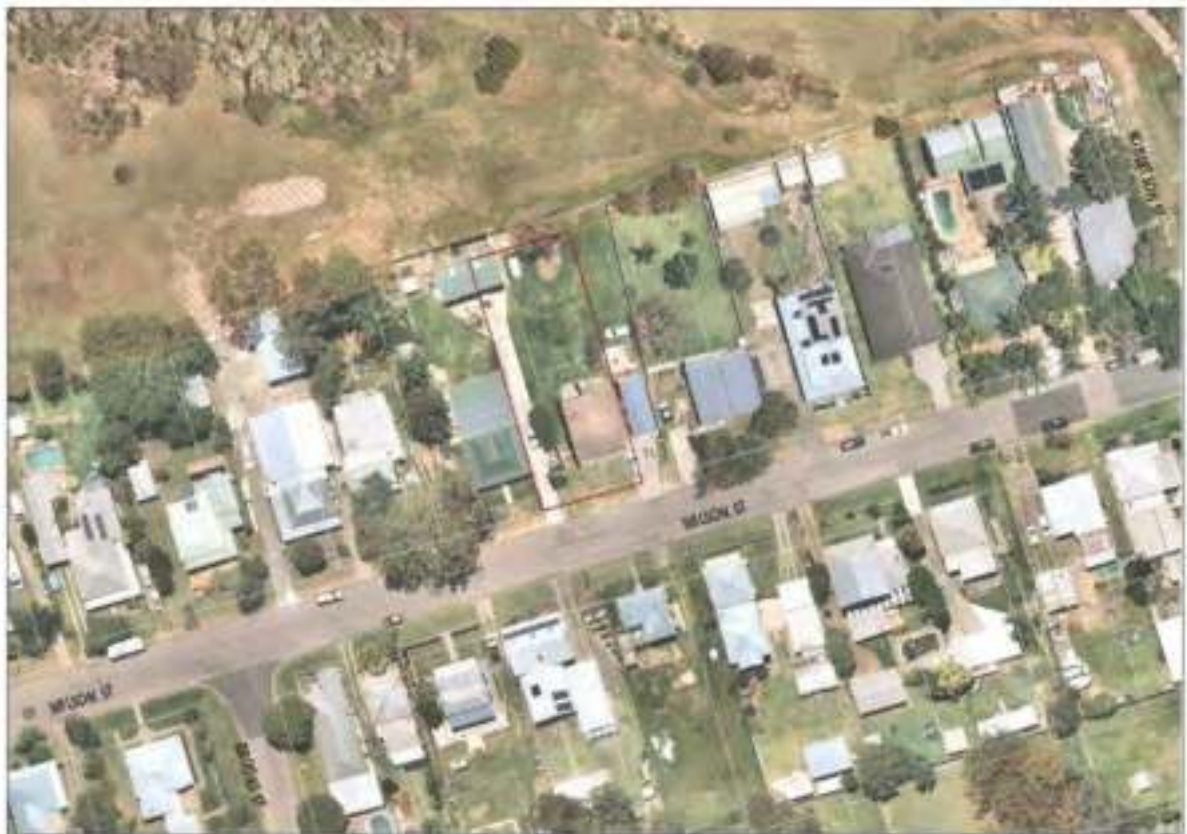
11 WILSON STREET, WEST WALLSEND 2286

Conservation Area Contribution Level	Est. Construction Date	Previous studies and/or community input
Contributory 2	Early to late 20 th century (broad range)	No prior heritage assessments or research undertaken.
Assessment Text		Observed Modifications
<p>The scale (single-storey) and general style of the dwelling is consistent with that of the streetscape and wider HCA. Dwelling contributes positively to the streetscape and wider HCA, particularly in comparison to Non-Contributory buildings.</p> <p>The dwelling features appropriately proportioned and positioned fenestrations, an appropriate roof form (gabled or hipped) and other features consistent with the architectural character of the area (e.g. front verandah with timber or brick posts, timber detailing, corrugated metal roofing, etc). The contributory value of the dwelling is limited however by either:</p> <ul style="list-style-type: none"> • External modifications that have in some way obscured the style, scale or design intent of the building and have resulted in less physical integrity than Contributory 1 buildings. • Being a later dwelling constructed in an appropriate referential style, but comprising little to no fabric of intrinsic heritage significance. 		<p>The brickwork veranda wall and supporting pillars are a contemporary addition, likely replacing original timber posts and balustrade.</p> <p>The concrete tiled roof is a recent modification, replacing the original iron or Colourbond roofing.</p>

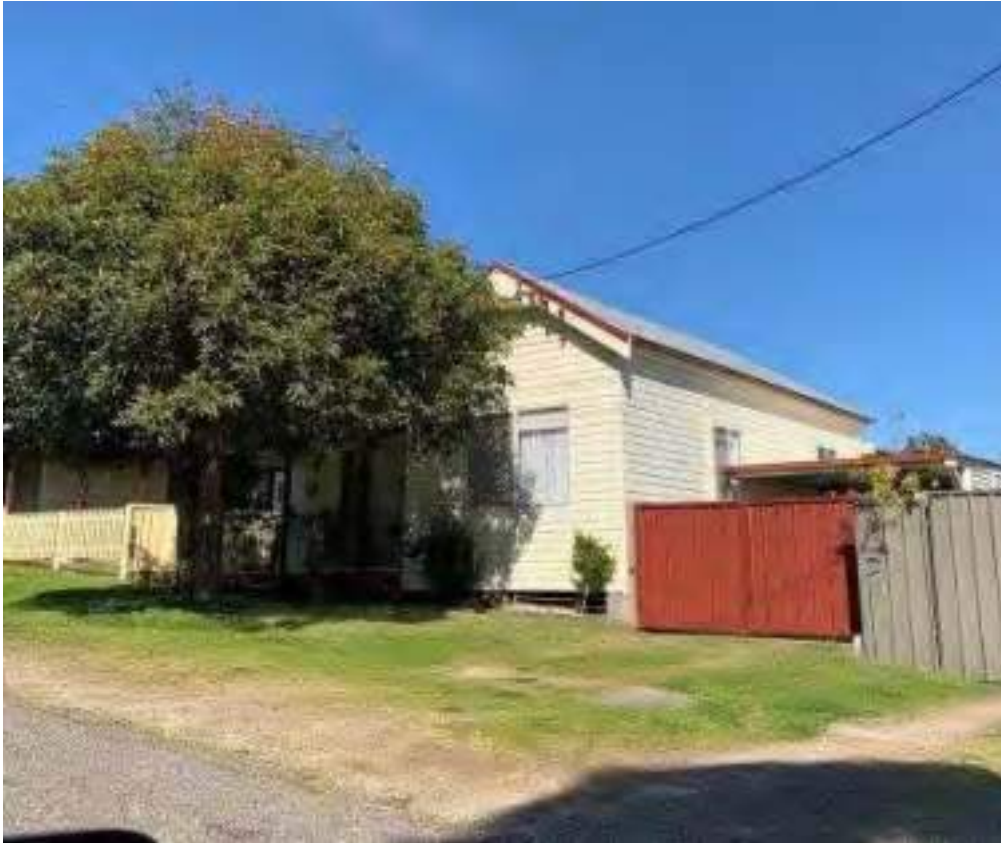
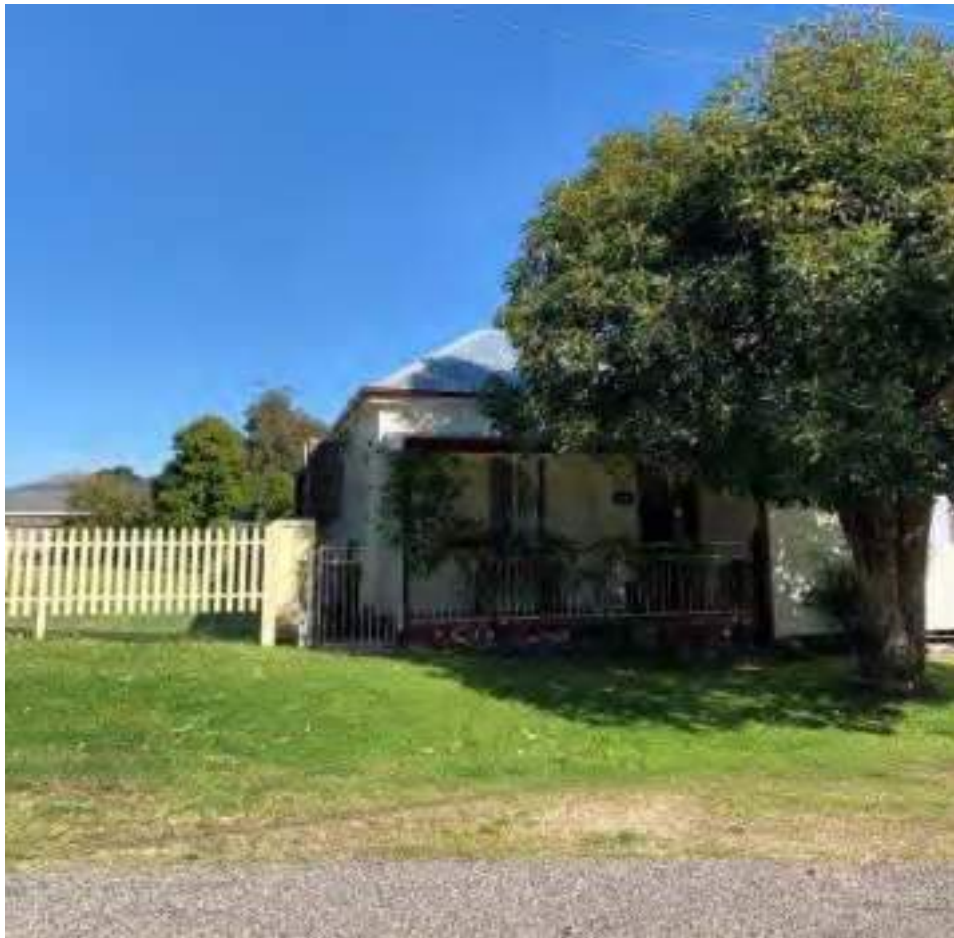
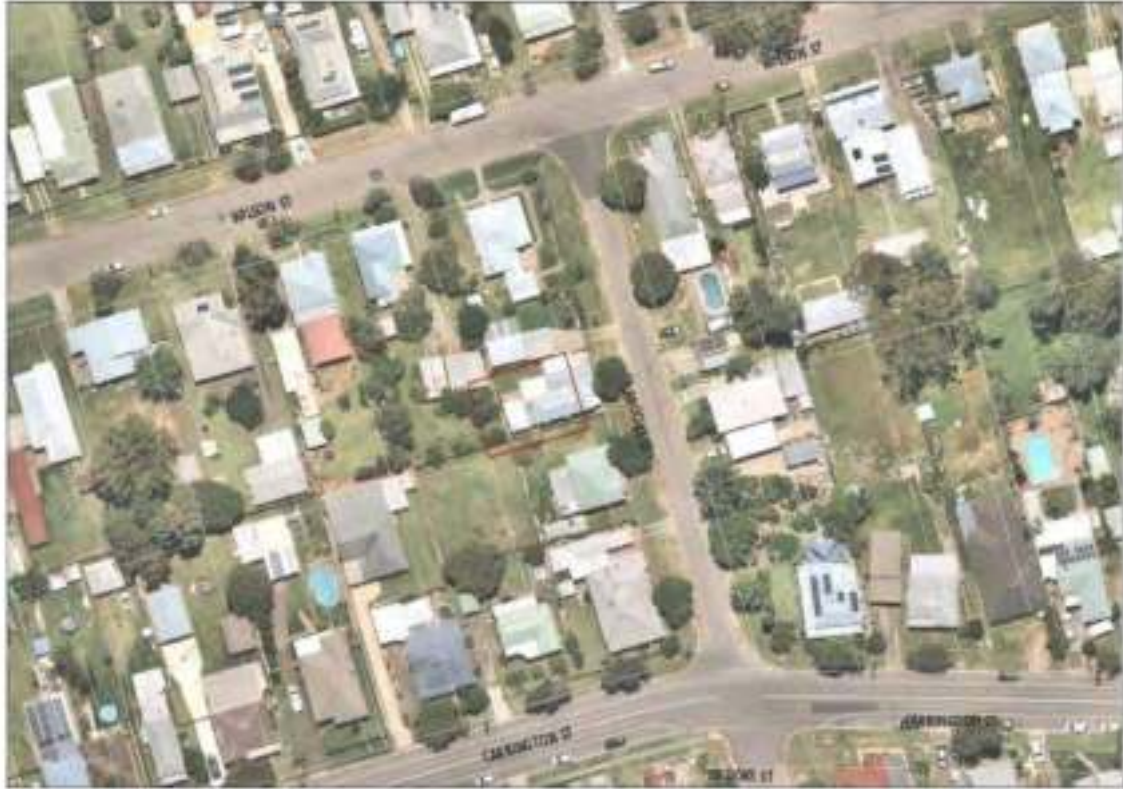
2 BROOKS STREET, WEST WALLSEND 2286

Conservation Area Contribution Level	Est. Construction Date	Previous studies and/or community input
Contributory 2	Early to late 20 th century (broad range)	No prior heritage assessments or research undertaken.
Assessment Text		Observed Modifications
<p>The scale (single-storey) and general style of the dwelling is consistent with that of the streetscape and wider HCA. Dwelling contributes positively to the streetscape and wider HCA, particularly in comparison to Non-Contributory buildings.</p> <p>The dwelling features appropriately proportioned and positioned fenestrations, an appropriate roof form (gabled or hipped) and other features consistent with the architectural character of the area (e.g. front verandah with timber or brick posts, timber detailing, corrugated metal roofing, etc). The contributory value of the dwelling is limited however by either:</p> <ul style="list-style-type: none"> • External modifications that have in some way obscured the style, scale or design intent of the building and have resulted in less physical integrity than Contributory 1 buildings. • Being a later dwelling constructed in an appropriate referential style, but comprising little to no fabric of intrinsic heritage significance. 		<p>The visible windows are contemporary in style.</p>

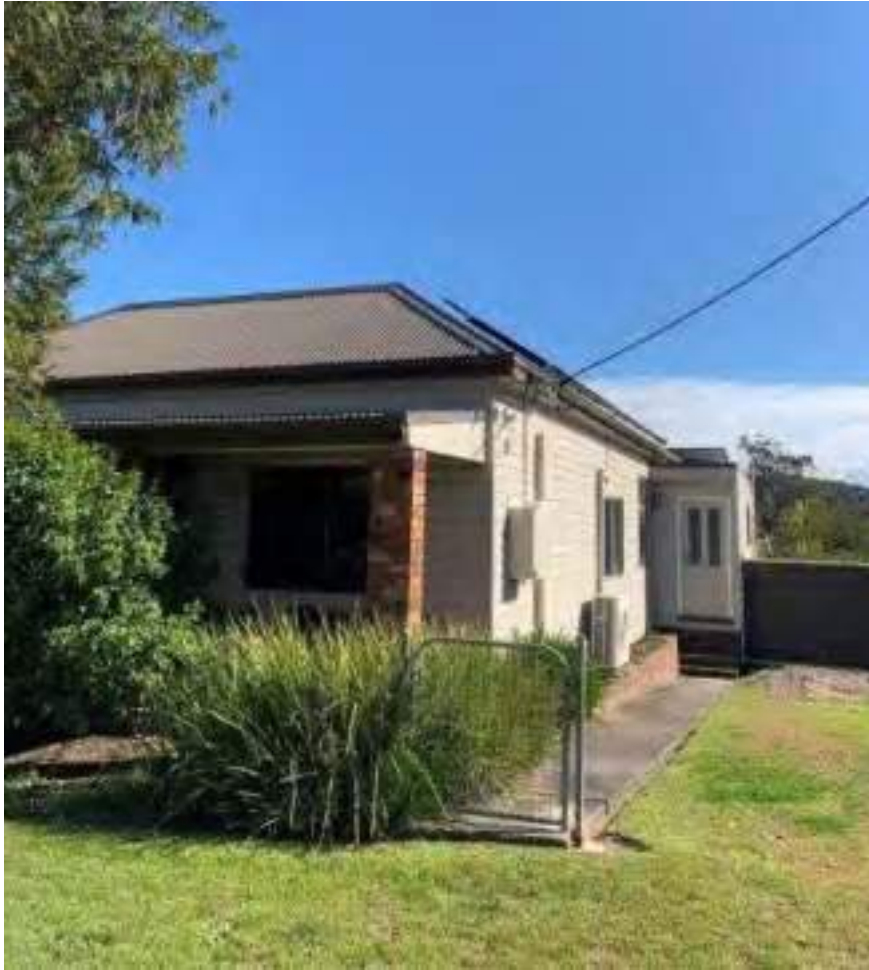
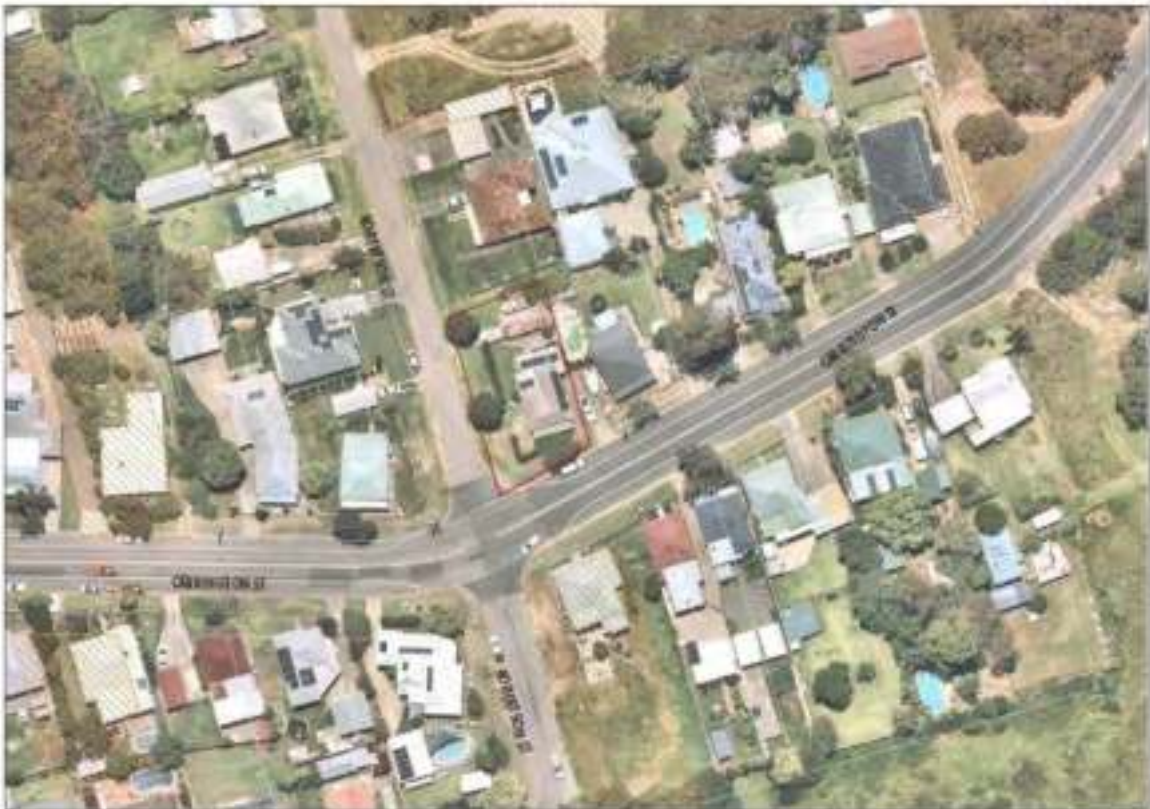
9 CARRINGTON STREET, WEST WALLSEND 2286

Conservation Area Contribution Level	Est. Construction Date	Previous studies and/or community input
Contributory 2	Early to late 20 th century (broad range)	No prior heritage assessments or research undertaken.
Assessment Text		Observed Modifications
<p>The scale (single-storey) and general style of the dwelling is consistent with that of the streetscape and wider HCA. Dwelling contributes positively to the streetscape and wider HCA, particularly in comparison to Non-Contributory buildings.</p> <p>The dwelling features appropriately proportioned and positioned fenestrations, an appropriate roof form (gabled or hipped) and other features consistent with the architectural character of the area (e.g. front verandah with timber or brick posts, timber detailing, corrugated metal roofing, etc). The contributory value of the dwelling is limited however by either:</p> <ul style="list-style-type: none"> • External modifications that have in some way obscured the style, scale or design intent of the building and have resulted in less physical integrity than Contributory 1 buildings. • Being a later dwelling constructed in an appropriate referential style, but comprising little to no fabric of intrinsic heritage significance. 		<p>Solar panels are visible along the eastern portion of the dwelling.</p> <p>The brickwork veranda support pillars are a contemporary addition, likely replacing original timber posts.</p> <p>An extension has been built onto the north/eastern portion of the dwelling. this is only partially visible and does not detract from the heritage streetscape.</p>

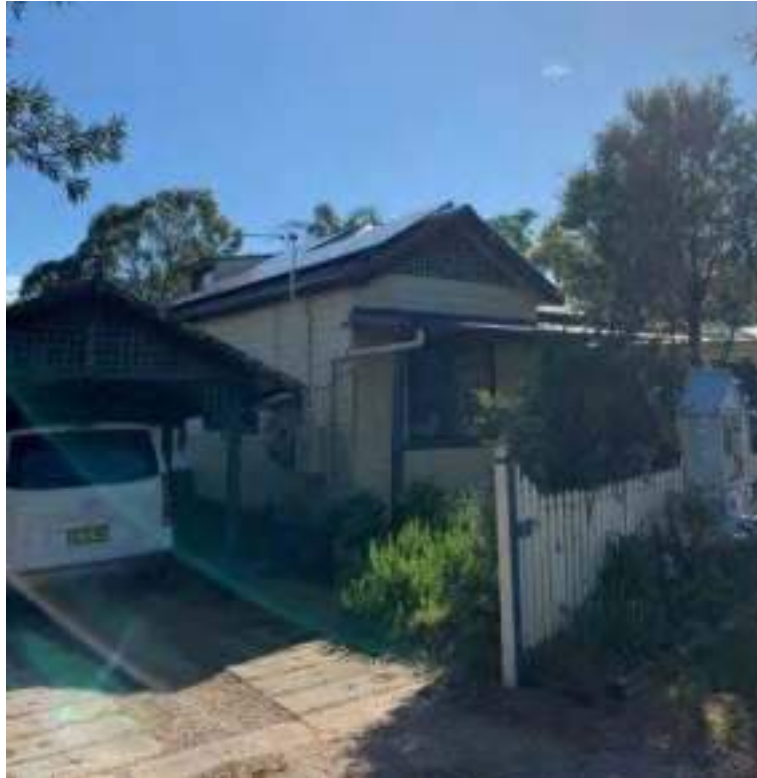
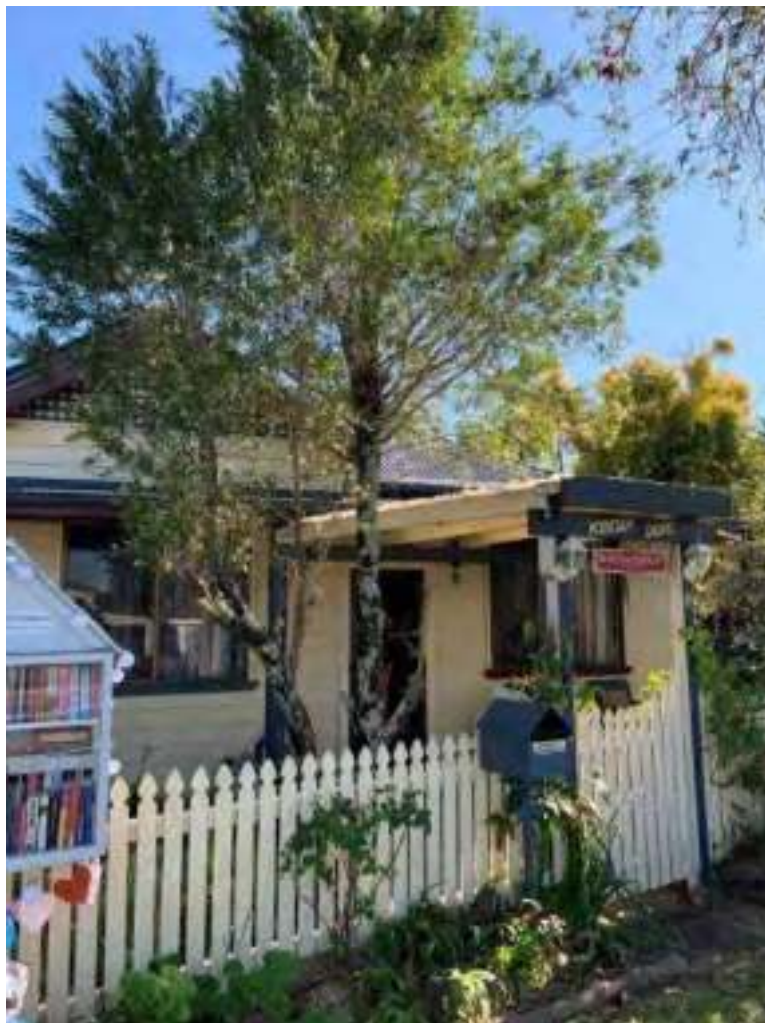
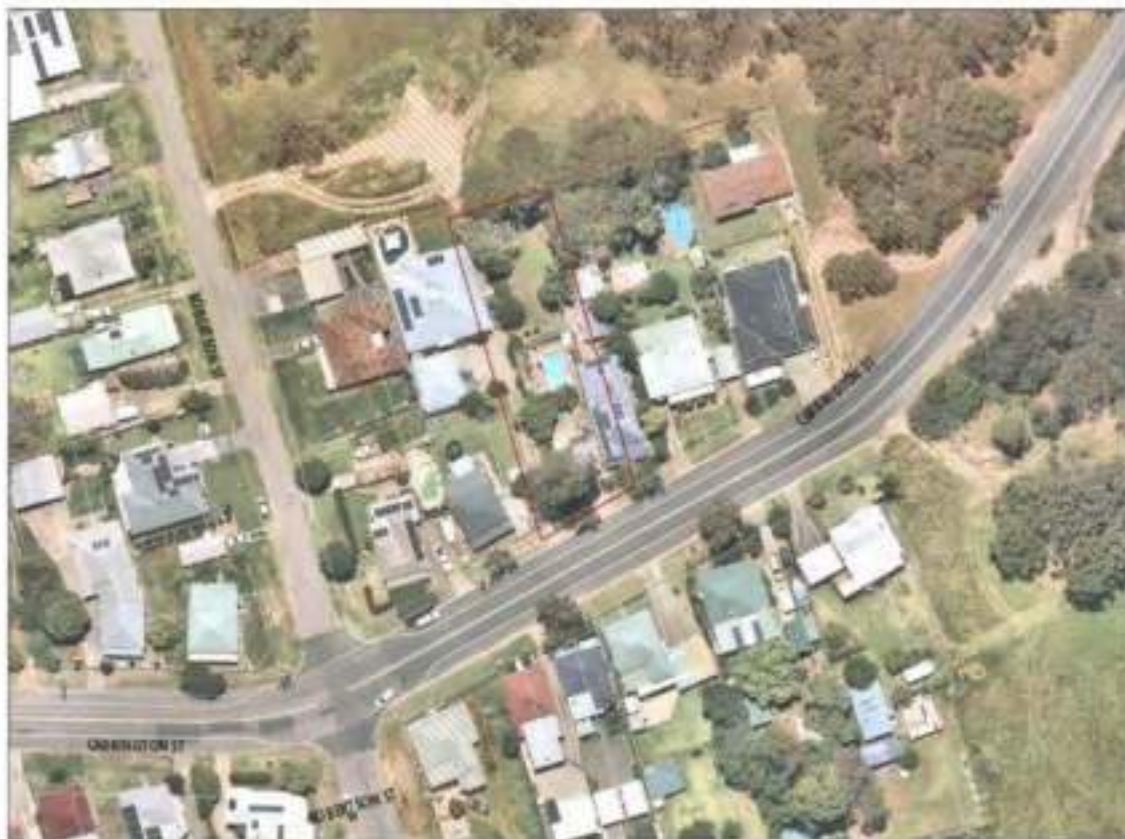
5 CARRINGTON STREET, WEST WALLSEND 2286

Conservation Area Contribution Level	Est. Construction Date	Previous studies and/or community input
Contributory 2	Early to late 20 th century (broad range)	No prior heritage assessments or research undertaken.
Assessment Text		Observed Modifications
<p>The scale (single-storey) and general style of the dwelling is consistent with that of the streetscape and wider HCA. Dwelling contributes positively to the streetscape and wider HCA, particularly in comparison to Non-Contributory buildings.</p> <p>The dwelling features appropriately proportioned and positioned fenestrations, an appropriate roof form (gabled or hipped) and other features consistent with the architectural character of the area (e.g. front verandah with timber or brick posts, timber detailing, corrugated metal roofing, etc). The contributory value of the dwelling is limited however by either:</p> <ul style="list-style-type: none"> • External modifications that have in some way obscured the style, scale or design intent of the building and have resulted in less physical integrity than Contributory 1 buildings. • Being a later dwelling constructed in an appropriate referential style, but comprising little to no fabric of intrinsic heritage significance. 		<p>Solar panels are visible on the western portion of the roof.</p> <p>A flat roof extension has been constructed, extending the veranda roof to the entrance gateway.</p>
