APPENDIX 2

Building Assessment Sheets (Inventory Sheets)

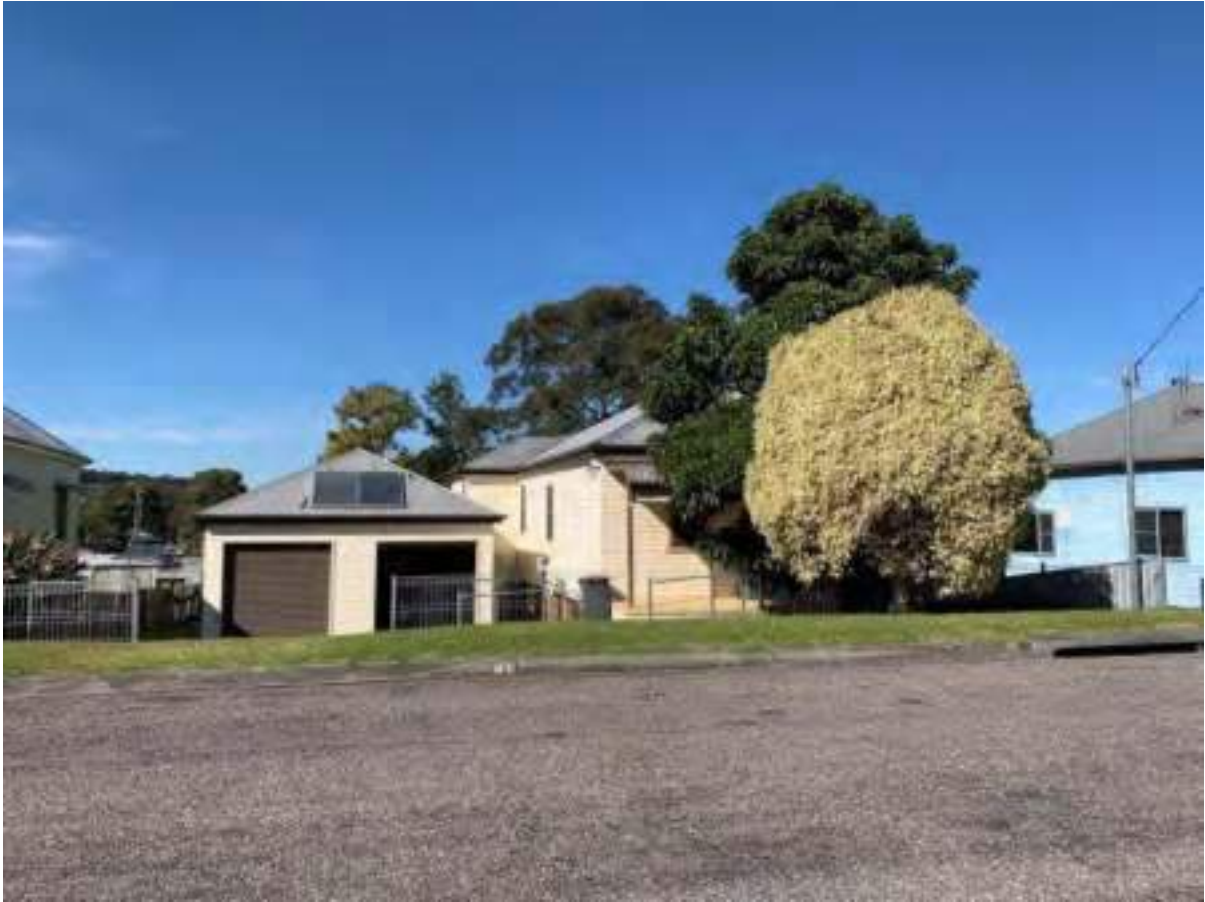
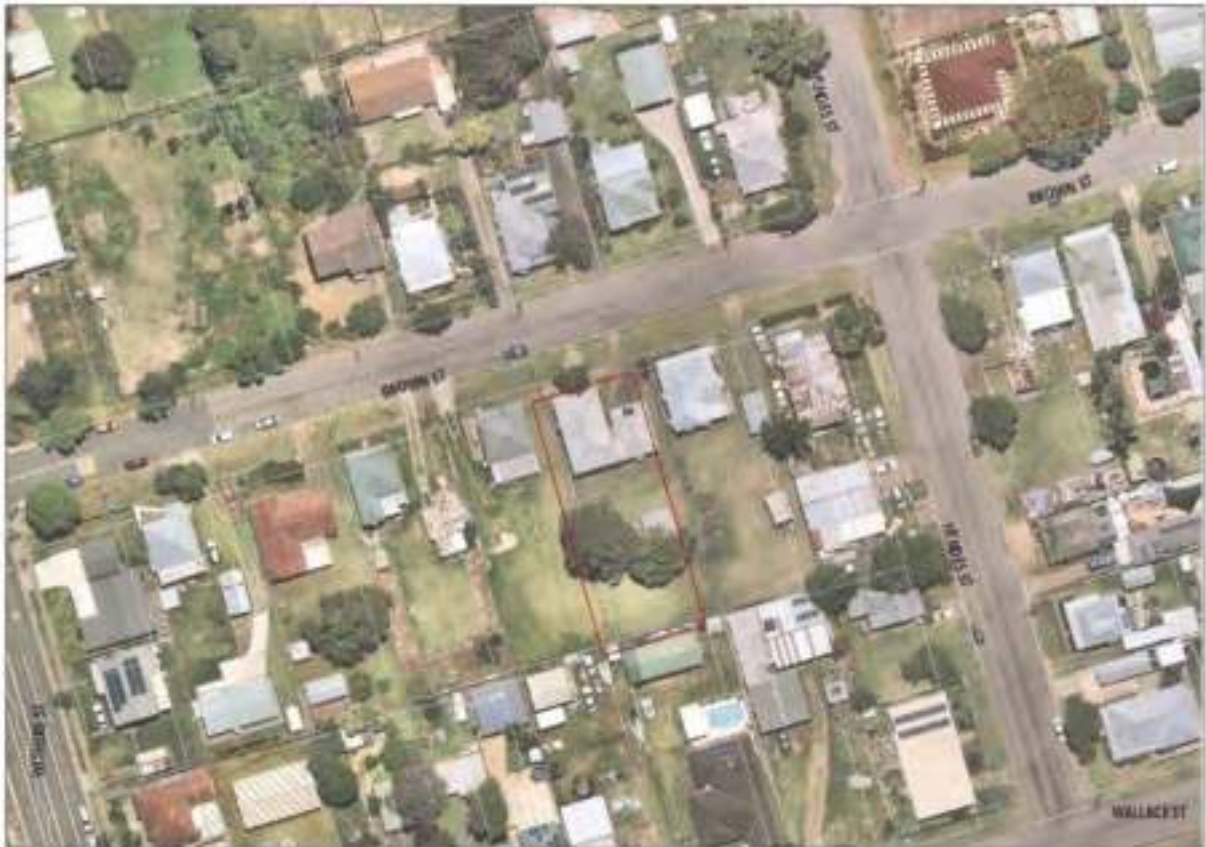
48 BROWN STREET, WEST WALLSEND 2286

Conservation Area Contribution Level	Est. Construction Date	Previous studies and/or community input
Contributory 2	Early to late 20 th century (broad range)	No prior heritage assessments or research undertaken.
Assessment Text		Observed Modifications
<p>The scale (single-storey) and general style of the dwelling is consistent with that of the streetscape and wider HCA. Dwelling contributes positively to the streetscape and wider HCA, particularly in comparison to Non-Contributory buildings.</p> <p>The dwelling features appropriately proportioned and positioned fenestrations, an appropriate roof form (gabled or hipped) and other features consistent with the architectural character of the area (e.g. front verandah with timber or brick posts, timber detailing, corrugated metal roofing, etc). The contributory value of the dwelling is limited however by either:</p> <ul style="list-style-type: none"> • External modifications that have in some way obscured the style, scale or design intent of the building and have resulted in less physical integrity than Contributory 1 buildings. • Being a later dwelling constructed in an appropriate referential style, but comprising little to no fabric of intrinsic heritage significance. 		<p>The veranda has been partially enclosed with the addition of a large canvas screen/blind.</p> <p>A double door garage with prominent solar panels has been constructed to the east of the dwelling. this is attached to the dwelling through A southern extension, which is not visible from the street and does not detract from the heritage streetscape.</p>

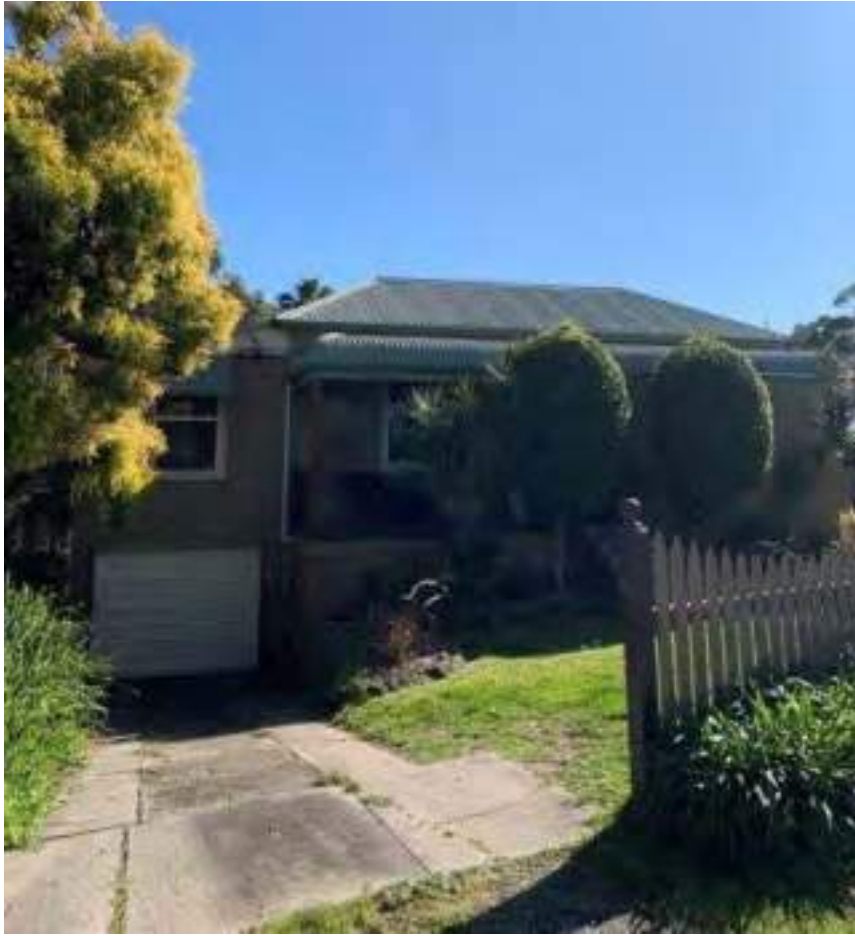
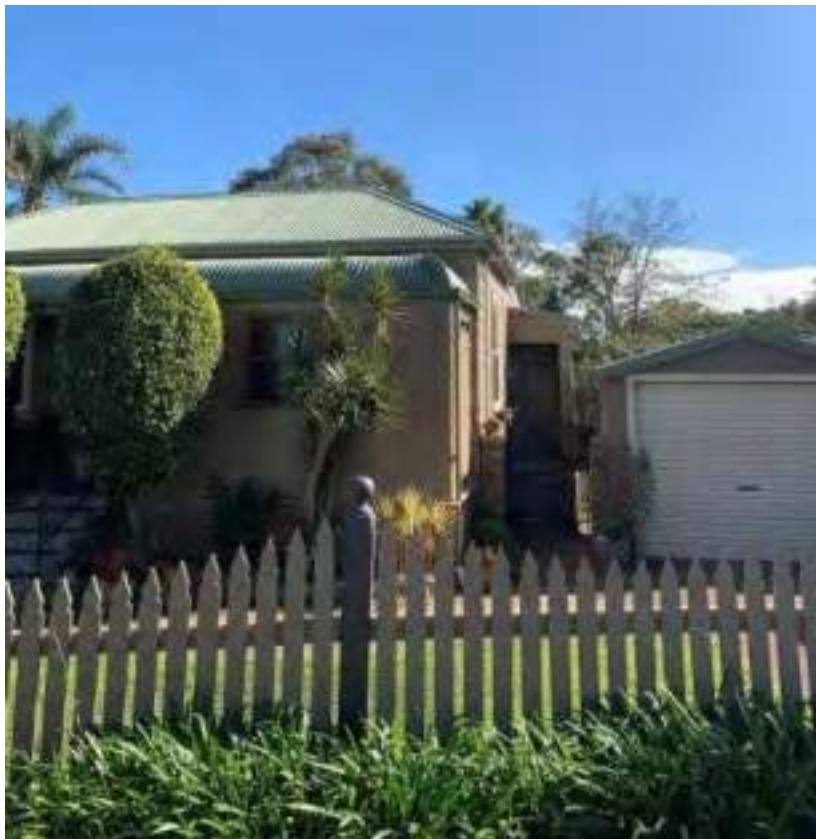
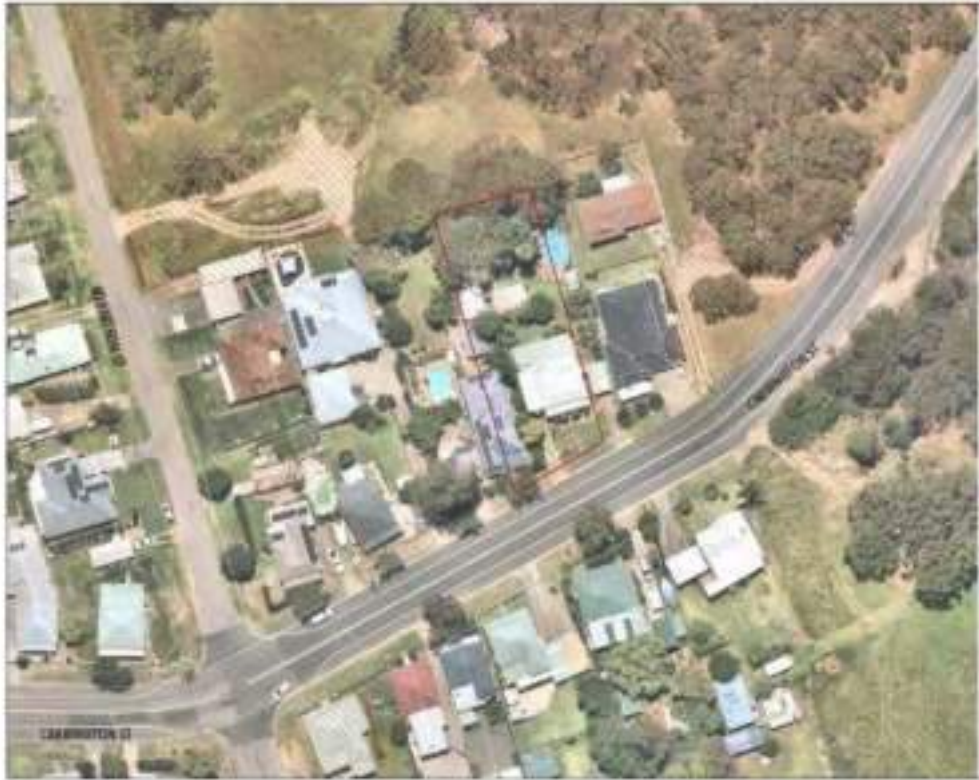
3 CARRINGTON STREET, WEST WALLSEND 2286

Conservation Area Contribution Level	Est. Construction Date	Previous studies and/or community input
Contributory 2	Early to late 20 th century (broad range)	No prior heritage assessments or research undertaken.
Assessment Text		Observed Modifications
<p>The scale (single-storey) and general style of the dwelling is consistent with that of the streetscape and wider HCA. Dwelling contributes positively to the streetscape and wider HCA, particularly in comparison to Non-Contributory buildings.</p> <p>The dwelling features appropriately proportioned and positioned fenestrations, an appropriate roof form (gabled or hipped) and other features consistent with the architectural character of the area (e.g. front verandah with timber or brick posts, timber detailing, corrugated metal roofing, etc). The contributory value of the dwelling is limited however by either:</p> <ul style="list-style-type: none"> • External modifications that have in some way obscured the style, scale or design intent of the building and have resulted in less physical integrity than Contributory 1 buildings. • Being a later dwelling constructed in an appropriate referential style, but comprising little to no fabric of intrinsic heritage significance. 		<p>The western portion of the dwelling is a recent extension, with an additional living area and in built garage constructed.</p>

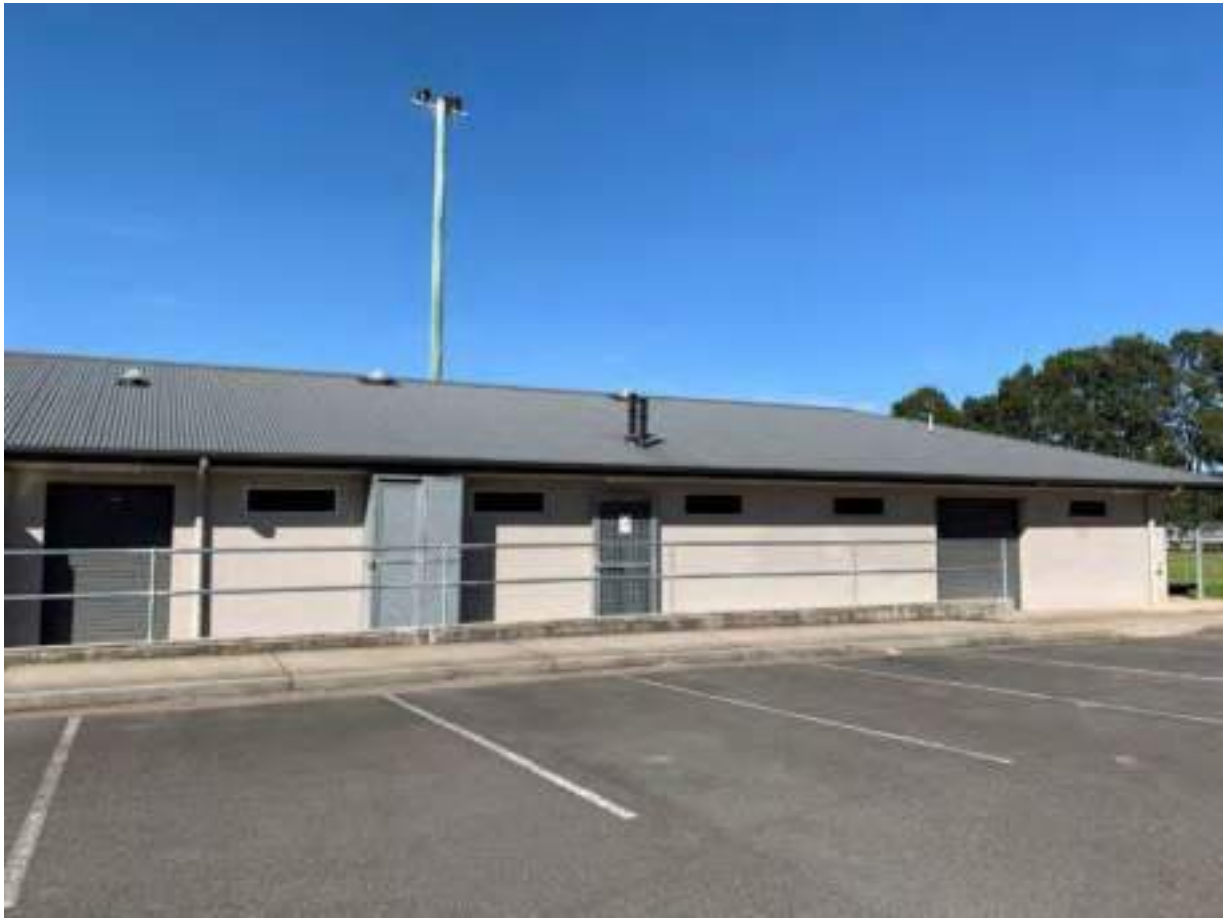
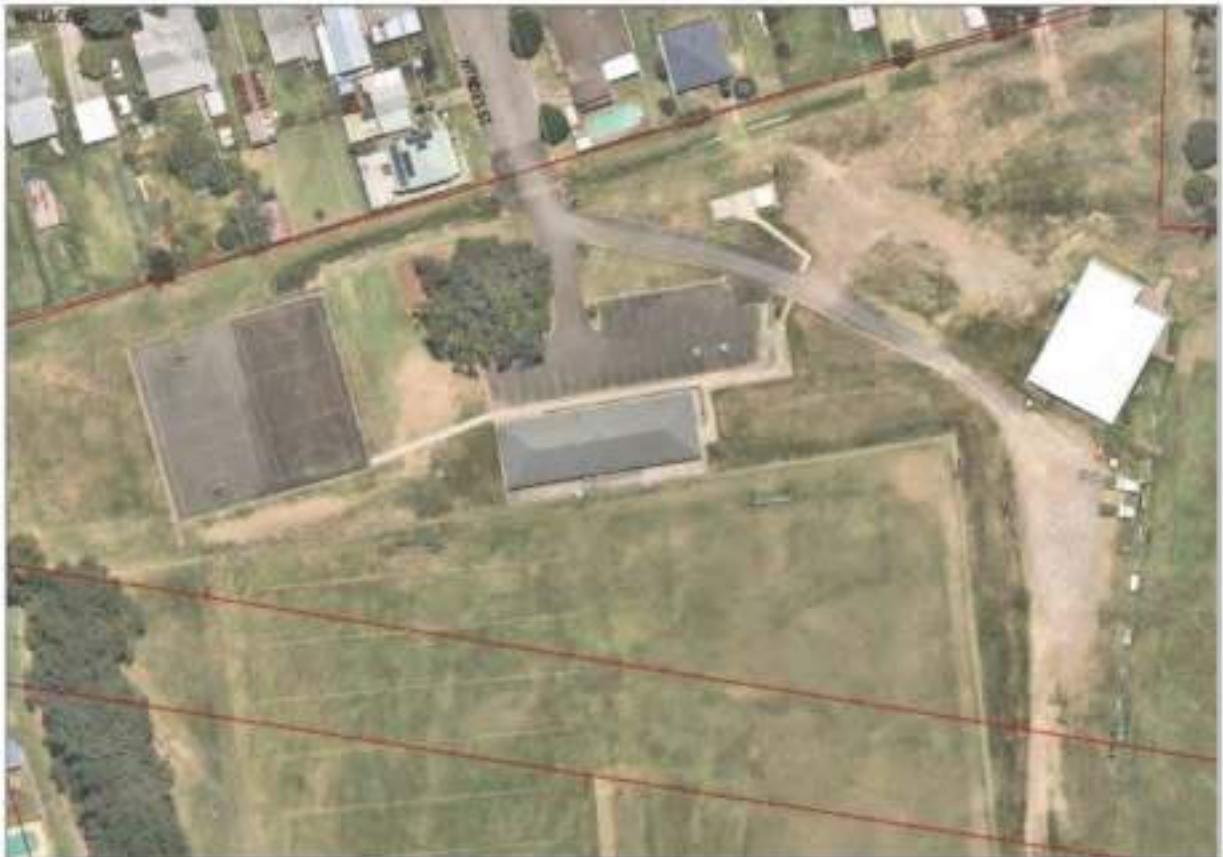
19 HYNES STREET, WEST WALLSEND 2286

Conservation Area Contribution Level	Est. Construction Date	Previous studies and/or community input
Contributory 2	Early to late 20 th century (broad range)	No prior heritage assessments or research undertaken.
Assessment Text		Observed Modifications
<p>The scale (single-storey) and general style of the dwelling is consistent with that of the streetscape and wider HCA. Dwelling contributes positively to the streetscape and wider HCA, particularly in comparison to Non-Contributory buildings.</p> <p>The dwelling features appropriately proportioned and positioned fenestrations, an appropriate roof form (gabled or hipped) and other features consistent with the architectural character of the area (e.g. front verandah with timber or brick posts, timber detailing, corrugated metal roofing, etc). The contributory value of the dwelling is limited however by either:</p> <ul style="list-style-type: none"> • External modifications that have in some way obscured the style, scale or design intent of the building and have resulted in less physical integrity than Contributory 1 buildings. • Being a later dwelling constructed in an appropriate referential style, but comprising little to no fabric of intrinsic heritage significance. 		A public recreational area. No modifications observed.

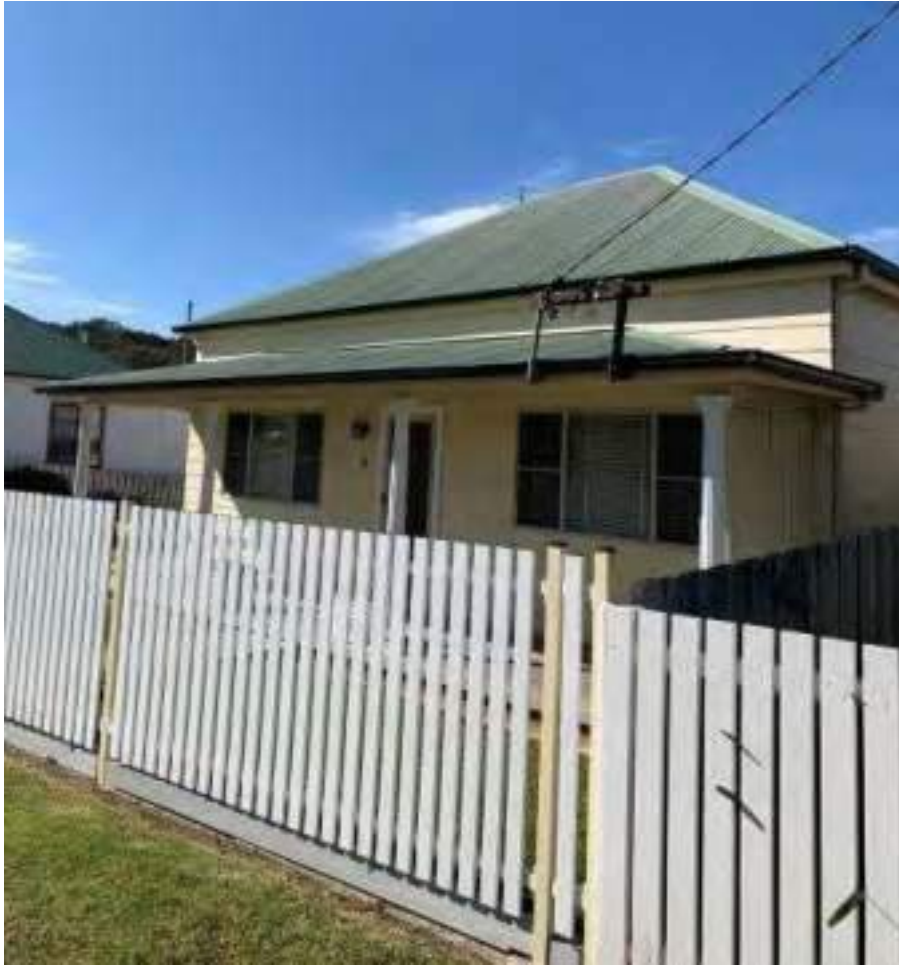
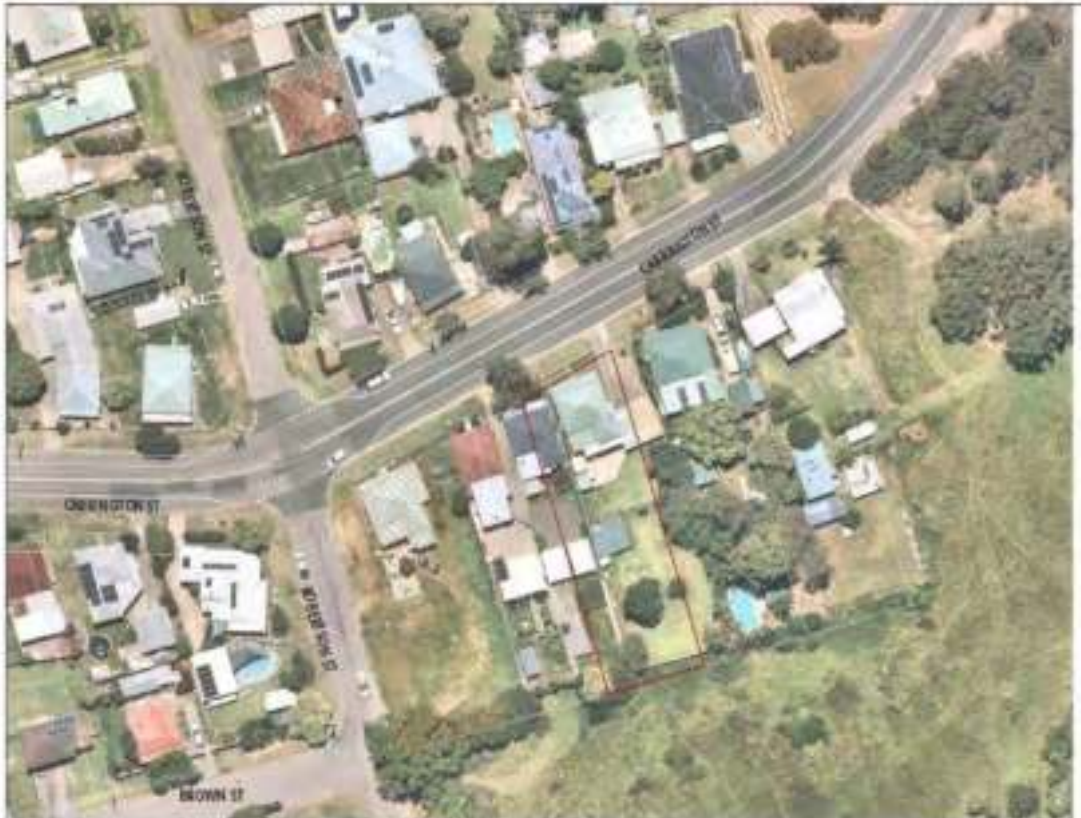
6 CARRINGTON STREET, WEST WALLSEND 2286

Conservation Area Contribution Level	Est. Construction Date	Previous studies and/or community input
Contributory 2	Early to late 20 th century (broad range)	No prior heritage assessments or research undertaken.
Assessment Text		Observed Modifications
<p>The scale (single-storey) and general style of the dwelling is consistent with that of the streetscape and wider HCA. Dwelling contributes positively to the streetscape and wider HCA, particularly in comparison to Non-Contributory buildings.</p> <p>The dwelling features appropriately proportioned and positioned fenestrations, an appropriate roof form (gabled or hipped) and other features consistent with the architectural character of the area (e.g. front verandah with timber or brick posts, timber detailing, corrugated metal roofing, etc). The contributory value of the dwelling is limited however by either:</p> <ul style="list-style-type: none"> • External modifications that have in some way obscured the style, scale or design intent of the building and have resulted in less physical integrity than Contributory 1 buildings. • Being a later dwelling constructed in an appropriate referential style, but comprising little to no fabric of intrinsic heritage significance. 		<p>The faux European pillars are contemporary additions, likely replacing original timber posts.</p> <p>All visible windows are contemporary in style.</p> <p>A garage and car port structure has been constructed onto the eastern portion of the dwelling.</p>

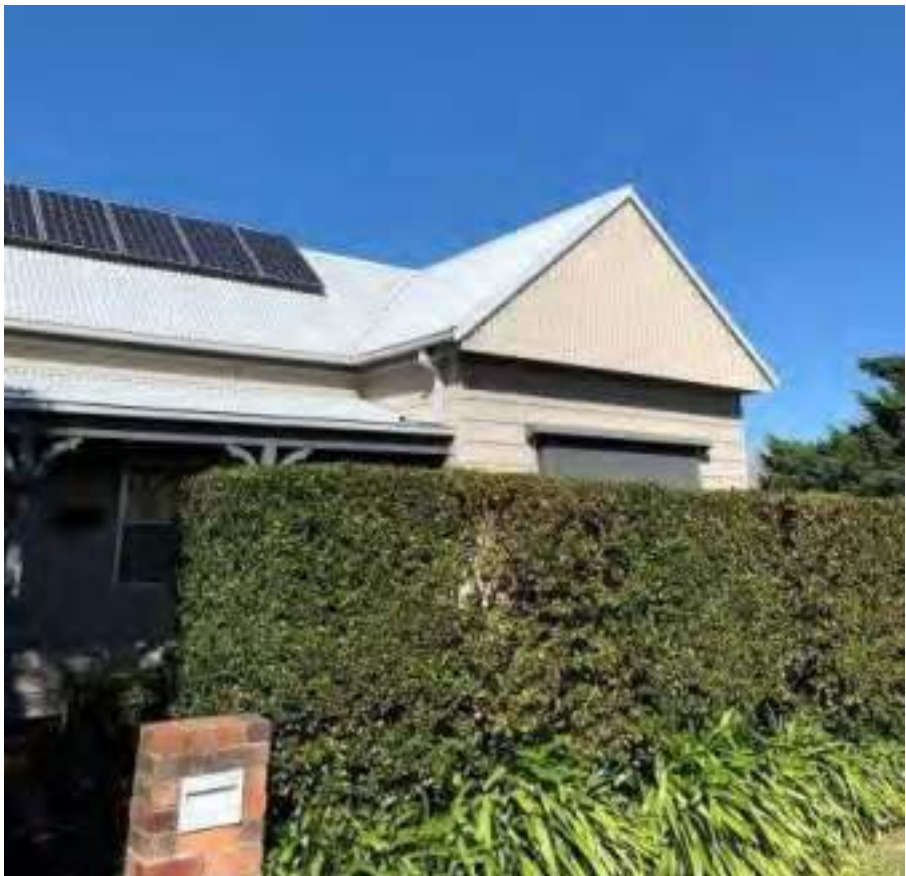
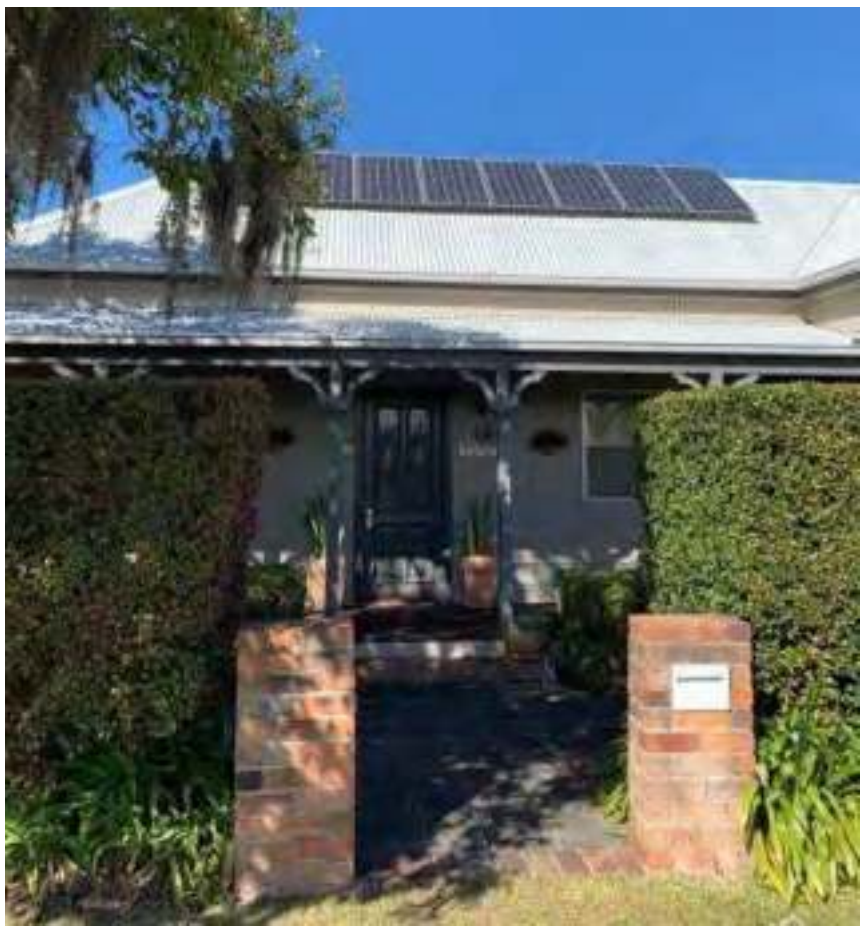
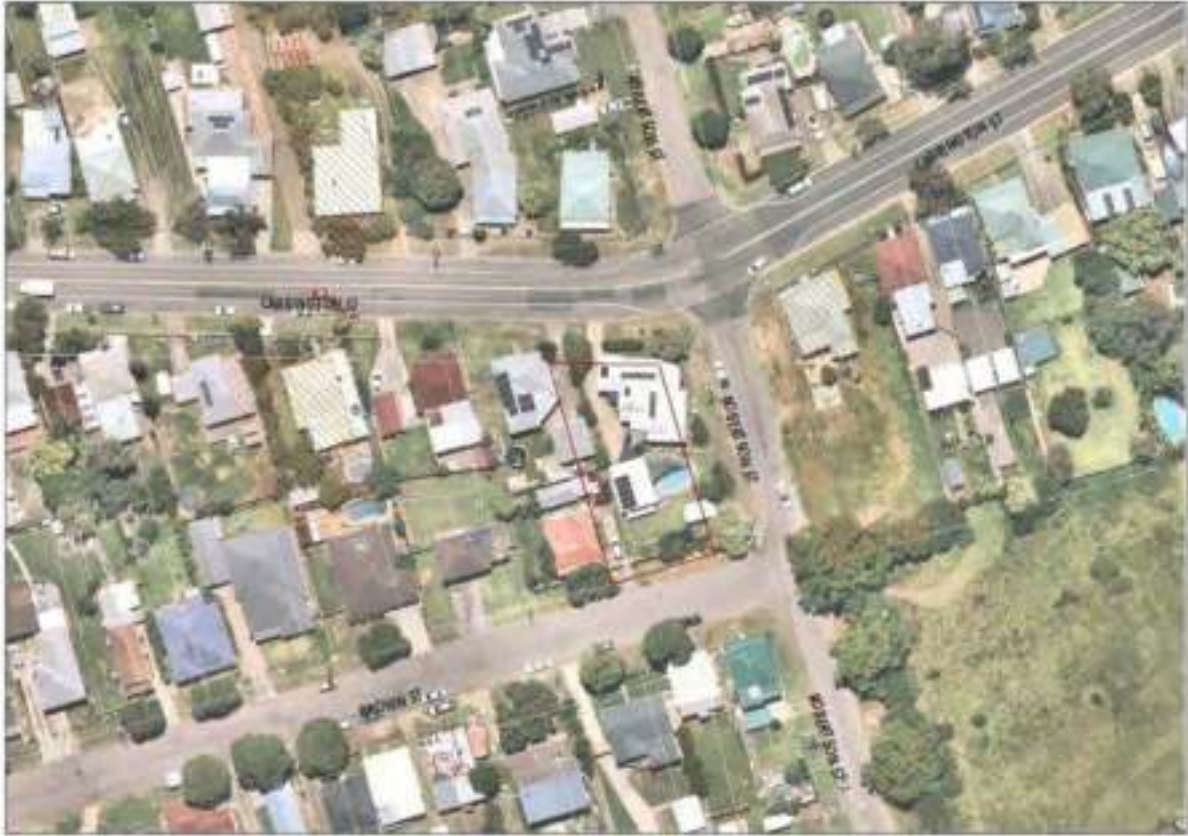
14 CARRINGTON STREET, WEST WALLSEND 2286

Conservation Area Contribution Level	Est. Construction Date	Previous studies and/or community input
Contributory 2	Early to late 20 th century (broad range)	No prior heritage assessments or research undertaken.
Assessment Text		Observed Modifications
<p>The scale (single-storey) and general style of the dwelling is consistent with that of the streetscape and wider HCA. Dwelling contributes positively to the streetscape and wider HCA, particularly in comparison to Non-Contributory buildings.</p> <p>The dwelling features appropriately proportioned and positioned fenestrations, an appropriate roof form (gabled or hipped) and other features consistent with the architectural character of the area (e.g. front verandah with timber or brick posts, timber detailing, corrugated metal roofing, etc). The contributory value of the dwelling is limited however by either:</p> <ul style="list-style-type: none"> • External modifications that have in some way obscured the style, scale or design intent of the building and have resulted in less physical integrity than Contributory 1 buildings. • Being a later dwelling constructed in an appropriate referential style, but comprising little to no fabric of intrinsic heritage significance. 		<p>Solar panels are highly visible along the northern portion of the roof.</p> <p>Colourbond panelling has built onto the exposed gable section of the roof. This is a contemporary modification and is not sympathetic in style.</p> <p>It is possible that all decorative features of the veranda are contemporary additions, designed in a comparable style to that of the original heritage features of the dwelling.</p>

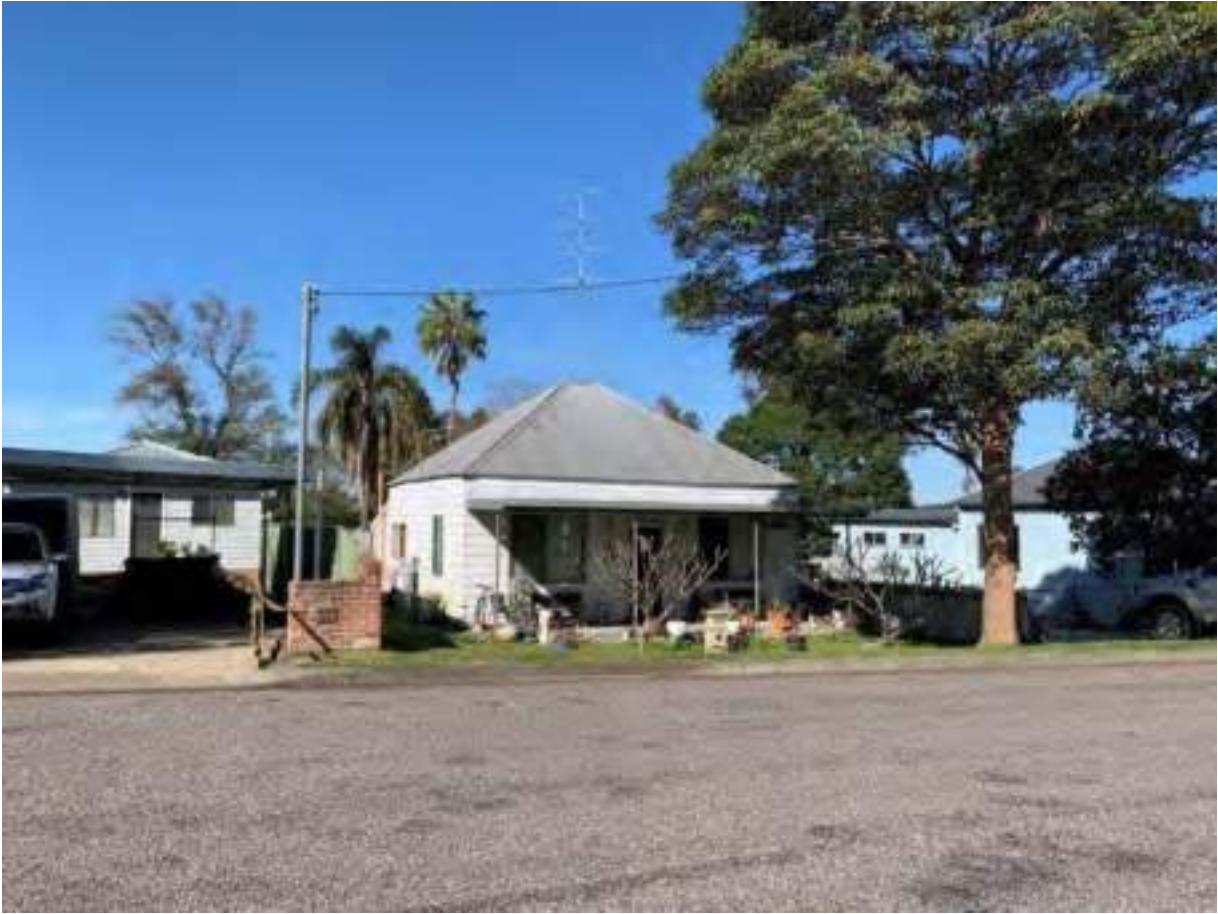
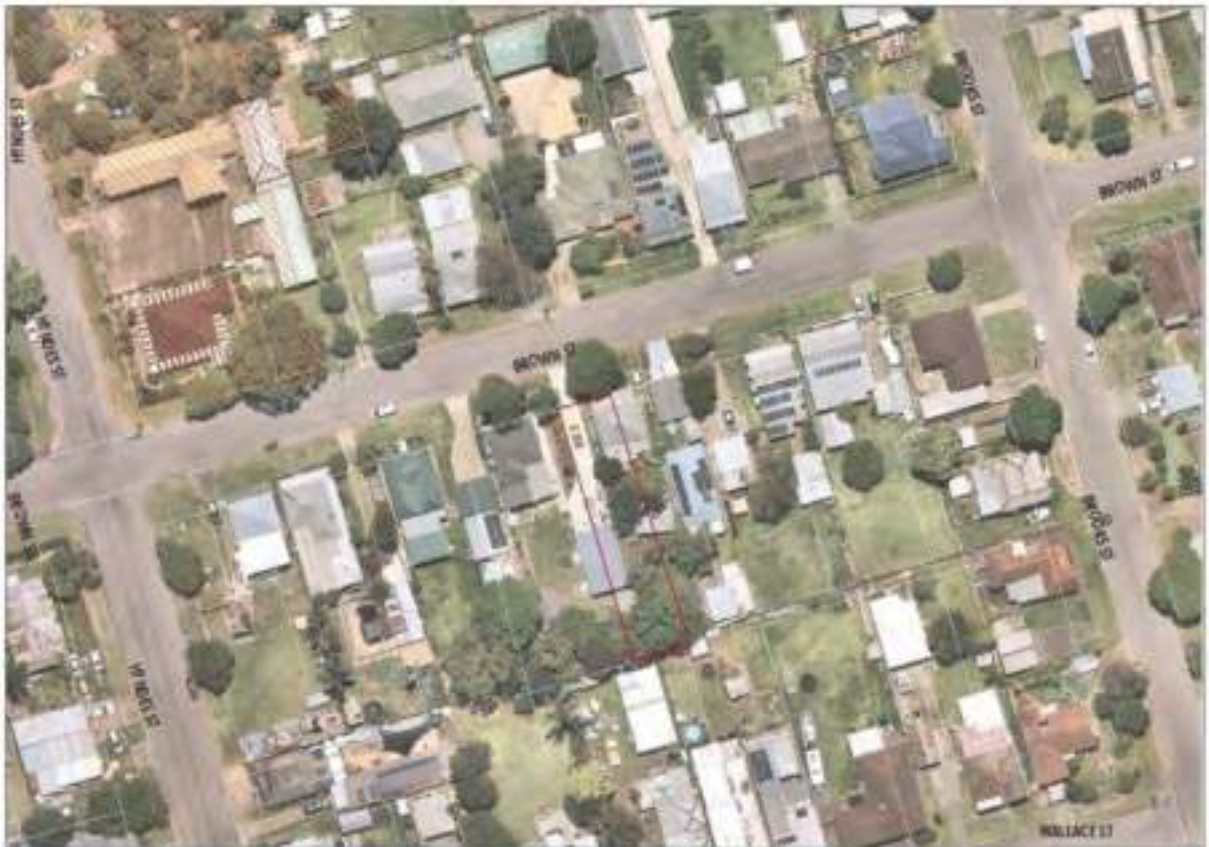
34 BROWN STREET, WEST WALLSEND 2286

Conservation Area Contribution Level	Est. Construction Date	Previous studies and/or community input
Contributory 2	Early to late 20 th century (broad range)	No prior heritage assessments or research undertaken.
Assessment Text		Observed Modifications
<p>The scale (single-storey) and general style of the dwelling is consistent with that of the streetscape and wider HCA. Dwelling contributes positively to the streetscape and wider HCA, particularly in comparison to Non-Contributory buildings.</p> <p>The dwelling features appropriately proportioned and positioned fenestrations, an appropriate roof form (gabled or hipped) and other features consistent with the architectural character of the area (e.g. front verandah with timber or brick posts, timber detailing, corrugated metal roofing, etc). The contributory value of the dwelling is limited however by either:</p> <ul style="list-style-type: none"> • External modifications that have in some way obscured the style, scale or design intent of the building and have resulted in less physical integrity than Contributory 1 buildings. • Being a later dwelling constructed in an appropriate referential style, but comprising little to no fabric of intrinsic heritage significance. 		<p>The flat veranda roof is a dated modification, likely replacing the original hipped or bull nosed design. The metal support posts are similarly modifications.</p> <p>All visible windows are contemporary in style.</p>

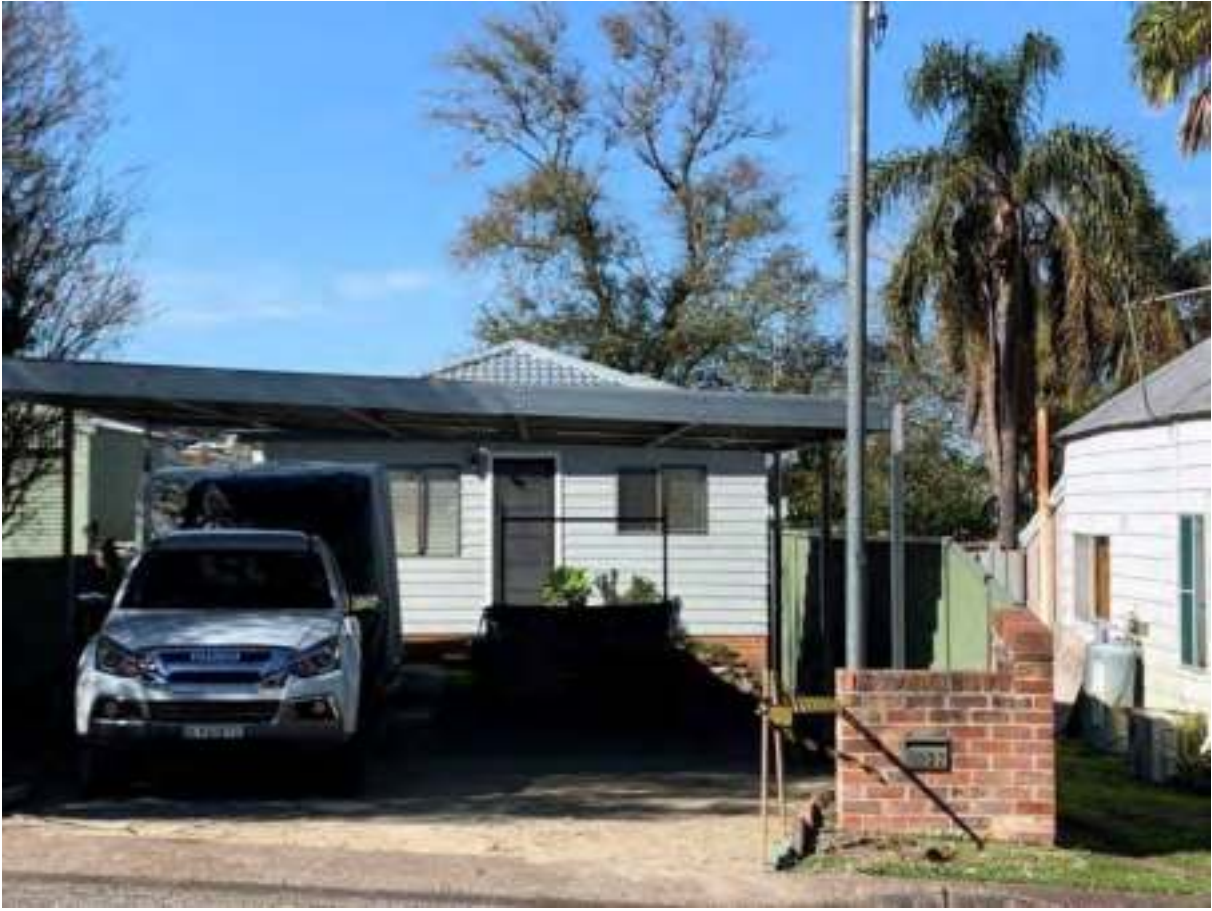
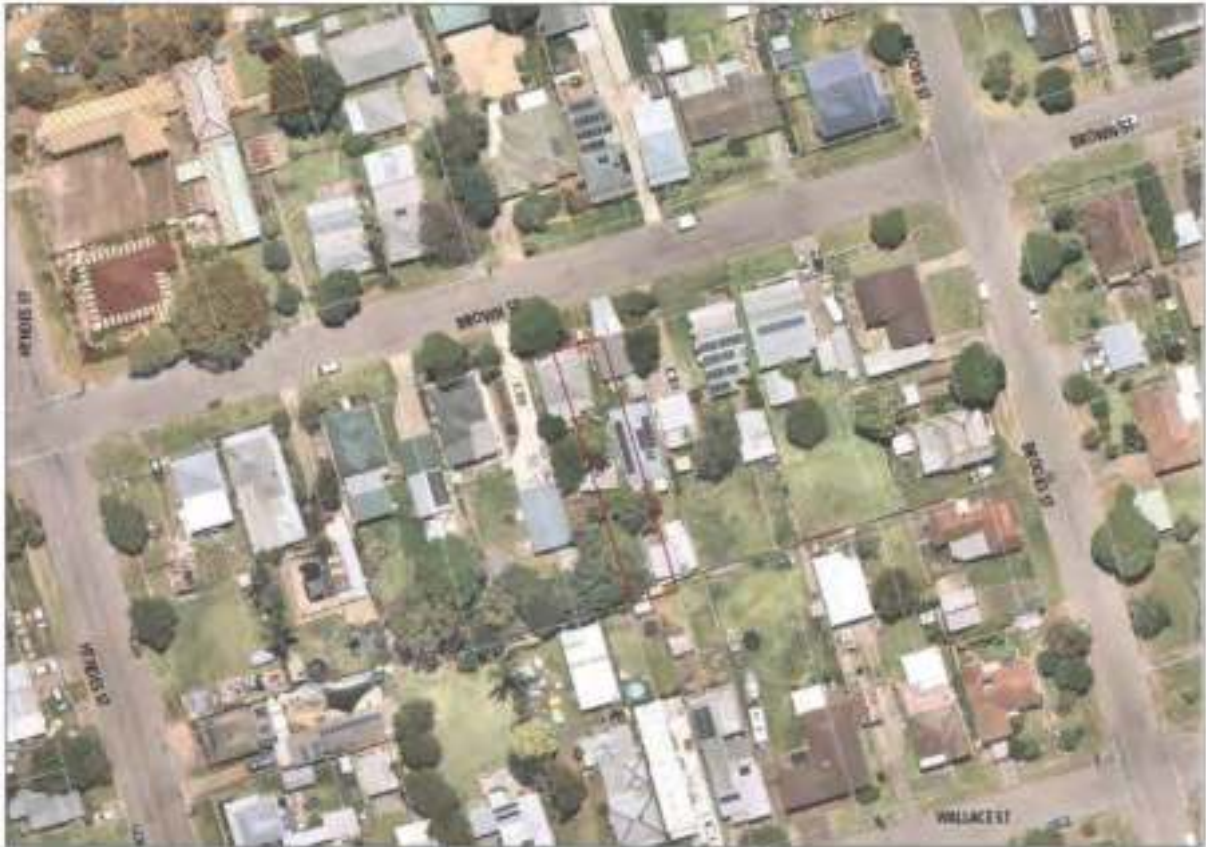
32 BROWN STREET, WEST WALLSEND 2286

Conservation Area Contribution Level	Est. Construction Date	Previous studies and/or community input
Contributory 2	Early to late 20 th century (broad range)	No prior heritage assessments or research undertaken.
Assessment Text		Observed Modifications
<p>The scale (single-storey) and general style of the dwelling is consistent with that of the streetscape and wider HCA. Dwelling contributes positively to the streetscape and wider HCA, particularly in comparison to Non-Contributory buildings.</p> <p>The dwelling features appropriately proportioned and positioned fenestrations, an appropriate roof form (gabled or hipped) and other features consistent with the architectural character of the area (e.g. front verandah with timber or brick posts, timber detailing, corrugated metal roofing, etc). The contributory value of the dwelling is limited however by either:</p> <ul style="list-style-type: none"> • External modifications that have in some way obscured the style, scale or design intent of the building and have resulted in less physical integrity than Contributory 1 buildings. • Being a later dwelling constructed in an appropriate referential style, but comprising little to no fabric of intrinsic heritage significance. 		<p>A large carport has been constructed at the northern front of the dwelling, obscuring the dwelling.</p>

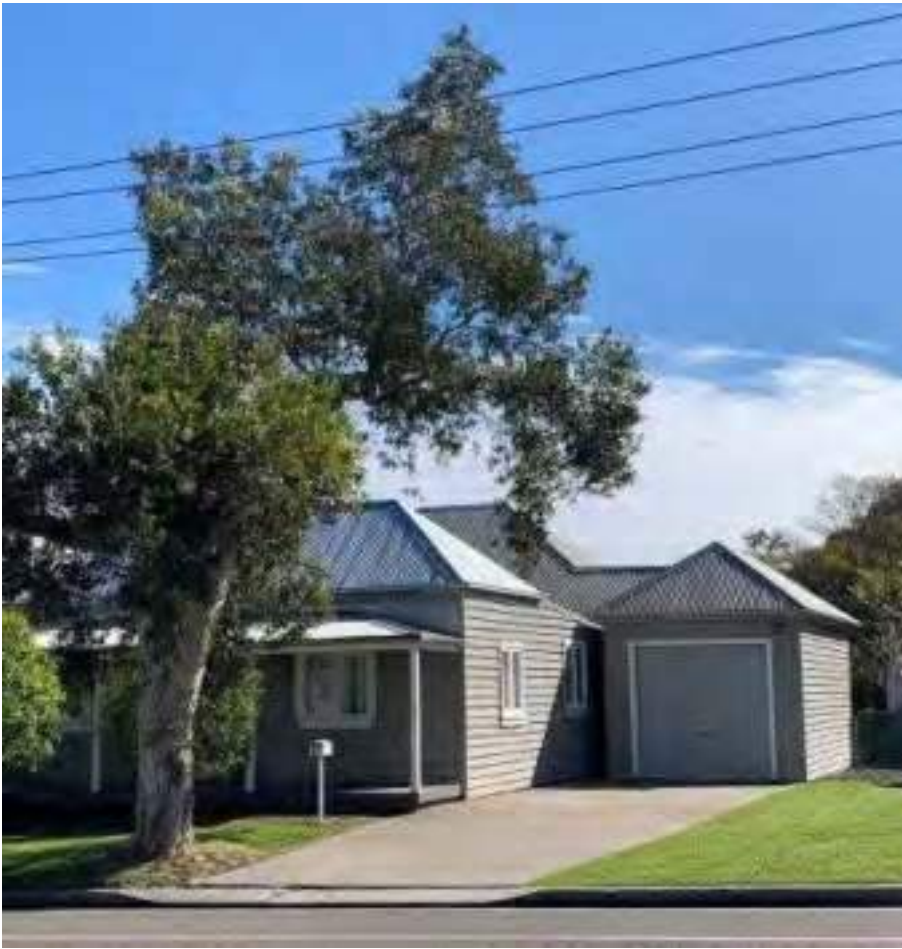
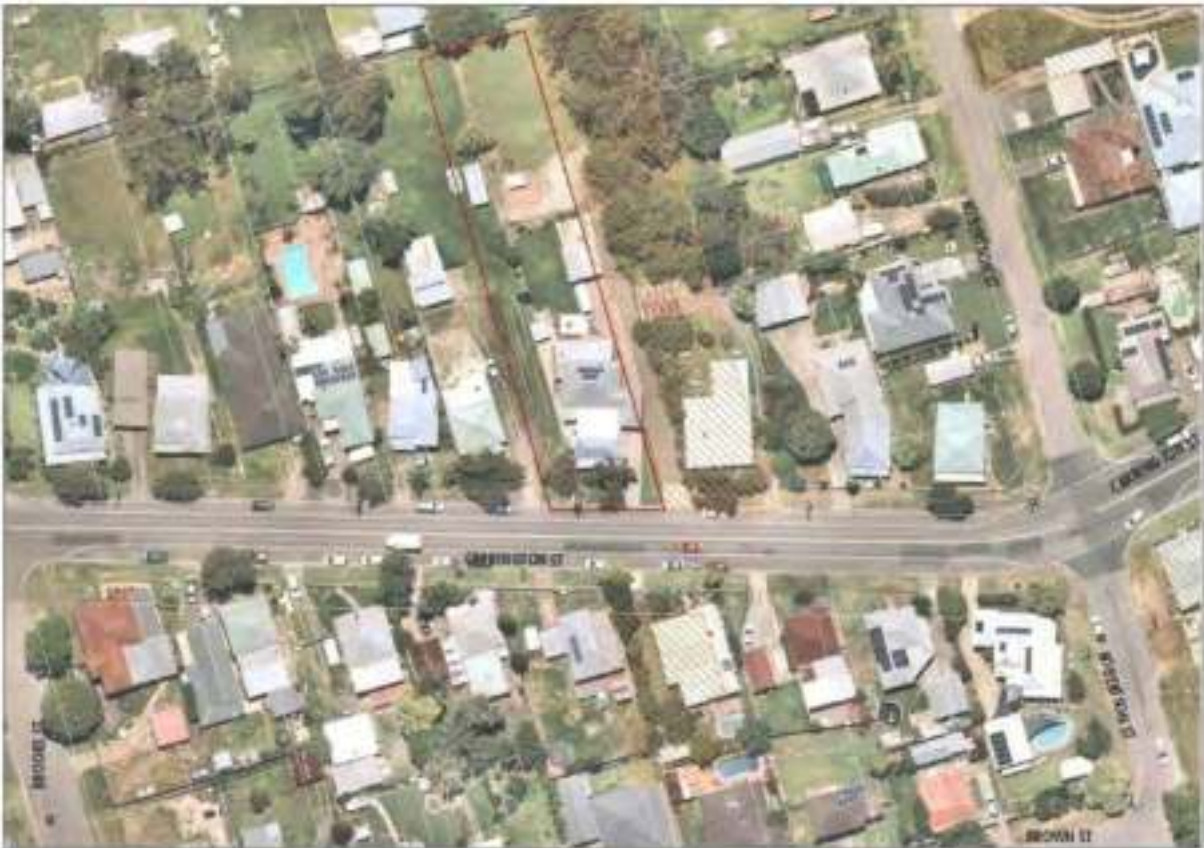
17 CARRINGTON STREET, WEST WALLSEND 2286

Conservation Area Contribution Level	Est. Construction Date	Previous studies and/or community input
Contributory 2	Early to late 20 th century (broad range)	No prior heritage assessments or research undertaken.
Assessment Text		Observed Modifications
<p>The scale (single-storey) and general style of the dwelling is consistent with that of the streetscape and wider HCA. Dwelling contributes positively to the streetscape and wider HCA, particularly in comparison to Non-Contributory buildings.</p> <p>The dwelling features appropriately proportioned and positioned fenestrations, an appropriate roof form (gabled or hipped) and other features consistent with the architectural character of the area (e.g. front verandah with timber or brick posts, timber detailing, corrugated metal roofing, etc). The contributory value of the dwelling is limited however by either:</p> <ul style="list-style-type: none"> • External modifications that have in some way obscured the style, scale or design intent of the building and have resulted in less physical integrity than Contributory 1 buildings. • Being a later dwelling constructed in an appropriate referential style, but comprising little to no fabric of intrinsic heritage significance. 		<p>The dwelling has undergone extensive external modifications, including a new Colourbond roof, all exterior paintwork and timber detailing.</p> <p>An extension has been constructed to the northern portion of the dwelling. this is partially visible, however does not detract from the heritage streetscape.</p> <p>A single door garage has been constructed to the east of the dwelling.</p>

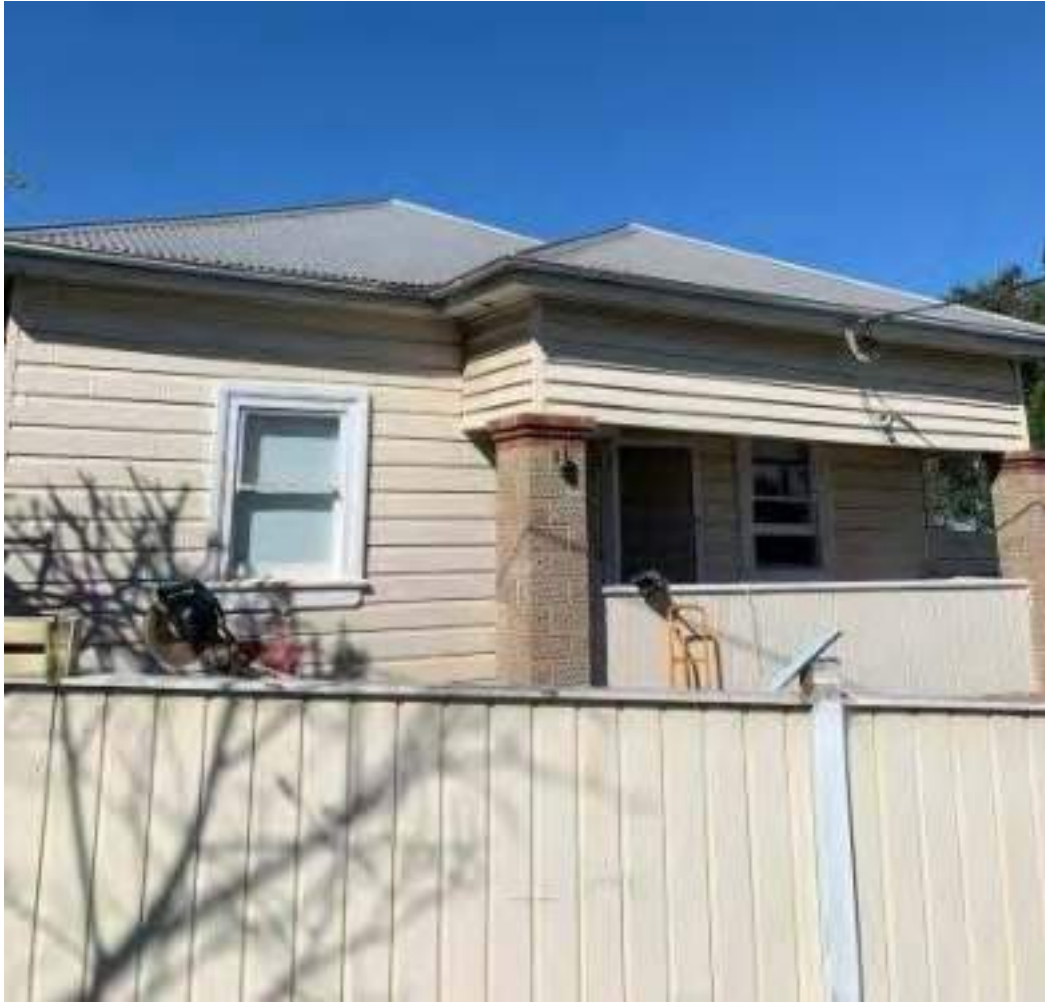
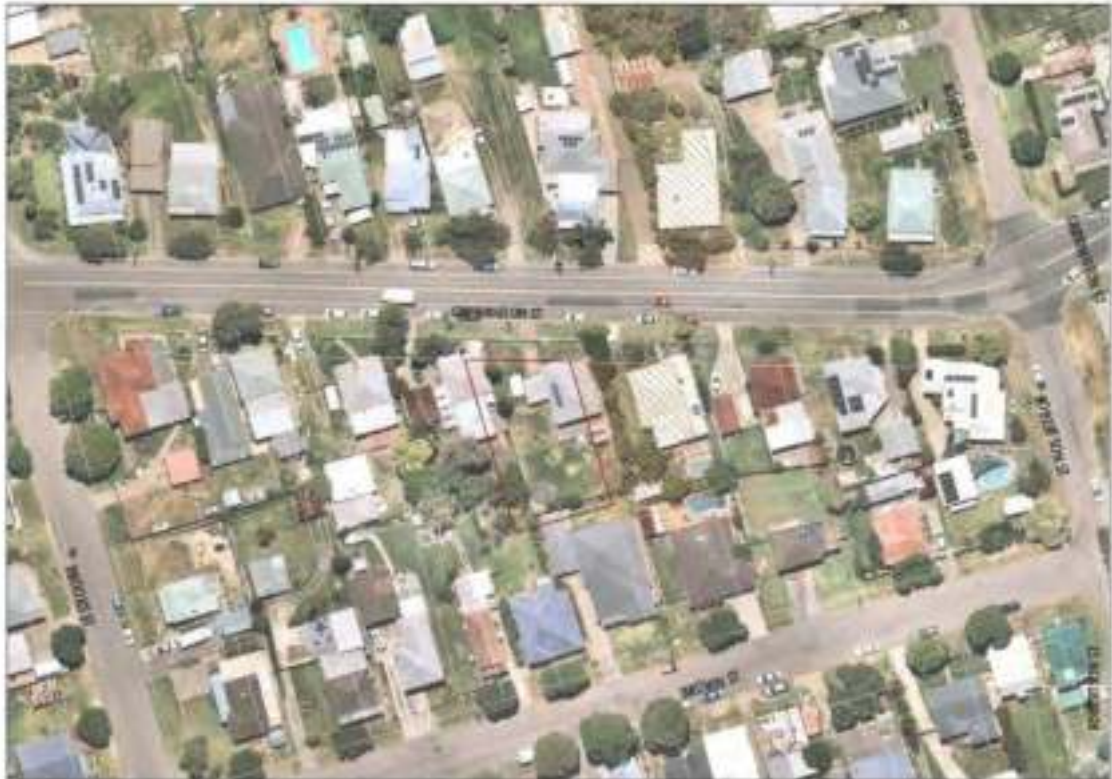
22 CARRINGTON STREET, WEST WALLSEND 2286

Conservation Area Contribution Level	Est. Construction Date	Previous studies and/or community input
Contributory 2	Early to late 20 th century (broad range)	No prior heritage assessments or research undertaken.
Assessment Text		Observed Modifications
<p>The scale (single-storey) and general style of the dwelling is consistent with that of the streetscape and wider HCA. Dwelling contributes positively to the streetscape and wider HCA, particularly in comparison to Non-Contributory buildings.</p> <p>The dwelling features appropriately proportioned and positioned fenestrations, an appropriate roof form (gabled or hipped) and other features consistent with the architectural character of the area (e.g. front verandah with timber or brick posts, timber detailing, corrugated metal roofing, etc). The contributory value of the dwelling is limited however by either:</p> <ul style="list-style-type: none"> • External modifications that have in some way obscured the style, scale or design intent of the building and have resulted in less physical integrity than Contributory 1 buildings. • Being a later dwelling constructed in an appropriate referential style, but comprising little to no fabric of intrinsic heritage significance. 		<p>The timber balustrade enclosing the veranda space is likely a contemporary addition.</p>
