APPENDIX 2

Building Assessment Sheets (Inventory Sheets)

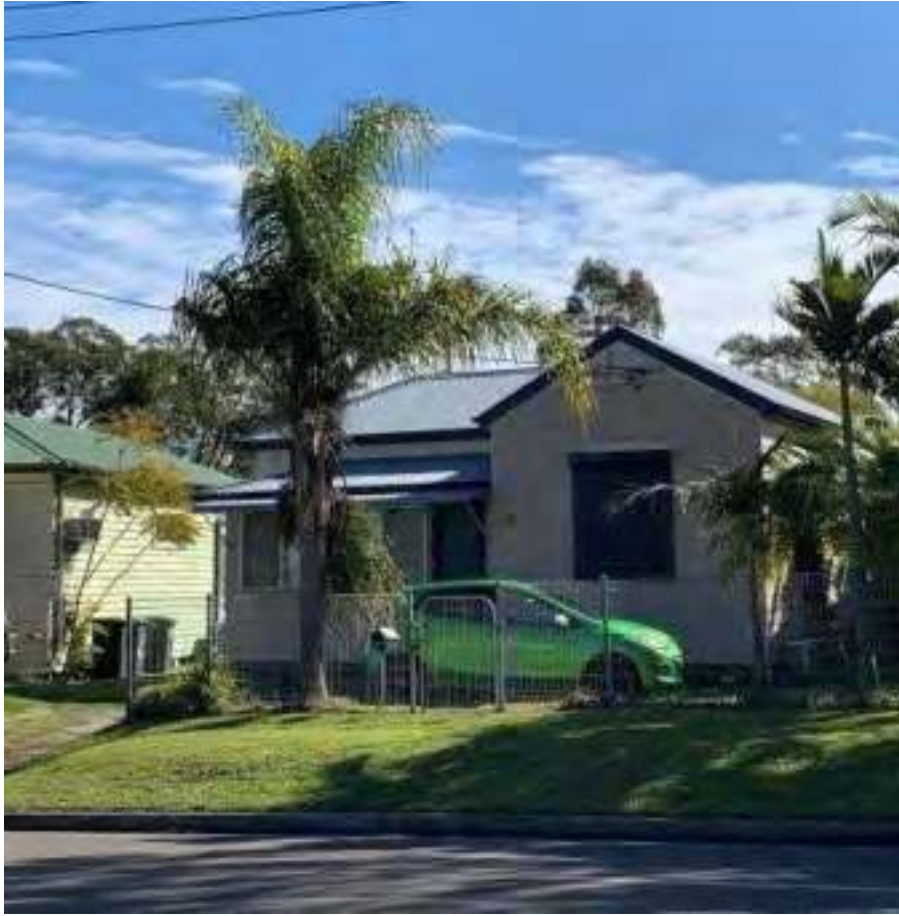
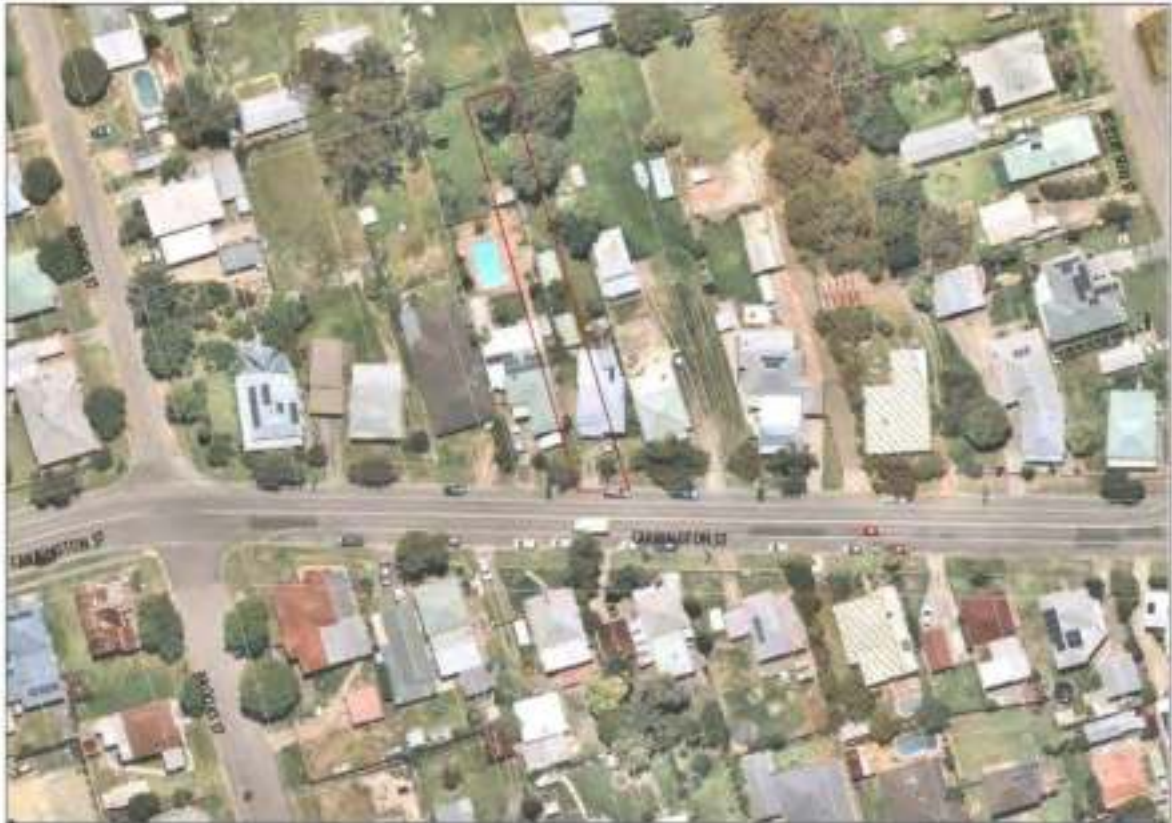
21 CARRINGTON STREET, WEST WALLSEND 2286

Conservation Area Contribution Level	Est. Construction Date	Previous studies and/or community input
Contributory 2	Early to late 20 th century (broad range)	No prior heritage assessments or research undertaken.
Assessment Text		Observed Modifications
<p>The scale (single-storey) and general style of the dwelling is consistent with that of the streetscape and wider HCA. Dwelling contributes positively to the streetscape and wider HCA, particularly in comparison to Non-Contributory buildings.</p> <p>The dwelling features appropriately proportioned and positioned fenestrations, an appropriate roof form (gabled or hipped) and other features consistent with the architectural character of the area (e.g. front verandah with timber or brick posts, timber detailing, corrugated metal roofing, etc). The contributory value of the dwelling is limited however by either:</p> <ul style="list-style-type: none"> • External modifications that have in some way obscured the style, scale or design intent of the building and have resulted in less physical integrity than Contributory 1 buildings. • Being a later dwelling constructed in an appropriate referential style, but comprising little to no fabric of intrinsic heritage significance. 		<p>The veranda has been built in to create an additional living area, with contemporary windows enclosing the space.</p> <p>All decorative external features have been removed.</p>

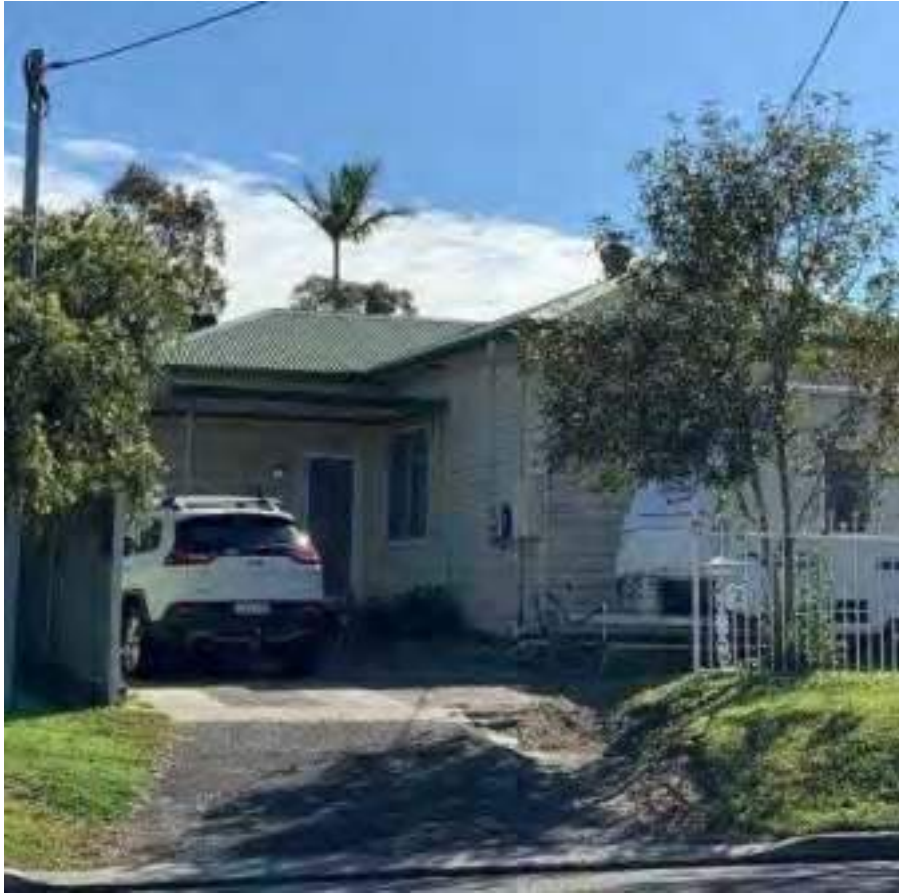
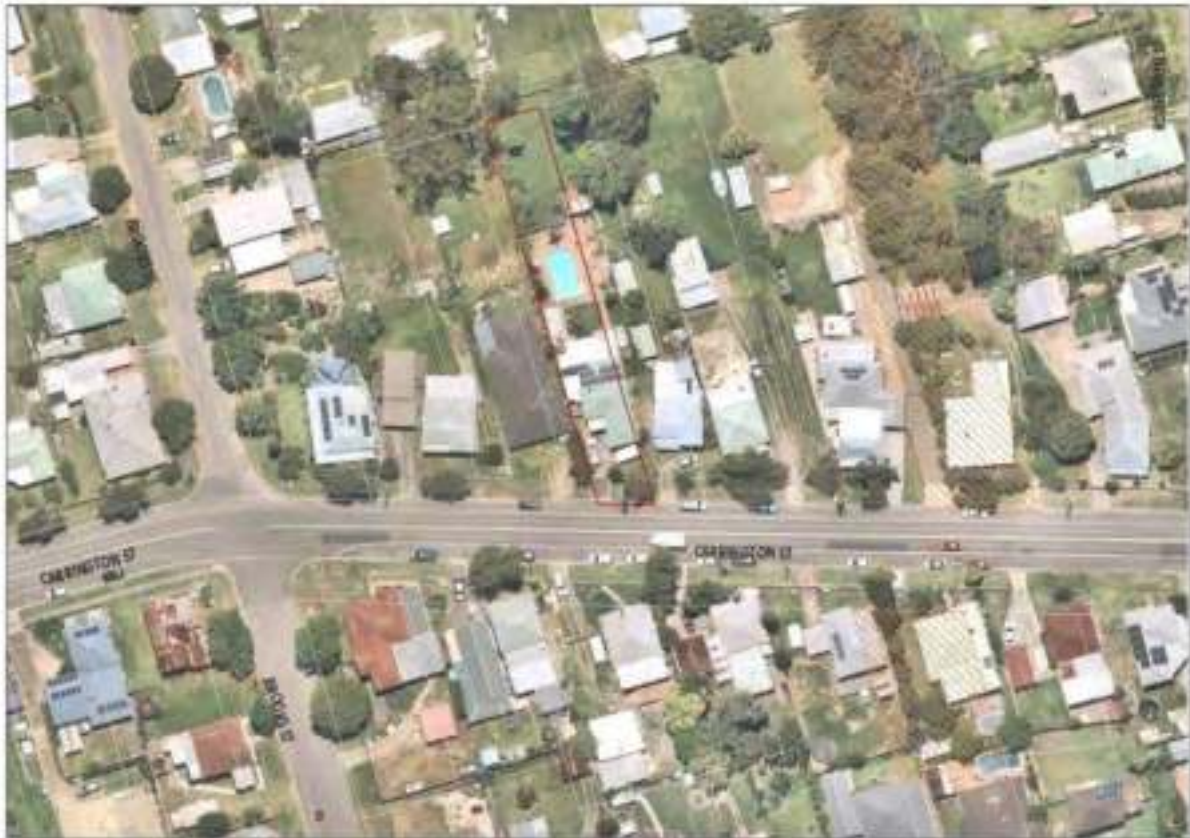
23 CARRINGTON STREET, WEST WALLSEND 2286

Conservation Area Contribution Level	Est. Construction Date	Previous studies and/or community input
Contributory 2	Early to late 20 th century (broad range)	No prior heritage assessments or research undertaken.
Assessment Text		Observed Modifications
<p>The scale (single-storey) and general style of the dwelling is consistent with that of the streetscape and wider HCA. Dwelling contributes positively to the streetscape and wider HCA, particularly in comparison to Non-Contributory buildings.</p> <p>The dwelling features appropriately proportioned and positioned fenestrations, an appropriate roof form (gabled or hipped) and other features consistent with the architectural character of the area (e.g. front verandah with timber or brick posts, timber detailing, corrugated metal roofing, etc). The contributory value of the dwelling is limited however by either:</p> <ul style="list-style-type: none"> • External modifications that have in some way obscured the style, scale or design intent of the building and have resulted in less physical integrity than Contributory 1 buildings. • Being a later dwelling constructed in an appropriate referential style, but comprising little to no fabric of intrinsic heritage significance. 		<p>A flat roof veranda extension has been constructed at the front southern portion of the dwelling.</p>

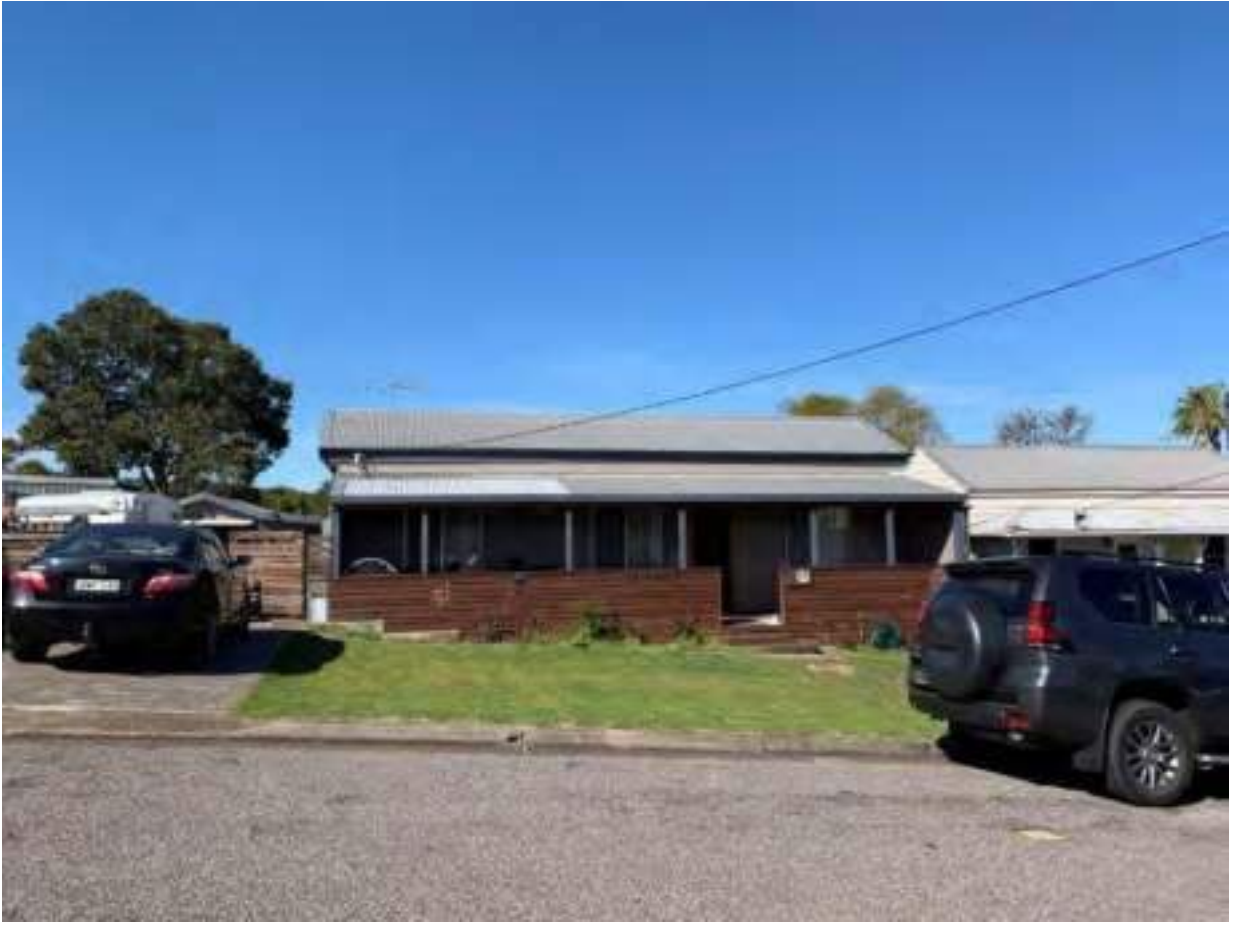
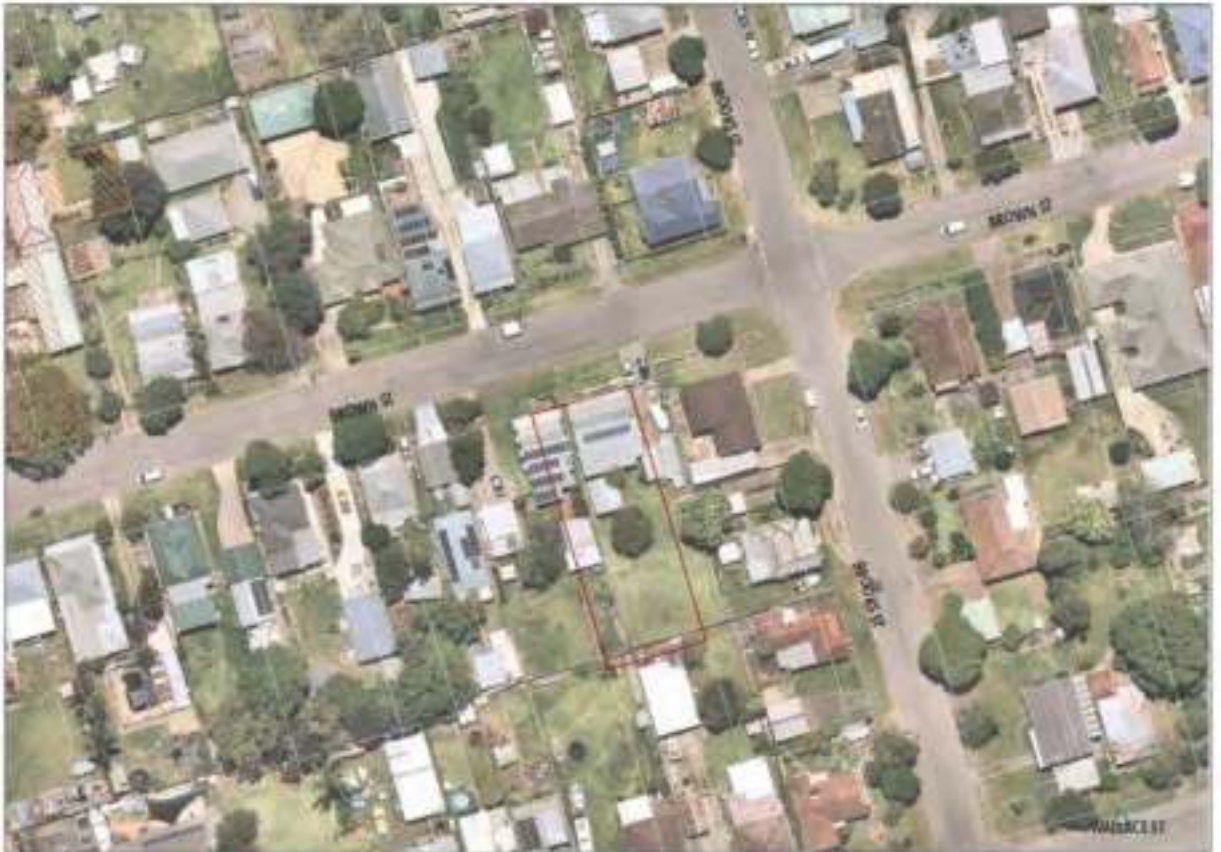
28 BROWN STREET, WEST WALLSEND 2286

Conservation Area Contribution Level	Est. Construction Date	Previous studies and/or community input
Contributory 2	Early to late 20 th century (broad range)	No prior heritage assessments or research undertaken.
Assessment Text		Observed Modifications
<p>The scale (single-storey) and general style of the dwelling is consistent with that of the streetscape and wider HCA. Dwelling contributes positively to the streetscape and wider HCA, particularly in comparison to Non-Contributory buildings.</p> <p>The dwelling features appropriately proportioned and positioned fenestrations, an appropriate roof form (gabled or hipped) and other features consistent with the architectural character of the area (e.g. front verandah with timber or brick posts, timber detailing, corrugated metal roofing, etc). The contributory value of the dwelling is limited however by either:</p> <ul style="list-style-type: none"> • External modifications that have in some way obscured the style, scale or design intent of the building and have resulted in less physical integrity than Contributory 1 buildings. • Being a later dwelling constructed in an appropriate referential style, but comprising little to no fabric of intrinsic heritage significance. 		<p>The prominent timber fencing enclosing the property is a contemporary addition.</p> <p>The dwelling is likely a highly modified Vernacular mining cottage, with extensions constructed on the eastern portion of the dwelling and veranda. This has expanded the dwelling and obscured the original design.</p> <p>All visible windows are contemporary in style.</p>

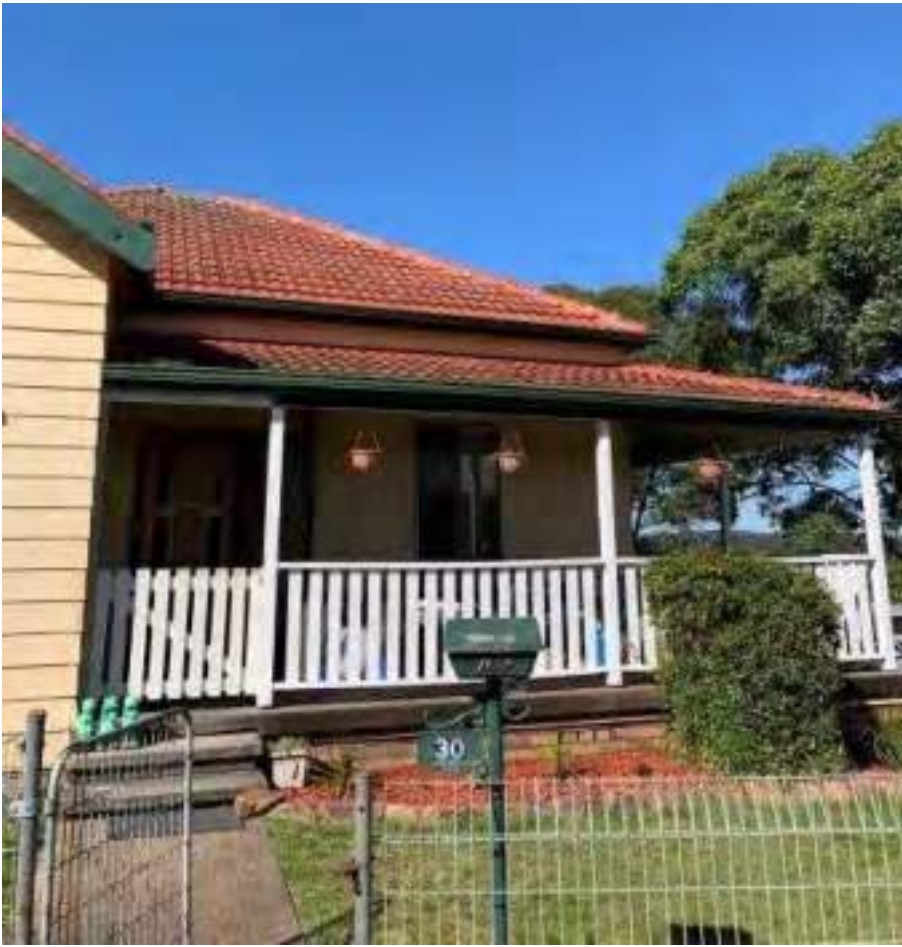
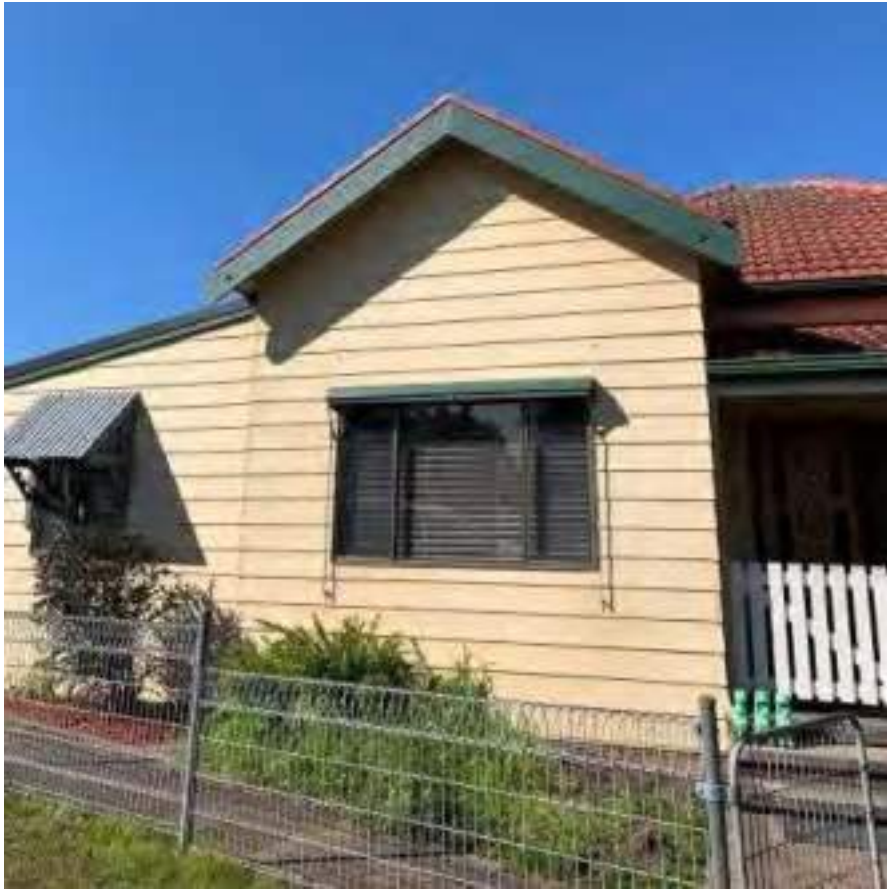
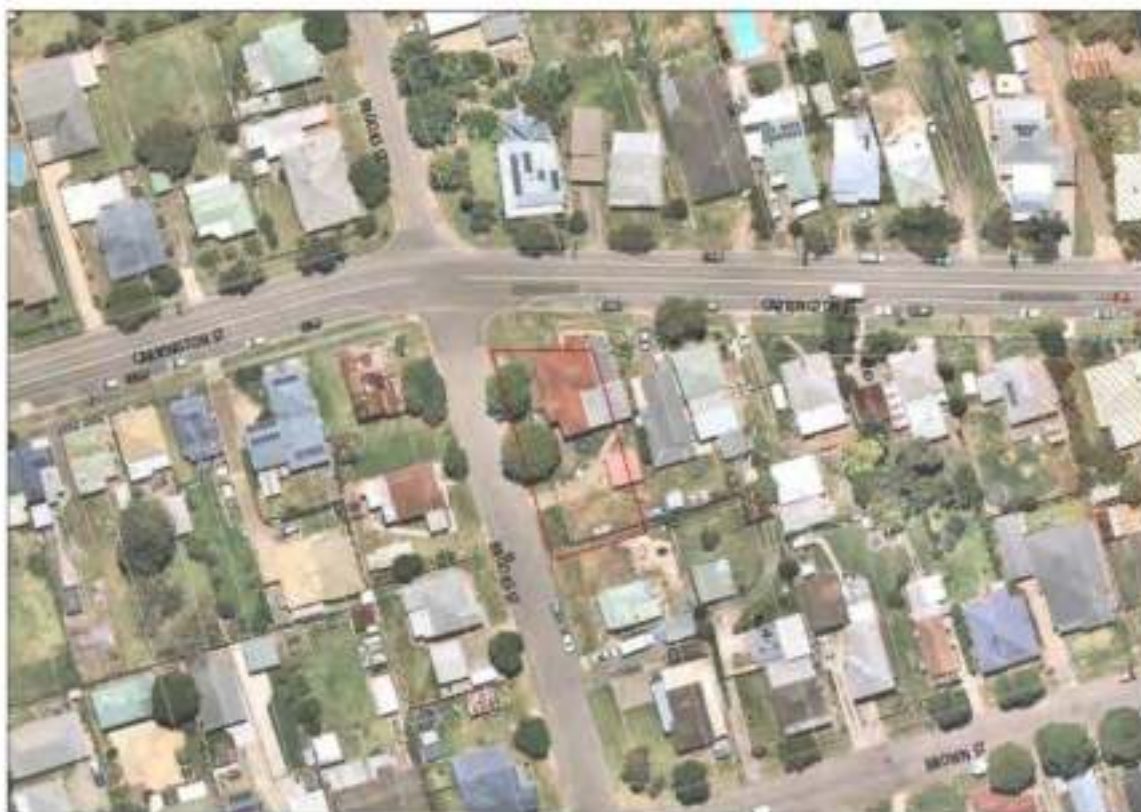
30 CARRINGTON STREET, WEST WALLSEND 2286

Conservation Area Contribution Level	Est. Construction Date	Previous studies and/or community input
Contributory 2	Early to late 20 th century (broad range)	No prior heritage assessments or research undertaken.
Assessment Text		Observed Modifications
<p>The scale (single-storey) and general style of the dwelling is consistent with that of the streetscape and wider HCA. Dwelling contributes positively to the streetscape and wider HCA, particularly in comparison to Non-Contributory buildings.</p> <p>The dwelling features appropriately proportioned and positioned fenestrations, an appropriate roof form (gabled or hipped) and other features consistent with the architectural character of the area (e.g. front verandah with timber or brick posts, timber detailing, corrugated metal roofing, etc). The contributory value of the dwelling is limited however by either:</p> <ul style="list-style-type: none"> • External modifications that have in some way obscured the style, scale or design intent of the building and have resulted in less physical integrity than Contributory 1 buildings. • Being a later dwelling constructed in an appropriate referential style, but comprising little to no fabric of intrinsic heritage significance. 		<p>The terracotta roof tiles are a contemporary modification, likely replacing original iron sheet or Colourbond roofing.</p> <p>The veranda timber balustrade is a recent addition, likely replacing a similar timber design. This is a sympathetic modification and does not detract from the remaining heritage features of the dwelling.</p> <p>An extension has been constructed on the eastern portion of the dwelling. this is highly visible, however has been constructed in a sympathetic style.</p>

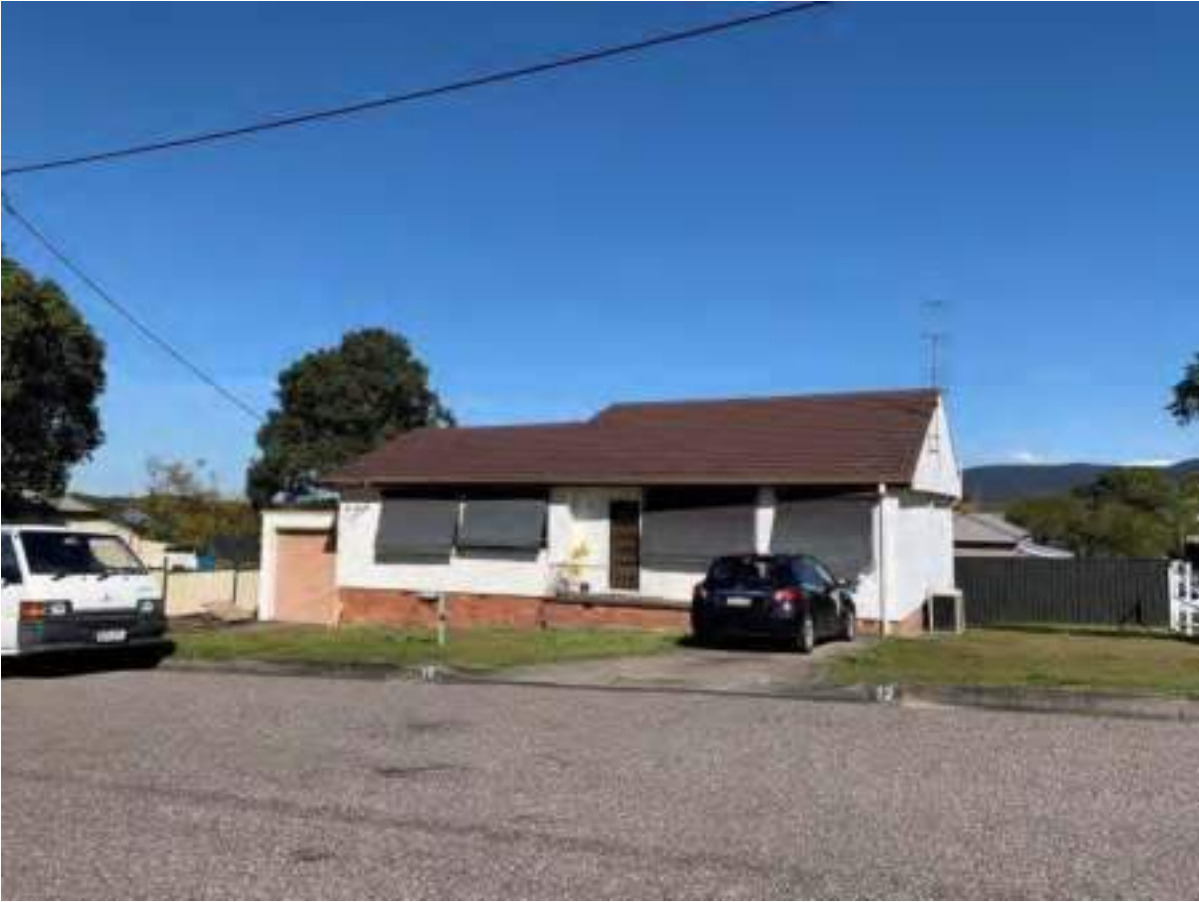
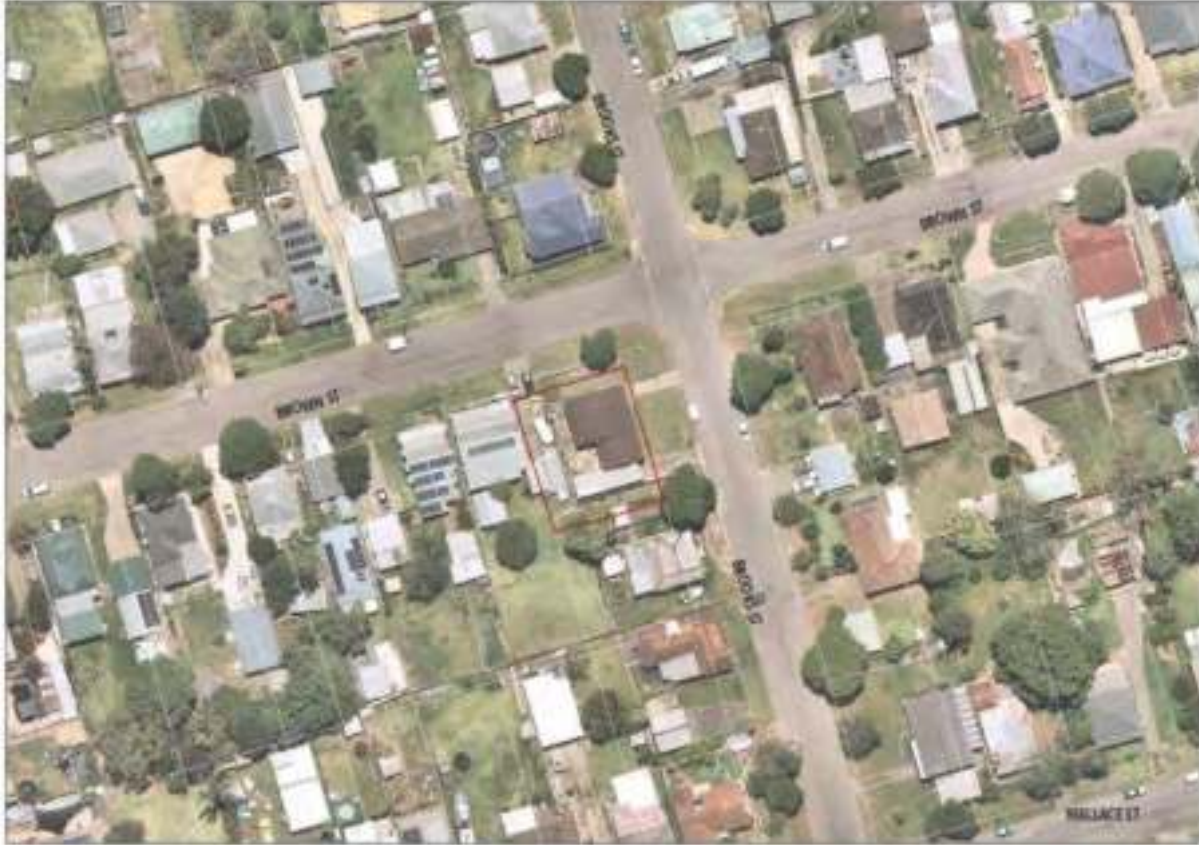
12 BROOKS STREET, WEST WALLSEND 2286

Conservation Area Contribution Level	Est. Construction Date	Previous studies and/or community input
Contributory 2	Early to late 20 th century (broad range)	No prior heritage assessments or research undertaken.
Assessment Text		Observed Modifications
<p>The scale (single-storey) and general style of the dwelling is consistent with that of the streetscape and wider HCA. Dwelling contributes positively to the streetscape and wider HCA, particularly in comparison to Non-Contributory buildings.</p> <p>The dwelling features appropriately proportioned and positioned fenestrations, an appropriate roof form (gabled or hipped) and other features consistent with the architectural character of the area (e.g. front verandah with timber or brick posts, timber detailing, corrugated metal roofing, etc). The contributory value of the dwelling is limited however by either:</p> <ul style="list-style-type: none"> • External modifications that have in some way obscured the style, scale or design intent of the building and have resulted in less physical integrity than Contributory 1 buildings. • Being a later dwelling constructed in an appropriate referential style, but comprising little to no fabric of intrinsic heritage significance. 		Canvas blinds have been installed on all façade windows.

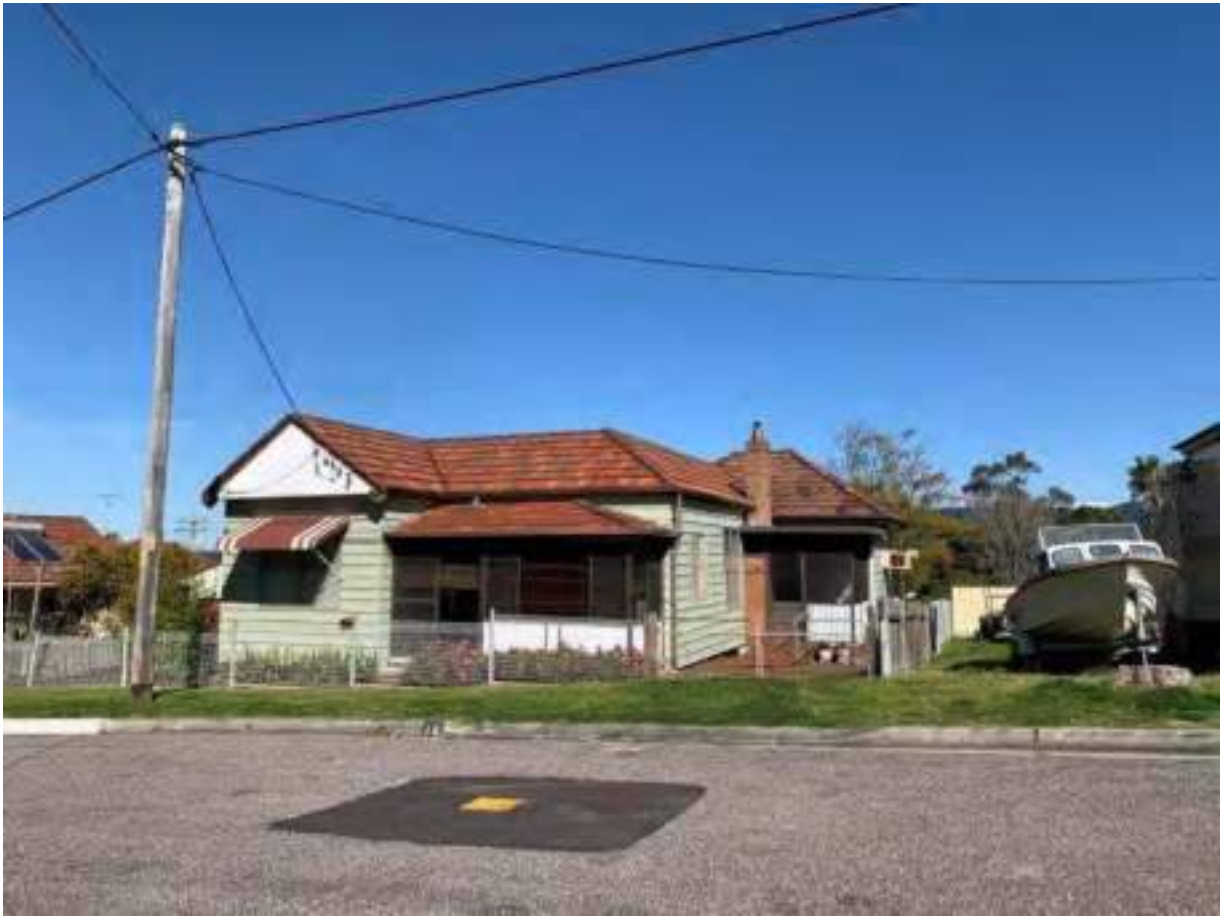
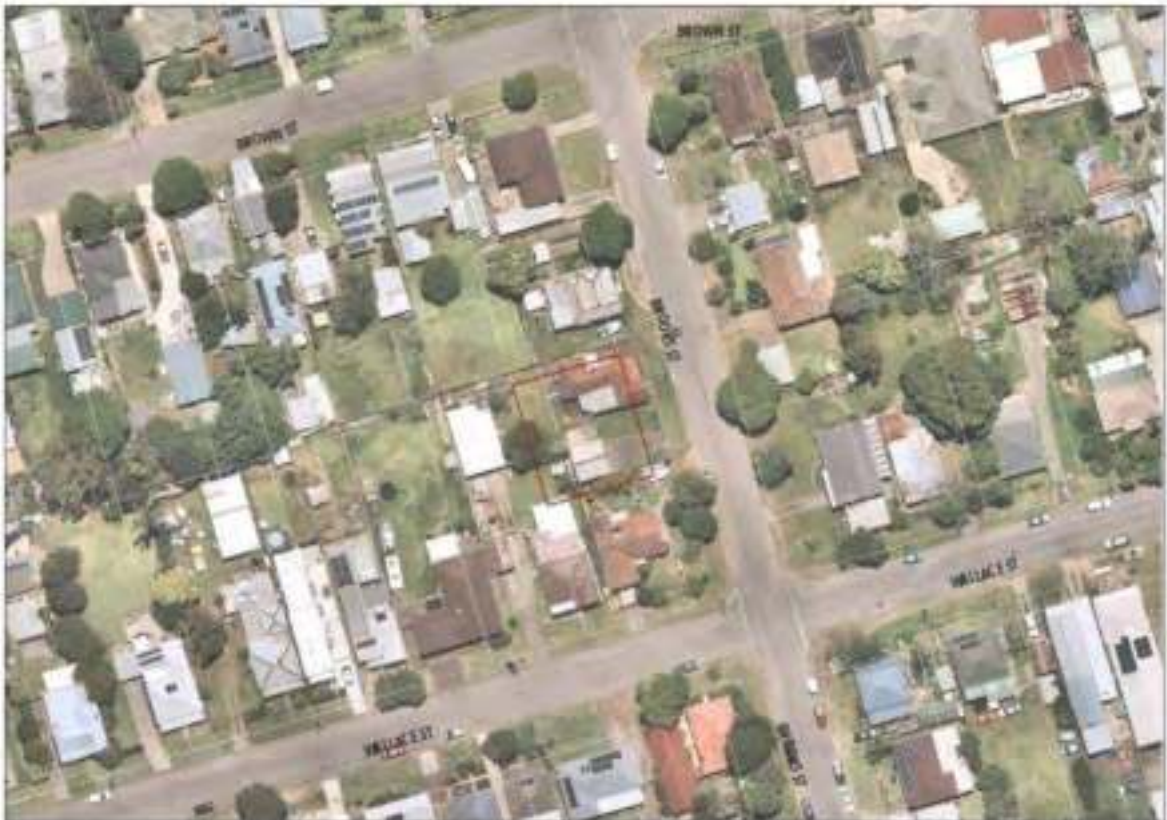
16 BROOKS STREET, WEST WALLSEND 2286

Conservation Area Contribution Level	Est. Construction Date	Previous studies and/or community input
Contributory 2	Early to late 20 th century (broad range)	No prior heritage assessments or research undertaken.
Assessment Text		Observed Modifications
<p>The scale (single-storey) and general style of the dwelling is consistent with that of the streetscape and wider HCA. Dwelling contributes positively to the streetscape and wider HCA, particularly in comparison to Non-Contributory buildings.</p> <p>The dwelling features appropriately proportioned and positioned fenestrations, an appropriate roof form (gabled or hipped) and other features consistent with the architectural character of the area (e.g. front verandah with timber or brick posts, timber detailing, corrugated metal roofing, etc). The contributory value of the dwelling is limited however by either:</p> <ul style="list-style-type: none"> • External modifications that have in some way obscured the style, scale or design intent of the building and have resulted in less physical integrity than Contributory 1 buildings. • Being a later dwelling constructed in an appropriate referential style, but comprising little to no fabric of intrinsic heritage significance. 		<p>The veranda has been enclosed to create an additional living area, this is a common modification for the area.</p> <p>The multi-coloured terracotta tile roof is an aged modification, likely occurring some years prior and replacing the original iron sheet or Colourbond roof.</p> <p>An extension has been built to the western portion of the dwelling. this is partially visible, however has been constructed in a sympathetic manner to the remaining dwelling.</p> <p>The window awning visible on the front eastern side of the dwelling is a contemporary variation, with the original likely being a timber design.</p>

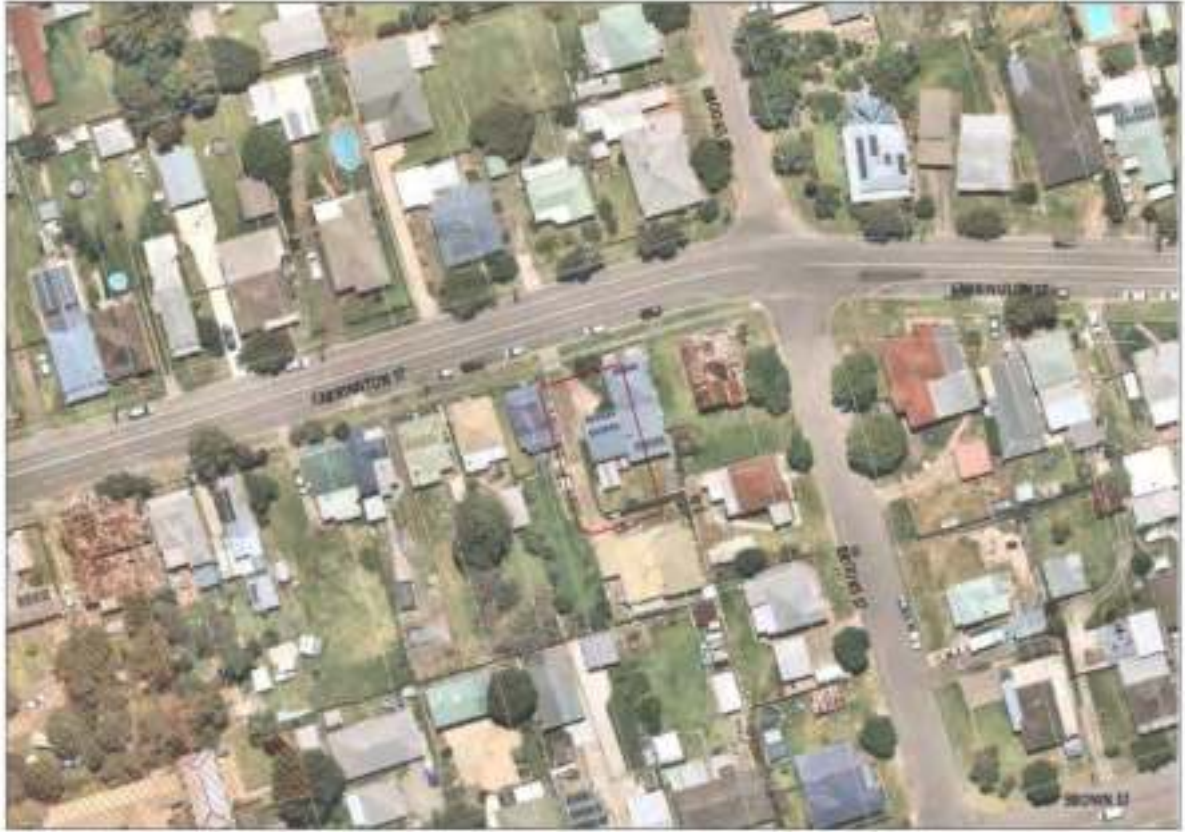
UNIT 1, 34 CARRINGTON STREET, WEST WALLSEND 2286

Conservation Area Contribution Level	Est. Construction Date	Previous studies and/or community input
Contributory 2	Early to late 20 th century (broad range)	No prior heritage assessments or research undertaken.
Assessment Text		Observed Modifications
<p>The scale (single-storey) and general style of the dwelling is consistent with that of the streetscape and wider HCA. Dwelling contributes positively to the streetscape and wider HCA, particularly in comparison to Non-Contributory buildings.</p> <p>The dwelling features appropriately proportioned and positioned fenestrations, an appropriate roof form (gabled or hipped) and other features consistent with the architectural character of the area (e.g. front verandah with timber or brick posts, timber detailing, corrugated metal roofing, etc). The contributory value of the dwelling is limited however by either:</p> <ul style="list-style-type: none"> External modifications that have in some way obscured the style, scale or design intent of the building and have resulted in less physical integrity than Contributory 1 buildings. Being a later dwelling constructed in an appropriate referential style, but comprising little to no fabric of intrinsic heritage significance. 		<p>Solar panels are highly visible along the northern portion of the roof.</p> <p>A large extension has been built onto the southern/western portions of the dwelling. This includes a second storey extension and is unsympathetic in style to the remaining heritage features of the dwelling and detracts from the heritage streetscape.</p> <p>A gable roof walkway has been constructed joining the entrance to the veranda.</p> <p>All visible windows are contemporary in style.</p>

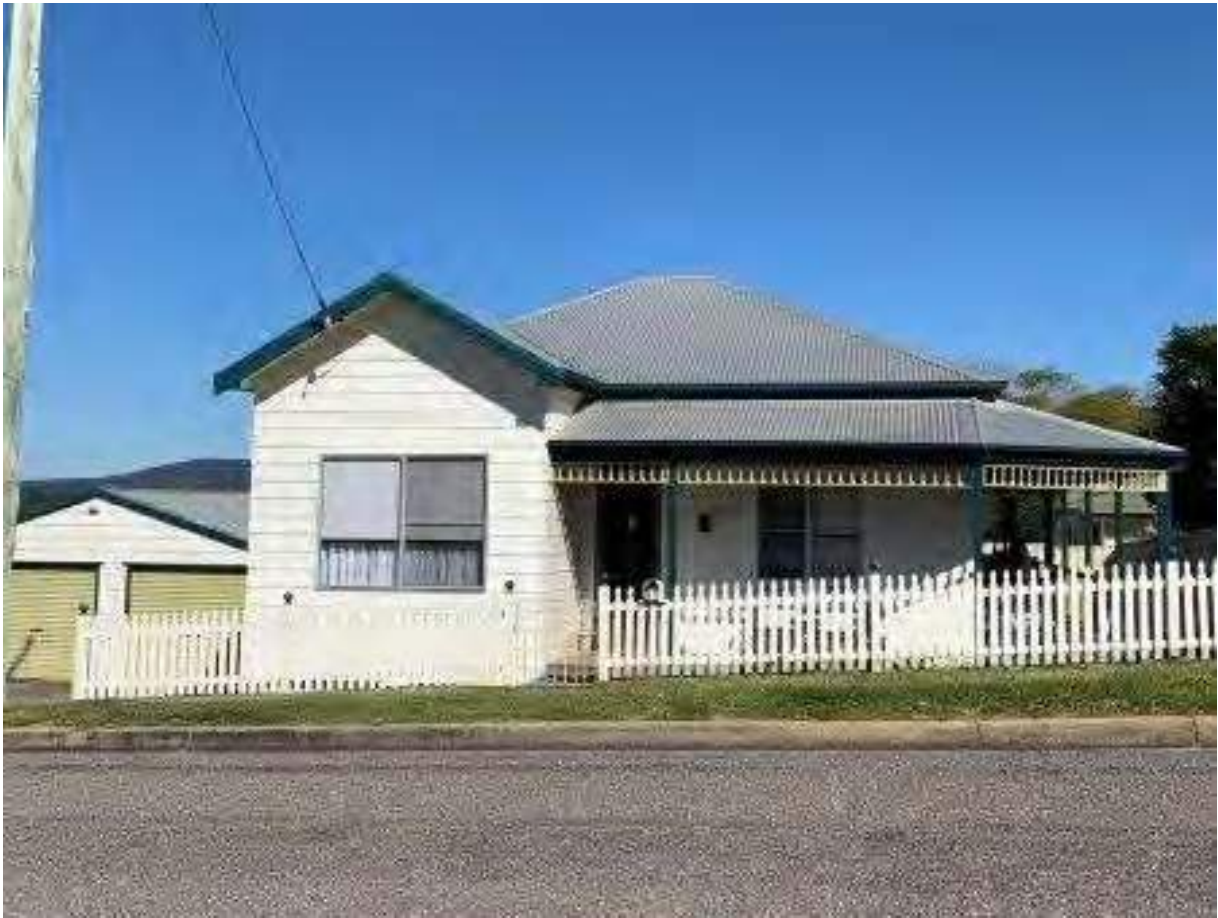
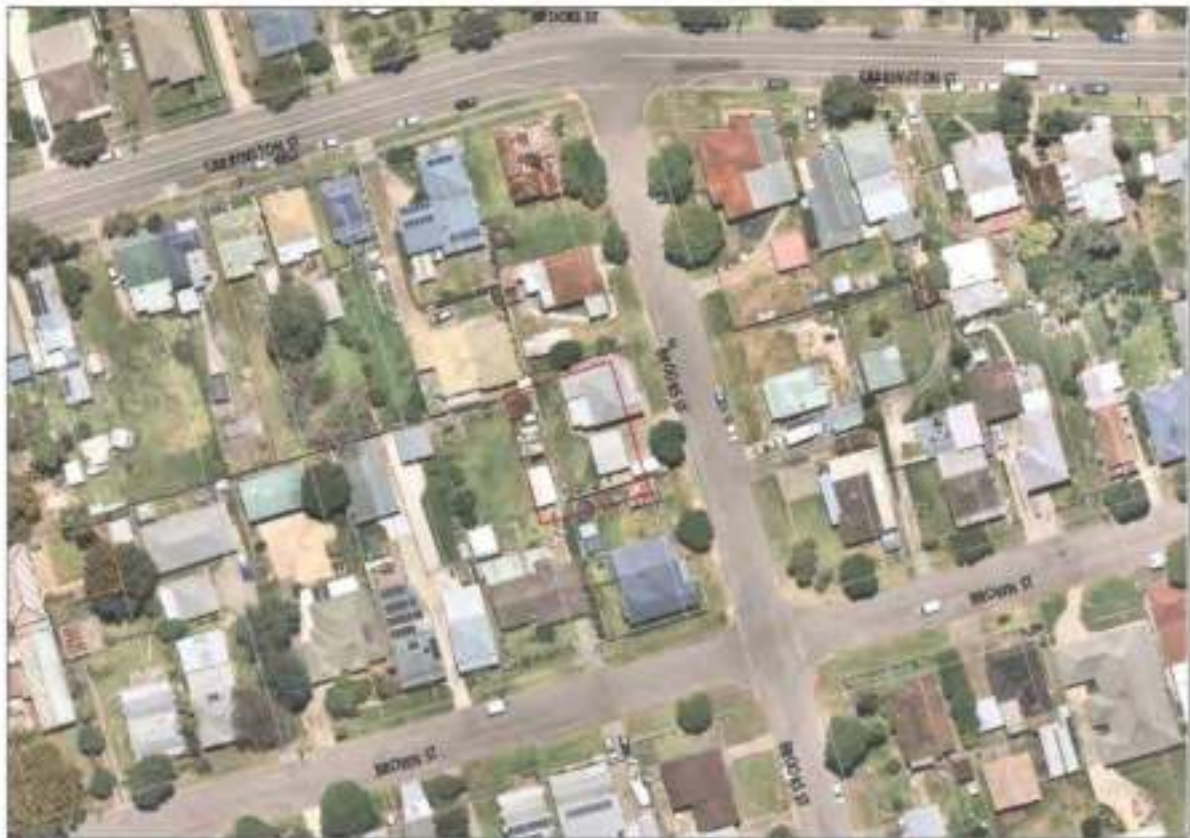
8 BROOKS STREET, WEST WALLSEND 2286

Conservation Area Contribution Level	Est. Construction Date	Previous studies and/or community input
Contributory 2	Early to late 20 th century (broad range)	No prior heritage assessments or research undertaken.
Assessment Text		Observed Modifications
<p>The scale (single-storey) and general style of the dwelling is consistent with that of the streetscape and wider HCA. Dwelling contributes positively to the streetscape and wider HCA, particularly in comparison to Non-Contributory buildings.</p> <p>The dwelling features appropriately proportioned and positioned fenestrations, an appropriate roof form (gabled or hipped) and other features consistent with the architectural character of the area (e.g. front verandah with timber or brick posts, timber detailing, corrugated metal roofing, etc). The contributory value of the dwelling is limited however by either:</p> <ul style="list-style-type: none"> • External modifications that have in some way obscured the style, scale or design intent of the building and have resulted in less physical integrity than Contributory 1 buildings. • Being a later dwelling constructed in an appropriate referential style, but comprising little to no fabric of intrinsic heritage significance. 		<p>The verandah has been extended to wrap around the northern portion of the dwelling, with a continuation of the timber valance. Both are contemporary additions to the dwelling, however has been undertaken in a sympathetic manner and does not detract from the heritage streetscape.</p> <p>All visible windows are contemporary in style.</p>

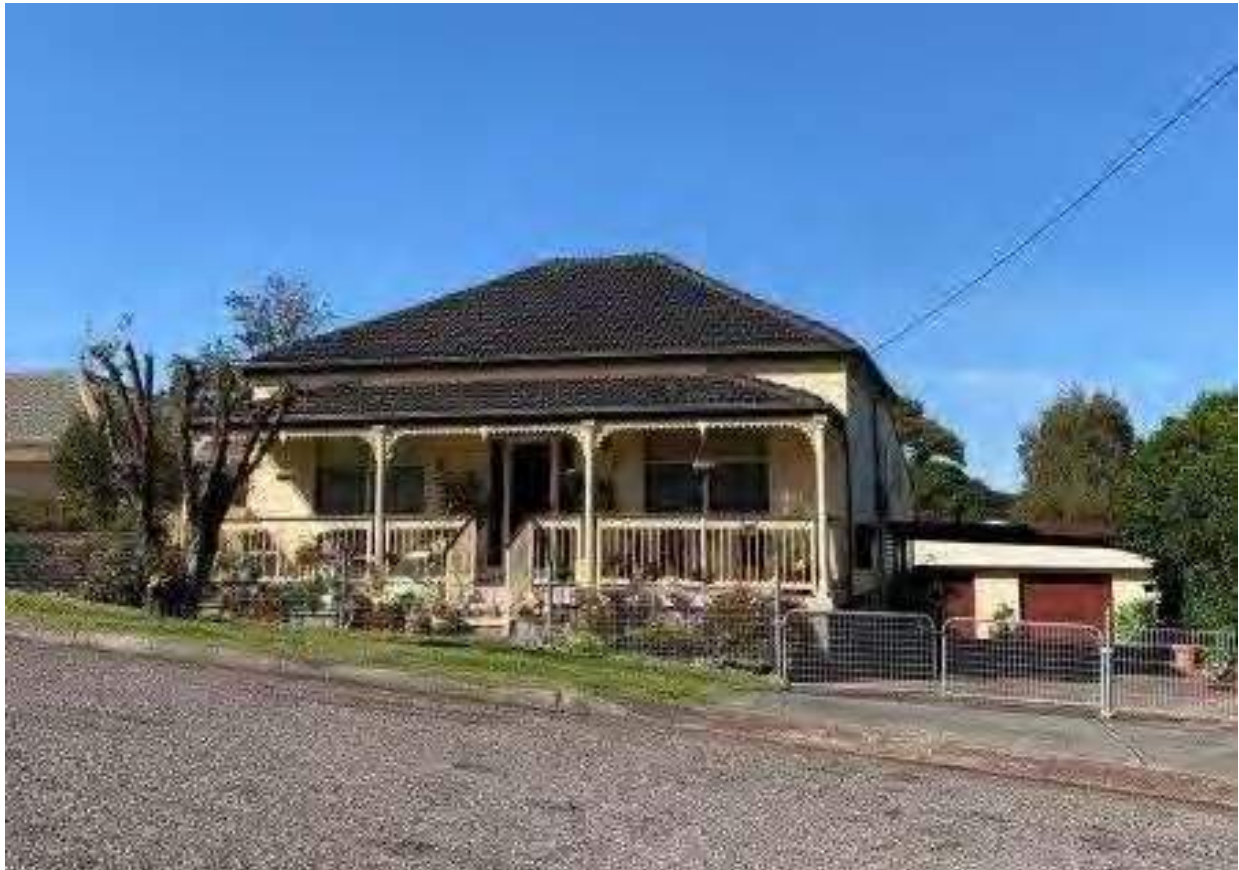
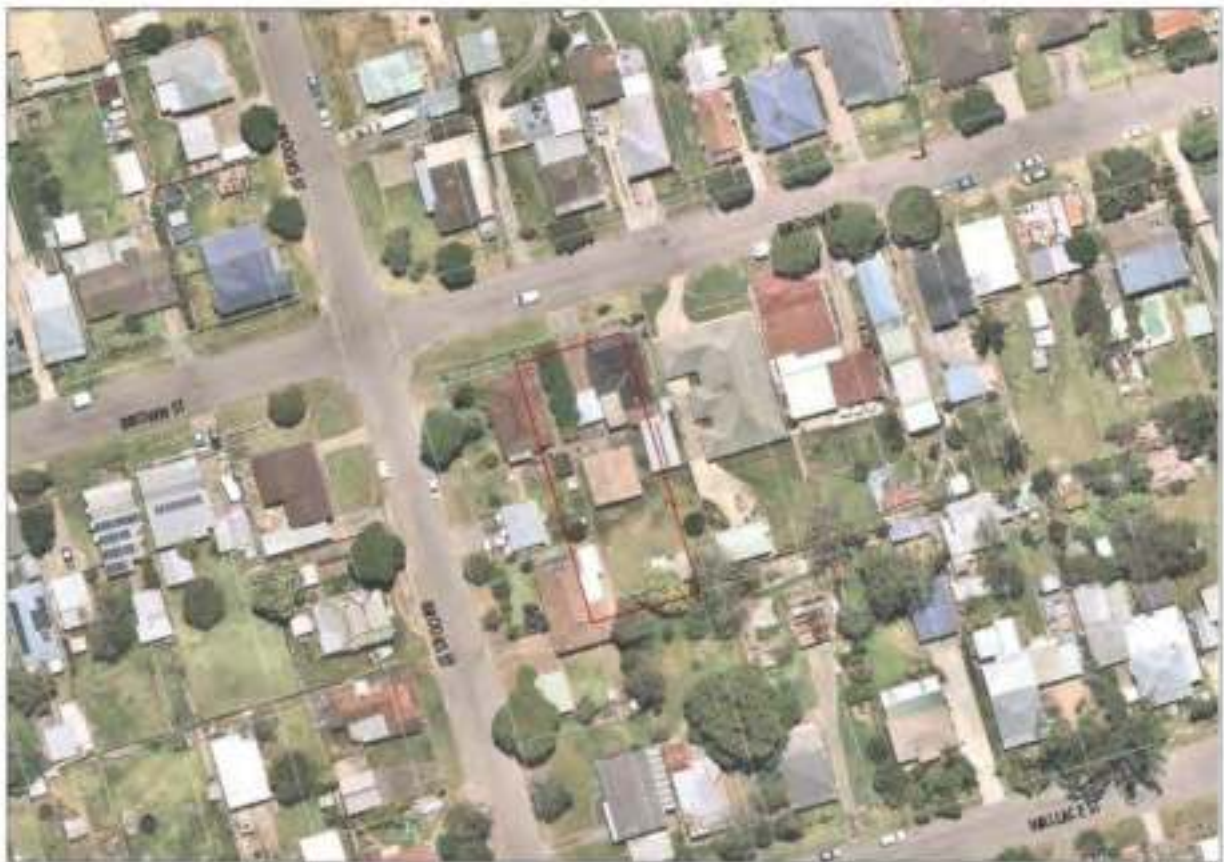
22 BROWN STREET, WEST WALLSEND 2286

Conservation Area Contribution Level	Est. Construction Date	Previous studies and/or community input
Contributory 2	Early to late 20 th century (broad range)	No prior heritage assessments or research undertaken.
Assessment Text		Observed Modifications
<p>The scale (single-storey) and general style of the dwelling is consistent with that of the streetscape and wider HCA. Dwelling contributes positively to the streetscape and wider HCA, particularly in comparison to Non-Contributory buildings.</p> <p>The dwelling features appropriately proportioned and positioned fenestrations, an appropriate roof form (gabled or hipped) and other features consistent with the architectural character of the area (e.g. front verandah with timber or brick posts, timber detailing, corrugated metal roofing, etc). The contributory value of the dwelling is limited however by either:</p> <ul style="list-style-type: none"> • External modifications that have in some way obscured the style, scale or design intent of the building and have resulted in less physical integrity than Contributory 1 buildings. • Being a later dwelling constructed in an appropriate referential style, but comprising little to no fabric of intrinsic heritage significance. 		<p>The concrete tiled roof is a prior modification, likely replacing an iron sheet or Colourbond roof.</p> <p>All visible windows are contemporary in style.</p> <p>The cast iron valance, balustrade and faux European pillars of the veranda are contemporary additions.</p>
