APPENDIX 2

Building Assessment Sheets (Inventory Sheets)

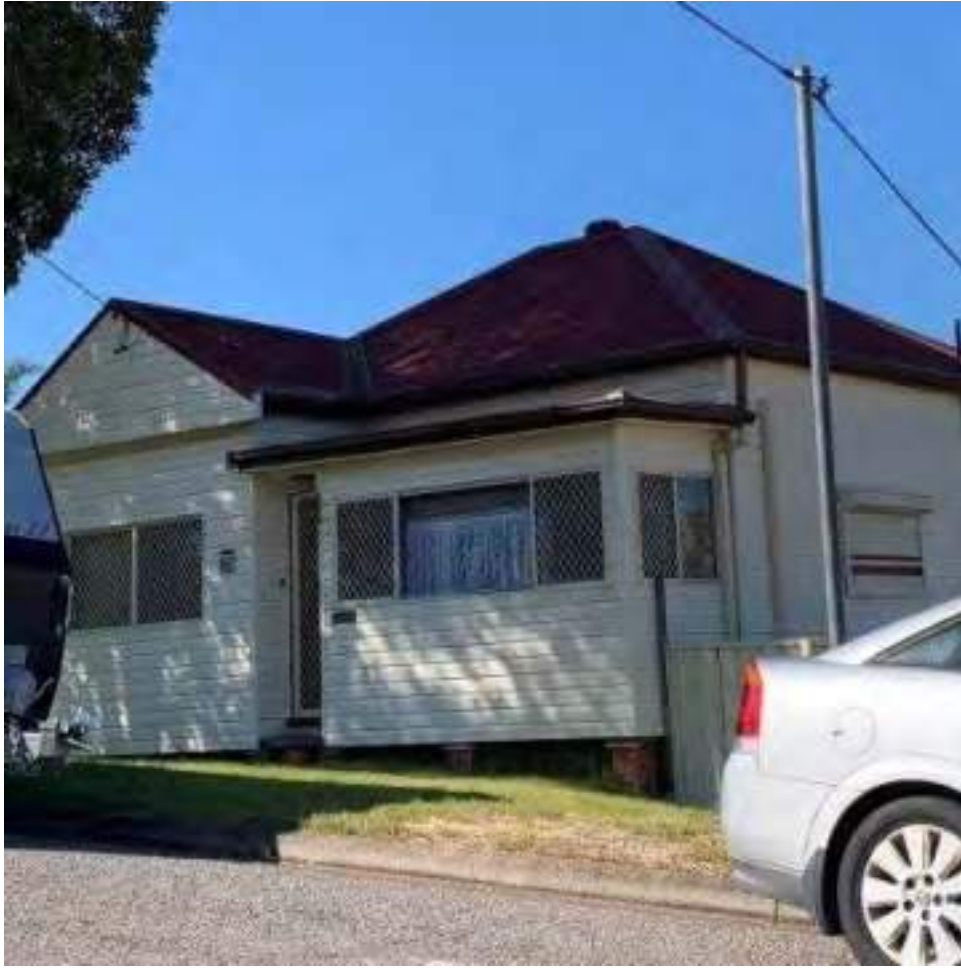
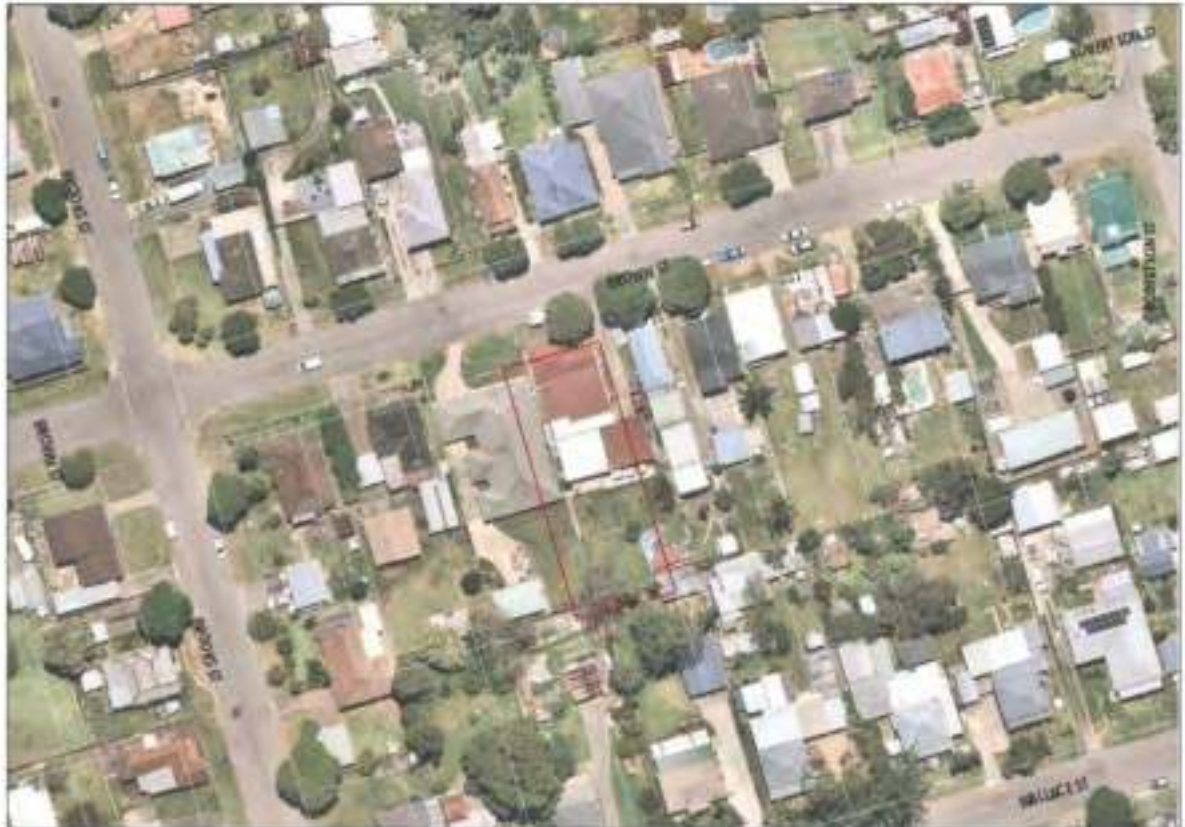
18 BROWN STREET, WEST WALLSEND 2286

Conservation Area Contribution Level	Est. Construction Date	Previous studies and/or community input
Contributory 2	Early to late 20 th century (broad range)	No prior heritage assessments or research undertaken.
Assessment Text		Observed Modifications
<p>The scale (single-storey) and general style of the dwelling is consistent with that of the streetscape and wider HCA. Dwelling contributes positively to the streetscape and wider HCA, particularly in comparison to Non-Contributory buildings.</p> <p>The dwelling features appropriately proportioned and positioned fenestrations, an appropriate roof form (gabled or hipped) and other features consistent with the architectural character of the area (e.g. front verandah with timber or brick posts, timber detailing, corrugated metal roofing, etc). The contributory value of the dwelling is limited however by either:</p> <ul style="list-style-type: none"> • External modifications that have in some way obscured the style, scale or design intent of the building and have resulted in less physical integrity than Contributory 1 buildings. • Being a later dwelling constructed in an appropriate referential style, but comprising little to no fabric of intrinsic heritage significance. 		<p>The veranda has been built in to create an additional living area.</p> <p>All visible windows are contemporary in style, with security screening installed.</p>

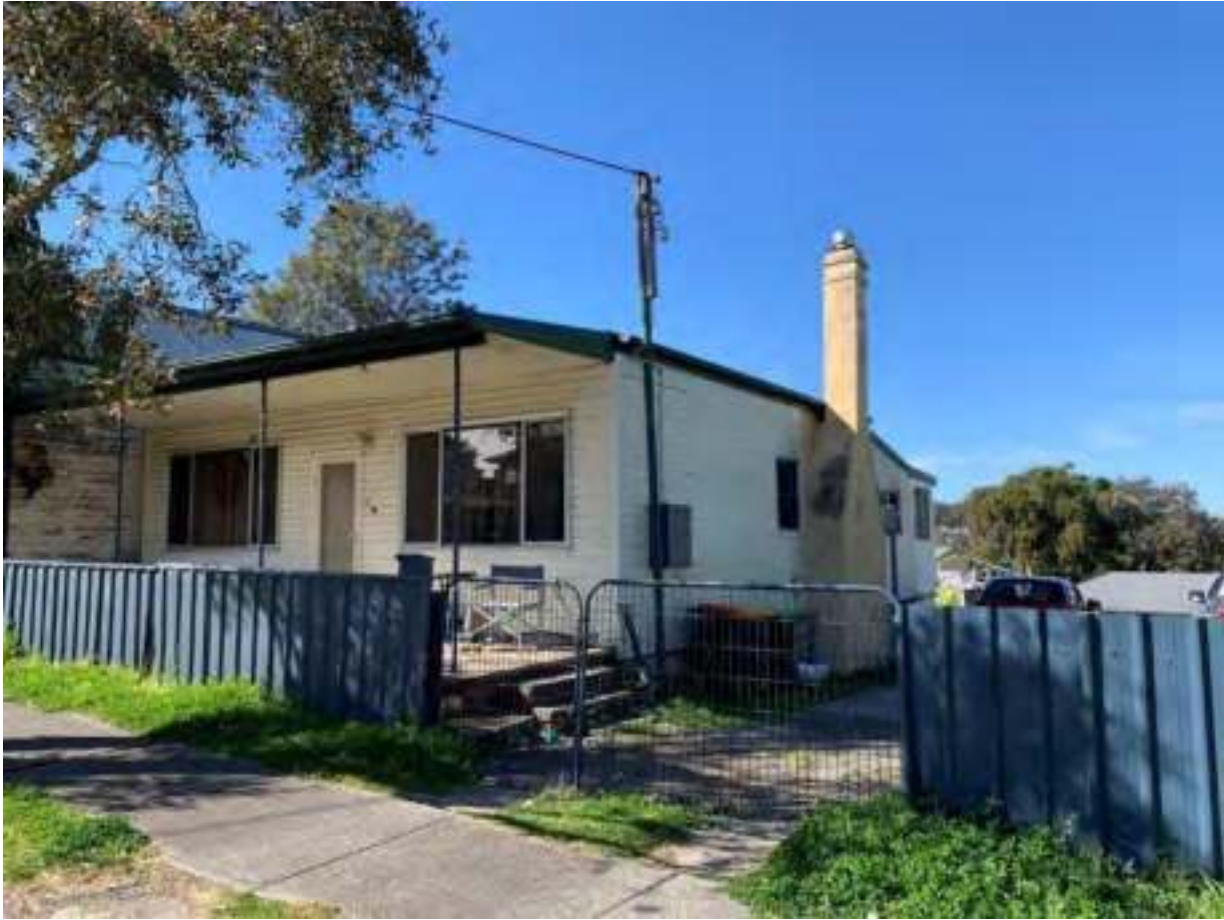
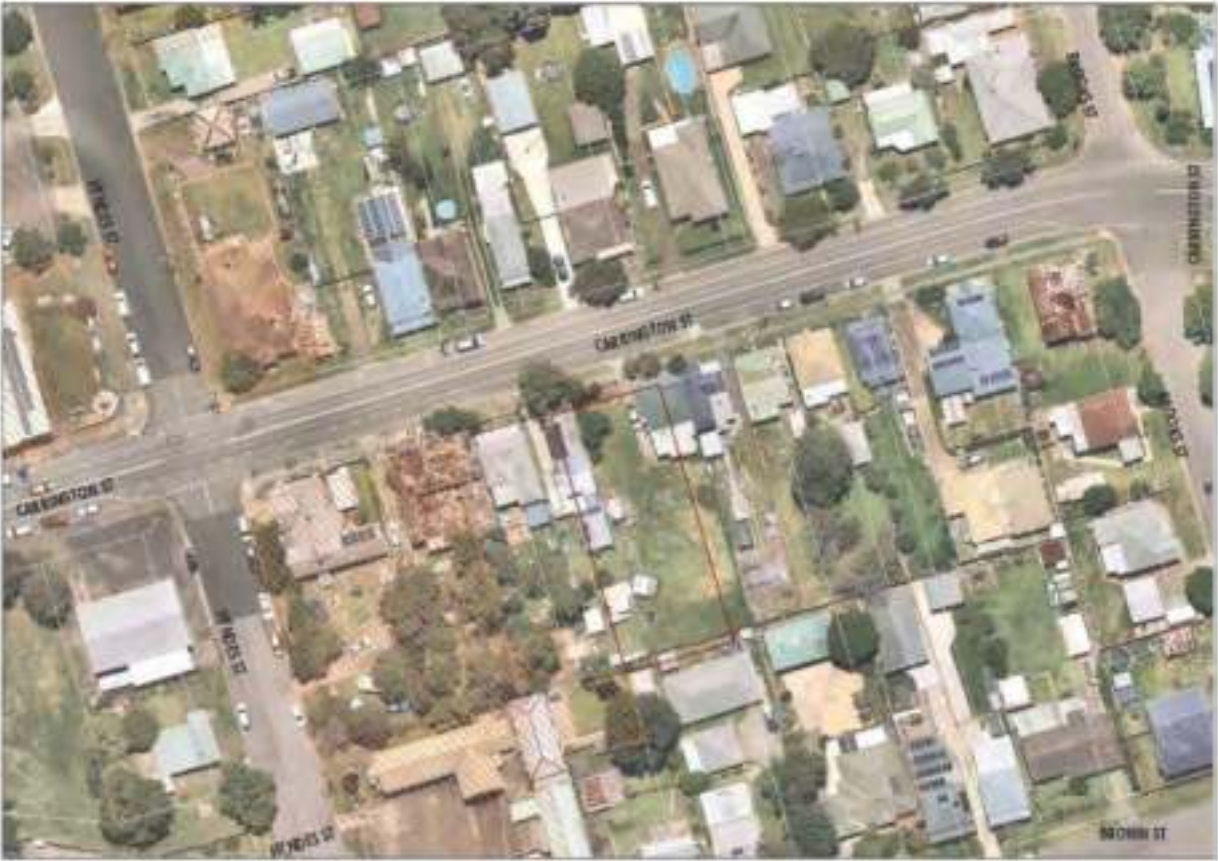
44 CARRINGTON STREET, WEST WALLSEND 2286

Conservation Area Contribution Level	Est. Construction Date	Previous studies and/or community input
Contributory 2	Early to late 20 th century (broad range)	No prior heritage assessments or research undertaken.
Assessment Text		Observed Modifications
<p>The scale (single-storey) and general style of the dwelling is consistent with that of the streetscape and wider HCA. Dwelling contributes positively to the streetscape and wider HCA, particularly in comparison to Non-Contributory buildings.</p> <p>The dwelling features appropriately proportioned and positioned fenestrations, an appropriate roof form (gabled or hipped) and other features consistent with the architectural character of the area (e.g. front verandah with timber or brick posts, timber detailing, corrugated metal roofing, etc). The contributory value of the dwelling is limited however by either:</p> <ul style="list-style-type: none"> • External modifications that have in some way obscured the style, scale or design intent of the building and have resulted in less physical integrity than Contributory 1 buildings. • Being a later dwelling constructed in an appropriate referential style, but comprising little to no fabric of intrinsic heritage significance. 		<p>All visible windows are contemporary in style.</p> <p>The front door has had a metal security screen door installed.</p> <p>The flat veranda roof and corresponding metal support posts are both contemporary additions, likely replacing a bull nosed roof and timber posts.</p> <p>The dwellings cladding has been replaced for a contemporary weatherboard style.</p>

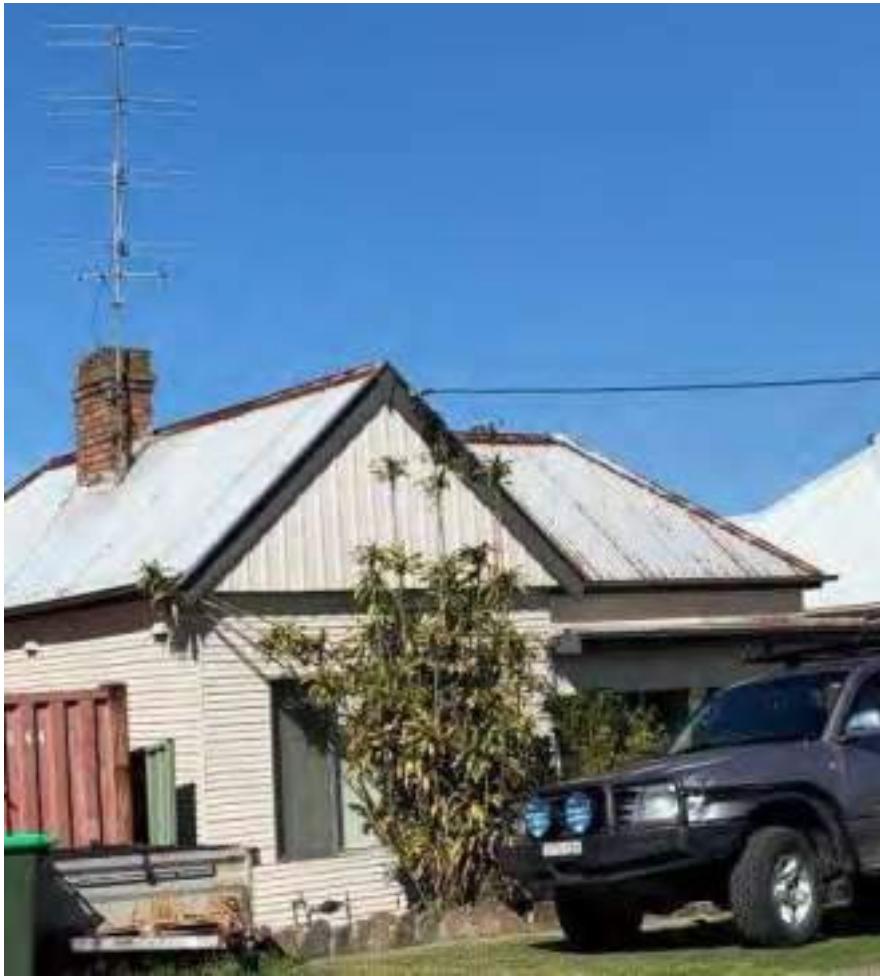
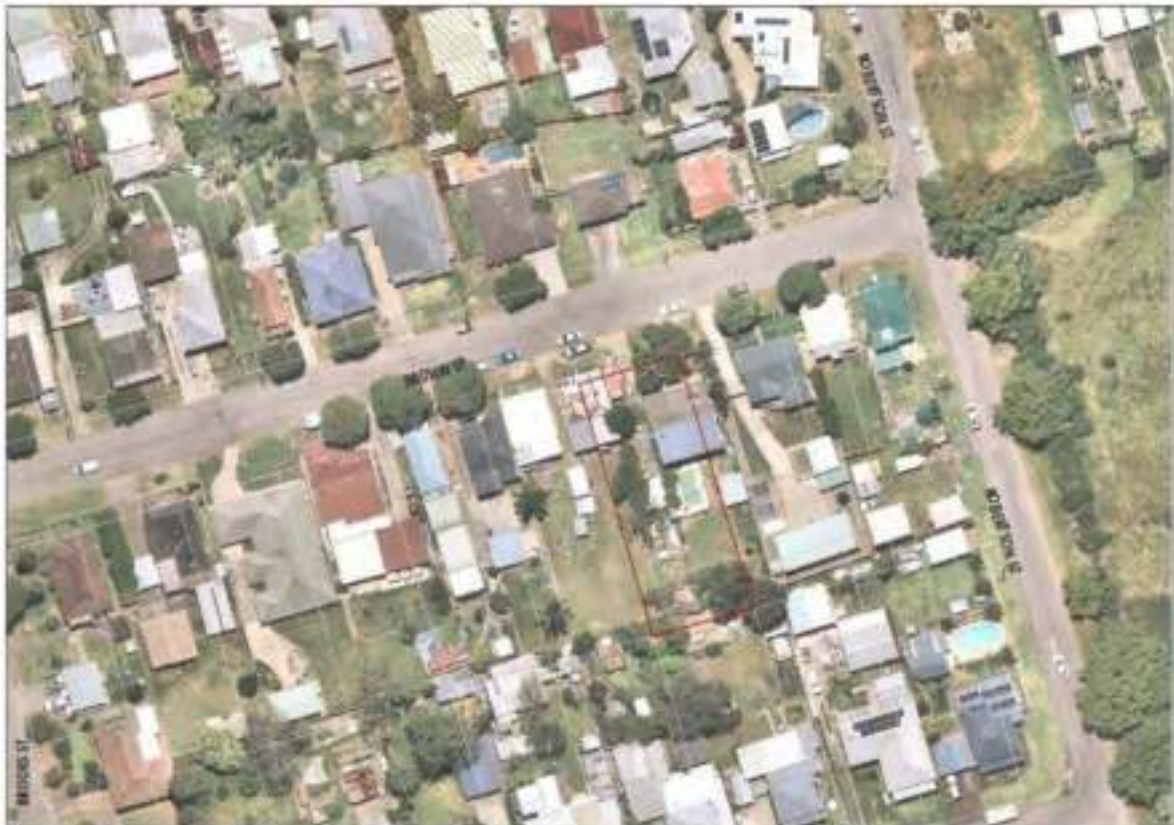
10 BROWN STREET, WEST WALLSEND 2286

Conservation Area Contribution Level	Est. Construction Date	Previous studies and/or community input
Contributory 2	Early to late 20 th century (broad range)	No prior heritage assessments or research undertaken.
Assessment Text		Observed Modifications
<p>The scale (single-storey) and general style of the dwelling is consistent with that of the streetscape and wider HCA. Dwelling contributes positively to the streetscape and wider HCA, particularly in comparison to Non-Contributory buildings.</p> <p>The dwelling features appropriately proportioned and positioned fenestrations, an appropriate roof form (gabled or hipped) and other features consistent with the architectural character of the area (e.g. front verandah with timber or brick posts, timber detailing, corrugated metal roofing, etc). The contributory value of the dwelling is limited however by either:</p> <ul style="list-style-type: none"> • External modifications that have in some way obscured the style, scale or design intent of the building and have resulted in less physical integrity than Contributory 1 buildings. • Being a later dwelling constructed in an appropriate referential style, but comprising little to no fabric of intrinsic heritage significance. 		<p>All visible windows are contemporary in style.</p> <p>The faux European pillars are a contemporary addition, likely replacing original timber posts.</p>

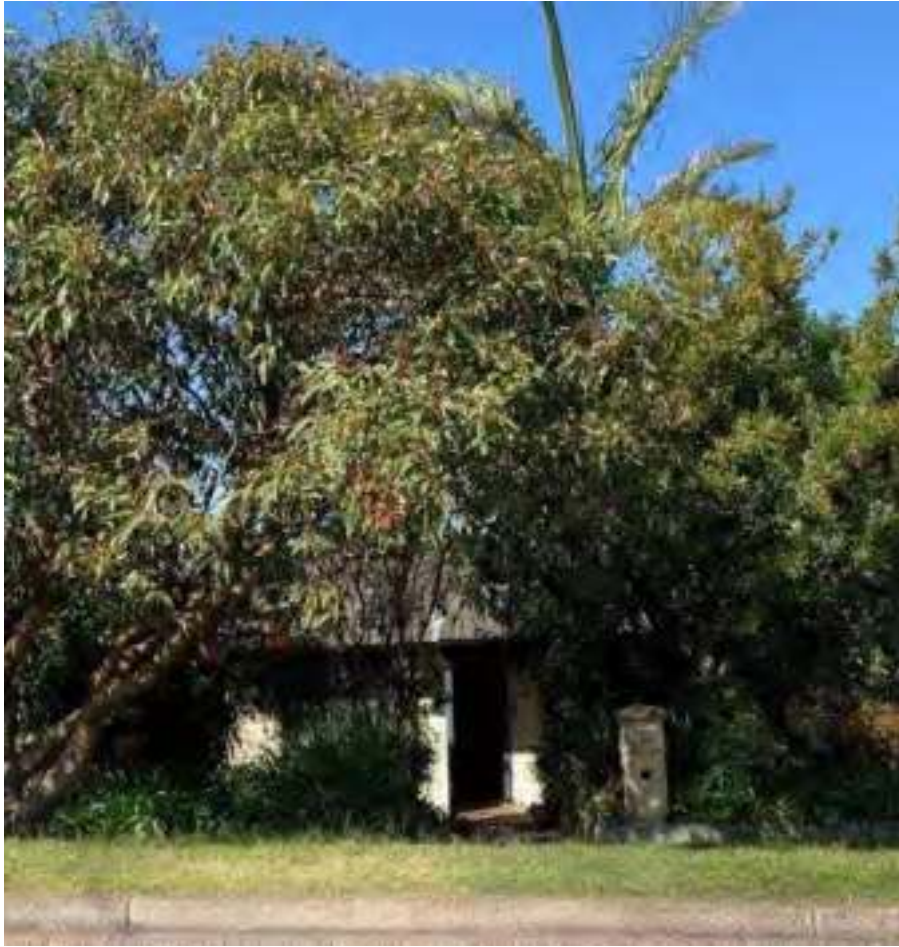
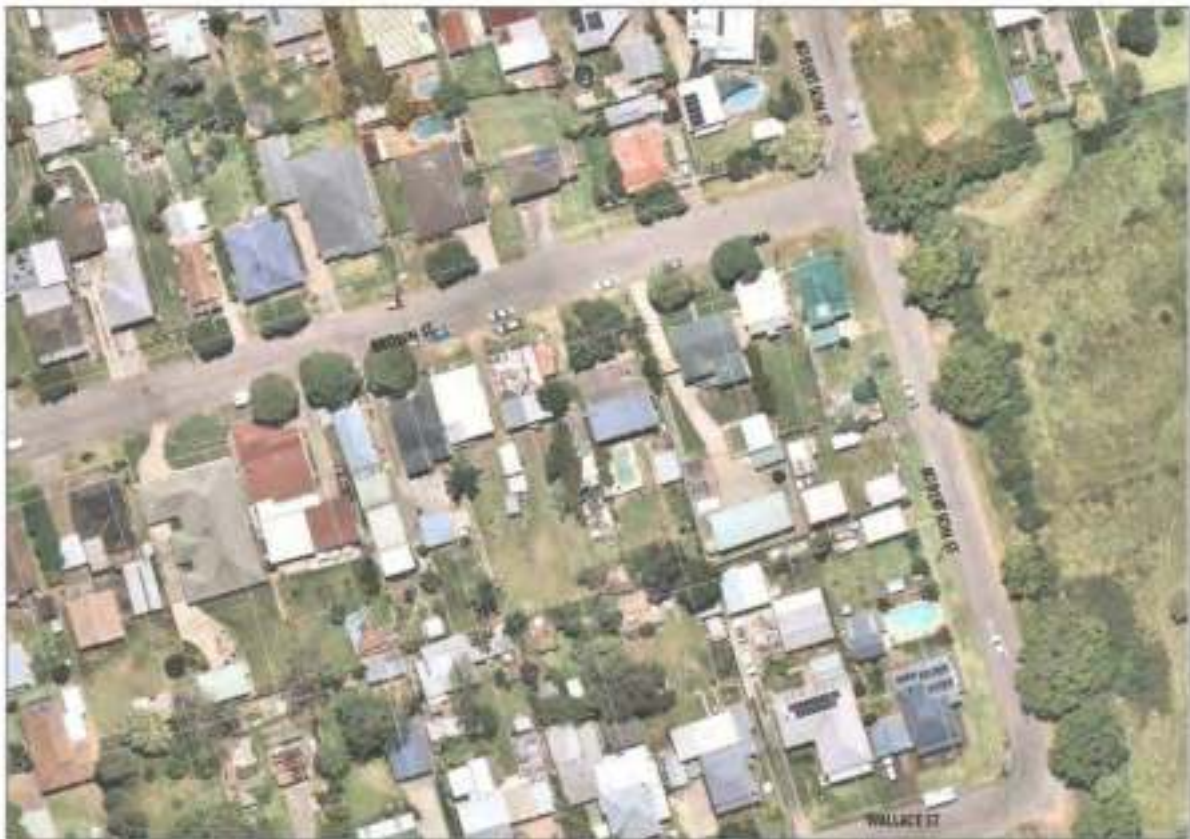
8 BROWN STREET, WEST WALLSEND 2286

Conservation Area Contribution Level	Est. Construction Date	Previous studies and/or community input
Contributory 2	Early to late 20 th century (broad range)	No prior heritage assessments or research undertaken.
Assessment Text		Observed Modifications
<p>The scale (single-storey) and general style of the dwelling is consistent with that of the streetscape and wider HCA. Dwelling contributes positively to the streetscape and wider HCA, particularly in comparison to Non-Contributory buildings.</p> <p>The dwelling features appropriately proportioned and positioned fenestrations, an appropriate roof form (gabled or hipped) and other features consistent with the architectural character of the area (e.g. front verandah with timber or brick posts, timber detailing, corrugated metal roofing, etc). The contributory value of the dwelling is limited however by either:</p> <ul style="list-style-type: none"> • External modifications that have in some way obscured the style, scale or design intent of the building and have resulted in less physical integrity than Contributory 1 buildings. • Being a later dwelling constructed in an appropriate referential style, but comprising little to no fabric of intrinsic heritage significance. 		<p>Mature vegetation partially obscured the dwelling. No modifications observed.</p>

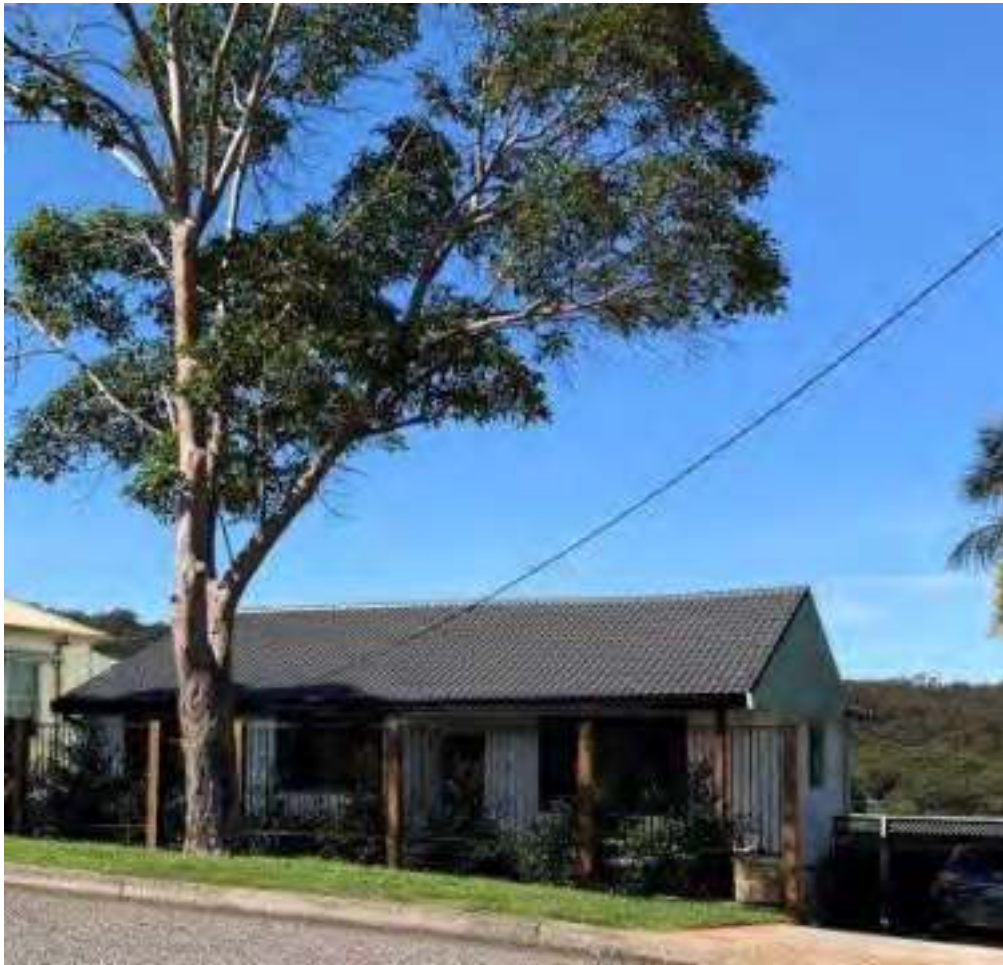
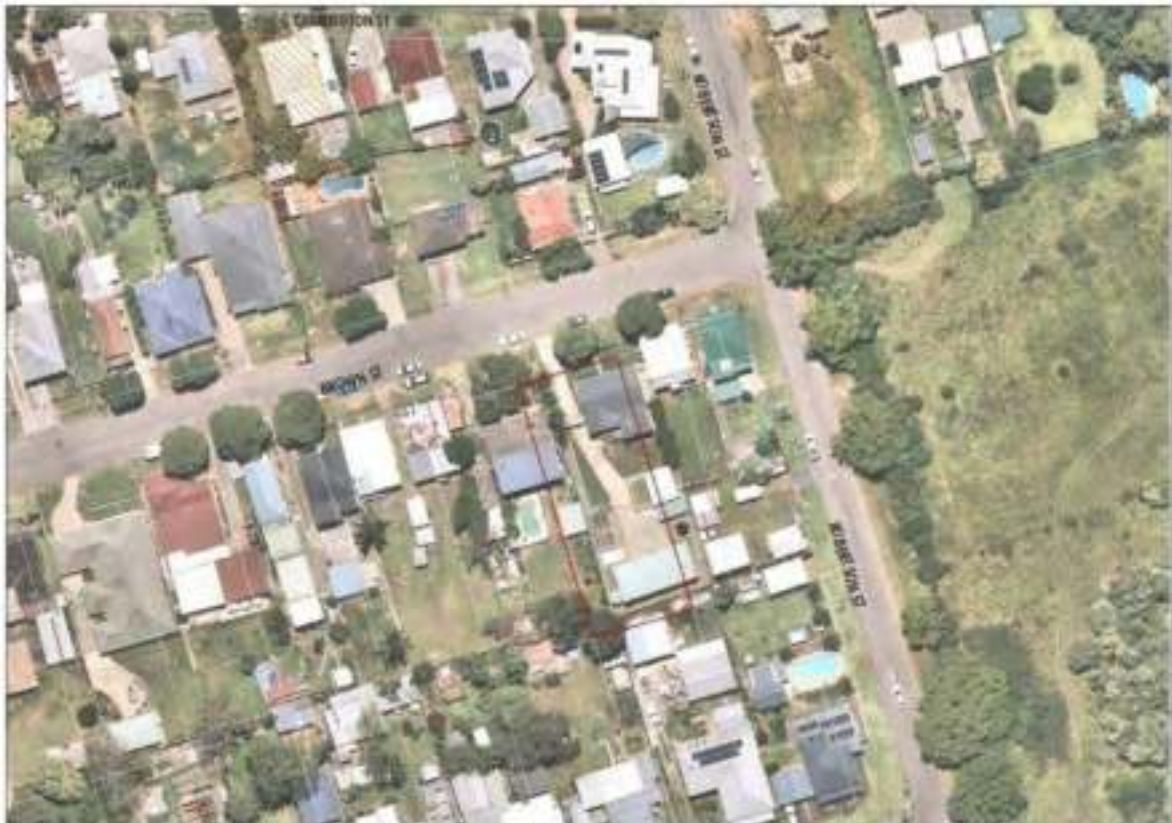
6 BROWN STREET, WEST WALLSEND 2286

Conservation Area Contribution Level	Est. Construction Date	Previous studies and/or community input
Contributory 2	Early to late 20 th century (broad range)	No prior heritage assessments or research undertaken.
Assessment Text		Observed Modifications
<p>The scale (single-storey) and general style of the dwelling is consistent with that of the streetscape and wider HCA. Dwelling contributes positively to the streetscape and wider HCA, particularly in comparison to Non-Contributory buildings.</p> <p>The dwelling features appropriately proportioned and positioned fenestrations, an appropriate roof form (gabled or hipped) and other features consistent with the architectural character of the area (e.g. front verandah with timber or brick posts, timber detailing, corrugated metal roofing, etc). The contributory value of the dwelling is limited however by either:</p> <ul style="list-style-type: none"> • External modifications that have in some way obscured the style, scale or design intent of the building and have resulted in less physical integrity than Contributory 1 buildings. • Being a later dwelling constructed in an appropriate referential style, but comprising little to no fabric of intrinsic heritage significance. 		<p>The fence enclosing the front portion of the property is a contemporary style, juxtaposing the heritage streetscape.</p>

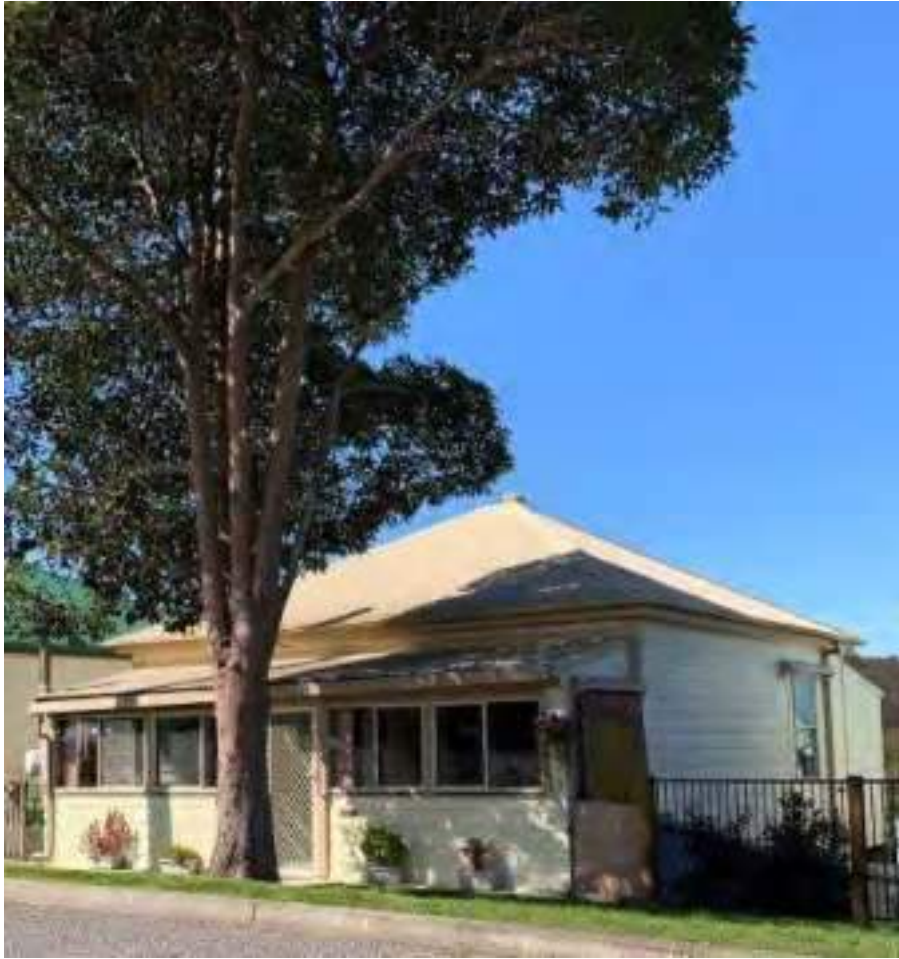
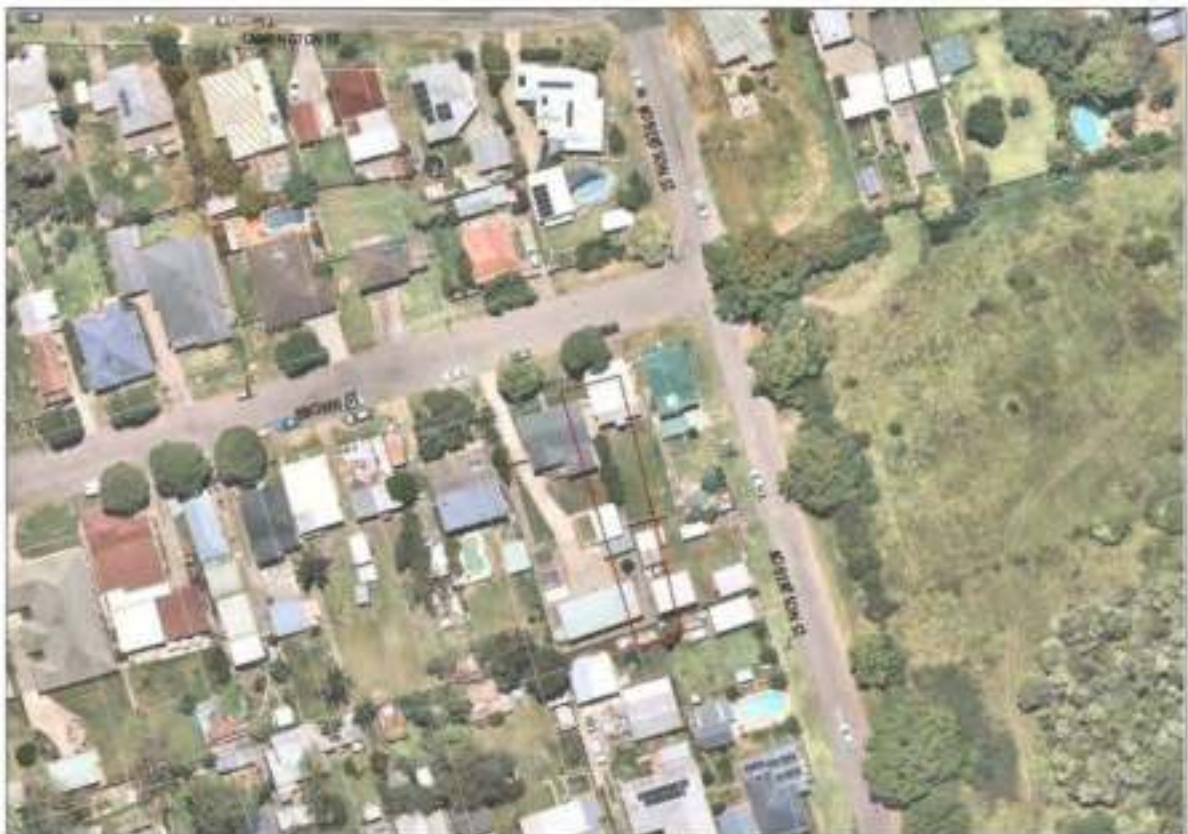
4 BROWN STREET, WEST WALLSEND 2286

Conservation Area Contribution Level	Est. Construction Date	Previous studies and/or community input
Contributory 2	Early to late 20 th century (broad range)	No prior heritage assessments or research undertaken.
Assessment Text		Observed Modifications
<p>The scale (single-storey) and general style of the dwelling is consistent with that of the streetscape and wider HCA. Dwelling contributes positively to the streetscape and wider HCA, particularly in comparison to Non-Contributory buildings.</p> <p>The dwelling features appropriately proportioned and positioned fenestrations, an appropriate roof form (gabled or hipped) and other features consistent with the architectural character of the area (e.g. front verandah with timber or brick posts, timber detailing, corrugated metal roofing, etc). The contributory value of the dwelling is limited however by either:</p> <ul style="list-style-type: none"> • External modifications that have in some way obscured the style, scale or design intent of the building and have resulted in less physical integrity than Contributory 1 buildings. • Being a later dwelling constructed in an appropriate referential style, but comprising little to no fabric of intrinsic heritage significance. 		<p>The veranda has been built in to create an additional living area, with contemporary windows enclosing the space.</p> <p>All visible windows are contemporary in style.</p>

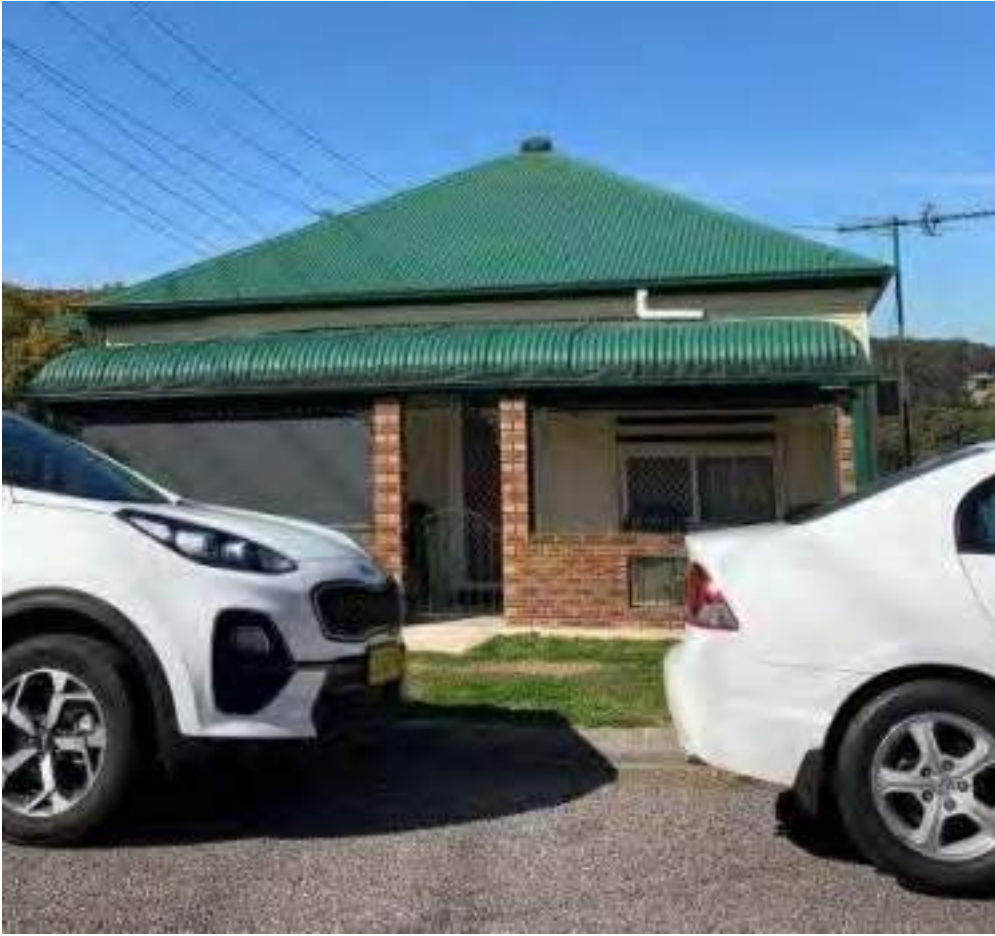
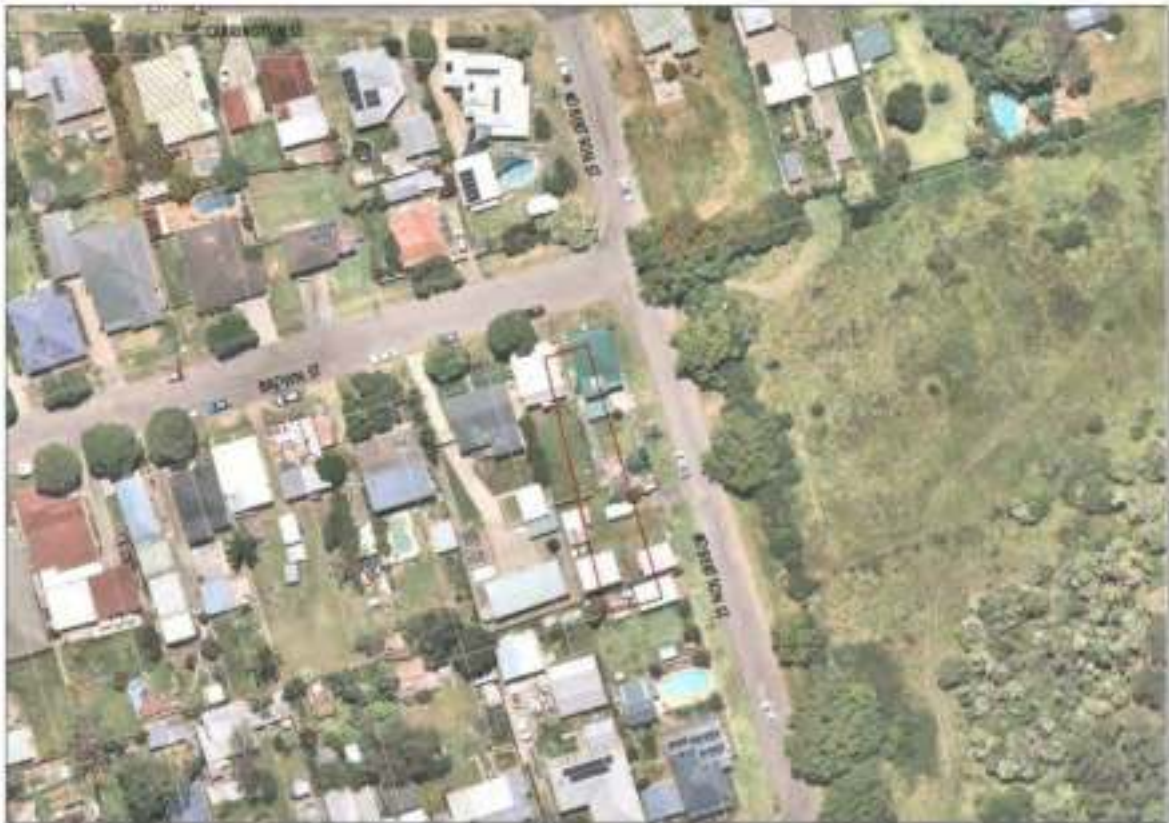
2 BROWN STREET, WEST WALLSEND 2286

Conservation Area Contribution Level	Est. Construction Date	Previous studies and/or community input
Contributory 2	Early to late 20 th century (broad range)	No prior heritage assessments or research undertaken.
Assessment Text		Observed Modifications
<p>The scale (single-storey) and general style of the dwelling is consistent with that of the streetscape and wider HCA. Dwelling contributes positively to the streetscape and wider HCA, particularly in comparison to Non-Contributory buildings.</p> <p>The dwelling features appropriately proportioned and positioned fenestrations, an appropriate roof form (gabled or hipped) and other features consistent with the architectural character of the area (e.g. front verandah with timber or brick posts, timber detailing, corrugated metal roofing, etc). The contributory value of the dwelling is limited however by either:</p> <ul style="list-style-type: none"> • External modifications that have in some way obscured the style, scale or design intent of the building and have resulted in less physical integrity than Contributory 1 buildings. • Being a later dwelling constructed in an appropriate referential style, but comprising little to no fabric of intrinsic heritage significance. 		<p>The roof structure and veranda bull nosed style has retained its structural integrity, however the roofing Colourbond is a contemporary modification from the original iron sheets.</p> <p>The brickwork pillars and low veranda wall are contemporary additions, partially enclosing the veranda space. The canvas blinds are a further modification. This is unsympathetic in style and detracts from the heritage streetscape.</p> <p>The visible windows are contemporary in style, with some having attached metal roller shutters.</p>

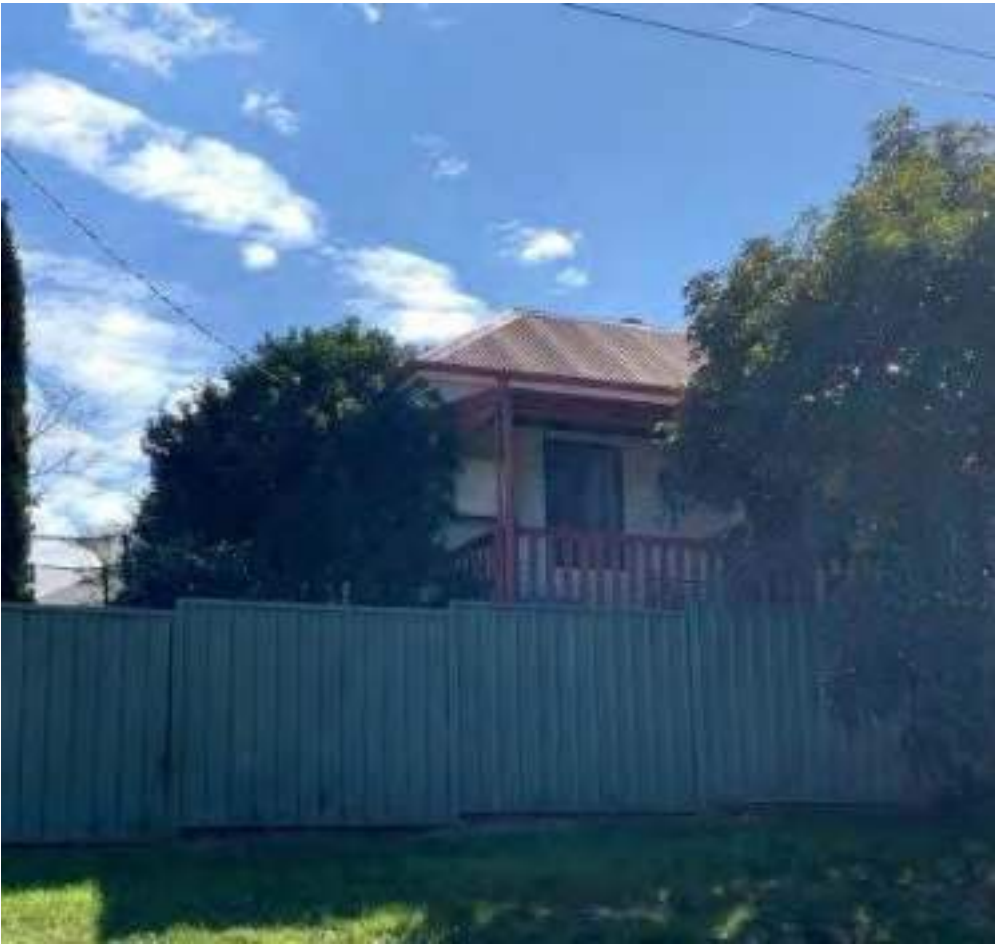
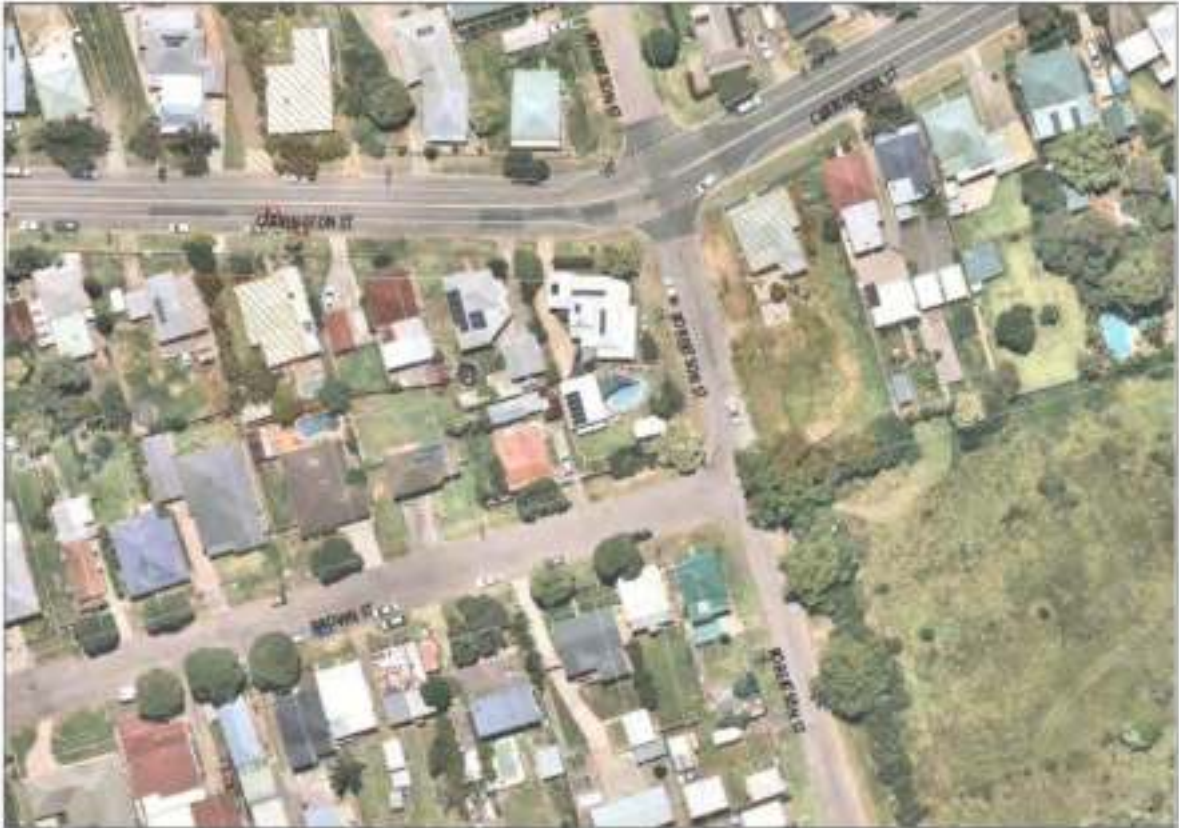
14 CARRINGTON STREET, WEST WALLSEND 2286

Conservation Area Contribution Level	Est. Construction Date	Previous studies and/or community input
Contributory 2	Early to late 20 th century (broad range)	No prior heritage assessments or research undertaken.
Assessment Text		Observed Modifications
<p>The scale (single-storey) and general style of the dwelling is consistent with that of the streetscape and wider HCA. Dwelling contributes positively to the streetscape and wider HCA, particularly in comparison to Non-Contributory buildings.</p> <p>The dwelling features appropriately proportioned and positioned fenestrations, an appropriate roof form (gabled or hipped) and other features consistent with the architectural character of the area (e.g. front verandah with timber or brick posts, timber detailing, corrugated metal roofing, etc). The contributory value of the dwelling is limited however by either:</p> <ul style="list-style-type: none"> • External modifications that have in some way obscured the style, scale or design intent of the building and have resulted in less physical integrity than Contributory 1 buildings. • Being a later dwelling constructed in an appropriate referential style, but comprising little to no fabric of intrinsic heritage significance. 		<p>An extension has been built onto the eastern/southern portion of the dwelling. this has been undertaken in a sympathetic manner and does not detract from the heritage streetscape.</p> <p>The decorative brackets visible along the veranda are potentially a contemporary replication of an original heritage design.</p> <p>Solar panels are highly visible along the northern portion of the roof.</p> <p>Colourbond sheeting has been installed at the gabled end of the roof.</p>

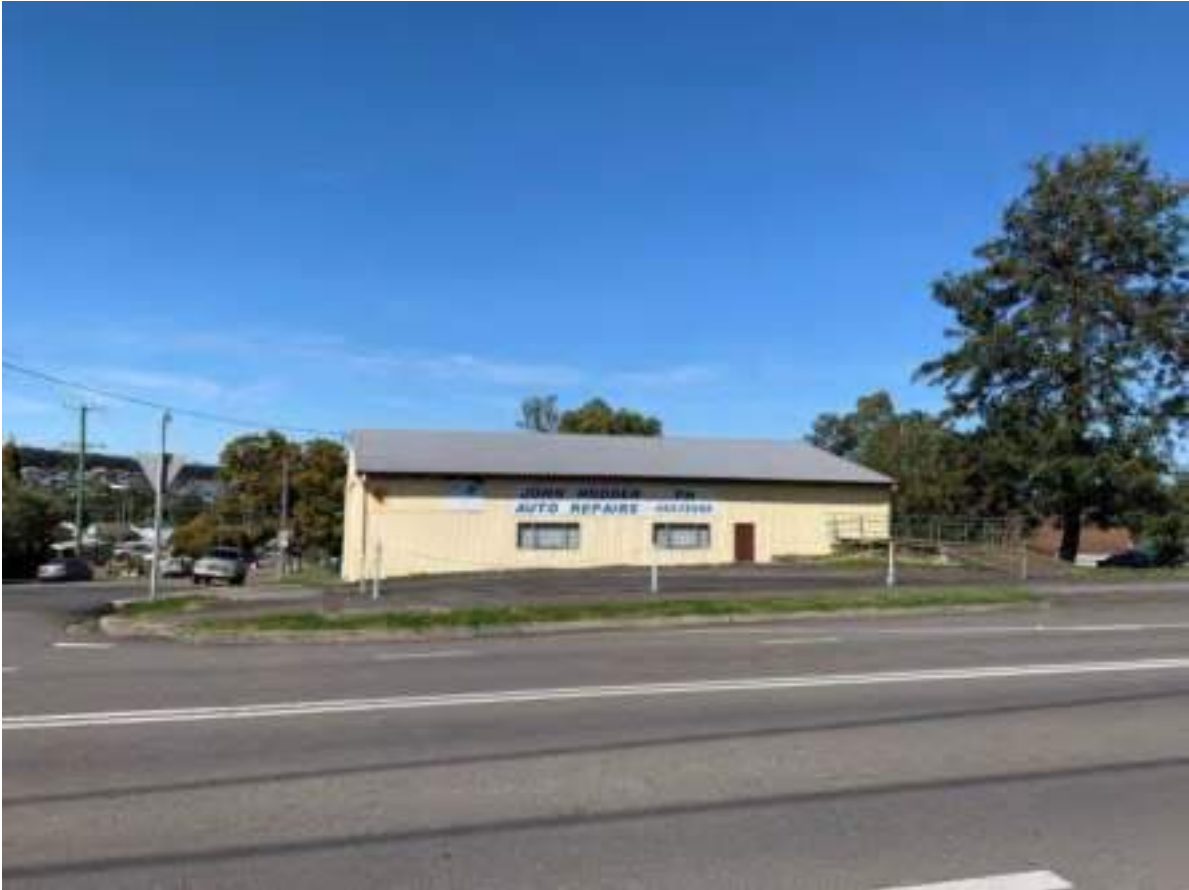
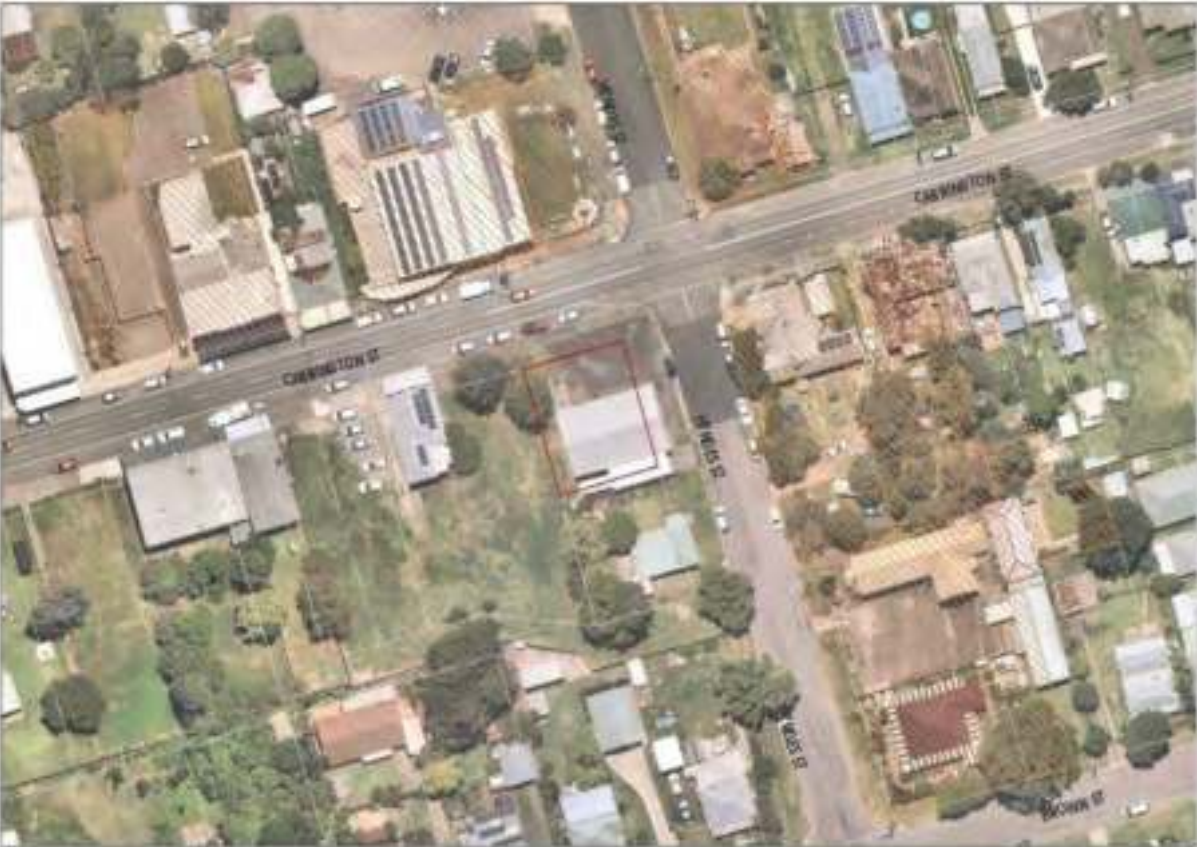
56 CARRINGTON STREET, WEST WALLSEND 2286

Conservation Area Contribution Level	Est. Construction Date	Previous studies and/or community input
Contributory 2	Early to late 20 th century (broad range)	No prior heritage assessments or research undertaken.
Assessment Text		Observed Modifications
<p>The scale (single-storey) and general style of the dwelling is consistent with that of the streetscape and wider HCA. Dwelling contributes positively to the streetscape and wider HCA, particularly in comparison to Non-Contributory buildings.</p> <p>The dwelling features appropriately proportioned and positioned fenestrations, an appropriate roof form (gabled or hipped) and other features consistent with the architectural character of the area (e.g. front verandah with timber or brick posts, timber detailing, corrugated metal roofing, etc). The contributory value of the dwelling is limited however by either:</p> <ul style="list-style-type: none"> • External modifications that have in some way obscured the style, scale or design intent of the building and have resulted in less physical integrity than Contributory 1 buildings. • Being a later dwelling constructed in an appropriate referential style, but comprising little to no fabric of intrinsic heritage significance. 		<p>Potentially the location for a prior business or structure. No modifications observed.</p>
