APPENDIX 2

Building Assessment Sheets (Inventory Sheets)

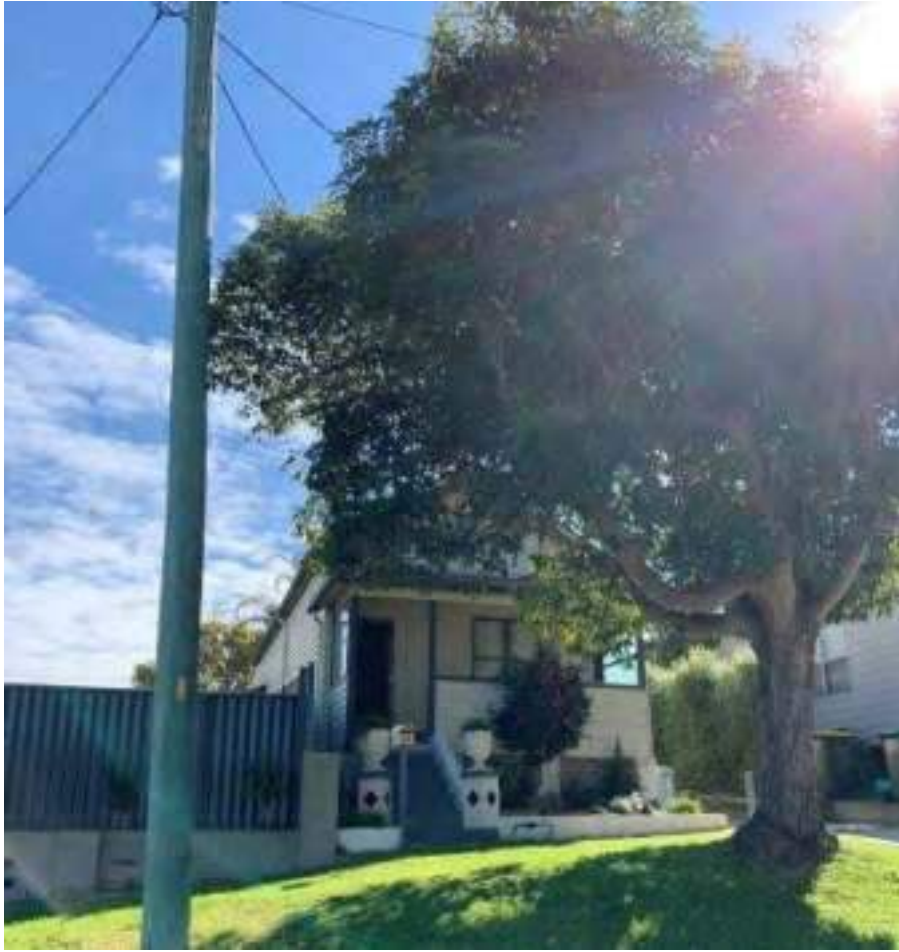
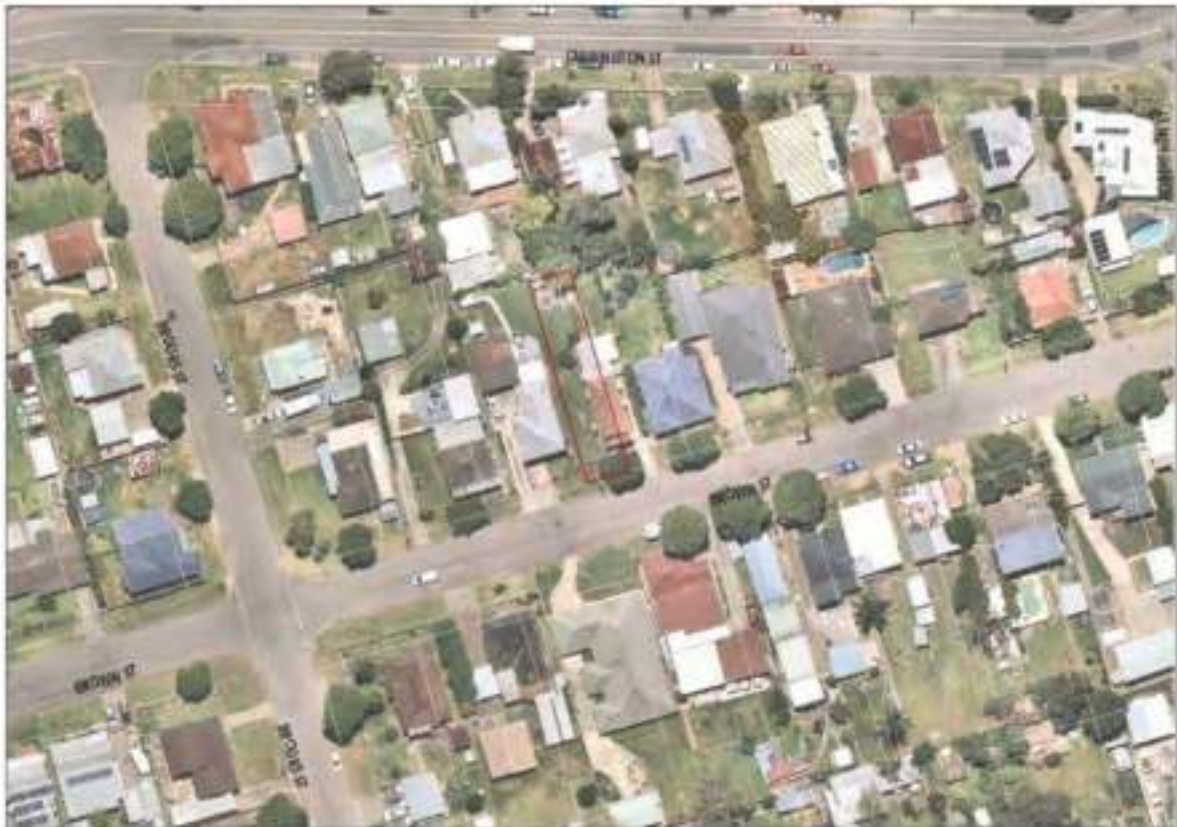
11 BROWN STREET, WEST WALLSEND 2286		
Conservation Area Contribution Level	Est. Construction Date	Previous studies and/or community input
Contributory 2	Early to late 20 th century (broad range)	No prior heritage assessments or research undertaken.
Assessment Text		Observed Modifications
<p>The scale (single-storey) and general style of the dwelling is consistent with that of the streetscape and wider HCA. Dwelling contributes positively to the streetscape and wider HCA, particularly in comparison to Non-Contributory buildings.</p> <p>The dwelling features appropriately proportioned and positioned fenestrations, an appropriate roof form (gabled or hipped) and other features consistent with the architectural character of the area (e.g. front verandah with timber or brick posts, timber detailing, corrugated metal roofing, etc). The contributory value of the dwelling is limited however by either:</p> <ul style="list-style-type: none"> • External modifications that have in some way obscured the style, scale or design intent of the building and have resulted in less physical integrity than Contributory 1 buildings. • Being a later dwelling constructed in an appropriate referential style, but comprising little to no fabric of intrinsic heritage significance. 		<p>The veranda has been partially enclosed by a solid timber veranda wall and the addition of timber framed windows.</p>

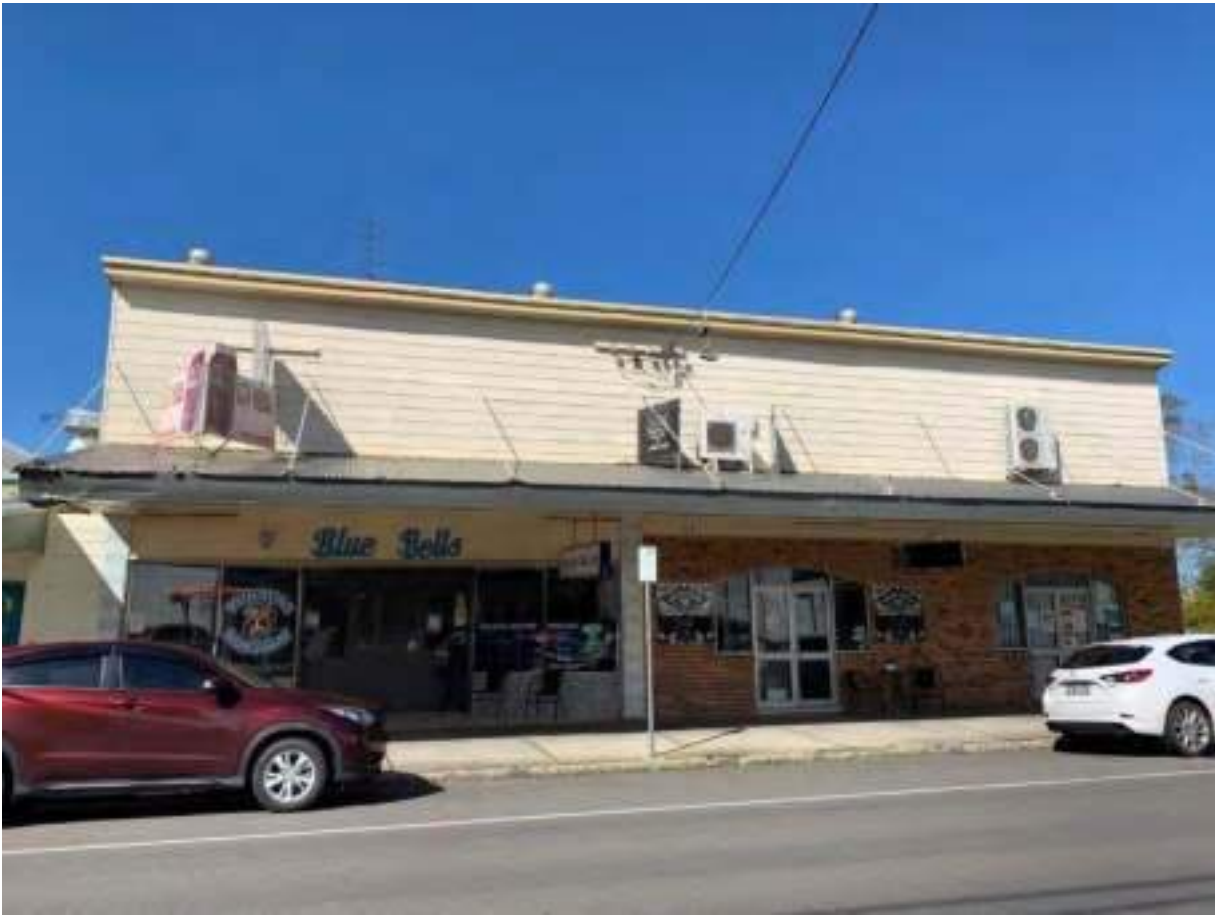
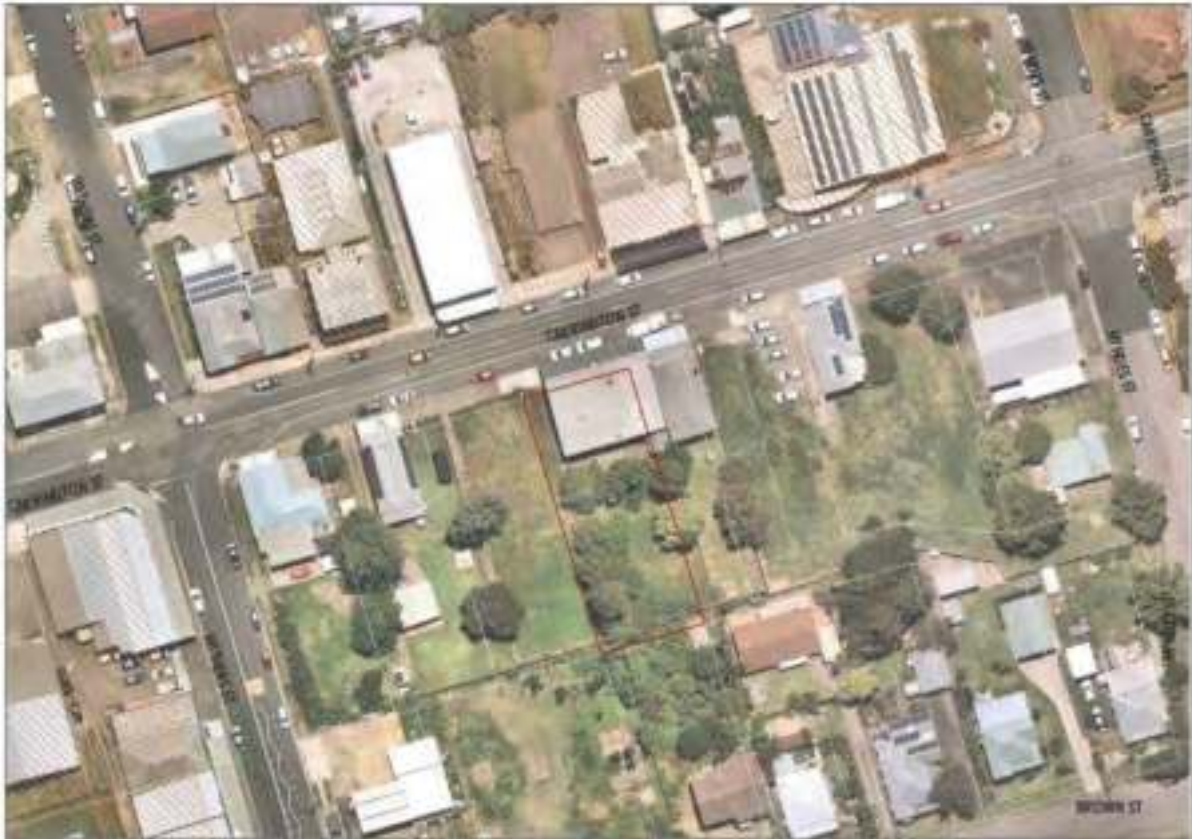
68 CARRINGTON STREET, WEST WALLSEND 2286

Conservation Area Contribution Level	Est. Construction Date	Previous studies and/or community input
Contributory 2	Early to late 20 th century (broad range)	No prior heritage assessments or research undertaken.
Assessment Text		Observed Modifications
<p>The scale (single-storey) and general style of the dwelling is consistent with that of the streetscape and wider HCA. Dwelling contributes positively to the streetscape and wider HCA, particularly in comparison to Non-Contributory buildings.</p> <p>The dwelling features appropriately proportioned and positioned fenestrations, an appropriate roof form (gabled or hipped) and other features consistent with the architectural character of the area (e.g. front verandah with timber or brick posts, timber detailing, corrugated metal roofing, etc). The contributory value of the dwelling is limited however by either:</p> <ul style="list-style-type: none"> • External modifications that have in some way obscured the style, scale or design intent of the building and have resulted in less physical integrity than Contributory 1 buildings. • Being a later dwelling constructed in an appropriate referential style, but comprising little to no fabric of intrinsic heritage significance. 		<p>The building complex has undergone exterior modifications relating to its current occupation, both of which are local businesses. No structural modifications observed.</p>

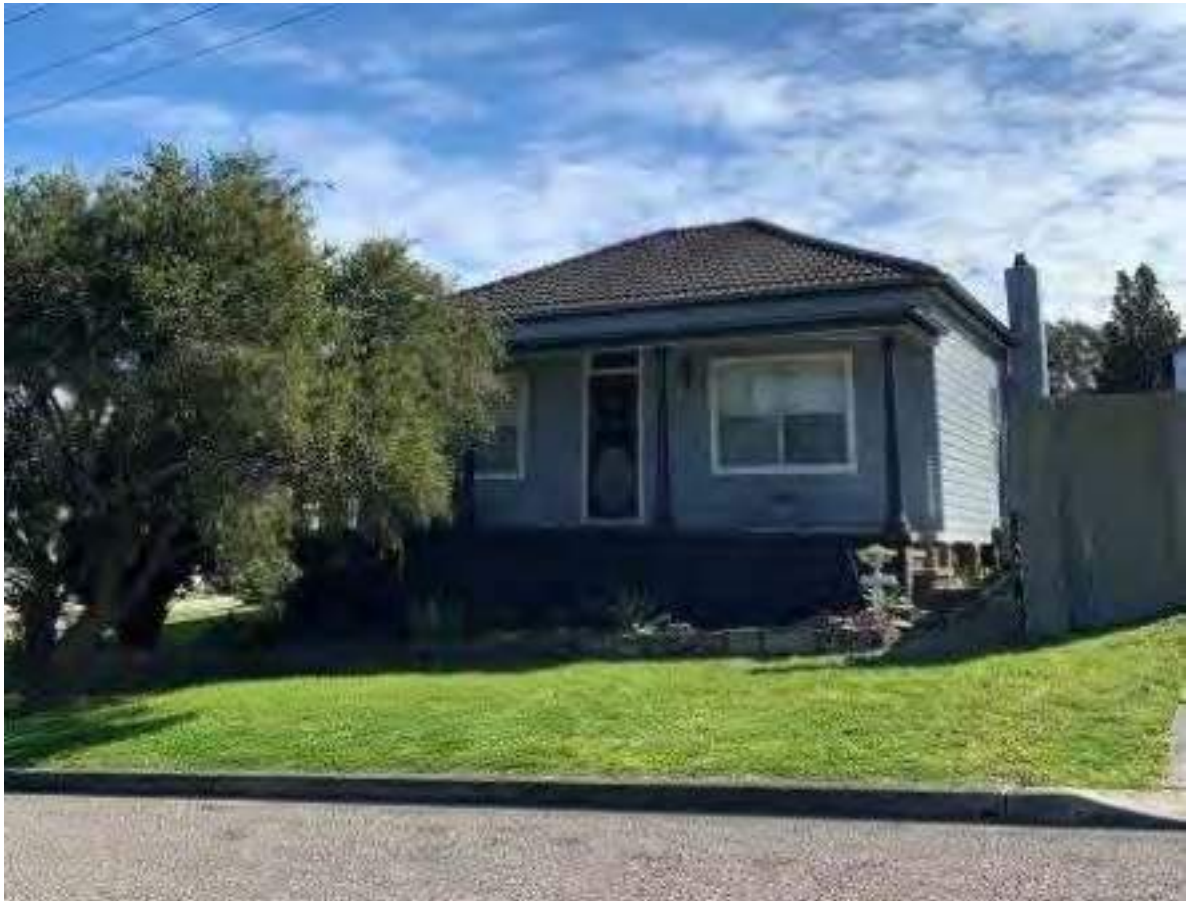
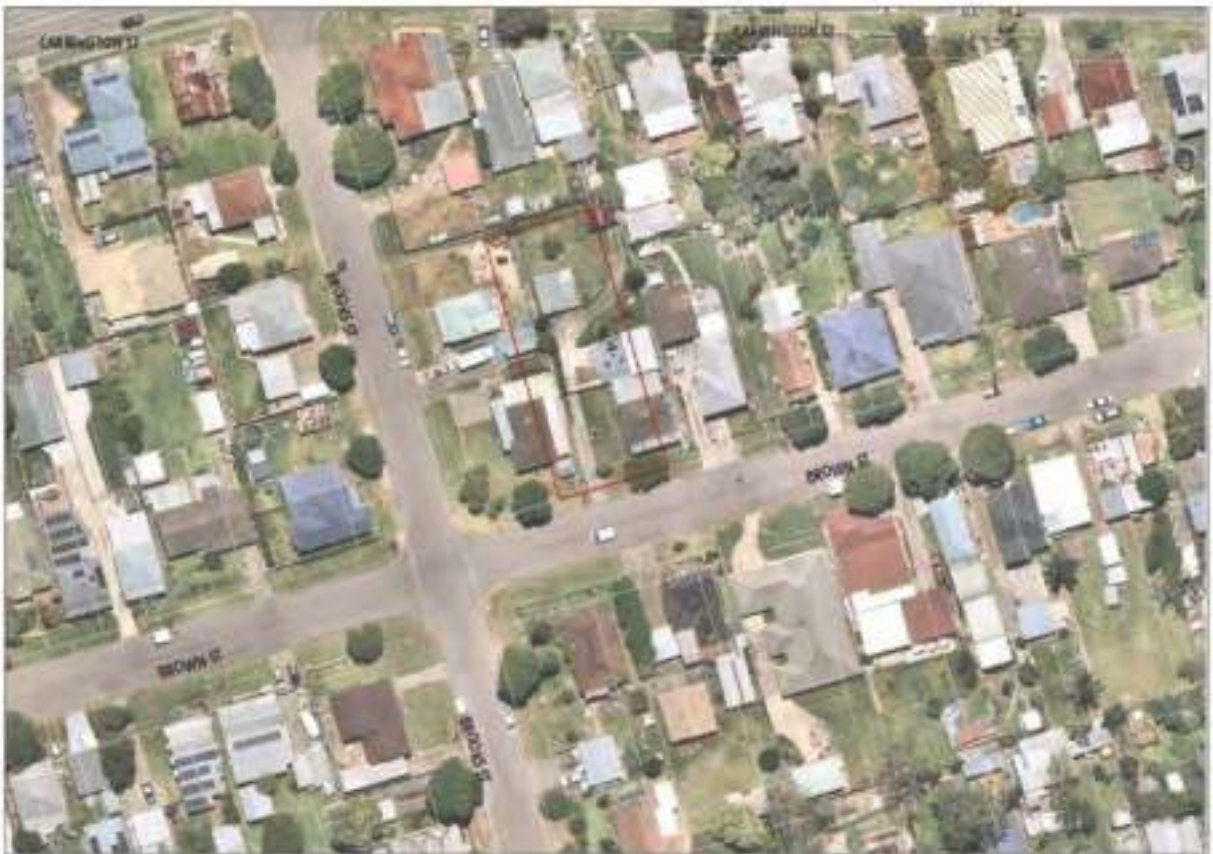
15 BROWN STREET, WEST WALLSEND 2286

Conservation Area Contribution Level	Est. Construction Date	Previous studies and/or community input
Contributory 2	Early to late 20 th century (broad range)	No prior heritage assessments or research undertaken.
Assessment Text		Observed Modifications
<p>The scale (single-storey) and general style of the dwelling is consistent with that of the streetscape and wider HCA. Dwelling contributes positively to the streetscape and wider HCA, particularly in comparison to Non-Contributory buildings.</p> <p>The dwelling features appropriately proportioned and positioned fenestrations, an appropriate roof form (gabled or hipped) and other features consistent with the architectural character of the area (e.g. front verandah with timber or brick posts, timber detailing, corrugated metal roofing, etc). The contributory value of the dwelling is limited however by either:</p> <ul style="list-style-type: none"> • External modifications that have in some way obscured the style, scale or design intent of the building and have resulted in less physical integrity than Contributory 1 buildings. • Being a later dwelling constructed in an appropriate referential style, but comprising little to no fabric of intrinsic heritage significance. 		<p>All visible windows are contemporary in style.</p> <p>The concrete tiled roof is a prior modification, likely replacing an original iron sheet or Colourbond roof.</p> <p>The faux European veranda pillars are a contemporary addition, replacing original timber posts.</p>

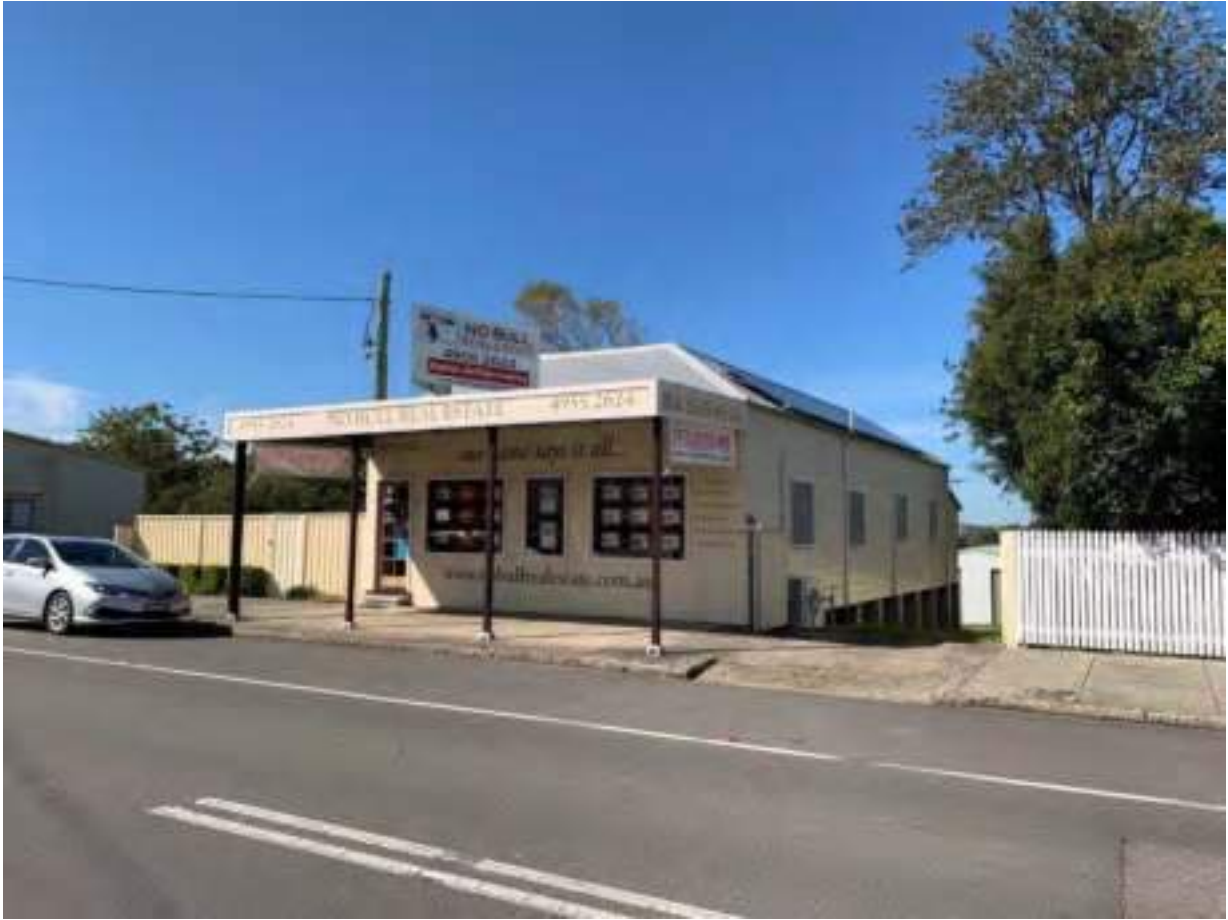
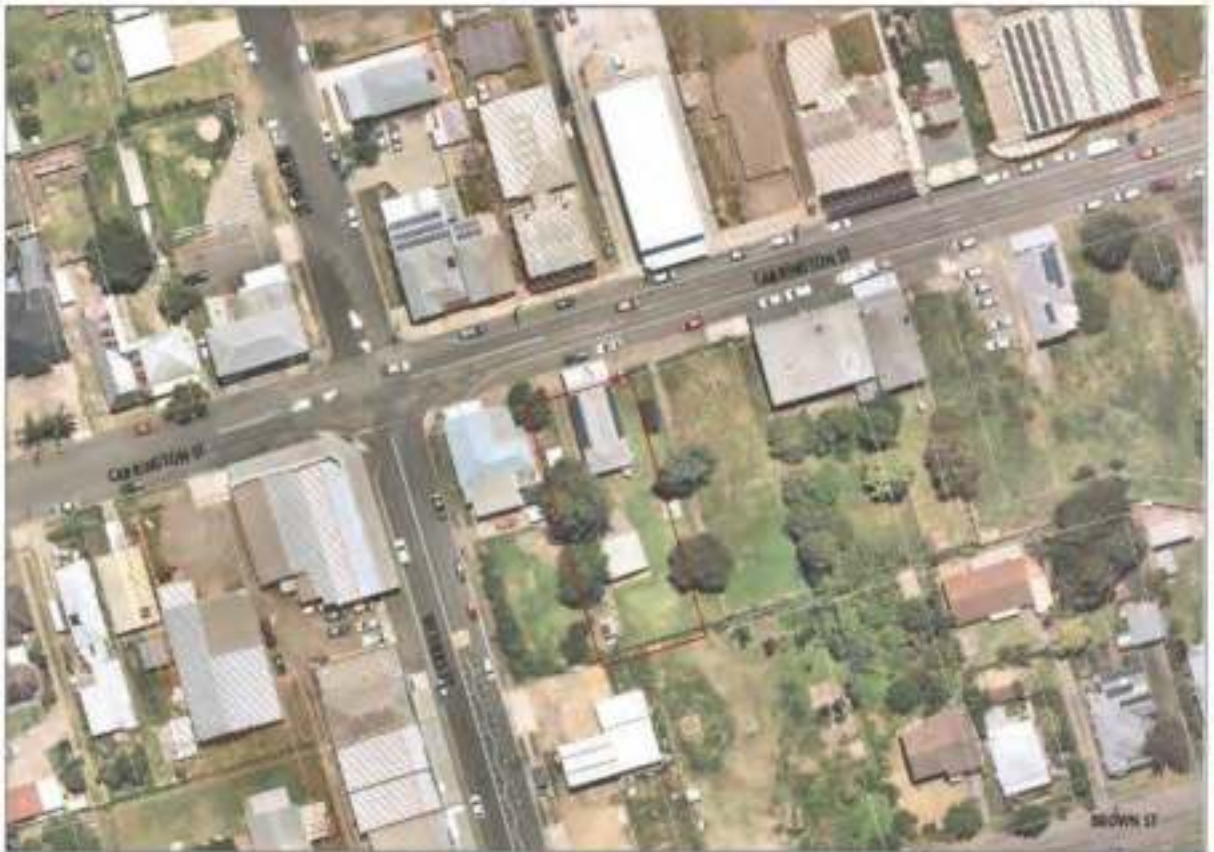
72 CARRINGTON STREET, WEST WALLSEND 2286

Conservation Area Contribution Level	Est. Construction Date	Previous studies and/or community input
Contributory 2	Early to late 20 th century (broad range)	No prior heritage assessments or research undertaken.
Assessment Text		Observed Modifications
<p>The scale (single-storey) and general style of the dwelling is consistent with that of the streetscape and wider HCA. Dwelling contributes positively to the streetscape and wider HCA, particularly in comparison to Non-Contributory buildings.</p> <p>The dwelling features appropriately proportioned and positioned fenestrations, an appropriate roof form (gabled or hipped) and other features consistent with the architectural character of the area (e.g. front verandah with timber or brick posts, timber detailing, corrugated metal roofing, etc). The contributory value of the dwelling is limited however by either:</p> <ul style="list-style-type: none"> • External modifications that have in some way obscured the style, scale or design intent of the building and have resulted in less physical integrity than Contributory 1 buildings. • Being a later dwelling constructed in an appropriate referential style, but comprising little to no fabric of intrinsic heritage significance. 		<p>The building has undergone external modifications in relation to its current use as the premise of a local business. This includes alterations to the windows, relocating the main door to the eastern side of the façade and business related information painted onto the building exterior.</p>

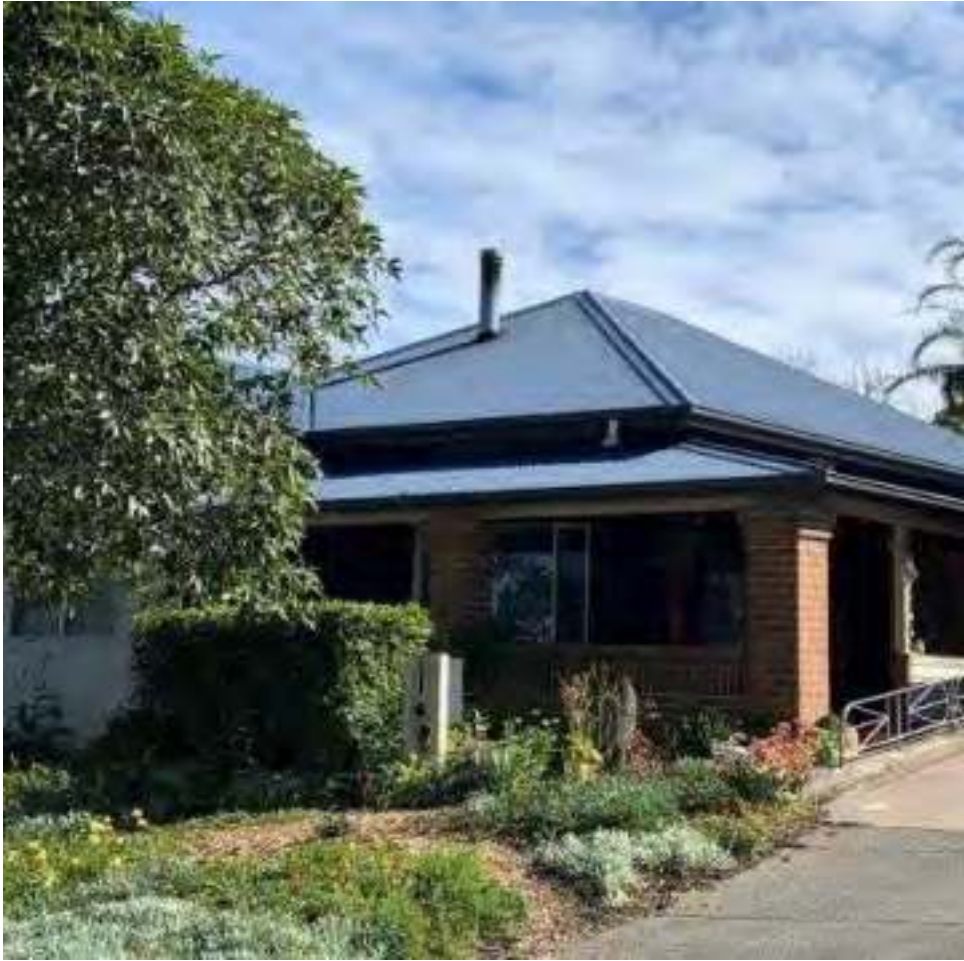
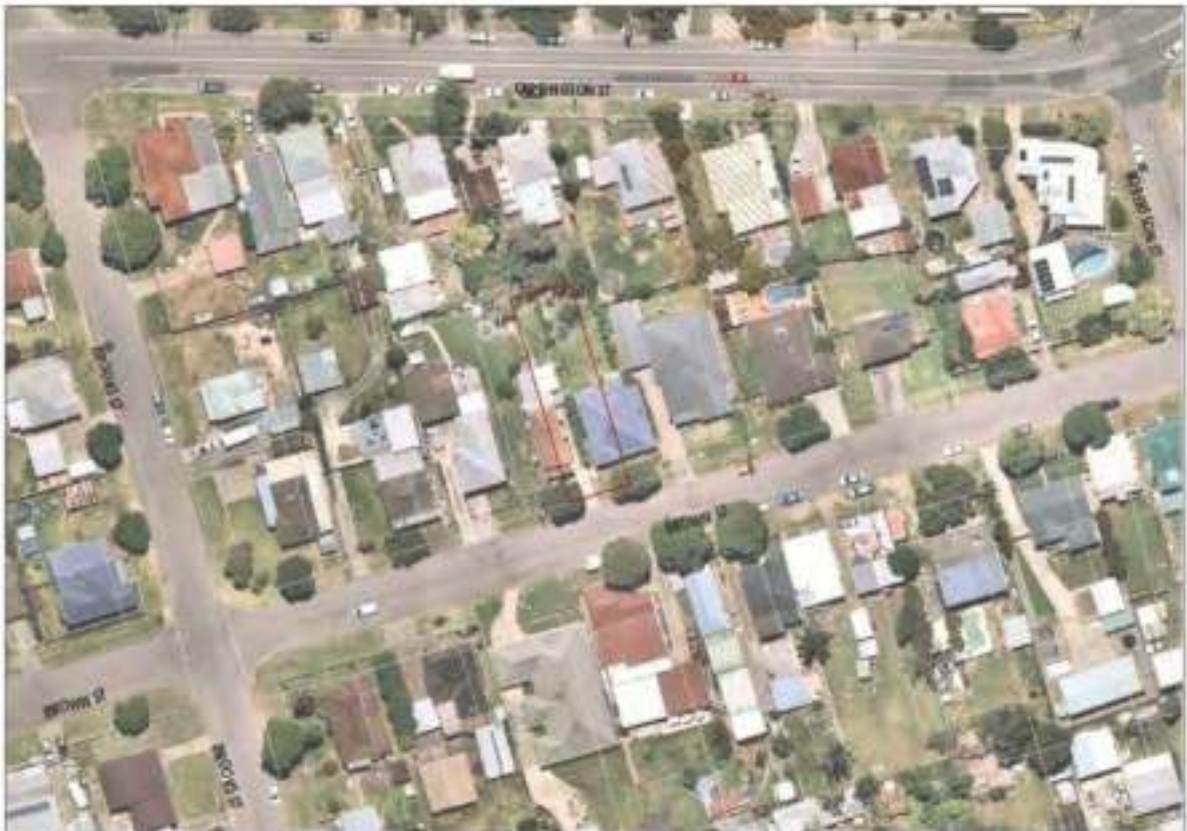
9 BROWN STREET, WEST WALLSEND 2286

Conservation Area Contribution Level	Est. Construction Date	Previous studies and/or community input
Contributory 2	Early to late 20 th century (broad range)	No prior heritage assessments or research undertaken.
Assessment Text		Observed Modifications
<p>The scale (single-storey) and general style of the dwelling is consistent with that of the streetscape and wider HCA. Dwelling contributes positively to the streetscape and wider HCA, particularly in comparison to Non-Contributory buildings.</p> <p>The dwelling features appropriately proportioned and positioned fenestrations, an appropriate roof form (gabled or hipped) and other features consistent with the architectural character of the area (e.g. front verandah with timber or brick posts, timber detailing, corrugated metal roofing, etc). The contributory value of the dwelling is limited however by either:</p> <ul style="list-style-type: none"> • External modifications that have in some way obscured the style, scale or design intent of the building and have resulted in less physical integrity than Contributory 1 buildings. • Being a later dwelling constructed in an appropriate referential style, but comprising little to no fabric of intrinsic heritage significance. 		<p>The brickwork veranda wall and support pillars are contemporary additions, likely replacing original timber posts and balustrade.</p> <p>The veranda has been extended to wrap around the eastern portion of the dwelling.</p>

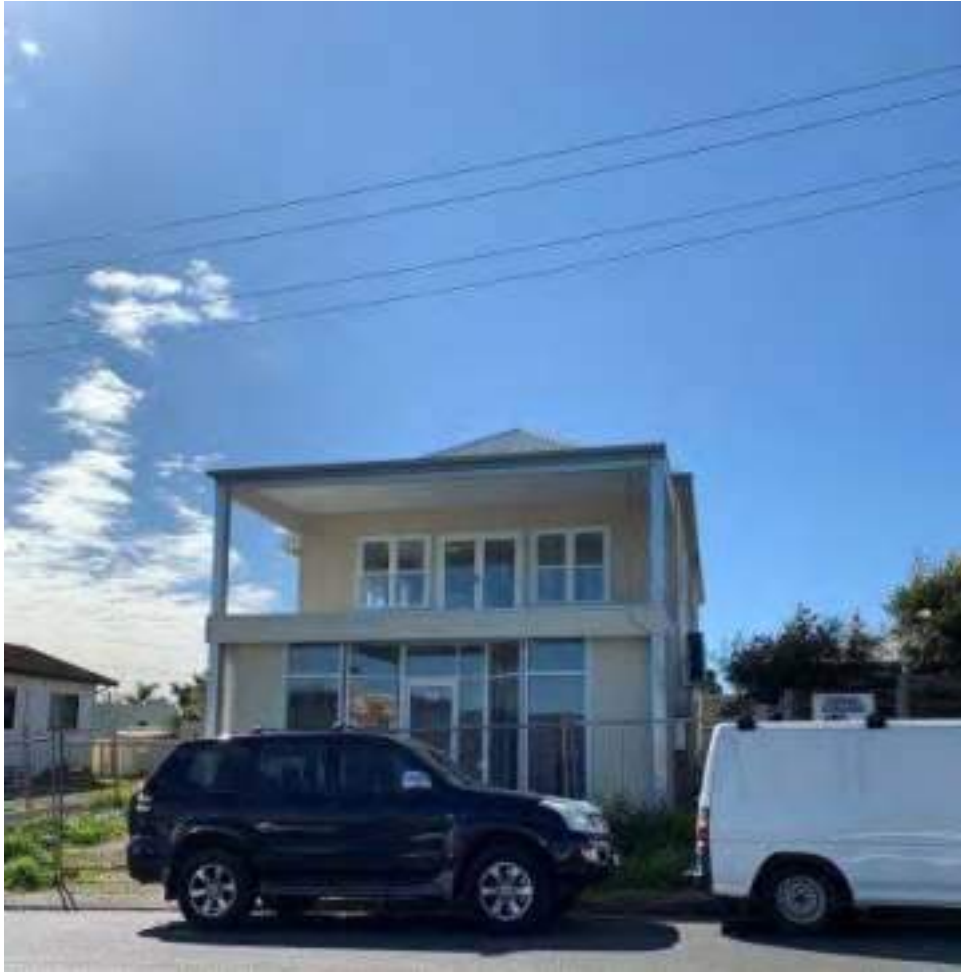
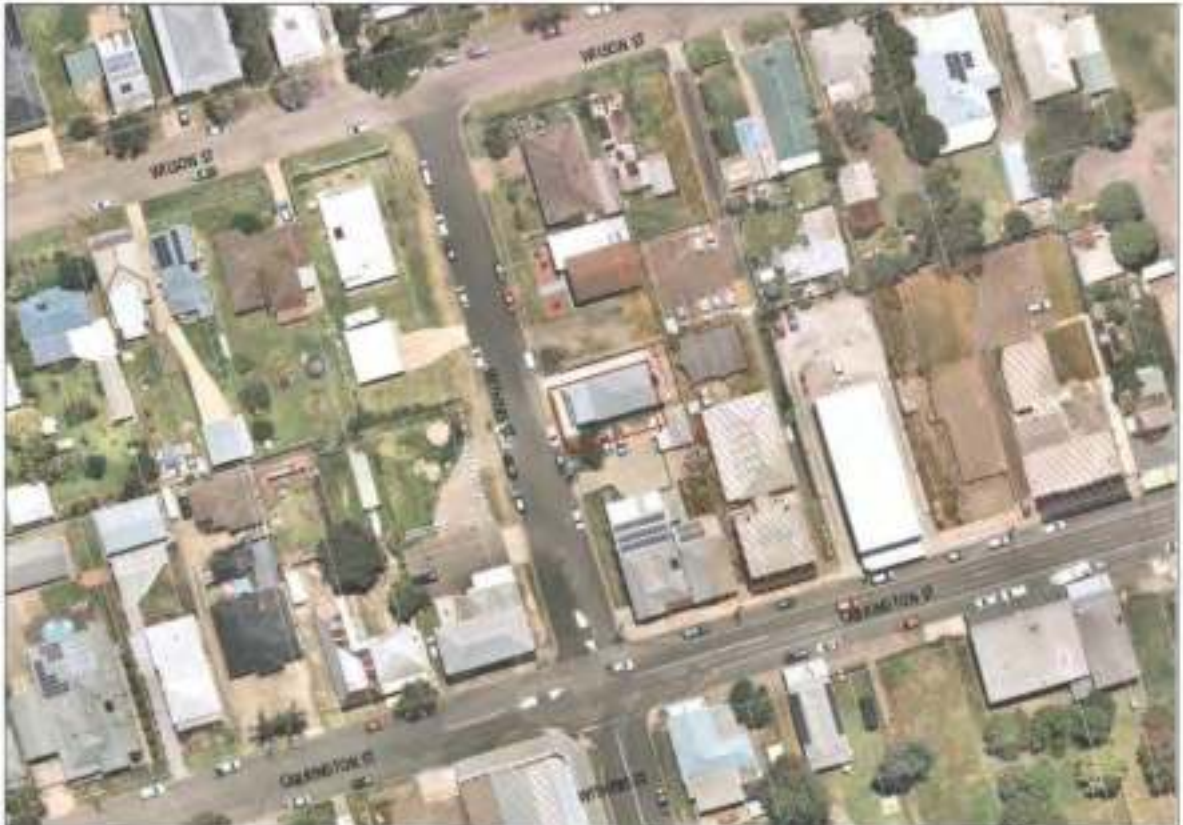
5 WITHERS STREET, WEST WALLSEND 2286

Conservation Area Contribution Level	Est. Construction Date	Previous studies and/or community input
Contributory 2	2000-2020	No prior heritage assessments or research undertaken.
Assessment Text		Observed Modifications
<p>The scale (single-storey) and general style of the dwelling is consistent with that of the streetscape and wider HCA. Dwelling contributes positively to the streetscape and wider HCA, particularly in comparison to Non-Contributory buildings.</p> <p>The dwelling features appropriately proportioned and positioned fenestrations, an appropriate roof form (gabled or hipped) and other features consistent with the architectural character of the area (e.g. front verandah with timber or brick posts, timber detailing, corrugated metal roofing, etc). The contributory value of the dwelling is limited however by either:</p> <ul style="list-style-type: none"> • External modifications that have in some way obscured the style, scale or design intent of the building and have resulted in less physical integrity than Contributory 1 buildings. • Being a later dwelling constructed in an appropriate referential style, but comprising little to no fabric of intrinsic heritage significance. 		No modifications observed.

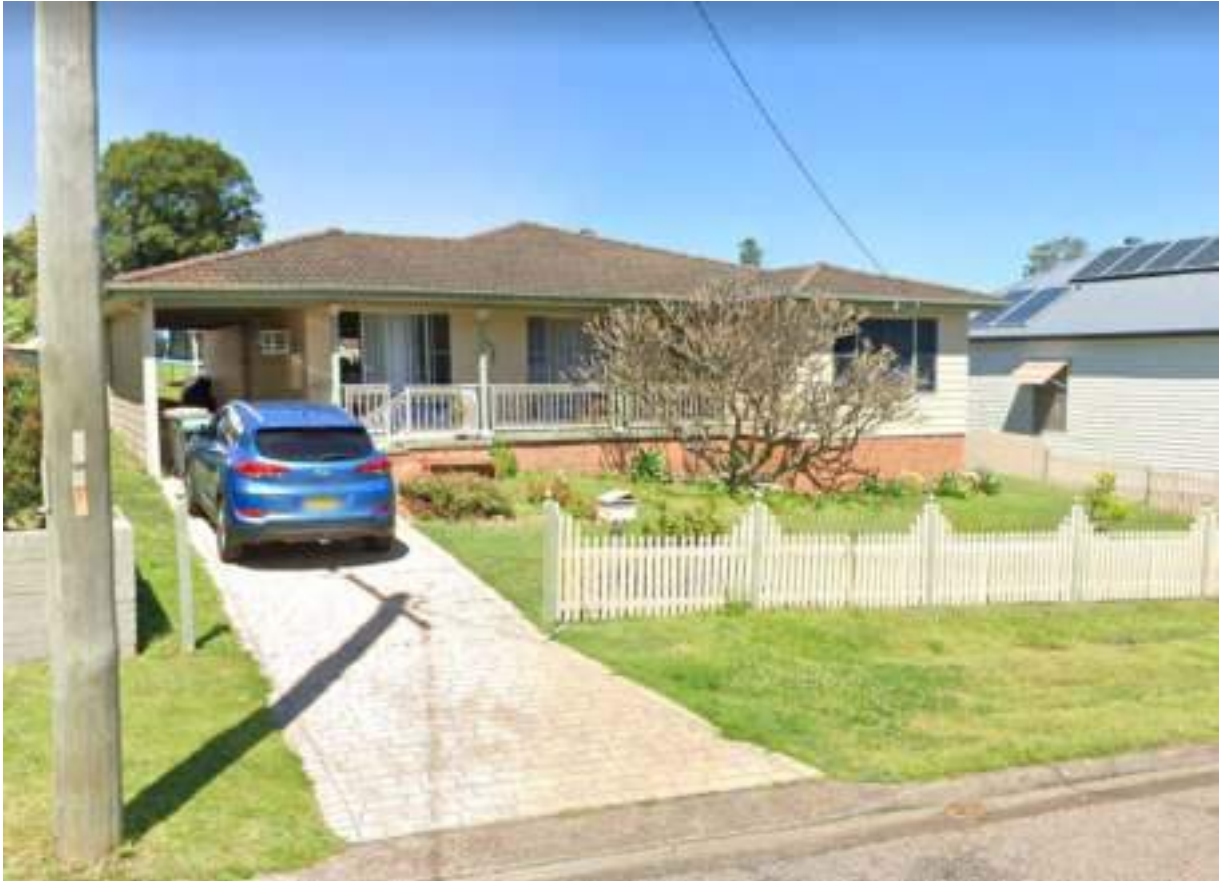
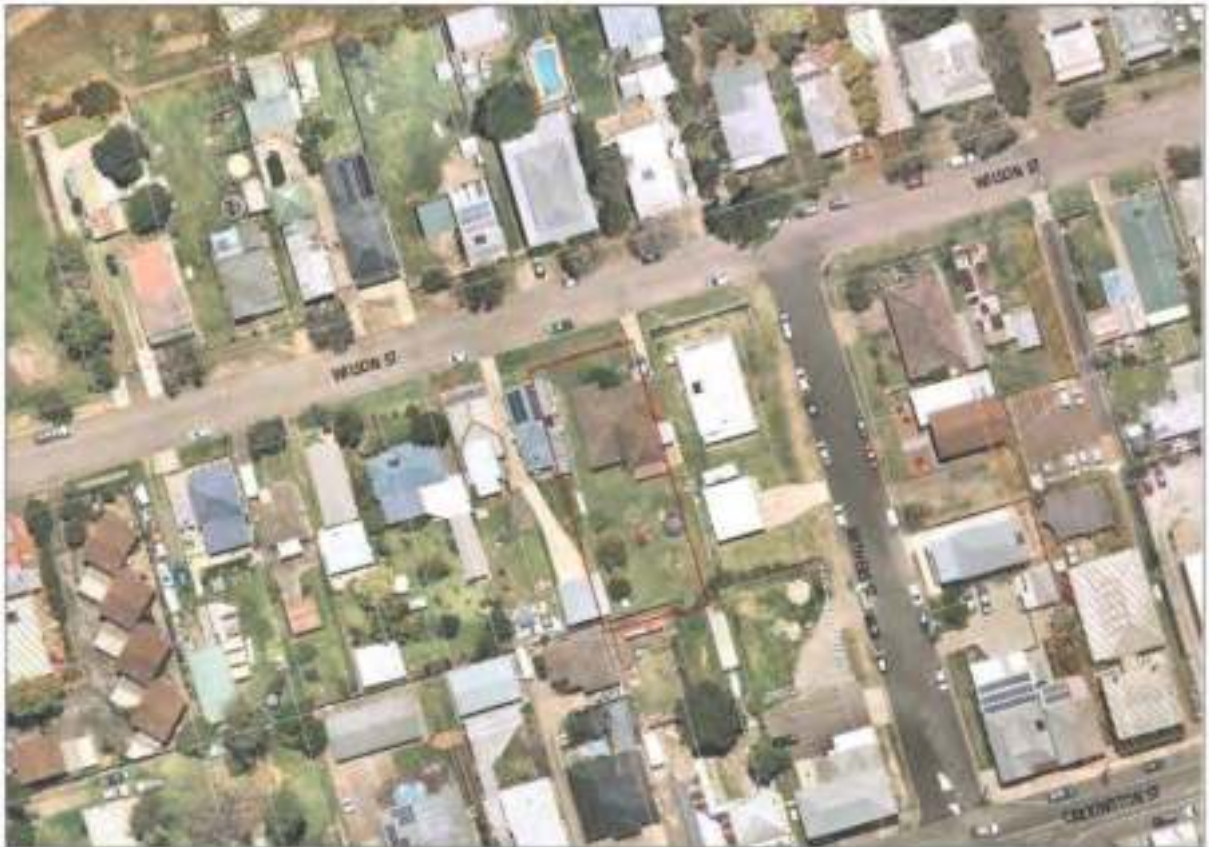
52 WILSON STREET, WEST WALLSEND 2286

Conservation Area Contribution Level	Est. Construction Date	Previous studies and/or community input
Contributory 2	Early to late 20 th century (broad range)	No prior heritage assessments or research undertaken.
Assessment Text		Observed Modifications
<p>The scale (single-storey) and general style of the dwelling is consistent with that of the streetscape and wider HCA. Dwelling contributes positively to the streetscape and wider HCA, particularly in comparison to Non-Contributory buildings.</p> <p>The dwelling features appropriately proportioned and positioned fenestrations, an appropriate roof form (gabled or hipped) and other features consistent with the architectural character of the area (e.g. front verandah with timber or brick posts, timber detailing, corrugated metal roofing, etc). The contributory value of the dwelling is limited however by either:</p> <ul style="list-style-type: none"> • External modifications that have in some way obscured the style, scale or design intent of the building and have resulted in less physical integrity than Contributory 1 buildings. • Being a later dwelling constructed in an appropriate referential style, but comprising little to no fabric of intrinsic heritage significance. 		No modifications observed.

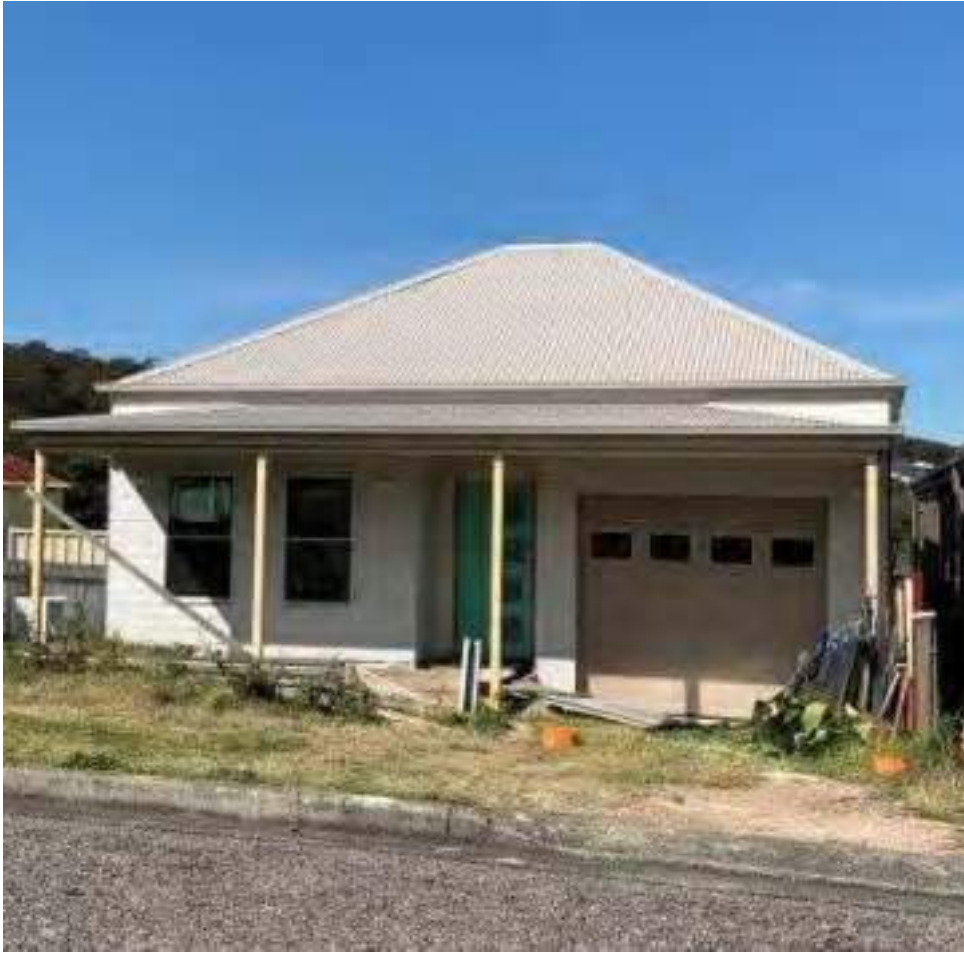
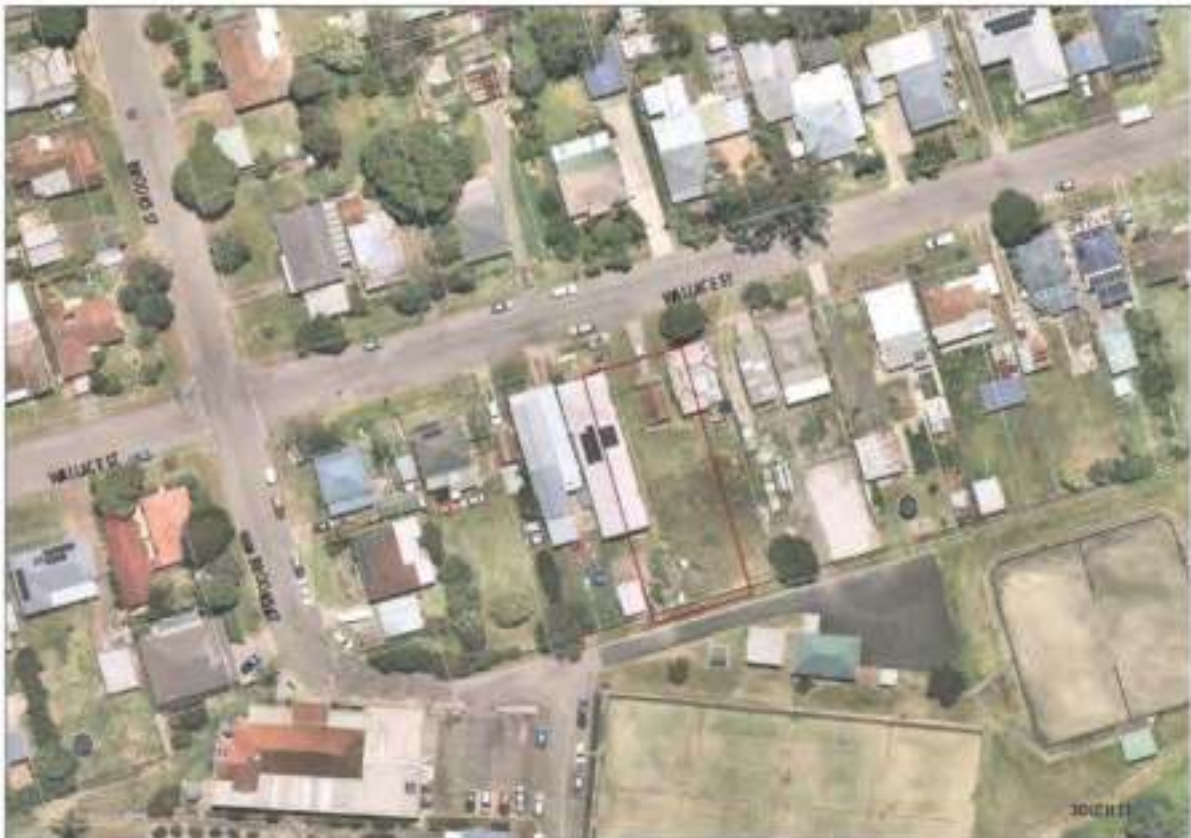
14 WALLACE STREET, WEST WALLESEND 2286

Conservation Area Contribution Level	Est. Construction Date	Previous studies and/or community input
Contributory 2	Early to late 20 th century (broad range)	No prior heritage assessments or research undertaken.
Assessment Text		Observed Modifications
<p>The scale (single-storey) and general style of the dwelling is consistent with that of the streetscape and wider HCA. Dwelling contributes positively to the streetscape and wider HCA, particularly in comparison to Non-Contributory buildings.</p> <p>The dwelling features appropriately proportioned and positioned fenestrations, an appropriate roof form (gabled or hipped) and other features consistent with the architectural character of the area (e.g. front verandah with timber or brick posts, timber detailing, corrugated metal roofing, etc). The contributory value of the dwelling is limited however by either:</p> <ul style="list-style-type: none"> • External modifications that have in some way obscured the style, scale or design intent of the building and have resulted in less physical integrity than Contributory 1 buildings. • Being a later dwelling constructed in an appropriate referential style, but comprising little to no fabric of intrinsic heritage significance. 		<p>No modifications observed. Dwelling is currently under construction.</p>

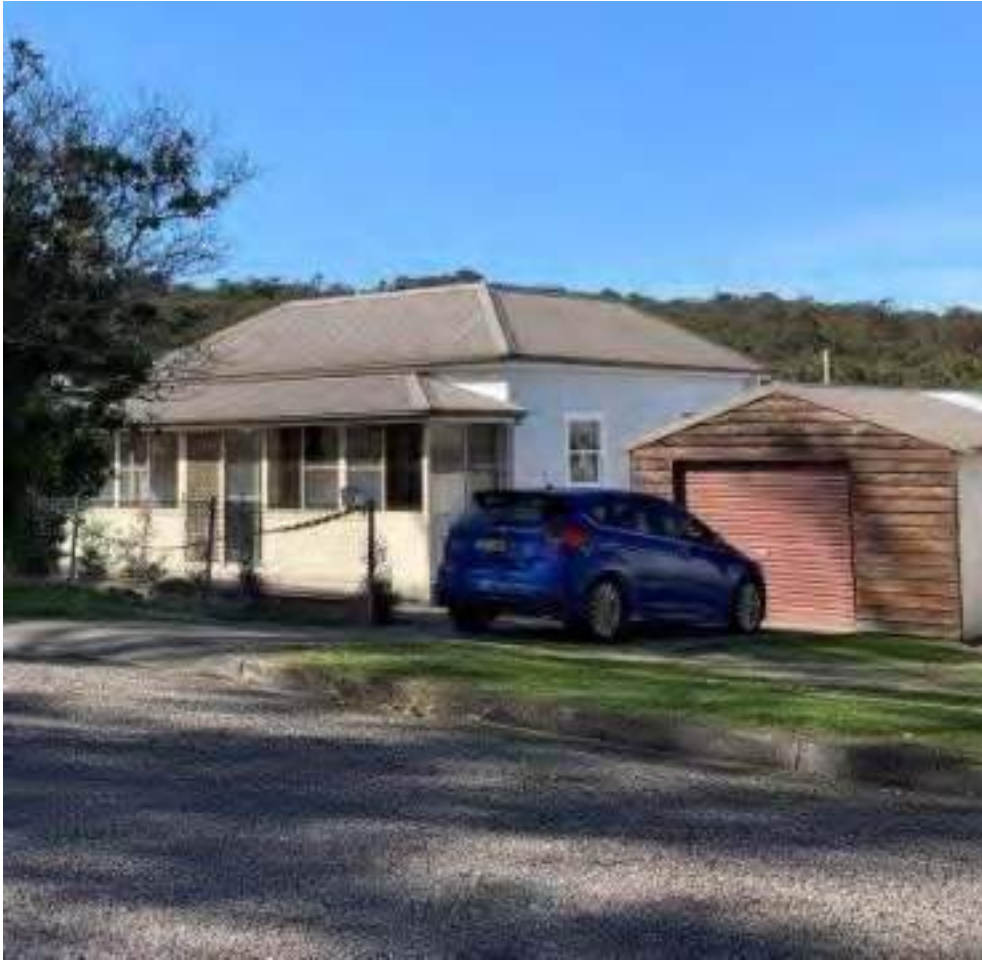
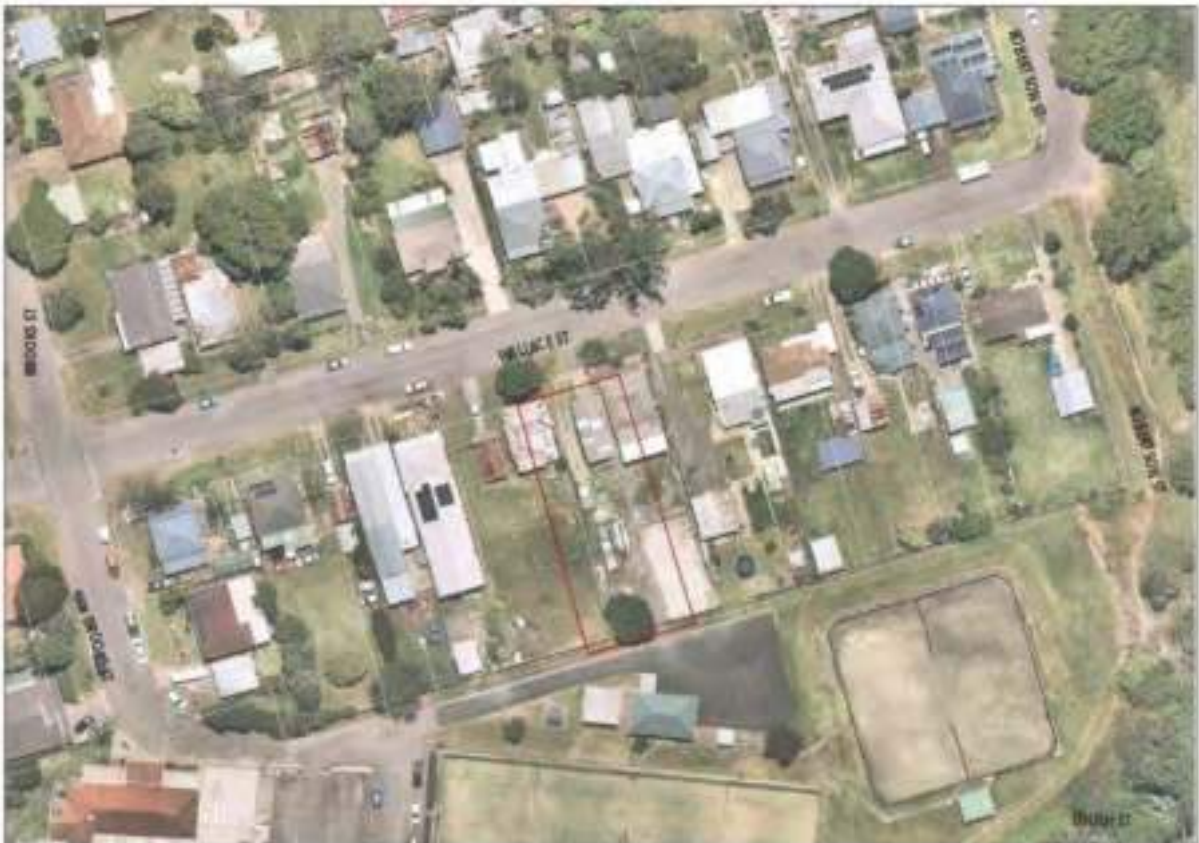
12 WALLACE STREET, WEST WALLESEND 2286

Conservation Area Contribution Level	Est. Construction Date	Previous studies and/or community input
Contributory 2	Early to late 20 th century (broad range)	No prior heritage assessments or research undertaken.
Assessment Text		Observed Modifications
<p>The scale (single-storey) and general style of the dwelling is consistent with that of the streetscape and wider HCA. Dwelling contributes positively to the streetscape and wider HCA, particularly in comparison to Non-Contributory buildings.</p> <p>The dwelling features appropriately proportioned and positioned fenestrations, an appropriate roof form (gabled or hipped) and other features consistent with the architectural character of the area (e.g. front verandah with timber or brick posts, timber detailing, corrugated metal roofing, etc). The contributory value of the dwelling is limited however by either:</p> <ul style="list-style-type: none"> • External modifications that have in some way obscured the style, scale or design intent of the building and have resulted in less physical integrity than Contributory 1 buildings. • Being a later dwelling constructed in an appropriate referential style, but comprising little to no fabric of intrinsic heritage significance. 		<p>The veranda has been built it to create an additional living area, with contemporary windows enclosing the space.</p> <p>All visible windows are contemporary in style.</p>
