APPENDIX 2

Building Assessment Sheets (Inventory Sheets)

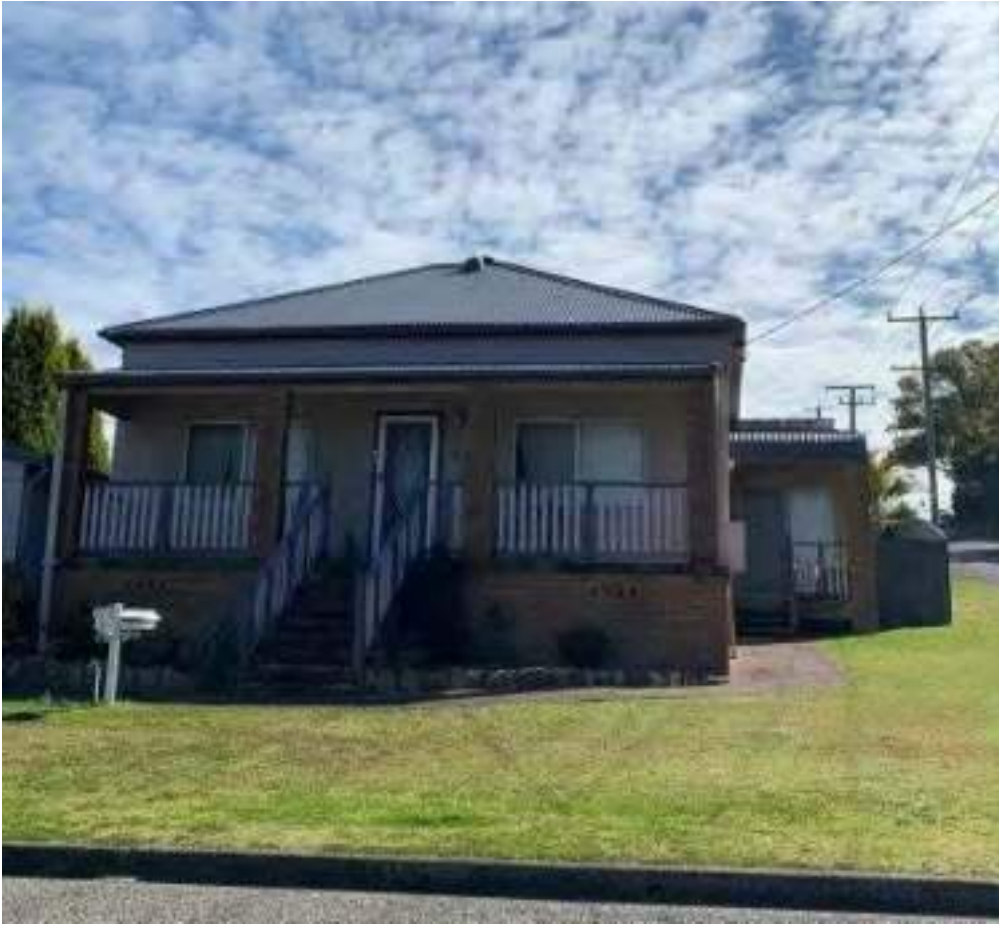
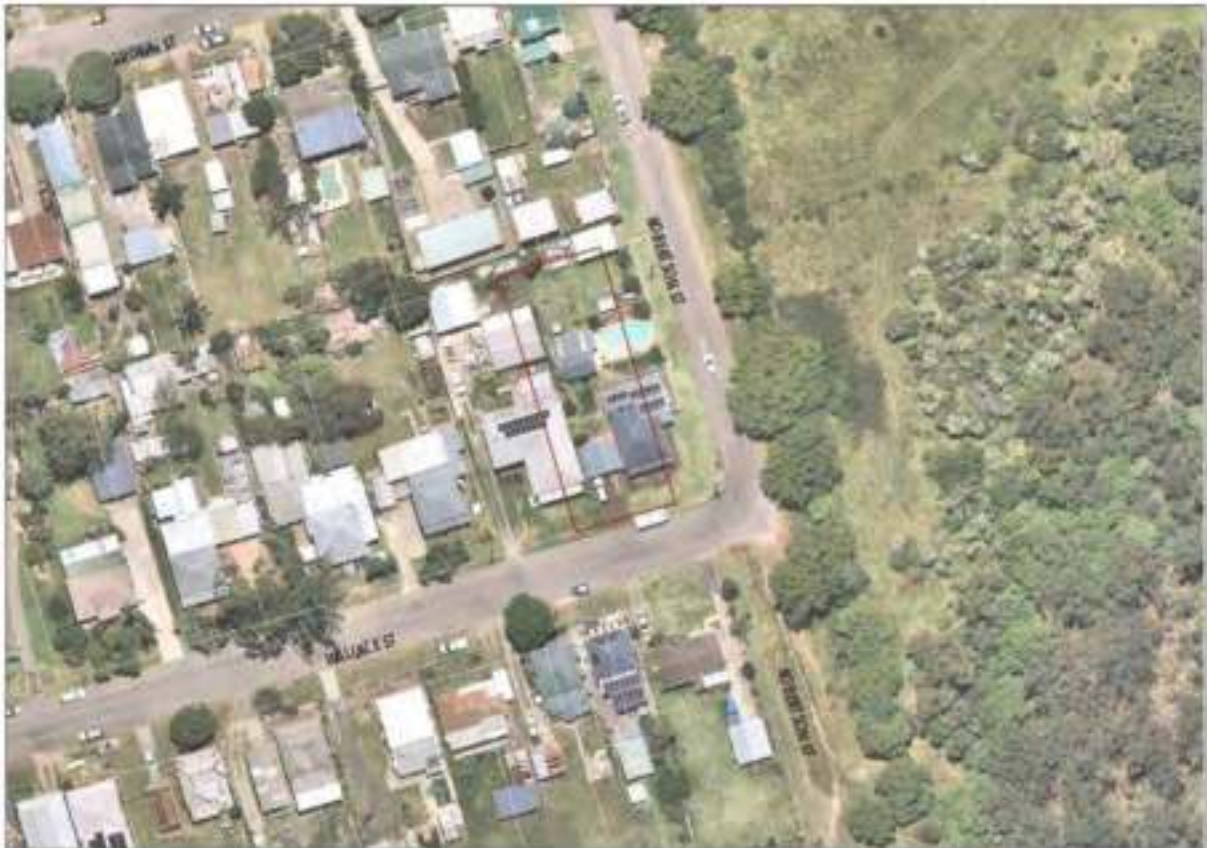
1 WALLACE STREET, WEST WALLSEND 2286

Conservation Area Contribution Level	Est. Construction Date	Previous studies and/or community input
Contributory 2	Early to late 20 th century (broad range)	No prior heritage assessments or research undertaken.
Assessment Text		Observed Modifications
<p>The scale (single-storey) and general style of the dwelling is consistent with that of the streetscape and wider HCA. Dwelling contributes positively to the streetscape and wider HCA, particularly in comparison to Non-Contributory buildings.</p> <p>The dwelling features appropriately proportioned and positioned fenestrations, an appropriate roof form (gabled or hipped) and other features consistent with the architectural character of the area (e.g. front verandah with timber or brick posts, timber detailing, corrugated metal roofing, etc). The contributory value of the dwelling is limited however by either:</p> <ul style="list-style-type: none"> • External modifications that have in some way obscured the style, scale or design intent of the building and have resulted in less physical integrity than Contributory 1 buildings. • Being a later dwelling constructed in an appropriate referential style, but comprising little to no fabric of intrinsic heritage significance. 		<p>The timber balustrade enclosing the veranda is a contemporary addition, likely replacing a similar heritage design. The brickwork support pillars are similarly contemporary, juxtaposing the remaining heritage features of the dwelling.</p> <p>An extension has been built onto the eastern/northern side of the dwelling.</p>

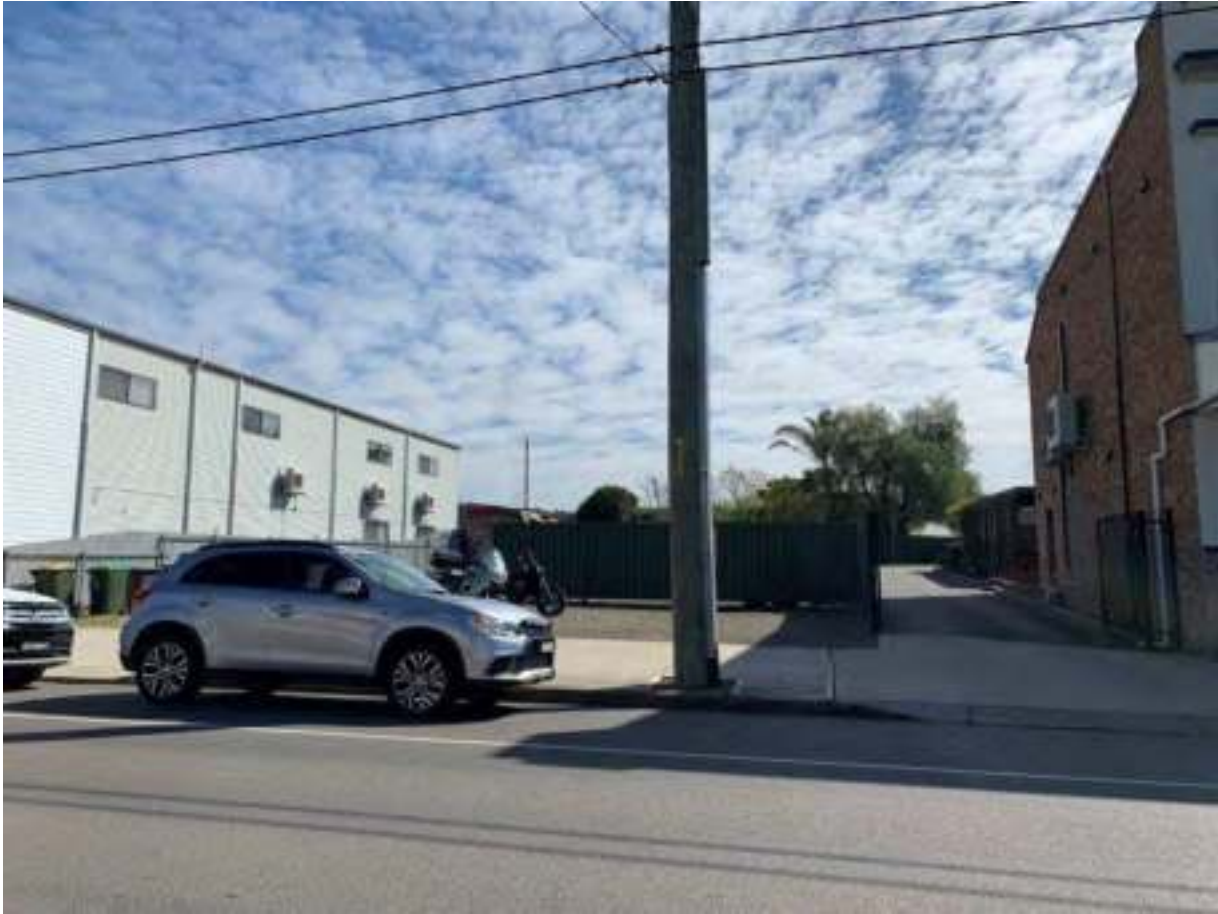
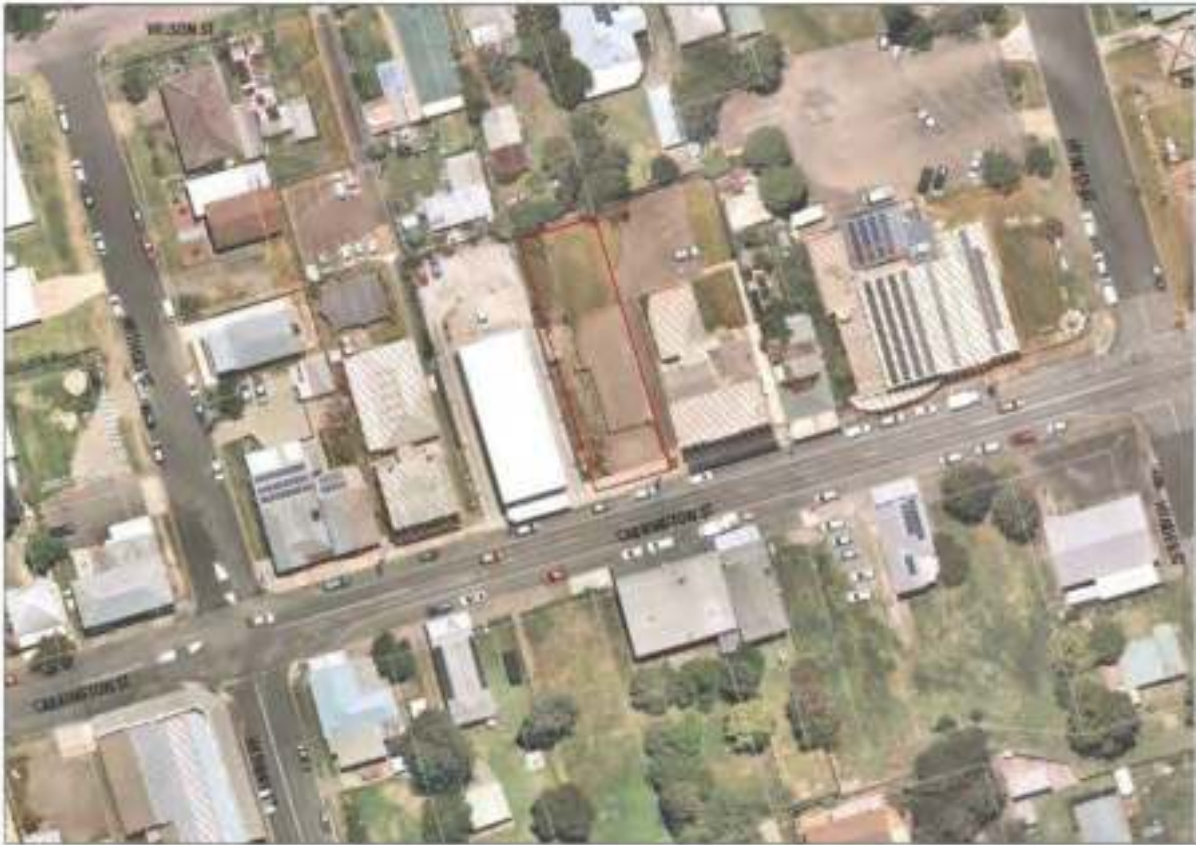
61 CARRINGTON STREET, WEST WALLSEND 2286		
Conservation Area Contribution Level	Est. Construction Date	Previous studies and/or community input
Contributory 2	N/A	No prior heritage assessments or research undertaken.
Assessment Text		Observed Modifications
Vacant lot.		Vacant lot with a concrete slab used for public parking. No modifications observed.

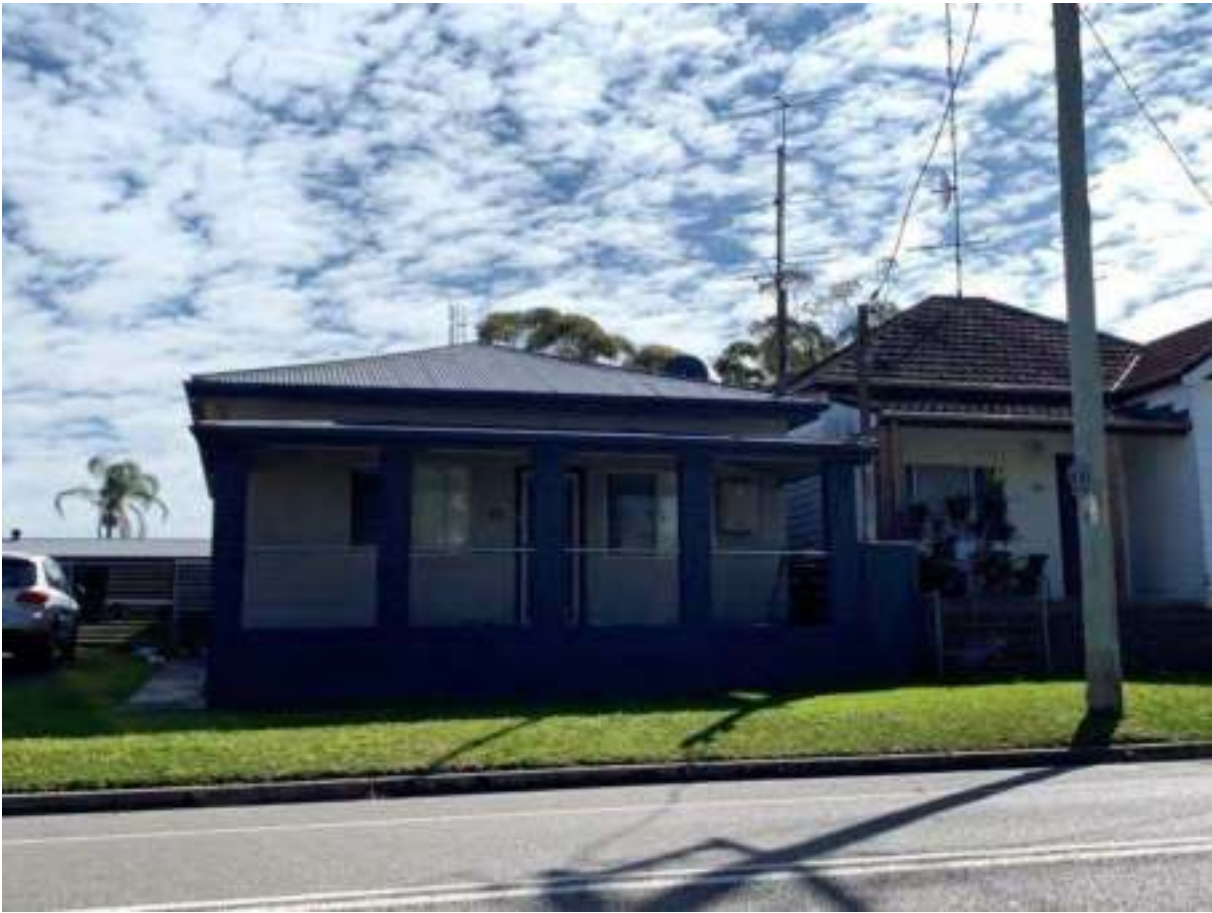
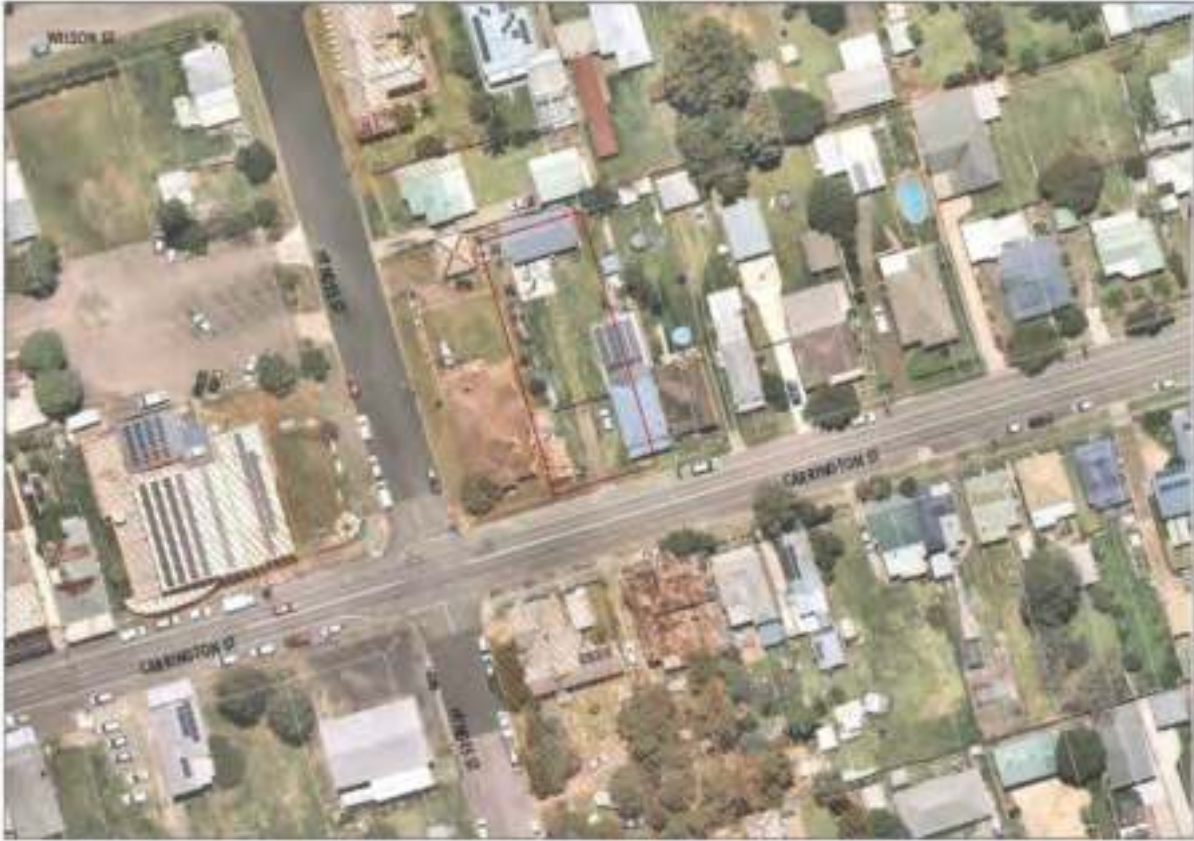
45 CARRINGTON STREET, WEST WALLSEND 2286

Conservation Area Contribution Level	Est. Construction Date	Previous studies and/or community input
Contributory 2	Early to late 20 th century (broad range)	No prior heritage assessments or research undertaken.
Assessment Text		Observed Modifications
<p>The scale (single-storey) and general style of the dwelling is consistent with that of the streetscape and wider HCA. Dwelling contributes positively to the streetscape and wider HCA, particularly in comparison to Non-Contributory buildings.</p> <p>The dwelling features appropriately proportioned and positioned fenestrations, an appropriate roof form (gabled or hipped) and other features consistent with the architectural character of the area (e.g. front verandah with timber or brick posts, timber detailing, corrugated metal roofing, etc). The contributory value of the dwelling is limited however by either:</p> <ul style="list-style-type: none"> • External modifications that have in some way obscured the style, scale or design intent of the building and have resulted in less physical integrity than Contributory 1 buildings. • Being a later dwelling constructed in an appropriate referential style, but comprising little to no fabric of intrinsic heritage significance. 		<p>The metal balustrade and brickwork veranda support pillars are contemporary additions to the dwelling. Both features juxtapose the remaining heritage aspects of the dwelling and are unsympathetic to the heritage streetscape.</p> <p>All visible windows are contemporary in style.</p>

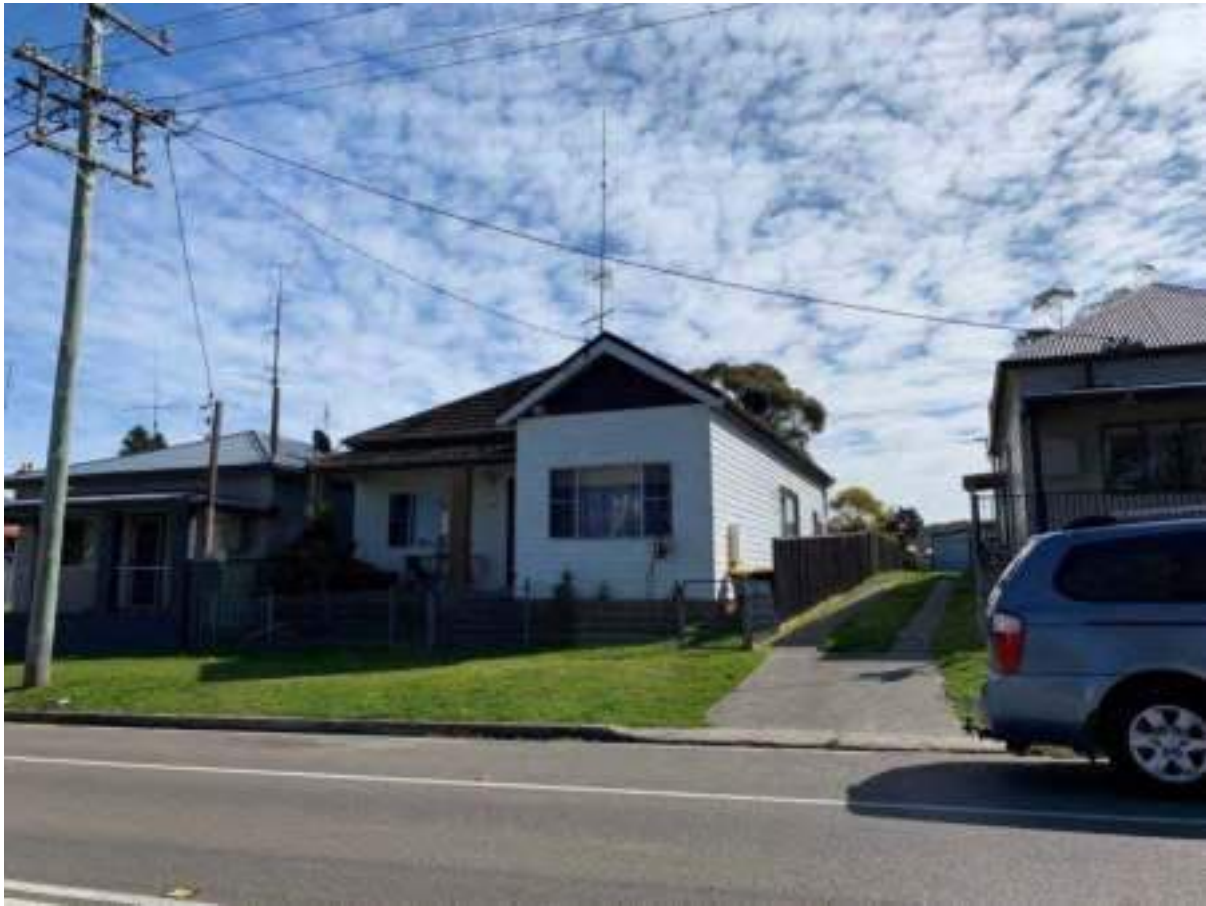
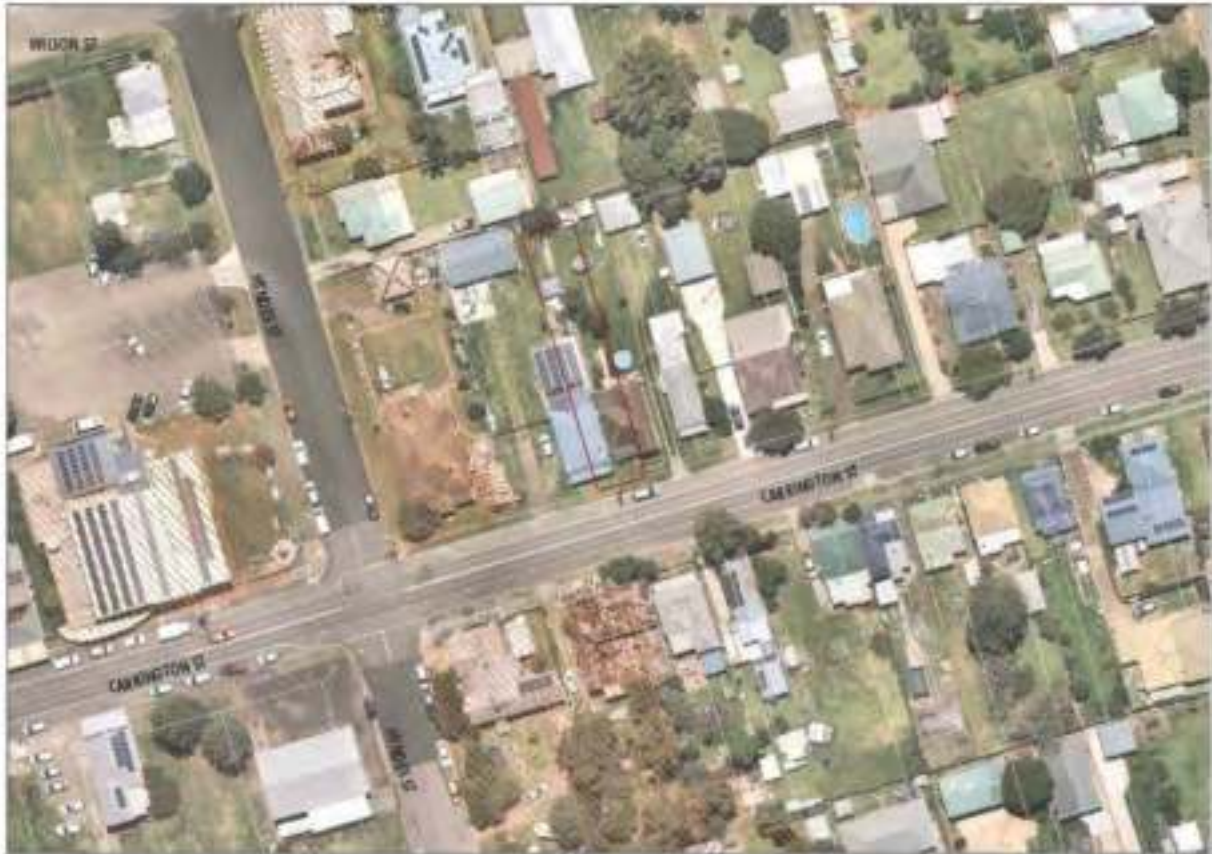
43 CARRINGTON STREET, WEST WALLSEND 2286

Conservation Area Contribution Level	Est. Construction Date	Previous studies and/or community input
Contributory 2	Early to late 20 th century (broad range)	No prior heritage assessments or research undertaken.
Assessment Text		Observed Modifications
<p>The scale (single-storey) and general style of the dwelling is consistent with that of the streetscape and wider HCA. Dwelling contributes positively to the streetscape and wider HCA, particularly in comparison to Non-Contributory buildings.</p> <p>The dwelling features appropriately proportioned and positioned fenestrations, an appropriate roof form (gabled or hipped) and other features consistent with the architectural character of the area (e.g. front verandah with timber or brick posts, timber detailing, corrugated metal roofing, etc). The contributory value of the dwelling is limited however by either:</p> <ul style="list-style-type: none"> • External modifications that have in some way obscured the style, scale or design intent of the building and have resulted in less physical integrity than Contributory 1 buildings. • Being a later dwelling constructed in an appropriate referential style, but comprising little to no fabric of intrinsic heritage significance. 		<p>All visible windows are contemporary in style.</p> <p>The concrete tiled roof is potentially a prior modification, with the original roof being iron sheet or Colourbond.</p> <p>The brickwork support veranda posts are a contemporary addition, replacing original timber posts.</p>

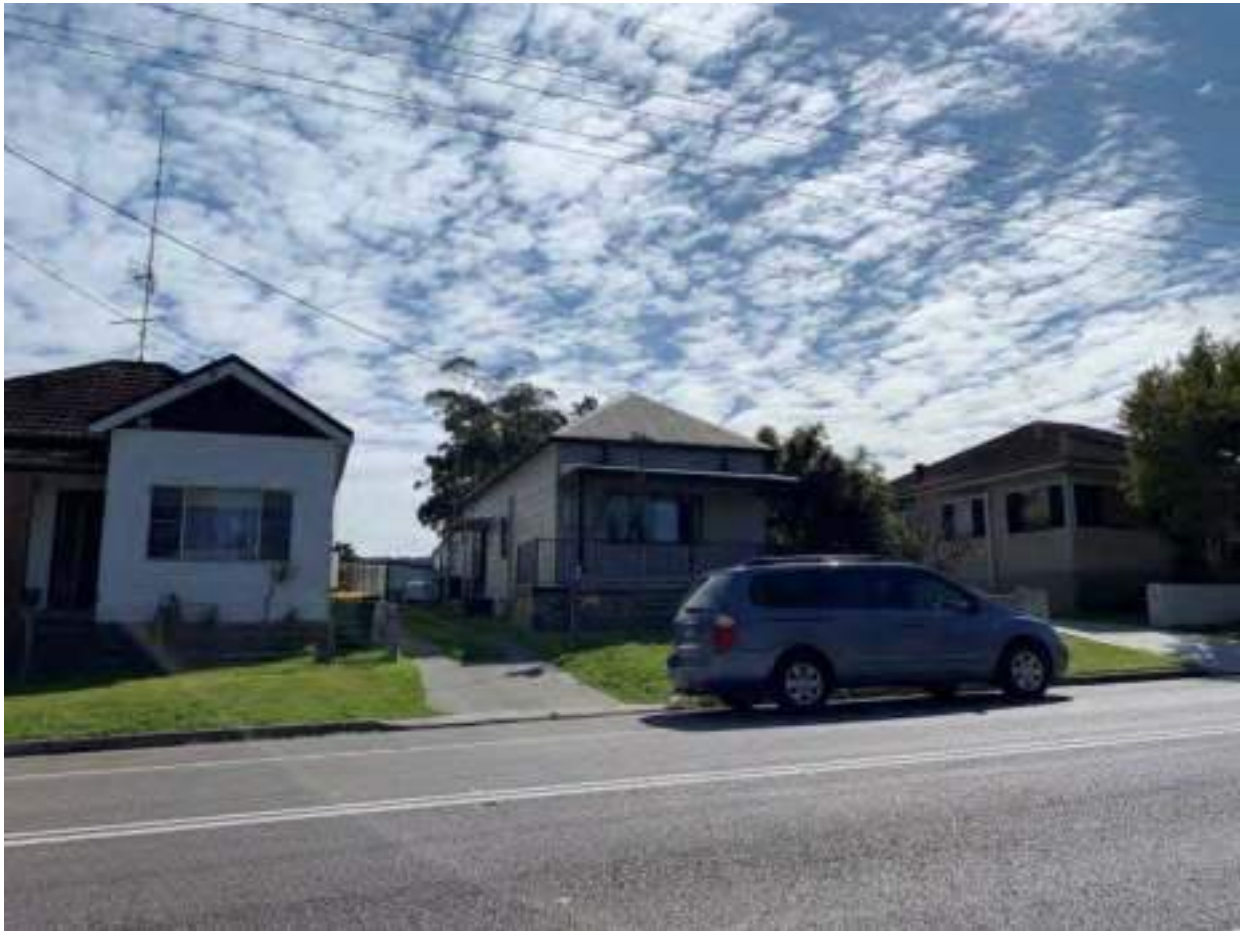
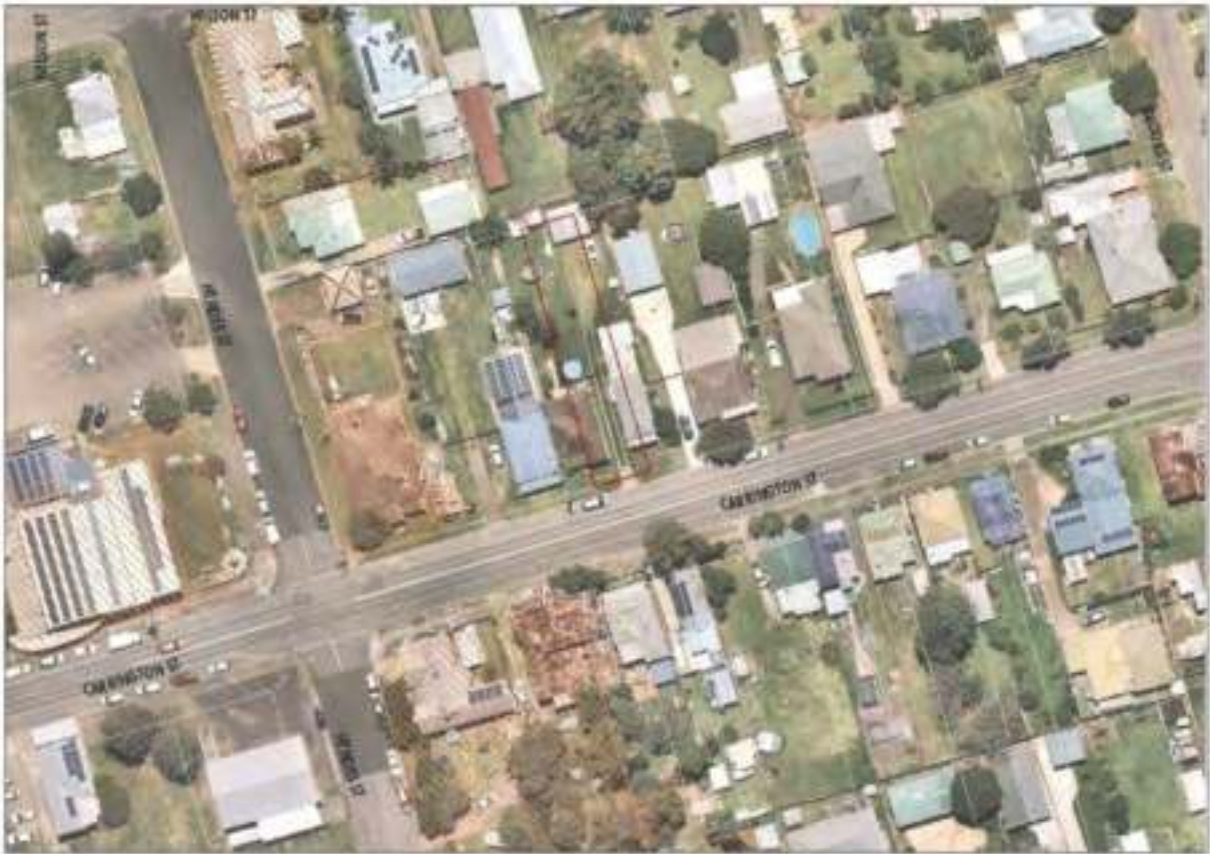
41 CARRINGTON STREET, WEST WALLSEND 2286

Conservation Area Contribution Level	Est. Construction Date	Previous studies and/or community input
Contributory 2	Early to late 20 th century (broad range)	No prior heritage assessments or research undertaken.
Assessment Text		Observed Modifications
<p>The scale (single-storey) and general style of the dwelling is consistent with that of the streetscape and wider HCA. Dwelling contributes positively to the streetscape and wider HCA, particularly in comparison to Non-Contributory buildings.</p> <p>The dwelling features appropriately proportioned and positioned fenestrations, an appropriate roof form (gabled or hipped) and other features consistent with the architectural character of the area (e.g. front verandah with timber or brick posts, timber detailing, corrugated metal roofing, etc). The contributory value of the dwelling is limited however by either:</p> <ul style="list-style-type: none"> • External modifications that have in some way obscured the style, scale or design intent of the building and have resulted in less physical integrity than Contributory 1 buildings. • Being a later dwelling constructed in an appropriate referential style, but comprising little to no fabric of intrinsic heritage significance. 		<p>The roofing is a recent Colourbond design, likely replacing a similar iron sheet or previous Colourbond design.</p> <p>The metal balustrade and support posts enclosing the veranda is a contemporary addition, juxtaposing the remaining heritage style of the dwelling.</p> <p>All visible windows are contemporary in style.</p> <p>An extension has been built onto the back northern portion of the dwelling, however this is not visible from the street and does not detract from the heritage streetscape.</p>

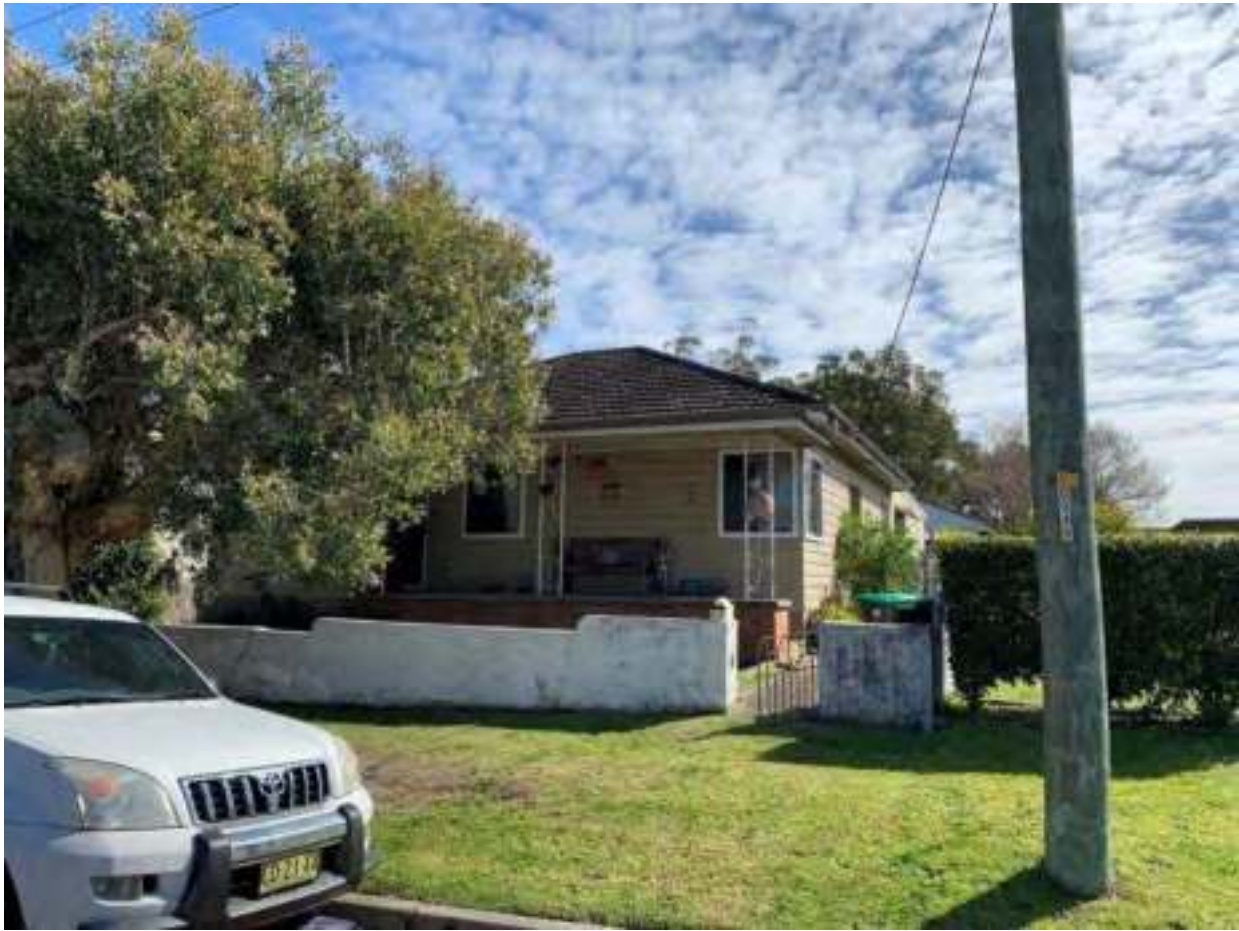
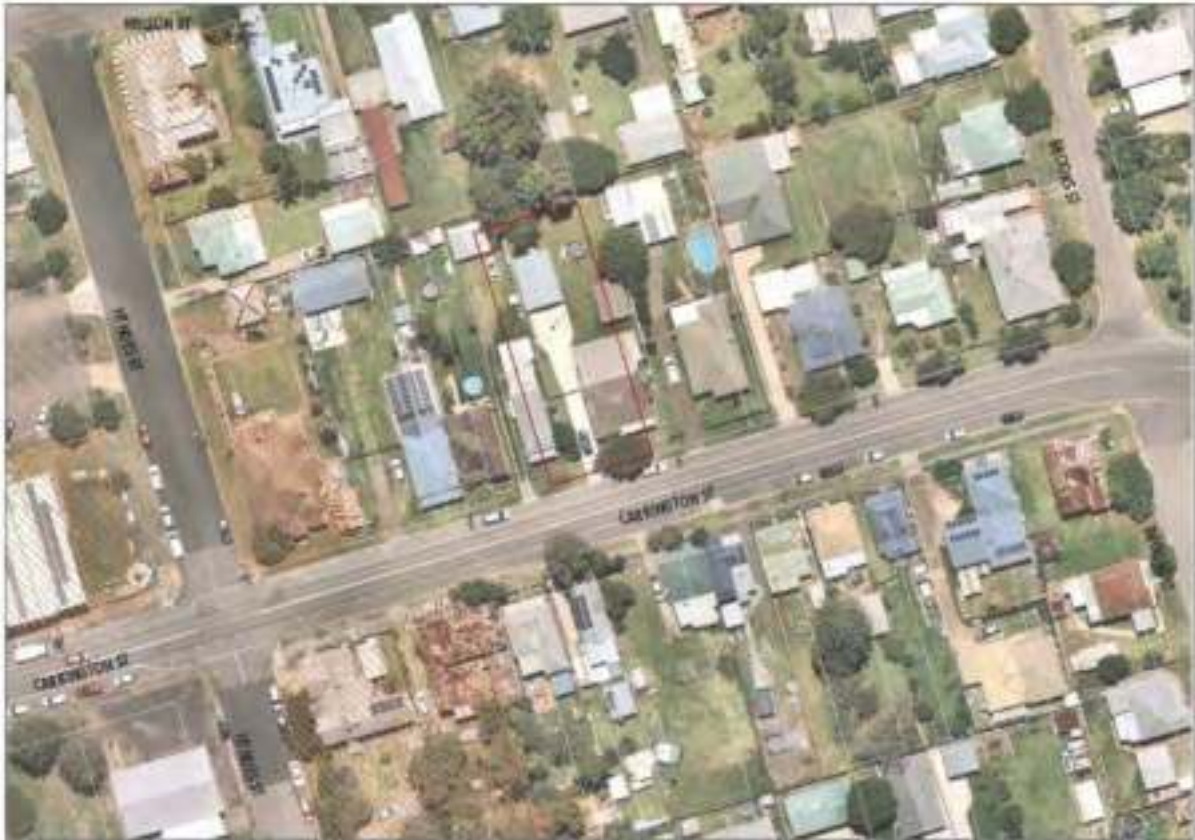
39 CARRINGTON STREET, WEST WALLSEND 2286

Conservation Area Contribution Level	Est. Construction Date	Previous studies and/or community input
Contributory 2	Early to late 20 th century (broad range)	No prior heritage assessments or research undertaken.
Assessment Text		Observed Modifications
<p>The scale (single-storey) and general style of the dwelling is consistent with that of the streetscape and wider HCA. Dwelling contributes positively to the streetscape and wider HCA, particularly in comparison to Non-Contributory buildings.</p> <p>The dwelling features appropriately proportioned and positioned fenestrations, an appropriate roof form (gabled or hipped) and other features consistent with the architectural character of the area (e.g. front verandah with timber or brick posts, timber detailing, corrugated metal roofing, etc). The contributory value of the dwelling is limited however by either:</p> <ul style="list-style-type: none"> • External modifications that have in some way obscured the style, scale or design intent of the building and have resulted in less physical integrity than Contributory 1 buildings. • Being a later dwelling constructed in an appropriate referential style, but comprising little to no fabric of intrinsic heritage significance. 		<p>The decorative metal posts are a contemporary addition, likely replacing original timber posts.</p> <p>All visible windows are contemporary in style.</p>

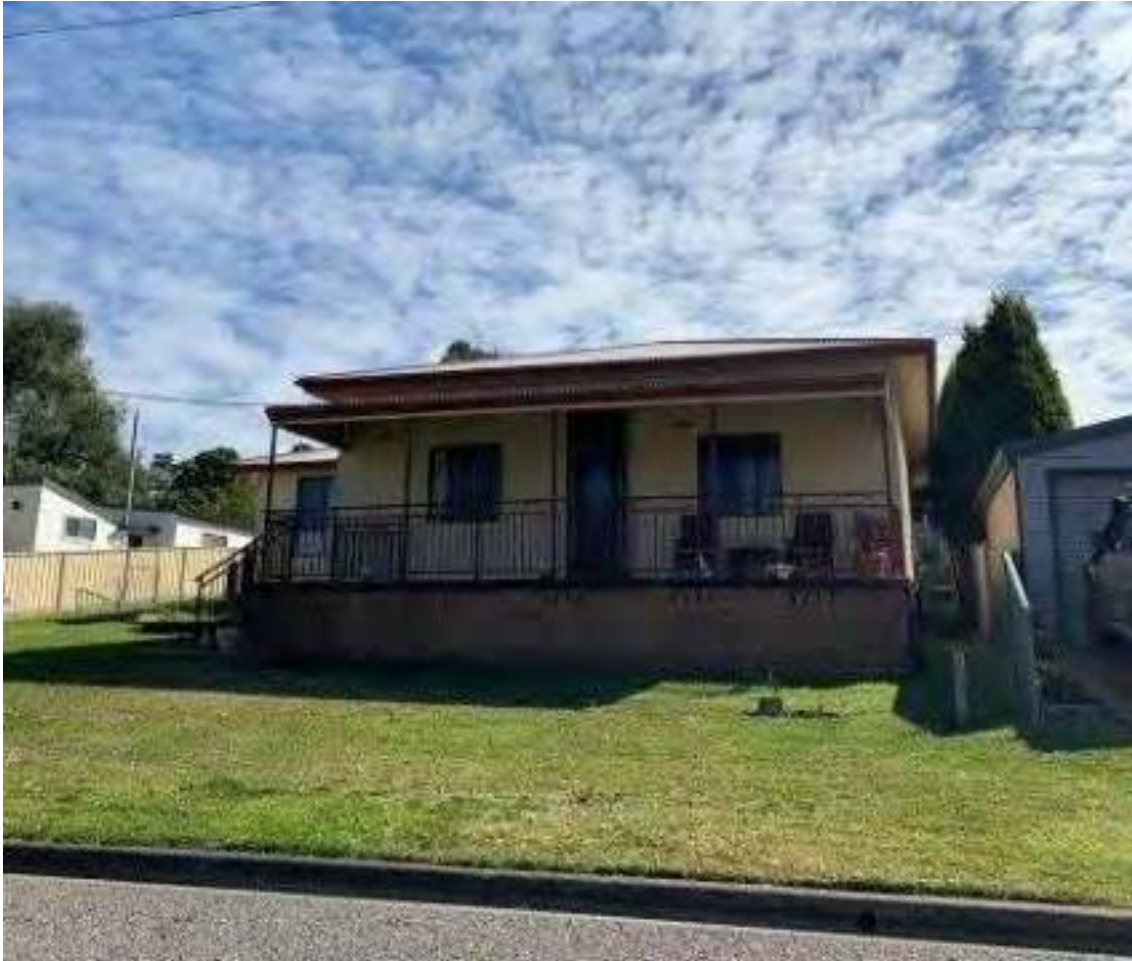
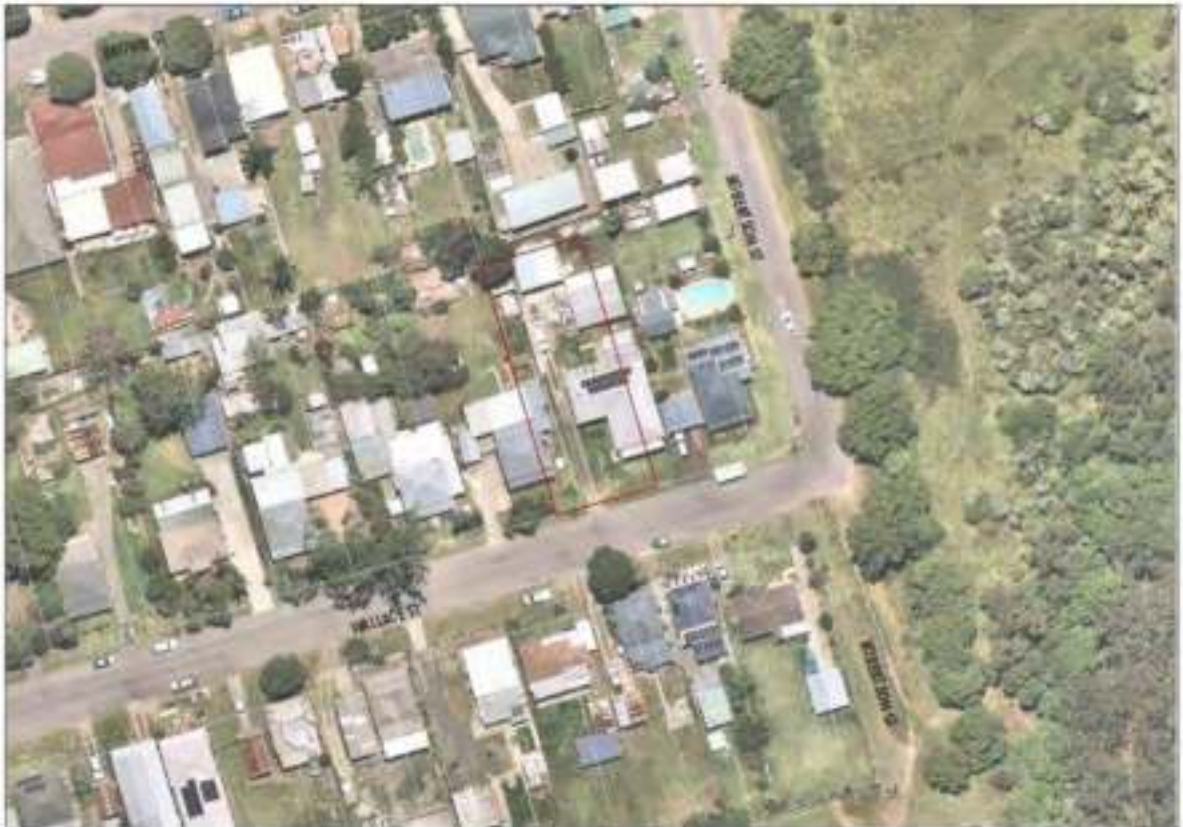
3 WALLACE STREET, WEST WALLSEND 2286

Conservation Area Contribution Level	Est. Construction Date	Previous studies and/or community input
Contributory 2	Early to late 20 th century (broad range)	No prior heritage assessments or research undertaken.
Assessment Text		Observed Modifications
<p>The scale (single-storey) and general style of the dwelling is consistent with that of the streetscape and wider HCA. Dwelling contributes positively to the streetscape and wider HCA, particularly in comparison to Non-Contributory buildings.</p> <p>The dwelling features appropriately proportioned and positioned fenestrations, an appropriate roof form (gabled or hipped) and other features consistent with the architectural character of the area (e.g. front verandah with timber or brick posts, timber detailing, corrugated metal roofing, etc). The contributory value of the dwelling is limited however by either:</p> <ul style="list-style-type: none"> • External modifications that have in some way obscured the style, scale or design intent of the building and have resulted in less physical integrity than Contributory 1 buildings. • Being a later dwelling constructed in an appropriate referential style, but comprising little to no fabric of intrinsic heritage significance. 		<p>All visible windows are contemporary in style.</p> <p>The veranda metal balustrade and support posts are contemporary additions, likely replacing original timber designs.</p> <p>An extension has been built onto the western portion of the dwelling. This is highly visible from the street and detracts from the heritage streetscape.</p>

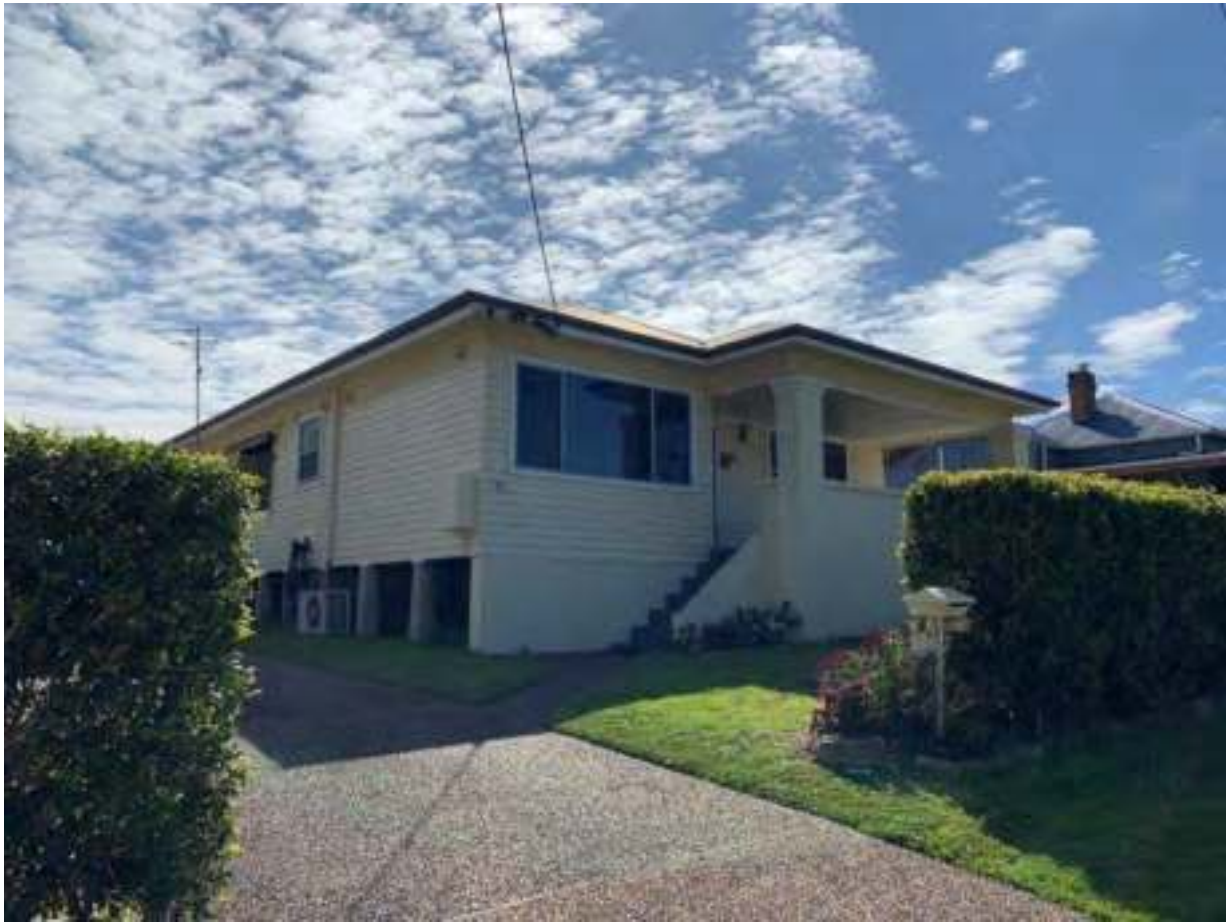
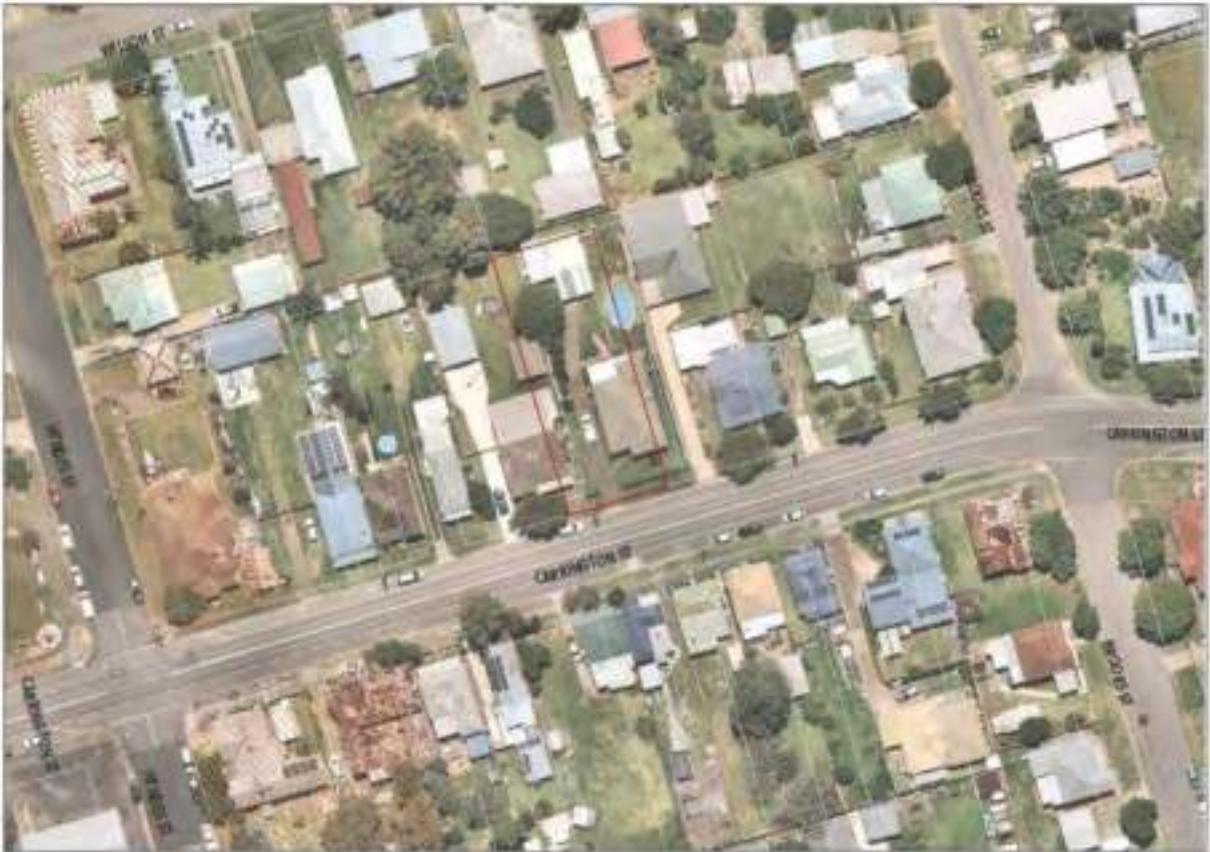
37 CARRINGTON STREET, WEST WALLSEND 2286

Conservation Area Contribution Level	Est. Construction Date	Previous studies and/or community input
Contributory 2	Early to late 20 th century (broad range)	No prior heritage assessments or research undertaken.
Assessment Text		Observed Modifications
<p>The scale (single-storey) and general style of the dwelling is consistent with that of the streetscape and wider HCA. Dwelling contributes positively to the streetscape and wider HCA, particularly in comparison to Non-Contributory buildings.</p> <p>The dwelling features appropriately proportioned and positioned fenestrations, an appropriate roof form (gabled or hipped) and other features consistent with the architectural character of the area (e.g. front verandah with timber or brick posts, timber detailing, corrugated metal roofing, etc). The contributory value of the dwelling is limited however by either:</p> <ul style="list-style-type: none"> • External modifications that have in some way obscured the style, scale or design intent of the building and have resulted in less physical integrity than Contributory 1 buildings. • Being a later dwelling constructed in an appropriate referential style, but comprising little to no fabric of intrinsic heritage significance. 		All visible windows are contemporary in style.

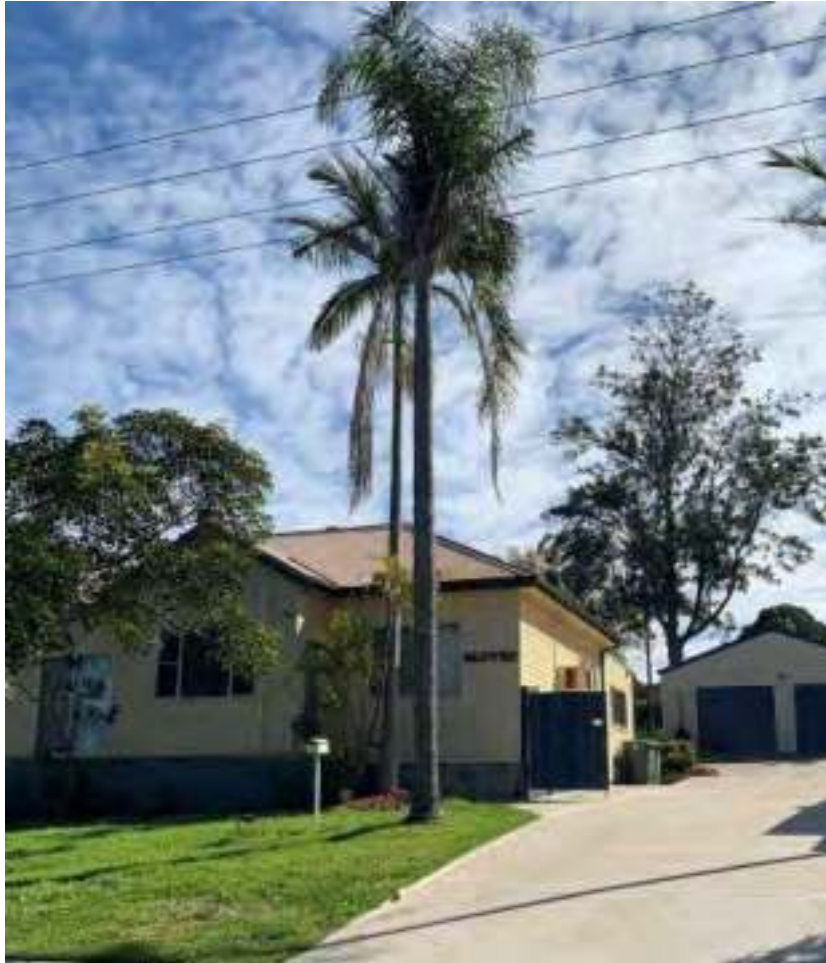
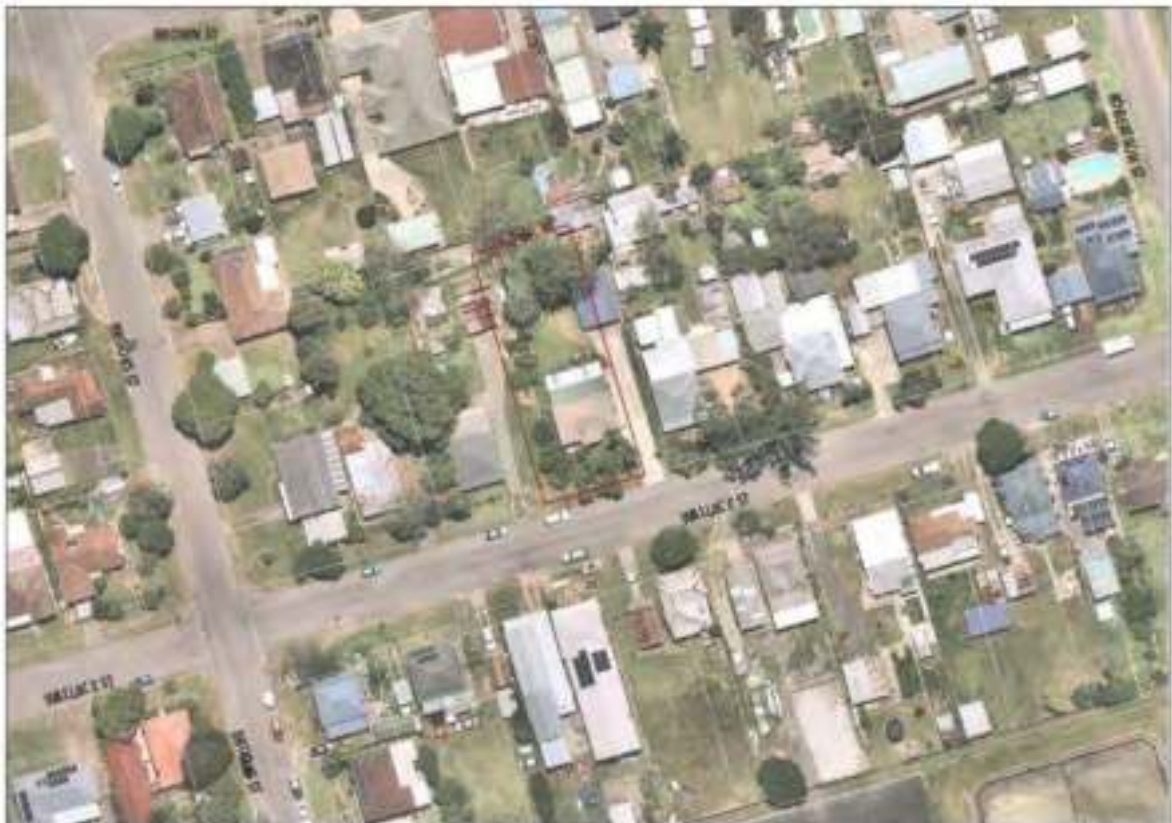
11 WALLACE STREET, WEST WALLSEND 2286

Conservation Area Contribution Level	Est. Construction Date	Previous studies and/or community input
Contributory 2	Early to late 20 th century (broad range)	No prior heritage assessments or research undertaken.
Assessment Text		Observed Modifications
<p>The scale (single-storey) and general style of the dwelling is consistent with that of the streetscape and wider HCA. Dwelling contributes positively to the streetscape and wider HCA, particularly in comparison to Non-Contributory buildings.</p> <p>The dwelling features appropriately proportioned and positioned fenestrations, an appropriate roof form (gabled or hipped) and other features consistent with the architectural character of the area (e.g. front verandah with timber or brick posts, timber detailing, corrugated metal roofing, etc). The contributory value of the dwelling is limited however by either:</p> <ul style="list-style-type: none"> • External modifications that have in some way obscured the style, scale or design intent of the building and have resulted in less physical integrity than Contributory 1 buildings. • Being a later dwelling constructed in an appropriate referential style, but comprising little to no fabric of intrinsic heritage significance. 		<p>An extension has been constructed on the western side of the dwelling. this was undertaken in a sympathetic style to the remaining dwelling, and does not detract from the heritage streetscape.</p> <p>All visible windows and doors are contemporary in style.</p>
