APPENDIX 2

Building Assessment Sheets (Inventory Sheets)

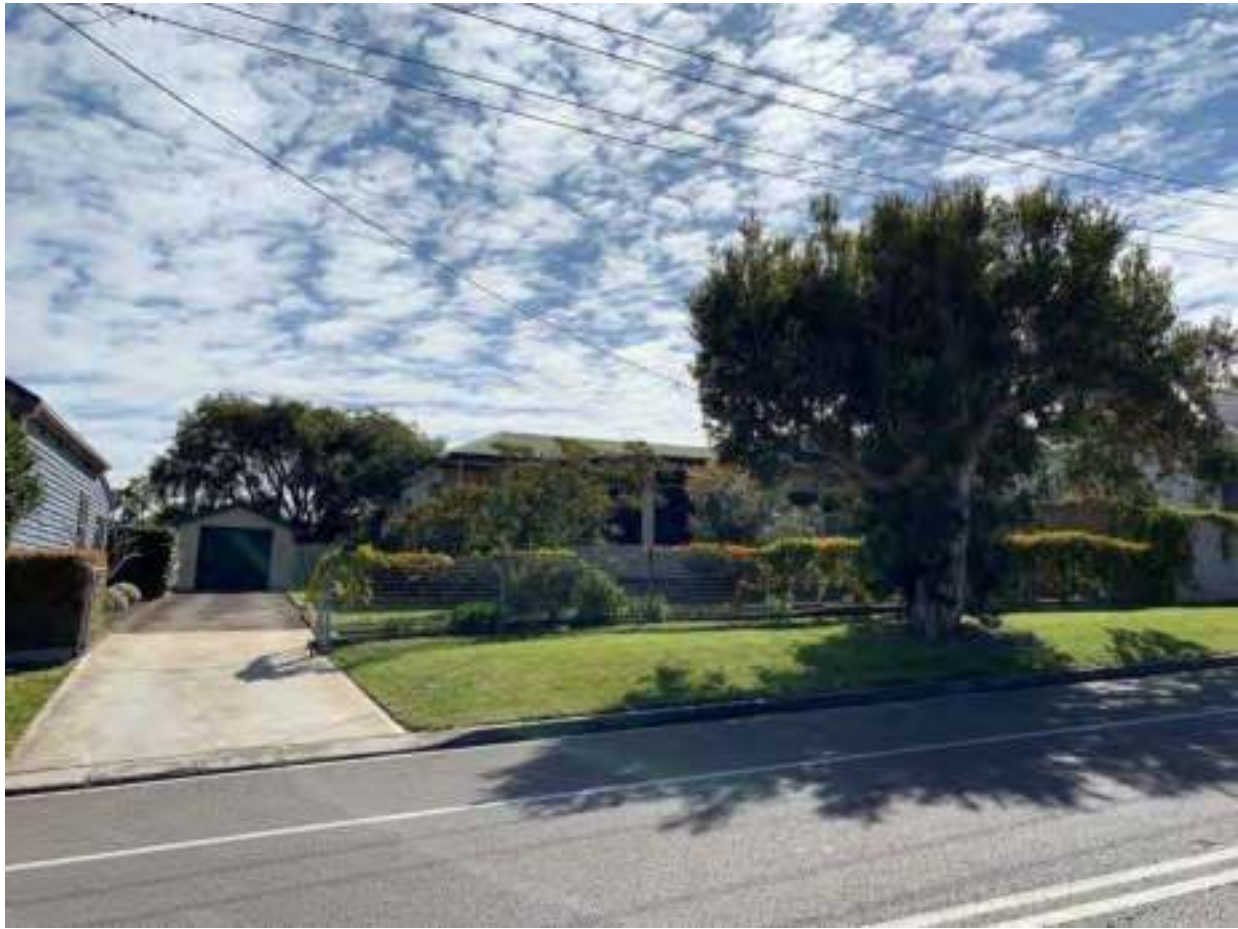
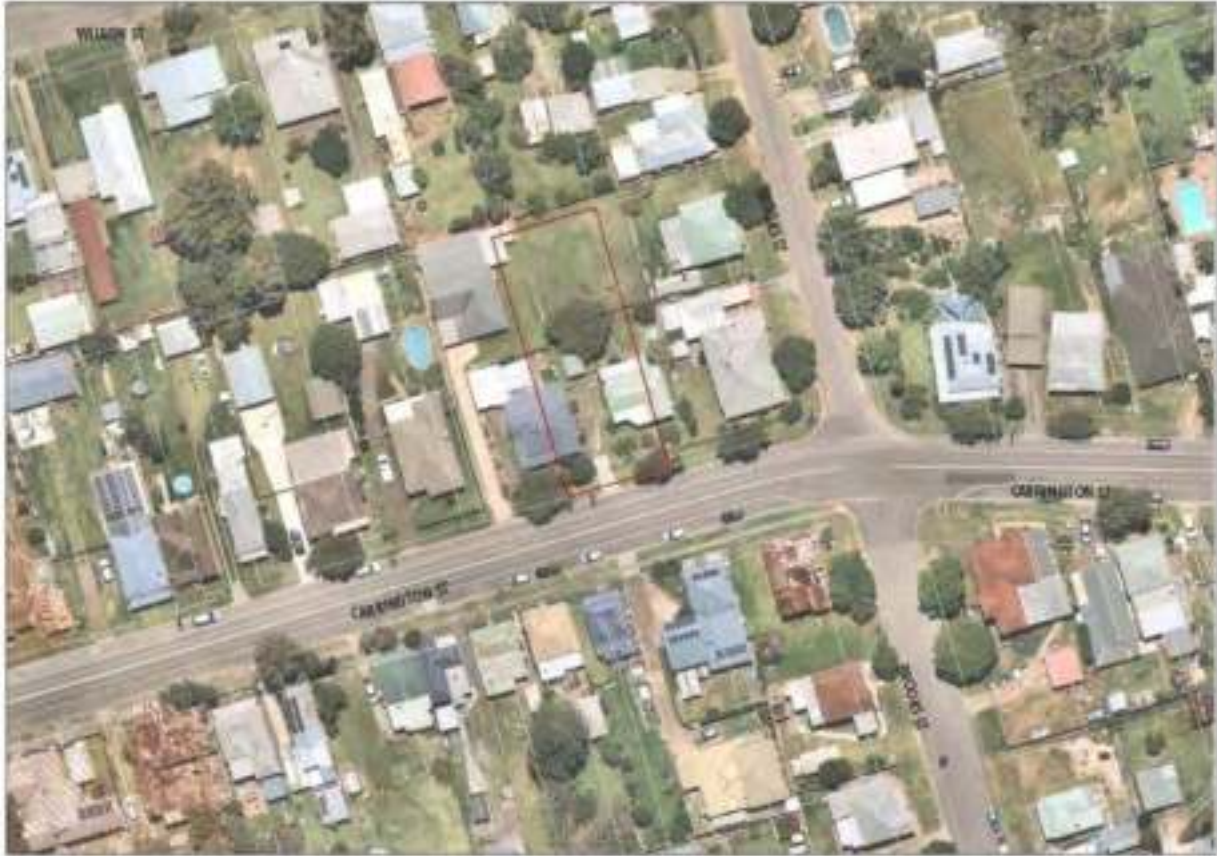
33 CARRINGTON STREET, WEST WALLSEND 2286

Conservation Area Contribution Level	Est. Construction Date	Previous studies and/or community input
Contributory 2	Early to late 20 th century (broad range)	No prior heritage assessments or research undertaken.
Assessment Text		Observed Modifications
<p>The scale (single-storey) and general style of the dwelling is consistent with that of the streetscape and wider HCA. Dwelling contributes positively to the streetscape and wider HCA, particularly in comparison to Non-Contributory buildings.</p> <p>The dwelling features appropriately proportioned and positioned fenestrations, an appropriate roof form (gabled or hipped) and other features consistent with the architectural character of the area (e.g. front verandah with timber or brick posts, timber detailing, corrugated metal roofing, etc). The contributory value of the dwelling is limited however by either:</p> <ul style="list-style-type: none"> • External modifications that have in some way obscured the style, scale or design intent of the building and have resulted in less physical integrity than Contributory 1 buildings. • Being a later dwelling constructed in an appropriate referential style, but comprising little to no fabric of intrinsic heritage significance. 		<p>The dwelling is partially obscured by vegetation. No modifications observed.</p>

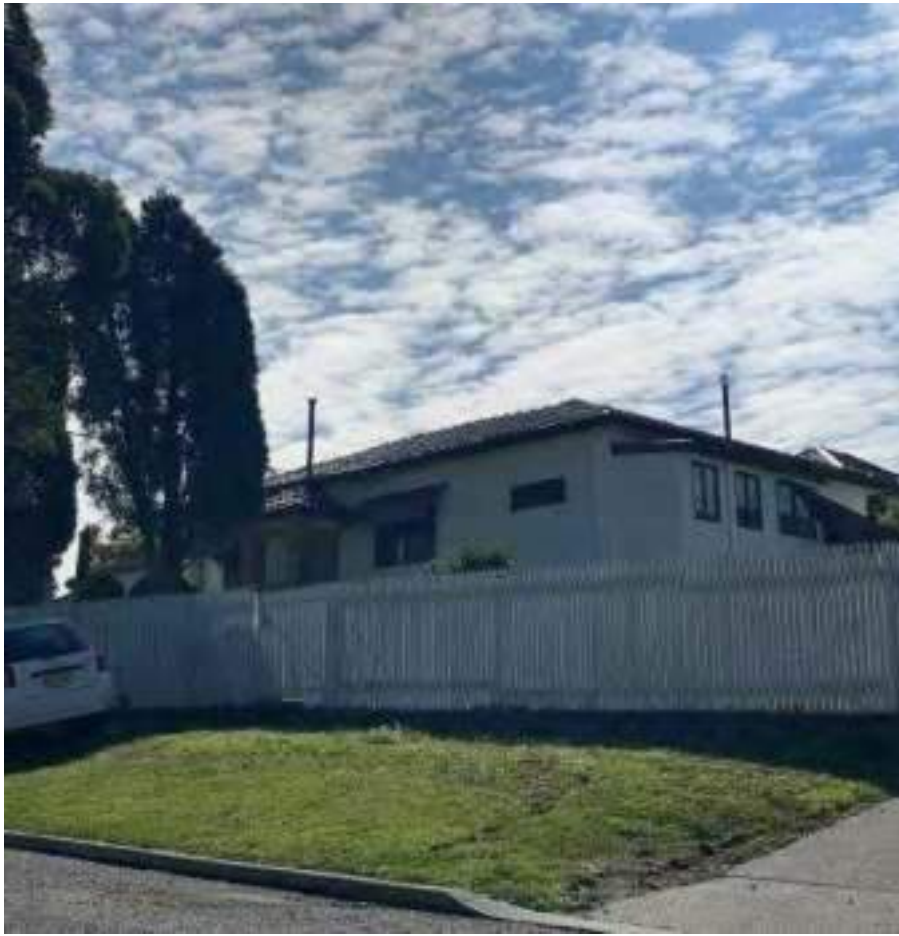
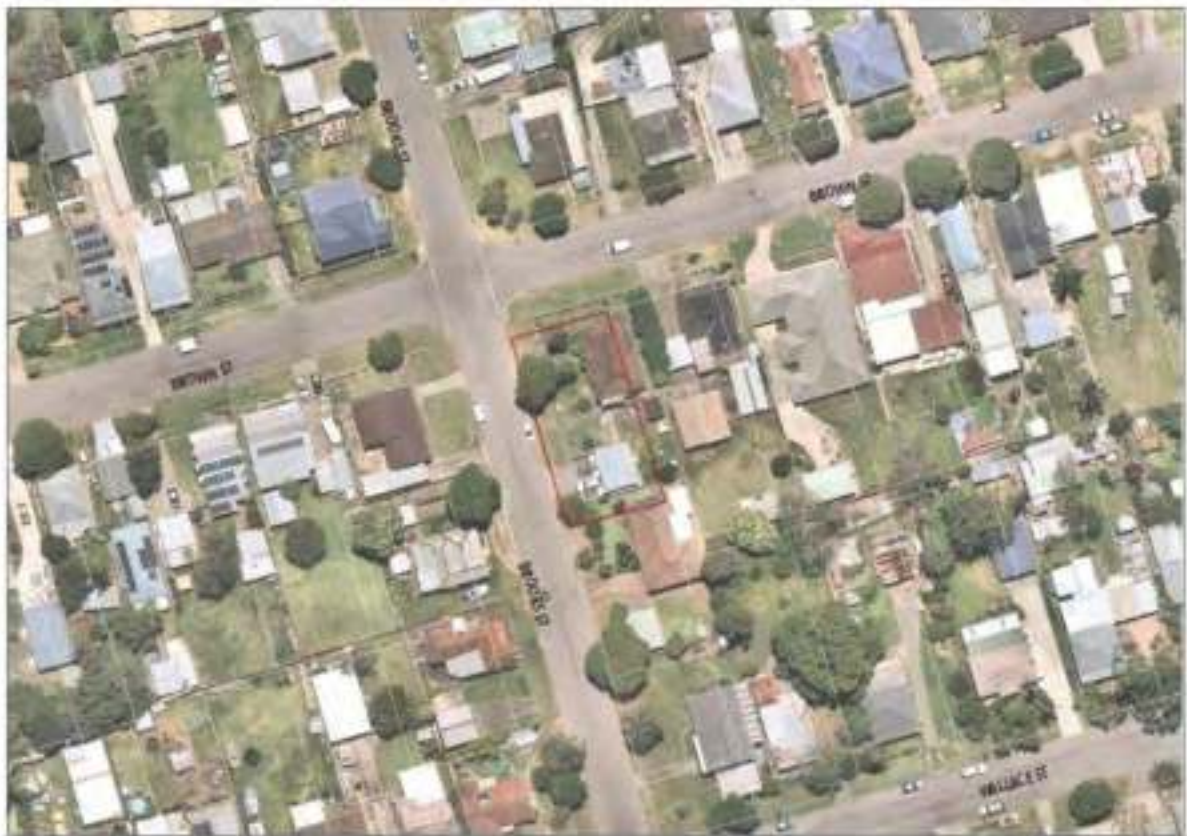
24 BROWN STREET, WEST WALLSEND 2286

Conservation Area Contribution Level	Est. Construction Date	Previous studies and/or community input
Contributory 2	Early to late 20 th century (broad range)	No prior heritage assessments or research undertaken.
Assessment Text		Observed Modifications
<p>The scale (single-storey) and general style of the dwelling is consistent with that of the streetscape and wider HCA. Dwelling contributes positively to the streetscape and wider HCA, particularly in comparison to Non-Contributory buildings.</p> <p>The dwelling features appropriately proportioned and positioned fenestrations, an appropriate roof form (gabled or hipped) and other features consistent with the architectural character of the area (e.g. front verandah with timber or brick posts, timber detailing, corrugated metal roofing, etc). The contributory value of the dwelling is limited however by either:</p> <ul style="list-style-type: none"> • External modifications that have in some way obscured the style, scale or design intent of the building and have resulted in less physical integrity than Contributory 1 buildings. • Being a later dwelling constructed in an appropriate referential style, but comprising little to no fabric of intrinsic heritage significance. 		<p>The veranda has been built it to create an additional living area. Contemporary windows have been installed to enclose the space.</p> <p>All visible windows are contemporary in style.</p>

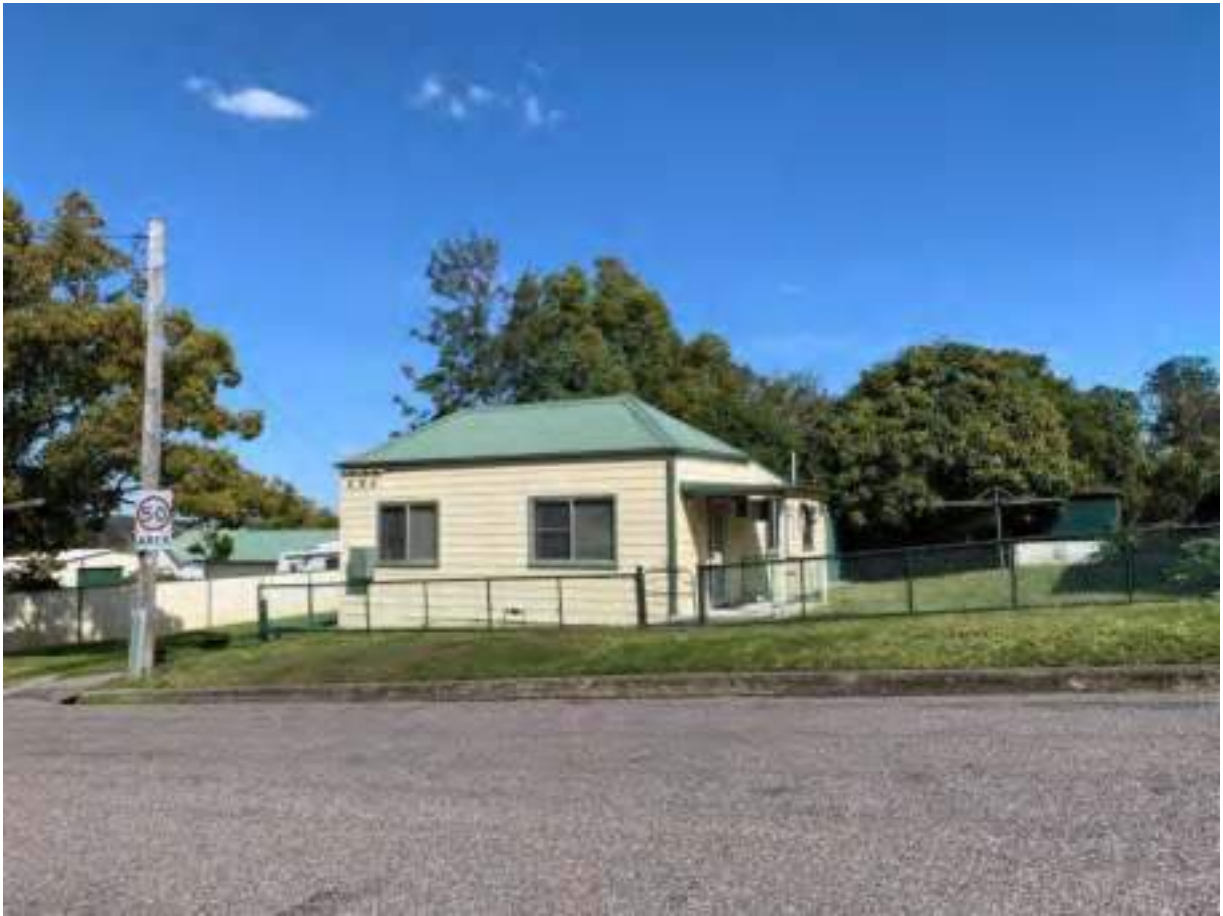
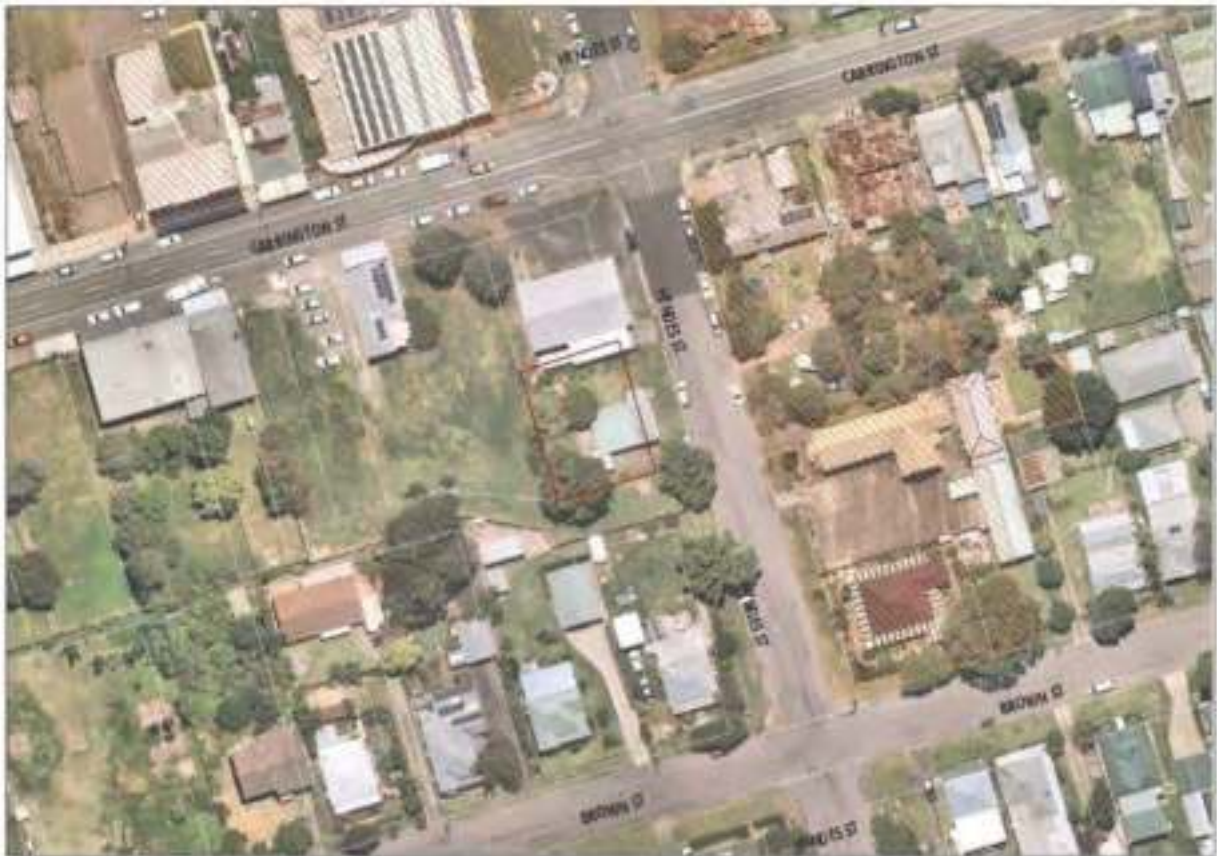
4 HYNDES STREET, WEST WALLSEND 2286

Conservation Area Contribution Level	Est. Construction Date	Previous studies and/or community input
Contributory 2	Early to late 20 th century (broad range)	No prior heritage assessments or research undertaken.
Assessment Text		Observed Modifications
<p>The scale (single-storey) and general style of the dwelling is consistent with that of the streetscape and wider HCA. Dwelling contributes positively to the streetscape and wider HCA, particularly in comparison to Non-Contributory buildings.</p> <p>The dwelling features appropriately proportioned and positioned fenestrations, an appropriate roof form (gabled or hipped) and other features consistent with the architectural character of the area (e.g. front verandah with timber or brick posts, timber detailing, corrugated metal roofing, etc). The contributory value of the dwelling is limited however by either:</p> <ul style="list-style-type: none"> • External modifications that have in some way obscured the style, scale or design intent of the building and have resulted in less physical integrity than Contributory 1 buildings. • Being a later dwelling constructed in an appropriate referential style, but comprising little to no fabric of intrinsic heritage significance. 		<p>All visible windows are contemporary in style.</p> <p>The weatherboard cladding has been replaced.</p>

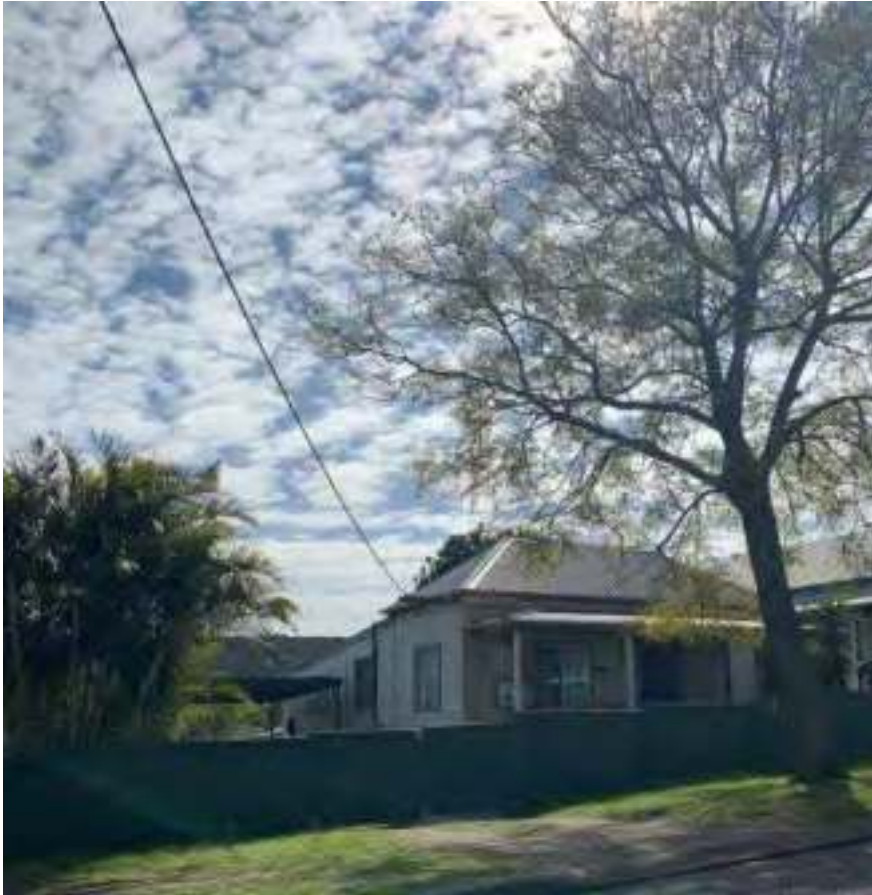
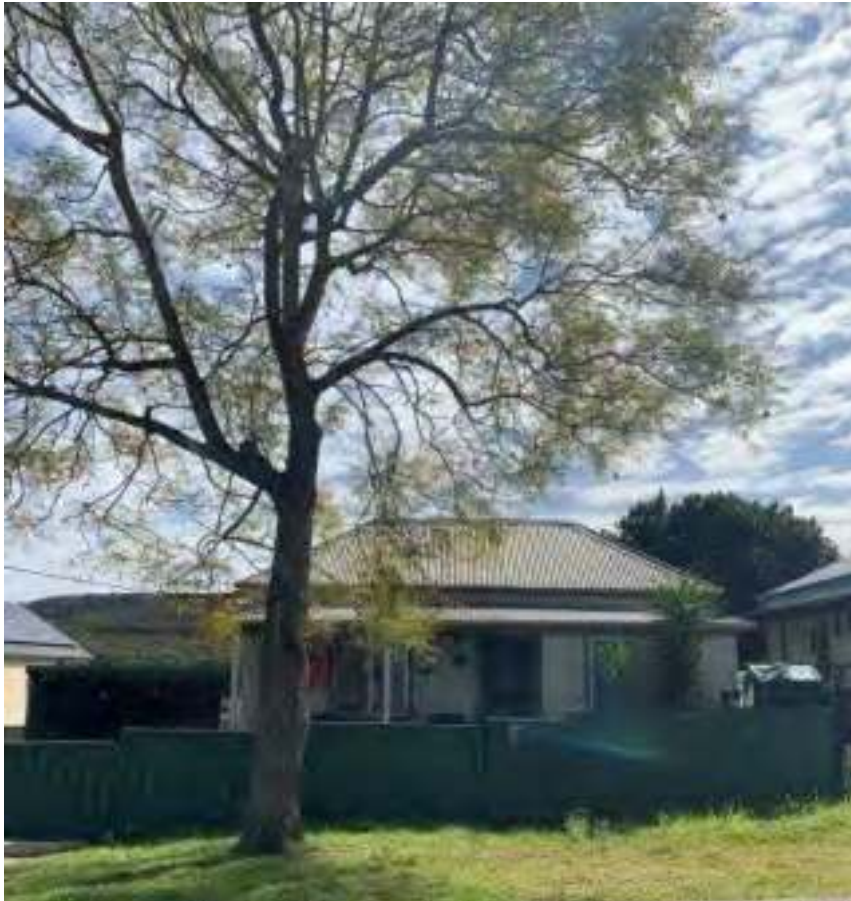
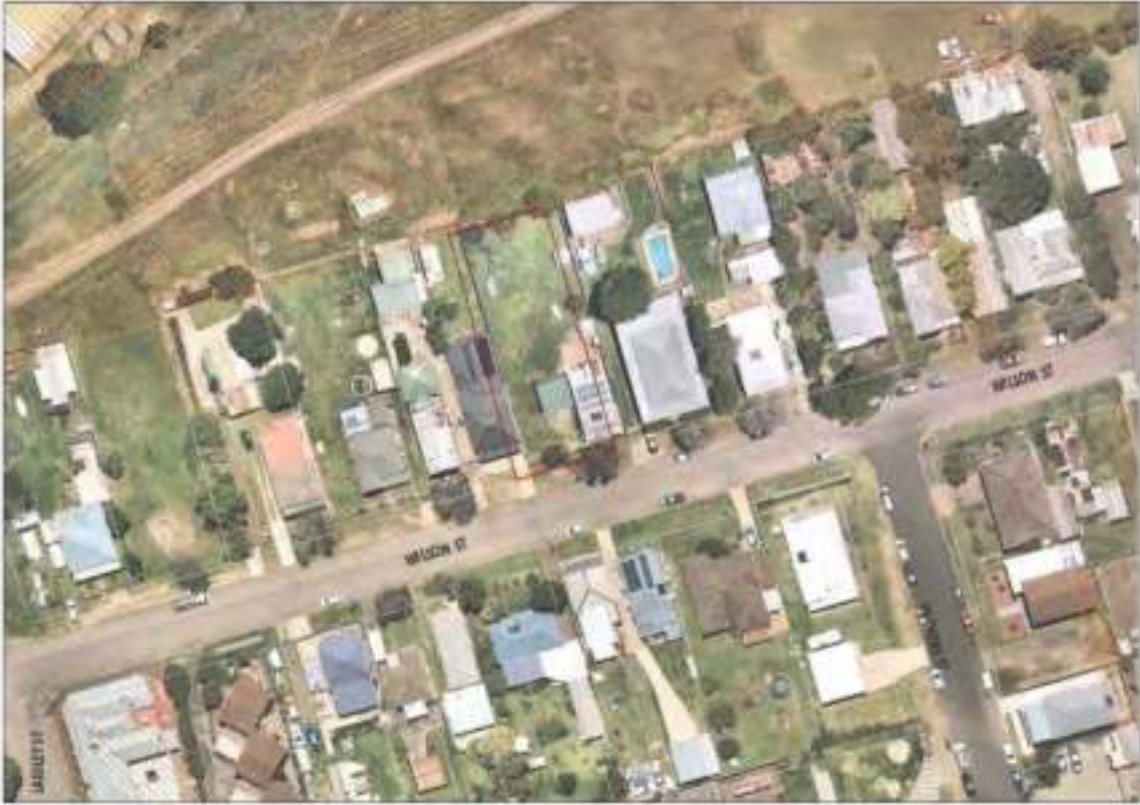
63 WILSON STREET, WEST WALLSEND 2286

Conservation Area Contribution Level	Est. Construction Date	Previous studies and/or community input
Contributory 2	Early to late 20 th century (broad range)	No prior heritage assessments or research undertaken.
Assessment Text		Observed Modifications
<p>The scale (single-storey) and general style of the dwelling is consistent with that of the streetscape and wider HCA. Dwelling contributes positively to the streetscape and wider HCA, particularly in comparison to Non-Contributory buildings.</p> <p>The dwelling features appropriately proportioned and positioned fenestrations, an appropriate roof form (gabled or hipped) and other features consistent with the architectural character of the area (e.g. front verandah with timber or brick posts, timber detailing, corrugated metal roofing, etc). The contributory value of the dwelling is limited however by either:</p> <ul style="list-style-type: none"> • External modifications that have in some way obscured the style, scale or design intent of the building and have resulted in less physical integrity than Contributory 1 buildings. • Being a later dwelling constructed in an appropriate referential style, but comprising little to no fabric of intrinsic heritage significance. 		<p>All visible windows are contemporary in style.</p> <p>The eastern portion of the veranda has been built in to create an additional living area.</p>

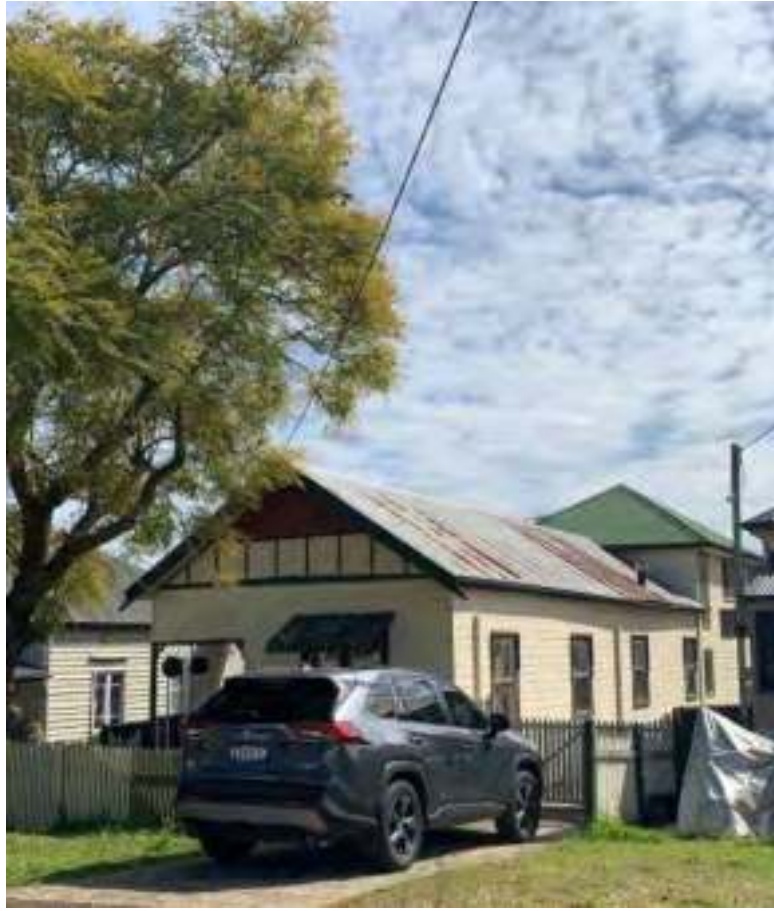
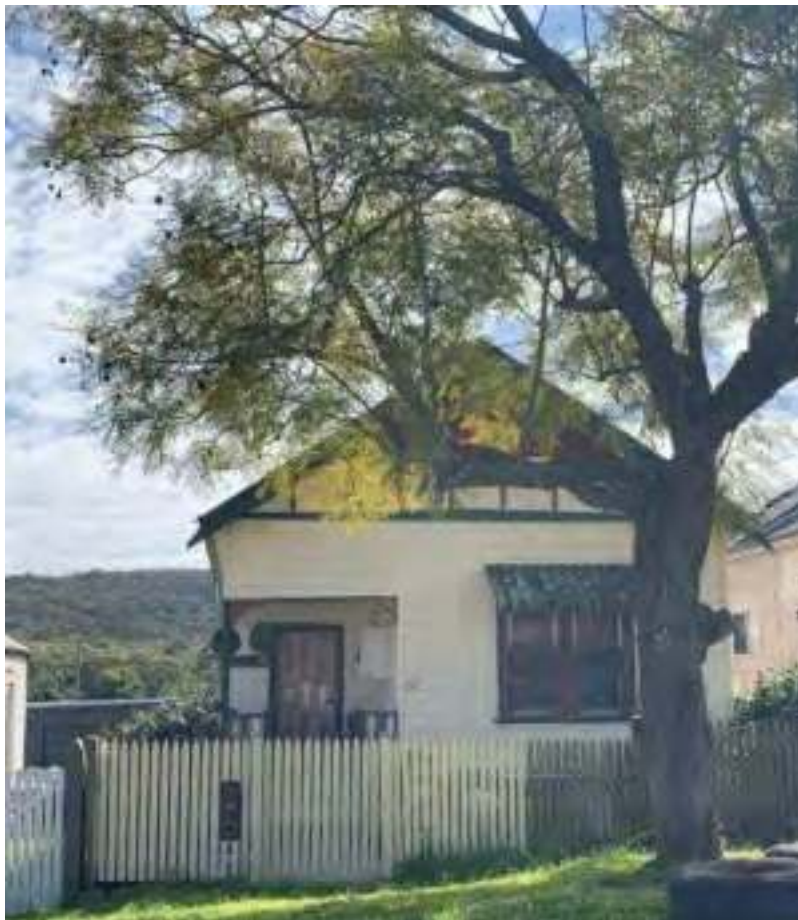
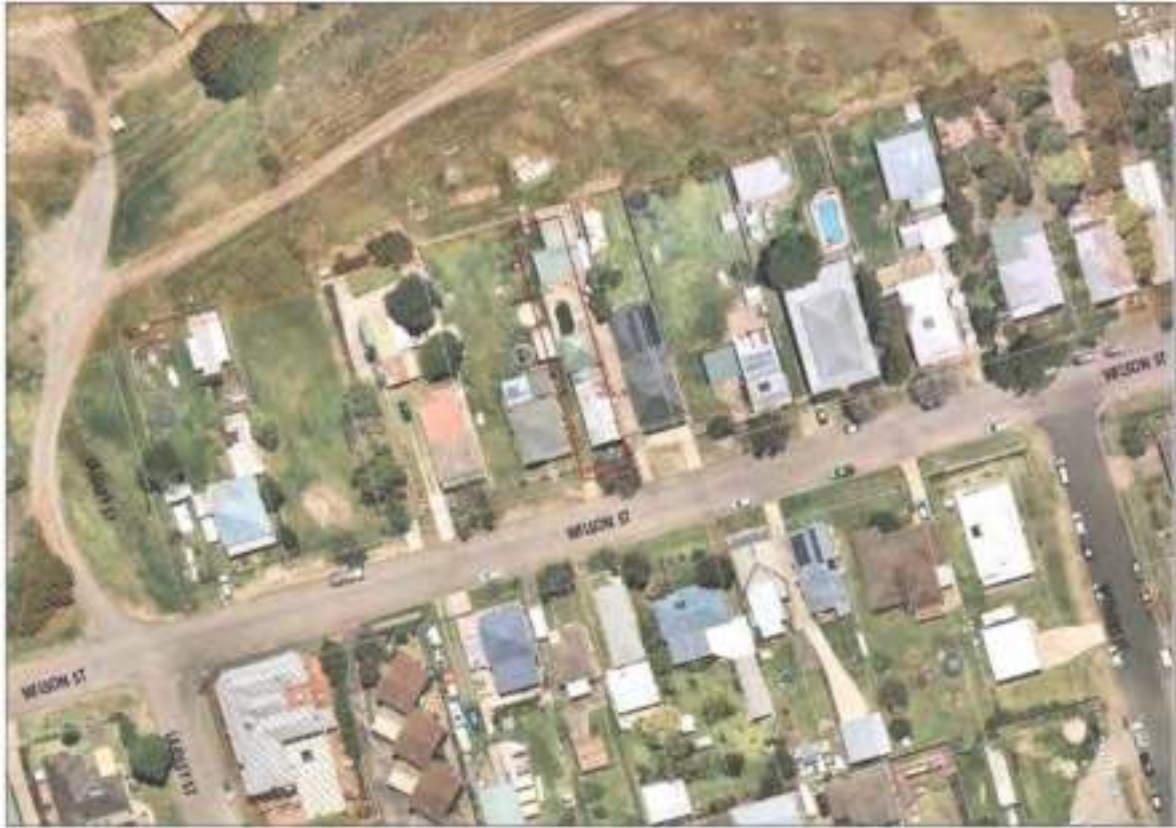
67 WILSON STREET, WEST WALLSEND 2286

Conservation Area Contribution Level	Est. Construction Date	Previous studies and/or community input
Contributory 2	Early to late 20 th century (broad range)	No prior heritage assessments or research undertaken.
Assessment Text		Observed Modifications
<p>The scale (single-storey) and general style of the dwelling is consistent with that of the streetscape and wider HCA. Dwelling contributes positively to the streetscape and wider HCA, particularly in comparison to Non-Contributory buildings.</p> <p>The dwelling features appropriately proportioned and positioned fenestrations, an appropriate roof form (gabled or hipped) and other features consistent with the architectural character of the area (e.g. front verandah with timber or brick posts, timber detailing, corrugated metal roofing, etc). The contributory value of the dwelling is limited however by either:</p> <ul style="list-style-type: none"> • External modifications that have in some way obscured the style, scale or design intent of the building and have resulted in less physical integrity than Contributory 1 buildings. • Being a later dwelling constructed in an appropriate referential style, but comprising little to no fabric of intrinsic heritage significance. 		<p>A two storey extension has been constructed at the back northern portion of the dwelling. This is not visible from the street and does not detract from the heritage streetscape.</p>

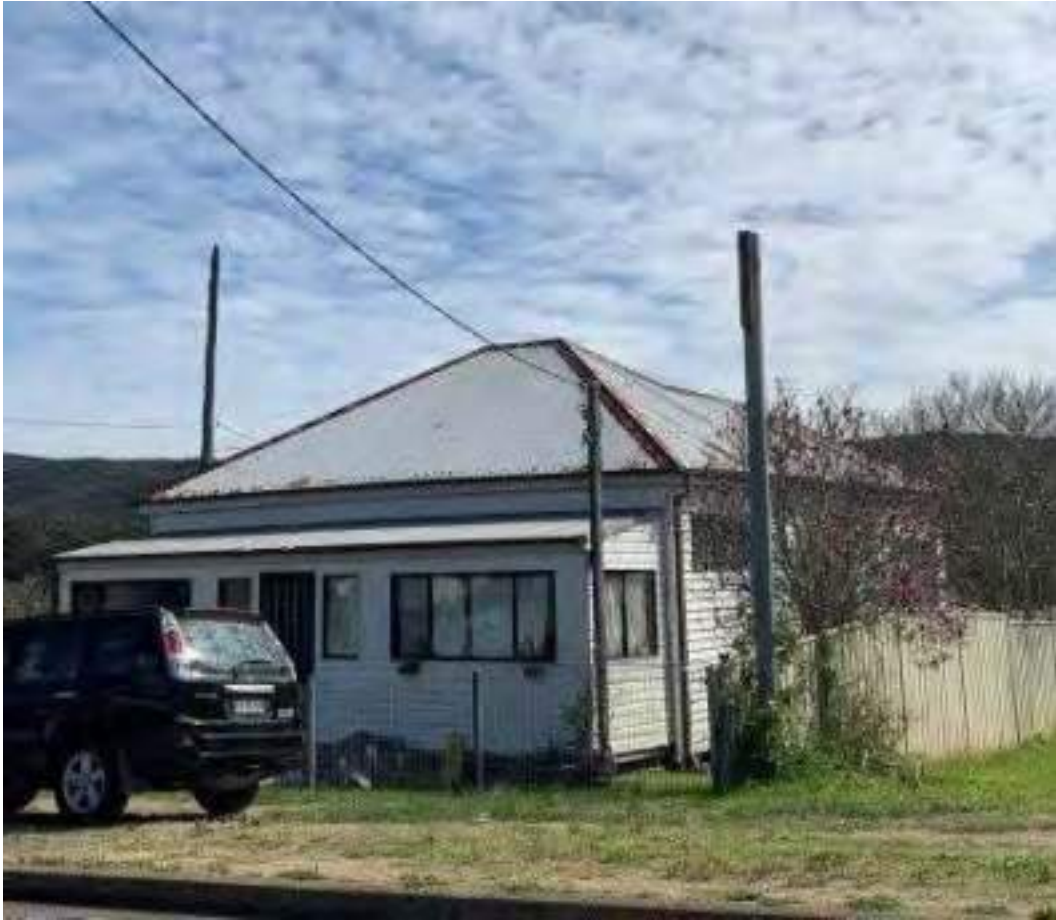
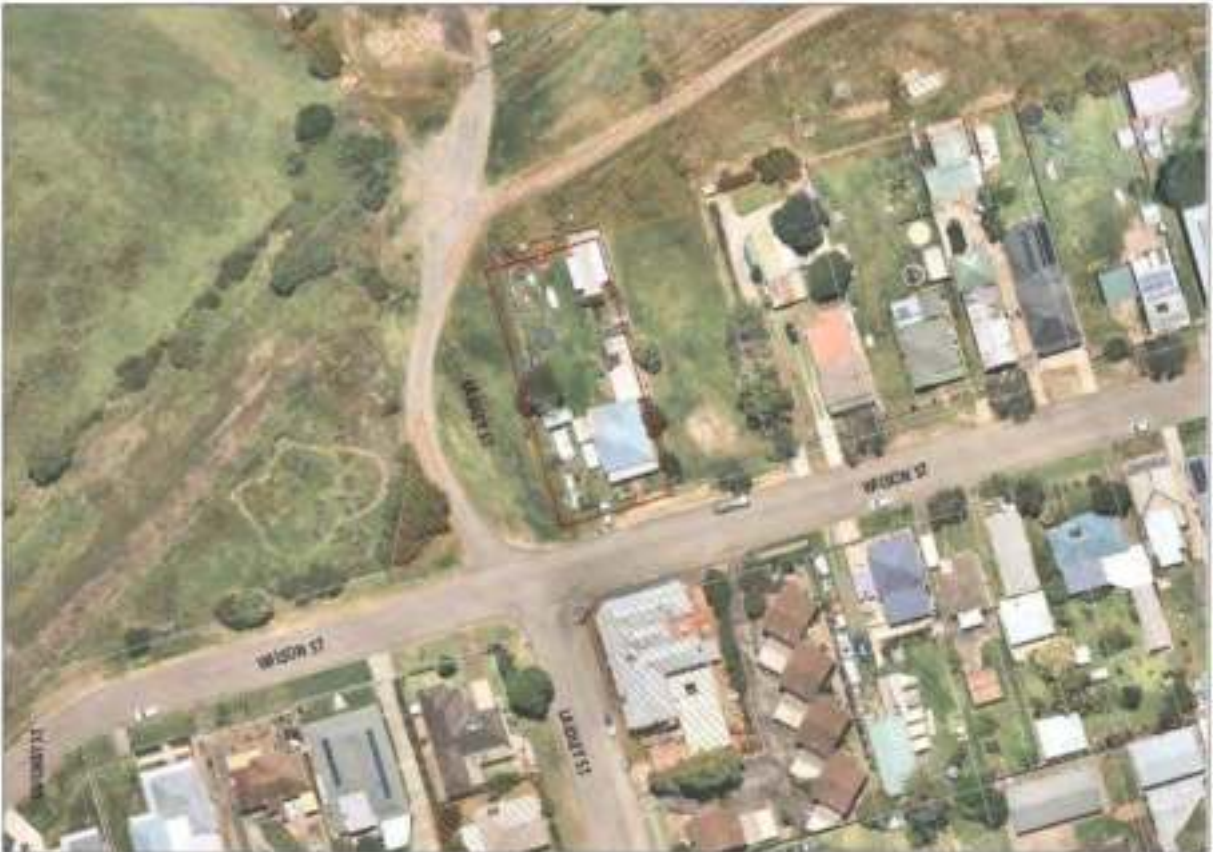
75 WILSON STREET, WEST WALLSEND 2286

Conservation Area Contribution Level	Est. Construction Date	Previous studies and/or community input
Contributory 2	Early to late 20 th century (broad range)	No prior heritage assessments or research undertaken.
Assessment Text		Observed Modifications
<p>The scale (single-storey) and general style of the dwelling is consistent with that of the streetscape and wider HCA. Dwelling contributes positively to the streetscape and wider HCA, particularly in comparison to Non-Contributory buildings.</p> <p>The dwelling features appropriately proportioned and positioned fenestrations, an appropriate roof form (gabled or hipped) and other features consistent with the architectural character of the area (e.g. front verandah with timber or brick posts, timber detailing, corrugated metal roofing, etc). The contributory value of the dwelling is limited however by either:</p> <ul style="list-style-type: none"> • External modifications that have in some way obscured the style, scale or design intent of the building and have resulted in less physical integrity than Contributory 1 buildings. • Being a later dwelling constructed in an appropriate referential style, but comprising little to no fabric of intrinsic heritage significance. 		<p>The veranda has been built in to create an additional living area, with contemporary styled windows enclosing the space. This is a common modification for the area, however it does detract from the heritage streetscape.</p> <p>All visible windows are contemporary in style.</p>

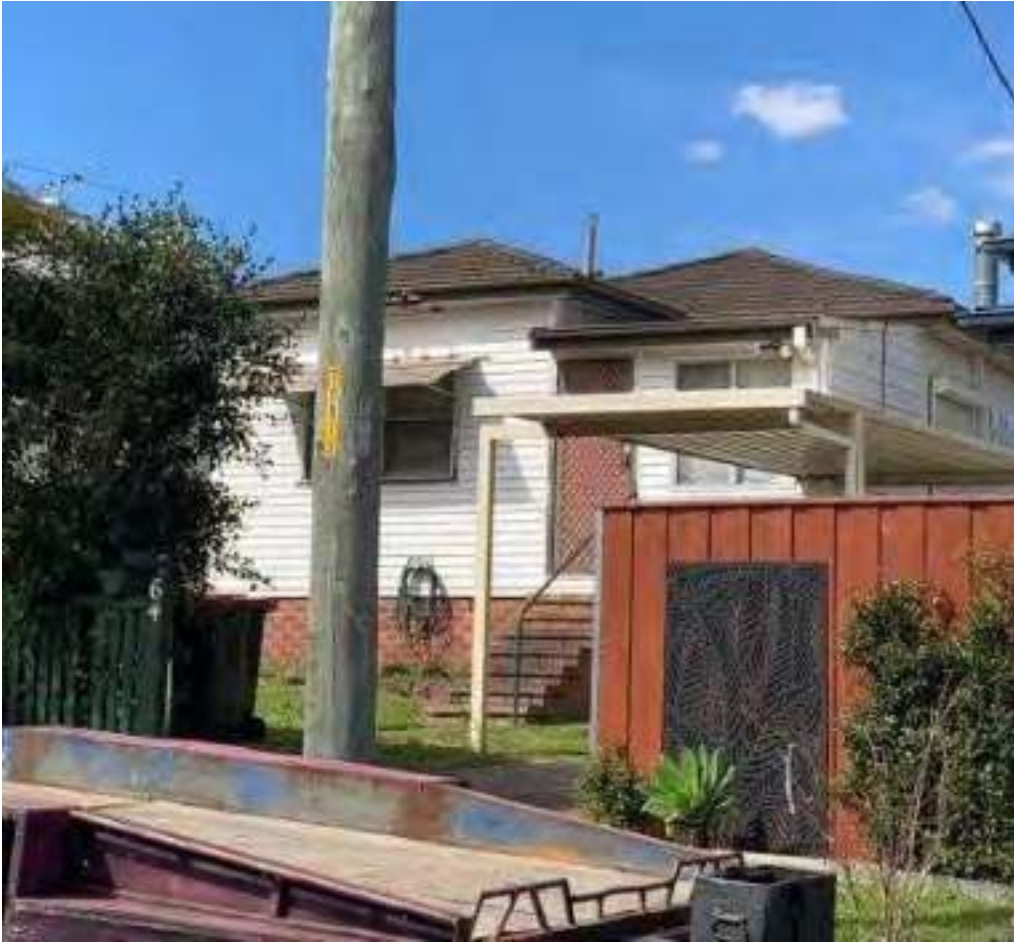
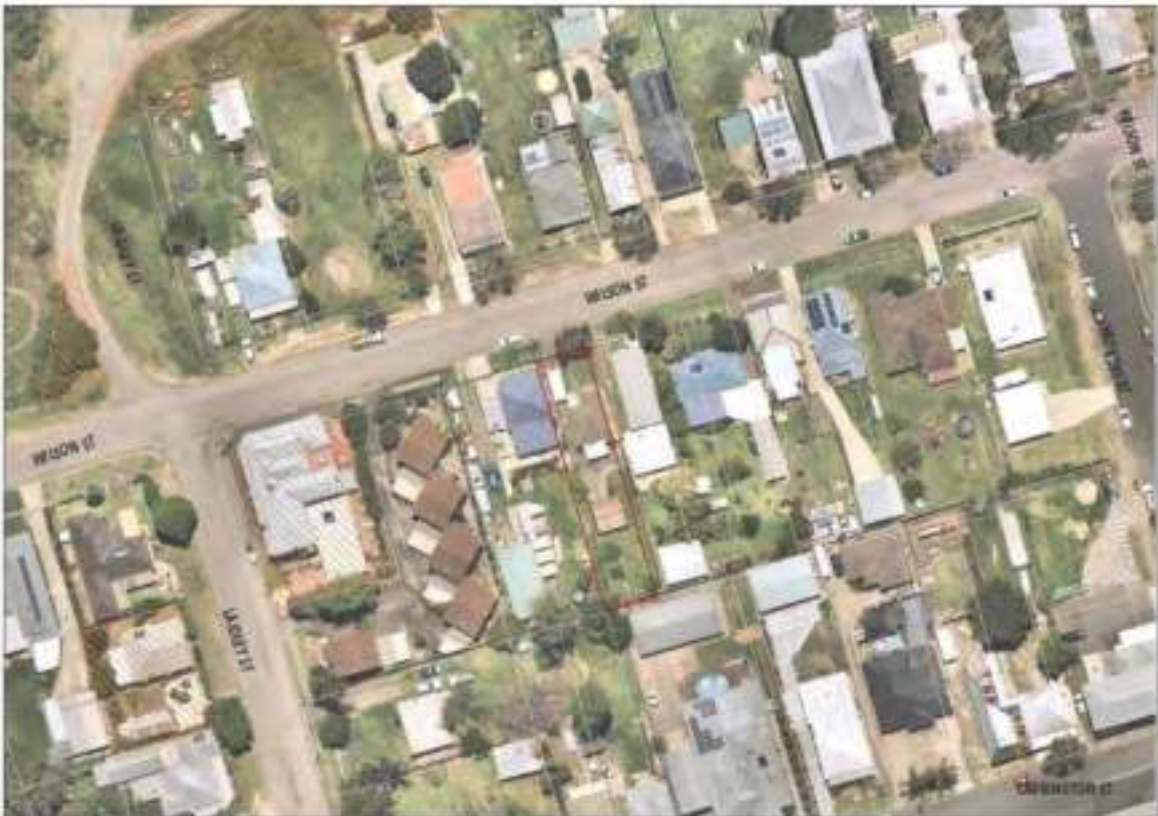
64 WILSON STREET, WEST WALLSEND 2286

Conservation Area Contribution Level	Est. Construction Date	Previous studies and/or community input
Contributory 2	Early to late 20 th century (broad range)	No prior heritage assessments or research undertaken.
Assessment Text		Observed Modifications
<p>The scale (single-storey) and general style of the dwelling is consistent with that of the streetscape and wider HCA. Dwelling contributes positively to the streetscape and wider HCA, particularly in comparison to Non-Contributory buildings.</p> <p>The dwelling features appropriately proportioned and positioned fenestrations, an appropriate roof form (gabled or hipped) and other features consistent with the architectural character of the area (e.g. front verandah with timber or brick posts, timber detailing, corrugated metal roofing, etc). The contributory value of the dwelling is limited however by either:</p> <ul style="list-style-type: none"> • External modifications that have in some way obscured the style, scale or design intent of the building and have resulted in less physical integrity than Contributory 1 buildings. • Being a later dwelling constructed in an appropriate referential style, but comprising little to no fabric of intrinsic heritage significance. 		<p>A carport has been constructed at the front northern side of the dwelling, partially obscuring the dwelling.</p>

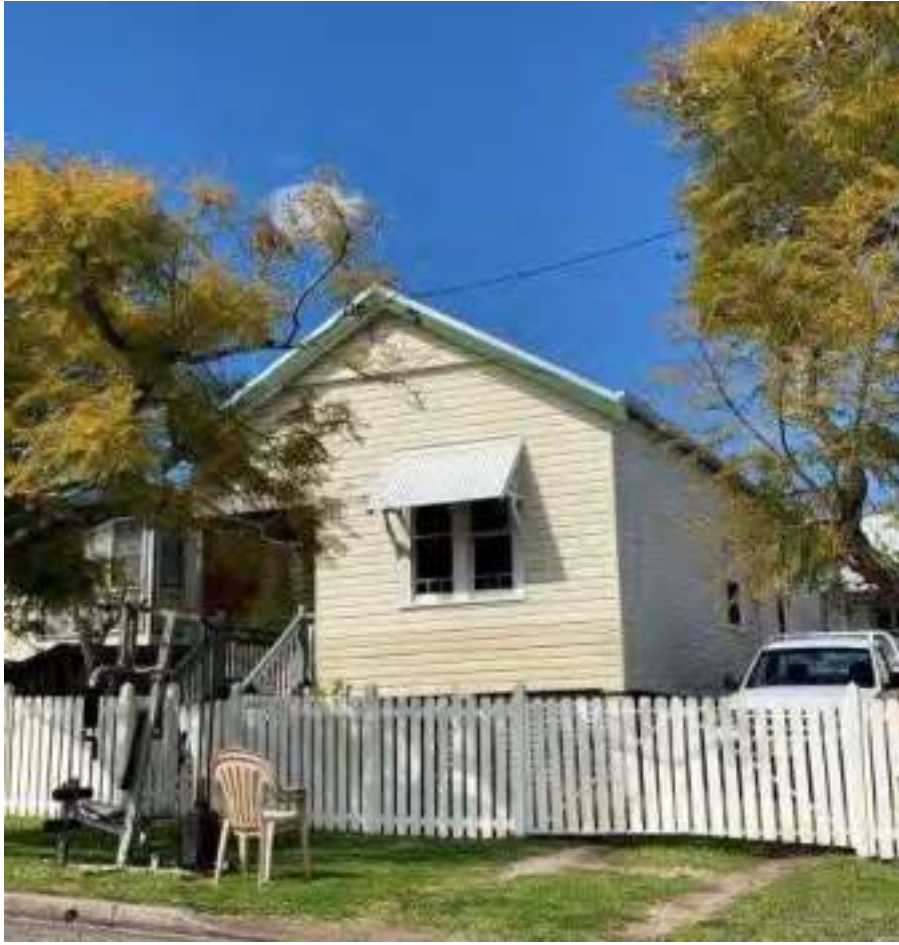
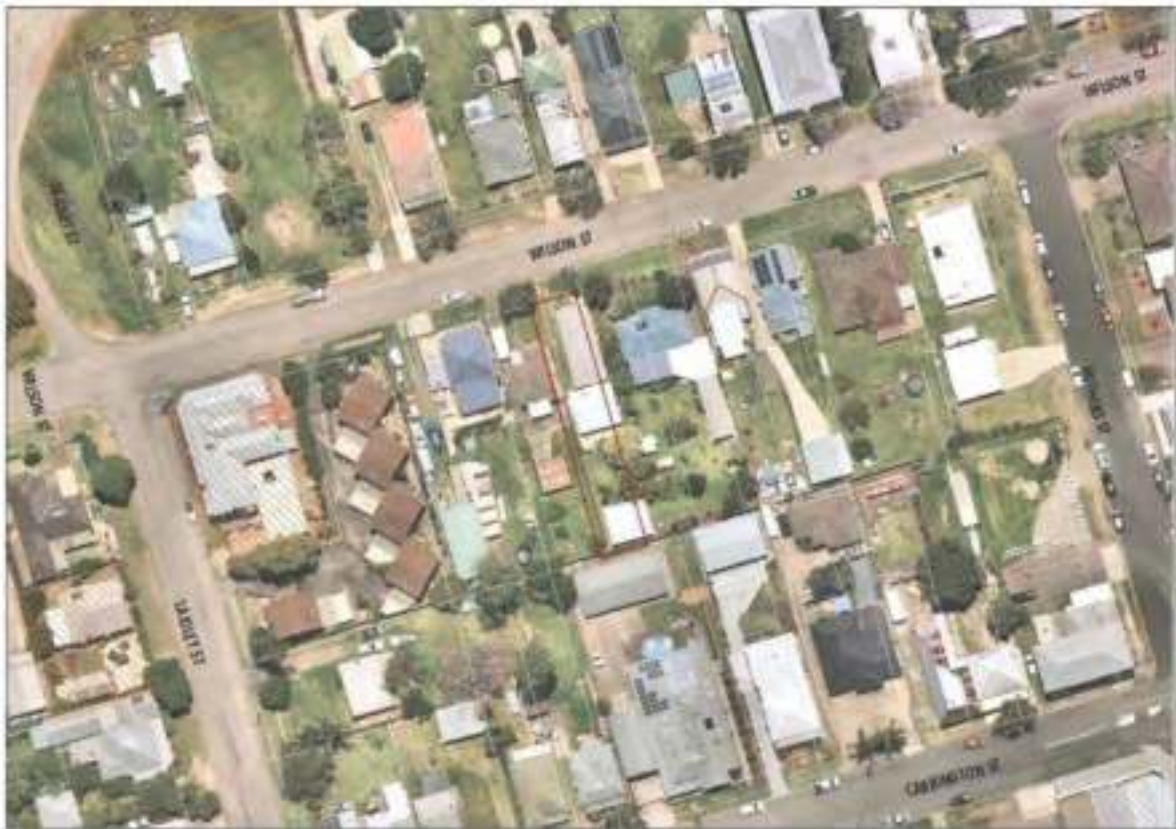
62 WILSON STREET, WEST WALLSEND 2286

Conservation Area Contribution Level	Est. Construction Date	Previous studies and/or community input
Contributory 2	Early to late 20 th century (broad range)	No prior heritage assessments or research undertaken.
Assessment Text		Observed Modifications
<p>The scale (single-storey) and general style of the dwelling is consistent with that of the streetscape and wider HCA. Dwelling contributes positively to the streetscape and wider HCA, particularly in comparison to Non-Contributory buildings.</p> <p>The dwelling features appropriately proportioned and positioned fenestrations, an appropriate roof form (gabled or hipped) and other features consistent with the architectural character of the area (e.g. front verandah with timber or brick posts, timber detailing, corrugated metal roofing, etc). The contributory value of the dwelling is limited however by either:</p> <ul style="list-style-type: none"> • External modifications that have in some way obscured the style, scale or design intent of the building and have resulted in less physical integrity than Contributory 1 buildings. • Being a later dwelling constructed in an appropriate referential style, but comprising little to no fabric of intrinsic heritage significance. 		<p>A large extension has been constructed at the back southern portion of the dwelling. This is partially visible from the street, however does not detract from the heritage streetscape.</p>

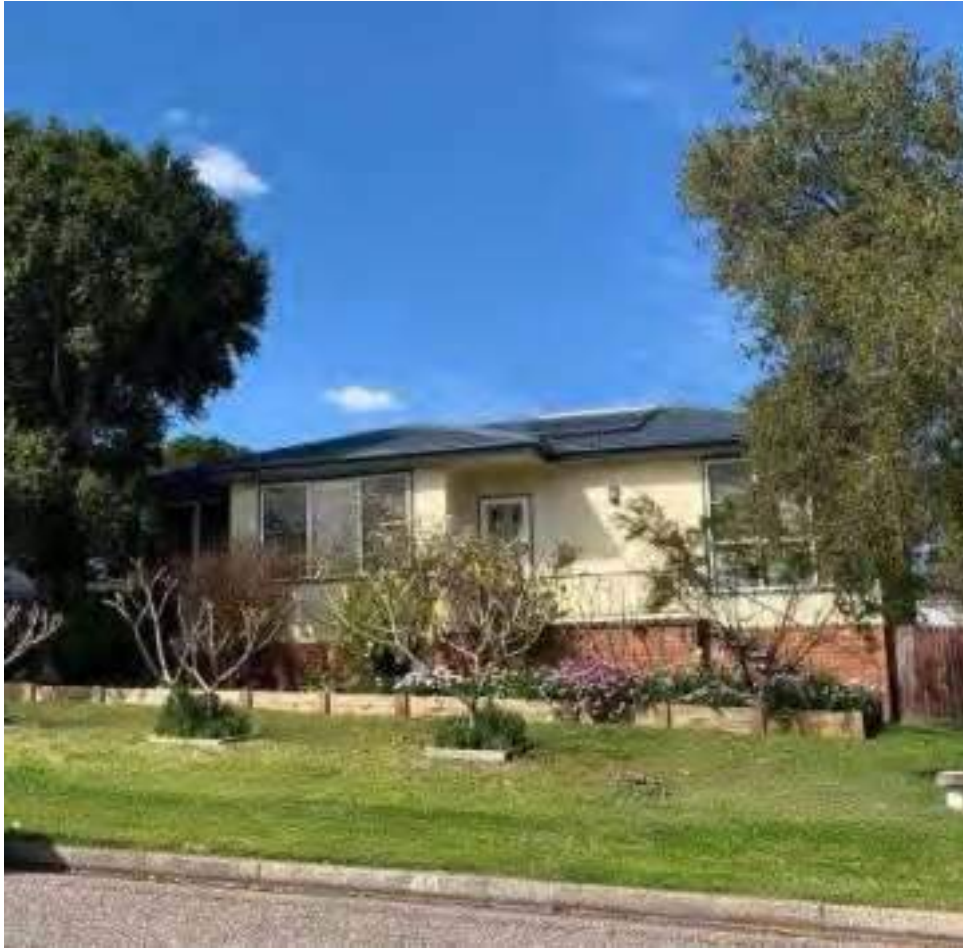
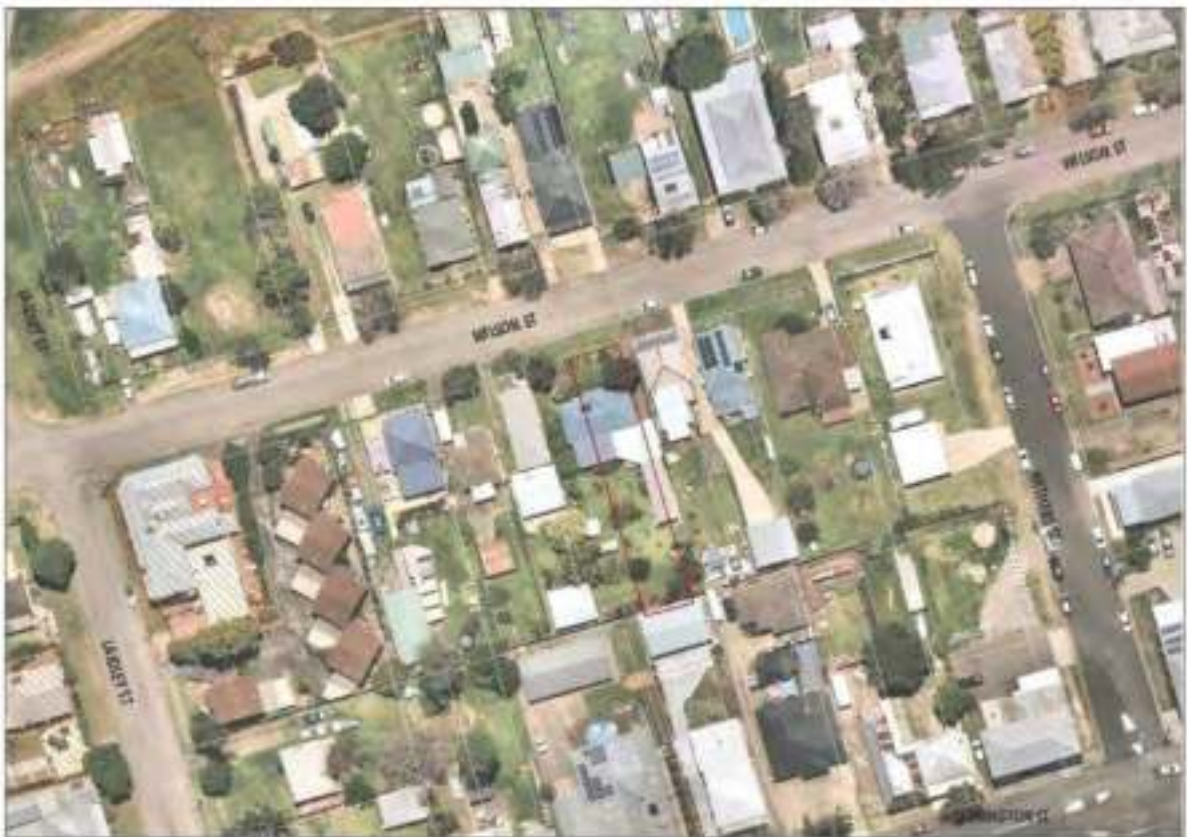
60 WILSON STREET, WEST WALLSEND 2286

Conservation Area Contribution Level	Est. Construction Date	Previous studies and/or community input
Contributory 2	Early to late 20 th century (broad range)	No prior heritage assessments or research undertaken.
Assessment Text		Observed Modifications
<p>The scale (single-storey) and general style of the dwelling is consistent with that of the streetscape and wider HCA. Dwelling contributes positively to the streetscape and wider HCA, particularly in comparison to Non-Contributory buildings.</p> <p>The dwelling features appropriately proportioned and positioned fenestrations, an appropriate roof form (gabled or hipped) and other features consistent with the architectural character of the area (e.g. front verandah with timber or brick posts, timber detailing, corrugated metal roofing, etc). The contributory value of the dwelling is limited however by either:</p> <ul style="list-style-type: none"> • External modifications that have in some way obscured the style, scale or design intent of the building and have resulted in less physical integrity than Contributory 1 buildings. • Being a later dwelling constructed in an appropriate referential style, but comprising little to no fabric of intrinsic heritage significance. 		<p>Solar panels/heating components are visible along the northern portion of the roof.</p>
