APPENDIX 2

Building Assessment Sheets (Inventory Sheets)

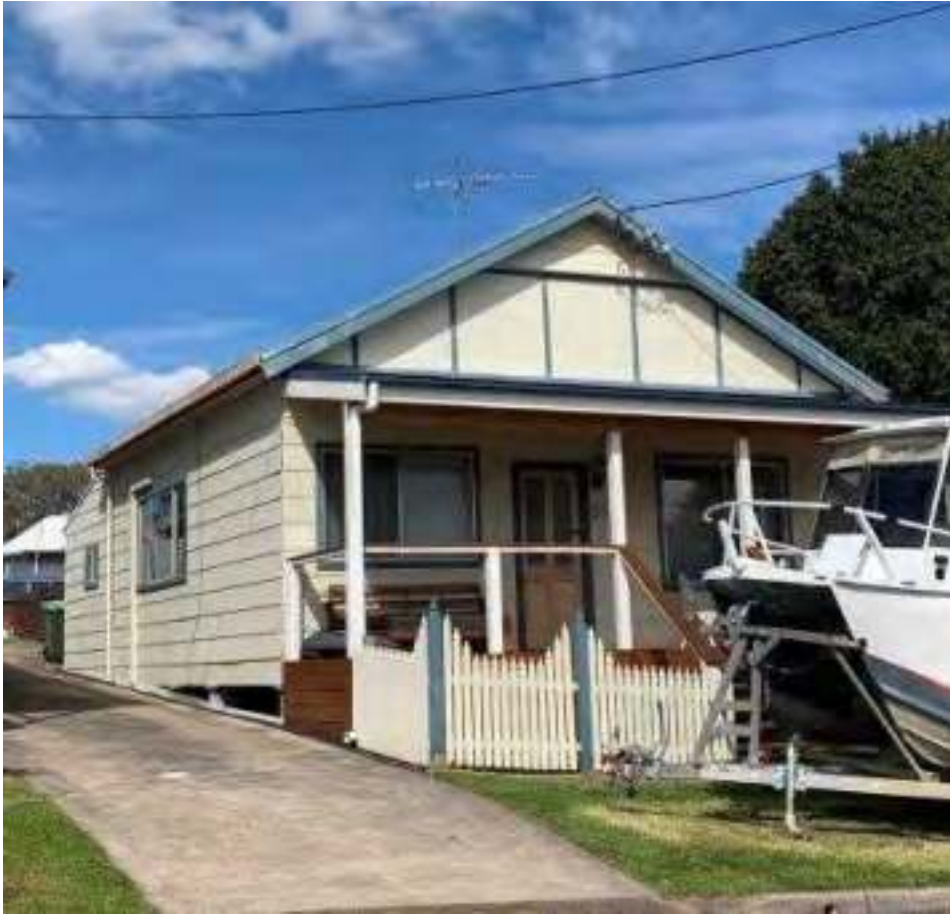
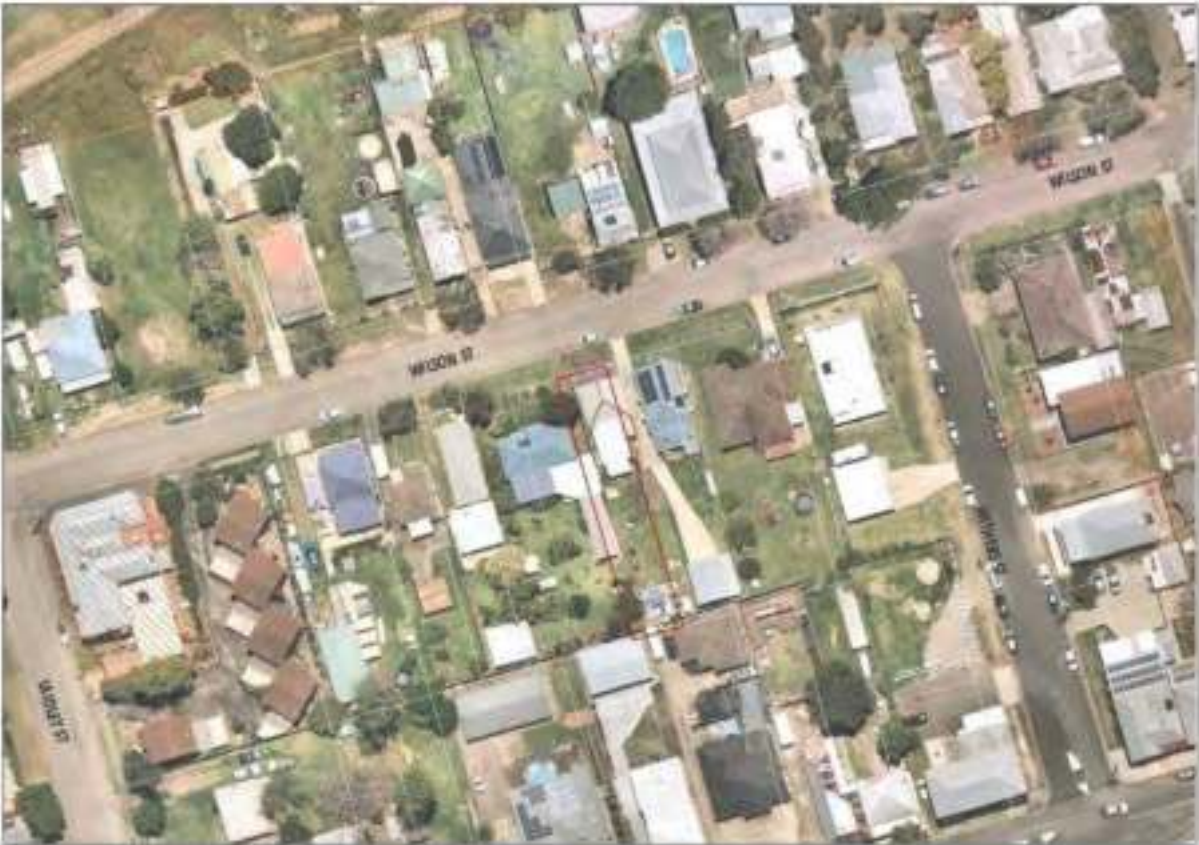
56 WILSON STREET, WEST WALLSEND 2286

Conservation Area Contribution Level	Est. Construction Date	Previous studies and/or community input
Contributory 2	Early to late 20 th century (broad range)	No prior heritage assessments or research undertaken.
Assessment Text		Observed Modifications
<p>The scale (single-storey) and general style of the dwelling is consistent with that of the streetscape and wider HCA. Dwelling contributes positively to the streetscape and wider HCA, particularly in comparison to Non-Contributory buildings.</p> <p>The dwelling features appropriately proportioned and positioned fenestrations, an appropriate roof form (gabled or hipped) and other features consistent with the architectural character of the area (e.g. front verandah with timber or brick posts, timber detailing, corrugated metal roofing, etc). The contributory value of the dwelling is limited however by either:</p> <ul style="list-style-type: none"> • External modifications that have in some way obscured the style, scale or design intent of the building and have resulted in less physical integrity than Contributory 1 buildings. • Being a later dwelling constructed in an appropriate referential style, but comprising little to no fabric of intrinsic heritage significance. 		<p>The timber veranda features, stairs and balustrade, are contemporary additions to the dwelling.</p> <p>All visible windows are contemporary in style.</p> <p>The skillion veranda roof was likely originally hipped or bull nosed.</p>

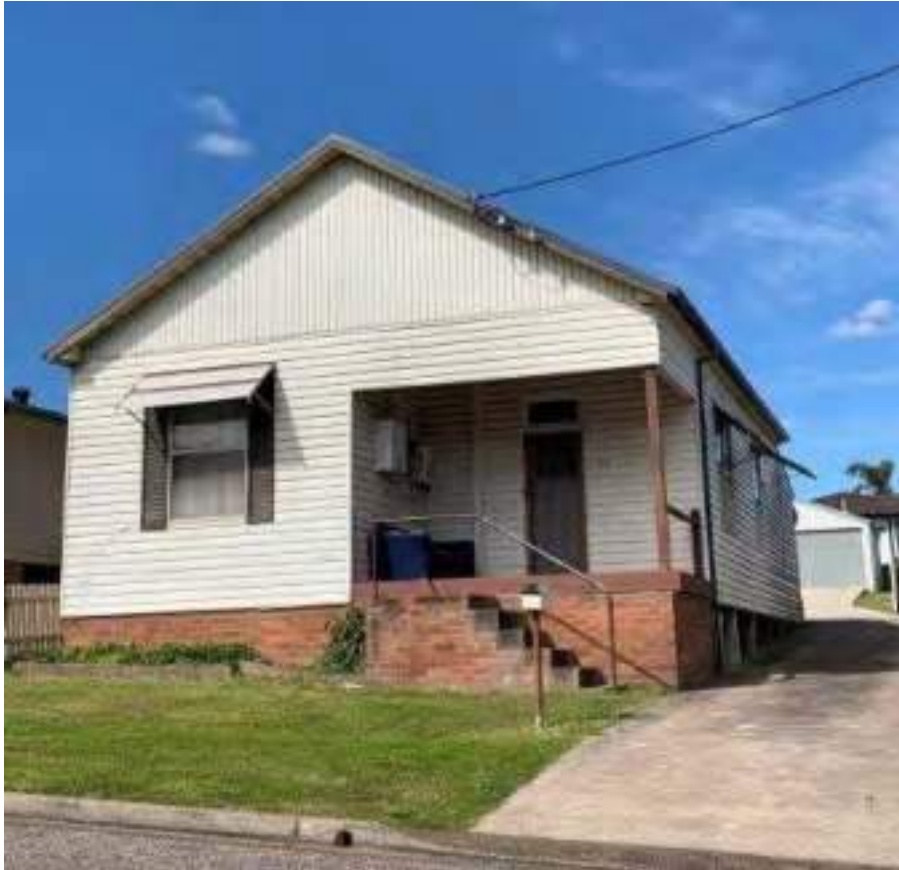
Conservation Area Contribution Level	Est. Construction Date	Previous studies and/or community input
Contributory 2	Early to late 20 th century (broad range)	No prior heritage assessments or research undertaken.
Assessment Text		Observed Modifications
<p>The scale (single-storey) and general style of the dwelling is consistent with that of the streetscape and wider HCA. Dwelling contributes positively to the streetscape and wider HCA, particularly in comparison to Non-Contributory buildings.</p> <p>The dwelling features appropriately proportioned and positioned fenestrations, an appropriate roof form (gabled or hipped) and other features consistent with the architectural character of the area (e.g. front verandah with timber or brick posts, timber detailing, corrugated metal roofing, etc). The contributory value of the dwelling is limited however by either:</p> <ul style="list-style-type: none"> • External modifications that have in some way obscured the style, scale or design intent of the building and have resulted in less physical integrity than Contributory 1 buildings. • Being a later dwelling constructed in an appropriate referential style, but comprising little to no fabric of intrinsic heritage significance. 		<p>All visible windows are contemporary in style, however retain external shutters.</p> <p>The metal support railing and absence of balustrade enclosing the veranda is likely a contemporary modification.</p>

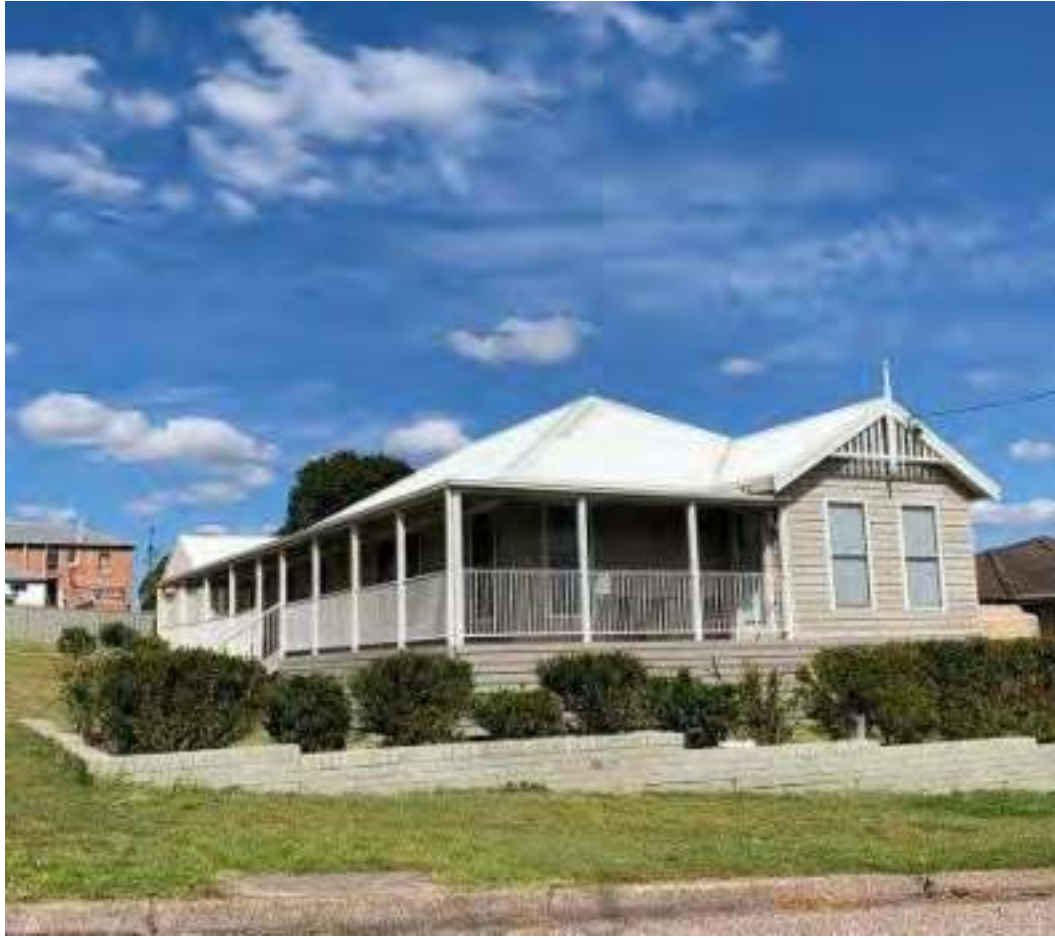
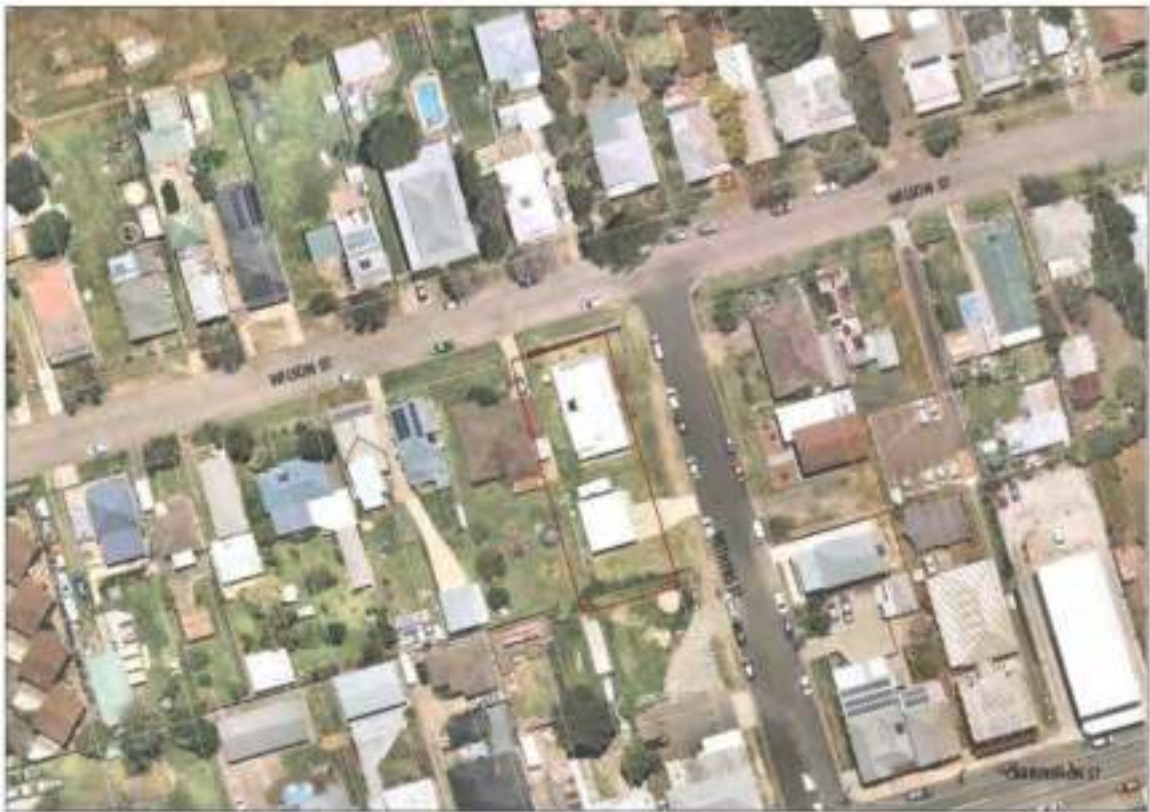
2 WITHERS STREET, WEST WALLSEND 2286

Conservation Area Contribution Level	Est. Construction Date	Previous studies and/or community input
Contributory 2	Early to late 20 th century (broad range)	No prior heritage assessments or research undertaken.
Assessment Text		Observed Modifications
<p>The scale (single-storey) and general style of the dwelling is consistent with that of the streetscape and wider HCA. Dwelling contributes positively to the streetscape and wider HCA, particularly in comparison to Non-Contributory buildings.</p> <p>The dwelling features appropriately proportioned and positioned fenestrations, an appropriate roof form (gabled or hipped) and other features consistent with the architectural character of the area (e.g. front verandah with timber or brick posts, timber detailing, corrugated metal roofing, etc). The contributory value of the dwelling is limited however by either:</p> <ul style="list-style-type: none"> • External modifications that have in some way obscured the style, scale or design intent of the building and have resulted in less physical integrity than Contributory 1 buildings. • Being a later dwelling constructed in an appropriate referential style, but comprising little to no fabric of intrinsic heritage significance. 		<p>The veranda has been extended to wrap around the eastern portion of the dwelling. This has been undertaken in a sympathetic style and does not detract from the heritage streetscape.</p> <p>The timber balustrade partially enclosing the veranda is a contemporary addition, as is the timber staircase leading onto the veranda landing. The original entrance to the dwelling would have been situated along the northern side of the dwelling. All visible windows are contemporary in style.</p>

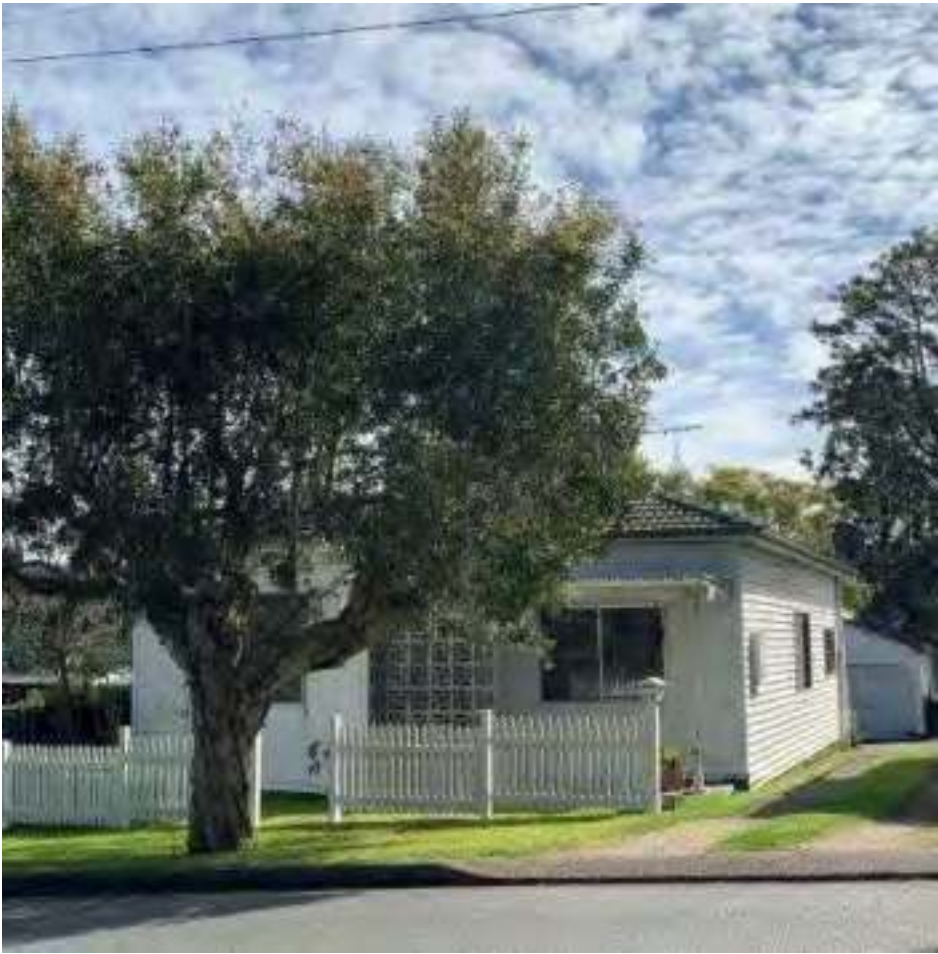
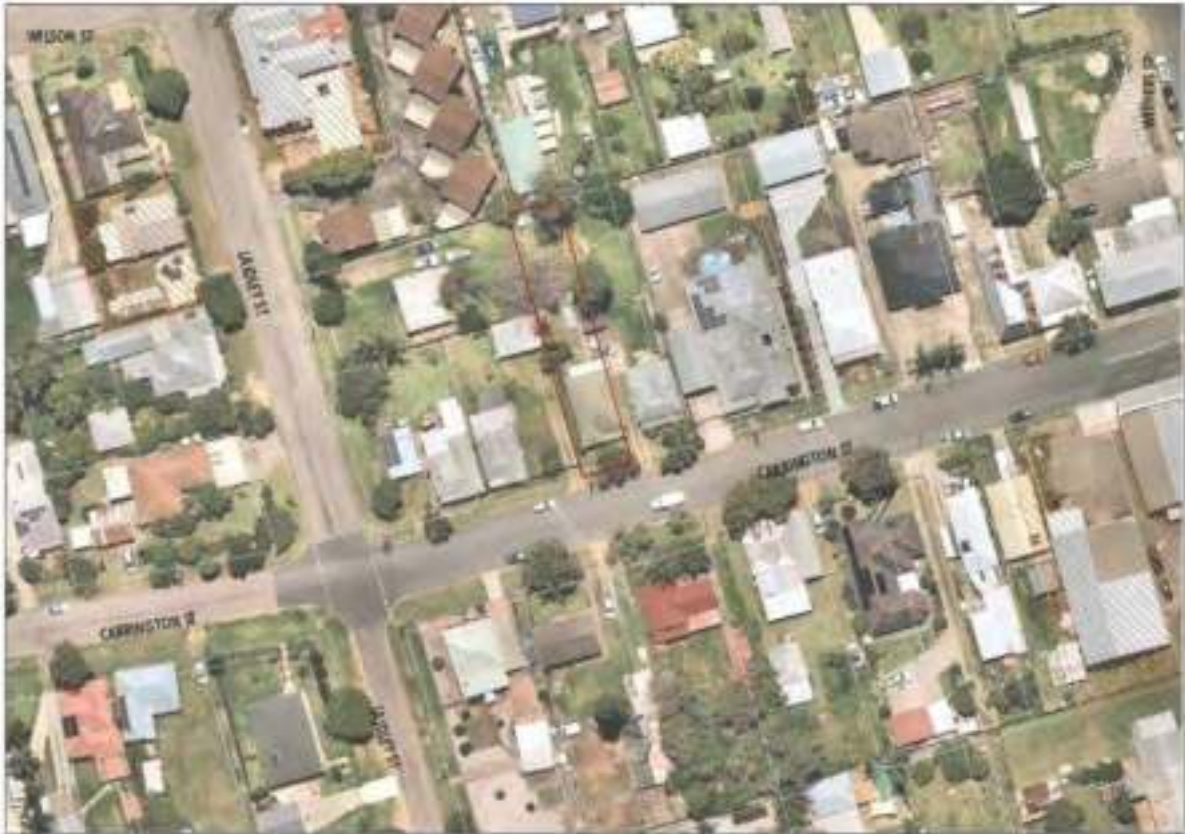
83 CARRINGTON STREET, WEST WALLSEND 2286

Conservation Area Contribution Level	Est. Construction Date	Previous studies and/or community input
Contributory 2	Early to late 20 th century (broad range)	No prior heritage assessments or research undertaken.
Assessment Text		Observed Modifications
<p>The scale (single-storey) and general style of the dwelling is consistent with that of the streetscape and wider HCA. Dwelling contributes positively to the streetscape and wider HCA, particularly in comparison to Non-Contributory buildings.</p> <p>The dwelling features appropriately proportioned and positioned fenestrations, an appropriate roof form (gabled or hipped) and other features consistent with the architectural character of the area (e.g. front verandah with timber or brick posts, timber detailing, corrugated metal roofing, etc). The contributory value of the dwelling is limited however by either:</p> <ul style="list-style-type: none"> • External modifications that have in some way obscured the style, scale or design intent of the building and have resulted in less physical integrity than Contributory 1 buildings. • Being a later dwelling constructed in an appropriate referential style, but comprising little to no fabric of intrinsic heritage significance. 		<p>All windows are contemporary in style.</p> <p>The decorative cinder block feature wall at the front southern side of the dwelling is potentially a prior modification.</p>

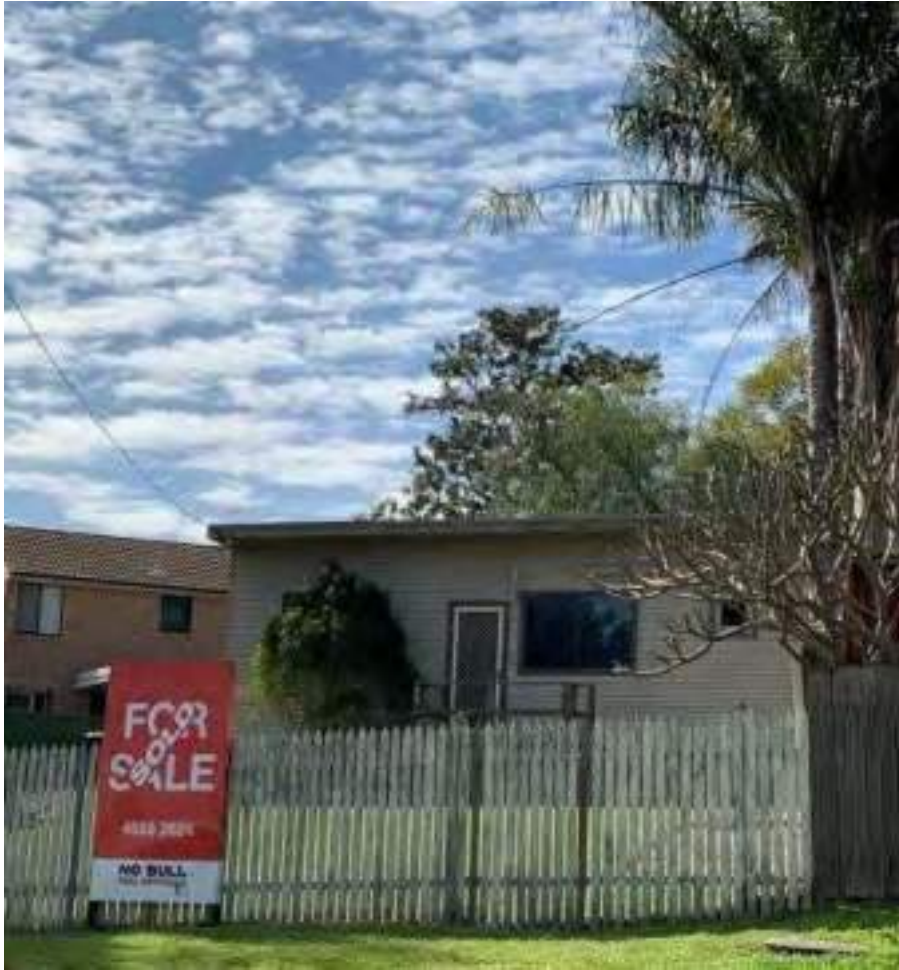
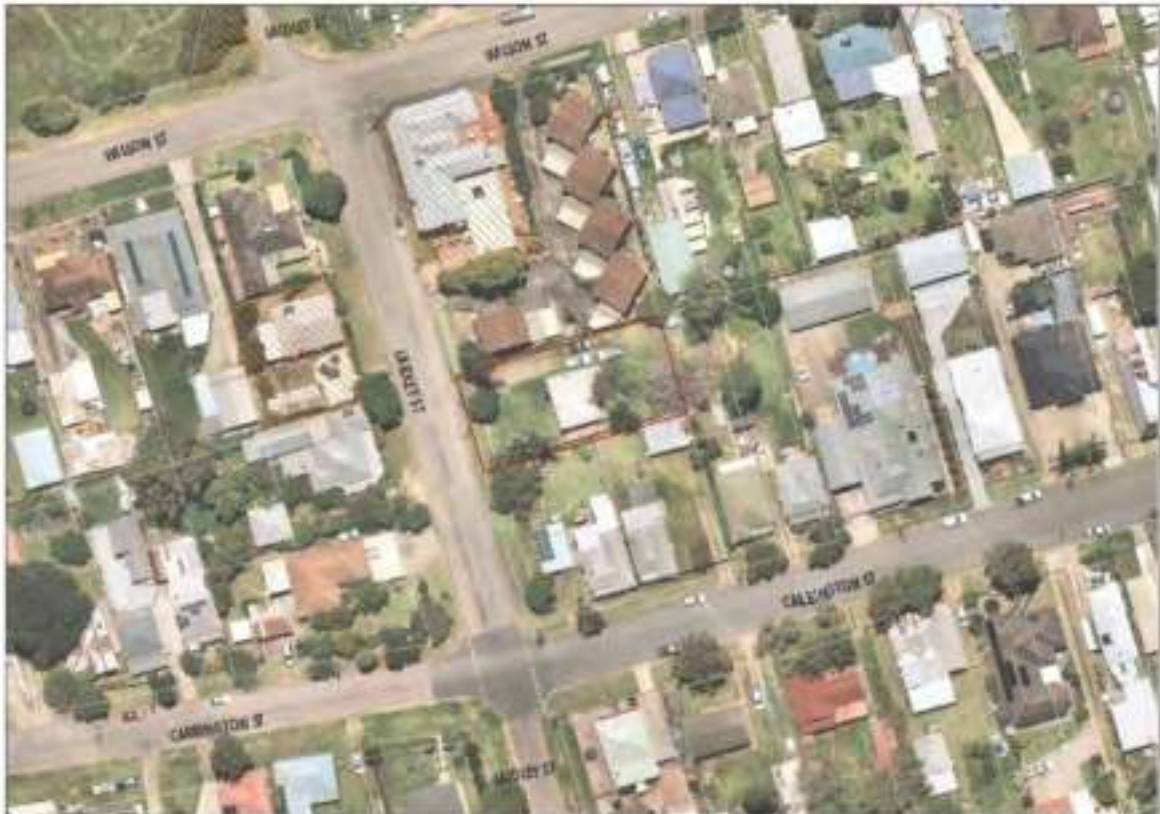
15 LAIDLEY STREET, WEST WALLSEND 2286		
Conservation Area Contribution Level	Est. Construction Date	Previous studies and/or community input
Contributory 2	Early to late 20 th century (broad range)	No prior heritage assessments or research undertaken.
Assessment Text		Observed Modifications
<p>The scale (single-storey) and general style of the dwelling is consistent with that of the streetscape and wider HCA. Dwelling contributes positively to the streetscape and wider HCA, particularly in comparison to Non-Contributory buildings.</p> <p>The dwelling features appropriately proportioned and positioned fenestrations, an appropriate roof form (gabled or hipped) and other features consistent with the architectural character of the area (e.g. front verandah with timber or brick posts, timber detailing, corrugated metal roofing, etc). The contributory value of the dwelling is limited however by either:</p> <ul style="list-style-type: none"> • External modifications that have in some way obscured the style, scale or design intent of the building and have resulted in less physical integrity than Contributory 1 buildings. • Being a later dwelling constructed in an appropriate referential style, but comprising little to no fabric of intrinsic heritage significance. 		<p>All visible windows are contemporary in style.</p> <p>The timber balustrade is a contemporary addition.</p>

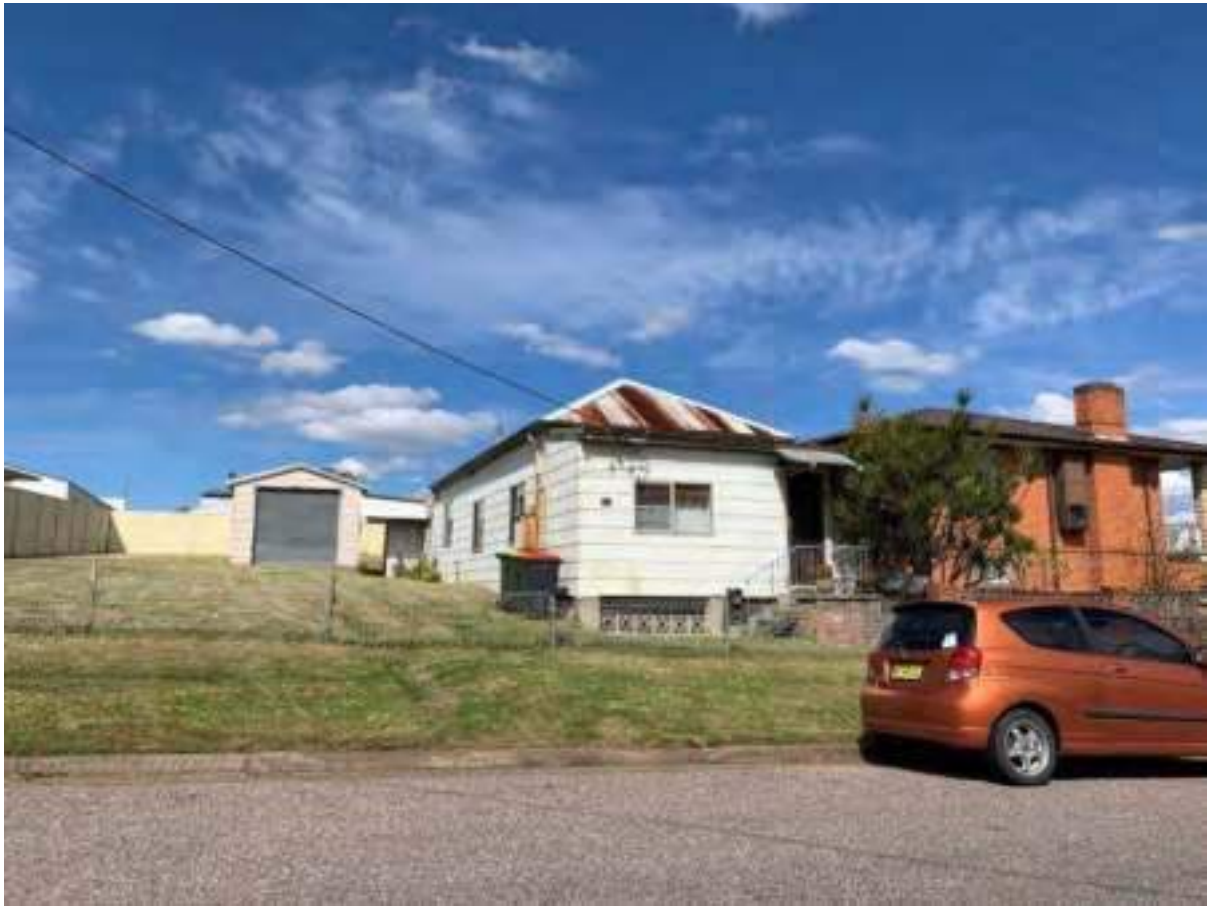
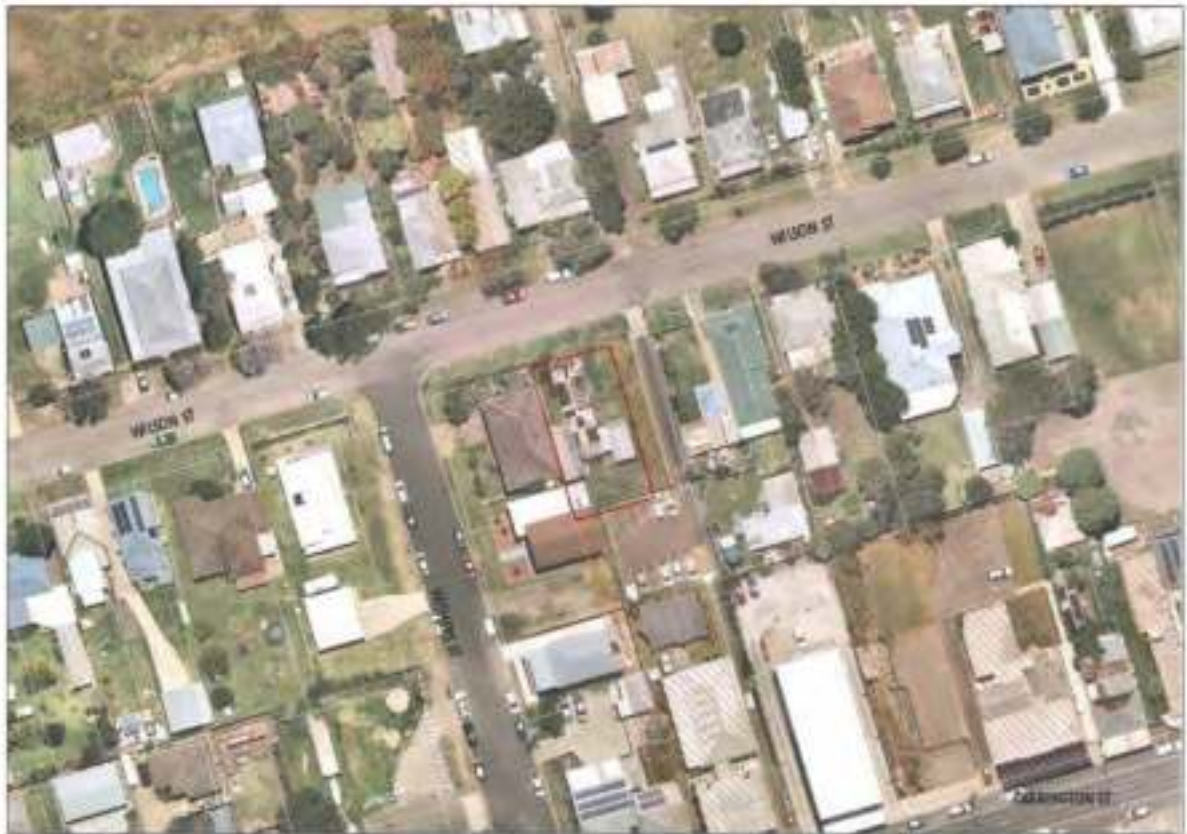
48 WILSON STREET, WEST WALLSEND 2286

Conservation Area Contribution Level	Est. Construction Date	Previous studies and/or community input
Contributory 2	Early to late 20 th century (broad range)	No prior heritage assessments or research undertaken.
Assessment Text		Observed Modifications
<p>The scale (single-storey) and general style of the dwelling is consistent with that of the streetscape and wider HCA. Dwelling contributes positively to the streetscape and wider HCA, particularly in comparison to Non-Contributory buildings.</p> <p>The dwelling features appropriately proportioned and positioned fenestrations, an appropriate roof form (gabled or hipped) and other features consistent with the architectural character of the area (e.g. front verandah with timber or brick posts, timber detailing, corrugated metal roofing, etc). The contributory value of the dwelling is limited however by either:</p> <ul style="list-style-type: none"> • External modifications that have in some way obscured the style, scale or design intent of the building and have resulted in less physical integrity than Contributory 1 buildings. • Being a later dwelling constructed in an appropriate referential style, but comprising little to no fabric of intrinsic heritage significance. 		<p>All visible windows are contemporary in design.</p>

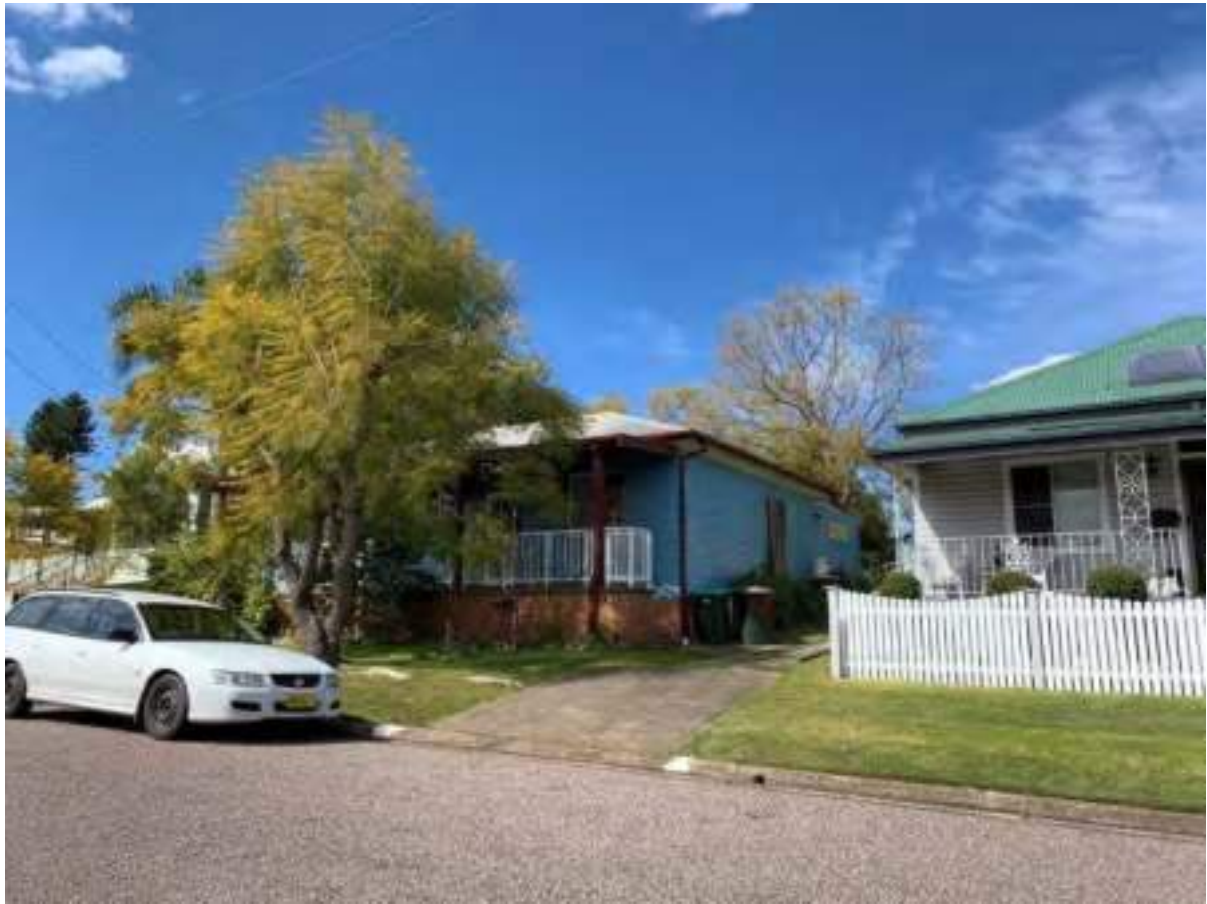
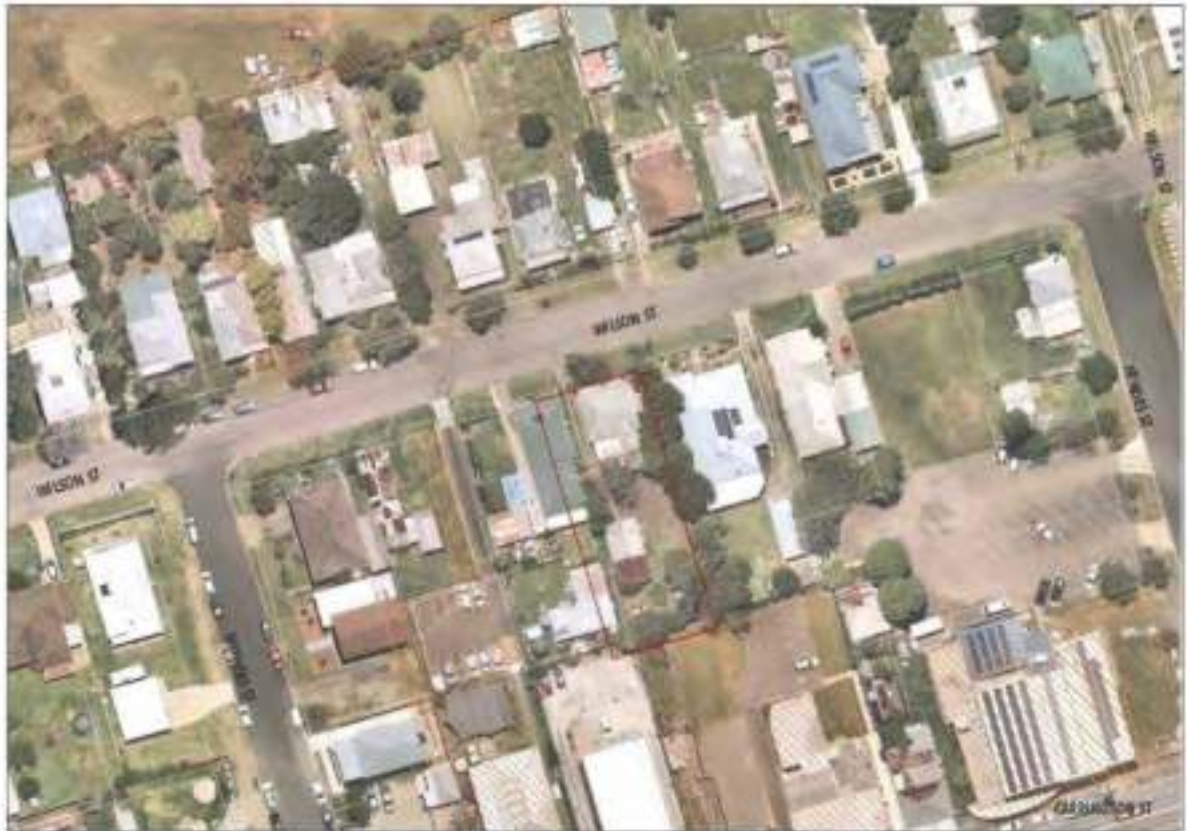
44 WILSON STREET, WEST WALLSEND 2286

Conservation Area Contribution Level	Est. Construction Date	Previous studies and/or community input
Contributory 2	Early to late 20 th century (broad range)	No prior heritage assessments or research undertaken.
Assessment Text		Observed Modifications
<p>The scale (single-storey) and general style of the dwelling is consistent with that of the streetscape and wider HCA. Dwelling contributes positively to the streetscape and wider HCA, particularly in comparison to Non-Contributory buildings.</p> <p>The dwelling features appropriately proportioned and positioned fenestrations, an appropriate roof form (gabled or hipped) and other features consistent with the architectural character of the area (e.g. front verandah with timber or brick posts, timber detailing, corrugated metal roofing, etc). The contributory value of the dwelling is limited however by either:</p> <ul style="list-style-type: none"> • External modifications that have in some way obscured the style, scale or design intent of the building and have resulted in less physical integrity than Contributory 1 buildings. • Being a later dwelling constructed in an appropriate referential style, but comprising little to no fabric of intrinsic heritage significance. 		<p>The metal balustrade partially enclosing the veranda is a contemporary addition, likely replacing an original timber design.</p> <p>The blue colour scheme is a contemporary modification and unsympathetic to the heritage streetscape. The colour juxtaposes the surrounding properties and is an inappropriate choice for the area.</p>

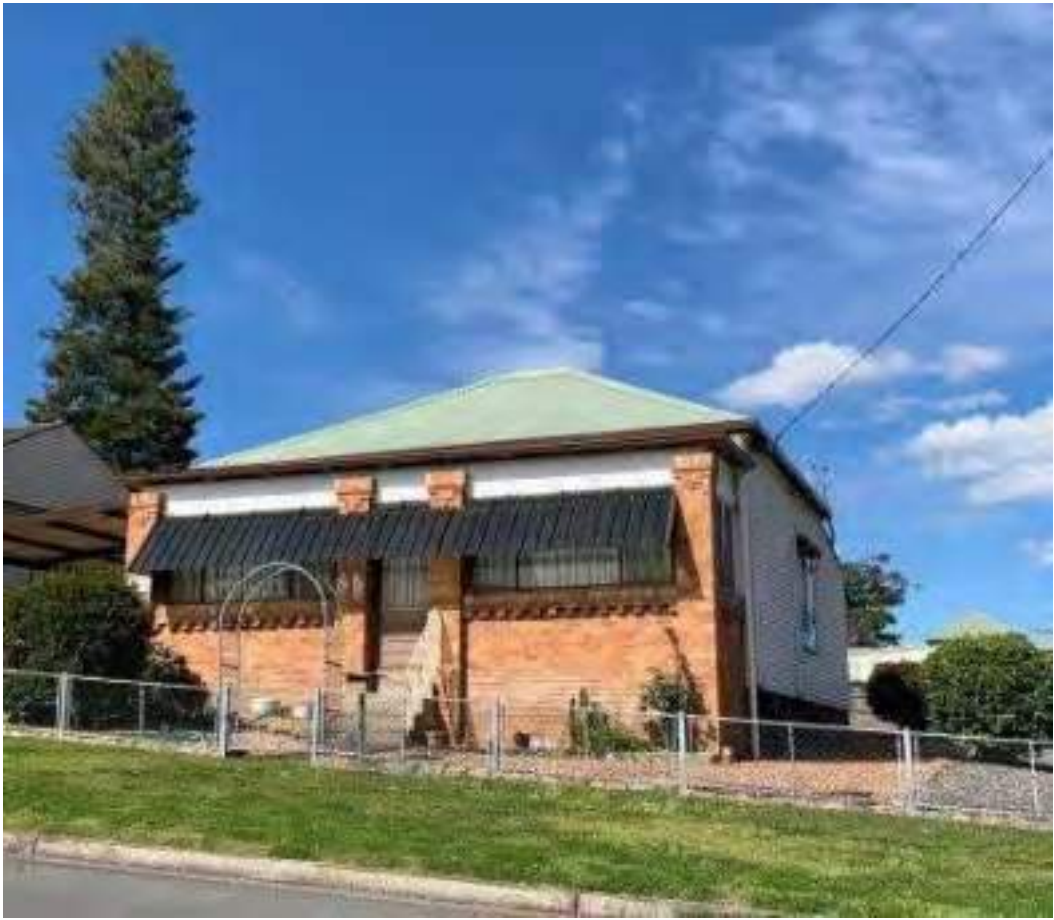
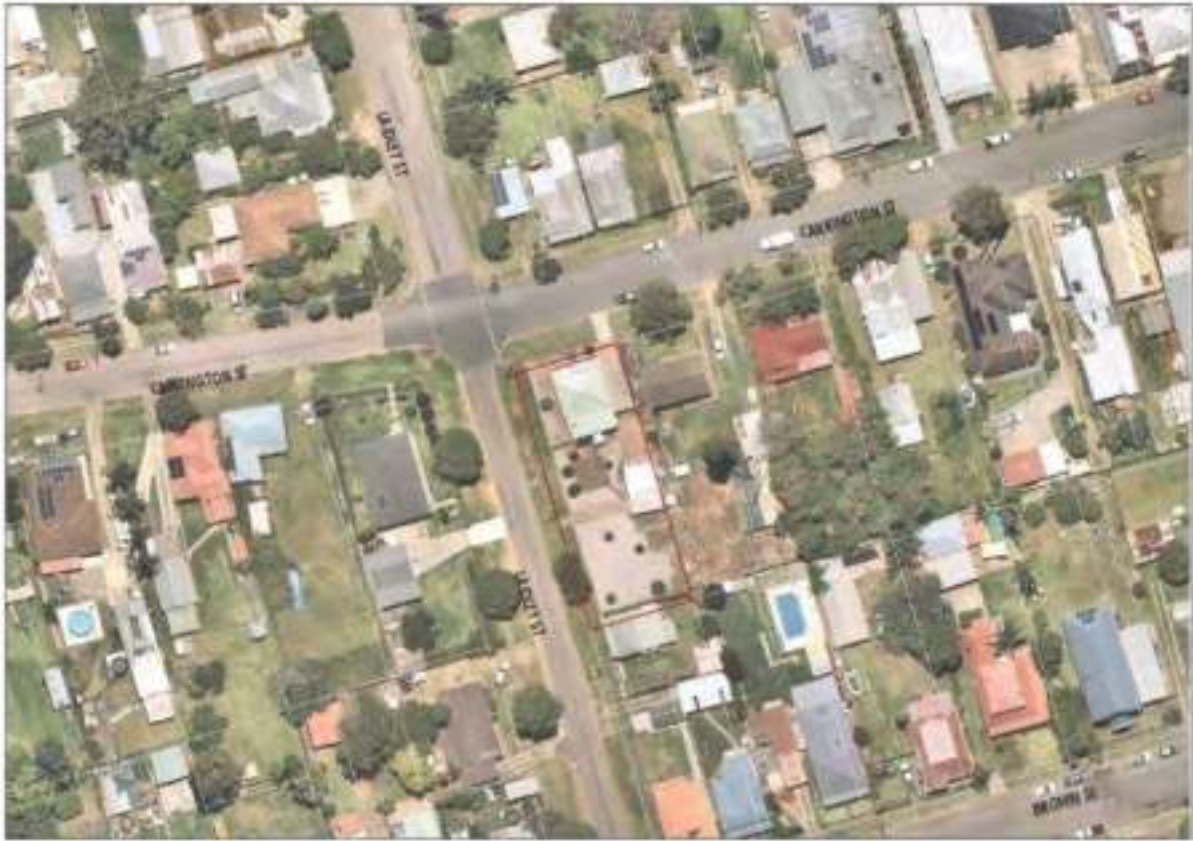
88 CARRINGTON STREET, WEST WALLSEND 2286

Conservation Area Contribution Level	Est. Construction Date	Previous studies and/or community input
Contributory 2	Early to late 20 th century (broad range)	No prior heritage assessments or research undertaken.
Assessment Text		Observed Modifications
<p>The scale (single-storey) and general style of the dwelling is consistent with that of the streetscape and wider HCA. Dwelling contributes positively to the streetscape and wider HCA, particularly in comparison to Non-Contributory buildings.</p> <p>The dwelling features appropriately proportioned and positioned fenestrations, an appropriate roof form (gabled or hipped) and other features consistent with the architectural character of the area (e.g. front verandah with timber or brick posts, timber detailing, corrugated metal roofing, etc). The contributory value of the dwelling is limited however by either:</p> <ul style="list-style-type: none"> • External modifications that have in some way obscured the style, scale or design intent of the building and have resulted in less physical integrity than Contributory 1 buildings. • Being a later dwelling constructed in an appropriate referential style, but comprising little to no fabric of intrinsic heritage significance. 		<p>The veranda has been built in to create an additional living area, with contemporary styled windows enclosing the space. The brickwork veranda wall and support pillars are contemporary additions, likely replacing an original timber post and balustrade design.</p> <p>The veranda skillion roof would have originally been a bullnosed or hipped design.</p>

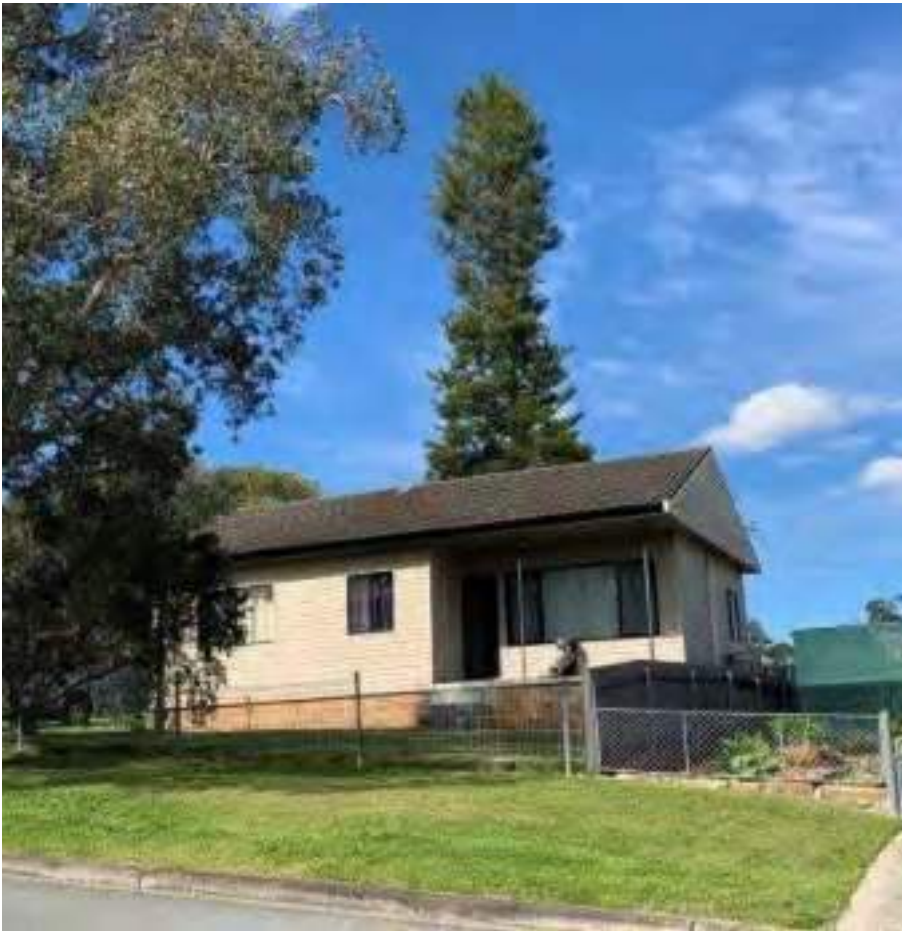
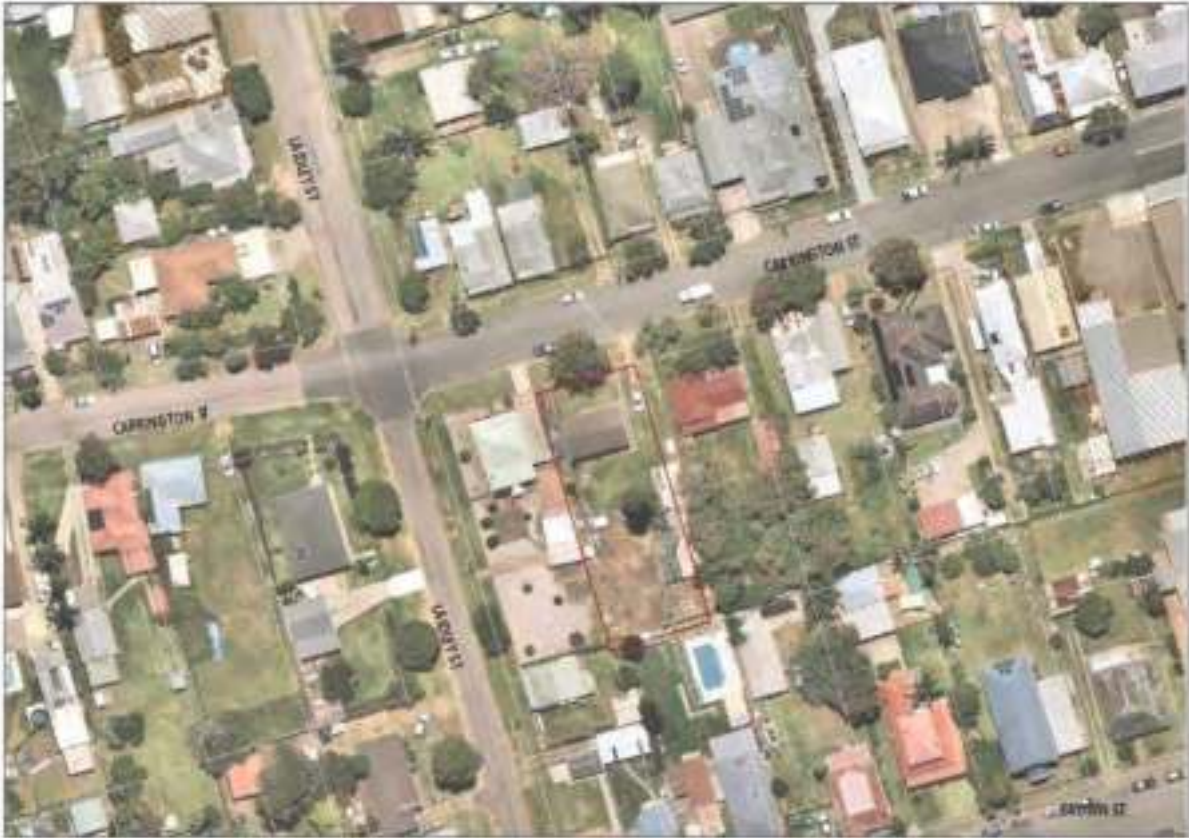
86 CARRINGTON STREET, WEST WALLSEND 2286

Conservation Area Contribution Level	Est. Construction Date	Previous studies and/or community input
Contributory 2	Early to late 20 th century (broad range)	No prior heritage assessments or research undertaken.
Assessment Text		Observed Modifications
<p>The scale (single-storey) and general style of the dwelling is consistent with that of the streetscape and wider HCA. Dwelling contributes positively to the streetscape and wider HCA, particularly in comparison to Non-Contributory buildings.</p> <p>The dwelling features appropriately proportioned and positioned fenestrations, an appropriate roof form (gabled or hipped) and other features consistent with the architectural character of the area (e.g. front verandah with timber or brick posts, timber detailing, corrugated metal roofing, etc). The contributory value of the dwelling is limited however by either:</p> <ul style="list-style-type: none"> • External modifications that have in some way obscured the style, scale or design intent of the building and have resulted in less physical integrity than Contributory 1 buildings. • Being a later dwelling constructed in an appropriate referential style, but comprising little to no fabric of intrinsic heritage significance. 		<p>All visible windows are contemporary in style.</p>

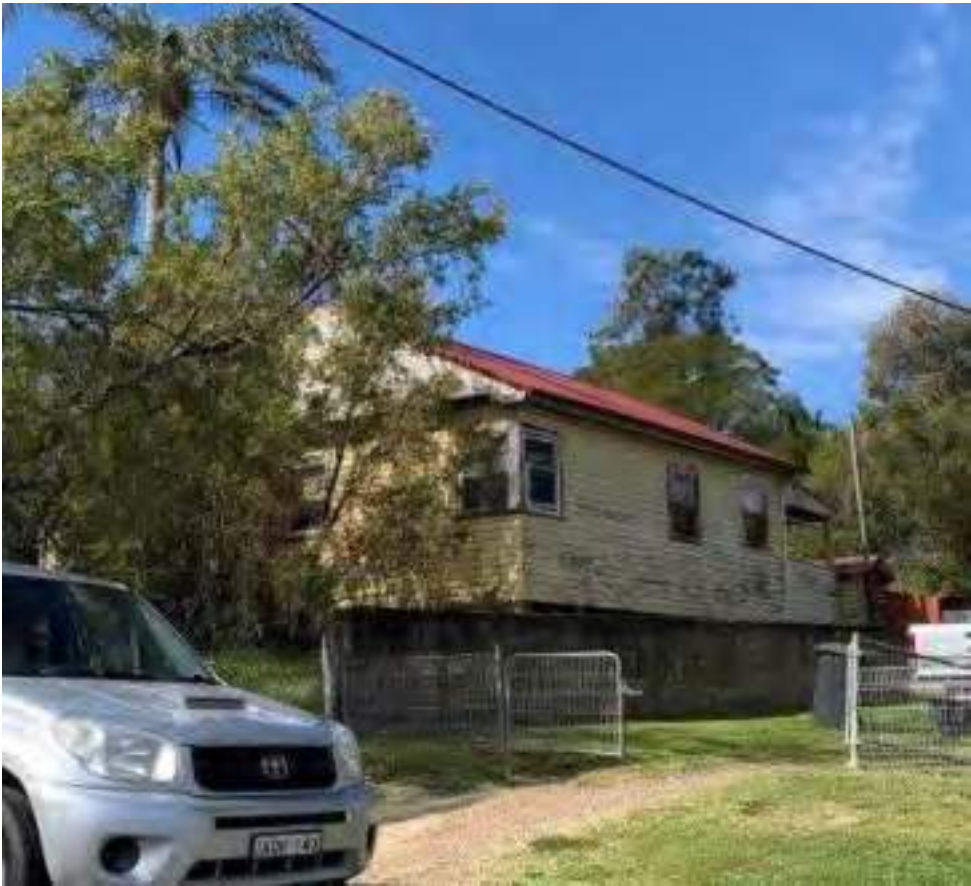
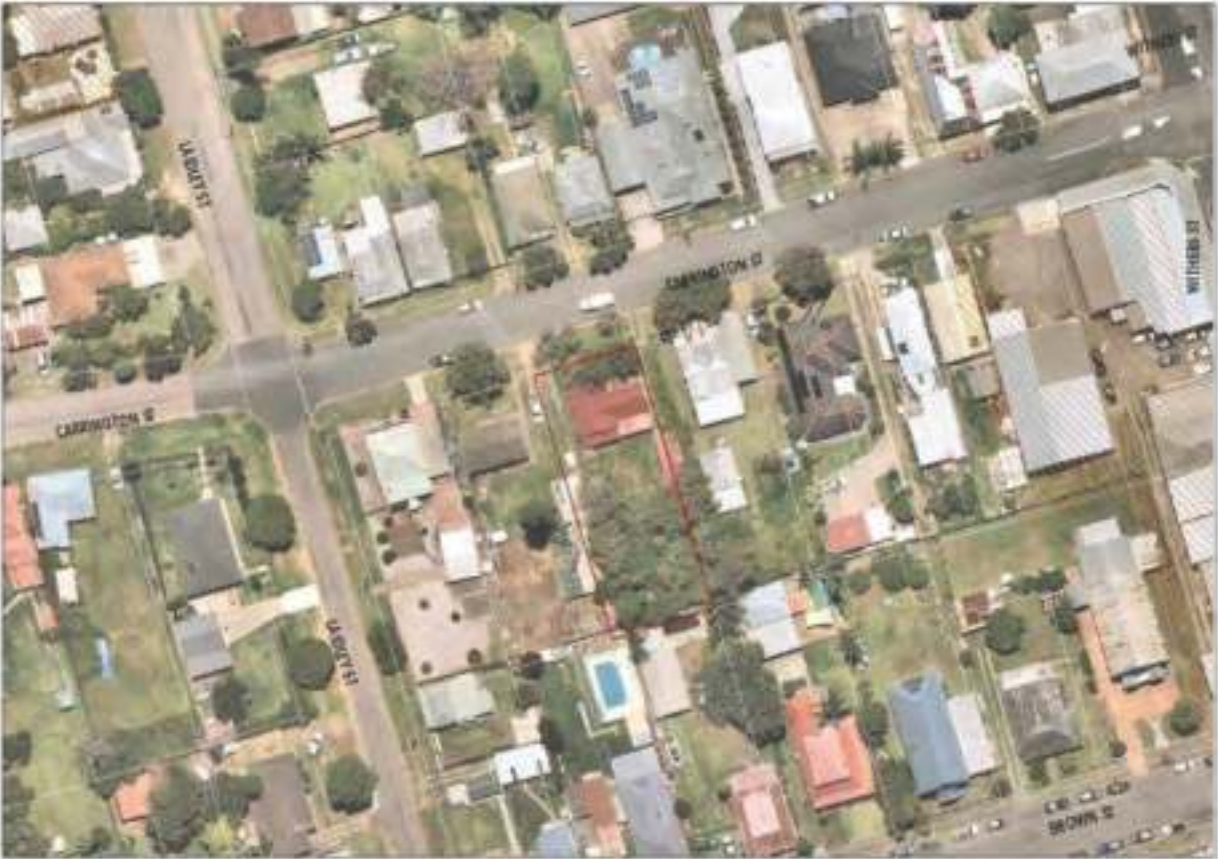
84 CARRINGTON STREET, WEST WALLSEND 2286

Conservation Area Contribution Level	Est. Construction Date	Previous studies and/or community input
Contributory 2	Early to late 20 th century (broad range)	No prior heritage assessments or research undertaken.
Assessment Text		Observed Modifications
<p>The scale (single-storey) and general style of the dwelling is consistent with that of the streetscape and wider HCA. Dwelling contributes positively to the streetscape and wider HCA, particularly in comparison to Non-Contributory buildings.</p> <p>The dwelling features appropriately proportioned and positioned fenestrations, an appropriate roof form (gabled or hipped) and other features consistent with the architectural character of the area (e.g. front verandah with timber or brick posts, timber detailing, corrugated metal roofing, etc). The contributory value of the dwelling is limited however by either:</p> <ul style="list-style-type: none"> • External modifications that have in some way obscured the style, scale or design intent of the building and have resulted in less physical integrity than Contributory 1 buildings. • Being a later dwelling constructed in an appropriate referential style, but comprising little to no fabric of intrinsic heritage significance. 		No modifications observed.
