APPENDIX 2

Building Assessment Sheets (Inventory Sheets)

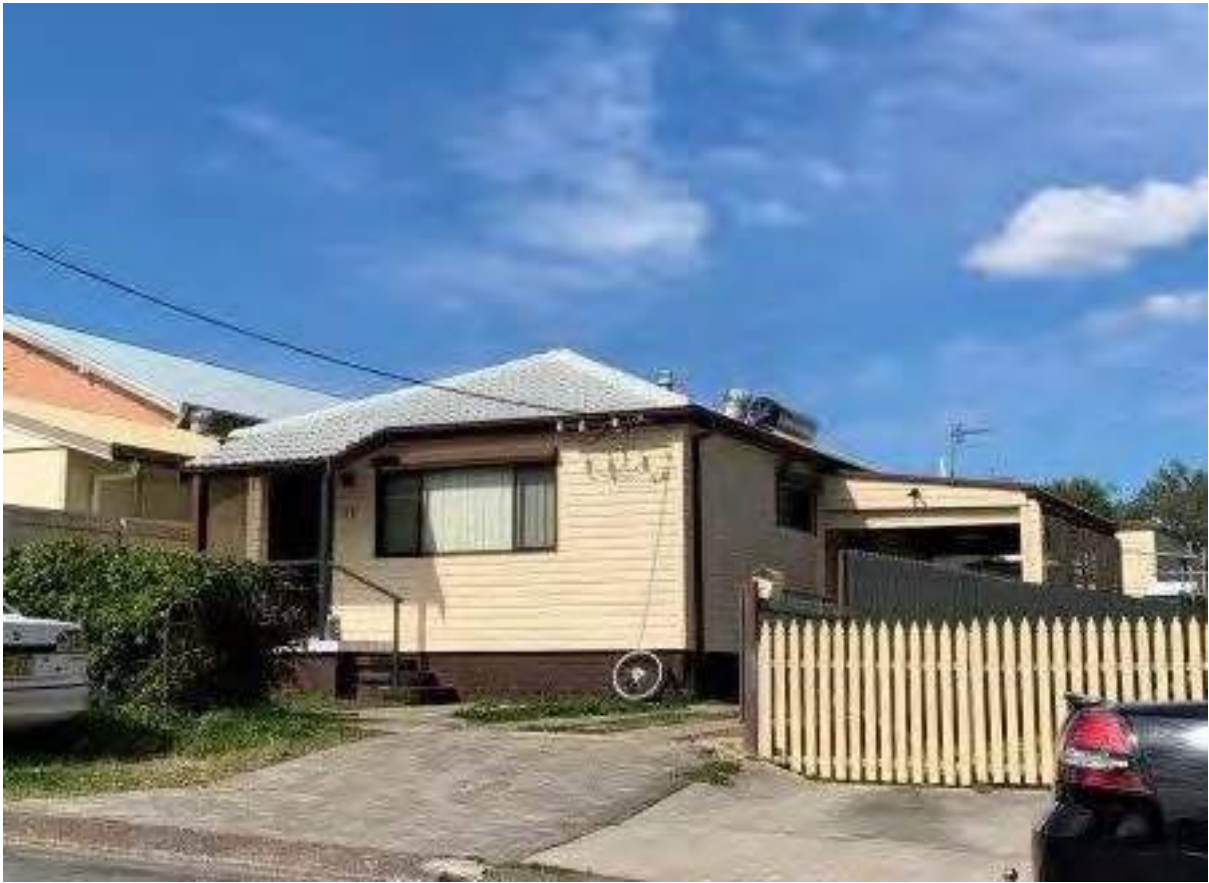
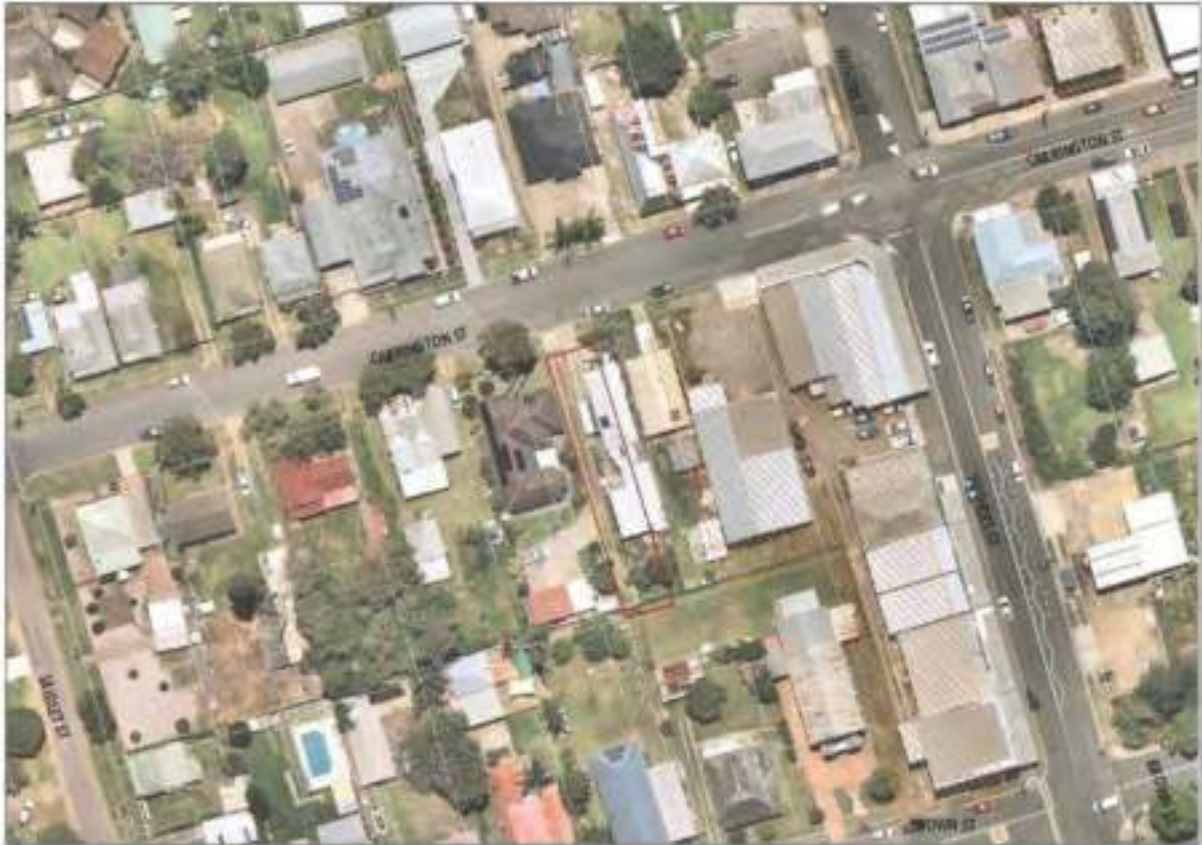
78 CARRINGTON STREET, WEST WALLSEND 2286

Conservation Area Contribution Level	Est. Construction Date	Previous studies and/or community input
Contributory 2	Early to late 20 th century (broad range)	No prior heritage assessments or research undertaken.
Assessment Text		Observed Modifications
<p>The scale (single-storey) and general style of the dwelling is consistent with that of the streetscape and wider HCA. Dwelling contributes positively to the streetscape and wider HCA, particularly in comparison to Non-Contributory buildings.</p> <p>The dwelling features appropriately proportioned and positioned fenestrations, an appropriate roof form (gabled or hipped) and other features consistent with the architectural character of the area (e.g. front verandah with timber or brick posts, timber detailing, corrugated metal roofing, etc). The contributory value of the dwelling is limited however by either:</p> <ul style="list-style-type: none"> • External modifications that have in some way obscured the style, scale or design intent of the building and have resulted in less physical integrity than Contributory 1 buildings. • Being a later dwelling constructed in an appropriate referential style, but comprising little to no fabric of intrinsic heritage significance. 		No modifications observed.

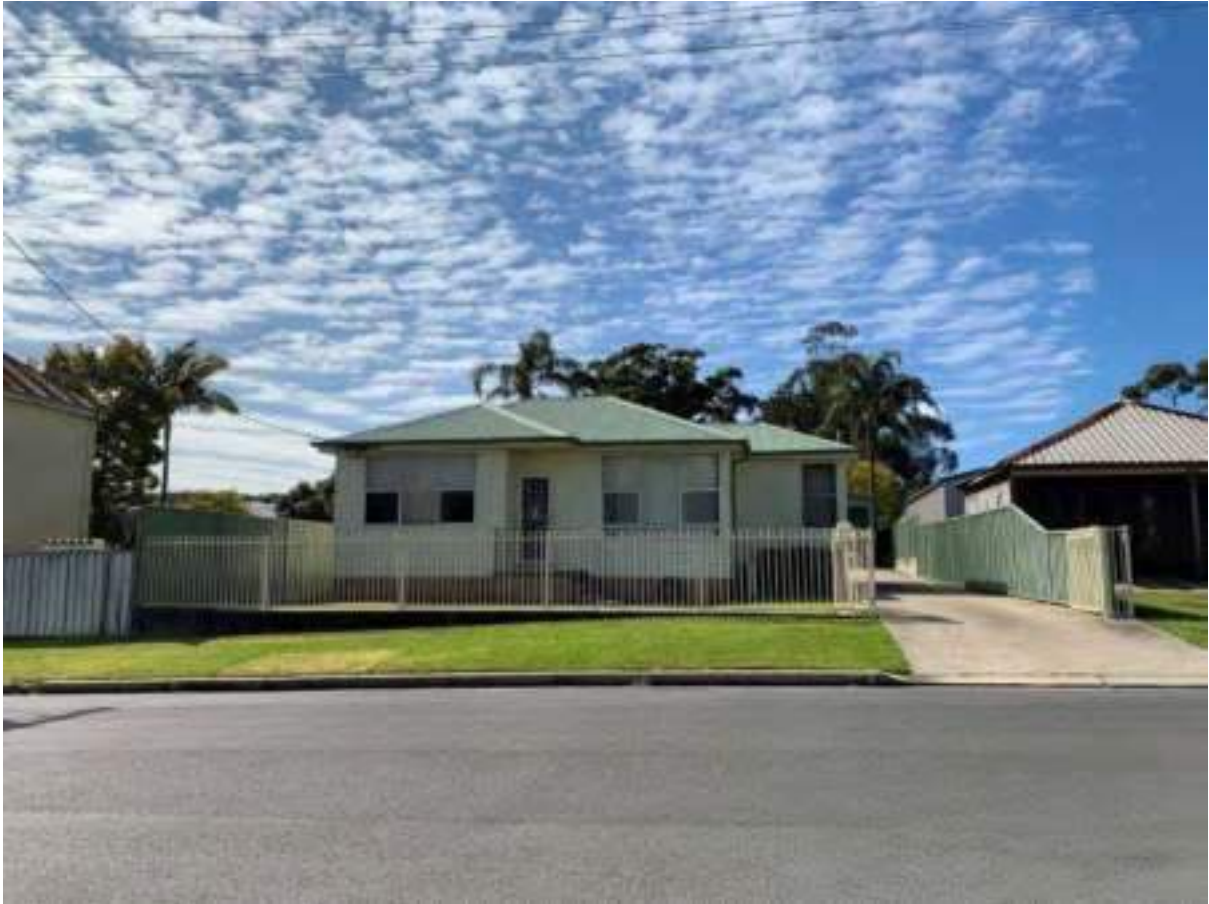
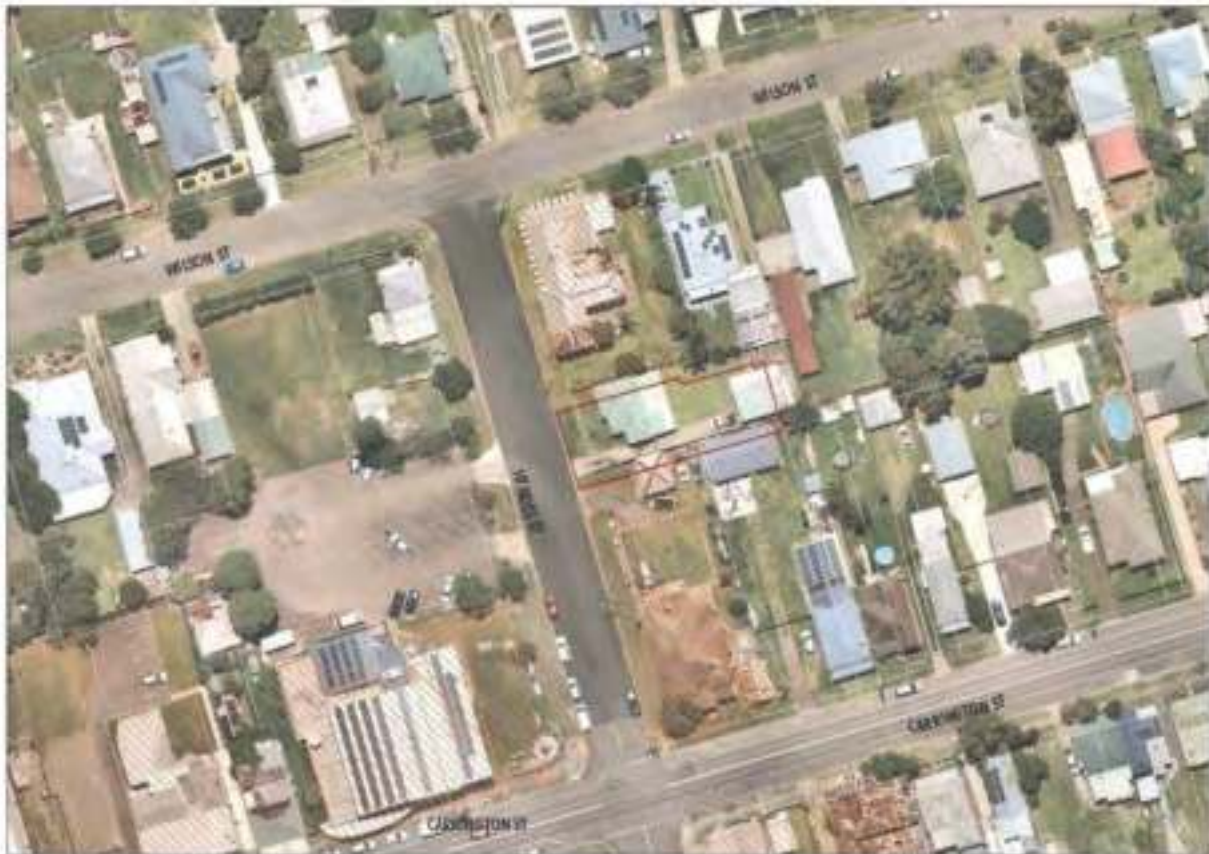
3 HYDNES STREET, WEST WALLSEND 2286

Conservation Area Contribution Level	Est. Construction Date	Previous studies and/or community input
Contributory 2	Early to late 20 th century (broad range)	No prior heritage assessments or research undertaken.
Assessment Text		Observed Modifications
<p>The scale (single-storey) and general style of the dwelling is consistent with that of the streetscape and wider HCA. Dwelling contributes positively to the streetscape and wider HCA, particularly in comparison to Non-Contributory buildings.</p> <p>The dwelling features appropriately proportioned and positioned fenestrations, an appropriate roof form (gabled or hipped) and other features consistent with the architectural character of the area (e.g. front verandah with timber or brick posts, timber detailing, corrugated metal roofing, etc). The contributory value of the dwelling is limited however by either:</p> <ul style="list-style-type: none"> • External modifications that have in some way obscured the style, scale or design intent of the building and have resulted in less physical integrity than Contributory 1 buildings. • Being a later dwelling constructed in an appropriate referential style, but comprising little to no fabric of intrinsic heritage significance. 		<p>An extension has been built onto the southern portion of the dwelling. this has been done in a sympathetic style as does not detract from the heritage streetscape.</p>

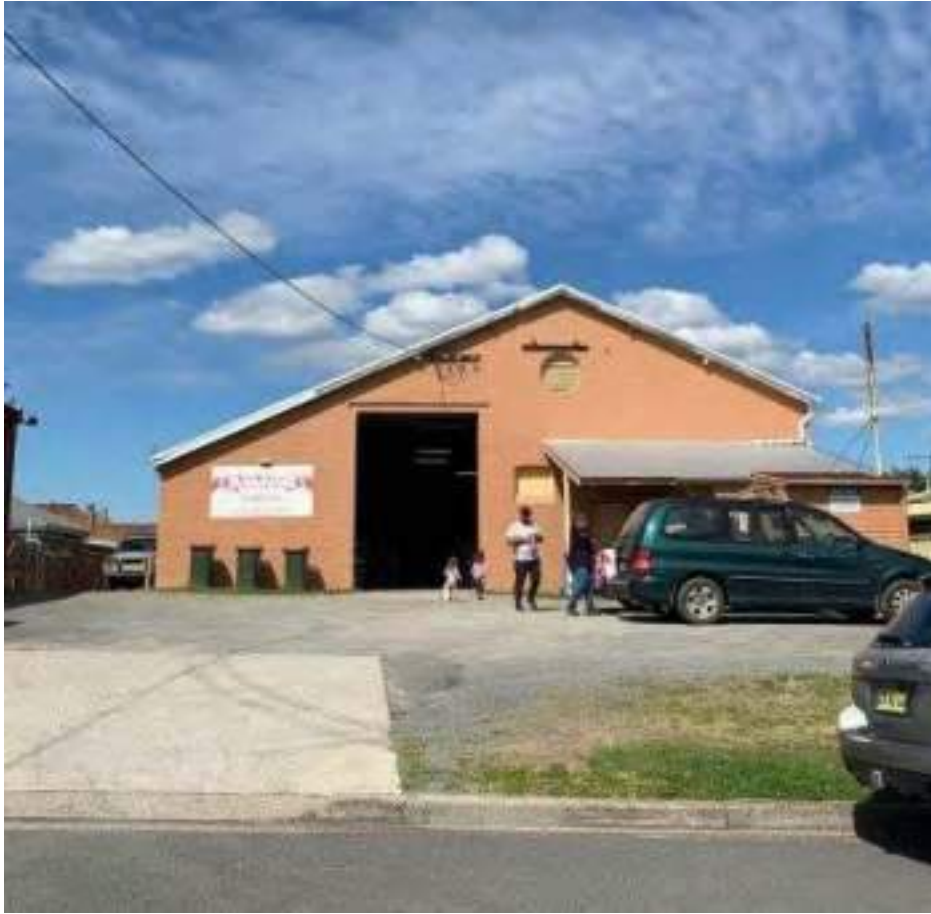
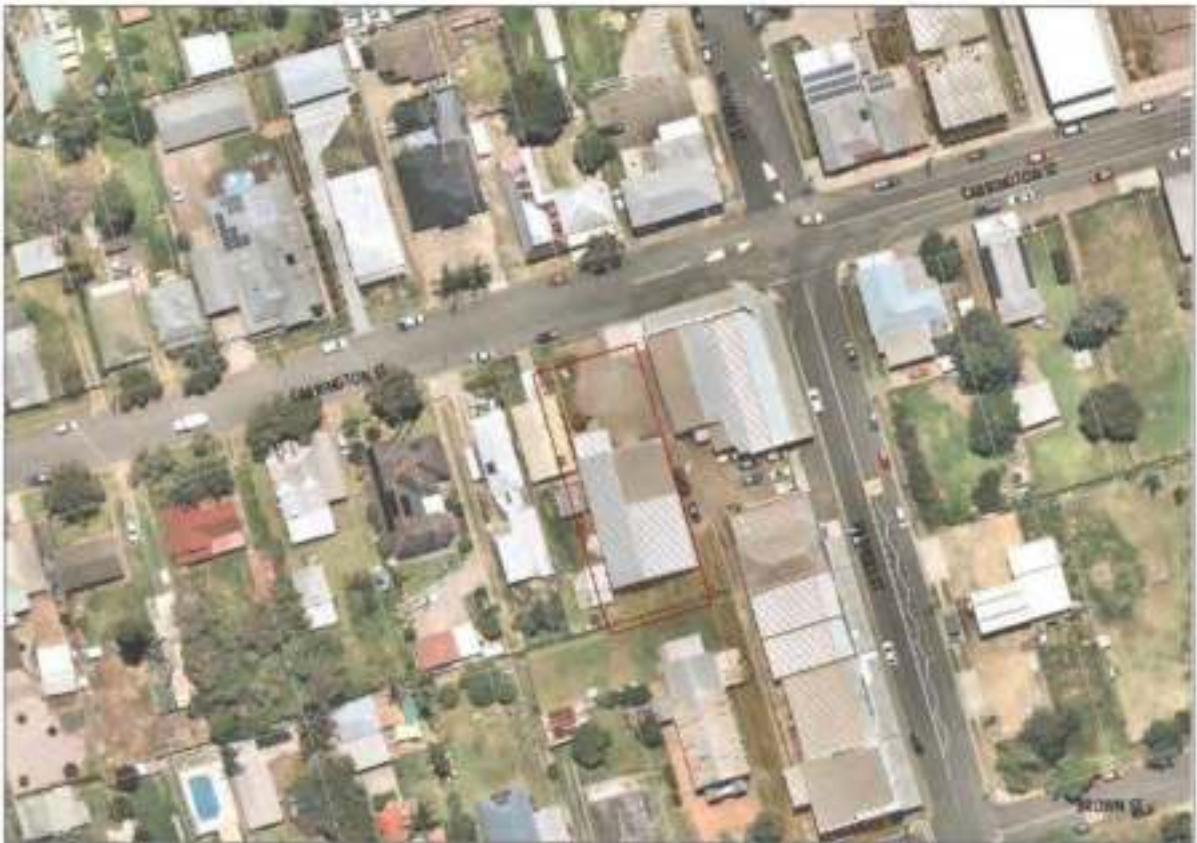
76 CARRINGTON STREET, WEST WALLSEND 2286

Conservation Area Contribution Level	Est. Construction Date	Previous studies and/or community input
Contributory 2	Early to late 20 th century (broad range)	No prior heritage assessments or research undertaken.
Assessment Text		Observed Modifications
<p>The scale (single-storey) and general style of the dwelling is consistent with that of the streetscape and wider HCA. Dwelling contributes positively to the streetscape and wider HCA, particularly in comparison to Non-Contributory buildings.</p> <p>The dwelling features appropriately proportioned and positioned fenestrations, an appropriate roof form (gabled or hipped) and other features consistent with the architectural character of the area (e.g. front verandah with timber or brick posts, timber detailing, corrugated metal roofing, etc). The contributory value of the dwelling is limited however by either:</p> <ul style="list-style-type: none"> • External modifications that have in some way obscured the style, scale or design intent of the building and have resulted in less physical integrity than Contributory 1 buildings. • Being a later dwelling constructed in an appropriate referential style, but comprising little to no fabric of intrinsic heritage significance. 		No modifications observed.

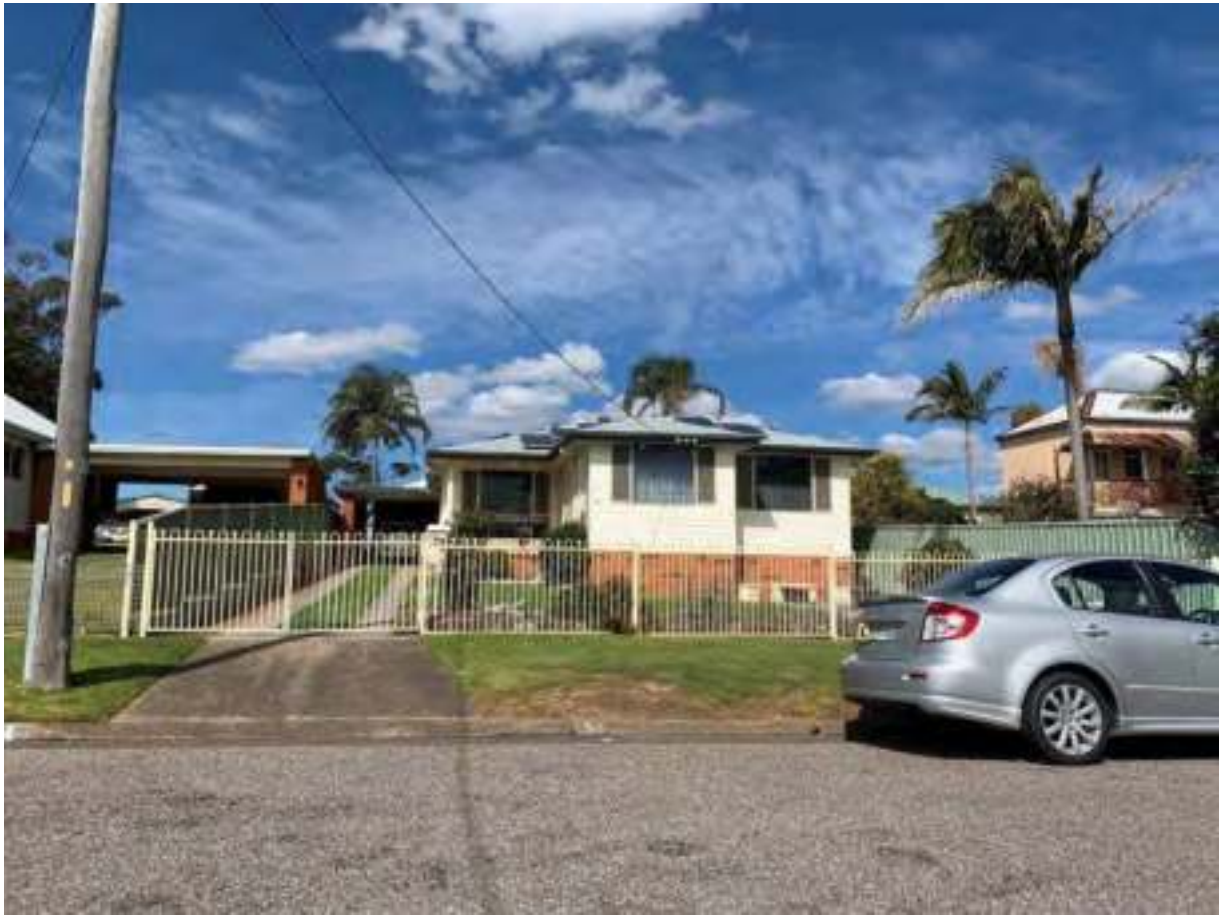
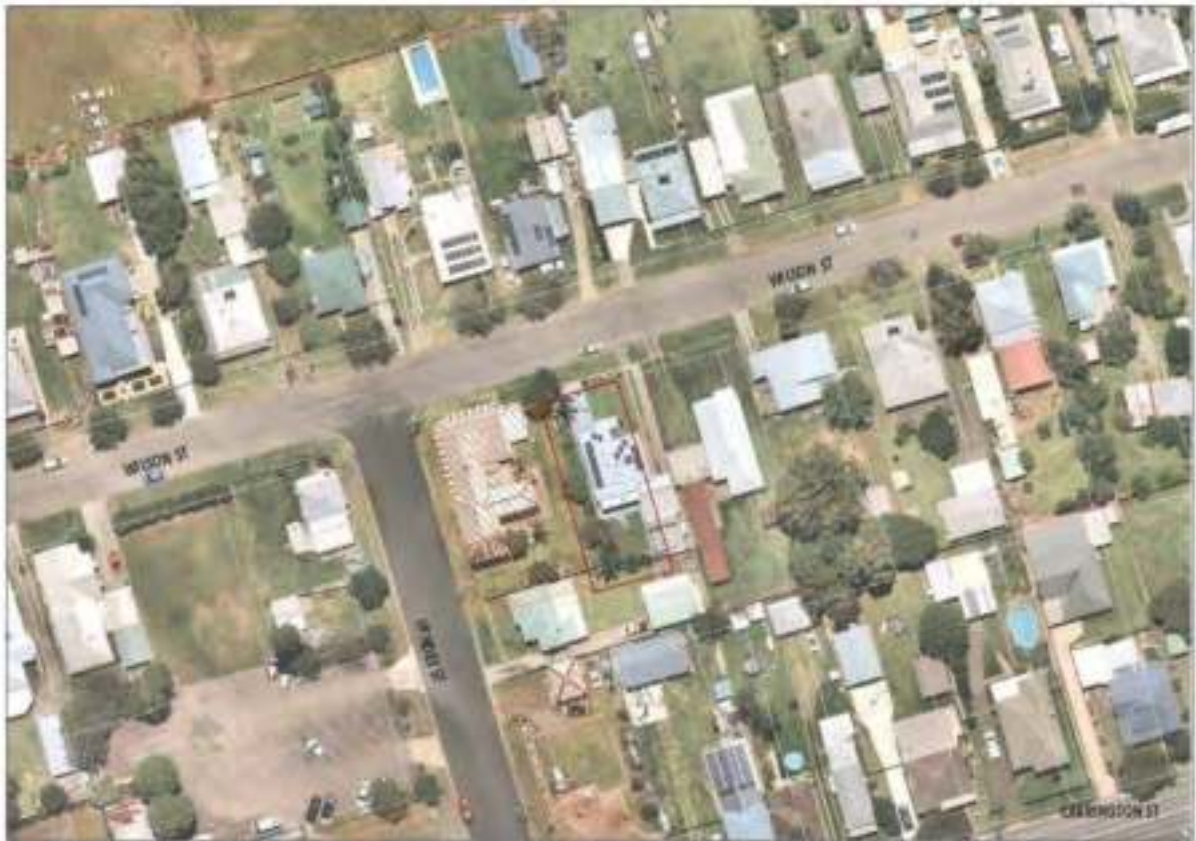
34 WILSON STREET, WEST WALLSEND 2286

Conservation Area Contribution Level	Est. Construction Date	Previous studies and/or community input
Contributory 2	Early to late 20 th century (broad range)	No prior heritage assessments or research undertaken.
Assessment Text		Observed Modifications
<p>The scale (single-storey) and general style of the dwelling is consistent with that of the streetscape and wider HCA. Dwelling contributes positively to the streetscape and wider HCA, particularly in comparison to Non-Contributory buildings.</p> <p>The dwelling features appropriately proportioned and positioned fenestrations, an appropriate roof form (gabled or hipped) and other features consistent with the architectural character of the area (e.g. front verandah with timber or brick posts, timber detailing, corrugated metal roofing, etc). The contributory value of the dwelling is limited however by either:</p> <ul style="list-style-type: none"> • External modifications that have in some way obscured the style, scale or design intent of the building and have resulted in less physical integrity than Contributory 1 buildings. • Being a later dwelling constructed in an appropriate referential style, but comprising little to no fabric of intrinsic heritage significance. 		<p>Solar panels are highly visible along the northern and eastern portions of the roof.</p> <p>All visible windows are contemporary in style.</p> <p>An extension has been built onto the southern portion of the dwelling. This is not visible from the street and as such does not detract from the heritage streetscape.</p>

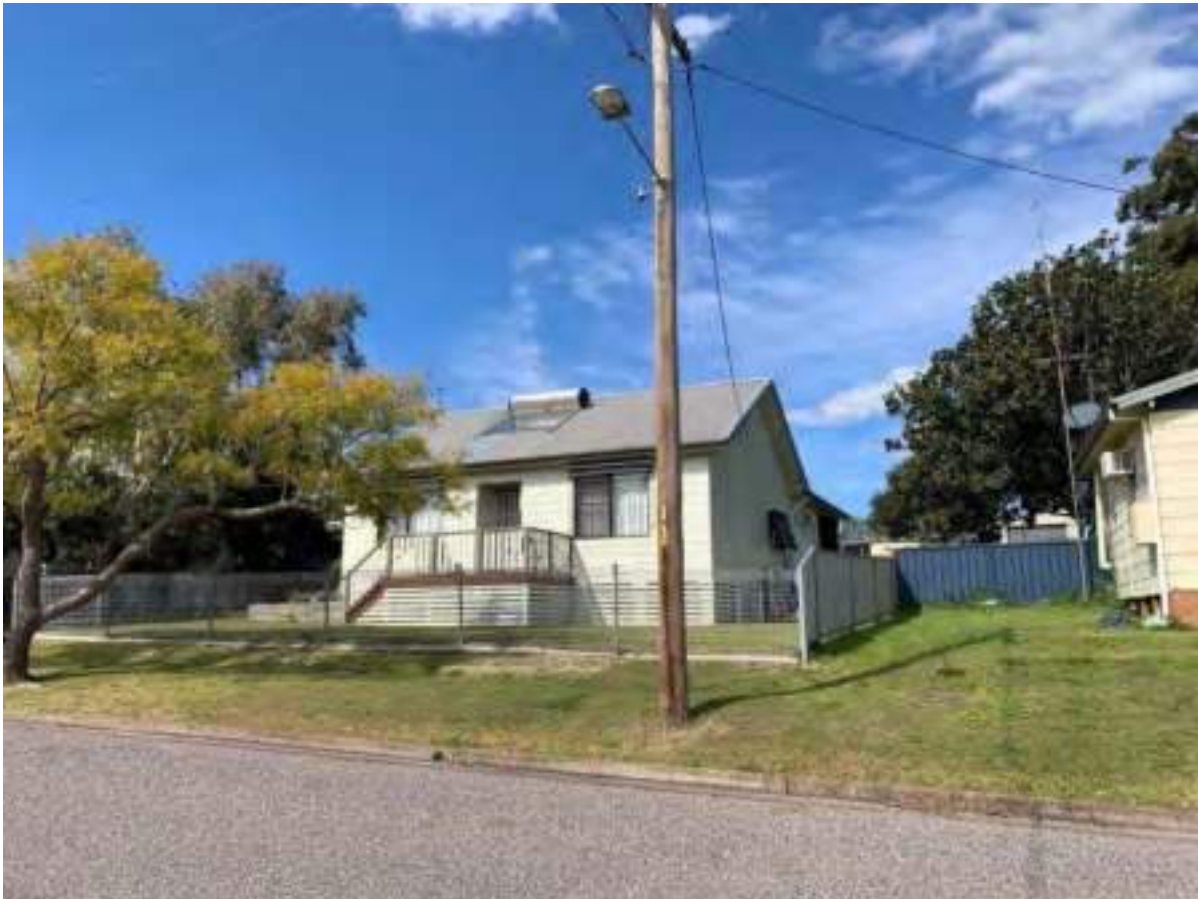
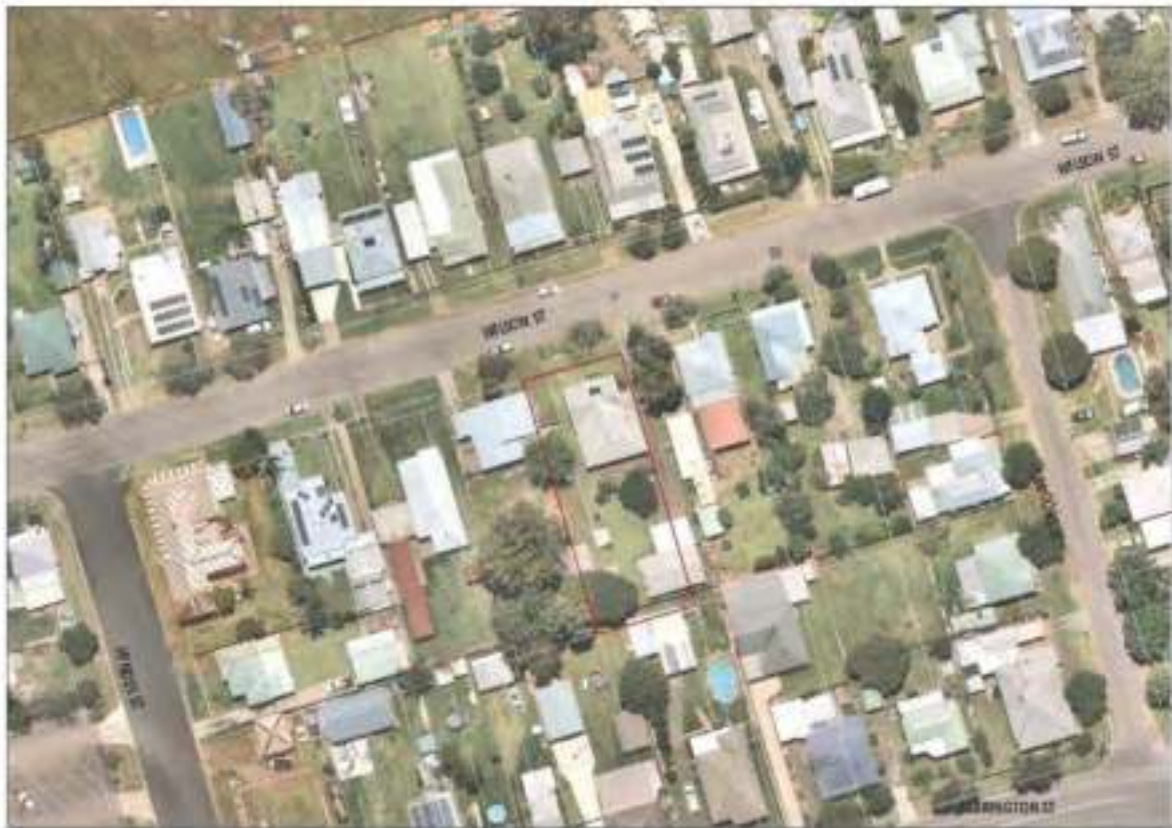
28 WILSON STREET, WEST WALLSEND 2286

Conservation Area Contribution Level	Est. Construction Date	Previous studies and/or community input
Contributory 2	Early to late 20 th century (broad range)	No prior heritage assessments or research undertaken.
Assessment Text		Observed Modifications
<p>The scale (single-storey) and general style of the dwelling is consistent with that of the streetscape and wider HCA. Dwelling contributes positively to the streetscape and wider HCA, particularly in comparison to Non-Contributory buildings.</p> <p>The dwelling features appropriately proportioned and positioned fenestrations, an appropriate roof form (gabled or hipped) and other features consistent with the architectural character of the area (e.g. front verandah with timber or brick posts, timber detailing, corrugated metal roofing, etc). The contributory value of the dwelling is limited however by either:</p> <ul style="list-style-type: none"> • External modifications that have in some way obscured the style, scale or design intent of the building and have resulted in less physical integrity than Contributory 1 buildings. • Being a later dwelling constructed in an appropriate referential style, but comprising little to no fabric of intrinsic heritage significance. 		<p>A heating panel is highly visible along the northern portion of the dwelling.</p> <p>The veranda, timber balustrade and associated staircase are contemporary additions to the dwelling.</p> <p>All visible windows are contemporary in style.</p>

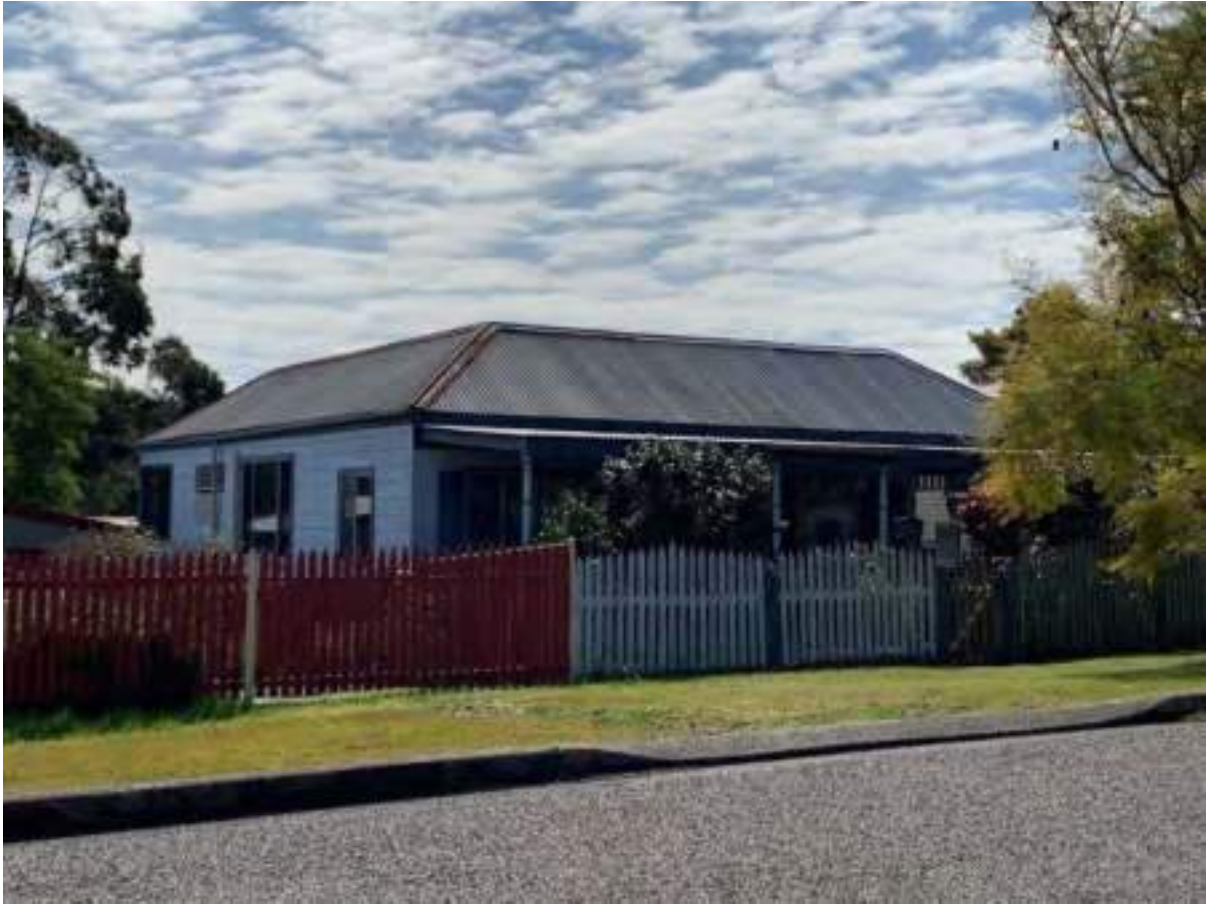
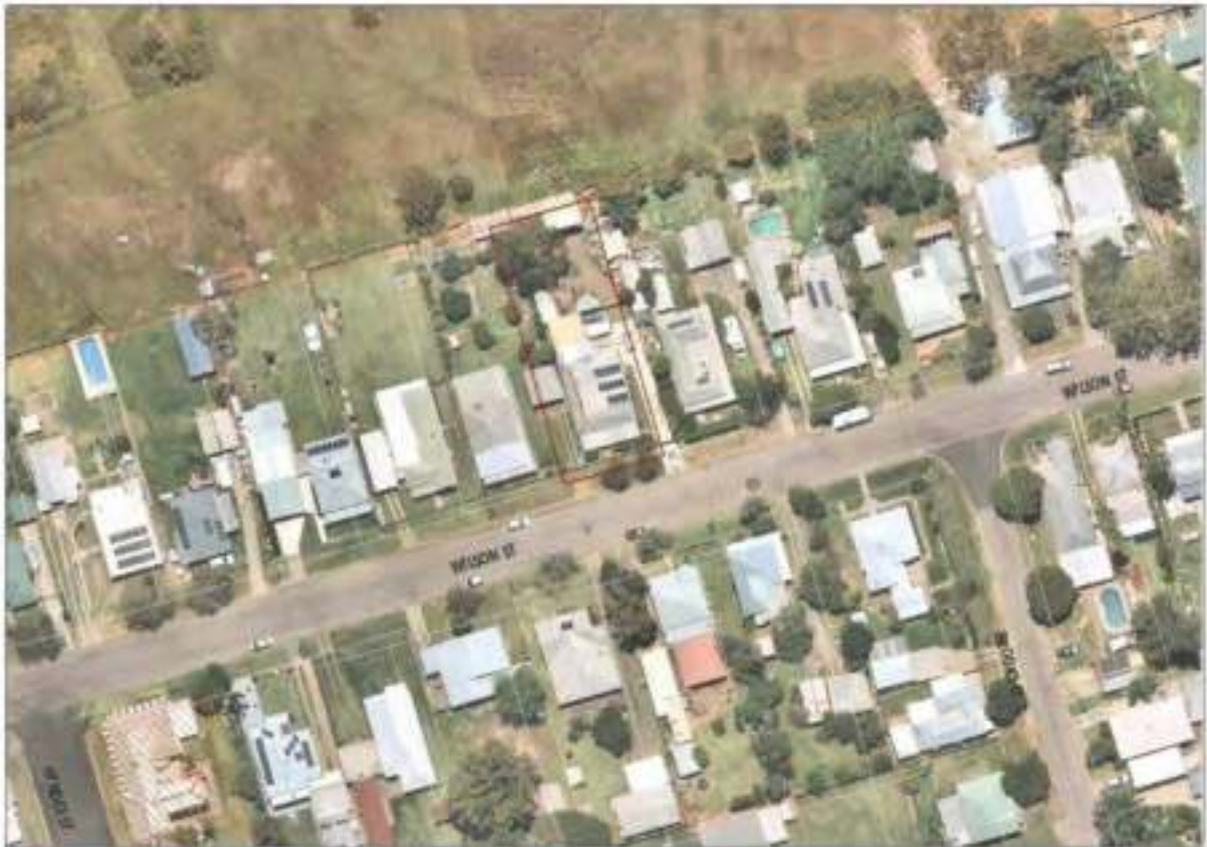
25 WILSON STREET, WEST WALLSEND 2286

Conservation Area Contribution Level	Est. Construction Date	Previous studies and/or community input
Contributory 2	Early to late 20 th century (broad range)	No prior heritage assessments or research undertaken.
Assessment Text		Observed Modifications
<p>The scale (single-storey) and general style of the dwelling is consistent with that of the streetscape and wider HCA. Dwelling contributes positively to the streetscape and wider HCA, particularly in comparison to Non-Contributory buildings.</p> <p>The dwelling features appropriately proportioned and positioned fenestrations, an appropriate roof form (gabled or hipped) and other features consistent with the architectural character of the area (e.g. front verandah with timber or brick posts, timber detailing, corrugated metal roofing, etc). The contributory value of the dwelling is limited however by either:</p> <ul style="list-style-type: none"> • External modifications that have in some way obscured the style, scale or design intent of the building and have resulted in less physical integrity than Contributory 1 buildings. • Being a later dwelling constructed in an appropriate referential style, but comprising little to no fabric of intrinsic heritage significance. 		<p>The visible windows are contemporary in style.</p> <p>The ornate timber posts and valance are likely a contemporary replication of a heritage style, and as such do not detract from the heritage streetscape.</p> <p>An extension has been constructed at the back north eastern portion of the dwelling. this has been built in a sympathetic style and does not detract from the heritage streetscape.</p>

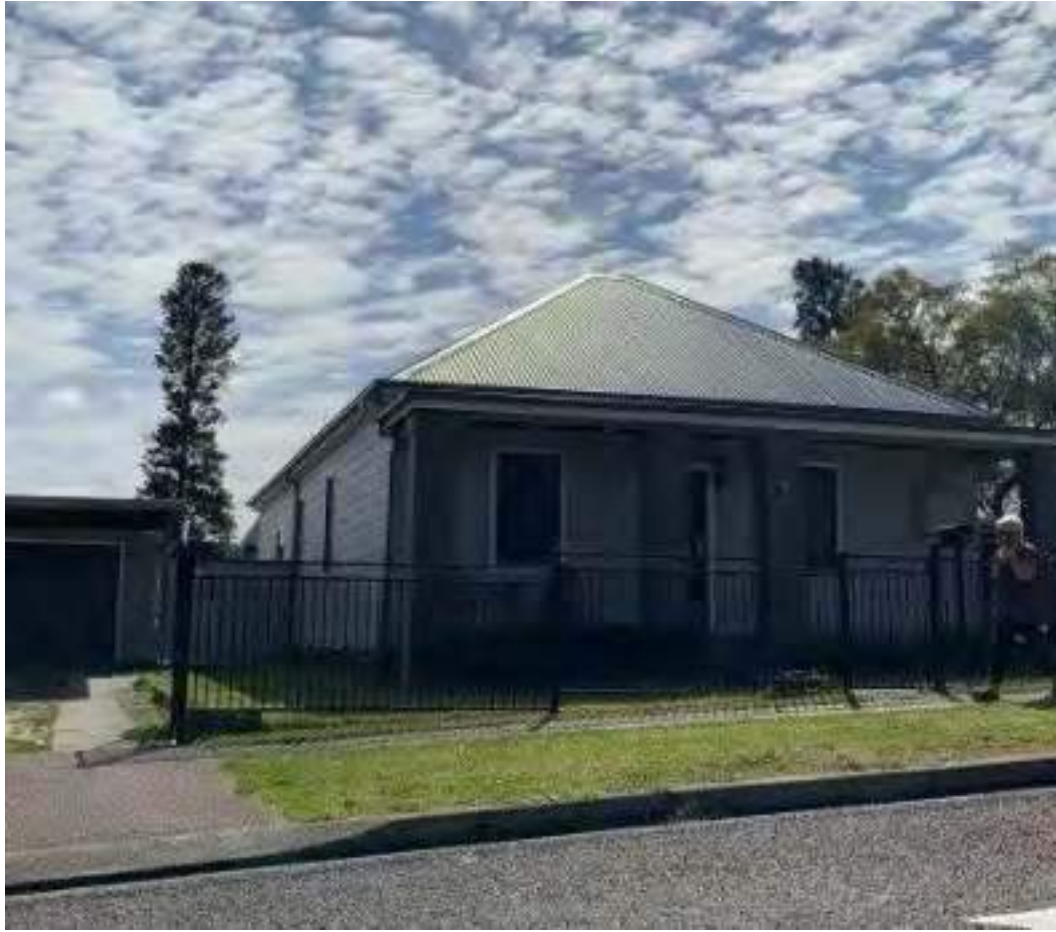
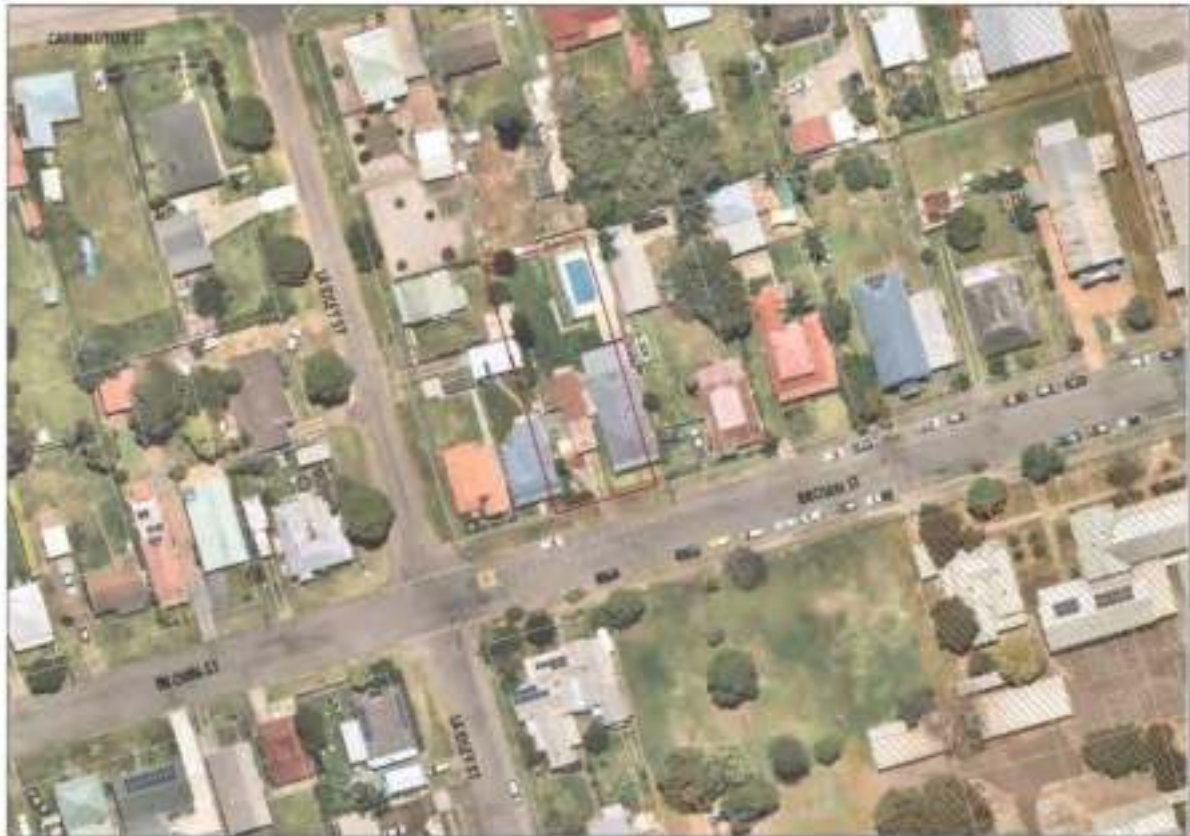
51 BROWN STREET, WEST WALLSEND 2286

Conservation Area Contribution Level	Est. Construction Date	Previous studies and/or community input
Contributory 2	Early to late 20 th century (broad range)	No prior heritage assessments or research undertaken.
Assessment Text		Observed Modifications
<p>The scale (single-storey) and general style of the dwelling is consistent with that of the streetscape and wider HCA. Dwelling contributes positively to the streetscape and wider HCA, particularly in comparison to Non-Contributory buildings.</p> <p>The dwelling features appropriately proportioned and positioned fenestrations, an appropriate roof form (gabled or hipped) and other features consistent with the architectural character of the area (e.g. front verandah with timber or brick posts, timber detailing, corrugated metal roofing, etc). The contributory value of the dwelling is limited however by either:</p> <ul style="list-style-type: none"> • External modifications that have in some way obscured the style, scale or design intent of the building and have resulted in less physical integrity than Contributory 1 buildings. • Being a later dwelling constructed in an appropriate referential style, but comprising little to no fabric of intrinsic heritage significance. 		<p>The brickwork pillars are a contemporary addition, likely replacing an original timber post design.</p> <p>The visible windows are contemporary in style, with additional security screening installed.</p>

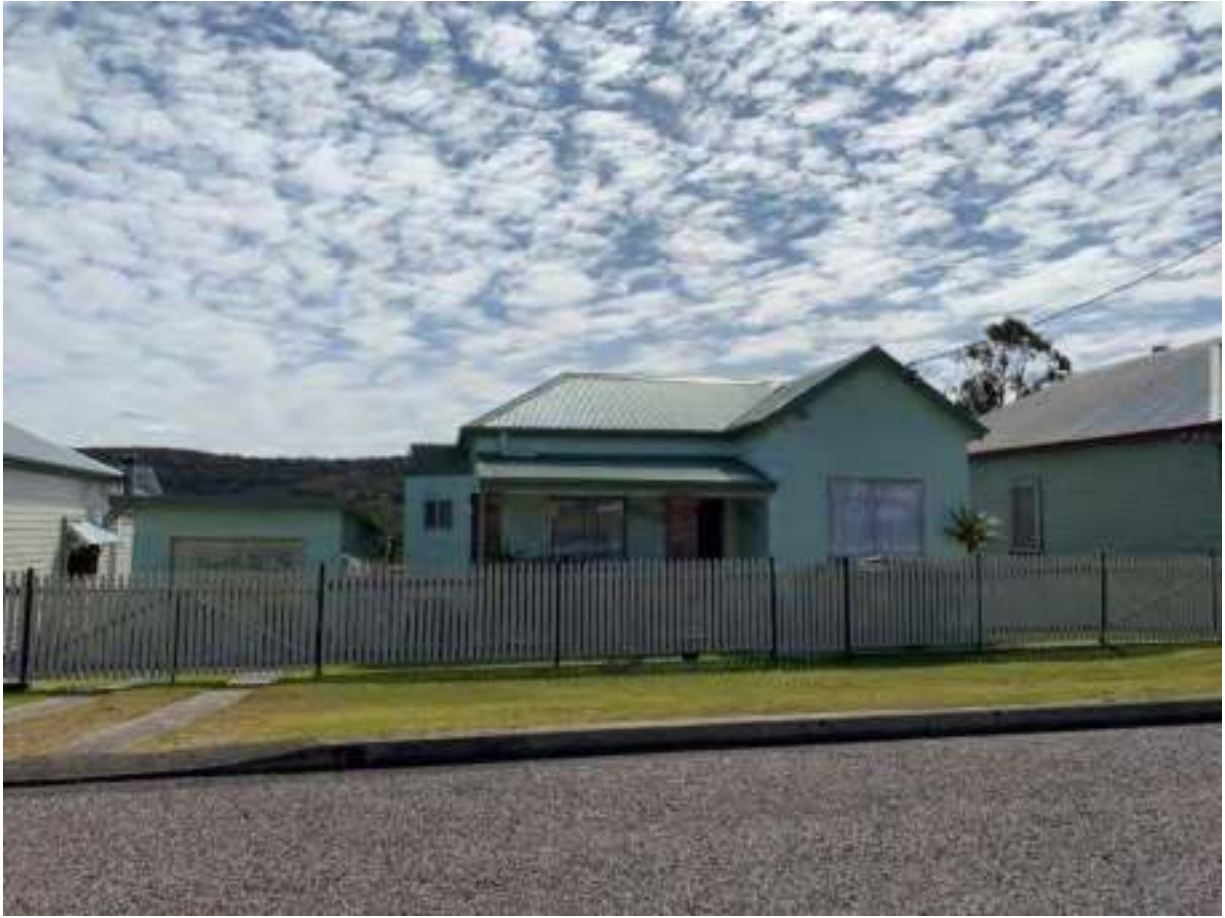
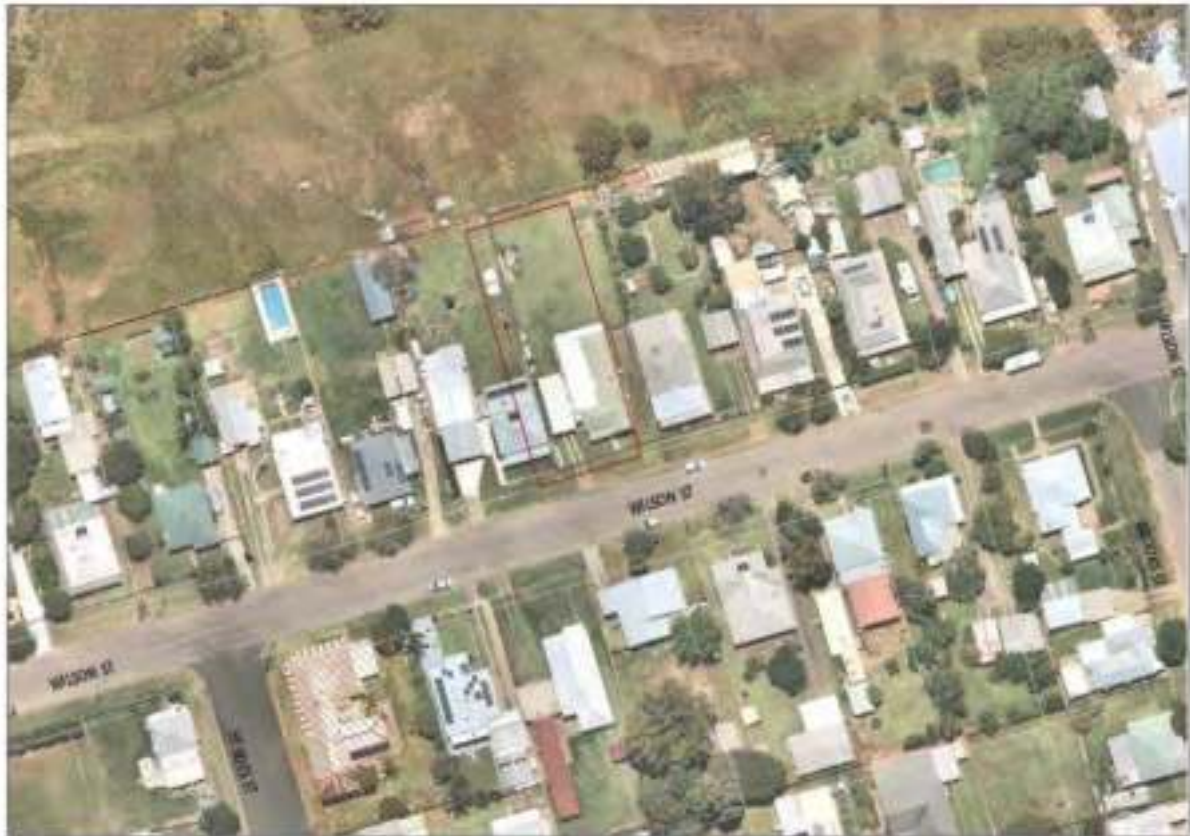
29 WILSON STREET, WEST WALLSEND 2286

Conservation Area Contribution Level	Est. Construction Date	Previous studies and/or community input
Contributory 2	Early to late 20 th century (broad range)	No prior heritage assessments or research undertaken.
Assessment Text		Observed Modifications
<p>The scale (single-storey) and general style of the dwelling is consistent with that of the streetscape and wider HCA. Dwelling contributes positively to the streetscape and wider HCA, particularly in comparison to Non-Contributory buildings.</p> <p>The dwelling features appropriately proportioned and positioned fenestrations, an appropriate roof form (gabled or hipped) and other features consistent with the architectural character of the area (e.g. front verandah with timber or brick posts, timber detailing, corrugated metal roofing, etc). The contributory value of the dwelling is limited however by either:</p> <ul style="list-style-type: none"> • External modifications that have in some way obscured the style, scale or design intent of the building and have resulted in less physical integrity than Contributory 1 buildings. • Being a later dwelling constructed in an appropriate referential style, but comprising little to no fabric of intrinsic heritage significance. 		<p>The brickwork veranda wall and support pillars are a contemporary addition to the dwelling, likely replacing an original timber post and balustrade design.</p> <p>All visible windows are contemporary in style.</p>

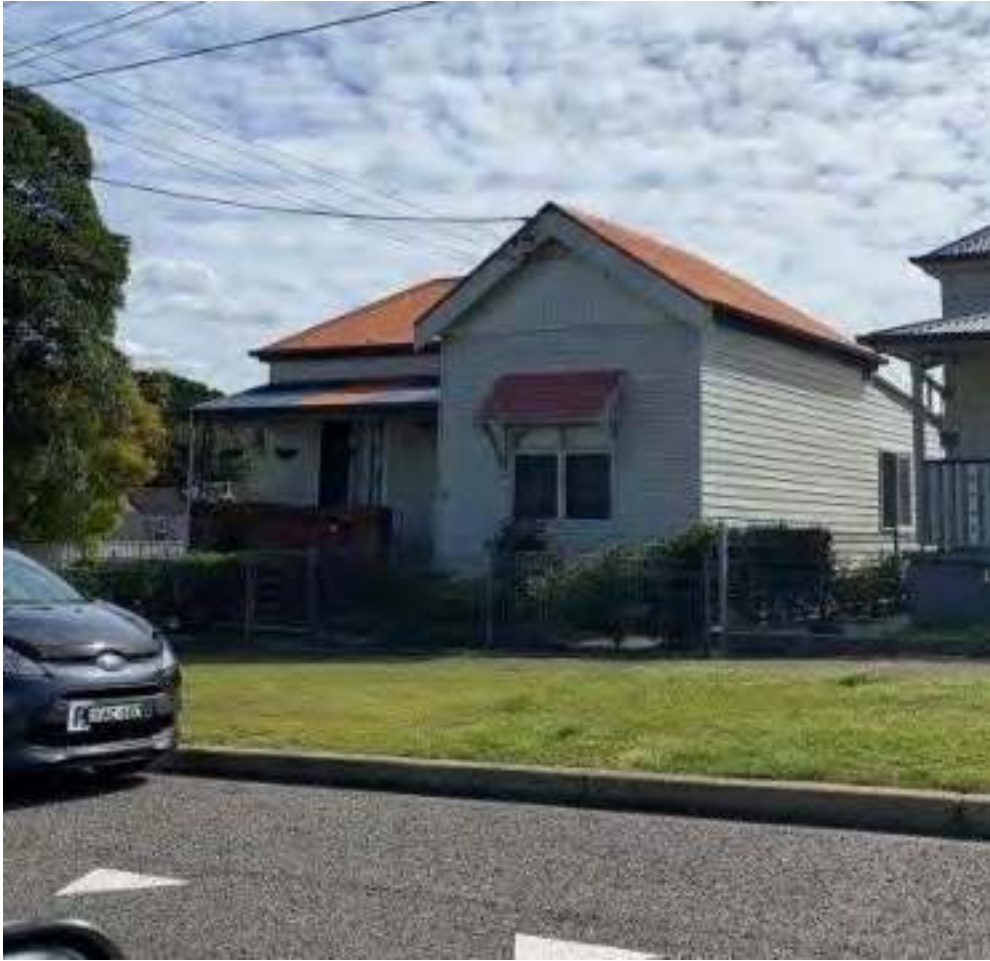
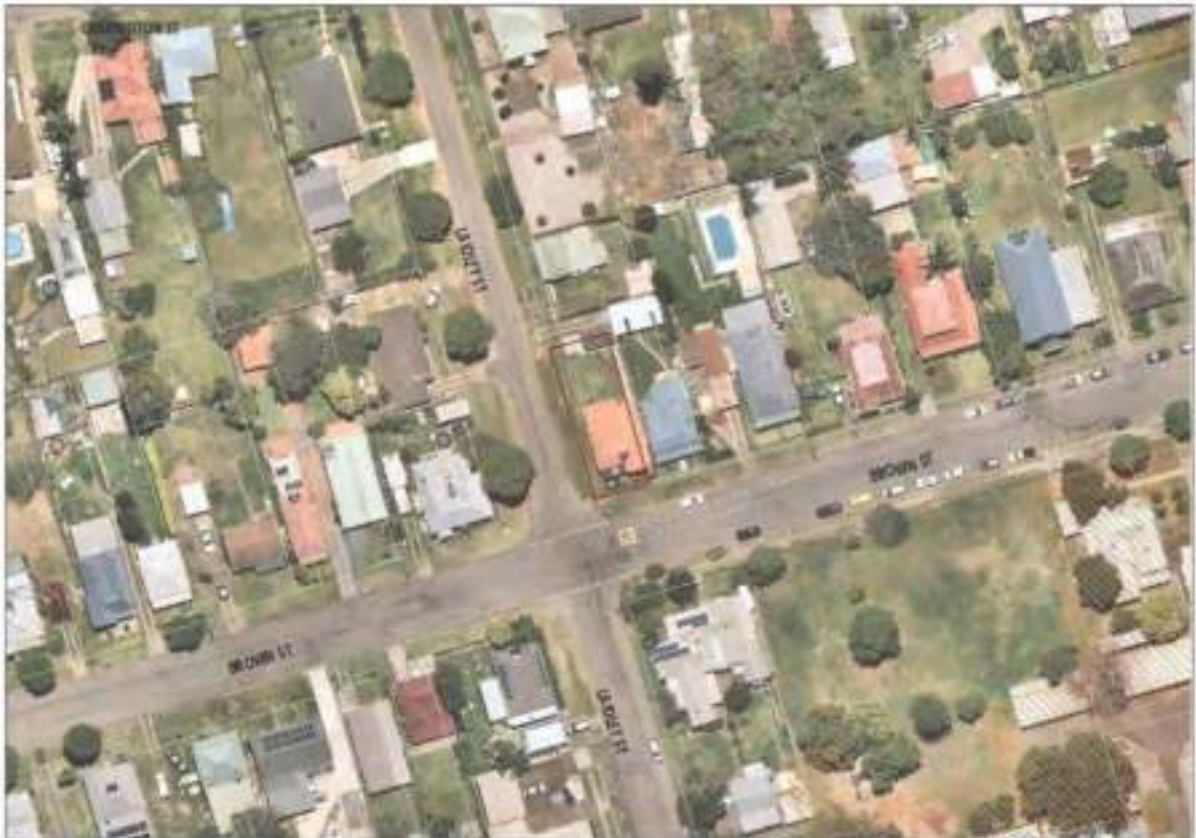
55 BROWN STREET, WEST WALLSEND 2286

Conservation Area Contribution Level	Est. Construction Date	Previous studies and/or community input
Contributory 2	Early to late 20 th century (broad range)	No prior heritage assessments or research undertaken.
Assessment Text		Observed Modifications
<p>The scale (single-storey) and general style of the dwelling is consistent with that of the streetscape and wider HCA. Dwelling contributes positively to the streetscape and wider HCA, particularly in comparison to Non-Contributory buildings.</p> <p>The dwelling features appropriately proportioned and positioned fenestrations, an appropriate roof form (gabled or hipped) and other features consistent with the architectural character of the area (e.g. front verandah with timber or brick posts, timber detailing, corrugated metal roofing, etc). The contributory value of the dwelling is limited however by either:</p> <ul style="list-style-type: none"> • External modifications that have in some way obscured the style, scale or design intent of the building and have resulted in less physical integrity than Contributory 1 buildings. • Being a later dwelling constructed in an appropriate referential style, but comprising little to no fabric of intrinsic heritage significance. 		<p>The visible windows are contemporary in style.</p> <p>The brickwork veranda wall is likely a prior modification, likely replacing an original timber balustrade and posts.</p> <p>The roof, including the veranda roof, has variations of colours. This is a contemporary modification, likely to impart additional colour to the dwelling.</p> <p>The dwelling façade has lost the majority of its original decorative features. Commonly similar dwellings have decorative.</p>
