APPENDIX 2

Building Assessment Sheets (Inventory Sheets)

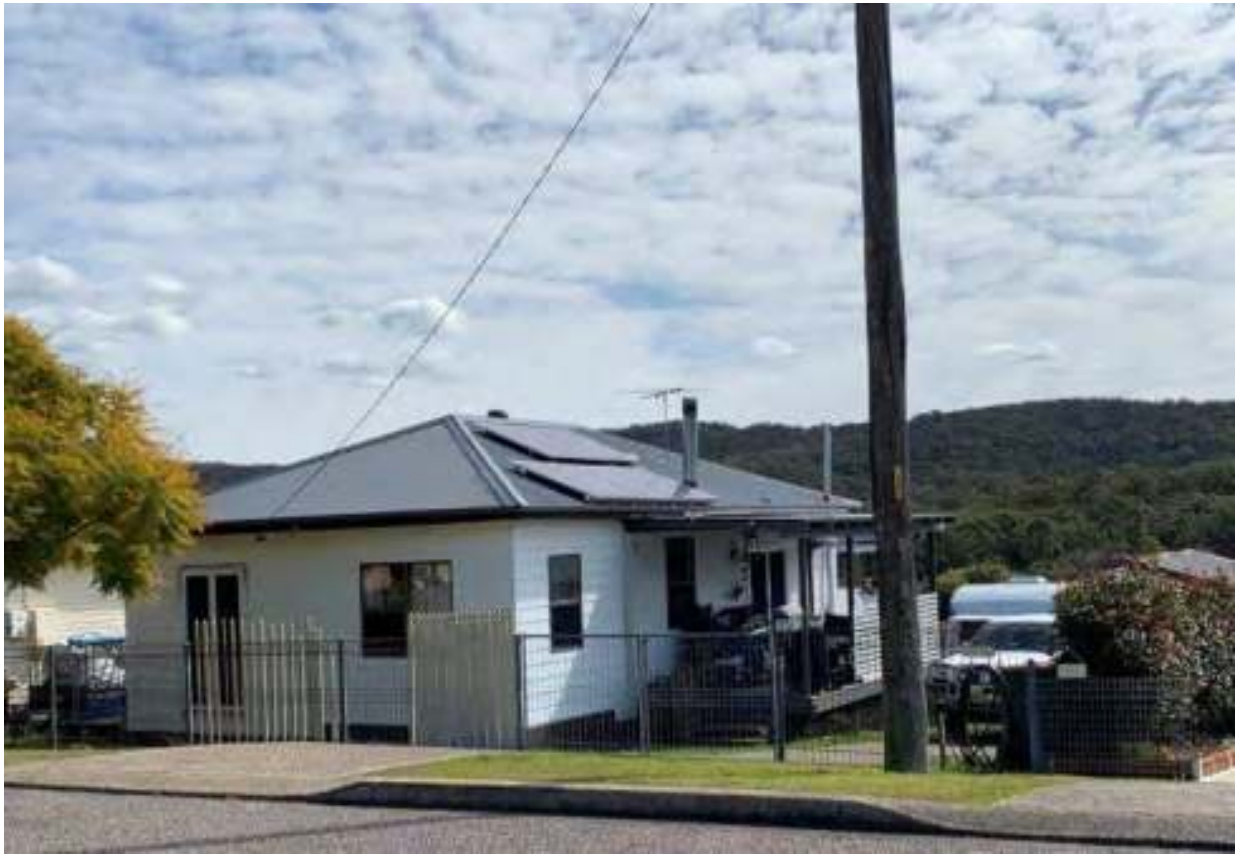
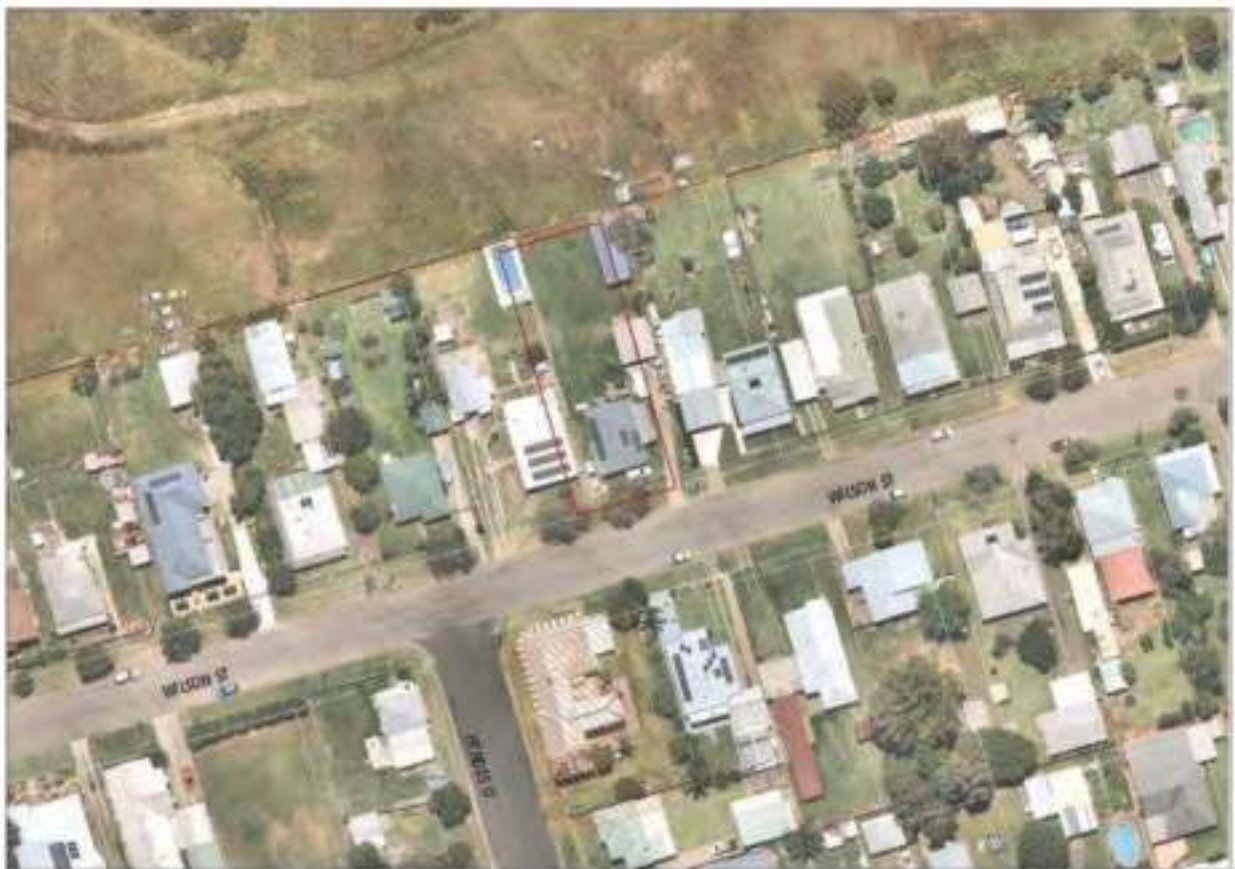
33 WILSON STREET, WEST WALLSEND 2286

Conservation Area Contribution Level	Est. Construction Date	Previous studies and/or community input
Contributory 2	Early to late 20 th century (broad range)	No prior heritage assessments or research undertaken.
Assessment Text		Observed Modifications
<p>The scale (single-storey) and general style of the dwelling is consistent with that of the streetscape and wider HCA. Dwelling contributes positively to the streetscape and wider HCA, particularly in comparison to Non-Contributory buildings.</p> <p>The dwelling features appropriately proportioned and positioned fenestrations, an appropriate roof form (gabled or hipped) and other features consistent with the architectural character of the area (e.g. front verandah with timber or brick posts, timber detailing, corrugated metal roofing, etc). The contributory value of the dwelling is limited however by either:</p> <ul style="list-style-type: none"> • External modifications that have in some way obscured the style, scale or design intent of the building and have resulted in less physical integrity than Contributory 1 buildings. • Being a later dwelling constructed in an appropriate referential style, but comprising little to no fabric of intrinsic heritage significance. 		<p>Solar panels are visible along the eastern and western portions of the roof.</p> <p>The flat veranda roof and veranda extension is a contemporary addition.</p> <p>The timber balustrade is similarly a contemporary addition.</p> <p>All windows are contemporary in style.</p>

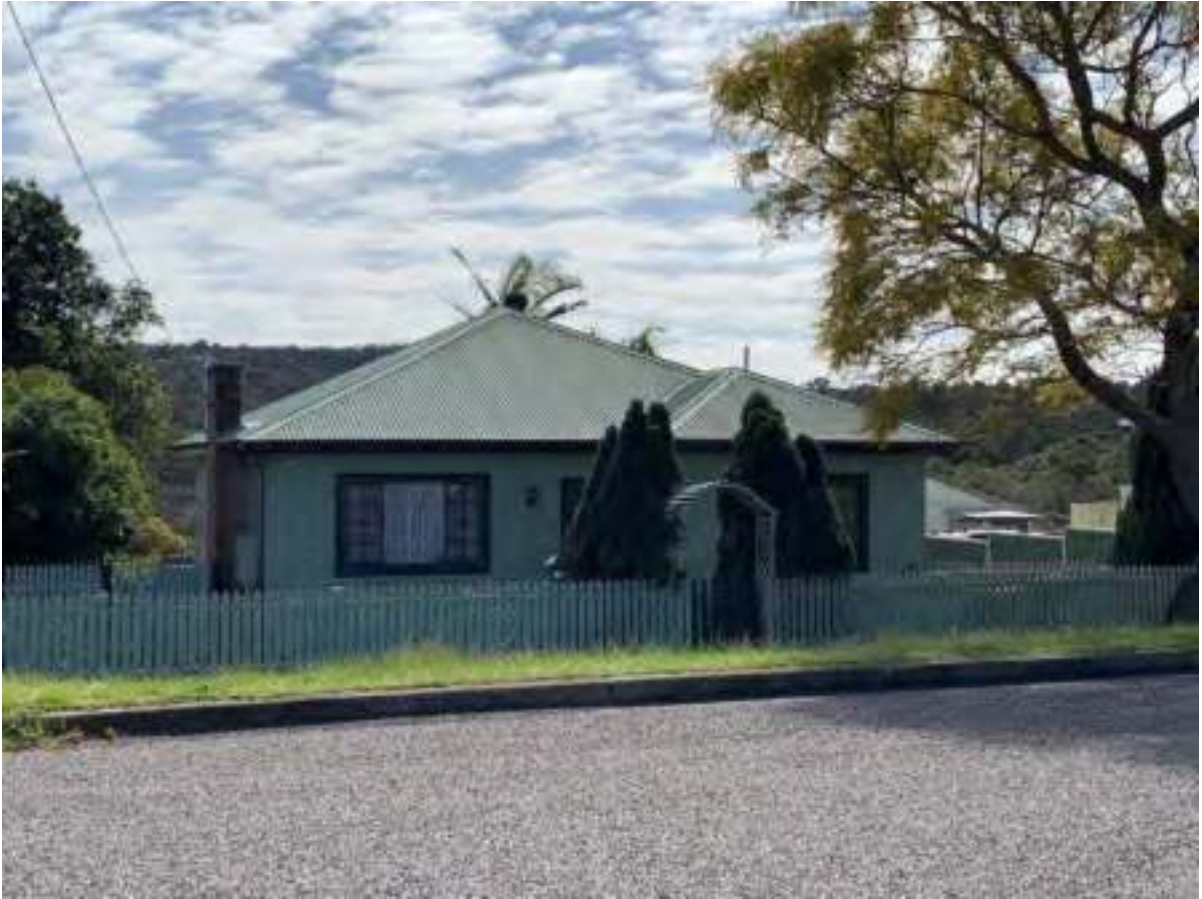
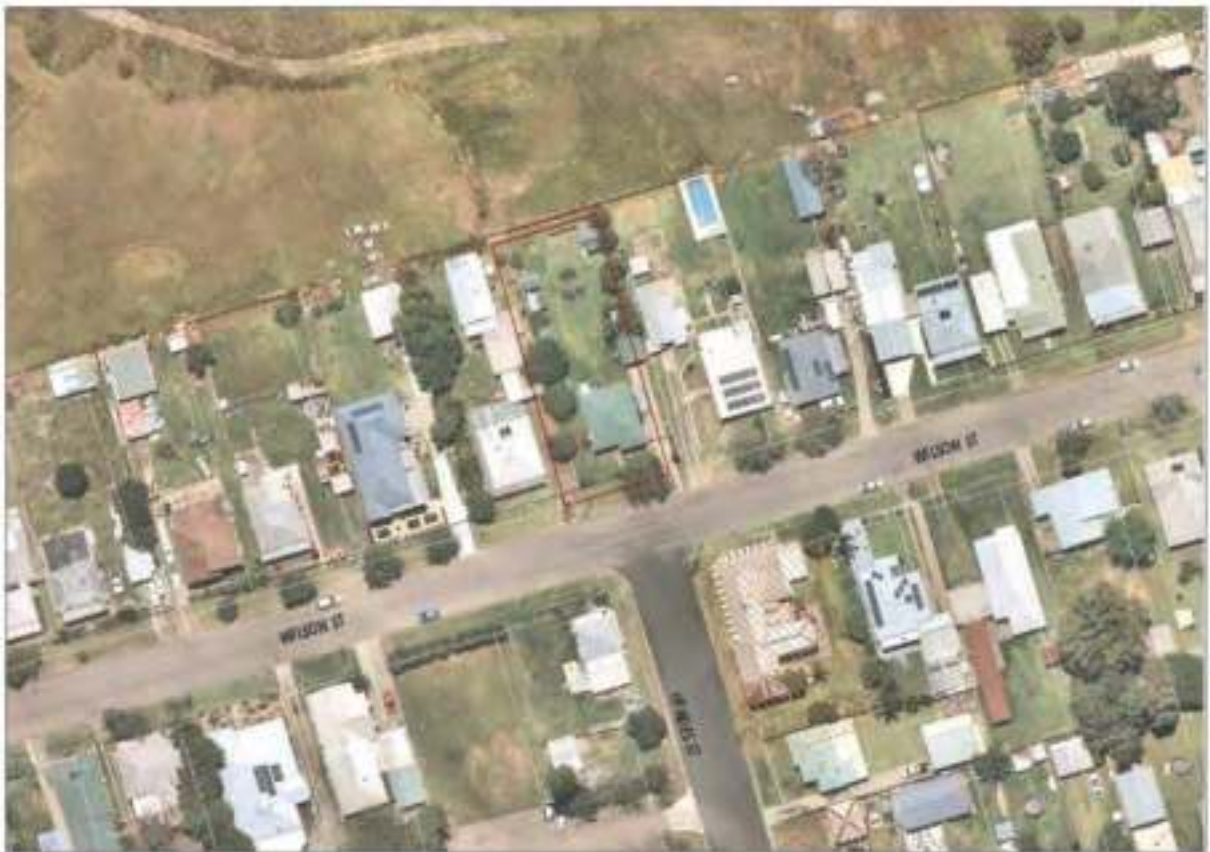
37 WILSON STREET, WEST WALLSEND 2286

Conservation Area Contribution Level	Est. Construction Date	Previous studies and/or community input
Contributory 2	Early to late 20 th century (broad range)	No prior heritage assessments or research undertaken.
Assessment Text		Observed Modifications
<p>The scale (single-storey) and general style of the dwelling is consistent with that of the streetscape and wider HCA. Dwelling contributes positively to the streetscape and wider HCA, particularly in comparison to Non-Contributory buildings.</p> <p>The dwelling features appropriately proportioned and positioned fenestrations, an appropriate roof form (gabled or hipped) and other features consistent with the architectural character of the area (e.g. front verandah with timber or brick posts, timber detailing, corrugated metal roofing, etc). The contributory value of the dwelling is limited however by either:</p> <ul style="list-style-type: none"> • External modifications that have in some way obscured the style, scale or design intent of the building and have resulted in less physical integrity than Contributory 1 buildings. • Being a later dwelling constructed in an appropriate referential style, but comprising little to no fabric of intrinsic heritage significance. 		All visible windows are contemporary in style.

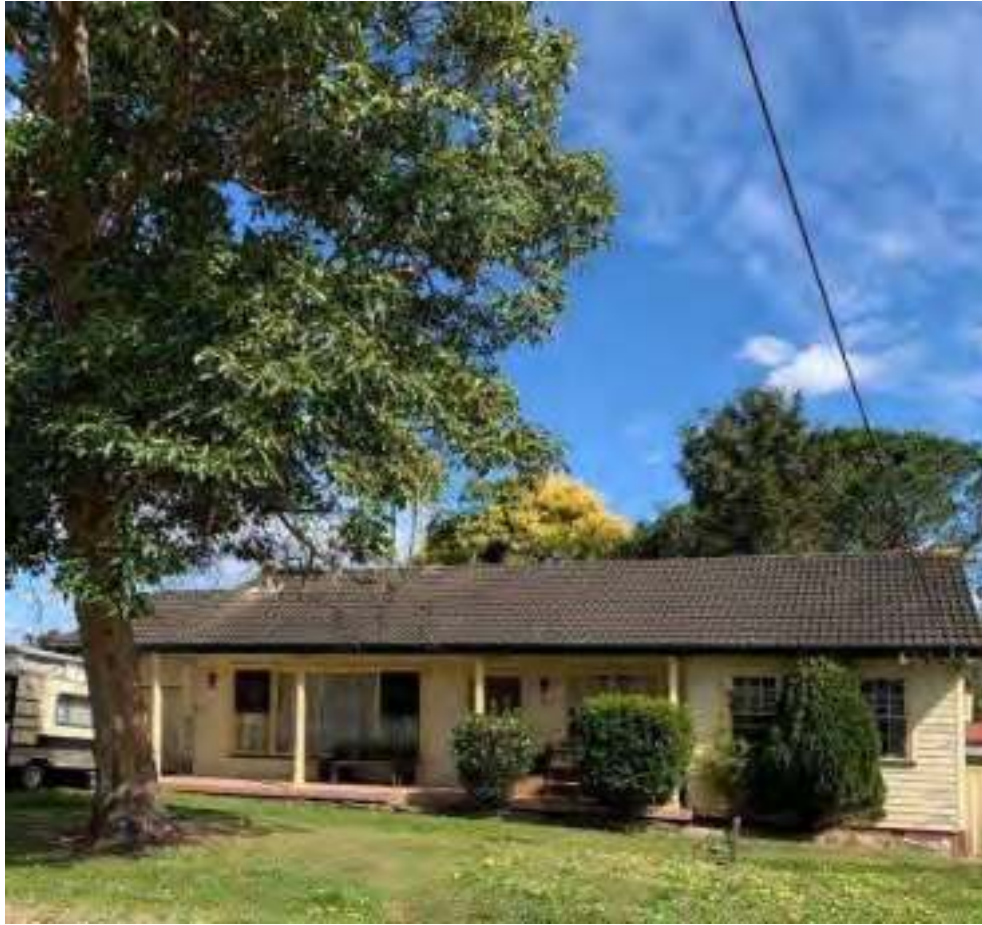
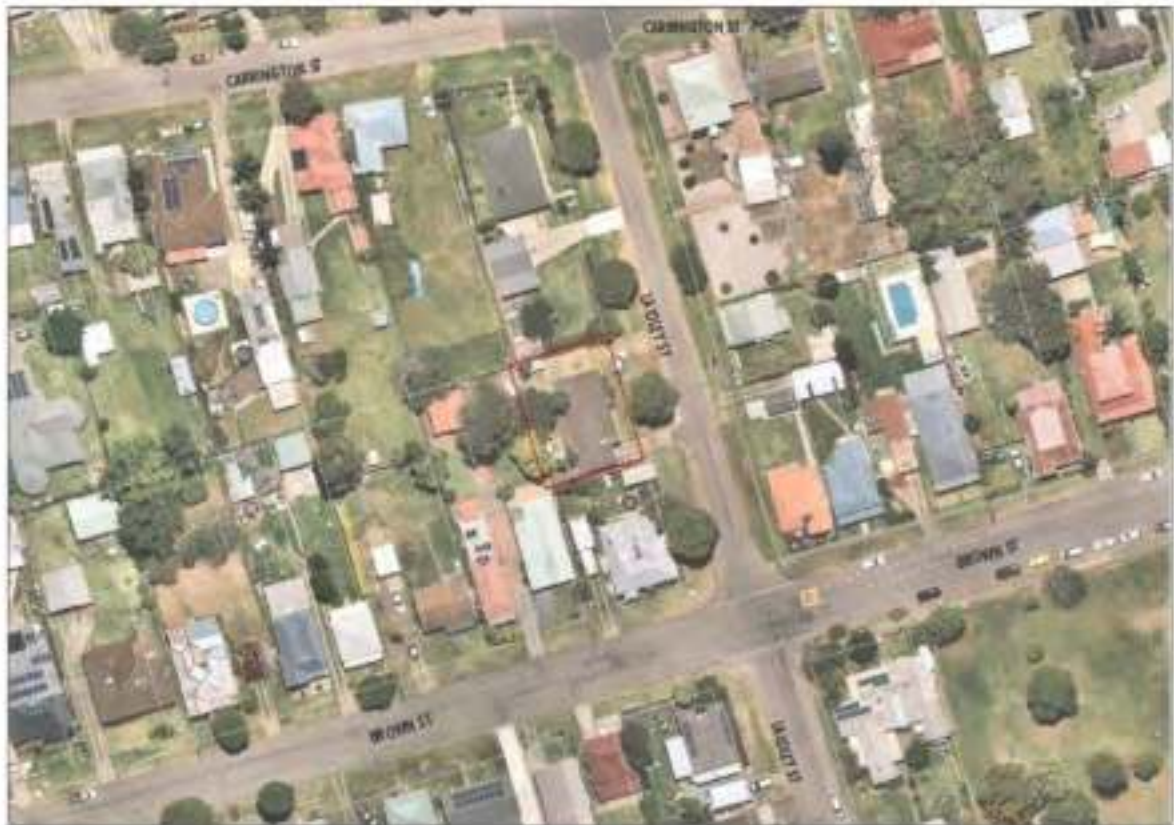
16 LAIDLEY STREET, WEST WALLSEND 2286

Conservation Area Contribution Level	Est. Construction Date	Previous studies and/or community input
Contributory 2	Early to late 20 th century (broad range)	No prior heritage assessments or research undertaken.
Assessment Text		Observed Modifications
<p>The scale (single-storey) and general style of the dwelling is consistent with that of the streetscape and wider HCA. Dwelling contributes positively to the streetscape and wider HCA, particularly in comparison to Non-Contributory buildings.</p> <p>The dwelling features appropriately proportioned and positioned fenestrations, an appropriate roof form (gabled or hipped) and other features consistent with the architectural character of the area (e.g. front verandah with timber or brick posts, timber detailing, corrugated metal roofing, etc). The contributory value of the dwelling is limited however by either:</p> <ul style="list-style-type: none"> • External modifications that have in some way obscured the style, scale or design intent of the building and have resulted in less physical integrity than Contributory 1 buildings. • Being a later dwelling constructed in an appropriate referential style, but comprising little to no fabric of intrinsic heritage significance. 		No modifications observed.

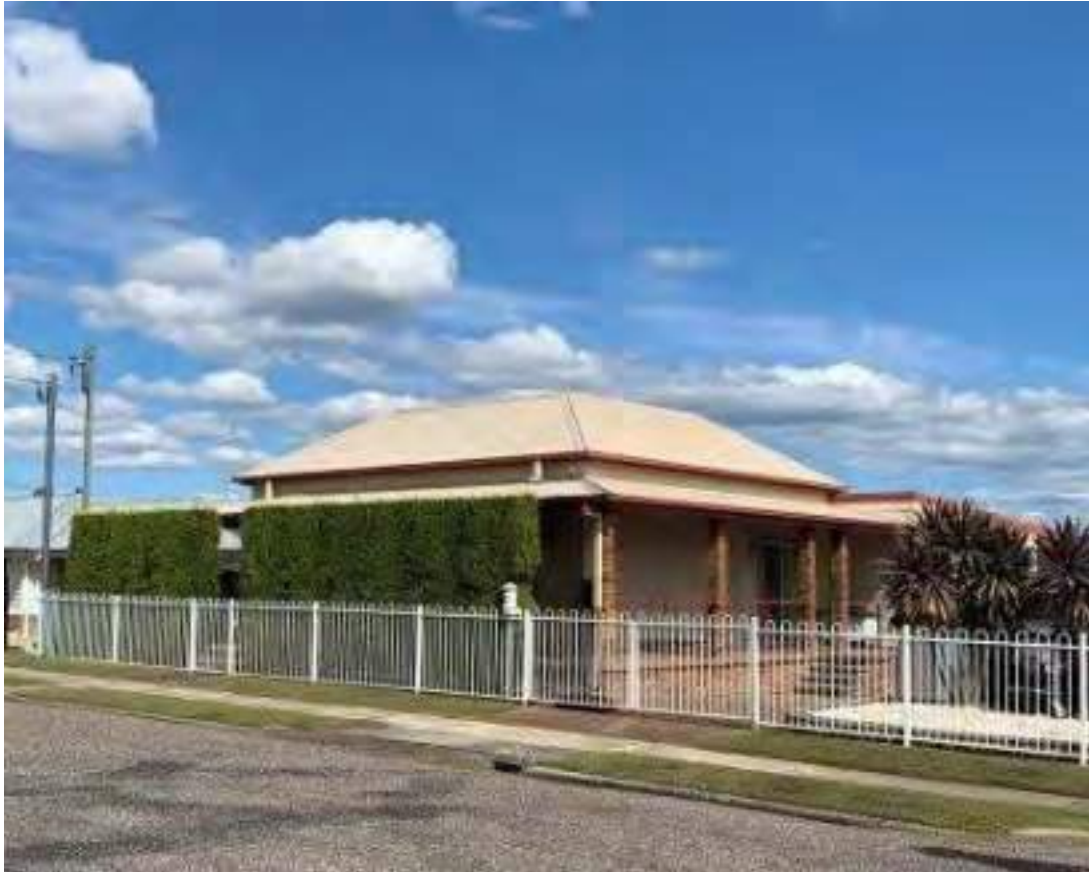
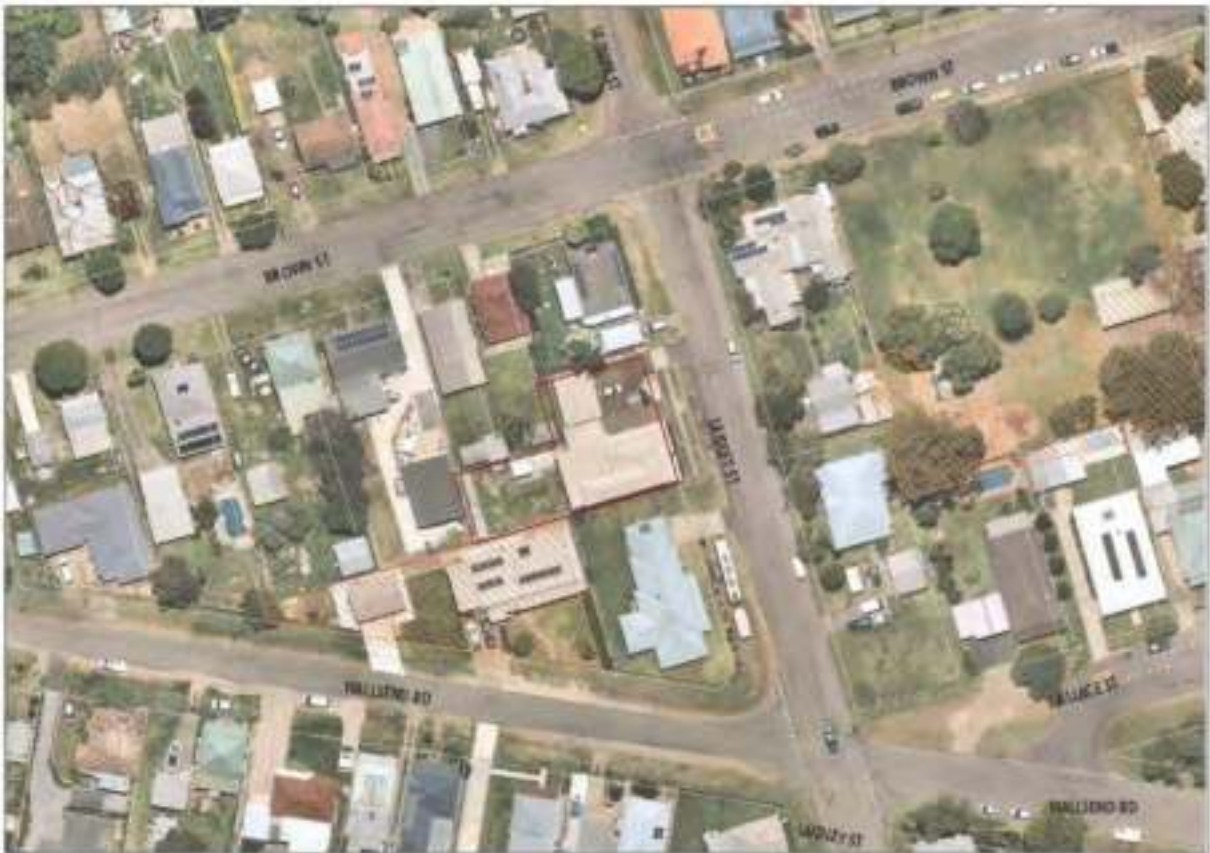
22 LAIDLEY STREET, WEST WALLSEND 2286

Conservation Area Contribution Level	Est. Construction Date	Previous studies and/or community input
Contributory 2	Early to late 20 th century (broad range)	No prior heritage assessments or research undertaken.
Assessment Text		Observed Modifications
<p>The scale (single-storey) and general style of the dwelling is consistent with that of the streetscape and wider HCA. Dwelling contributes positively to the streetscape and wider HCA, particularly in comparison to Non-Contributory buildings.</p> <p>The dwelling features appropriately proportioned and positioned fenestrations, an appropriate roof form (gabled or hipped) and other features consistent with the architectural character of the area (e.g. front verandah with timber or brick posts, timber detailing, corrugated metal roofing, etc). The contributory value of the dwelling is limited however by either:</p> <ul style="list-style-type: none"> • External modifications that have in some way obscured the style, scale or design intent of the building and have resulted in less physical integrity than Contributory 1 buildings. • Being a later dwelling constructed in an appropriate referential style, but comprising little to no fabric of intrinsic heritage significance. 		<p>The brickwork pillars of the veranda are a contemporary addition, likely replacing original timber posts.</p> <p>All visible windows are contemporary in style.</p> <p>The veranda has been extended to wrap around the northern portion of the dwelling, with a timber and metal wire balustrade. Brick and concrete stairs have been installed to accommodate this extension.</p> <p>An additional extension has been constructed at the back western side of the dwelling. this is only partially visible and does not detract from the heritage streetscape.</p>

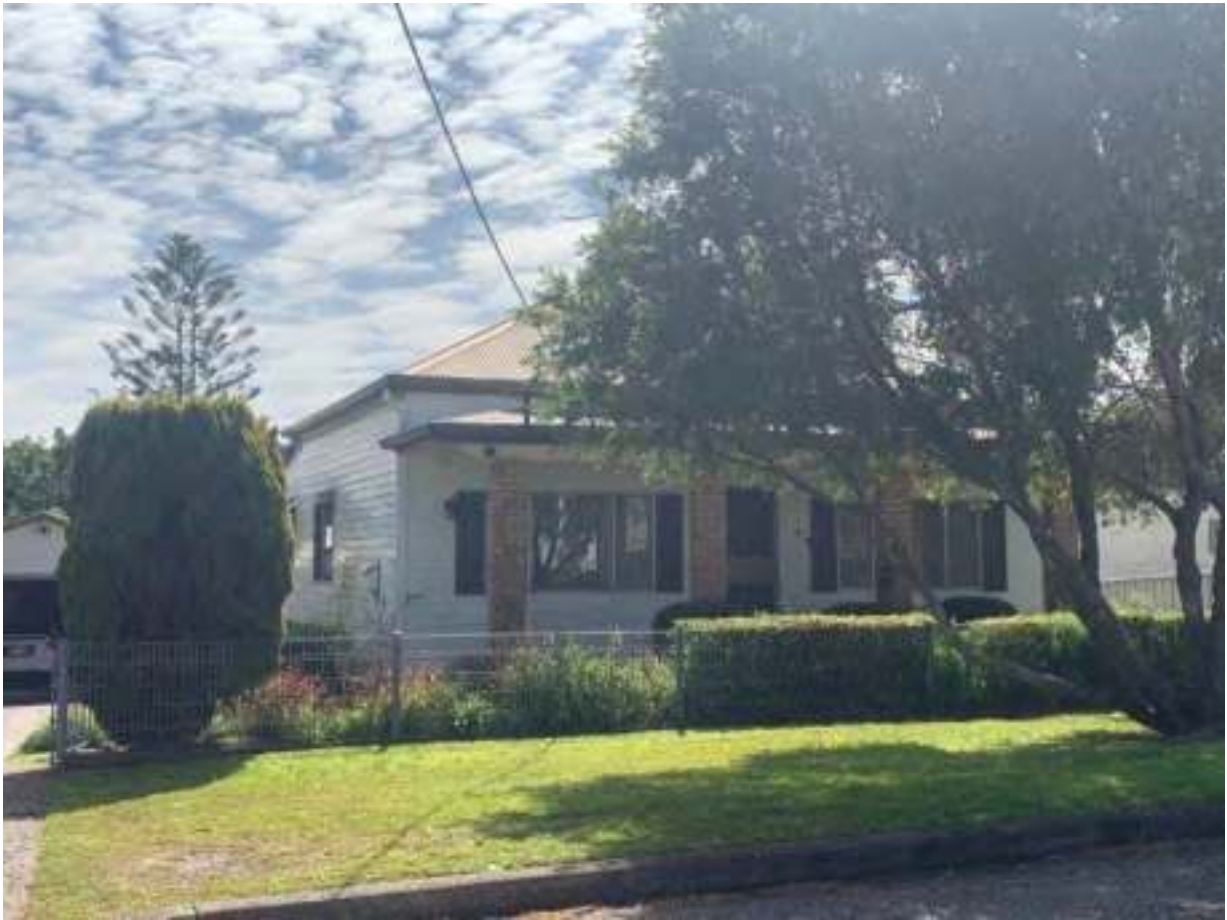
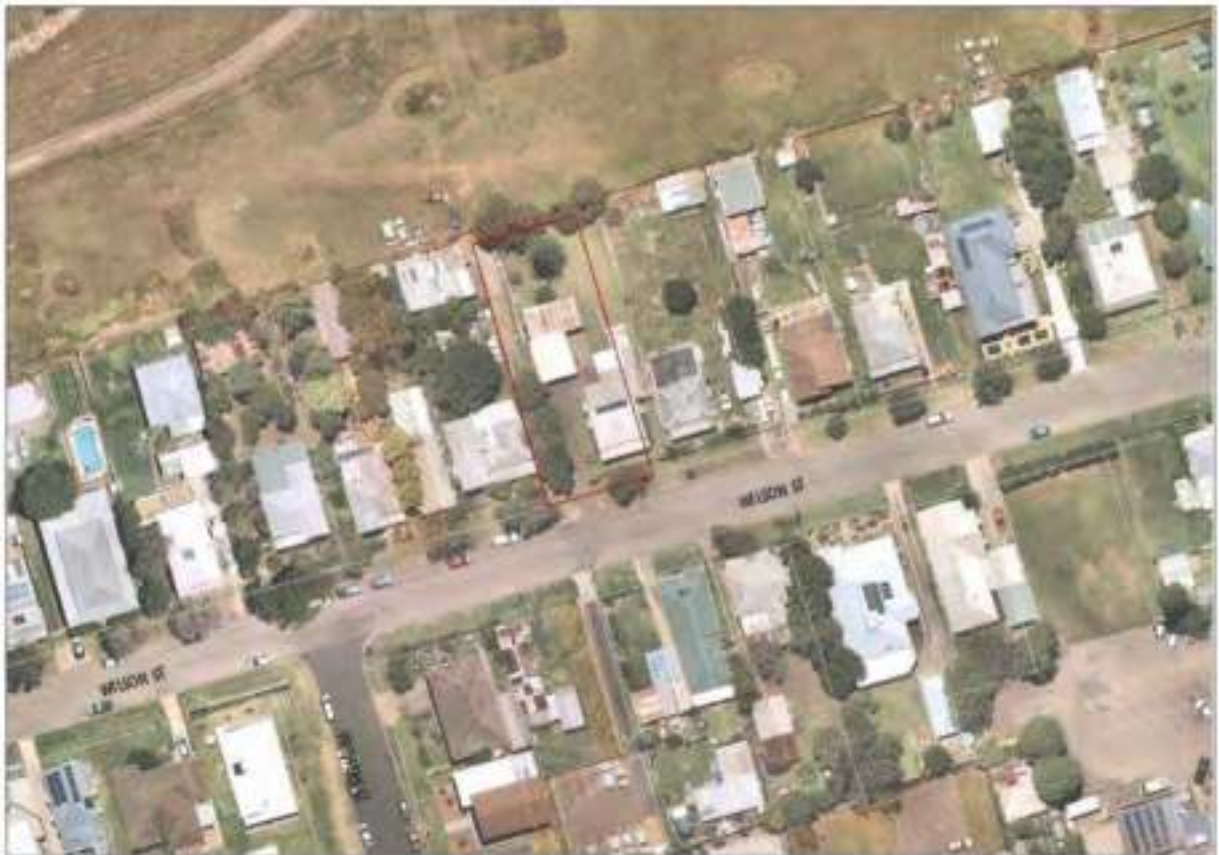
49 WILSON STREET, WEST WALLSEND 2286

Conservation Area Contribution Level	Est. Construction Date	Previous studies and/or community input
Contributory 2	Early to late 20 th century (broad range)	No prior heritage assessments or research undertaken.
Assessment Text		Observed Modifications
<p>The scale (single-storey) and general style of the dwelling is consistent with that of the streetscape and wider HCA. Dwelling contributes positively to the streetscape and wider HCA, particularly in comparison to Non-Contributory buildings.</p> <p>The dwelling features appropriately proportioned and positioned fenestrations, an appropriate roof form (gabled or hipped) and other features consistent with the architectural character of the area (e.g. front verandah with timber or brick posts, timber detailing, corrugated metal roofing, etc). The contributory value of the dwelling is limited however by either:</p> <ul style="list-style-type: none"> • External modifications that have in some way obscured the style, scale or design intent of the building and have resulted in less physical integrity than Contributory 1 buildings. • Being a later dwelling constructed in an appropriate referential style, but comprising little to no fabric of intrinsic heritage significance. 		<p>The brickwork pillars of the veranda are a contemporary addition, likely replacing an original timber post design.</p> <p>All visible windows are contemporary in style.</p>

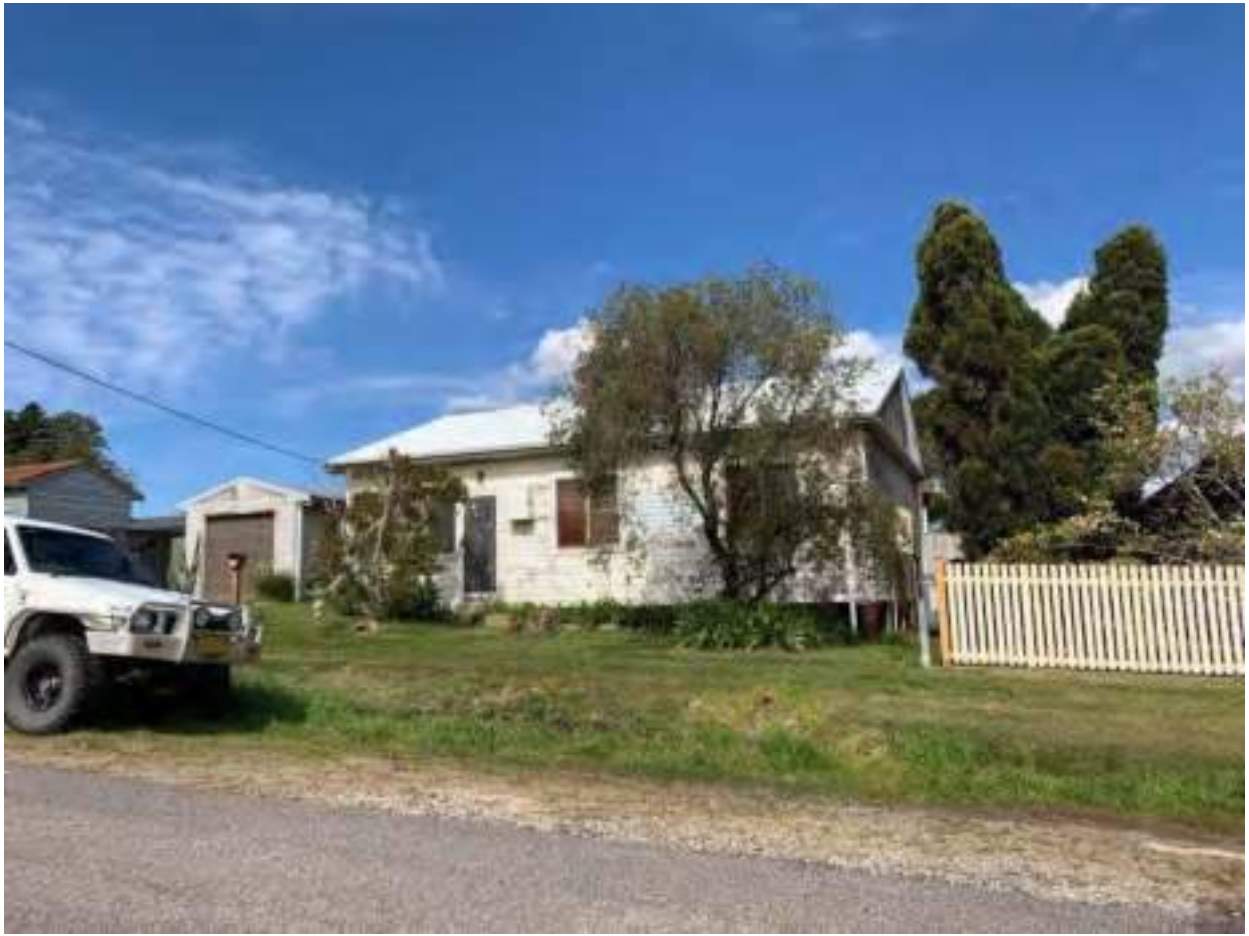
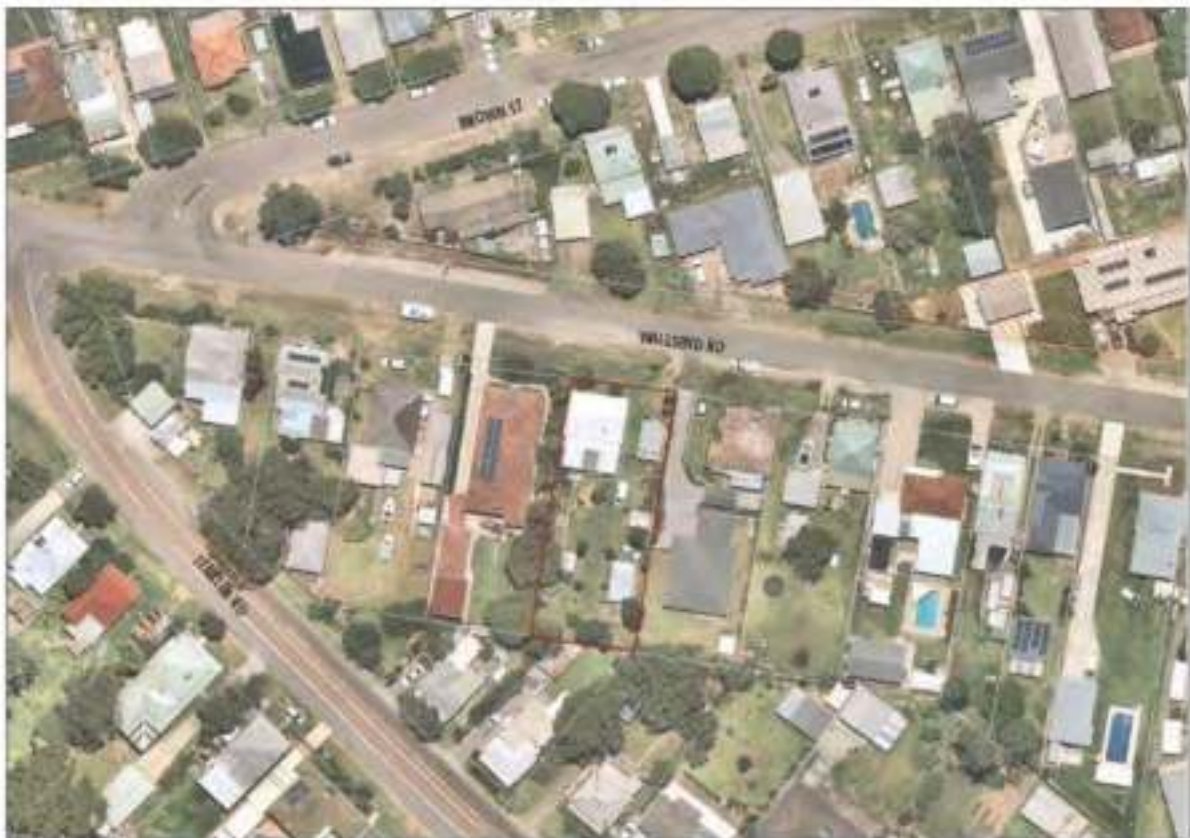
34 WALLSEND ROAD, WEST WALLSEND 2286

Conservation Area Contribution Level	Est. Construction Date	Previous studies and/or community input
Contributory 2	Early to late 20 th century (broad range)	No prior heritage assessments or research undertaken.
Assessment Text		Observed Modifications
<p>The scale (single-storey) and general style of the dwelling is consistent with that of the streetscape and wider HCA. Dwelling contributes positively to the streetscape and wider HCA, particularly in comparison to Non-Contributory buildings.</p> <p>The dwelling features appropriately proportioned and positioned fenestrations, an appropriate roof form (gabled or hipped) and other features consistent with the architectural character of the area (e.g. front verandah with timber or brick posts, timber detailing, corrugated metal roofing, etc). The contributory value of the dwelling is limited however by either:</p> <ul style="list-style-type: none"> • External modifications that have in some way obscured the style, scale or design intent of the building and have resulted in less physical integrity than Contributory 1 buildings. • Being a later dwelling constructed in an appropriate referential style, but comprising little to no fabric of intrinsic heritage significance. 		No modifications observed.

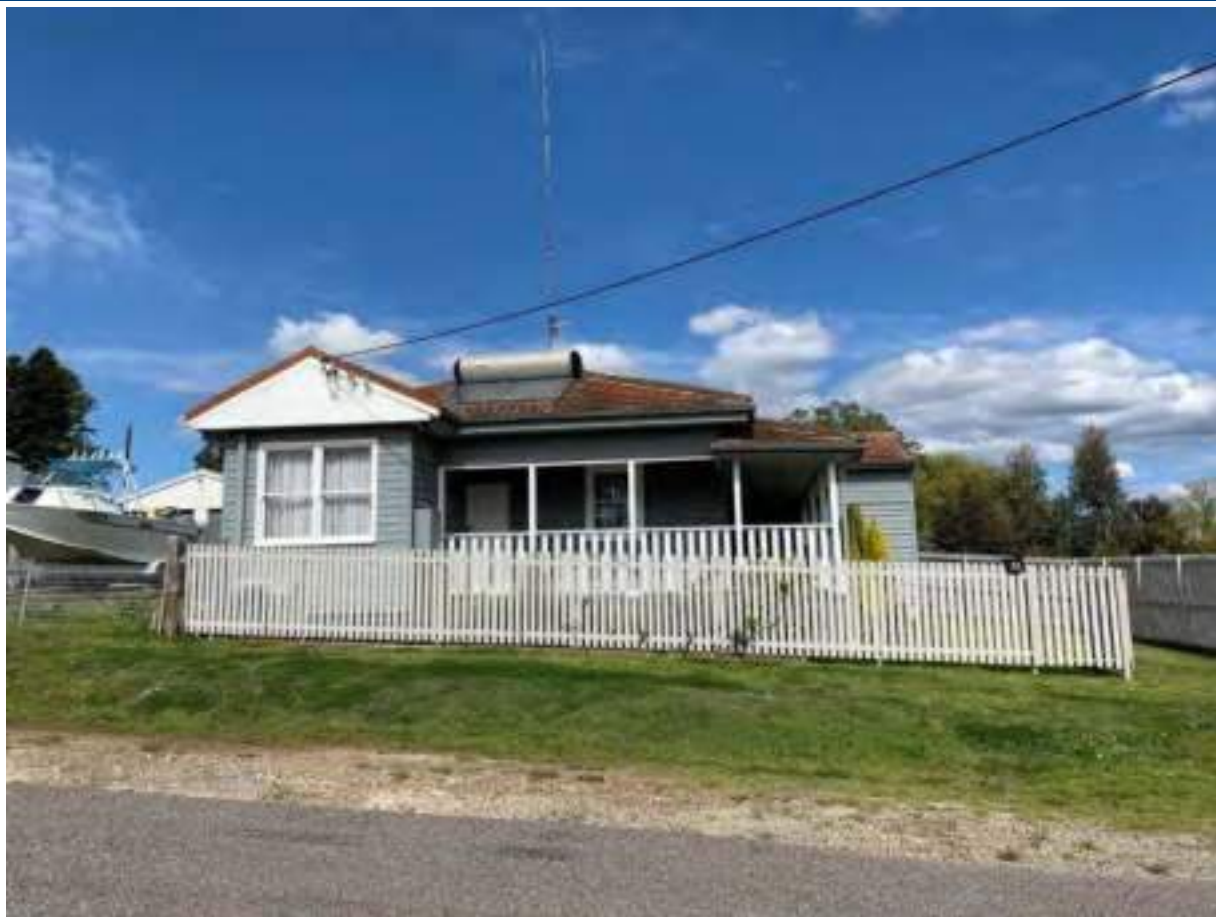
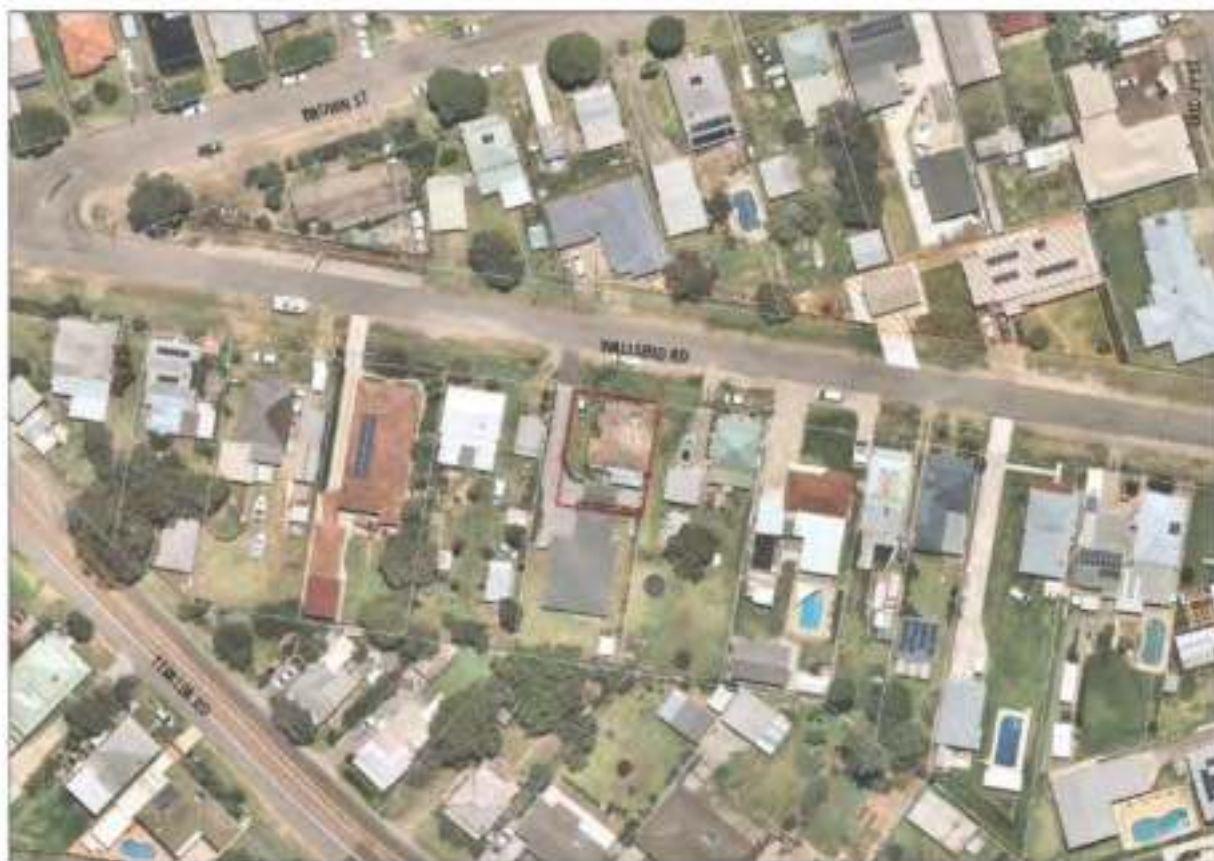
32 WALLSEND ROAD, WEST WALLSEND 2286

Conservation Area Contribution Level	Est. Construction Date	Previous studies and/or community input
Contributory 2	Early to late 20 th century (broad range)	No prior heritage assessments or research undertaken.
Assessment Text		Observed Modifications
<p>The scale (single-storey) and general style of the dwelling is consistent with that of the streetscape and wider HCA. Dwelling contributes positively to the streetscape and wider HCA, particularly in comparison to Non-Contributory buildings.</p> <p>The dwelling features appropriately proportioned and positioned fenestrations, an appropriate roof form (gabled or hipped) and other features consistent with the architectural character of the area (e.g. front verandah with timber or brick posts, timber detailing, corrugated metal roofing, etc). The contributory value of the dwelling is limited however by either:</p> <ul style="list-style-type: none"> External modifications that have in some way obscured the style, scale or design intent of the building and have resulted in less physical integrity than Contributory 1 buildings. Being a later dwelling constructed in an appropriate referential style, but comprising little to no fabric of intrinsic heritage significance. 		<p>A heating panel is highly visible along the northern portion of the dwelling.</p> <p>The veranda has been extended to wrap around the western portion of the dwelling. Timber balustrade has also been built to enclose this space. Both modifications are contemporary.</p> <p>An extension has been built onto the south western portion of the dwelling.</p>

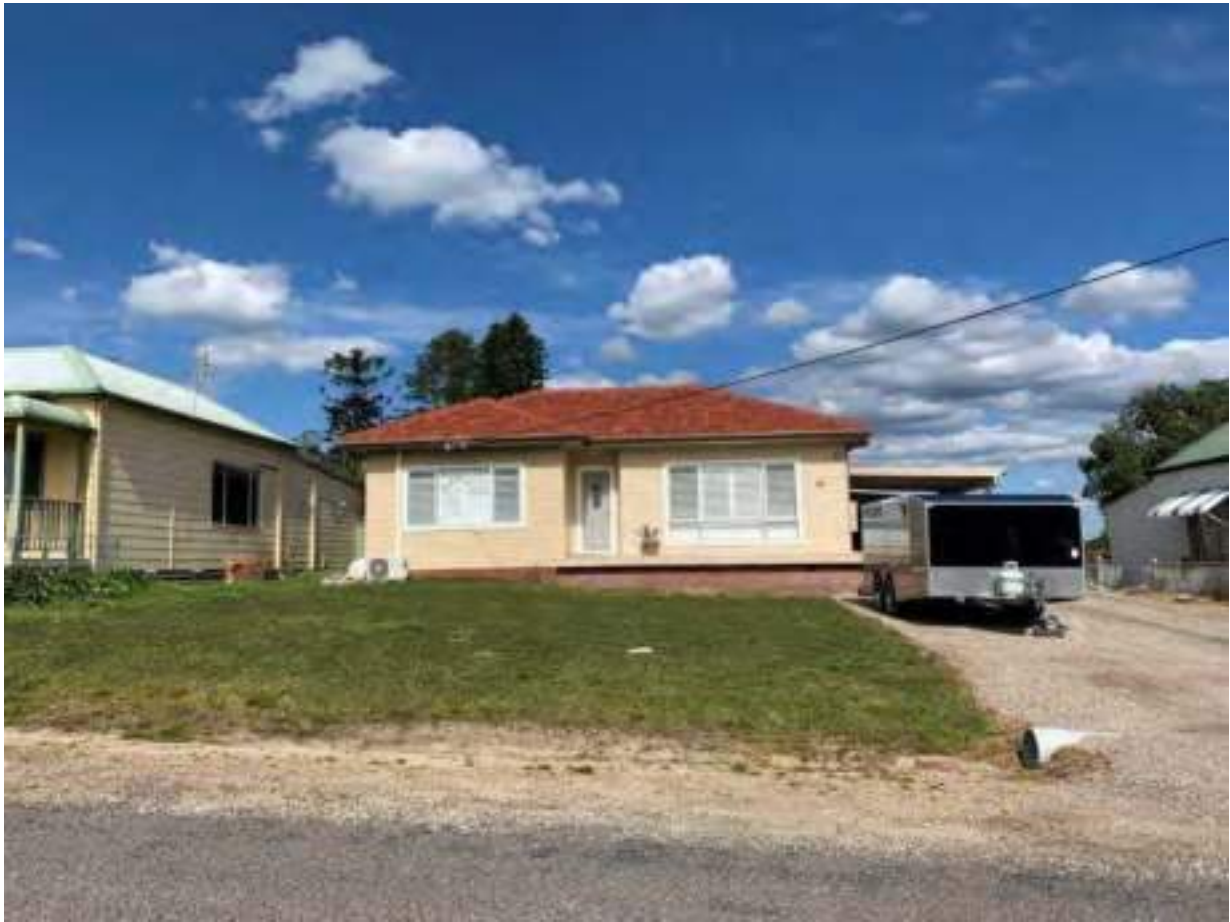
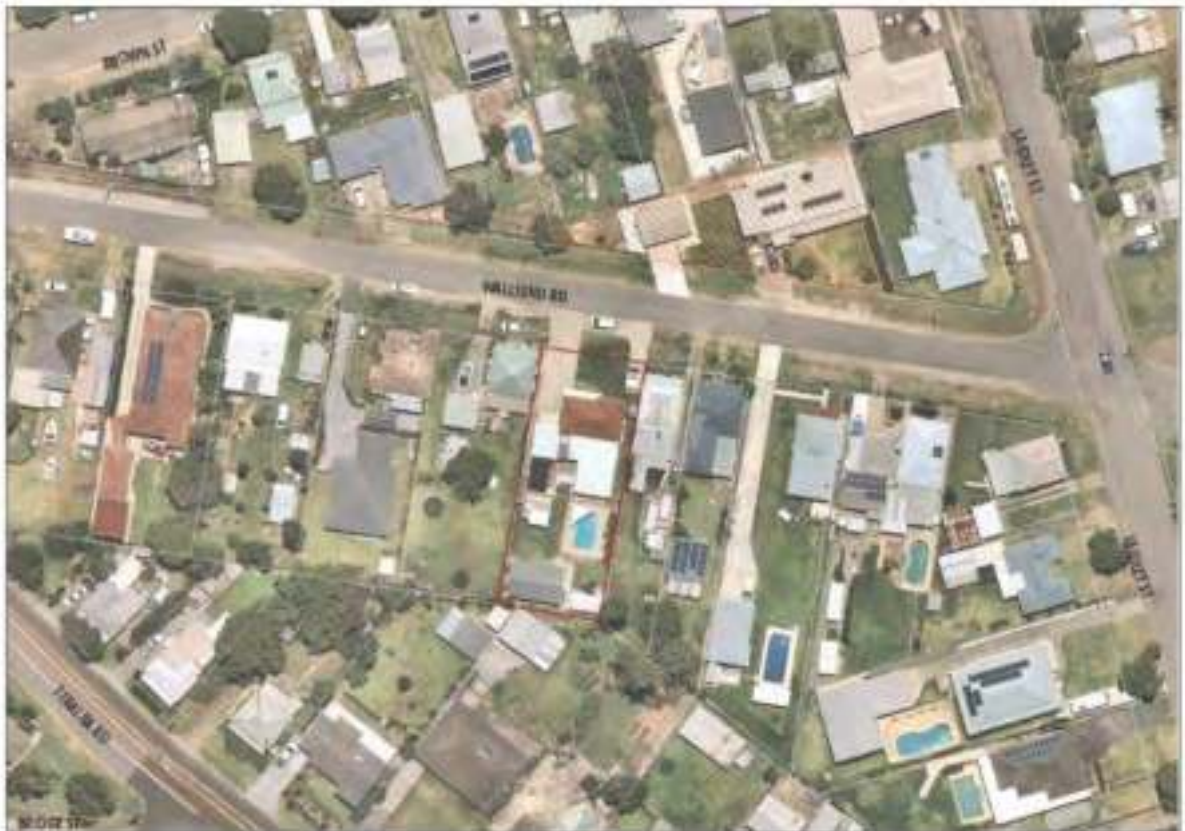
28 WALLSEND ROAD, WEST WALLSEND 2286

Conservation Area Contribution Level	Est. Construction Date	Previous studies and/or community input
Contributory 2	Early to late 20 th century (broad range)	No prior heritage assessments or research undertaken.
Assessment Text		Observed Modifications
<p>The scale (single-storey) and general style of the dwelling is consistent with that of the streetscape and wider HCA. Dwelling contributes positively to the streetscape and wider HCA, particularly in comparison to Non-Contributory buildings.</p> <p>The dwelling features appropriately proportioned and positioned fenestrations, an appropriate roof form (gabled or hipped) and other features consistent with the architectural character of the area (e.g. front verandah with timber or brick posts, timber detailing, corrugated metal roofing, etc). The contributory value of the dwelling is limited however by either:</p> <ul style="list-style-type: none"> • External modifications that have in some way obscured the style, scale or design intent of the building and have resulted in less physical integrity than Contributory 1 buildings. • Being a later dwelling constructed in an appropriate referential style, but comprising little to no fabric of intrinsic heritage significance. 		<p>All visible windows are contemporary in style.</p> <p>A carport has been built onto the western side of the dwelling.</p> <p>A large extension has been built onto the back southern portion of the dwelling. This is not visible from the street and does not detract from the heritage streetscape.</p>

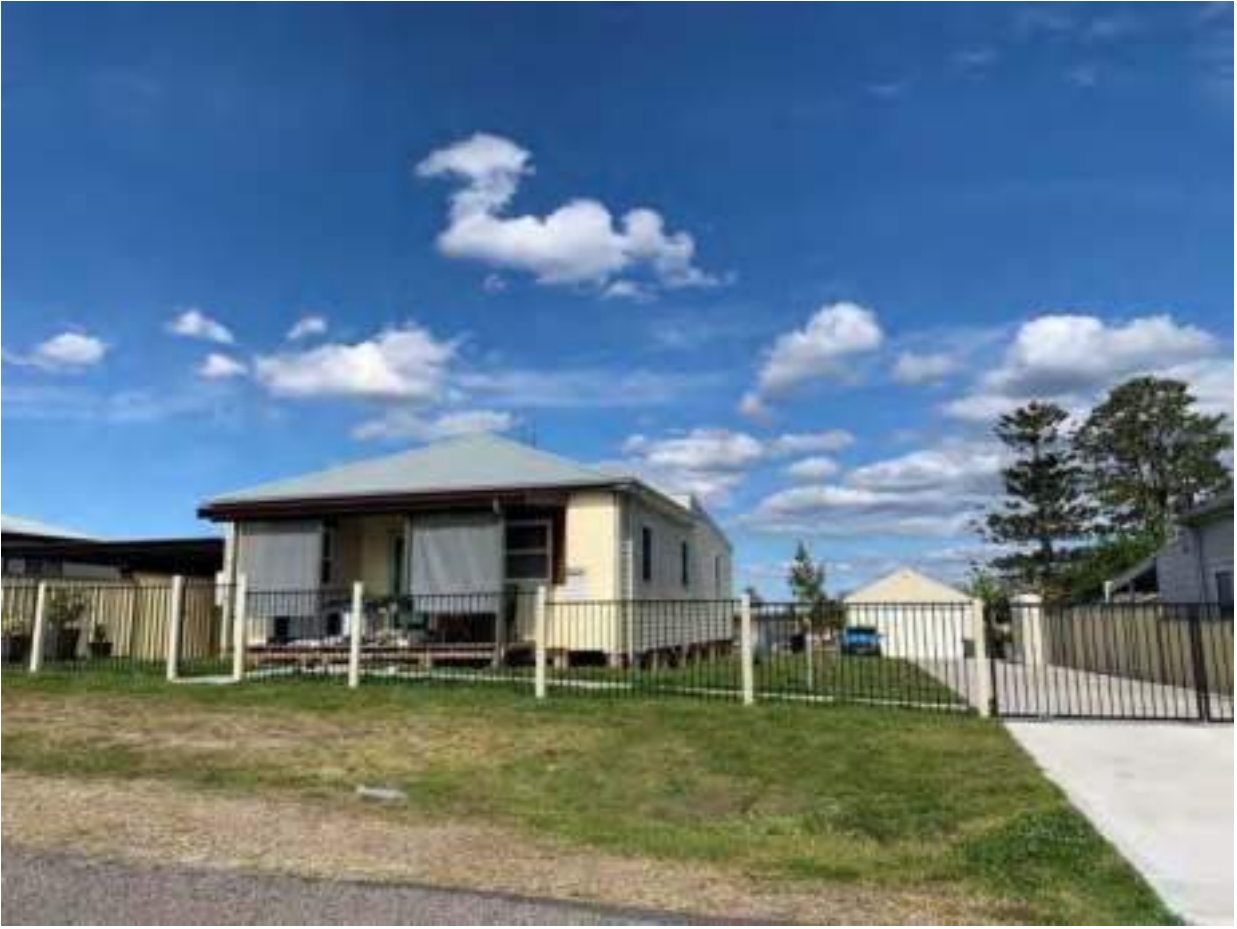
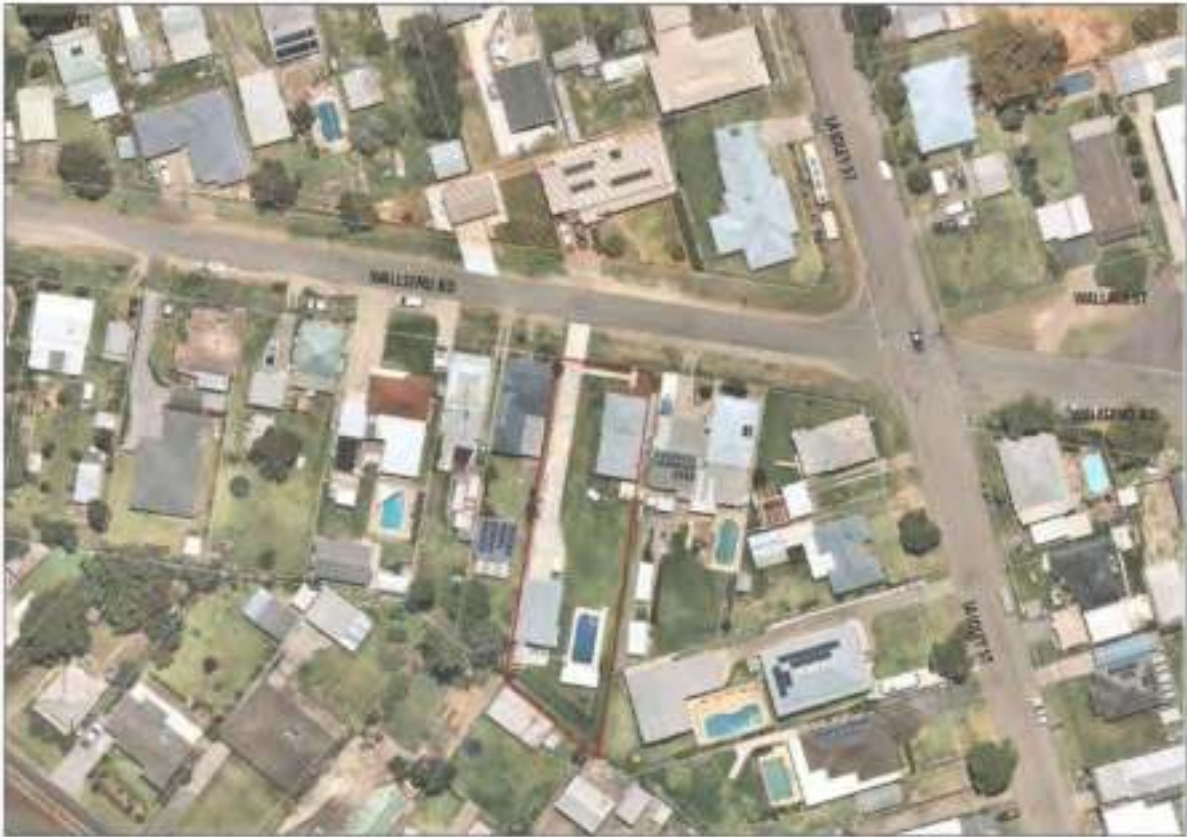
22 WALLSEND ROAD, WEST WALLSEND 2286

Conservation Area Contribution Level	Est. Construction Date	Previous studies and/or community input
Contributory 2	Early to late 20 th century (broad range)	No prior heritage assessments or research undertaken.
Assessment Text		Observed Modifications
<p>The scale (single-storey) and general style of the dwelling is consistent with that of the streetscape and wider HCA. Dwelling contributes positively to the streetscape and wider HCA, particularly in comparison to Non-Contributory buildings.</p> <p>The dwelling features appropriately proportioned and positioned fenestrations, an appropriate roof form (gabled or hipped) and other features consistent with the architectural character of the area (e.g. front verandah with timber or brick posts, timber detailing, corrugated metal roofing, etc). The contributory value of the dwelling is limited however by either:</p> <ul style="list-style-type: none"> • External modifications that have in some way obscured the style, scale or design intent of the building and have resulted in less physical integrity than Contributory 1 buildings. • Being a later dwelling constructed in an appropriate referential style, but comprising little to no fabric of intrinsic heritage significance. 		<p>The visible doors and windows are contemporary in style.</p> <p>Large canvas blinds have been installed at the front northern portion of the dwelling, obscuring the façade.</p> <p>An extension has been built onto the southern portion of the dwelling. This is not visible from the street and does not detract from the heritage streetscape.</p>
