APPENDIX 2

Building Assessment Sheets (Inventory Sheets)

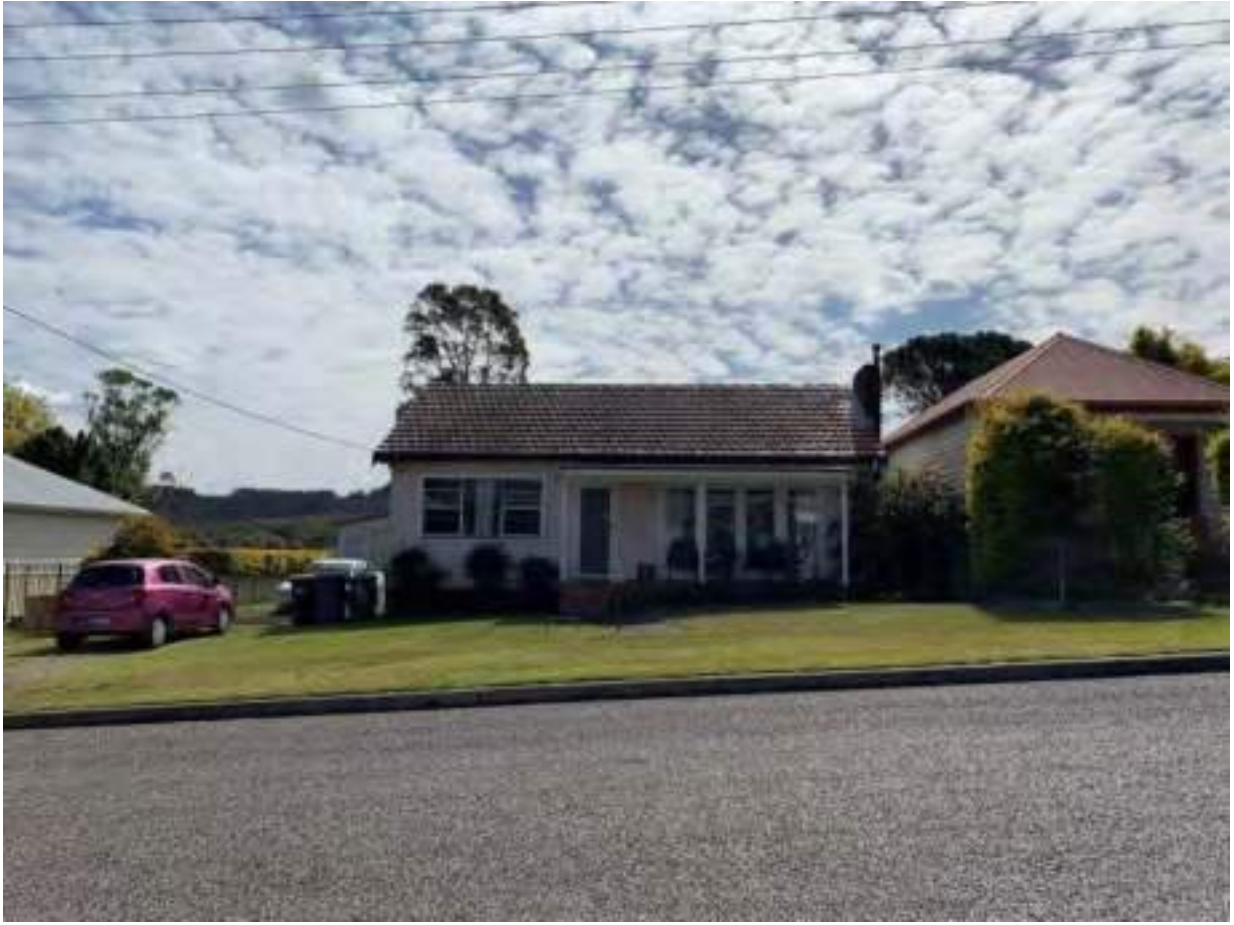
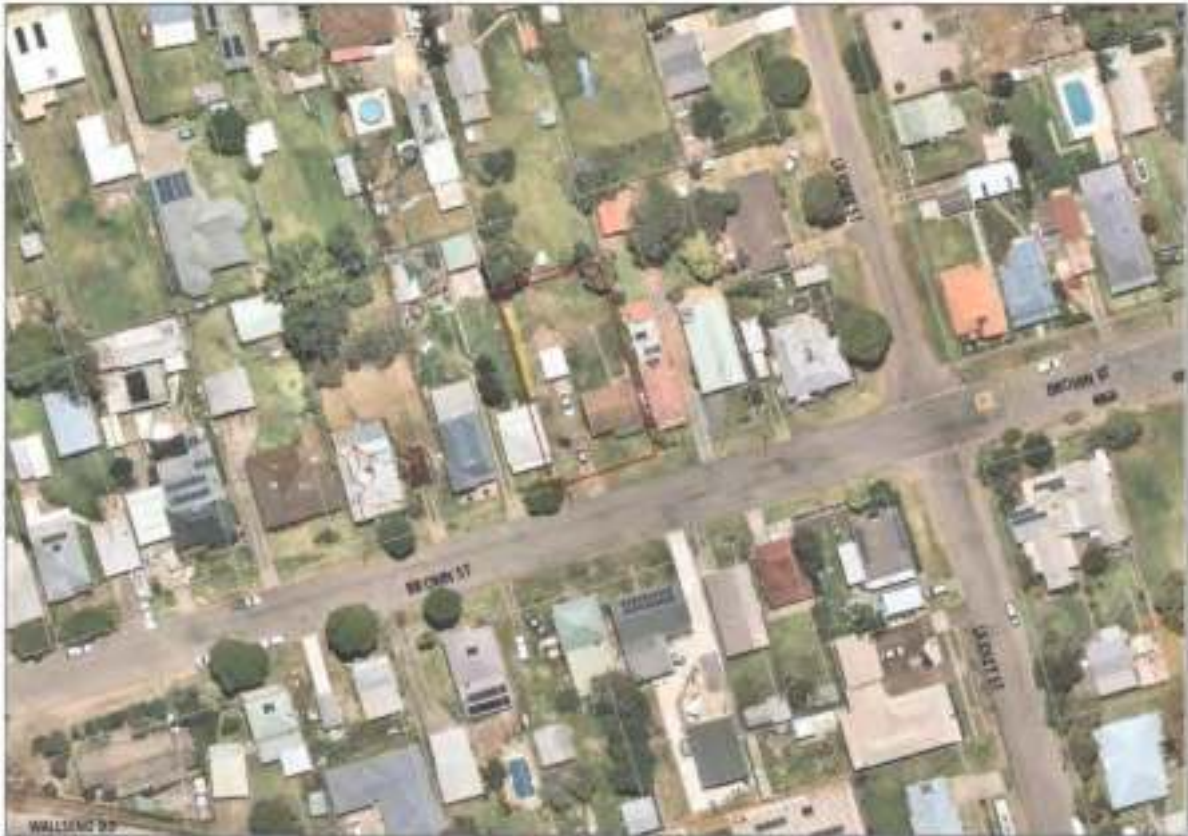
61 BROWN STREET, WEST WALLSEND 2286

Conservation Area Contribution Level	Est. Construction Date	Previous studies and/or community input
Contributory 2	Early to late 20 th century (broad range)	No prior heritage assessments or research undertaken.
Assessment Text		Observed Modifications
<p>The scale (single-storey) and general style of the dwelling is consistent with that of the streetscape and wider HCA. Dwelling contributes positively to the streetscape and wider HCA, particularly in comparison to Non-Contributory buildings.</p> <p>The dwelling features appropriately proportioned and positioned fenestrations, an appropriate roof form (gabled or hipped) and other features consistent with the architectural character of the area (e.g. front verandah with timber or brick posts, timber detailing, corrugated metal roofing, etc). The contributory value of the dwelling is limited however by either:</p> <ul style="list-style-type: none"> • External modifications that have in some way obscured the style, scale or design intent of the building and have resulted in less physical integrity than Contributory 1 buildings. • Being a later dwelling constructed in an appropriate referential style, but comprising little to no fabric of intrinsic heritage significance. 		<p>The flat veranda roof is a contemporary addition.</p> <p>All visible windows and doors are contemporary in style.</p>

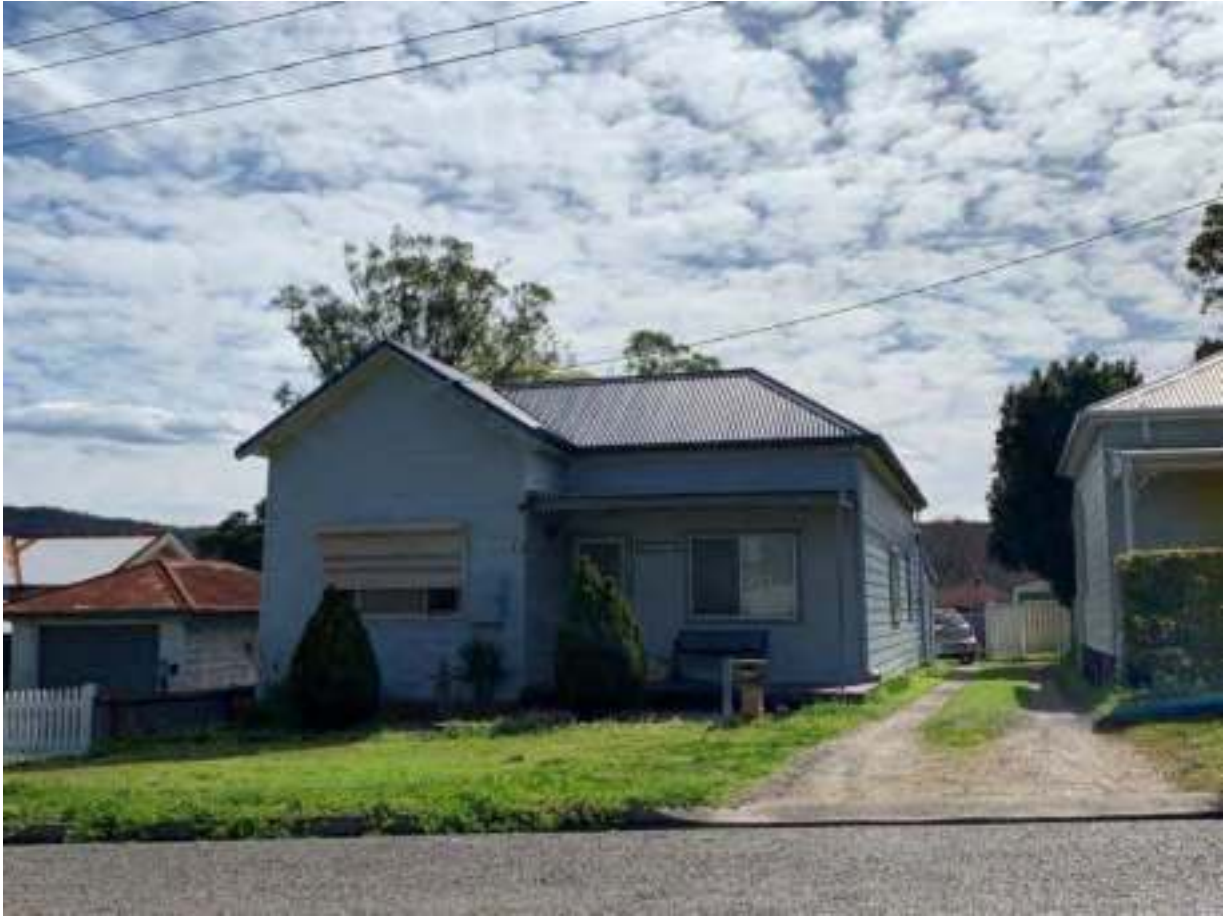
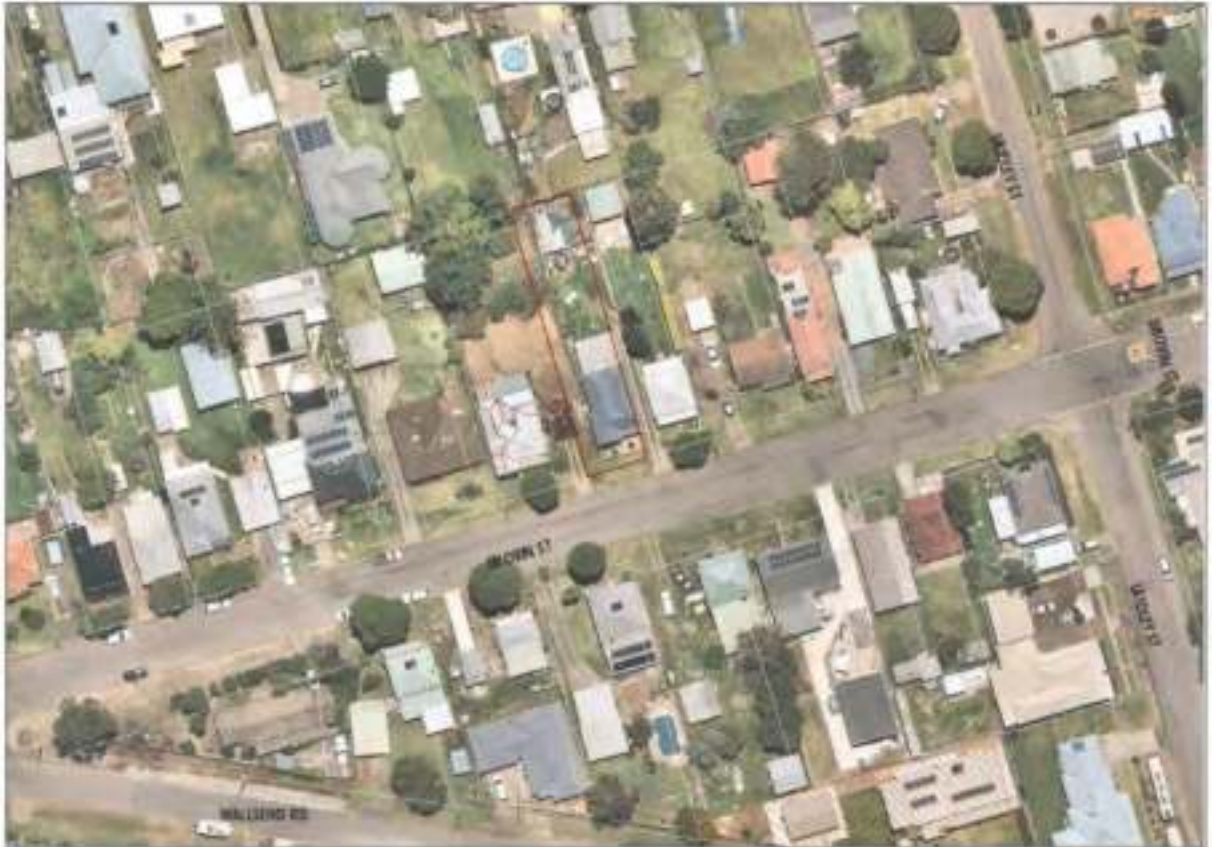
65 BROWN STREET, WEST WALLSEND 2286

Conservation Area Contribution Level	Est. Construction Date	Previous studies and/or community input
Contributory 2	Early to late 20 th century (broad range)	No prior heritage assessments or research undertaken.
Assessment Text		Observed Modifications
<p>The scale (single-storey) and general style of the dwelling is consistent with that of the streetscape and wider HCA. Dwelling contributes positively to the streetscape and wider HCA, particularly in comparison to Non-Contributory buildings.</p> <p>The dwelling features appropriately proportioned and positioned fenestrations, an appropriate roof form (gabled or hipped) and other features consistent with the architectural character of the area (e.g. front verandah with timber or brick posts, timber detailing, corrugated metal roofing, etc). The contributory value of the dwelling is limited however by either:</p> <ul style="list-style-type: none"> • External modifications that have in some way obscured the style, scale or design intent of the building and have resulted in less physical integrity than Contributory 1 buildings. • Being a later dwelling constructed in an appropriate referential style, but comprising little to no fabric of intrinsic heritage significance. 		<p>The visible windows are contemporary in style, with the addition of metal roller shutters.</p> <p>The flat veranda roof is a prior modification, likely replacing an original hipped or bull nosed design.</p>

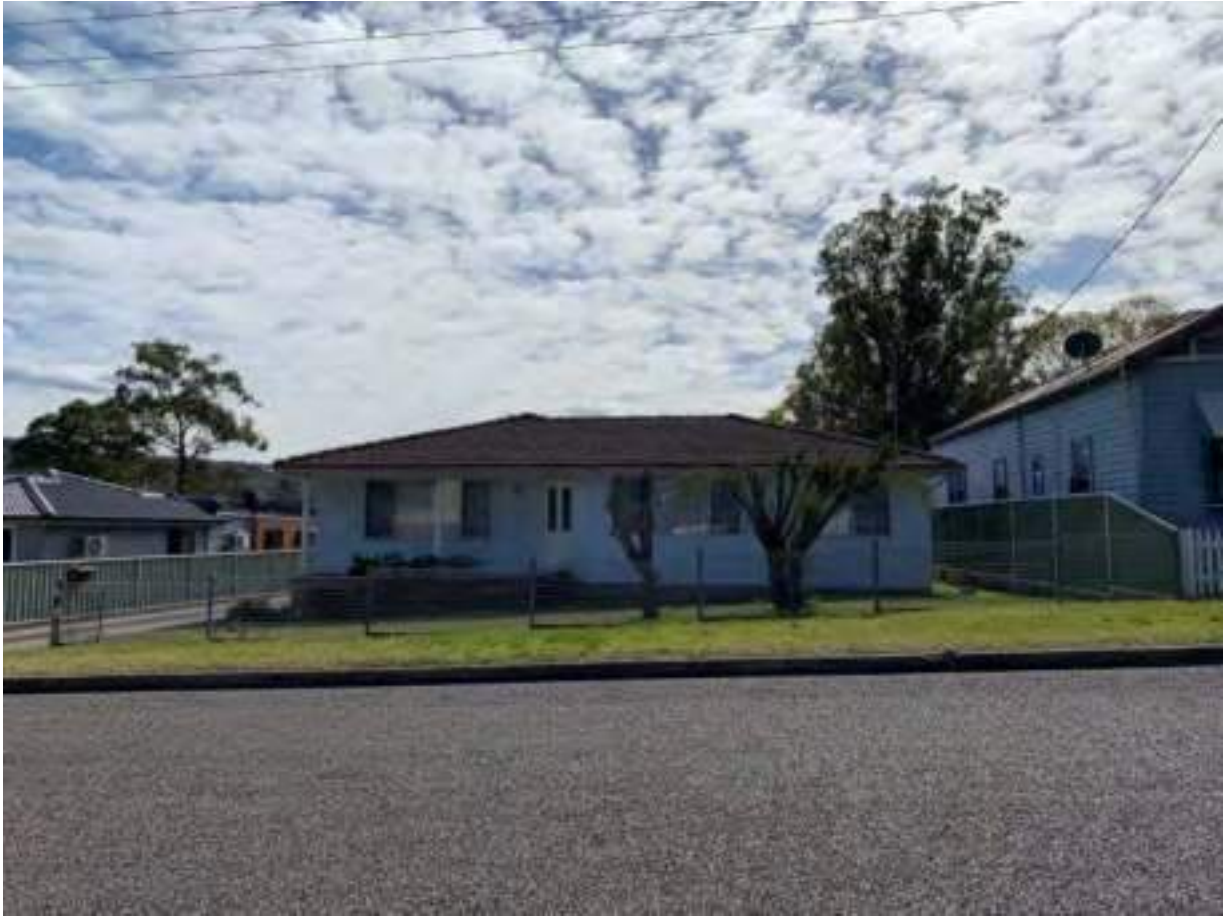
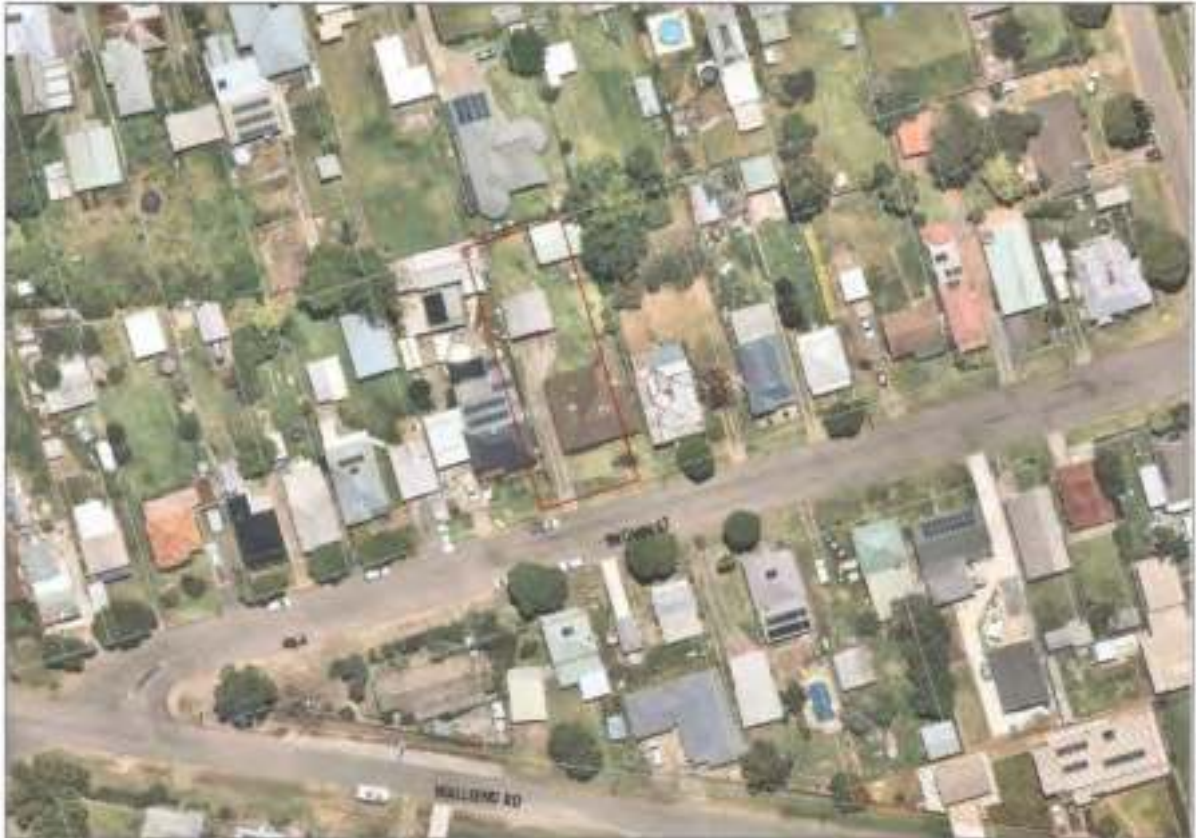
69 BROWN STREET, WEST WALLSEND 2286		
Conservation Area Contribution Level	Est. Construction Date	Previous studies and/or community input
Contributory 2	Early to late 20 th century (broad range)	No prior heritage assessments or research undertaken.
Assessment Text		Observed Modifications
<p>The scale (single-storey) and general style of the dwelling is consistent with that of the streetscape and wider HCA. Dwelling contributes positively to the streetscape and wider HCA, particularly in comparison to Non-Contributory buildings.</p> <p>The dwelling features appropriately proportioned and positioned fenestrations, an appropriate roof form (gabled or hipped) and other features consistent with the architectural character of the area (e.g. front verandah with timber or brick posts, timber detailing, corrugated metal roofing, etc). The contributory value of the dwelling is limited however by either:</p> <ul style="list-style-type: none"> • External modifications that have in some way obscured the style, scale or design intent of the building and have resulted in less physical integrity than Contributory 1 buildings. • Being a later dwelling constructed in an appropriate referential style, but comprising little to no fabric of intrinsic heritage significance. 		No modifications observed.

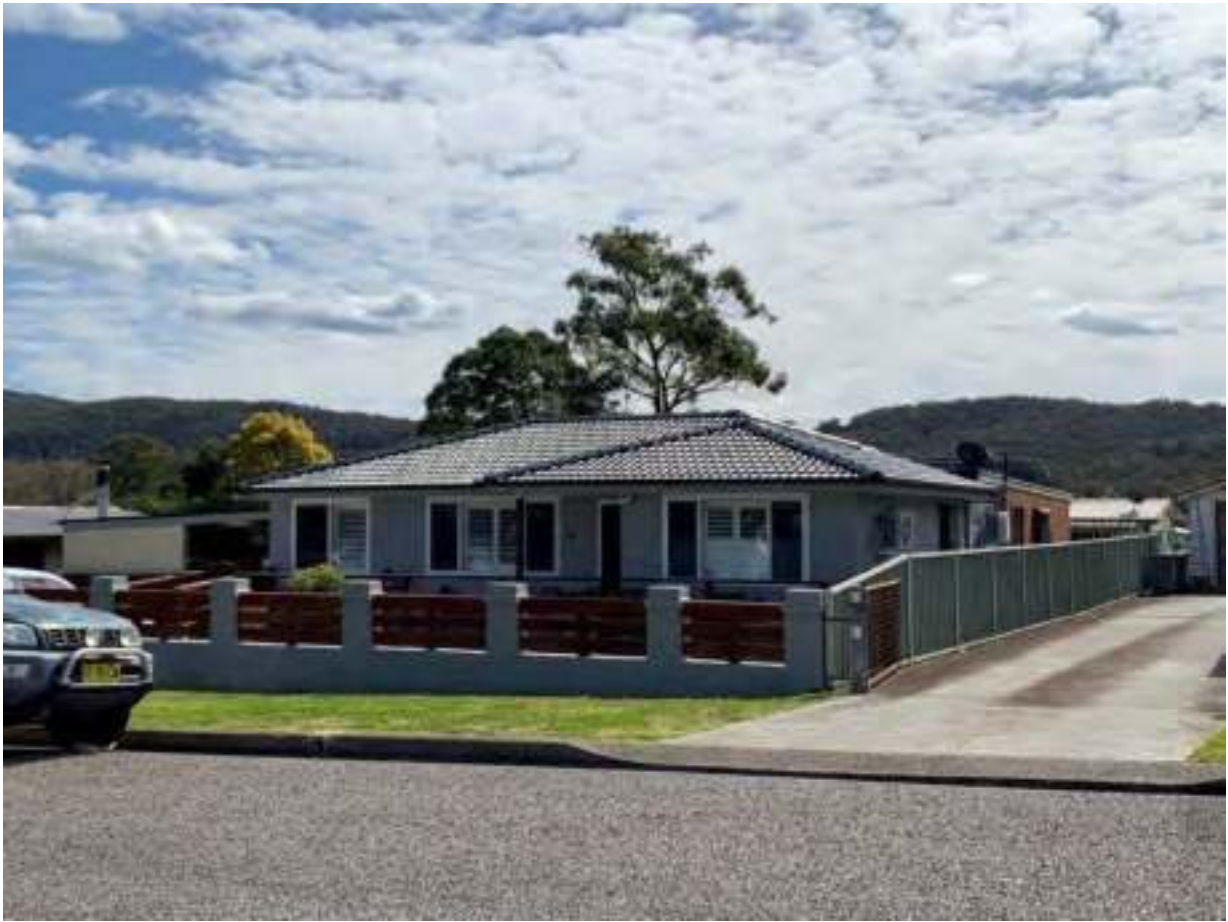
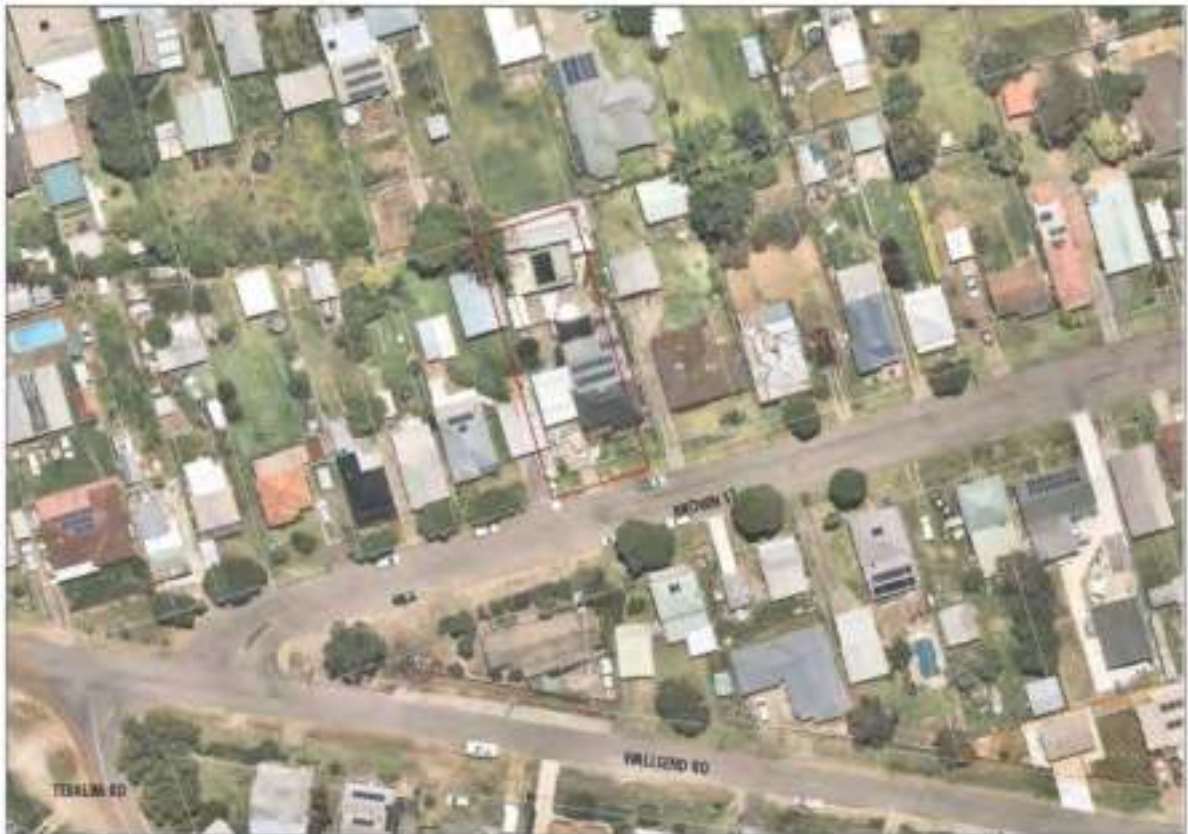
71 BROWN STREET, WEST WALLSEND 2286

Conservation Area Contribution Level	Est. Construction Date	Previous studies and/or community input
Contributory 2	Early to late 20 th century (broad range)	No prior heritage assessments or research undertaken.
Assessment Text		Observed Modifications
<p>The scale (single-storey) and general style of the dwelling is consistent with that of the streetscape and wider HCA. Dwelling contributes positively to the streetscape and wider HCA, particularly in comparison to Non-Contributory buildings.</p> <p>The dwelling features appropriately proportioned and positioned fenestrations, an appropriate roof form (gabled or hipped) and other features consistent with the architectural character of the area (e.g. front verandah with timber or brick posts, timber detailing, corrugated metal roofing, etc). The contributory value of the dwelling is limited however by either:</p> <ul style="list-style-type: none"> • External modifications that have in some way obscured the style, scale or design intent of the building and have resulted in less physical integrity than Contributory 1 buildings. • Being a later dwelling constructed in an appropriate referential style, but comprising little to no fabric of intrinsic heritage significance. 		<p>The front timber and brick fence is a contemporary addition to the dwelling. this was likely originally a brick fence, however has been modernized through the addition of the timber planks.</p> <p>All visible windows are contemporary in style.</p> <p>An extension has been built onto the back northern portion of the dwelling. This is not visible from the street and does not detract from the heritage streetscape.</p>

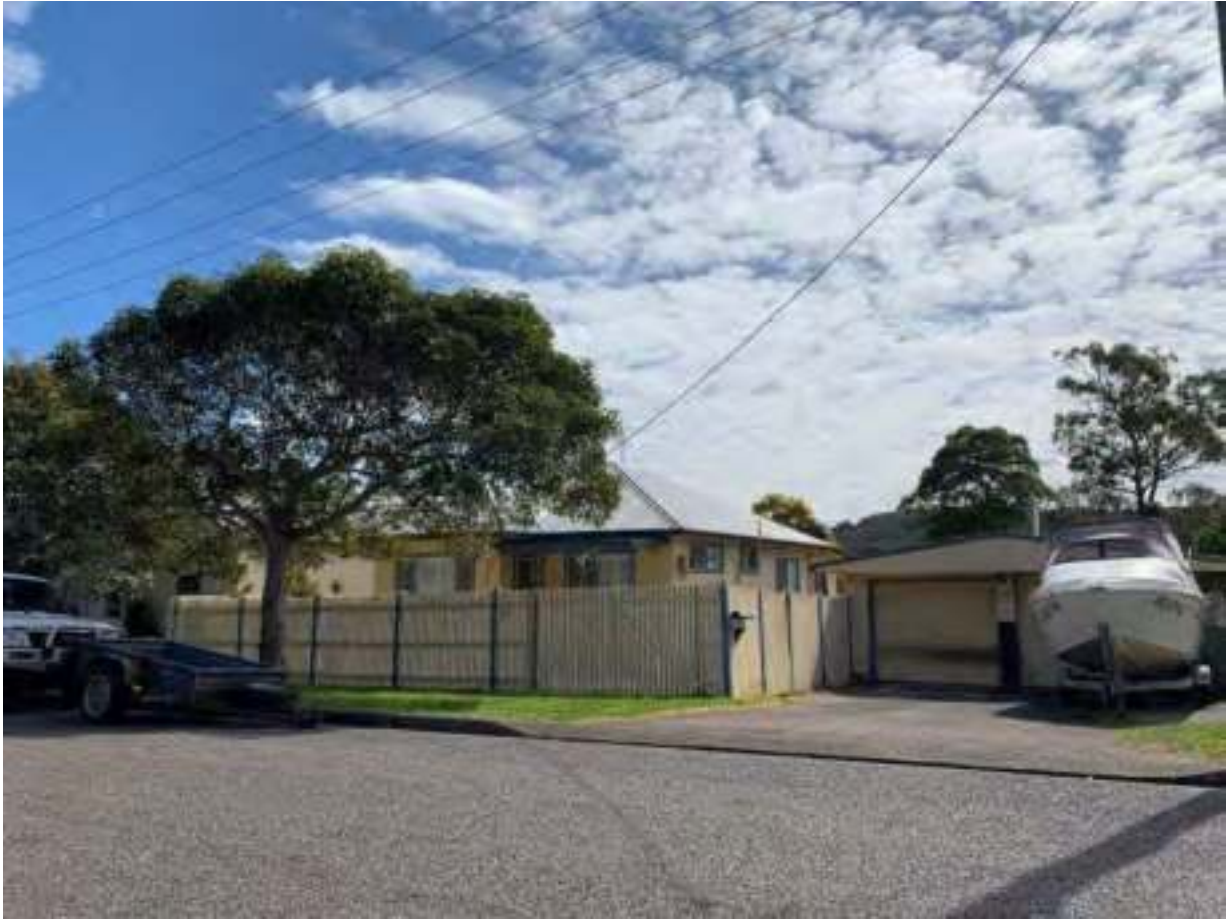
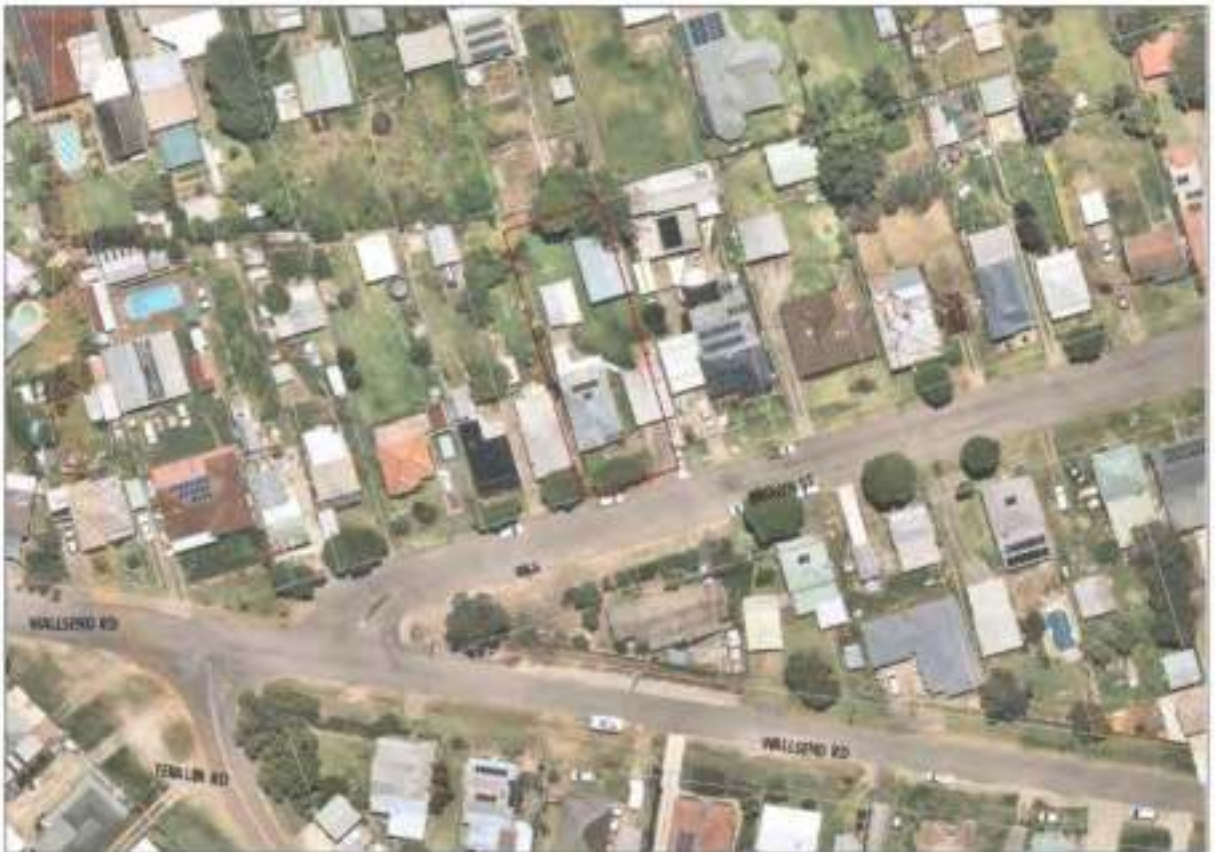
73 BROWN STREET, WEST WALLSEND 2286

Conservation Area Contribution Level	Est. Construction Date	Previous studies and/or community input
Contributory 2	Early to late 20 th century (broad range)	No prior heritage assessments or research undertaken.
Assessment Text		Observed Modifications
<p>The scale (single-storey) and general style of the dwelling is consistent with that of the streetscape and wider HCA. Dwelling contributes positively to the streetscape and wider HCA, particularly in comparison to Non-Contributory buildings.</p> <p>The dwelling features appropriately proportioned and positioned fenestrations, an appropriate roof form (gabled or hipped) and other features consistent with the architectural character of the area (e.g. front verandah with timber or brick posts, timber detailing, corrugated metal roofing, etc). The contributory value of the dwelling is limited however by either:</p> <ul style="list-style-type: none"> • External modifications that have in some way obscured the style, scale or design intent of the building and have resulted in less physical integrity than Contributory 1 buildings. • Being a later dwelling constructed in an appropriate referential style, but comprising little to no fabric of intrinsic heritage significance. 		<p>The flat veranda roof is a contemporary addition.</p> <p>All visible windows are contemporary in style.</p>

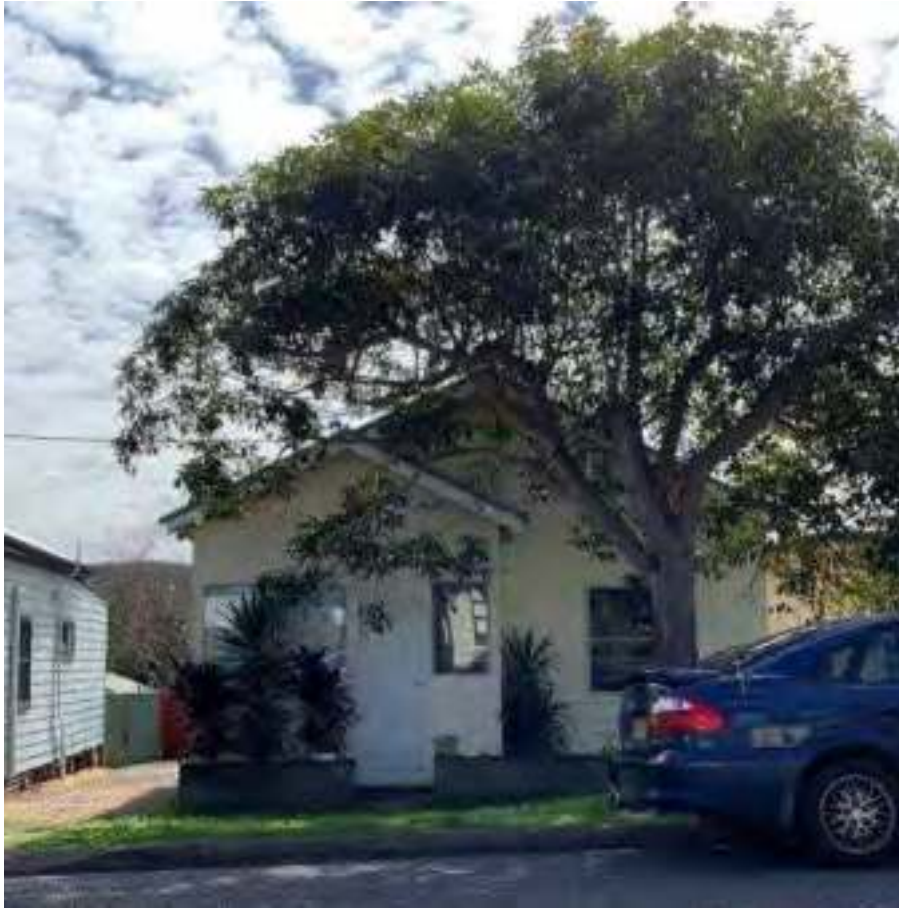
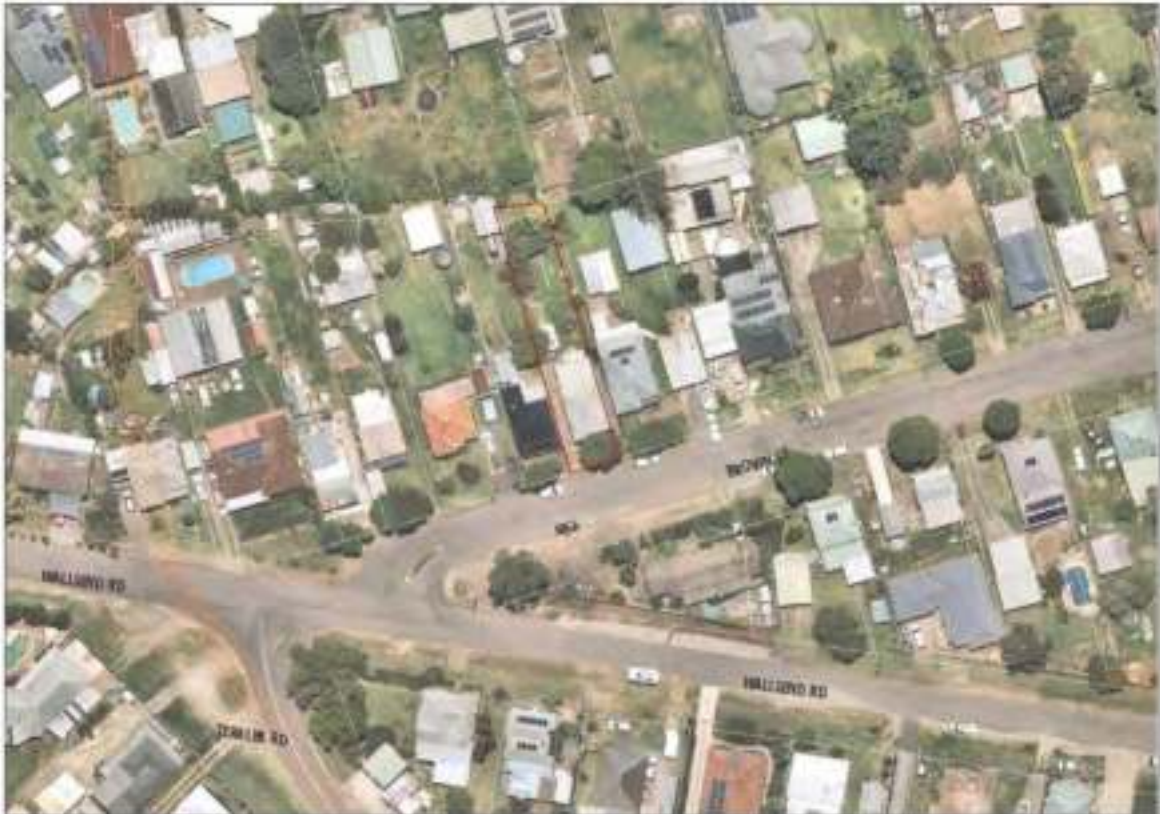
77 BROWN STREET, WEST WALLSEND 2286

Conservation Area Contribution Level	Est. Construction Date	Previous studies and/or community input
Contributory 2	Early to late 20 th century (broad range)	No prior heritage assessments or research undertaken.
Assessment Text		Observed Modifications
<p>The scale (single-storey) and general style of the dwelling is consistent with that of the streetscape and wider HCA. Dwelling contributes positively to the streetscape and wider HCA, particularly in comparison to Non-Contributory buildings.</p> <p>The dwelling features appropriately proportioned and positioned fenestrations, an appropriate roof form (gabled or hipped) and other features consistent with the architectural character of the area (e.g. front verandah with timber or brick posts, timber detailing, corrugated metal roofing, etc). The contributory value of the dwelling is limited however by either:</p> <ul style="list-style-type: none"> • External modifications that have in some way obscured the style, scale or design intent of the building and have resulted in less physical integrity than Contributory 1 buildings. • Being a later dwelling constructed in an appropriate referential style, but comprising little to no fabric of intrinsic heritage significance. 		<p>All visible windows and doors are contemporary in style.</p> <p>An extension has been built onto the back northern portion of the dwelling. This is not visible from the street and does not detract from the heritage streetscape.</p>

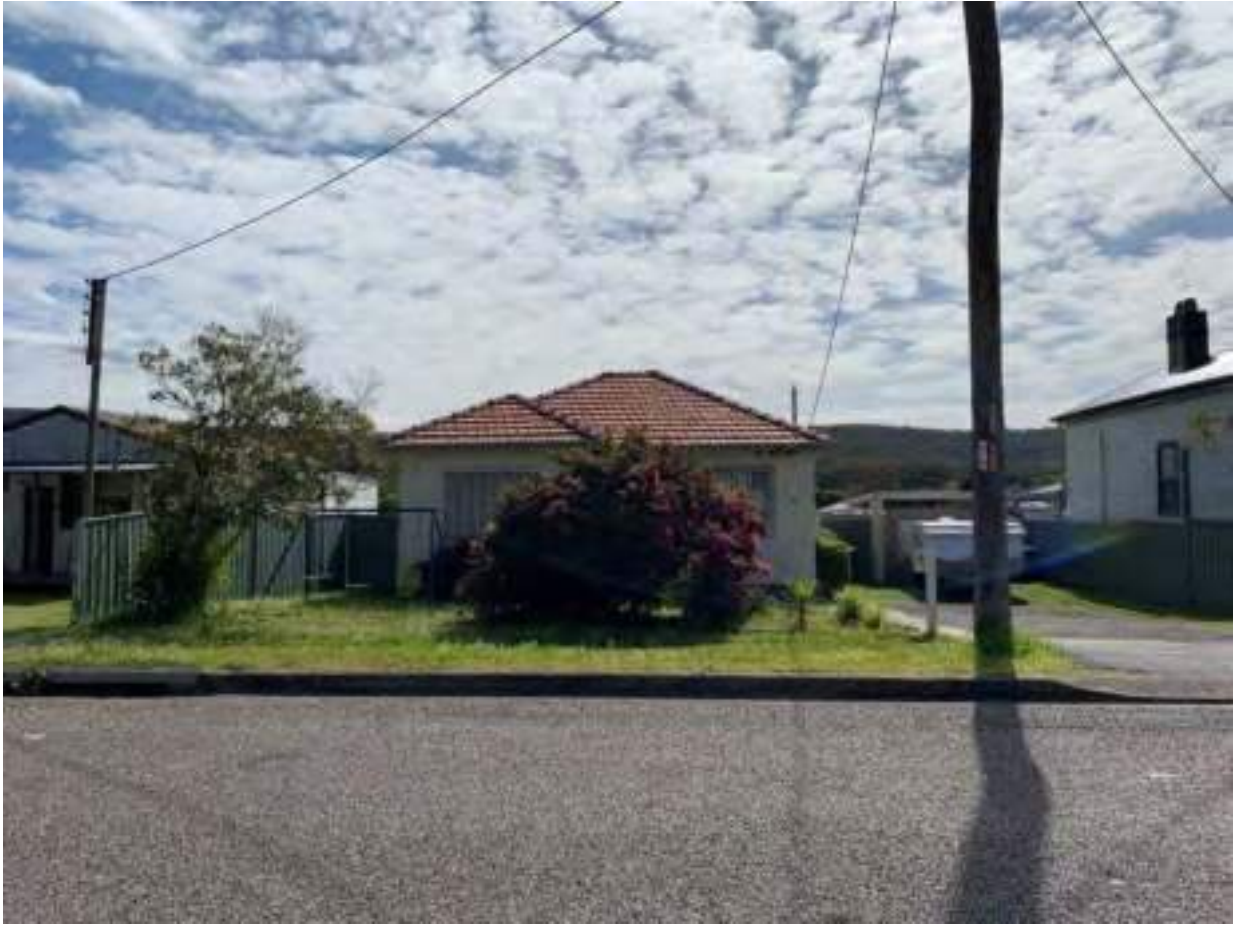
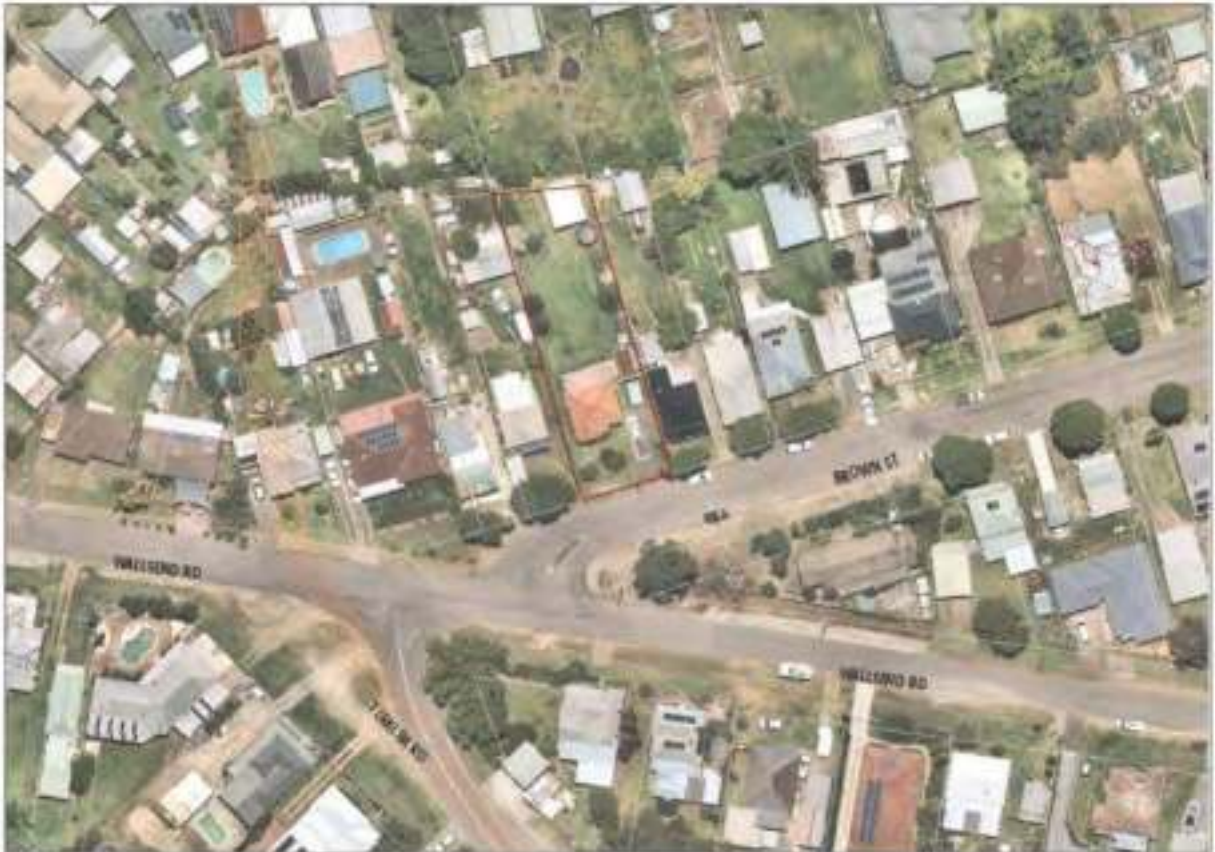
81 BROWN STREET, WEST WALLSEND 2286

Conservation Area Contribution Level	Est. Construction Date	Previous studies and/or community input
Contributory 2	Early to late 20 th century (broad range)	No prior heritage assessments or research undertaken.
Assessment Text		Observed Modifications
<p>The scale (single-storey) and general style of the dwelling is consistent with that of the streetscape and wider HCA. Dwelling contributes positively to the streetscape and wider HCA, particularly in comparison to Non-Contributory buildings.</p> <p>The dwelling features appropriately proportioned and positioned fenestrations, an appropriate roof form (gabled or hipped) and other features consistent with the architectural character of the area (e.g. front verandah with timber or brick posts, timber detailing, corrugated metal roofing, etc). The contributory value of the dwelling is limited however by either:</p> <ul style="list-style-type: none"> • External modifications that have in some way obscured the style, scale or design intent of the building and have resulted in less physical integrity than Contributory 1 buildings. • Being a later dwelling constructed in an appropriate referential style, but comprising little to no fabric of intrinsic heritage significance. 		<p>An extension has been built onto the back northern portion of the dwelling. this is not visible from the street and does not detract from the heritage streetscape.</p> <p>All visible windows are contemporary in style.</p>

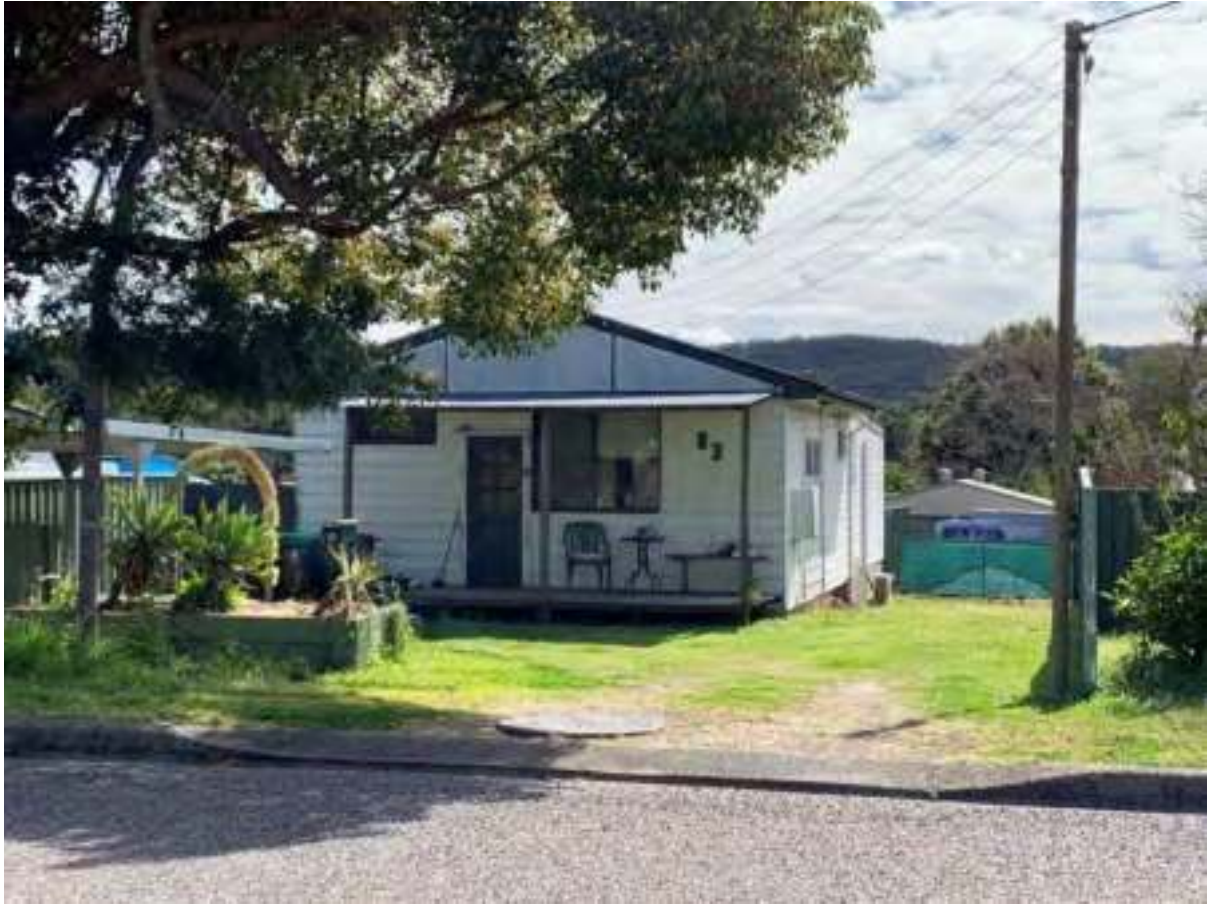
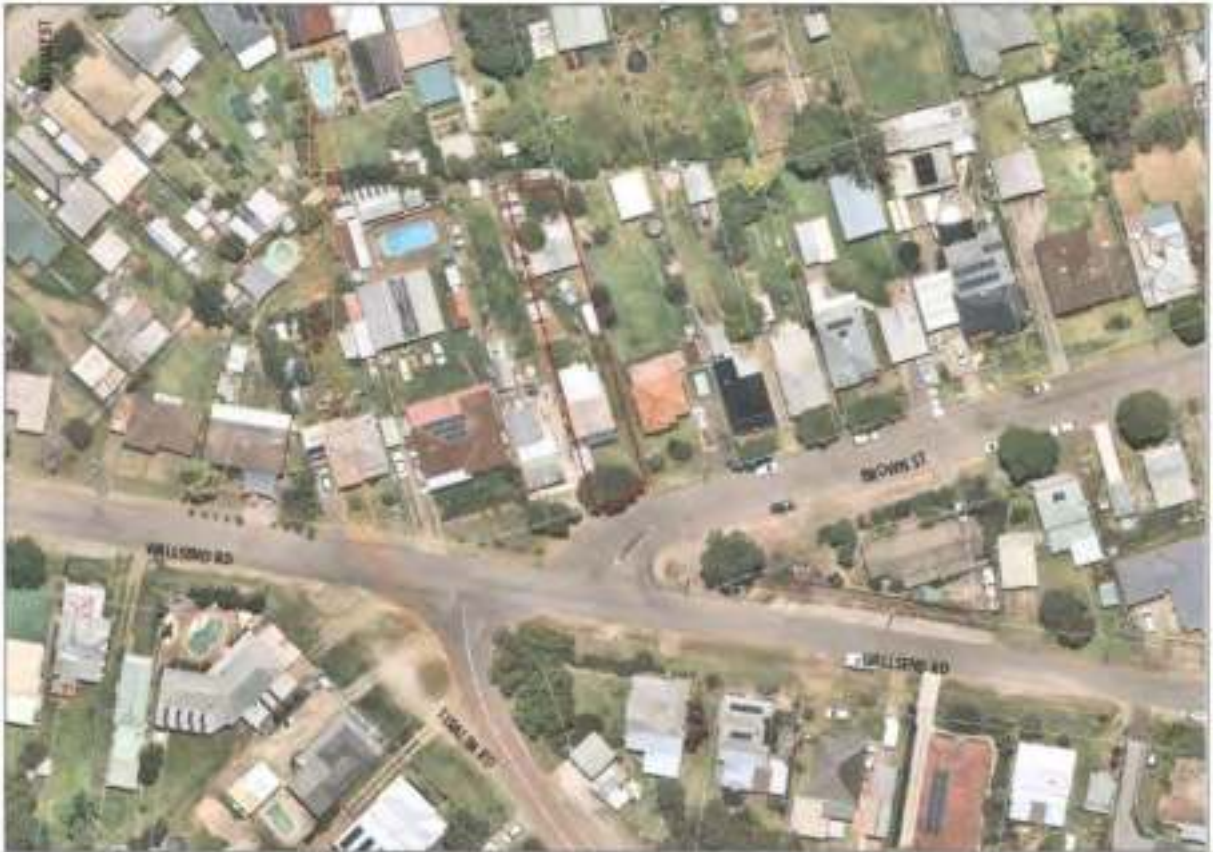
83 BROWN STREET, WEST WALLSEND 2286

Conservation Area Contribution Level	Est. Construction Date	Previous studies and/or community input
Contributory 2	Early to late 20 th century (broad range)	No prior heritage assessments or research undertaken.
Assessment Text		Observed Modifications
<p>The scale (single-storey) and general style of the dwelling is consistent with that of the streetscape and wider HCA. Dwelling contributes positively to the streetscape and wider HCA, particularly in comparison to Non-Contributory buildings.</p> <p>The dwelling features appropriately proportioned and positioned fenestrations, an appropriate roof form (gabled or hipped) and other features consistent with the architectural character of the area (e.g. front verandah with timber or brick posts, timber detailing, corrugated metal roofing, etc). The contributory value of the dwelling is limited however by either:</p> <ul style="list-style-type: none"> • External modifications that have in some way obscured the style, scale or design intent of the building and have resulted in less physical integrity than Contributory 1 buildings. • Being a later dwelling constructed in an appropriate referential style, but comprising little to no fabric of intrinsic heritage significance. 		<p>The flat veranda roof is a contemporary modification, likely replacing an original hipped or bull nosed design, or not roof at all.</p> <p>All visible windows and doors are contemporary in style.</p>

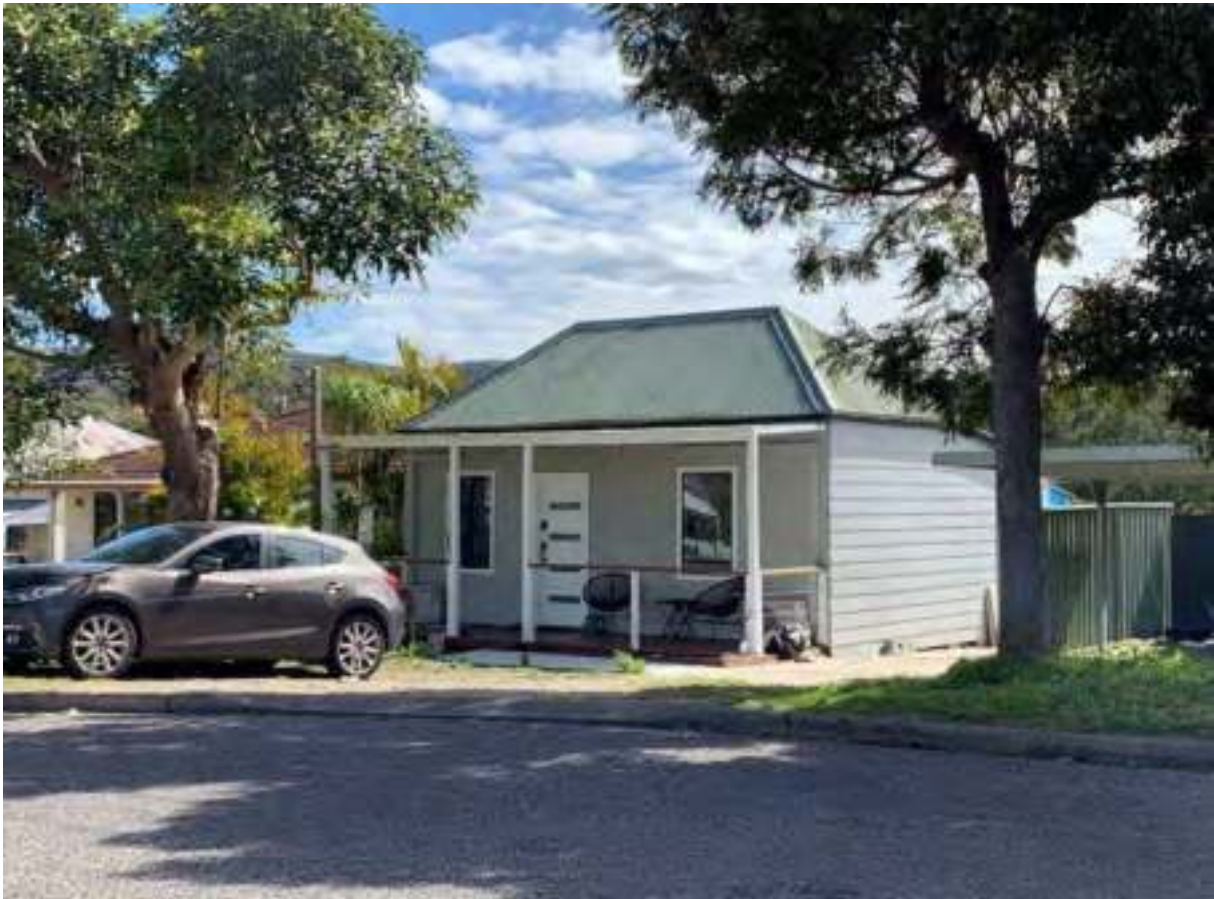
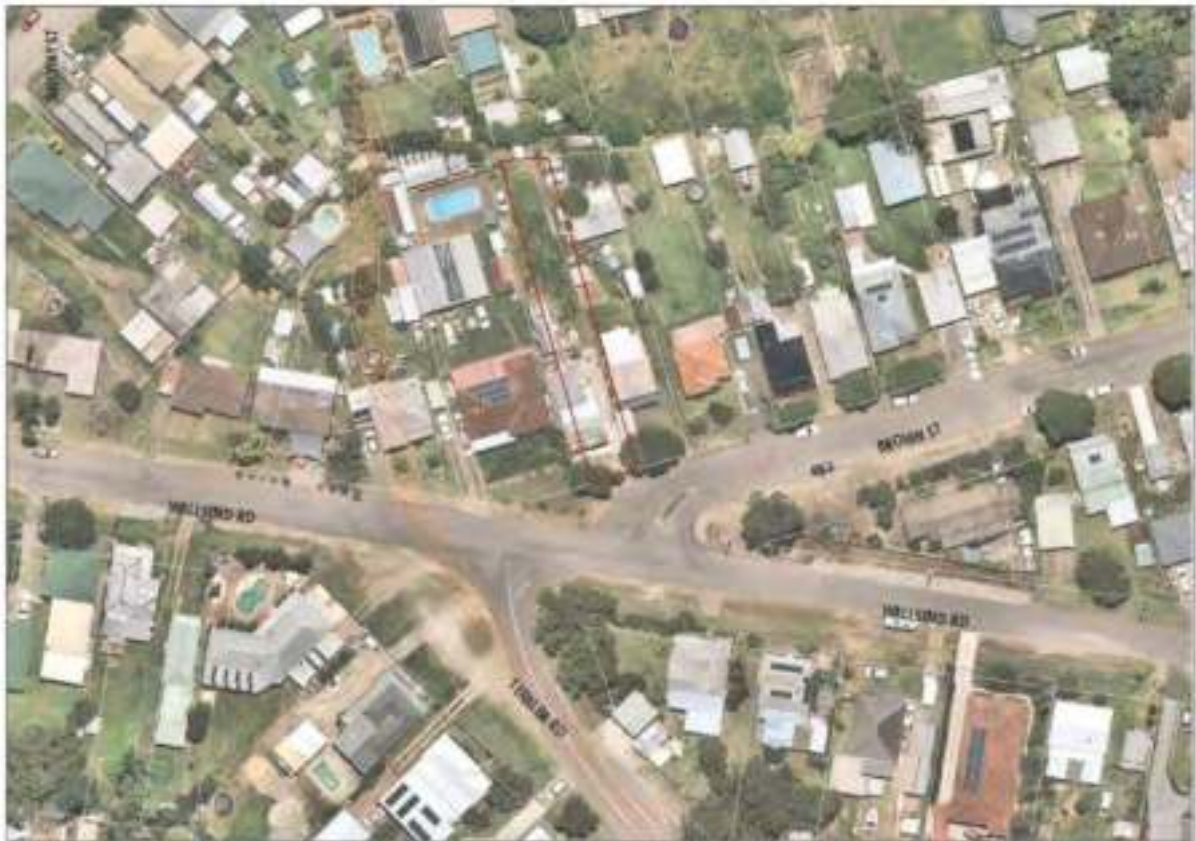
85 BROWN STREET, WEST WALLSEND 2286

Conservation Area Contribution Level	Est. Construction Date	Previous studies and/or community input
Contributory 2	Early to late 20 th century (broad range)	No prior heritage assessments or research undertaken.
Assessment Text		Observed Modifications
<p>The scale (single-storey) and general style of the dwelling is consistent with that of the streetscape and wider HCA. Dwelling contributes positively to the streetscape and wider HCA, particularly in comparison to Non-Contributory buildings.</p> <p>The dwelling features appropriately proportioned and positioned fenestrations, an appropriate roof form (gabled or hipped) and other features consistent with the architectural character of the area (e.g. front verandah with timber or brick posts, timber detailing, corrugated metal roofing, etc). The contributory value of the dwelling is limited however by either:</p> <ul style="list-style-type: none"> External modifications that have in some way obscured the style, scale or design intent of the building and have resulted in less physical integrity than Contributory 1 buildings. Being a later dwelling constructed in an appropriate referential style, but comprising little to no fabric of intrinsic heritage significance. 		<p>The dwelling has undergone extensive modifications to the external façade.</p> <p>The flat veranda roof, timber posts and balustrade are contemporary additions, likely replacing a bull nosed or hipped roof and solid timber designs.</p> <p>All visible windows and doors are contemporary in style. This modernistic style juxtaposes the remaining heritage features of the dwelling.</p> <p>The timber decking is a contemporary addition, likely replacing an original timber design.</p> <p>An extension has been built onto the back northern portion of the dwelling. This is not visible from the street and does not detract from the heritage streetscape.</p>
