APPENDIX 2

Building Assessment Sheets (Inventory Sheets)

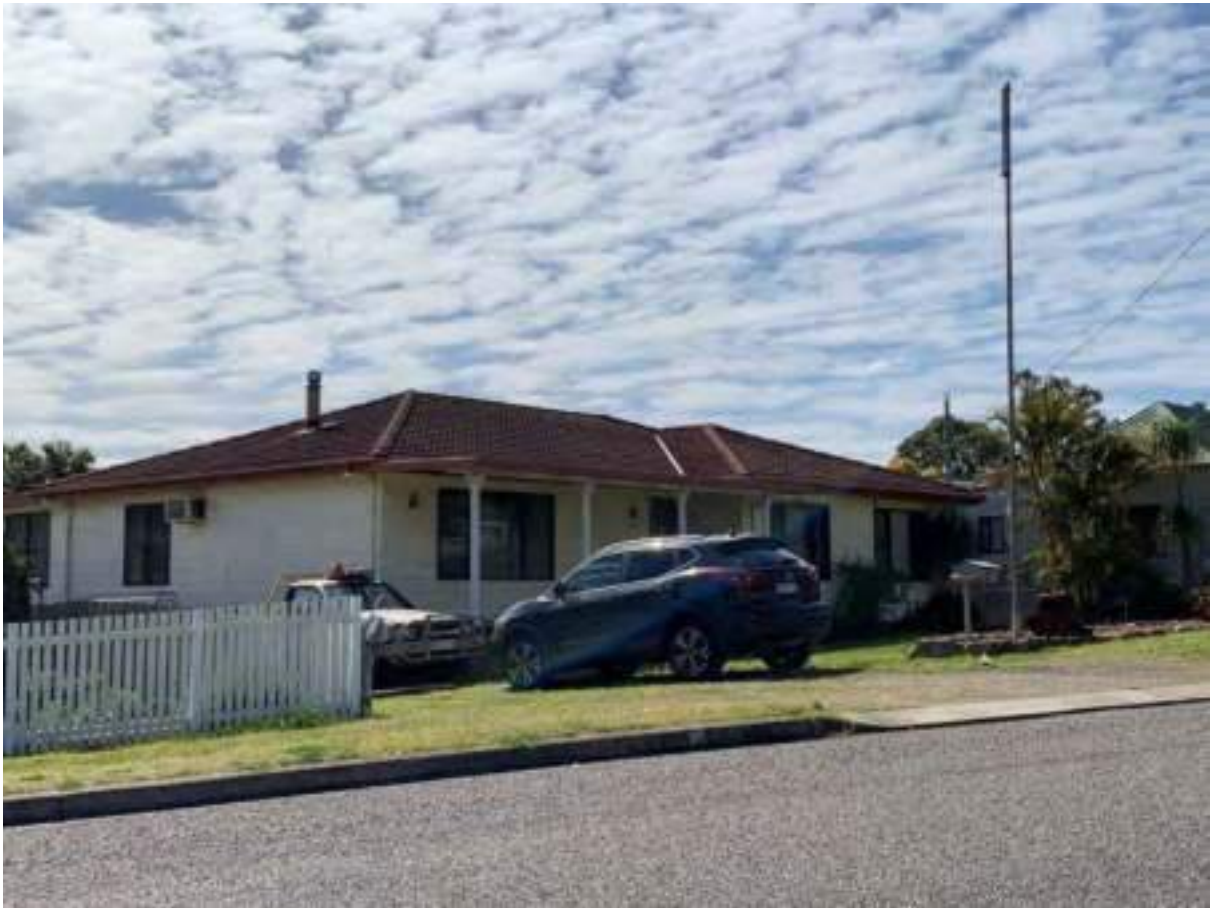
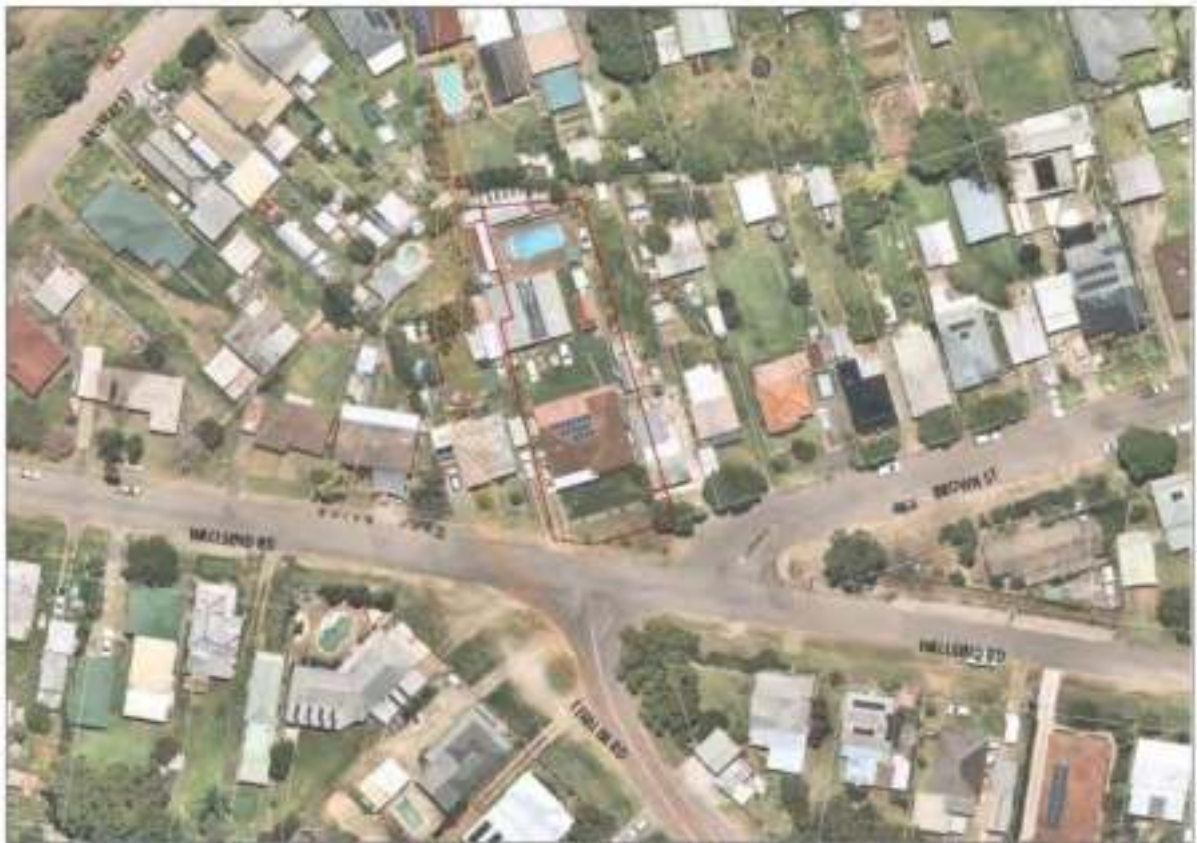
87 BROWN STREET, WEST WALLSEND 2286

Conservation Area Contribution Level	Est. Construction Date	Previous studies and/or community input
Contributory 2	Early to late 20 th century (broad range)	No prior heritage assessments or research undertaken.
Assessment Text		Observed Modifications
<p>The scale (single-storey) and general style of the dwelling is consistent with that of the streetscape and wider HCA. Dwelling contributes positively to the streetscape and wider HCA, particularly in comparison to Non-Contributory buildings.</p> <p>The dwelling features appropriately proportioned and positioned fenestrations, an appropriate roof form (gabled or hipped) and other features consistent with the architectural character of the area (e.g. front verandah with timber or brick posts, timber detailing, corrugated metal roofing, etc). The contributory value of the dwelling is limited however by either:</p> <ul style="list-style-type: none"> • External modifications that have in some way obscured the style, scale or design intent of the building and have resulted in less physical integrity than Contributory 1 buildings. • Being a later dwelling constructed in an appropriate referential style, but comprising little to no fabric of intrinsic heritage significance. 		<p>The faux European style pillars may be a prior modification, being a common alteration in the area.</p> <p>An extension has been built onto the northern portion of the dwelling. This is not visible from the street and does not detract from the heritage streetscape.</p>

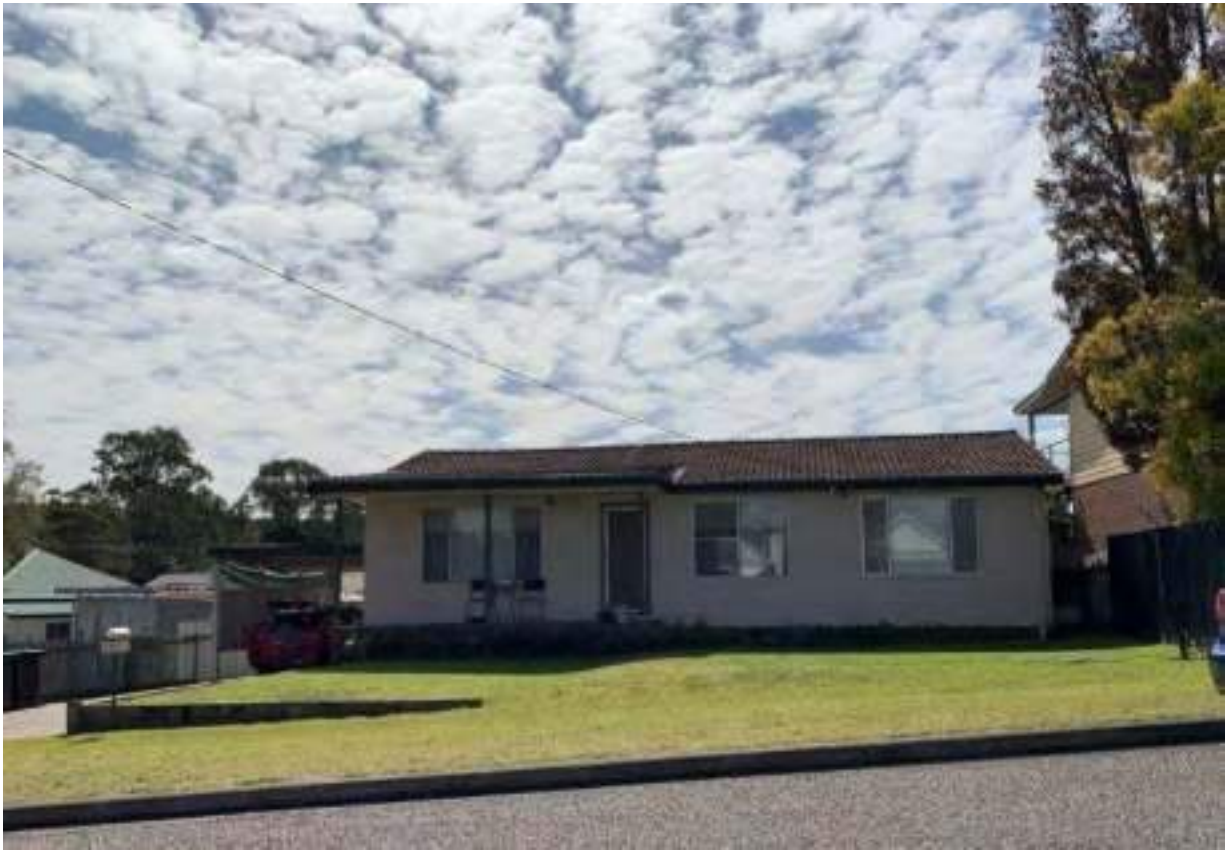
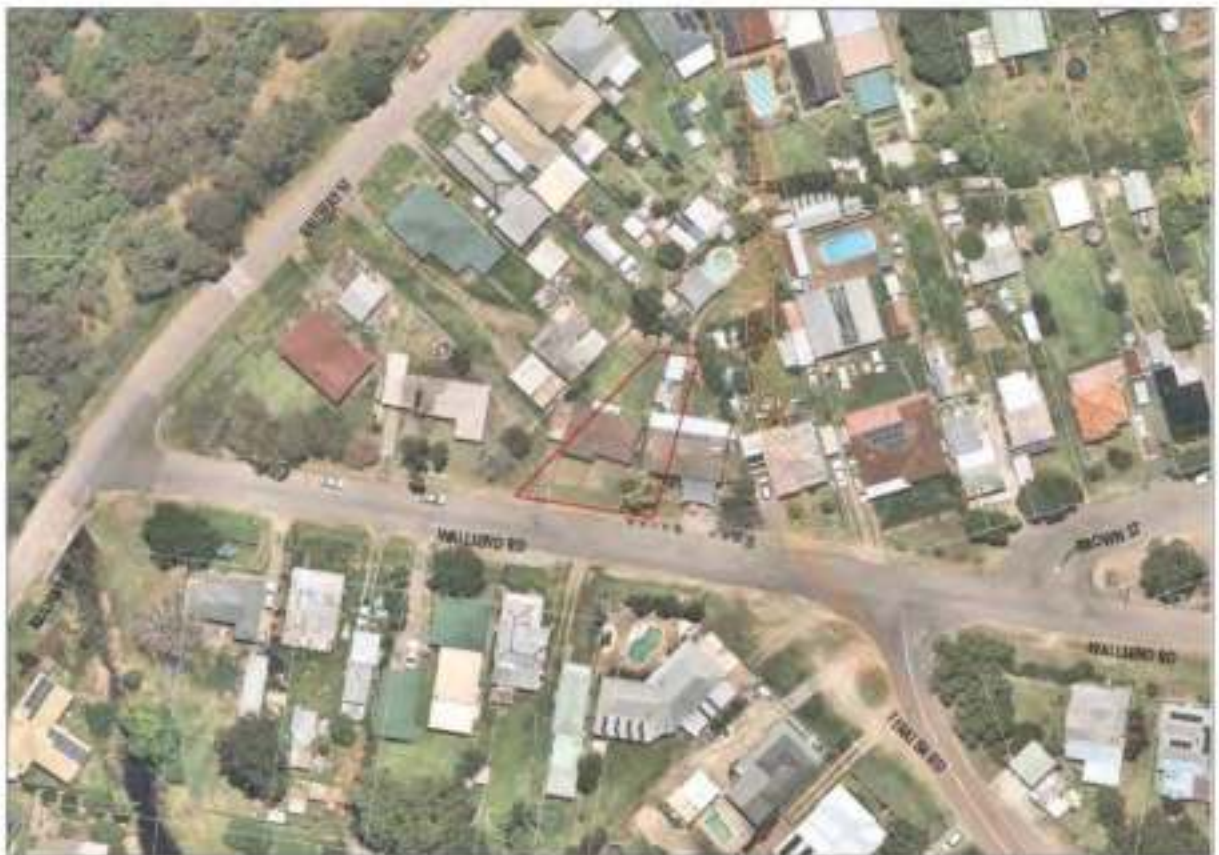
17 WALLSEND ROAD, WEST WALLSEND 2286

Conservation Area Contribution Level	Est. Construction Date	Previous studies and/or community input
Contributory 2	Early to late 20 th century (broad range)	No prior heritage assessments or research undertaken.
Assessment Text		Observed Modifications
<p>The scale (single-storey) and general style of the dwelling is consistent with that of the streetscape and wider HCA. Dwelling contributes positively to the streetscape and wider HCA, particularly in comparison to Non-Contributory buildings.</p> <p>The dwelling features appropriately proportioned and positioned fenestrations, an appropriate roof form (gabled or hipped) and other features consistent with the architectural character of the area (e.g. front verandah with timber or brick posts, timber detailing, corrugated metal roofing, etc). The contributory value of the dwelling is limited however by either:</p> <ul style="list-style-type: none"> • External modifications that have in some way obscured the style, scale or design intent of the building and have resulted in less physical integrity than Contributory 1 buildings. • Being a later dwelling constructed in an appropriate referential style, but comprising little to no fabric of intrinsic heritage significance. 		No modifications observed.

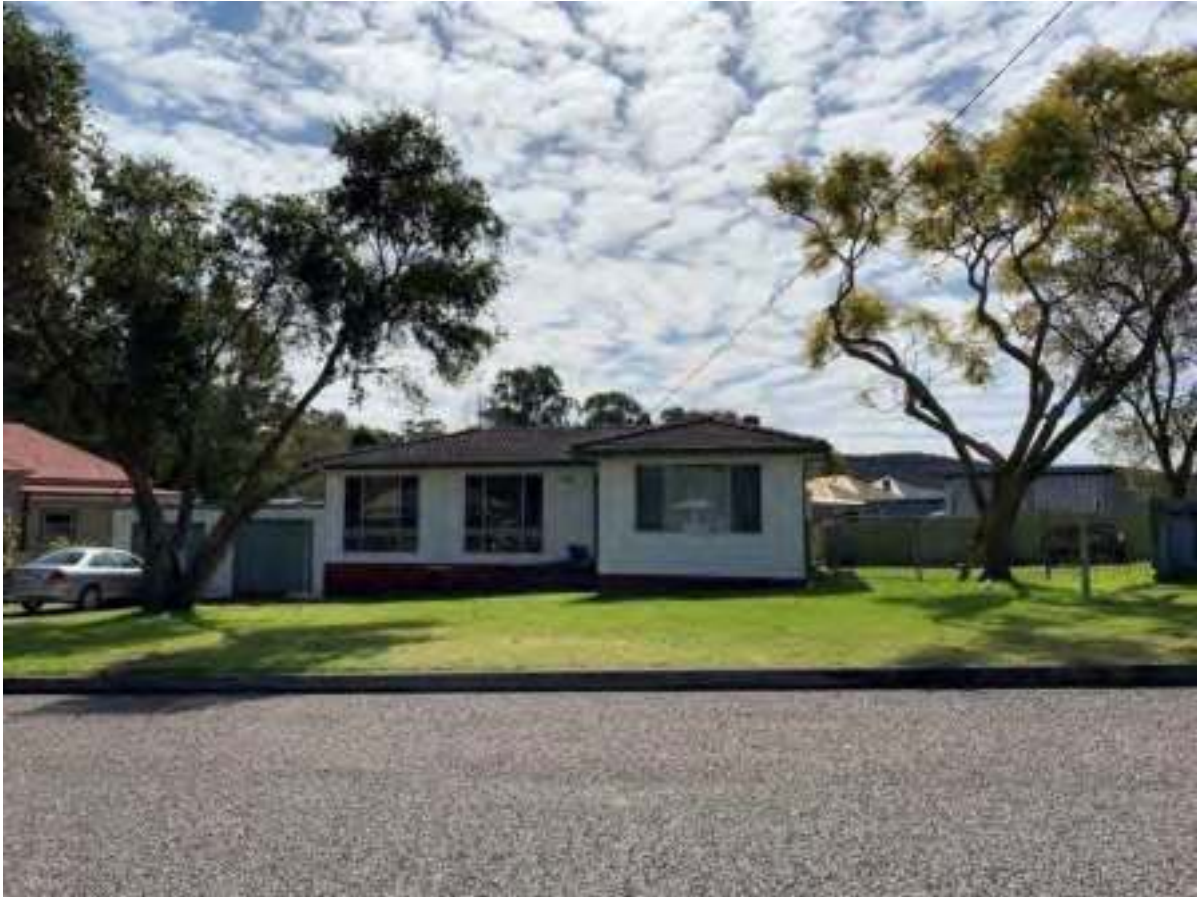
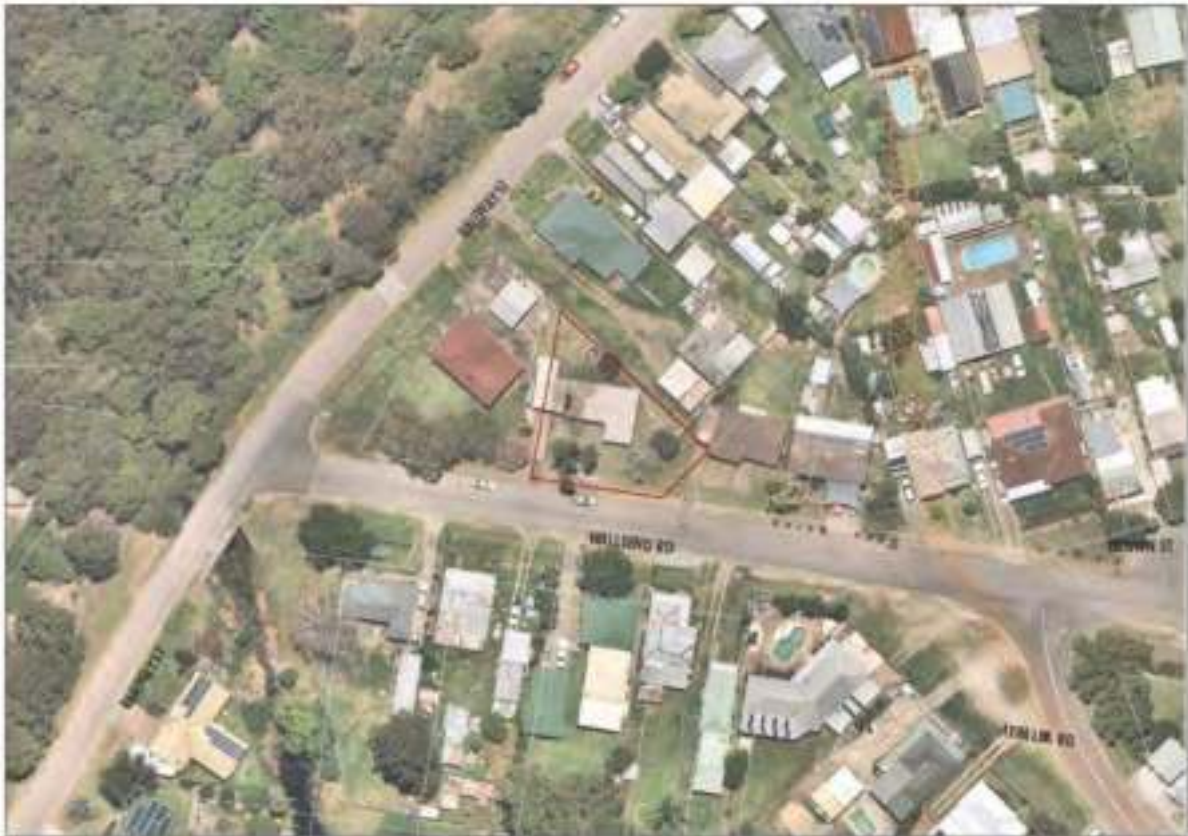
19 WALLSEND ROAD, WEST WALLSEND 2286

Conservation Area Contribution Level	Est. Construction Date	Previous studies and/or community input
Contributory 2	Early to late 20 th century (broad range)	No prior heritage assessments or research undertaken.
Assessment Text		Observed Modifications
<p>The scale (single-storey) and general style of the dwelling is consistent with that of the streetscape and wider HCA. Dwelling contributes positively to the streetscape and wider HCA, particularly in comparison to Non-Contributory buildings.</p> <p>The dwelling features appropriately proportioned and positioned fenestrations, an appropriate roof form (gabled or hipped) and other features consistent with the architectural character of the area (e.g. front verandah with timber or brick posts, timber detailing, corrugated metal roofing, etc). The contributory value of the dwelling is limited however by either:</p> <ul style="list-style-type: none"> • External modifications that have in some way obscured the style, scale or design intent of the building and have resulted in less physical integrity than Contributory 1 buildings. • Being a later dwelling constructed in an appropriate referential style, but comprising little to no fabric of intrinsic heritage significance. 		<p>A double garage has been built onto the western side of the dwelling.</p>

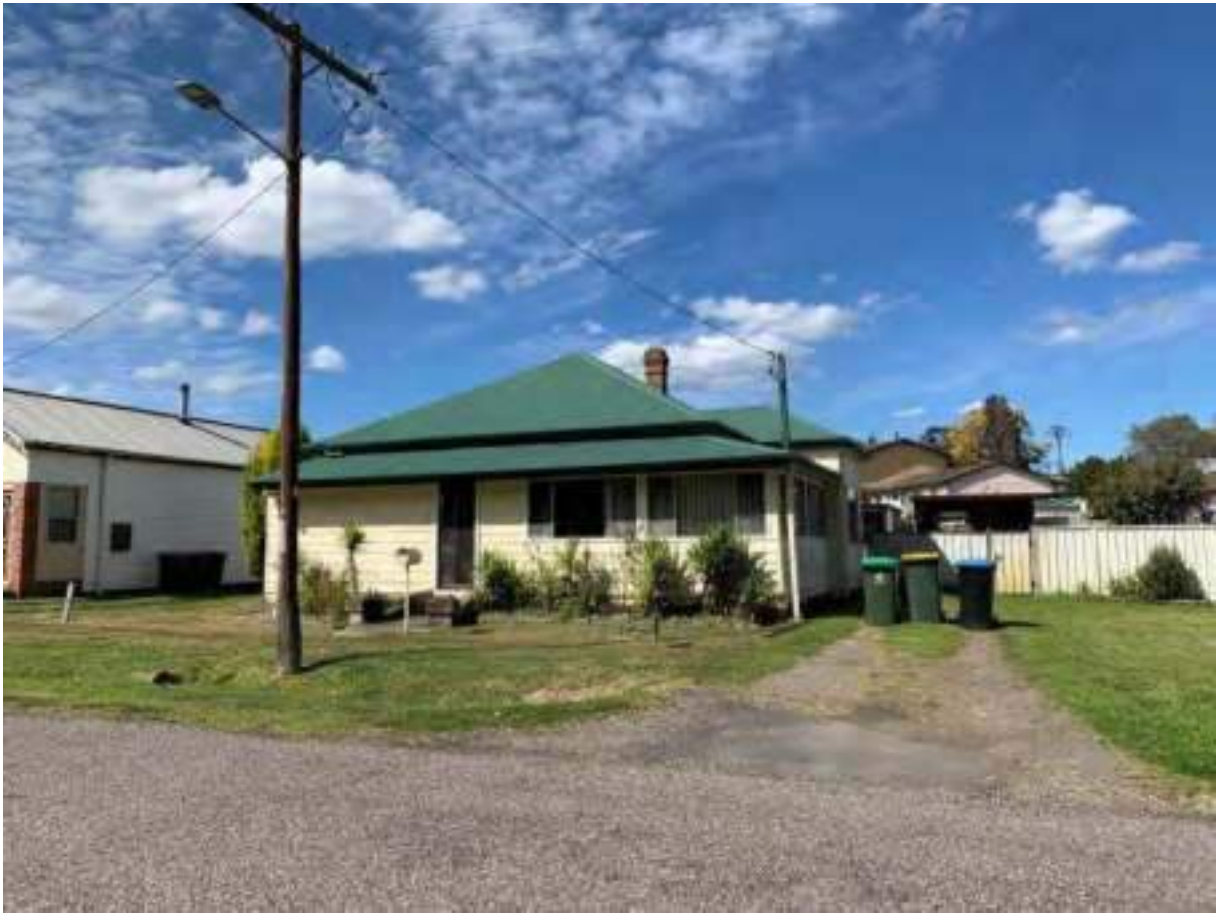
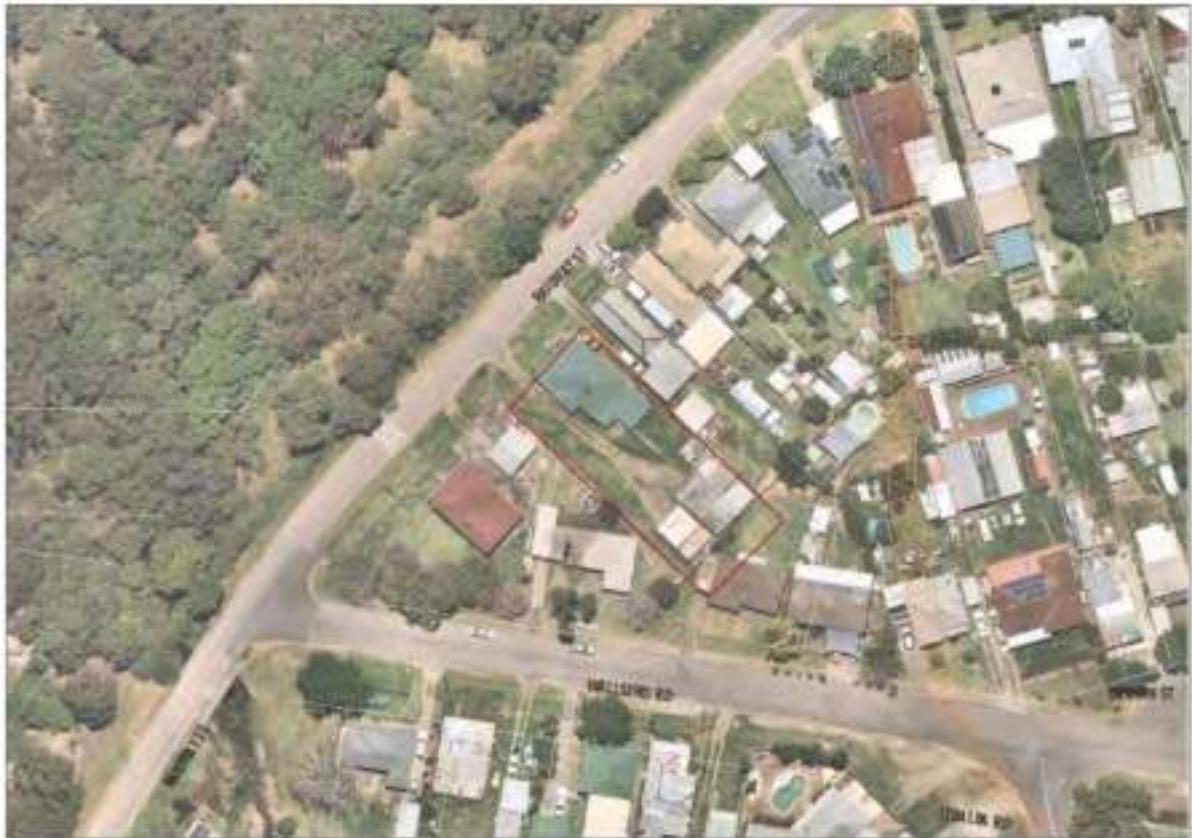
17 RAILWAY STREET, WEST WALLSEND 2286

Conservation Area Contribution Level	Est. Construction Date	Previous studies and/or community input
Contributory 2	Early to late 20 th century (broad range)	No prior heritage assessments or research undertaken.
Assessment Text		Observed Modifications
<p>The scale (single-storey) and general style of the dwelling is consistent with that of the streetscape and wider HCA. Dwelling contributes positively to the streetscape and wider HCA, particularly in comparison to Non-Contributory buildings.</p> <p>The dwelling features appropriately proportioned and positioned fenestrations, an appropriate roof form (gabled or hipped) and other features consistent with the architectural character of the area (e.g. front verandah with timber or brick posts, timber detailing, corrugated metal roofing, etc). The contributory value of the dwelling is limited however by either:</p> <ul style="list-style-type: none"> External modifications that have in some way obscured the style, scale or design intent of the building and have resulted in less physical integrity than Contributory 1 buildings. Being a later dwelling constructed in an appropriate referential style, but comprising little to no fabric of intrinsic heritage significance. 		<p>The veranda has been built in to create an additional living area, as well as extended to wrap around the south western portion of the dwelling. this has been undertaken in a sympathetic manner, however it has altered the façade of the dwelling to the extent that the original Vernacular Mining Cottage style is unrecognisable.</p> <p>An extension has been built onto the back south eastern portion of the dwelling. This is not visible from the street and does not detract from the heritage streetscape.</p>

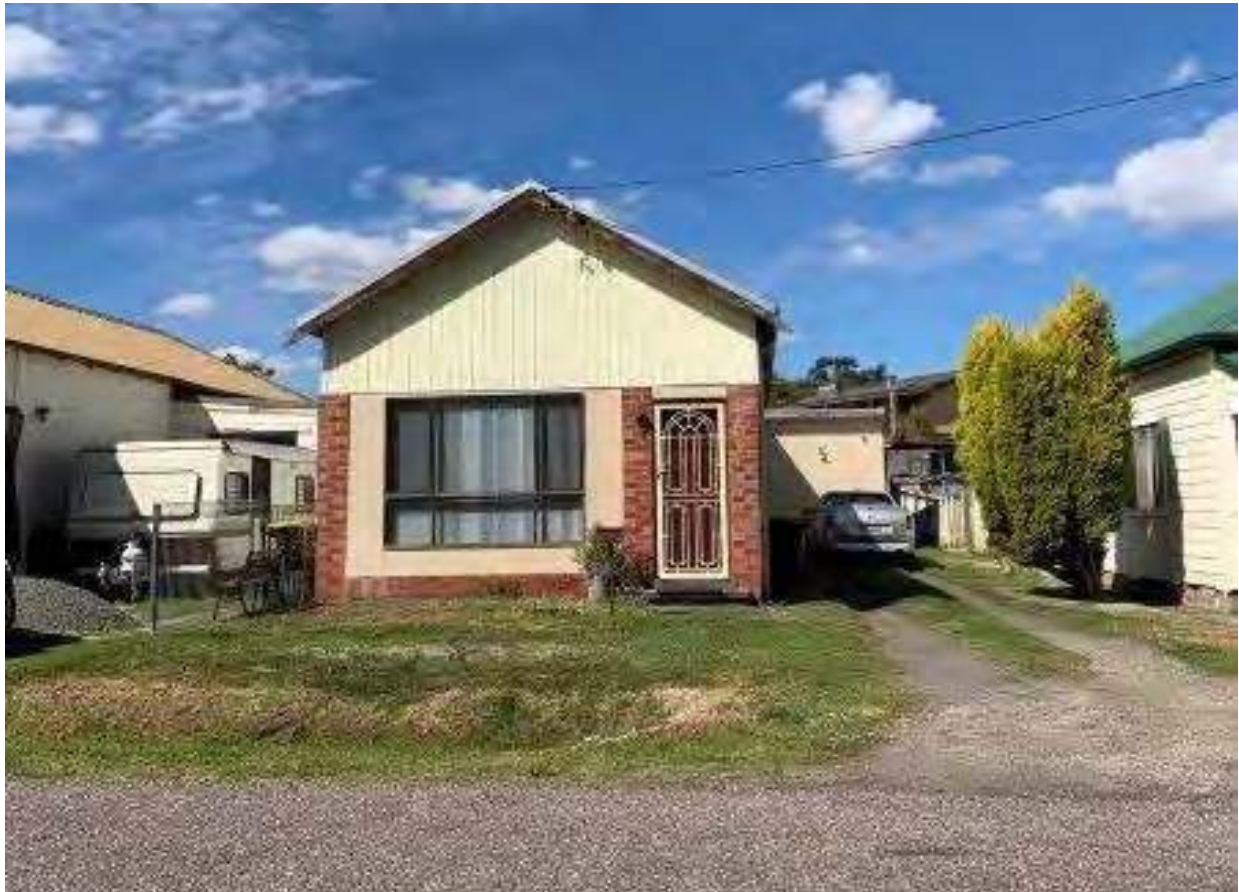
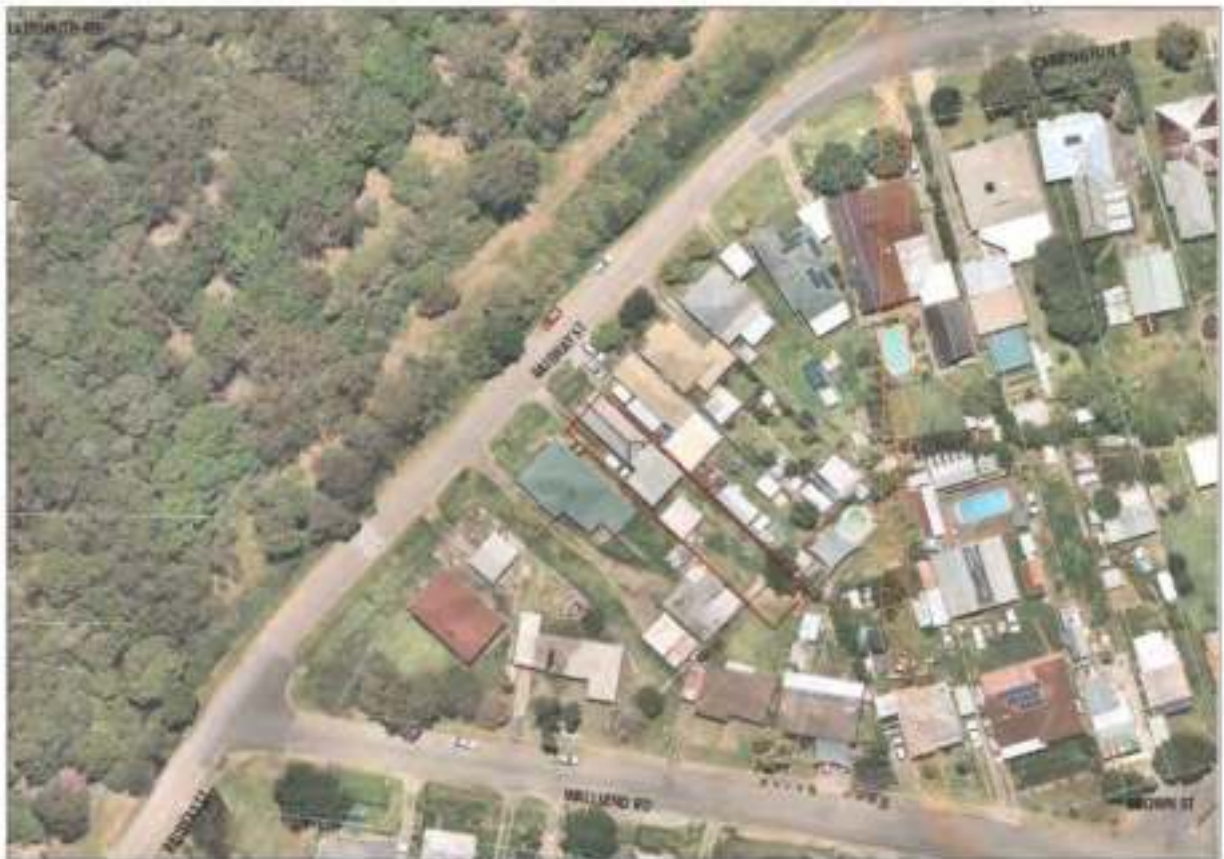
15 RAILWAY STREET, WEST WALLSEND 2286

Conservation Area Contribution Level	Est. Construction Date	Previous studies and/or community input
Contributory 2	Early to late 20 th century (broad range)	No prior heritage assessments or research undertaken.
Assessment Text		Observed Modifications
<p>The scale (single-storey) and general style of the dwelling is consistent with that of the streetscape and wider HCA. Dwelling contributes positively to the streetscape and wider HCA, particularly in comparison to Non-Contributory buildings.</p> <p>The dwelling features appropriately proportioned and positioned fenestrations, an appropriate roof form (gabled or hipped) and other features consistent with the architectural character of the area (e.g. front verandah with timber or brick posts, timber detailing, corrugated metal roofing, etc). The contributory value of the dwelling is limited however by either:</p> <ul style="list-style-type: none"> • External modifications that have in some way obscured the style, scale or design intent of the building and have resulted in less physical integrity than Contributory 1 buildings. • Being a later dwelling constructed in an appropriate referential style, but comprising little to no fabric of intrinsic heritage significance. 		<p>The brickwork across the façade is likely a contemporary addition. It is likely that the space was an open veranda beforehand.</p> <p>A large extension has been built onto the back south eastern portion of the dwelling. This is not visible from the street and does not detract from the heritage streetscape.</p>

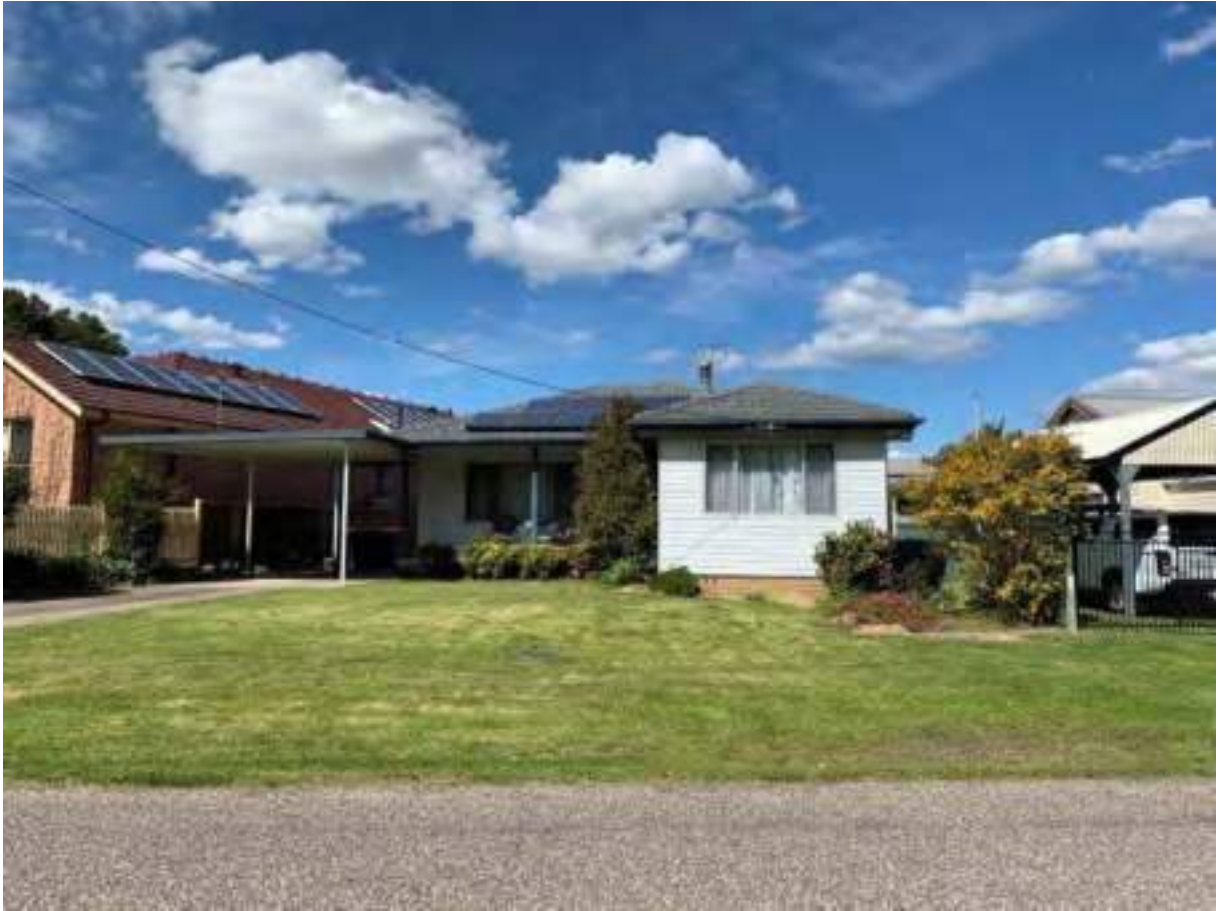
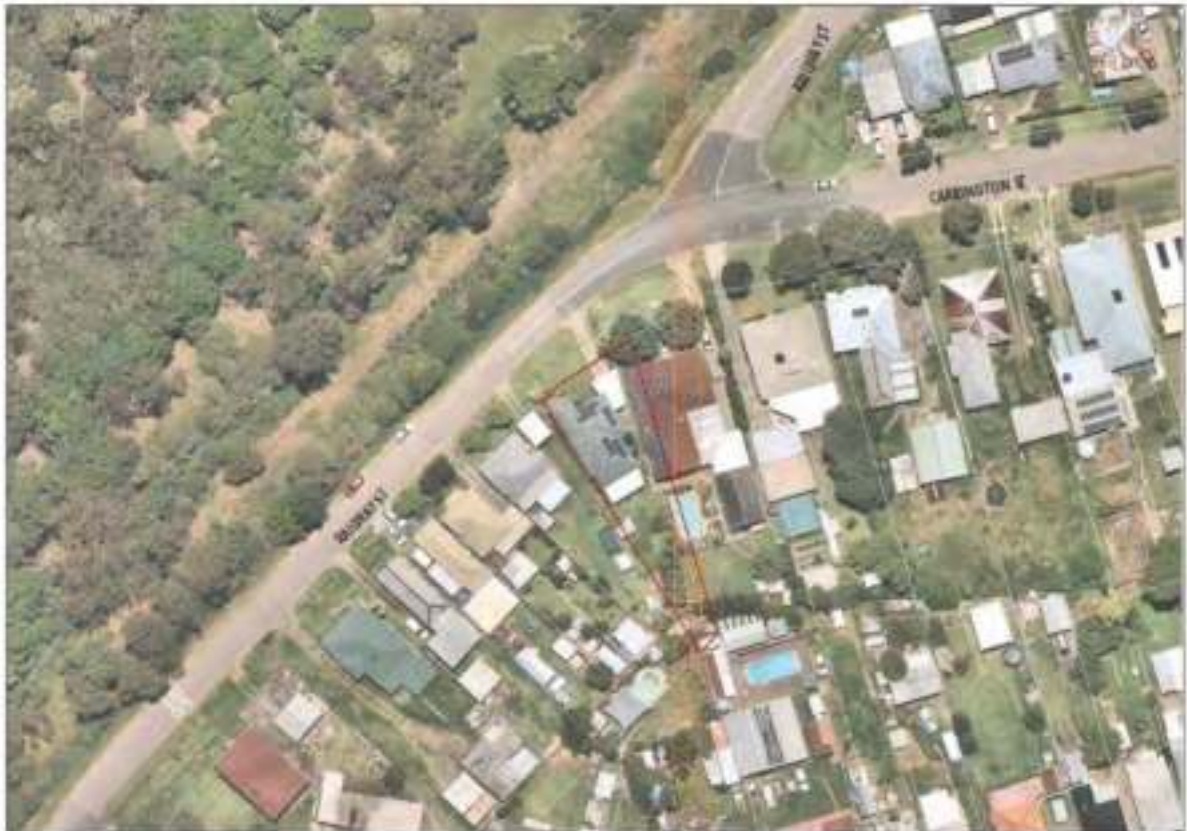
7 RAILWAY STREET, WEST WALLSEND 2286

Conservation Area Contribution Level	Est. Construction Date	Previous studies and/or community input
Contributory 2	Early to late 20 th century (broad range)	No prior heritage assessments or research undertaken.
Assessment Text		Observed Modifications
<p>The scale (single-storey) and general style of the dwelling is consistent with that of the streetscape and wider HCA. Dwelling contributes positively to the streetscape and wider HCA, particularly in comparison to Non-Contributory buildings.</p> <p>The dwelling features appropriately proportioned and positioned fenestrations, an appropriate roof form (gabled or hipped) and other features consistent with the architectural character of the area (e.g. front verandah with timber or brick posts, timber detailing, corrugated metal roofing, etc). The contributory value of the dwelling is limited however by either:</p> <ul style="list-style-type: none"> • External modifications that have in some way obscured the style, scale or design intent of the building and have resulted in less physical integrity than Contributory 1 buildings. • Being a later dwelling constructed in an appropriate referential style, but comprising little to no fabric of intrinsic heritage significance. 		<p>Solar panels are highly visible along the north western side of the roof.</p> <p>A carport has been built onto the eastern side of the dwelling.</p>

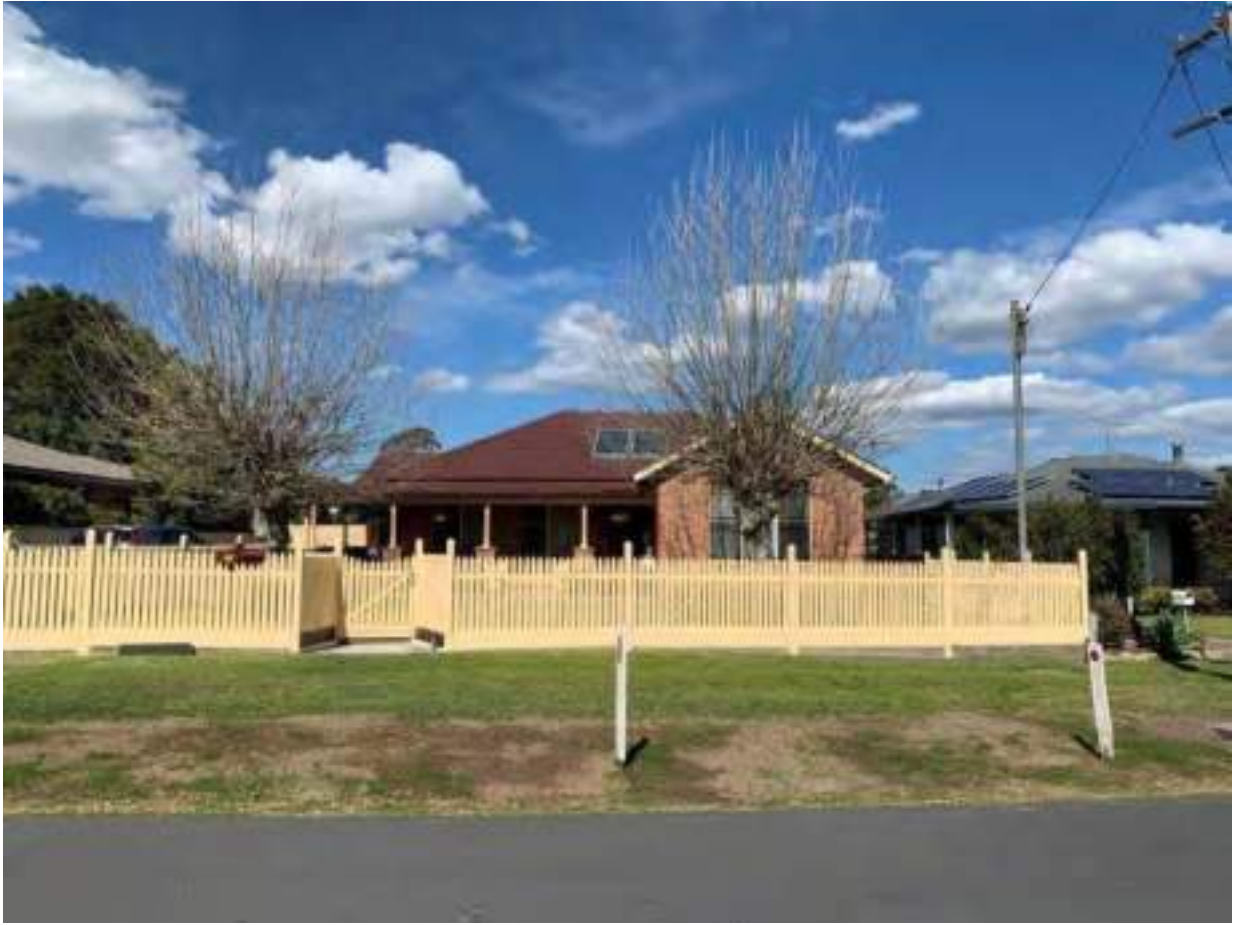
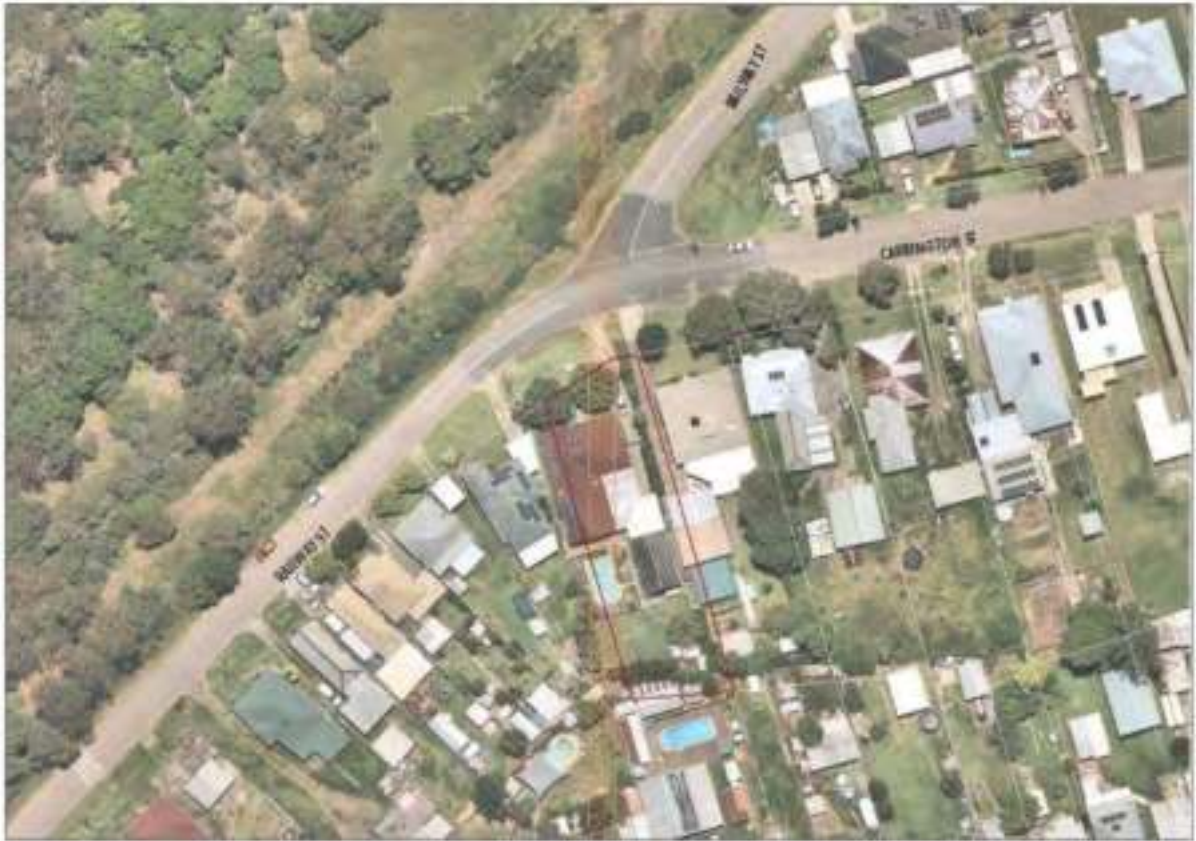
114 CARRINGTON STREET, WEST WALLSEND 2286

Conservation Area Contribution Level	Est. Construction Date	Previous studies and/or community input
Contributory 2	Early to late 20 th century (broad range)	No prior heritage assessments or research undertaken.
Assessment Text		Observed Modifications
<p>The scale (single-storey) and general style of the dwelling is consistent with that of the streetscape and wider HCA. Dwelling contributes positively to the streetscape and wider HCA, particularly in comparison to Non-Contributory buildings.</p> <p>The dwelling features appropriately proportioned and positioned fenestrations, an appropriate roof form (gabled or hipped) and other features consistent with the architectural character of the area (e.g. front verandah with timber or brick posts, timber detailing, corrugated metal roofing, etc). The contributory value of the dwelling is limited however by either:</p> <ul style="list-style-type: none"> • External modifications that have in some way obscured the style, scale or design intent of the building and have resulted in less physical integrity than Contributory 1 buildings. • Being a later dwelling constructed in an appropriate referential style, but comprising little to no fabric of intrinsic heritage significance. 		Solar panels/heating components are visible along the northern side of the roof.

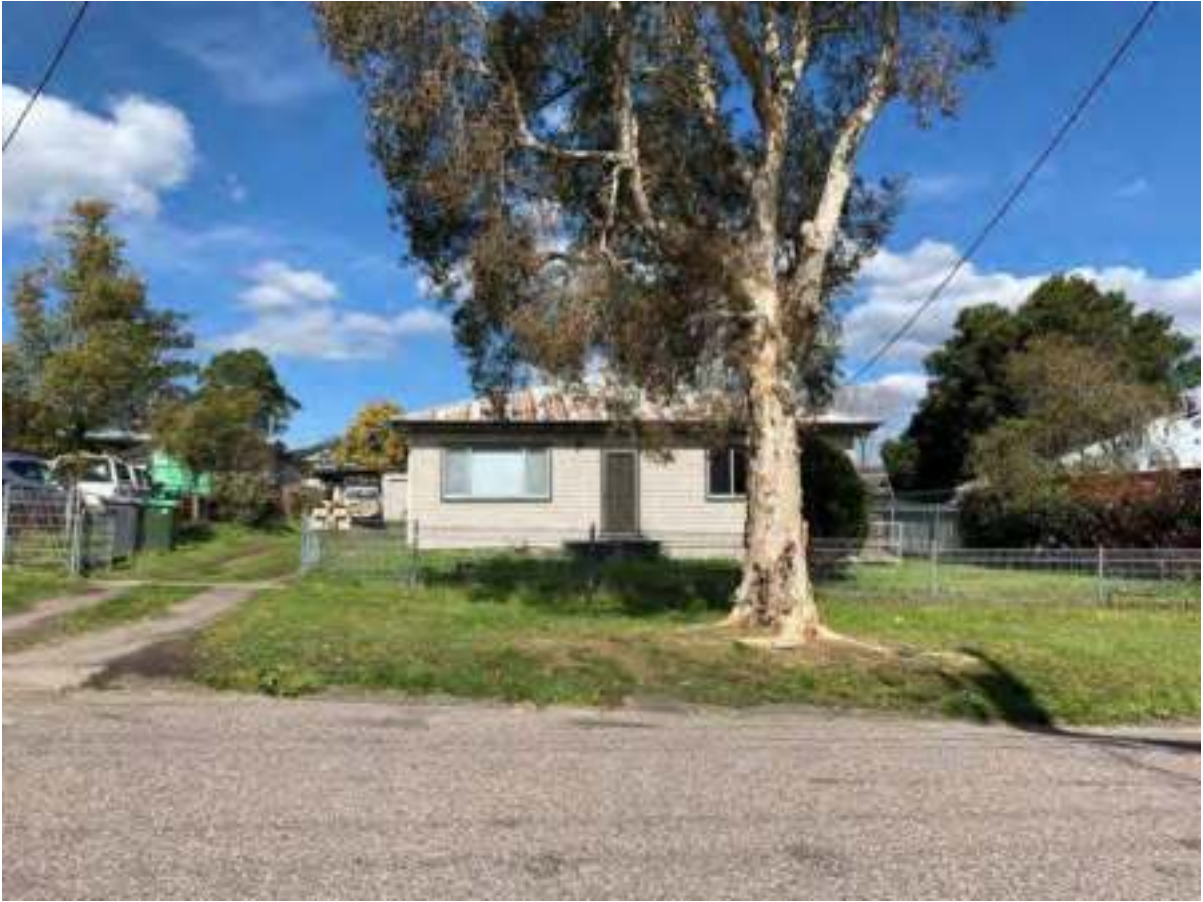
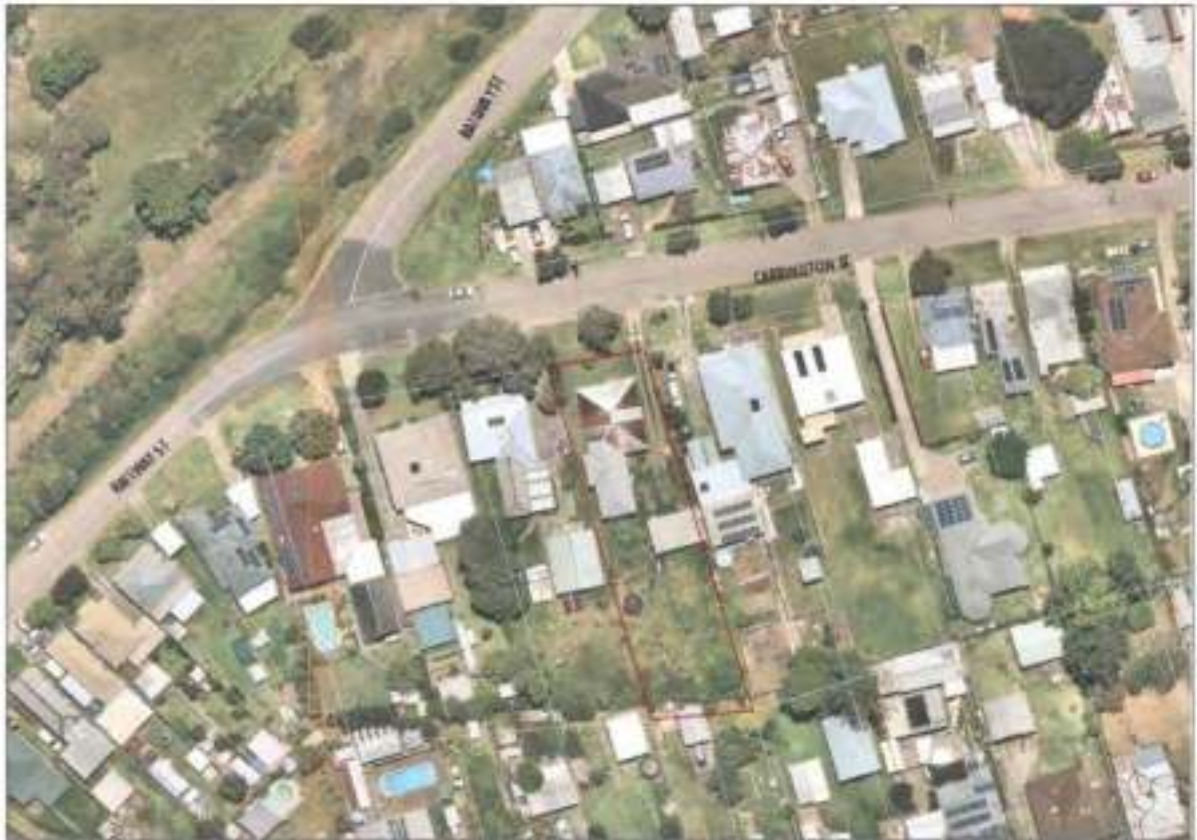
108 CARRINGTON STREET, WEST WALLSEND 2286

Conservation Area Contribution Level	Est. Construction Date	Previous studies and/or community input
Contributory 2	Early to late 20 th century (broad range)	No prior heritage assessments or research undertaken.
Assessment Text		Observed Modifications
<p>The scale (single-storey) and general style of the dwelling is consistent with that of the streetscape and wider HCA. Dwelling contributes positively to the streetscape and wider HCA, particularly in comparison to Non-Contributory buildings.</p> <p>The dwelling features appropriately proportioned and positioned fenestrations, an appropriate roof form (gabled or hipped) and other features consistent with the architectural character of the area (e.g. front verandah with timber or brick posts, timber detailing, corrugated metal roofing, etc). The contributory value of the dwelling is limited however by either:</p> <ul style="list-style-type: none"> • External modifications that have in some way obscured the style, scale or design intent of the building and have resulted in less physical integrity than Contributory 1 buildings. • Being a later dwelling constructed in an appropriate referential style, but comprising little to no fabric of intrinsic heritage significance. 		<p>All visible windows are contemporary in style.</p> <p>An extension has been built onto the back southern portion of the dwelling. This is not visible from the street and does not detract from the heritage streetscape.</p>

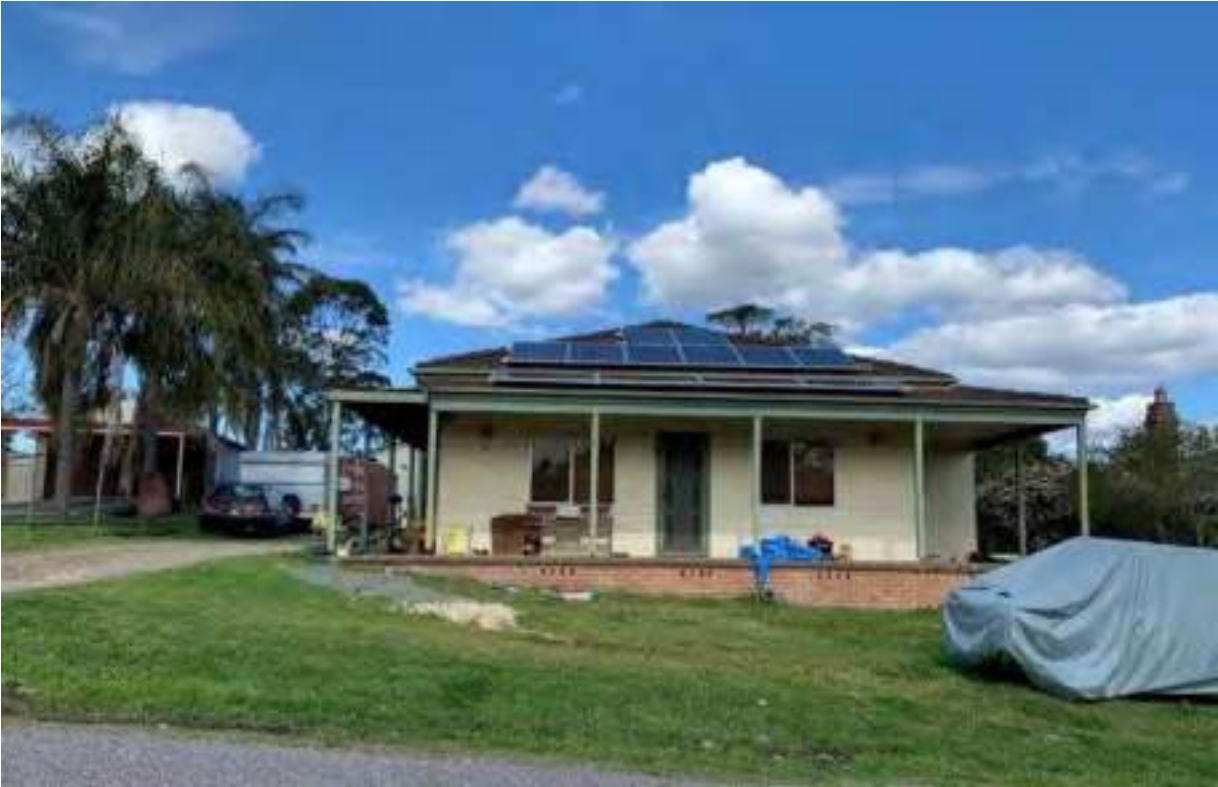
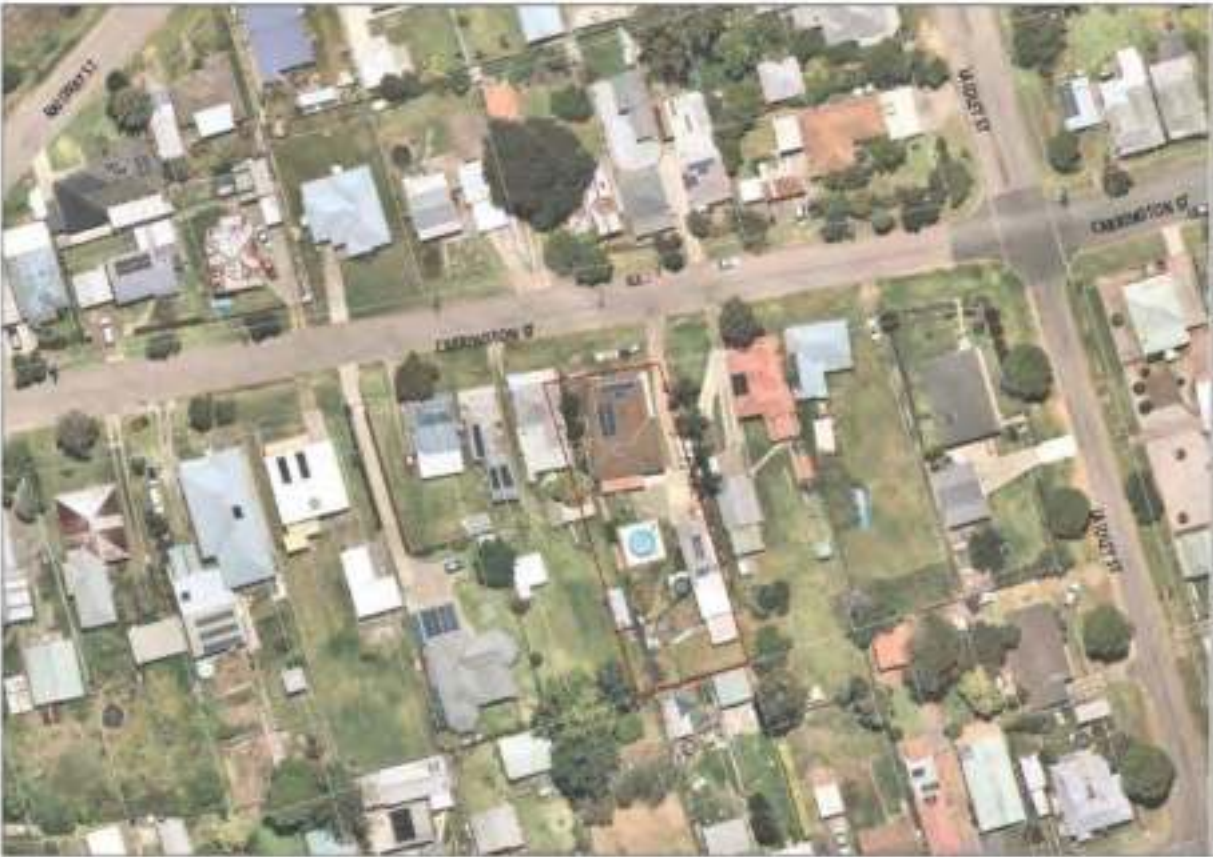
96 CARRINGTON STREET, WEST WALLSEND 2286

Conservation Area Contribution Level	Est. Construction Date	Previous studies and/or community input
Contributory 2	Early to late 20 th century (broad range)	No prior heritage assessments or research undertaken.
Assessment Text		Observed Modifications
<p>The scale (single-storey) and general style of the dwelling is consistent with that of the streetscape and wider HCA. Dwelling contributes positively to the streetscape and wider HCA, particularly in comparison to Non-Contributory buildings.</p> <p>The dwelling features appropriately proportioned and positioned fenestrations, an appropriate roof form (gabled or hipped) and other features consistent with the architectural character of the area (e.g. front verandah with timber or brick posts, timber detailing, corrugated metal roofing, etc). The contributory value of the dwelling is limited however by either:</p> <ul style="list-style-type: none"> • External modifications that have in some way obscured the style, scale or design intent of the building and have resulted in less physical integrity than Contributory 1 buildings. • Being a later dwelling constructed in an appropriate referential style, but comprising little to no fabric of intrinsic heritage significance. 		<p>Solar panels are highly visible along the northern portion of the roof.</p> <p>The veranda has been extended to wrap around the eastern and western sides of the dwelling.</p> <p>All visible windows are contemporary in style.</p>
