APPENDIX 2

Building Assessment Sheets (Inventory Sheets)

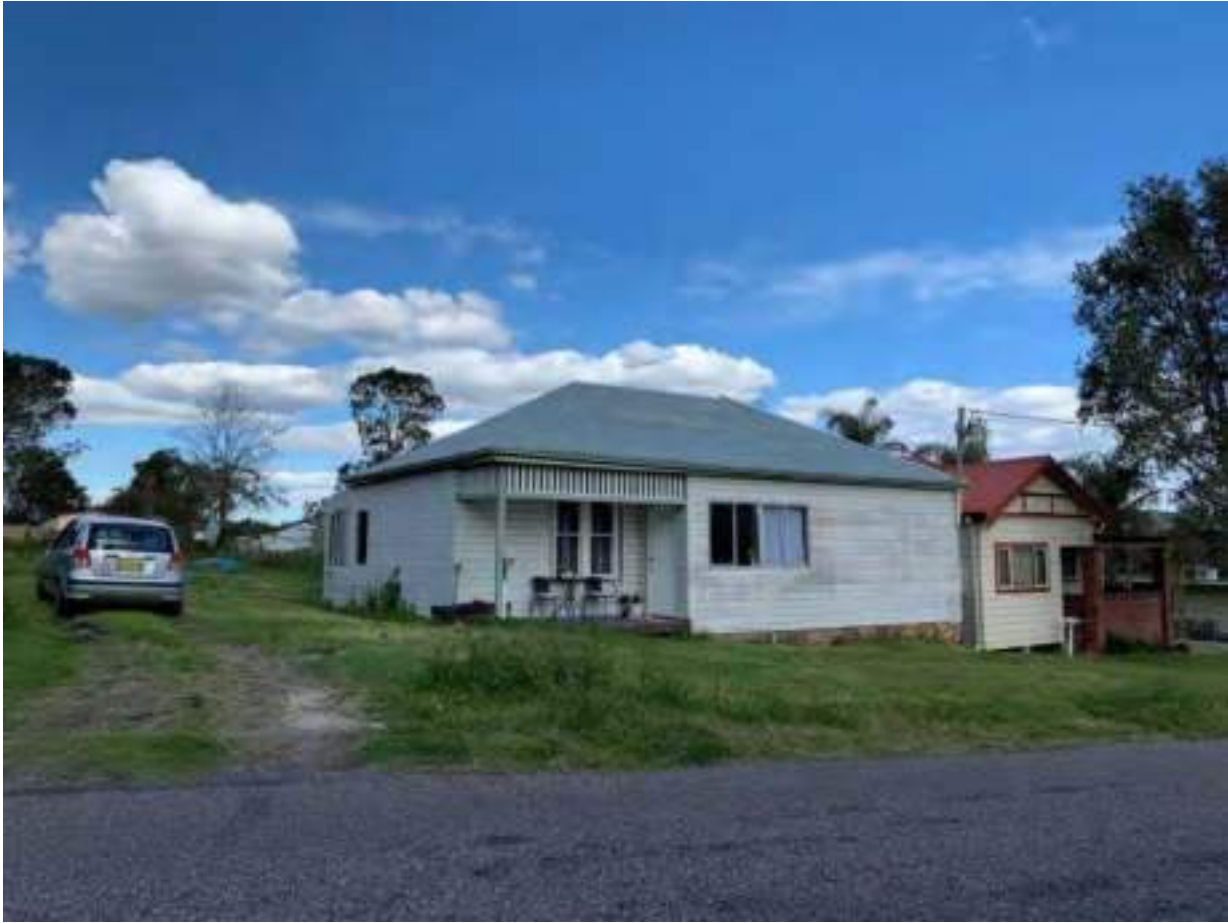
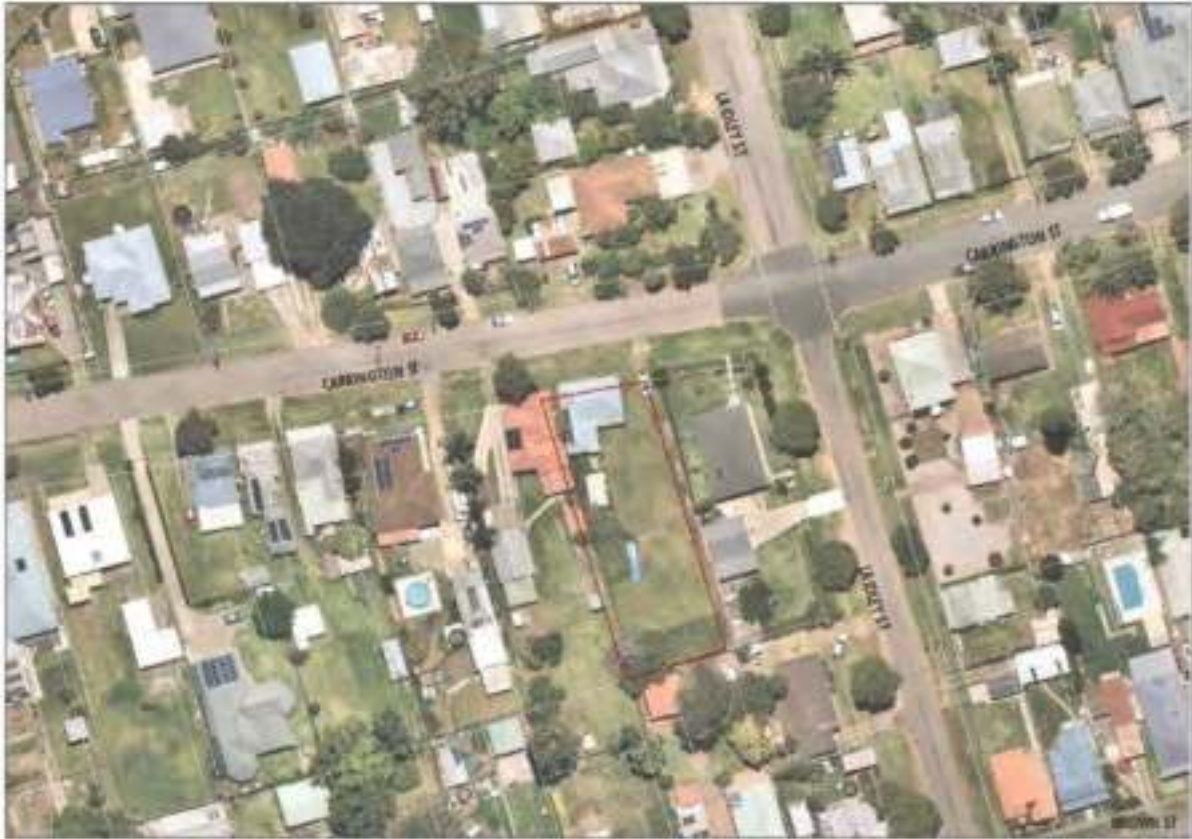
92 CARRINGTON STREET, WEST WALLSEND 2286

Conservation Area Contribution Level	Est. Construction Date	Previous studies and/or community input
Contributory 2	Early to late 20 th century (broad range)	No prior heritage assessments or research undertaken.
Assessment Text		Observed Modifications
<p>The scale (single-storey) and general style of the dwelling is consistent with that of the streetscape and wider HCA. Dwelling contributes positively to the streetscape and wider HCA, particularly in comparison to Non-Contributory buildings.</p> <p>The dwelling features appropriately proportioned and positioned fenestrations, an appropriate roof form (gabled or hipped) and other features consistent with the architectural character of the area (e.g. front verandah with timber or brick posts, timber detailing, corrugated metal roofing, etc). The contributory value of the dwelling is limited however by either:</p> <ul style="list-style-type: none"> • External modifications that have in some way obscured the style, scale or design intent of the building and have resulted in less physical integrity than Contributory 1 buildings. • Being a later dwelling constructed in an appropriate referential style, but comprising little to no fabric of intrinsic heritage significance. 		<p>Some windows have been replaced with contemporary designs, including those at the front northern side of the dwelling.</p> <p>The timber valance is potentially a contemporary replication of an original heritage design.</p>

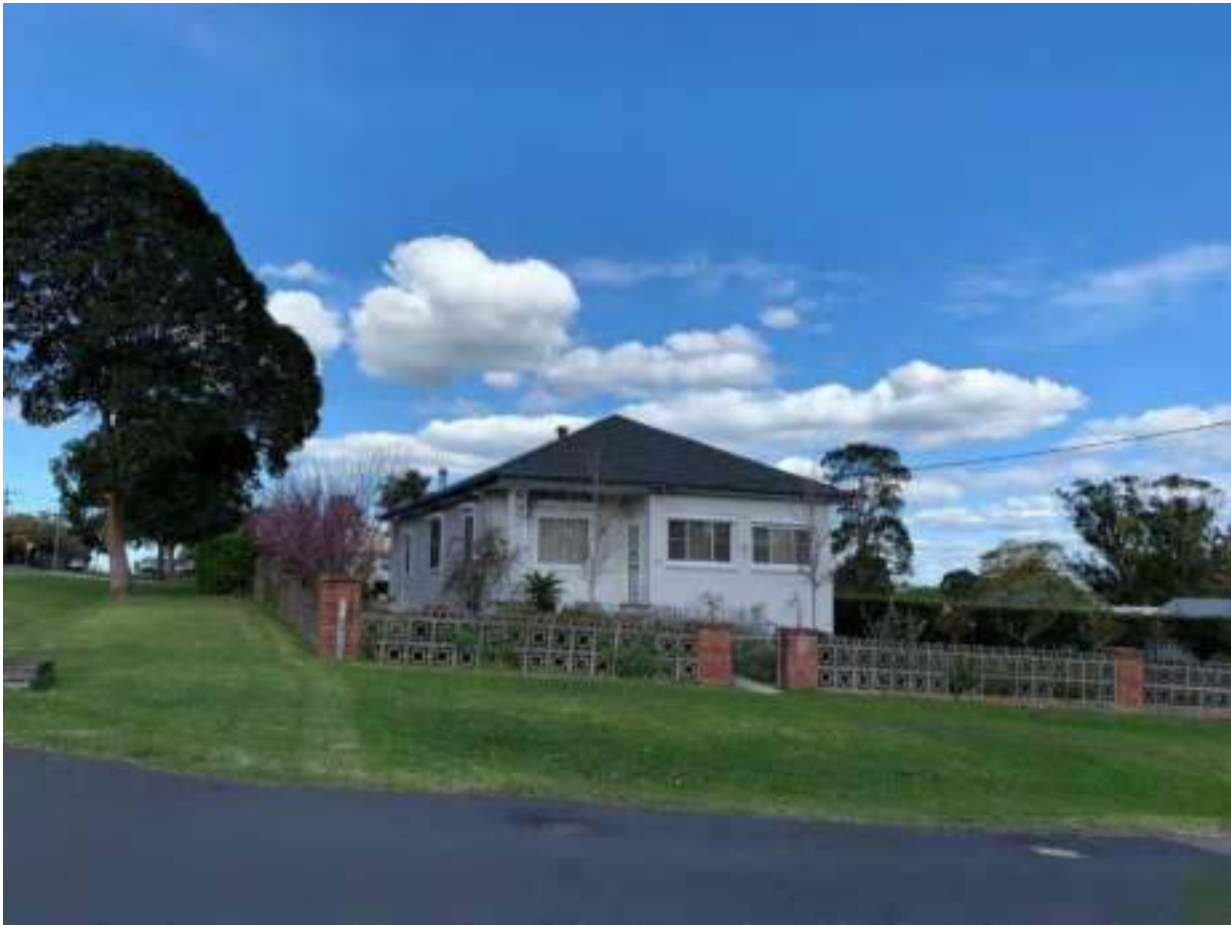
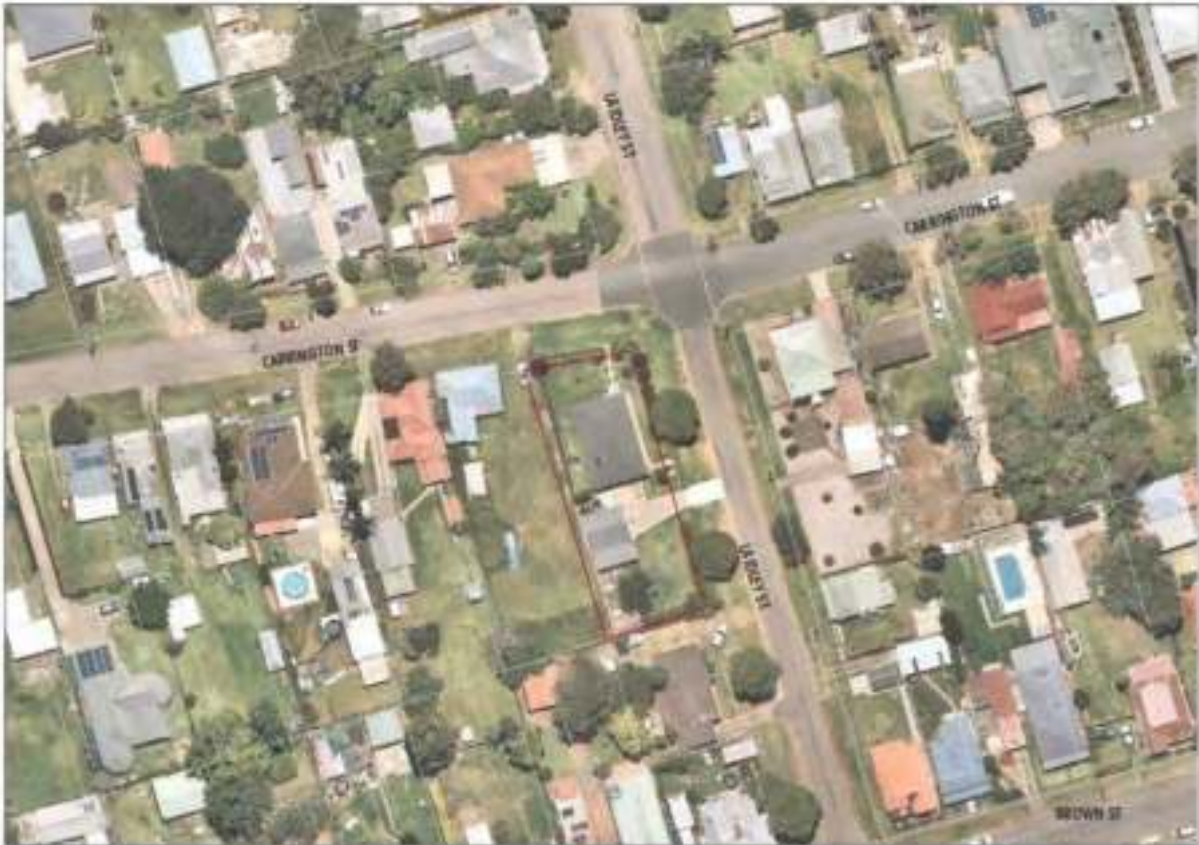
90 CARRINGTON STREET, WEST WALLSEND 2286

Conservation Area Contribution Level	Est. Construction Date	Previous studies and/or community input
Contributory 2	Early to late 20 th century (broad range)	No prior heritage assessments or research undertaken.
Assessment Text		Observed Modifications
<p>The scale (single-storey) and general style of the dwelling is consistent with that of the streetscape and wider HCA. Dwelling contributes positively to the streetscape and wider HCA, particularly in comparison to Non-Contributory buildings.</p> <p>The dwelling features appropriately proportioned and positioned fenestrations, an appropriate roof form (gabled or hipped) and other features consistent with the architectural character of the area (e.g. front verandah with timber or brick posts, timber detailing, corrugated metal roofing, etc). The contributory value of the dwelling is limited however by either:</p> <ul style="list-style-type: none"> • External modifications that have in some way obscured the style, scale or design intent of the building and have resulted in less physical integrity than Contributory 1 buildings. • Being a later dwelling constructed in an appropriate referential style, but comprising little to no fabric of intrinsic heritage significance. 		<p>All windows are contemporary in style, with metal roller shutters.</p>

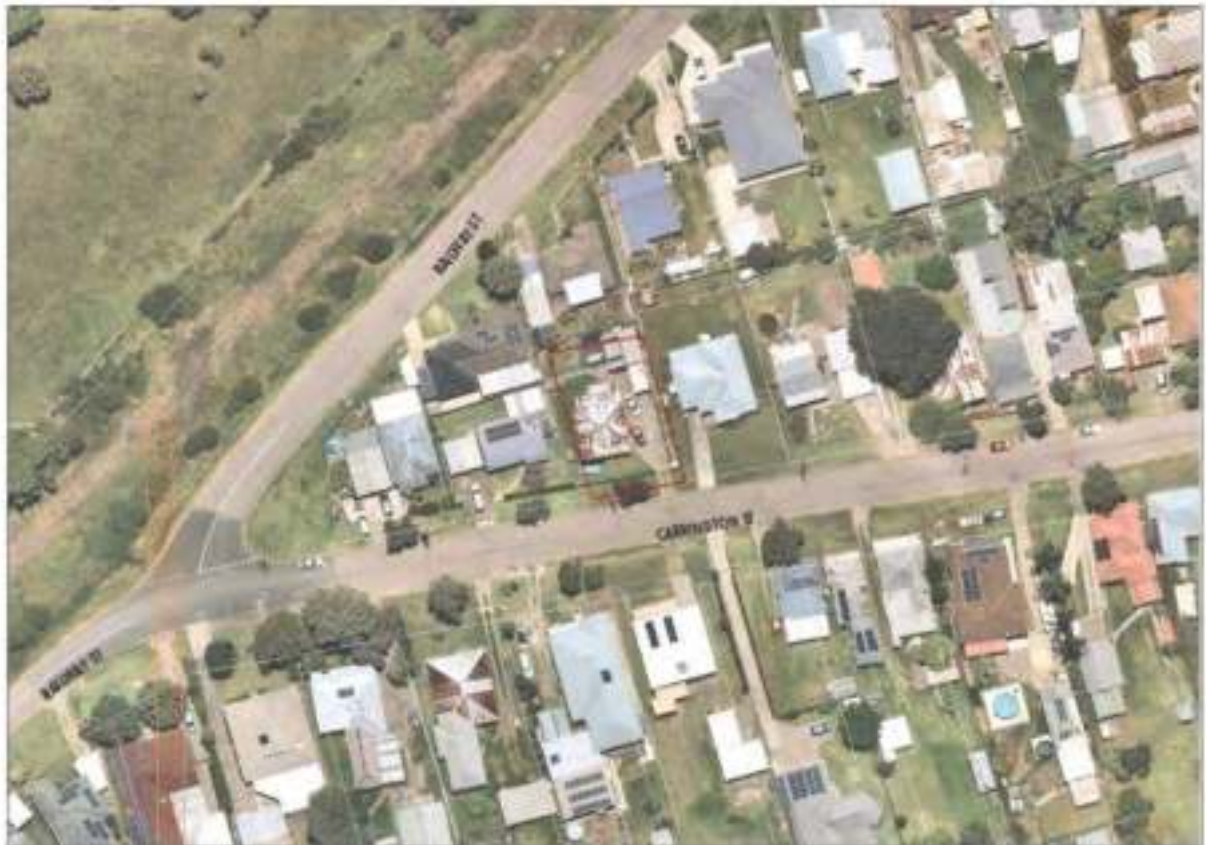
105 CARRINGTON STREET, WEST WALLSEND 2286

Conservation Area Contribution Level	Est. Construction Date	Previous studies and/or community input
Contributory 2	Early to late 20 th century (broad range)	No prior heritage assessments or research undertaken.
Assessment Text		Observed Modifications
<p>The scale (single-storey) and general style of the dwelling is consistent with that of the streetscape and wider HCA. Dwelling contributes positively to the streetscape and wider HCA, particularly in comparison to Non-Contributory buildings.</p> <p>The dwelling features appropriately proportioned and positioned fenestrations, an appropriate roof form (gabled or hipped) and other features consistent with the architectural character of the area (e.g. front verandah with timber or brick posts, timber detailing, corrugated metal roofing, etc). The contributory value of the dwelling is limited however by either:</p> <ul style="list-style-type: none"> • External modifications that have in some way obscured the style, scale or design intent of the building and have resulted in less physical integrity than Contributory 1 buildings. • Being a later dwelling constructed in an appropriate referential style, but comprising little to no fabric of intrinsic heritage significance. 		<p>All visible windows are contemporary in style, with security screens installed.</p> <p>No external decorative or detailed features remain.</p> <p>The veranda has been built in to create an additional living area. This is a common modification for the area, however is unsympathetic to the heritage streetscape.</p>

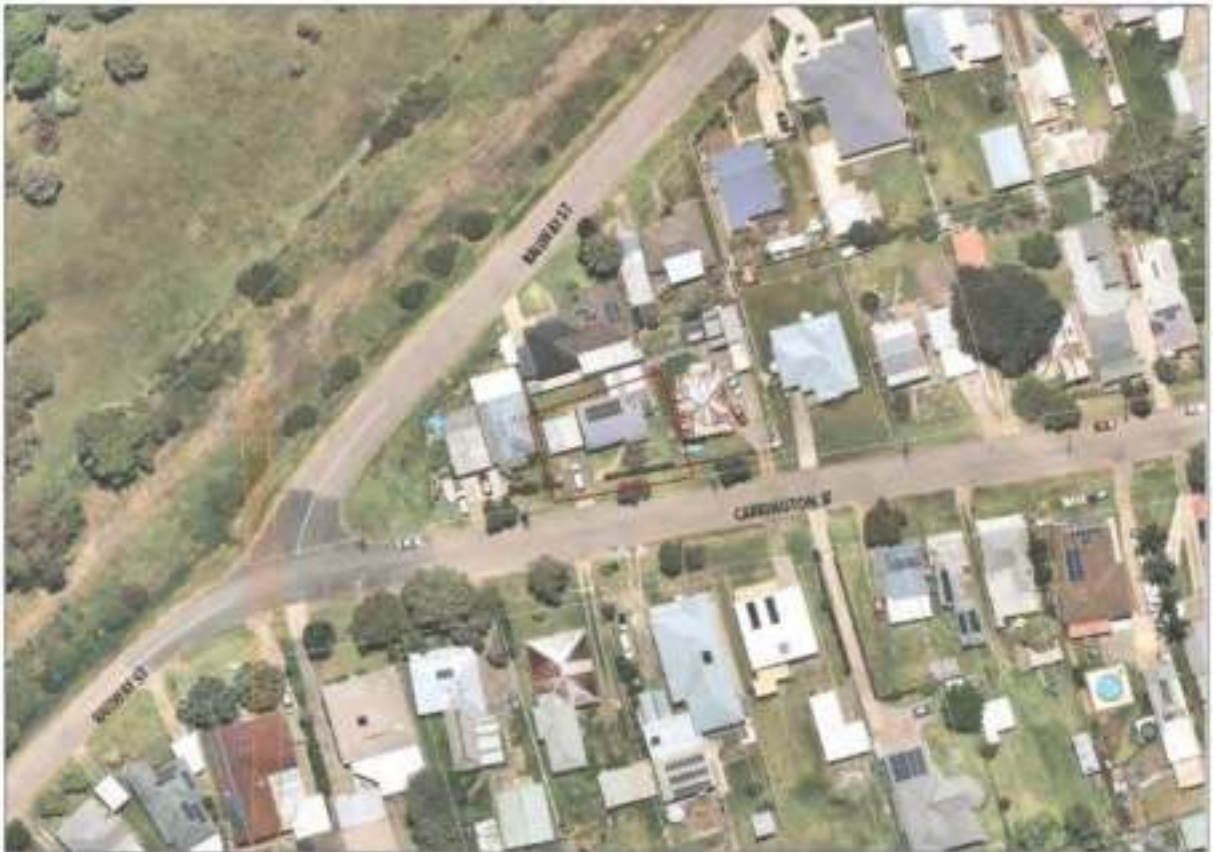
107 CARRINGTON STREET, WEST WALLSEND 2286

Conservation Area Contribution Level	Est. Construction Date	Previous studies and/or community input
Contributory 2	Early to late 20 th century (broad range)	No prior heritage assessments or research undertaken.
Assessment Text		Observed Modifications
<p>The scale (single-storey) and general style of the dwelling is consistent with that of the streetscape and wider HCA. Dwelling contributes positively to the streetscape and wider HCA, particularly in comparison to Non-Contributory buildings.</p> <p>The dwelling features appropriately proportioned and positioned fenestrations, an appropriate roof form (gabled or hipped) and other features consistent with the architectural character of the area (e.g. front verandah with timber or brick posts, timber detailing, corrugated metal roofing, etc). The contributory value of the dwelling is limited however by either:</p> <ul style="list-style-type: none"> • External modifications that have in some way obscured the style, scale or design intent of the building and have resulted in less physical integrity than Contributory 1 buildings. • Being a later dwelling constructed in an appropriate referential style, but comprising little to no fabric of intrinsic heritage significance. 		No modifications observed.

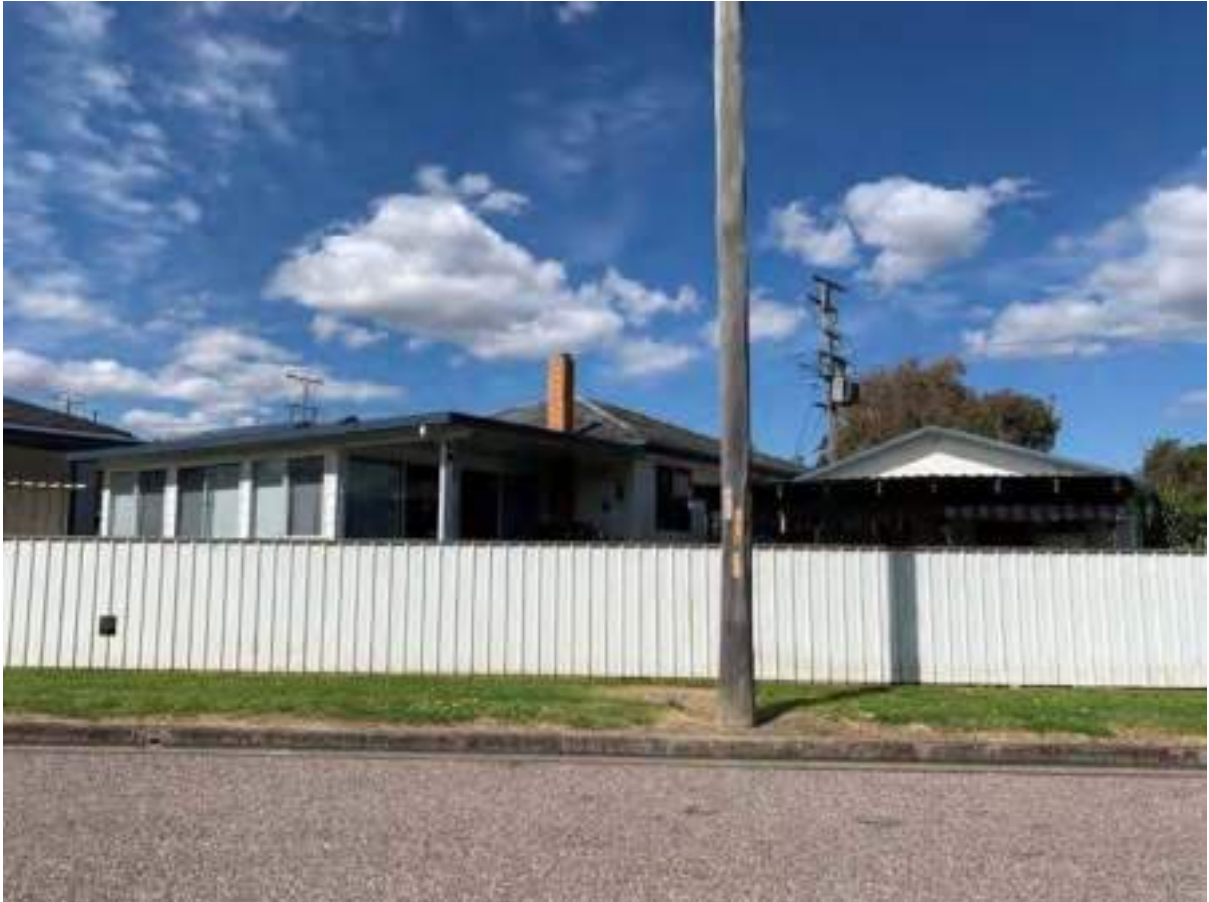
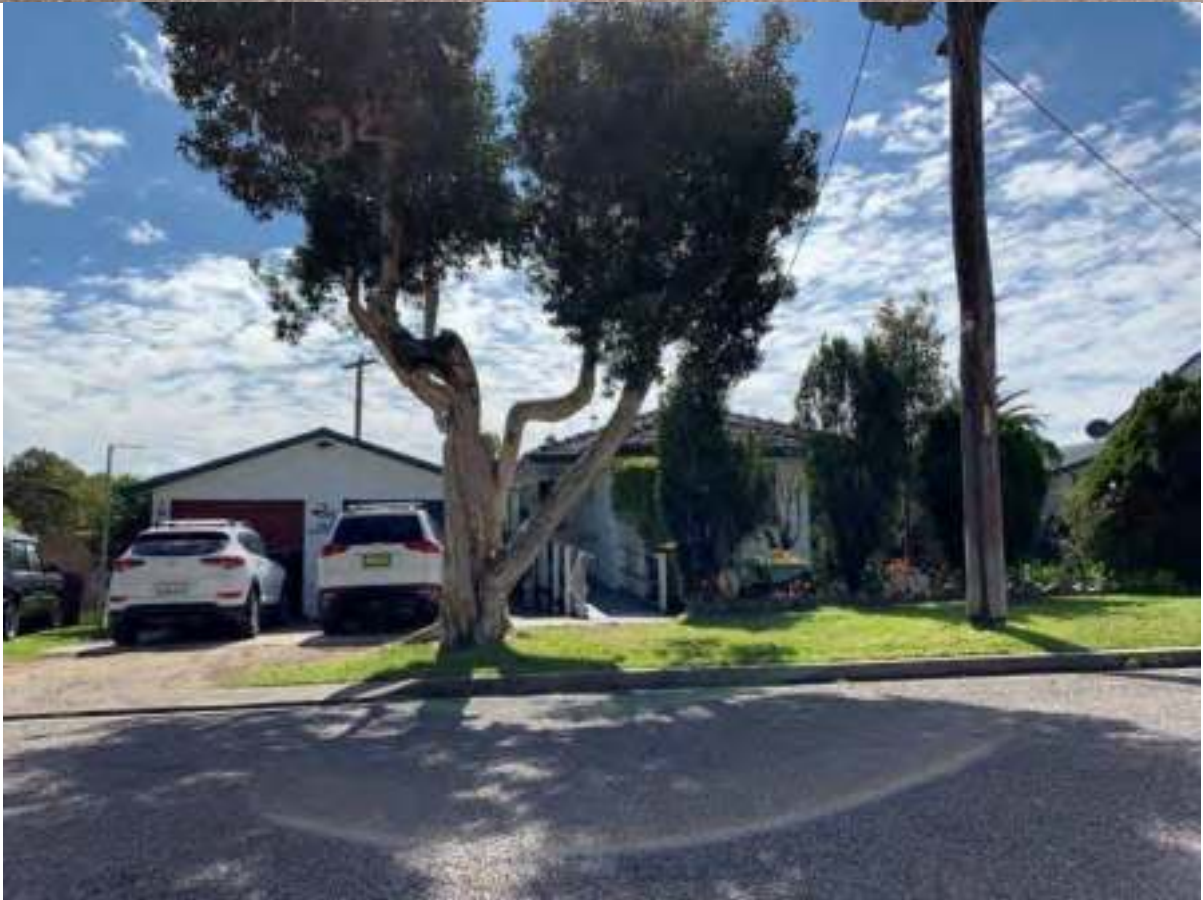
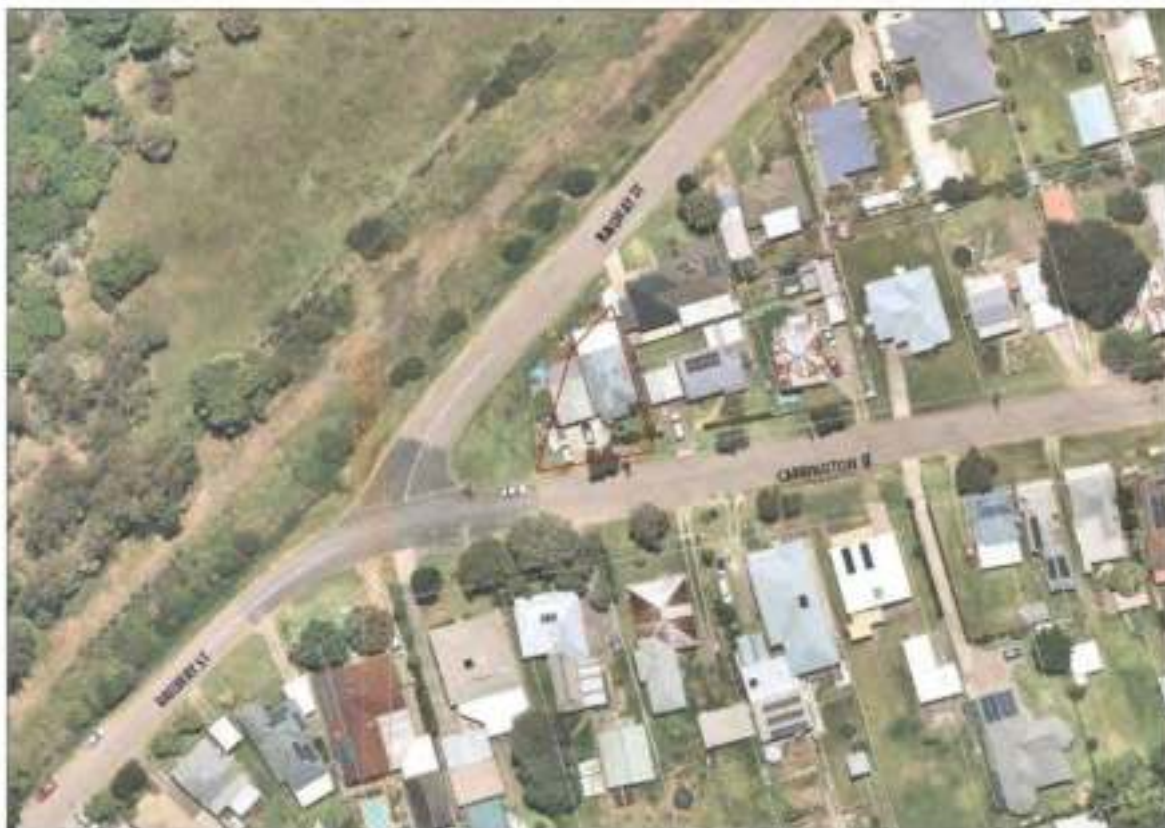
Conservation Area Contribution Level	Est. Construction Date	Previous studies and/or community input
Contributory 2	Early to late 20 th century (broad range)	No prior heritage assessments or research undertaken.
Assessment Text		Observed Modifications
<p>The scale (single-storey) and general style of the dwelling is consistent with that of the streetscape and wider HCA. Dwelling contributes positively to the streetscape and wider HCA, particularly in comparison to Non-Contributory buildings.</p> <p>The dwelling features appropriately proportioned and positioned fenestrations, an appropriate roof form (gabled or hipped) and other features consistent with the architectural character of the area (e.g. front verandah with timber or brick posts, timber detailing, corrugated metal roofing, etc). The contributory value of the dwelling is limited however by either:</p> <ul style="list-style-type: none"> • External modifications that have in some way obscured the style, scale or design intent of the building and have resulted in less physical integrity than Contributory 1 buildings. • Being a later dwelling constructed in an appropriate referential style, but comprising little to no fabric of intrinsic heritage significance. 		<p>A timber ramp and balustrade has been constructed, a contemporary addition.</p> <p>A double garage has been built onto the western side of the dwelling.</p>

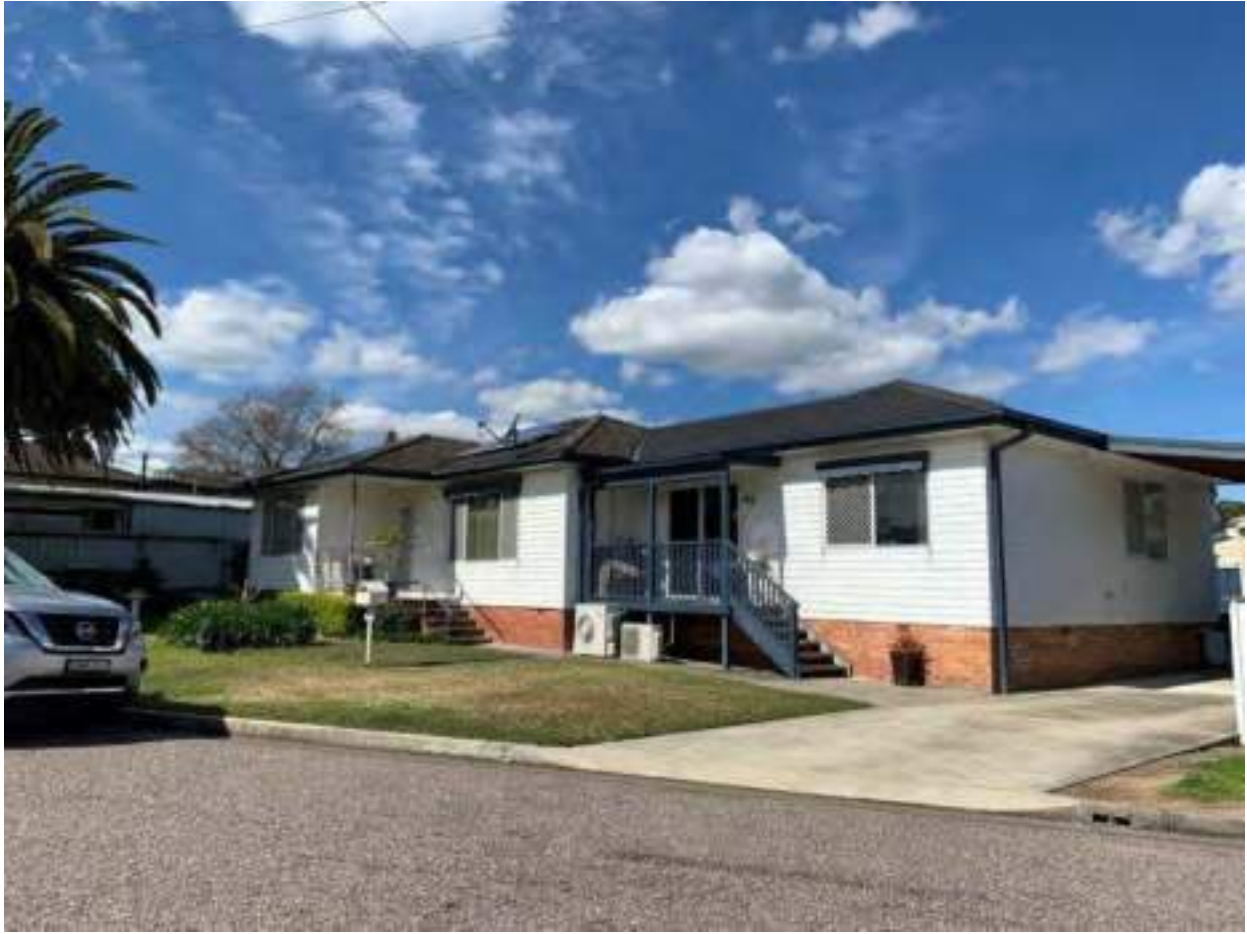
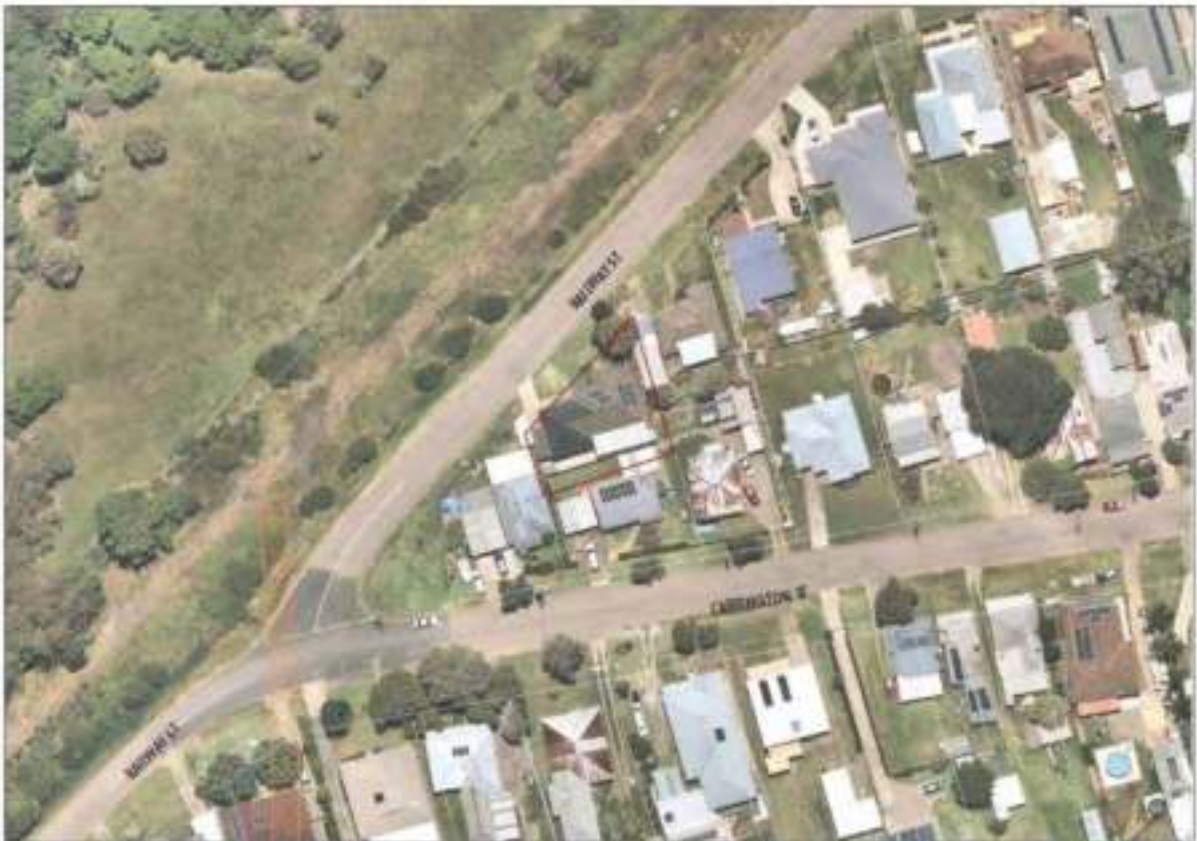
5 RAILWAY STREET, WEST WALLSEND 2286

Conservation Area Contribution Level	Est. Construction Date	Previous studies and/or community input
Contributory 2	Early to late 20 th century (broad range)	No prior heritage assessments or research undertaken.
Assessment Text		Observed Modifications
<p>The scale (single-storey) and general style of the dwelling is consistent with that of the streetscape and wider HCA. Dwelling contributes positively to the streetscape and wider HCA, particularly in comparison to Non-Contributory buildings.</p> <p>The dwelling features appropriately proportioned and positioned fenestrations, an appropriate roof form (gabled or hipped) and other features consistent with the architectural character of the area (e.g. front verandah with timber or brick posts, timber detailing, corrugated metal roofing, etc). The contributory value of the dwelling is limited however by either:</p> <ul style="list-style-type: none"> • External modifications that have in some way obscured the style, scale or design intent of the building and have resulted in less physical integrity than Contributory 1 buildings. • Being a later dwelling constructed in an appropriate referential style, but comprising little to no fabric of intrinsic heritage significance. 		<p>The timber balustrade enclosing the veranda is a contemporary addition.</p> <p>The western portion of the dwelling is a contemporary extension. This has been undertaken in a sympathetic style and does not detract from the heritage streetscape.</p>

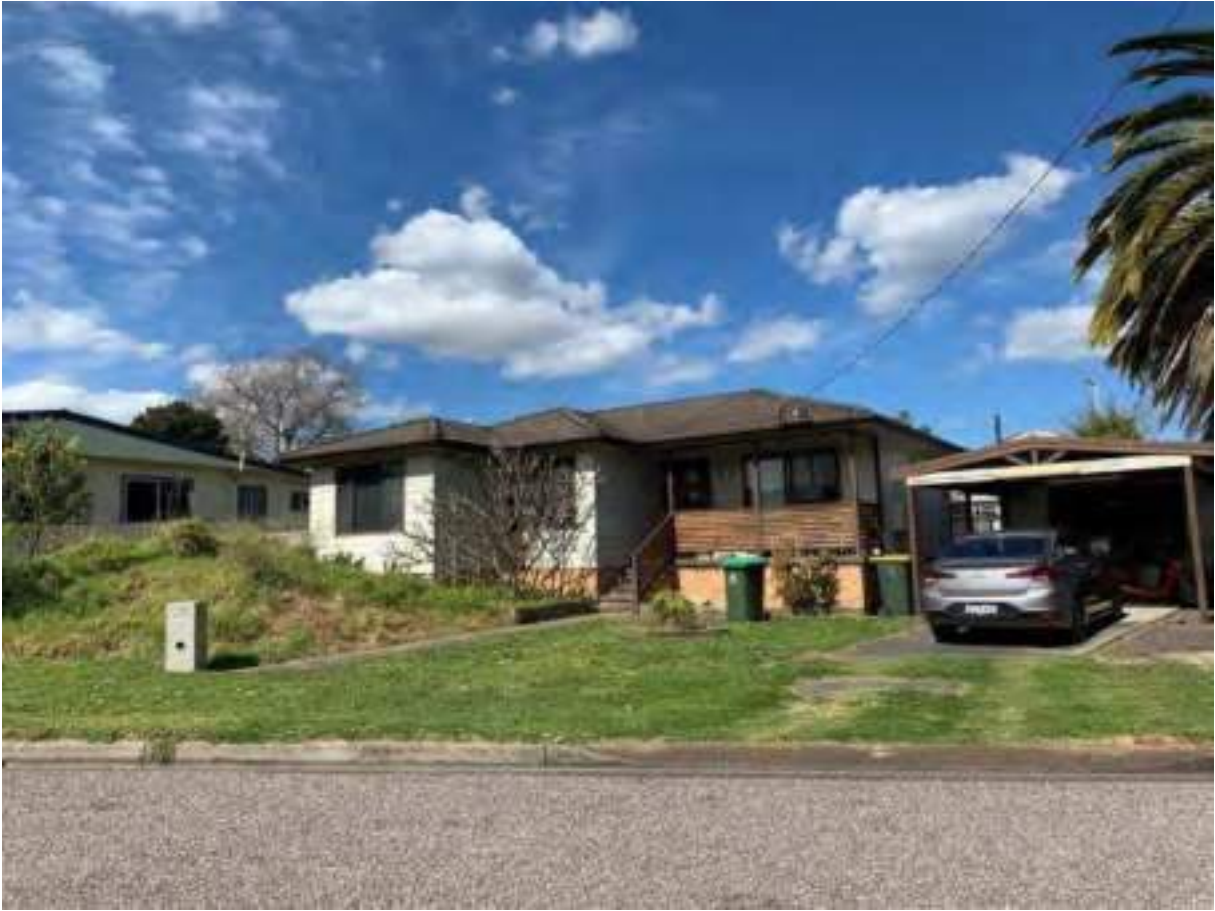
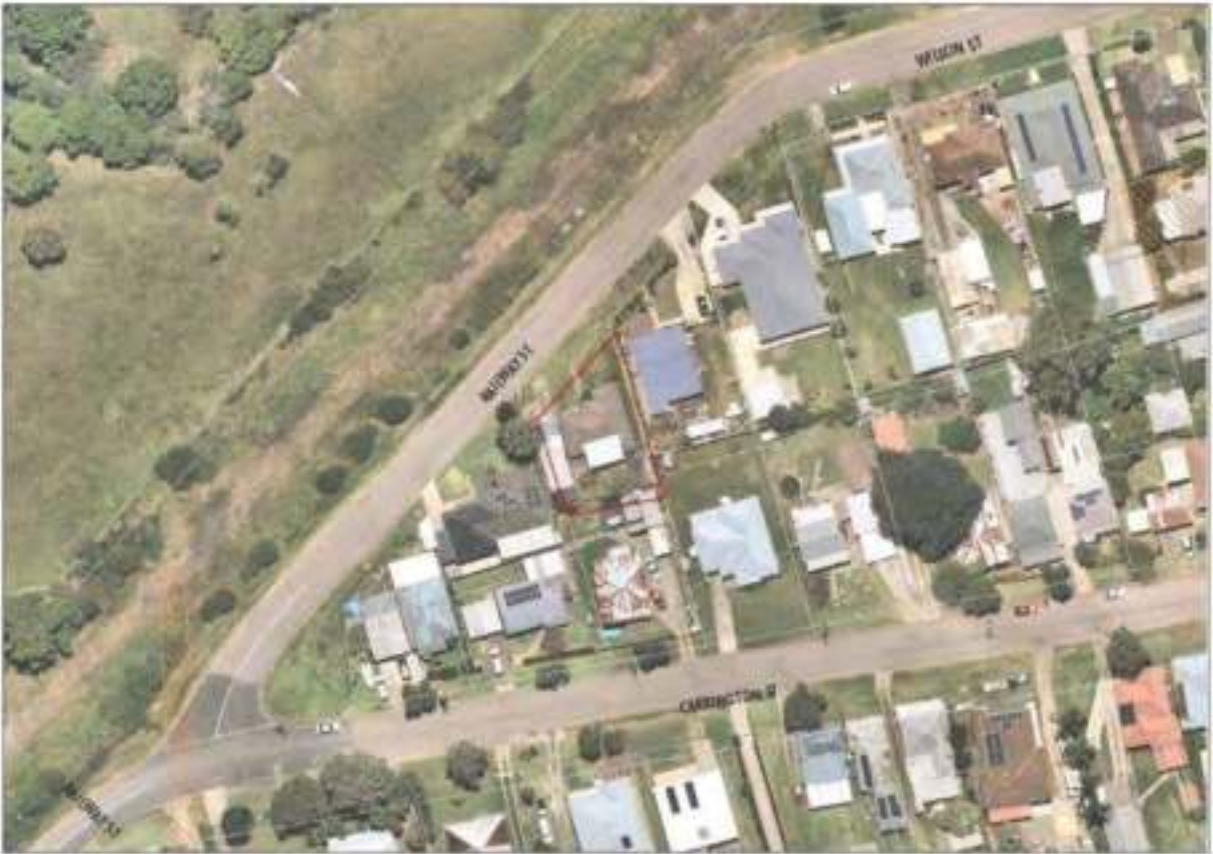
3A RAILWAY STREET, WEST WALLSEND 2286

Conservation Area Contribution Level	Est. Construction Date	Previous studies and/or community input
Contributory 2	Early to late 20 th century (broad range)	No prior heritage assessments or research undertaken.
Assessment Text		Observed Modifications
<p>The scale (single-storey) and general style of the dwelling is consistent with that of the streetscape and wider HCA. Dwelling contributes positively to the streetscape and wider HCA, particularly in comparison to Non-Contributory buildings.</p> <p>The dwelling features appropriately proportioned and positioned fenestrations, an appropriate roof form (gabled or hipped) and other features consistent with the architectural character of the area (e.g. front verandah with timber or brick posts, timber detailing, corrugated metal roofing, etc). The contributory value of the dwelling is limited however by either:</p> <ul style="list-style-type: none"> • External modifications that have in some way obscured the style, scale or design intent of the building and have resulted in less physical integrity than Contributory 1 buildings. • Being a later dwelling constructed in an appropriate referential style, but comprising little to no fabric of intrinsic heritage significance. 		<p>The timber balustrade enclosing the veranda is a contemporary addition.</p> <p>A gable roof car port has been built on the western side of the dwelling.</p>

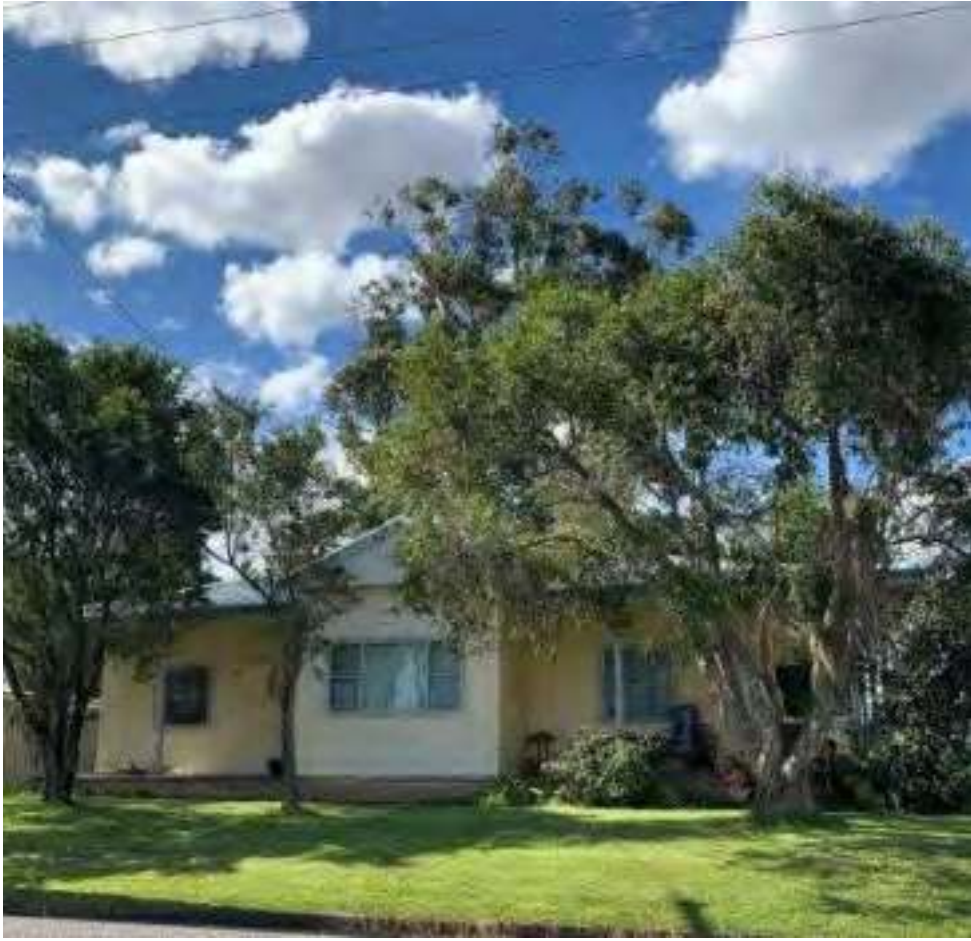
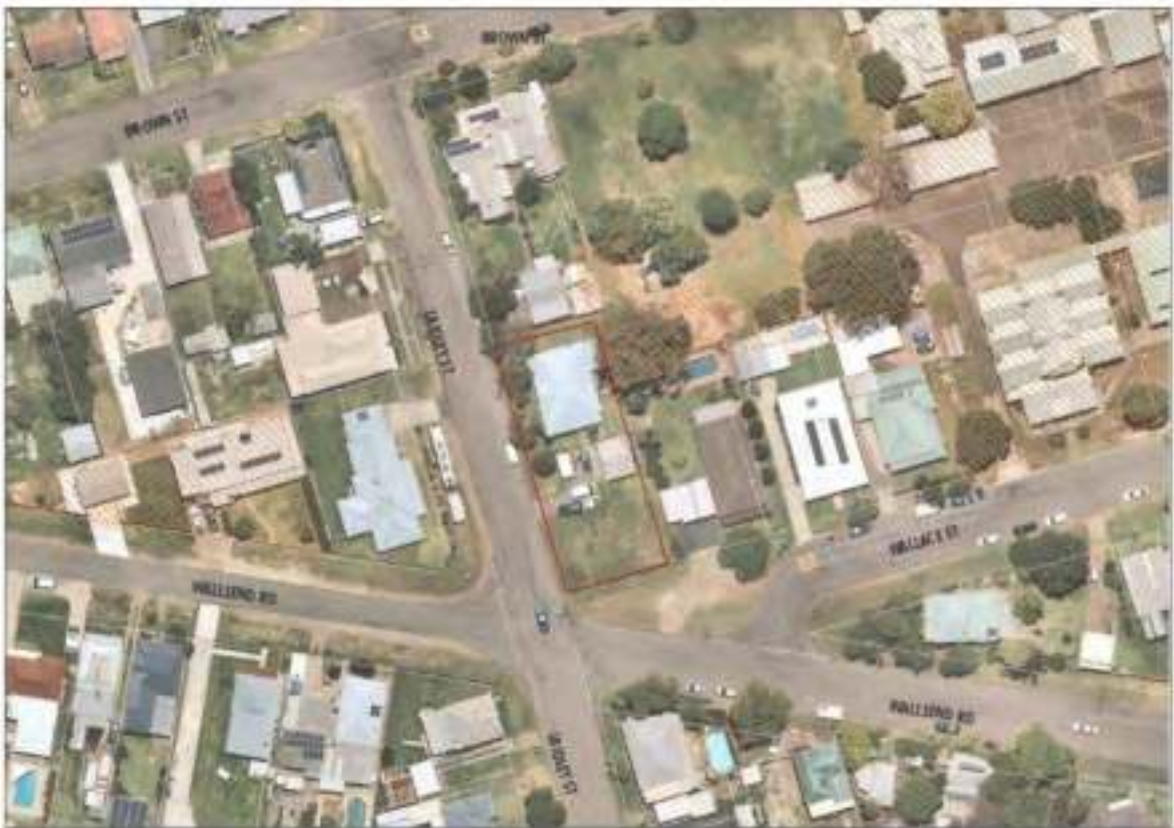
27 LAIDLEY STREET, WEST WALLSEND 2286

Conservation Area Contribution Level	Est. Construction Date	Previous studies and/or community input
Contributory 2	Early to late 20 th century (broad range)	No prior heritage assessments or research undertaken.
Assessment Text		Observed Modifications
<p>The scale (single-storey) and general style of the dwelling is consistent with that of the streetscape and wider HCA. Dwelling contributes positively to the streetscape and wider HCA, particularly in comparison to Non-Contributory buildings.</p> <p>The dwelling features appropriately proportioned and positioned fenestrations, an appropriate roof form (gabled or hipped) and other features consistent with the architectural character of the area (e.g. front verandah with timber or brick posts, timber detailing, corrugated metal roofing, etc). The contributory value of the dwelling is limited however by either:</p> <ul style="list-style-type: none"> • External modifications that have in some way obscured the style, scale or design intent of the building and have resulted in less physical integrity than Contributory 1 buildings. • Being a later dwelling constructed in an appropriate referential style, but comprising little to no fabric of intrinsic heritage significance. 		No modifications observed.

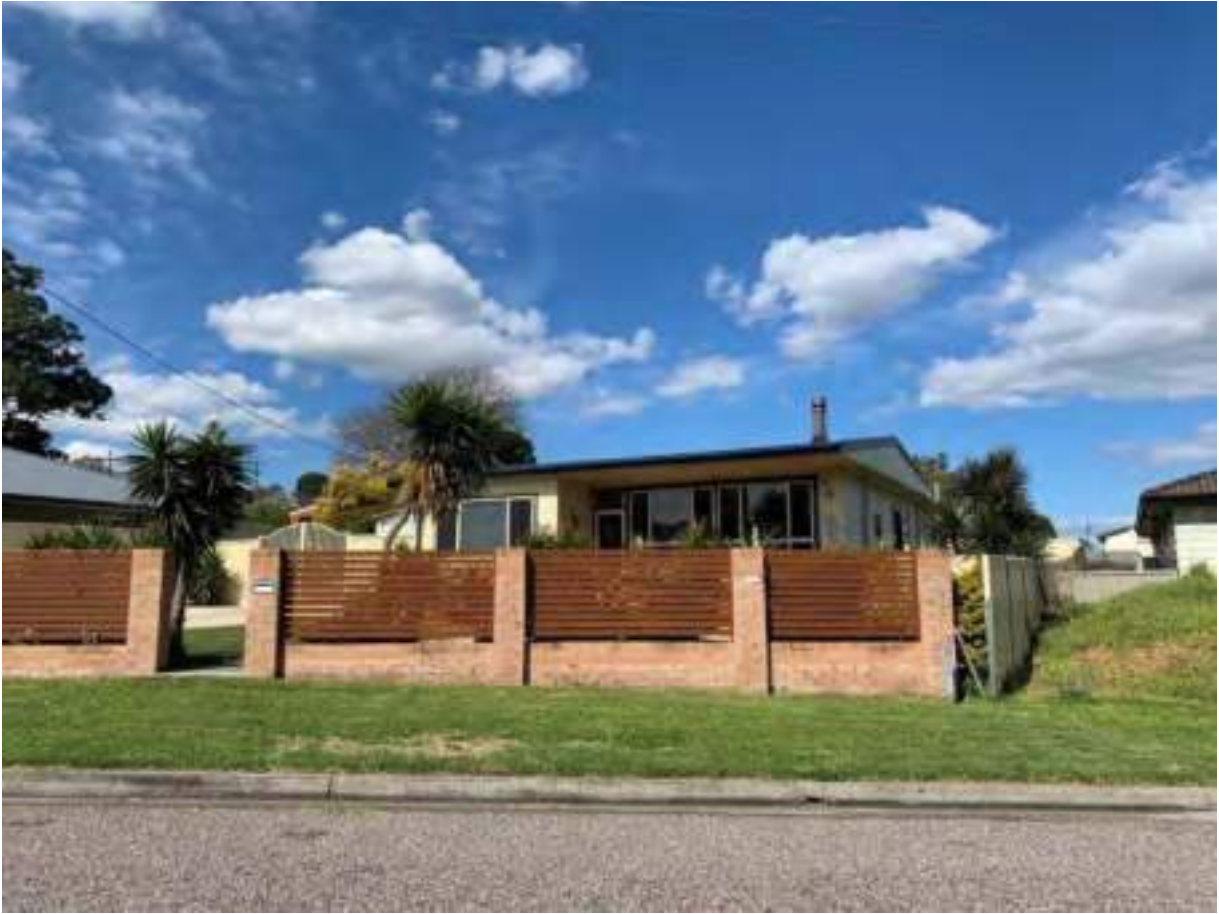
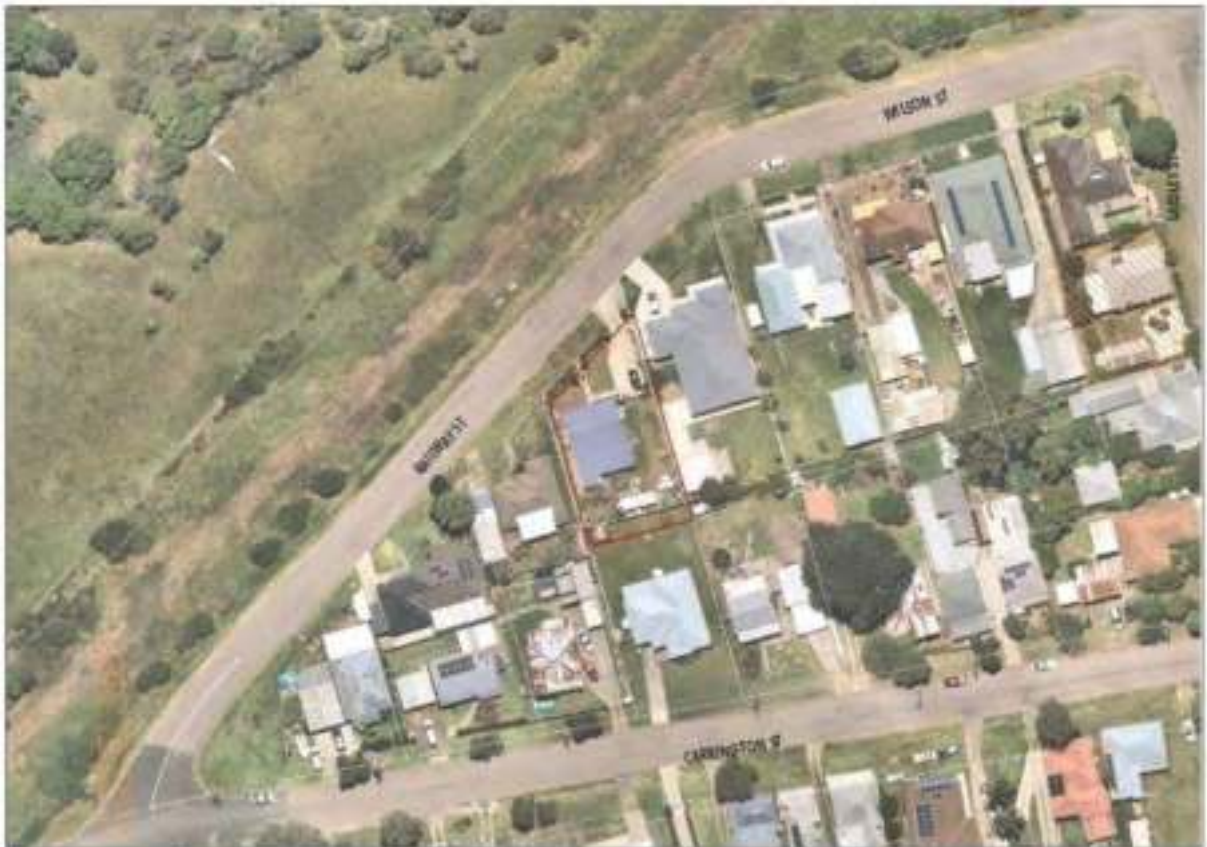
3 RAILWAY STREET, WEST WALLSEND 2286		
Conservation Area Contribution Level	Est. Construction Date	Previous studies and/or community input
Contributory 2	Early to late 20 th century (broad range)	No prior heritage assessments or research undertaken.
Assessment Text		Observed Modifications
<p>The scale (single-storey) and general style of the dwelling is consistent with that of the streetscape and wider HCA. Dwelling contributes positively to the streetscape and wider HCA, particularly in comparison to Non-Contributory buildings.</p> <p>The dwelling features appropriately proportioned and positioned fenestrations, an appropriate roof form (gabled or hipped) and other features consistent with the architectural character of the area (e.g. front verandah with timber or brick posts, timber detailing, corrugated metal roofing, etc). The contributory value of the dwelling is limited however by either:</p> <ul style="list-style-type: none"> • External modifications that have in some way obscured the style, scale or design intent of the building and have resulted in less physical integrity than Contributory 1 buildings. • Being a later dwelling constructed in an appropriate referential style, but comprising little to no fabric of intrinsic heritage significance. 		<p>The brick and timber fence at the front of the property is a contemporary addition. This is an unsympathetic choice of fencing and detracts from the heritage streetscape.</p> <p>All visible windows are contemporary in style.</p>
