APPENDIX 2

Building Assessment Sheets (Inventory Sheets)

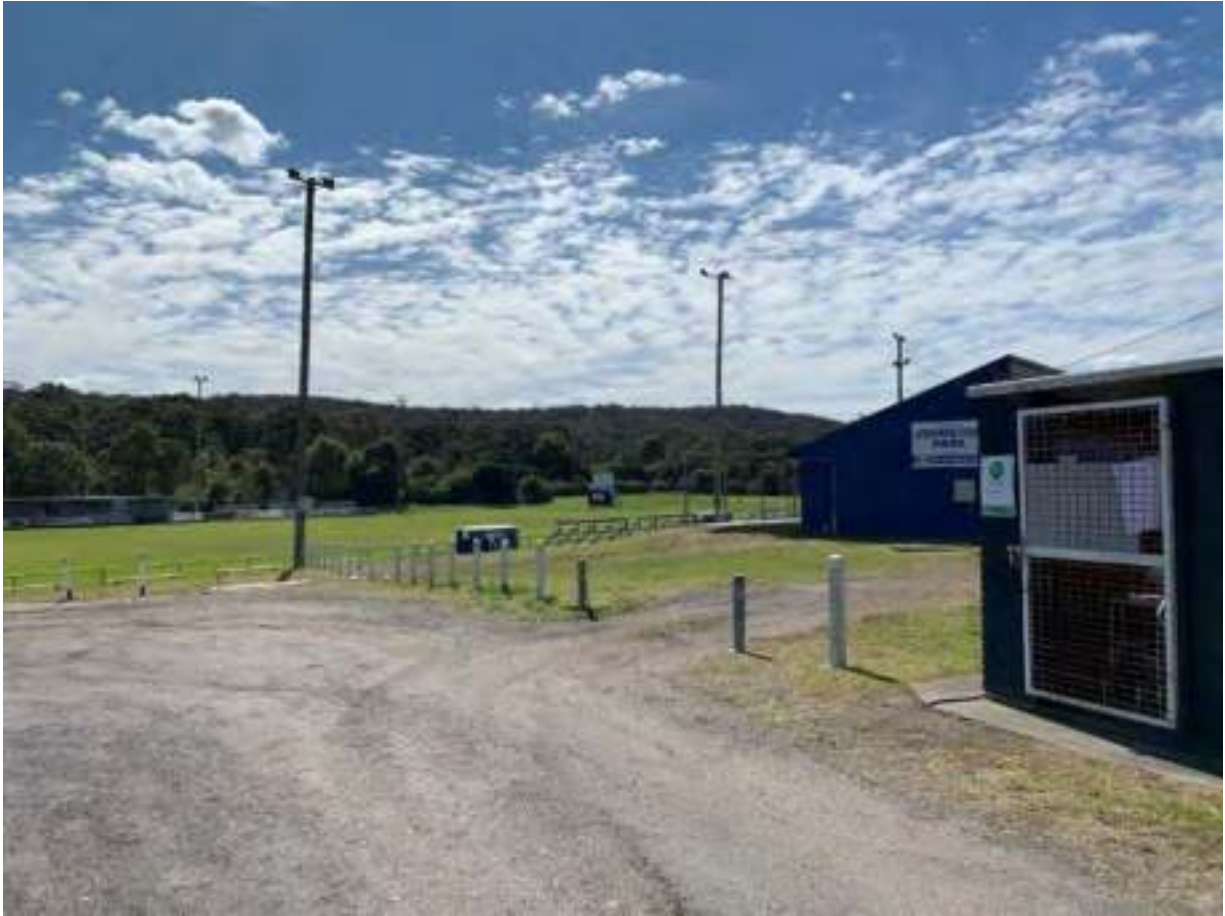
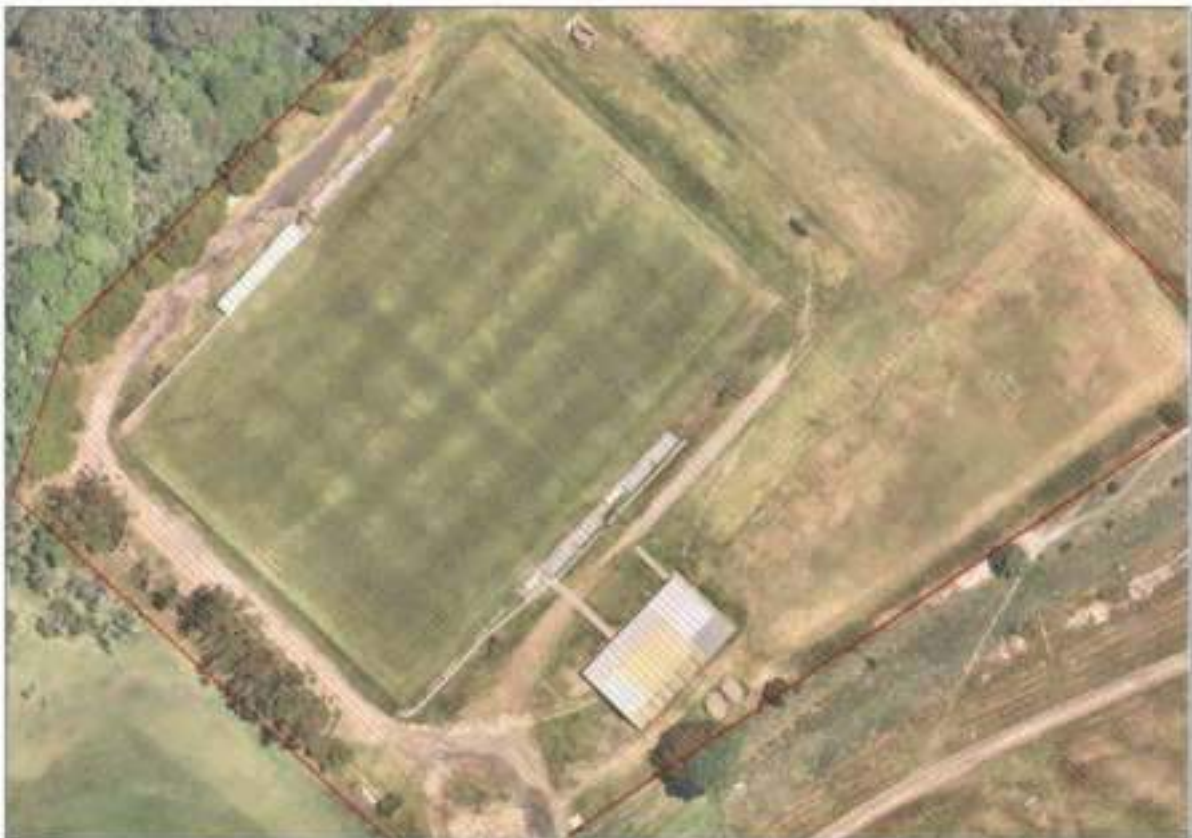
Conservation Area Contribution Level	Est. Construction Date	Previous studies and/or community input
Contributory 2	Early to late 20 th century (broad range)	No prior heritage assessments or research undertaken.
Assessment Text		Observed Modifications
<p>The scale (single-storey) and general style of the dwelling is consistent with that of the streetscape and wider HCA. Dwelling contributes positively to the streetscape and wider HCA, particularly in comparison to Non-Contributory buildings.</p> <p>The dwelling features appropriately proportioned and positioned fenestrations, an appropriate roof form (gabled or hipped) and other features consistent with the architectural character of the area (e.g. front verandah with timber or brick posts, timber detailing, corrugated metal roofing, etc). The contributory value of the dwelling is limited however by either:</p> <ul style="list-style-type: none"> • External modifications that have in some way obscured the style, scale or design intent of the building and have resulted in less physical integrity than Contributory 1 buildings. • Being a later dwelling constructed in an appropriate referential style, but comprising little to no fabric of intrinsic heritage significance. 		<p>Canvas/metal awnings have been installed a top the front northern windows.</p>

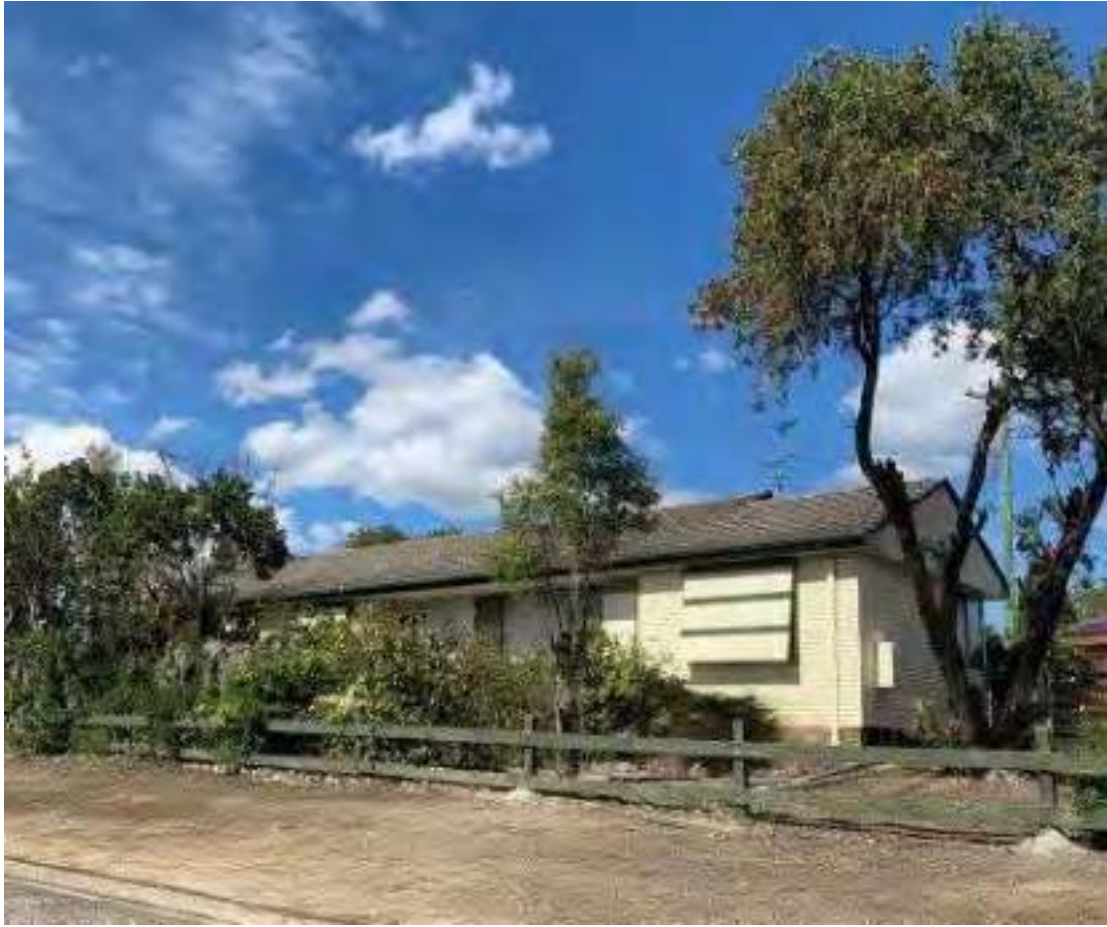
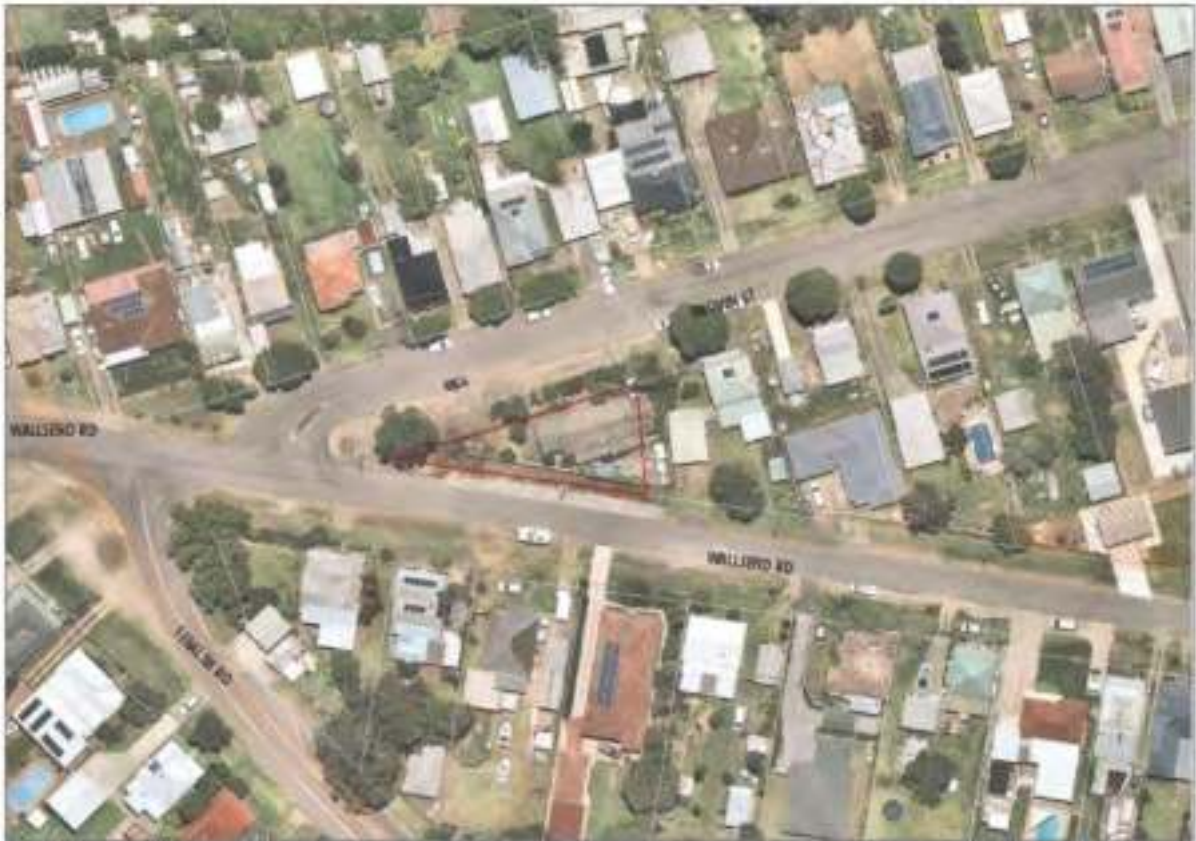
88 BROWN STREET, WEST WALLSEND 2286		
Conservation Area Contribution Level	Est. Construction Date	Previous studies and/or community input
Contributory 2	Early to late 20 th century (broad range)	No prior heritage assessments or research undertaken.
Assessment Text		Observed Modifications
<p>The scale (single-storey) and general style of the dwelling is consistent with that of the streetscape and wider HCA. Dwelling contributes positively to the streetscape and wider HCA, particularly in comparison to Non-Contributory buildings.</p> <p>The dwelling features appropriately proportioned and positioned fenestrations, an appropriate roof form (gabled or hipped) and other features consistent with the architectural character of the area (e.g. front verandah with timber or brick posts, timber detailing, corrugated metal roofing, etc). The contributory value of the dwelling is limited however by either:</p> <ul style="list-style-type: none"> • External modifications that have in some way obscured the style, scale or design intent of the building and have resulted in less physical integrity than Contributory 1 buildings. • Being a later dwelling constructed in an appropriate referential style, but comprising little to no fabric of intrinsic heritage significance. 		<p>Canvas/metal awnings have been installed a top the front northern windows.</p>

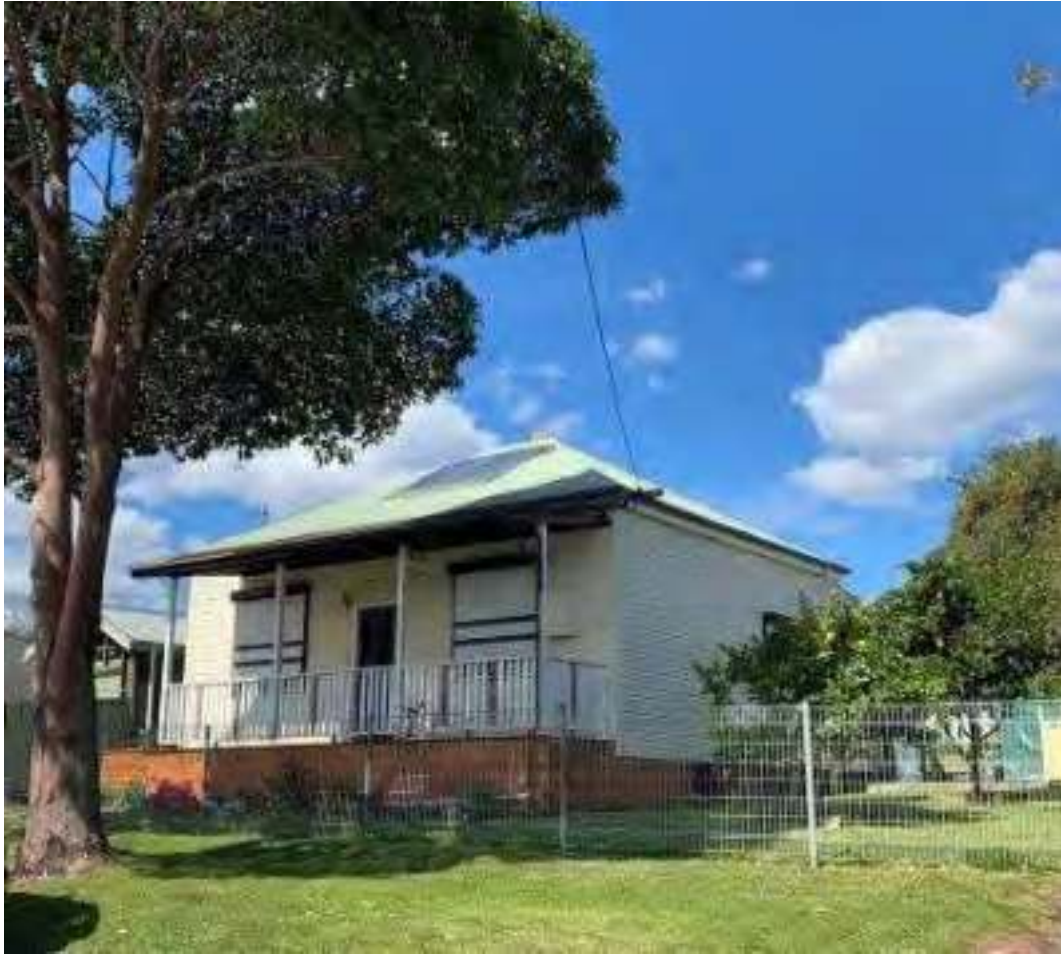
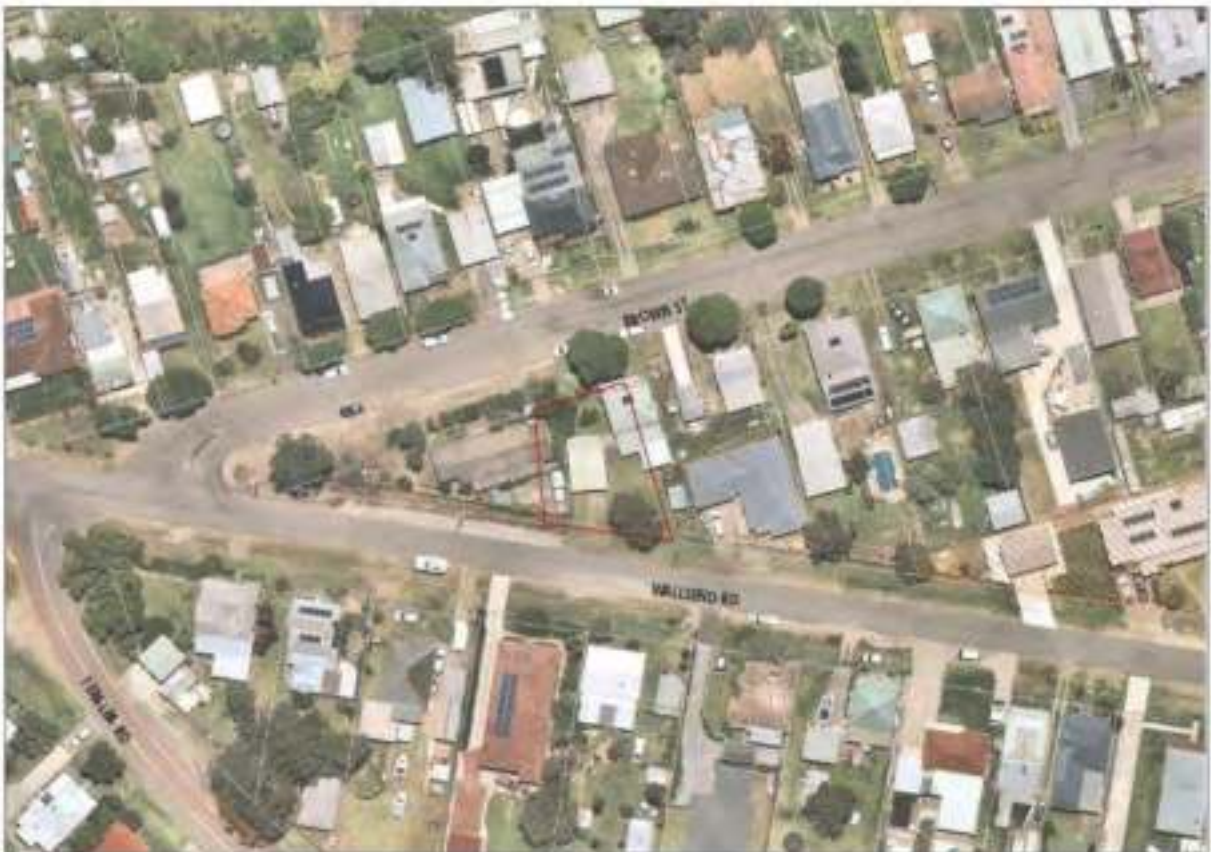
86 BROWN STREET, WEST WALLSEND 2286

Conservation Area Contribution Level	Est. Construction Date	Previous studies and/or community input
Contributory 2	Early to late 20 th century (broad range)	No prior heritage assessments or research undertaken.
Assessment Text		Observed Modifications
<p>The scale (single-storey) and general style of the dwelling is consistent with that of the streetscape and wider HCA. Dwelling contributes positively to the streetscape and wider HCA, particularly in comparison to Non-Contributory buildings.</p> <p>The dwelling features appropriately proportioned and positioned fenestrations, an appropriate roof form (gabled or hipped) and other features consistent with the architectural character of the area (e.g. front verandah with timber or brick posts, timber detailing, corrugated metal roofing, etc). The contributory value of the dwelling is limited however by either:</p> <ul style="list-style-type: none"> External modifications that have in some way obscured the style, scale or design intent of the building and have resulted in less physical integrity than Contributory 1 buildings. Being a later dwelling constructed in an appropriate referential style, but comprising little to no fabric of intrinsic heritage significance. 		<p>Solar panels are visible along the northern side of the roof.</p> <p>The timber posts and balustrade are a contemporary addition, likely replacing an original timber design.</p> <p>The visible windows are contemporary in style, with metal roller shutters.</p>

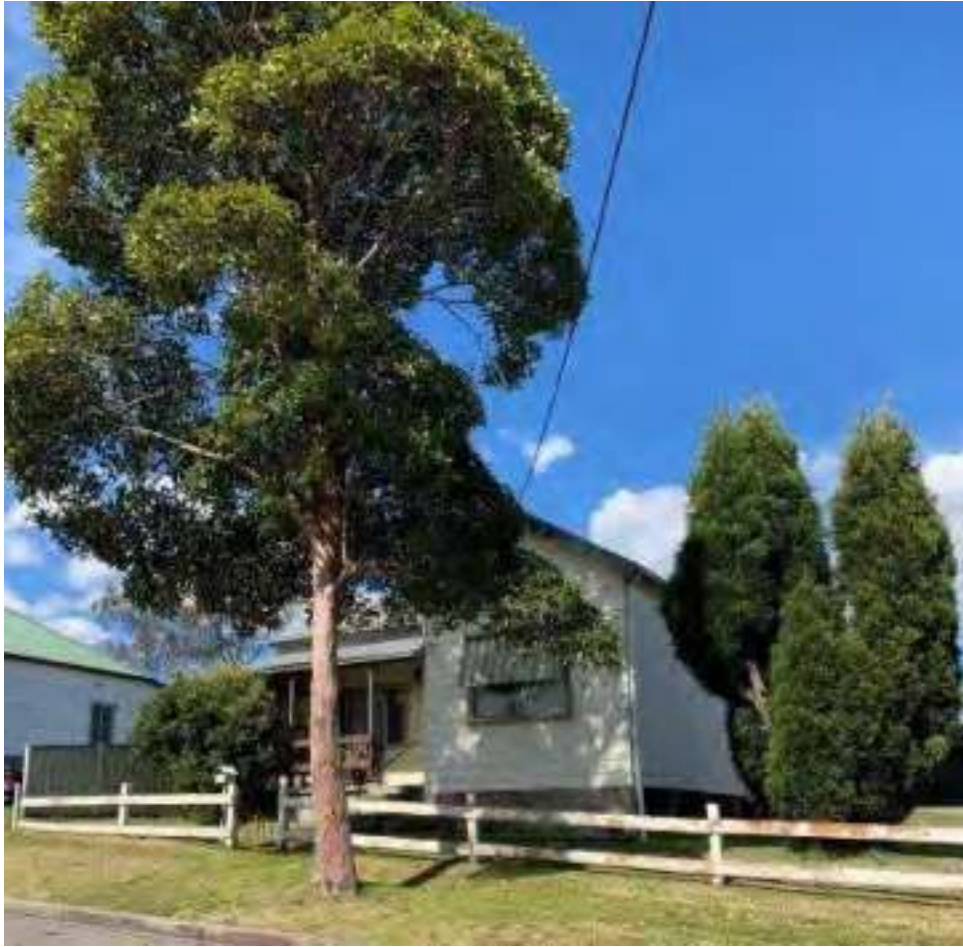
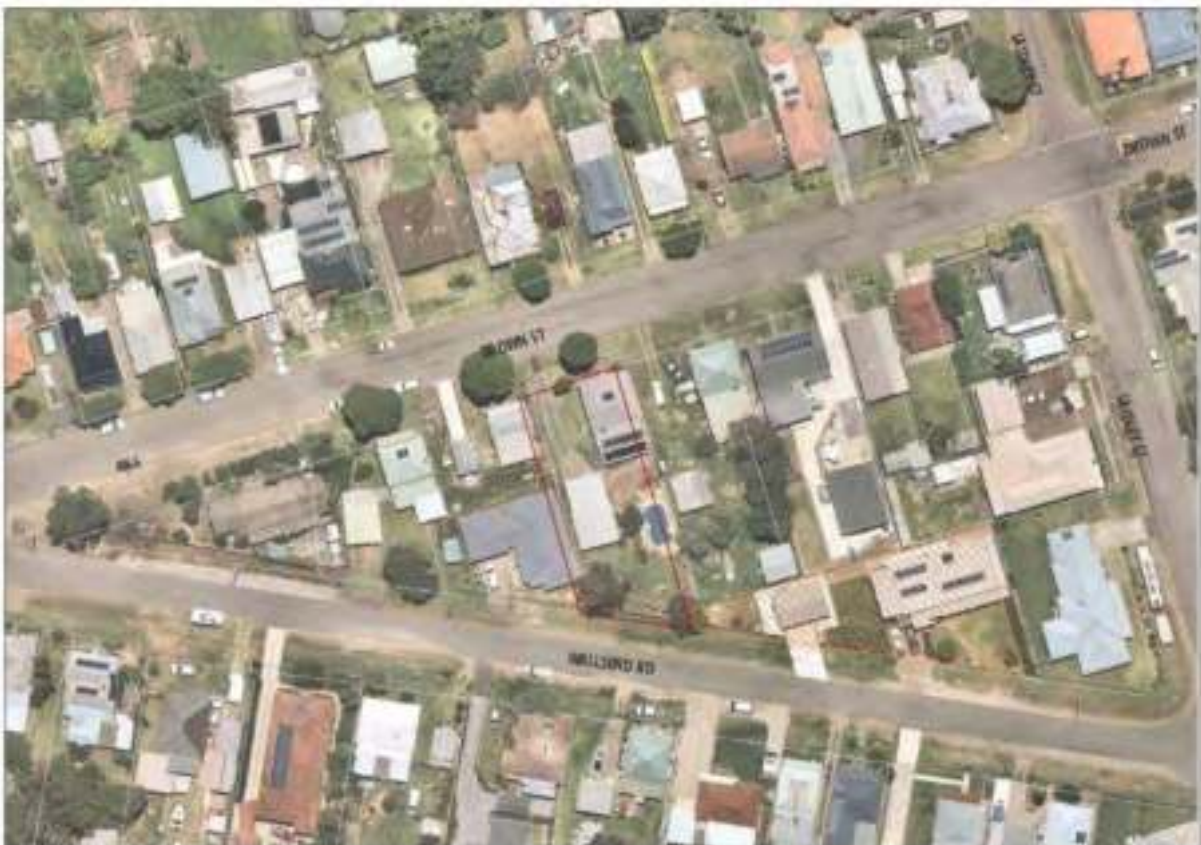
82 BROWN STREET, WEST WALLSEND 2286

Conservation Area Contribution Level	Est. Construction Date	Previous studies and/or community input
Contributory 2	Early to late 20 th century (broad range)	No prior heritage assessments or research undertaken.
Assessment Text		Observed Modifications
<p>The scale (single-storey) and general style of the dwelling is consistent with that of the streetscape and wider HCA. Dwelling contributes positively to the streetscape and wider HCA, particularly in comparison to Non-Contributory buildings.</p> <p>The dwelling features appropriately proportioned and positioned fenestrations, an appropriate roof form (gabled or hipped) and other features consistent with the architectural character of the area (e.g. front verandah with timber or brick posts, timber detailing, corrugated metal roofing, etc). The contributory value of the dwelling is limited however by either:</p> <ul style="list-style-type: none"> • External modifications that have in some way obscured the style, scale or design intent of the building and have resulted in less physical integrity than Contributory 1 buildings. • Being a later dwelling constructed in an appropriate referential style, but comprising little to no fabric of intrinsic heritage significance. 		<p>Solar panels/heating components are visible along the northern side of the roof.</p> <p>The timber balustrade and metal railing of the stairs are contemporary additions.</p> <p>All visible windows are contemporary in style, with canvas awnings installed.</p>

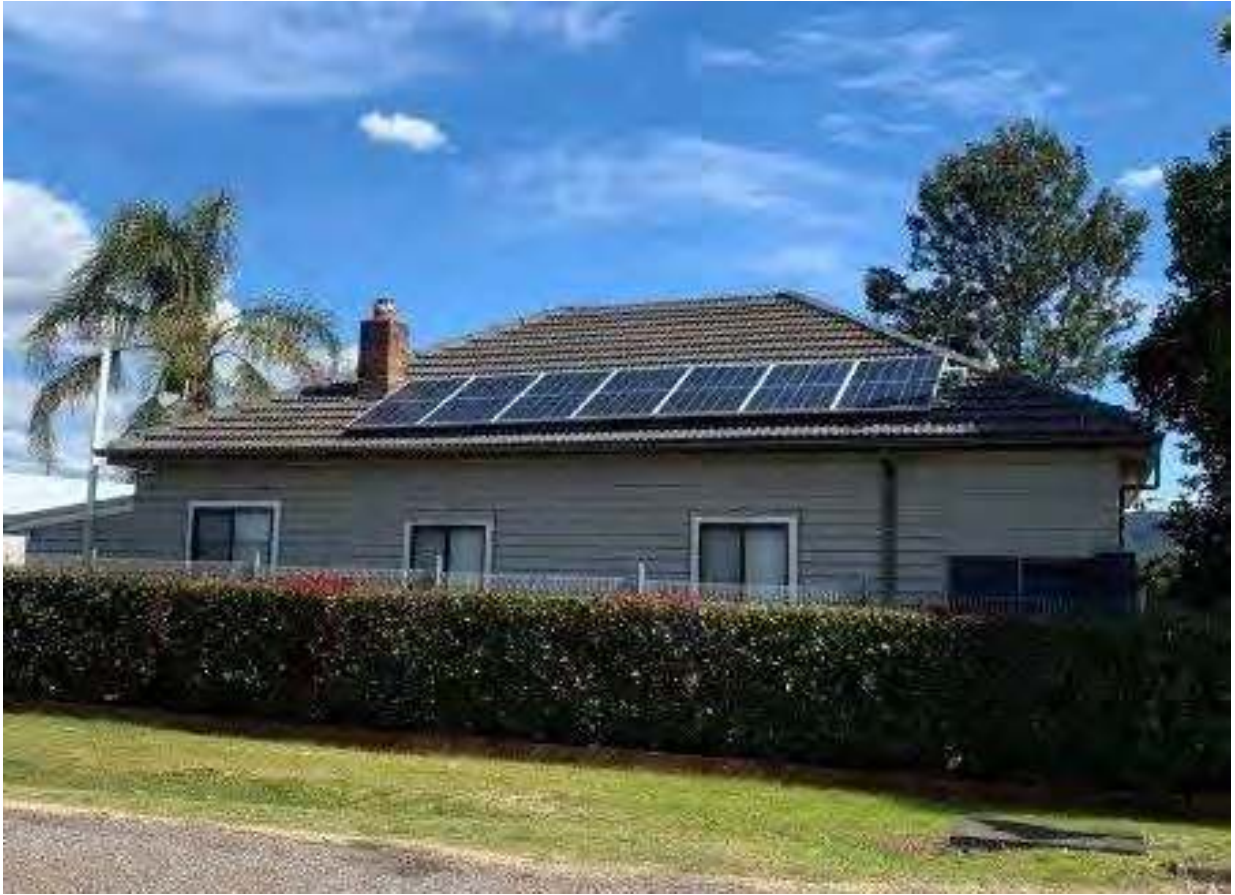
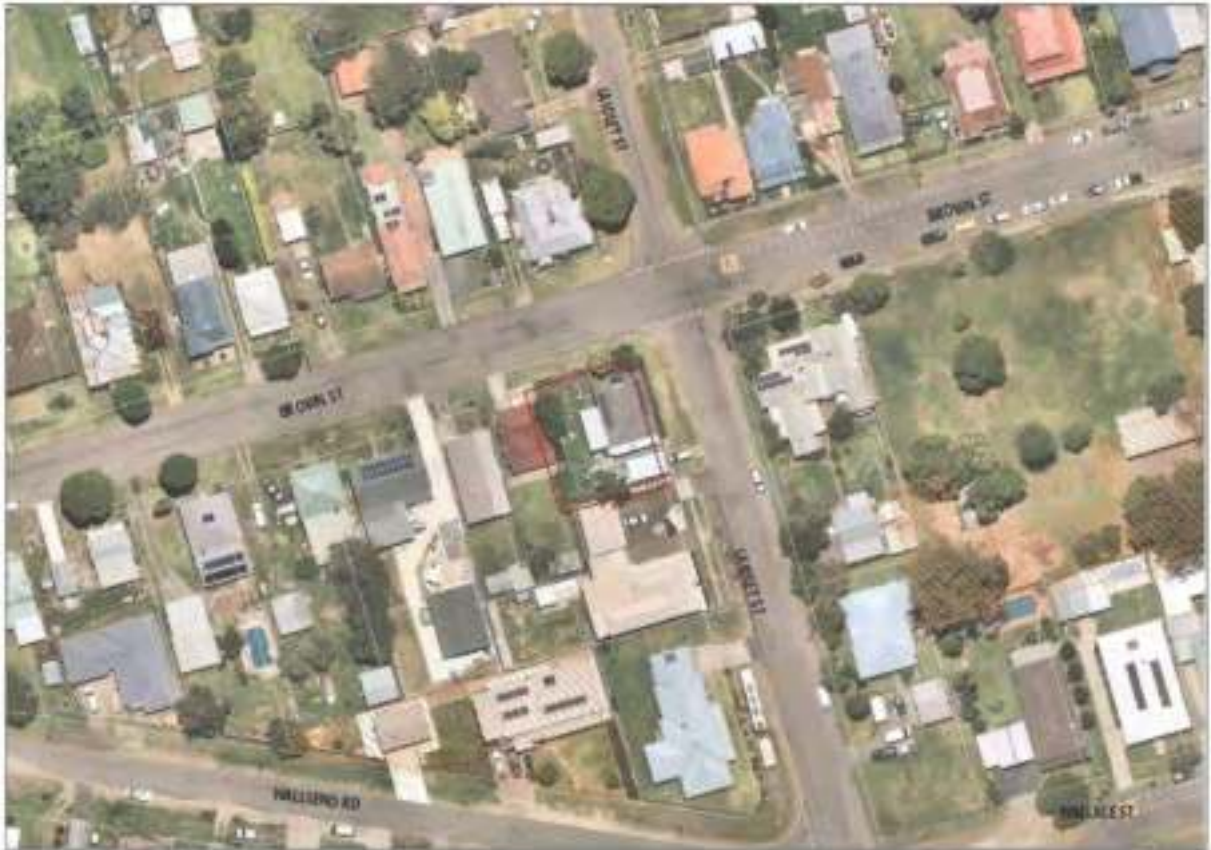
72 BROWN STREET, WEST WALLSEND 2286		
Conservation Area Contribution Level	Est. Construction Date	Previous studies and/or community input
Contributory 2	Early to late 20 th century (broad range)	No prior heritage assessments or research undertaken.
Assessment Text		Observed Modifications
<p>The scale (single-storey) and general style of the dwelling is consistent with that of the streetscape and wider HCA. Dwelling contributes positively to the streetscape and wider HCA, particularly in comparison to Non-Contributory buildings.</p> <p>The dwelling features appropriately proportioned and positioned fenestrations, an appropriate roof form (gabled or hipped) and other features consistent with the architectural character of the area (e.g. front verandah with timber or brick posts, timber detailing, corrugated metal roofing, etc). The contributory value of the dwelling is limited however by either:</p> <ul style="list-style-type: none"> • External modifications that have in some way obscured the style, scale or design intent of the building and have resulted in less physical integrity than Contributory 1 buildings. • Being a later dwelling constructed in an appropriate referential style, but comprising little to no fabric of intrinsic heritage significance. 		<p>Solar panels are highly visible along the eastern side of the dwelling.</p> <p>All visible windows are a contemporary style.</p>

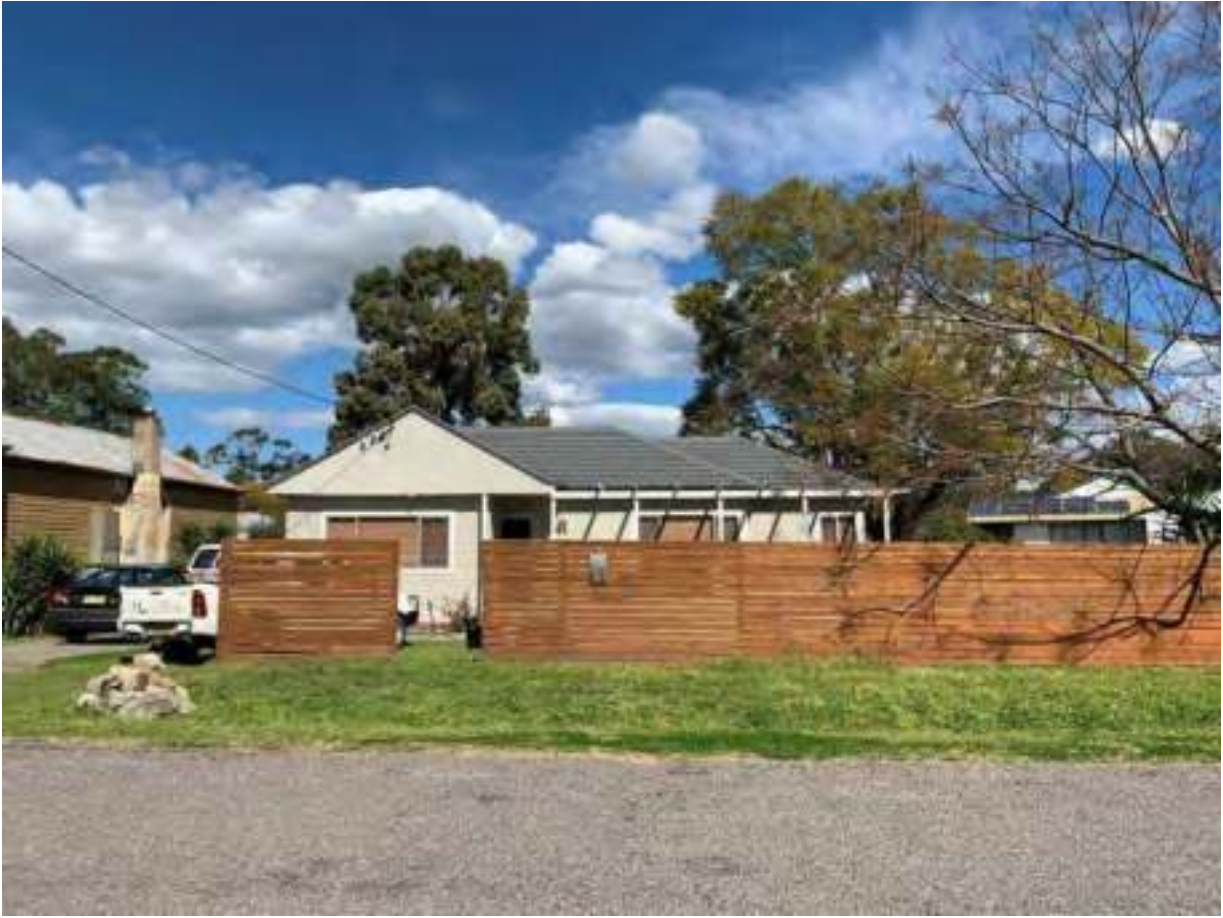
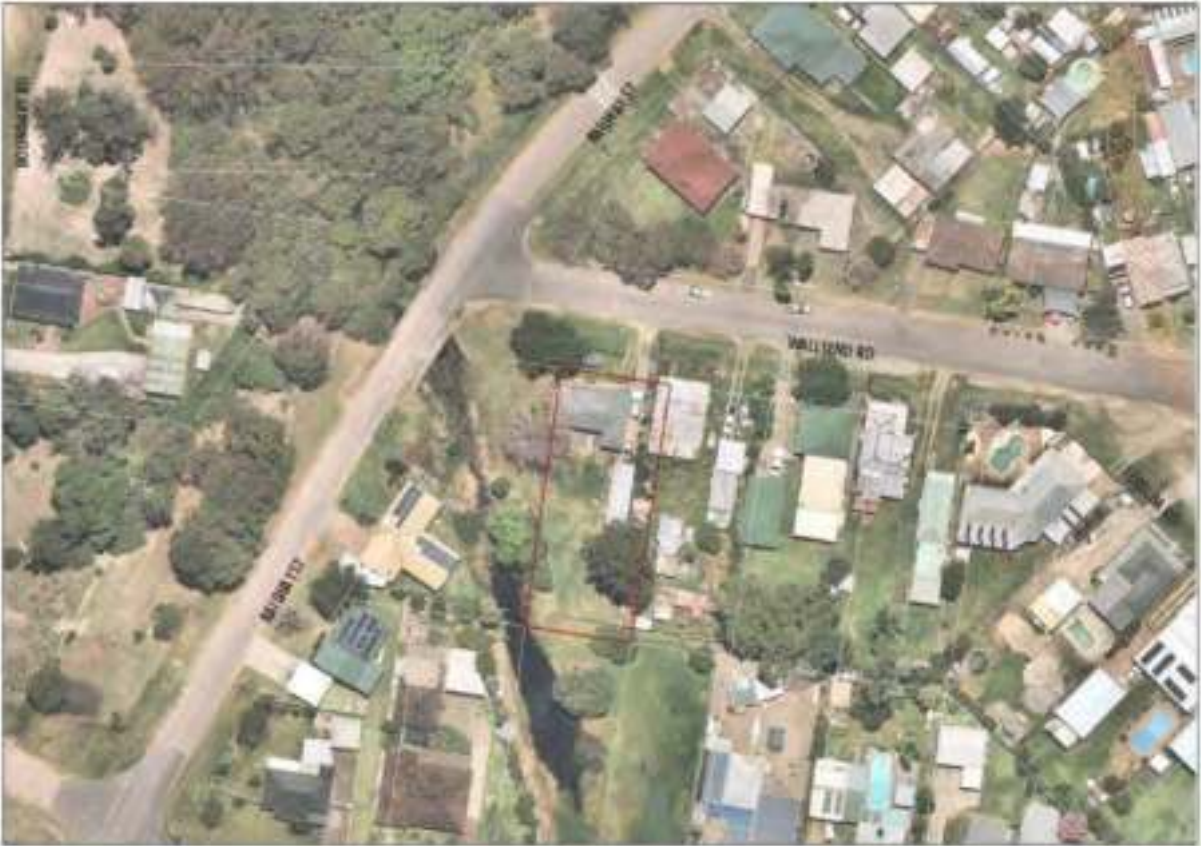
50 WALLSEND ROAD, WEST WALLSEND 2286

Conservation Area Contribution Level	Est. Construction Date	Previous studies and/or community input
Contributory 2	Early to late 20 th century (broad range)	No prior heritage assessments or research undertaken.
Assessment Text		Observed Modifications
<p>The scale (single-storey) and general style of the dwelling is consistent with that of the streetscape and wider HCA. Dwelling contributes positively to the streetscape and wider HCA, particularly in comparison to Non-Contributory buildings.</p> <p>The dwelling features appropriately proportioned and positioned fenestrations, an appropriate roof form (gabled or hipped) and other features consistent with the architectural character of the area (e.g. front verandah with timber or brick posts, timber detailing, corrugated metal roofing, etc). The contributory value of the dwelling is limited however by either:</p> <ul style="list-style-type: none"> • External modifications that have in some way obscured the style, scale or design intent of the building and have resulted in less physical integrity than Contributory 1 buildings. • Being a later dwelling constructed in an appropriate referential style, but comprising little to no fabric of intrinsic heritage significance. 		<p>The timber northern fence enclosing the property is a contemporary addition, juxtaposing the surrounding properties and the heritage streetscape. All visible windows are contemporary in style.</p>

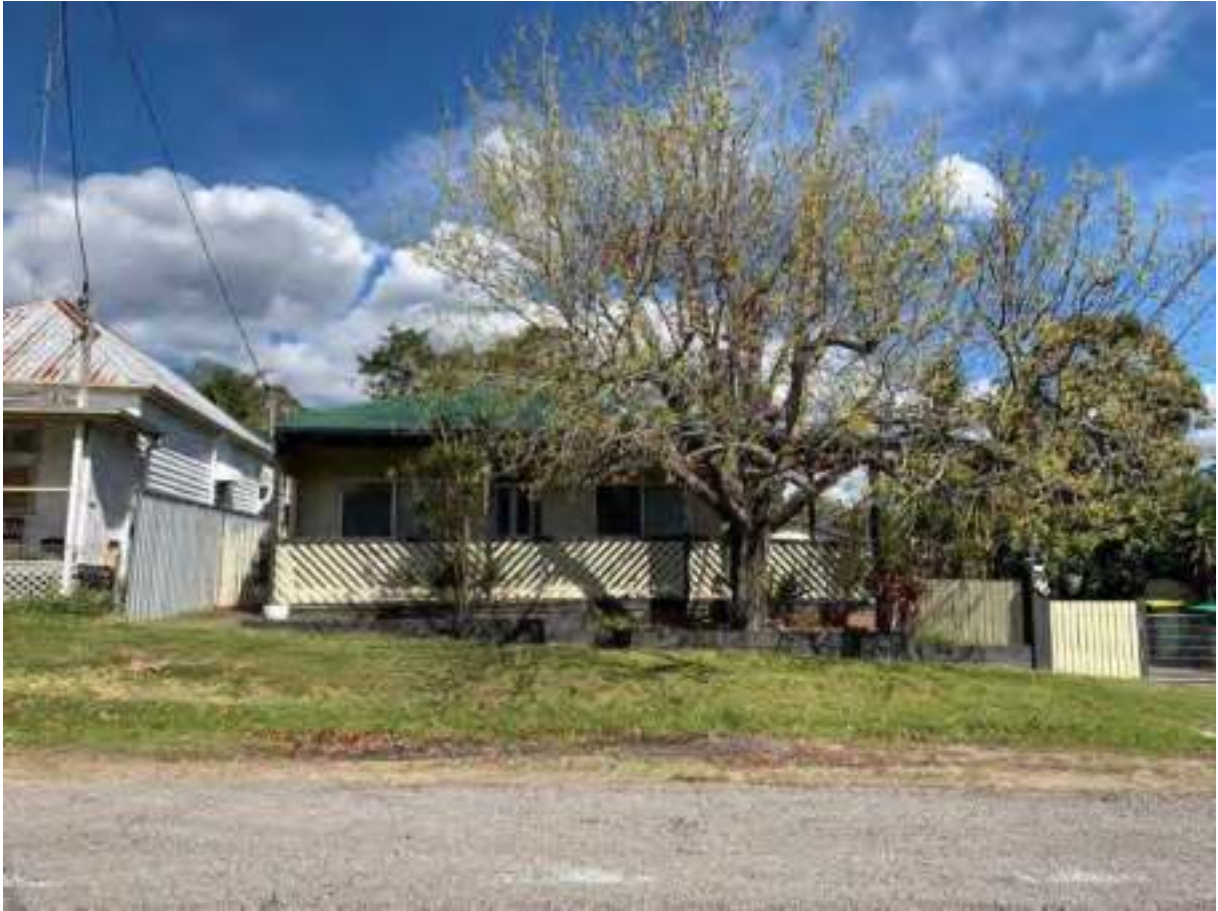
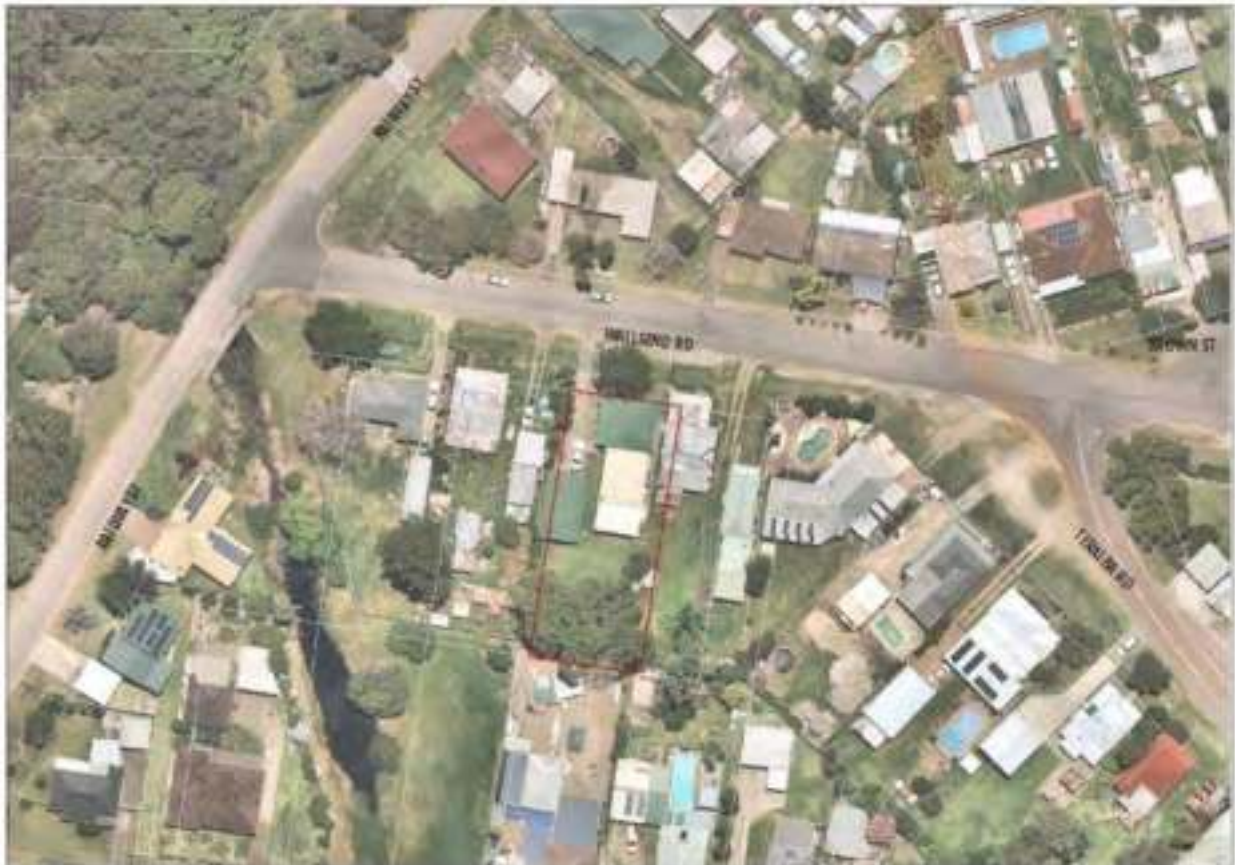
46 WALLSEND ROAD, WEST WALLSEND 2286

Conservation Area Contribution Level	Est. Construction Date	Previous studies and/or community input
Contributory 2	Early to late 20 th century (broad range)	No prior heritage assessments or research undertaken.
Assessment Text		Observed Modifications
<p>The scale (single-storey) and general style of the dwelling is consistent with that of the streetscape and wider HCA. Dwelling contributes positively to the streetscape and wider HCA, particularly in comparison to Non-Contributory buildings.</p> <p>The dwelling features appropriately proportioned and positioned fenestrations, an appropriate roof form (gabled or hipped) and other features consistent with the architectural character of the area (e.g. front verandah with timber or brick posts, timber detailing, corrugated metal roofing, etc). The contributory value of the dwelling is limited however by either:</p> <ul style="list-style-type: none"> • External modifications that have in some way obscured the style, scale or design intent of the building and have resulted in less physical integrity than Contributory 1 buildings. • Being a later dwelling constructed in an appropriate referential style, but comprising little to no fabric of intrinsic heritage significance. 		<p>The timber balustrade enclosing the veranda is a contemporary addition, likely replacing a comparable timber design.</p> <p>All visible windows are contemporary in style.</p> <p>An extension has been built onto the back southern side of the dwelling. This is not visible from the street and does not detract from the heritage streetscape.</p>

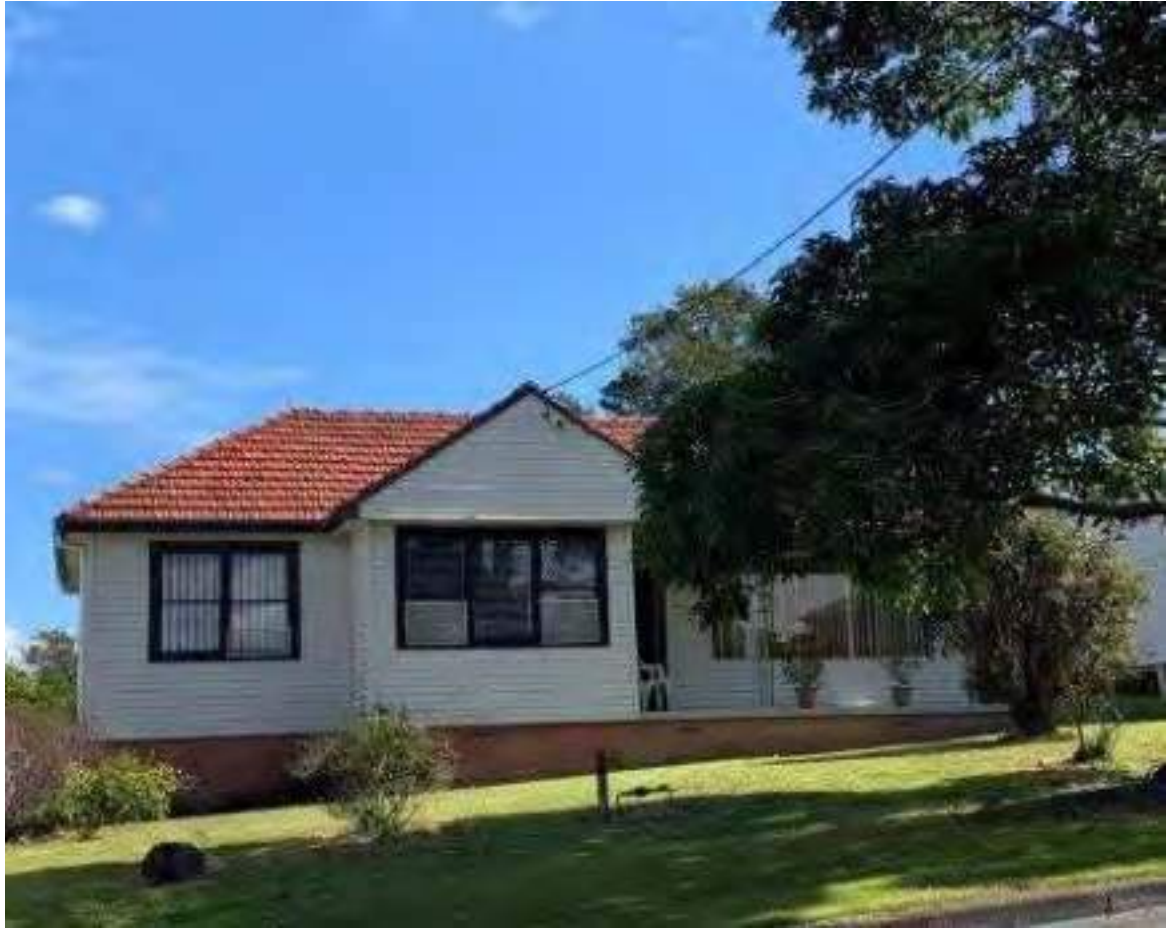
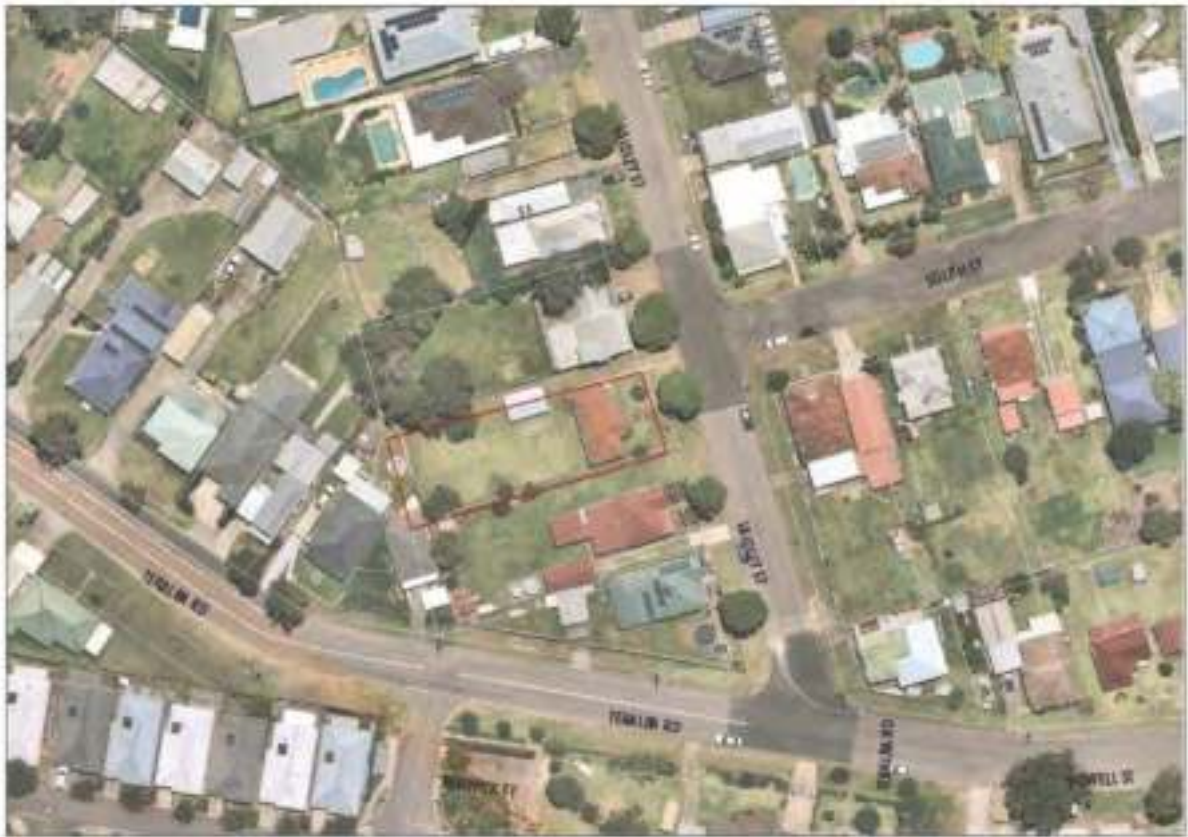
38 LAIDLEY STREET, WEST WALLSEND 2286

Conservation Area Contribution Level	Est. Construction Date	Previous studies and/or community input
Contributory 2	Early to late 20 th century (broad range)	No prior heritage assessments or research undertaken.
Assessment Text		Observed Modifications
<p>The scale (single-storey) and general style of the dwelling is consistent with that of the streetscape and wider HCA. Dwelling contributes positively to the streetscape and wider HCA, particularly in comparison to Non-Contributory buildings.</p> <p>The dwelling features appropriately proportioned and positioned fenestrations, an appropriate roof form (gabled or hipped) and other features consistent with the architectural character of the area (e.g. front verandah with timber or brick posts, timber detailing, corrugated metal roofing, etc). The contributory value of the dwelling is limited however by either:</p> <ul style="list-style-type: none"> • External modifications that have in some way obscured the style, scale or design intent of the building and have resulted in less physical integrity than Contributory 1 buildings. • Being a later dwelling constructed in an appropriate referential style, but comprising little to no fabric of intrinsic heritage significance. 		No modifications observed.

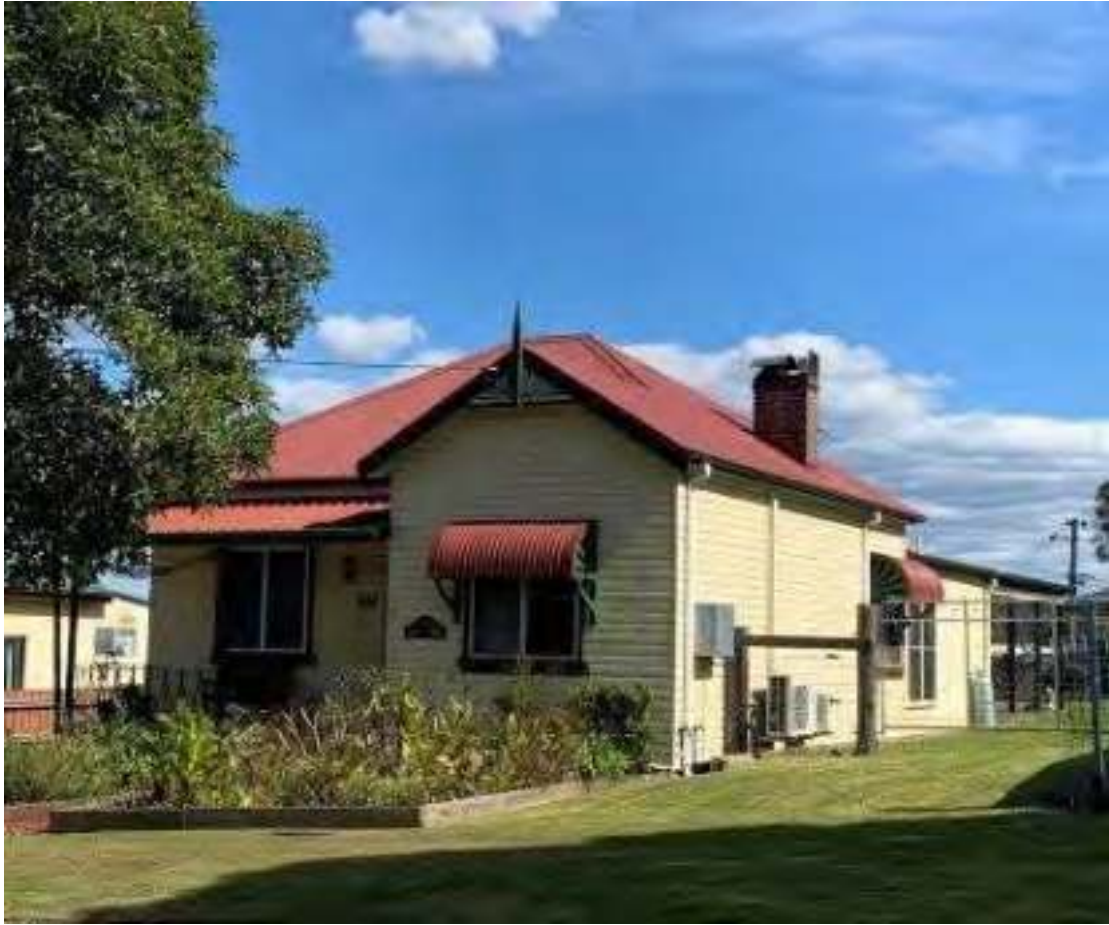
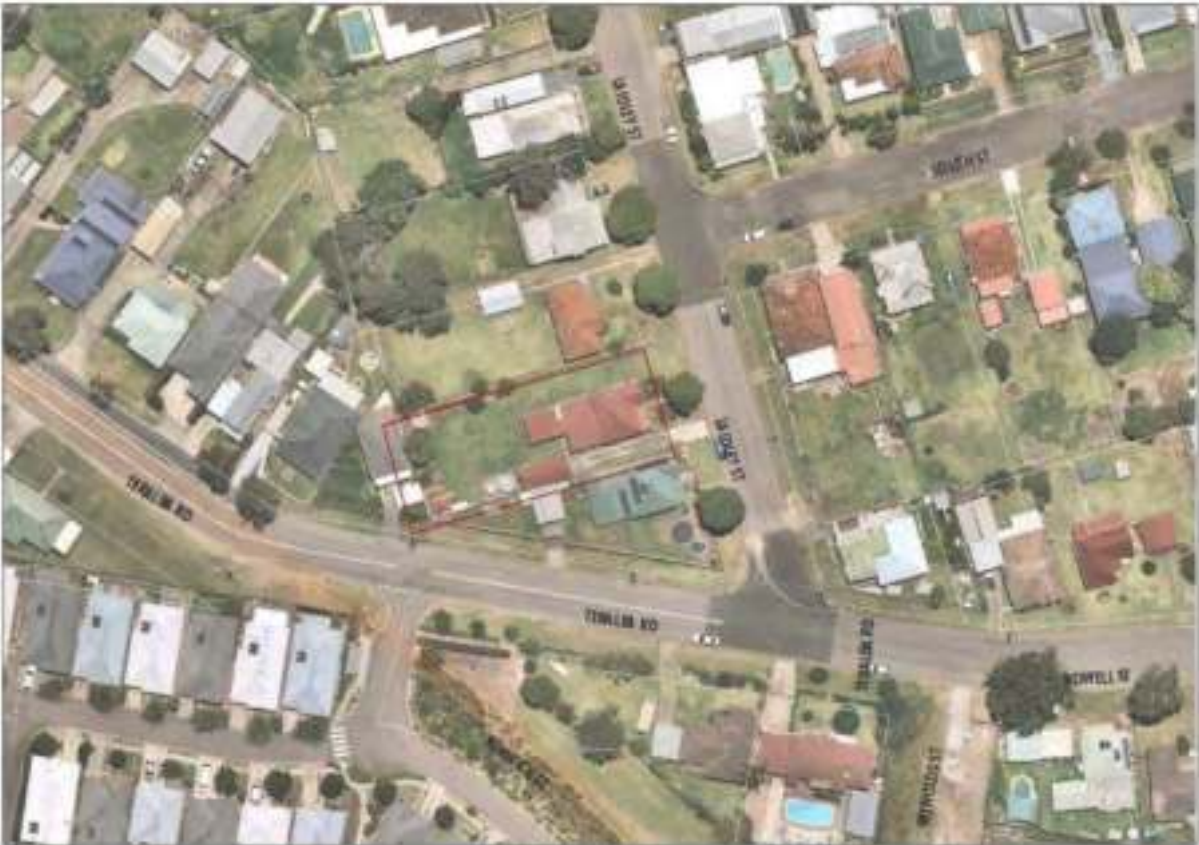
40 LAIDLEY STREET, WEST WALLSEND 2286

Conservation Area Contribution Level	Est. Construction Date	Previous studies and/or community input
Contributory 2	Early to late 20 th century (broad range)	No prior heritage assessments or research undertaken.
Assessment Text		Observed Modifications
<p>The scale (single-storey) and general style of the dwelling is consistent with that of the streetscape and wider HCA. Dwelling contributes positively to the streetscape and wider HCA, particularly in comparison to Non-Contributory buildings.</p> <p>The dwelling features appropriately proportioned and positioned fenestrations, an appropriate roof form (gabled or hipped) and other features consistent with the architectural character of the area (e.g. front verandah with timber or brick posts, timber detailing, corrugated metal roofing, etc). The contributory value of the dwelling is limited however by either:</p> <ul style="list-style-type: none"> • External modifications that have in some way obscured the style, scale or design intent of the building and have resulted in less physical integrity than Contributory 1 buildings. • Being a later dwelling constructed in an appropriate referential style, but comprising little to no fabric of intrinsic heritage significance. 		<p>An extension has been built onto the back western side of the dwelling. this is only partially visible from the street and does not detract from the heritage streetscape.</p> <p>The metal window hoods are a contemporary variation of the original heritage design.</p> <p>All visible windows are contemporary in design.</p> <p>The skillion veranda roof is a contemporary addition, likely replacing an original hipped or bull nosed design.</p>
