APPENDIX 2

Building Assessment Sheets (Inventory Sheets)

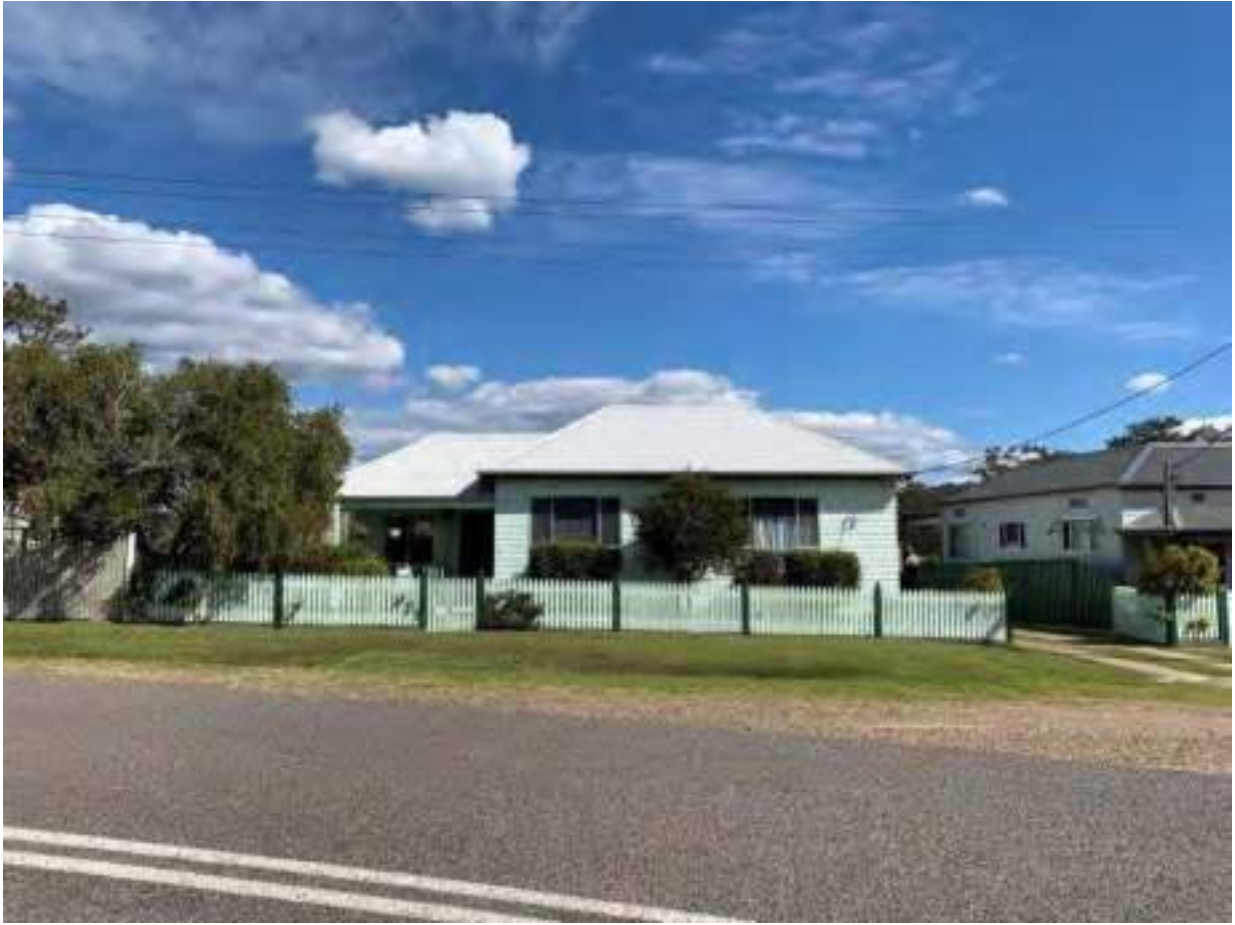
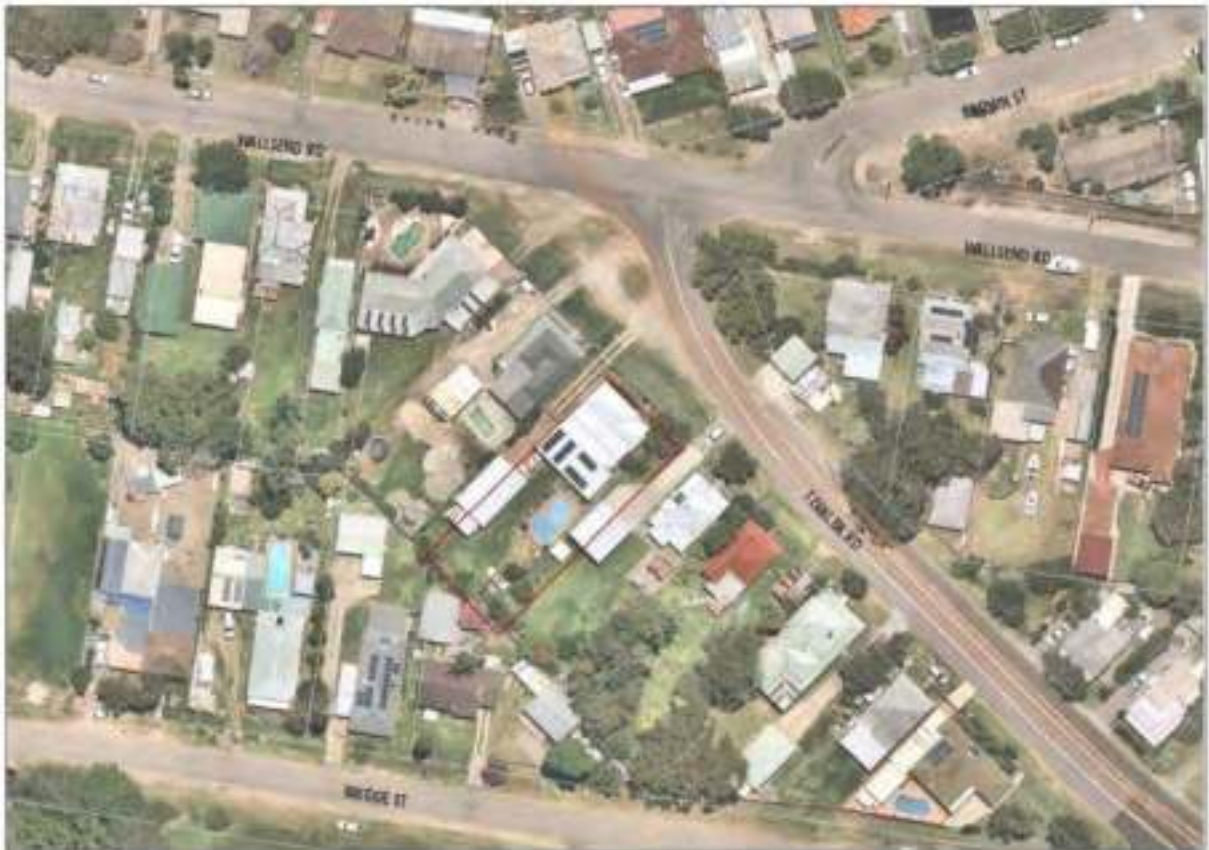
6 TERALBA STREET, WEST WALLSEND 2286

Conservation Area Contribution Level	Est. Construction Date	Previous studies and/or community input
Contributory 2	Early to late 20 th century (broad range)	No prior heritage assessments or research undertaken.
Assessment Text		Observed Modifications
<p>The scale (single-storey) and general style of the dwelling is consistent with that of the streetscape and wider HCA. Dwelling contributes positively to the streetscape and wider HCA, particularly in comparison to Non-Contributory buildings.</p> <p>The dwelling features appropriately proportioned and positioned fenestrations, an appropriate roof form (gabled or hipped) and other features consistent with the architectural character of the area (e.g. front verandah with timber or brick posts, timber detailing, corrugated metal roofing, etc). The contributory value of the dwelling is limited however by either:</p> <ul style="list-style-type: none"> • External modifications that have in some way obscured the style, scale or design intent of the building and have resulted in less physical integrity than Contributory 1 buildings. • Being a later dwelling constructed in an appropriate referential style, but comprising little to no fabric of intrinsic heritage significance. 		<p>An extension has been built onto the south western side of the dwelling. This is not visible from the street and does not detract from the heritage streetscape.</p>

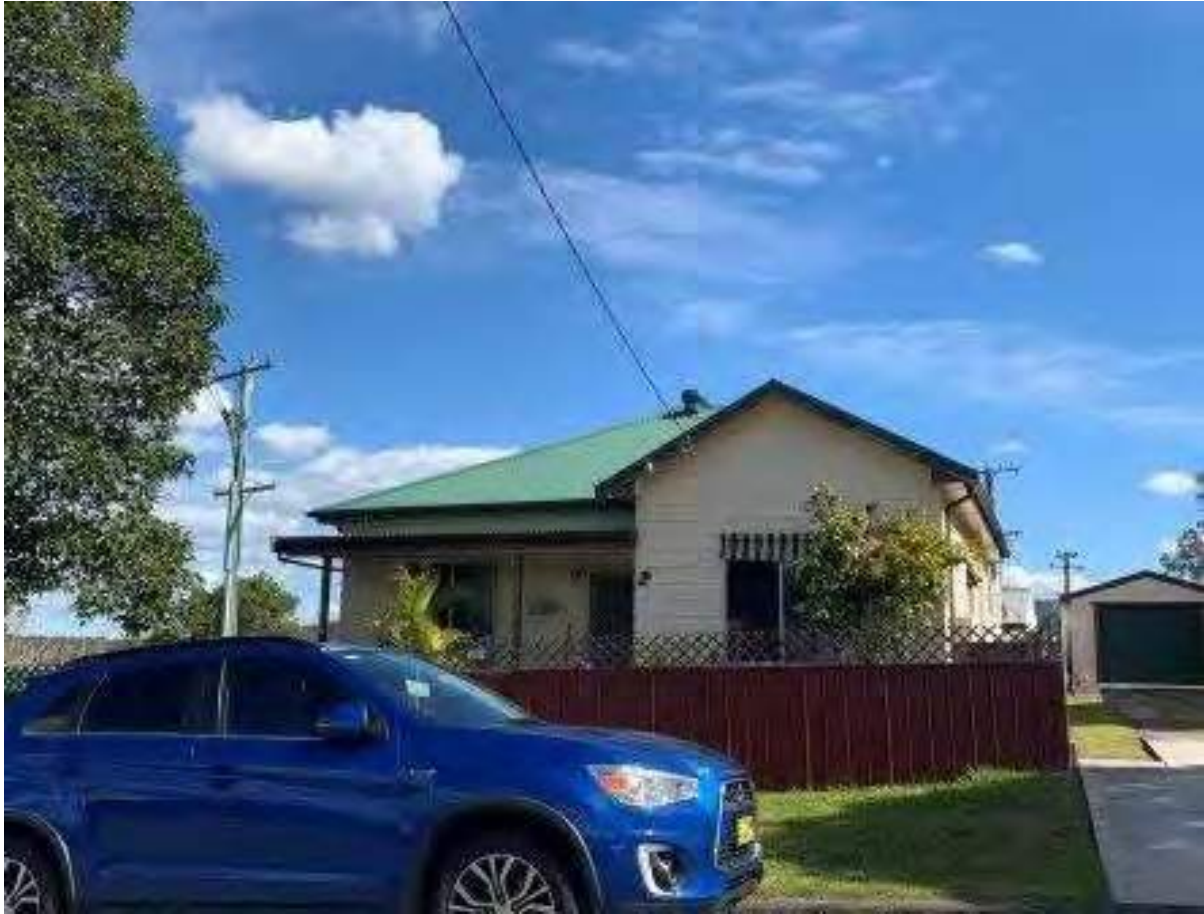
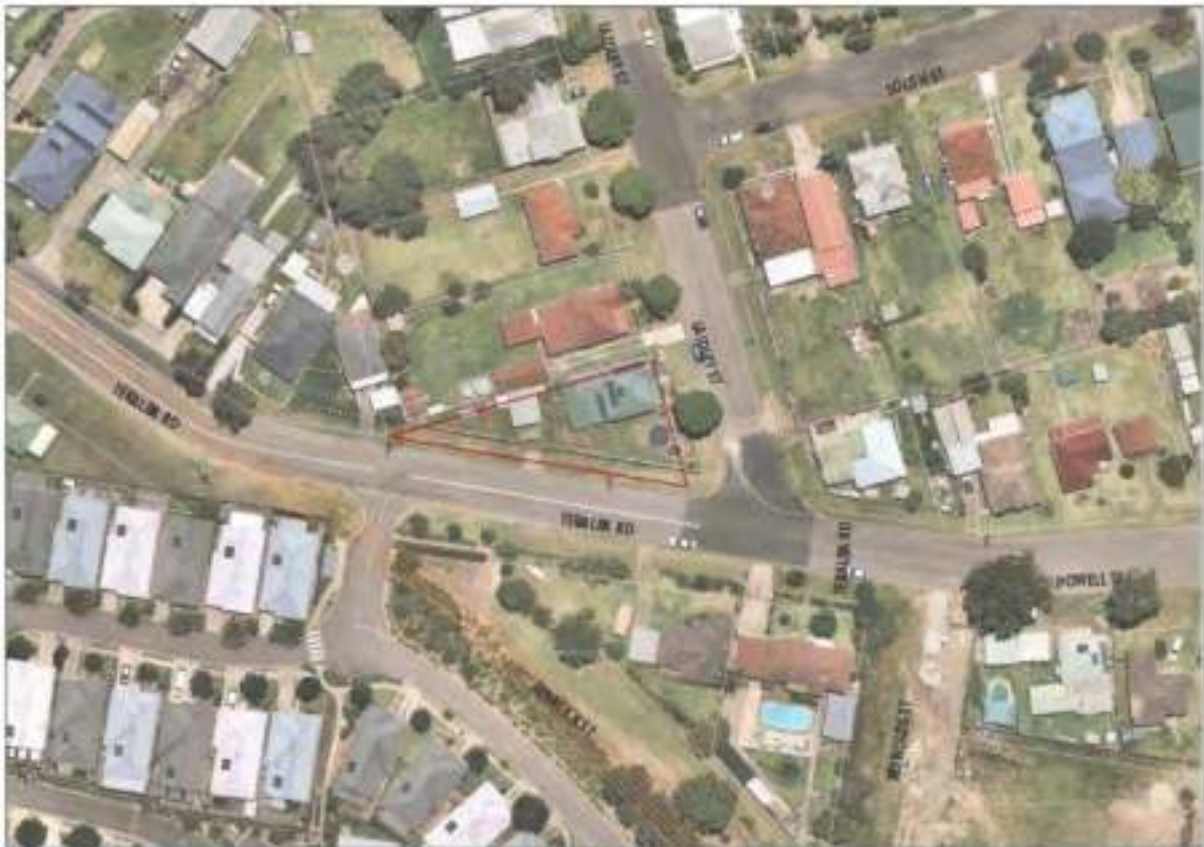
42 LAIDLEY STREET, WEST WALLSEND 2286

Conservation Area Contribution Level	Est. Construction Date	Previous studies and/or community input
Contributory 2	Early to late 20 th century (broad range)	No prior heritage assessments or research undertaken.
Assessment Text		Observed Modifications
<p>The scale (single-storey) and general style of the dwelling is consistent with that of the streetscape and wider HCA. Dwelling contributes positively to the streetscape and wider HCA, particularly in comparison to Non-Contributory buildings.</p> <p>The dwelling features appropriately proportioned and positioned fenestrations, an appropriate roof form (gabled or hipped) and other features consistent with the architectural character of the area (e.g. front verandah with timber or brick posts, timber detailing, corrugated metal roofing, etc). The contributory value of the dwelling is limited however by either:</p> <ul style="list-style-type: none"> • External modifications that have in some way obscured the style, scale or design intent of the building and have resulted in less physical integrity than Contributory 1 buildings. • Being a later dwelling constructed in an appropriate referential style, but comprising little to no fabric of intrinsic heritage significance. 		<p>All visible windows are contemporary in style, with some having additional canvas awnings installed.</p> <p>An extension has been built onto the western side of the dwelling. This is partially visible from the street, however does not detract from the heritage streetscape.</p>

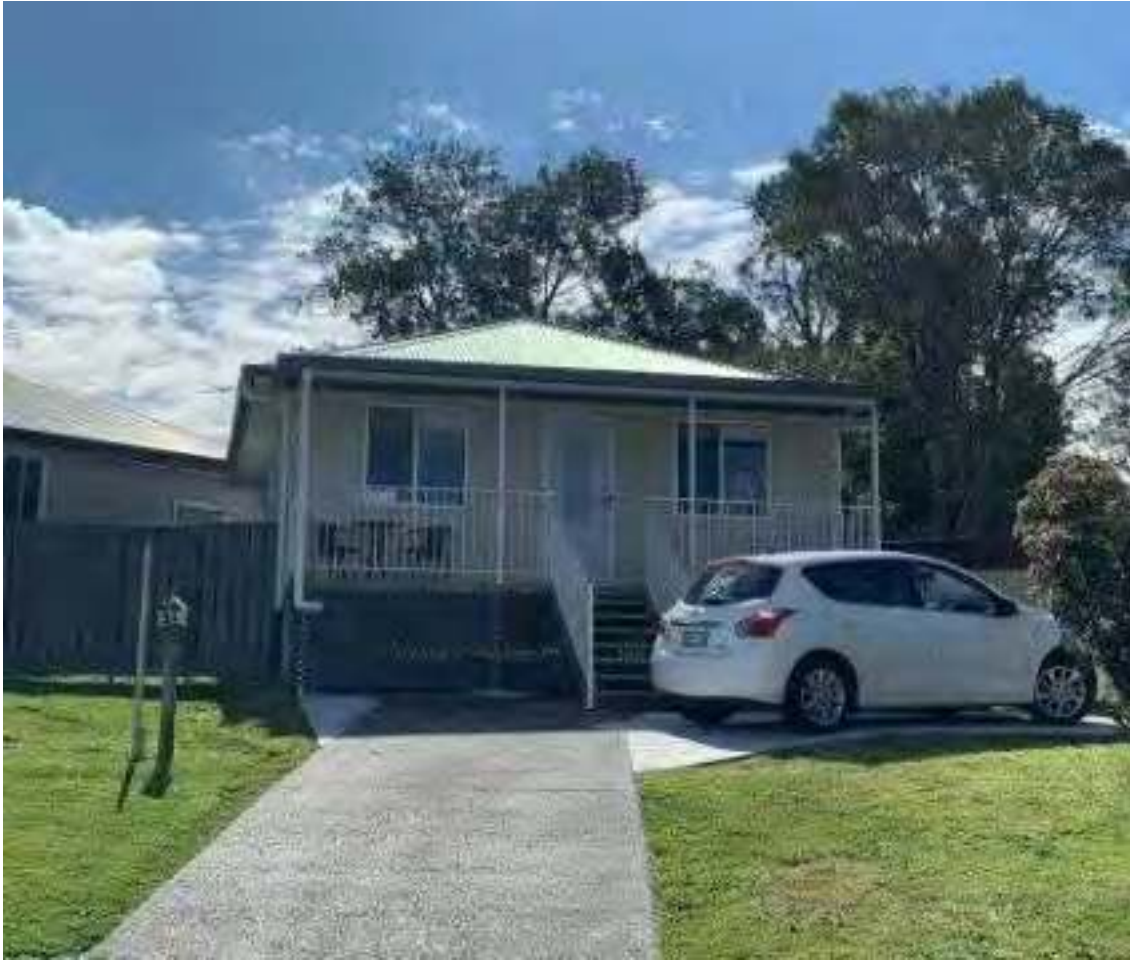
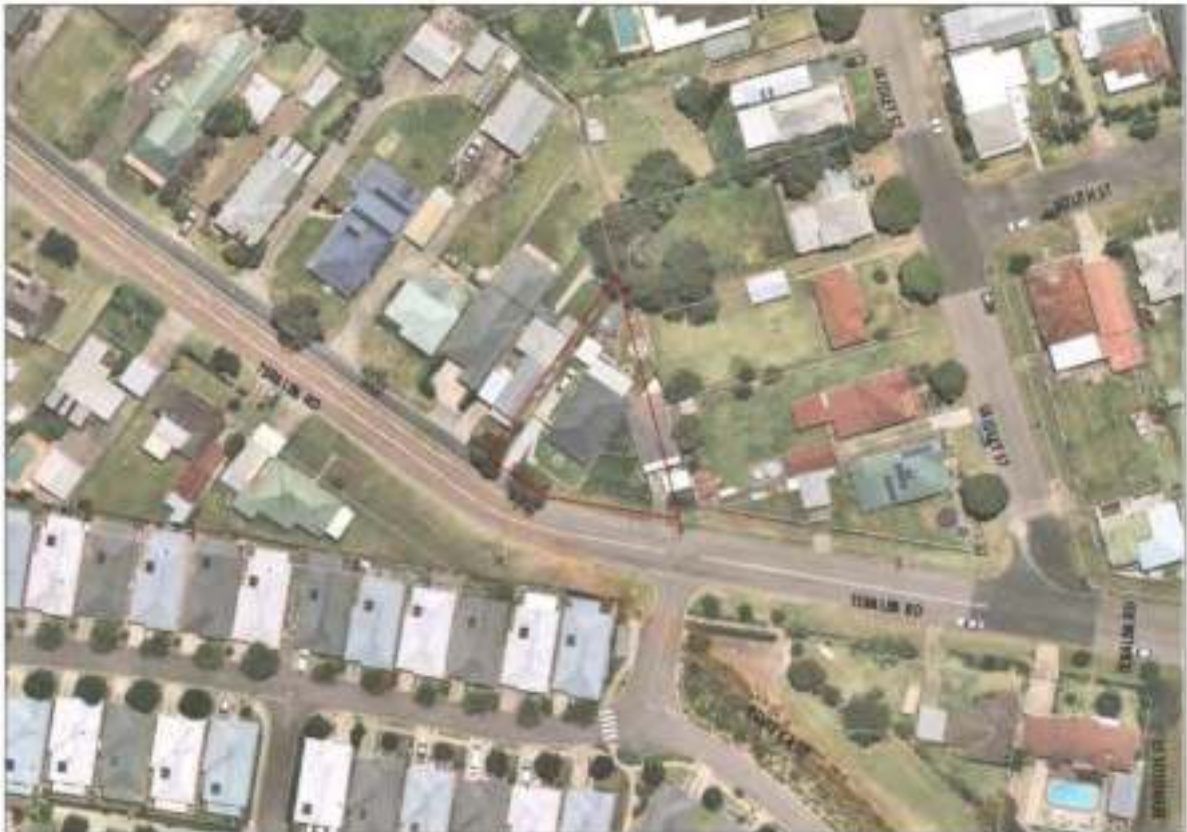
31 TERALBA ROAD, WEST WALLSEND 2286

Conservation Area Contribution Level	Est. Construction Date	Previous studies and/or community input
Contributory 2	Early to late 20 th century (broad range)	No prior heritage assessments or research undertaken.
Assessment Text		Observed Modifications
<p>The scale (single-storey) and general style of the dwelling is consistent with that of the streetscape and wider HCA. Dwelling contributes positively to the streetscape and wider HCA, particularly in comparison to Non-Contributory buildings.</p> <p>The dwelling features appropriately proportioned and positioned fenestrations, an appropriate roof form (gabled or hipped) and other features consistent with the architectural character of the area (e.g. front verandah with timber or brick posts, timber detailing, corrugated metal roofing, etc). The contributory value of the dwelling is limited however by either:</p> <ul style="list-style-type: none"> • External modifications that have in some way obscured the style, scale or design intent of the building and have resulted in less physical integrity than Contributory 1 buildings. • Being a later dwelling constructed in an appropriate referential style, but comprising little to no fabric of intrinsic heritage significance. 		<p>The visible windows and doors are contemporary in style.</p> <p>The metal balustrade is a contemporary addition, replacing a prior timber design.</p> <p>The stairs leading to the veranda landing have been repositioned, originally being found on the western side of the dwelling. The current central position is a contemporary modification.</p>

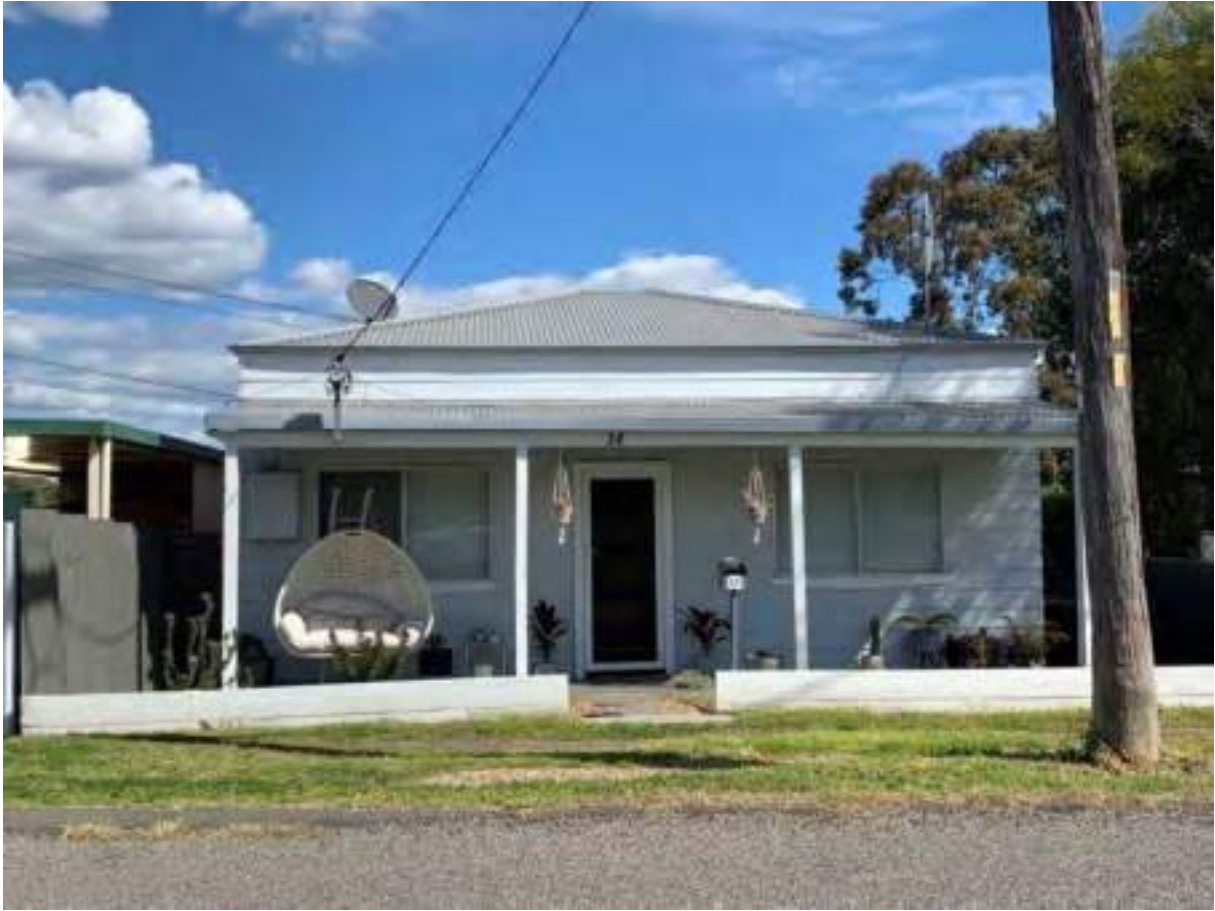
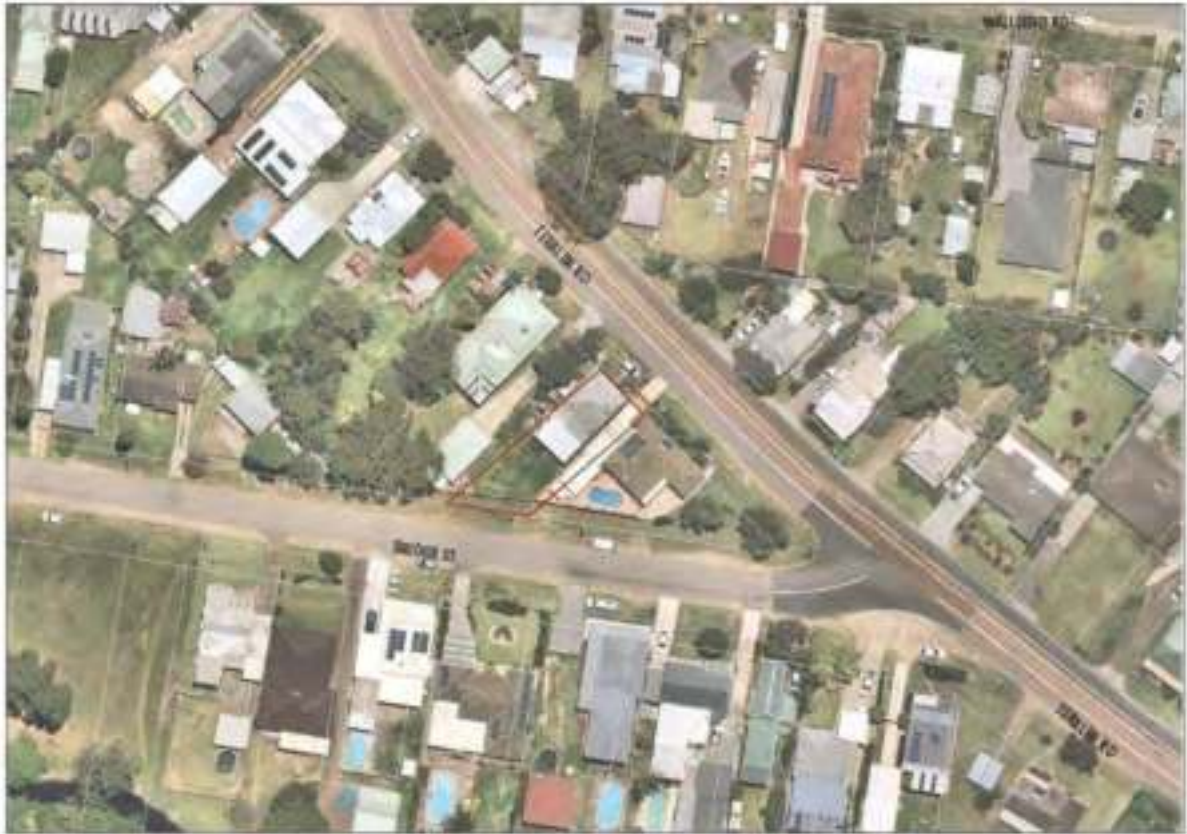
14 TERALBA ROAD, WEST WALLSEND 2286

Conservation Area Contribution Level	Est. Construction Date	Previous studies and/or community input
Contributory 2	Early to late 20 th century (broad range)	No prior heritage assessments or research undertaken.
Assessment Text		Observed Modifications
<p>The scale (single-storey) and general style of the dwelling is consistent with that of the streetscape and wider HCA. Dwelling contributes positively to the streetscape and wider HCA, particularly in comparison to Non-Contributory buildings.</p> <p>The dwelling features appropriately proportioned and positioned fenestrations, an appropriate roof form (gabled or hipped) and other features consistent with the architectural character of the area (e.g. front verandah with timber or brick posts, timber detailing, corrugated metal roofing, etc). The contributory value of the dwelling is limited however by either:</p> <ul style="list-style-type: none"> • External modifications that have in some way obscured the style, scale or design intent of the building and have resulted in less physical integrity than Contributory 1 buildings. • Being a later dwelling constructed in an appropriate referential style, but comprising little to no fabric of intrinsic heritage significance. 		<p>All visible windows and doors are a contemporary style.</p> <p>The flat veranda roof is a prior modification, likely replacing an original hipped or bull nosed design.</p> <p>An extension has been built onto the back south western side of the dwelling. This is not visible from the street and does not detract from the heritage streetscape.</p>

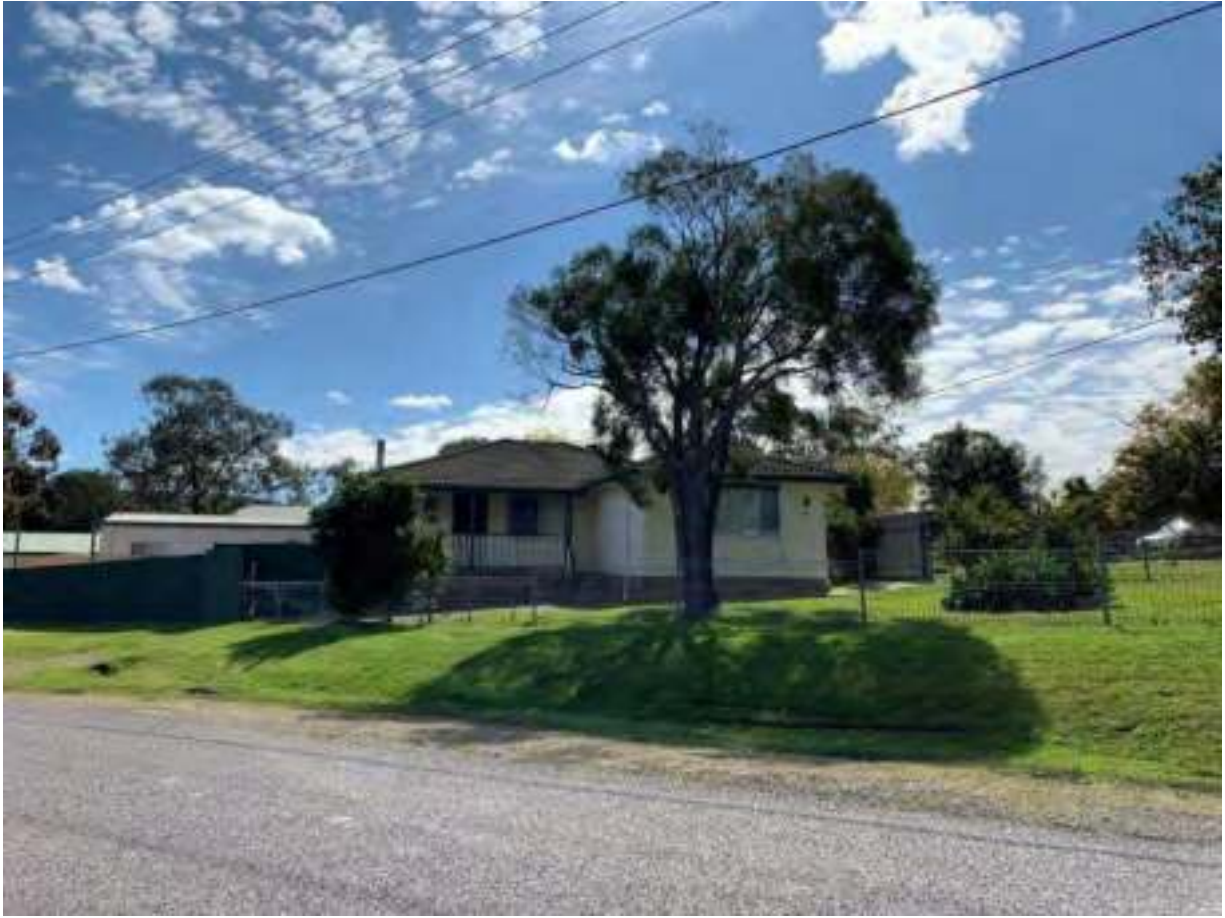
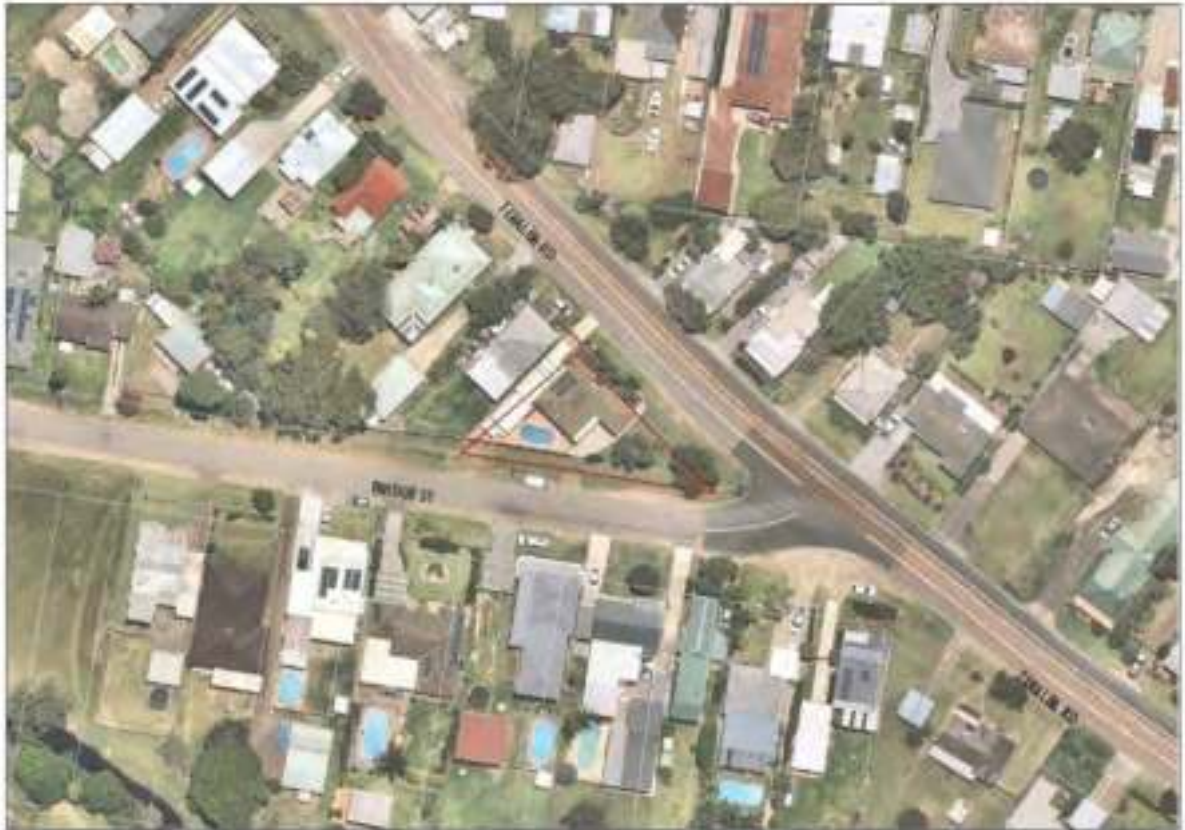
16 TERALBA ROAD, WEST WALLSEND 2286

Conservation Area Contribution Level	Est. Construction Date	Previous studies and/or community input
Contributory 2	Early to late 20 th century (broad range)	No prior heritage assessments or research undertaken.
Assessment Text		Observed Modifications
<p>The scale (single-storey) and general style of the dwelling is consistent with that of the streetscape and wider HCA. Dwelling contributes positively to the streetscape and wider HCA, particularly in comparison to Non-Contributory buildings.</p> <p>The dwelling features appropriately proportioned and positioned fenestrations, an appropriate roof form (gabled or hipped) and other features consistent with the architectural character of the area (e.g. front verandah with timber or brick posts, timber detailing, corrugated metal roofing, etc). The contributory value of the dwelling is limited however by either:</p> <ul style="list-style-type: none"> • External modifications that have in some way obscured the style, scale or design intent of the building and have resulted in less physical integrity than Contributory 1 buildings. • Being a later dwelling constructed in an appropriate referential style, but comprising little to no fabric of intrinsic heritage significance. 		<p>The balustrade is a contemporary addition, likely replacing a comparable timber design.</p>

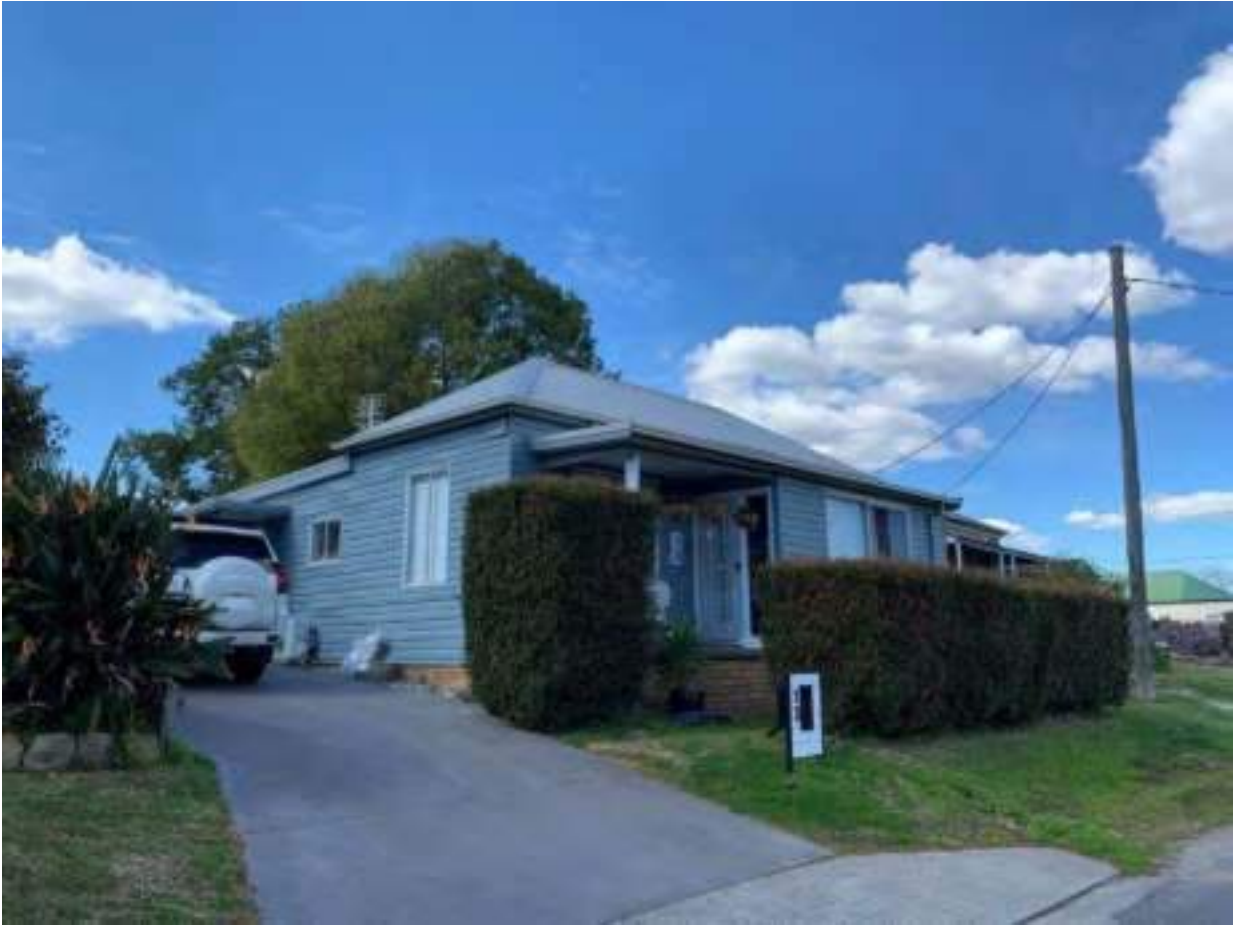
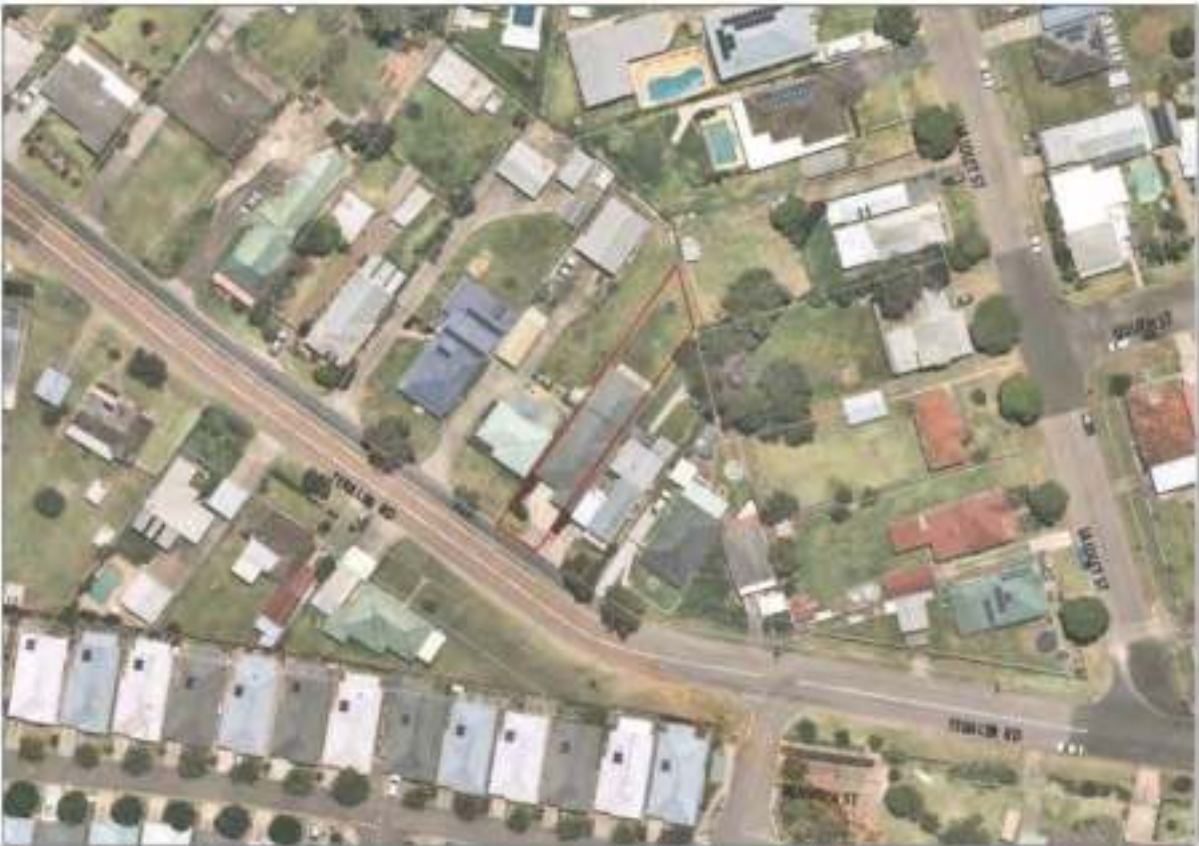
29A TERALBA ROAD, WEST WALLSEND 2286

Conservation Area Contribution Level	Est. Construction Date	Previous studies and/or community input
Contributory 2	Early to late 20 th century (broad range)	No prior heritage assessments or research undertaken.
Assessment Text		Observed Modifications
<p>The scale (single-storey) and general style of the dwelling is consistent with that of the streetscape and wider HCA. Dwelling contributes positively to the streetscape and wider HCA, particularly in comparison to Non-Contributory buildings.</p> <p>The dwelling features appropriately proportioned and positioned fenestrations, an appropriate roof form (gabled or hipped) and other features consistent with the architectural character of the area (e.g. front verandah with timber or brick posts, timber detailing, corrugated metal roofing, etc). The contributory value of the dwelling is limited however by either:</p> <ul style="list-style-type: none"> • External modifications that have in some way obscured the style, scale or design intent of the building and have resulted in less physical integrity than Contributory 1 buildings. • Being a later dwelling constructed in an appropriate referential style, but comprising little to no fabric of intrinsic heritage significance. 		<p>All visible windows are contemporary in style.</p> <p>The veranda has been built in on the south eastern side, creating an additional living area. This is a common modification to the area, however does detract from the heritage streetscape.</p> <p>An extension has been built onto the back north eastern side of the dwelling. This is not visible from the street and does not detract from the heritage streetscape.</p>

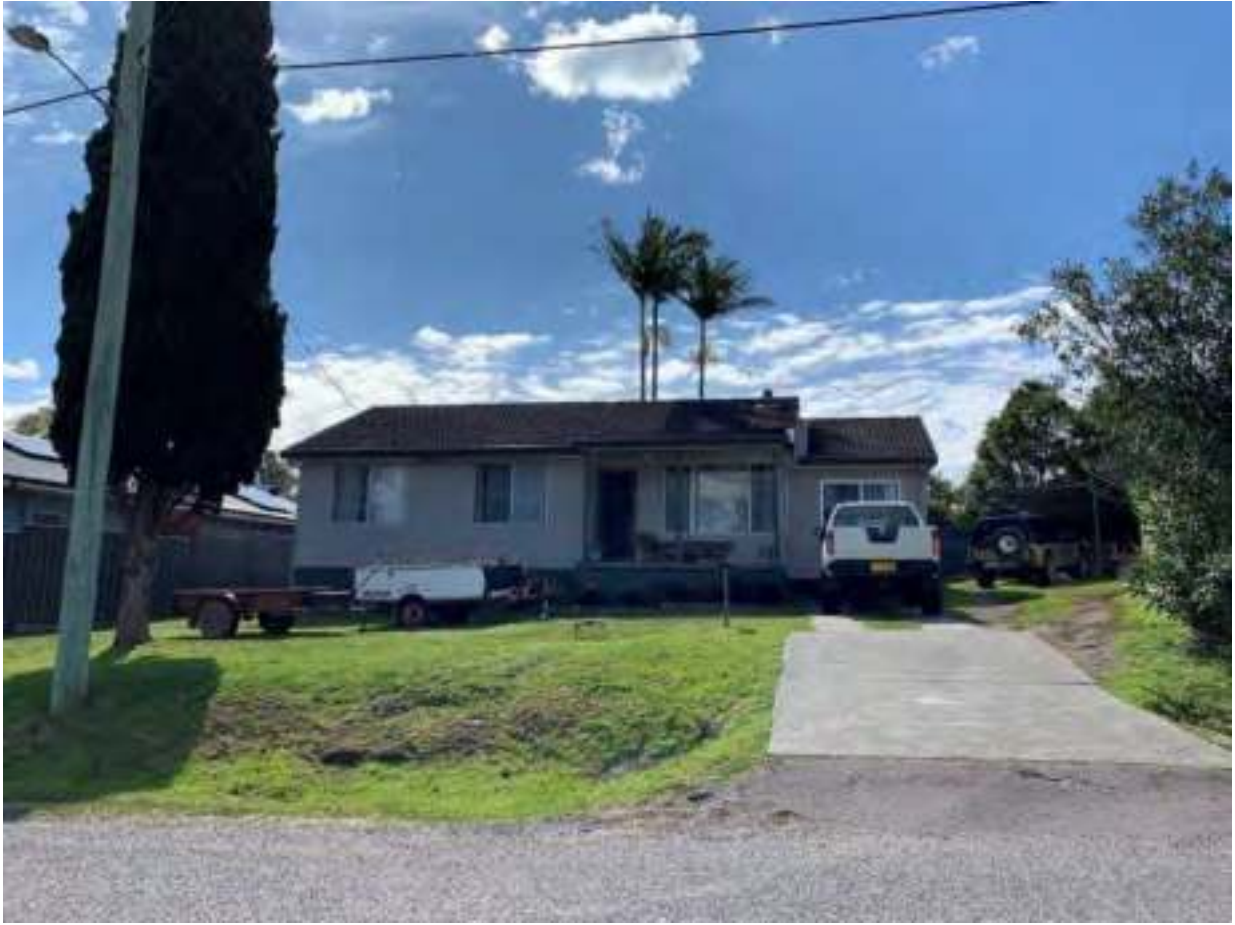
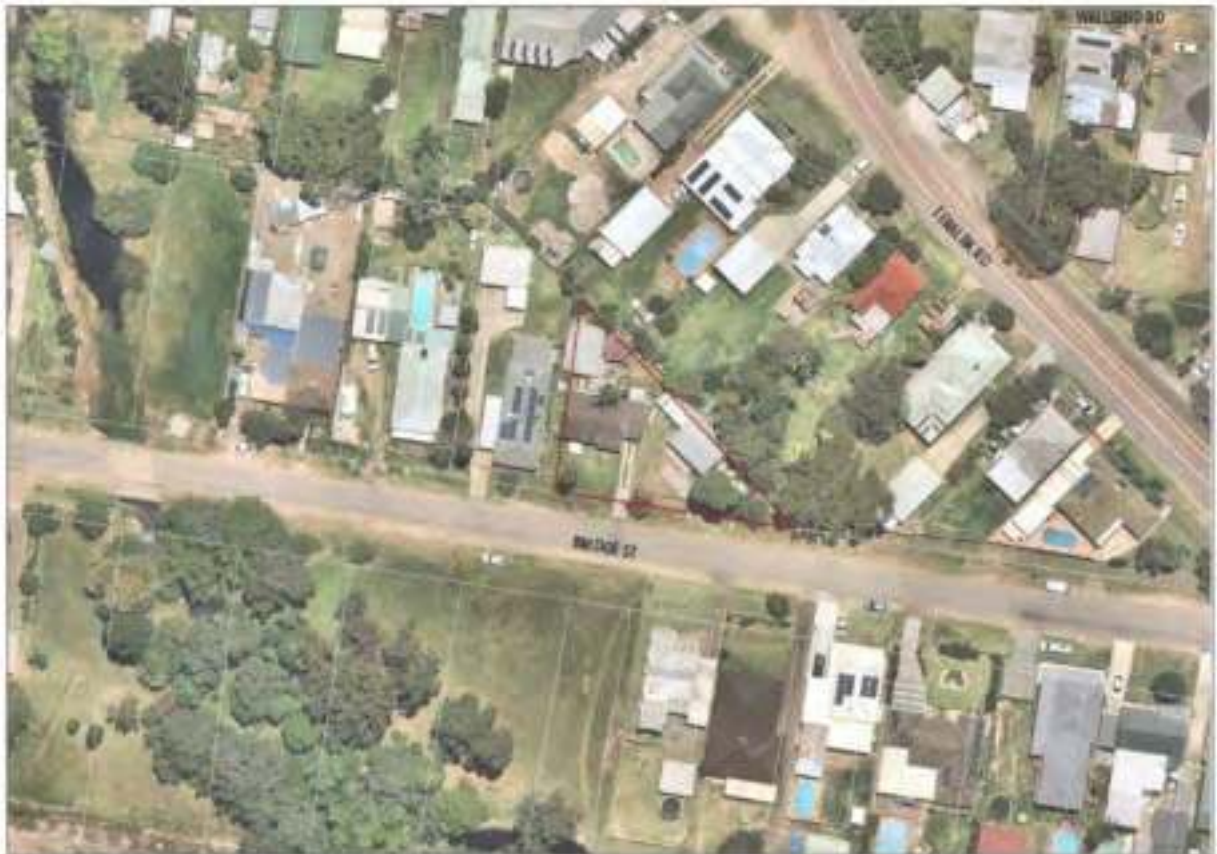
1 BRIDGE STREET, WEST WALLSEND 2286

Conservation Area Contribution Level	Est. Construction Date	Previous studies and/or community input
Contributory 2	Early to late 20 th century (broad range)	No prior heritage assessments or research undertaken.
Assessment Text		Observed Modifications
<p>The scale (single-storey) and general style of the dwelling is consistent with that of the streetscape and wider HCA. Dwelling contributes positively to the streetscape and wider HCA, particularly in comparison to Non-Contributory buildings.</p> <p>The dwelling features appropriately proportioned and positioned fenestrations, an appropriate roof form (gabled or hipped) and other features consistent with the architectural character of the area (e.g. front verandah with timber or brick posts, timber detailing, corrugated metal roofing, etc). The contributory value of the dwelling is limited however by either:</p> <ul style="list-style-type: none"> • External modifications that have in some way obscured the style, scale or design intent of the building and have resulted in less physical integrity than Contributory 1 buildings. • Being a later dwelling constructed in an appropriate referential style, but comprising little to no fabric of intrinsic heritage significance. 		All visible windows are contemporary in style.

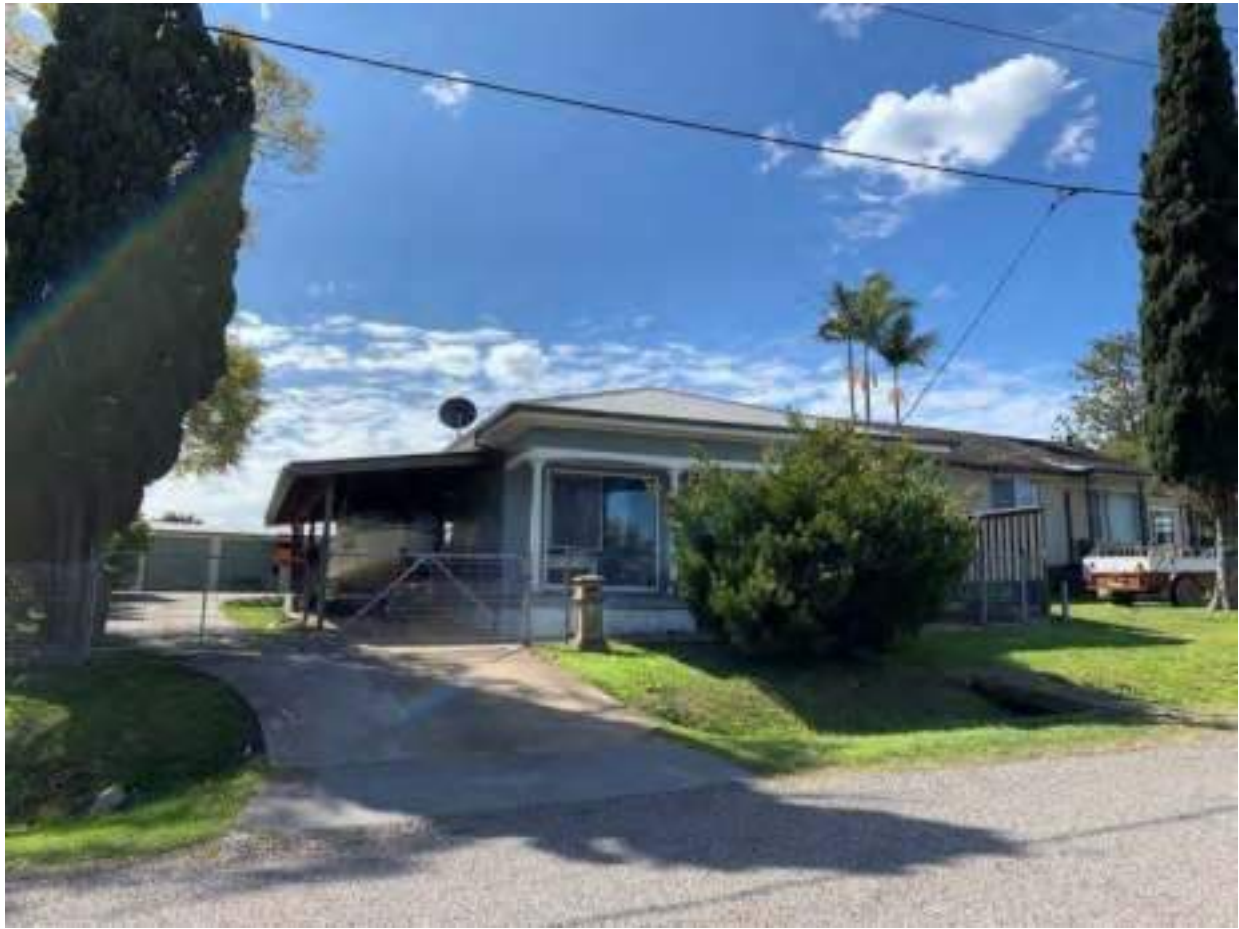
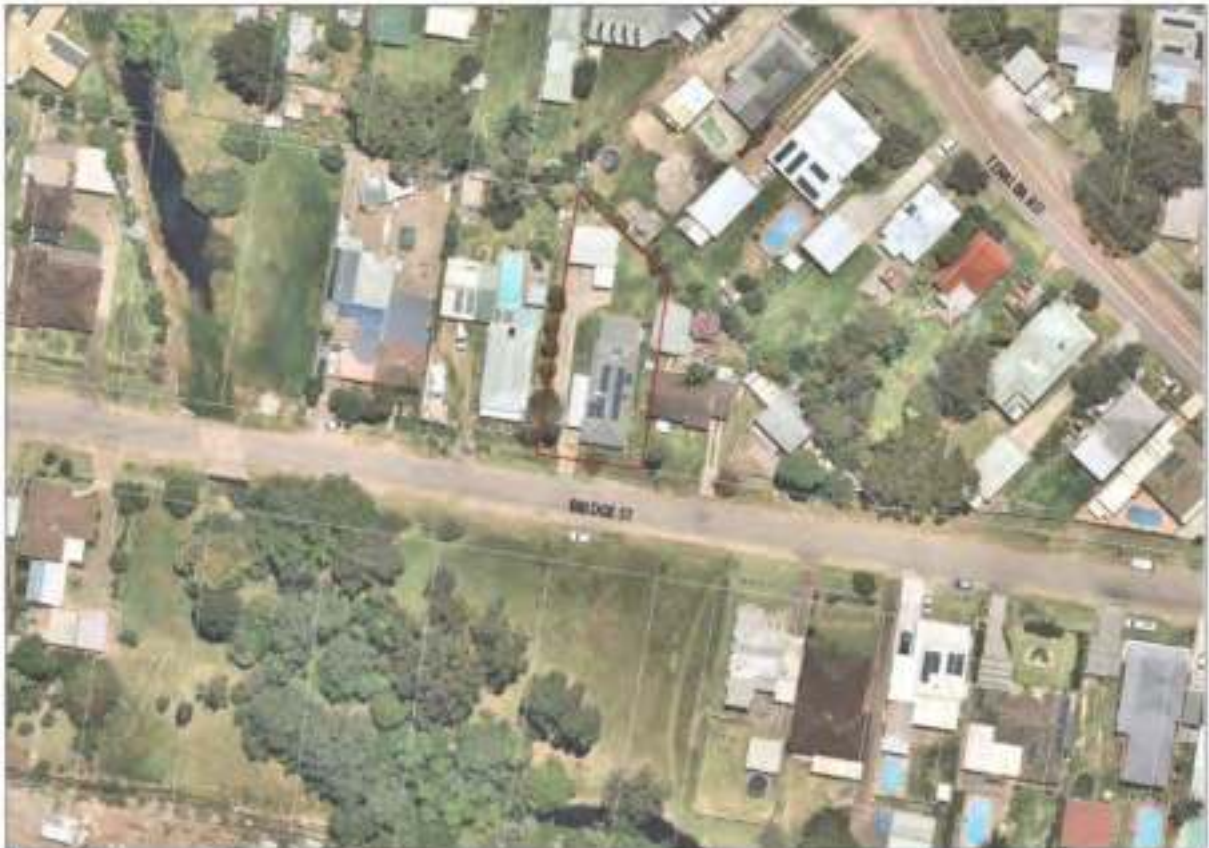
3 BRIDGE STREET, WEST WALLSEND 2286

Conservation Area Contribution Level	Est. Construction Date	Previous studies and/or community input
Contributory 2	Early to late 20 th century (broad range)	No prior heritage assessments or research undertaken.
Assessment Text		Observed Modifications
<p>The scale (single-storey) and general style of the dwelling is consistent with that of the streetscape and wider HCA. Dwelling contributes positively to the streetscape and wider HCA, particularly in comparison to Non-Contributory buildings.</p> <p>The dwelling features appropriately proportioned and positioned fenestrations, an appropriate roof form (gabled or hipped) and other features consistent with the architectural character of the area (e.g. front verandah with timber or brick posts, timber detailing, corrugated metal roofing, etc). The contributory value of the dwelling is limited however by either:</p> <ul style="list-style-type: none"> • External modifications that have in some way obscured the style, scale or design intent of the building and have resulted in less physical integrity than Contributory 1 buildings. • Being a later dwelling constructed in an appropriate referential style, but comprising little to no fabric of intrinsic heritage significance. 		<p>The faux European style pillars and border are contemporary additions to the dwelling.</p> <p>All visible windows are contemporary in style, with security screening installed.</p> <p>A carport has been built onto the western side of the dwelling.</p>

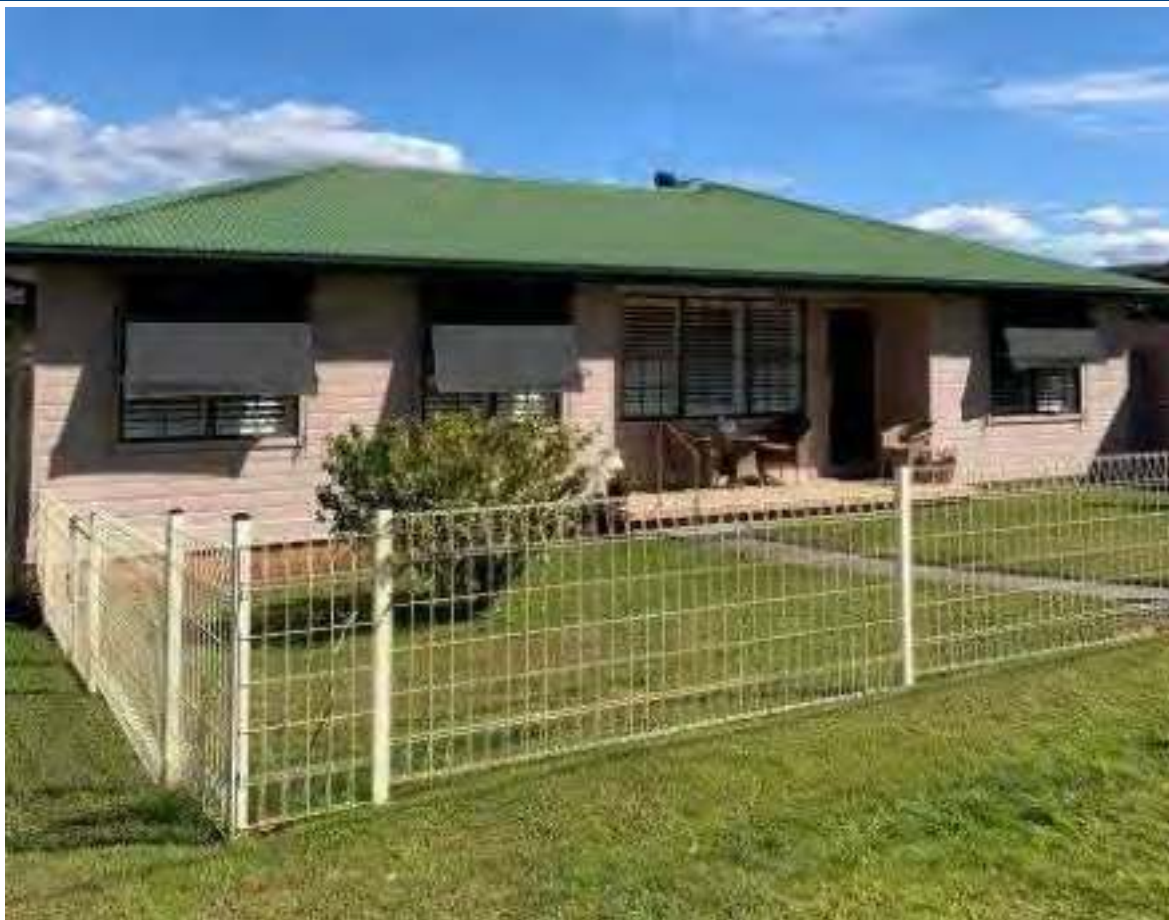
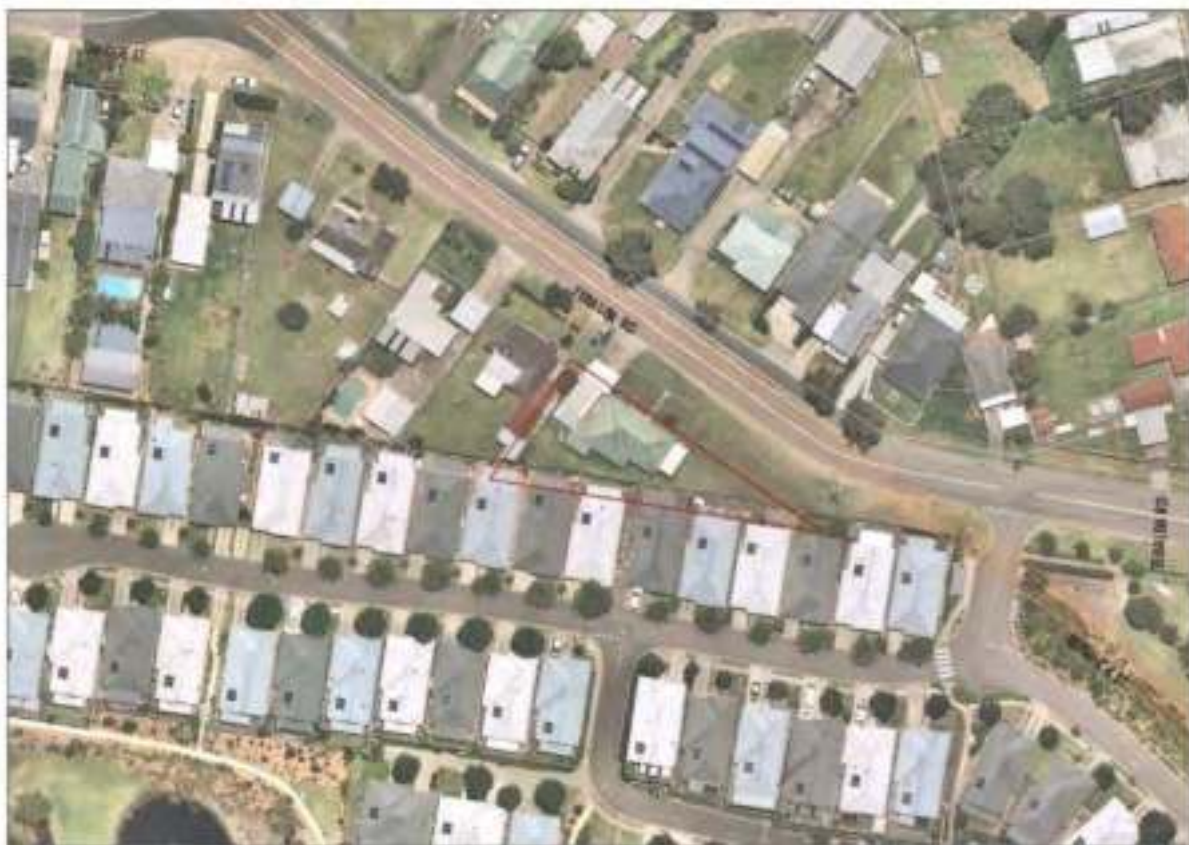
24 TERALBA STREET, WEST WALLSEND 2286

Conservation Area Contribution Level	Est. Construction Date	Previous studies and/or community input
Contributory 2	Early to late 20 th century (broad range)	No prior heritage assessments or research undertaken.
Assessment Text		Observed Modifications
<p>The scale (single-storey) and general style of the dwelling is consistent with that of the streetscape and wider HCA. Dwelling contributes positively to the streetscape and wider HCA, particularly in comparison to Non-Contributory buildings.</p> <p>The dwelling features appropriately proportioned and positioned fenestrations, an appropriate roof form (gabled or hipped) and other features consistent with the architectural character of the area (e.g. front verandah with timber or brick posts, timber detailing, corrugated metal roofing, etc). The contributory value of the dwelling is limited however by either:</p> <ul style="list-style-type: none"> • External modifications that have in some way obscured the style, scale or design intent of the building and have resulted in less physical integrity than Contributory 1 buildings. • Being a later dwelling constructed in an appropriate referential style, but comprising little to no fabric of intrinsic heritage significance. 		<p>Canvas blinds have been installed a top all front north eastern facing windows.</p>
