APPENDIX 2

Building Assessment Sheets (Inventory Sheets)

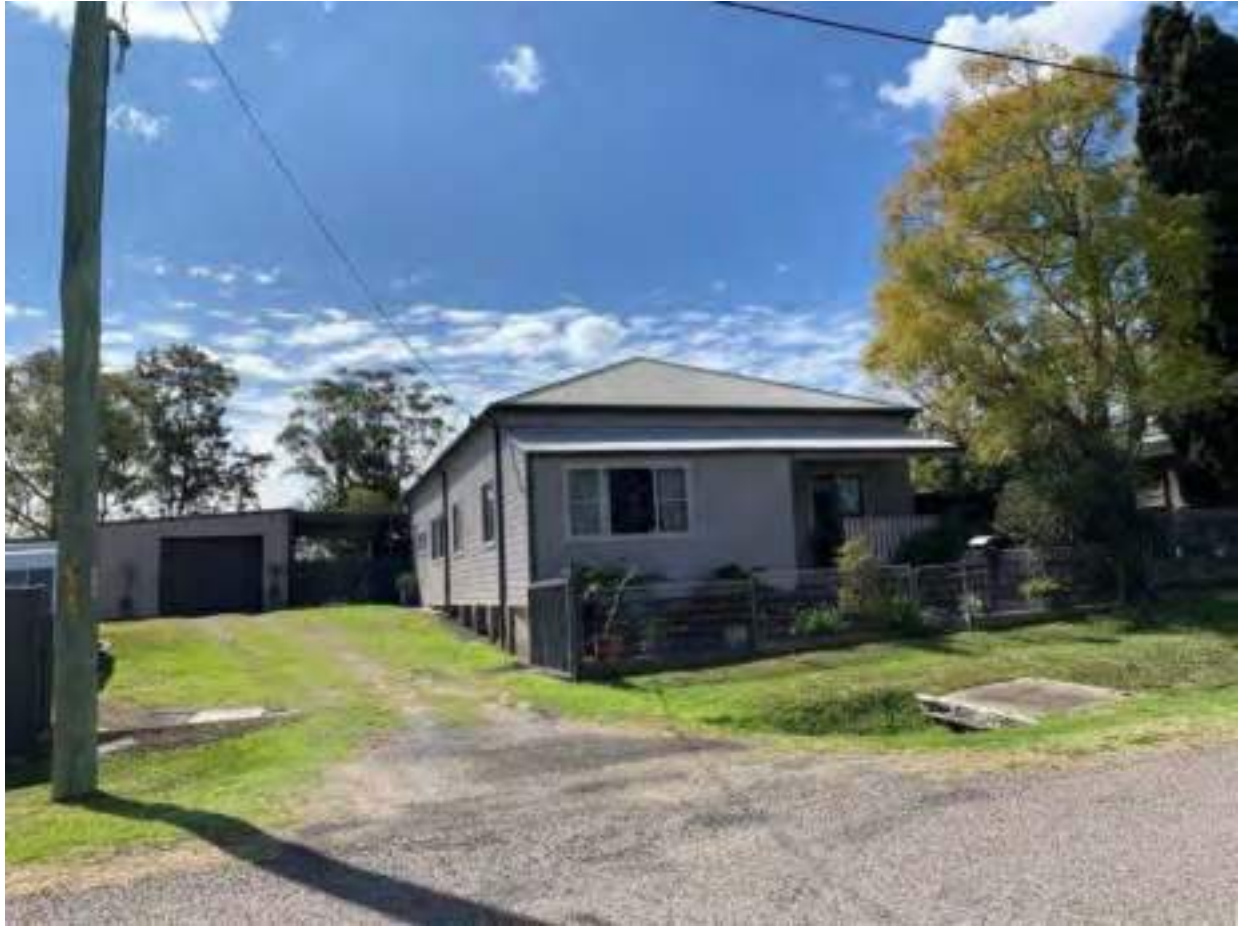
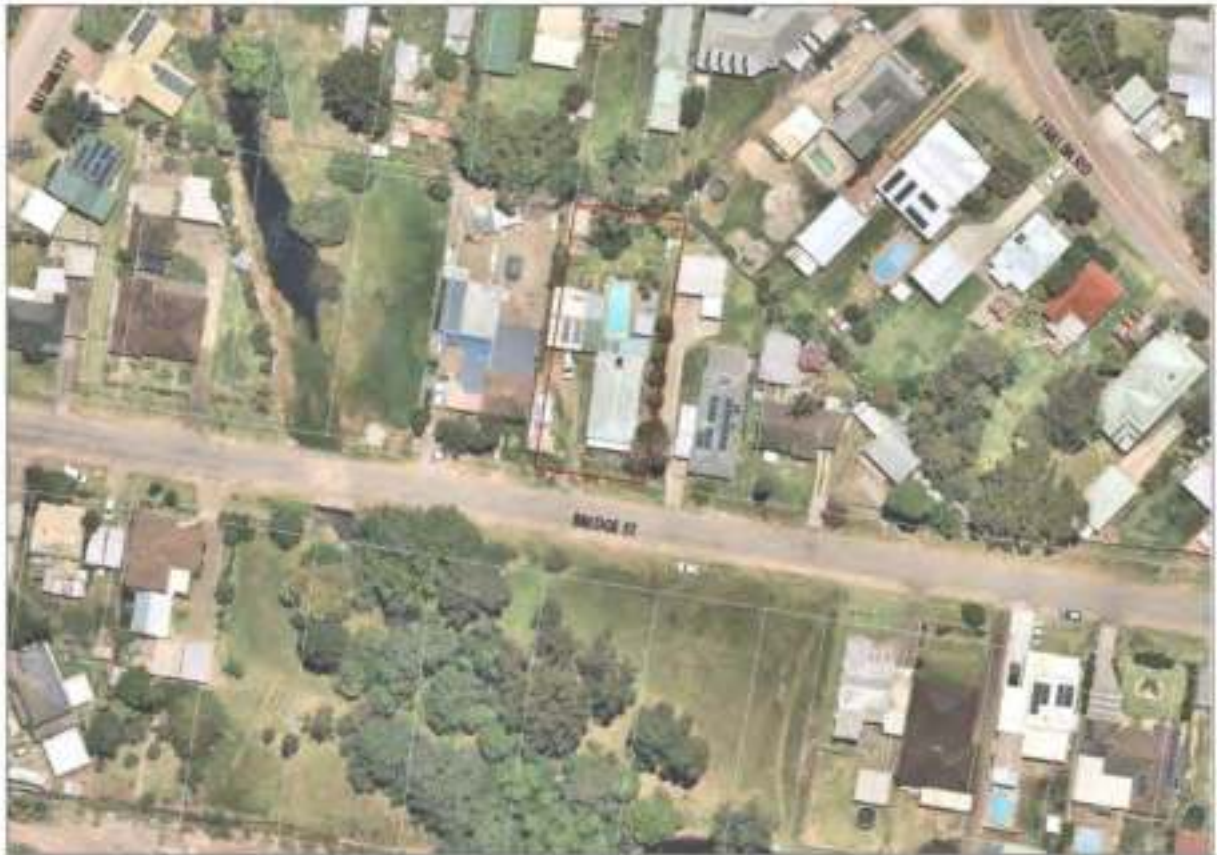
5 BRIDGE STREET, WEST WALLSEND 2286

Conservation Area Contribution Level	Est. Construction Date	Previous studies and/or community input
Contributory 2	Early to late 20 th century (broad range)	No prior heritage assessments or research undertaken.
Assessment Text		Observed Modifications
<p>The scale (single-storey) and general style of the dwelling is consistent with that of the streetscape and wider HCA. Dwelling contributes positively to the streetscape and wider HCA, particularly in comparison to Non-Contributory buildings.</p> <p>The dwelling features appropriately proportioned and positioned fenestrations, an appropriate roof form (gabled or hipped) and other features consistent with the architectural character of the area (e.g. front verandah with timber or brick posts, timber detailing, corrugated metal roofing, etc). The contributory value of the dwelling is limited however by either:</p> <ul style="list-style-type: none"> • External modifications that have in some way obscured the style, scale or design intent of the building and have resulted in less physical integrity than Contributory 1 buildings. • Being a later dwelling constructed in an appropriate referential style, but comprising little to no fabric of intrinsic heritage significance. 		<p>The veranda has been partially built in to create an additional living area. This is a common modification for the area, however it does detract from the heritage streetscape. The timber balustrade is a contemporary addition.</p> <p>All visible windows are contemporary in style.</p> <p>An extension has been built onto the back northern portion of the dwelling. This is not visible from the street and does not detract from the heritage streetscape.</p>

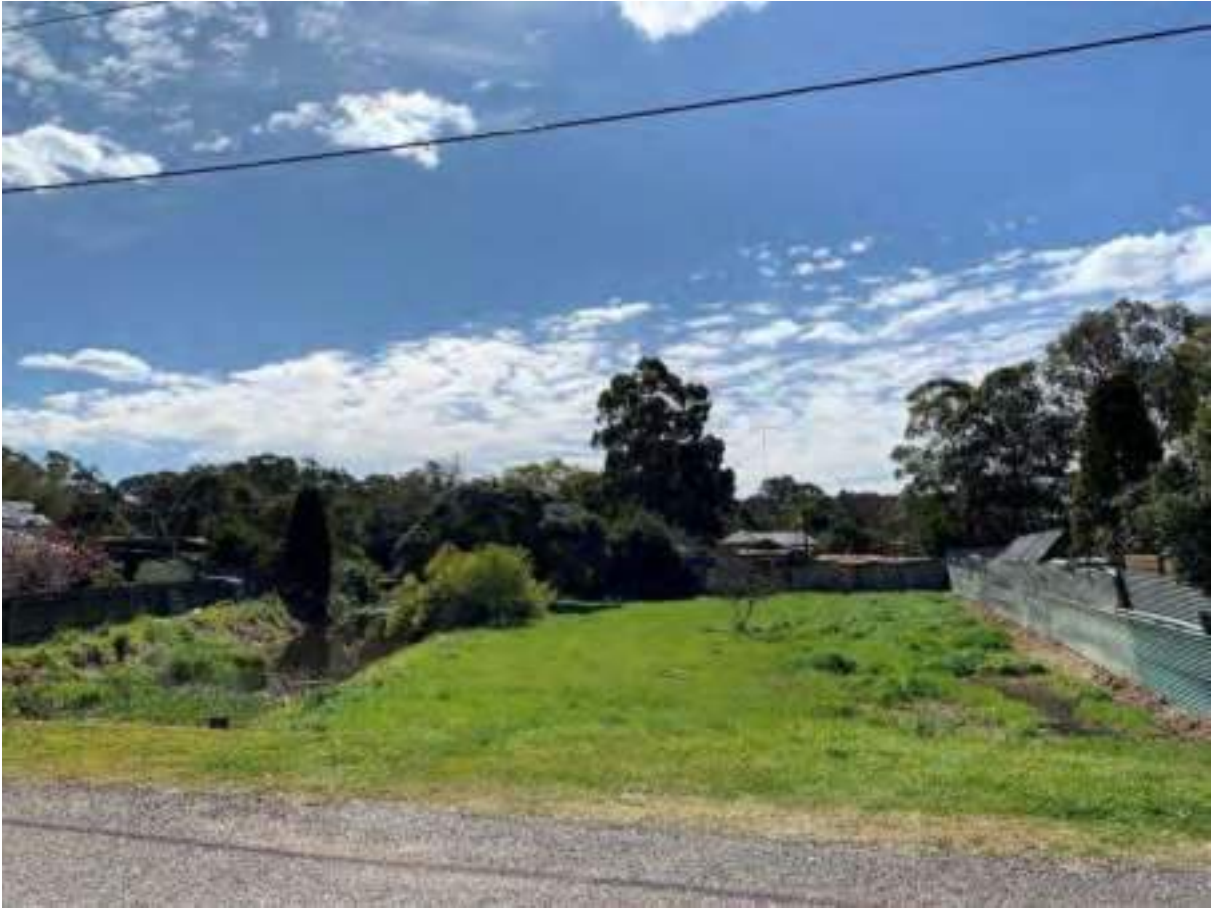
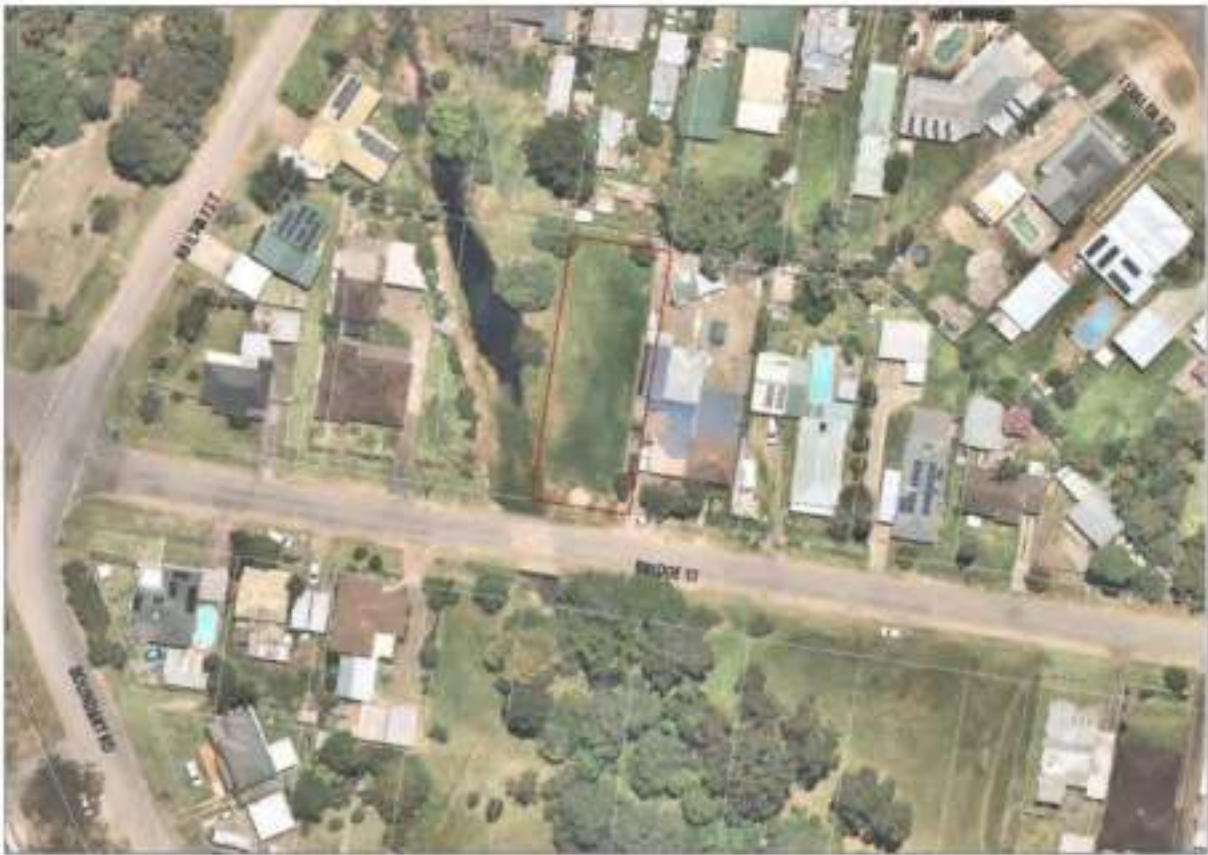
9 BRIDGE STREET, WEST WALLSEND 2286		
Conservation Area Contribution Level	Est. Construction Date	Previous studies and/or community input
Contributory 2	N/A	No prior heritage assessments or research undertaken.
Assessment Text		Observed Modifications
Vacant lot.		A vacant lot. No modifications observed.

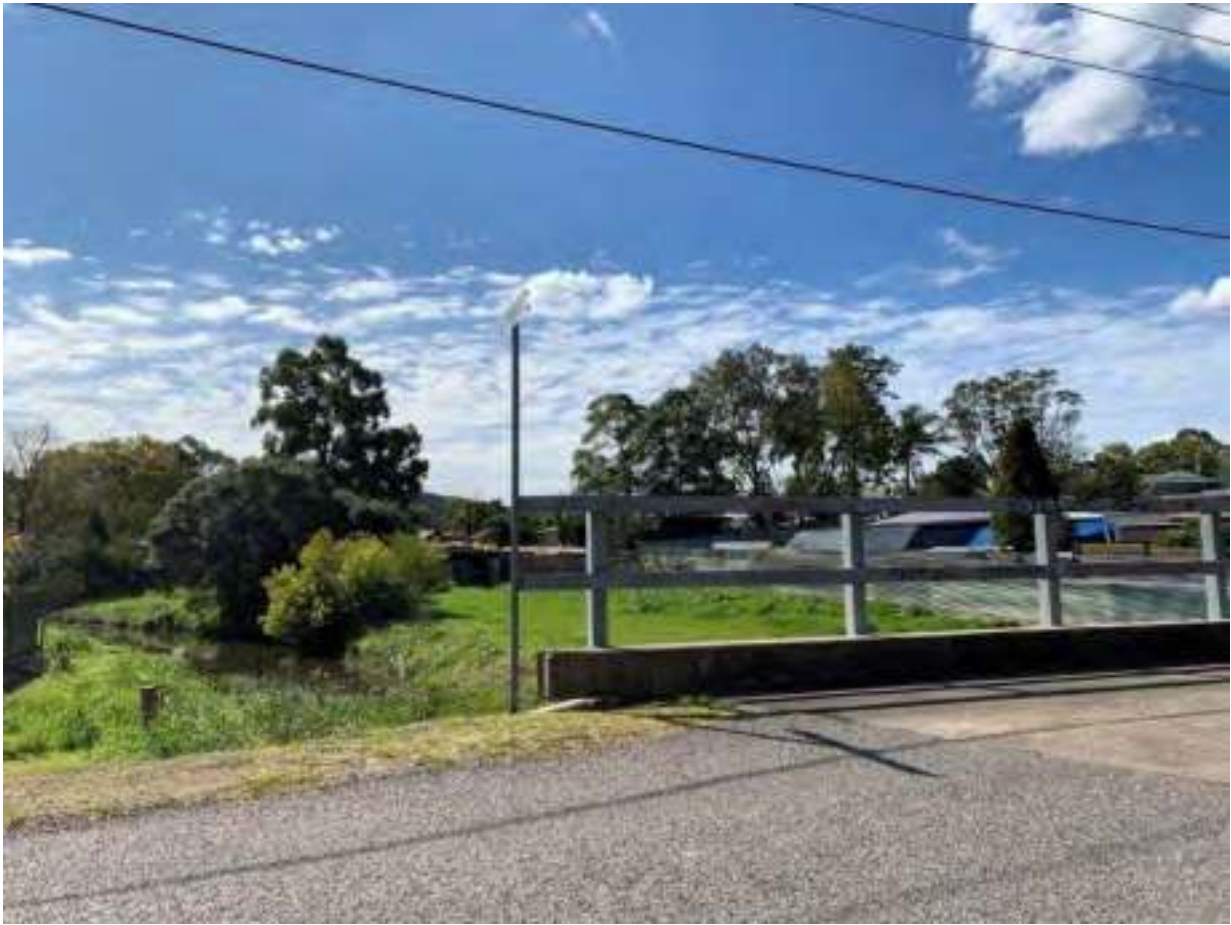
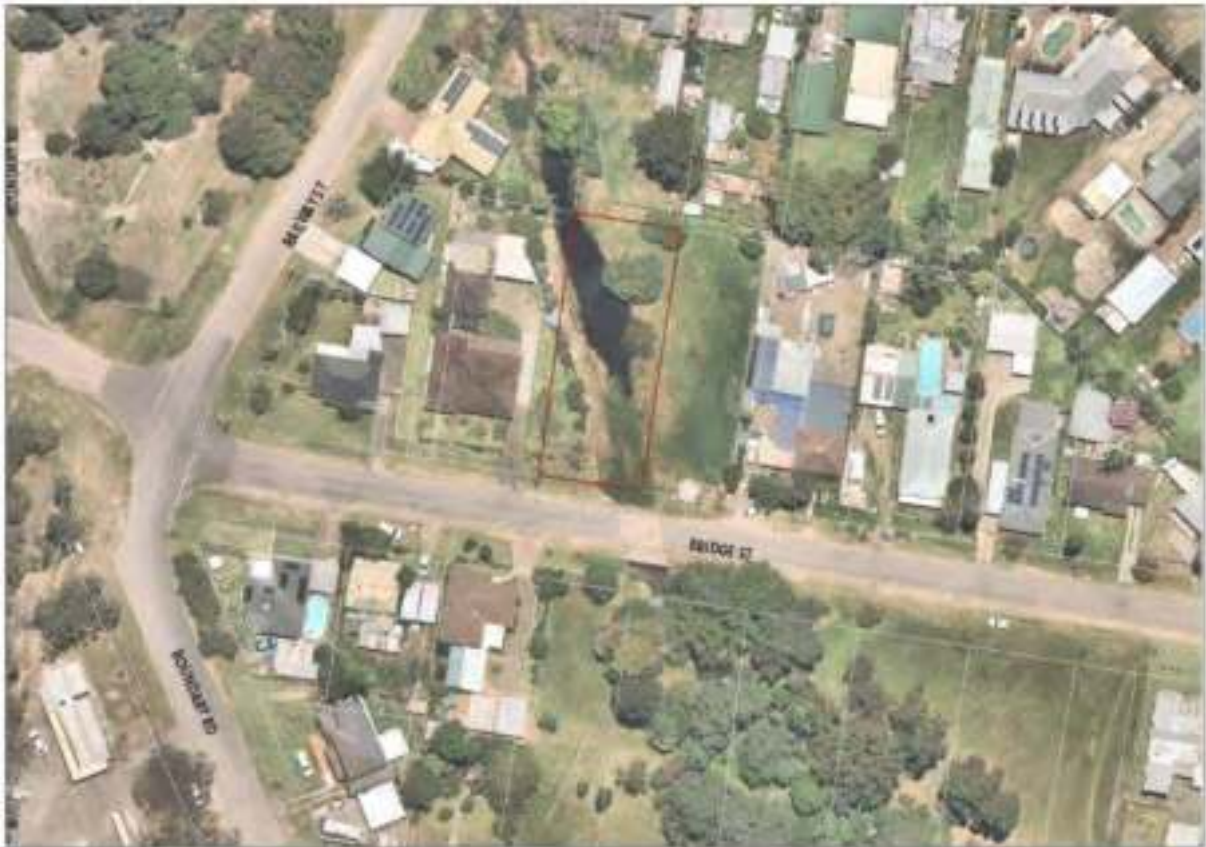
11 BRIDGE STREET, WEST WALLSEND 2286		
Conservation Area Contribution Level	Est. Construction Date	Previous studies and/or community input
Contributory 2	N/A	No prior heritage assessments or research undertaken.
Assessment Text		Observed Modifications
Vacant lot.		A vacant lot. No modifications observed.

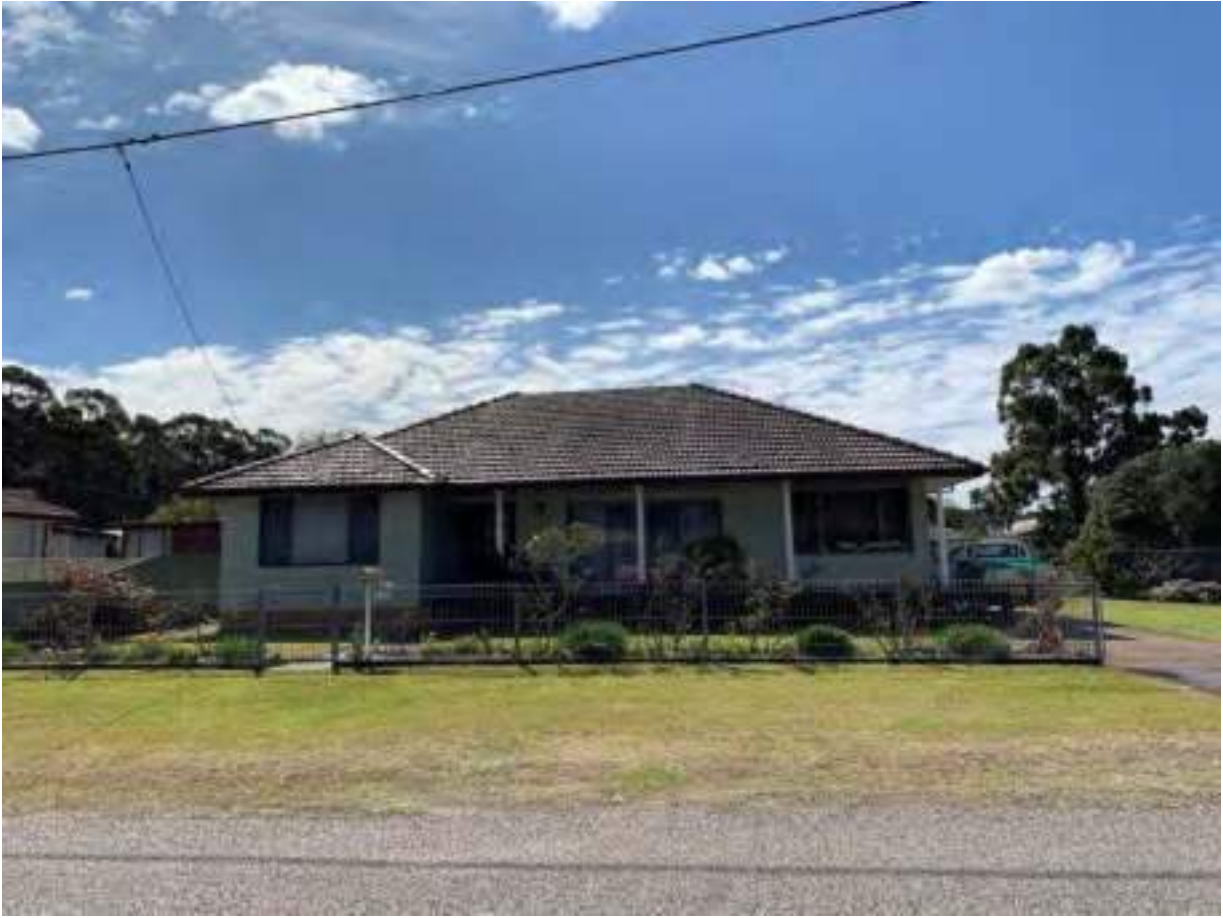
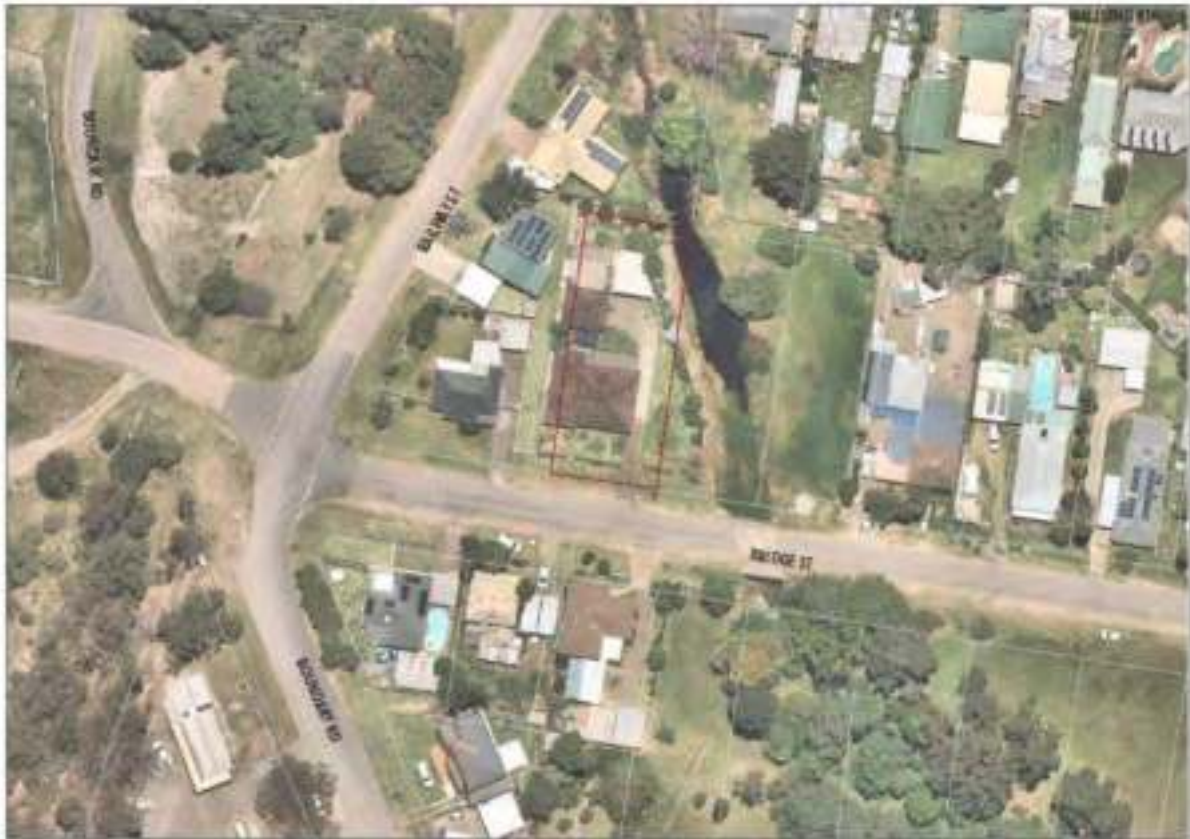
13 BRIDGE STREET, WEST WALLSEND 2286

Conservation Area Contribution Level	Est. Construction Date	Previous studies and/or community input
Contributory 2	Early to late 20 th century (broad range)	No prior heritage assessments or research undertaken.
Assessment Text		Observed Modifications
<p>The scale (single-storey) and general style of the dwelling is consistent with that of the streetscape and wider HCA. Dwelling contributes positively to the streetscape and wider HCA, particularly in comparison to Non-Contributory buildings.</p> <p>The dwelling features appropriately proportioned and positioned fenestrations, an appropriate roof form (gabled or hipped) and other features consistent with the architectural character of the area (e.g. front verandah with timber or brick posts, timber detailing, corrugated metal roofing, etc). The contributory value of the dwelling is limited however by either:</p> <ul style="list-style-type: none"> • External modifications that have in some way obscured the style, scale or design intent of the building and have resulted in less physical integrity than Contributory 1 buildings. • Being a later dwelling constructed in an appropriate referential style, but comprising little to no fabric of intrinsic heritage significance. 		<p>The faux European pillars are likely a contemporary addition.</p>

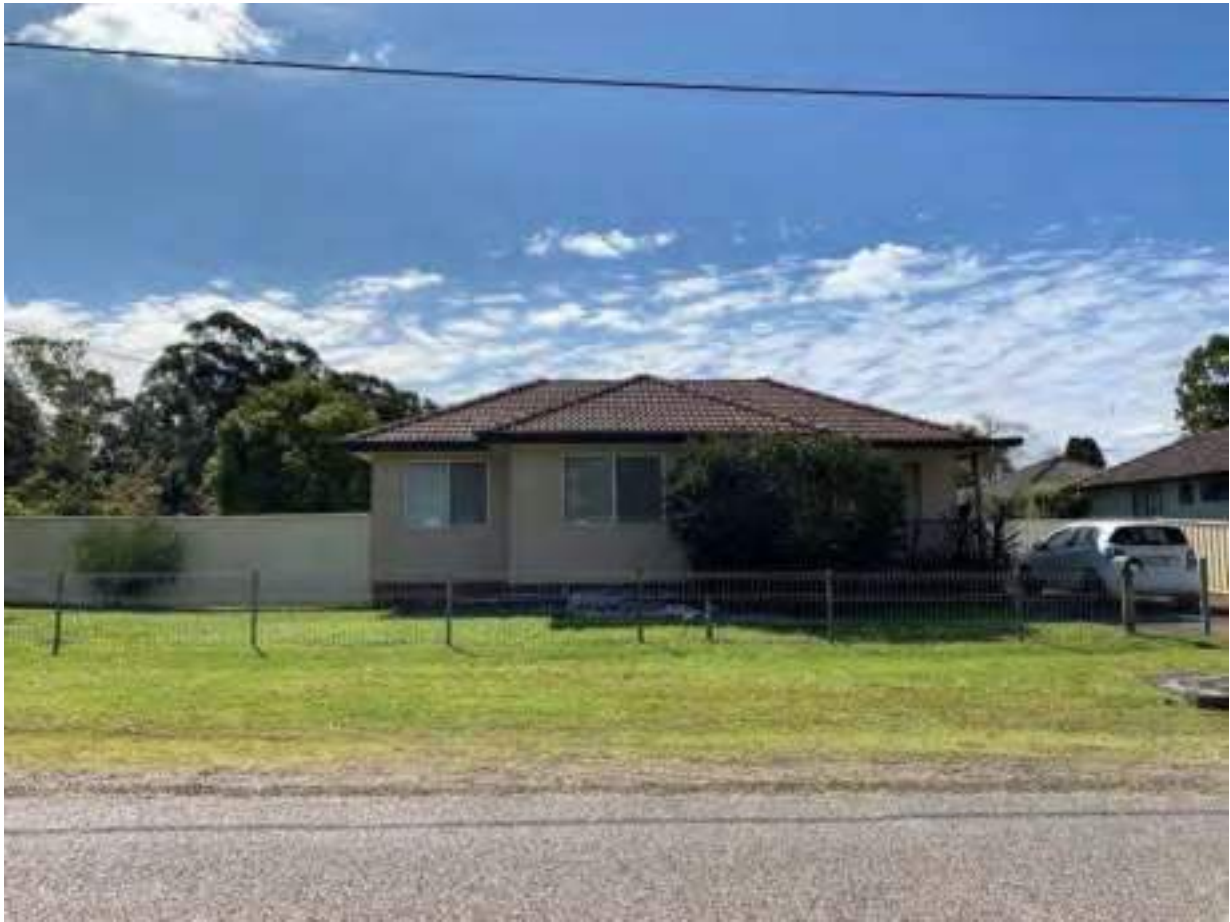
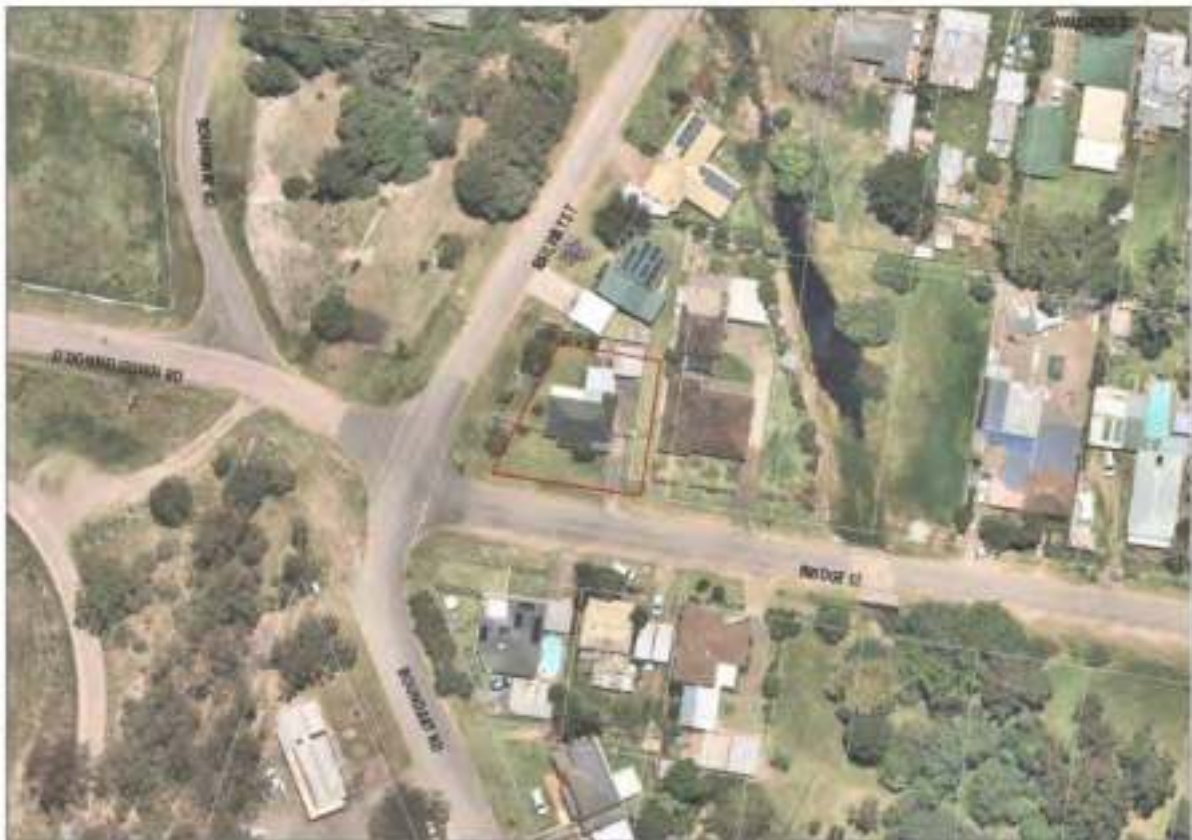
15 BRIDGE STREET, WEST WALLSEND 2286

Conservation Area Contribution Level	Est. Construction Date	Previous studies and/or community input
Contributory 2	Early to late 20 th century (broad range)	No prior heritage assessments or research undertaken.
Assessment Text		Observed Modifications
<p>The scale (single-storey) and general style of the dwelling is consistent with that of the streetscape and wider HCA. Dwelling contributes positively to the streetscape and wider HCA, particularly in comparison to Non-Contributory buildings.</p> <p>The dwelling features appropriately proportioned and positioned fenestrations, an appropriate roof form (gabled or hipped) and other features consistent with the architectural character of the area (e.g. front verandah with timber or brick posts, timber detailing, corrugated metal roofing, etc). The contributory value of the dwelling is limited however by either:</p> <ul style="list-style-type: none"> • External modifications that have in some way obscured the style, scale or design intent of the building and have resulted in less physical integrity than Contributory 1 buildings. • Being a later dwelling constructed in an appropriate referential style, but comprising little to no fabric of intrinsic heritage significance. 		All visible windows are contemporary in style.

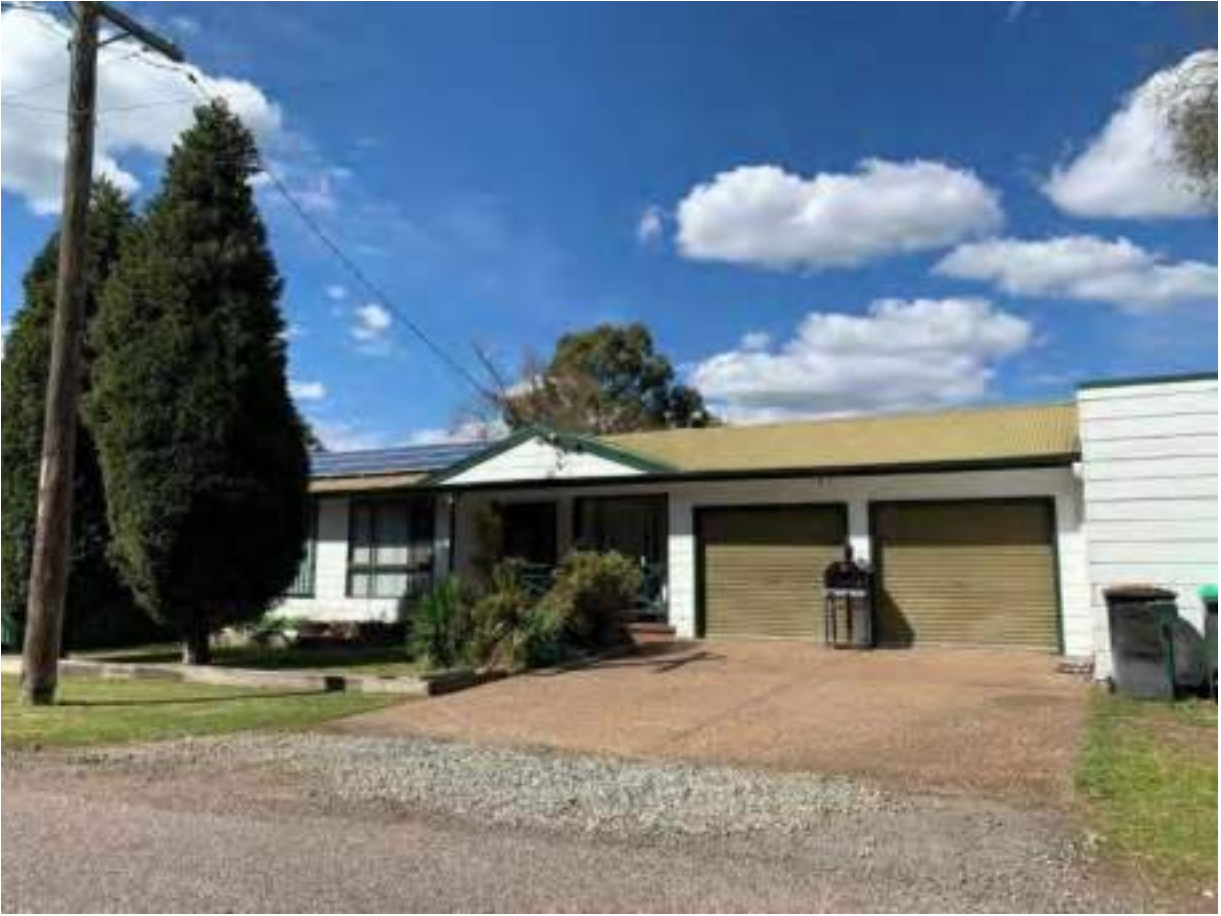
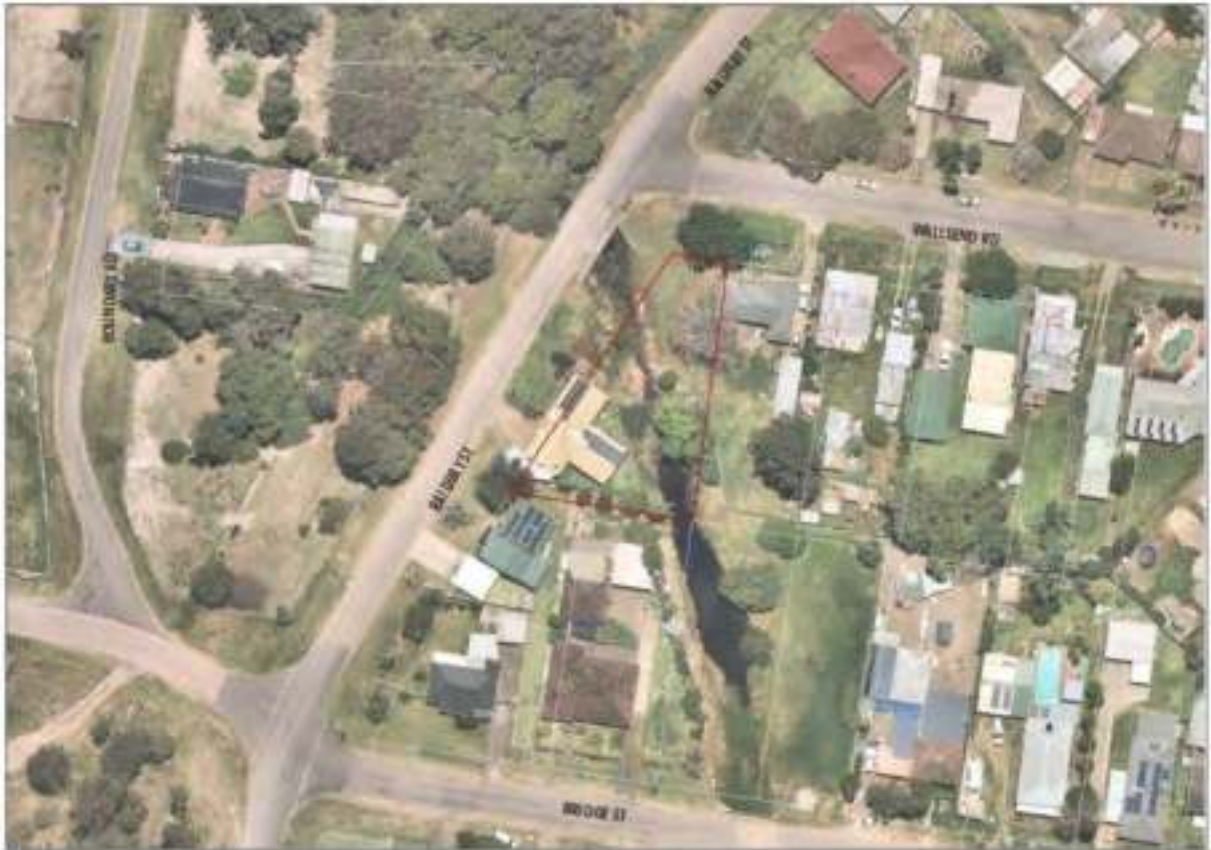
52 WALLSEND ROAD, WEST WALLSEND 2286

Conservation Area Contribution Level	Est. Construction Date	Previous studies and/or community input
Contributory 2	Early to late 20 th century (broad range)	No prior heritage assessments or research undertaken.
Assessment Text		Observed Modifications
<p>The scale (single-storey) and general style of the dwelling is consistent with that of the streetscape and wider HCA. Dwelling contributes positively to the streetscape and wider HCA, particularly in comparison to Non-Contributory buildings.</p> <p>The dwelling features appropriately proportioned and positioned fenestrations, an appropriate roof form (gabled or hipped) and other features consistent with the architectural character of the area (e.g. front verandah with timber or brick posts, timber detailing, corrugated metal roofing, etc). The contributory value of the dwelling is limited however by either:</p> <ul style="list-style-type: none"> • External modifications that have in some way obscured the style, scale or design intent of the building and have resulted in less physical integrity than Contributory 1 buildings. • Being a later dwelling constructed in an appropriate referential style, but comprising little to no fabric of intrinsic heritage significance. 		Solar panels are visible along the north western side of the roof.

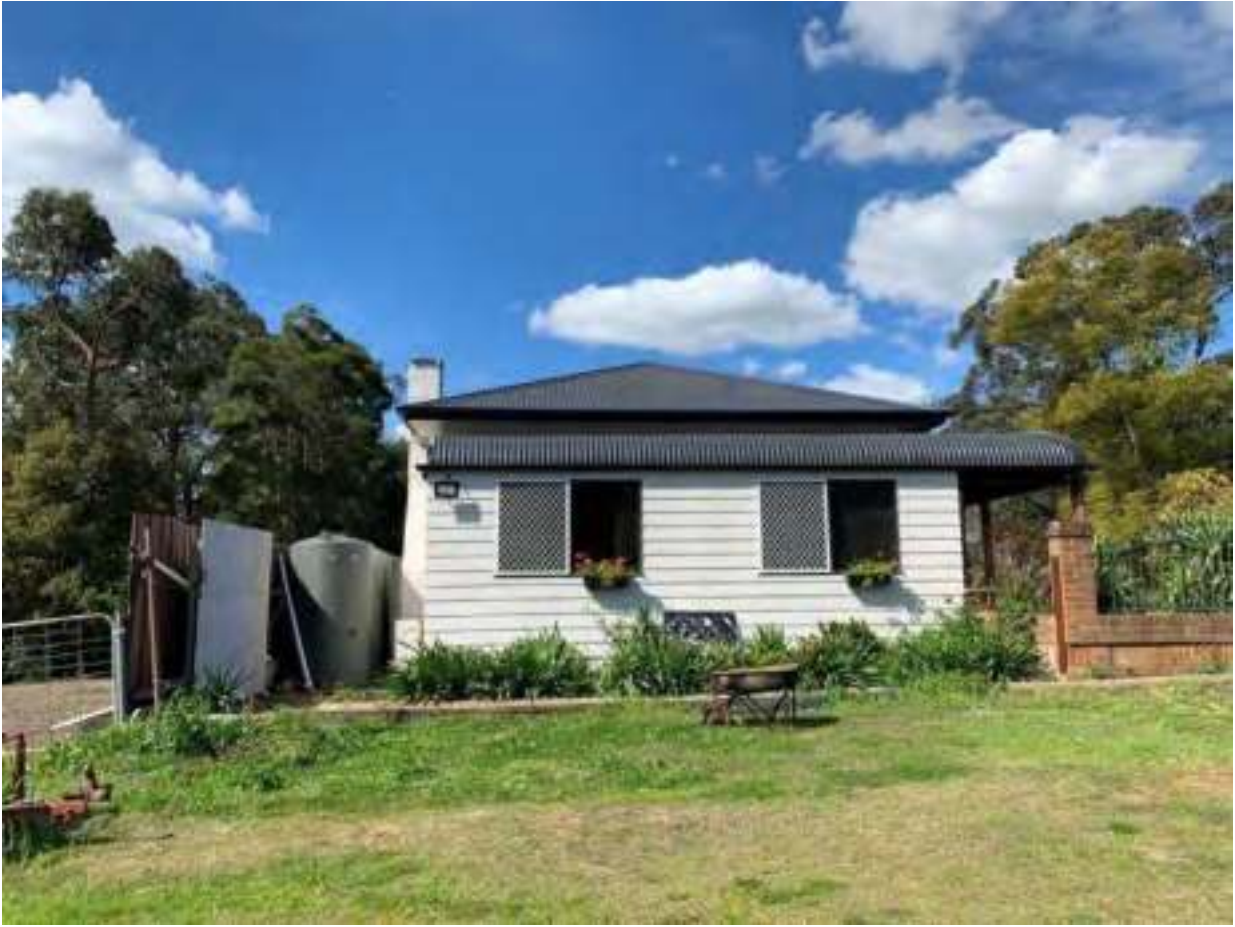
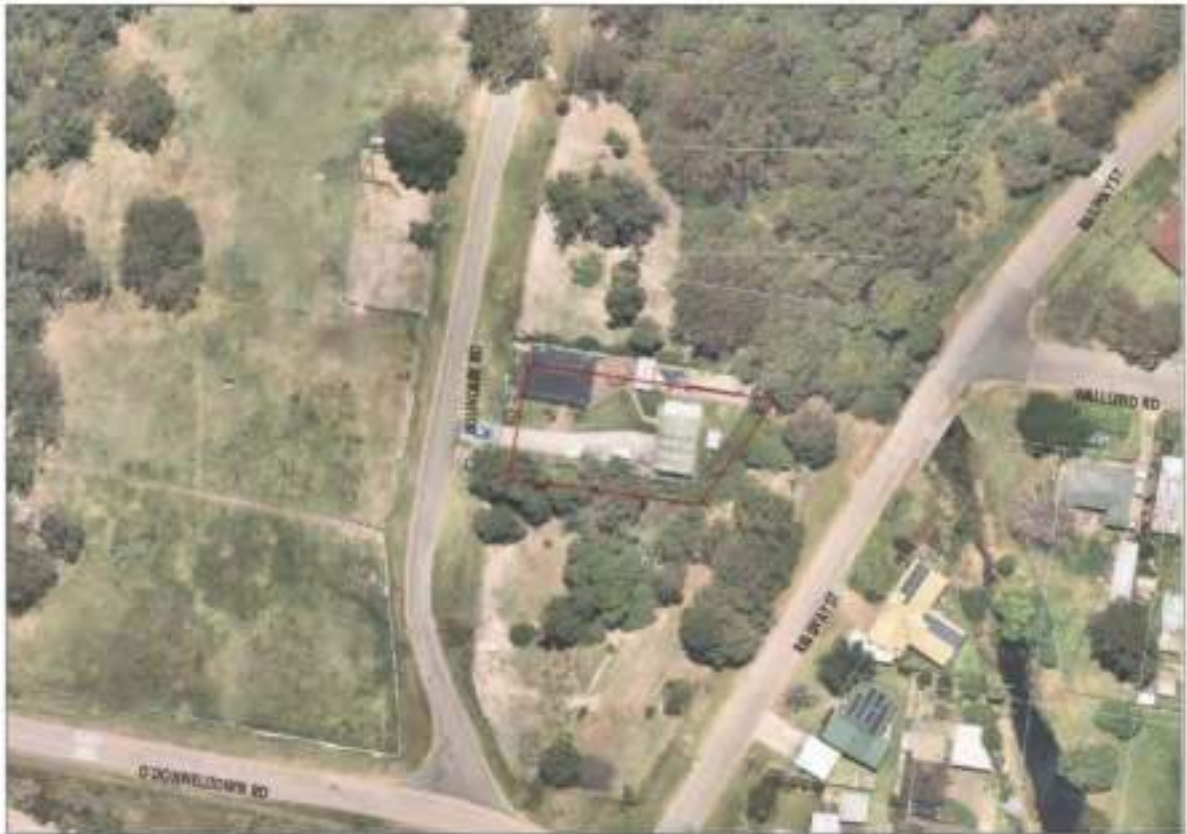
1 BOUNDARY ROAD, WEST WALLSEND 2286

Conservation Area Contribution Level	Est. Construction Date	Previous studies and/or community input
Contributory 2	Early to late 20 th century (broad range)	No prior heritage assessments or research undertaken.
Assessment Text		Observed Modifications
<p>The scale (single-storey) and general style of the dwelling is consistent with that of the streetscape and wider HCA. Dwelling contributes positively to the streetscape and wider HCA, particularly in comparison to Non-Contributory buildings.</p> <p>The dwelling features appropriately proportioned and positioned fenestrations, an appropriate roof form (gabled or hipped) and other features consistent with the architectural character of the area (e.g. front verandah with timber or brick posts, timber detailing, corrugated metal roofing, etc). The contributory value of the dwelling is limited however by either:</p> <ul style="list-style-type: none"> • External modifications that have in some way obscured the style, scale or design intent of the building and have resulted in less physical integrity than Contributory 1 buildings. • Being a later dwelling constructed in an appropriate referential style, but comprising little to no fabric of intrinsic heritage significance. 		<p>All visible windows are contemporary in style.</p> <p>The veranda has been built in to create an additional living area. This has been undertaken in a sympathetic manner, and does not detract from the heritage streetscape.</p>

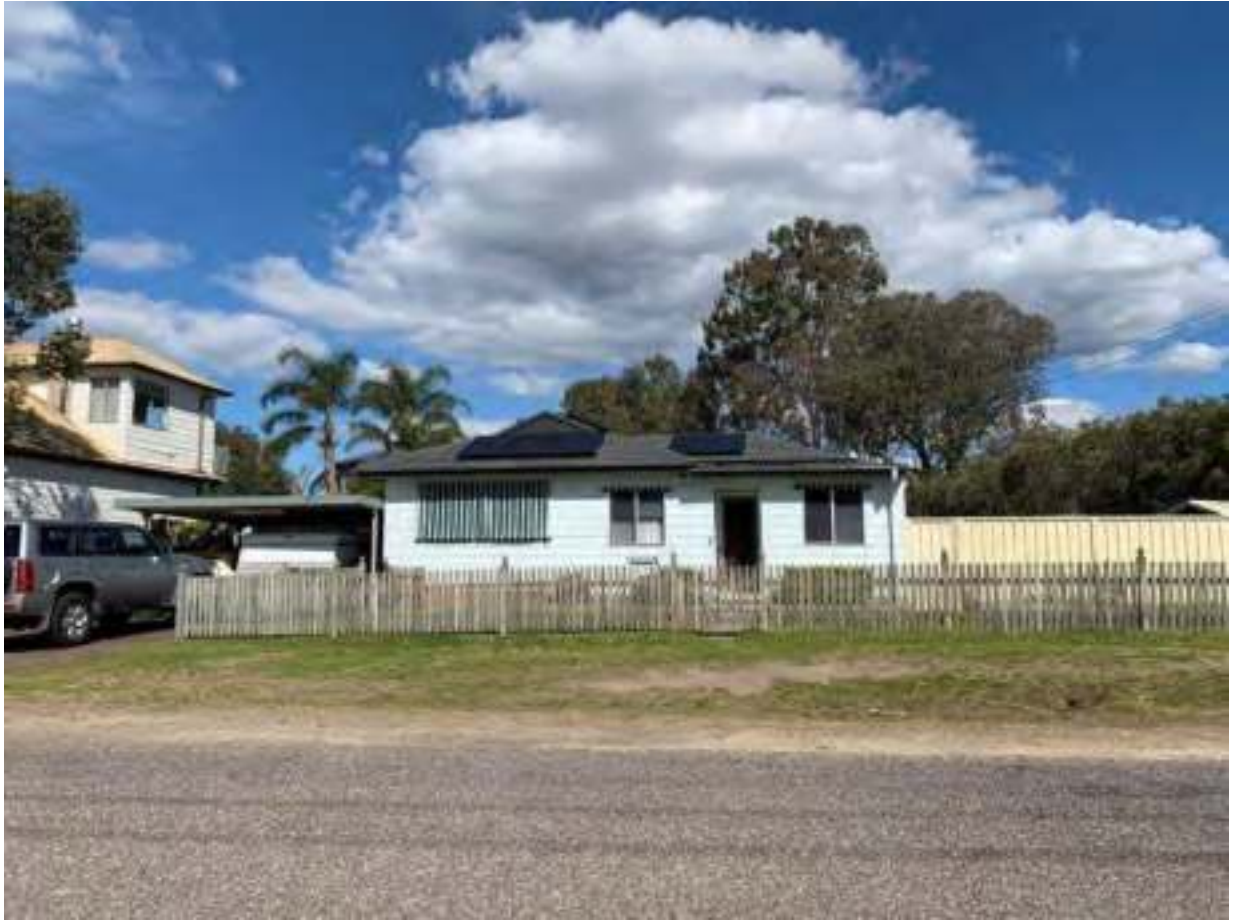
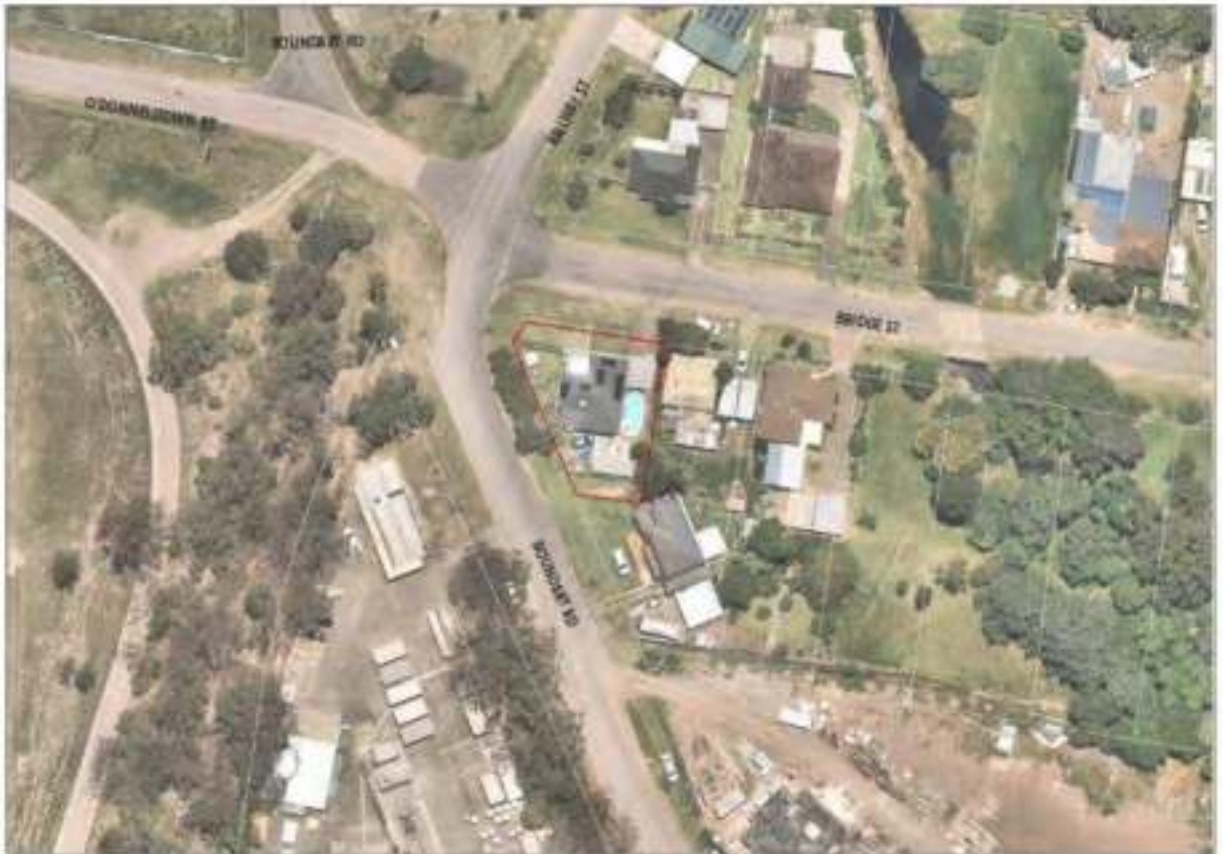
38 BRIDGE STREET, WEST WALLSEND 2286

Conservation Area Contribution Level	Est. Construction Date	Previous studies and/or community input
Contributory 2	Early to late 20 th century (broad range)	No prior heritage assessments or research undertaken.
Assessment Text		Observed Modifications
<p>The scale (single-storey) and general style of the dwelling is consistent with that of the streetscape and wider HCA. Dwelling contributes positively to the streetscape and wider HCA, particularly in comparison to Non-Contributory buildings.</p> <p>The dwelling features appropriately proportioned and positioned fenestrations, an appropriate roof form (gabled or hipped) and other features consistent with the architectural character of the area (e.g. front verandah with timber or brick posts, timber detailing, corrugated metal roofing, etc). The contributory value of the dwelling is limited however by either:</p> <ul style="list-style-type: none"> • External modifications that have in some way obscured the style, scale or design intent of the building and have resulted in less physical integrity than Contributory 1 buildings. • Being a later dwelling constructed in an appropriate referential style, but comprising little to no fabric of intrinsic heritage significance. 		<p>Solar panels are highly visible along the northern side of the roof.</p> <p>All visible windows are contemporary in style, with canvas awnings being installed.</p>

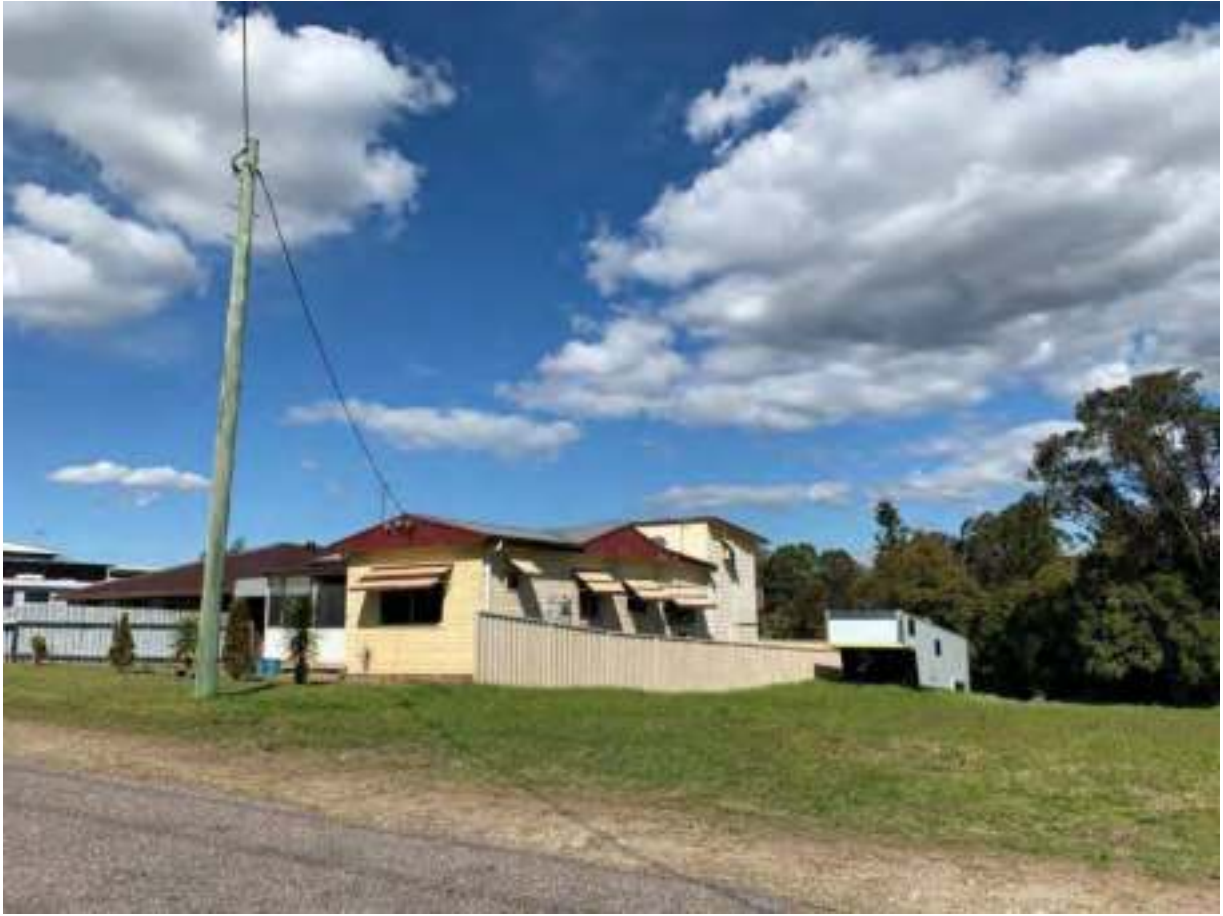
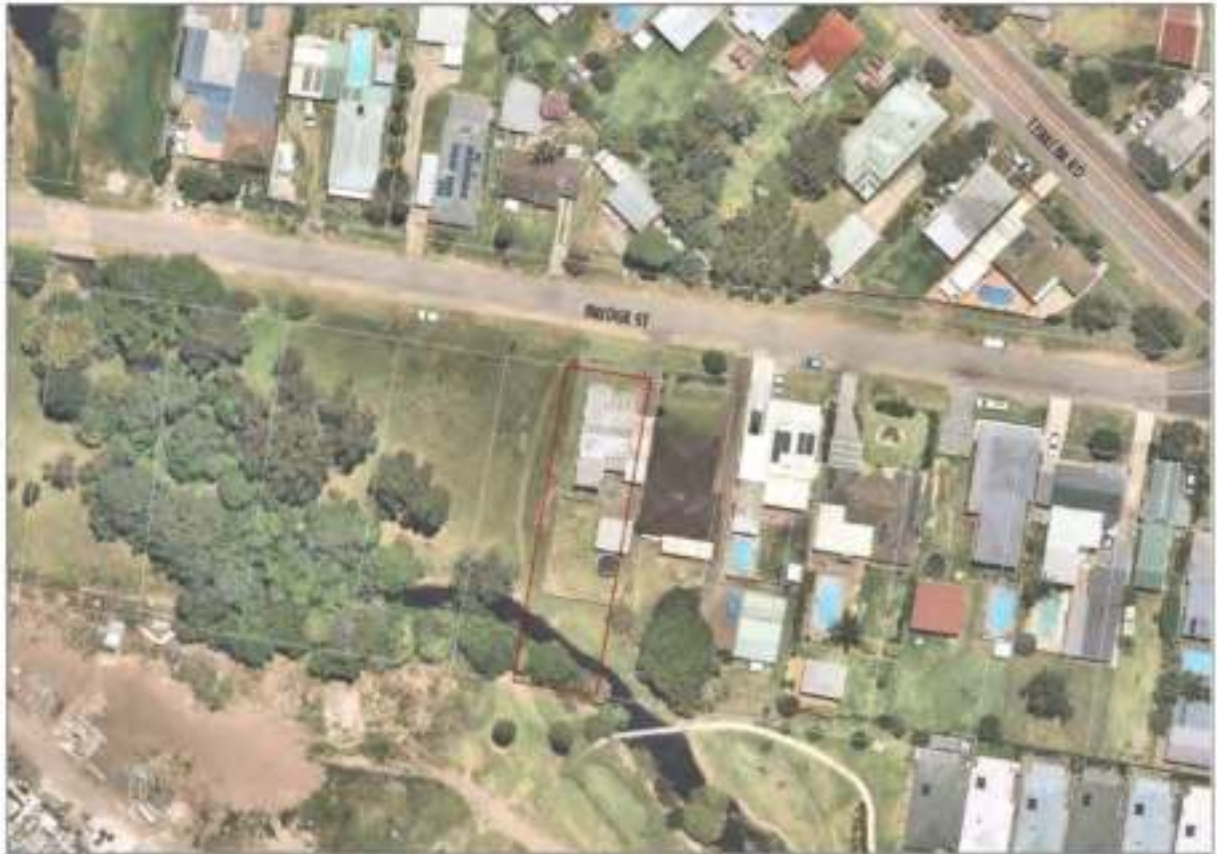
20 BRIDGE STREET, WEST WALLSEND 2286

Conservation Area Contribution Level	Est. Construction Date	Previous studies and/or community input
Contributory 2	Early to late 20 th century (broad range)	No prior heritage assessments or research undertaken.
Assessment Text		Observed Modifications
<p>The scale (single-storey) and general style of the dwelling is consistent with that of the streetscape and wider HCA. Dwelling contributes positively to the streetscape and wider HCA, particularly in comparison to Non-Contributory buildings.</p> <p>The dwelling features appropriately proportioned and positioned fenestrations, an appropriate roof form (gabled or hipped) and other features consistent with the architectural character of the area (e.g. front verandah with timber or brick posts, timber detailing, corrugated metal roofing, etc). The contributory value of the dwelling is limited however by either:</p> <ul style="list-style-type: none"> • External modifications that have in some way obscured the style, scale or design intent of the building and have resulted in less physical integrity than Contributory 1 buildings. • Being a later dwelling constructed in an appropriate referential style, but comprising little to no fabric of intrinsic heritage significance. 		<p>A second storey extension has been built at the back southern portion of the dwelling. This is visible from the street and is an uncommon feature for the area. This juxtaposes the surrounding properties and is unsympathetic to the heritage streetscape.</p> <p>The veranda has been built in to create an additional living area, with Colourbond panels and mesh screening being installed to enclose the space.</p> <p>A carport has been built onto the eastern side of the dwelling.</p>
