APPENDIX 2

Building Assessment Sheets (Inventory Sheets)

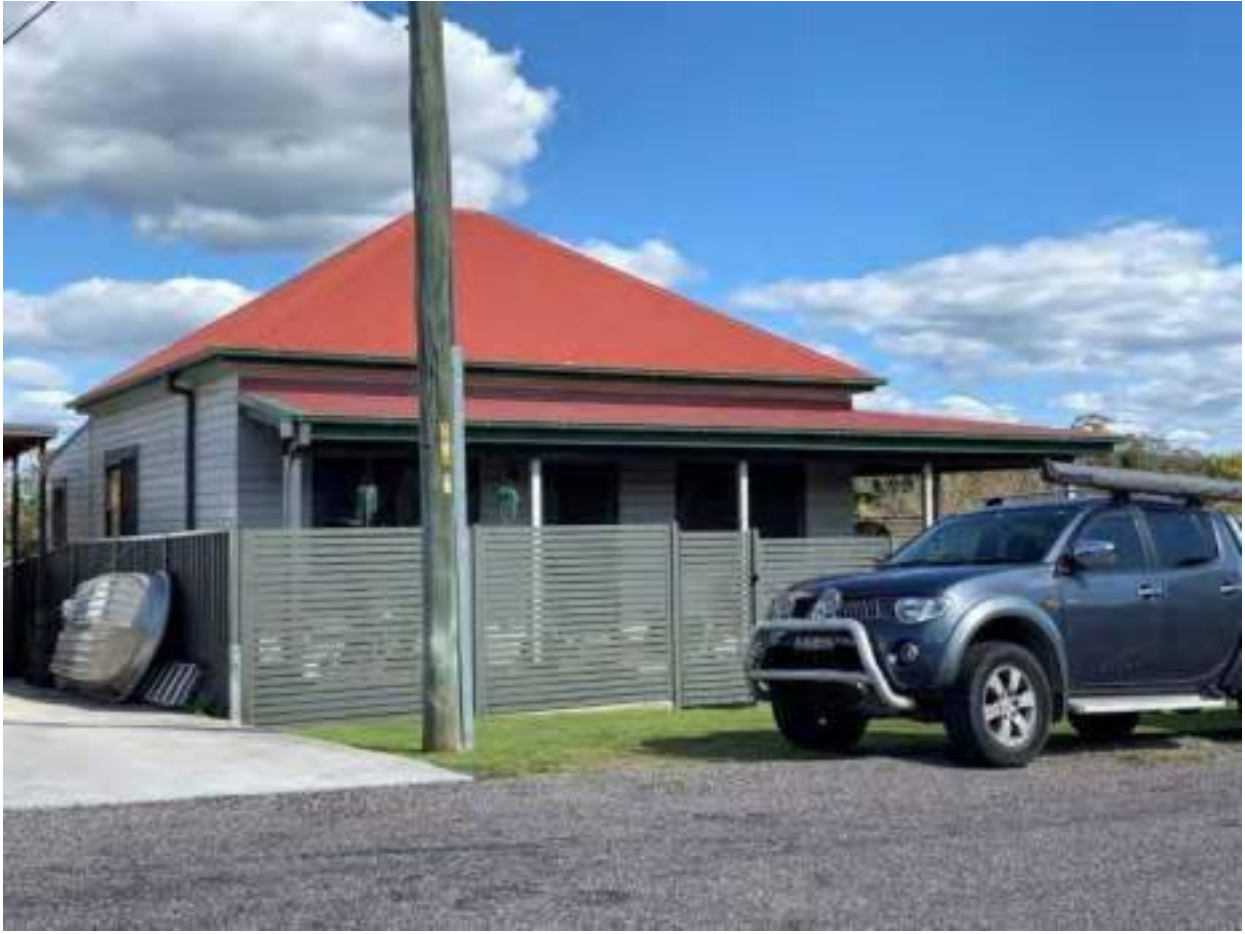
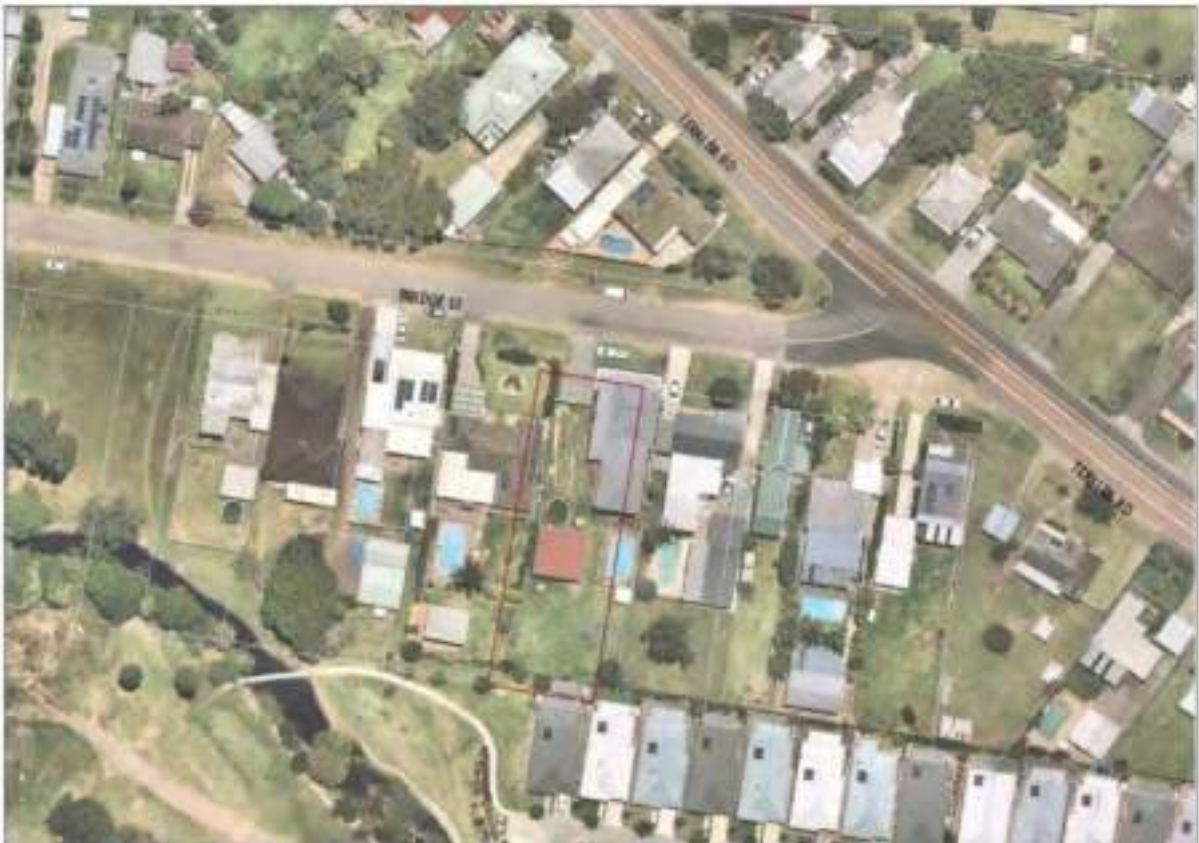
10 BRIDGE STREET, WEST WALLSEND 2286

Conservation Area Contribution Level	Est. Construction Date	Previous studies and/or community input
Contributory 2	Early to late 20 th century (broad range)	No prior heritage assessments or research undertaken.
Assessment Text		Observed Modifications
<p>The scale (single-storey) and general style of the dwelling is consistent with that of the streetscape and wider HCA. Dwelling contributes positively to the streetscape and wider HCA, particularly in comparison to Non-Contributory buildings.</p> <p>The dwelling features appropriately proportioned and positioned fenestrations, an appropriate roof form (gabled or hipped) and other features consistent with the architectural character of the area (e.g. front verandah with timber or brick posts, timber detailing, corrugated metal roofing, etc). The contributory value of the dwelling is limited however by either:</p> <ul style="list-style-type: none"> • External modifications that have in some way obscured the style, scale or design intent of the building and have resulted in less physical integrity than Contributory 1 buildings. • Being a later dwelling constructed in an appropriate referential style, but comprising little to no fabric of intrinsic heritage significance. 		<p>The veranda has been extended to wrap around the western side of the dwelling, with all associated timber posts and hipped veranda roof also being a recent addition.</p> <p>An extension has been built onto the back southern portion of the dwelling. This is not visible from the street and does not detract from the heritage streetscape.</p>

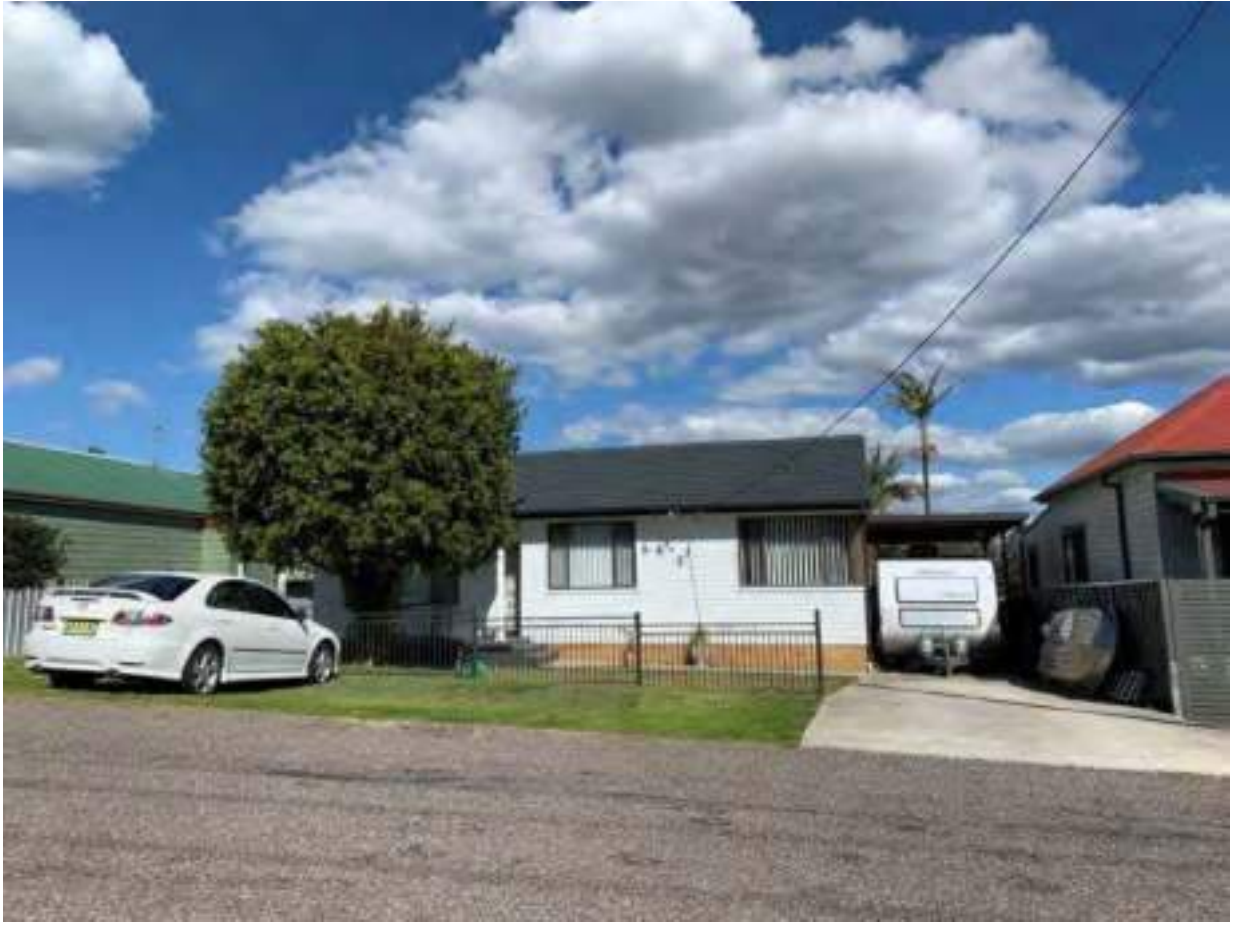
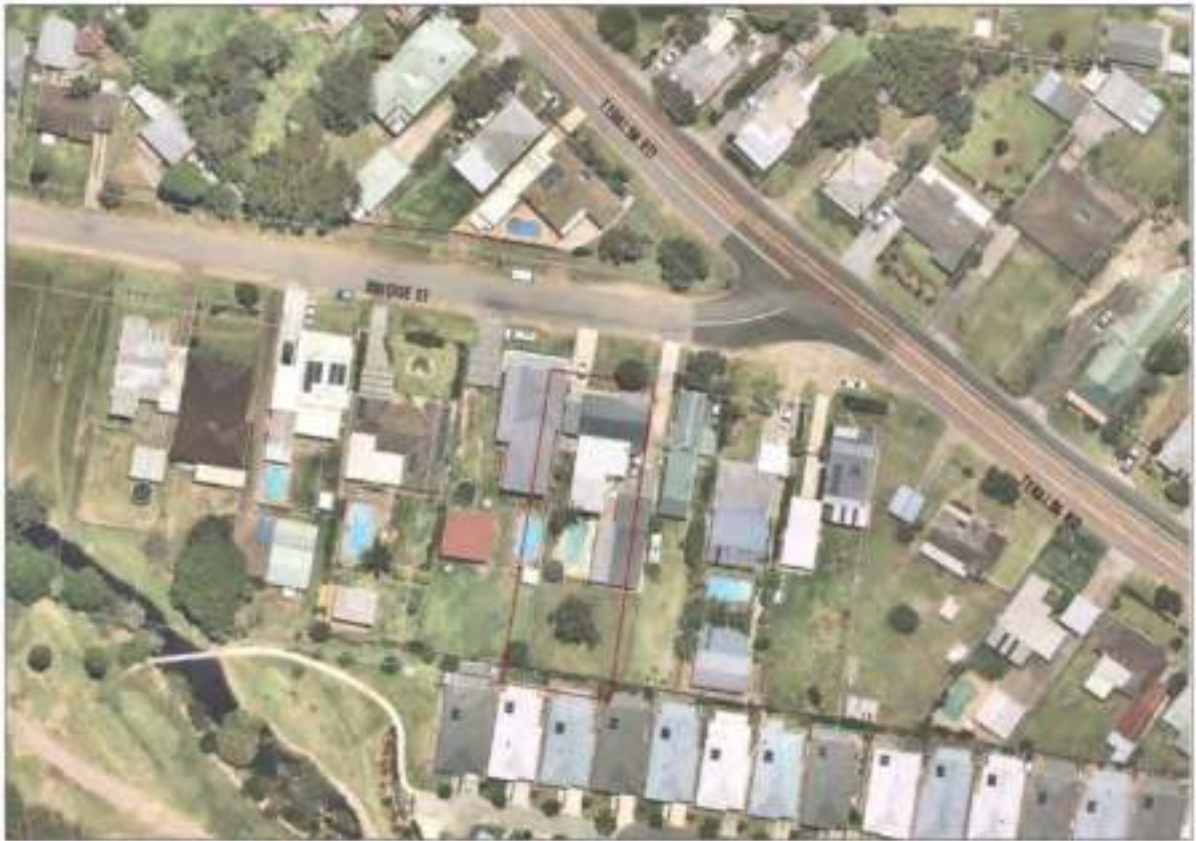
8 BRIDGE STREET, WEST WALLSEND 2286

Conservation Area Contribution Level	Est. Construction Date	Previous studies and/or community input
Contributory 2	Early to late 20 th century (broad range)	No prior heritage assessments or research undertaken.
Assessment Text		Observed Modifications
<p>The scale (single-storey) and general style of the dwelling is consistent with that of the streetscape and wider HCA. Dwelling contributes positively to the streetscape and wider HCA, particularly in comparison to Non-Contributory buildings.</p> <p>The dwelling features appropriately proportioned and positioned fenestrations, an appropriate roof form (gabled or hipped) and other features consistent with the architectural character of the area (e.g. front verandah with timber or brick posts, timber detailing, corrugated metal roofing, etc). The contributory value of the dwelling is limited however by either:</p> <ul style="list-style-type: none"> • External modifications that have in some way obscured the style, scale or design intent of the building and have resulted in less physical integrity than Contributory 1 buildings. • Being a later dwelling constructed in an appropriate referential style, but comprising little to no fabric of intrinsic heritage significance. 		<p>An extension has been built onto the back southern portion of the dwelling. This is not visible from the street and does not detract from the heritage streetscape.</p> <p>A carport has been constructed on the western side of the dwelling.</p>

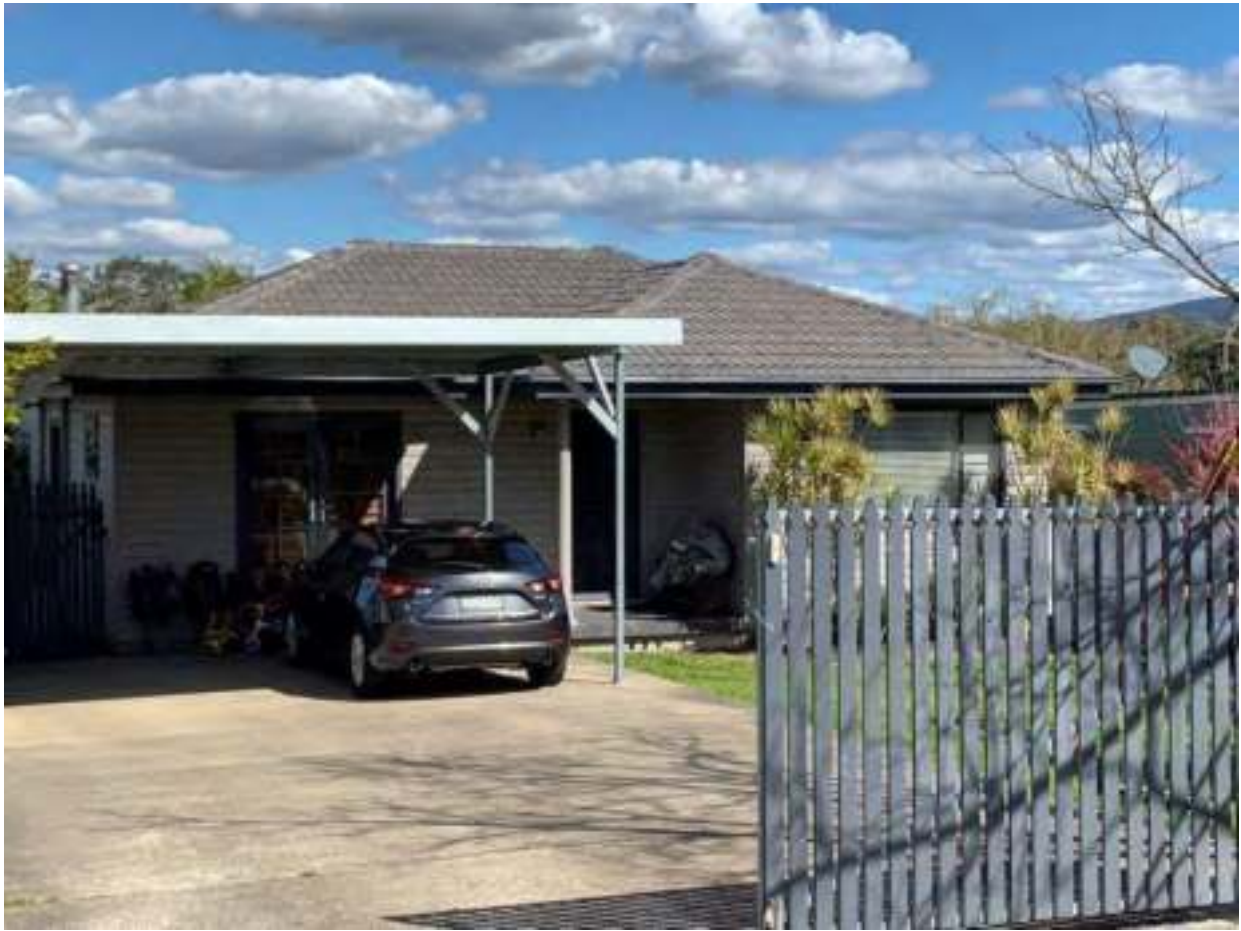
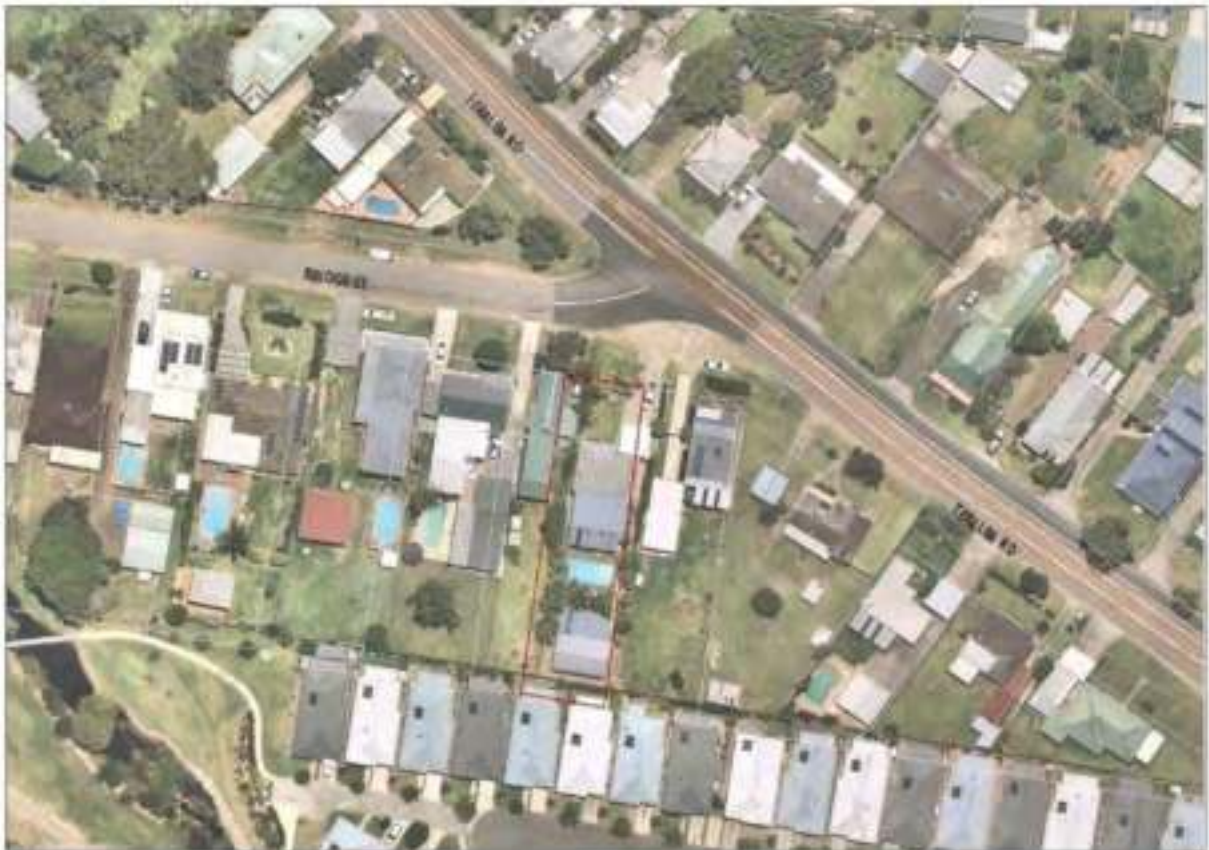
4 BRIDGE STREET, WEST WALLSEND 2286

Conservation Area Contribution Level	Est. Construction Date	Previous studies and/or community input
Contributory 2	Early to late 20 th century (broad range)	No prior heritage assessments or research undertaken.
Assessment Text		Observed Modifications
<p>The scale (single-storey) and general style of the dwelling is consistent with that of the streetscape and wider HCA. Dwelling contributes positively to the streetscape and wider HCA, particularly in comparison to Non-Contributory buildings.</p> <p>The dwelling features appropriately proportioned and positioned fenestrations, an appropriate roof form (gabled or hipped) and other features consistent with the architectural character of the area (e.g. front verandah with timber or brick posts, timber detailing, corrugated metal roofing, etc). The contributory value of the dwelling is limited however by either:</p> <ul style="list-style-type: none"> • External modifications that have in some way obscured the style, scale or design intent of the building and have resulted in less physical integrity than Contributory 1 buildings. • Being a later dwelling constructed in an appropriate referential style, but comprising little to no fabric of intrinsic heritage significance. 		<p>A car port has been constructed at the front northern side of the dwelling, partially obscuring the dwelling.</p>

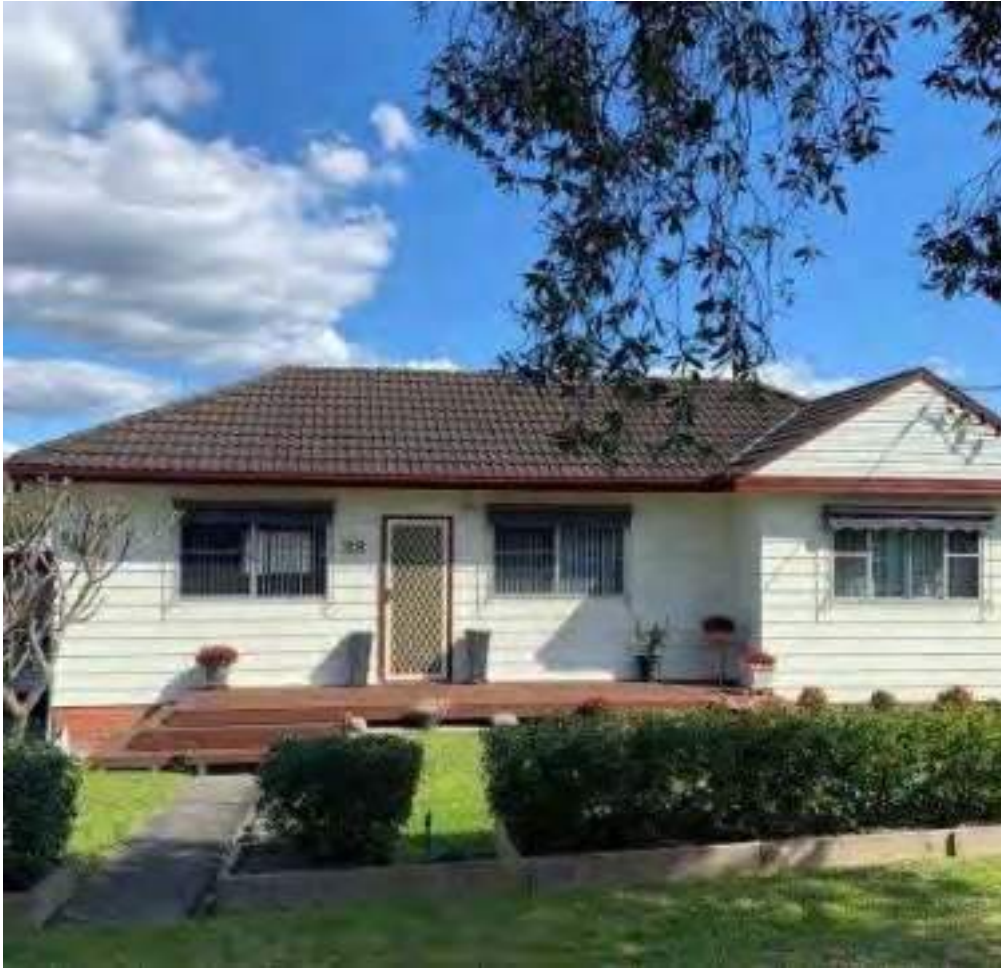
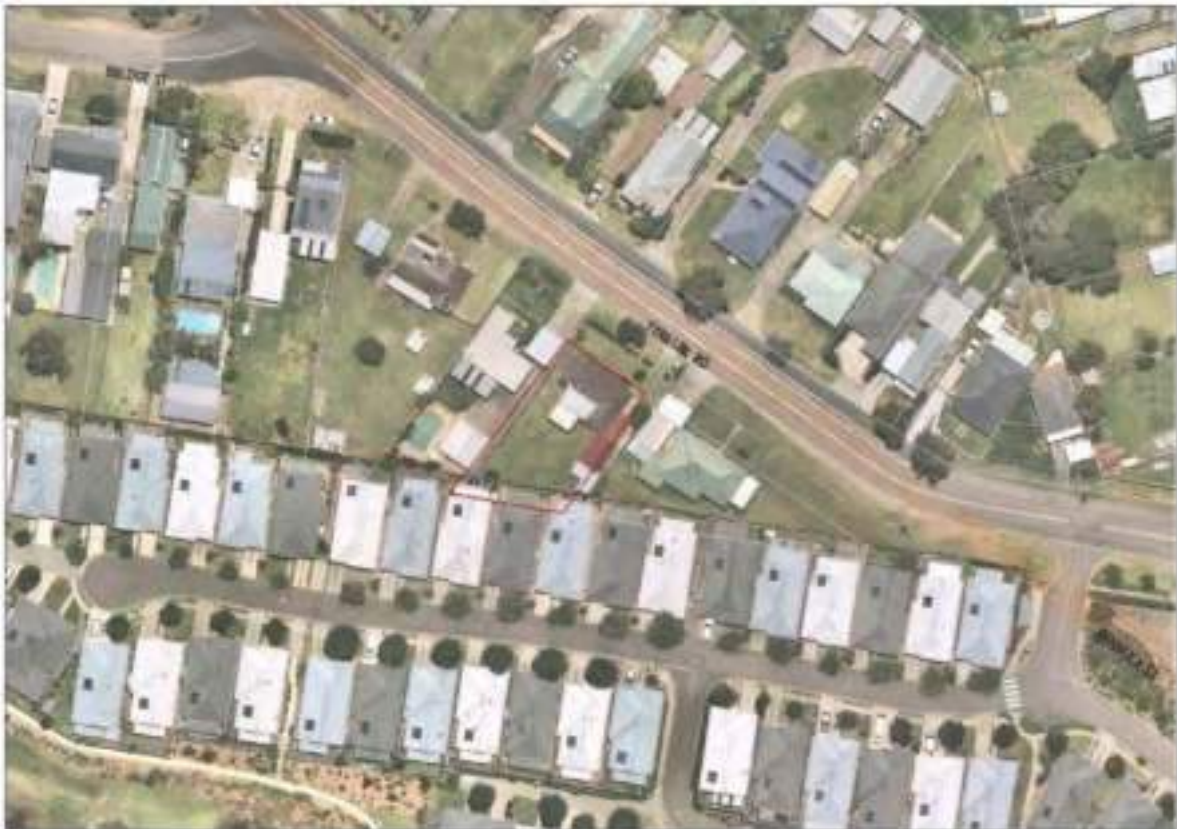
22 TERALBA ROAD, WEST WALLSEND 2286

Conservation Area Contribution Level	Est. Construction Date	Previous studies and/or community input
Contributory 2	Early to late 20 th century (broad range)	No prior heritage assessments or research undertaken.
Assessment Text		Observed Modifications
<p>The scale (single-storey) and general style of the dwelling is consistent with that of the streetscape and wider HCA. Dwelling contributes positively to the streetscape and wider HCA, particularly in comparison to Non-Contributory buildings.</p> <p>The dwelling features appropriately proportioned and positioned fenestrations, an appropriate roof form (gabled or hipped) and other features consistent with the architectural character of the area (e.g. front verandah with timber or brick posts, timber detailing, corrugated metal roofing, etc). The contributory value of the dwelling is limited however by either:</p> <ul style="list-style-type: none"> • External modifications that have in some way obscured the style, scale or design intent of the building and have resulted in less physical integrity than Contributory 1 buildings. • Being a later dwelling constructed in an appropriate referential style, but comprising little to no fabric of intrinsic heritage significance. 		No modifications observed.

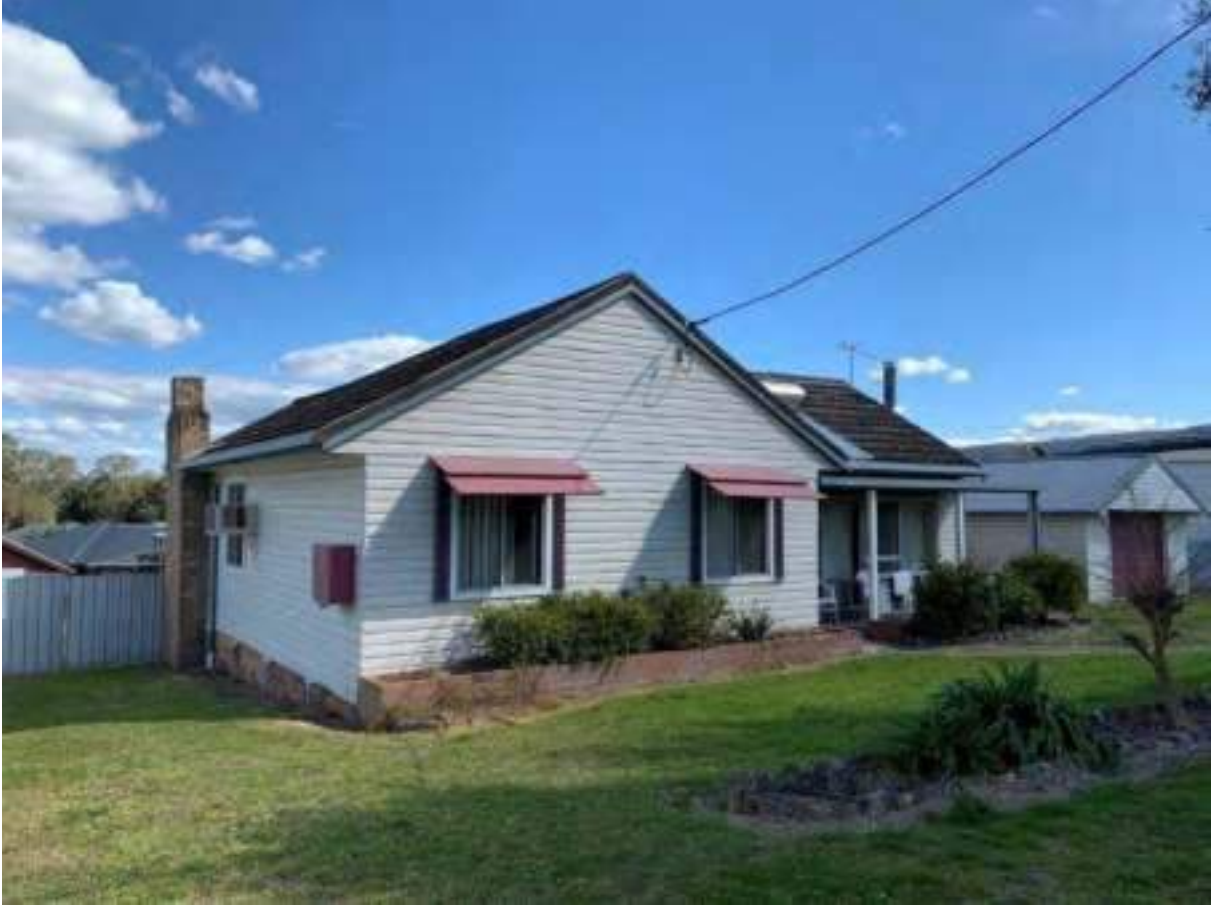
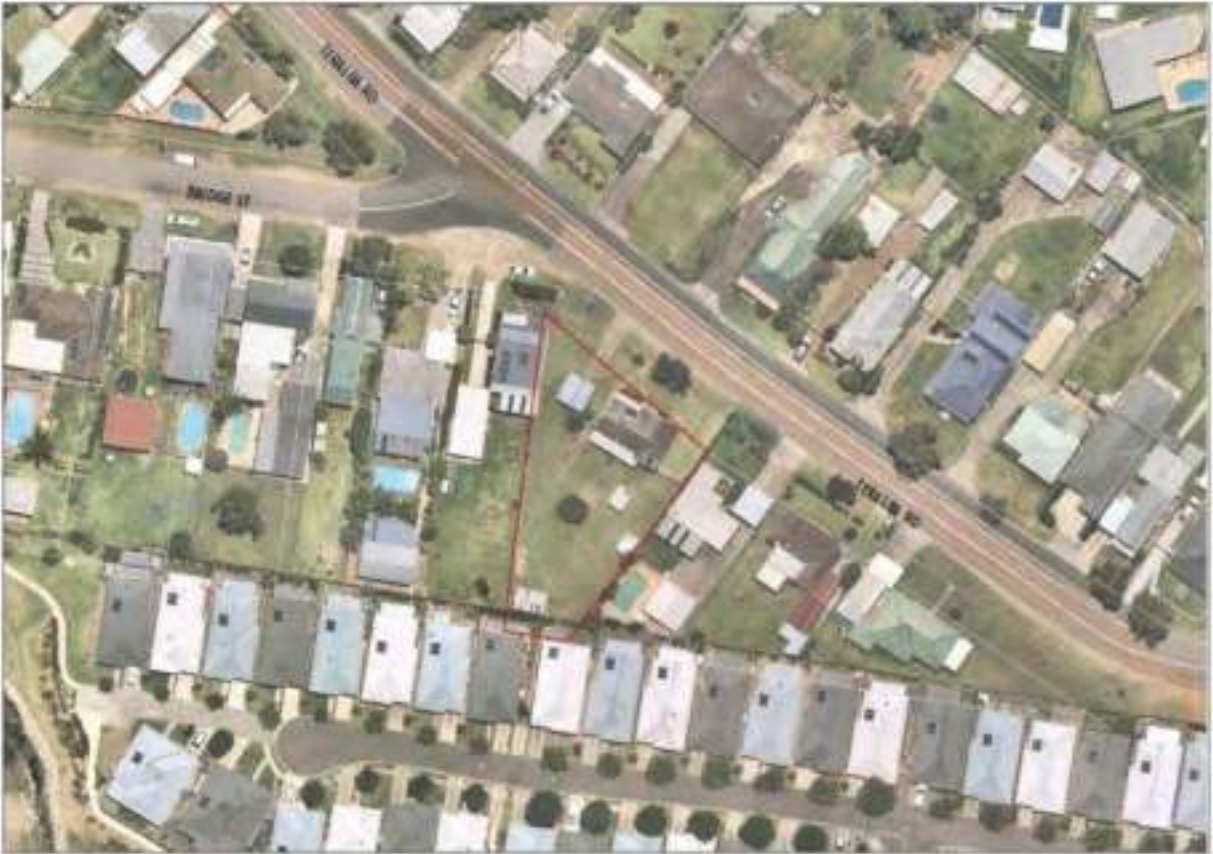
18 TERALBA ROAD, WEST WALLSEND 2286

Conservation Area Contribution Level	Est. Construction Date	Previous studies and/or community input
Contributory 2	Early to late 20 th century (broad range)	No prior heritage assessments or research undertaken.
Assessment Text		Observed Modifications
<p>The scale (single-storey) and general style of the dwelling is consistent with that of the streetscape and wider HCA. Dwelling contributes positively to the streetscape and wider HCA, particularly in comparison to Non-Contributory buildings.</p> <p>The dwelling features appropriately proportioned and positioned fenestrations, an appropriate roof form (gabled or hipped) and other features consistent with the architectural character of the area (e.g. front verandah with timber or brick posts, timber detailing, corrugated metal roofing, etc). The contributory value of the dwelling is limited however by either:</p> <ul style="list-style-type: none"> • External modifications that have in some way obscured the style, scale or design intent of the building and have resulted in less physical integrity than Contributory 1 buildings. • Being a later dwelling constructed in an appropriate referential style, but comprising little to no fabric of intrinsic heritage significance. 		<p>Heating panels are highly visible along the north eastern side of the dwelling.</p> <p>The flat veranda roof is a contemporary addition.</p>

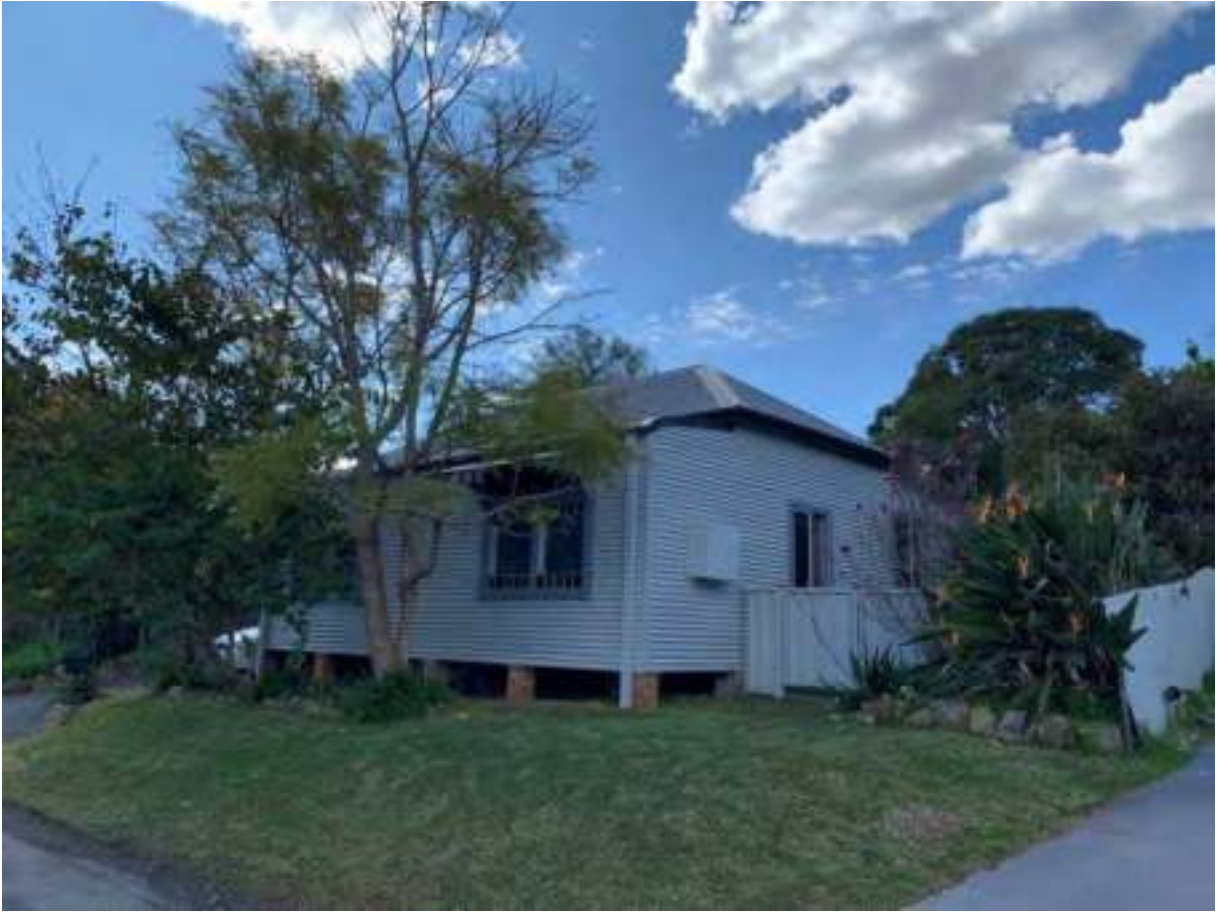
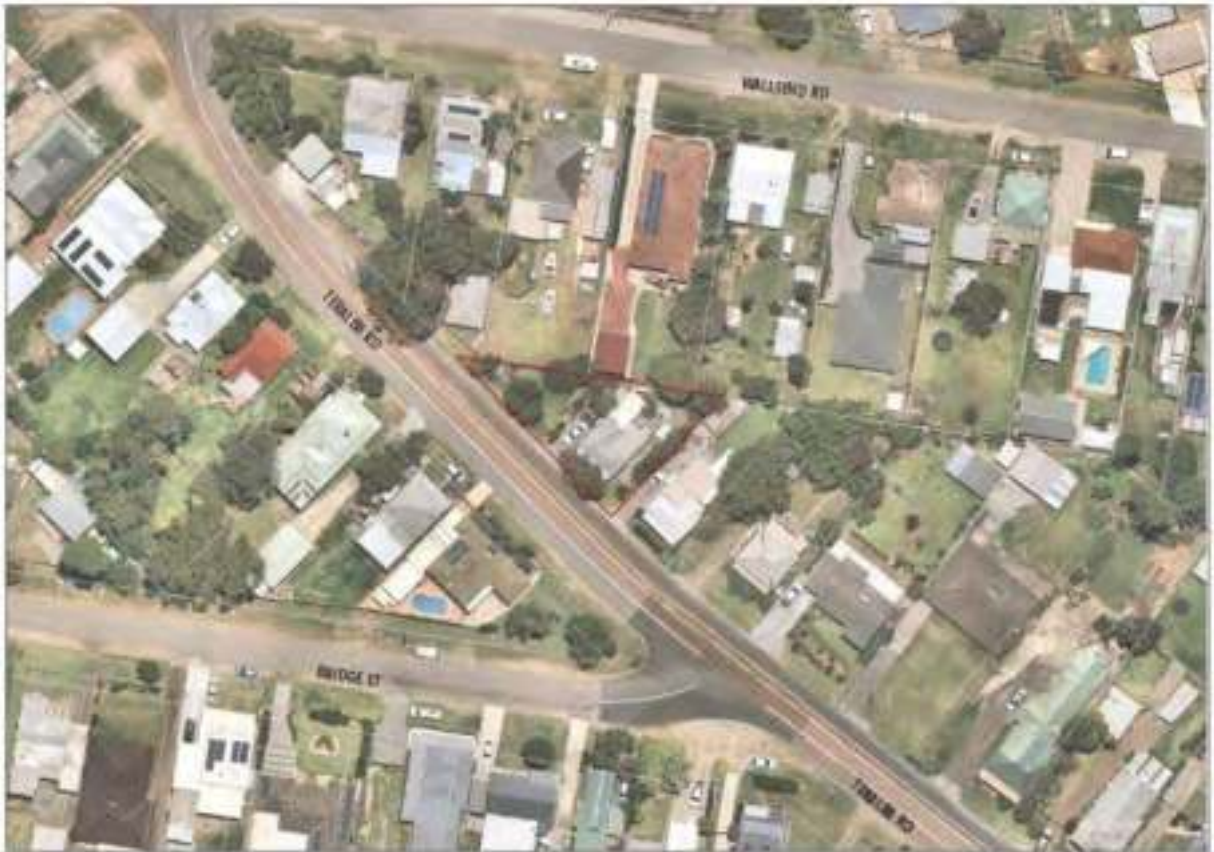
11 TERALBA ROAD, WEST WALLSEND 2286

Conservation Area Contribution Level	Est. Construction Date	Previous studies and/or community input
Contributory 2	Early to late 20 th century (broad range)	No prior heritage assessments or research undertaken.
Assessment Text		Observed Modifications
<p>The scale (single-storey) and general style of the dwelling is consistent with that of the streetscape and wider HCA. Dwelling contributes positively to the streetscape and wider HCA, particularly in comparison to Non-Contributory buildings.</p> <p>The dwelling features appropriately proportioned and positioned fenestrations, an appropriate roof form (gabled or hipped) and other features consistent with the architectural character of the area (e.g. front verandah with timber or brick posts, timber detailing, corrugated metal roofing, etc). The contributory value of the dwelling is limited however by either:</p> <ul style="list-style-type: none"> • External modifications that have in some way obscured the style, scale or design intent of the building and have resulted in less physical integrity than Contributory 1 buildings. • Being a later dwelling constructed in an appropriate referential style, but comprising little to no fabric of intrinsic heritage significance. 		<p>The veranda has been fully built in to create an additional living area. This is a common modification for the area, however does detract from the heritage streetscape.</p> <p>All visible windows are contemporary in style.</p>

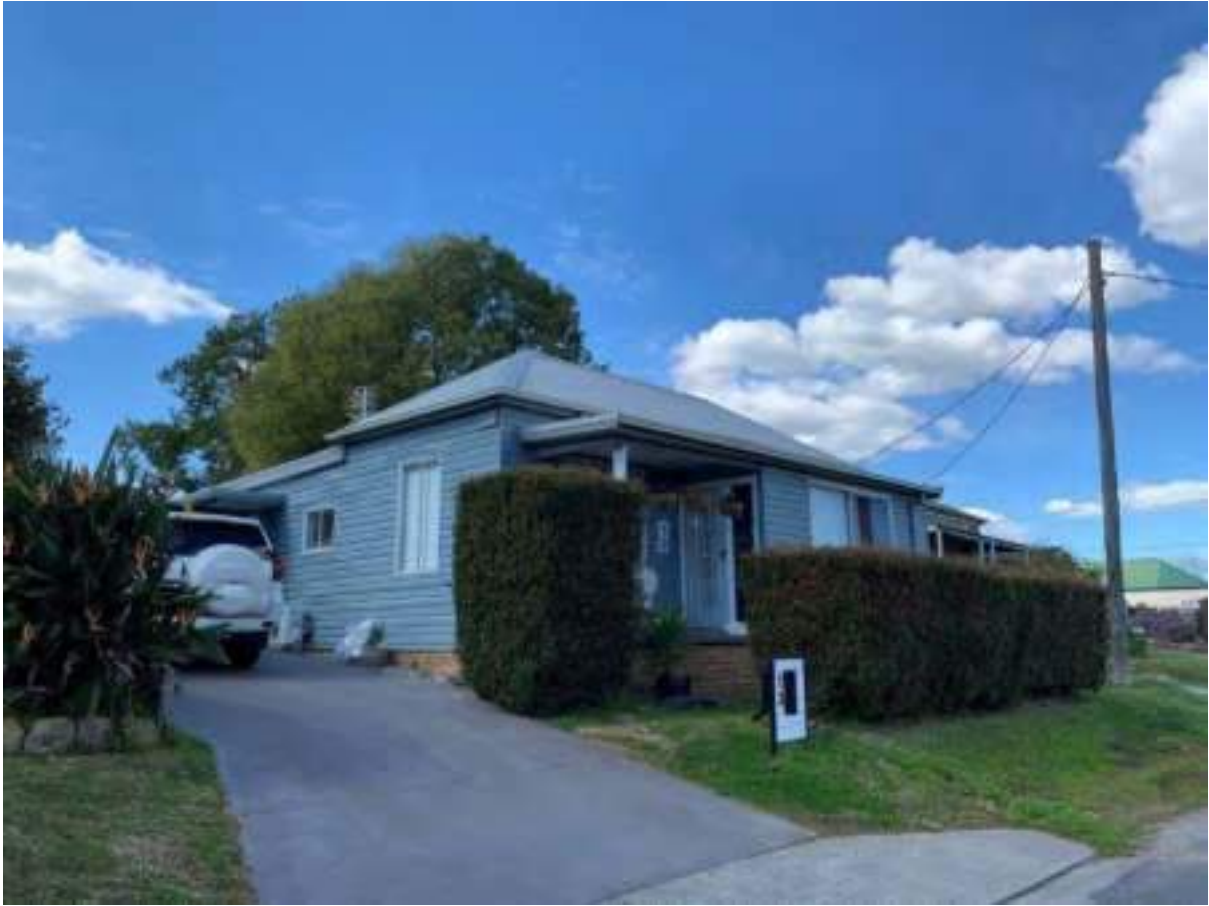
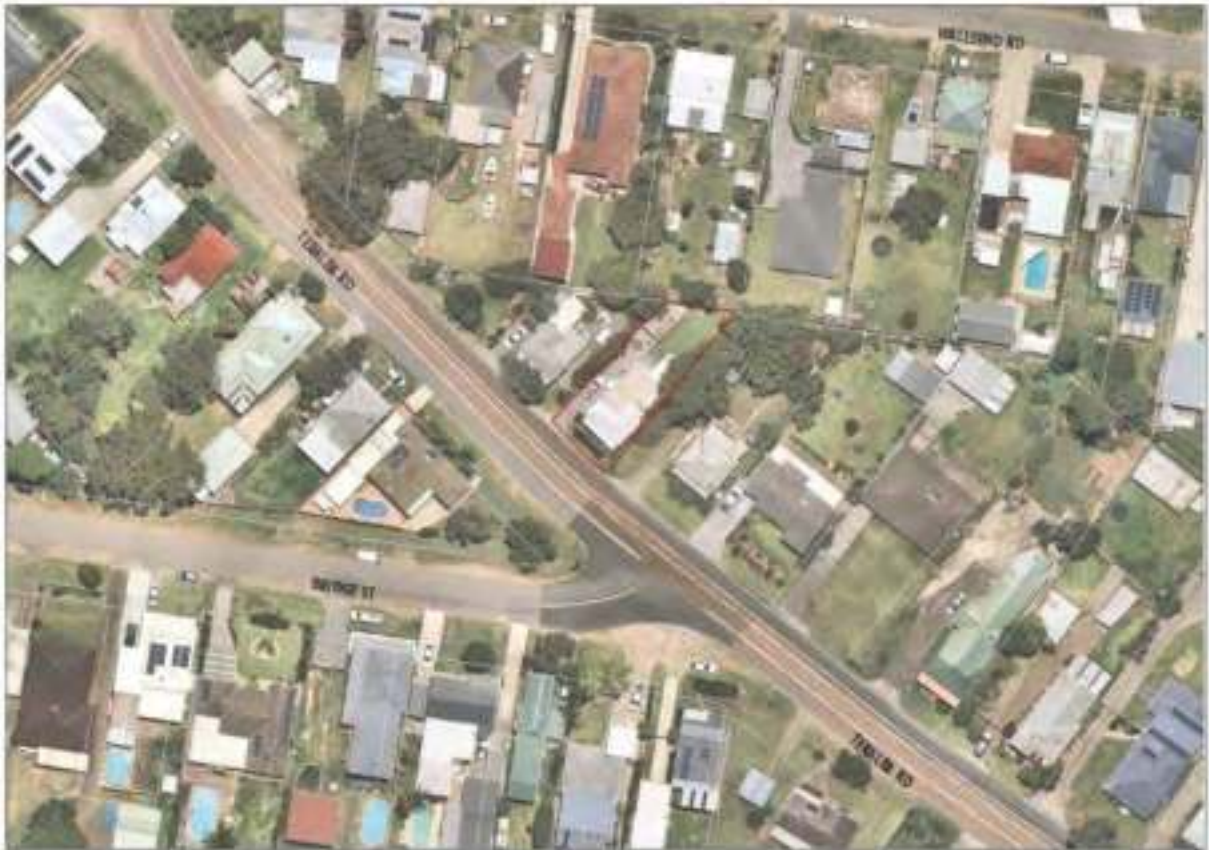
13 TERALBA ROAD, WEST WALLSEND 2286

Conservation Area Contribution Level	Est. Construction Date	Previous studies and/or community input
Contributory 2	Early to late 20 th century (broad range)	No prior heritage assessments or research undertaken.
Assessment Text		Observed Modifications
<p>The scale (single-storey) and general style of the dwelling is consistent with that of the streetscape and wider HCA. Dwelling contributes positively to the streetscape and wider HCA, particularly in comparison to Non-Contributory buildings.</p> <p>The dwelling features appropriately proportioned and positioned fenestrations, an appropriate roof form (gabled or hipped) and other features consistent with the architectural character of the area (e.g. front verandah with timber or brick posts, timber detailing, corrugated metal roofing, etc). The contributory value of the dwelling is limited however by either:</p> <ul style="list-style-type: none"> • External modifications that have in some way obscured the style, scale or design intent of the building and have resulted in less physical integrity than Contributory 1 buildings. • Being a later dwelling constructed in an appropriate referential style, but comprising little to no fabric of intrinsic heritage significance. 		<p>The veranda has been partially built in, creating an additional living area. This is a common modification, however does detract from the heritage streetscape.</p> <p>All visible windows are contemporary in style.</p> <p>An extension has been built onto the back north eastern portion of the dwelling. This is not visible and does not detract from the heritage streetscape.</p>

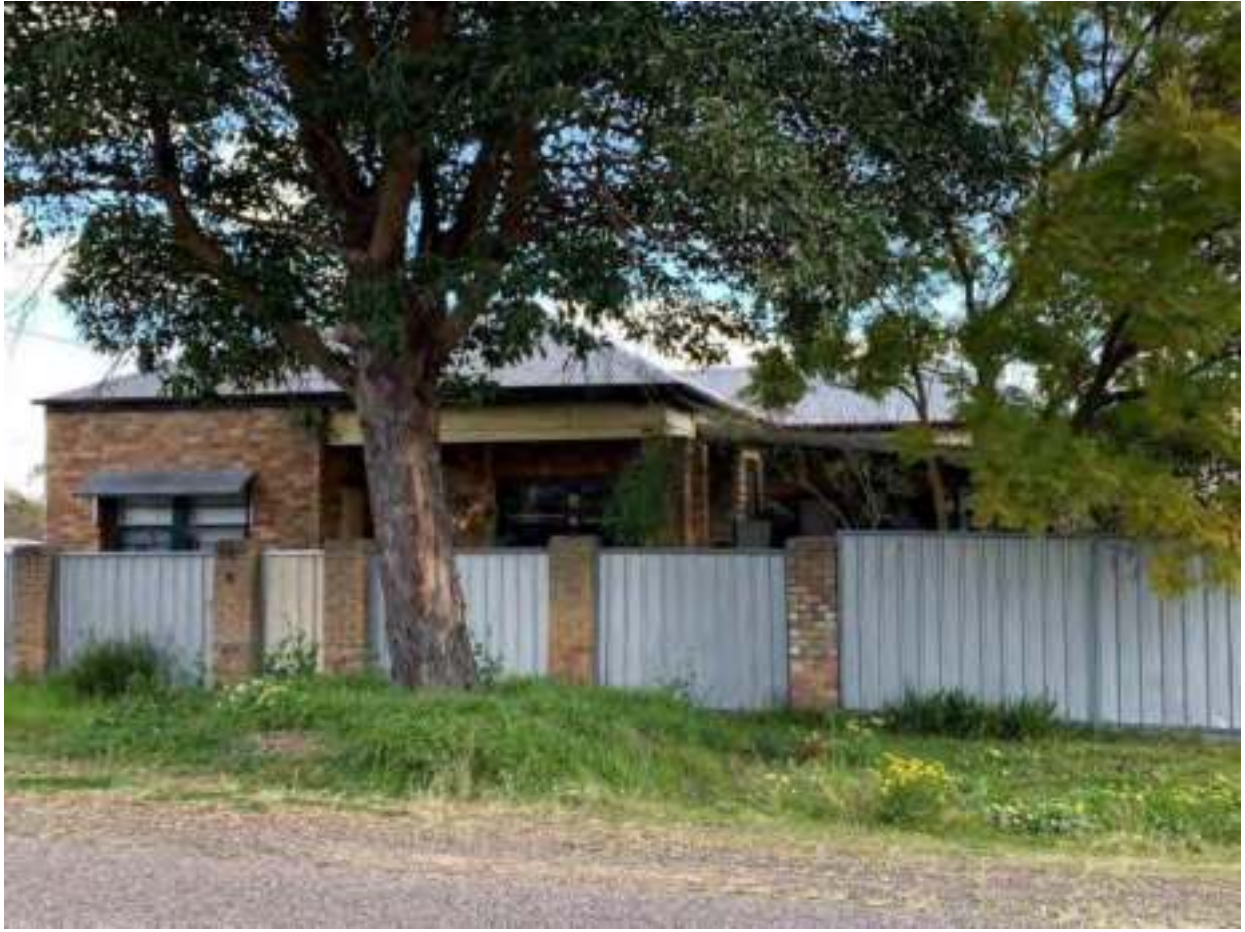
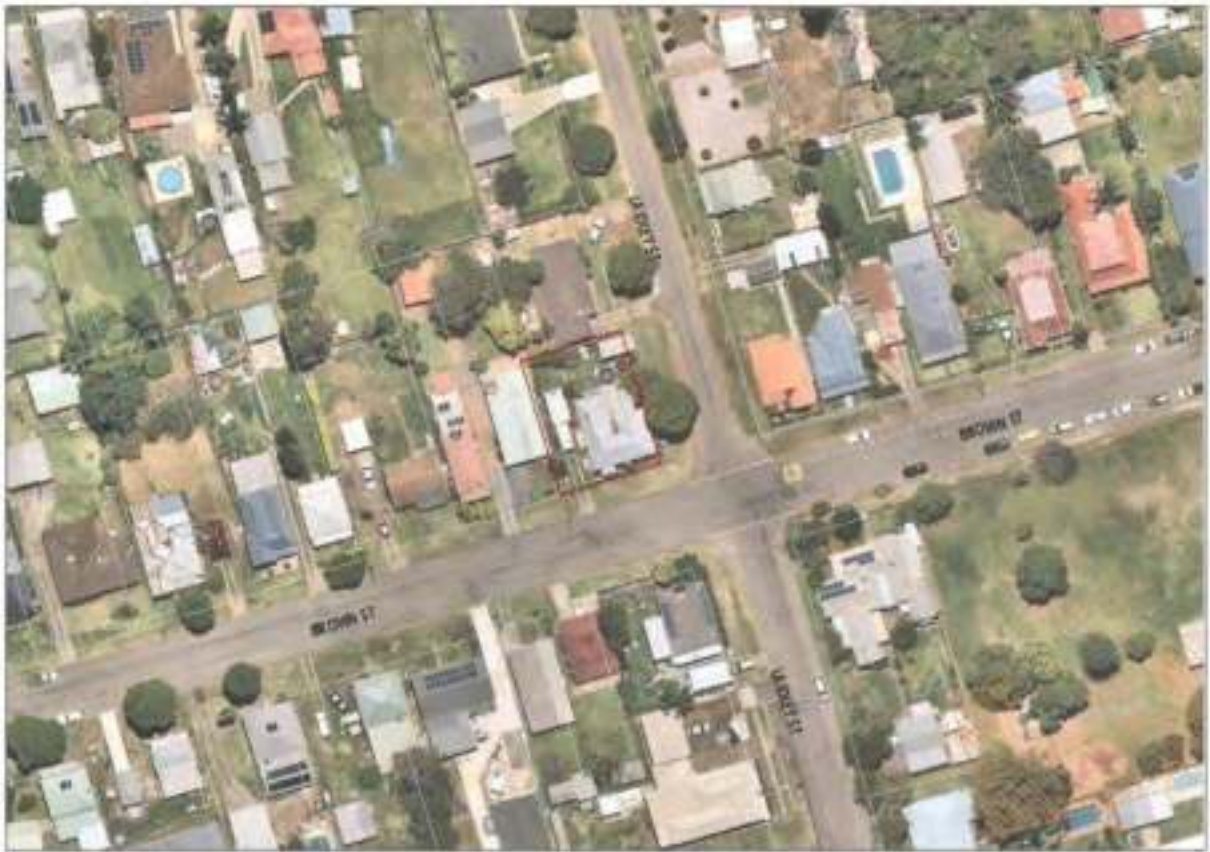
18 LAIDLEY STREET, WEST WALLSEND 2286

Conservation Area Contribution Level	Est. Construction Date	Previous studies and/or community input
Contributory 2	Early to late 20 th century (broad range)	No prior heritage assessments or research undertaken.
Assessment Text		Observed Modifications
<p>The scale (single-storey) and general style of the dwelling is consistent with that of the streetscape and wider HCA. Dwelling contributes positively to the streetscape and wider HCA, particularly in comparison to Non-Contributory buildings.</p> <p>The dwelling features appropriately proportioned and positioned fenestrations, an appropriate roof form (gabled or hipped) and other features consistent with the architectural character of the area (e.g. front verandah with timber or brick posts, timber detailing, corrugated metal roofing, etc). The contributory value of the dwelling is limited however by either:</p> <ul style="list-style-type: none"> External modifications that have in some way obscured the style, scale or design intent of the building and have resulted in less physical integrity than Contributory 1 buildings. Being a later dwelling constructed in an appropriate referential style, but comprising little to no fabric of intrinsic heritage significance. 		<p>The brickwork façade is a contemporary addition, likely in relation to renovation works or a prior modification. Similarly the brick pillars are a recent addition, likely replacing original timber posts.</p> <p>The southern entrance and associated hipped alcove, brick pillars and wall are likely contemporary modifications.</p>

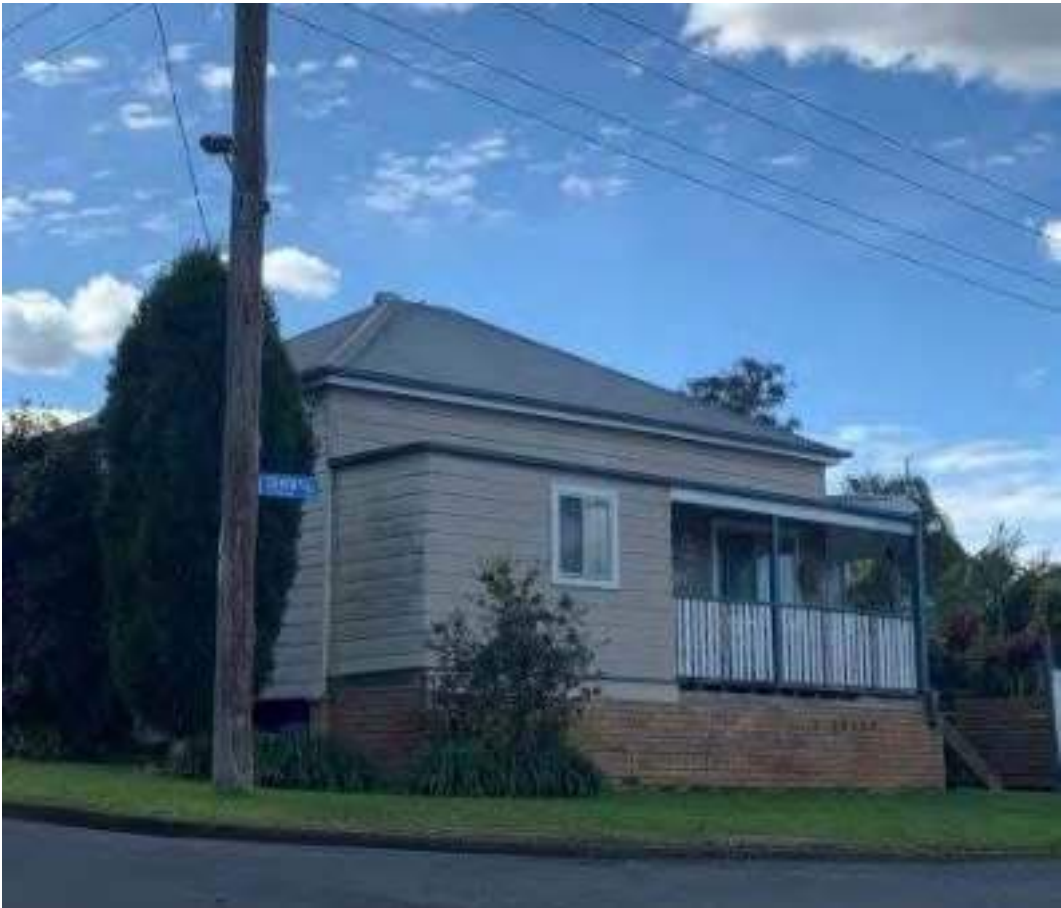
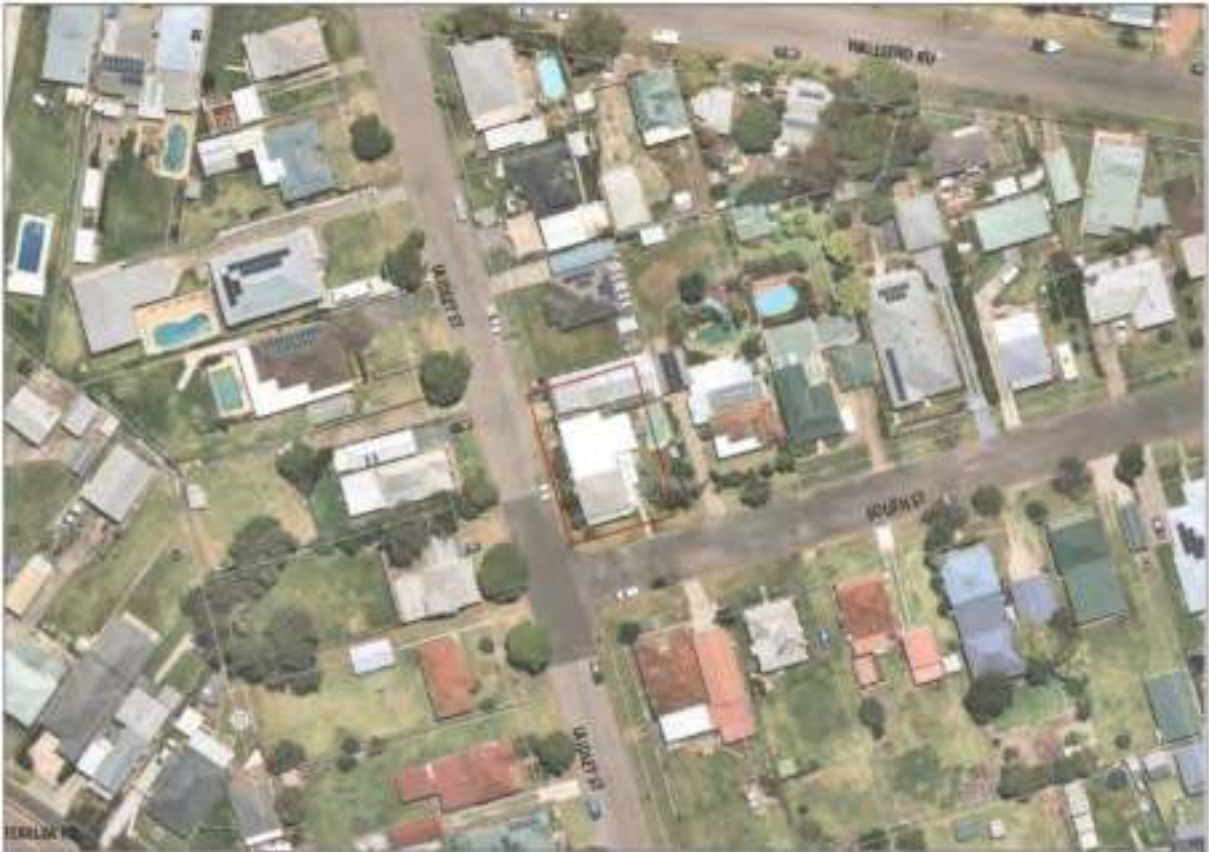
9 SOUTH STREET, WEST WALLSEND 2286

Conservation Area Contribution Level	Est. Construction Date	Previous studies and/or community input
Contributory 2	Early to late 20 th century (broad range)	No prior heritage assessments or research undertaken.
Assessment Text		Observed Modifications
<p>The scale (single-storey) and general style of the dwelling is consistent with that of the streetscape and wider HCA. Dwelling contributes positively to the streetscape and wider HCA, particularly in comparison to Non-Contributory buildings.</p> <p>The dwelling features appropriately proportioned and positioned fenestrations, an appropriate roof form (gabled or hipped) and other features consistent with the architectural character of the area (e.g. front verandah with timber or brick posts, timber detailing, corrugated metal roofing, etc). The contributory value of the dwelling is limited however by either:</p> <ul style="list-style-type: none"> • External modifications that have in some way obscured the style, scale or design intent of the building and have resulted in less physical integrity than Contributory 1 buildings. • Being a later dwelling constructed in an appropriate referential style, but comprising little to no fabric of intrinsic heritage significance. 		<p>The veranda has been partially built in to create an additional living area. This is a common modification for the area, however does detract from the heritage streetscape.</p> <p>The timber balustrade, additional gabled detailing and timber finial along the veranda are all contemporary replications of a heritage style. This has been undertaken in a sympathetic manner and does not detract from the heritage streetscape.</p> <p>All visible windows are contemporary in style.</p> <p>An extension has been built onto the northern portion of the dwelling. This is partially visible from the street, however does not detract from the heritage streetscape.</p>
