APPENDIX 2

Building Assessment Sheets (Inventory Sheets)

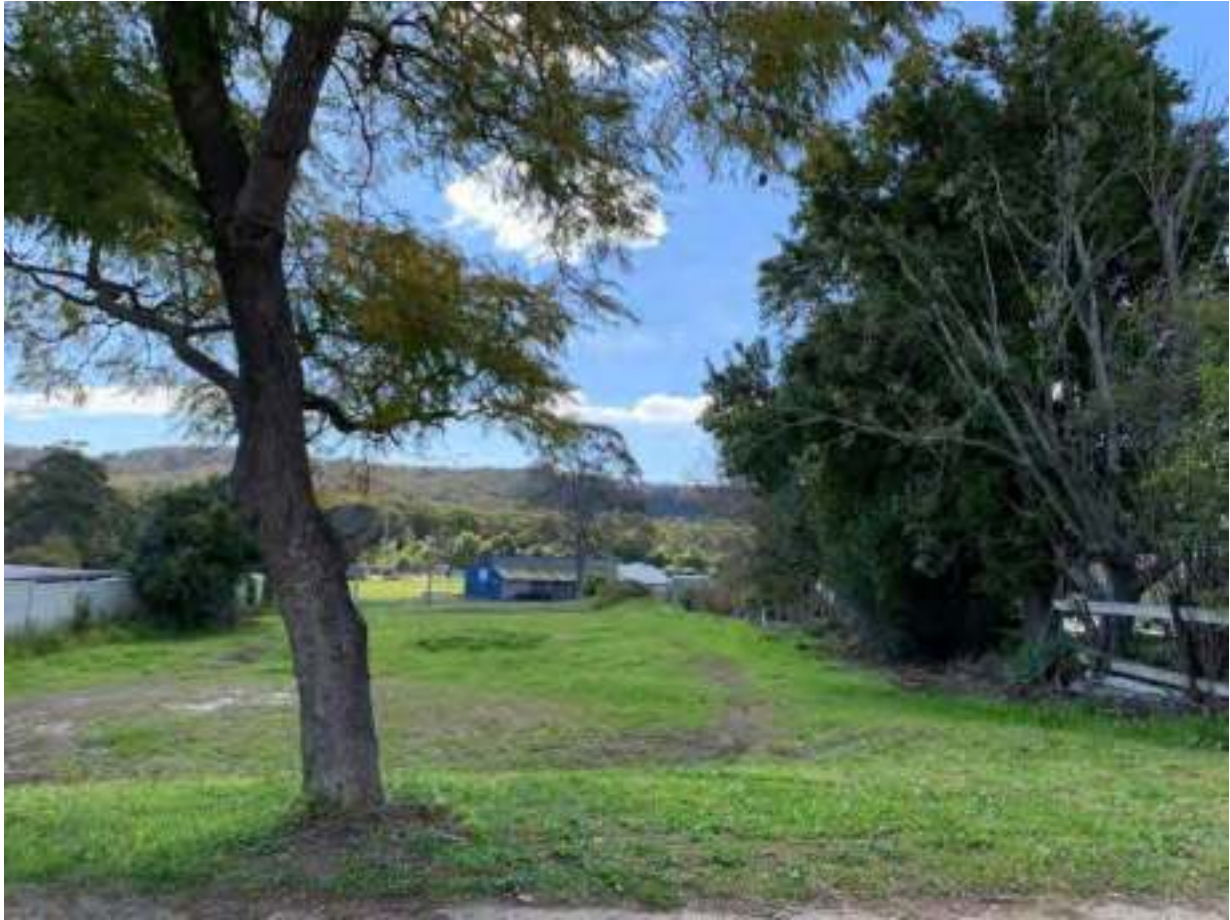
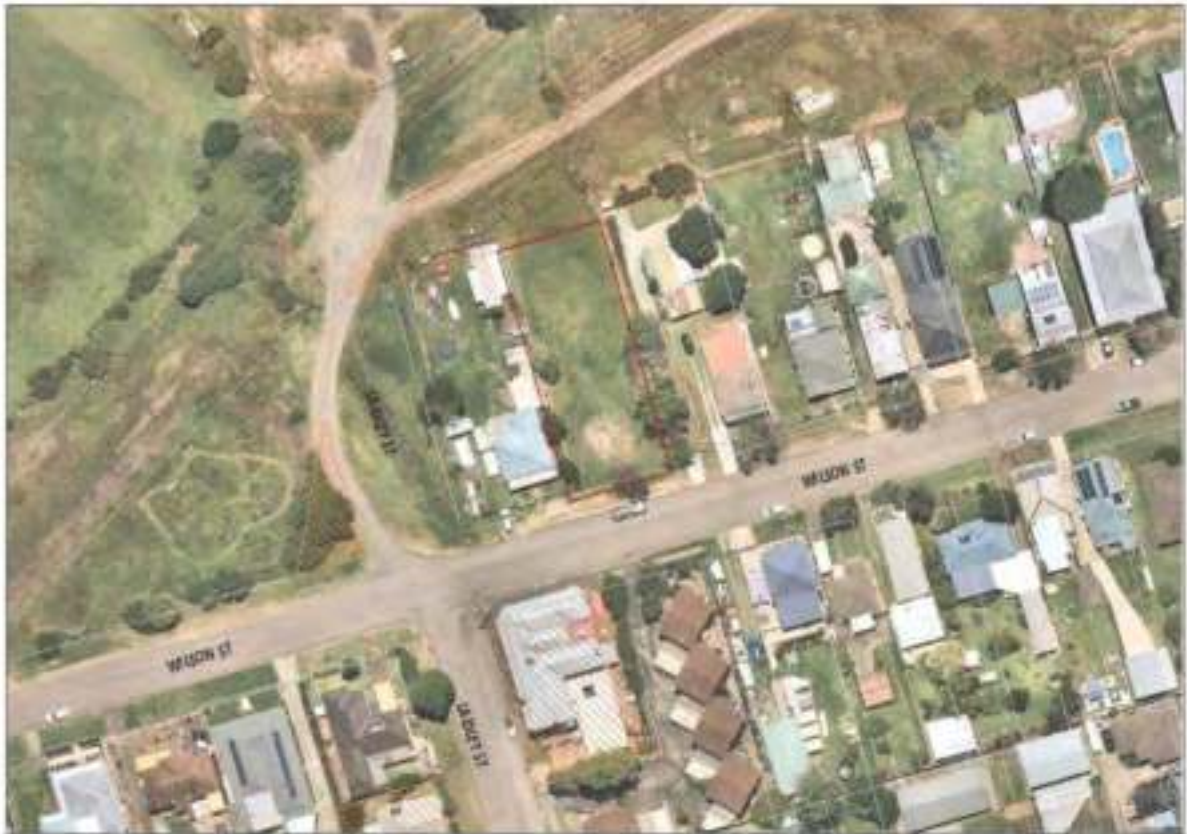
73 WILSON STREET, WEST WALLSEND 2286		
Conservation Area Contribution Level	Est. Construction Date	Previous studies and/or community input
Contributory 2	N/A	No prior heritage assessments or research undertaken.
Assessment Text		Observed Modifications
Vacant lot.		Vacant lot. No modifications observed.

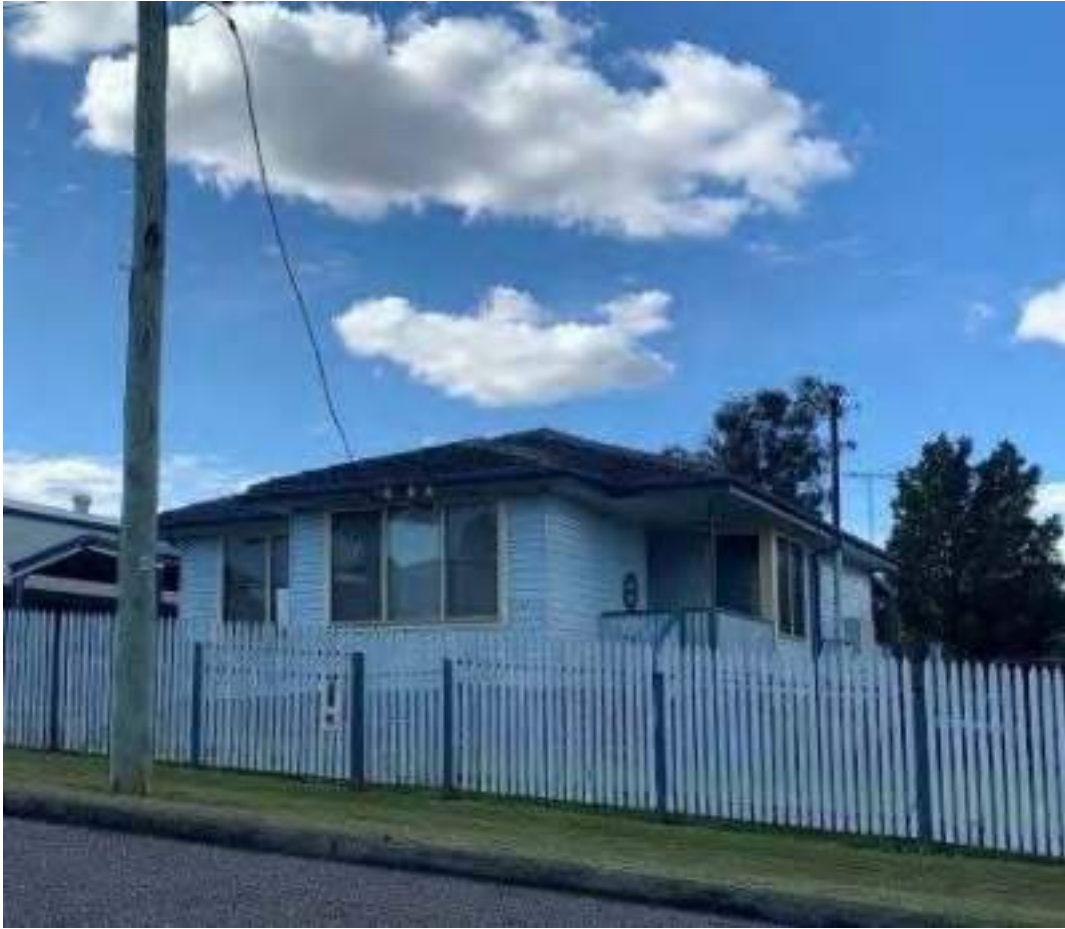
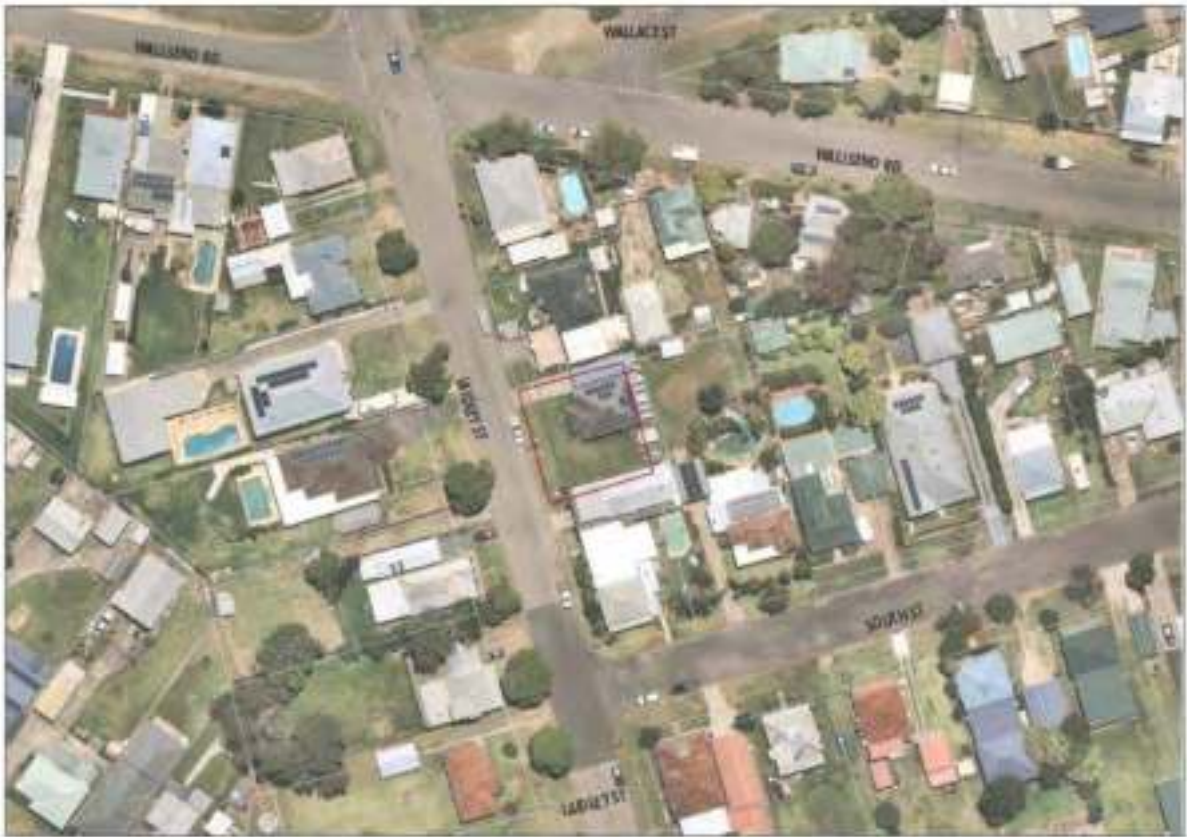
33 LAIDLEY STREET, WEST WALLSEND 2286

Conservation Area Contribution Level	Est. Construction Date	Previous studies and/or community input
Contributory 2	Early to late 20 th century (broad range)	No prior heritage assessments or research undertaken.
Assessment Text		Observed Modifications
<p>The scale (single-storey) and general style of the dwelling is consistent with that of the streetscape and wider HCA. Dwelling contributes positively to the streetscape and wider HCA, particularly in comparison to Non-Contributory buildings.</p> <p>The dwelling features appropriately proportioned and positioned fenestrations, an appropriate roof form (gabled or hipped) and other features consistent with the architectural character of the area (e.g. front verandah with timber or brick posts, timber detailing, corrugated metal roofing, etc). The contributory value of the dwelling is limited however by either:</p> <ul style="list-style-type: none"> • External modifications that have in some way obscured the style, scale or design intent of the building and have resulted in less physical integrity than Contributory 1 buildings. • Being a later dwelling constructed in an appropriate referential style, but comprising little to no fabric of intrinsic heritage significance. 		No modifications observed.

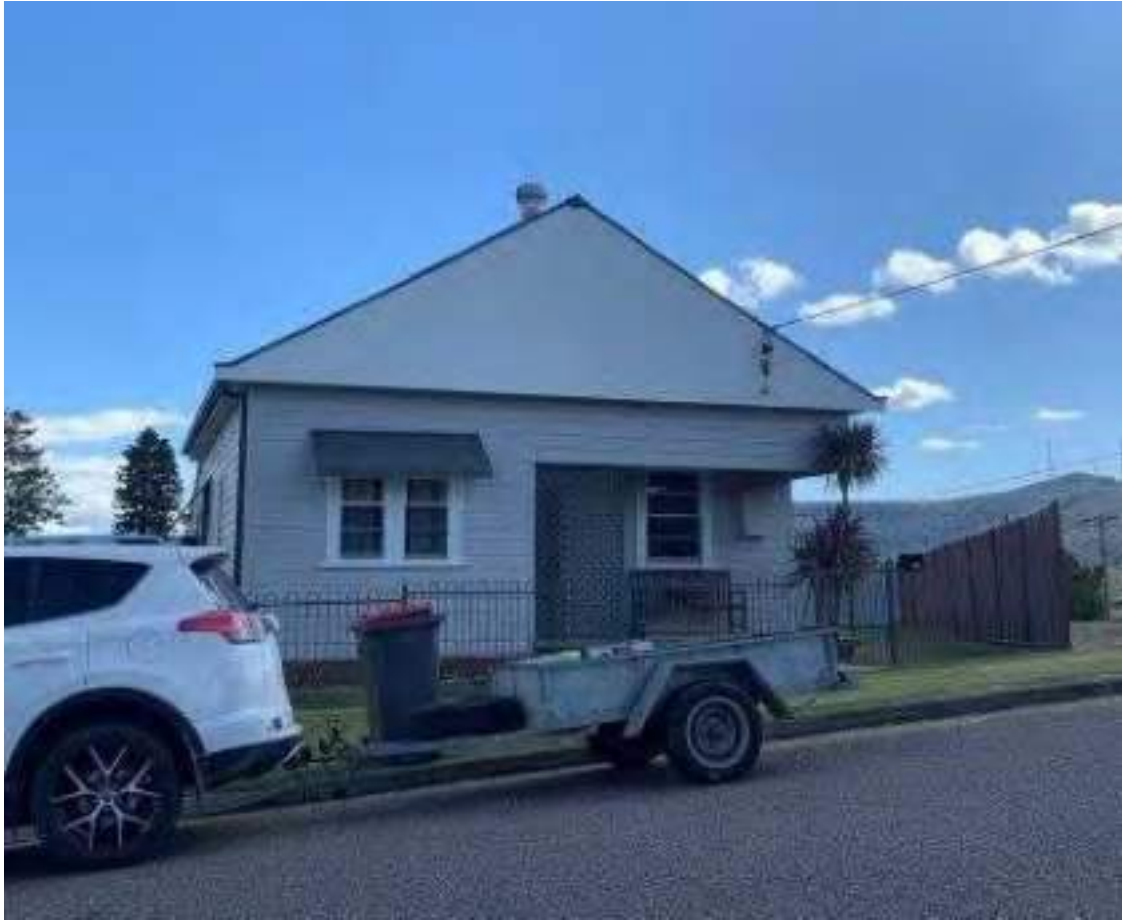
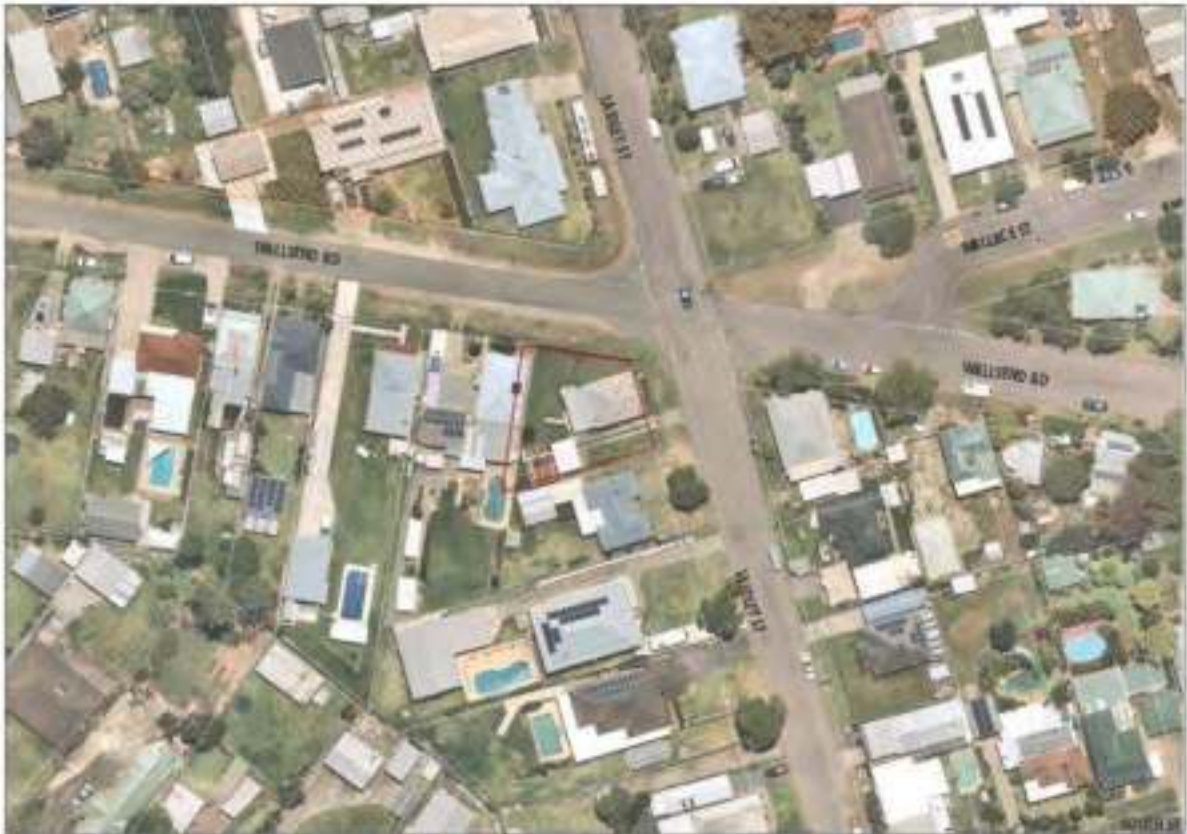
26 LAIDLEY STREET, WEST WALLSEND 2286		
Conservation Area Contribution Level	Est. Construction Date	Previous studies and/or community input
Contributory 2	Early to late 20 th century (broad range)	No prior heritage assessments or research undertaken.
Assessment Text		Observed Modifications
<p>The scale (single-storey) and general style of the dwelling is consistent with that of the streetscape and wider HCA. Dwelling contributes positively to the streetscape and wider HCA, particularly in comparison to Non-Contributory buildings.</p> <p>The dwelling features appropriately proportioned and positioned fenestrations, an appropriate roof form (gabled or hipped) and other features consistent with the architectural character of the area (e.g. front verandah with timber or brick posts, timber detailing, corrugated metal roofing, etc). The contributory value of the dwelling is limited however by either:</p> <ul style="list-style-type: none"> • External modifications that have in some way obscured the style, scale or design intent of the building and have resulted in less physical integrity than Contributory 1 buildings. • Being a later dwelling constructed in an appropriate referential style, but comprising little to no fabric of intrinsic heritage significance. 		No modifications observed.

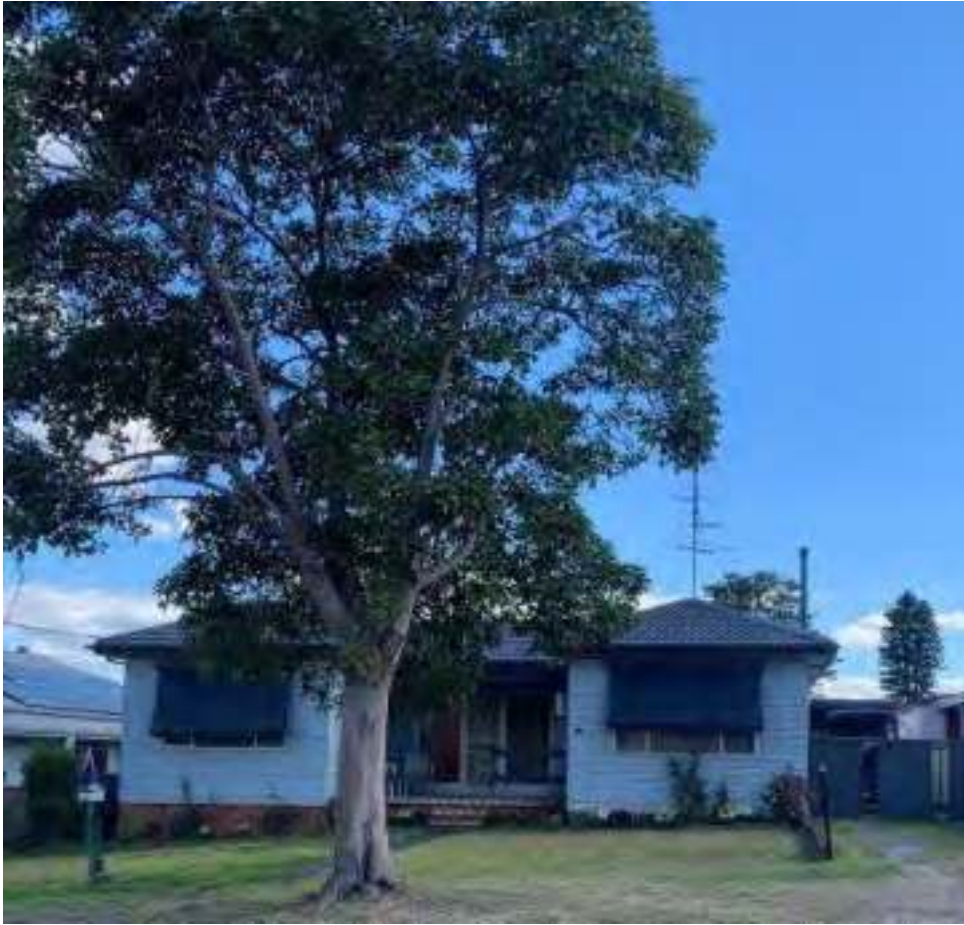
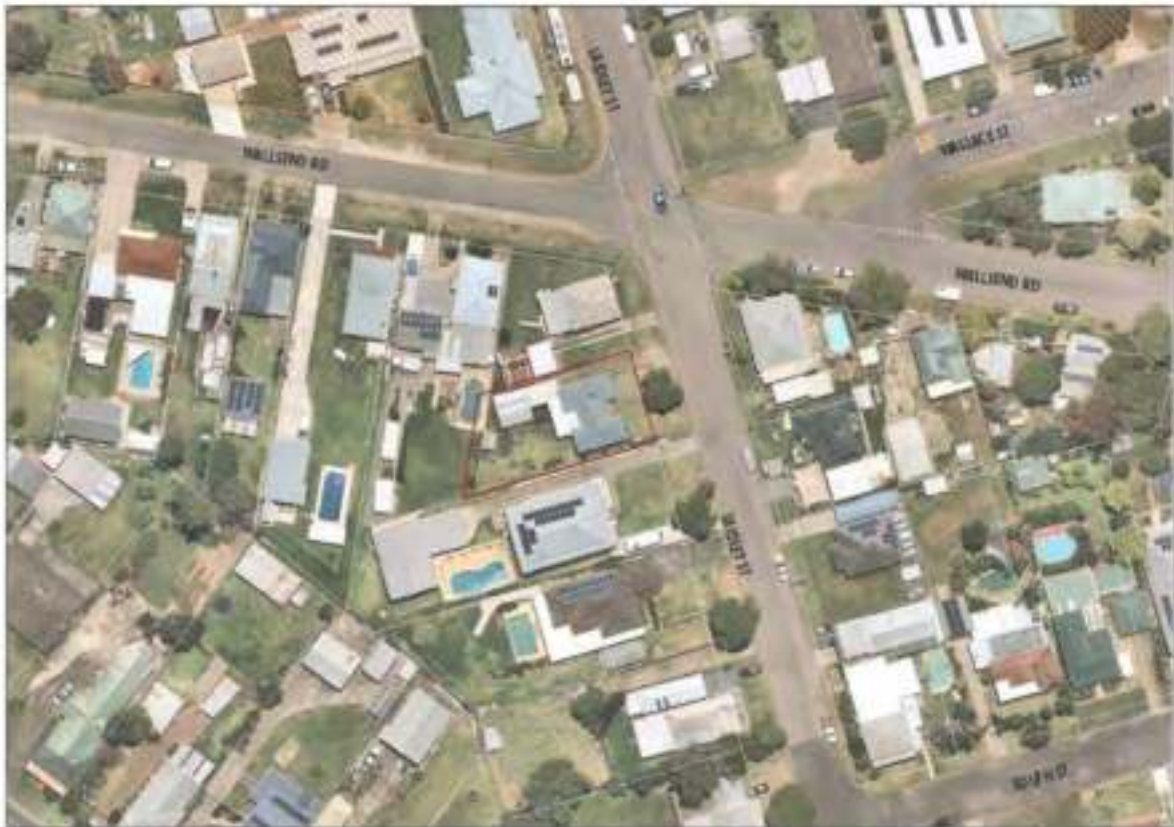
28 LAIDLEY STREET, WEST WALLSEND 2286

Conservation Area Contribution Level	Est. Construction Date	Previous studies and/or community input
Contributory 2	Early to late 20 th century (broad range)	No prior heritage assessments or research undertaken.
Assessment Text		Observed Modifications
<p>The scale (single-storey) and general style of the dwelling is consistent with that of the streetscape and wider HCA. Dwelling contributes positively to the streetscape and wider HCA, particularly in comparison to Non-Contributory buildings.</p> <p>The dwelling features appropriately proportioned and positioned fenestrations, an appropriate roof form (gabled or hipped) and other features consistent with the architectural character of the area (e.g. front verandah with timber or brick posts, timber detailing, corrugated metal roofing, etc). The contributory value of the dwelling is limited however by either:</p> <ul style="list-style-type: none"> • External modifications that have in some way obscured the style, scale or design intent of the building and have resulted in less physical integrity than Contributory 1 buildings. • Being a later dwelling constructed in an appropriate referential style, but comprising little to no fabric of intrinsic heritage significance. 		<p>Canvas awnings have been installed on the front eastern windows.</p> <p>An extension has been built onto the back western portion of the dwelling. This is not visible from the street and does not detract from the heritage streetscape.</p>

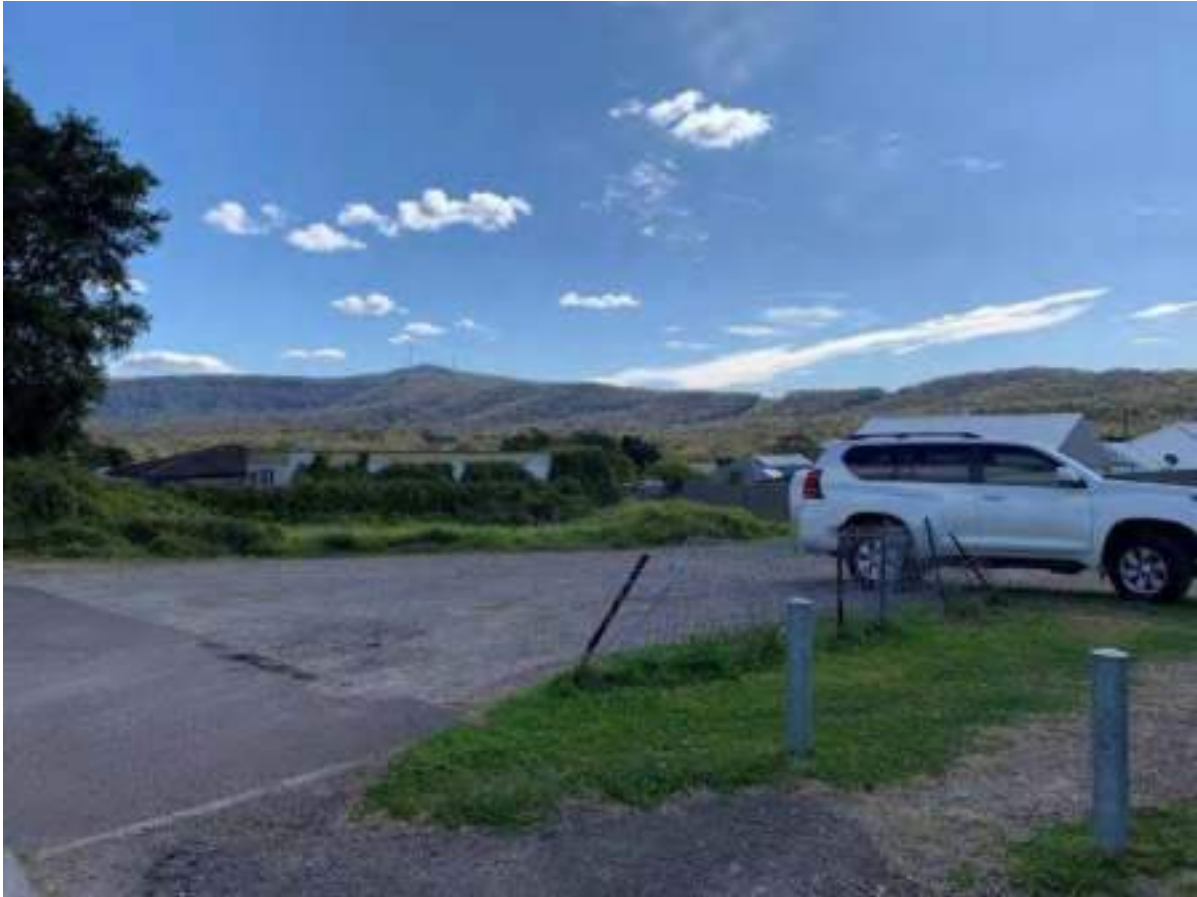
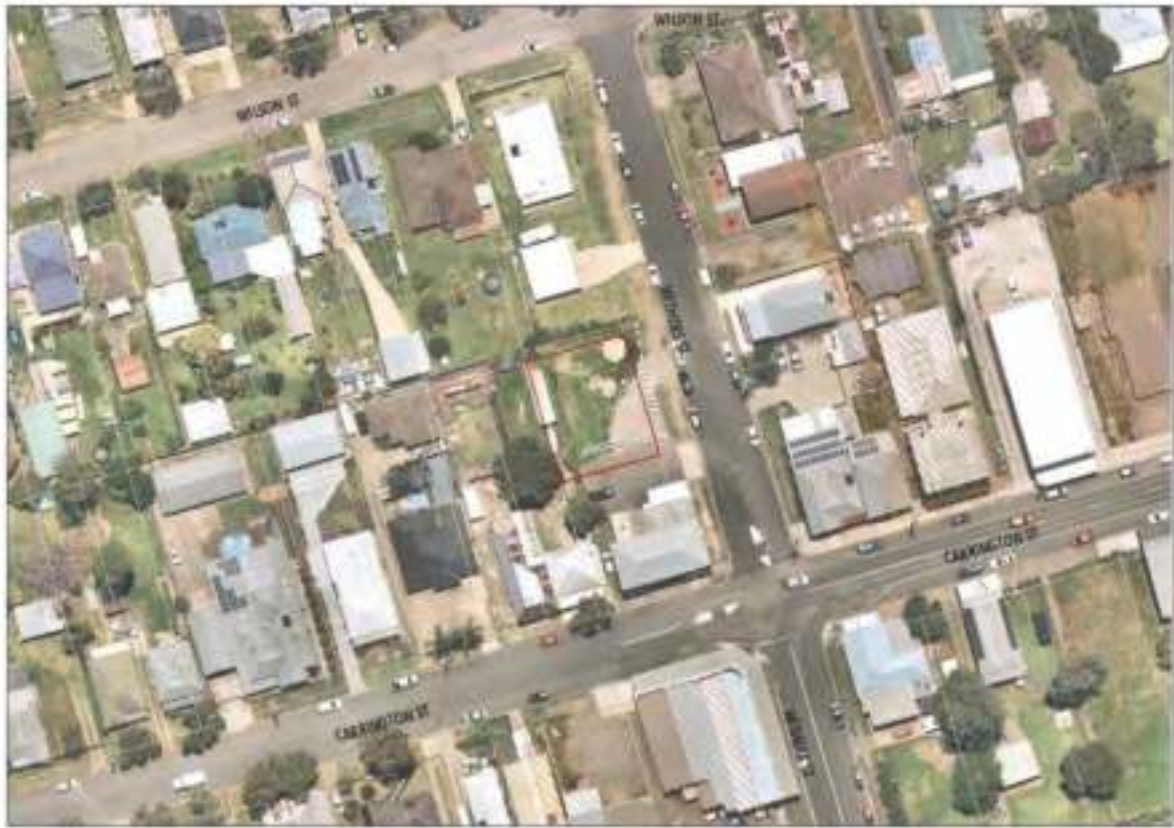
4 WITHERS STREET, WEST WALLSEND 2286		
Conservation Area Contribution Level	Est. Construction Date	Previous studies and/or community input
Contributory 2	N/A	No prior heritage assessments or research undertaken.
Assessment Text		Observed Modifications
Vacant lot.		Predominately vacant lot with concrete slab and likely the site of a previous building. No modifications observed.

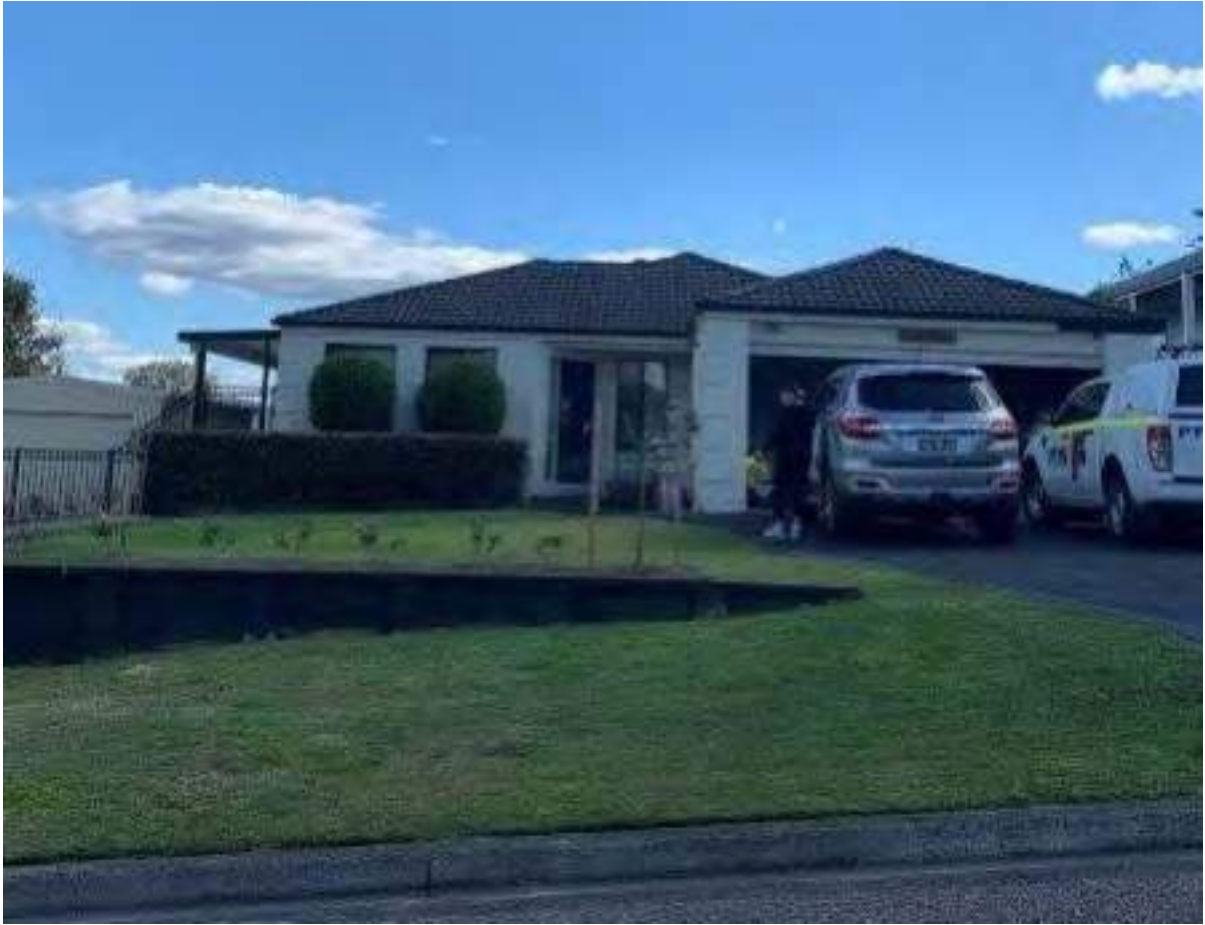
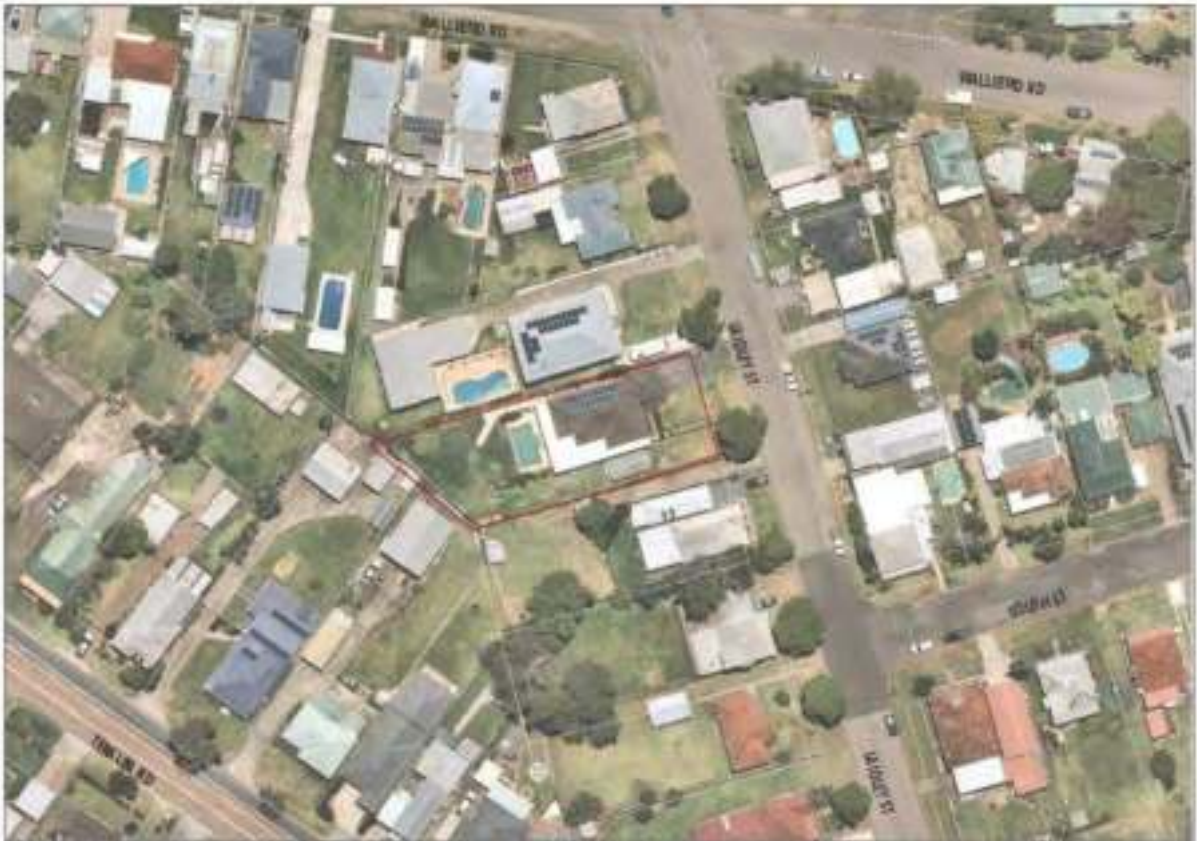
32 LAIDLEY STREET, WEST WALLSEND 2286

Conservation Area Contribution Level	Est. Construction Date	Previous studies and/or community input
Contributory 2	Early to late 20 th century (broad range)	No prior heritage assessments or research undertaken.
Assessment Text		Observed Modifications
<p>The scale (single-storey) and general style of the dwelling is consistent with that of the streetscape and wider HCA. Dwelling contributes positively to the streetscape and wider HCA, particularly in comparison to Non-Contributory buildings.</p> <p>The dwelling features appropriately proportioned and positioned fenestrations, an appropriate roof form (gabled or hipped) and other features consistent with the architectural character of the area (e.g. front verandah with timber or brick posts, timber detailing, corrugated metal roofing, etc). The contributory value of the dwelling is limited however by either:</p> <ul style="list-style-type: none"> • External modifications that have in some way obscured the style, scale or design intent of the building and have resulted in less physical integrity than Contributory 1 buildings. • Being a later dwelling constructed in an appropriate referential style, but comprising little to no fabric of intrinsic heritage significance. 		<p>An extension has been built onto the back western portion of the dwelling. This is not visible from the street and does not detract from the heritage streetscape.</p>

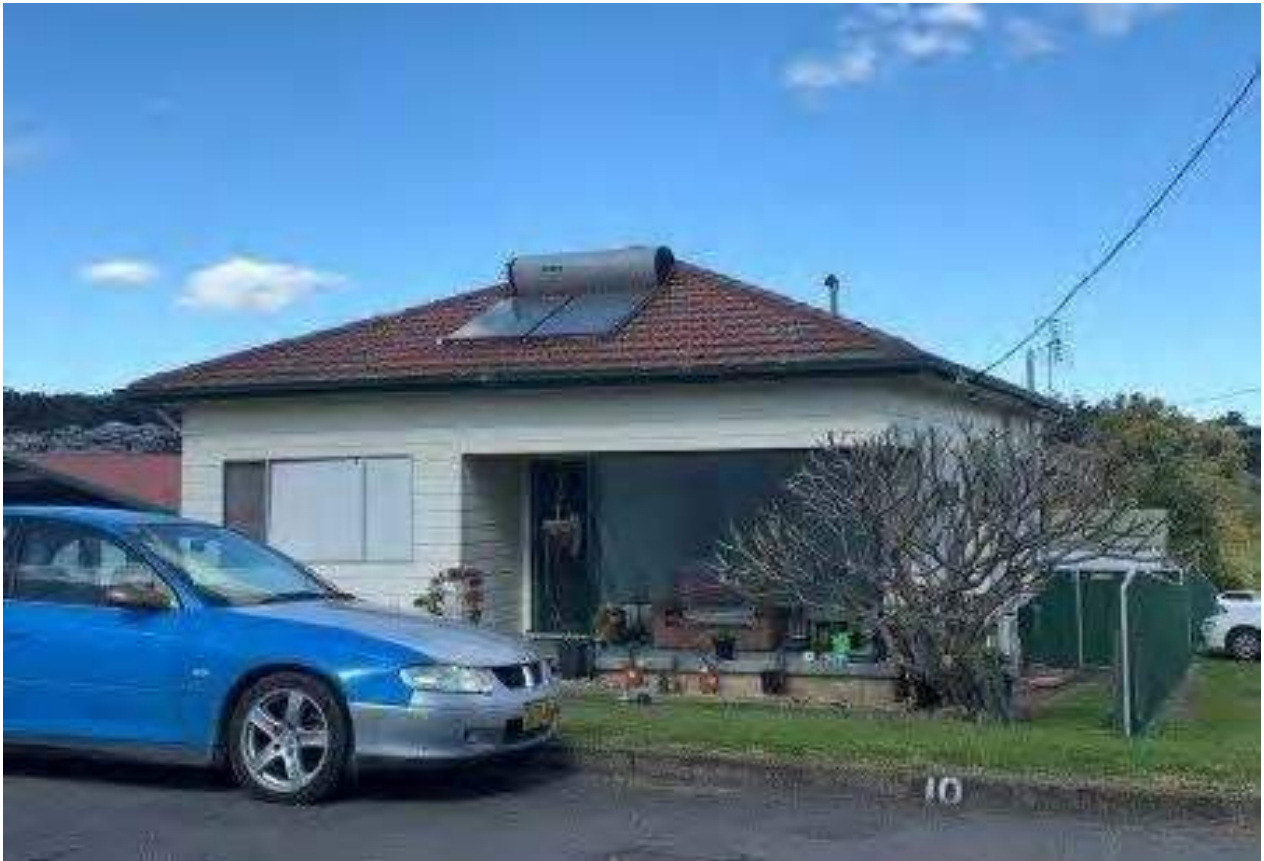
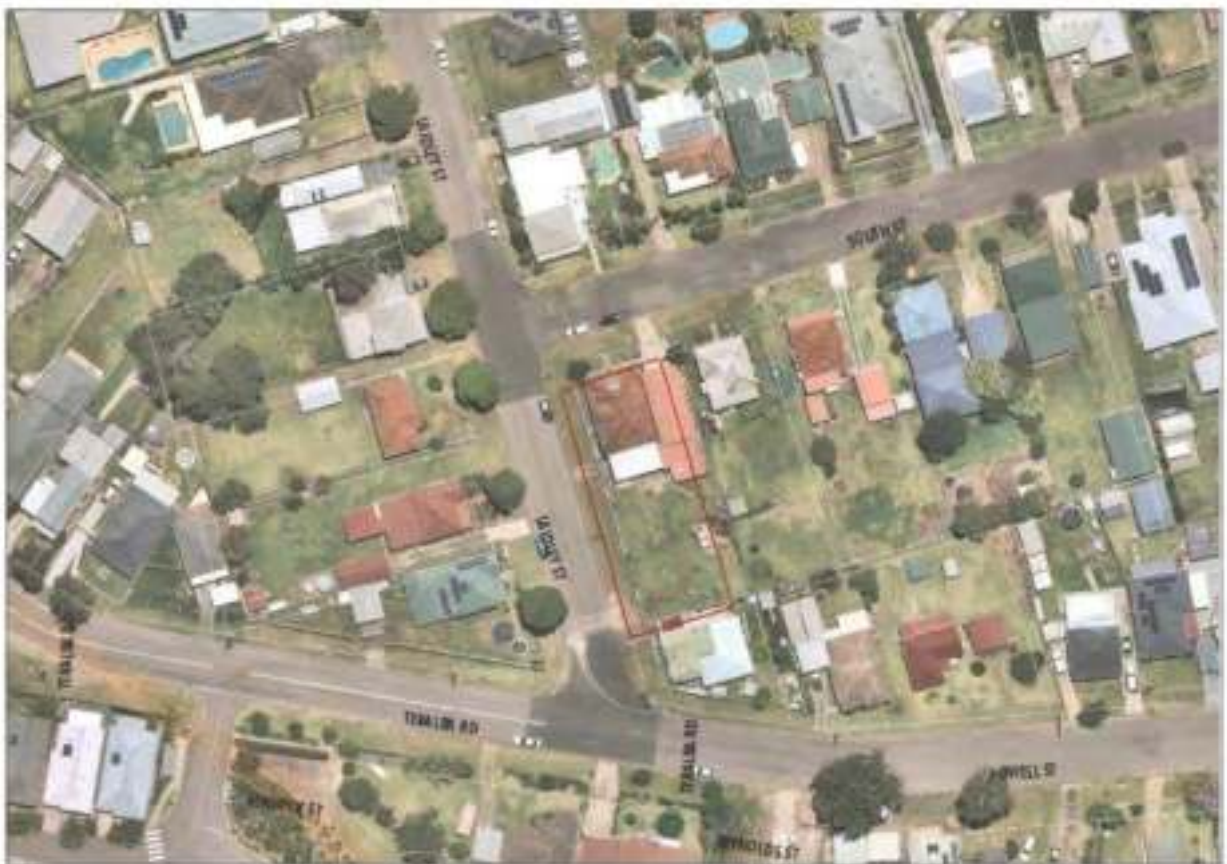
10 SOUTH STREET, WEST WALLSEND 2286

Conservation Area Contribution Level	Est. Construction Date	Previous studies and/or community input
Contributory 2	Early to late 20 th century (broad range)	No prior heritage assessments or research undertaken.
Assessment Text		Observed Modifications
<p>The scale (single-storey) and general style of the dwelling is consistent with that of the streetscape and wider HCA. Dwelling contributes positively to the streetscape and wider HCA, particularly in comparison to Non-Contributory buildings.</p> <p>The dwelling features appropriately proportioned and positioned fenestrations, an appropriate roof form (gabled or hipped) and other features consistent with the architectural character of the area (e.g. front verandah with timber or brick posts, timber detailing, corrugated metal roofing, etc). The contributory value of the dwelling is limited however by either:</p> <ul style="list-style-type: none"> • External modifications that have in some way obscured the style, scale or design intent of the building and have resulted in less physical integrity than Contributory 1 buildings. • Being a later dwelling constructed in an appropriate referential style, but comprising little to no fabric of intrinsic heritage significance. 		<p>Heating panels are visible along the northern side of roof.</p> <p>All visible windows are contemporary in style.</p> <p>A carport and garage have been built onto the eastern side of the dwelling.</p>

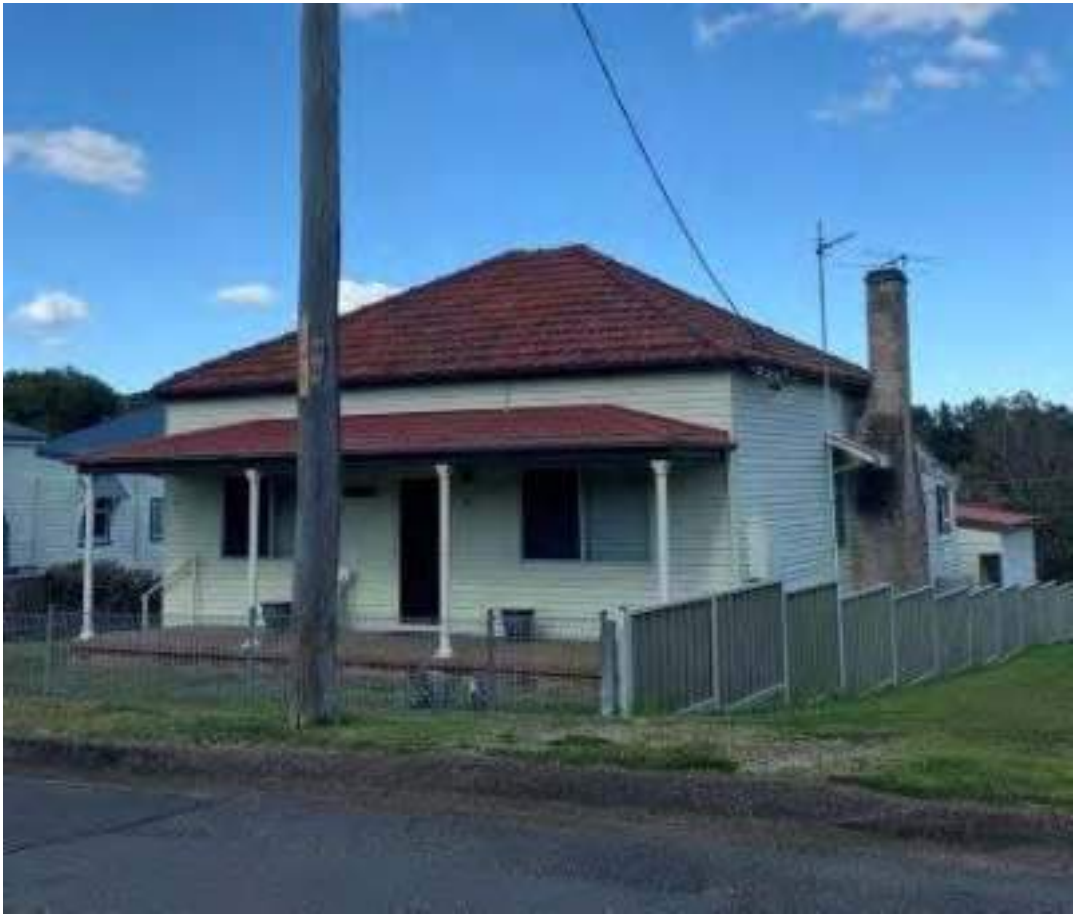
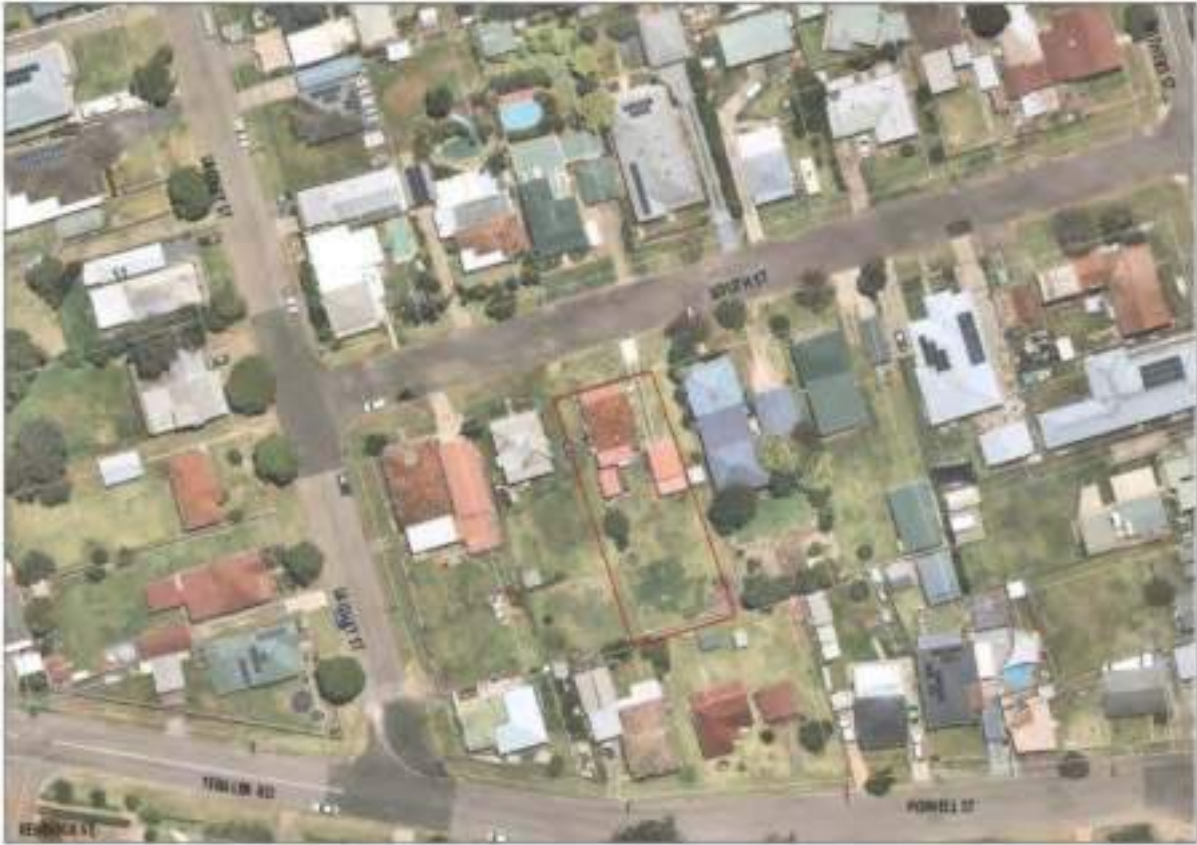
6 SOUTH STREET, WEST WALLSEND 2286

Conservation Area Contribution Level	Est. Construction Date	Previous studies and/or community input
Contributory 2	Early to late 20 th century (broad range)	No prior heritage assessments or research undertaken.
Assessment Text		Observed Modifications
<p>The scale (single-storey) and general style of the dwelling is consistent with that of the streetscape and wider HCA. Dwelling contributes positively to the streetscape and wider HCA, particularly in comparison to Non-Contributory buildings.</p> <p>The dwelling features appropriately proportioned and positioned fenestrations, an appropriate roof form (gabled or hipped) and other features consistent with the architectural character of the area (e.g. front verandah with timber or brick posts, timber detailing, corrugated metal roofing, etc). The contributory value of the dwelling is limited however by either:</p> <ul style="list-style-type: none"> • External modifications that have in some way obscured the style, scale or design intent of the building and have resulted in less physical integrity than Contributory 1 buildings. • Being a later dwelling constructed in an appropriate referential style, but comprising little to no fabric of intrinsic heritage significance. 		<p>The terracotta tile roof is a contemporary modification, with the original roof likely being corrugated iron or Colourbond in style.</p> <p>The faux European pillars are a contemporary addition, likely replacing timber posts.</p> <p>All visible windows are contemporary in style.</p>

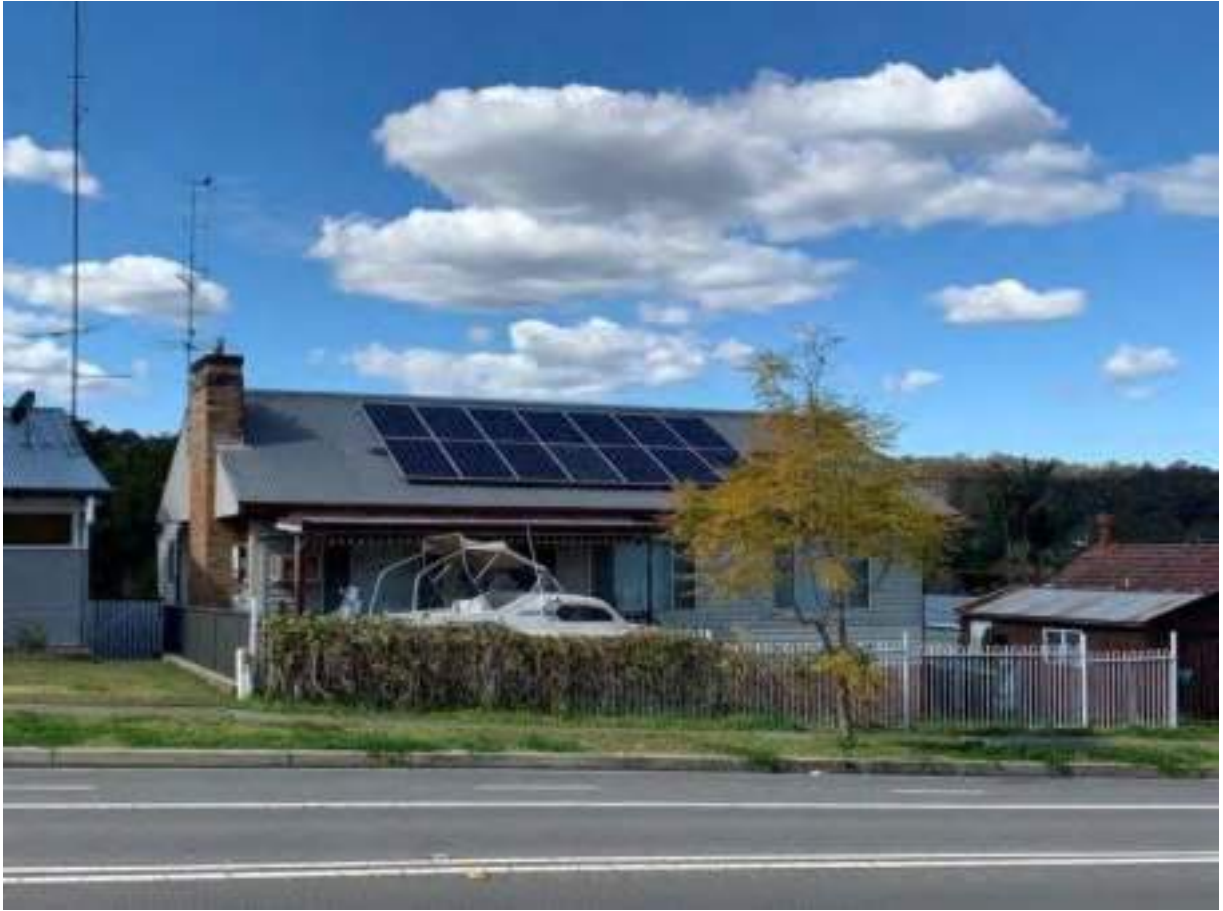
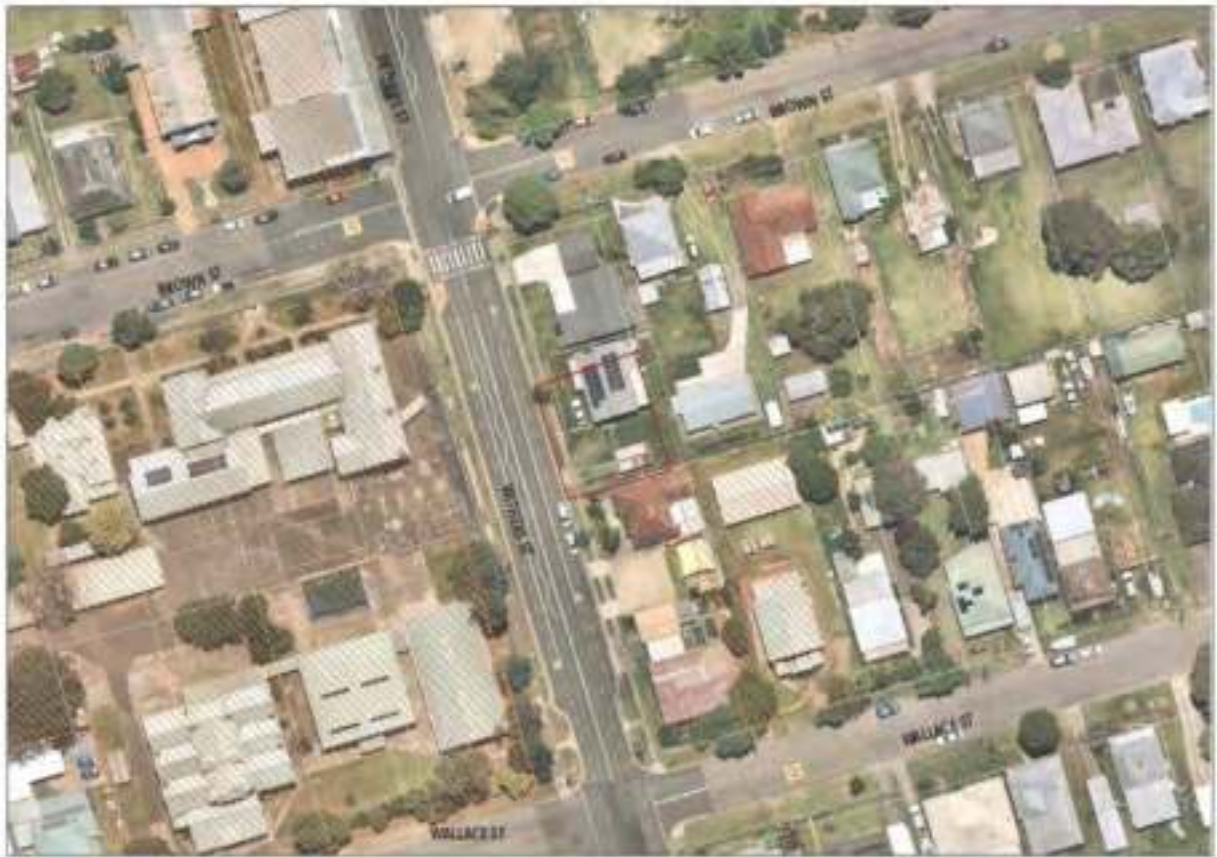
9 WITHERS STREET, WEST WALLSEND 2286

Conservation Area Contribution Level	Est. Construction Date	Previous studies and/or community input
Contributory 2	Early to late 20 th century (broad range)	No prior heritage assessments or research undertaken.
Assessment Text		Observed Modifications
<p>The scale (single-storey) and general style of the dwelling is consistent with that of the streetscape and wider HCA. Dwelling contributes positively to the streetscape and wider HCA, particularly in comparison to Non-Contributory buildings.</p> <p>The dwelling features appropriately proportioned and positioned fenestrations, an appropriate roof form (gabled or hipped) and other features consistent with the architectural character of the area (e.g. front verandah with timber or brick posts, timber detailing, corrugated metal roofing, etc). The contributory value of the dwelling is limited however by either:</p> <ul style="list-style-type: none"> • External modifications that have in some way obscured the style, scale or design intent of the building and have resulted in less physical integrity than Contributory 1 buildings. • Being a later dwelling constructed in an appropriate referential style, but comprising little to no fabric of intrinsic heritage significance. 		<p>Solar panels are highly visible along the western side of the roof.</p>
