APPENDIX 2

Building Assessment Sheets (Inventory Sheets)

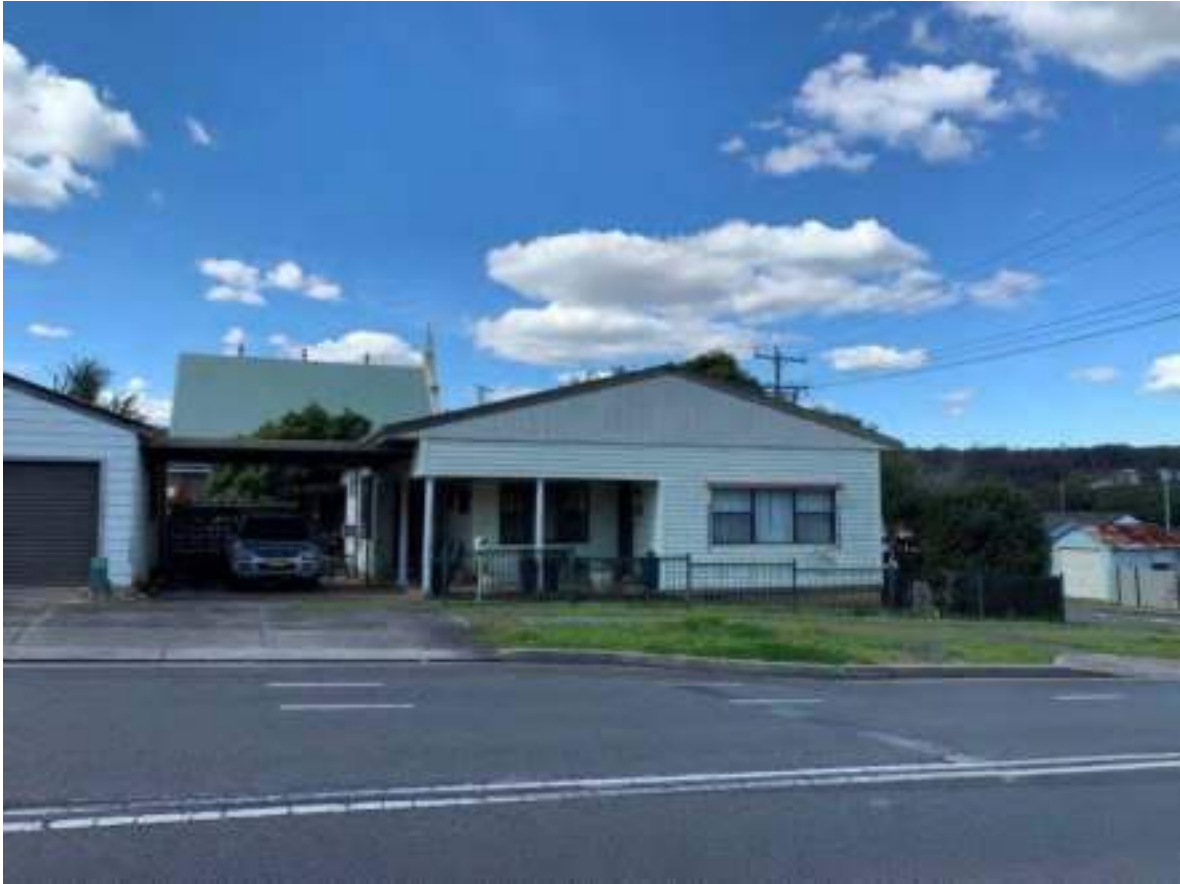
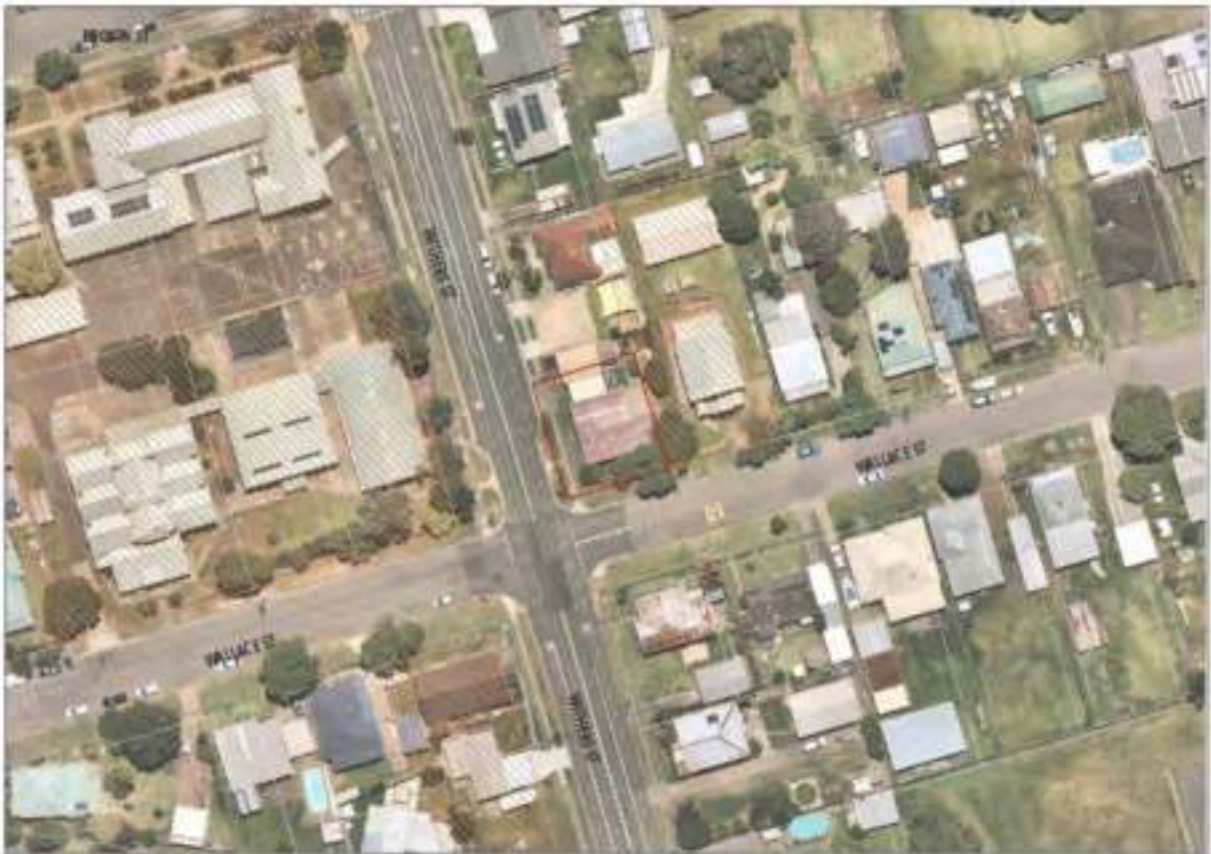
13 WITHERS STREET, WEST WALLSEND 2286

Conservation Area Contribution Level	Est. Construction Date	Previous studies and/or community input
Contributory 2	Early to late 20 th century (broad range)	No prior heritage assessments or research undertaken.
Assessment Text		Observed Modifications
<p>The scale (single-storey) and general style of the dwelling is consistent with that of the streetscape and wider HCA. Dwelling contributes positively to the streetscape and wider HCA, particularly in comparison to Non-Contributory buildings.</p> <p>The dwelling features appropriately proportioned and positioned fenestrations, an appropriate roof form (gabled or hipped) and other features consistent with the architectural character of the area (e.g. front verandah with timber or brick posts, timber detailing, corrugated metal roofing, etc). The contributory value of the dwelling is limited however by either:</p> <ul style="list-style-type: none"> • External modifications that have in some way obscured the style, scale or design intent of the building and have resulted in less physical integrity than Contributory 1 buildings. • Being a later dwelling constructed in an appropriate referential style, but comprising little to no fabric of intrinsic heritage significance. 		<p>The faux European pillars are likely a contemporary modification, replacing original timber posts.</p> <p>A carport has been built on the northern side of the dwelling.</p>

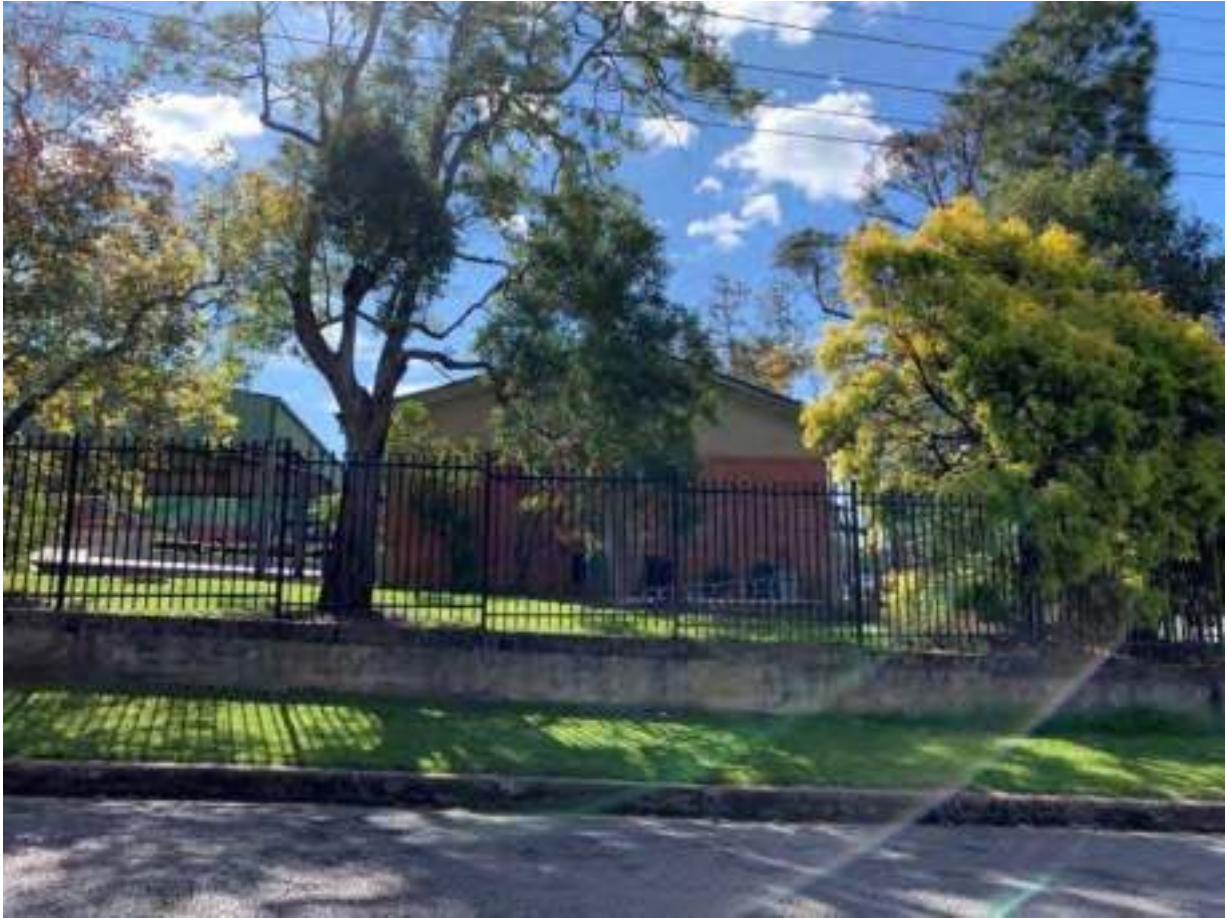
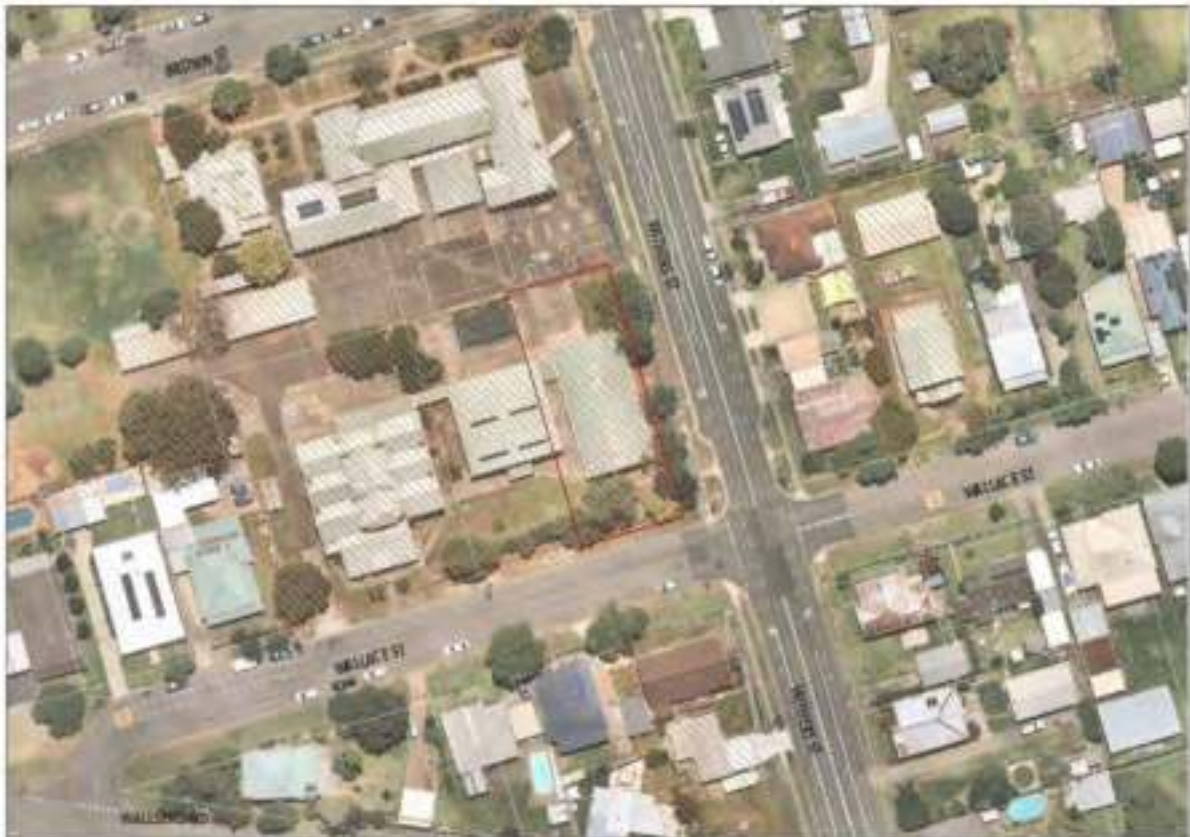
11 WITHERS STREET, WEST WALLSEND 2286

Conservation Area Contribution Level	Est. Construction Date	Previous studies and/or community input
Contributory 2	Early to late 20 th century (broad range)	No prior heritage assessments or research undertaken.
Assessment Text		Observed Modifications
<p>The scale (single-storey) and general style of the dwelling is consistent with that of the streetscape and wider HCA. Dwelling contributes positively to the streetscape and wider HCA, particularly in comparison to Non-Contributory buildings.</p> <p>The dwelling features appropriately proportioned and positioned fenestrations, an appropriate roof form (gabled or hipped) and other features consistent with the architectural character of the area (e.g. front verandah with timber or brick posts, timber detailing, corrugated metal roofing, etc). The contributory value of the dwelling is limited however by either:</p> <ul style="list-style-type: none"> • External modifications that have in some way obscured the style, scale or design intent of the building and have resulted in less physical integrity than Contributory 1 buildings. • Being a later dwelling constructed in an appropriate referential style, but comprising little to no fabric of intrinsic heritage significance. 		<p>School building is partially obscured by high fencing and mature vegetation growth, as well as the distance from the viewing area. No modifications observed.</p>

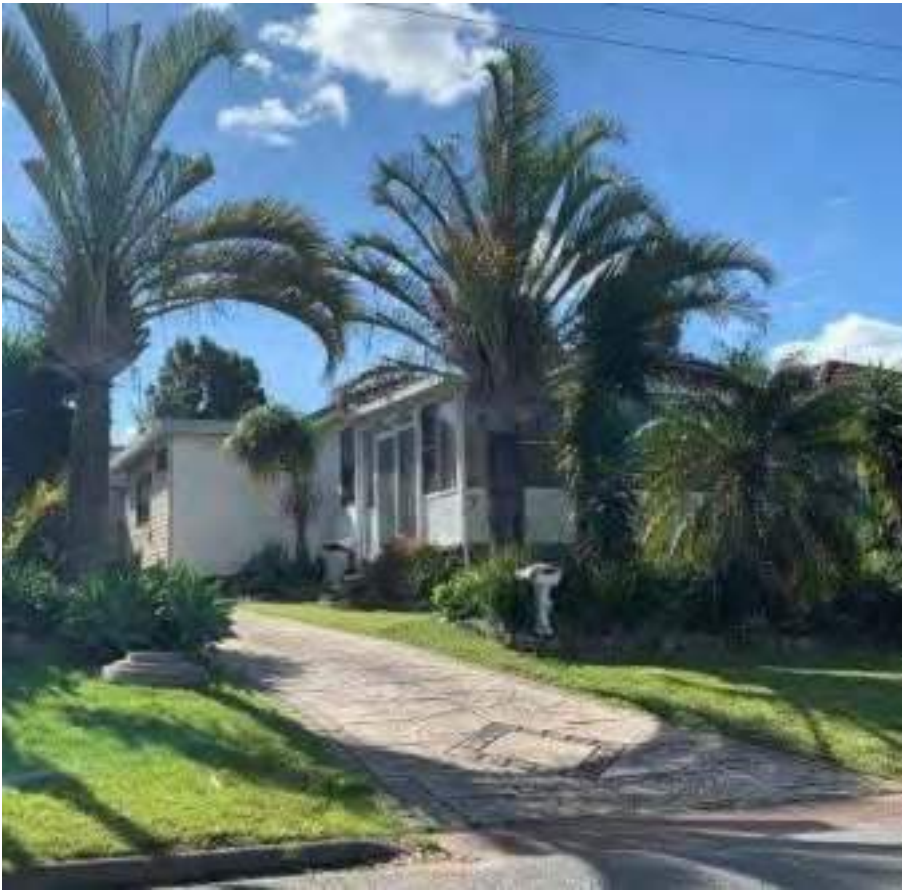
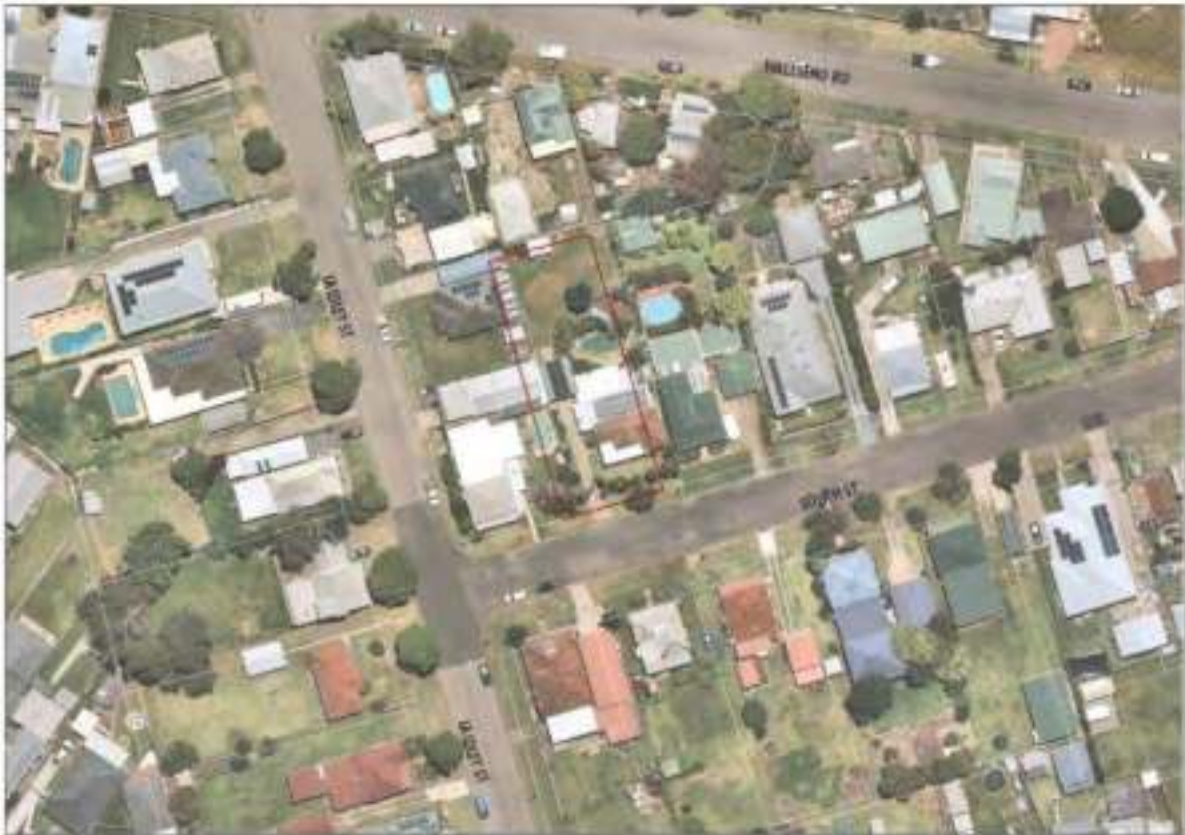
7 SOUTH STREET, WEST WALLSEND 2286

Conservation Area Contribution Level	Est. Construction Date	Previous studies and/or community input
Contributory 2	Early to late 20 th century (broad range)	No prior heritage assessments or research undertaken.
Assessment Text		Observed Modifications
<p>The scale (single-storey) and general style of the dwelling is consistent with that of the streetscape and wider HCA. Dwelling contributes positively to the streetscape and wider HCA, particularly in comparison to Non-Contributory buildings.</p> <p>The dwelling features appropriately proportioned and positioned fenestrations, an appropriate roof form (gabled or hipped) and other features consistent with the architectural character of the area (e.g. front verandah with timber or brick posts, timber detailing, corrugated metal roofing, etc). The contributory value of the dwelling is limited however by either:</p> <ul style="list-style-type: none"> • External modifications that have in some way obscured the style, scale or design intent of the building and have resulted in less physical integrity than Contributory 1 buildings. • Being a later dwelling constructed in an appropriate referential style, but comprising little to no fabric of intrinsic heritage significance. 		<p>The veranda has been fully enclosed to create an additional living area.</p> <p>An extension has been built onto the back northern portion of the dwelling. This is not visible from the street and does not detract from the heritage streetscape.</p> <p>The dwelling is partially obscured by mature vegetation growth.</p>

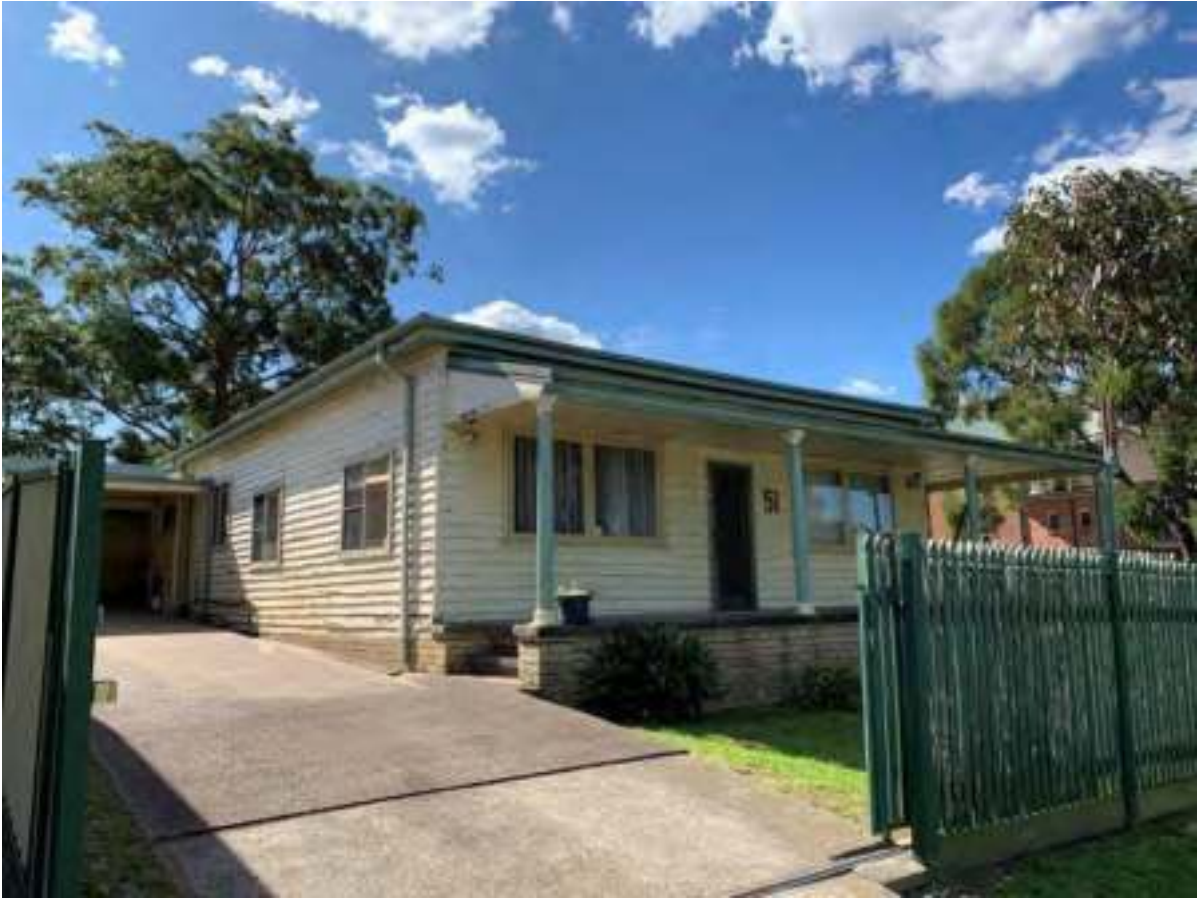
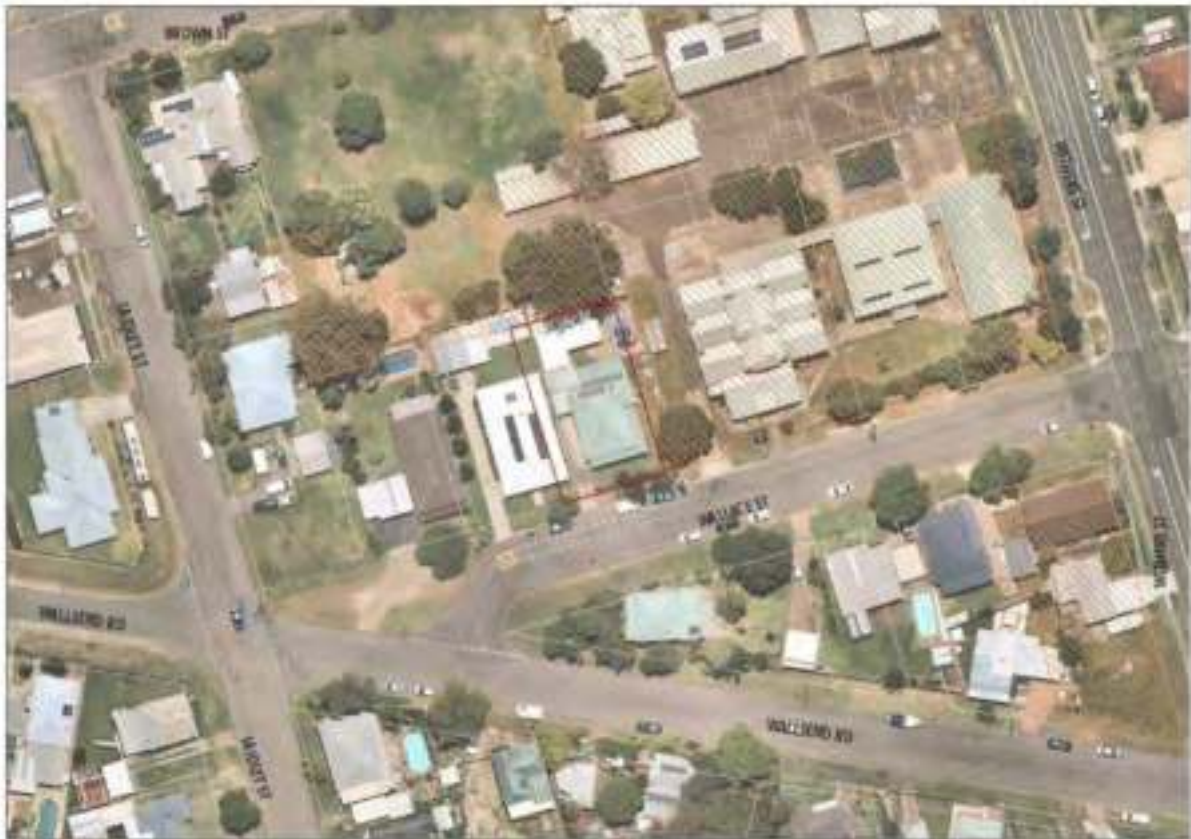
51 WALLACE STREET, WEST WALLSEND 2286

Conservation Area Contribution Level	Est. Construction Date	Previous studies and/or community input
Contributory 2	Early to late 20 th century (broad range)	No prior heritage assessments or research undertaken.
Assessment Text		Observed Modifications
<p>The scale (single-storey) and general style of the dwelling is consistent with that of the streetscape and wider HCA. Dwelling contributes positively to the streetscape and wider HCA, particularly in comparison to Non-Contributory buildings.</p> <p>The dwelling features appropriately proportioned and positioned fenestrations, an appropriate roof form (gabled or hipped) and other features consistent with the architectural character of the area (e.g. front verandah with timber or brick posts, timber detailing, corrugated metal roofing, etc). The contributory value of the dwelling is limited however by either:</p> <ul style="list-style-type: none"> • External modifications that have in some way obscured the style, scale or design intent of the building and have resulted in less physical integrity than Contributory 1 buildings. • Being a later dwelling constructed in an appropriate referential style, but comprising little to no fabric of intrinsic heritage significance. 		<p>The faux European pillars are a contemporary addition.</p> <p>The skillion veranda roof is a contemporary addition, having been extended to wrap around the eastern side of the dwelling.</p> <p>All visible windows and doors are contemporary in style.</p> <p>An extension has been constructed on the northern side of the dwelling. This is not visible from the street and does not detract from the heritage streetscape.</p>

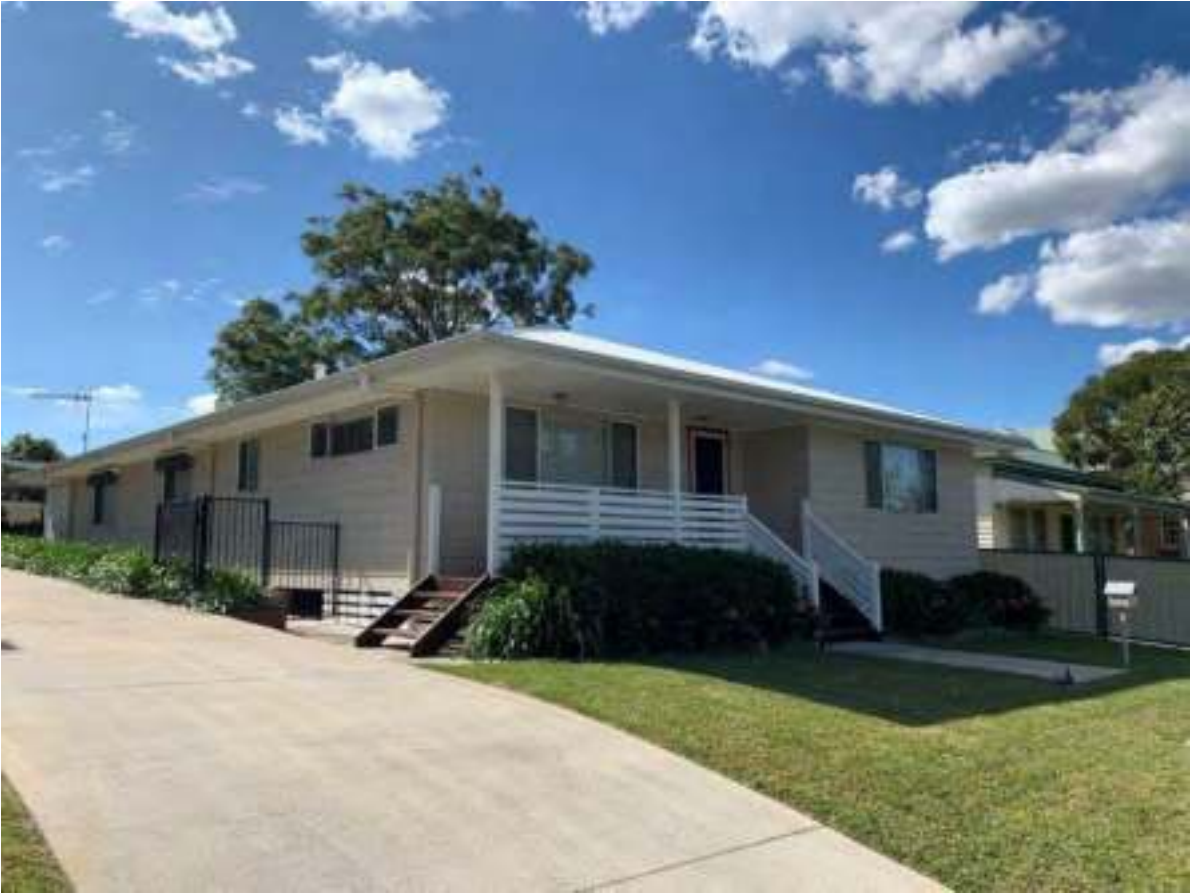
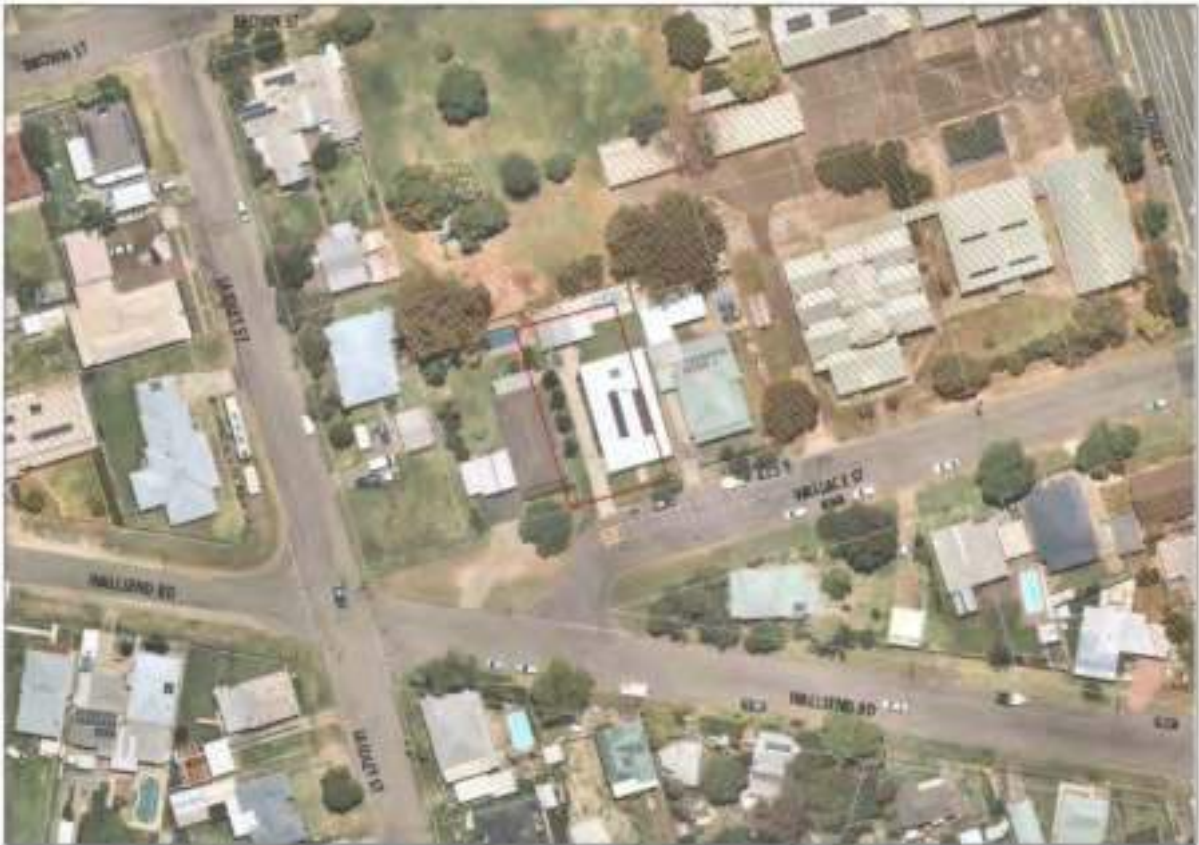
53 WALLACE STREET, WEST WALLSEND 2286

Conservation Area Contribution Level	Est. Construction Date	Previous studies and/or community input
Contributory 2	Early to late 20 th century (broad range)	No prior heritage assessments or research undertaken.
Assessment Text		Observed Modifications
<p>The scale (single-storey) and general style of the dwelling is consistent with that of the streetscape and wider HCA. Dwelling contributes positively to the streetscape and wider HCA, particularly in comparison to Non-Contributory buildings. The dwelling features appropriately proportioned and positioned fenestrations, an appropriate roof form (gabled or hipped) and other features consistent with the architectural character of the area (e.g. front verandah with timber or brick posts, timber detailing, corrugated metal roofing, etc). The contributory value of the dwelling is limited however by either:</p> <ul style="list-style-type: none"> • External modifications that have in some way obscured the style, scale or design intent of the building and have resulted in less physical integrity than Contributory 1 buildings. • Being a later dwelling constructed in an appropriate referential style, but comprising little to no fabric of intrinsic heritage significance. 		<p>All visible windows are contemporary in style.</p> <p>The timber balustrade is likely a recent modification, replacing a similar timber design.</p>

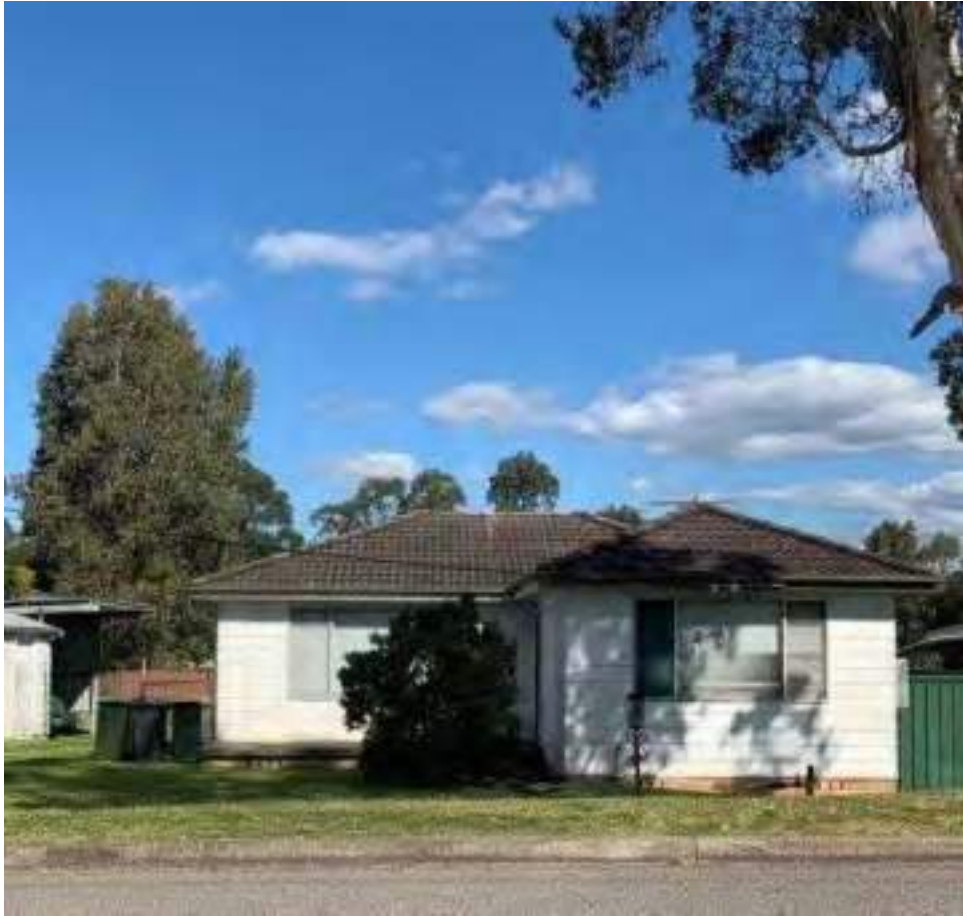
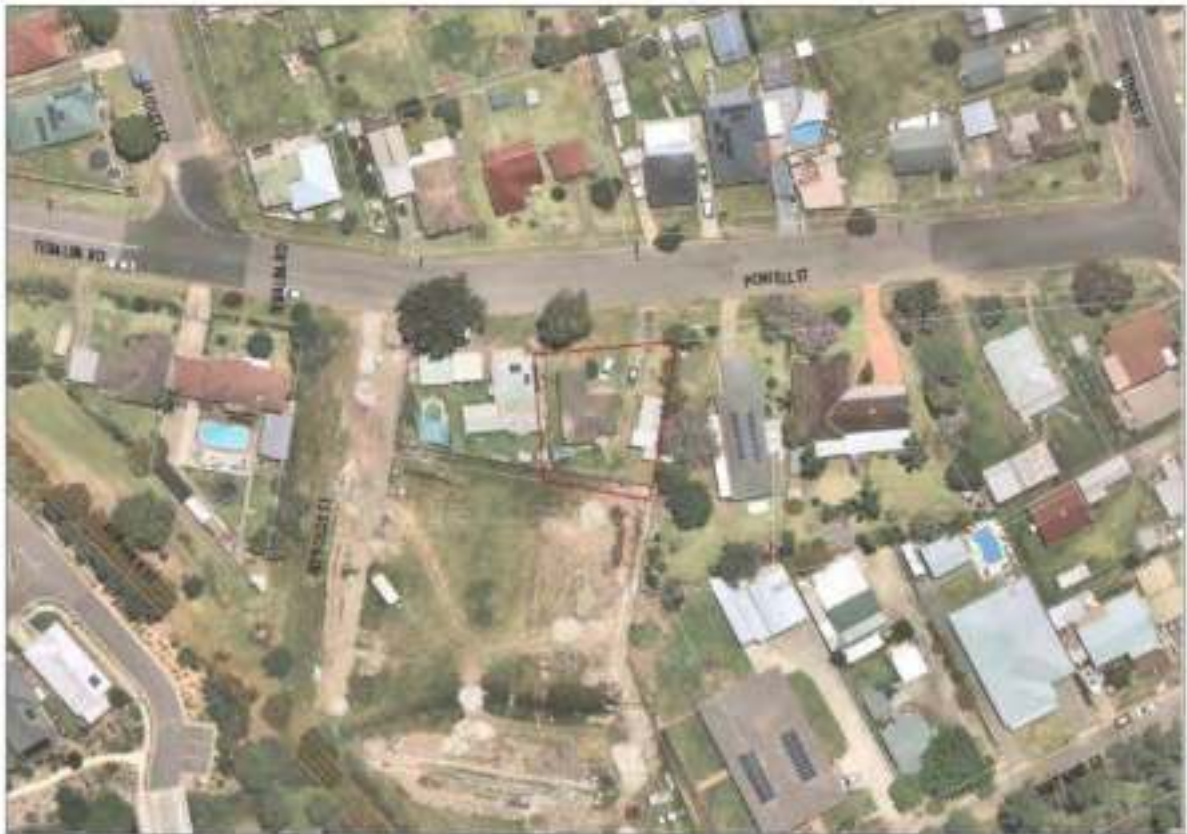
6 POWELL STREET, WEST WALLSEND 2286

Conservation Area Contribution Level	Est. Construction Date	Previous studies and/or community input
Contributory 2	Early to late 20 th century (broad range)	No prior heritage assessments or research undertaken.
Assessment Text		Observed Modifications
<p>The scale (single-storey) and general style of the dwelling is consistent with that of the streetscape and wider HCA. Dwelling contributes positively to the streetscape and wider HCA, particularly in comparison to Non-Contributory buildings.</p> <p>The dwelling features appropriately proportioned and positioned fenestrations, an appropriate roof form (gabled or hipped) and other features consistent with the architectural character of the area (e.g. front verandah with timber or brick posts, timber detailing, corrugated metal roofing, etc). The contributory value of the dwelling is limited however by either:</p> <ul style="list-style-type: none"> • External modifications that have in some way obscured the style, scale or design intent of the building and have resulted in less physical integrity than Contributory 1 buildings. • Being a later dwelling constructed in an appropriate referential style, but comprising little to no fabric of intrinsic heritage significance. 		No modifications observed.

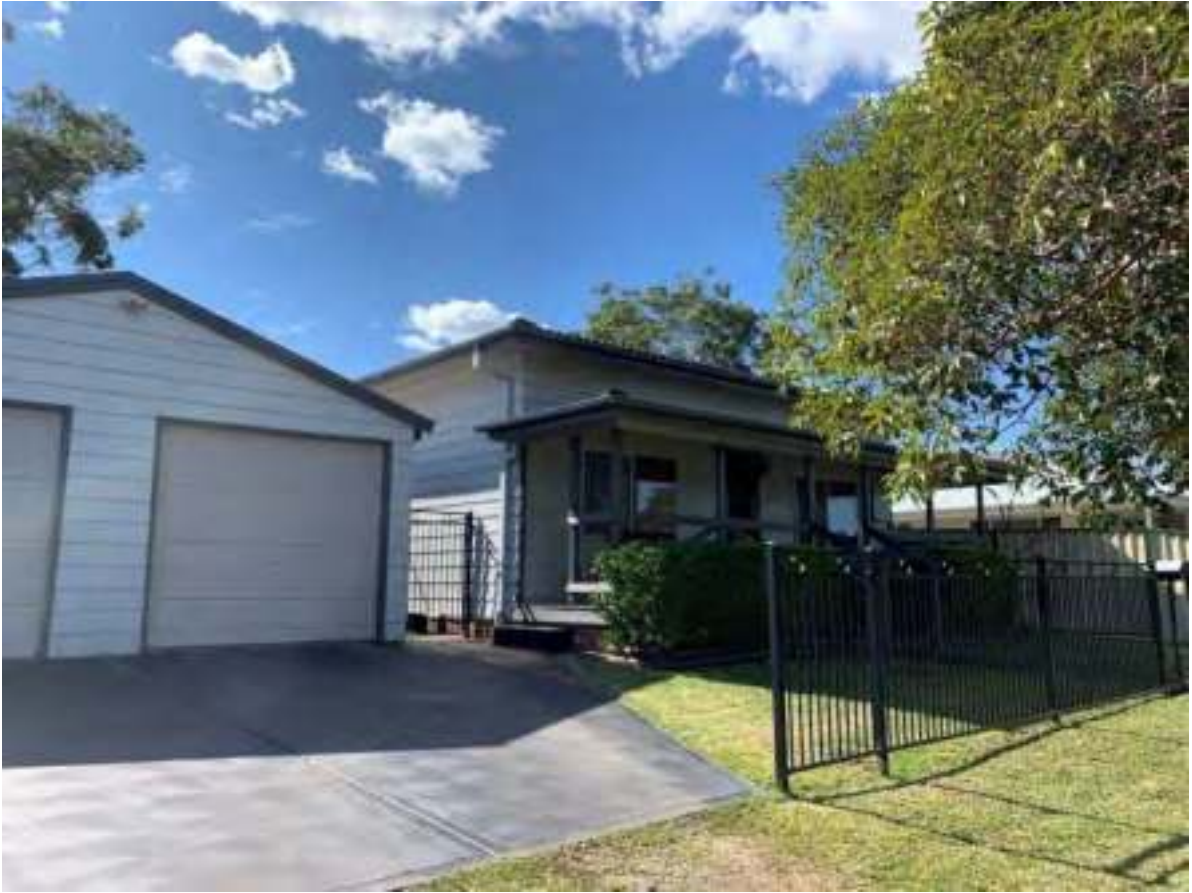
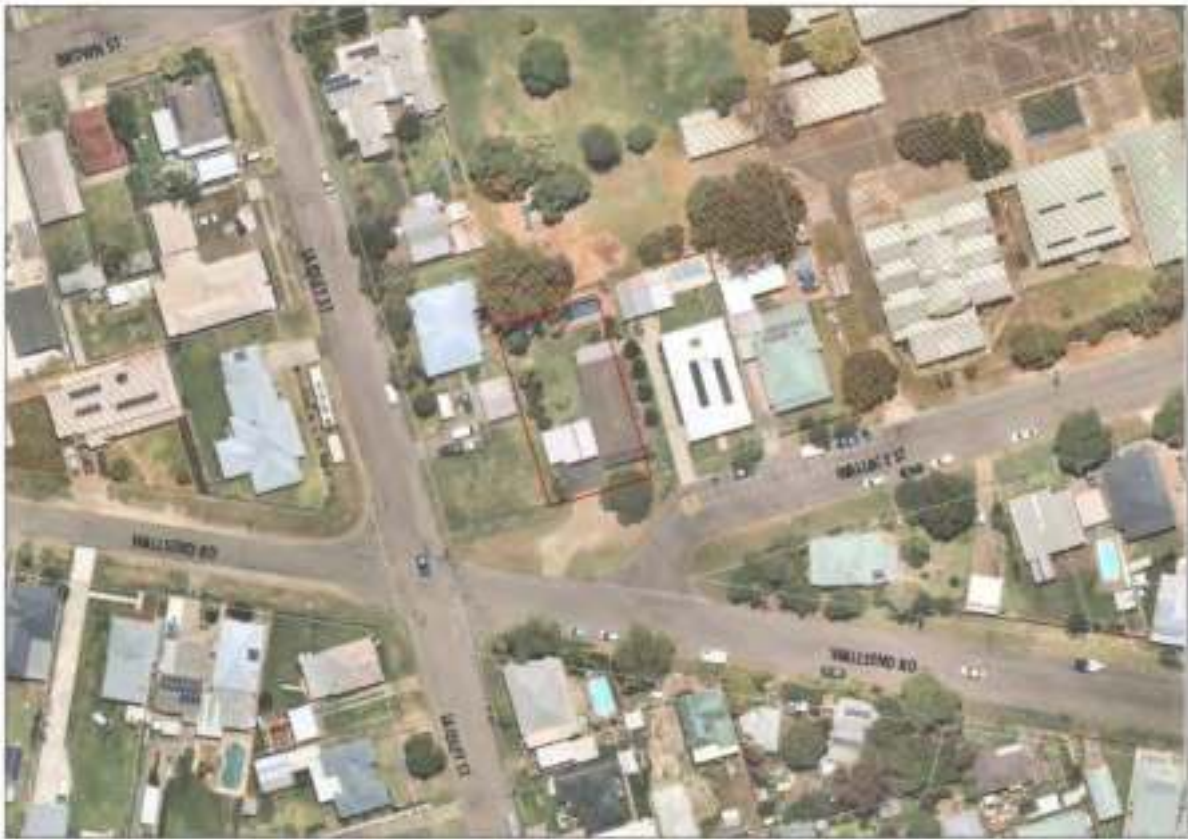
55 WALLACE STREET, WEST WALLSEND 2286

Conservation Area Contribution Level	Est. Construction Date	Previous studies and/or community input
Contributory 2	Early to late 20 th century (broad range)	No prior heritage assessments or research undertaken.
Assessment Text		Observed Modifications
<p>The scale (single-storey) and general style of the dwelling is consistent with that of the streetscape and wider HCA. Dwelling contributes positively to the streetscape and wider HCA, particularly in comparison to Non-Contributory buildings.</p> <p>The dwelling features appropriately proportioned and positioned fenestrations, an appropriate roof form (gabled or hipped) and other features consistent with the architectural character of the area (e.g. front verandah with timber or brick posts, timber detailing, corrugated metal roofing, etc). The contributory value of the dwelling is limited however by either:</p> <ul style="list-style-type: none"> • External modifications that have in some way obscured the style, scale or design intent of the building and have resulted in less physical integrity than Contributory 1 buildings. • Being a later dwelling constructed in an appropriate referential style, but comprising little to no fabric of intrinsic heritage significance. 		<p>A double garage has been built on the western side of the dwelling.</p> <p>The timber balustrade is potentially contemporary modification.</p>

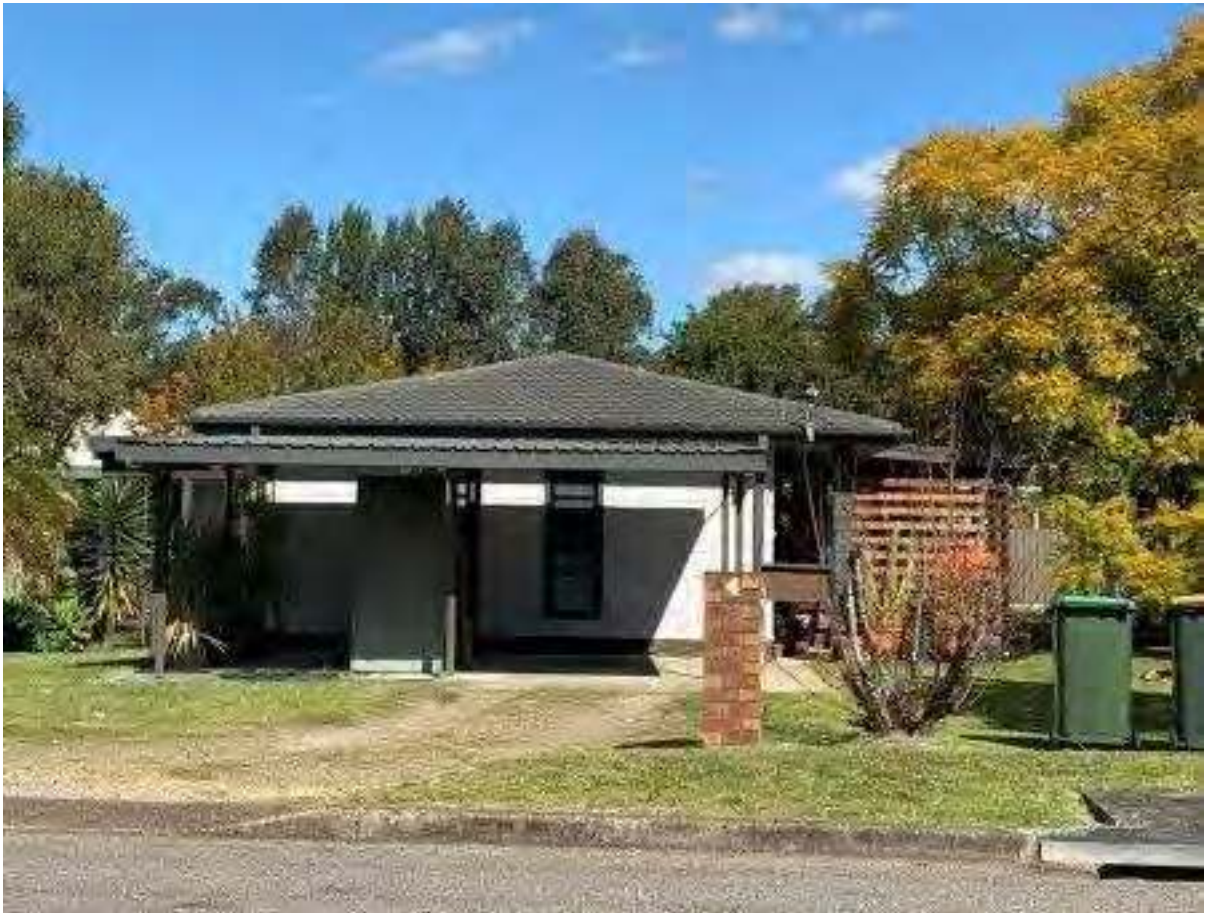
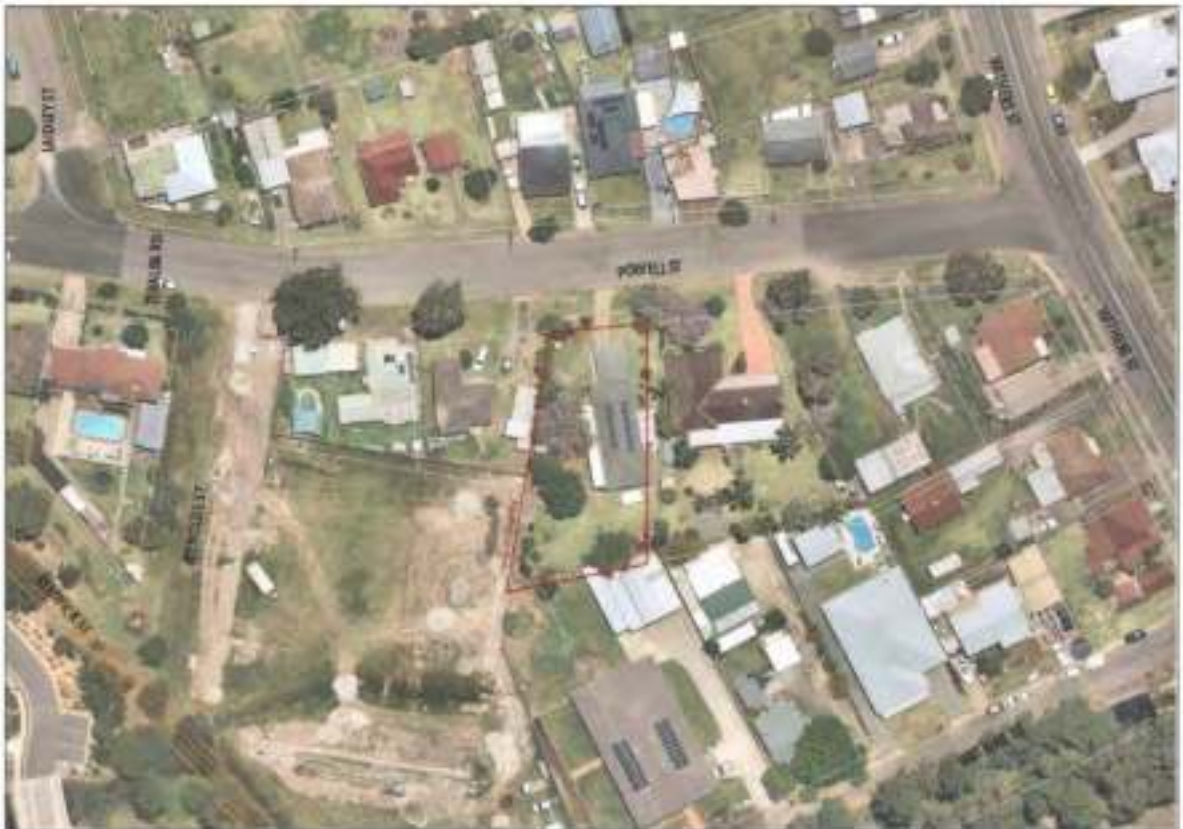
4 POWELL STREET, WEST WALLSEND 2286

Conservation Area Contribution Level	Est. Construction Date	Previous studies and/or community input
Contributory 2	Early to late 20 th century (broad range)	No prior heritage assessments or research undertaken.
Assessment Text		Observed Modifications
<p>The scale (single-storey) and general style of the dwelling is consistent with that of the streetscape and wider HCA. Dwelling contributes positively to the streetscape and wider HCA, particularly in comparison to Non-Contributory buildings.</p> <p>The dwelling features appropriately proportioned and positioned fenestrations, an appropriate roof form (gabled or hipped) and other features consistent with the architectural character of the area (e.g. front verandah with timber or brick posts, timber detailing, corrugated metal roofing, etc). The contributory value of the dwelling is limited however by either:</p> <ul style="list-style-type: none"> • External modifications that have in some way obscured the style, scale or design intent of the building and have resulted in less physical integrity than Contributory 1 buildings. • Being a later dwelling constructed in an appropriate referential style, but comprising little to no fabric of intrinsic heritage significance. 		<p>A carport has been built at the front northern side of the dwelling, partially obscuring the dwelling.</p> <p>All visible windows are contemporary in style.</p>

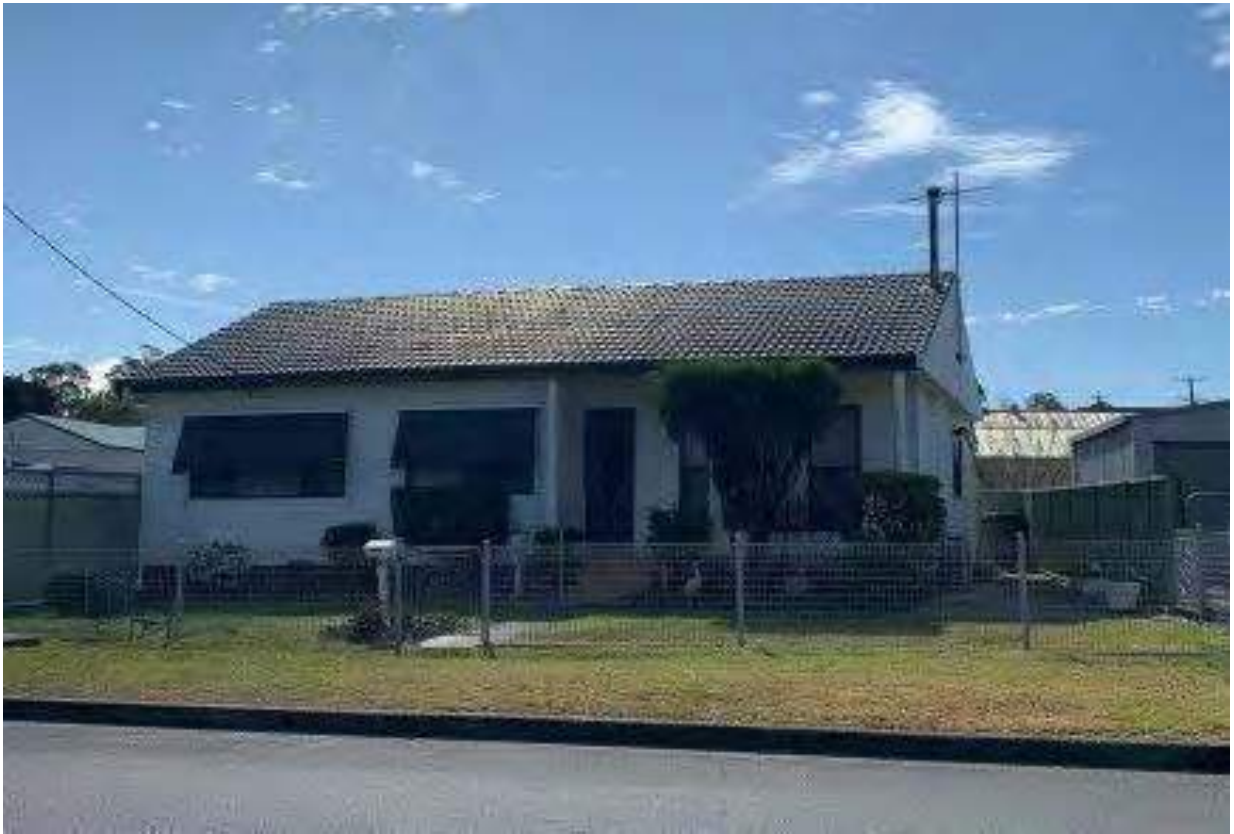
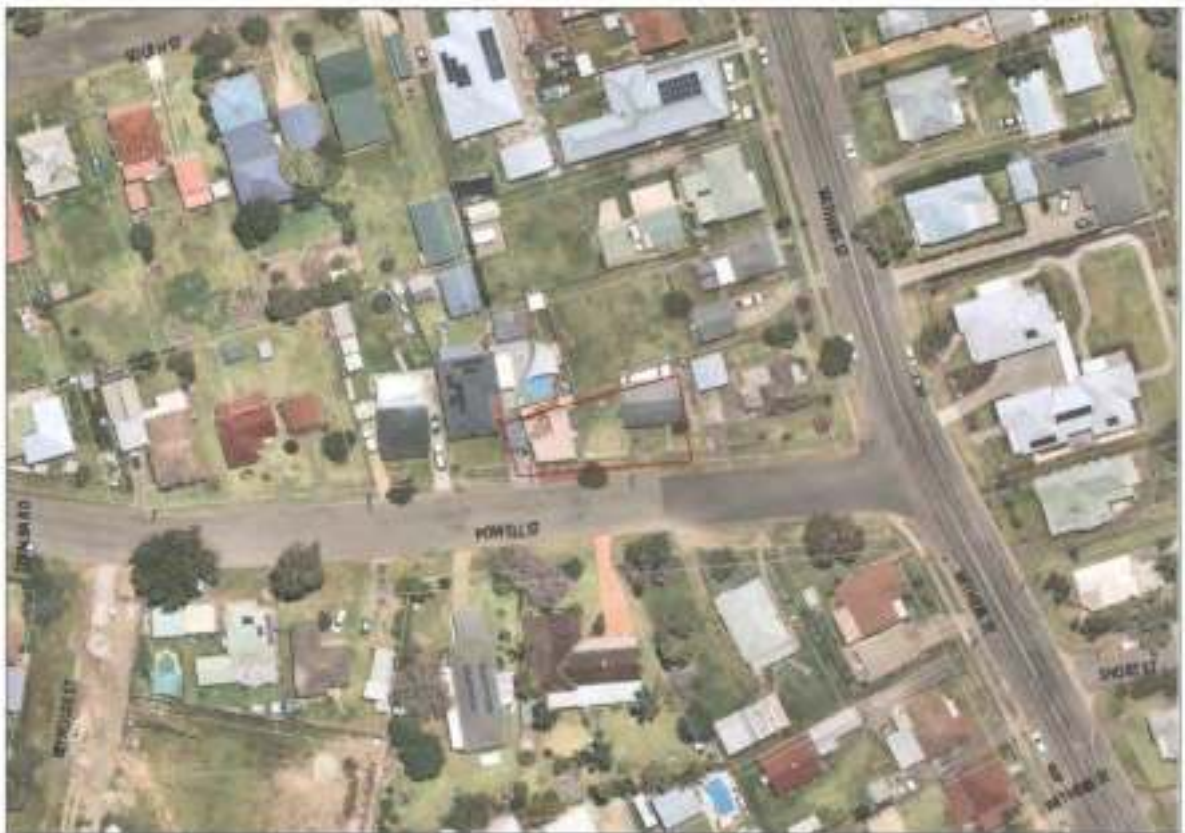
3 POWELL STREET, WEST WALLSEND 2286

Conservation Area Contribution Level	Est. Construction Date	Previous studies and/or community input
Contributory 2	Early to late 20 th century (broad range)	No prior heritage assessments or research undertaken.
Assessment Text		Observed Modifications
<p>The scale (single-storey) and general style of the dwelling is consistent with that of the streetscape and wider HCA. Dwelling contributes positively to the streetscape and wider HCA, particularly in comparison to Non-Contributory buildings.</p> <p>The dwelling features appropriately proportioned and positioned fenestrations, an appropriate roof form (gabled or hipped) and other features consistent with the architectural character of the area (e.g. front verandah with timber or brick posts, timber detailing, corrugated metal roofing, etc). The contributory value of the dwelling is limited however by either:</p> <ul style="list-style-type: none"> • External modifications that have in some way obscured the style, scale or design intent of the building and have resulted in less physical integrity than Contributory 1 buildings. • Being a later dwelling constructed in an appropriate referential style, but comprising little to no fabric of intrinsic heritage significance. 		No modifications observed.
