APPENDIX 2

Building Assessment Sheets (Inventory Sheets)

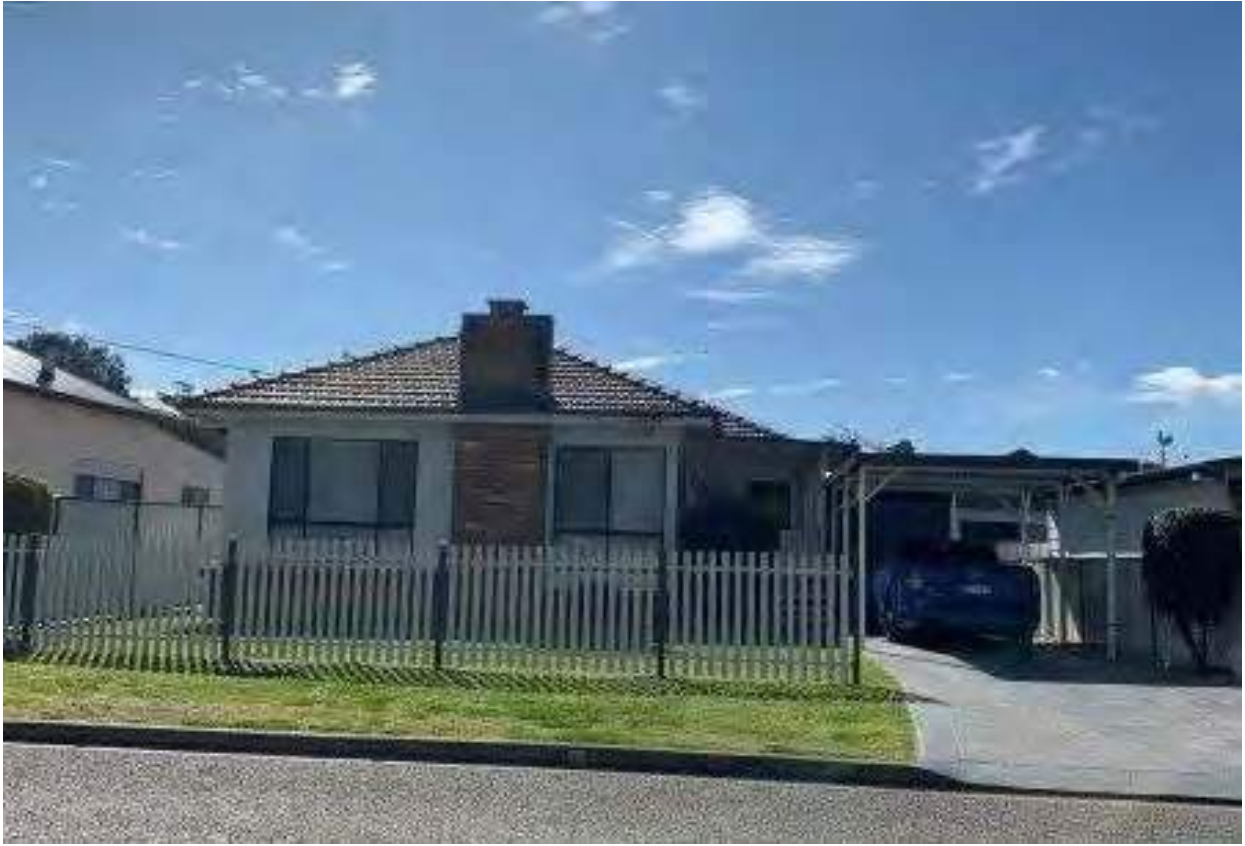
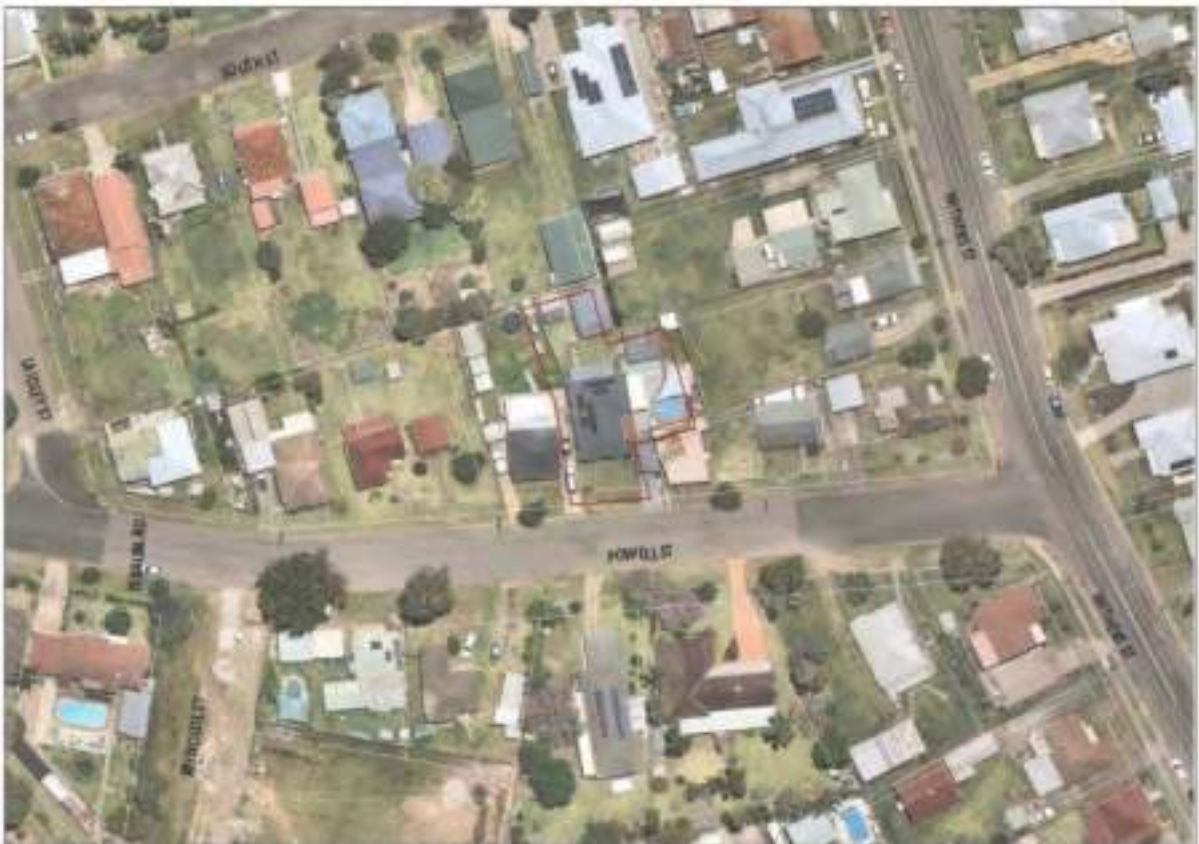
3A POWELL STREET, WEST WALLSEND 2286

Conservation Area Contribution Level	Est. Construction Date	Previous studies and/or community input
Contributory 2	Early to late 20 th century (broad range)	No prior heritage assessments or research undertaken.
Assessment Text		Observed Modifications
<p>The scale (single-storey) and general style of the dwelling is consistent with that of the streetscape and wider HCA. Dwelling contributes positively to the streetscape and wider HCA, particularly in comparison to Non-Contributory buildings.</p> <p>The dwelling features appropriately proportioned and positioned fenestrations, an appropriate roof form (gabled or hipped) and other features consistent with the architectural character of the area (e.g. front verandah with timber or brick posts, timber detailing, corrugated metal roofing, etc). The contributory value of the dwelling is limited however by either:</p> <ul style="list-style-type: none"> • External modifications that have in some way obscured the style, scale or design intent of the building and have resulted in less physical integrity than Contributory 1 buildings. • Being a later dwelling constructed in an appropriate referential style, but comprising little to no fabric of intrinsic heritage significance. 		<p>A carport has been built onto the western side of the dwelling.</p>

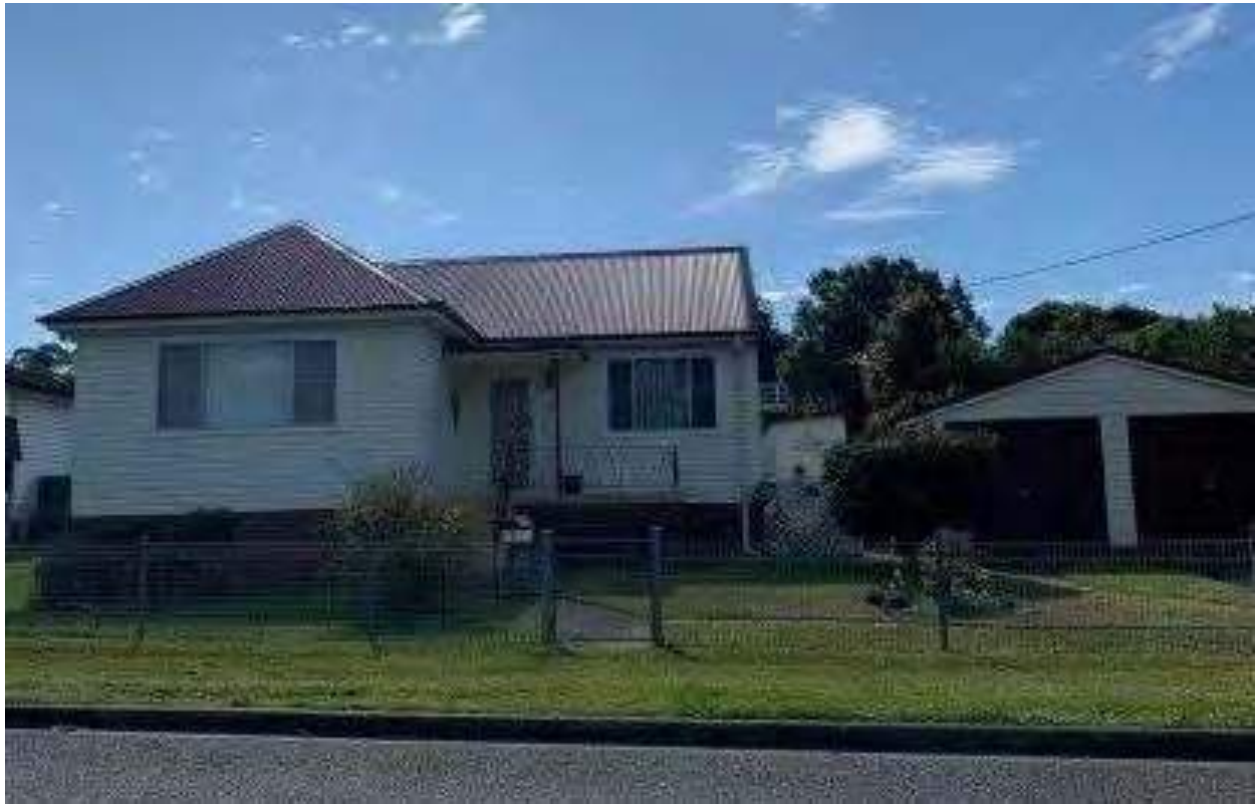
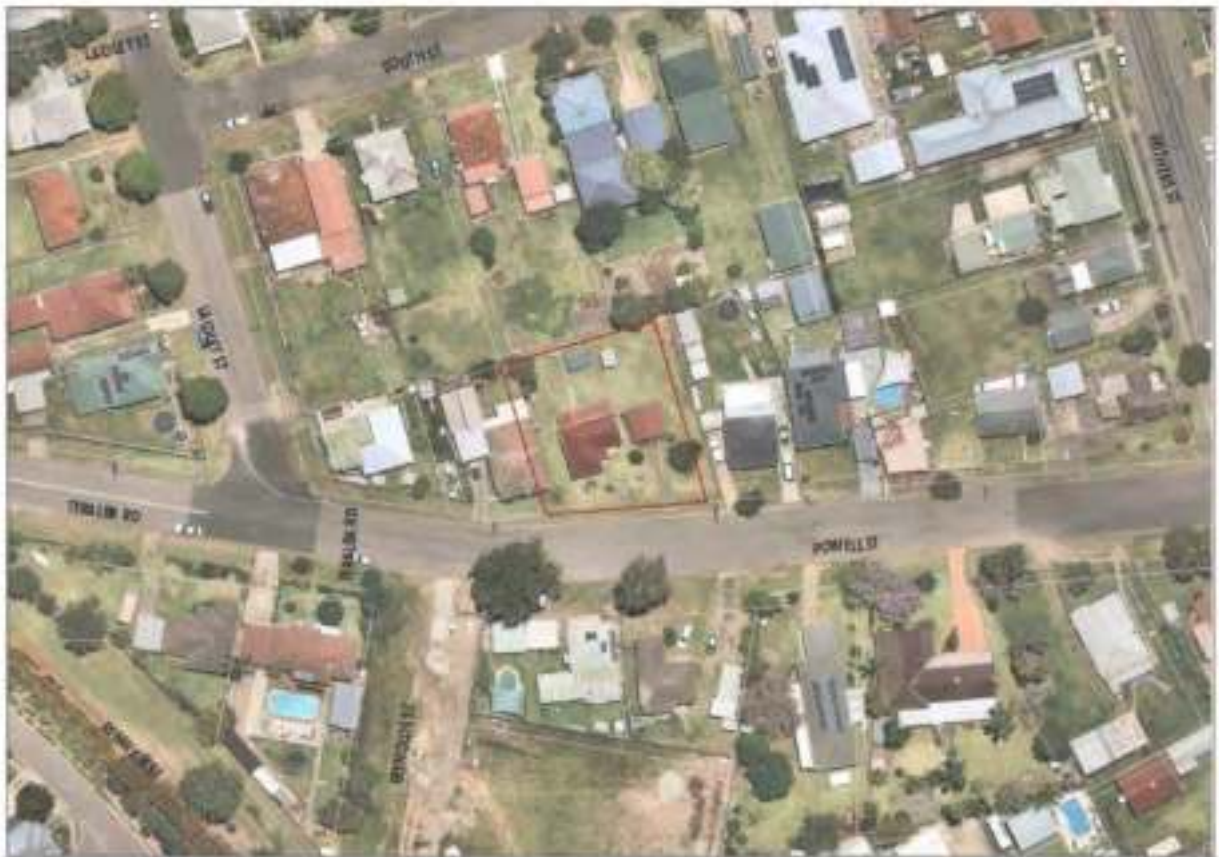
7 POWELL STREET, WEST WALLSEND 2286

Conservation Area Contribution Level	Est. Construction Date	Previous studies and/or community input
Contributory 2	Early to late 20 th century (broad range)	No prior heritage assessments or research undertaken.
Assessment Text		Observed Modifications
<p>The scale (single-storey) and general style of the dwelling is consistent with that of the streetscape and wider HCA. Dwelling contributes positively to the streetscape and wider HCA, particularly in comparison to Non-Contributory buildings.</p> <p>The dwelling features appropriately proportioned and positioned fenestrations, an appropriate roof form (gabled or hipped) and other features consistent with the architectural character of the area (e.g. front verandah with timber or brick posts, timber detailing, corrugated metal roofing, etc). The contributory value of the dwelling is limited however by either:</p> <ul style="list-style-type: none"> • External modifications that have in some way obscured the style, scale or design intent of the building and have resulted in less physical integrity than Contributory 1 buildings. • Being a later dwelling constructed in an appropriate referential style, but comprising little to no fabric of intrinsic heritage significance. 		<p>The metal balustrade is a contemporary addition, likely replacing an earlier timber design.</p>

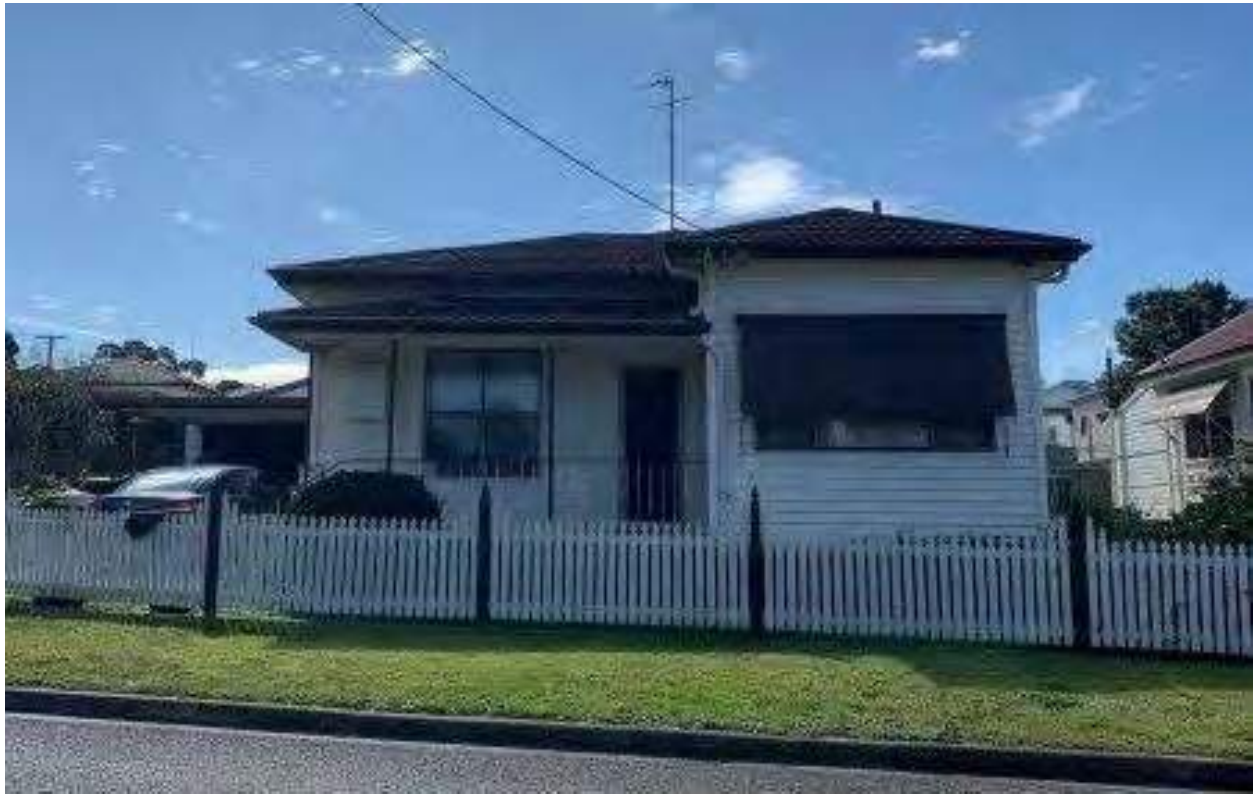
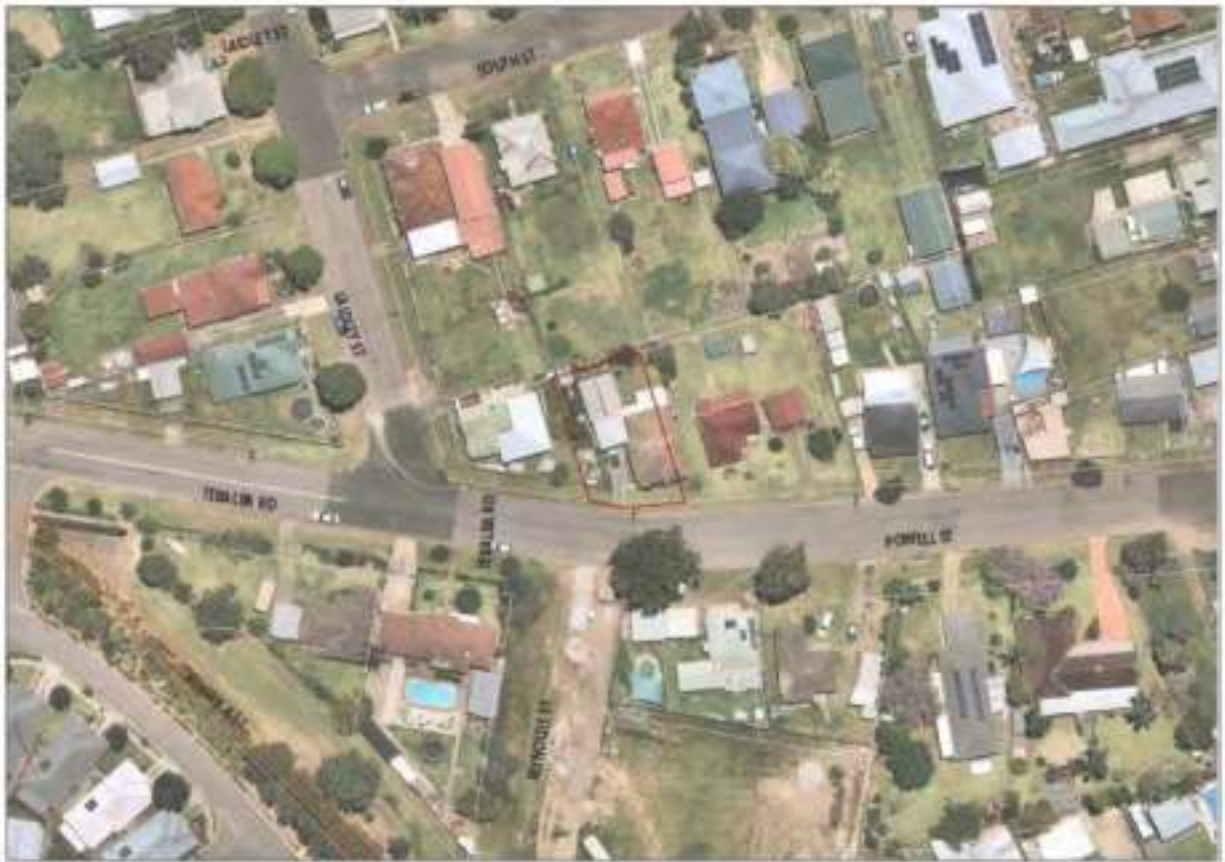
9 POWELL STREET, WEST WALLSEND 2286

Conservation Area Contribution Level	Est. Construction Date	Previous studies and/or community input
Contributory 2	Early to late 20 th century (broad range)	No prior heritage assessments or research undertaken.
Assessment Text		Observed Modifications
<p>The scale (single-storey) and general style of the dwelling is consistent with that of the streetscape and wider HCA. Dwelling contributes positively to the streetscape and wider HCA, particularly in comparison to Non-Contributory buildings.</p> <p>The dwelling features appropriately proportioned and positioned fenestrations, an appropriate roof form (gabled or hipped) and other features consistent with the architectural character of the area (e.g. front verandah with timber or brick posts, timber detailing, corrugated metal roofing, etc). The contributory value of the dwelling is limited however by either:</p> <ul style="list-style-type: none"> • External modifications that have in some way obscured the style, scale or design intent of the building and have resulted in less physical integrity than Contributory 1 buildings. • Being a later dwelling constructed in an appropriate referential style, but comprising little to no fabric of intrinsic heritage significance. 		<p>The visible windows are contemporary in style, with canvas awnings installed.</p> <p>The metal balustrade is a contemporary addition, likely replacing a previous timber design.</p>

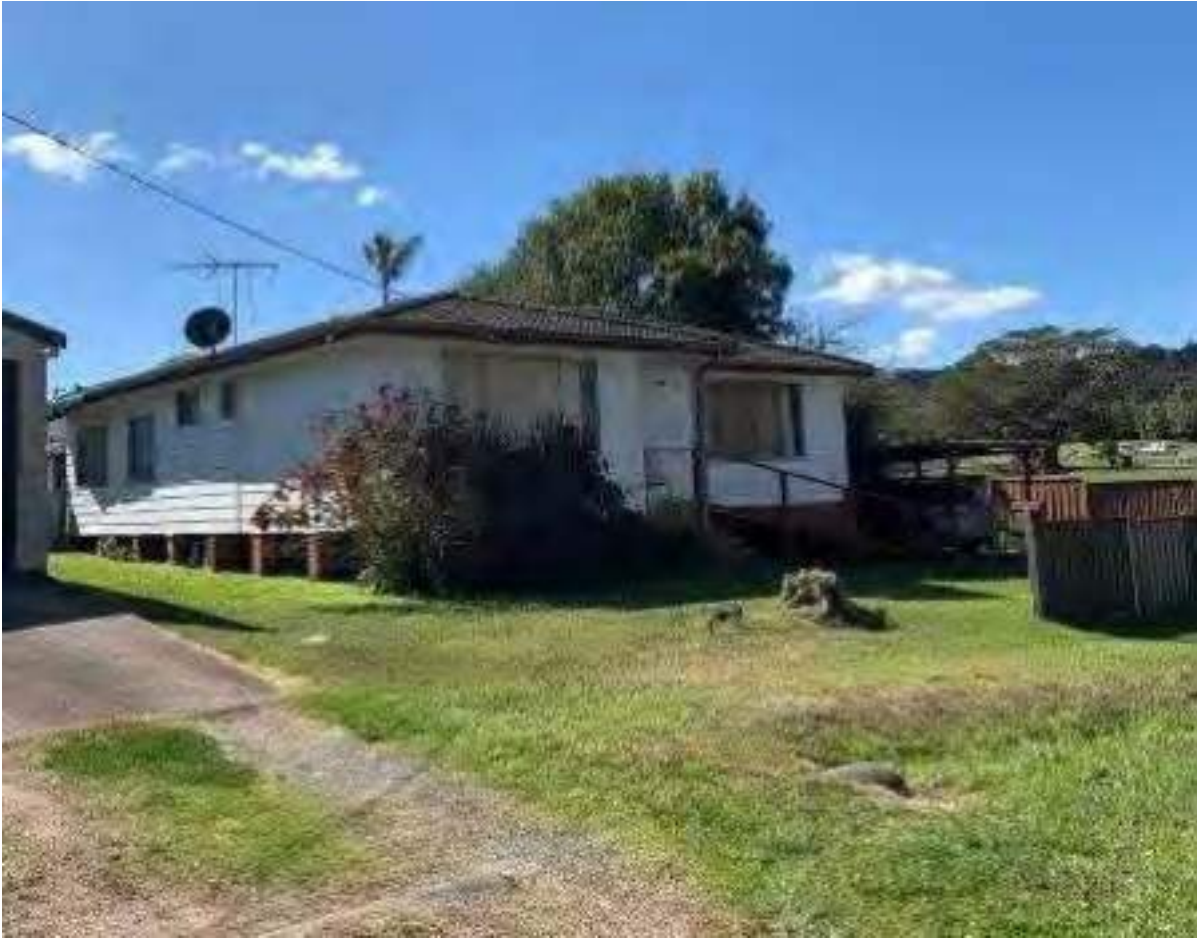
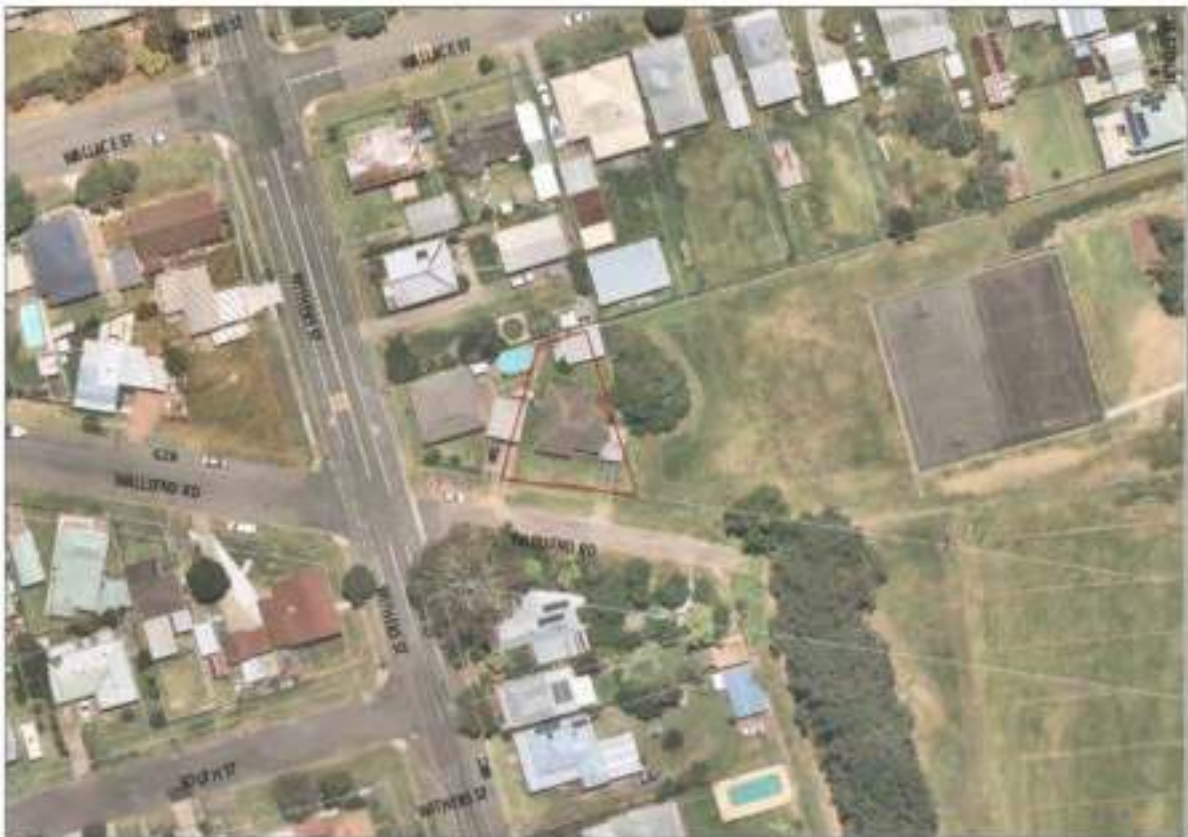
1 WALLSEND ROAD, WEST WALLSEND 2286

Conservation Area Contribution Level	Est. Construction Date	Previous studies and/or community input
Contributory 2	Early to late 20 th century (broad range)	No prior heritage assessments or research undertaken.
Assessment Text		Observed Modifications
<p>The scale (single-storey) and general style of the dwelling is consistent with that of the streetscape and wider HCA. Dwelling contributes positively to the streetscape and wider HCA, particularly in comparison to Non-Contributory buildings.</p> <p>The dwelling features appropriately proportioned and positioned fenestrations, an appropriate roof form (gabled or hipped) and other features consistent with the architectural character of the area (e.g. front verandah with timber or brick posts, timber detailing, corrugated metal roofing, etc). The contributory value of the dwelling is limited however by either:</p> <ul style="list-style-type: none"> • External modifications that have in some way obscured the style, scale or design intent of the building and have resulted in less physical integrity than Contributory 1 buildings. • Being a later dwelling constructed in an appropriate referential style, but comprising little to no fabric of intrinsic heritage significance. 		<p>A timber ramp and support rail has been constructed at the front southern side of the dwelling.</p>

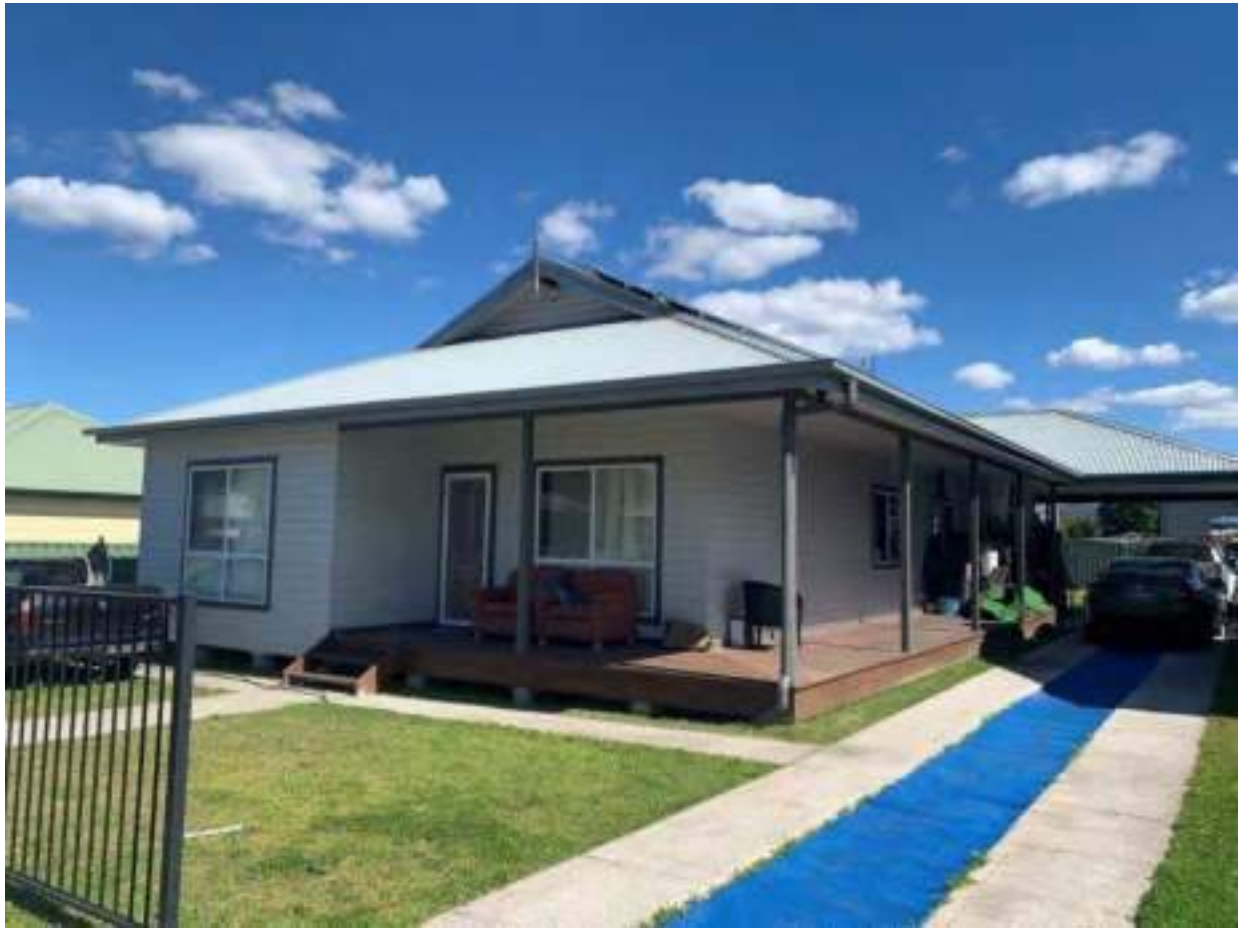
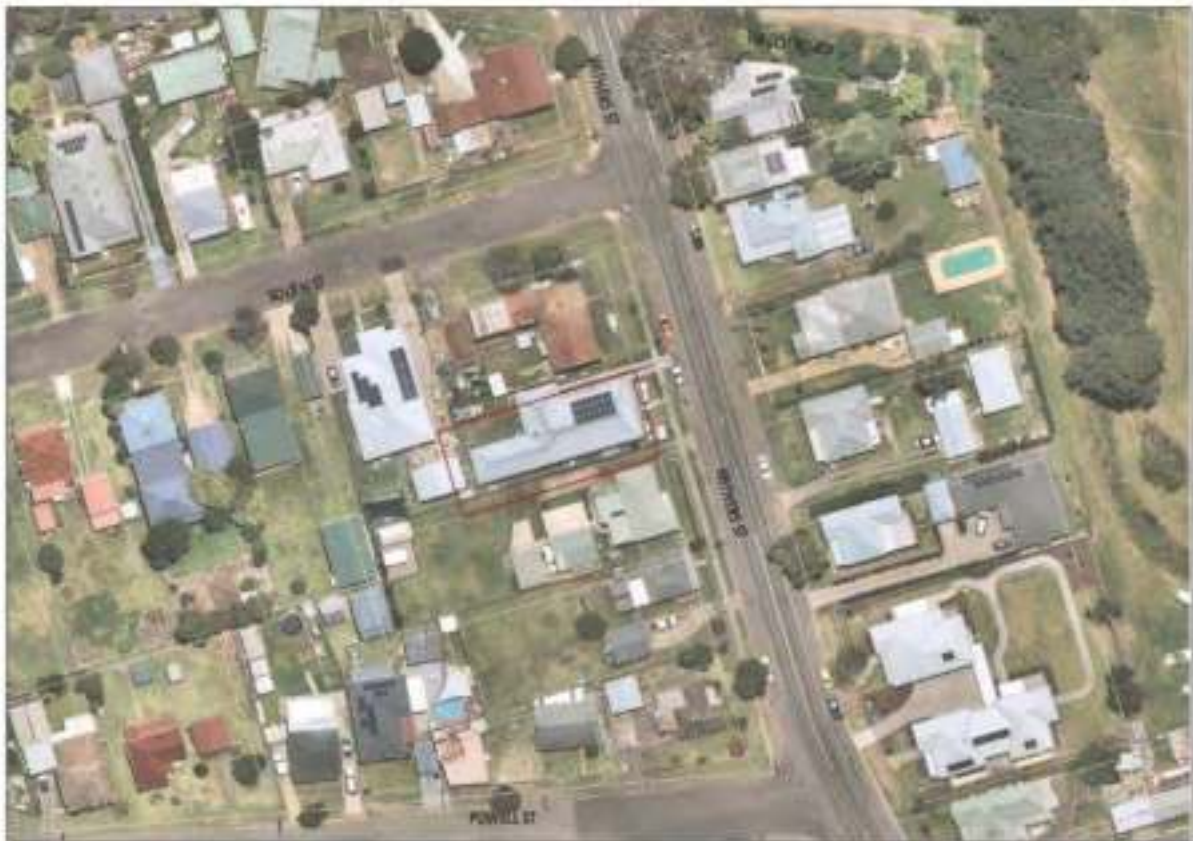
14 WITHERS STREET, WEST WALLSEND 2286

Conservation Area Contribution Level	Est. Construction Date	Previous studies and/or community input
Contributory 2	Early to late 20 th century (broad range)	No prior heritage assessments or research undertaken.
Assessment Text		Observed Modifications
<p>The scale (single-storey) and general style of the dwelling is consistent with that of the streetscape and wider HCA. Dwelling contributes positively to the streetscape and wider HCA, particularly in comparison to Non-Contributory buildings.</p> <p>The dwelling features appropriately proportioned and positioned fenestrations, an appropriate roof form (gabled or hipped) and other features consistent with the architectural character of the area (e.g. front verandah with timber or brick posts, timber detailing, corrugated metal roofing, etc). The contributory value of the dwelling is limited however by either:</p> <ul style="list-style-type: none"> • External modifications that have in some way obscured the style, scale or design intent of the building and have resulted in less physical integrity than Contributory 1 buildings. • Being a later dwelling constructed in an appropriate referential style, but comprising little to no fabric of intrinsic heritage significance. 		No modifications observed.

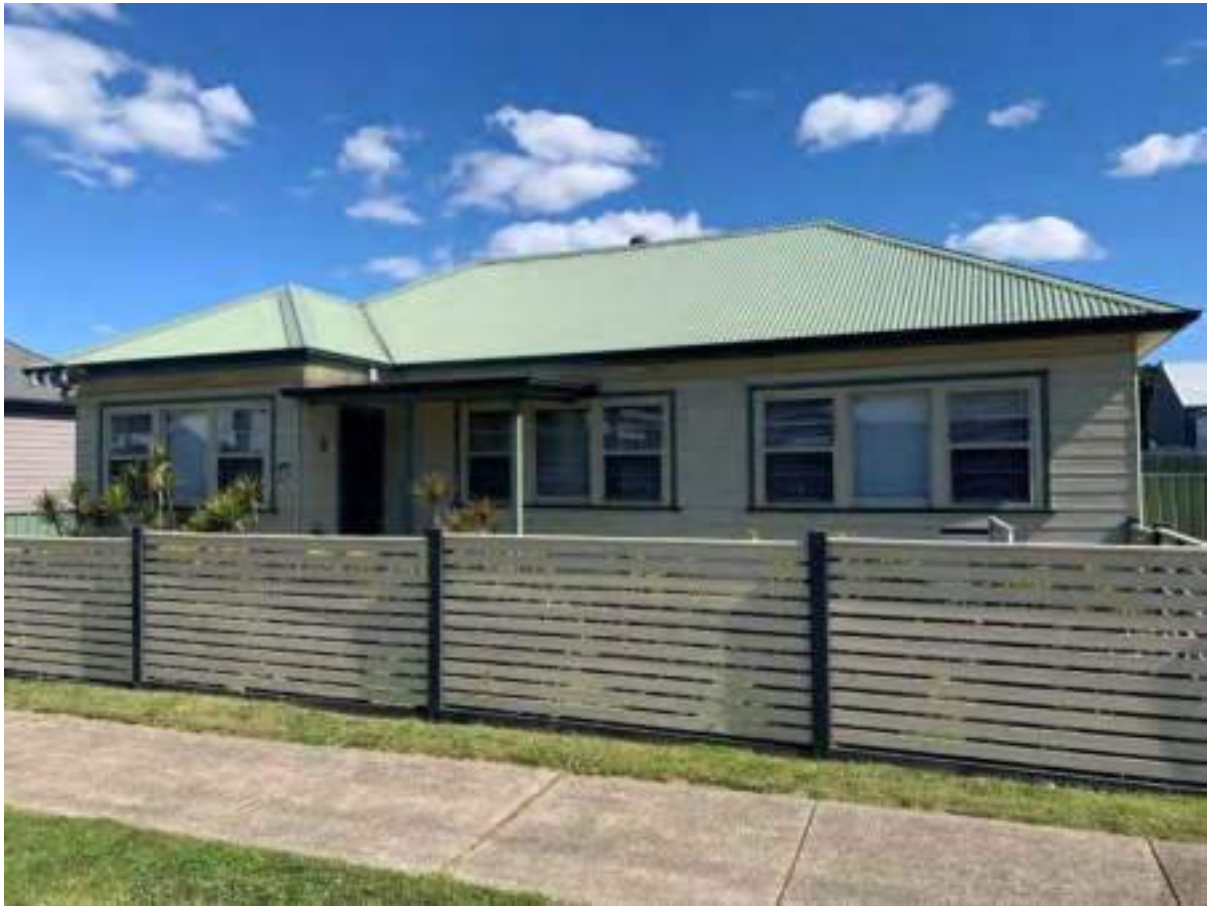
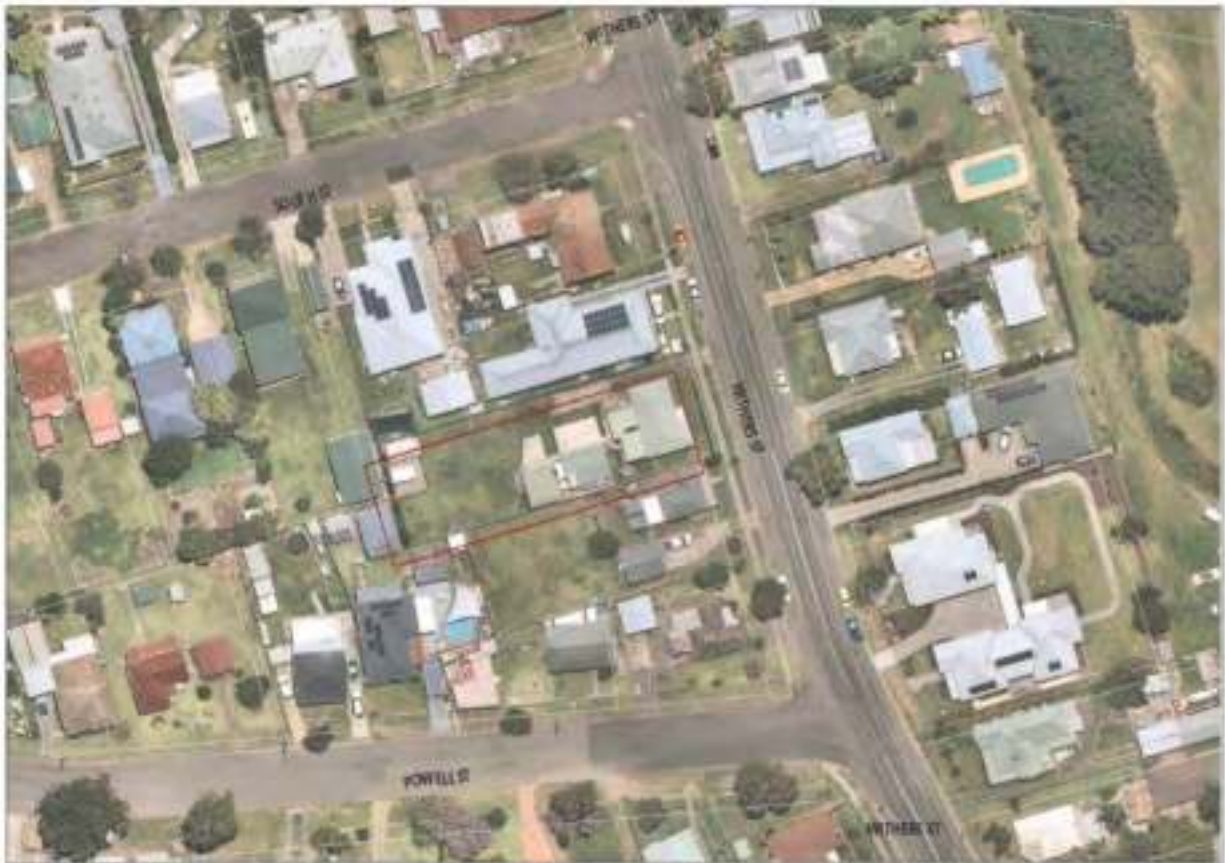
16 WITHERS STREET, WEST WALLSEND 2286

Conservation Area Contribution Level	Est. Construction Date	Previous studies and/or community input
Contributory 2	Early to late 20 th century (broad range)	No prior heritage assessments or research undertaken.
Assessment Text		Observed Modifications
<p>The scale (single-storey) and general style of the dwelling is consistent with that of the streetscape and wider HCA. Dwelling contributes positively to the streetscape and wider HCA, particularly in comparison to Non-Contributory buildings.</p> <p>The dwelling features appropriately proportioned and positioned fenestrations, an appropriate roof form (gabled or hipped) and other features consistent with the architectural character of the area (e.g. front verandah with timber or brick posts, timber detailing, corrugated metal roofing, etc). The contributory value of the dwelling is limited however by either:</p> <ul style="list-style-type: none"> • External modifications that have in some way obscured the style, scale or design intent of the building and have resulted in less physical integrity than Contributory 1 buildings. • Being a later dwelling constructed in an appropriate referential style, but comprising little to no fabric of intrinsic heritage significance. 		<p>The timber fencing at the front of the property is a contemporary addition and unsympathetic to the heritage streetscape.</p> <p>The small flat veranda roof is a contemporary addition to the dwelling.</p> <p>An extension has been built onto the western portion of the dwelling. This is not visible from the street and does not detract from the heritage streetscape.</p>

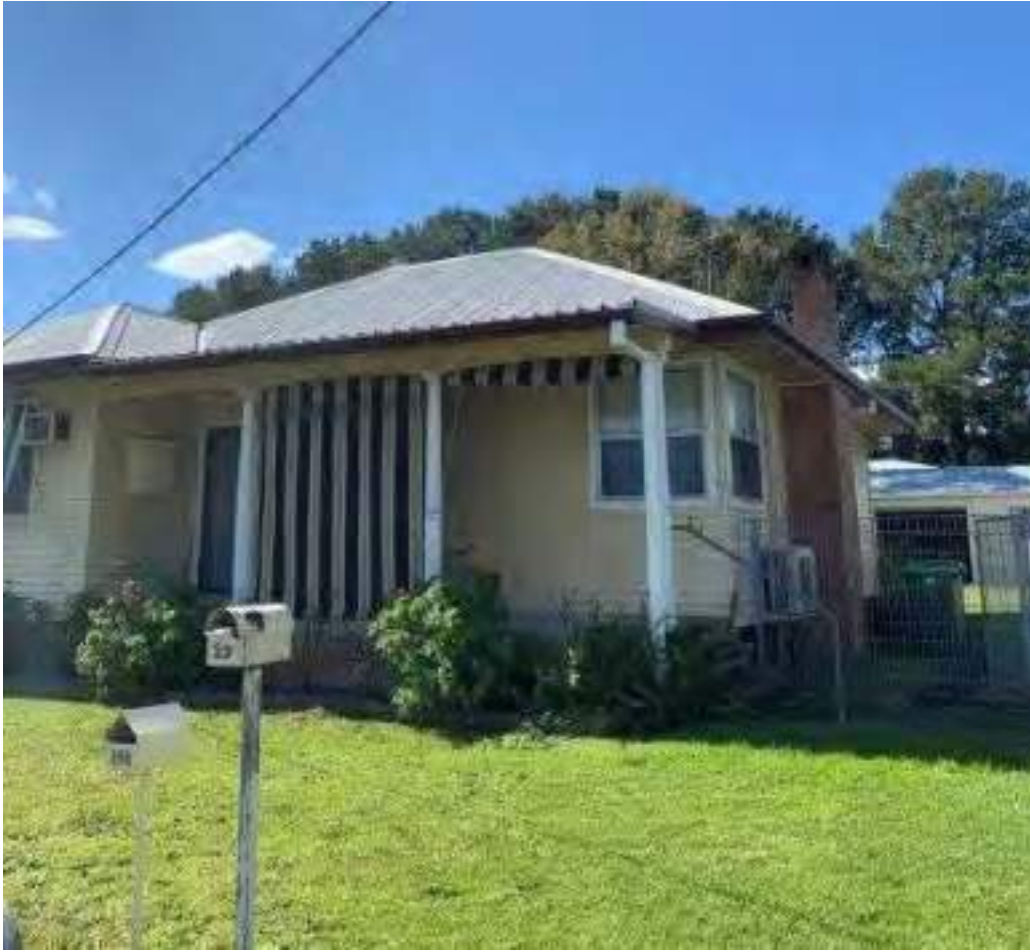
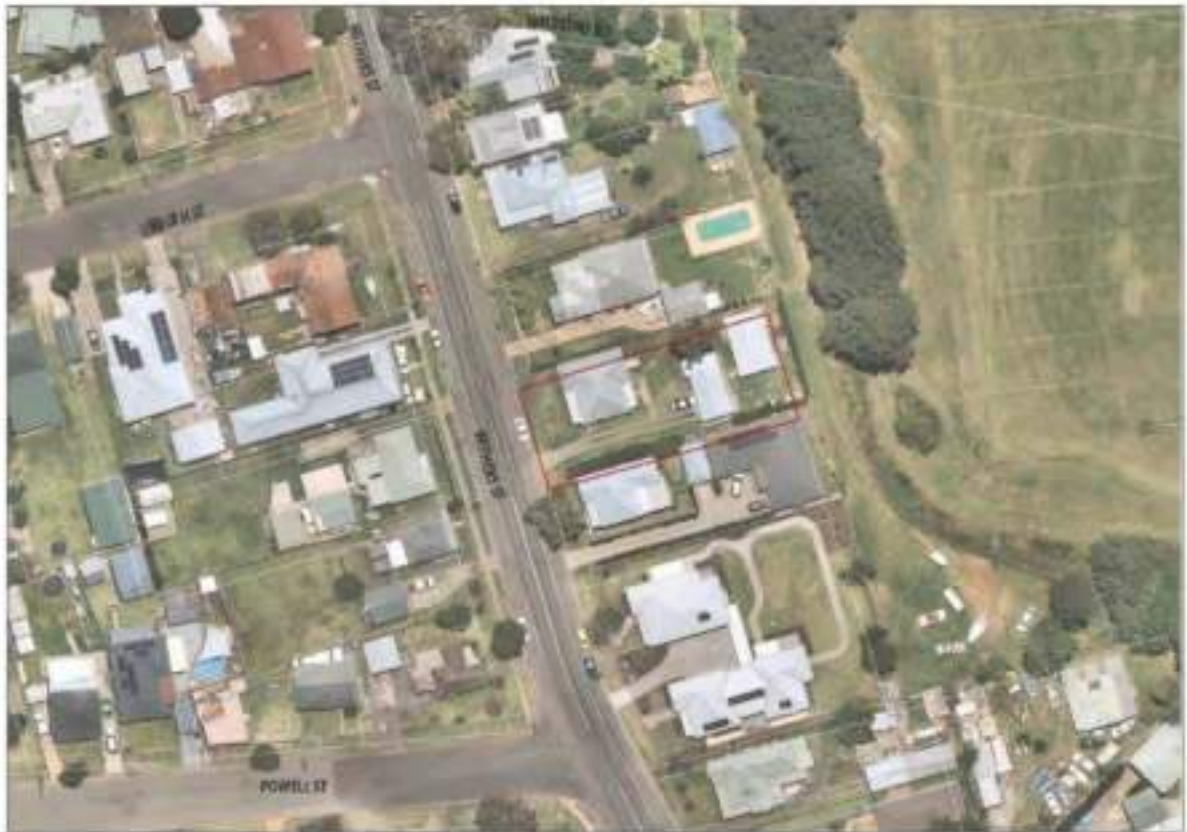
29 WITHERS STREET, WEST WALLSEND 2286

Conservation Area Contribution Level	Est. Construction Date	Previous studies and/or community input
Contributory 2	Early to late 20 th century (broad range)	No prior heritage assessments or research undertaken.
Assessment Text		Observed Modifications
<p>The scale (single-storey) and general style of the dwelling is consistent with that of the streetscape and wider HCA. Dwelling contributes positively to the streetscape and wider HCA, particularly in comparison to Non-Contributory buildings.</p> <p>The dwelling features appropriately proportioned and positioned fenestrations, an appropriate roof form (gabled or hipped) and other features consistent with the architectural character of the area (e.g. front verandah with timber or brick posts, timber detailing, corrugated metal roofing, etc). The contributory value of the dwelling is limited however by either:</p> <ul style="list-style-type: none"> • External modifications that have in some way obscured the style, scale or design intent of the building and have resulted in less physical integrity than Contributory 1 buildings. • Being a later dwelling constructed in an appropriate referential style, but comprising little to no fabric of intrinsic heritage significance. 		<p>The faux European pillars are a contemporary addition to the dwelling. This is a common modification in the area.</p> <p>Canvas awnings and blinds have been installed above the western windows and veranda area.</p> <p>All visible windows are contemporary in style.</p>

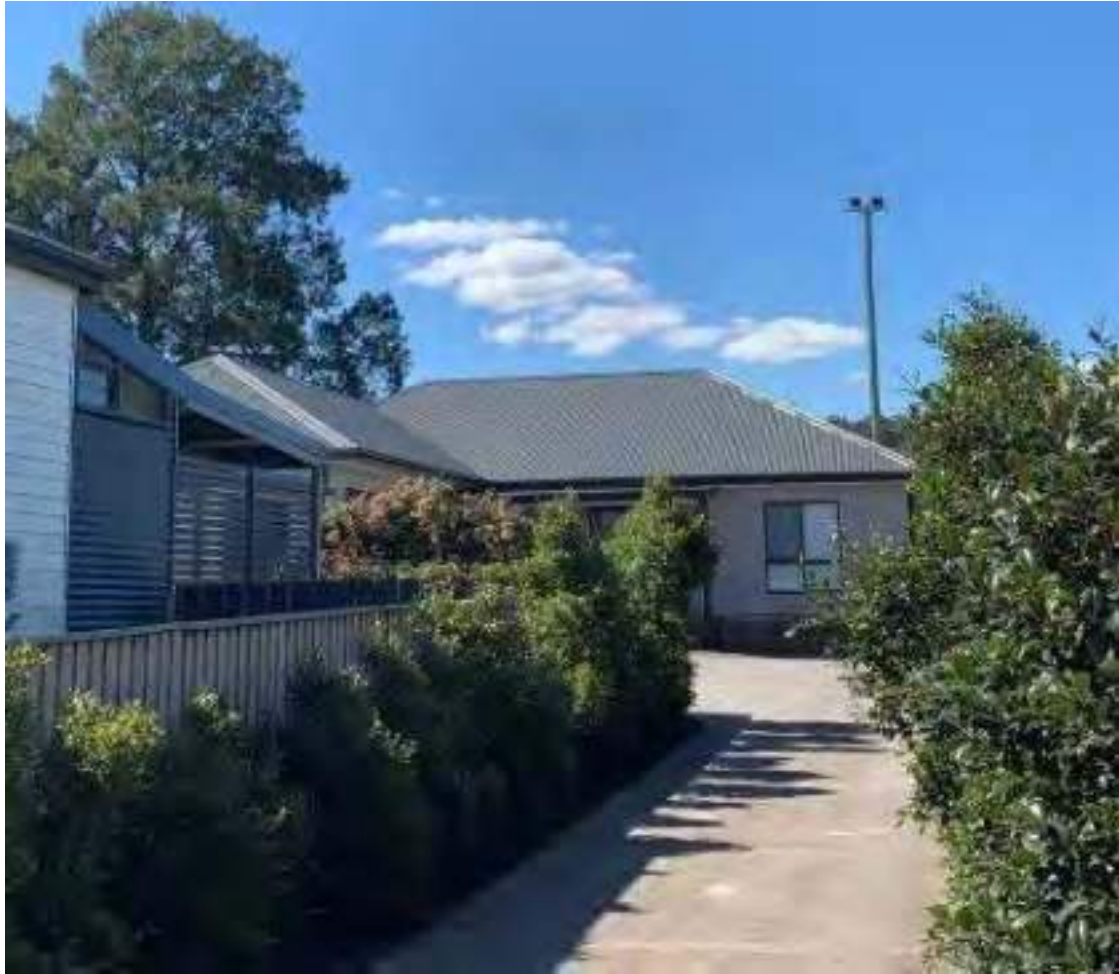
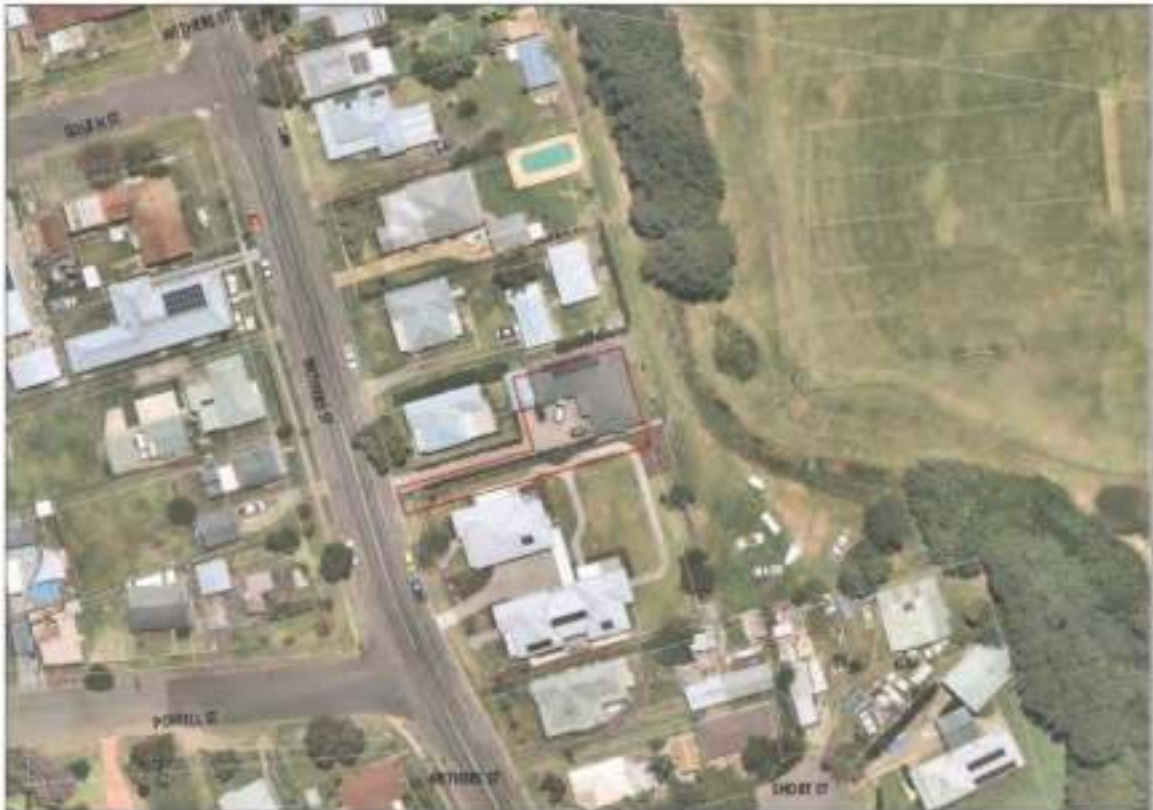
31A WITHERS STREET, WEST WALLSEND 2286

Conservation Area Contribution Level	Est. Construction Date	Previous studies and/or community input
Contributory 2	Early to late 20 th century (broad range)	No prior heritage assessments or research undertaken.
Assessment Text		Observed Modifications
<p>The scale (single-storey) and general style of the dwelling is consistent with that of the streetscape and wider HCA. Dwelling contributes positively to the streetscape and wider HCA, particularly in comparison to Non-Contributory buildings.</p> <p>The dwelling features appropriately proportioned and positioned fenestrations, an appropriate roof form (gabled or hipped) and other features consistent with the architectural character of the area (e.g. front verandah with timber or brick posts, timber detailing, corrugated metal roofing, etc). The contributory value of the dwelling is limited however by either:</p> <ul style="list-style-type: none"> • External modifications that have in some way obscured the style, scale or design intent of the building and have resulted in less physical integrity than Contributory 1 buildings. • Being a later dwelling constructed in an appropriate referential style, but comprising little to no fabric of intrinsic heritage significance. 		No modifications observed.

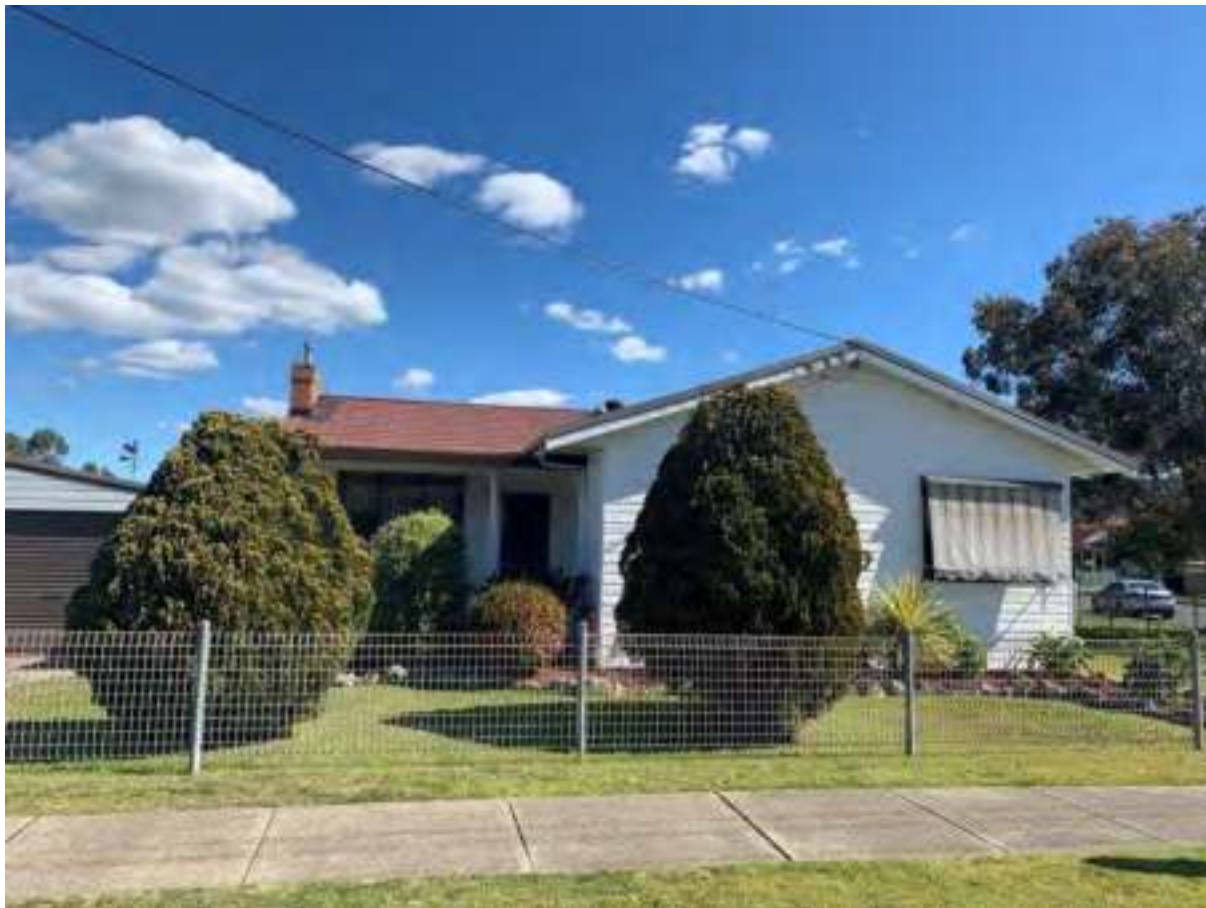
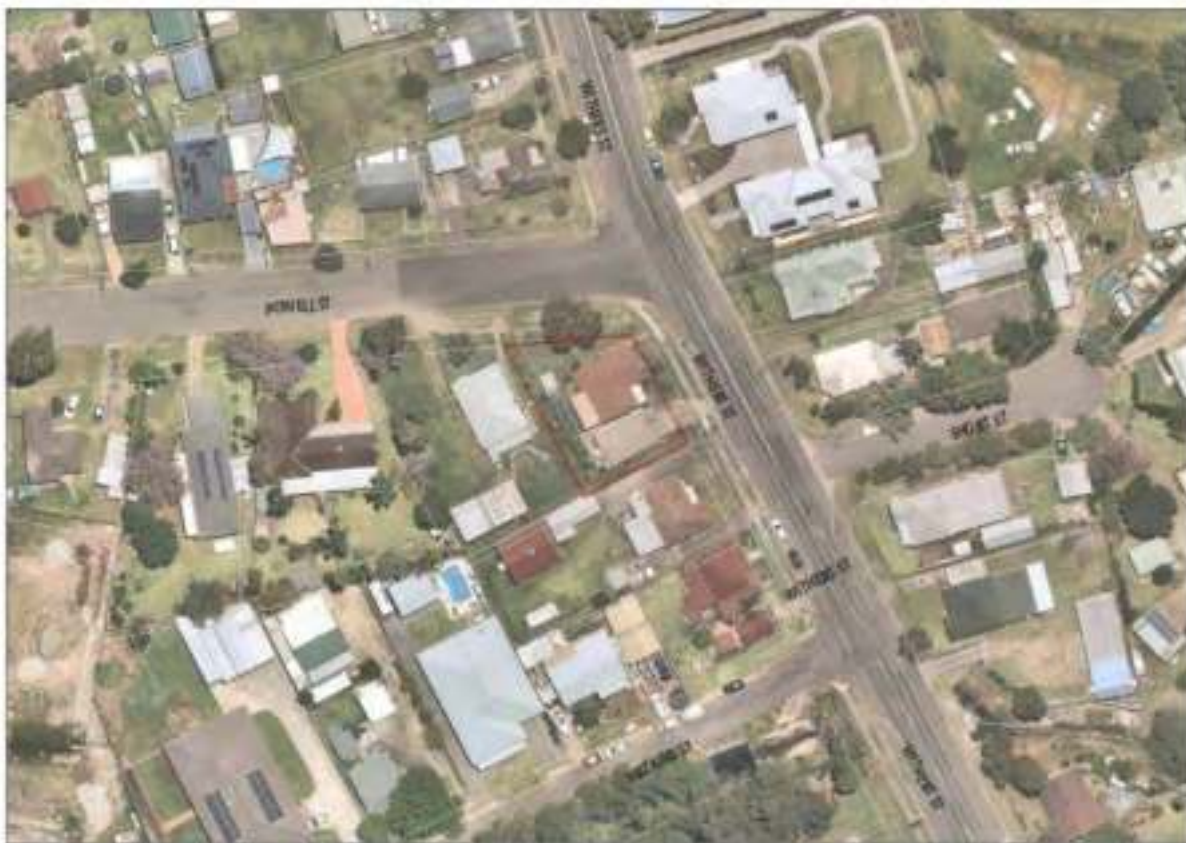
22 WITHERS STREET, WEST WALLSEND 2286

Conservation Area Contribution Level	Est. Construction Date	Previous studies and/or community input
Contributory 2	Early to late 20 th century (broad range)	No prior heritage assessments or research undertaken.
Assessment Text		Observed Modifications
<p>The scale (single-storey) and general style of the dwelling is consistent with that of the streetscape and wider HCA. Dwelling contributes positively to the streetscape and wider HCA, particularly in comparison to Non-Contributory buildings.</p> <p>The dwelling features appropriately proportioned and positioned fenestrations, an appropriate roof form (gabled or hipped) and other features consistent with the architectural character of the area (e.g. front verandah with timber or brick posts, timber detailing, corrugated metal roofing, etc). The contributory value of the dwelling is limited however by either:</p> <ul style="list-style-type: none"> • External modifications that have in some way obscured the style, scale or design intent of the building and have resulted in less physical integrity than Contributory 1 buildings. • Being a later dwelling constructed in an appropriate referential style, but comprising little to no fabric of intrinsic heritage significance. 		No modifications observed.
