APPENDIX 2

Building Assessment Sheets (Inventory Sheets)

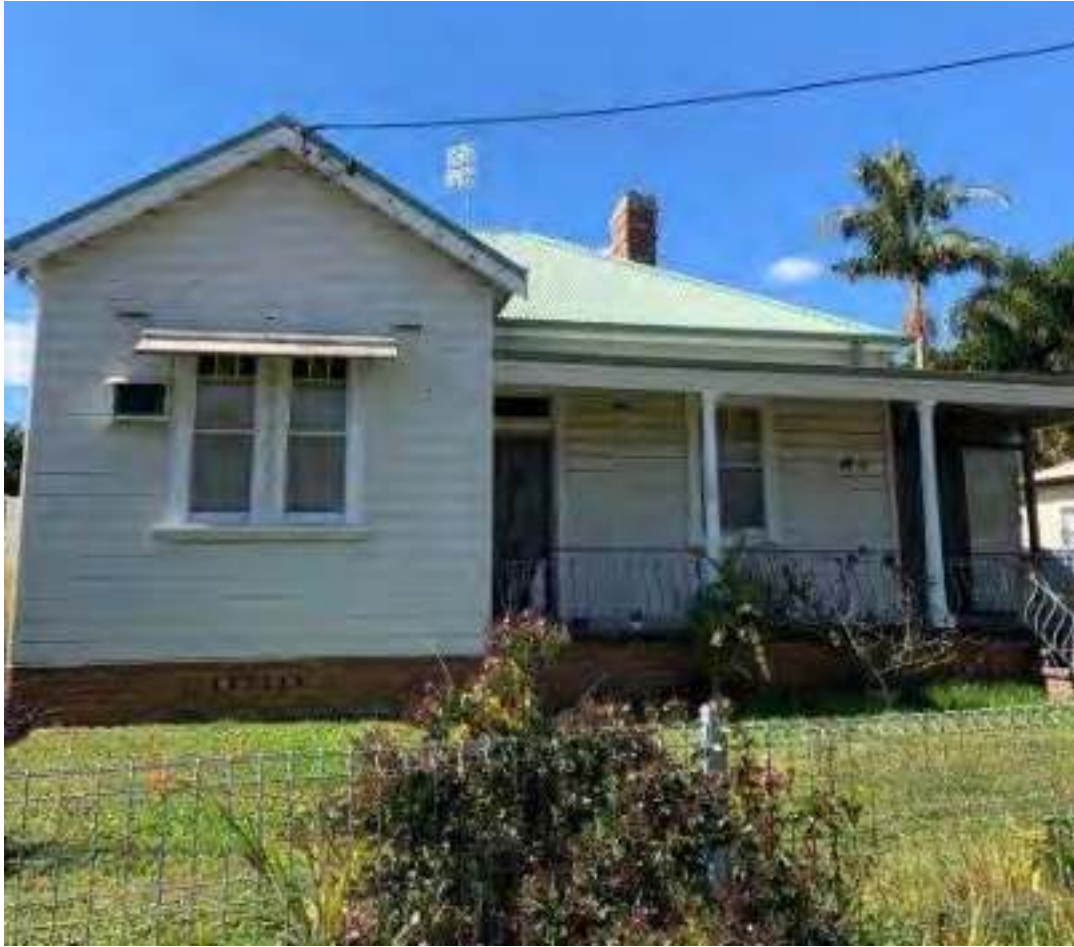
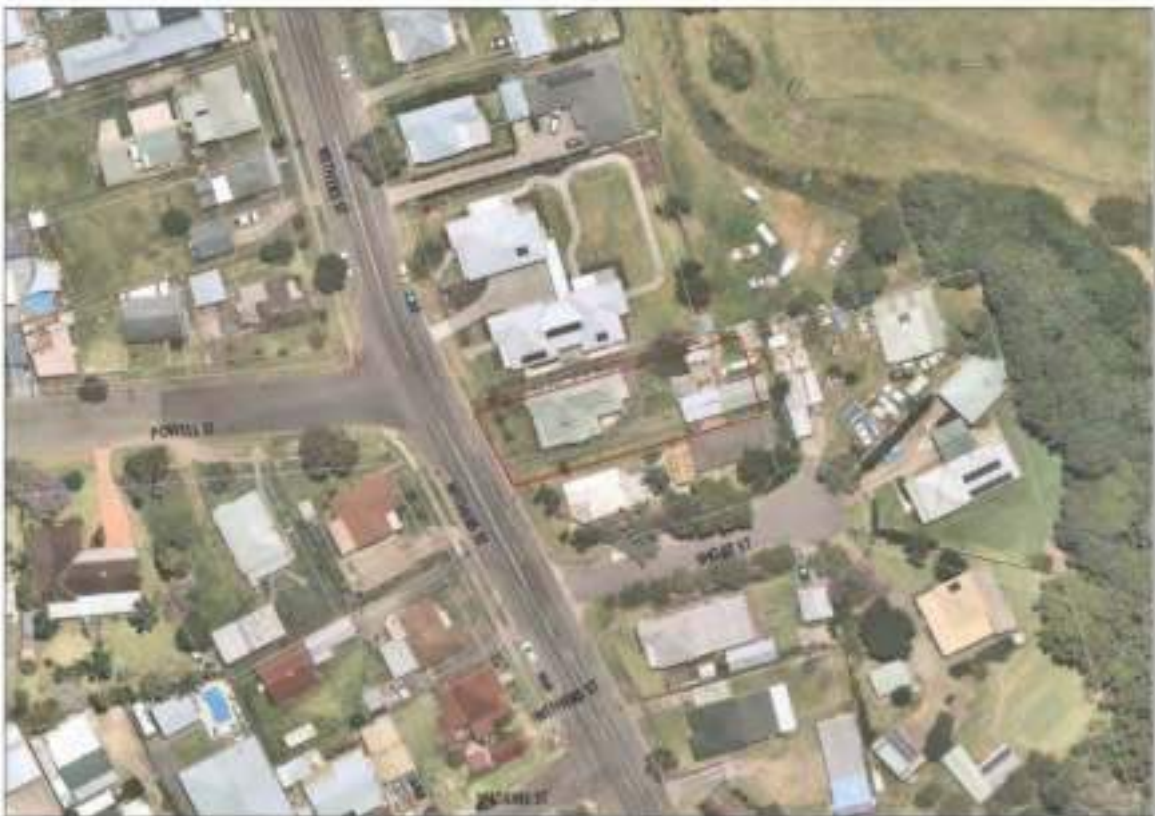
37 WITHERS STREET, WEST WALLSEND 2286

Conservation Area Contribution Level	Est. Construction Date	Previous studies and/or community input
Contributory 2	Early to late 20 th century (broad range)	No prior heritage assessments or research undertaken.
Assessment Text		Observed Modifications
<p>The scale (single-storey) and general style of the dwelling is consistent with that of the streetscape and wider HCA. Dwelling contributes positively to the streetscape and wider HCA, particularly in comparison to Non-Contributory buildings.</p> <p>The dwelling features appropriately proportioned and positioned fenestrations, an appropriate roof form (gabled or hipped) and other features consistent with the architectural character of the area (e.g. front verandah with timber or brick posts, timber detailing, corrugated metal roofing, etc). The contributory value of the dwelling is limited however by either:</p> <ul style="list-style-type: none"> • External modifications that have in some way obscured the style, scale or design intent of the building and have resulted in less physical integrity than Contributory 1 buildings. • Being a later dwelling constructed in an appropriate referential style, but comprising little to no fabric of intrinsic heritage significance. 		<p>The faux European pillars are a contemporary addition to the dwelling.</p> <p>The skillion veranda roof is a contemporary addition, likely replacing a hipped or bull nosed design.</p> <p>An extension has been built onto the southern side of the veranda.</p>

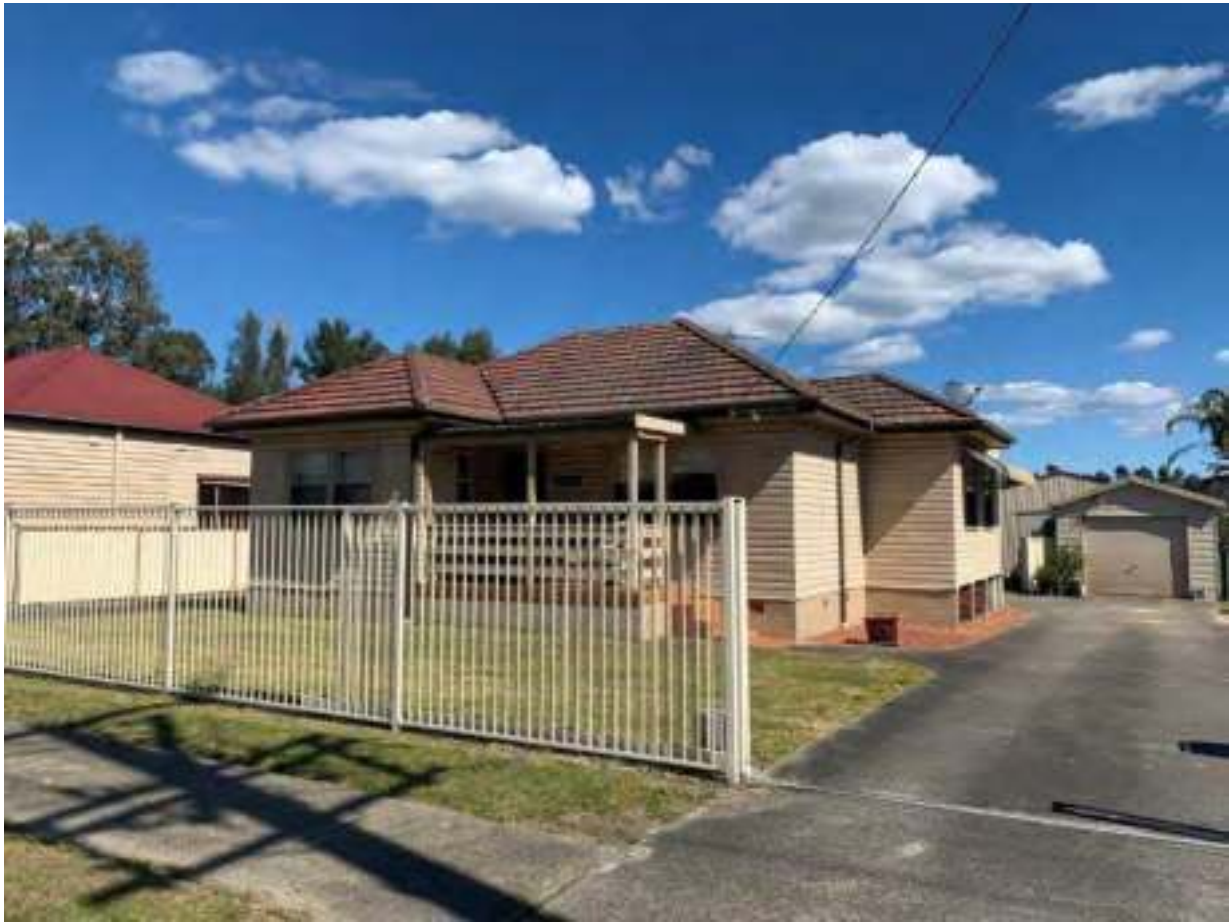
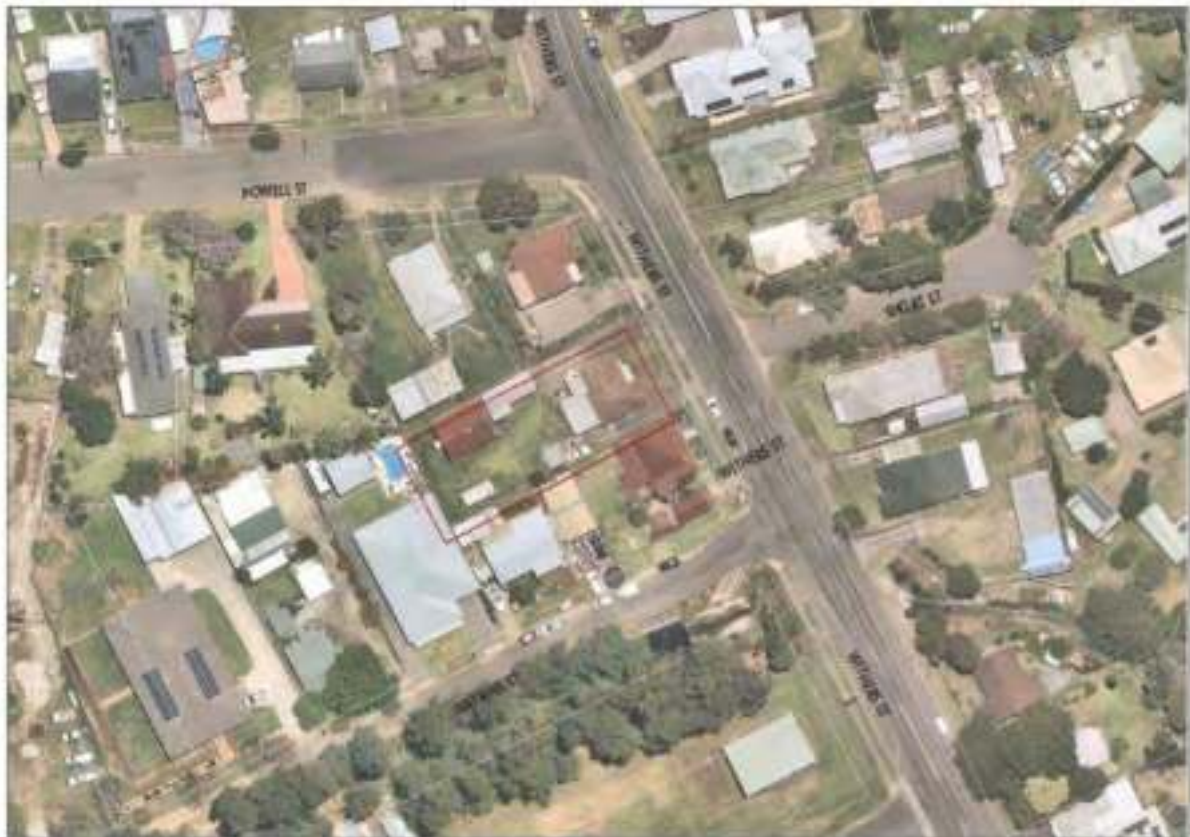
24 WITHERS STREET, WEST WALLSEND 2286

Conservation Area Contribution Level	Est. Construction Date	Previous studies and/or community input
Contributory 2	Early to late 20 th century (broad range)	No prior heritage assessments or research undertaken.
Assessment Text		Observed Modifications
<p>The scale (single-storey) and general style of the dwelling is consistent with that of the streetscape and wider HCA. Dwelling contributes positively to the streetscape and wider HCA, particularly in comparison to Non-Contributory buildings.</p> <p>The dwelling features appropriately proportioned and positioned fenestrations, an appropriate roof form (gabled or hipped) and other features consistent with the architectural character of the area (e.g. front verandah with timber or brick posts, timber detailing, corrugated metal roofing, etc). The contributory value of the dwelling is limited however by either:</p> <ul style="list-style-type: none"> • External modifications that have in some way obscured the style, scale or design intent of the building and have resulted in less physical integrity than Contributory 1 buildings. • Being a later dwelling constructed in an appropriate referential style, but comprising little to no fabric of intrinsic heritage significance. 		<p>The timber balustrade is a contemporary addition to the dwelling.</p>

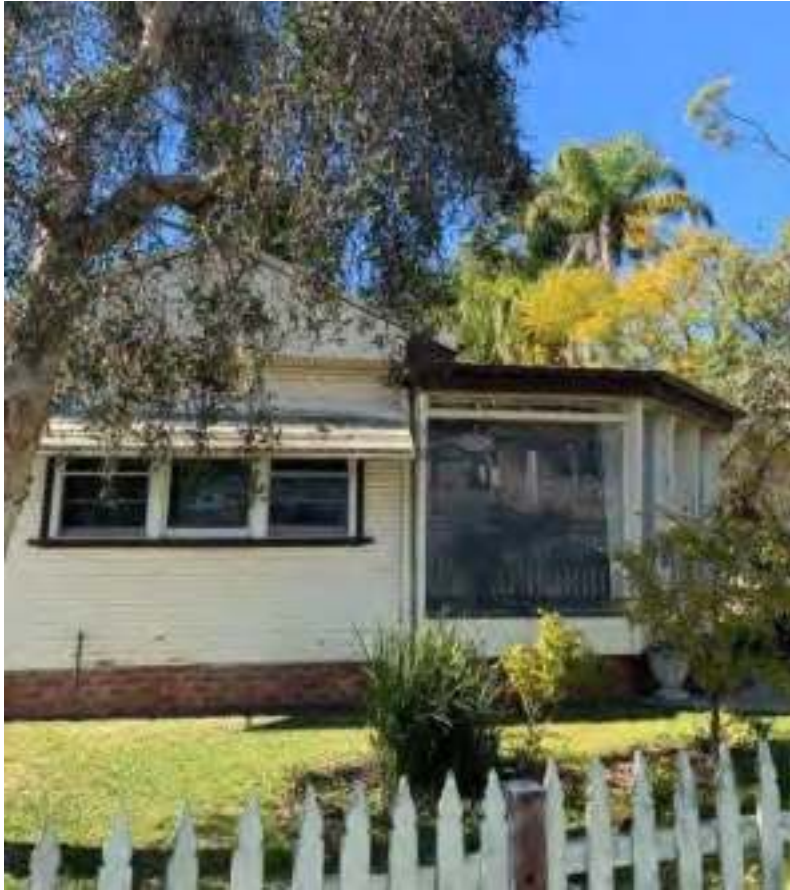
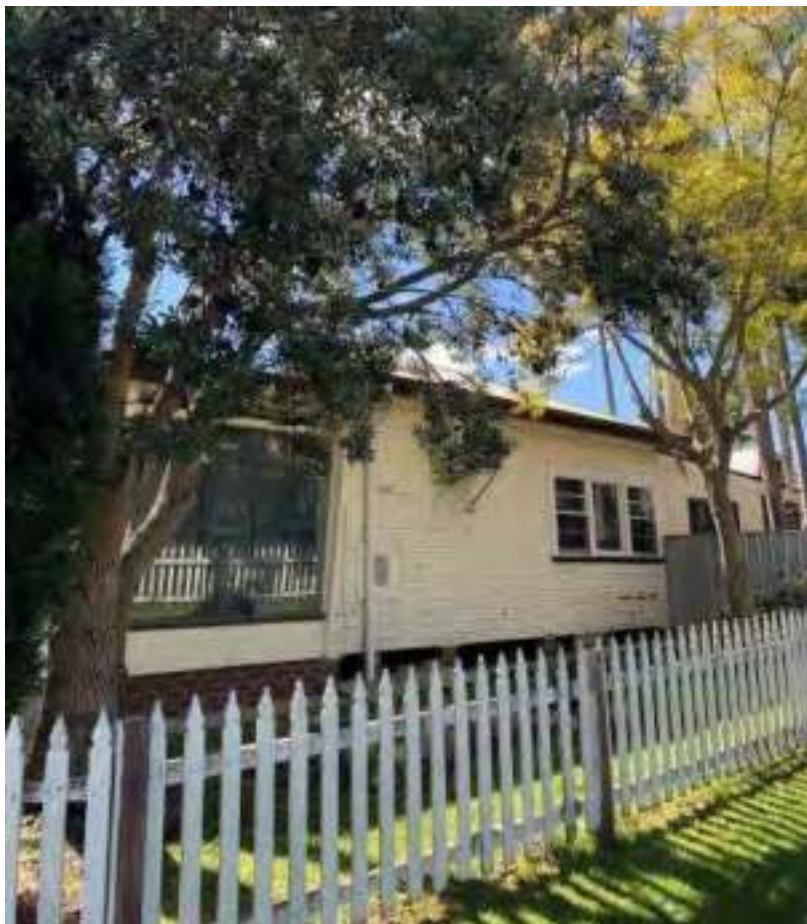
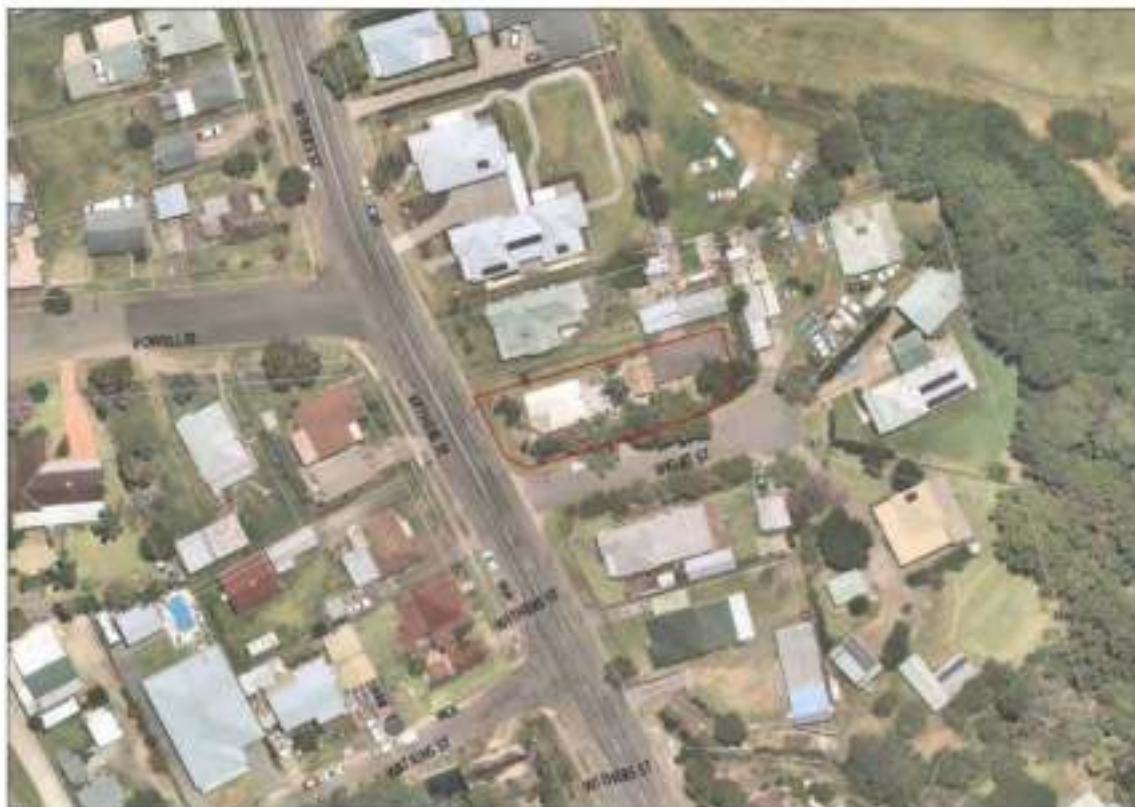
1A SHORT STREET, WEST WALLSEND 2286

Conservation Area Contribution Level	Est. Construction Date	Previous studies and/or community input
Contributory 2	Early to late 20 th century (broad range)	No prior heritage assessments or research undertaken.
Assessment Text		Observed Modifications
<p>The scale (single-storey) and general style of the dwelling is consistent with that of the streetscape and wider HCA. Dwelling contributes positively to the streetscape and wider HCA, particularly in comparison to Non-Contributory buildings.</p> <p>The dwelling features appropriately proportioned and positioned fenestrations, an appropriate roof form (gabled or hipped) and other features consistent with the architectural character of the area (e.g. front verandah with timber or brick posts, timber detailing, corrugated metal roofing, etc). The contributory value of the dwelling is limited however by either:</p> <ul style="list-style-type: none"> External modifications that have in some way obscured the style, scale or design intent of the building and have resulted in less physical integrity than Contributory 1 buildings. Being a later dwelling constructed in an appropriate referential style, but comprising little to no fabric of intrinsic heritage significance. 		<p>The sunroom located on the south western corner of the dwelling is likely a modification, being originally an open veranda space. This is a contemporary modification, however has been undertaken in a sympathetic manner to the dwellings existing material and structure.</p> <p>An extension has been built onto the back eastern portion of the dwelling. This is not visible from the street and does not detract from the heritage streetscape.</p>

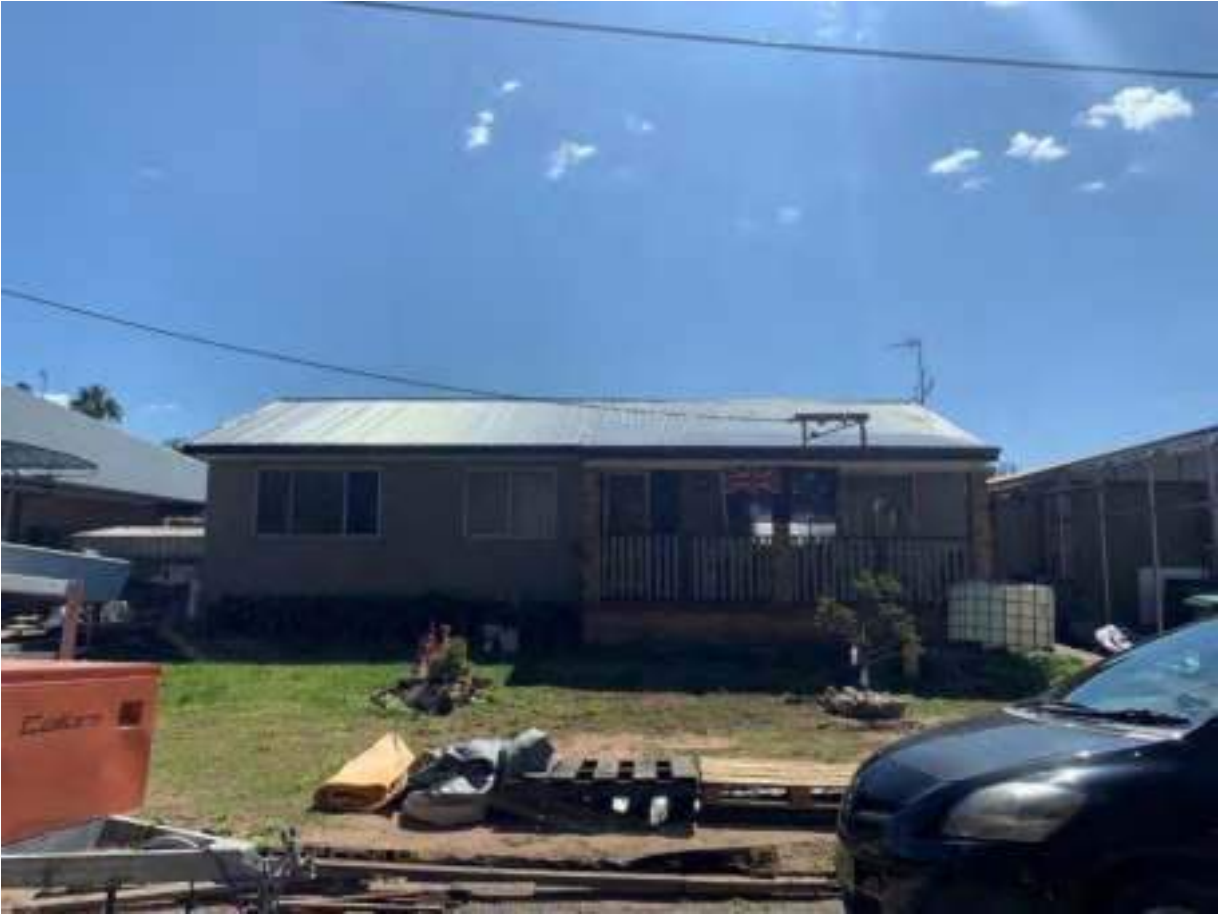
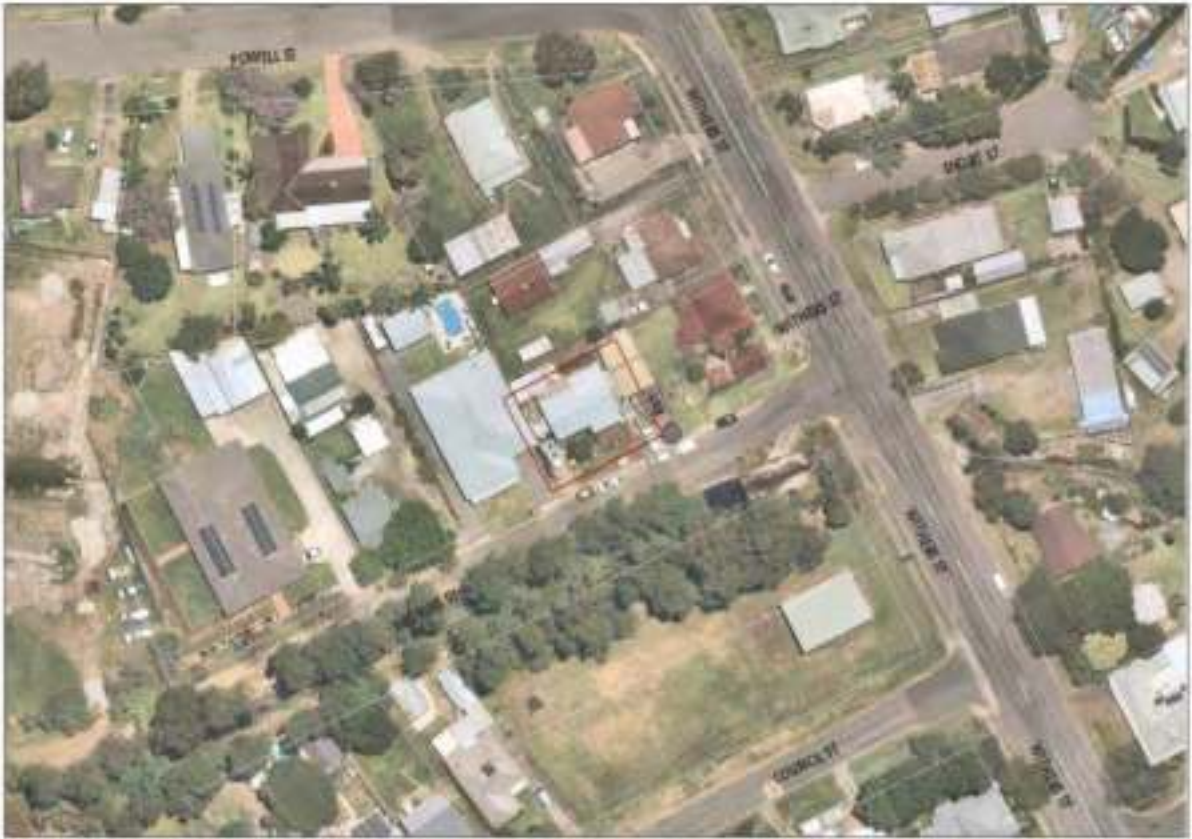
1A WATKINS STREET, WEST WALLSEND 2286

Conservation Area Contribution Level	Est. Construction Date	Previous studies and/or community input
Contributory 2	Early to late 20 th century (broad range)	No prior heritage assessments or research undertaken.
Assessment Text		Observed Modifications
<p>The scale (single-storey) and general style of the dwelling is consistent with that of the streetscape and wider HCA. Dwelling contributes positively to the streetscape and wider HCA, particularly in comparison to Non-Contributory buildings.</p> <p>The dwelling features appropriately proportioned and positioned fenestrations, an appropriate roof form (gabled or hipped) and other features consistent with the architectural character of the area (e.g. front verandah with timber or brick posts, timber detailing, corrugated metal roofing, etc). The contributory value of the dwelling is limited however by either:</p> <ul style="list-style-type: none"> • External modifications that have in some way obscured the style, scale or design intent of the building and have resulted in less physical integrity than Contributory 1 buildings. • Being a later dwelling constructed in an appropriate referential style, but comprising little to no fabric of intrinsic heritage significance. 		<p>The brickwork veranda is potentially a contemporary addition to the dwelling, replacing a previous design. The timber balustrade and posts, as well as the skillion veranda roof are similarly contemporary additions.</p> <p>All visible windows are contemporary in style.</p>

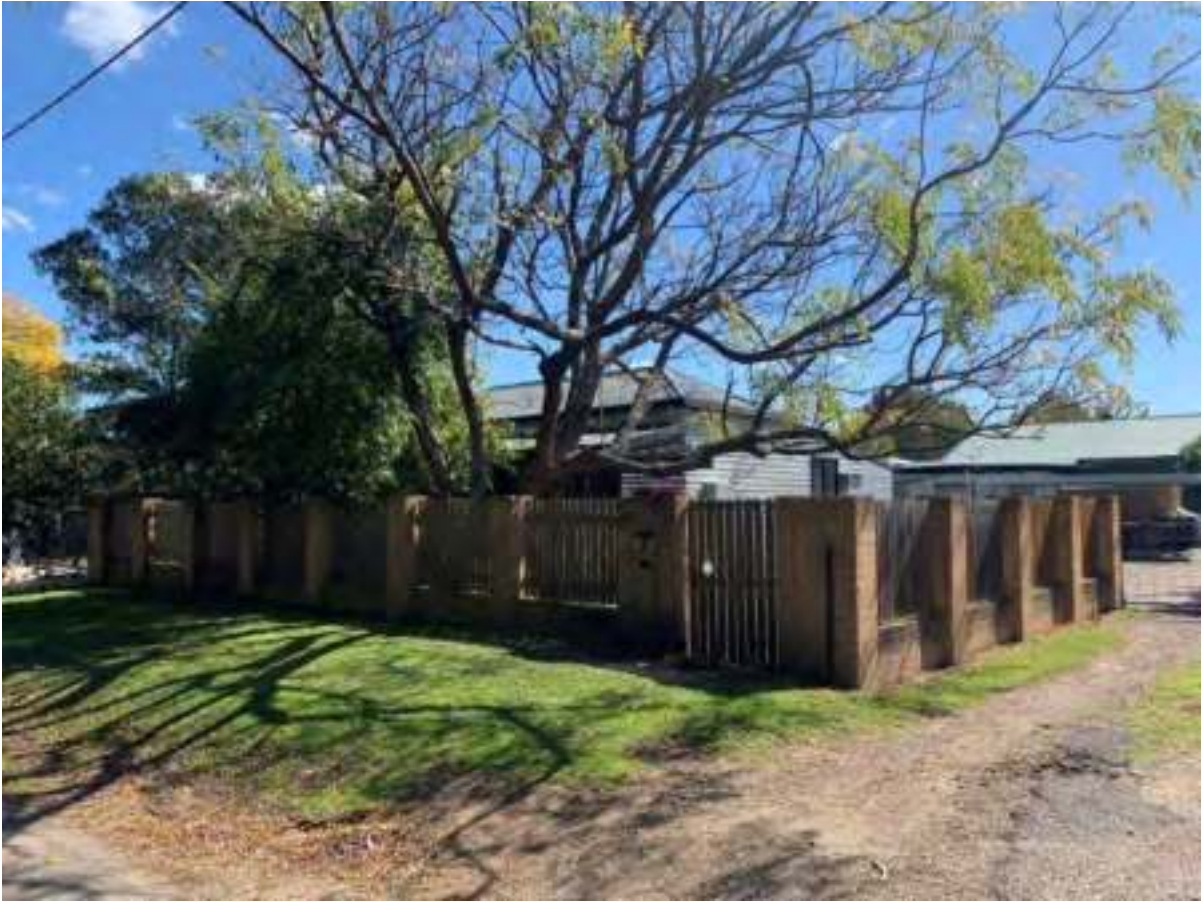
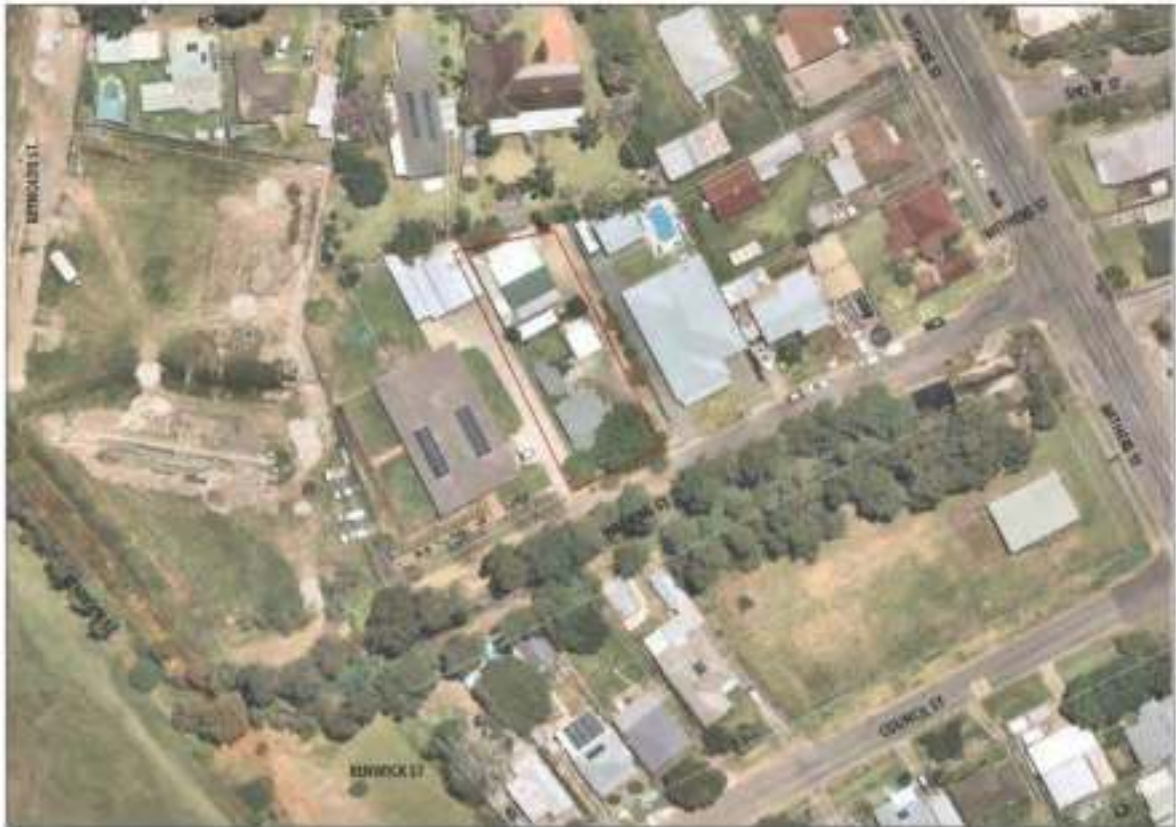
3 WATKINS STREET, WEST WALLSEND 2286

Conservation Area Contribution Level	Est. Construction Date	Previous studies and/or community input
Contributory 2	Early to late 20 th century (broad range)	No prior heritage assessments or research undertaken.
Assessment Text		Observed Modifications
<p>The scale (single-storey) and general style of the dwelling is consistent with that of the streetscape and wider HCA. Dwelling contributes positively to the streetscape and wider HCA, particularly in comparison to Non-Contributory buildings.</p> <p>The dwelling features appropriately proportioned and positioned fenestrations, an appropriate roof form (gabled or hipped) and other features consistent with the architectural character of the area (e.g. front verandah with timber or brick posts, timber detailing, corrugated metal roofing, etc). The contributory value of the dwelling is limited however by either:</p> <ul style="list-style-type: none"> • External modifications that have in some way obscured the style, scale or design intent of the building and have resulted in less physical integrity than Contributory 1 buildings. • Being a later dwelling constructed in an appropriate referential style, but comprising little to no fabric of intrinsic heritage significance. 		<p>The brick and timber fence enclosing the property is a contemporary addition, and unsympathetic to the heritage streetscape.</p> <p>The dwelling is obscured due to mature vegetation.</p>

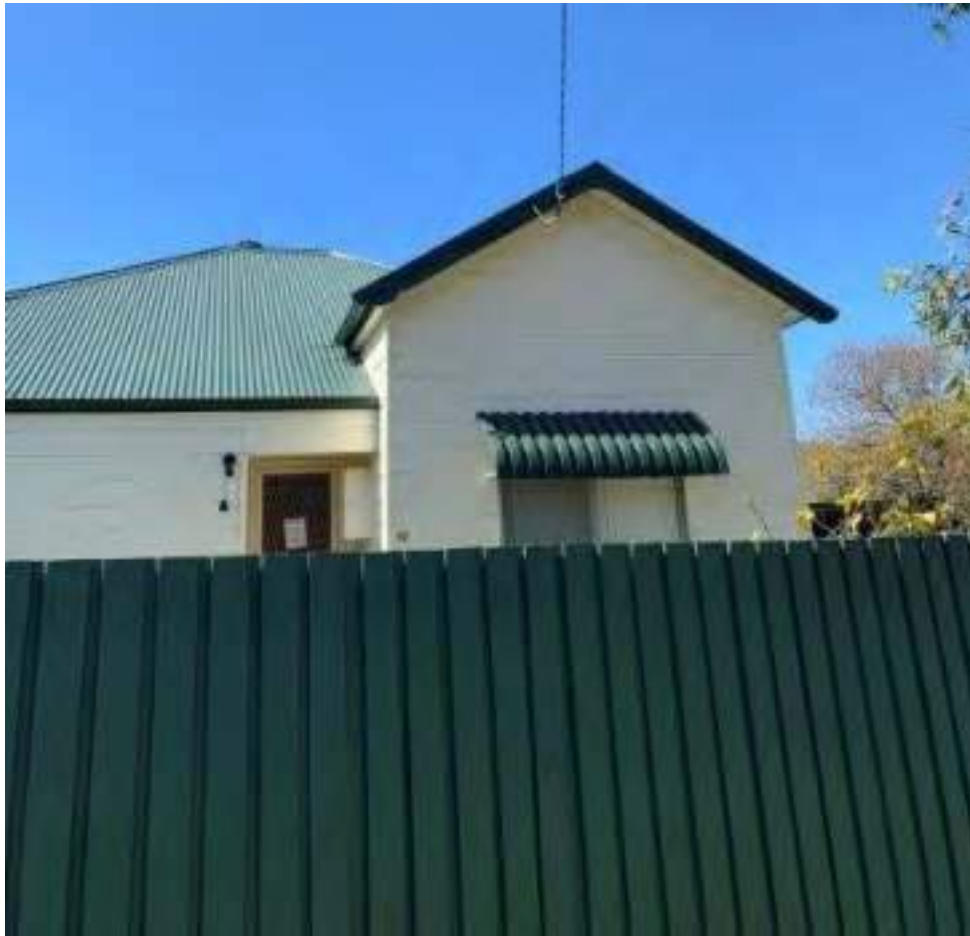
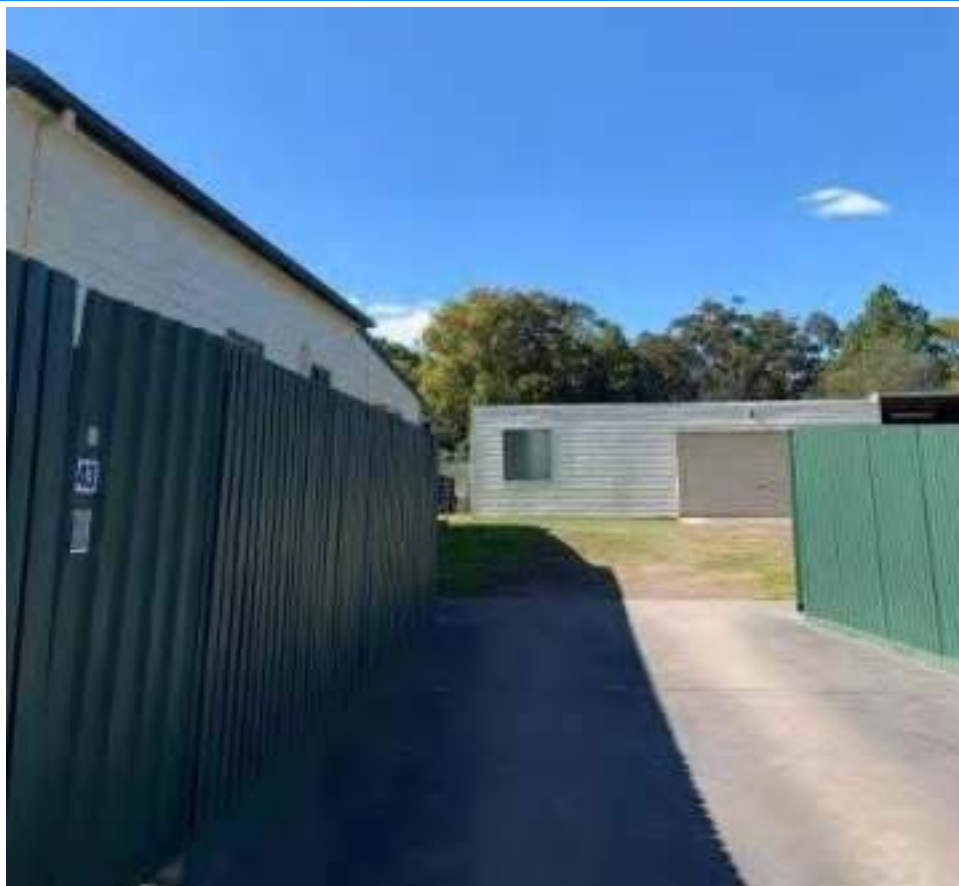
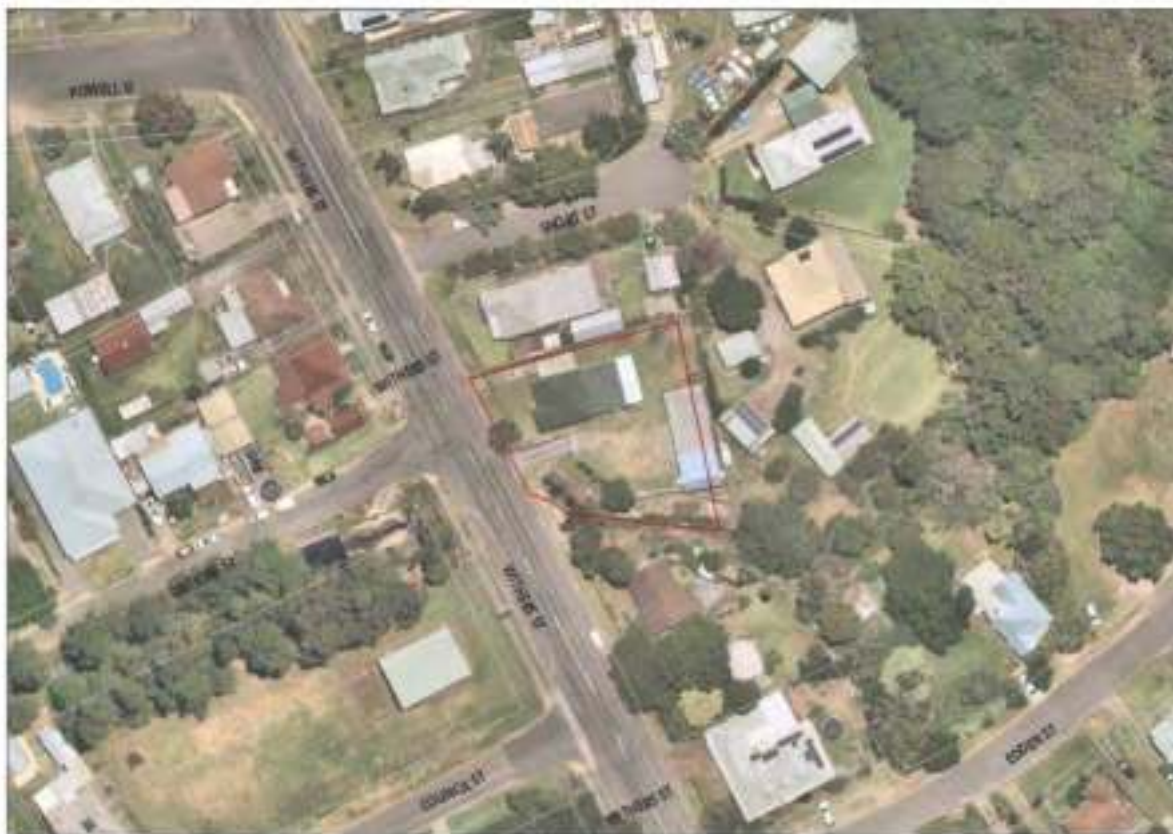
43 WITHERS STREET, WEST WALLSEND 2286

Conservation Area Contribution Level	Est. Construction Date	Previous studies and/or community input
Contributory 2	Early to late 20 th century (broad range)	No prior heritage assessments or research undertaken.
Assessment Text		Observed Modifications
<p>The scale (single-storey) and general style of the dwelling is consistent with that of the streetscape and wider HCA. Dwelling contributes positively to the streetscape and wider HCA, particularly in comparison to Non-Contributory buildings.</p> <p>The dwelling features appropriately proportioned and positioned fenestrations, an appropriate roof form (gabled or hipped) and other features consistent with the architectural character of the area (e.g. front verandah with timber or brick posts, timber detailing, corrugated metal roofing, etc). The contributory value of the dwelling is limited however by either:</p> <ul style="list-style-type: none"> • External modifications that have in some way obscured the style, scale or design intent of the building and have resulted in less physical integrity than Contributory 1 buildings. • Being a later dwelling constructed in an appropriate referential style, but comprising little to no fabric of intrinsic heritage significance. 		<p>The visible windows are contemporary in style.</p> <p>The dwelling is partially obscured by the high Colourbond fence enclosing the property. The fence itself is unsympathetic to the heritage streetscape.</p>

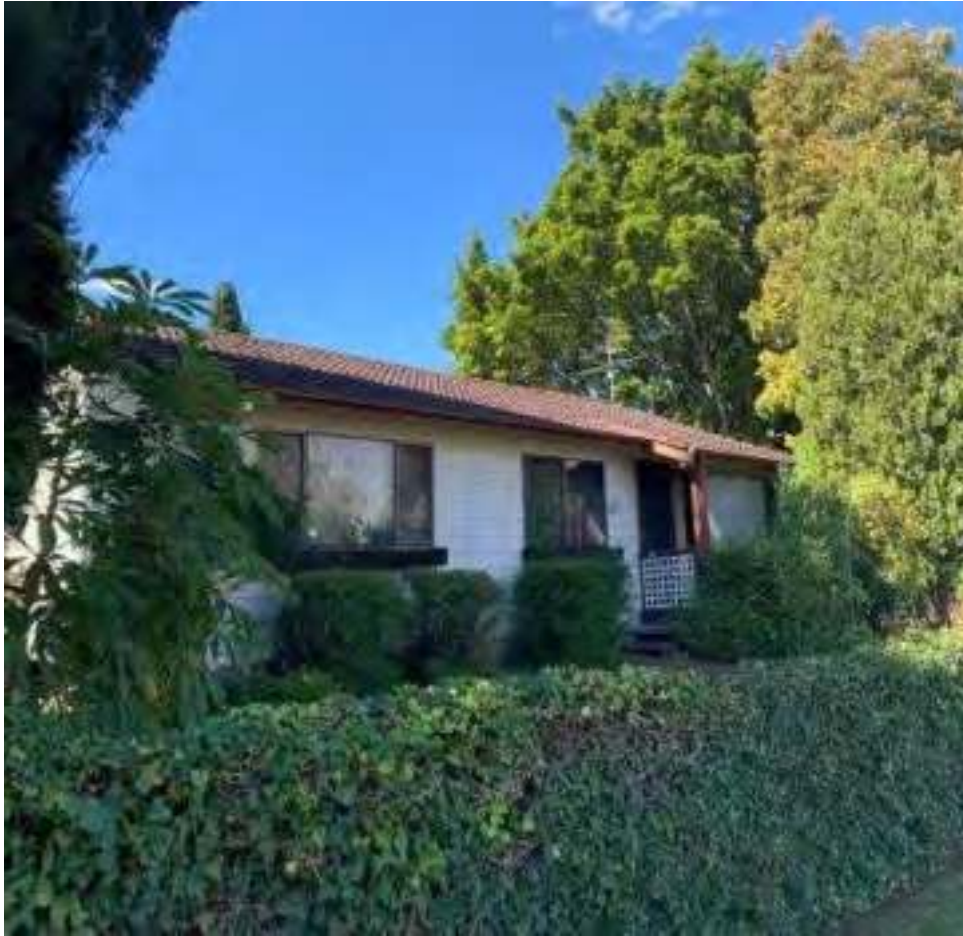
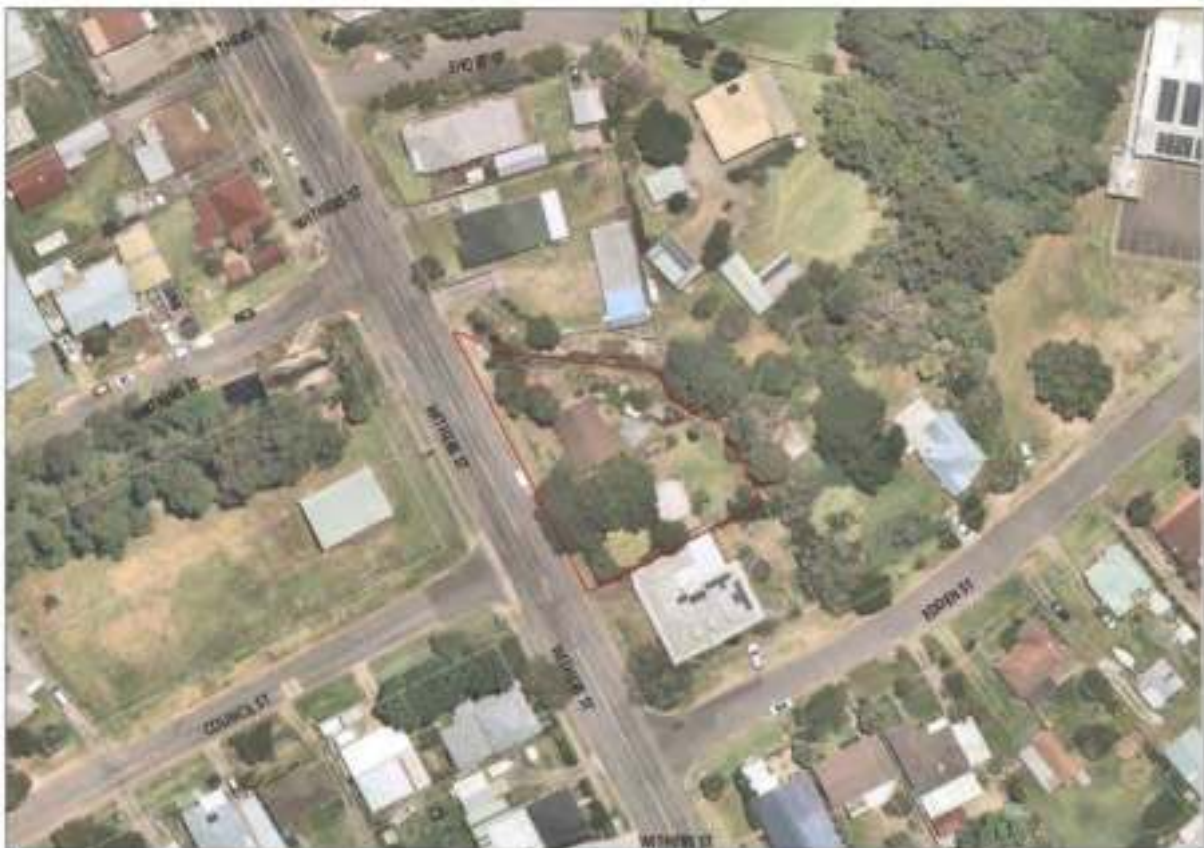
45 WITHERS STREET, WEST WALLSEND 2286

Conservation Area Contribution Level	Est. Construction Date	Previous studies and/or community input
Contributory 2	Early to late 20 th century (broad range)	No prior heritage assessments or research undertaken.
Assessment Text		Observed Modifications
<p>The scale (single-storey) and general style of the dwelling is consistent with that of the streetscape and wider HCA. Dwelling contributes positively to the streetscape and wider HCA, particularly in comparison to Non-Contributory buildings.</p> <p>The dwelling features appropriately proportioned and positioned fenestrations, an appropriate roof form (gabled or hipped) and other features consistent with the architectural character of the area (e.g. front verandah with timber or brick posts, timber detailing, corrugated metal roofing, etc). The contributory value of the dwelling is limited however by either:</p> <ul style="list-style-type: none"> • External modifications that have in some way obscured the style, scale or design intent of the building and have resulted in less physical integrity than Contributory 1 buildings. • Being a later dwelling constructed in an appropriate referential style, but comprising little to no fabric of intrinsic heritage significance. 		<p>The timber lattice balustrade is a contemporary addition to the dwelling.</p>

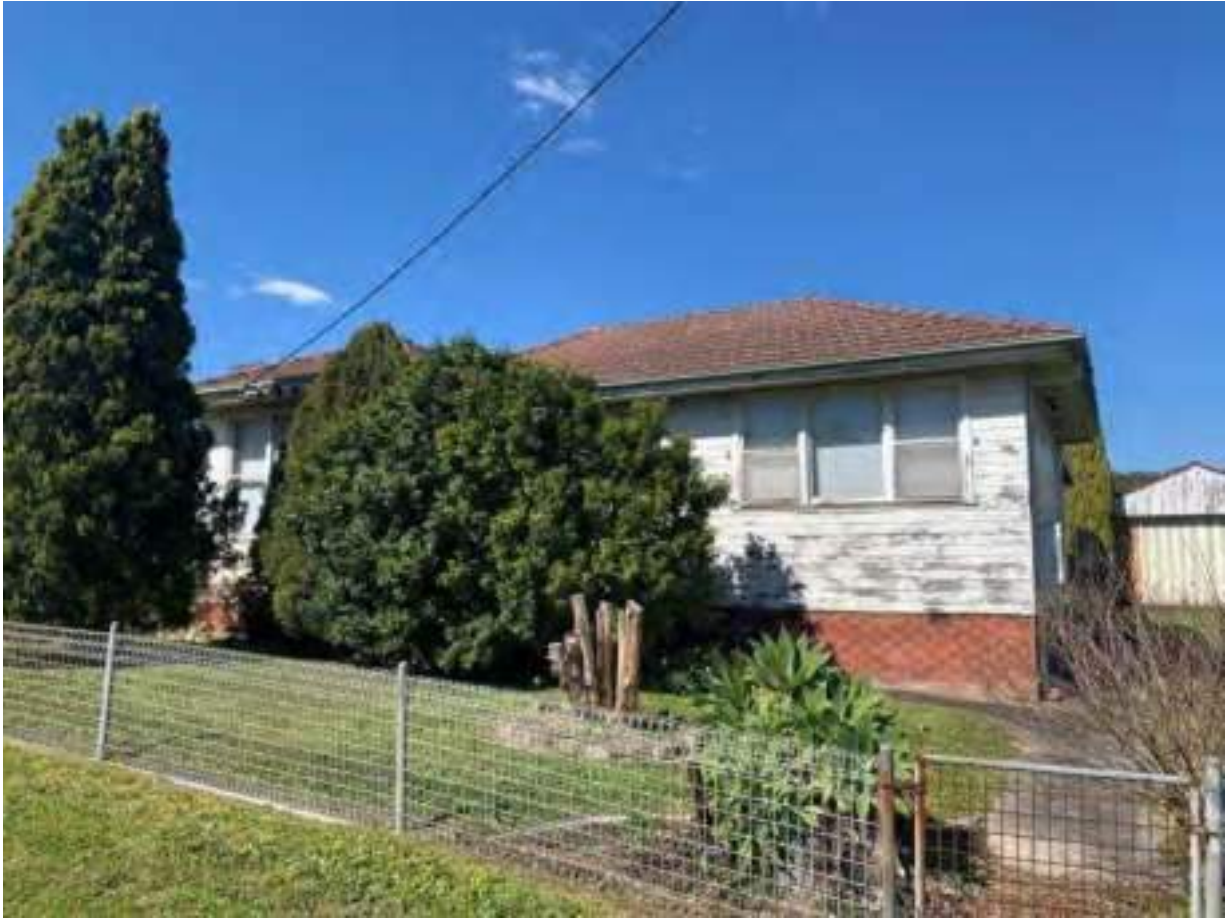
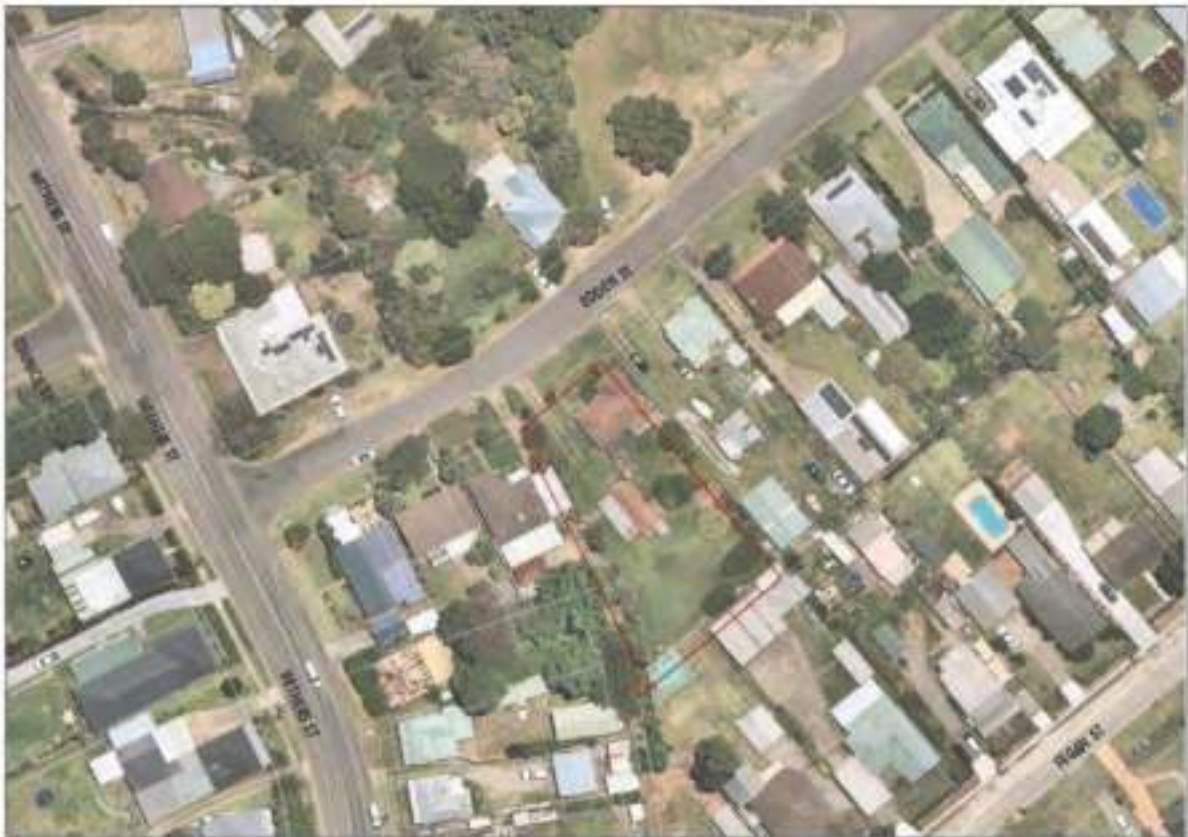
36 EDDEN STREET, WEST WALLSEND 2286

Conservation Area Contribution Level	Est. Construction Date	Previous studies and/or community input
Contributory 2	Early to late 20 th century (broad range)	No prior heritage assessments or research undertaken.
Assessment Text		Observed Modifications
<p>The scale (single-storey) and general style of the dwelling is consistent with that of the streetscape and wider HCA. Dwelling contributes positively to the streetscape and wider HCA, particularly in comparison to Non-Contributory buildings.</p> <p>The dwelling features appropriately proportioned and positioned fenestrations, an appropriate roof form (gabled or hipped) and other features consistent with the architectural character of the area (e.g. front verandah with timber or brick posts, timber detailing, corrugated metal roofing, etc). The contributory value of the dwelling is limited however by either:</p> <ul style="list-style-type: none"> • External modifications that have in some way obscured the style, scale or design intent of the building and have resulted in less physical integrity than Contributory 1 buildings. • Being a later dwelling constructed in an appropriate referential style, but comprising little to no fabric of intrinsic heritage significance. 		No modifications observed.
