APPENDIX 2

Building Assessment Sheets (Inventory Sheets)

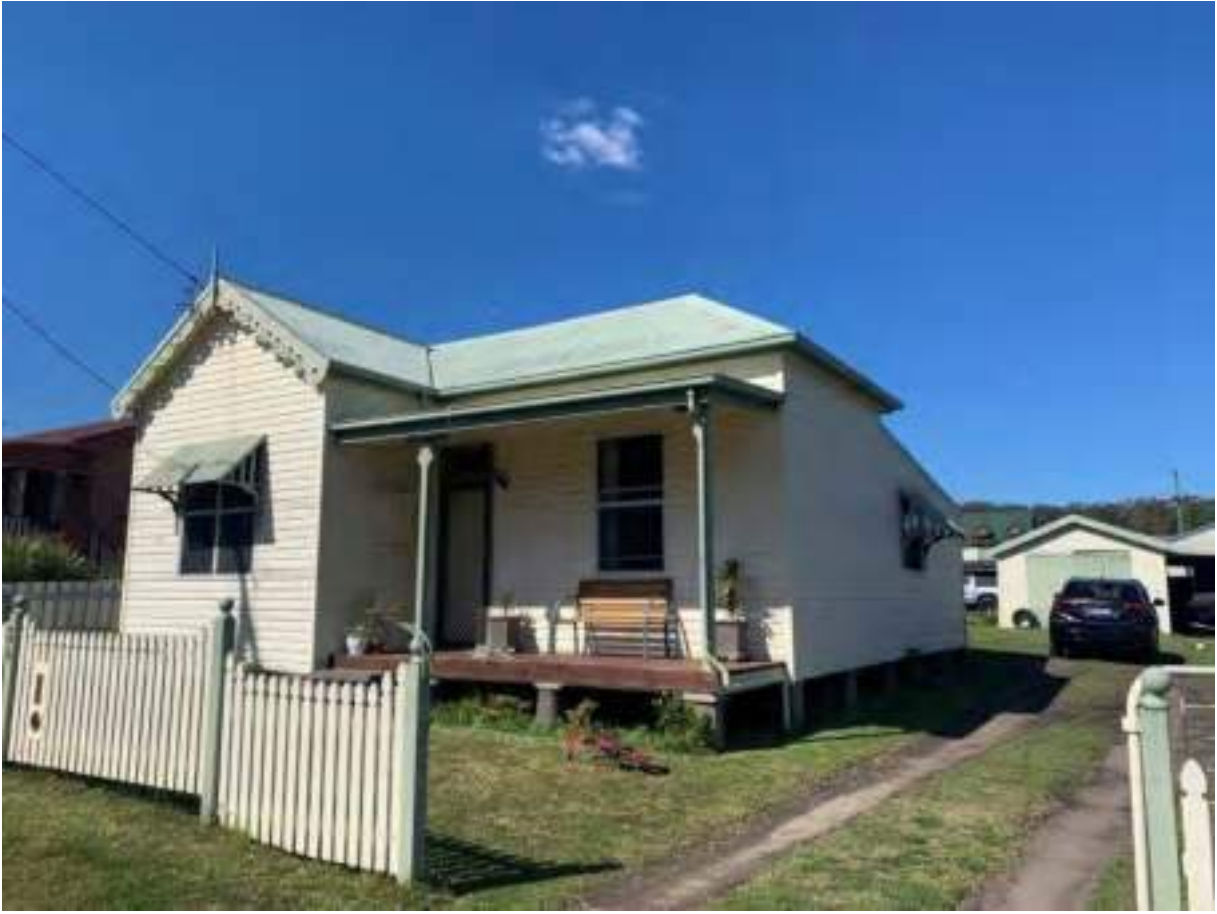
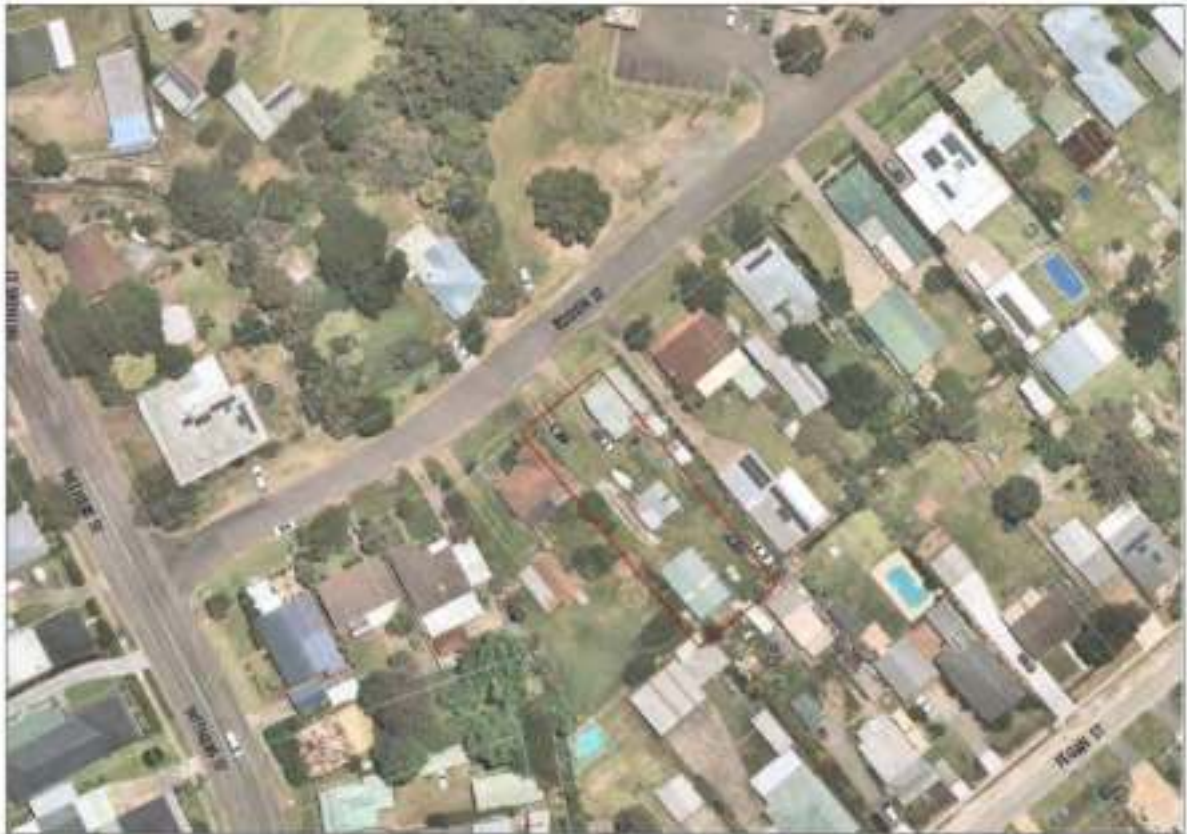
34 EDDEN STREET, WEST WALLSEND 2286

Conservation Area Contribution Level	Est. Construction Date	Previous studies and/or community input
Contributory 2	Early to late 20 th century (broad range)	No prior heritage assessments or research undertaken.
Assessment Text		Observed Modifications
<p>The scale (single-storey) and general style of the dwelling is consistent with that of the streetscape and wider HCA. Dwelling contributes positively to the streetscape and wider HCA, particularly in comparison to Non-Contributory buildings.</p> <p>The dwelling features appropriately proportioned and positioned fenestrations, an appropriate roof form (gabled or hipped) and other features consistent with the architectural character of the area (e.g. front verandah with timber or brick posts, timber detailing, corrugated metal roofing, etc). The contributory value of the dwelling is limited however by either:</p> <ul style="list-style-type: none"> • External modifications that have in some way obscured the style, scale or design intent of the building and have resulted in less physical integrity than Contributory 1 buildings. • Being a later dwelling constructed in an appropriate referential style, but comprising little to no fabric of intrinsic heritage significance. 		<p>The skillion veranda roof is a contemporary modification, likely replacing an original hipped or bull nosed design.</p> <p>The visible windows are contemporary in style.</p>

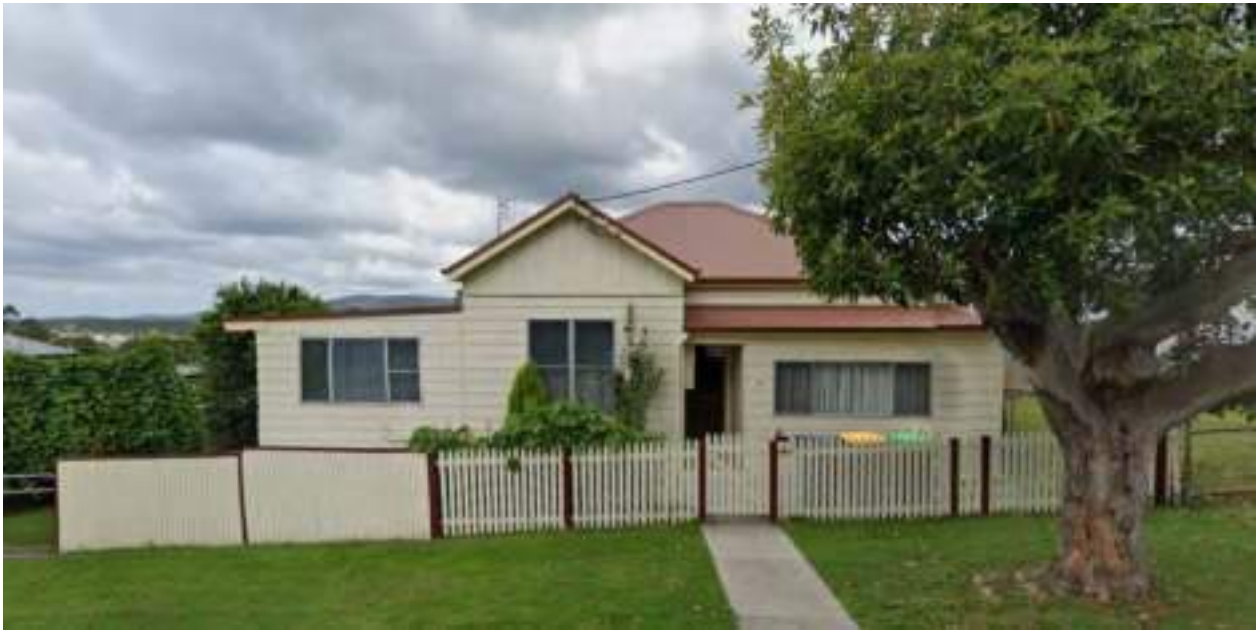
6 BROOKS STREET WEST WALLSEND 2286

Conservation Area Contribution Level	Est. Construction Date	Previous studies and/or community input
Contributory 2	Early to late 20th century (broad range)	No prior heritage assessments or research undertaken.
Assessment Text		Observed Modifications
<p>The scale (single-storey) and general style of the dwelling is consistent with that of the streetscape and wider HCA. Dwelling contributes positively to the streetscape and wider HCA, particularly in comparison to Non-Contributory buildings.</p> <p>The dwelling features appropriately proportioned and positioned fenestrations, an appropriate roof form (gabled or hipped) and other features consistent with the architectural character of the area (e.g. front verandah with timber or brick posts, timber detailing, corrugated metal roofing, etc). The contributory value of the dwelling is limited however by either:</p> <ul style="list-style-type: none"> • External modifications that have in some way obscured the style, scale or design intent of the building and have resulted in less physical integrity than Contributory 1 buildings. • Being a later dwelling constructed in an appropriate referential style, but comprising little to no fabric of intrinsic heritage significance. 		<p>Skillion roof addition to side of house has altered the presentation of the principal façade to Brooks Street.</p>

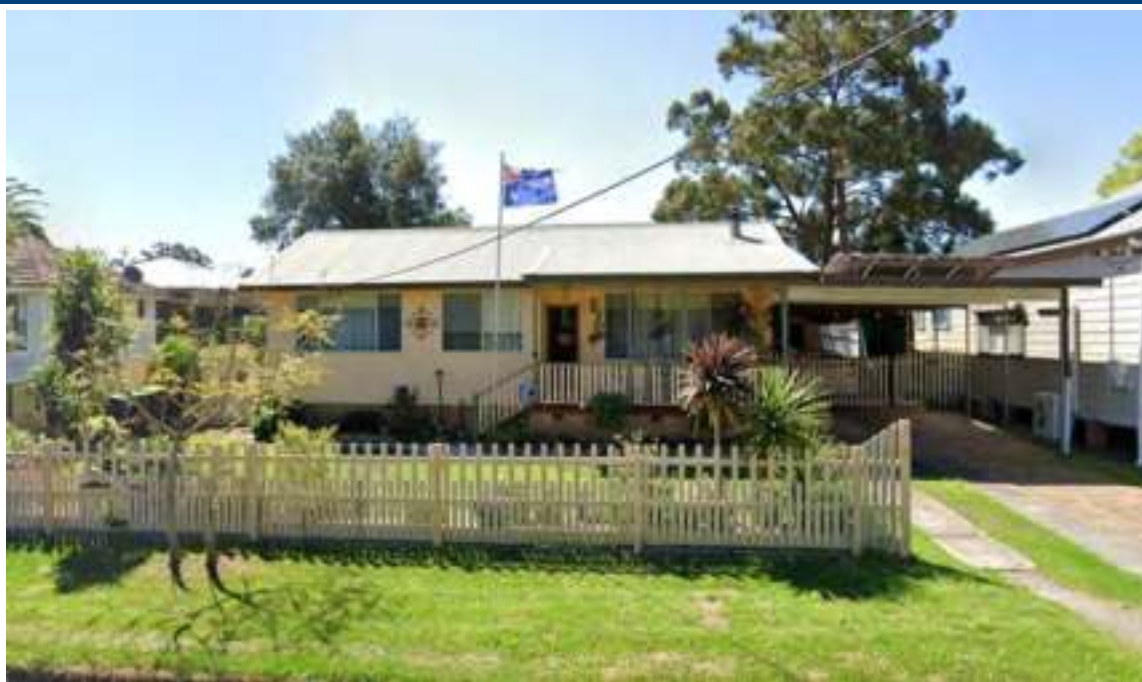
7 WILLIAM STREET HOLMESVILLE 2286

Conservation Area Contribution Level	Est. Construction Date	Previous studies and/or community input
Contributory 2	Mid to late 20th century (broad range)	No prior heritage assessments or research undertaken.
Assessment Text		Observed Modifications
<p>The scale (single-storey) and general style of the dwelling is consistent with that of the streetscape and wider HCA. Dwelling contributes positively to the streetscape and wider HCA, particularly in comparison to Non-Contributory buildings.</p> <p>The dwelling features appropriately proportioned and positioned fenestrations, an appropriate roof form (gabled or hipped) and other features consistent with the architectural character of the area (e.g. front verandah with timber or brick posts, timber detailing, corrugated metal roofing, etc). The contributory value of the dwelling is limited however by either:</p> <ul style="list-style-type: none"> • External modifications that have in some way obscured the style, scale or design intent of the building and have resulted in less physical integrity than Contributory 1 buildings. • Being a later dwelling constructed in an appropriate referential style, but comprising little to no fabric of intrinsic heritage significance. 		<p>Carport to side of house has altered the presentation of the principal façade. Principal façade has the typical proportions and appearance of a mid-to-late 20th century house that is sympathetic to surroundings but is not of a significant architectural style.</p>

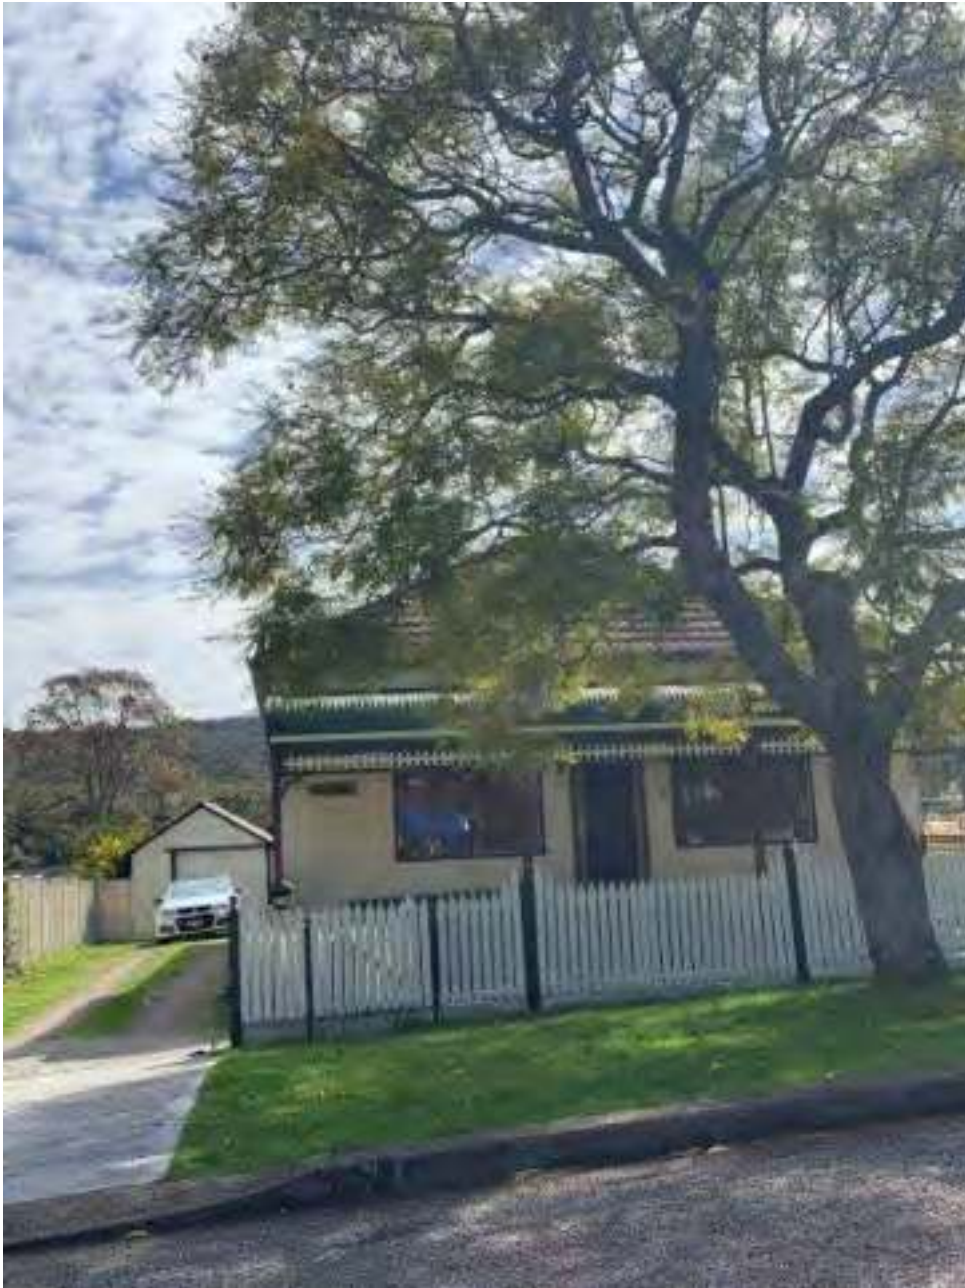
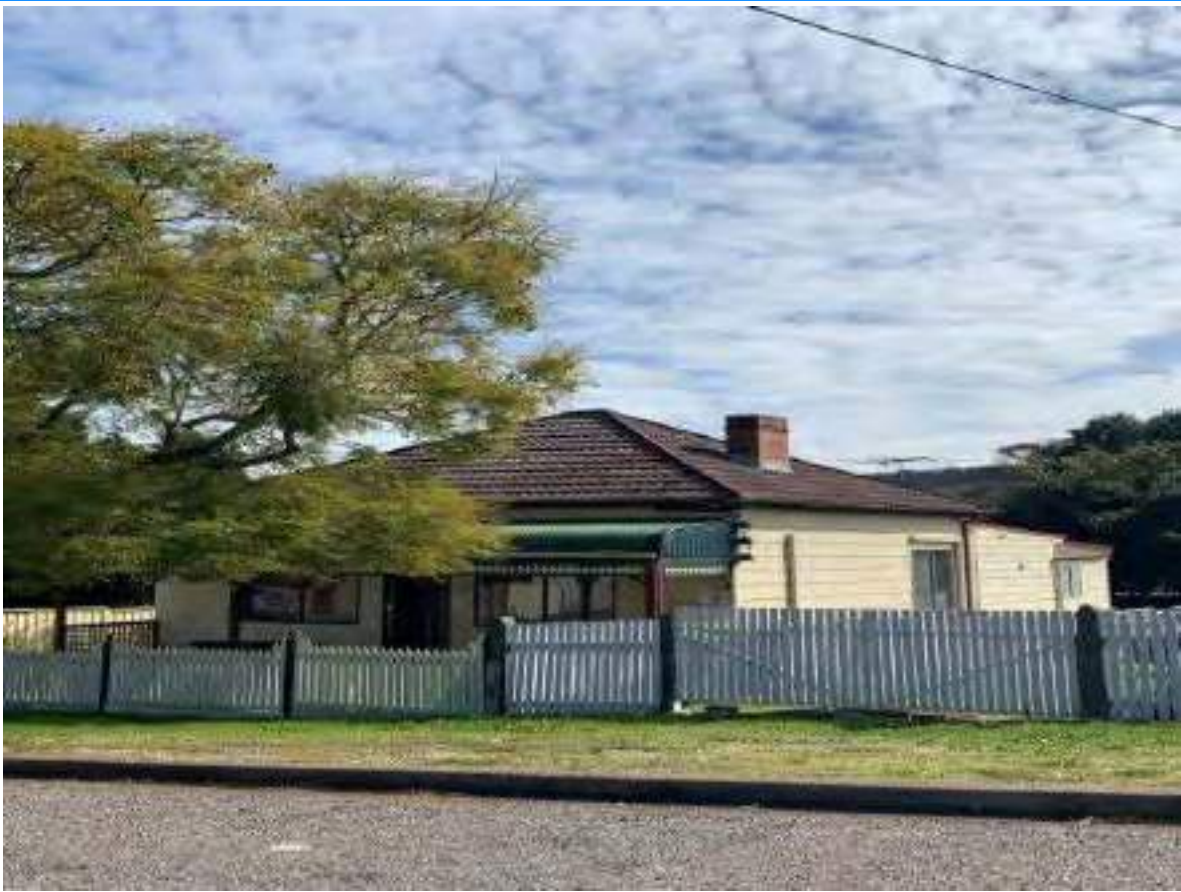
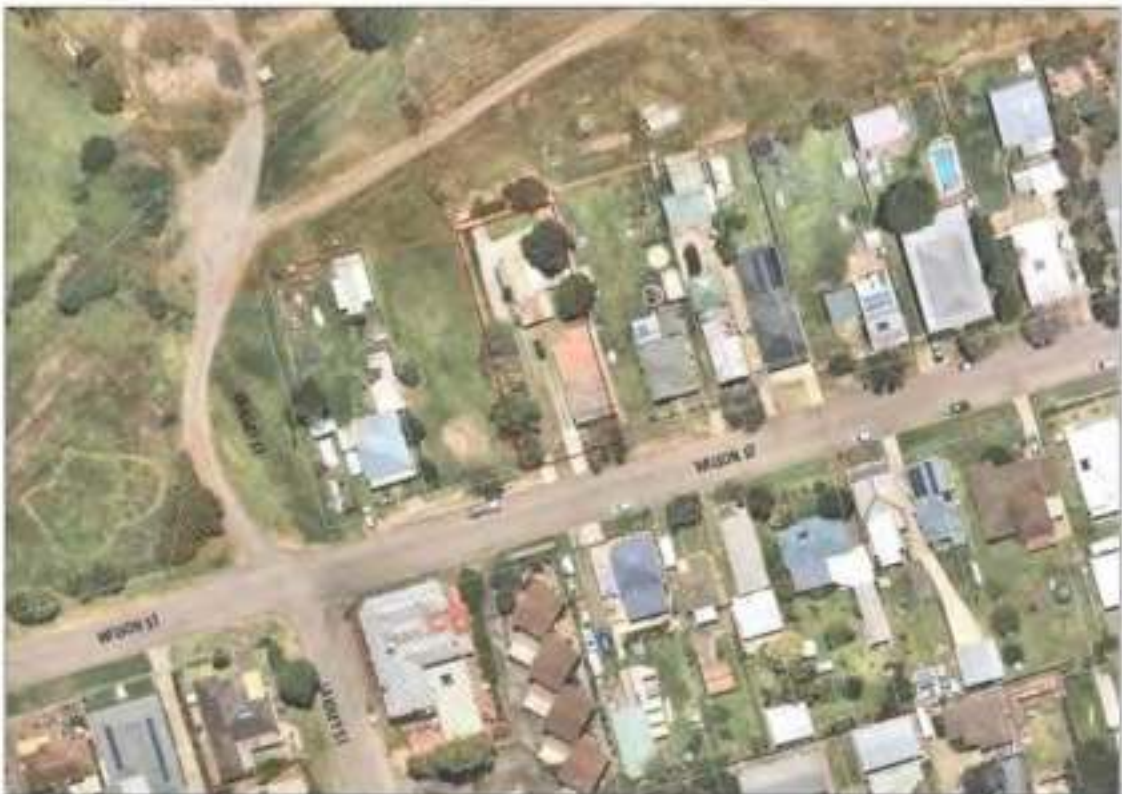
71 WILSON STREET, WEST WALLSEND 2286

Conservation Area Contribution Level	Est. Construction Date	Previous studies and/or community input
Contributory 2	Mid 20 th century	No prior heritage investigations and no additional information required.
Assessment Text		Observed Modifications
<p>Single story Vernacular 'Mining Cottage' style dwelling with hipped tiled roof and weatherboard cladding. The veranda roof is bull nosed and supported by timber posts with ornate bracketing. The veranda roof is framed by a simple timber valance. Information provided by the property owner would suggest that the dwelling emulates the vernacular style, however is a mid-century build.</p> <p>The veranda is partially enclosed by timber lattice panels.</p> <p>The front door has a metal security screen with sliding windows either side.</p> <p>A brickwork chimney is visible on the eastern side of the dwelling.</p> <p>The scale (single-storey) and general style of the dwelling is consistent with that of the streetscape and wider HCA. Dwelling contributes positively to the streetscape and wider HCA, particularly in comparison to Non-Contributory buildings.</p> <p>The dwelling features appropriately proportioned and positioned fenestrations, an appropriate roof form (gabled or hipped) and other features consistent with the architectural character of the area (e.g. front verandah with timber or brick posts, timber detailing, corrugated metal roofing, etc).</p> <p>The contributory value of the dwelling is limited however by either:</p> <ul style="list-style-type: none"> • External modifications that have in some way obscured the style, scale or design intent of the building and have resulted in less physical integrity than Contributory 1 buildings. • Being a later dwelling constructed in an appropriate referential style, but comprising little to no fabric of intrinsic heritage significance. 		<p>The tiled roof is a contemporary variation on the traditional Colourbond or corrugated iron sheeting of the style.</p> <p>The timber valance and lattice work are a recent addition to the dwelling and detract from the heritage style.</p> <p>The brick chimney is potentially a replacement for the original brickwork chimney commonly found.</p>

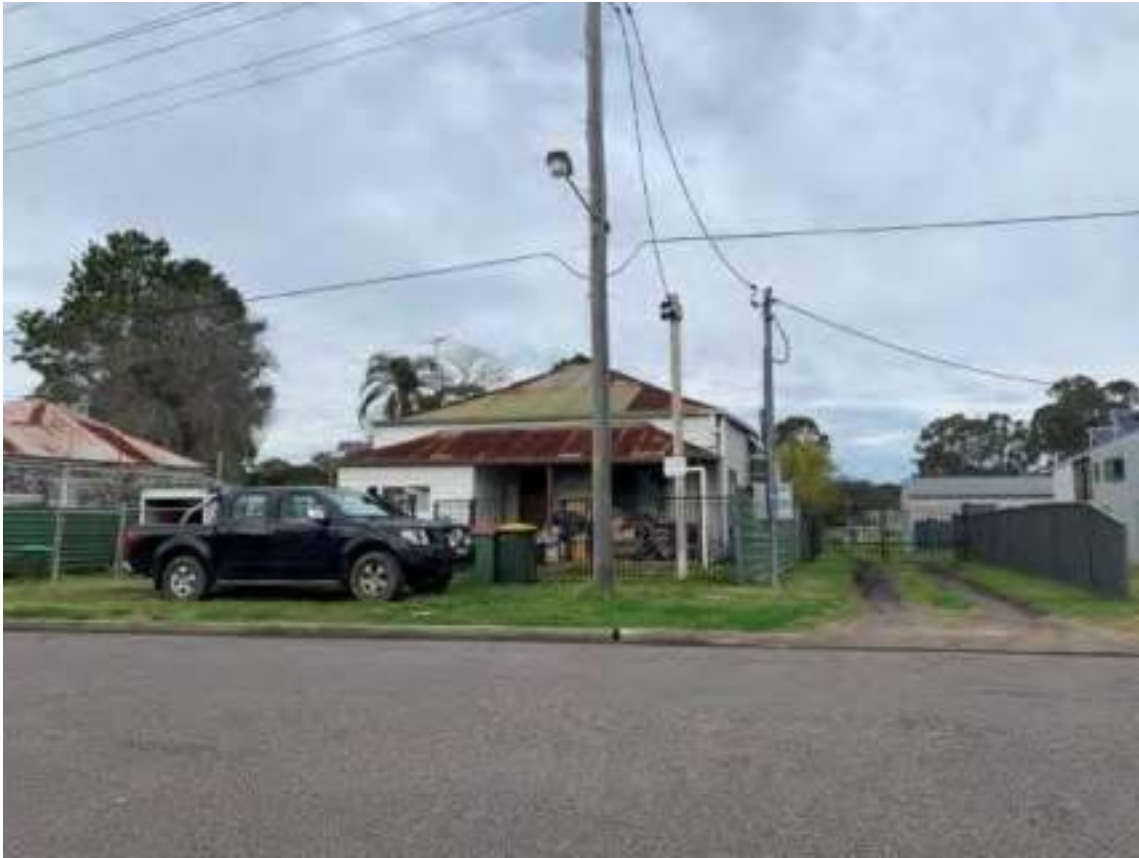
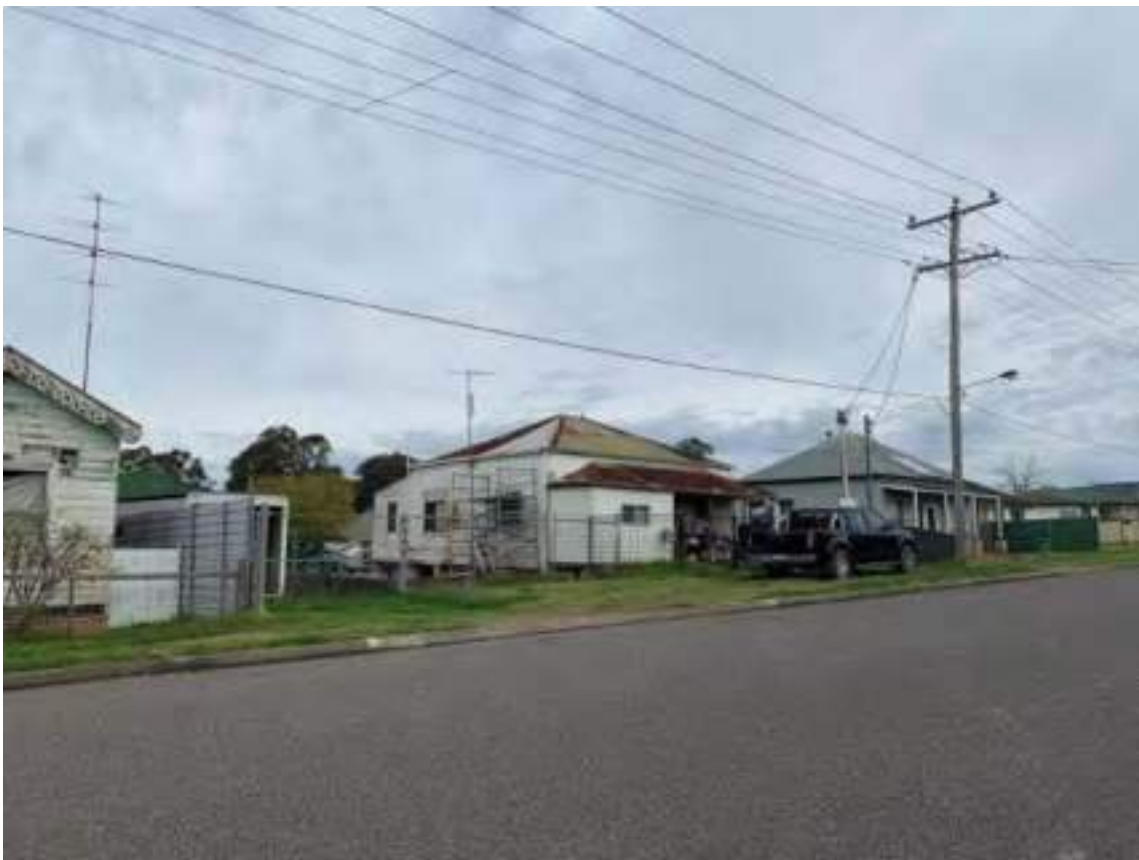
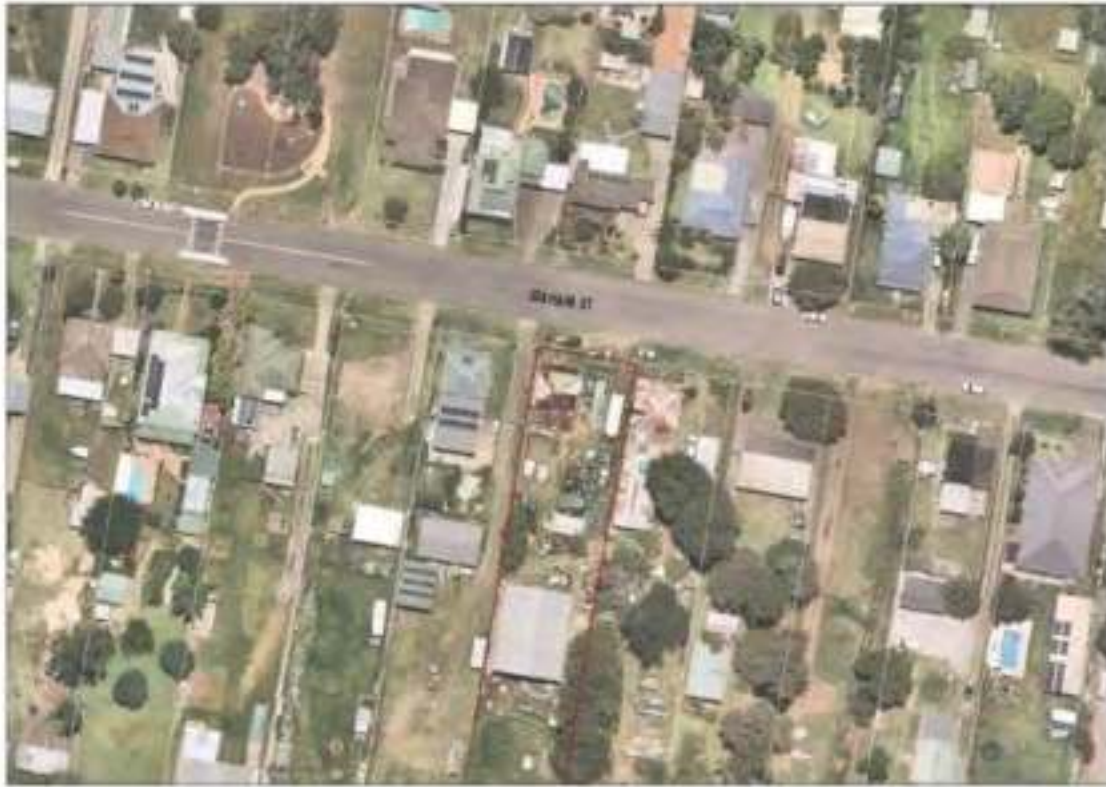
68 SEAHAM STREET, HOLMESVILLE 2286

Conservation Area Contribution Level	Est. Construction Date	Previous studies and/or community input
Contributory 2	1905-1910	Holmesville Heritage Study 1993. In connection with 70 and 66 Seaham Street.
Assessment Text		Observed Modifications
<p>Single storey Vernacular cottage style dwelling with hipped Colourbond roof and weatherboard cladding. The veranda roof is hipped and supported by timber posts.</p> <p>The veranda is partially enclosed, with only the western portion remaining an open space. There is no balustrade, and the floor is concrete.</p> <p>The front door is centrally located, with a solid timber frame. Modern sliding metal framed windows are found either side. similar sliding windows are also evident on the western side of the dwelling.</p> <p>A large green metal sheet garage is located at the back southern portion of the property, being visible from the street. It has a high gable roof and is not sympathetic to the heritage style of the surroundings. A secondary structure, likely a shipping container is also used for vehicle storage.</p> <p>A metal fence encloses the property, with Colourbond fencing to the east.</p> <p>The scale (single-storey) and general style of the dwelling is consistent with that of the streetscape and wider HCA. Dwelling</p>		<p>The veranda space has been partially enclosed through the addition of a front facing room, a common modification amongst this style of dwelling.</p> <p>At the time of the assessment, the dwelling was undergoing construction and may have altered further.</p> <p>The original windows, likely sash, have been removed and replaced by modern sliding designs.</p> <p>A small extension has been constructed on the western side of the dwelling, partially constructed of red brick and glass. A metal chimney extends from the room.</p>

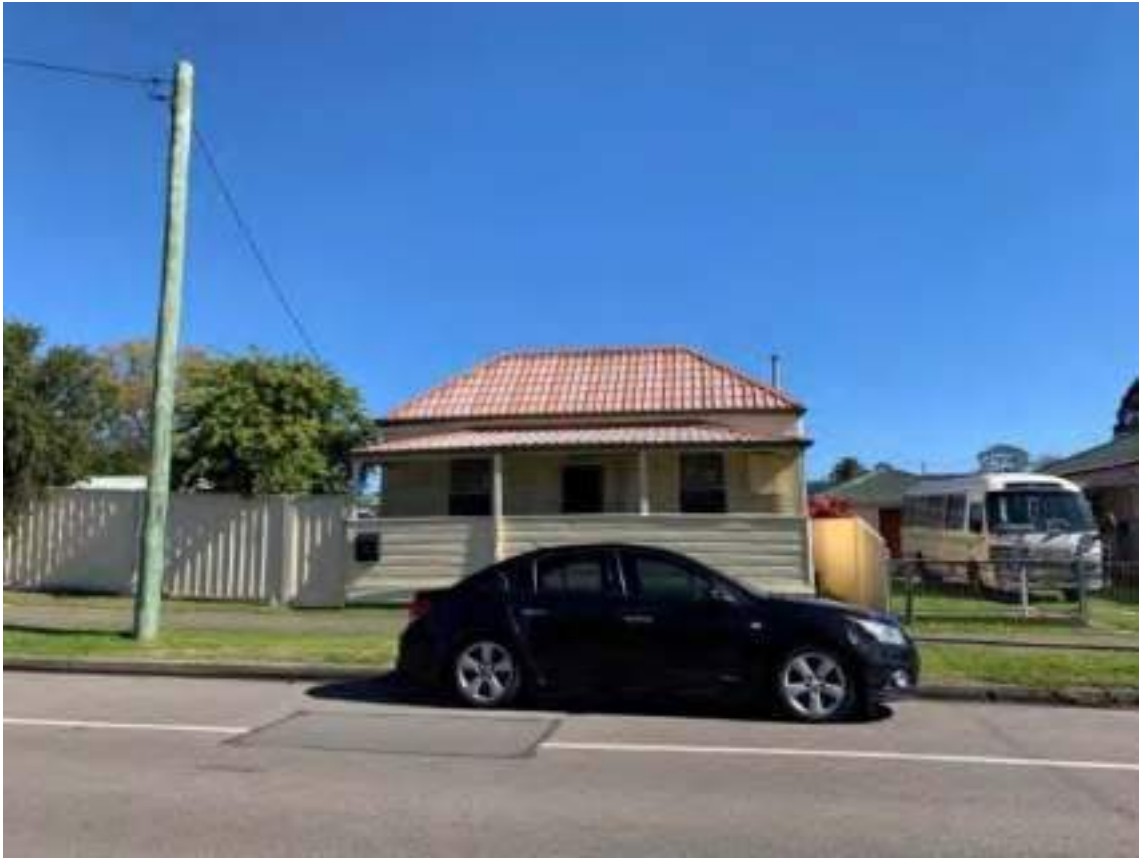
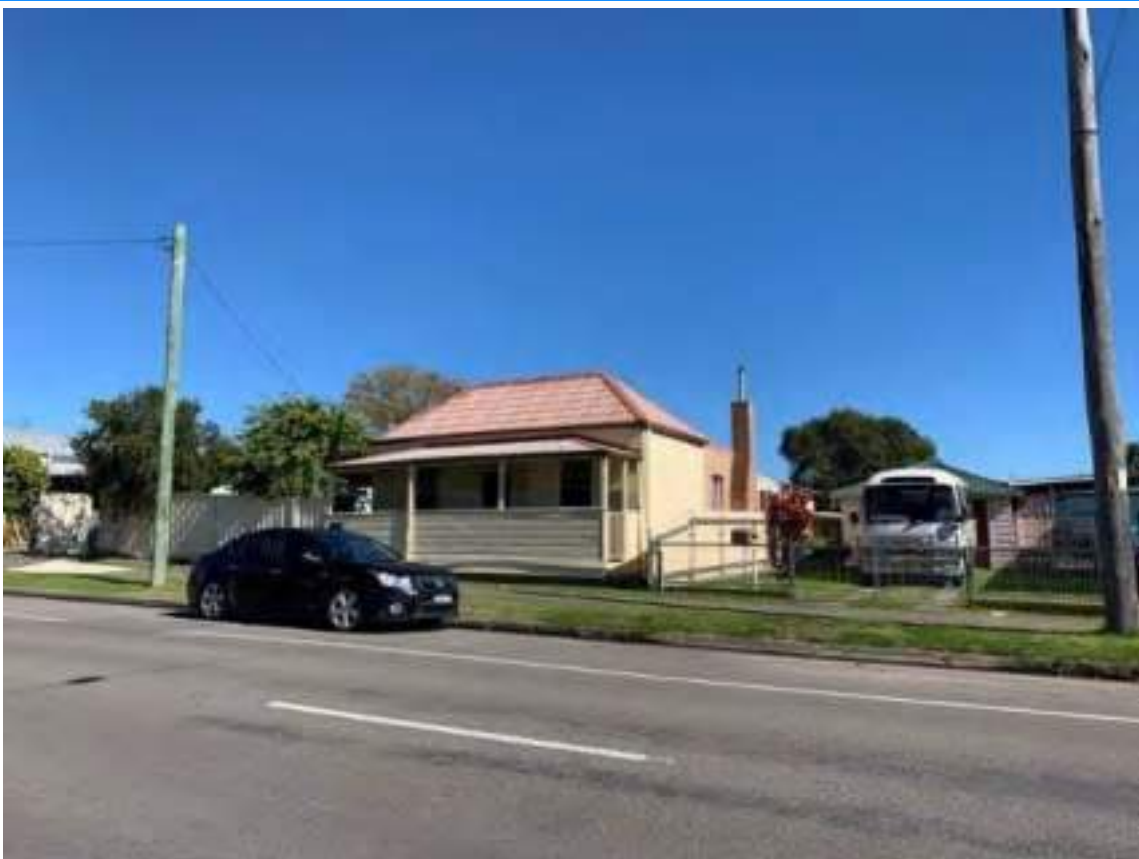
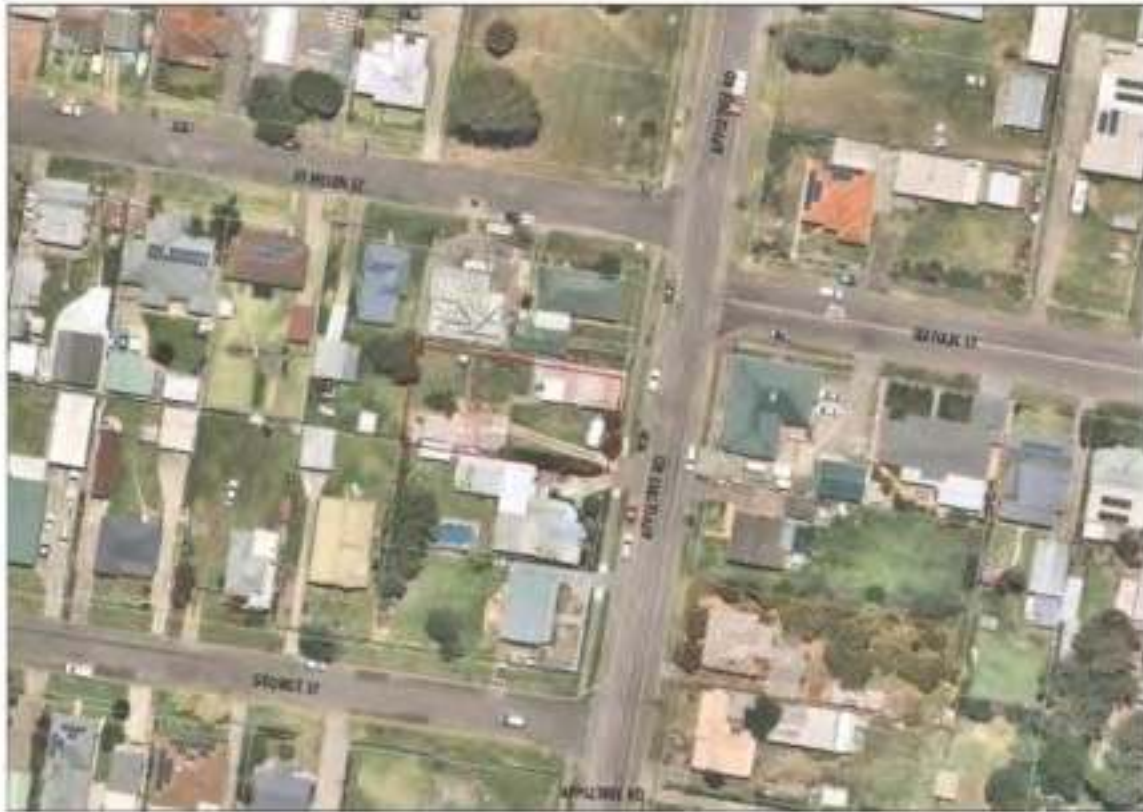
42 APPLETREE ROAD, HOLMESVILLE 2286

Conservation Area Contribution Level	Est. Construction Date	Previous studies and/or community input
Contributory 2	1900–1915	No prior heritage investigations and no additional information required.
Assessment Text		Observed Modifications
<p>Single storey Vernacular ‘Mining Cottage’ style dwelling with terracotta tiled hipped roof and weatherboard cladding. The veranda roof is also terracotta hipped in design, and is supported by timber pillars.</p> <p>The veranda space is partially enclosed by a timber panel veranda wall, with access to the dwelling achieved with a southern gate to the side of the veranda space.</p> <p>The front door is centrally located, with a modern timber and glass design, with a metal framed screen door in front. Either side of the door are double hung timber framed windows.</p> <p>A brickwork chimney with metal top is located on the southern side of the dwelling.</p> <p>The dwelling displays architectural features of a heritage style and is representative of the local</p>		<p>The front door has been replaced with a modern style comprised of a timber frame, and glass panels. This likely replaced a traditional four panel timber door.</p> <p>The veranda space is enclosed with timber panels, a recent addition to the dwelling. likely originally there were not balustrades or walls enclosing the space, and the veranda was open as is common with the style.</p> <p>The brickwork chimney is a modification to the original chimney, being simplistic in style and lacking any of the decorative features such as corbels.</p> <p>The terracotta tiled roof has likely replaced an original corrugated roof.</p> <p>Information provided by the property owner relays that the dwelling has been extensively modified</p>

<p>development of this period, being of historical significance for the HCA.</p> <p>The scale (single-storey) and general style of the dwelling is consistent with that of the streetscape and wider HCA. Dwelling contributes positively to the streetscape and wider HCA, particularly in comparison to Non-Contributory buildings.</p> <p>The dwelling features appropriately proportioned and positioned fenestrations, an appropriate roof form (gabled or hipped) and other features consistent with the architectural character of the area (e.g. front verandah with timber or brick posts, timber detailing, corrugated metal roofing, etc).</p> <p>The contributory value of the dwelling is limited however by either:</p> <ul style="list-style-type: none">• External modifications that have in some way obscured the style, scale or design intent of the building and have resulted in less physical integrity than Contributory 1 buildings.• Being a later dwelling constructed in an appropriate referential style, but comprising little to no fabric of intrinsic heritage significance.	<p>internally and externally, and is currently undergoing works.</p>

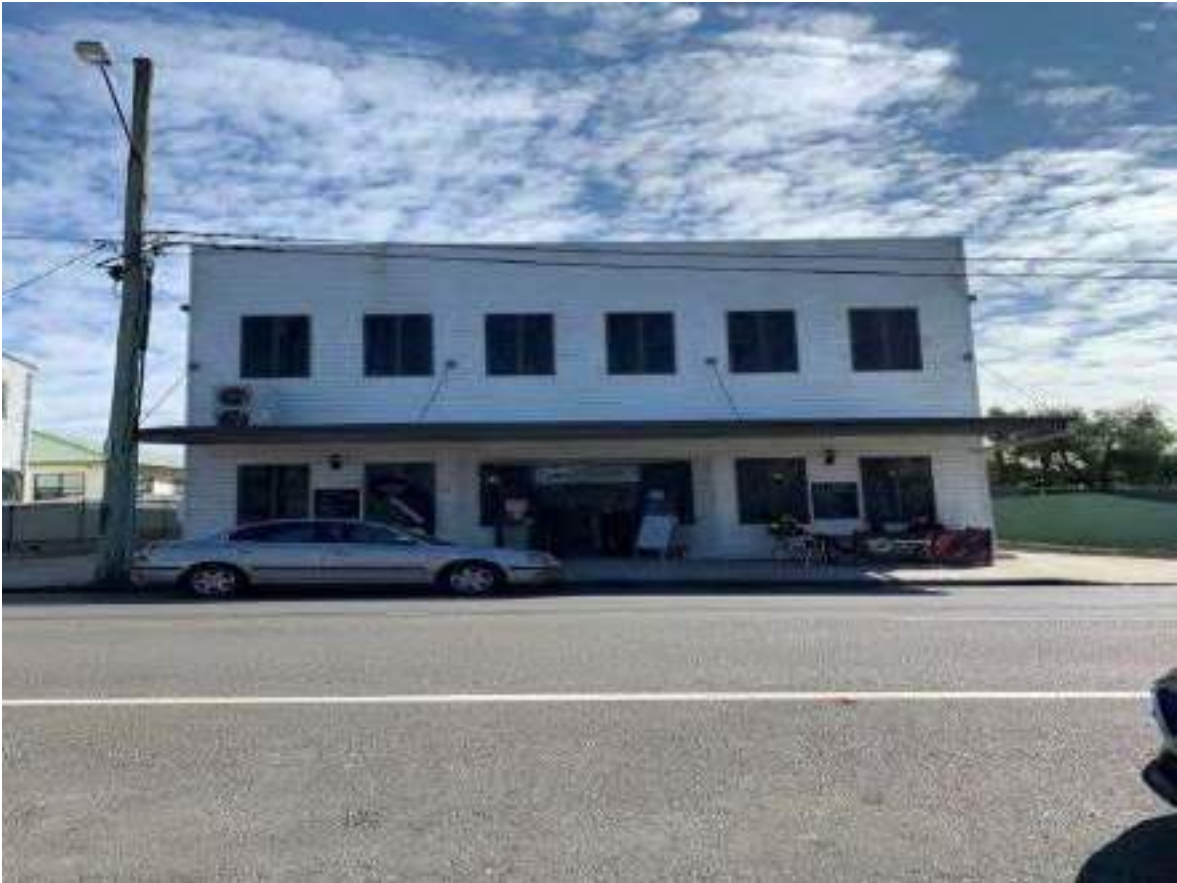
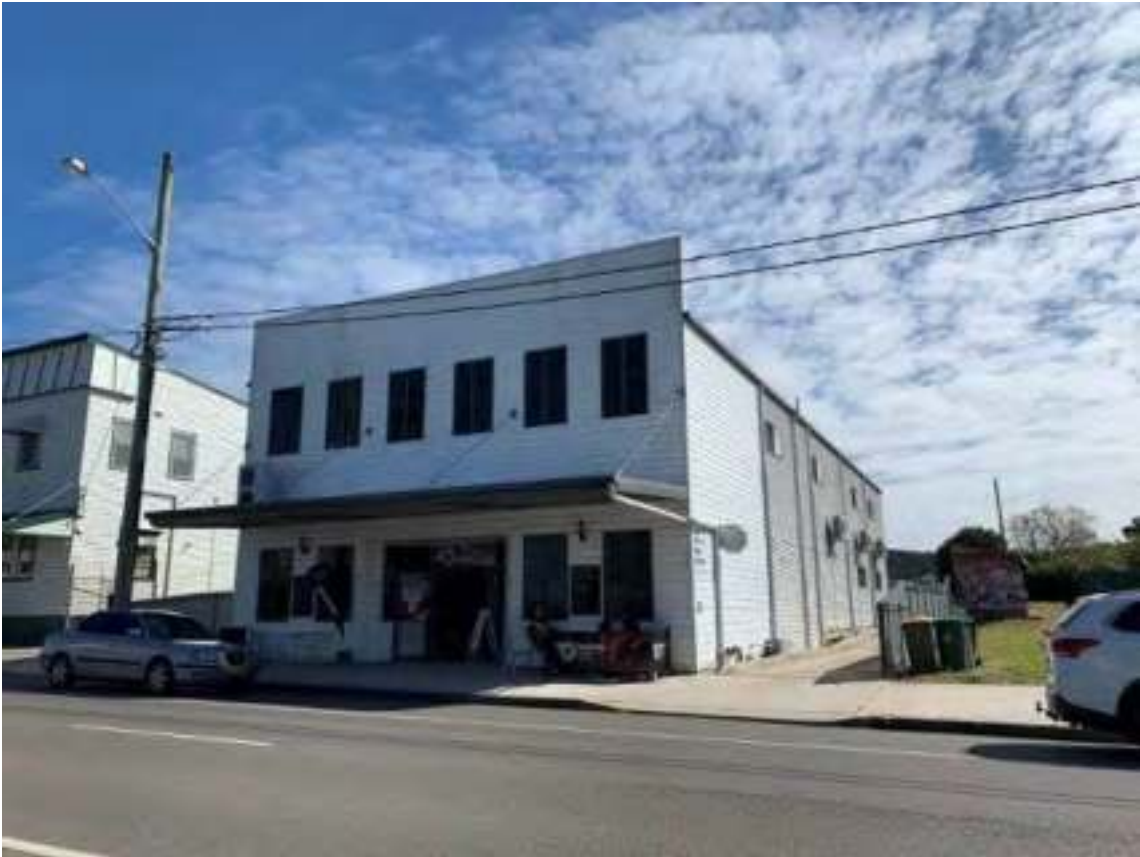
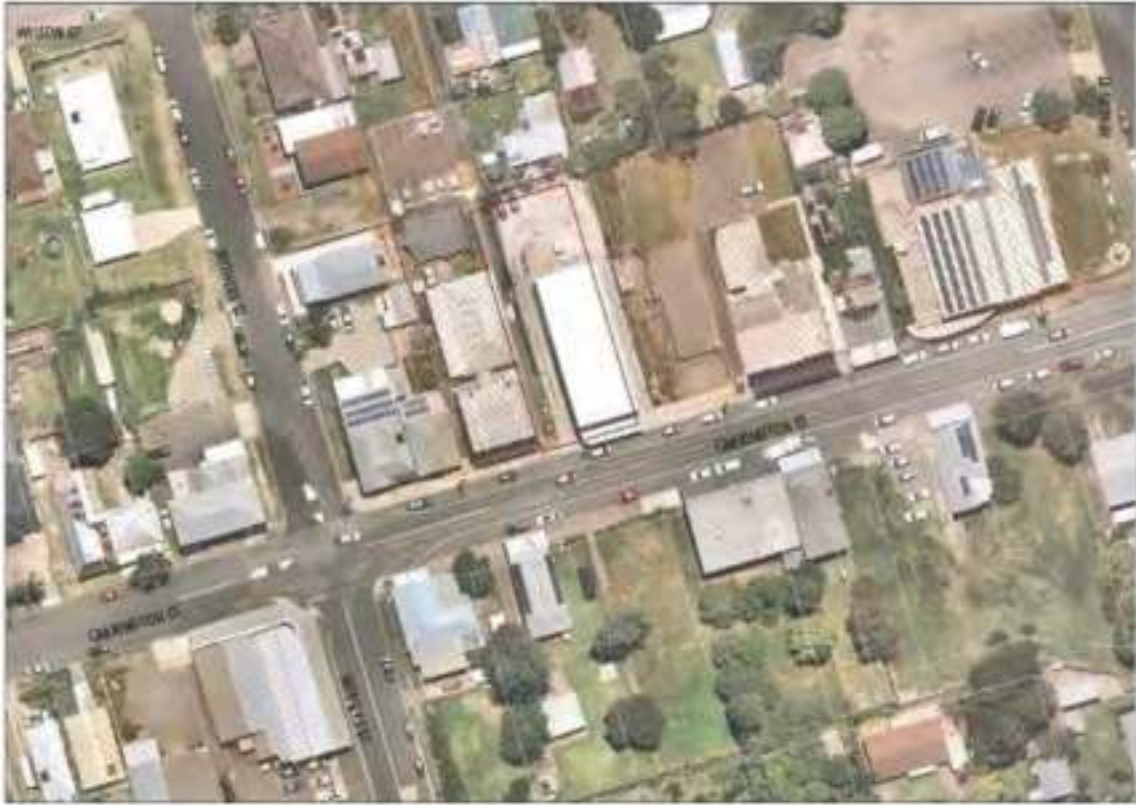
63 CARRINGTON STREET, WEST WALLSEND 2286

Conservation Area Contribution Level	Est. Construction Date	Previous studies and/or community input
Contributory 2	2016	<p>West Wallsend Heritage Study 1993.</p> <p>Location of the Former Royal Hotel (no longer present due to fire).</p>
Assessment Text		Observed Modifications
<p>Two storey building with skillion Colourbond roof and weatherboard cladding. The veranda roof is skillion and supported by metal wiring. The building has been constructed in a sympathetic manner, having replaced the former Royal Hotel. All visible windows are four pane designs with the front door being a double door metal security screen.</p> <p>A timber parapet is visible above the secondary floor.</p> <p>The scale (single-storey) and general style of the dwelling is consistent with that of the streetscape and wider HCA. Dwelling contributes positively to the streetscape and wider HCA, particularly in comparison to Non-Contributory buildings.</p> <p>The dwelling features appropriately proportioned and positioned fenestrations, an appropriate roof form (gabled or hipped) and other features consistent with the architectural character of the area (e.g. front verandah with timber or brick posts, timber detailing, corrugated metal roofing, etc).</p>		N/A

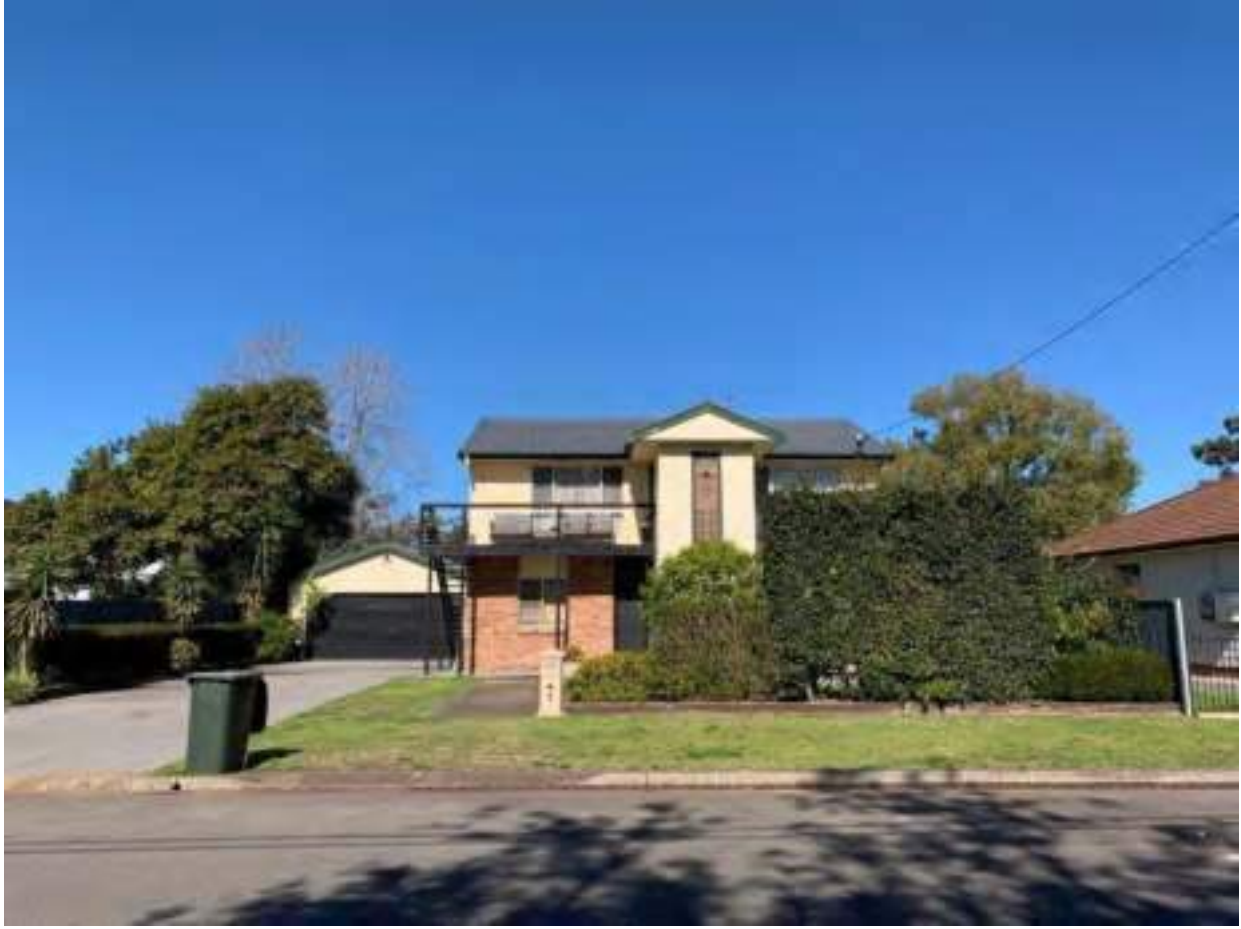
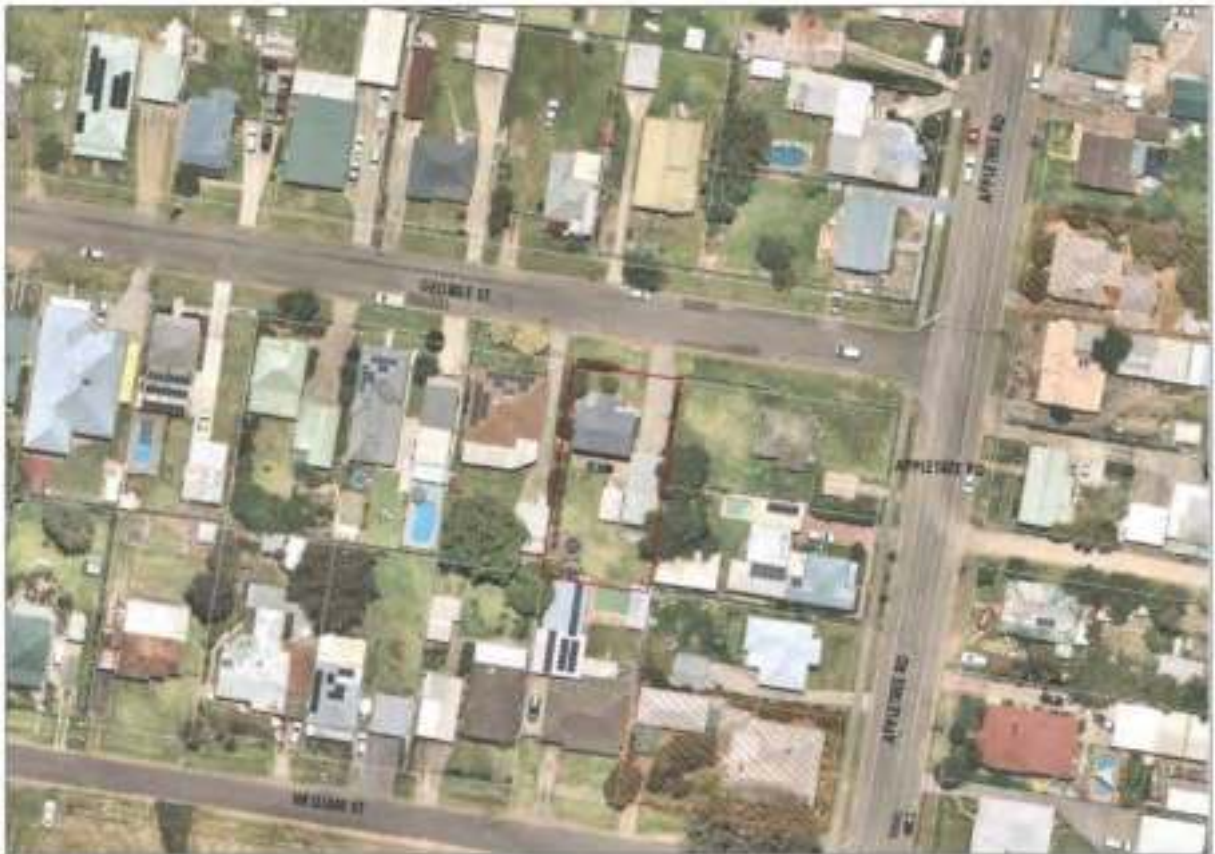
2 GEORGE STREET, HOLMESVILLE 2286		
Conservation Area Contribution Level	Est. Construction Date	Previous studies and/or community input
Non-Contributory	Mid to late 20 th century onwards	No prior heritage assessments or research undertaken.
Assessment Text		Observed Modifications
<p>The scale (e.g. double-storey or greater) and general style of the dwelling is inconsistent with that of the streetscape and wider HCA.</p> <p>The dwelling does not contribute positively to the streetscape and wider HCA, particularly in comparison to Contributory 1 and 2 buildings. The presence of the building has an adverse impact on the streetscape and/or wider HCA.</p> <p>The dwelling features inappropriately proportioned and positioned fenestrations, an inappropriate roof form (gabled or hipped) and/or other features that are inconsistent with the architectural character of the area (e.g. unsympathetic additions, inconsistent [contemporary] building materials, etc).</p>		No modifications observed due to the contemporary construction.
