APPENDIX 2

Building Assessment Sheets (Inventory Sheets)

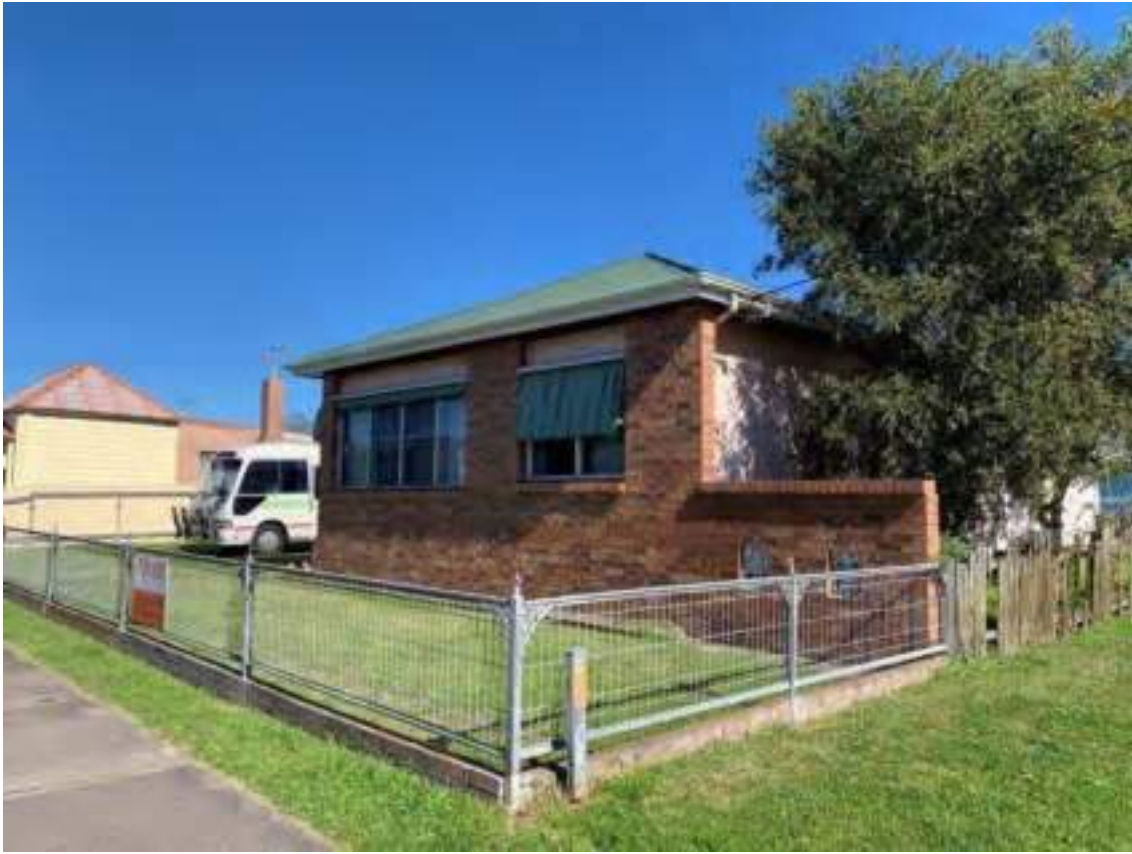
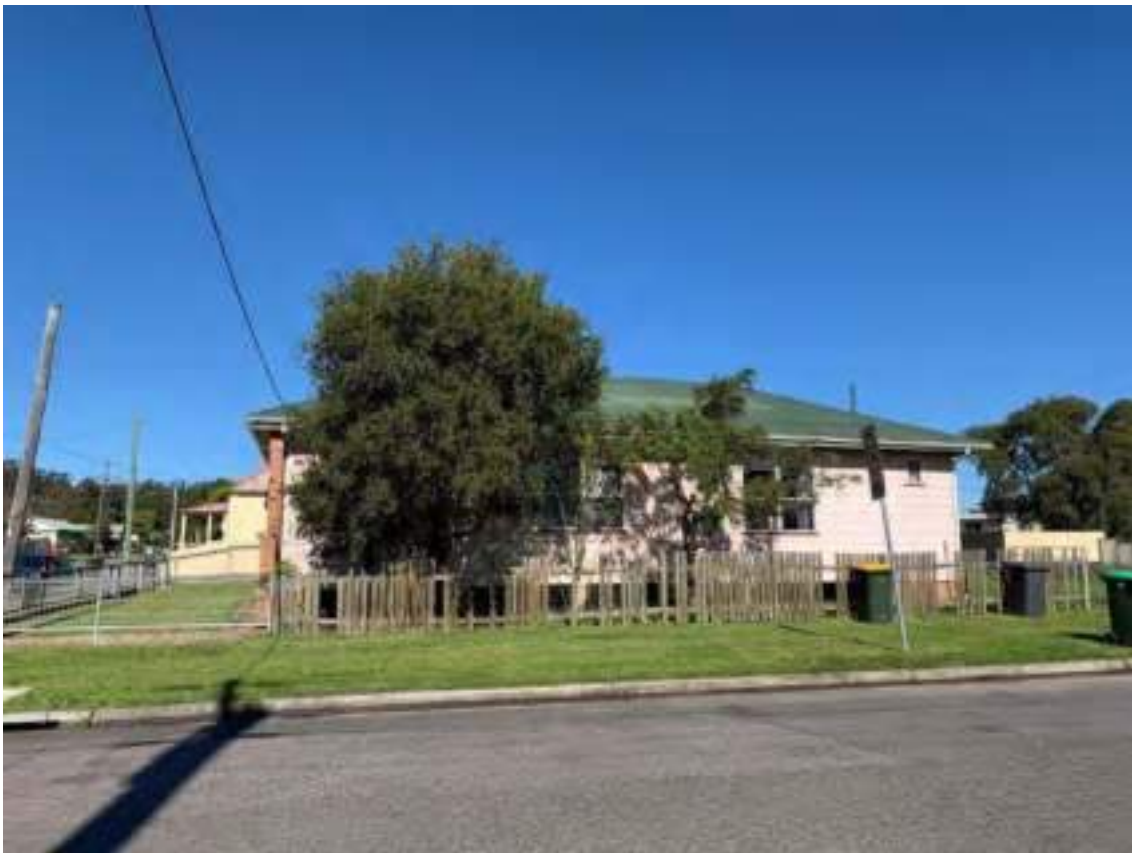
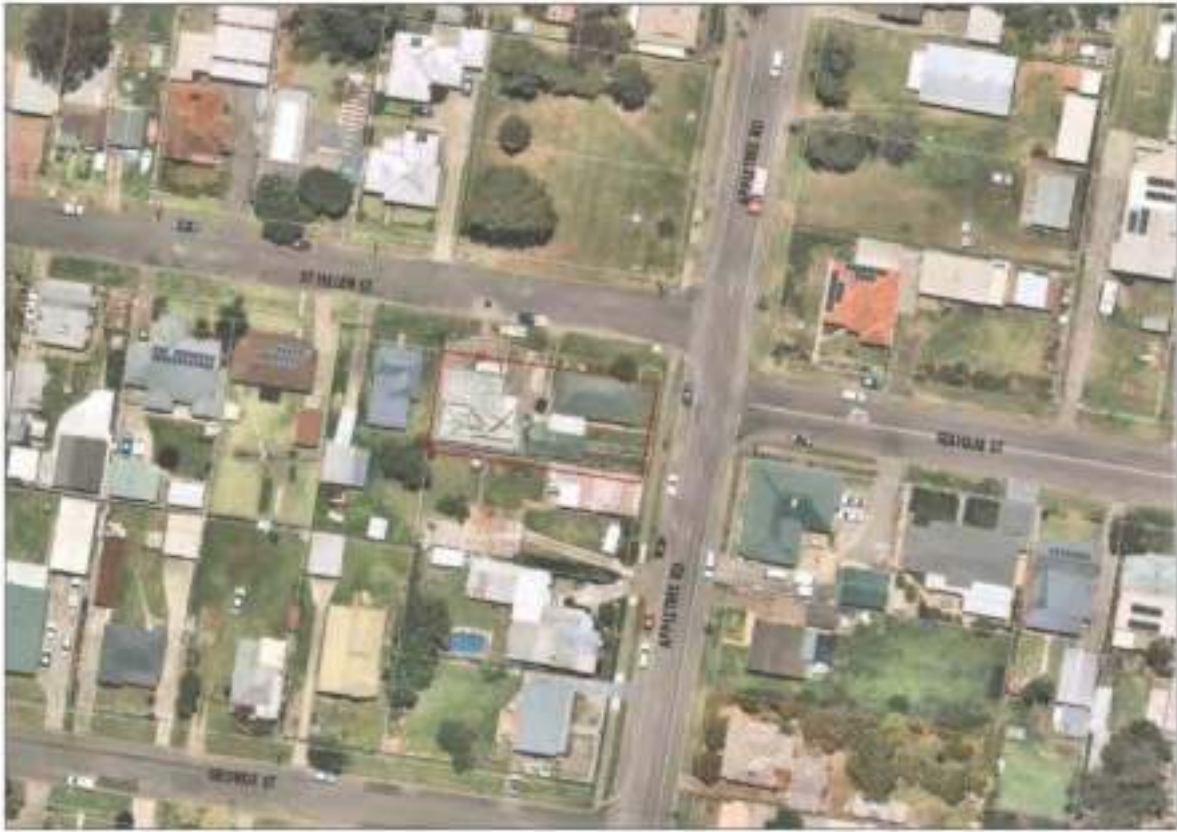
40 APPLETREE ROAD, HOLMESVILLE 2286

Conservation Area Contribution Level	Est. Construction Date	Previous studies and/or community input
Non-Contributory	Mid to late 20 th century onwards	No prior heritage assessments or research undertaken.
Assessment Text		Observed Modifications
<p>The scale (e.g. double-storey or greater) and general style of the dwelling is inconsistent with that of the streetscape and wider HCA.</p> <p>The dwelling does not contribute positively to the streetscape and wider HCA, particularly in comparison to Contributory 1 and 2 buildings. The presence of the building has an adverse impact on the streetscape and/or wider HCA.</p> <p>The dwelling features inappropriately proportioned and positioned fenestrations, an inappropriate roof form (gabled or hipped) and/or other features that are inconsistent with the architectural character of the area (e.g. unsympathetic additions, inconsistent [contemporary] building materials, etc).</p>		<p>The veranda has been enclosed through the installation of window panels to create an additional living area. This is a dated modification and is common to the area.</p>

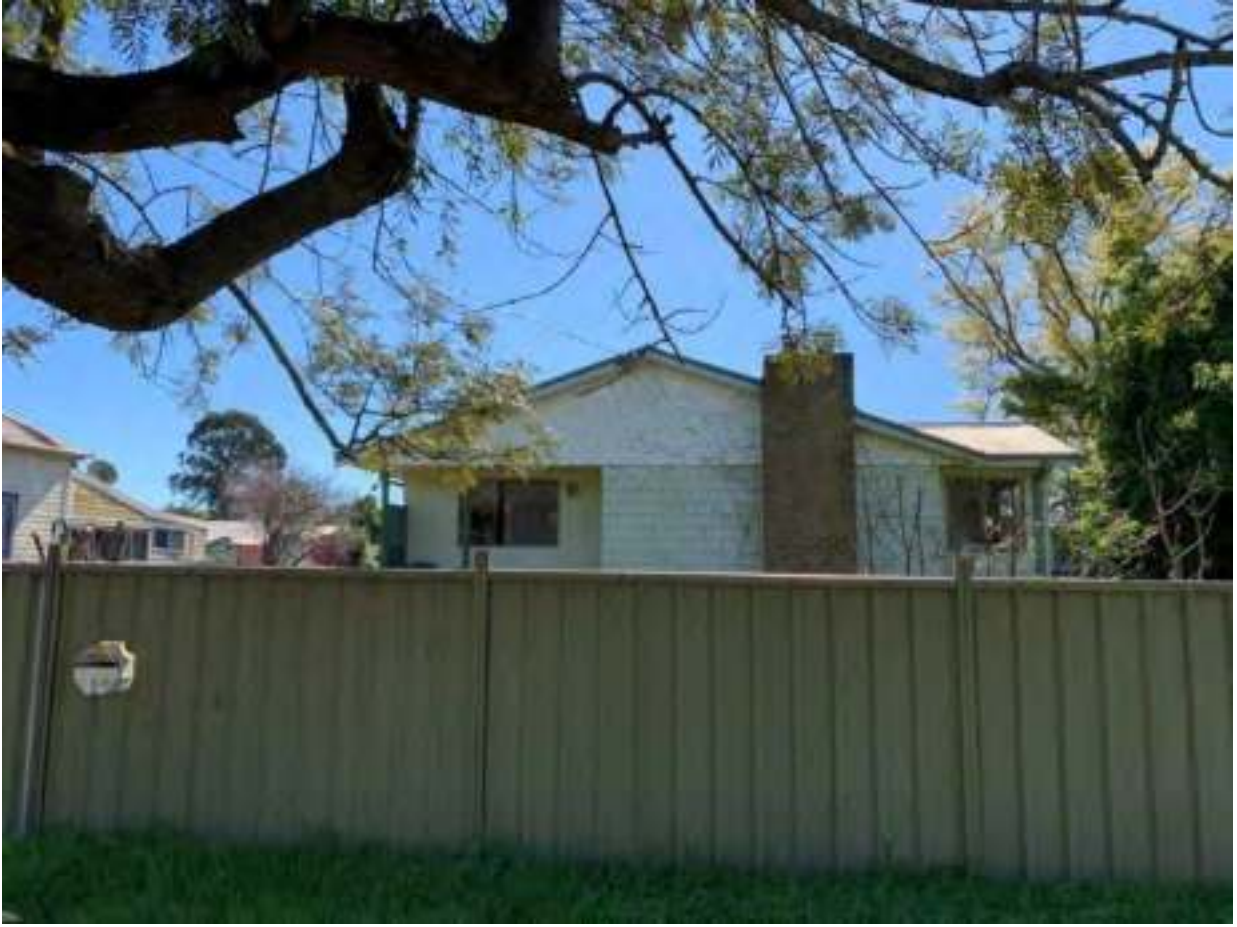
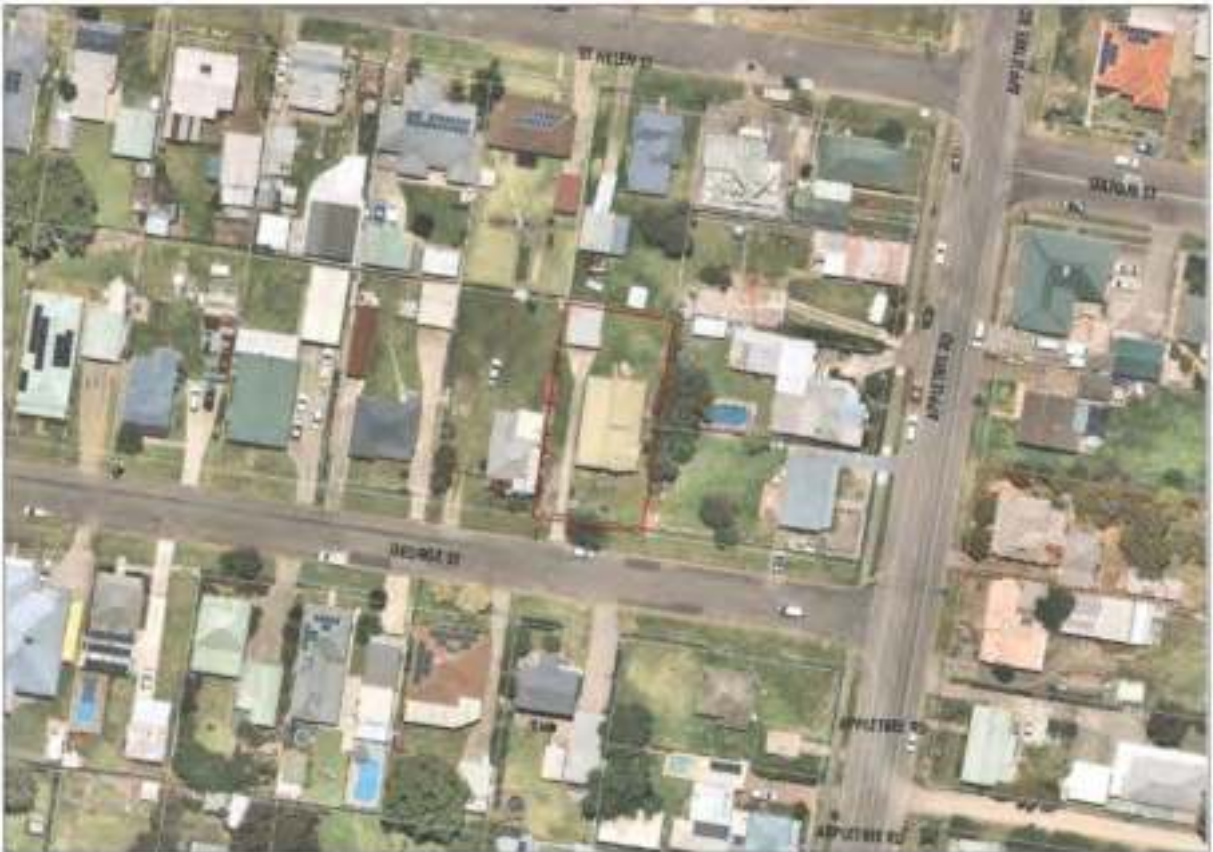
1 GEORGE STREET, HOLMESVILLE 2286		
Conservation Area Contribution Level	Est. Construction Date	Previous studies and/or community input
Non-Contributory	Mid to late 20 th century onwards	No prior heritage assessments or research undertaken.
Assessment Text		Observed Modifications
<p>The scale (e.g. double-storey or greater) and general style of the dwelling is inconsistent with that of the streetscape and wider HCA.</p> <p>The dwelling does not contribute positively to the streetscape and wider HCA, particularly in comparison to Contributory 1 and 2 buildings. The presence of the building has an adverse impact on the streetscape and/or wider HCA.</p> <p>The dwelling features inappropriately proportioned and positioned fenestrations, an inappropriate roof form (gabled or hipped) and/or other features that are inconsistent with the architectural character of the area (e.g. unsympathetic additions, inconsistent [contemporary] building materials, etc).</p>		No modifications observed.

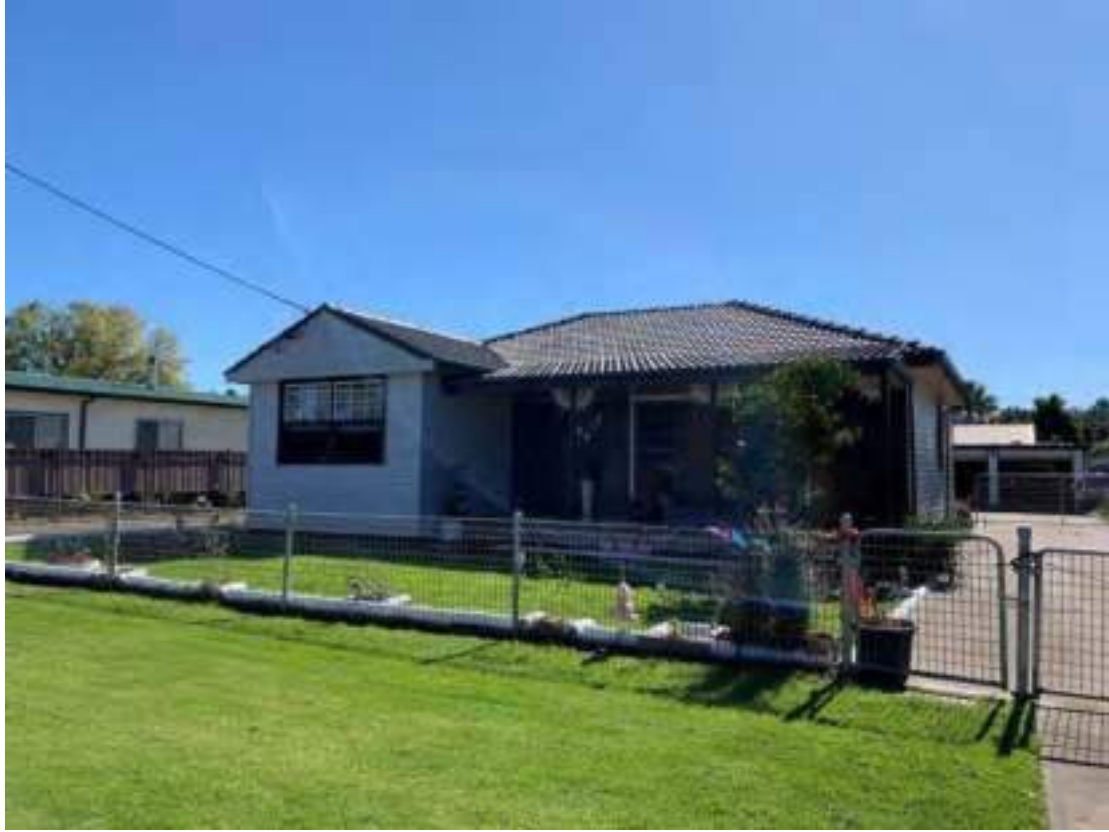
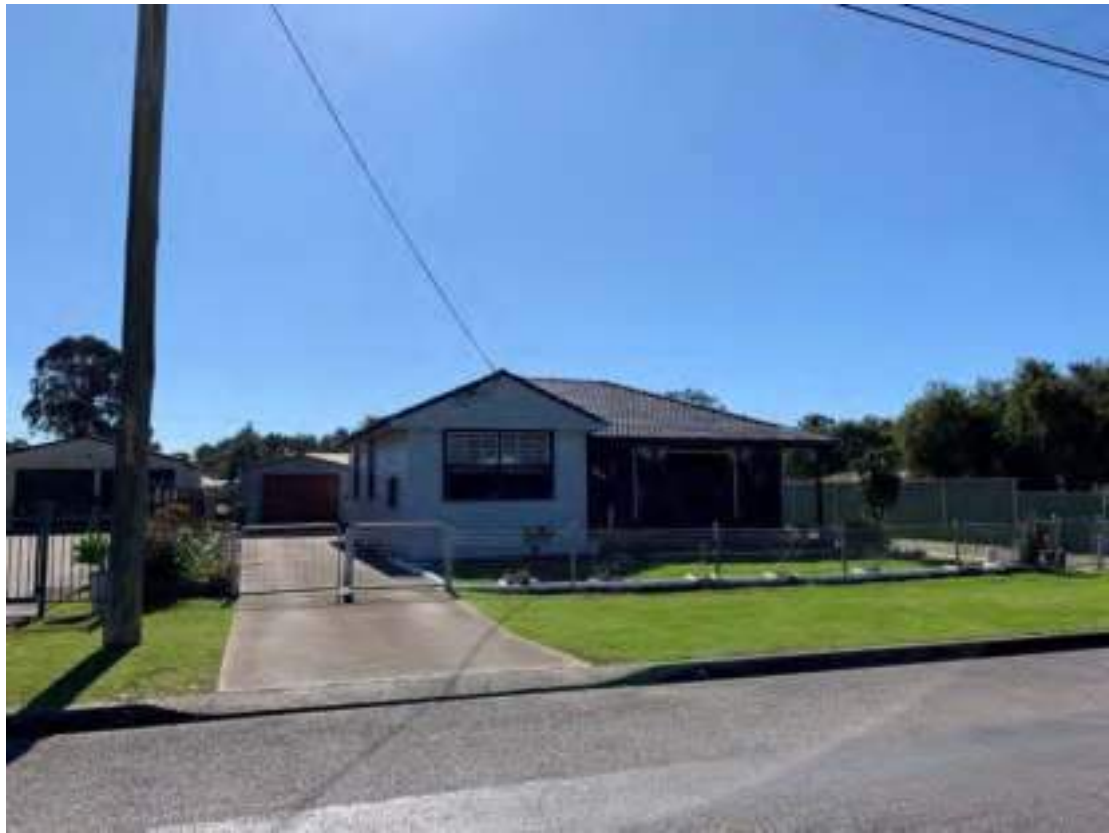
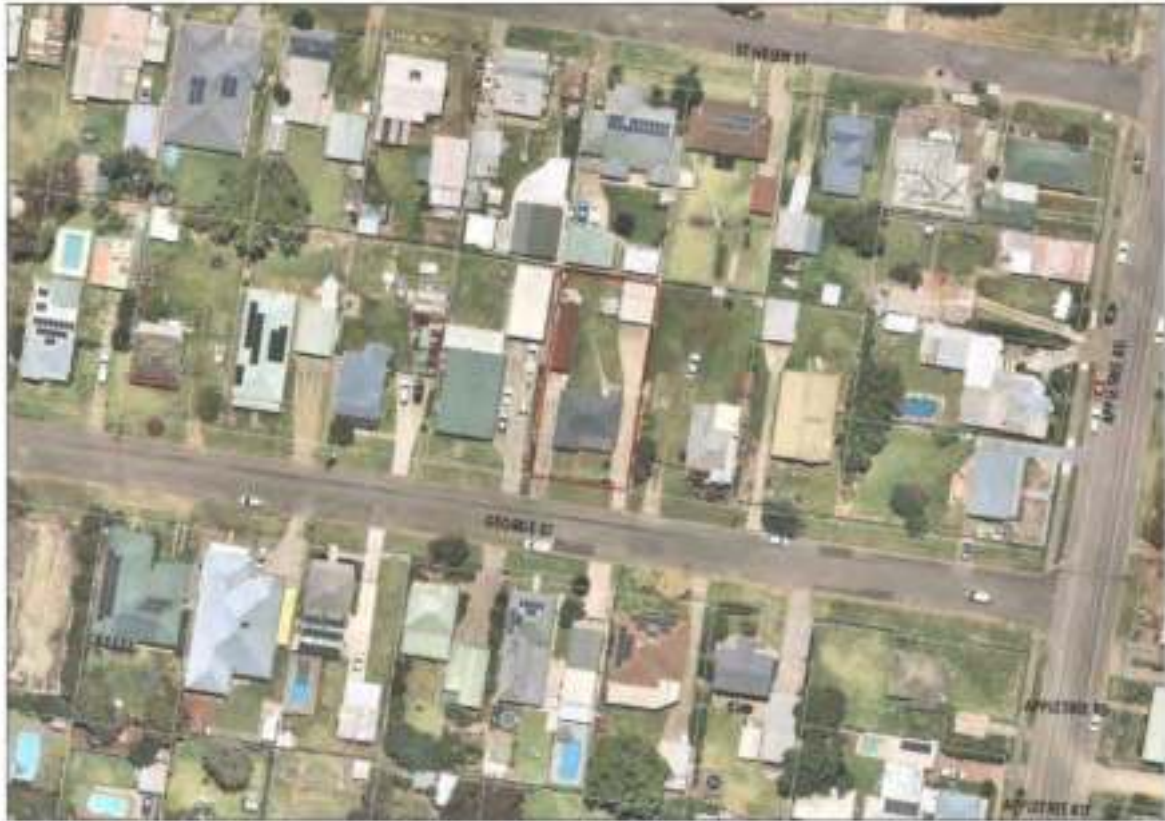
5 GEORGE STREET, HOLMESVILLE 2286

Conservation Area Contribution Level	Est. Construction Date	Previous studies and/or community input
Non-Contributory	Mid to late 20 th century onwards	No prior heritage assessments or research undertaken.
Assessment Text		Observed Modifications
<p>The scale (e.g. double-storey or greater) and general style of the dwelling is inconsistent with that of the streetscape and wider HCA.</p> <p>The dwelling does not contribute positively to the streetscape and wider HCA, particularly in comparison to Contributory 1 and 2 buildings. The presence of the building has an adverse impact on the streetscape and/or wider HCA.</p> <p>The dwelling features inappropriately proportioned and positioned fenestrations, an inappropriate roof form (gabled or hipped) and/or other features that are inconsistent with the architectural character of the area (e.g. unsympathetic additions, inconsistent [contemporary] building materials, etc).</p>		<p>All visible windows are contemporary designs.</p> <p>The ornate timber brackets a top the veranda posts are a contemporary addition, and although of a historical design, juxtapose with the dwellings remaining features.</p> <p>The timber panelling of the veranda space is a contemporary addition.</p>

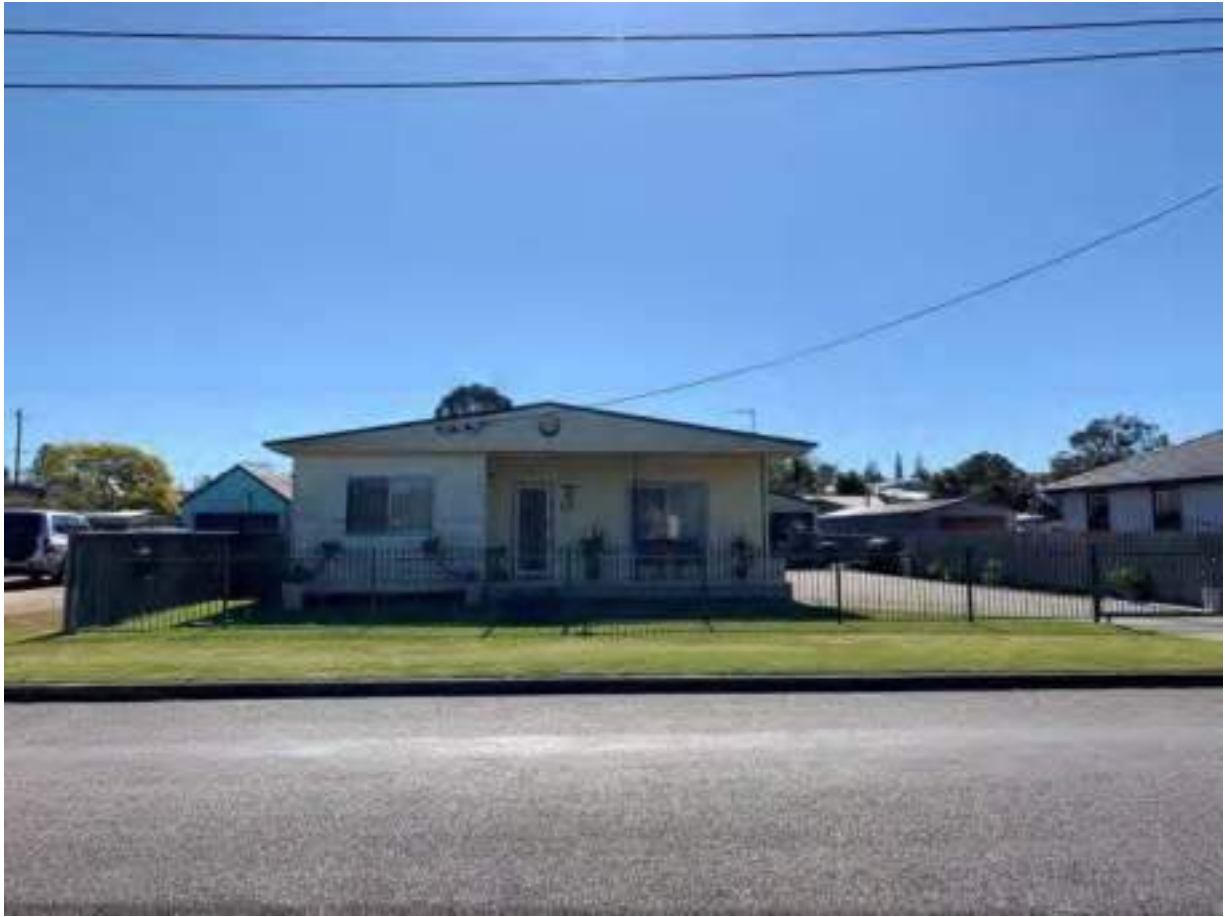
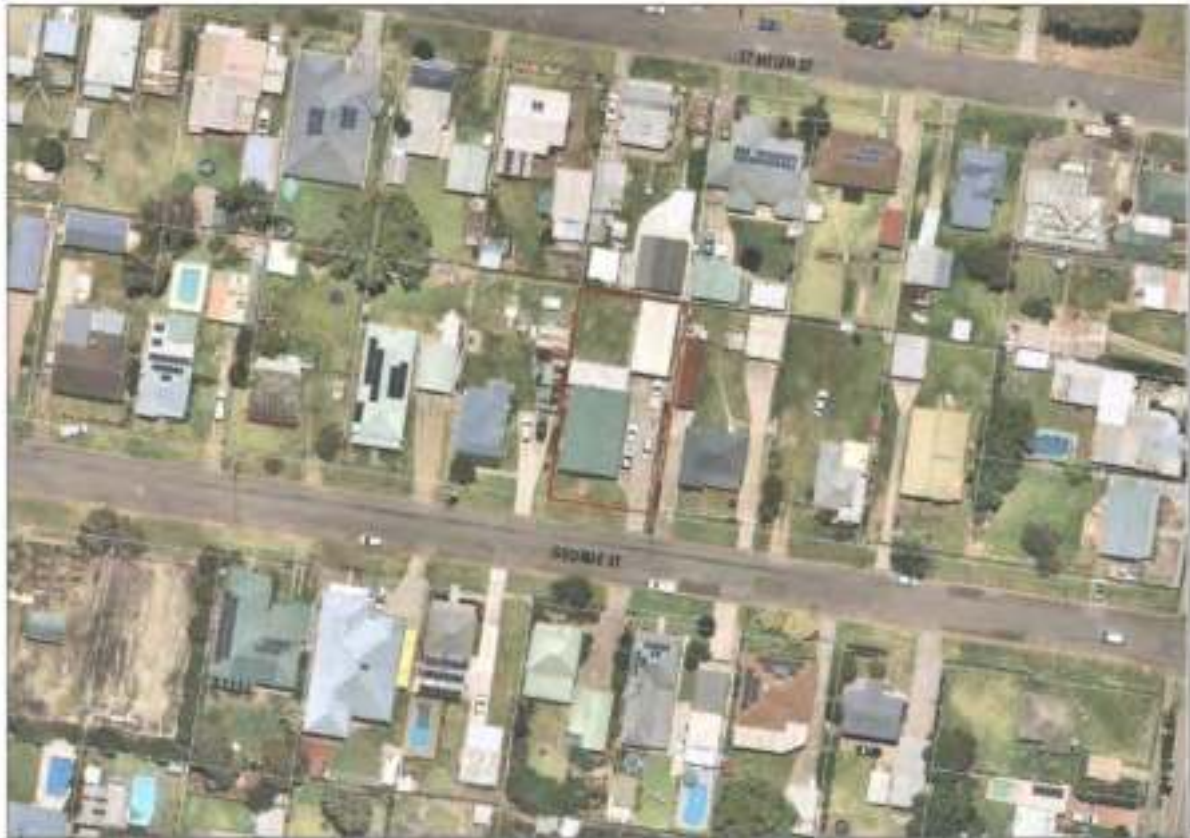
7 GEORGE STREET, HOLMESVILLE 2286		
Conservation Area Contribution Level	Est. Construction Date	Previous studies and/or community input
Non-Contributory	Mid to late 20 th century onwards	No prior heritage assessments or research undertaken.
Assessment Text		Observed Modifications
<p>The scale (e.g. double-storey or greater) and general style of the dwelling is inconsistent with that of the streetscape and wider HCA.</p> <p>The dwelling does not contribute positively to the streetscape and wider HCA, particularly in comparison to Contributory 1 and 2 buildings. The presence of the building has an adverse impact on the streetscape and/or wider HCA.</p> <p>The dwelling features inappropriately proportioned and positioned fenestrations, an inappropriate roof form (gabled or hipped) and/or other features that are inconsistent with the architectural character of the area (e.g. unsympathetic additions, inconsistent [contemporary] building materials, etc).</p>		No modifications observed.

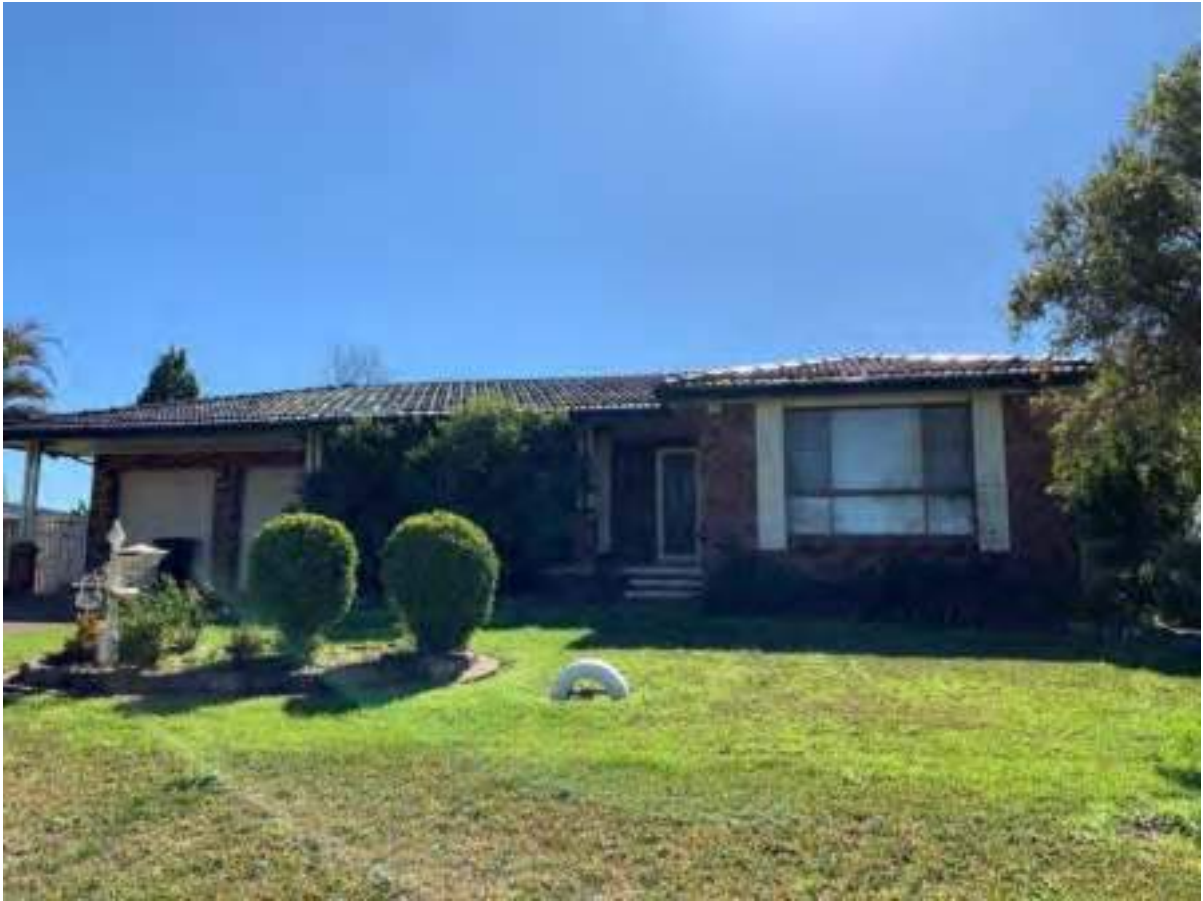
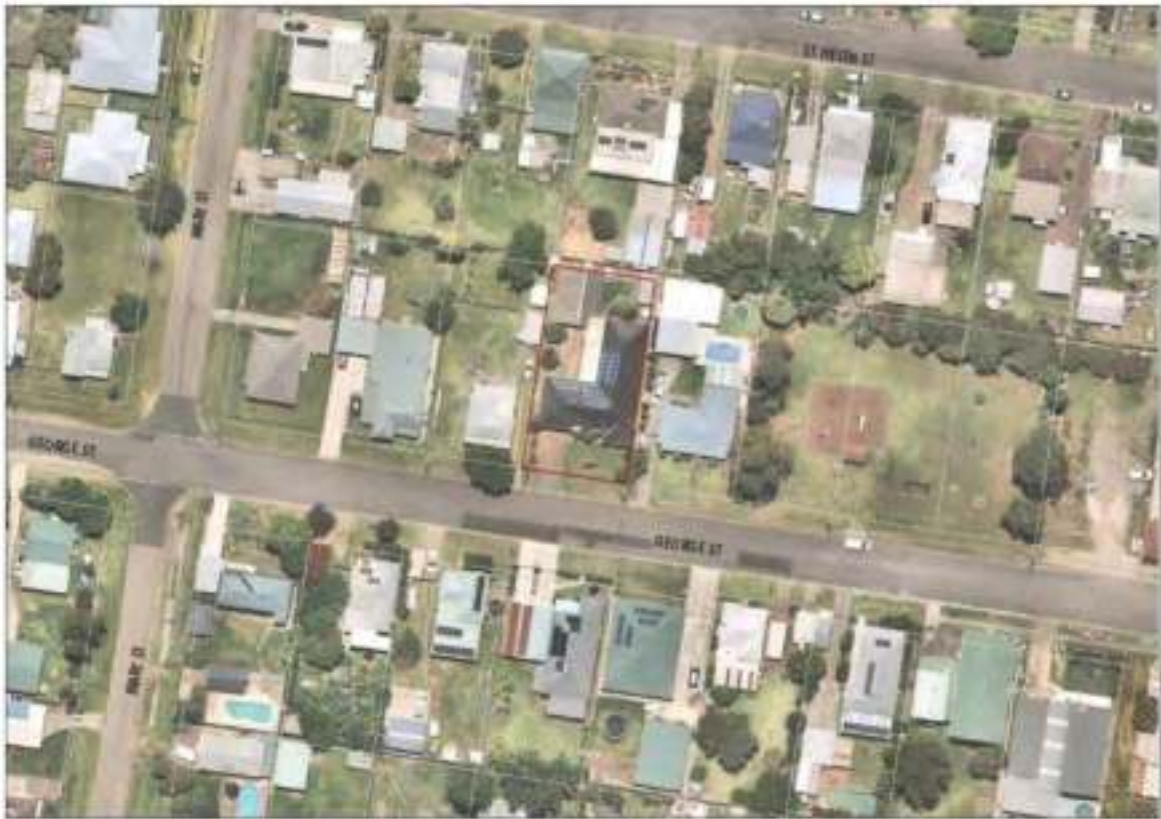
27 GEORGE STREET, HOLMESVILLE 2286		
Conservation Area Contribution Level	Est. Construction Date	Previous studies and/or community input
Non-Contributory	Mid to late 20 th century onwards	No prior heritage assessments or research undertaken.
Assessment Text		Observed Modifications
<p>The scale (e.g. double-storey or greater) and general style of the dwelling is inconsistent with that of the streetscape and wider HCA.</p> <p>The dwelling does not contribute positively to the streetscape and wider HCA, particularly in comparison to Contributory 1 and 2 buildings. The presence of the building has an adverse impact on the streetscape and/or wider HCA.</p> <p>The dwelling features inappropriately proportioned and positioned fenestrations, an inappropriate roof form (gabled or hipped) and/or other features that are inconsistent with the architectural character of the area (e.g. unsympathetic additions, inconsistent [contemporary] building materials, etc).</p>		No modifications observed.

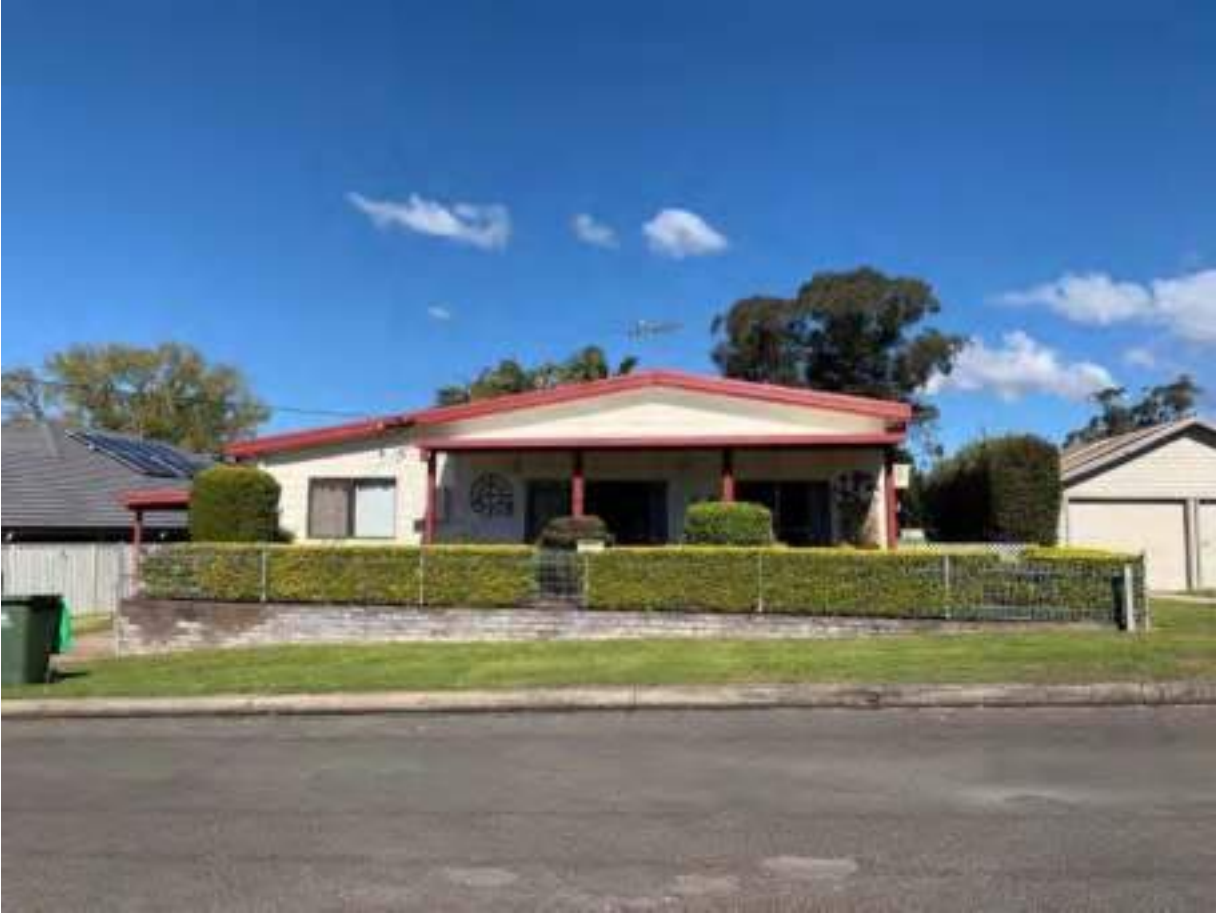
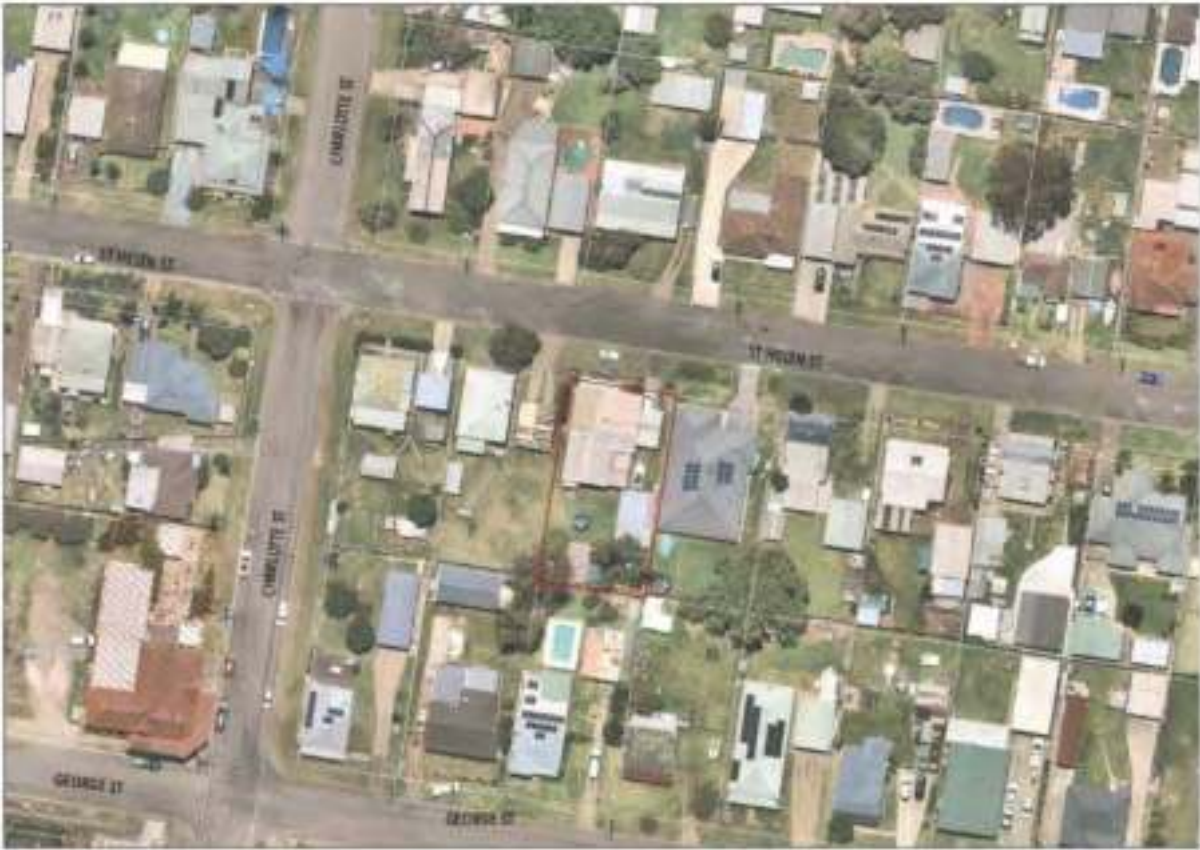
16 ST HELEN STREET, HOLMESVILLE 2286		
Conservation Area Contribution Level	Est. Construction Date	Previous studies and/or community input
Non-Contributory	Mid to late 20 th century onwards	No prior heritage assessments or research undertaken.
Assessment Text		Observed Modifications
<p>The scale (e.g. double-storey or greater) and general style of the dwelling is inconsistent with that of the streetscape and wider HCA.</p> <p>The dwelling does not contribute positively to the streetscape and wider HCA, particularly in comparison to Contributory 1 and 2 buildings. The presence of the building has an adverse impact on the streetscape and/or wider HCA.</p> <p>The dwelling features inappropriately proportioned and positioned fenestrations, an inappropriate roof form (gabled or hipped) and/or other features that are inconsistent with the architectural character of the area (e.g. unsympathetic additions, inconsistent [contemporary] building materials, etc).</p>		<p>All visible windows are of a contemporary design</p> <p>The veranda has been partially enclosed by Colourbond panels.</p>

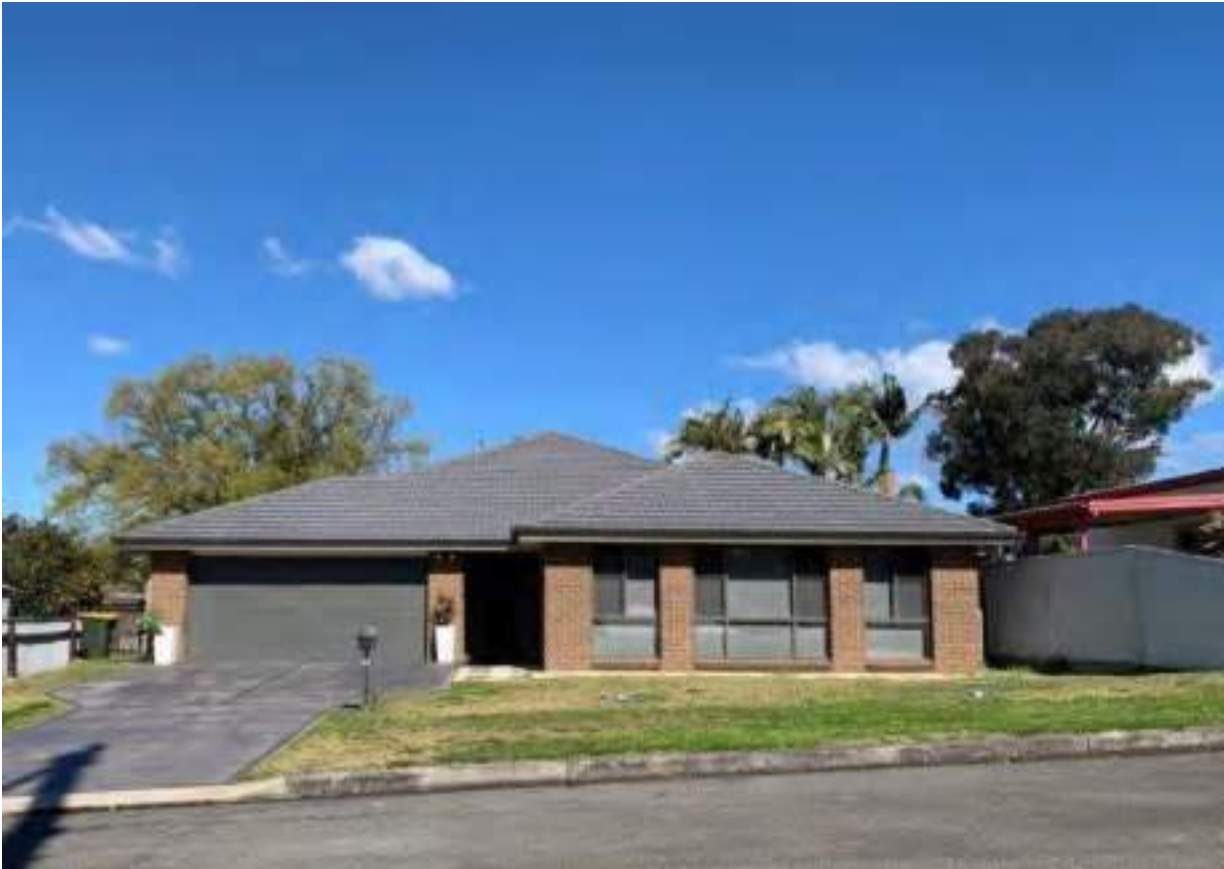
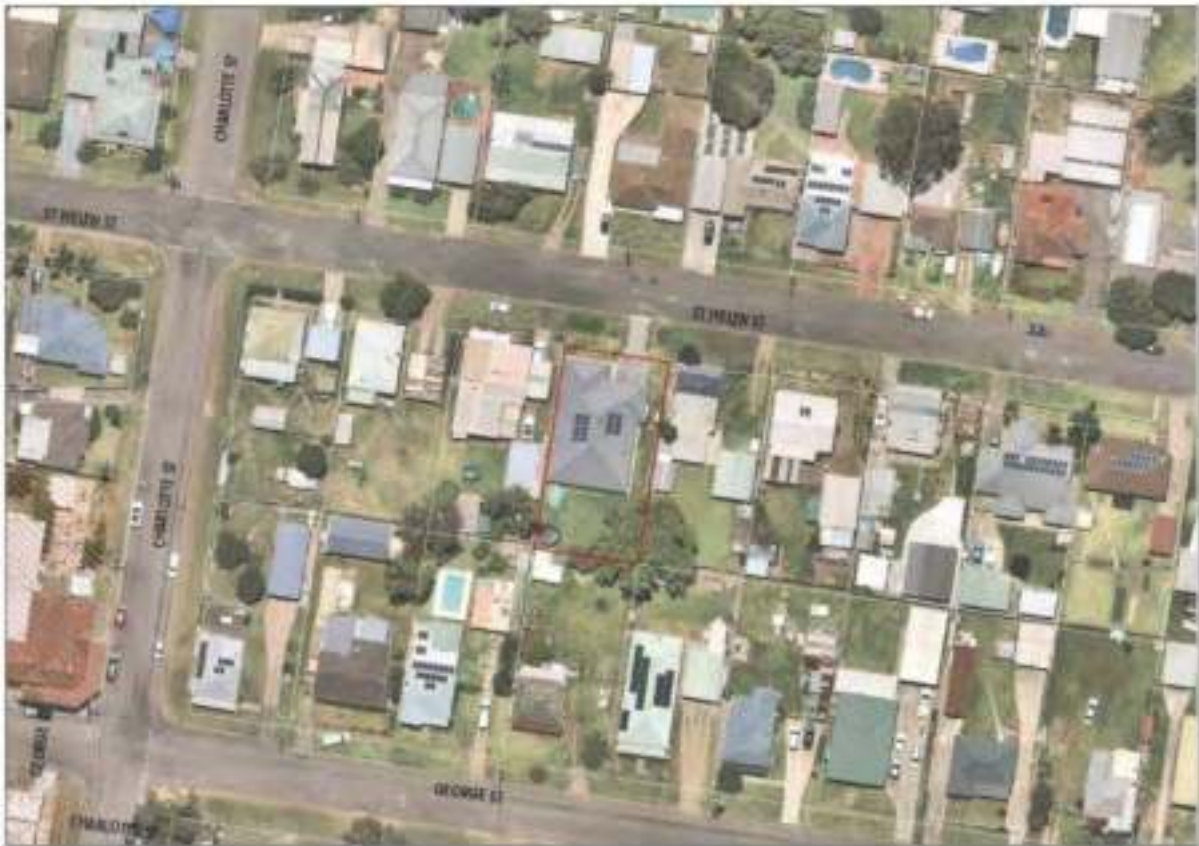
14 ST HELEN STREET, HOLMESVILLE 2286		
Conservation Area Contribution Level	Est. Construction Date	Previous studies and/or community input
Non-Contributory	Mid to late 20 th century onwards	No prior heritage assessments or research undertaken.
Assessment Text		Observed Modifications
<p>The scale (e.g. double-storey or greater) and general style of the dwelling is inconsistent with that of the streetscape and wider HCA.</p> <p>The dwelling does not contribute positively to the streetscape and wider HCA, particularly in comparison to Contributory 1 and 2 buildings. The presence of the building has an adverse impact on the streetscape and/or wider HCA.</p> <p>The dwelling features inappropriately proportioned and positioned fenestrations, an inappropriate roof form (gabled or hipped) and/or other features that are inconsistent with the architectural character of the area (e.g. unsympathetic additions, inconsistent [contemporary] building materials, etc).</p>		No modifications observed.

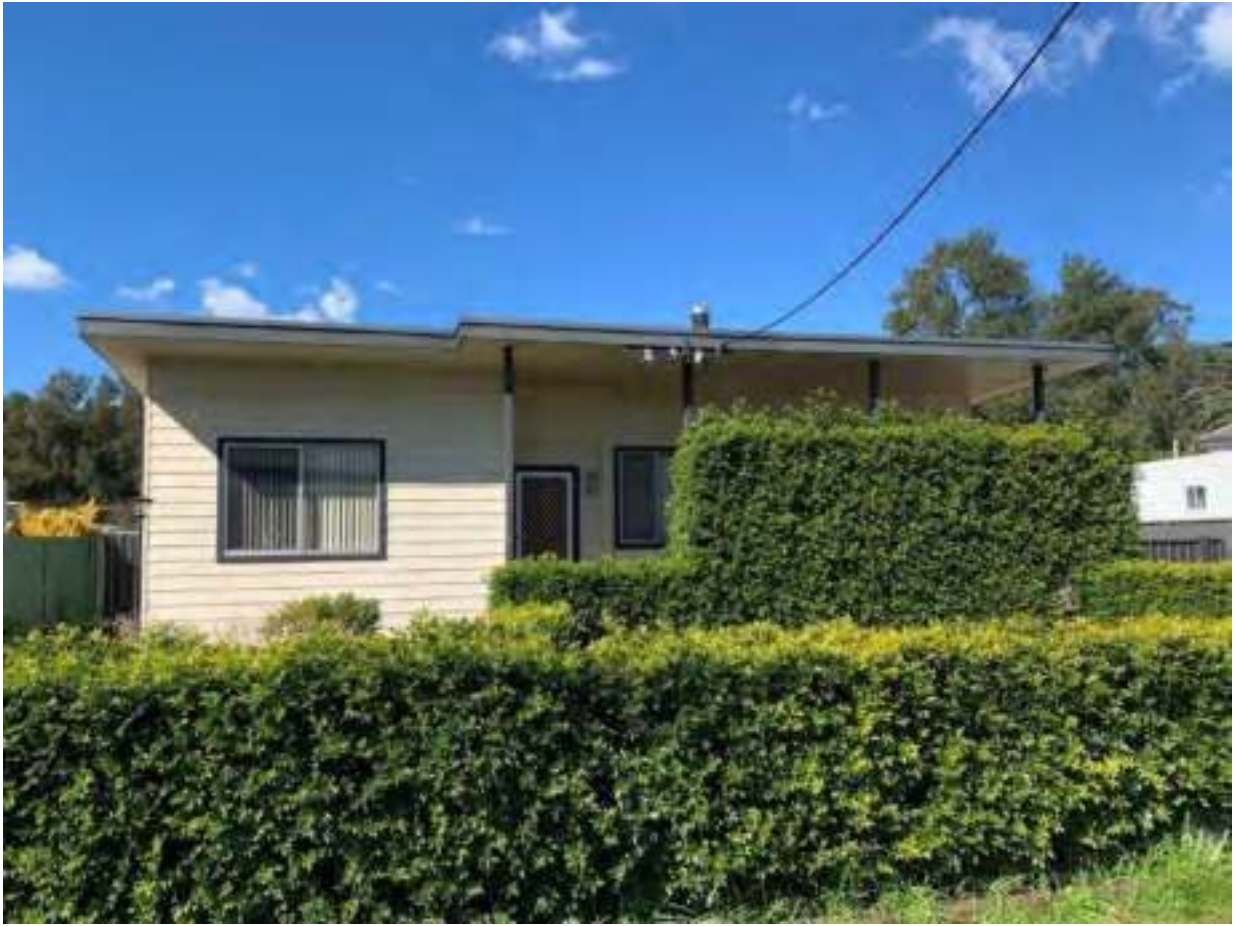
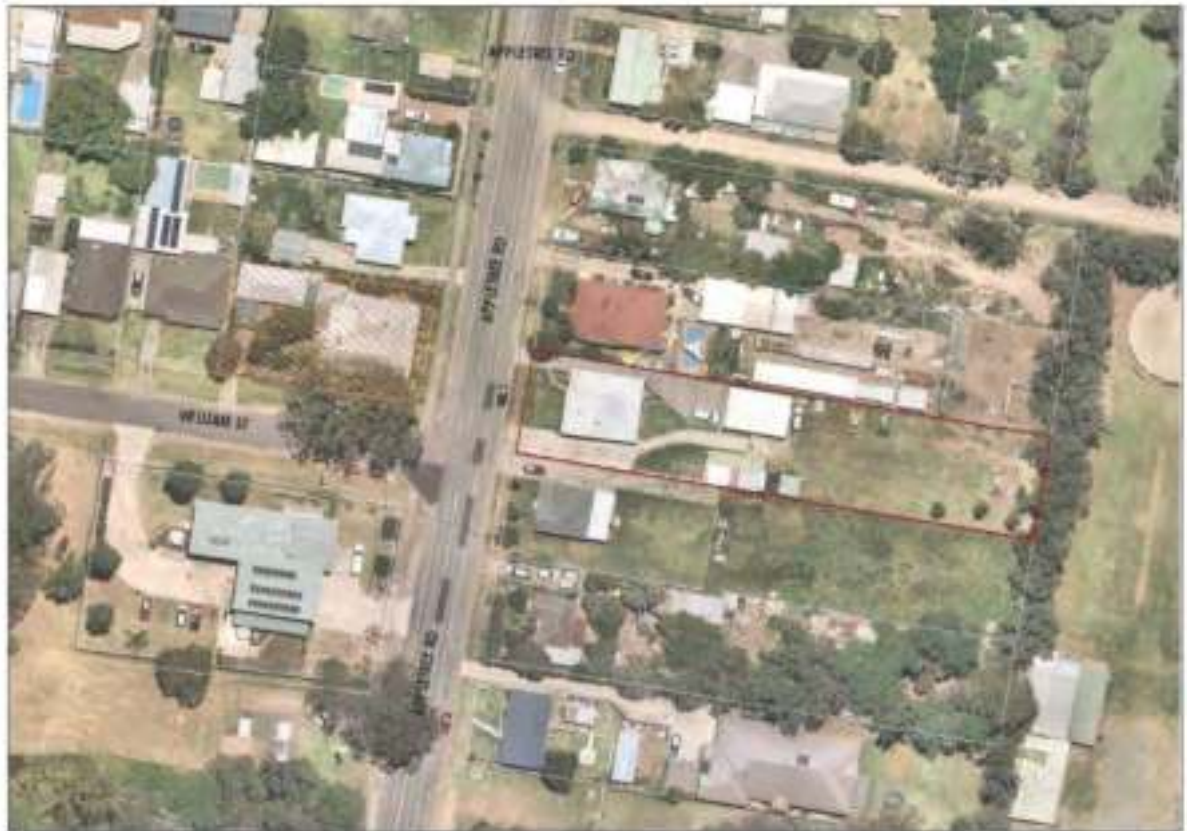
Conservation Area Contribution Level	Est. Construction Date	Previous studies and/or community input
Non-Contributory	Mid to late 20 th century onwards	No prior heritage assessments or research undertaken.
Assessment Text		Observed Modifications
<p>The scale (e.g. double-storey or greater) and general style of the dwelling is inconsistent with that of the streetscape and wider HCA.</p> <p>The dwelling does not contribute positively to the streetscape and wider HCA, particularly in comparison to Contributory 1 and 2 buildings. The presence of the building has an adverse impact on the streetscape and/or wider HCA.</p> <p>The dwelling features inappropriately proportioned and positioned fenestrations, an inappropriate roof form (gabled or hipped) and/or other features that are inconsistent with the architectural character of the area (e.g. unsympathetic additions, inconsistent [contemporary] building materials, etc).</p>		No modifications observed.
