APPENDIX 2

Building Assessment Sheets (Inventory Sheets)

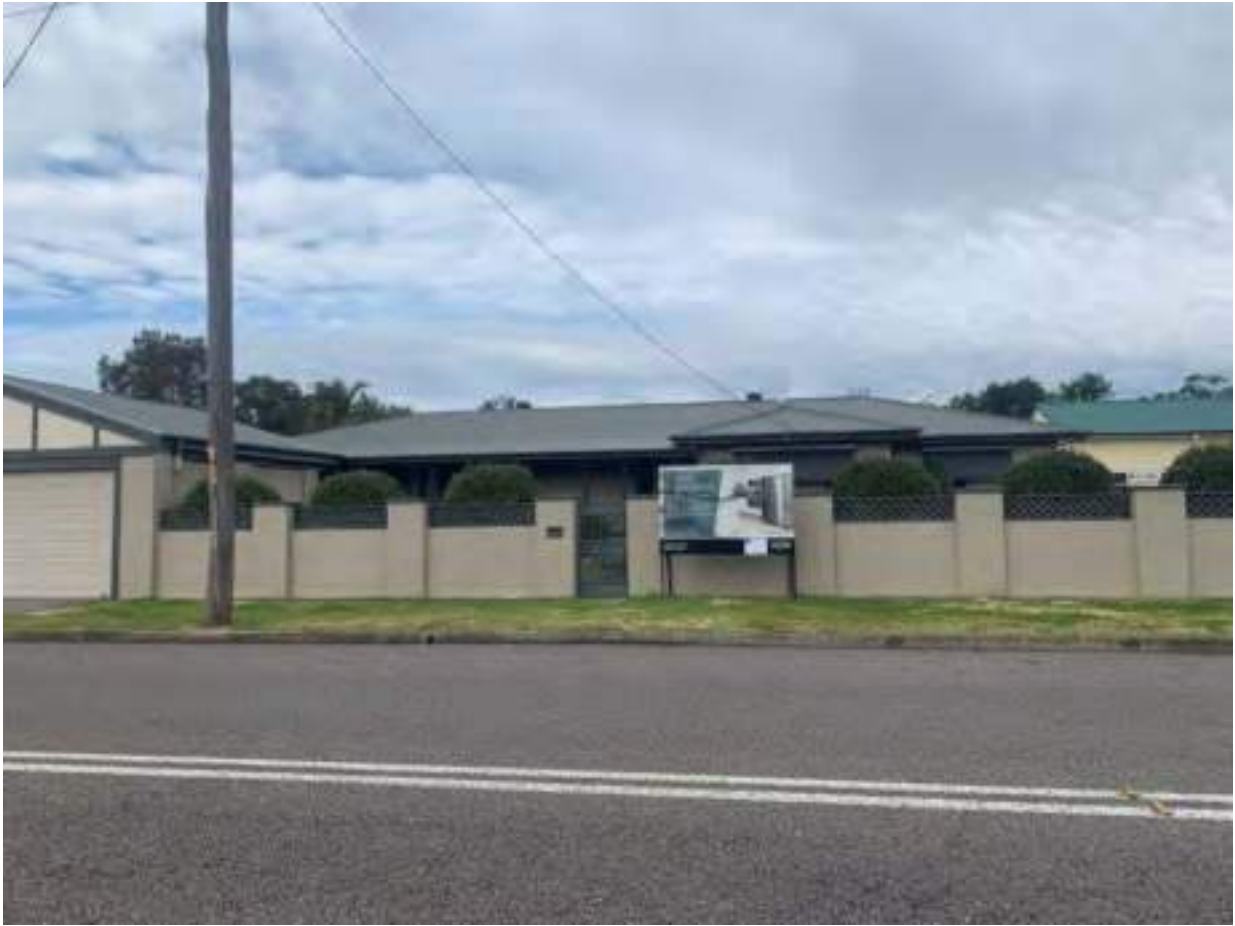
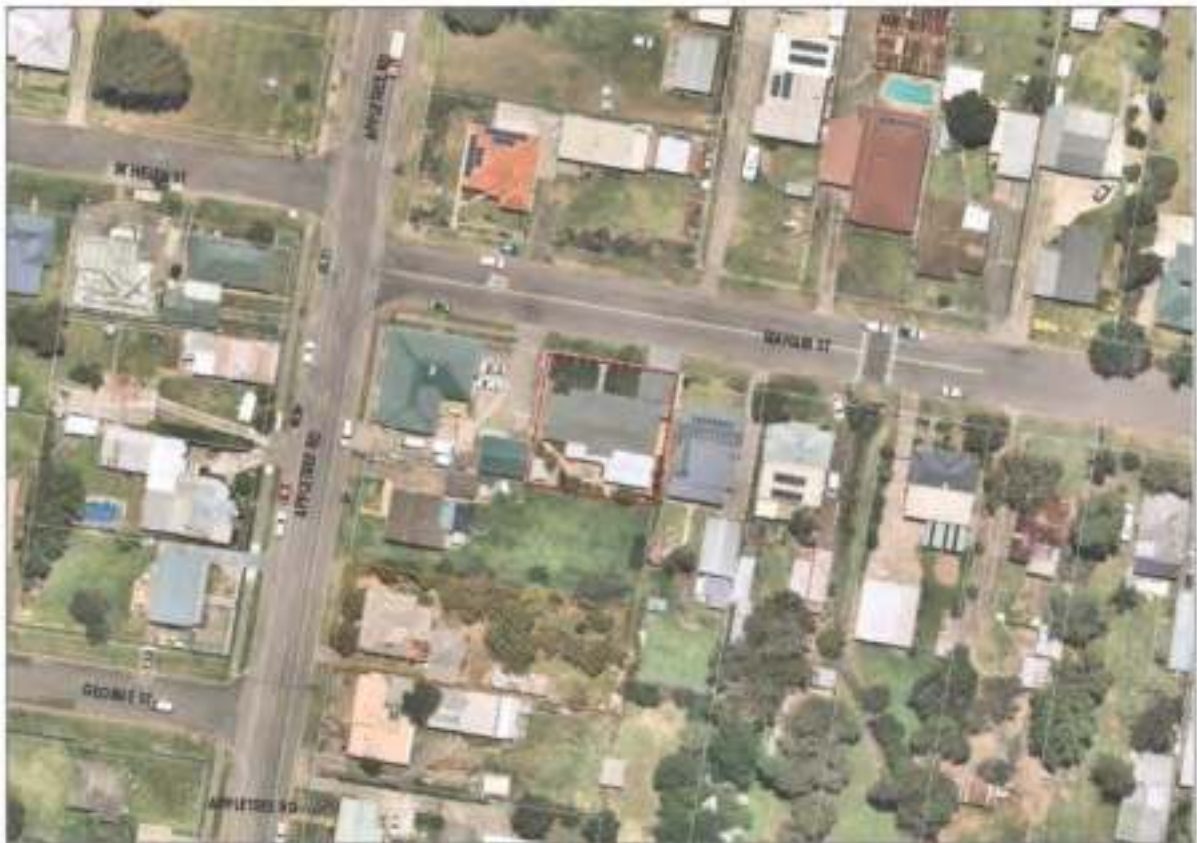
106 SEAHAM STREET, HOLMESVILLE 2286		
Conservation Area Contribution Level	Est. Construction Date	Previous studies and/or community input
Non-Contributory	Mid to late 20 th century onwards	No prior heritage assessments or research undertaken.
Assessment Text		Observed Modifications
<p>The scale (e.g. double-storey or greater) and general style of the dwelling is inconsistent with that of the streetscape and wider HCA.</p> <p>The dwelling does not contribute positively to the streetscape and wider HCA, particularly in comparison to Contributory 1 and 2 buildings. The presence of the building has an adverse impact on the streetscape and/or wider HCA.</p> <p>The dwelling features inappropriately proportioned and positioned fenestrations, an inappropriate roof form (gabled or hipped) and/or other features that are inconsistent with the architectural character of the area (e.g. unsympathetic additions, inconsistent [contemporary] building materials, etc).</p>		No modifications observed.

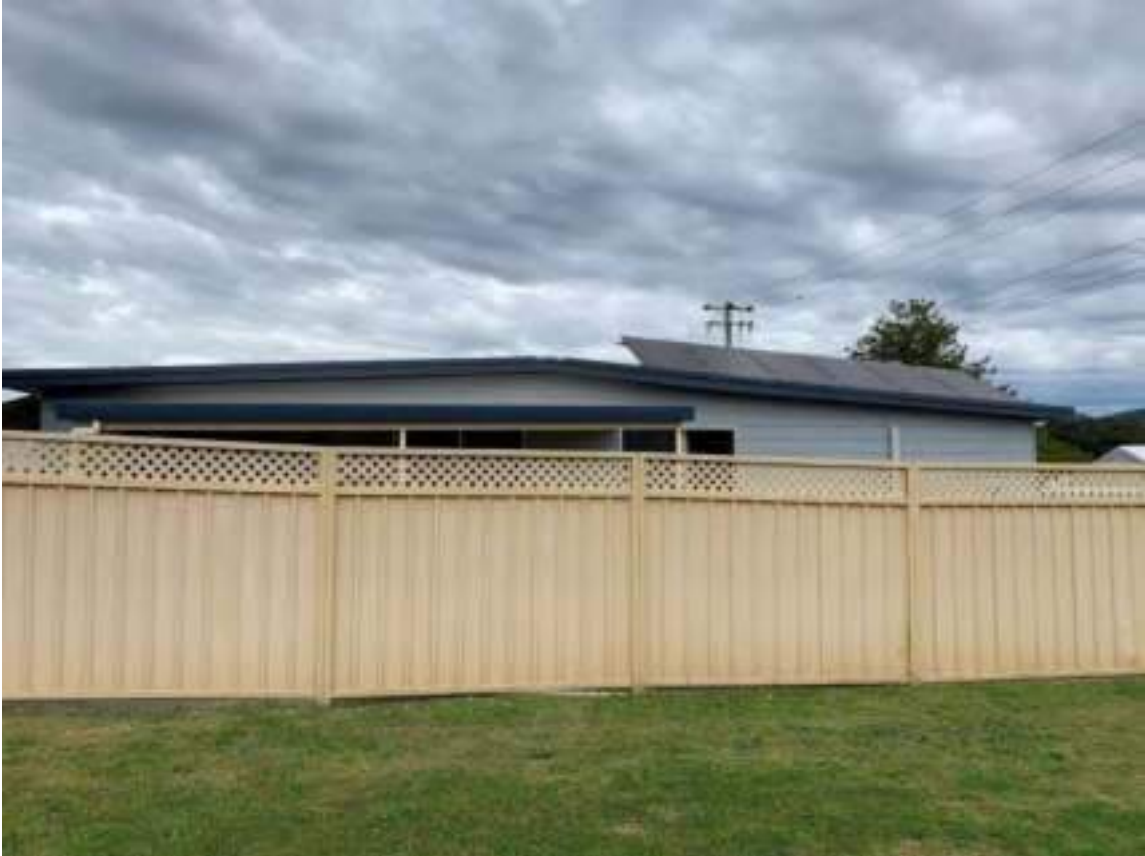
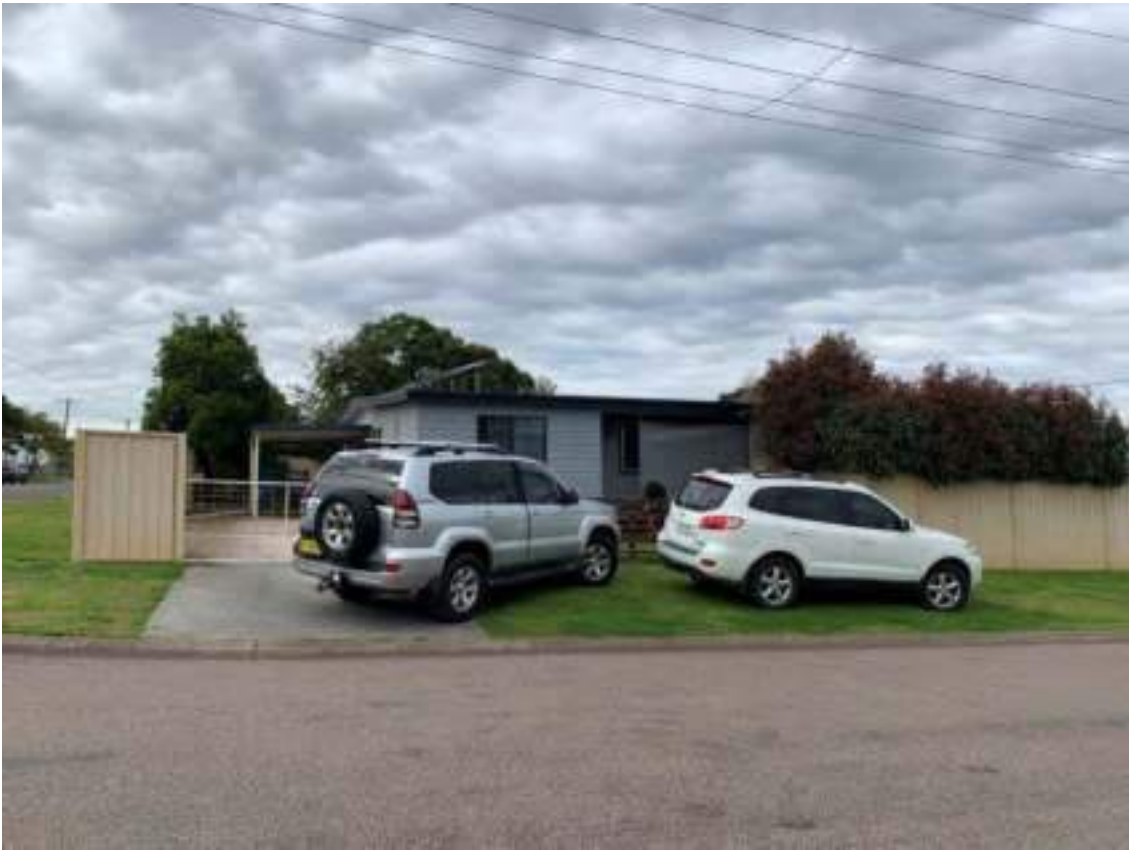
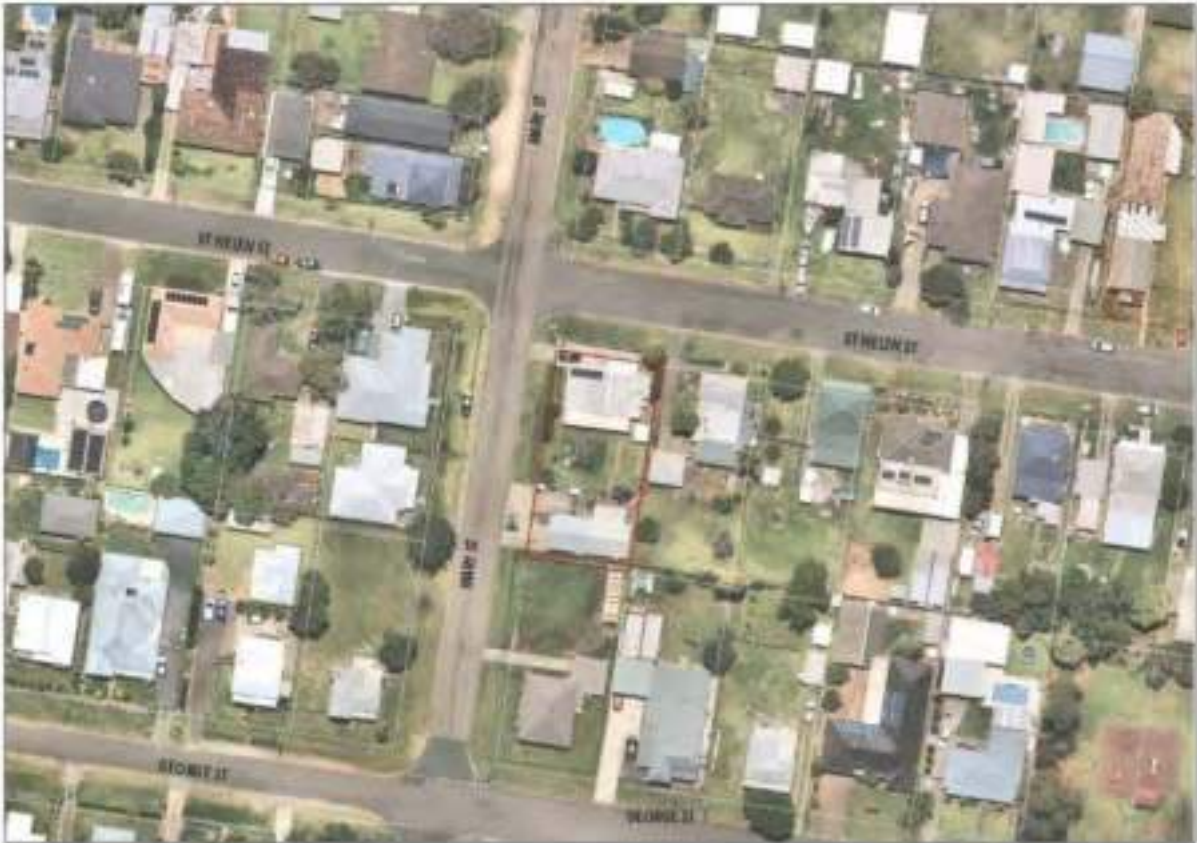
40 ST HELEN STREET, HOLMESVILLE 2286

Conservation Area Contribution Level	Est. Construction Date	Previous studies and/or community input
Non-Contributory	Mid to late 20 th century onwards	No prior heritage assessments or research undertaken.
Assessment Text		Observed Modifications
<p>The scale (e.g. double-storey or greater) and general style of the dwelling is inconsistent with that of the streetscape and wider HCA.</p> <p>The dwelling does not contribute positively to the streetscape and wider HCA, particularly in comparison to Contributory 1 and 2 buildings. The presence of the building has an adverse impact on the streetscape and/or wider HCA.</p> <p>The dwelling features inappropriately proportioned and positioned fenestrations, an inappropriate roof form (gabled or hipped) and/or other features that are inconsistent with the architectural character of the area (e.g. unsympathetic additions, inconsistent [contemporary] building materials, etc).</p>		<p>Solar panels are visible along the northern/western portion of the roof.</p>

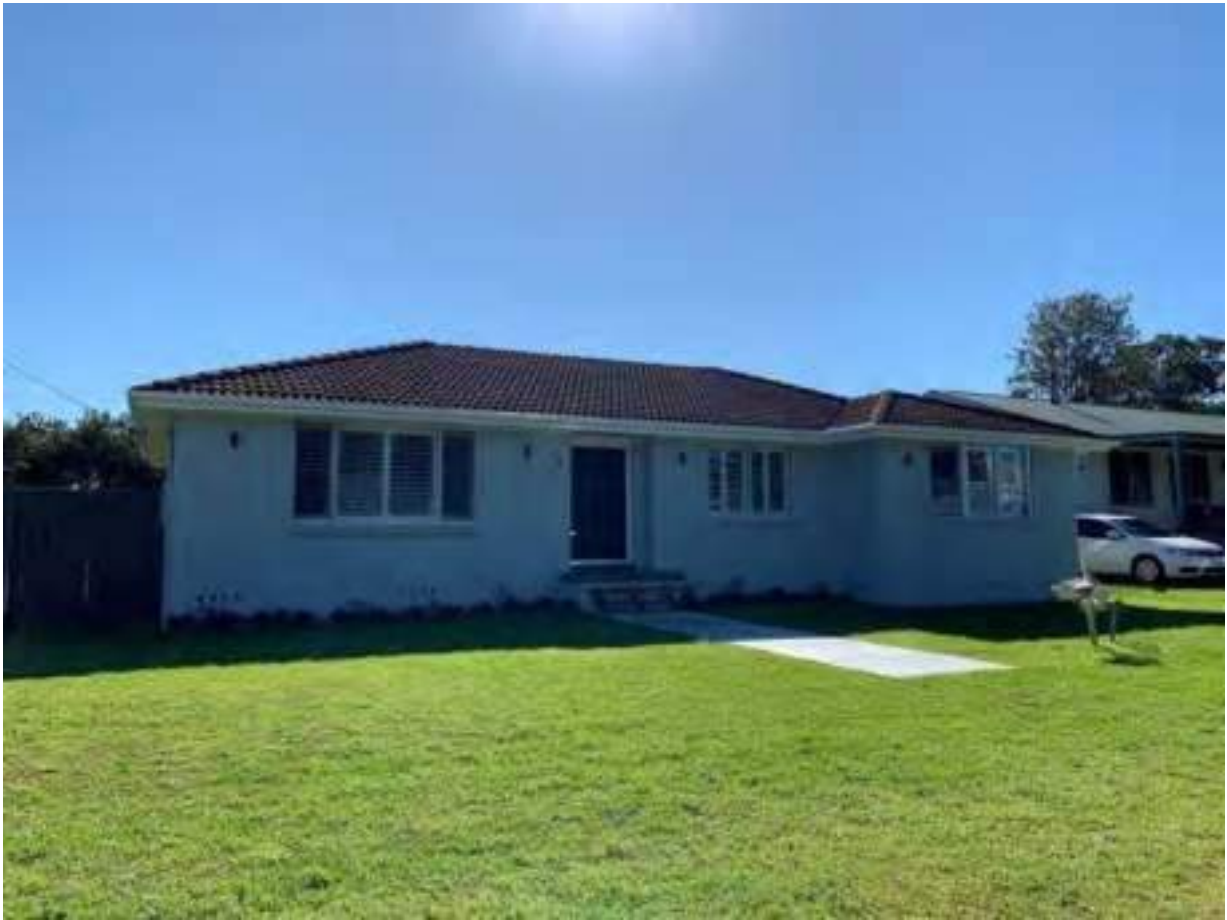
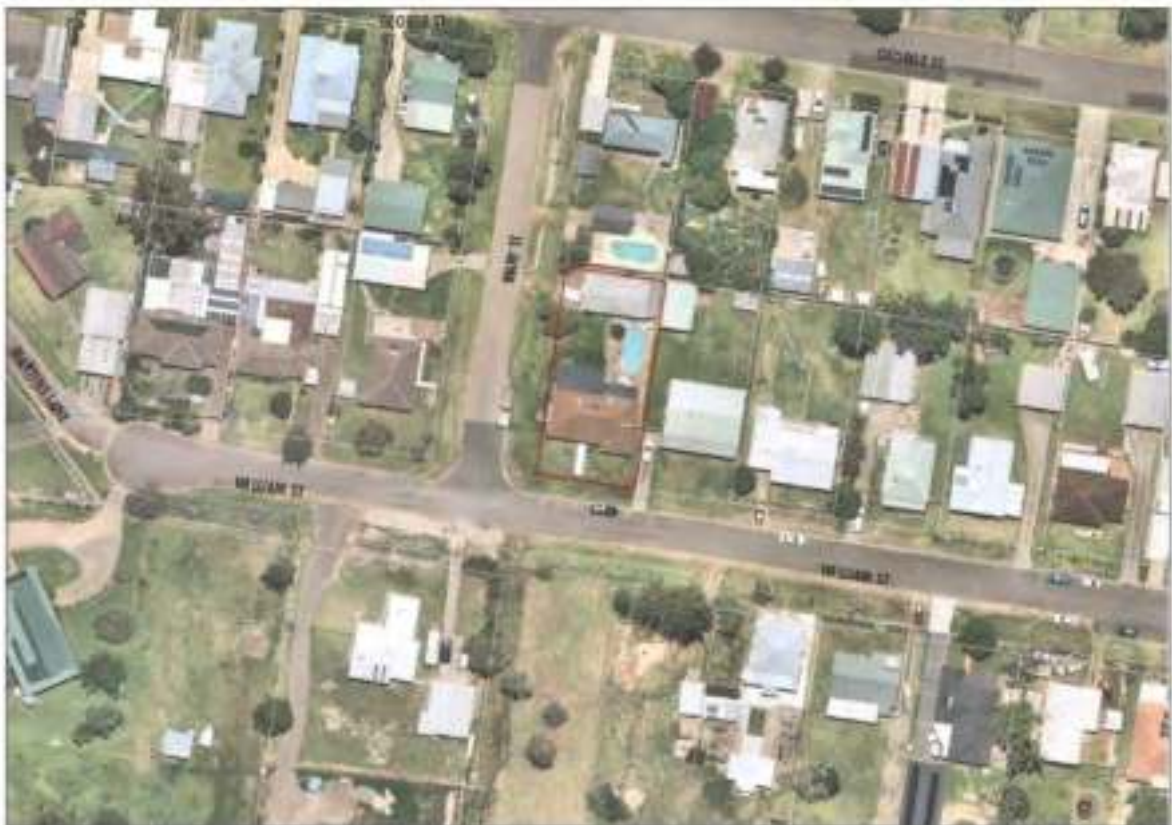
39 WILLIAM STREET, HOLMESVILLE 2286

Conservation Area Contribution Level	Est. Construction Date	Previous studies and/or community input
Non-Contributory	Mid to late 20th century onwards	No prior heritage assessments or research undertaken.
Assessment Text		Observed Modifications
<p>The scale (e.g. double-storey or greater) and general style of the dwelling is inconsistent with that of the streetscape and wider HCA.</p> <p>The dwelling does not contribute positively to the streetscape and wider HCA, particularly in comparison to Contributory 1 and 2 buildings. The presence of the building has an adverse impact on the streetscape and/or wider HCA.</p> <p>The dwelling features inappropriately proportioned and positioned fenestrations, an inappropriate roof form (gabled or hipped) and/or other features that are inconsistent with the architectural character of the area (e.g. unsympathetic additions, inconsistent [contemporary] building materials, etc).</p>		No modifications observed.

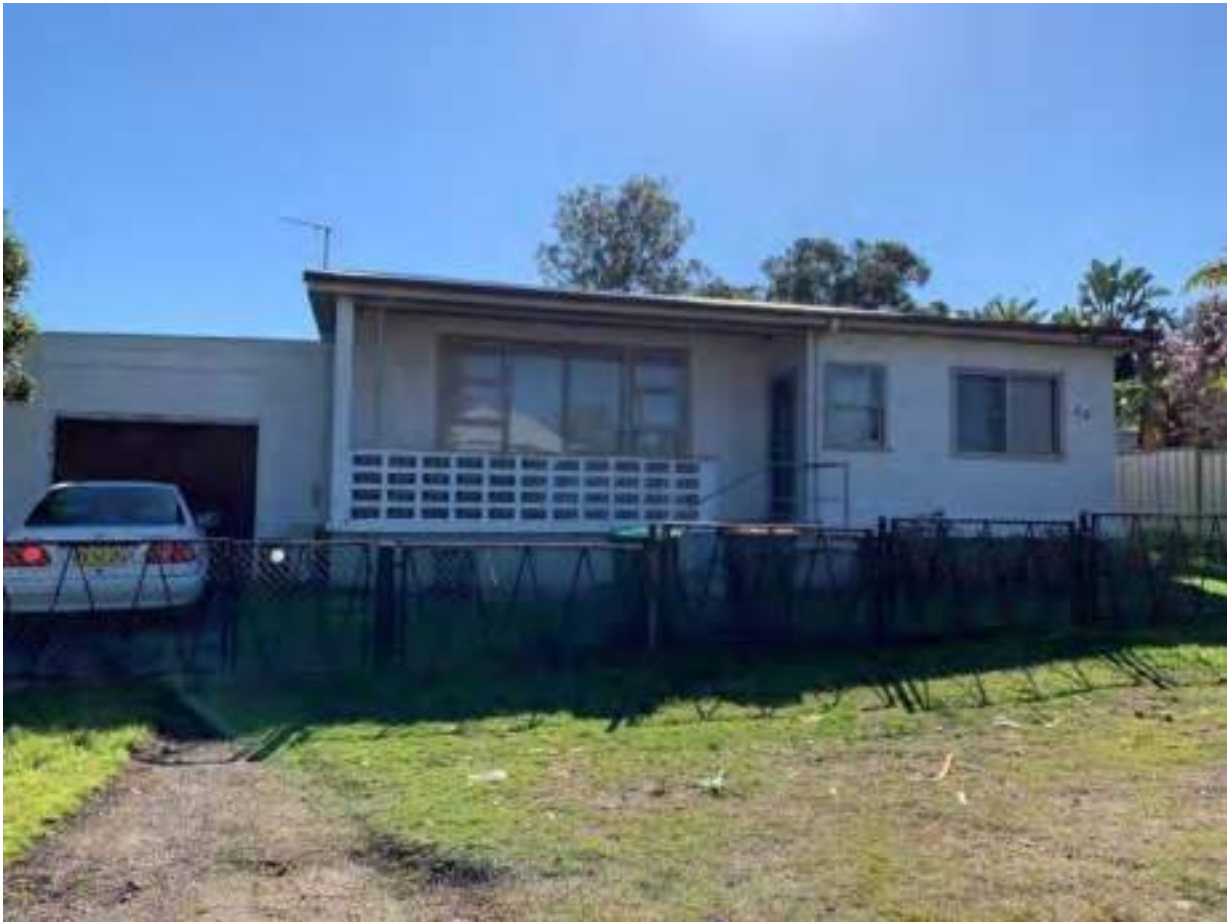
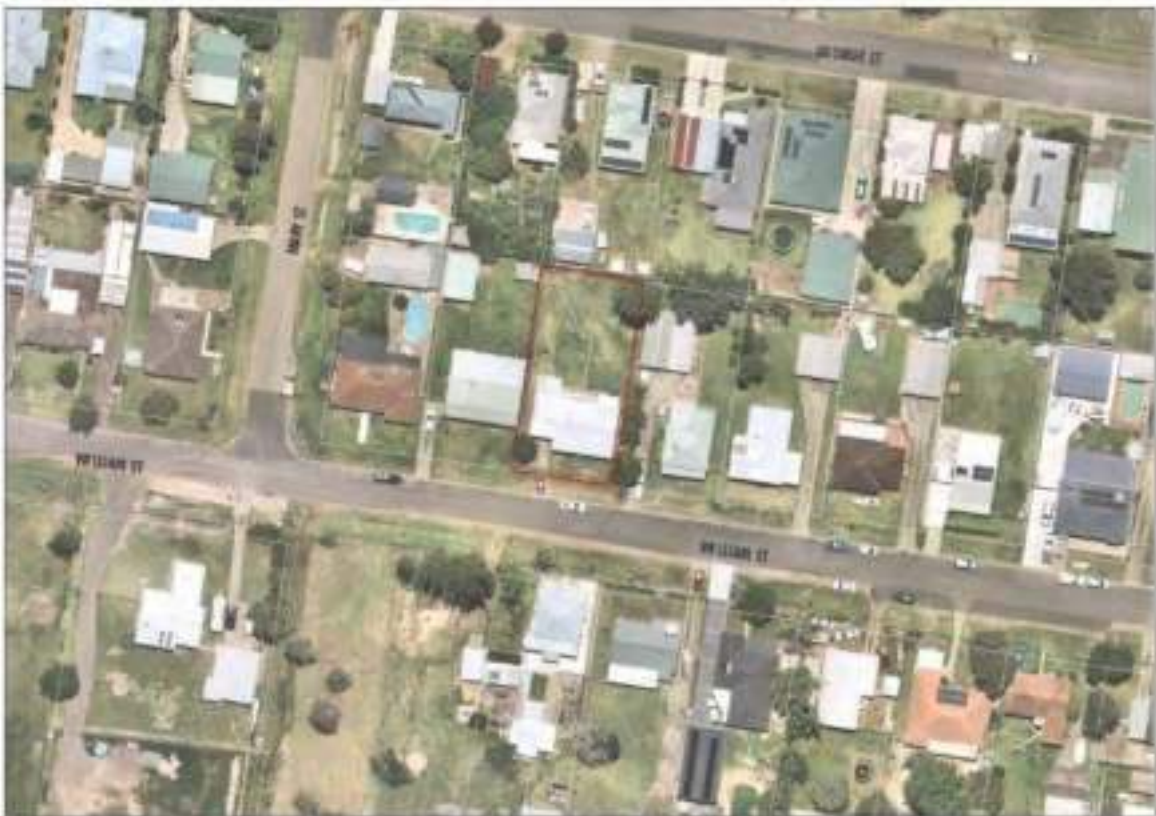
35 WILLIAM STREET, HOLMESVILLE 2286

Conservation Area Contribution Level	Est. Construction Date	Previous studies and/or community input
Non-Contributory	Mid to late 20 th century onwards	No prior heritage assessments or research undertaken.
Assessment Text		Observed Modifications
<p>The scale (e.g. double-storey or greater) and general style of the dwelling is inconsistent with that of the streetscape and wider HCA.</p> <p>The dwelling does not contribute positively to the streetscape and wider HCA, particularly in comparison to Contributory 1 and 2 buildings. The presence of the building has an adverse impact on the streetscape and/or wider HCA.</p> <p>The dwelling features inappropriately proportioned and positioned fenestrations, an inappropriate roof form (gabled or hipped) and/or other features that are inconsistent with the architectural character of the area (e.g. unsympathetic additions, inconsistent [contemporary] building materials, etc).</p>		No modifications observed.

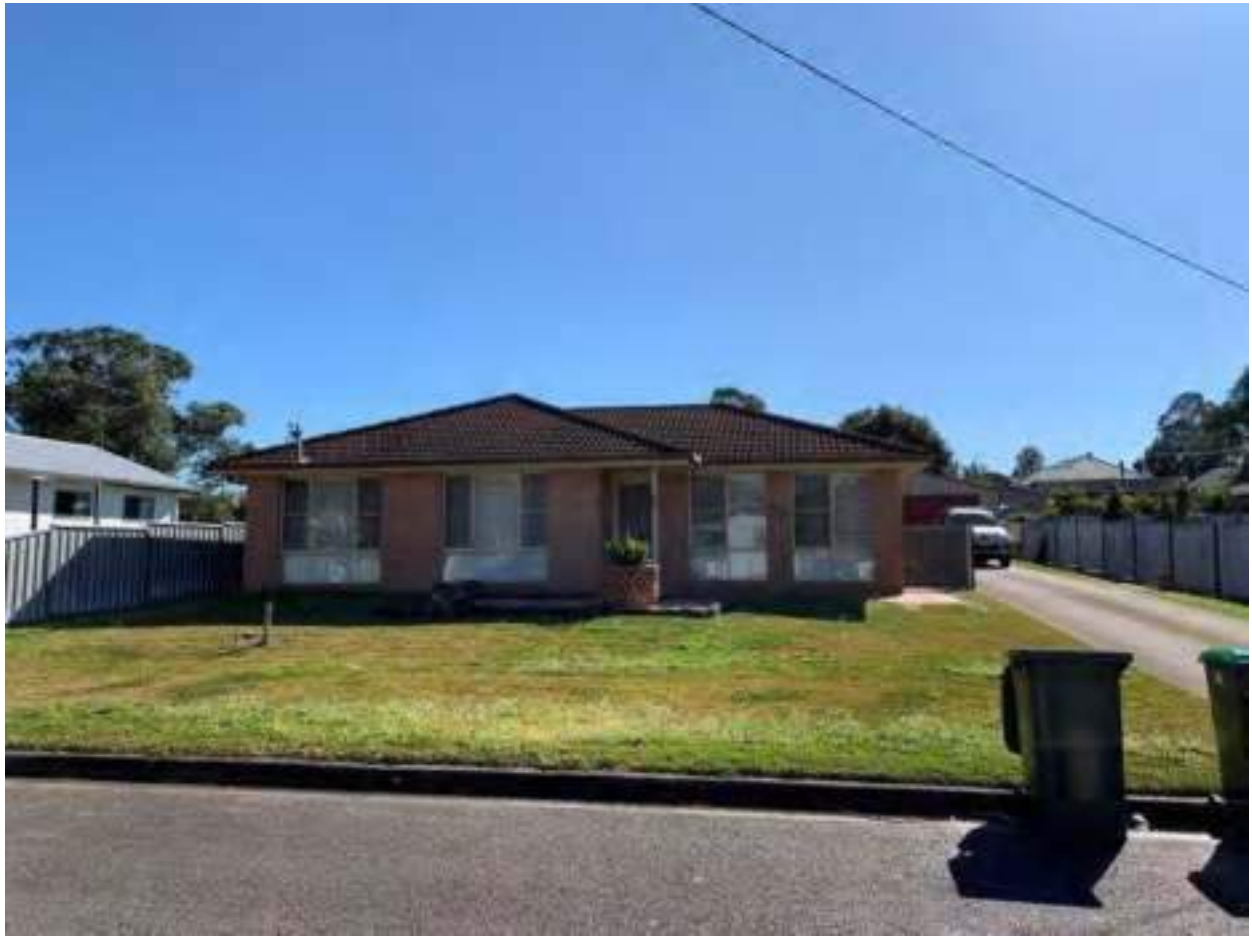
31 WILLIAM STREET, HOLMESVILLE 2286

Conservation Area Contribution Level	Est. Construction Date	Previous studies and/or community input
Non-Contributory	Mid to late 20 th century onwards	No prior heritage assessments or research undertaken.
Assessment Text		Observed Modifications
<p>The scale (e.g. double-storey or greater) and general style of the dwelling is inconsistent with that of the streetscape and wider HCA.</p> <p>The dwelling does not contribute positively to the streetscape and wider HCA, particularly in comparison to Contributory 1 and 2 buildings. The presence of the building has an adverse impact on the streetscape and/or wider HCA.</p> <p>The dwelling features inappropriately proportioned and positioned fenestrations, an inappropriate roof form (gabled or hipped) and/or other features that are inconsistent with the architectural character of the area (e.g. unsympathetic additions, inconsistent [contemporary] building materials, etc).</p> <p>Information provided by the current property owner suggests the dwelling has remained largely consistent in form from the late 1970s.</p>		<p>A veranda extension has been constructed on the eastern side of the dwelling. The timber boarding and contemporary decorative frieze contrasts the dwellings materiality.</p> <p>The double garage is a contemporary addition, and was constructed in a similar style to the main dwelling.</p>

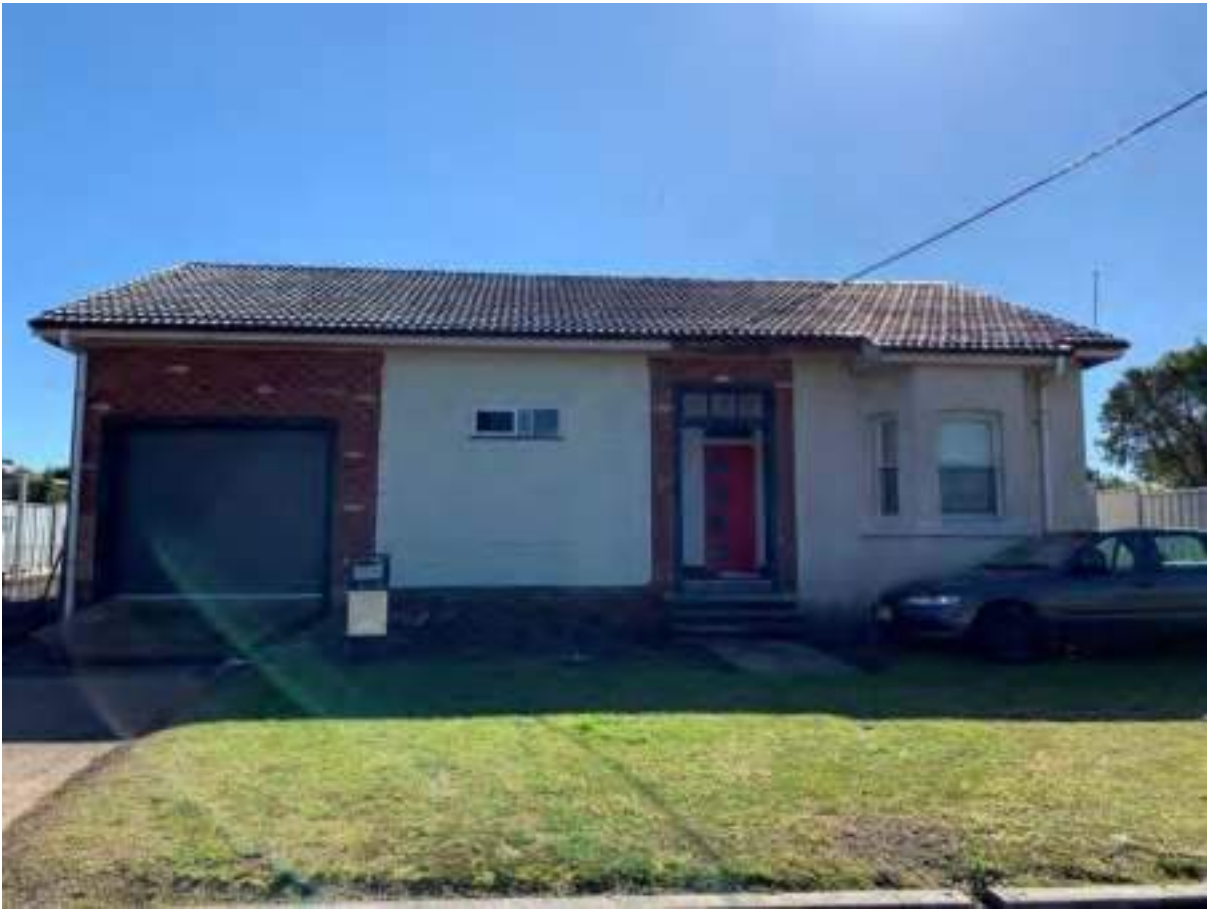
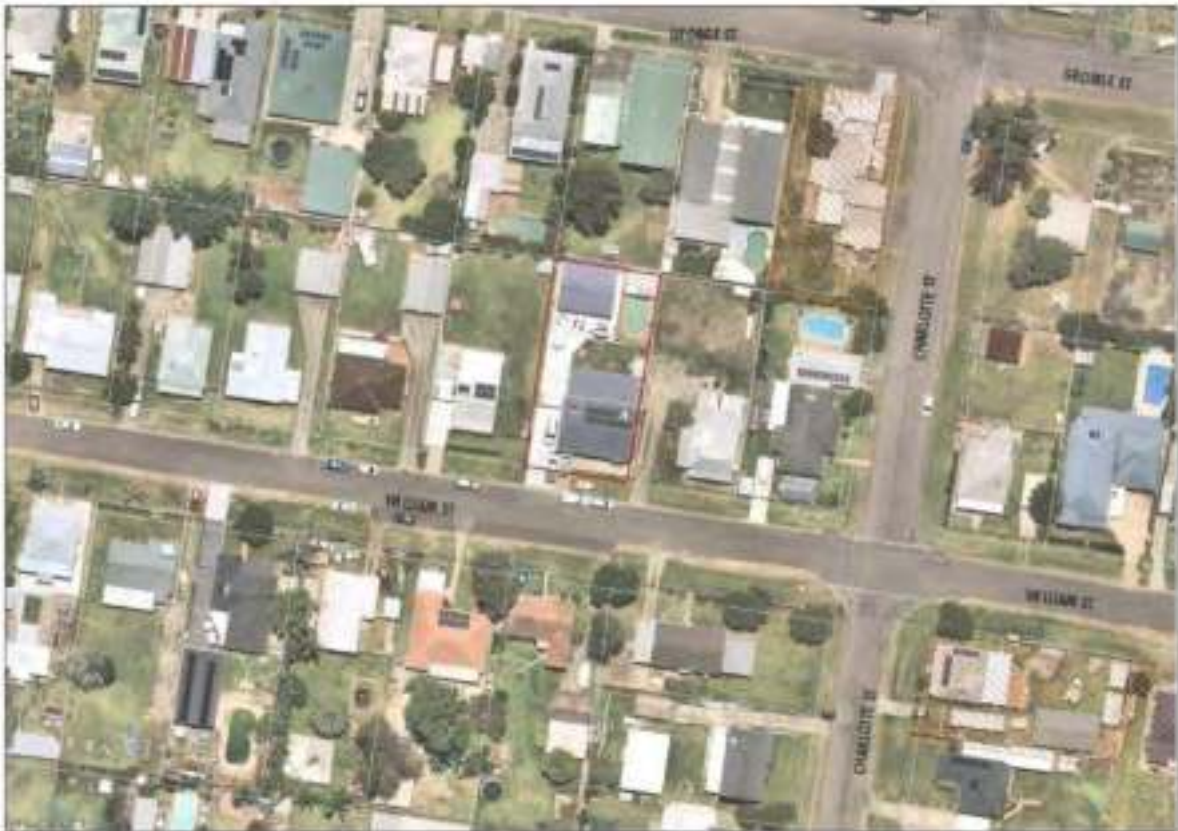
25 WILLIAM STREET, HOLMESVILLE 2286

Conservation Area Contribution Level	Est. Construction Date	Previous studies and/or community input
Non-Contributory	Mid to late 20 th century onwards	No prior heritage assessments or research undertaken.
Assessment Text		Observed Modifications
<p>The scale (e.g. double-storey or greater) and general style of the dwelling is inconsistent with that of the streetscape and wider HCA.</p> <p>The dwelling does not contribute positively to the streetscape and wider HCA, particularly in comparison to Contributory 1 and 2 buildings. The presence of the building has an adverse impact on the streetscape and/or wider HCA.</p> <p>The dwelling features inappropriately proportioned and positioned fenestrations, an inappropriate roof form (gabled or hipped) and/or other features that are inconsistent with the architectural character of the area (e.g. unsympathetic additions, inconsistent [contemporary] building materials, etc).</p>		<p>The dwelling has undergone extensive modifications across the façade, with elements of brickwork, weatherboard and rendering being applied. It is unclear which medium is the original.</p> <p>The front door is brightly coloured and in a contemporary style.</p>

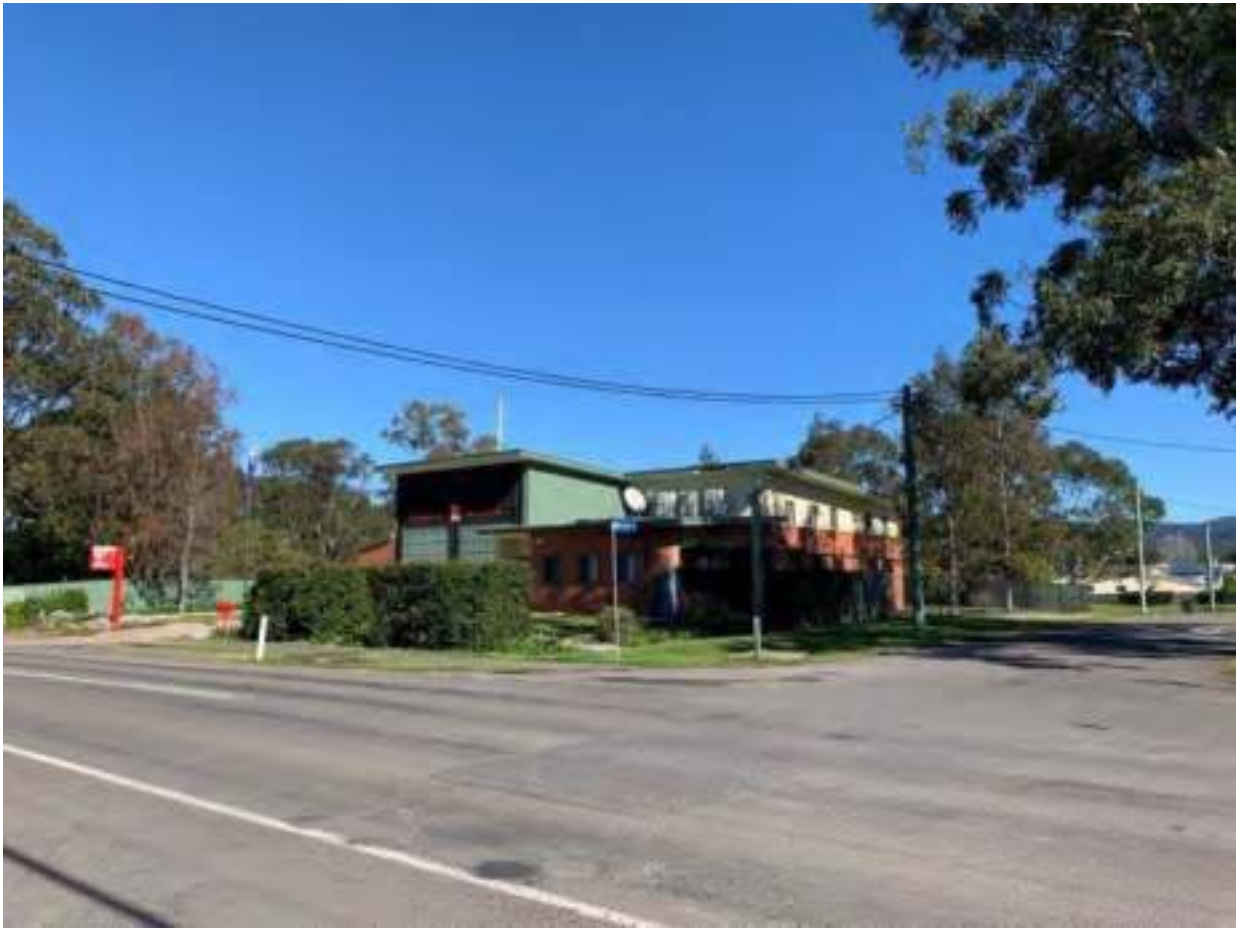
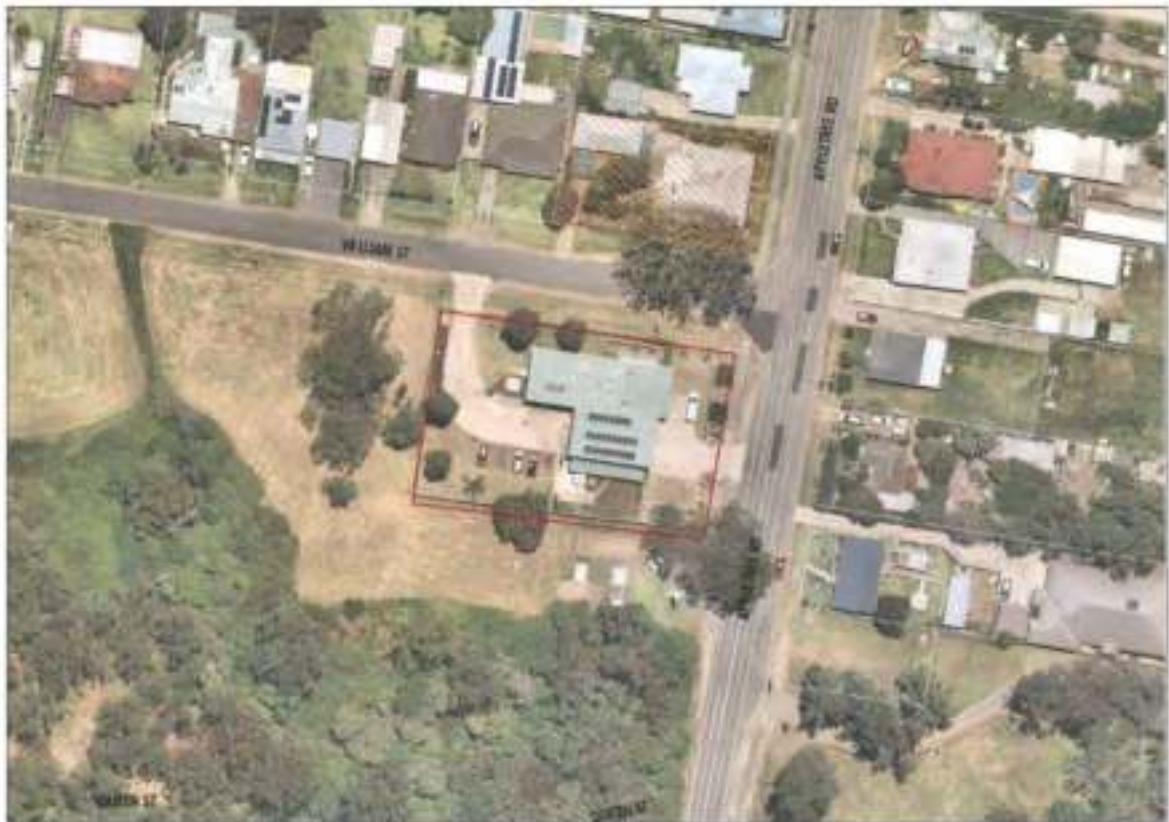
56 APPLETREE ROAD, HOLMESVILLE 2286

Conservation Area Contribution Level	Est. Construction Date	Previous studies and/or community input
Non-Contributory	Mid to late 20 th century onwards	No prior heritage assessments or research undertaken.
Assessment Text		Observed Modifications
<p>The scale (e.g. double-storey or greater) and general style of the dwelling is inconsistent with that of the streetscape and wider HCA.</p> <p>The dwelling does not contribute positively to the streetscape and wider HCA, particularly in comparison to Contributory 1 and 2 buildings. The presence of the building has an adverse impact on the streetscape and/or wider HCA.</p> <p>The dwelling features inappropriately proportioned and positioned fenestrations, an inappropriate roof form (gabled or hipped) and/or other features that are inconsistent with the architectural character of the area (e.g. unsympathetic additions, inconsistent [contemporary] building materials, etc).</p>		No modifications observed.

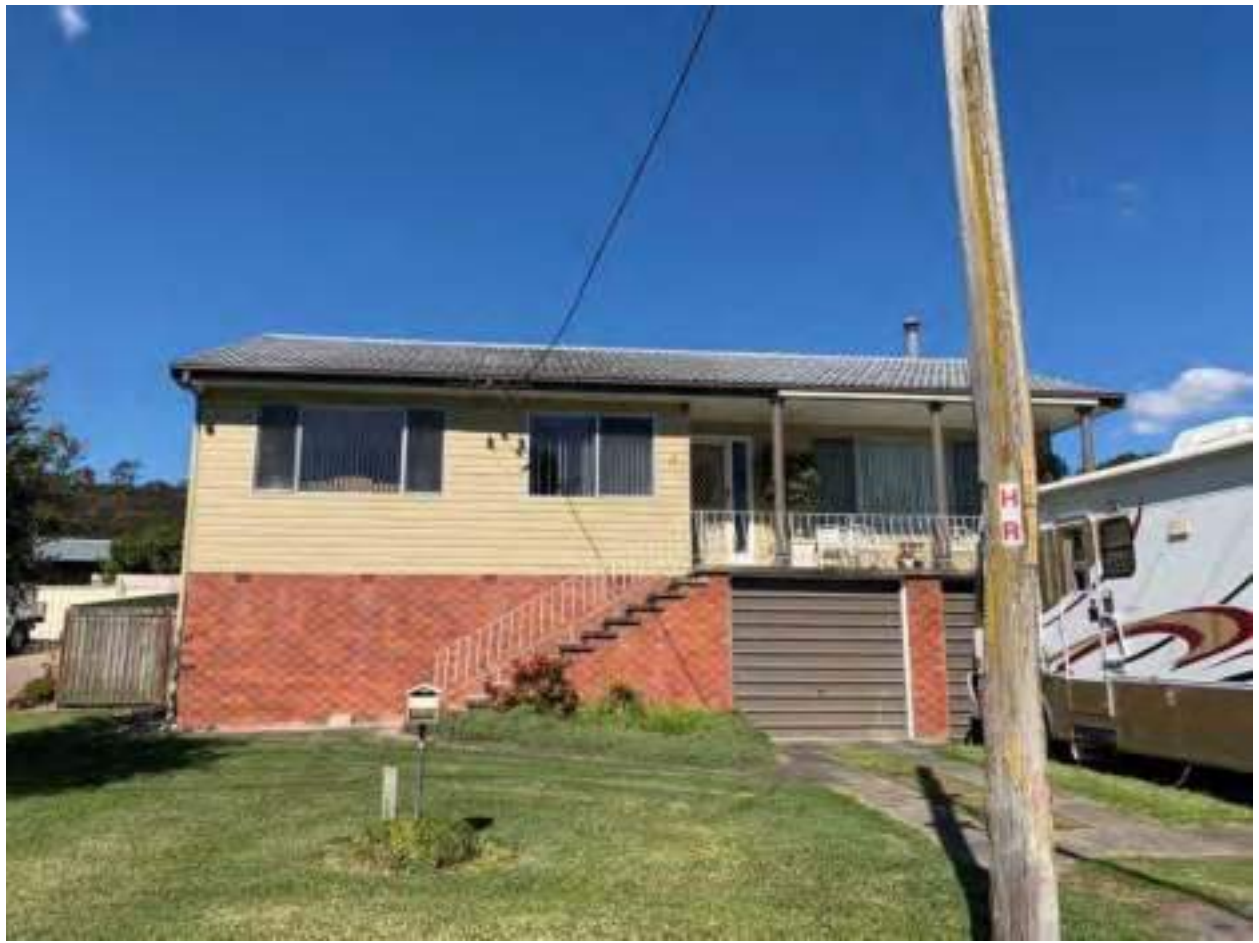
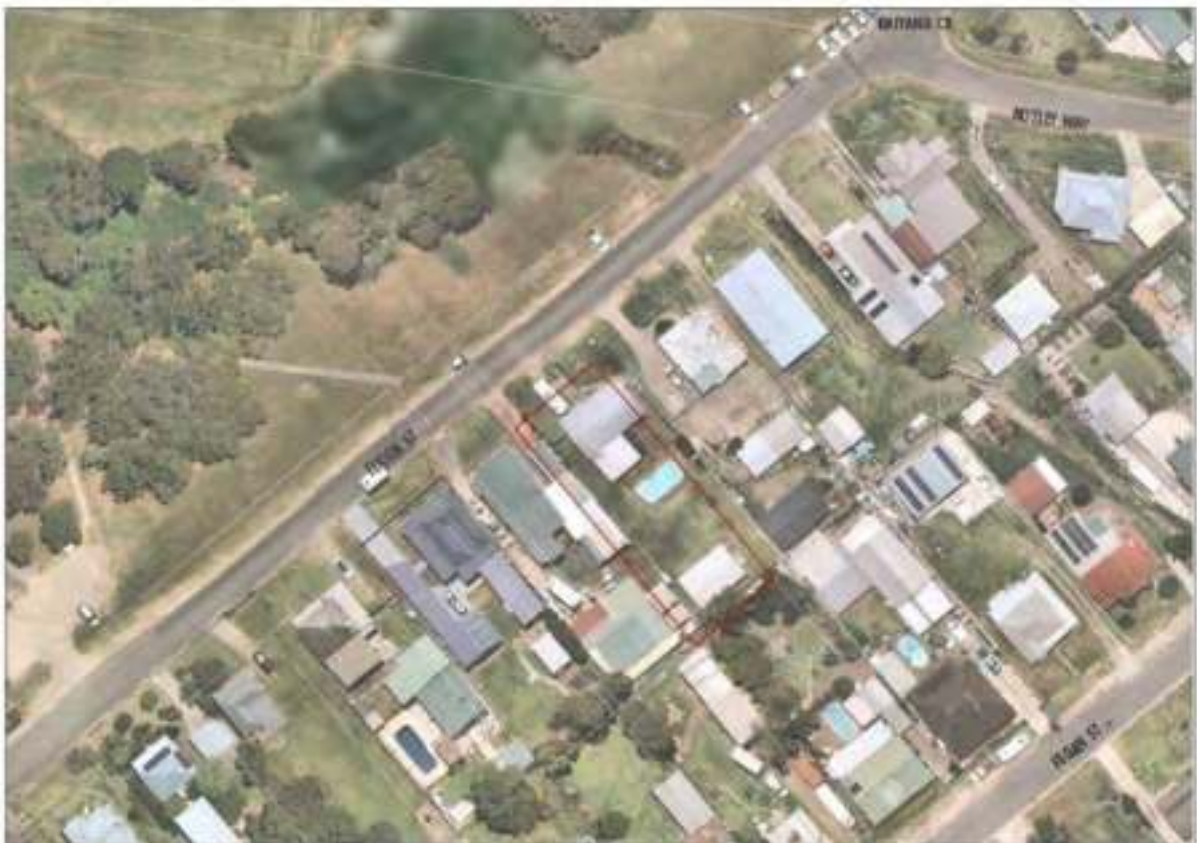
10 EDDEN STREET, WEST WALLSEND 2286

Conservation Area Contribution Level	Est. Construction Date	Previous studies and/or community input
Non-Contributory	Mid to late 20 th century onwards	No prior heritage assessments or research undertaken.
Assessment Text		Observed Modifications
<p>The scale (e.g. double-storey or greater) and general style of the dwelling is inconsistent with that of the streetscape and wider HCA.</p> <p>The dwelling does not contribute positively to the streetscape and wider HCA, particularly in comparison to Contributory 1 and 2 buildings. The presence of the building has an adverse impact on the streetscape and/or wider HCA.</p> <p>The dwelling features inappropriately proportioned and positioned fenestrations, an inappropriate roof form (gabled or hipped) and/or other features that are inconsistent with the architectural character of the area (e.g. unsympathetic additions, inconsistent [contemporary] building materials, etc).</p>		<p>The faux European style pillars are likely a contemporary addition.</p>

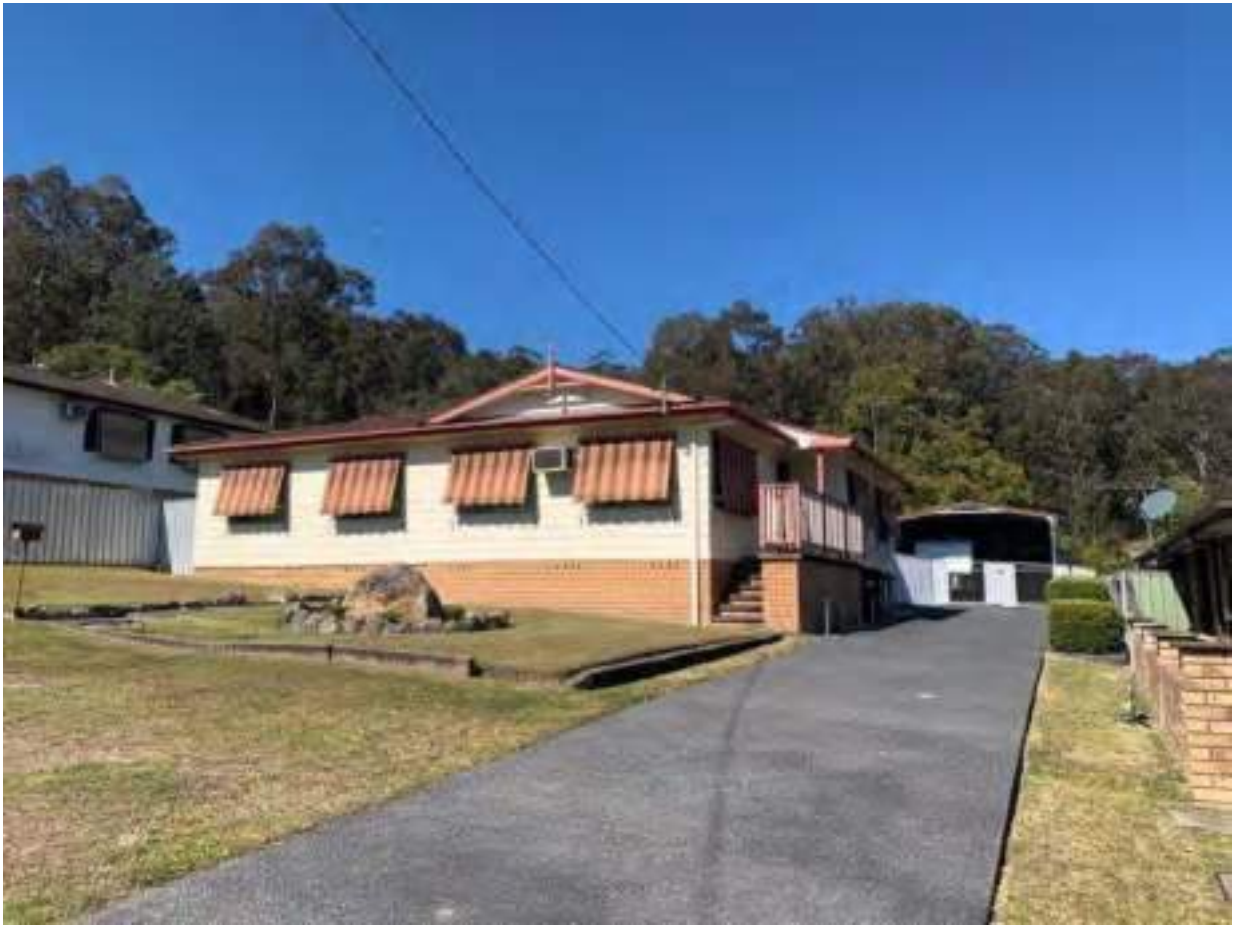
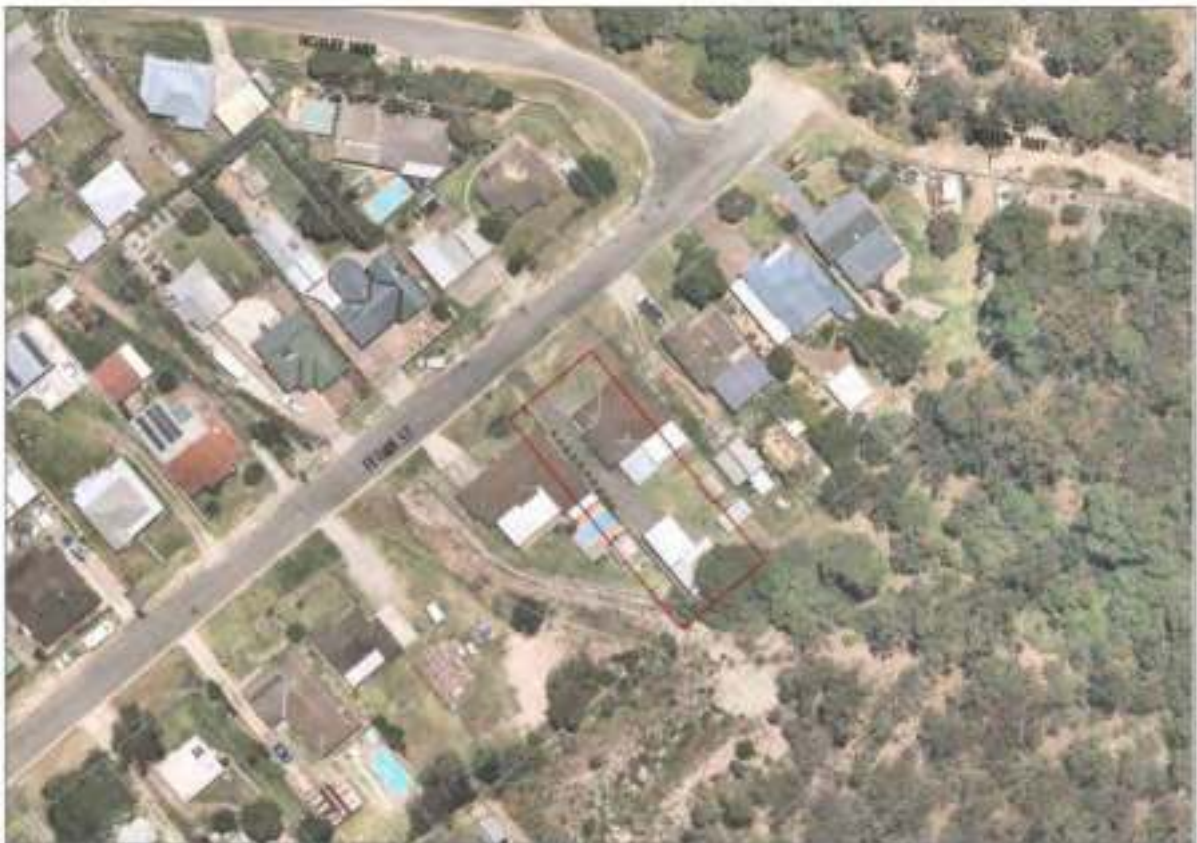
8 FEGAN STREET, WEST WALLSEND 2286		
Conservation Area Contribution Level	Est. Construction Date	Previous studies and/or community input
Non-Contributory	Mid to late 20 th century onwards	No prior heritage assessments or research undertaken.
Assessment Text		Observed Modifications
<p>The scale (e.g. double-storey or greater) and general style of the dwelling is inconsistent with that of the streetscape and wider HCA.</p> <p>The dwelling does not contribute positively to the streetscape and wider HCA, particularly in comparison to Contributory 1 and 2 buildings. The presence of the building has an adverse impact on the streetscape and/or wider HCA.</p> <p>The dwelling features inappropriately proportioned and positioned fenestrations, an inappropriate roof form (gabled or hipped) and/or other features that are inconsistent with the architectural character of the area (e.g. unsympathetic additions, inconsistent [contemporary] building materials, etc).</p>		<p>The timber balustrade is likely a recent addition to the dwelling.</p>
