APPENDIX 2

Building Assessment Sheets (Inventory Sheets)

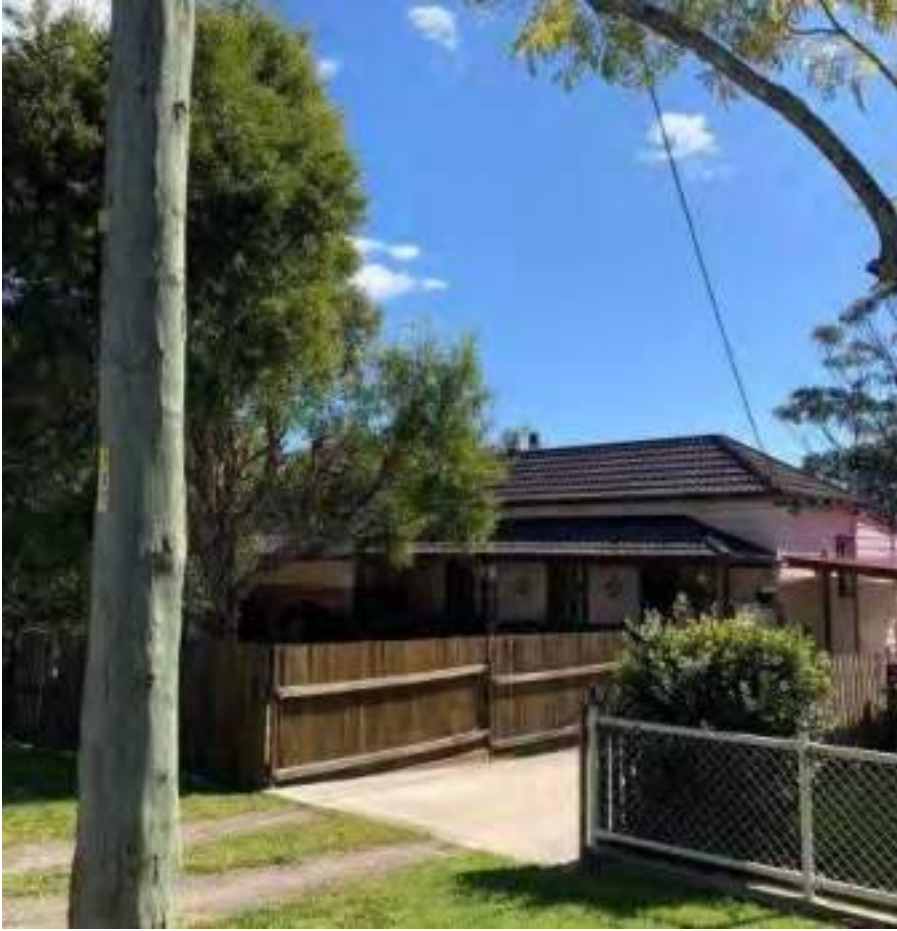
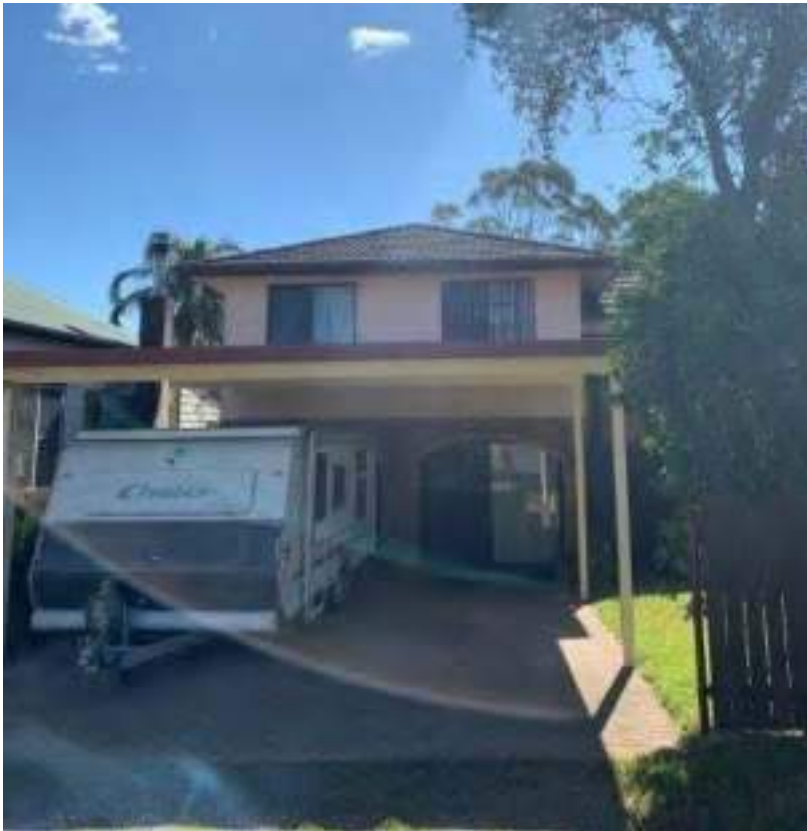
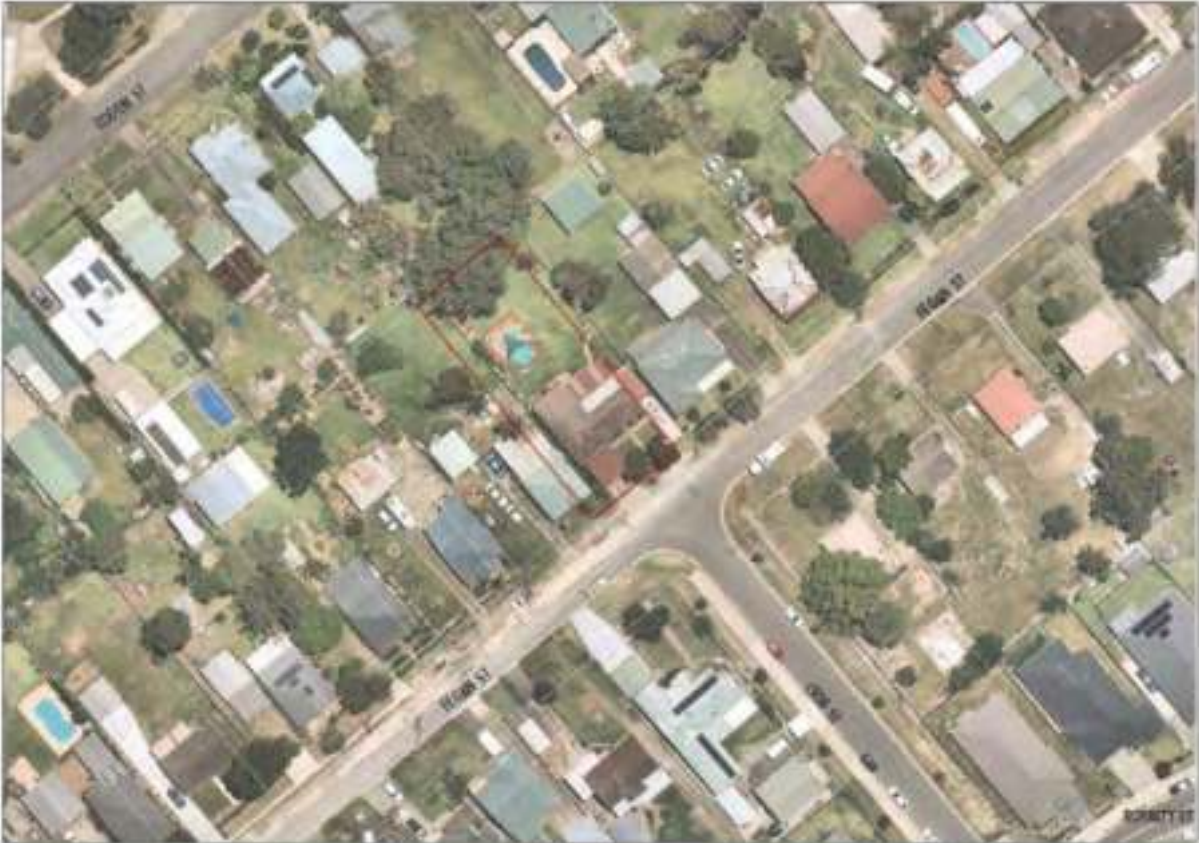
23 FEGAN STREET, WEST WALLSEND 2286

Conservation Area Contribution Level	Est. Construction Date	Previous studies and/or community input
Non-Contributory	Mid to late 20 th century onwards	No prior heritage assessments or research undertaken.
Assessment Text		Observed Modifications
<p>The scale (e.g. double-storey or greater) and general style of the dwelling is inconsistent with that of the streetscape and wider HCA.</p> <p>The dwelling does not contribute positively to the streetscape and wider HCA, particularly in comparison to Contributory 1 and 2 buildings. The presence of the building has an adverse impact on the streetscape and/or wider HCA.</p> <p>The dwelling features inappropriately proportioned and positioned fenestrations, an inappropriate roof form (gabled or hipped) and/or other features that are inconsistent with the architectural character of the area (e.g. unsympathetic additions, inconsistent [contemporary] building materials, etc).</p>		<p>Potential for the second storey extension to be a contemporary, yet dated addition to the dwelling. this may be original, or constructed following the initial construction of the dwelling.</p> <p>An extensive car port has been constructed at the front south eastern side of the dwelling.</p>

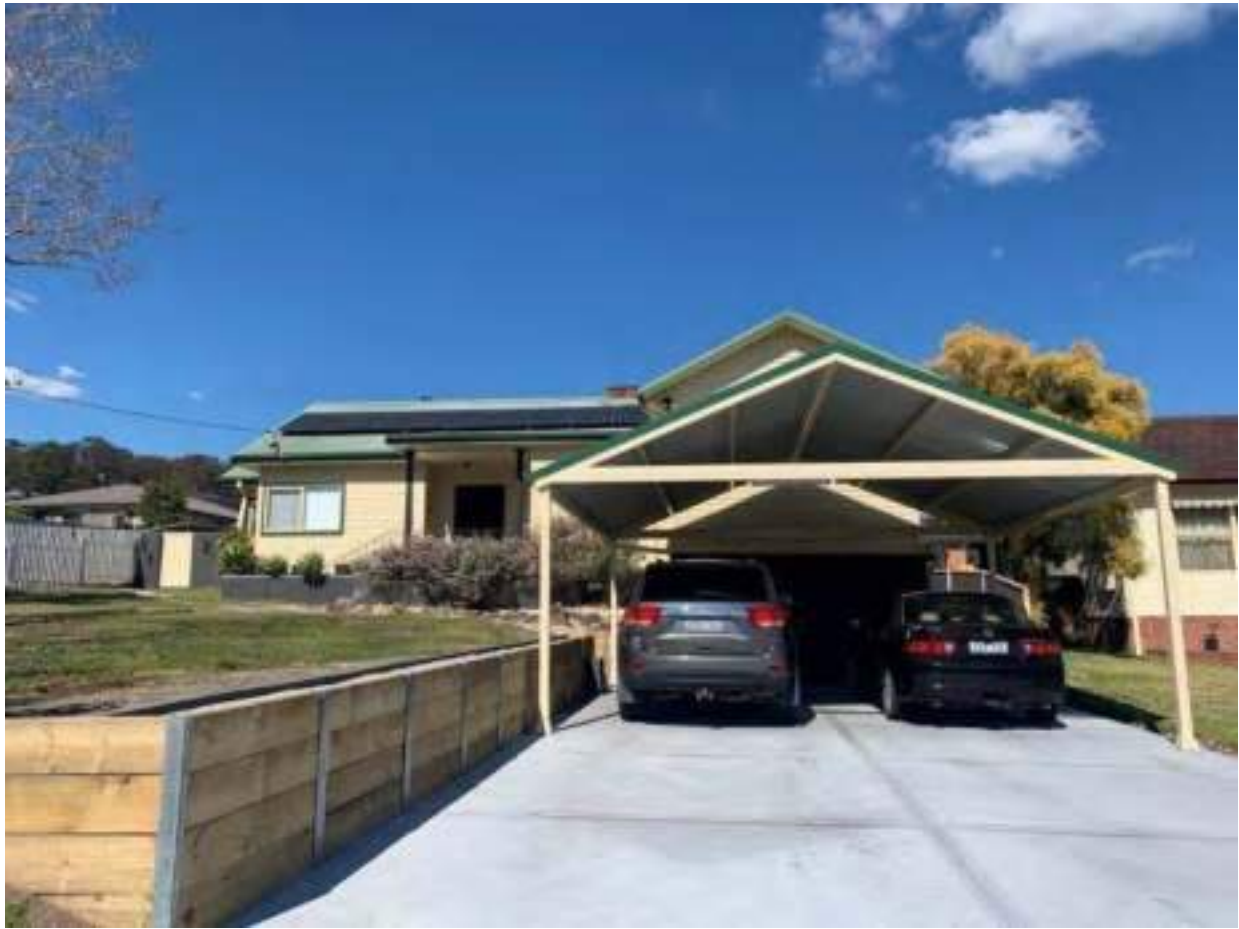
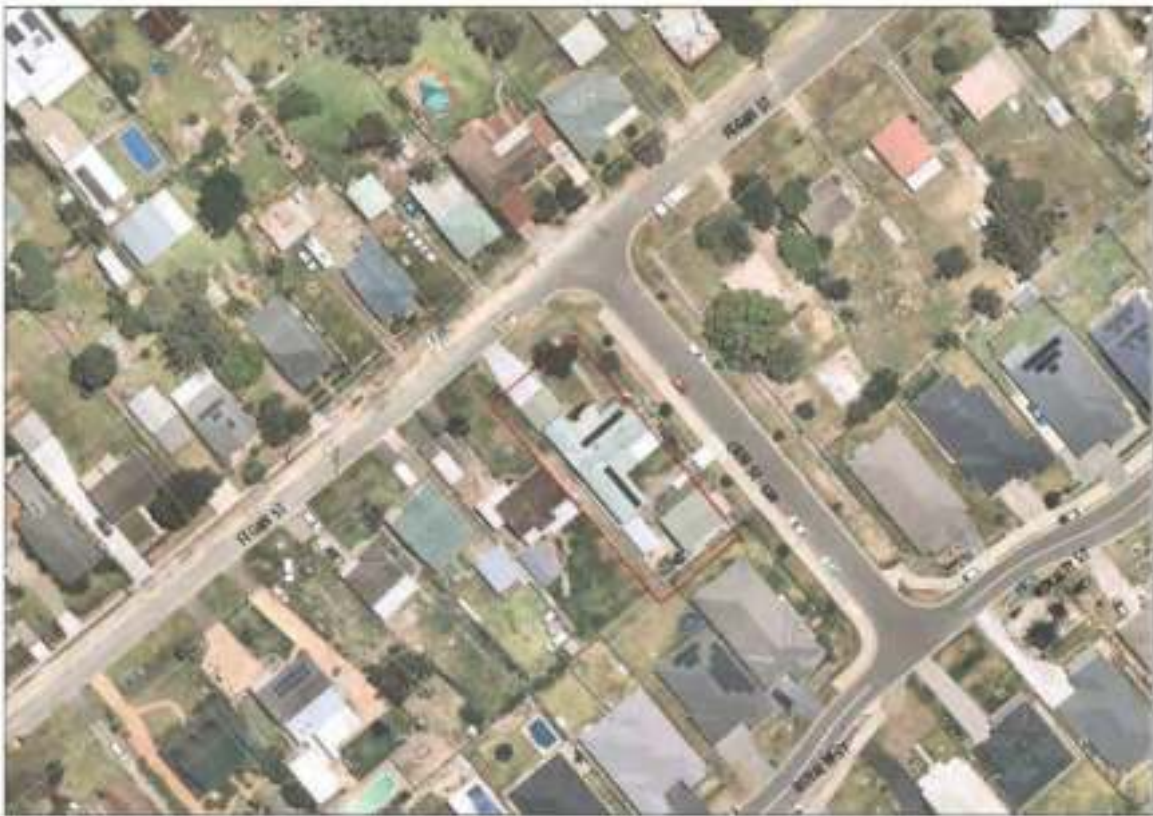
30 FEGAN STREET, WEST WALLSEND 2286		
Conservation Area Contribution Level	Est. Construction Date	Previous studies and/or community input
Non-Contributory	Mid to late 20 th century onwards	No prior heritage assessments or research undertaken.
Assessment Text		Observed Modifications
<p>The scale (e.g. double-storey or greater) and general style of the dwelling is inconsistent with that of the streetscape and wider HCA.</p> <p>The dwelling does not contribute positively to the streetscape and wider HCA, particularly in comparison to Contributory 1 and 2 buildings. The presence of the building has an adverse impact on the streetscape and/or wider HCA.</p> <p>The dwelling features inappropriately proportioned and positioned fenestrations, an inappropriate roof form (gabled or hipped) and/or other features that are inconsistent with the architectural character of the area (e.g. unsympathetic additions, inconsistent [contemporary] building materials, etc).</p>		<p>Solar panels are highly visible along the northern portion of the roof.</p> <p>An extensive gable roof carport has been constructed at the front northern side of the dwelling.</p>

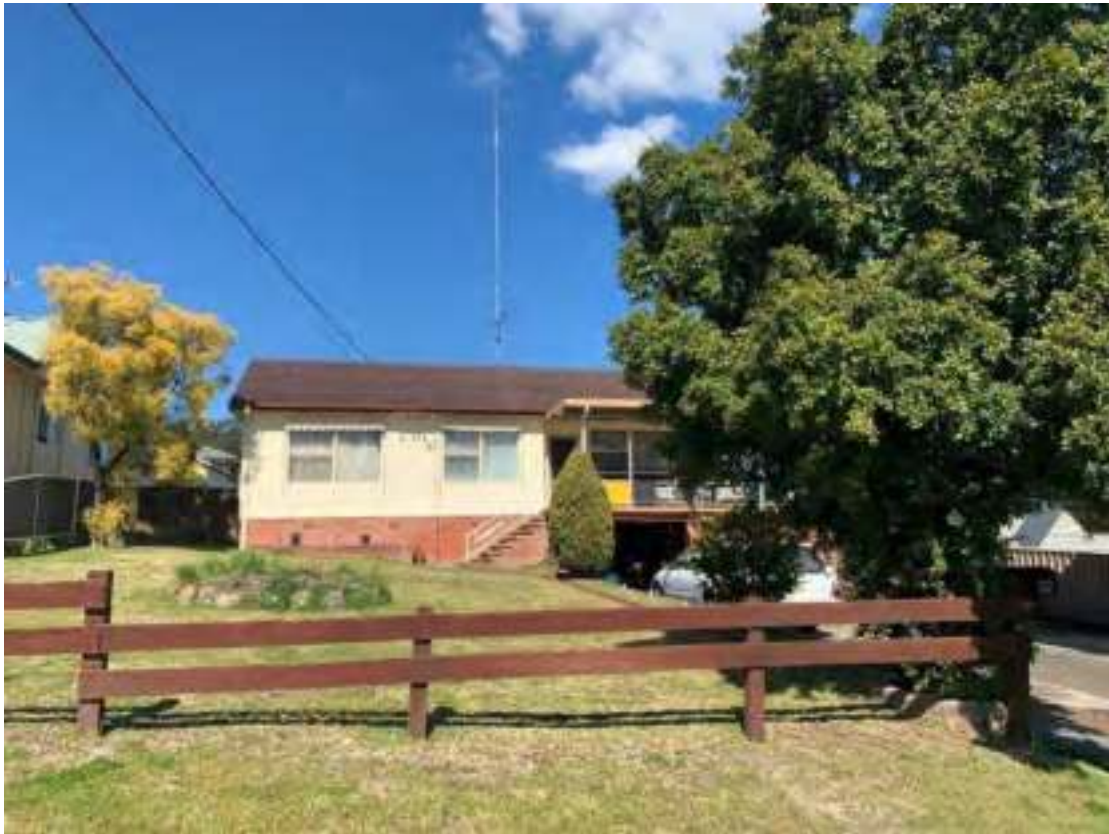
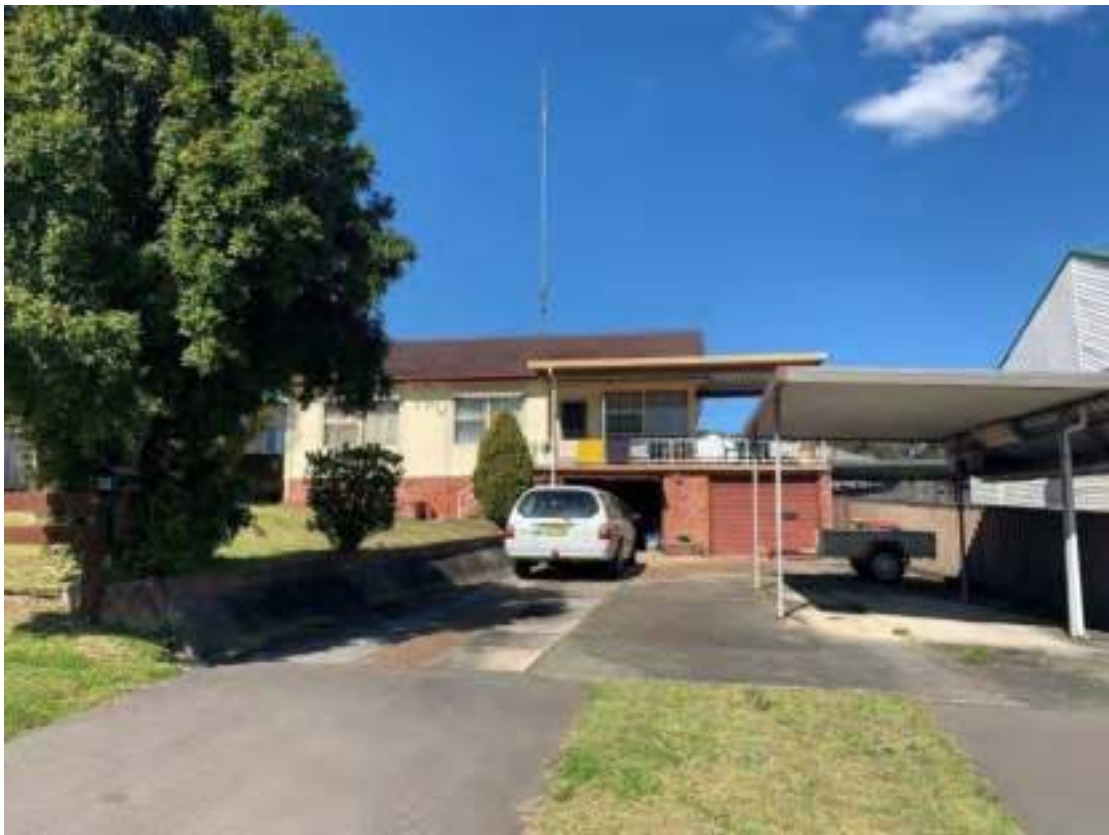
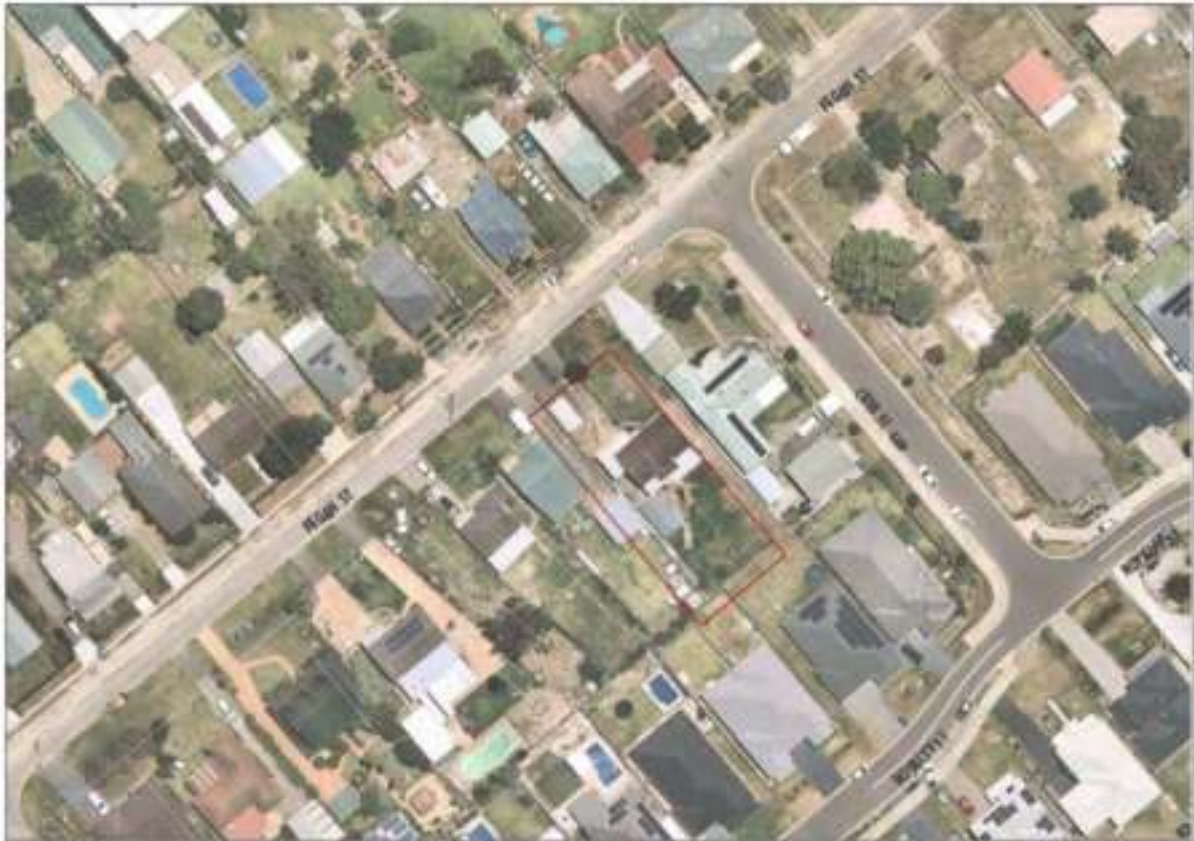
32 FEGAN STREET, WEST WALLSEND 2286

Conservation Area Contribution Level	Est. Construction Date	Previous studies and/or community input
Non-Contributory	Mid to late 20 th century onwards	No prior heritage assessments or research undertaken.
Assessment Text		Observed Modifications
<p>The scale (e.g. double-storey or greater) and general style of the dwelling is inconsistent with that of the streetscape and wider HCA.</p> <p>The dwelling does not contribute positively to the streetscape and wider HCA, particularly in comparison to Contributory 1 and 2 buildings. The presence of the building has an adverse impact on the streetscape and/or wider HCA.</p> <p>The dwelling features inappropriately proportioned and positioned fenestrations, an inappropriate roof form (gabled or hipped) and/or other features that are inconsistent with the architectural character of the area (e.g. unsympathetic additions, inconsistent [contemporary] building materials, etc).</p>		<p>A car port has been constructed at the front north western side of the dwelling.</p>

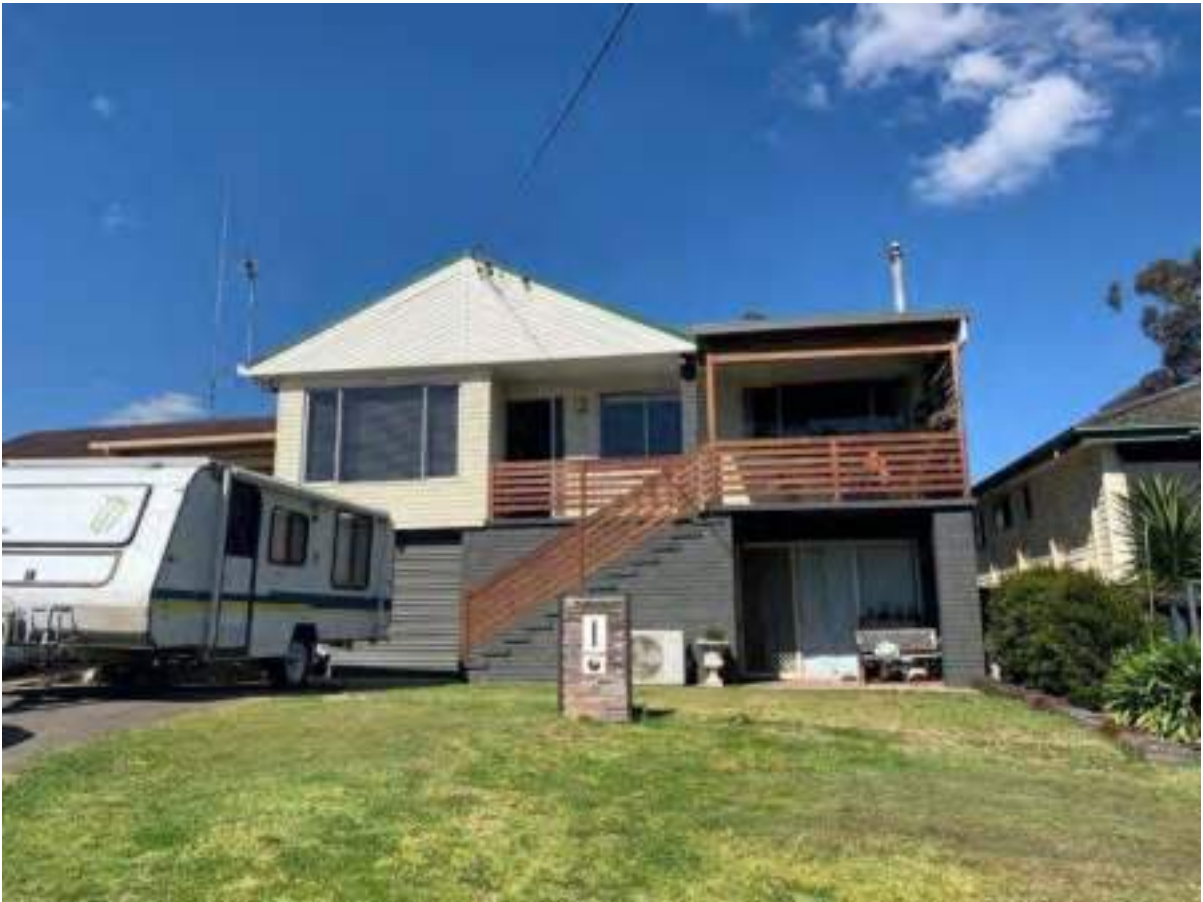
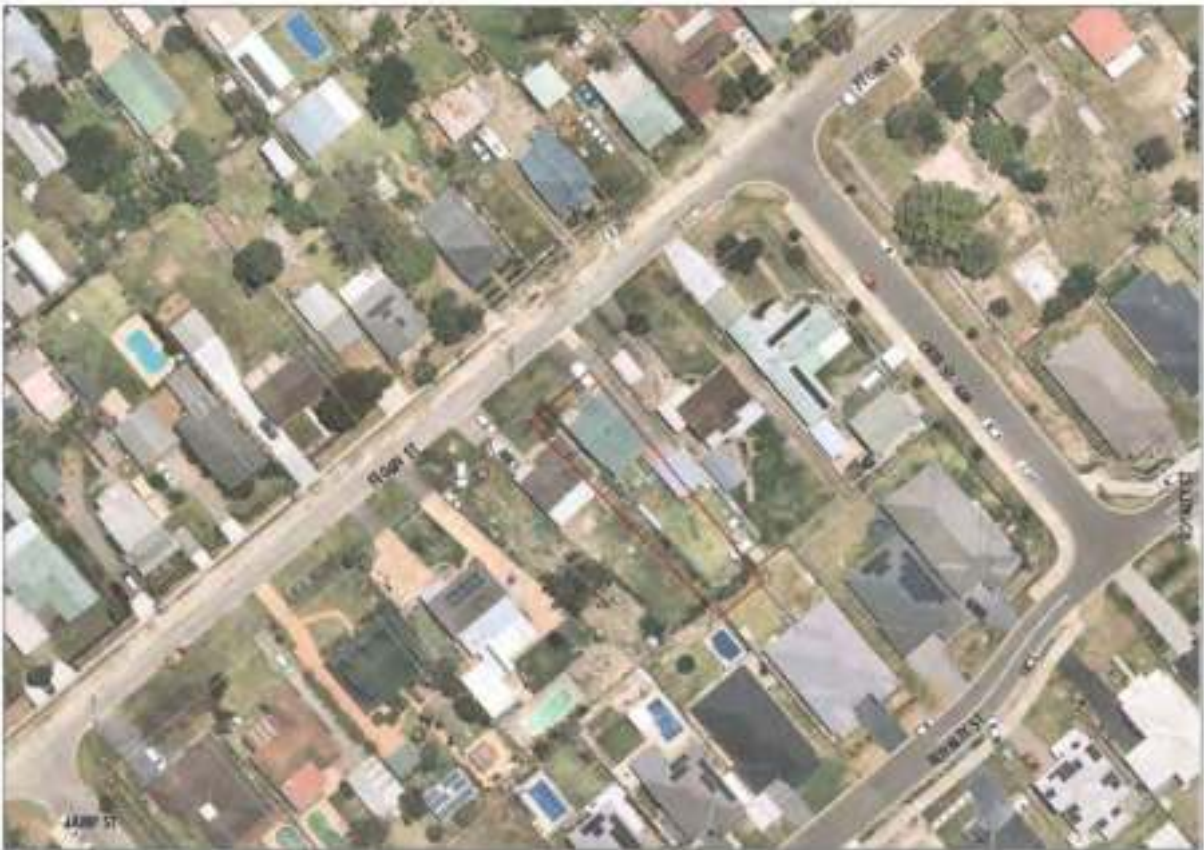
34 FEGAN STREET, WEST WALLSEND 2286		
Conservation Area Contribution Level	Est. Construction Date	Previous studies and/or community input
Non-Contributory	Mid to late 20 th century onwards	No prior heritage assessments or research undertaken.
Assessment Text		Observed Modifications
<p>The scale (e.g. double-storey or greater) and general style of the dwelling is inconsistent with that of the streetscape and wider HCA.</p> <p>The dwelling does not contribute positively to the streetscape and wider HCA, particularly in comparison to Contributory 1 and 2 buildings. The presence of the building has an adverse impact on the streetscape and/or wider HCA.</p> <p>The dwelling features inappropriately proportioned and positioned fenestrations, an inappropriate roof form (gabled or hipped) and/or other features that are inconsistent with the architectural character of the area (e.g. unsympathetic additions, inconsistent [contemporary] building materials, etc).</p>		<p>The timber balustrade enclosing the veranda is a recent addition to the dwelling. The veranda roof has been extended, with similar timber posts supporting the flat roof. Timber panelling further encloses the veranda space.</p>

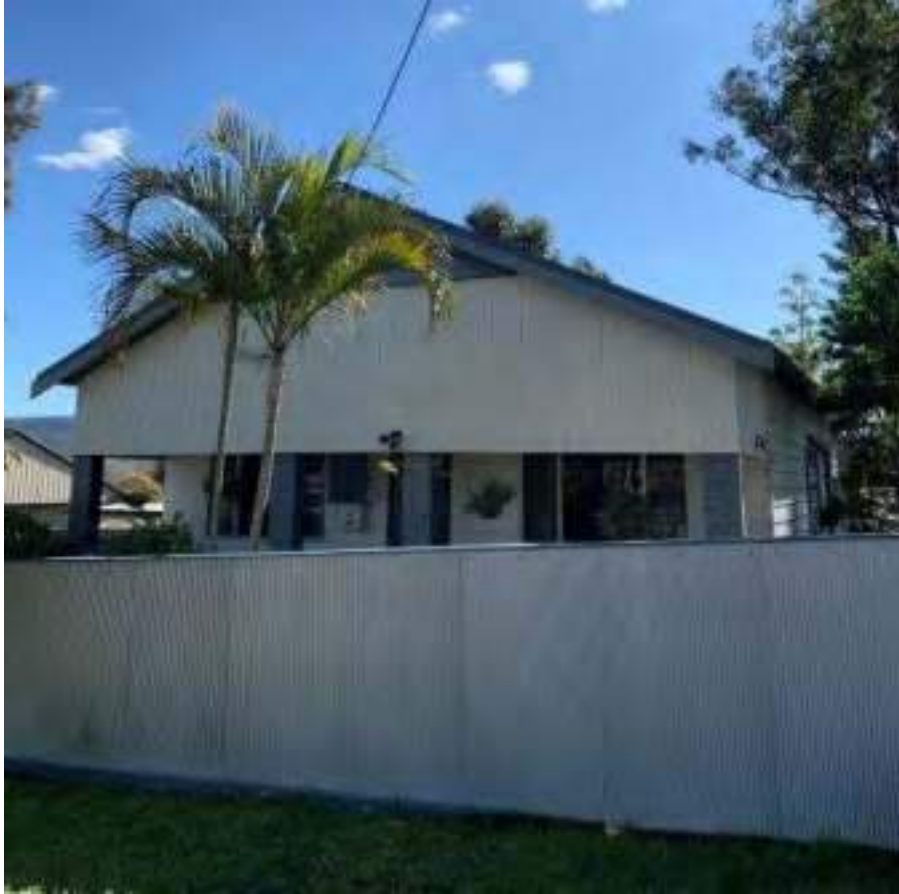
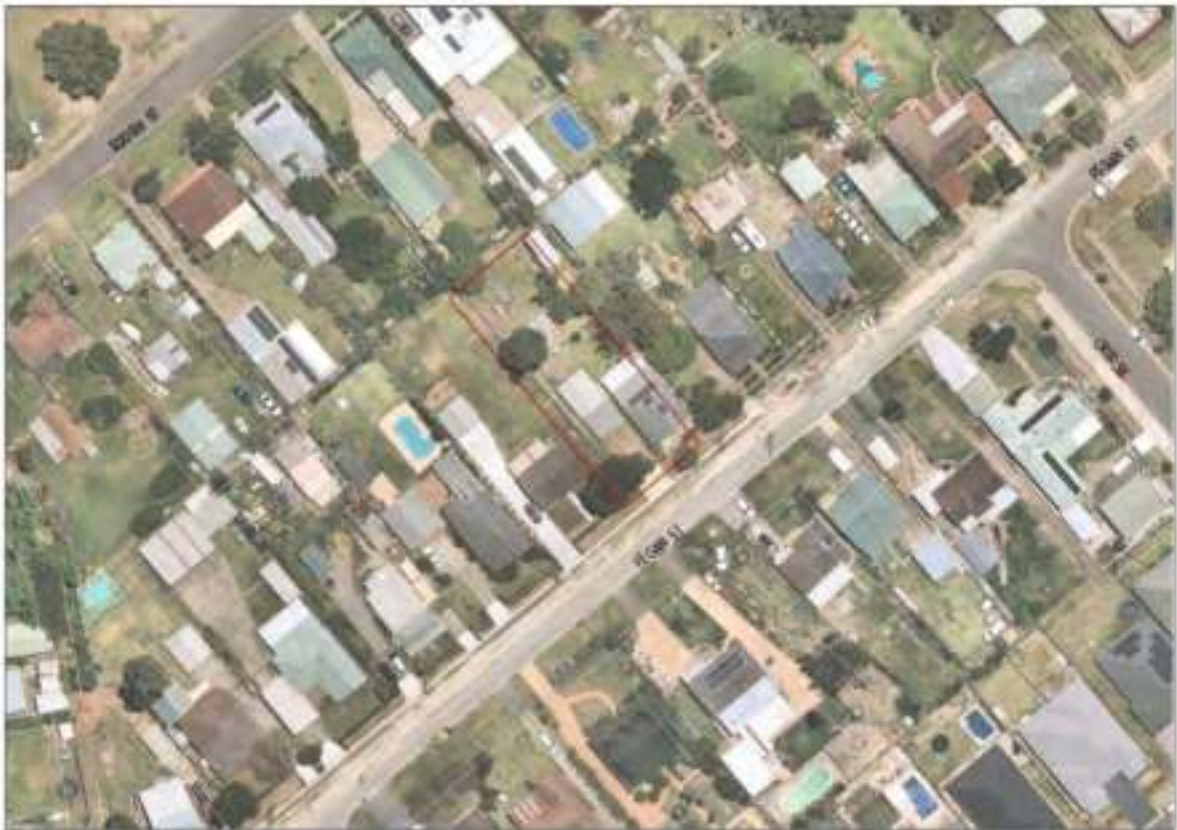
31 FEGAN STREET, WEST WALLSEND 2286		
Conservation Area Contribution Level	Est. Construction Date	Previous studies and/or community input
Non-Contributory	Mid to late 20 th century onwards	No prior heritage assessments or research undertaken.
Assessment Text		Observed Modifications
<p>The scale (e.g. double-storey or greater) and general style of the dwelling is inconsistent with that of the streetscape and wider HCA.</p> <p>The dwelling does not contribute positively to the streetscape and wider HCA, particularly in comparison to Contributory 1 and 2 buildings. The presence of the building has an adverse impact on the streetscape and/or wider HCA.</p> <p>The dwelling features inappropriately proportioned and positioned fenestrations, an inappropriate roof form (gabled or hipped) and/or other features that are inconsistent with the architectural character of the area (e.g. unsympathetic additions, inconsistent [contemporary] building materials, etc).</p>		<p>The brick pillars supporting the veranda space is likely a contemporary addition, replacing a timber design.</p>

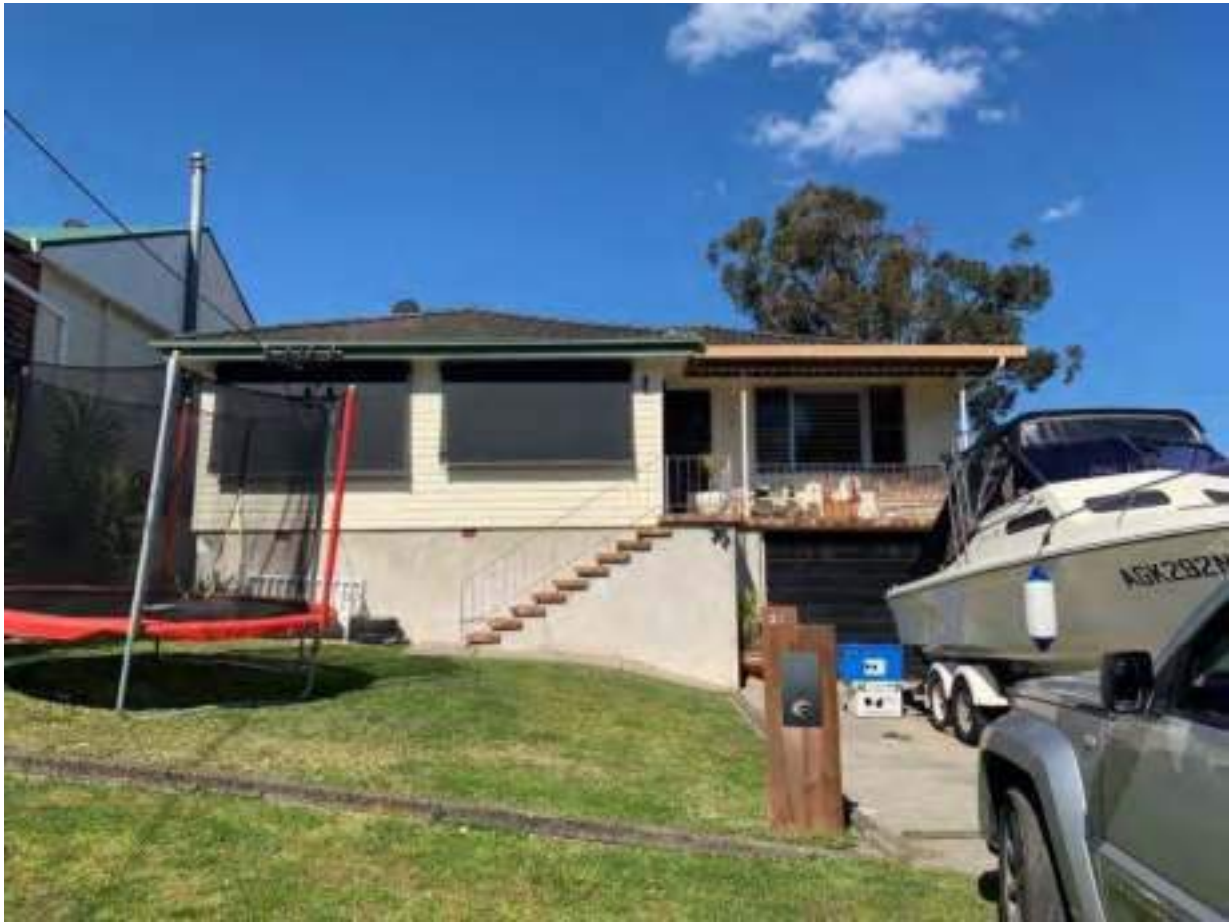
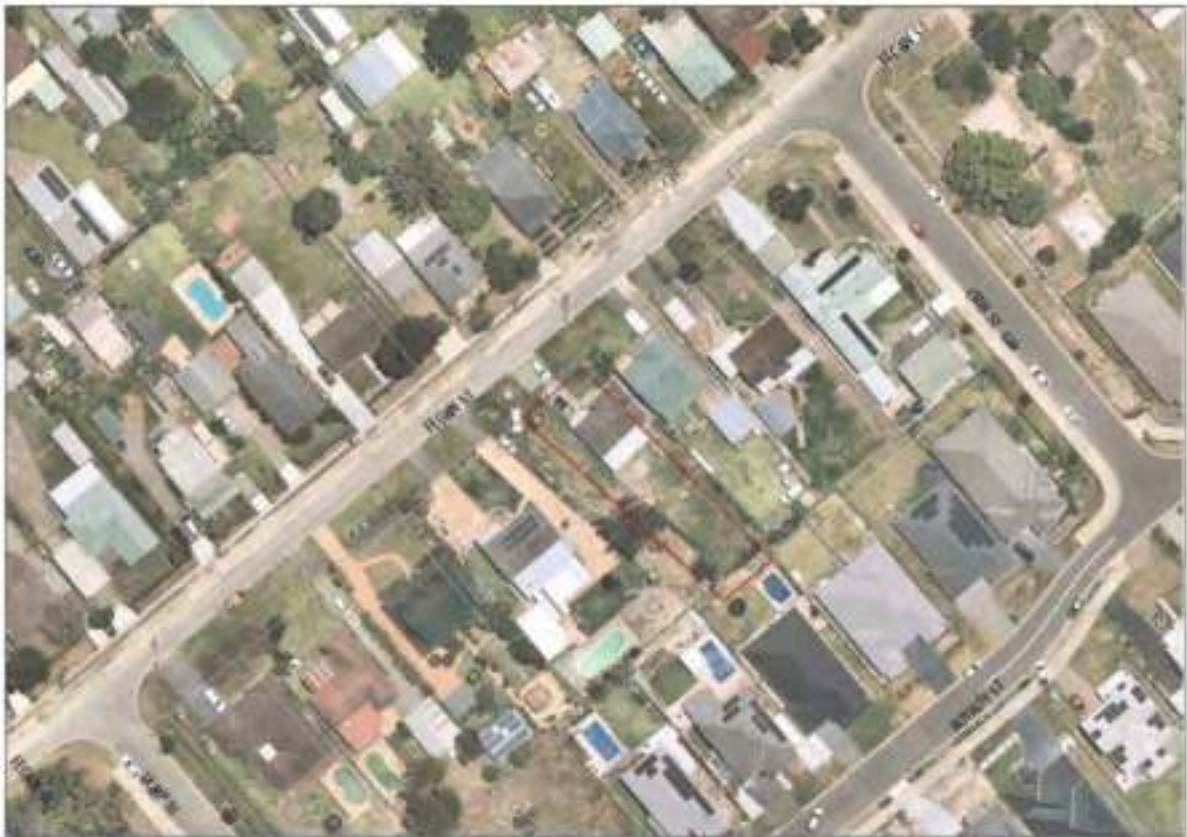
36 FEGAN STREET, WEST WALLSEND 2286

Conservation Area Contribution Level	Est. Construction Date	Previous studies and/or community input
Non-Contributory	Mid to late 20 th century onwards	No prior heritage assessments or research undertaken.
Assessment Text		Observed Modifications
<p>The scale (e.g. double-storey or greater) and general style of the dwelling is inconsistent with that of the streetscape and wider HCA.</p> <p>The dwelling does not contribute positively to the streetscape and wider HCA, particularly in comparison to Contributory 1 and 2 buildings. The presence of the building has an adverse impact on the streetscape and/or wider HCA.</p> <p>The dwelling features inappropriately proportioned and positioned fenestrations, an inappropriate roof form (gabled or hipped) and/or other features that are inconsistent with the architectural character of the area (e.g. unsympathetic additions, inconsistent [contemporary] building materials, etc).</p>		No modifications observed.

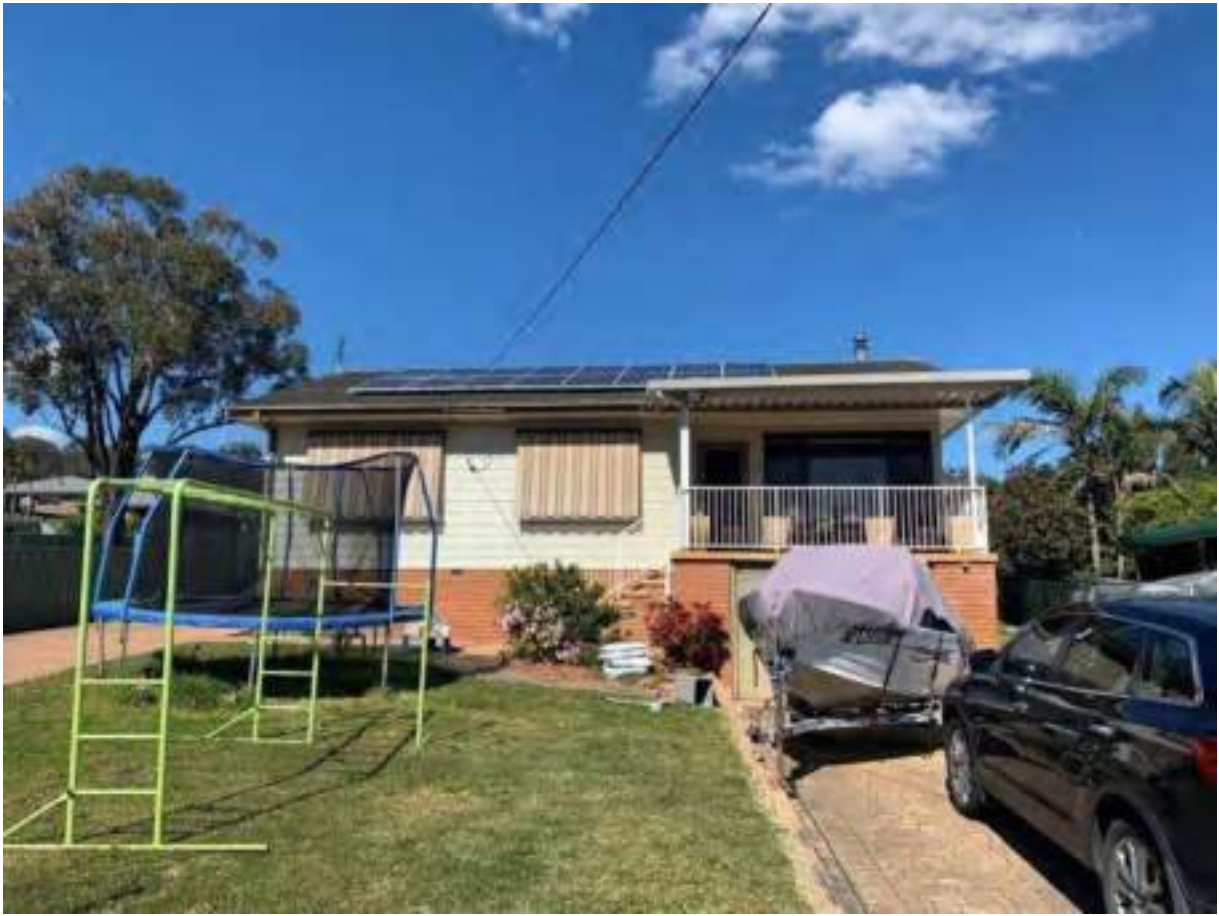
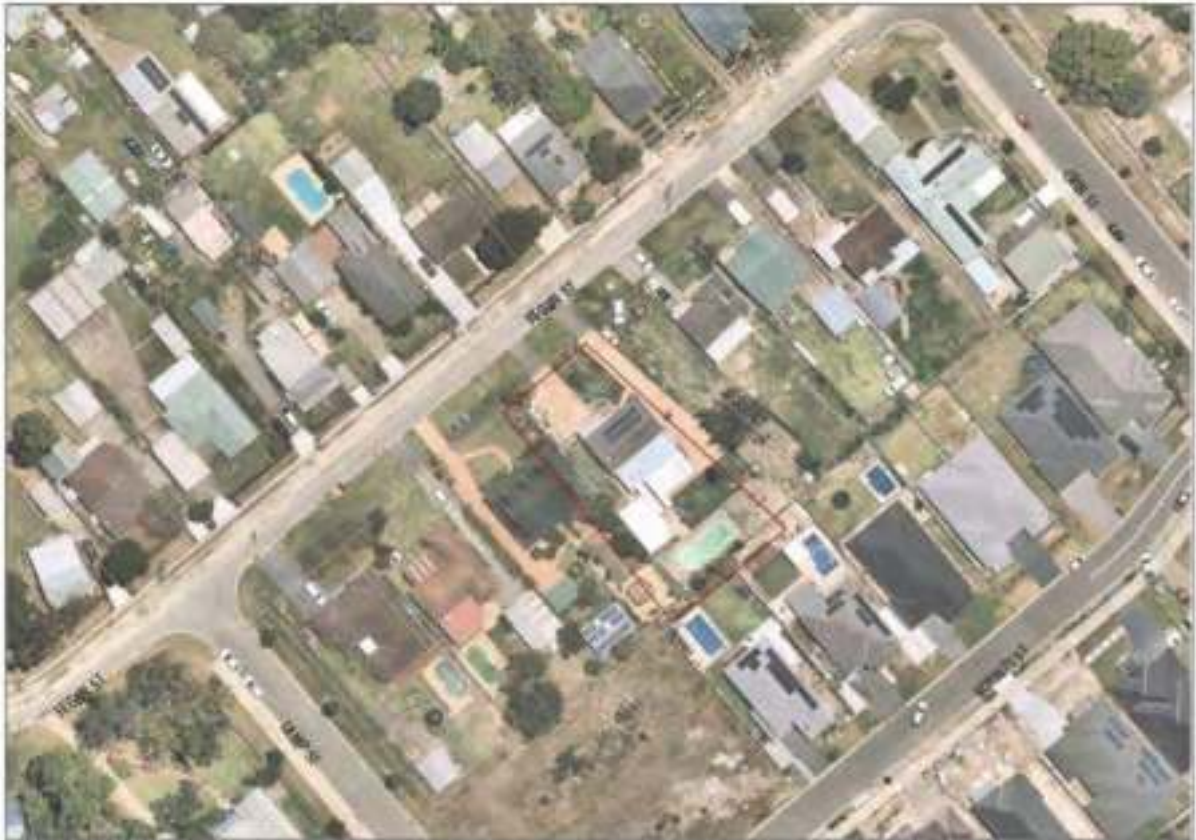
38 FEGAN STREET, WEST WALLSEND 2286

Conservation Area Contribution Level	Est. Construction Date	Previous studies and/or community input
Non-Contributory	Mid to late 20 th century onwards	No prior heritage assessments or research undertaken.
Assessment Text		Observed Modifications
<p>The scale (e.g. double-storey or greater) and general style of the dwelling is inconsistent with that of the streetscape and wider HCA.</p> <p>The dwelling does not contribute positively to the streetscape and wider HCA, particularly in comparison to Contributory 1 and 2 buildings. The presence of the building has an adverse impact on the streetscape and/or wider HCA.</p> <p>The dwelling features inappropriately proportioned and positioned fenestrations, an inappropriate roof form (gabled or hipped) and/or other features that are inconsistent with the architectural character of the area (e.g. unsympathetic additions, inconsistent [contemporary] building materials, etc).</p>		Solar panels are visible on the north western portion of the roof.

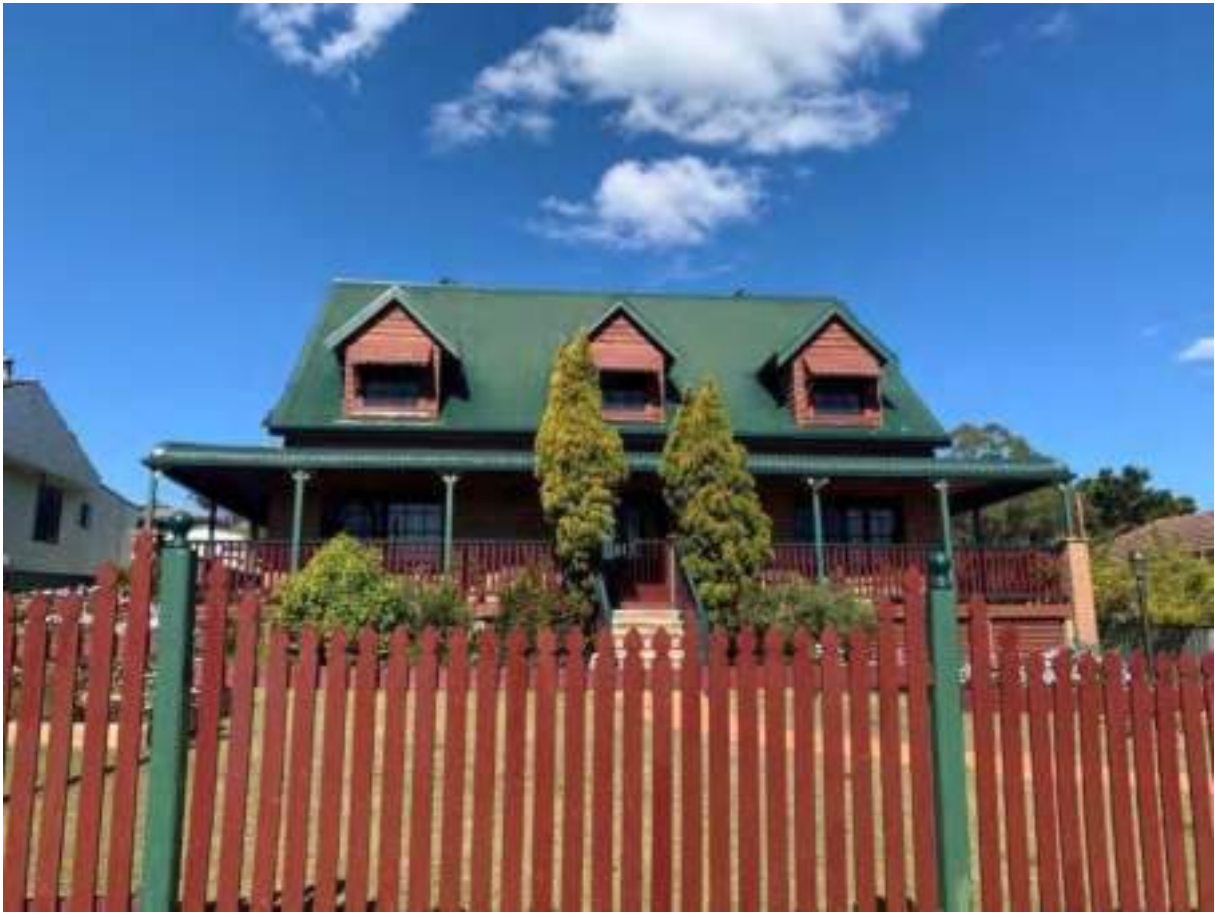
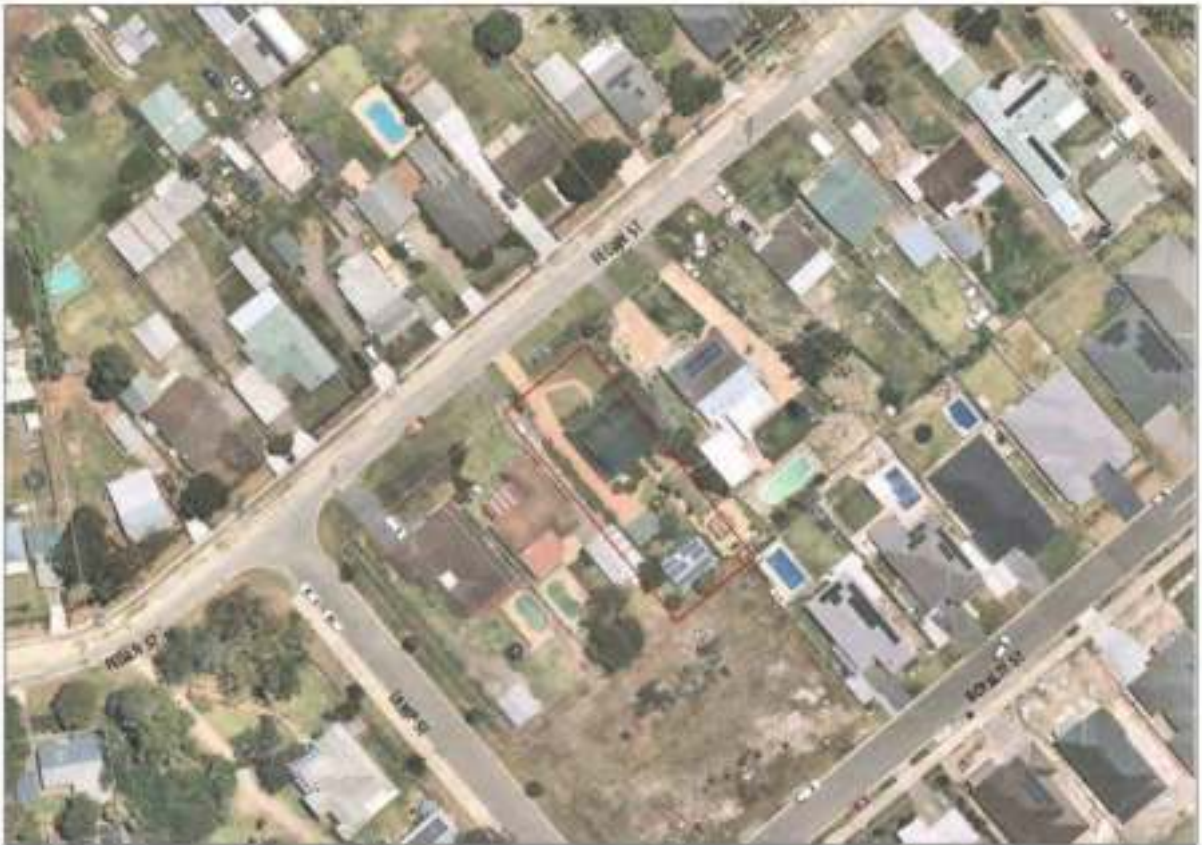
40 FEGAN STREET, WEST WALLSEND 2286

Conservation Area Contribution Level	Est. Construction Date	Previous studies and/or community input
Non-Contributory	Mid to late 20 th century onwards	No prior heritage assessments or research undertaken.
Assessment Text		Observed Modifications
<p>The scale (e.g. double-storey or greater) and general style of the dwelling is inconsistent with that of the streetscape and wider HCA.</p> <p>The dwelling does not contribute positively to the streetscape and wider HCA, particularly in comparison to Contributory 1 and 2 buildings. The presence of the building has an adverse impact on the streetscape and/or wider HCA.</p> <p>The dwelling features inappropriately proportioned and positioned fenestrations, an inappropriate roof form (gabled or hipped) and/or other features that are inconsistent with the architectural character of the area (e.g. unsympathetic additions, inconsistent [contemporary] building materials, etc).</p>		No modifications observed.

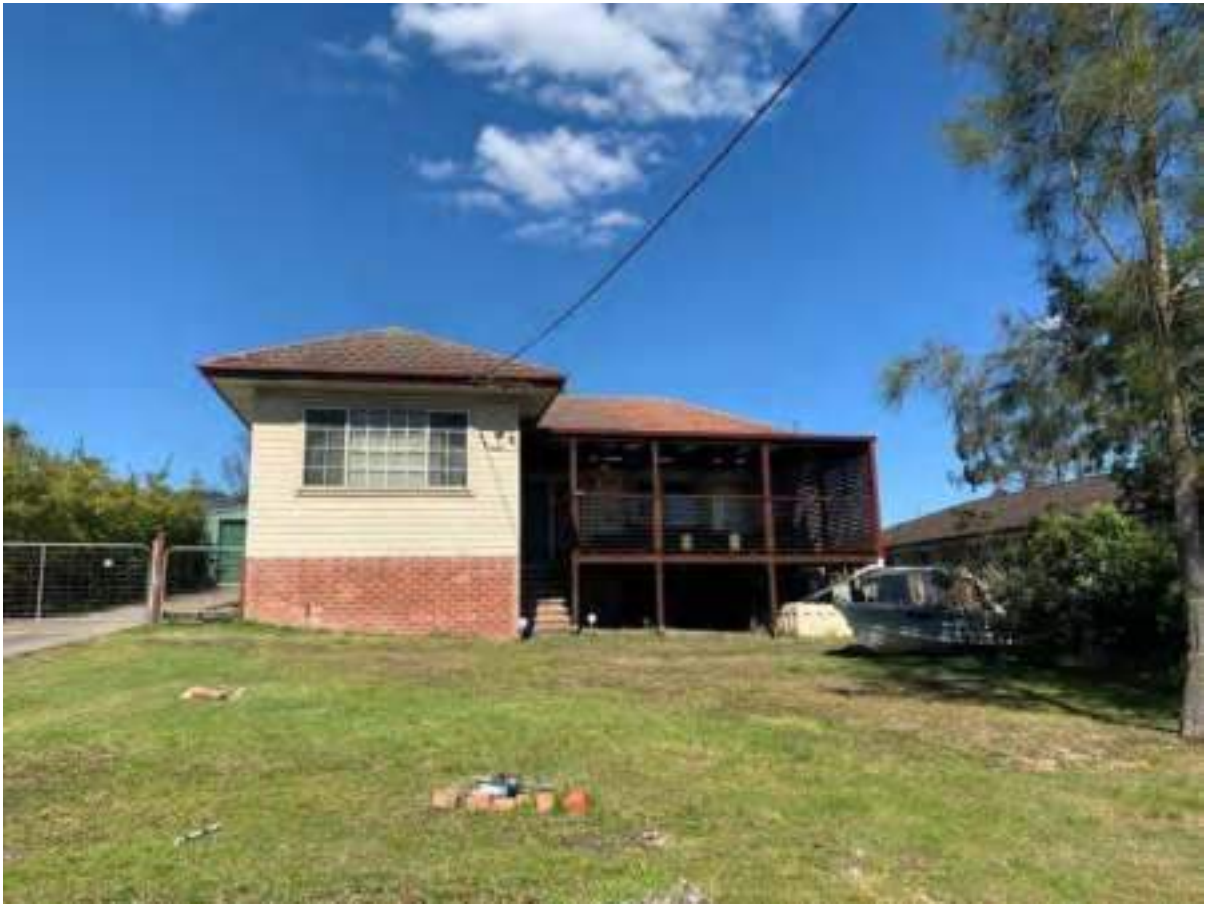
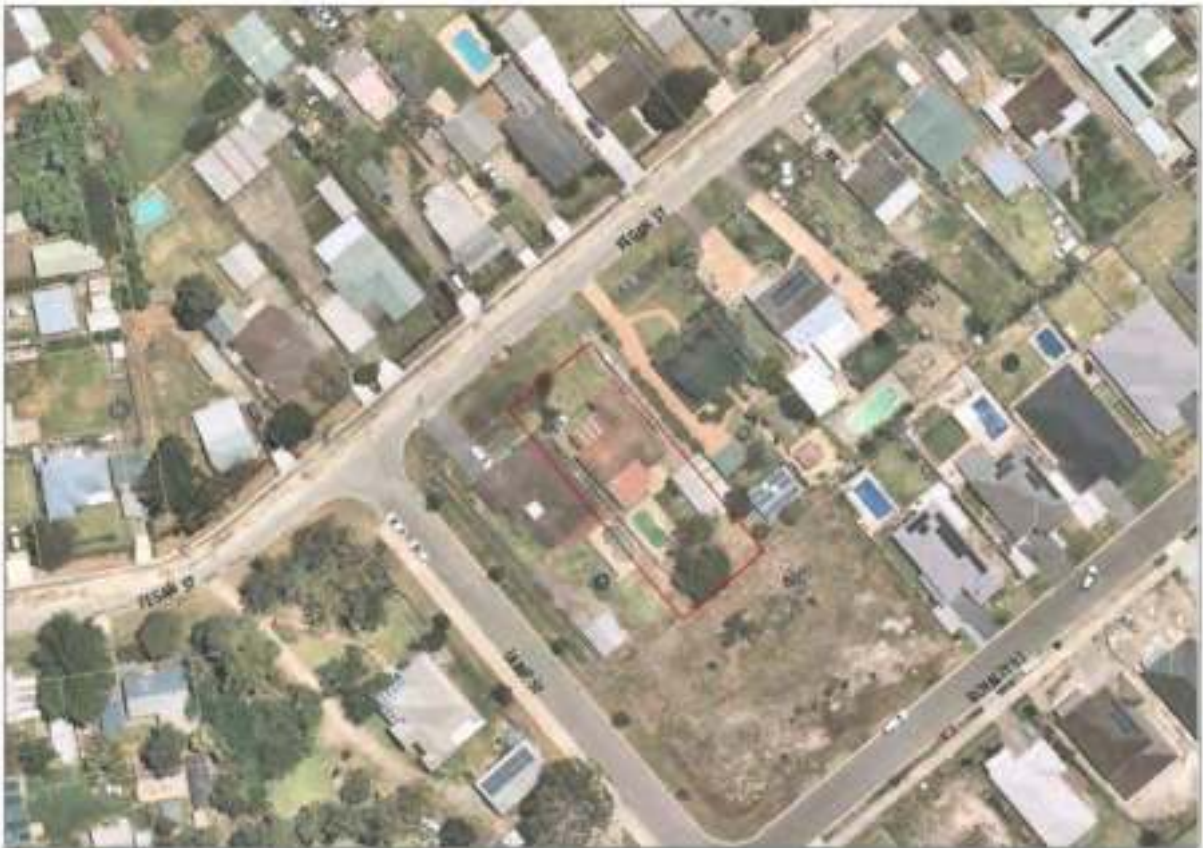
42 FEGAN STREET, WEST WALLSEND 2286

Conservation Area Contribution Level	Est. Construction Date	Previous studies and/or community input
Non-Contributory	Mid to late 20 th century onwards	No prior heritage assessments or research undertaken.
Assessment Text		Observed Modifications
<p>The scale (e.g. double-storey or greater) and general style of the dwelling is inconsistent with that of the streetscape and wider HCA.</p> <p>The dwelling does not contribute positively to the streetscape and wider HCA, particularly in comparison to Contributory 1 and 2 buildings. The presence of the building has an adverse impact on the streetscape and/or wider HCA.</p> <p>The dwelling features inappropriately proportioned and positioned fenestrations, an inappropriate roof form (gabled or hipped) and/or other features that are inconsistent with the architectural character of the area (e.g. unsympathetic additions, inconsistent [contemporary] building materials, etc).</p>		<p>The veranda space has been partially enclosed by timber balustrade and posts, both of which are a contemporary addition to the dwelling.</p>
