APPENDIX 2

Building Assessment Sheets (Inventory Sheets)

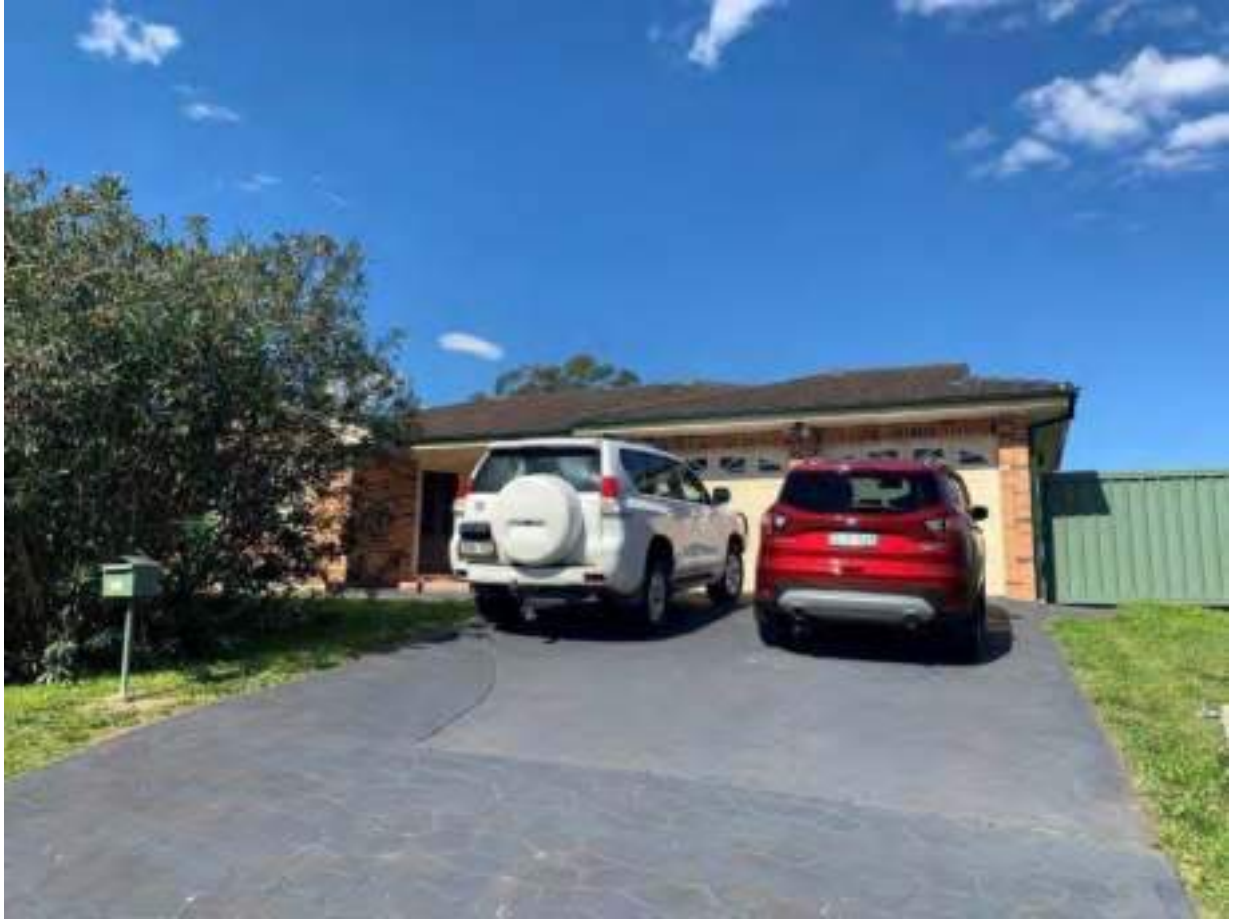
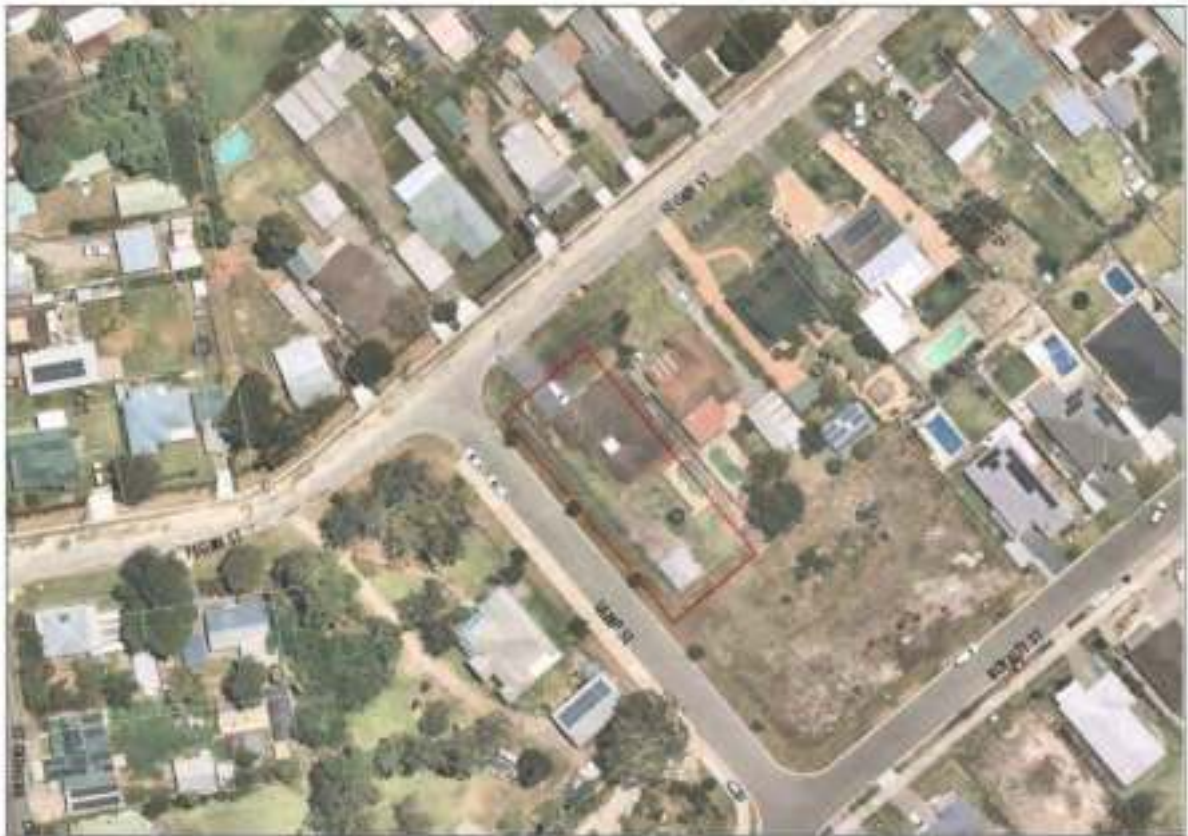
44 FEGAN STREET, WEST WALLSEND 2286

Conservation Area Contribution Level	Est. Construction Date	Previous studies and/or community input
Non-Contributory	Mid to late 20 th century onwards	No prior heritage assessments or research undertaken.
Assessment Text		Observed Modifications
<p>The scale (e.g. double-storey or greater) and general style of the dwelling is inconsistent with that of the streetscape and wider HCA.</p> <p>The dwelling does not contribute positively to the streetscape and wider HCA, particularly in comparison to Contributory 1 and 2 buildings. The presence of the building has an adverse impact on the streetscape and/or wider HCA.</p> <p>The dwelling features inappropriately proportioned and positioned fenestrations, an inappropriate roof form (gabled or hipped) and/or other features that are inconsistent with the architectural character of the area (e.g. unsympathetic additions, inconsistent [contemporary] building materials, etc).</p>		No modifications observed.

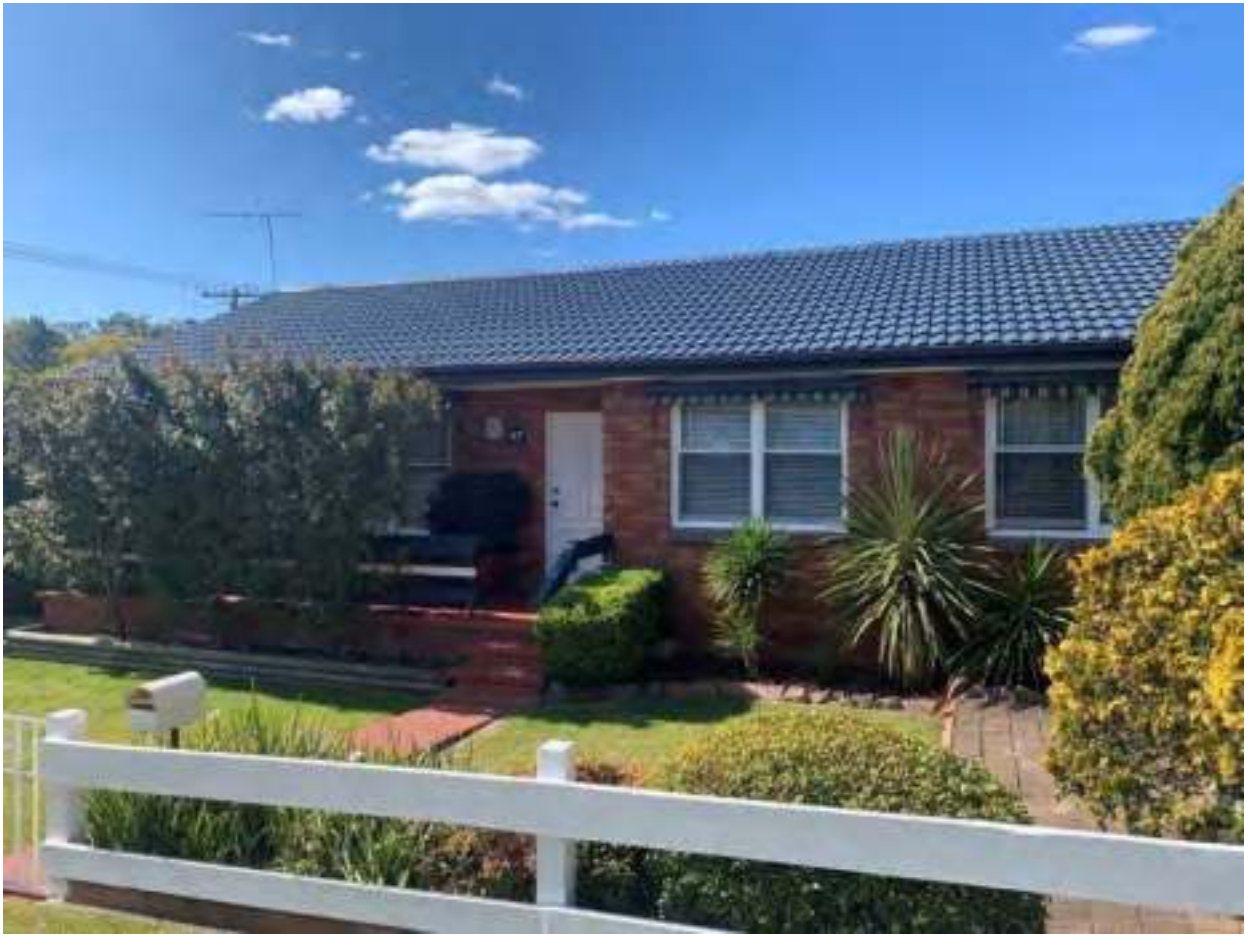
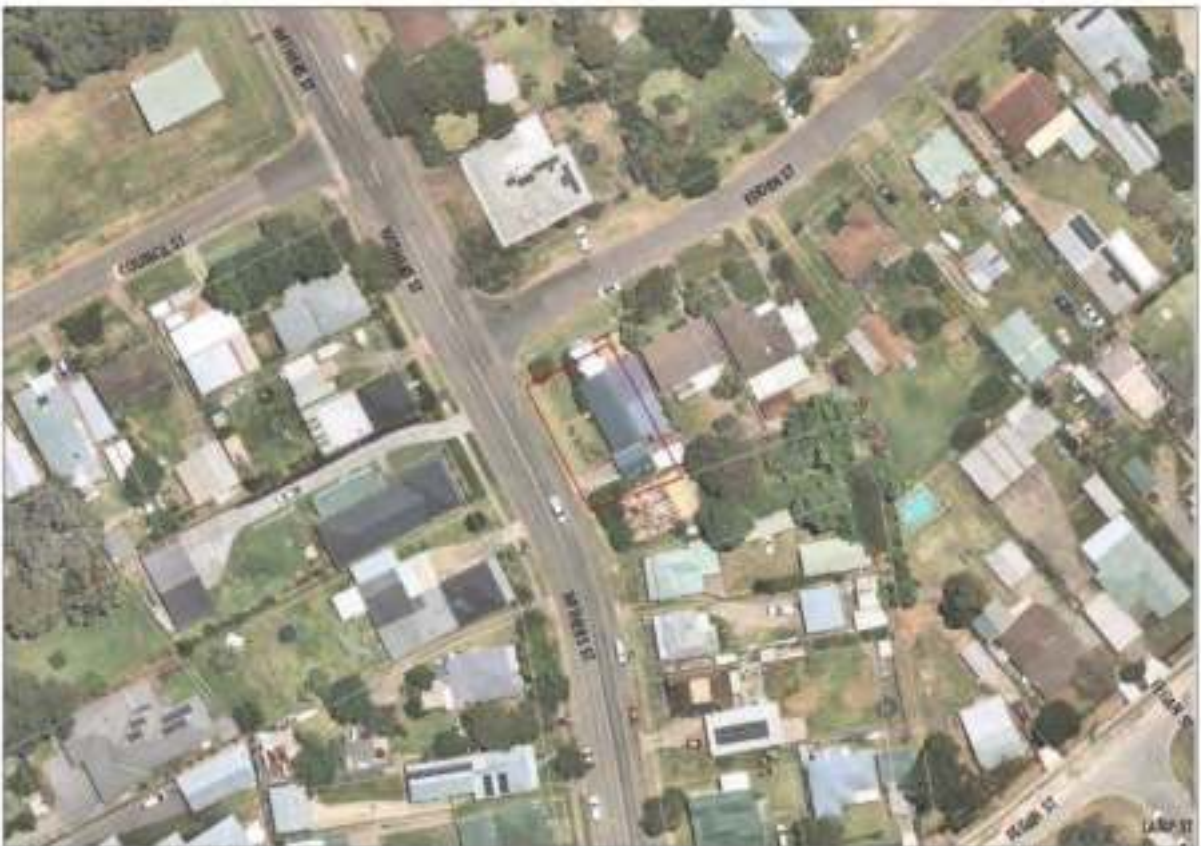
47 WITHERS STREET, WEST WALLSEND 2286

Conservation Area Contribution Level	Est. Construction Date	Previous studies and/or community input
Non-Contributory	Mid to late 20 th century onwards	No prior heritage assessments or research undertaken.
Assessment Text		Observed Modifications
<p>The scale (e.g. double-storey or greater) and general style of the dwelling is inconsistent with that of the streetscape and wider HCA.</p> <p>The dwelling does not contribute positively to the streetscape and wider HCA, particularly in comparison to Contributory 1 and 2 buildings. The presence of the building has an adverse impact on the streetscape and/or wider HCA.</p> <p>The dwelling features inappropriately proportioned and positioned fenestrations, an inappropriate roof form (gabled or hipped) and/or other features that are inconsistent with the architectural character of the area (e.g. unsympathetic additions, inconsistent [contemporary] building materials, etc).</p>		No modifications observed.

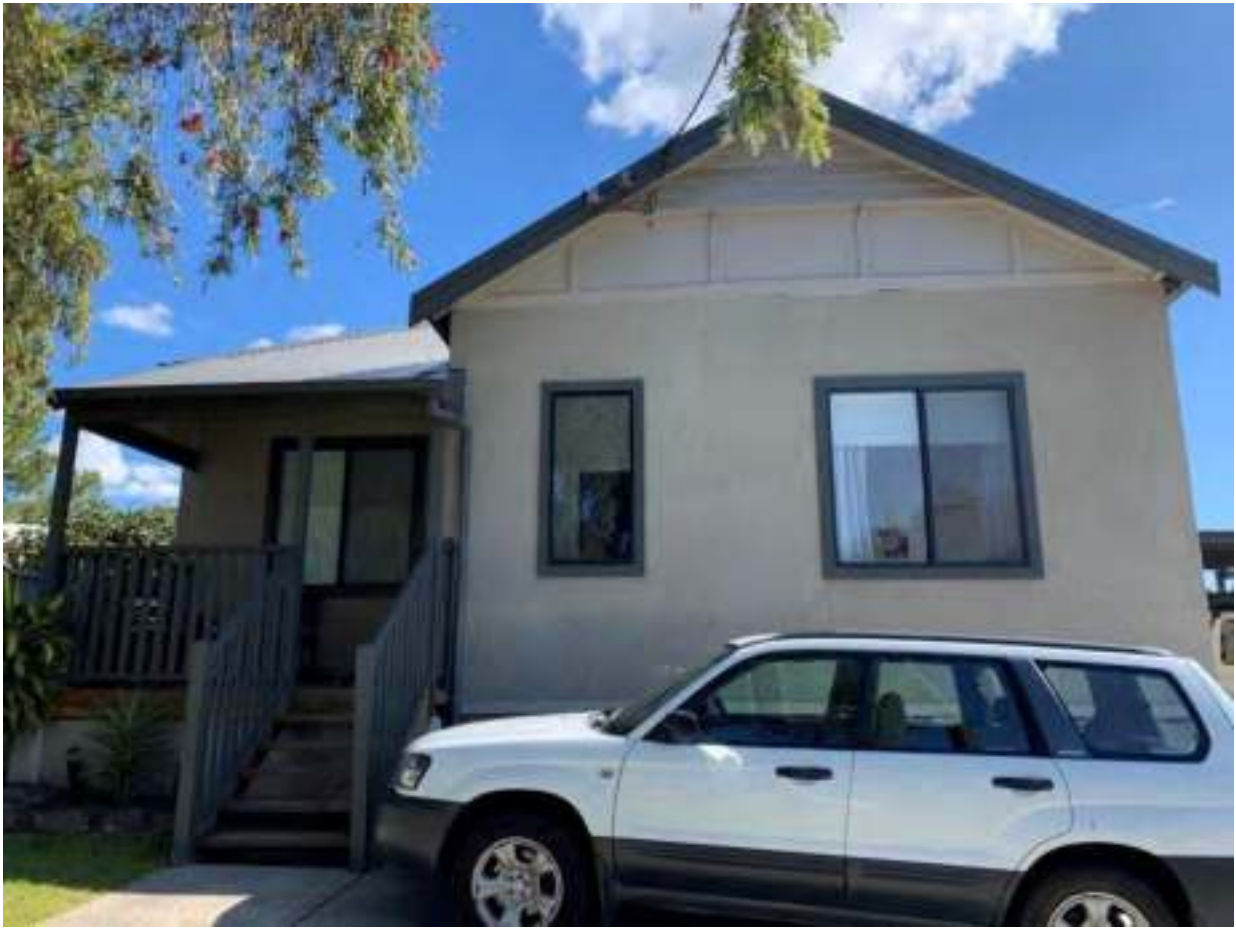
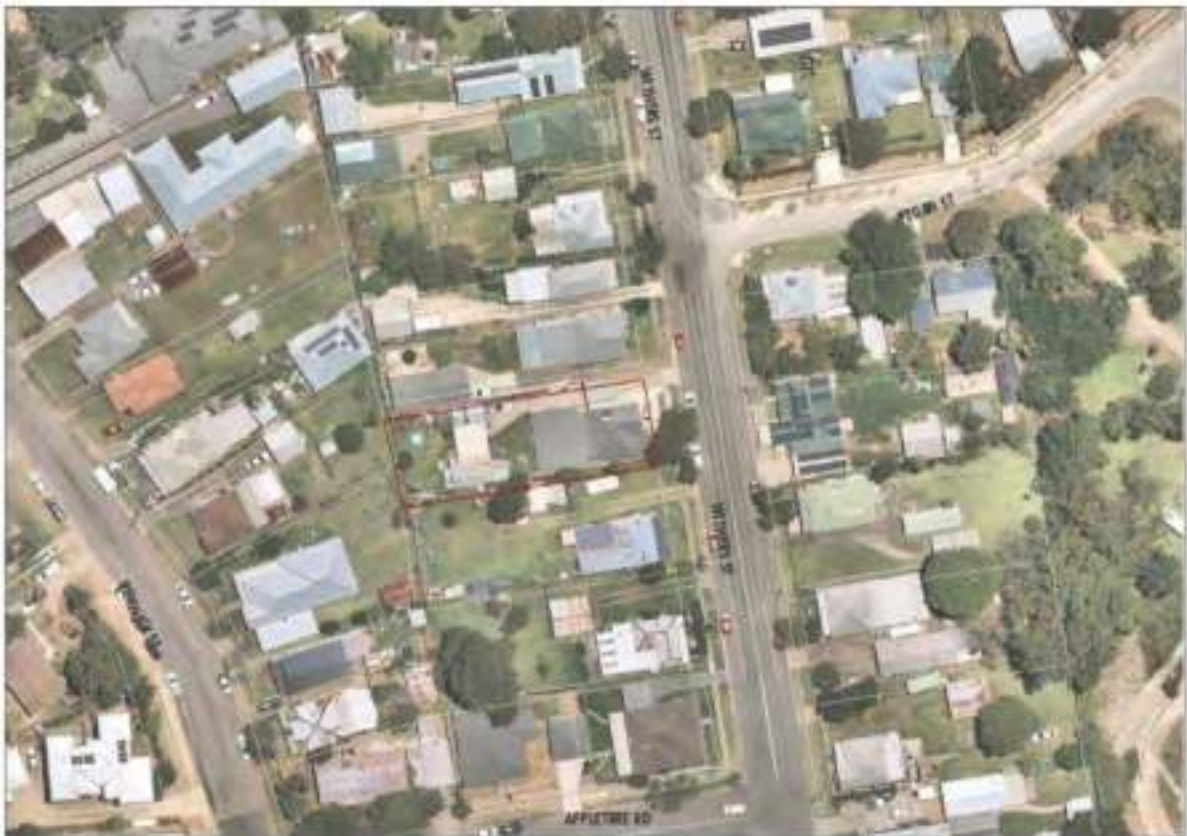
50 WITHERS STREET, WEST WALLSEND 2286

Conservation Area Contribution Level	Est. Construction Date	Previous studies and/or community input
Non-Contributory	Mid to late 20 th century onwards	No prior heritage assessments or research undertaken.
Assessment Text		Observed Modifications
<p>The scale (e.g. double-storey or greater) and general style of the dwelling is inconsistent with that of the streetscape and wider HCA.</p> <p>The dwelling does not contribute positively to the streetscape and wider HCA, particularly in comparison to Contributory 1 and 2 buildings. The presence of the building has an adverse impact on the streetscape and/or wider HCA.</p> <p>The dwelling features inappropriately proportioned and positioned fenestrations, an inappropriate roof form (gabled or hipped) and/or other features that are inconsistent with the architectural character of the area (e.g. unsympathetic additions, inconsistent [contemporary] building materials, etc).</p>		No modifications observed.

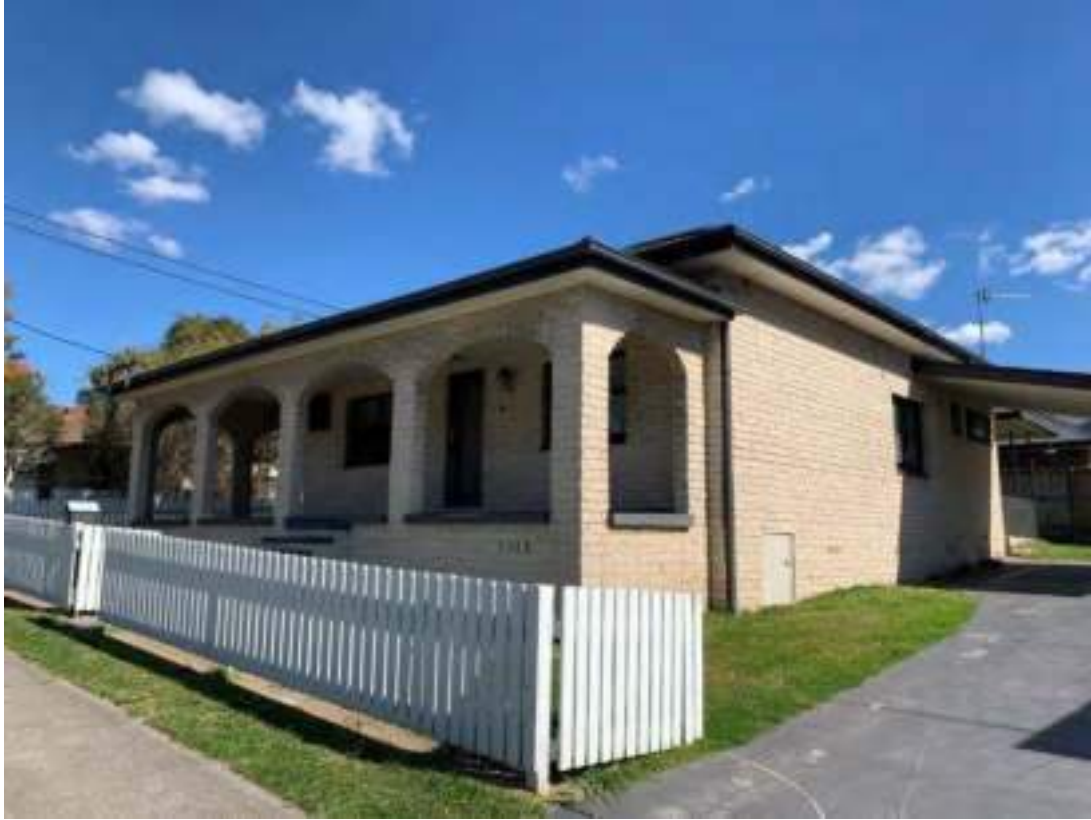
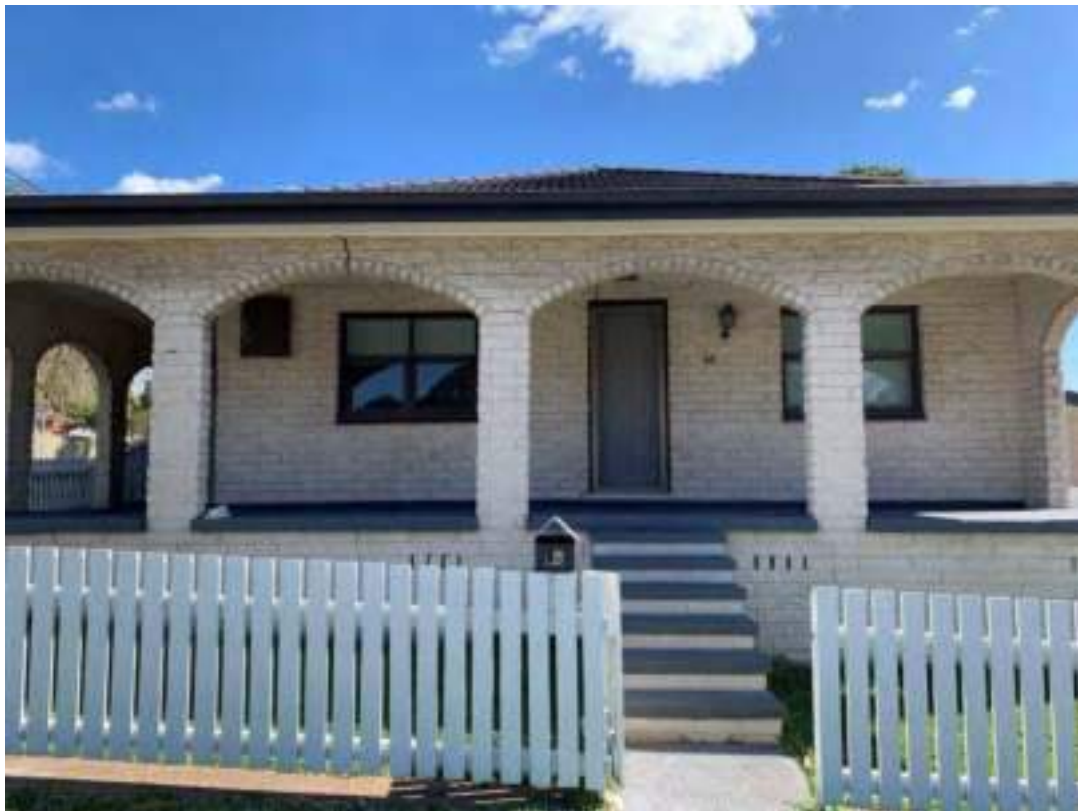
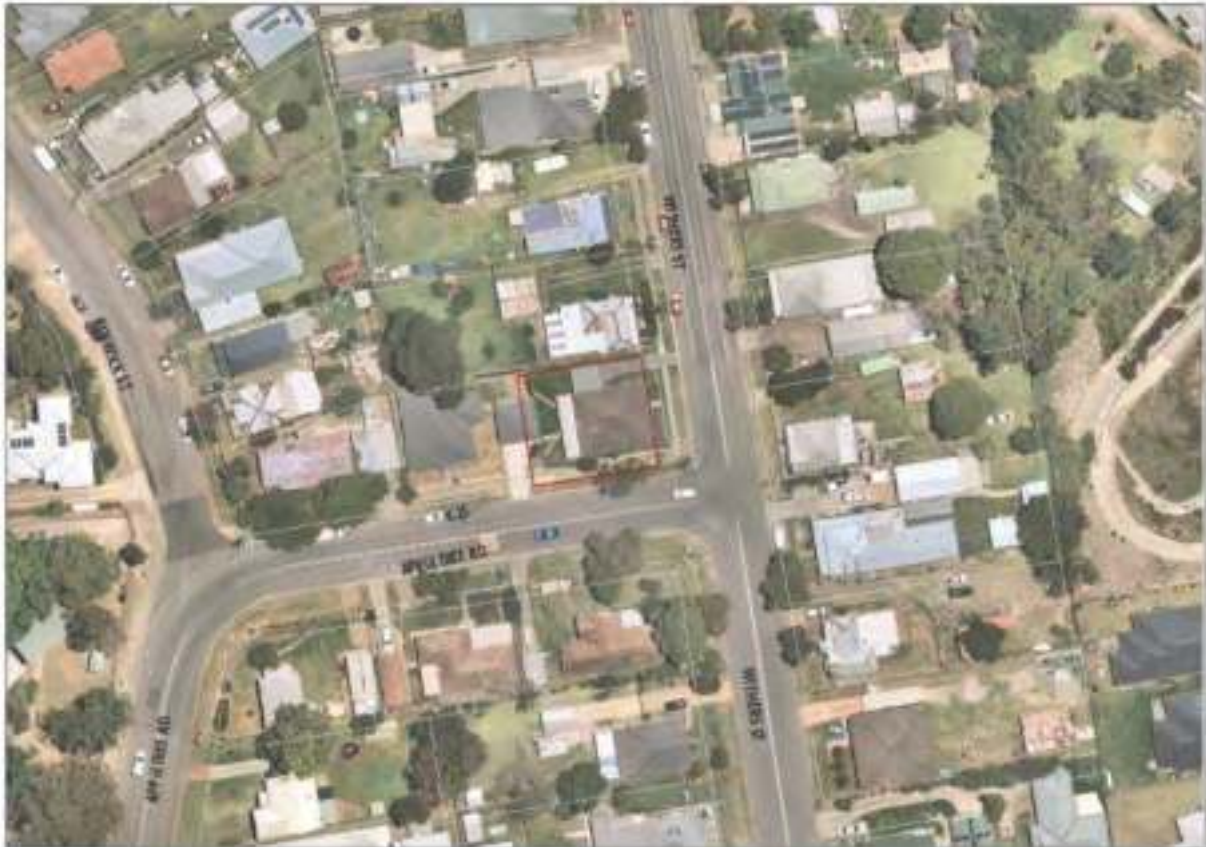
56 WITHERS STREET, WEST WALLSEND 2286

Conservation Area Contribution Level	Est. Construction Date	Previous studies and/or community input
Non-Contributory	Mid to late 20 th century onwards	No prior heritage assessments or research undertaken.
Assessment Text		Observed Modifications
<p>The scale (e.g. double-storey or greater) and general style of the dwelling is inconsistent with that of the streetscape and wider HCA.</p> <p>The dwelling does not contribute positively to the streetscape and wider HCA, particularly in comparison to Contributory 1 and 2 buildings. The presence of the building has an adverse impact on the streetscape and/or wider HCA.</p> <p>The dwelling features inappropriately proportioned and positioned fenestrations, an inappropriate roof form (gabled or hipped) and/or other features that are inconsistent with the architectural character of the area (e.g. unsympathetic additions, inconsistent [contemporary] building materials, etc).</p>		No modifications observed.

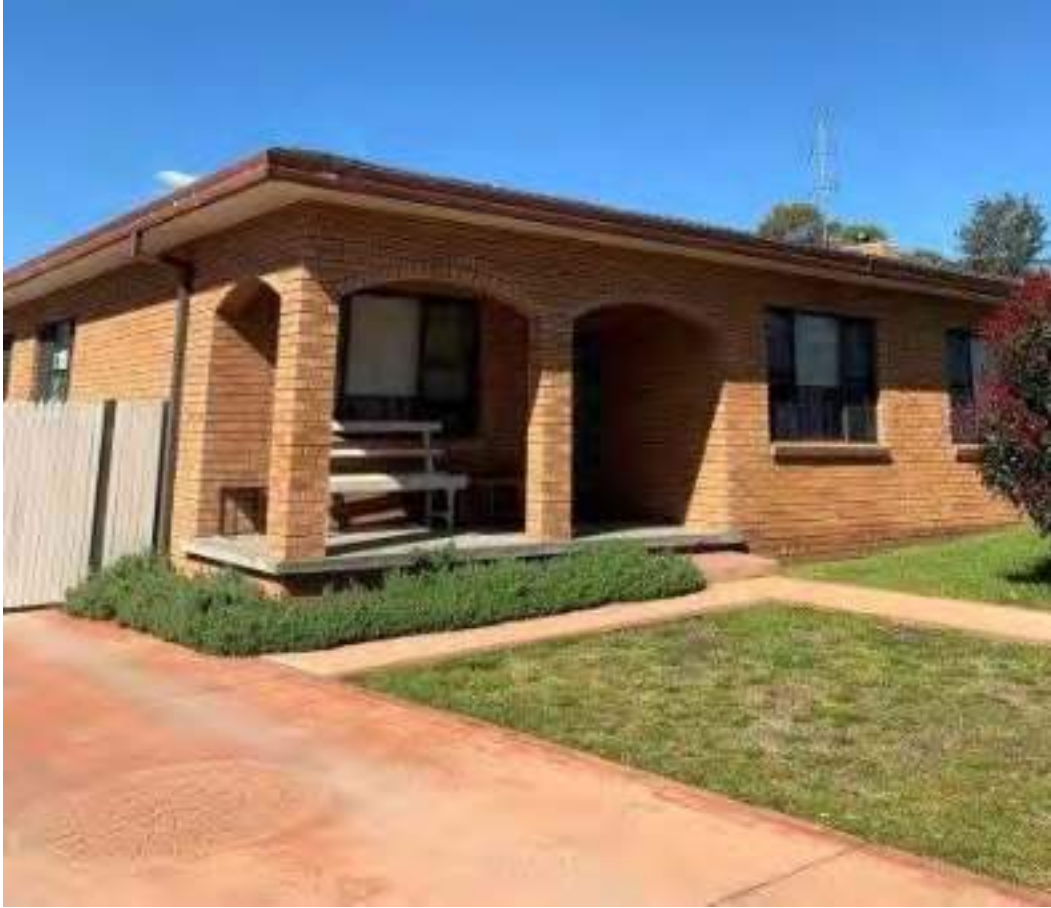
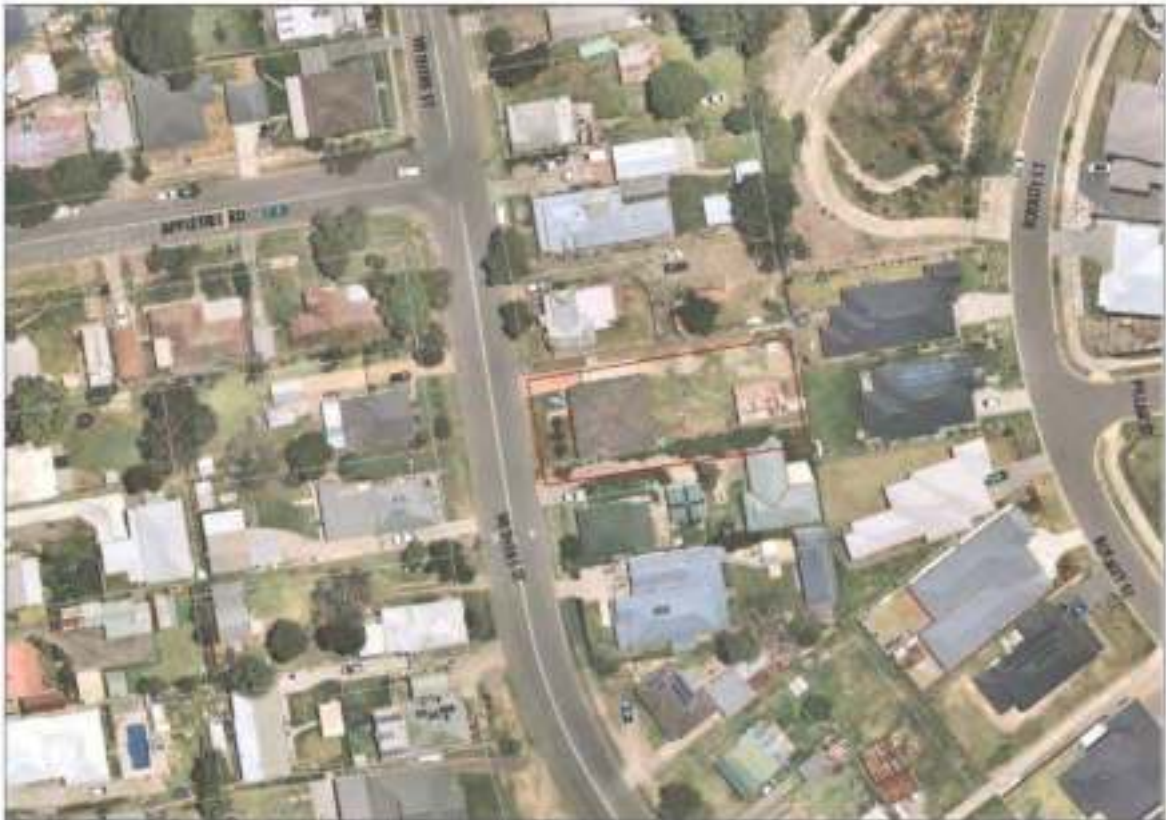
73 WITHERS STREET, WEST WALLSEND 2286

Conservation Area Contribution Level	Est. Construction Date	Previous studies and/or community input
Non-Contributory	Mid to late 20 th century onwards	No prior heritage assessments or research undertaken.
Assessment Text		Observed Modifications
<p>The scale (e.g. double-storey or greater) and general style of the dwelling is inconsistent with that of the streetscape and wider HCA.</p> <p>The dwelling does not contribute positively to the streetscape and wider HCA, particularly in comparison to Contributory 1 and 2 buildings. The presence of the building has an adverse impact on the streetscape and/or wider HCA.</p> <p>The dwelling features inappropriately proportioned and positioned fenestrations, an inappropriate roof form (gabled or hipped) and/or other features that are inconsistent with the architectural character of the area (e.g. unsympathetic additions, inconsistent [contemporary] building materials, etc).</p>		No modifications observed.

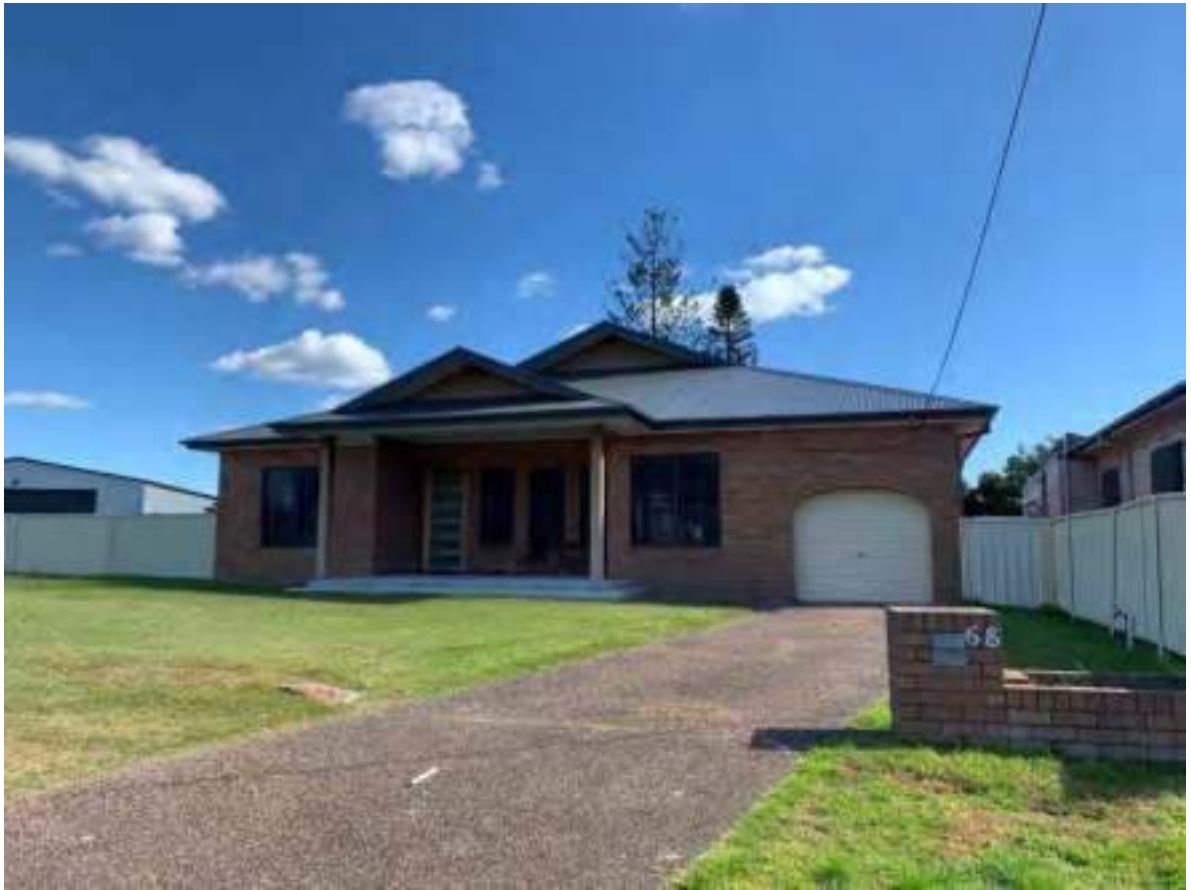
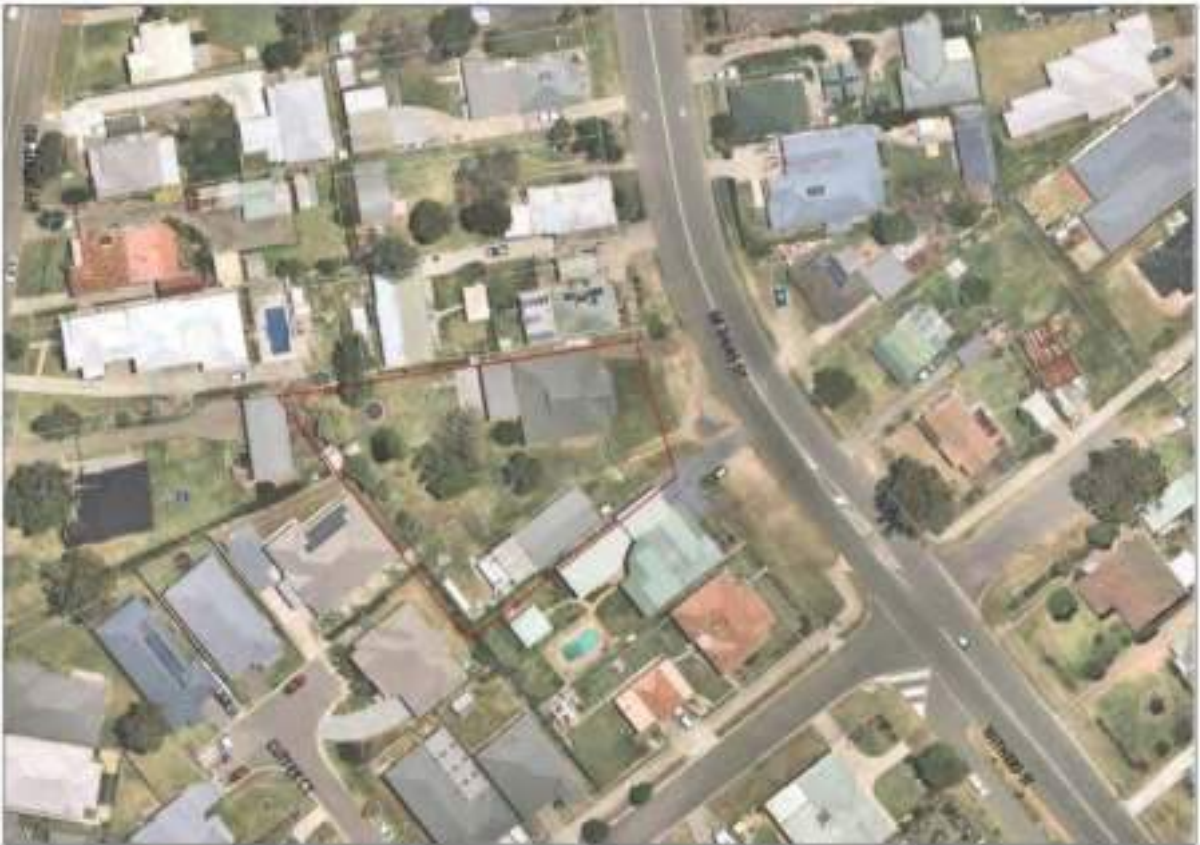
68 WITHERS STREET , WEST WALLSEND 2286

Conservation Area Contribution Level	Est. Construction Date	Previous studies and/or community input
Non-Contributory	Mid to late 20 th century onwards	No prior heritage assessments or research undertaken.
Assessment Text		Observed Modifications
<p>The scale (e.g. double-storey or greater) and general style of the dwelling is inconsistent with that of the streetscape and wider HCA.</p> <p>The dwelling does not contribute positively to the streetscape and wider HCA, particularly in comparison to Contributory 1 and 2 buildings. The presence of the building has an adverse impact on the streetscape and/or wider HCA.</p> <p>The dwelling features inappropriately proportioned and positioned fenestrations, an inappropriate roof form (gabled or hipped) and/or other features that are inconsistent with the architectural character of the area (e.g. unsympathetic additions, inconsistent [contemporary] building materials, etc).</p>		No modifications observed.

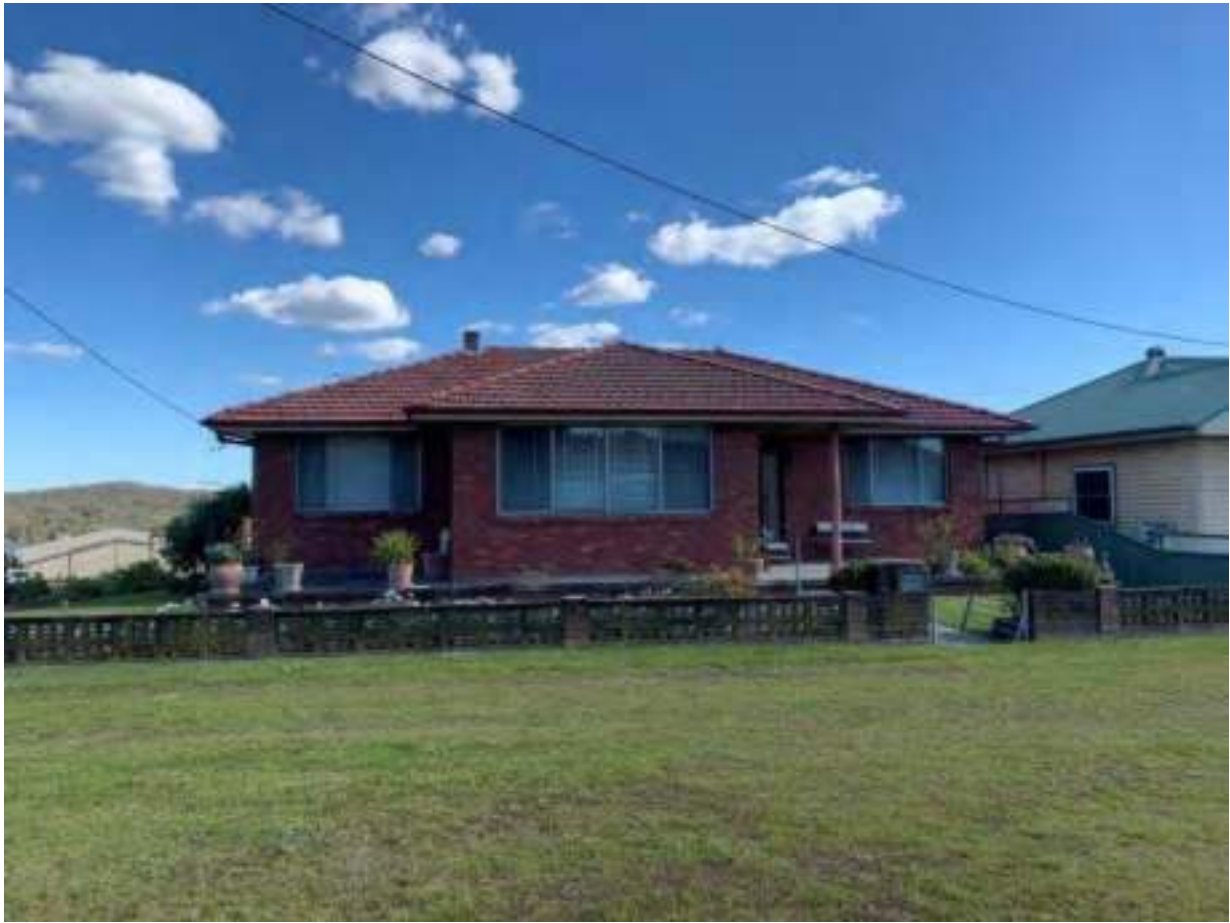
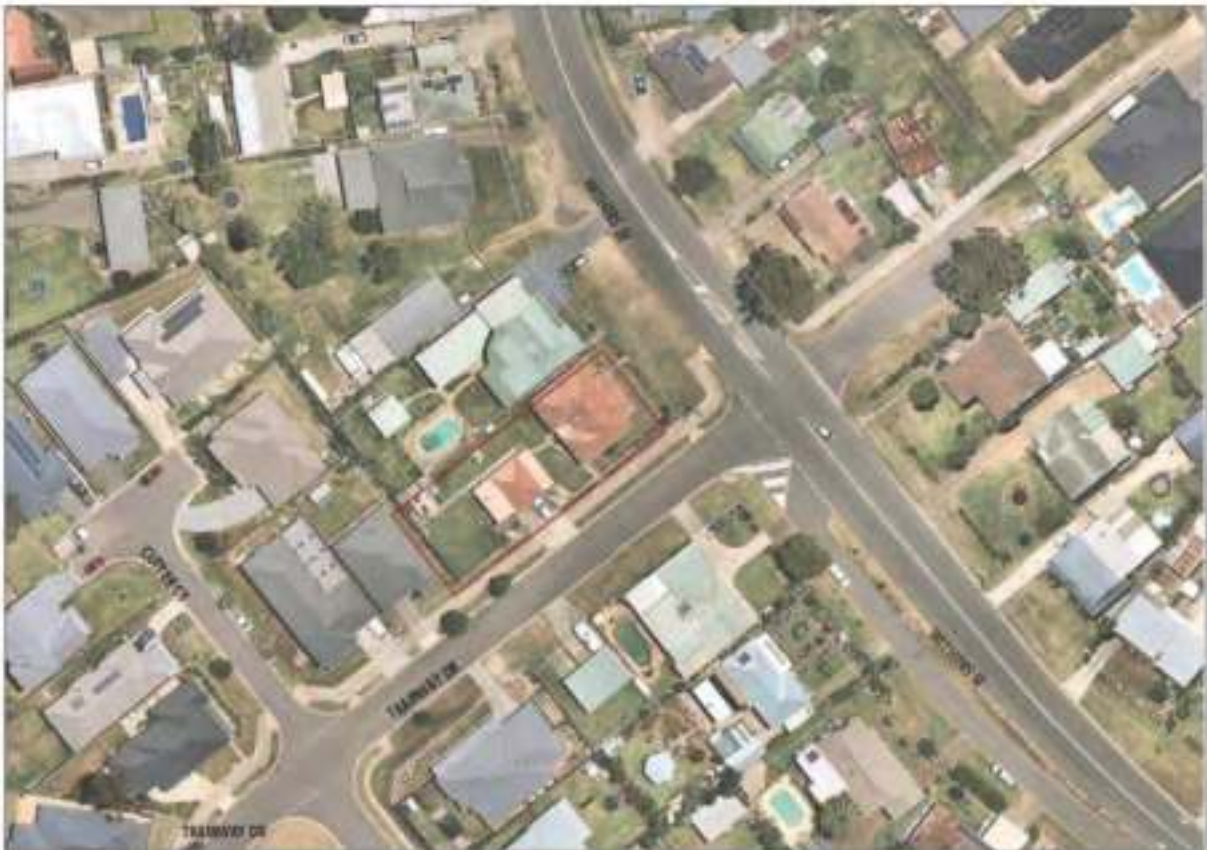
72 WITHERS STREET, WEST WALLSEND 2286

Conservation Area Contribution Level	Est. Construction Date	Previous studies and/or community input
Non-Contributory	Mid to late 20 th century onwards	No prior heritage assessments or research undertaken.
Assessment Text		Observed Modifications
<p>The scale (e.g. double-storey or greater) and general style of the dwelling is inconsistent with that of the streetscape and wider HCA.</p> <p>The dwelling does not contribute positively to the streetscape and wider HCA, particularly in comparison to Contributory 1 and 2 buildings. The presence of the building has an adverse impact on the streetscape and/or wider HCA.</p> <p>The dwelling features inappropriately proportioned and positioned fenestrations, an inappropriate roof form (gabled or hipped) and/or other features that are inconsistent with the architectural character of the area (e.g. unsympathetic additions, inconsistent [contemporary] building materials, etc).</p>		No modifications observed.

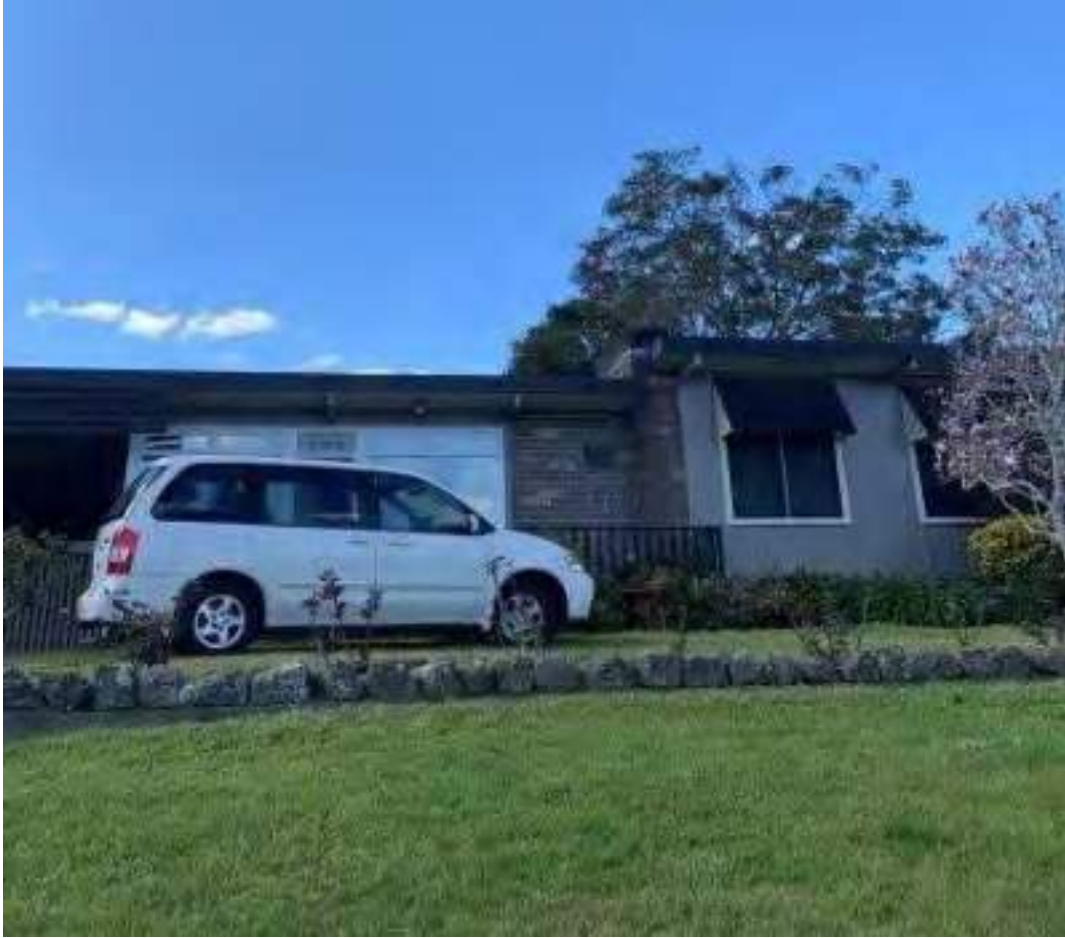
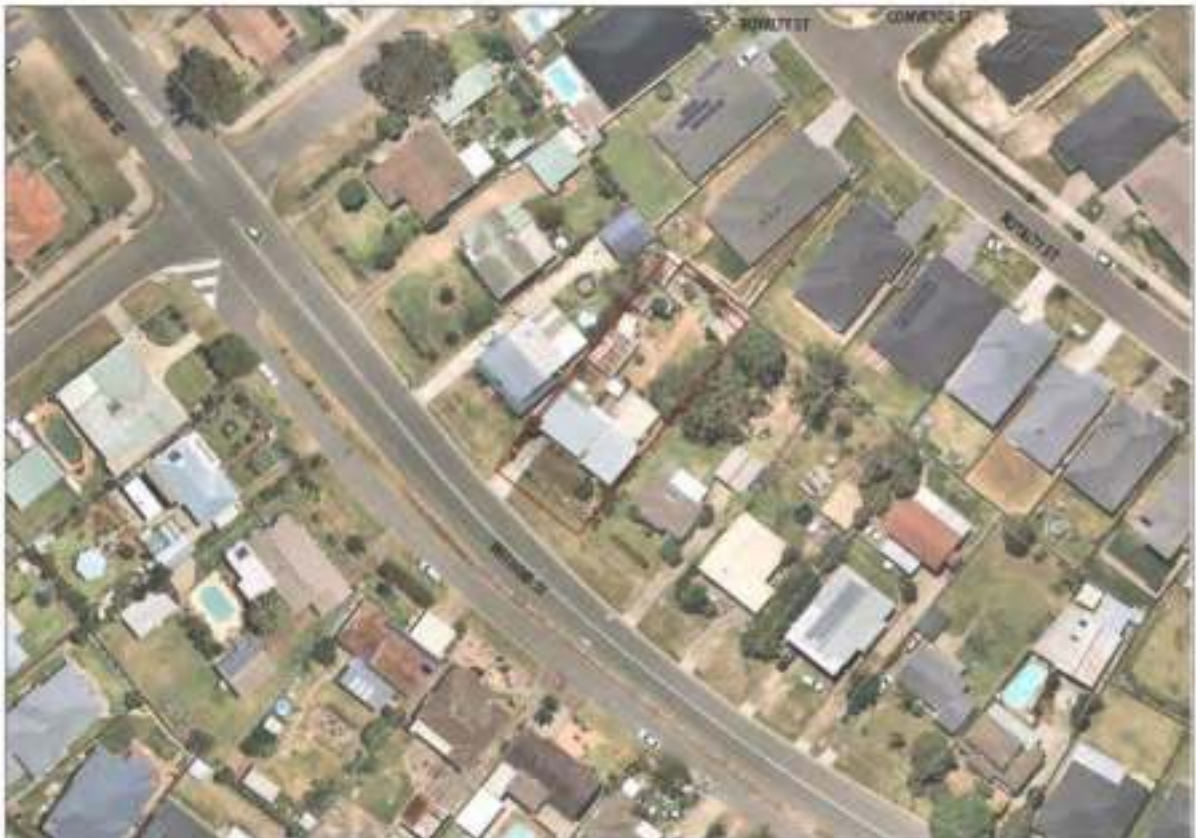
91 WITHERS STREET, WEST WALLSEND 2286

Conservation Area Contribution Level	Est. Construction Date	Previous studies and/or community input
Non-Contributory	Mid to late 20 th century onwards	No prior heritage assessments or research undertaken.
Assessment Text		Observed Modifications
<p>The scale (e.g. double-storey or greater) and general style of the dwelling is inconsistent with that of the streetscape and wider HCA.</p> <p>The dwelling does not contribute positively to the streetscape and wider HCA, particularly in comparison to Contributory 1 and 2 buildings. The presence of the building has an adverse impact on the streetscape and/or wider HCA.</p> <p>The dwelling features inappropriately proportioned and positioned fenestrations, an inappropriate roof form (gabled or hipped) and/or other features that are inconsistent with the architectural character of the area (e.g. unsympathetic additions, inconsistent [contemporary] building materials, etc).</p>		<p>The eastern portion of the dwelling is likely a dated extension, with a differential façade and material type.</p>

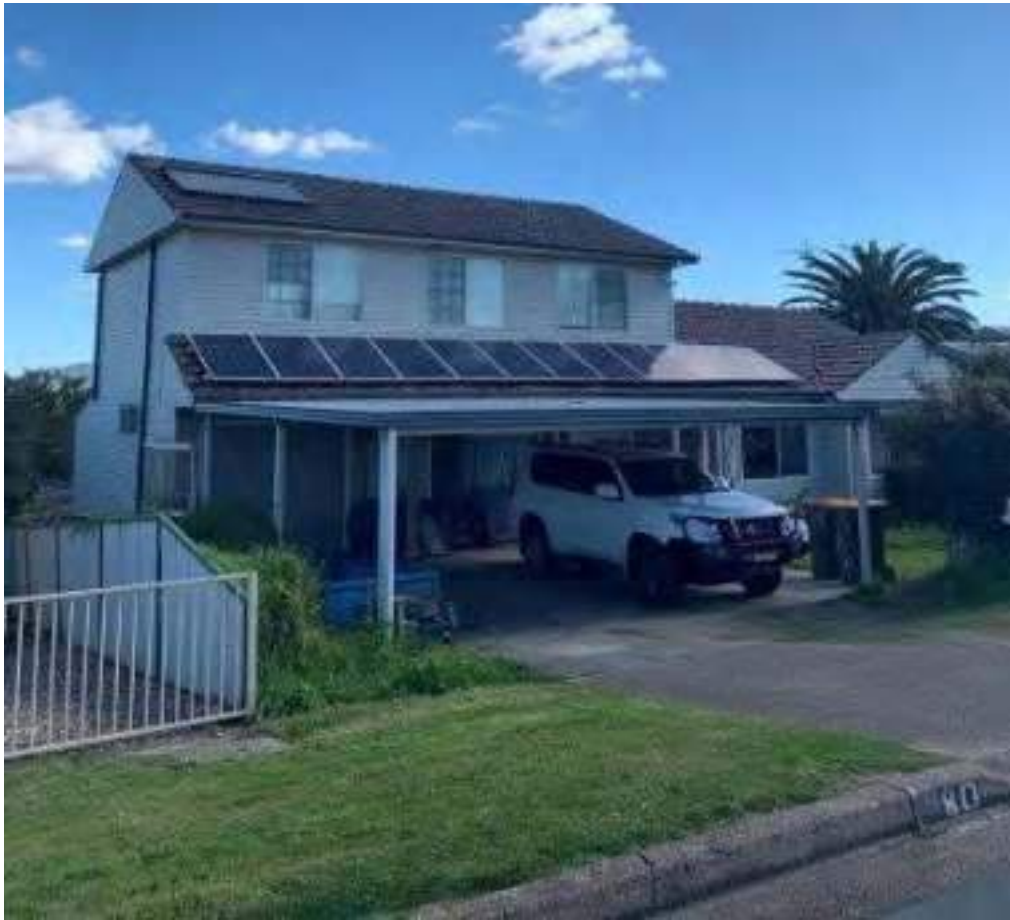
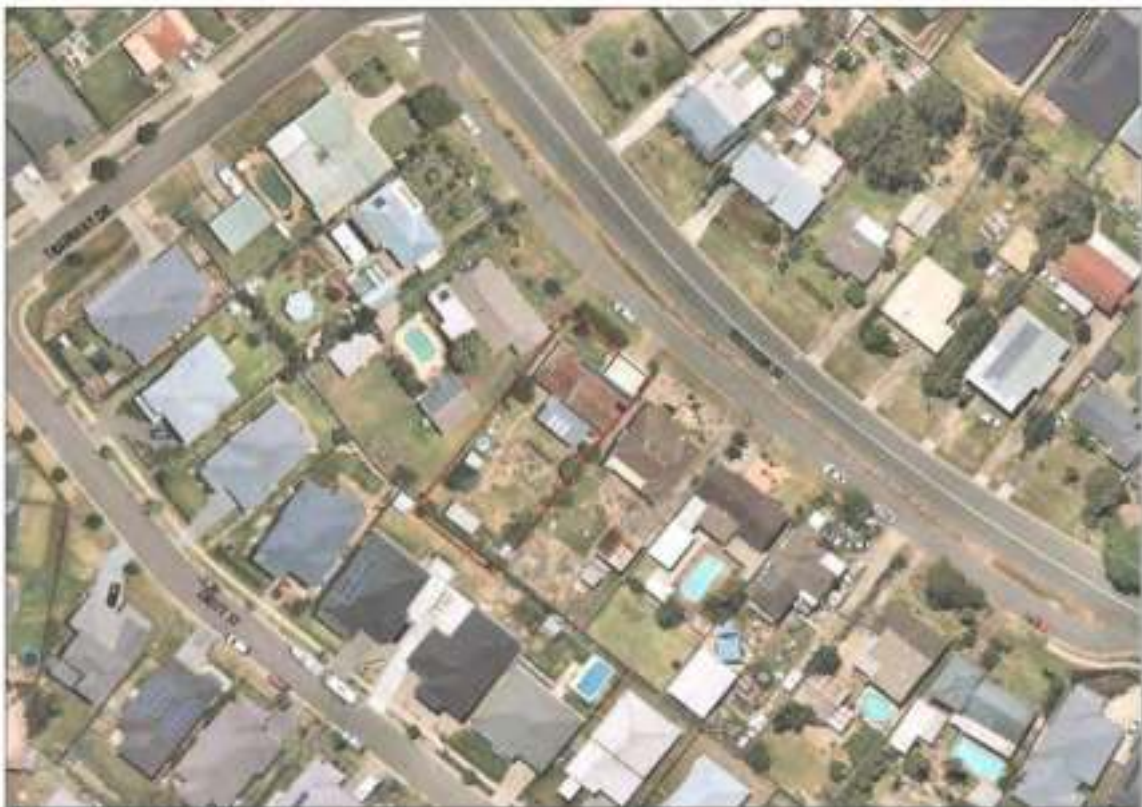
80 WITHERS STREET, WEST WALLSEND 2286		
Conservation Area Contribution Level	Est. Construction Date	Previous studies and/or community input
Non-Contributory	Mid to late 20 th century onwards	No prior heritage assessments or research undertaken.
Assessment Text		Observed Modifications
<p>The scale (e.g. double-storey or greater) and general style of the dwelling is inconsistent with that of the streetscape and wider HCA.</p> <p>The dwelling does not contribute positively to the streetscape and wider HCA, particularly in comparison to Contributory 1 and 2 buildings. The presence of the building has an adverse impact on the streetscape and/or wider HCA.</p> <p>The dwelling features inappropriately proportioned and positioned fenestrations, an inappropriate roof form (gabled or hipped) and/or other features that are inconsistent with the architectural character of the area (e.g. unsympathetic additions, inconsistent [contemporary] building materials, etc).</p>		<p>Solar panels are highly visible along the northern portion of the dwelling.</p> <p>A carport has been constructed at the front northern side of the dwelling.</p>
