APPENDIX 2

Building Assessment Sheets (Inventory Sheets)

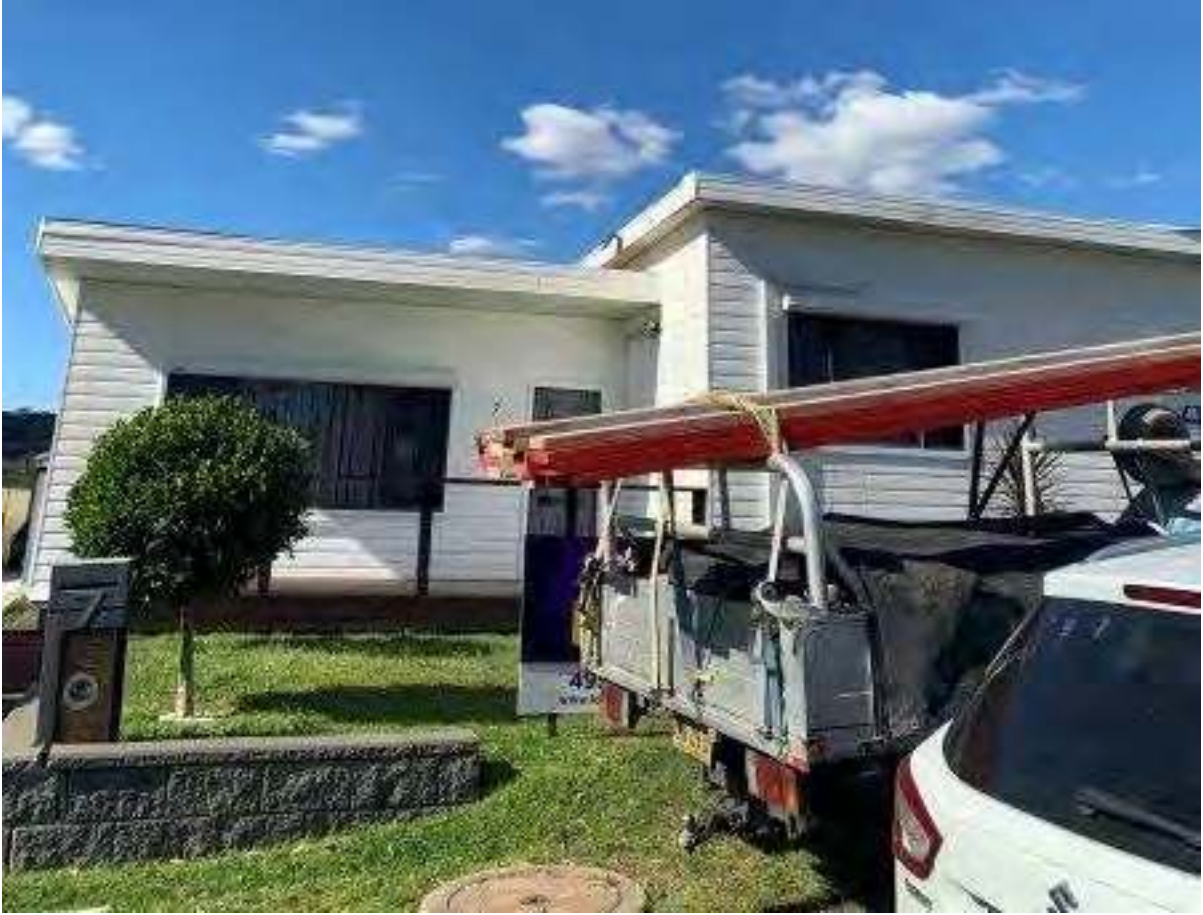
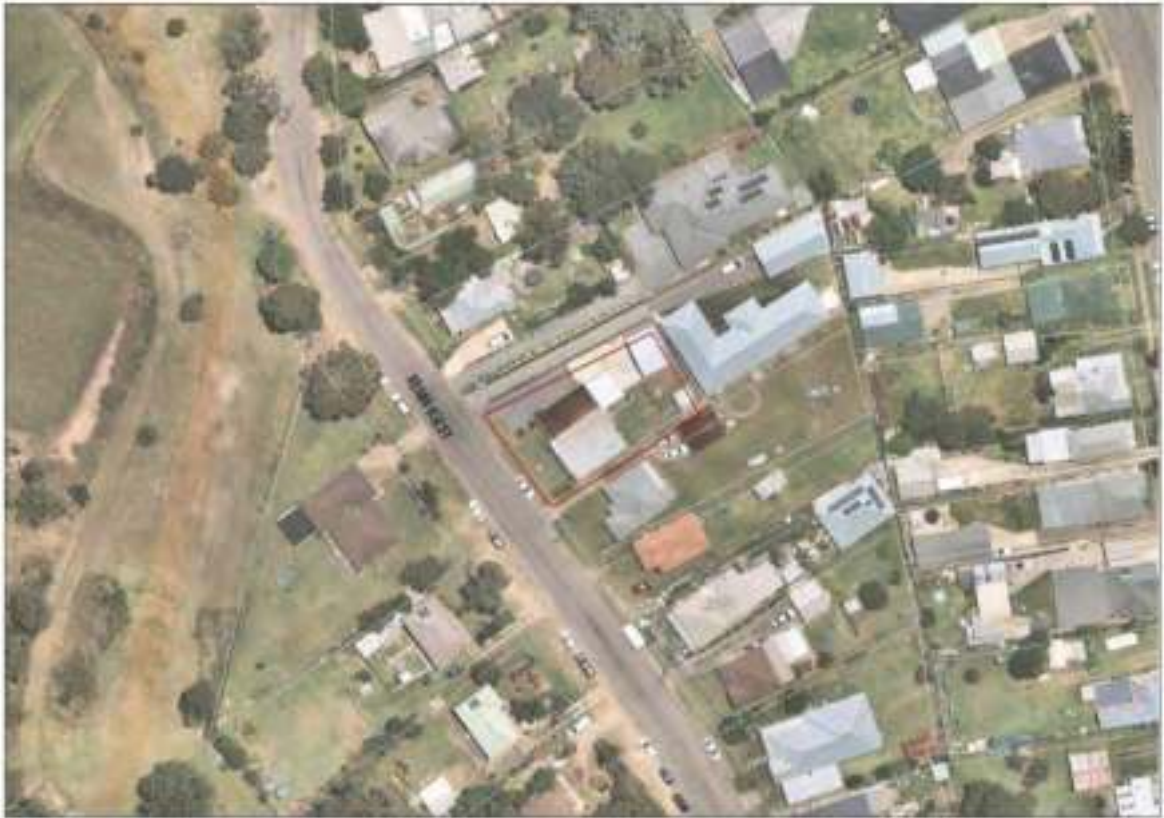
7 RENWICK STREET, WEST WALLSEND 2286		
Conservation Area Contribution Level	Est. Construction Date	Previous studies and/or community input
Non-Contributory	Mid to late 20th century onwards	No prior heritage assessments or research undertaken.
Assessment Text		Observed Modifications
<p>The scale (e.g. double-storey or greater) and general style of the dwelling is inconsistent with that of the streetscape and wider HCA.</p> <p>The dwelling does not contribute positively to the streetscape and wider HCA, particularly in comparison to Contributory 1 and 2 buildings. The presence of the building has an adverse impact on the streetscape and/or wider HCA.</p> <p>The dwelling features inappropriately proportioned and positioned fenestrations, an inappropriate roof form (gabled or hipped) and/or other features that are inconsistent with the architectural character of the area (e.g. unsympathetic additions, inconsistent [contemporary] building materials, etc).</p>		<p>Metal roller shutters have been installed a top the façade windows.</p> <p>A veranda extension has been constructed at the front eastern side of the dwelling, with a timber and metal wire balustrade.</p>

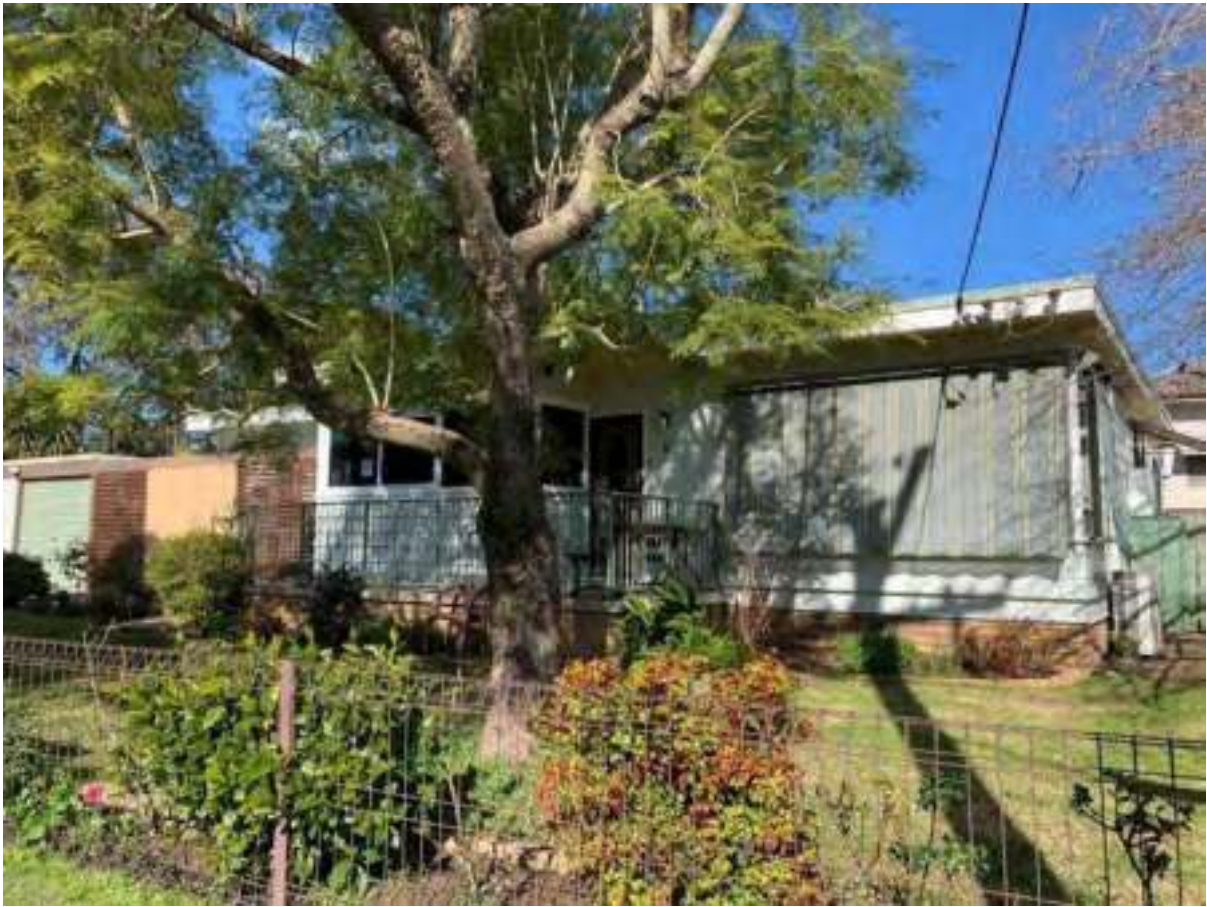
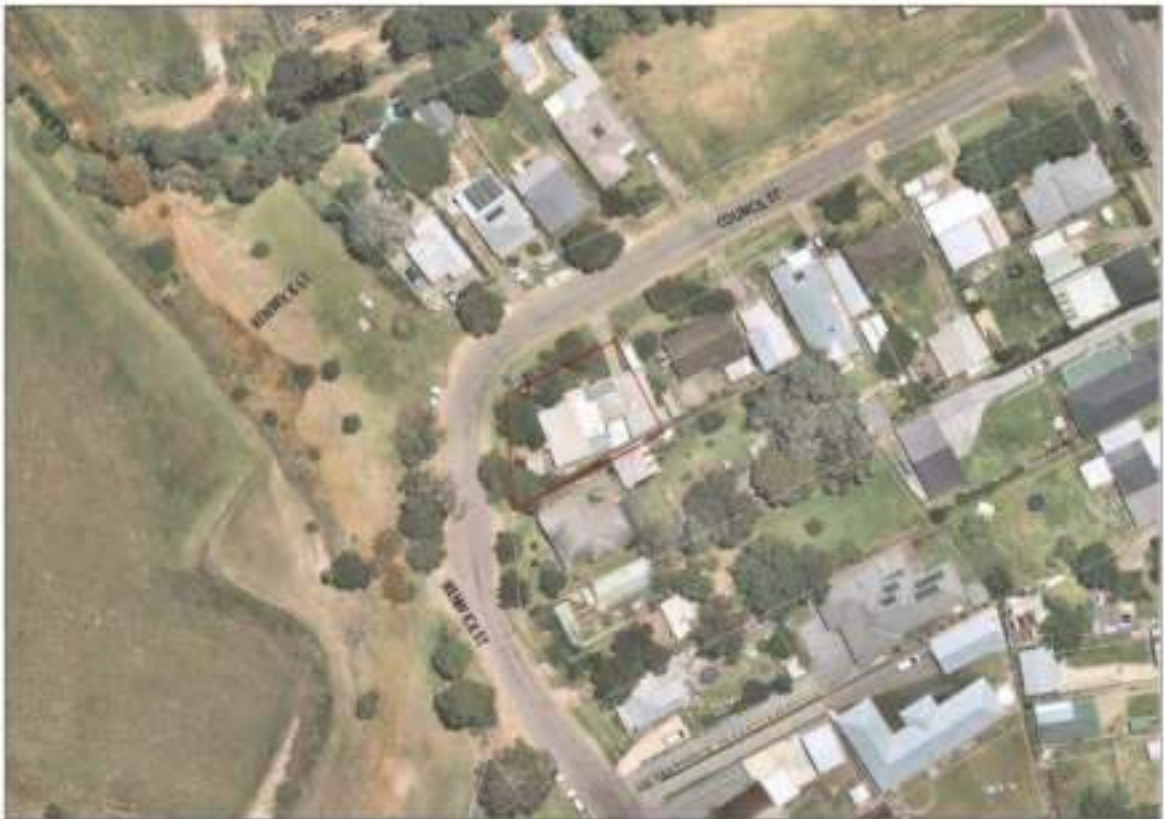
6 COUNCIL STREET, WEST WALLSEND 2286

Conservation Area Contribution Level	Est. Construction Date	Previous studies and/or community input
Non-Contributory	Mid to late 20 th century onwards	No prior heritage assessments or research undertaken.
Assessment Text		Observed Modifications
<p>The scale (e.g. double-storey or greater) and general style of the dwelling is inconsistent with that of the streetscape and wider HCA.</p> <p>The dwelling does not contribute positively to the streetscape and wider HCA, particularly in comparison to Contributory 1 and 2 buildings. The presence of the building has an adverse impact on the streetscape and/or wider HCA.</p> <p>The dwelling features inappropriately proportioned and positioned fenestrations, an inappropriate roof form (gabled or hipped) and/or other features that are inconsistent with the architectural character of the area (e.g. unsympathetic additions, inconsistent [contemporary] building materials, etc).</p>		<p>The metal balustrade partially enclosing the veranda is a contemporary addition, although dated in design.</p> <p>Timber panel screening has been installed along the eastern side of the dwelling.</p>

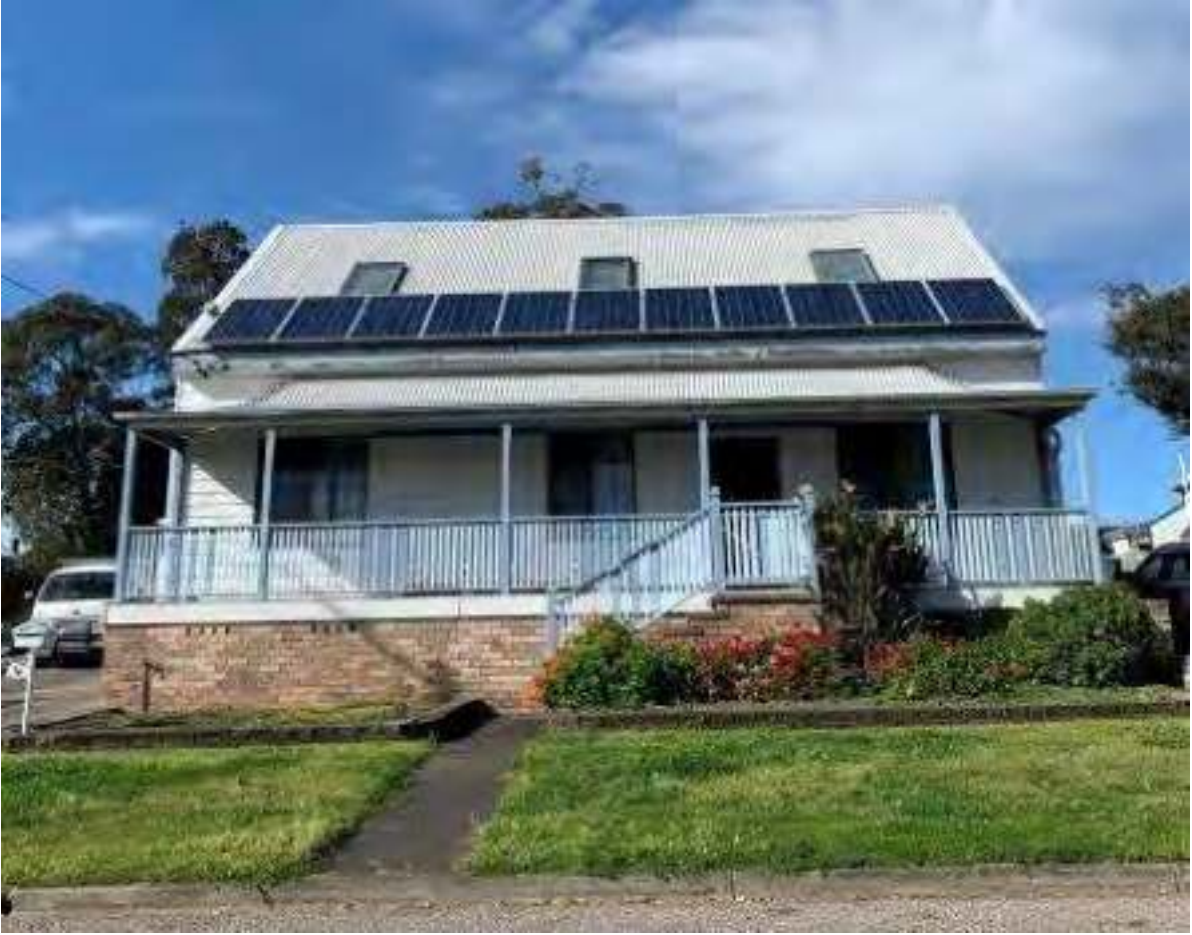
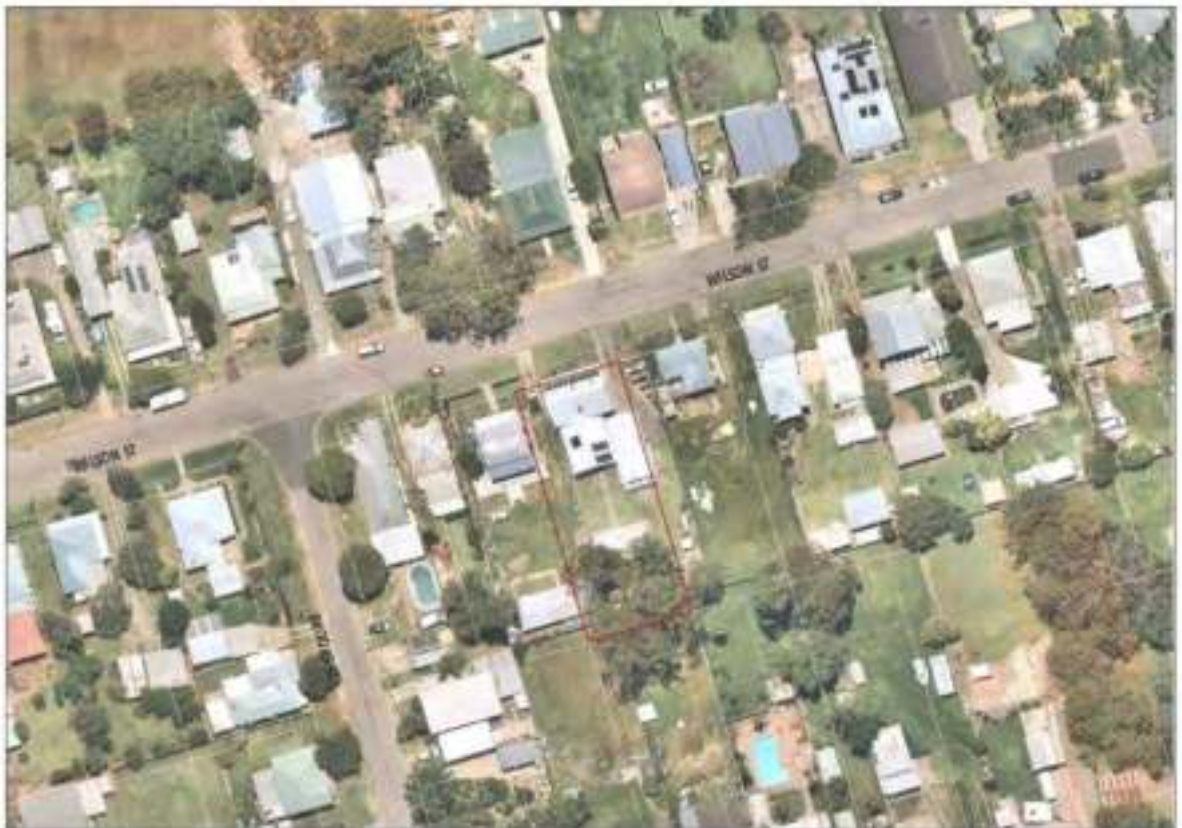
14 WILSON STREET, WEST WALLSEND 2286

Conservation Area Contribution Level	Est. Construction Date	Previous studies and/or community input
Non-Contributory	Mid to late 20 th century onwards	No prior heritage assessments or research undertaken.
Assessment Text		Observed Modifications
<p>The scale (e.g. double-storey or greater) and general style of the dwelling is inconsistent with that of the streetscape and wider HCA.</p> <p>The dwelling does not contribute positively to the streetscape and wider HCA, particularly in comparison to Contributory 1 and 2 buildings. The presence of the building has an adverse impact on the streetscape and/or wider HCA.</p> <p>The dwelling features inappropriately proportioned and positioned fenestrations, an inappropriate roof form (gabled or hipped) and/or other features that are inconsistent with the architectural character of the area (e.g. unsympathetic additions, inconsistent [contemporary] building materials, etc).</p>		Solar panels are highly visible along the northern portion of the roof.

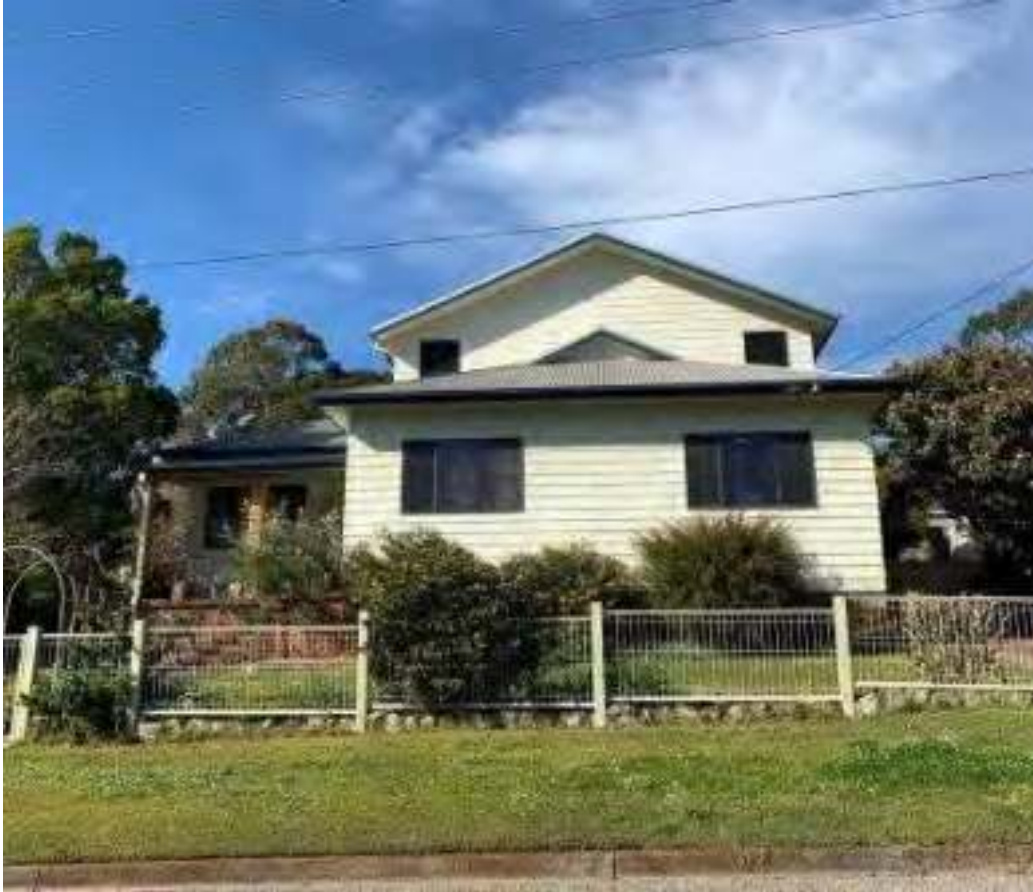
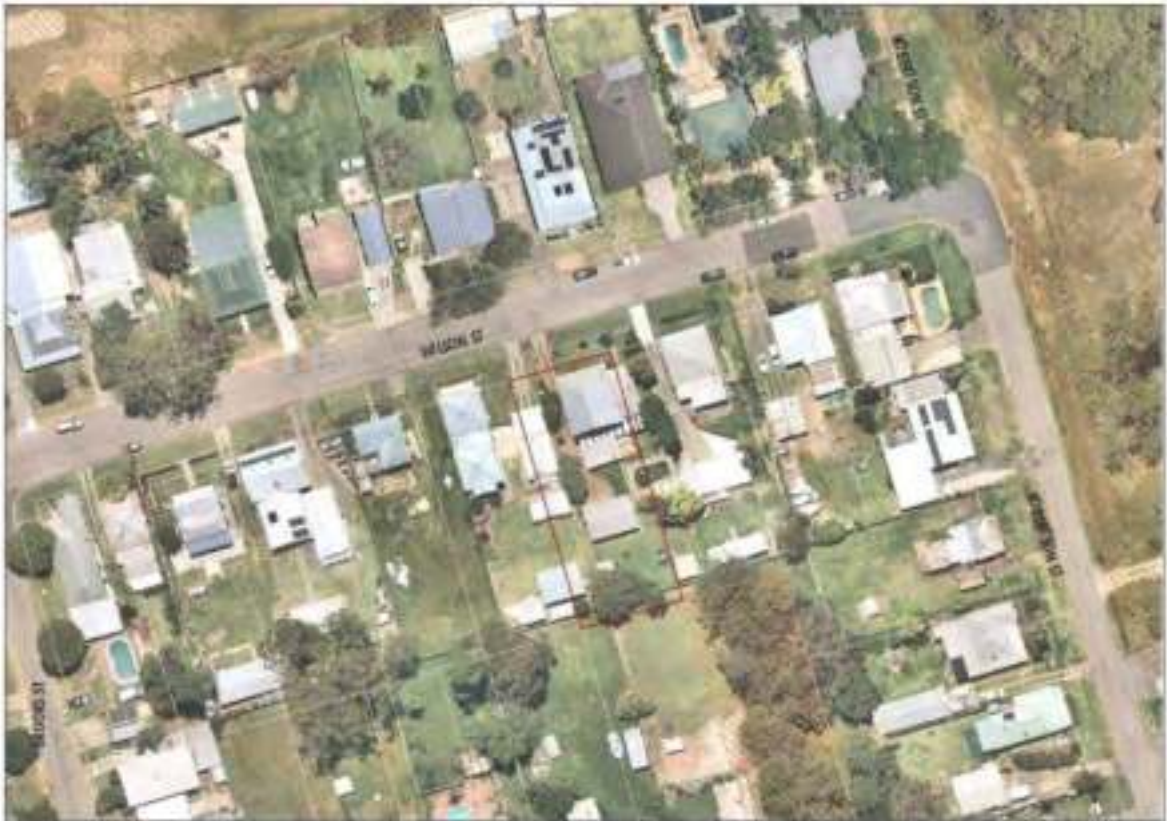
8 WILSON STREET, WEST WALLSEND 2286

Conservation Area Contribution Level	Est. Construction Date	Previous studies and/or community input
Non-Contributory	Mid to late 20 th century onwards	No prior heritage assessments or research undertaken.
Assessment Text		Observed Modifications
<p>The scale (e.g. double-storey or greater) and general style of the dwelling is inconsistent with that of the streetscape and wider HCA.</p> <p>The dwelling does not contribute positively to the streetscape and wider HCA, particularly in comparison to Contributory 1 and 2 buildings. The presence of the building has an adverse impact on the streetscape and/or wider HCA.</p> <p>The dwelling features inappropriately proportioned and positioned fenestrations, an inappropriate roof form (gabled or hipped) and/or other features that are inconsistent with the architectural character of the area (e.g. unsympathetic additions, inconsistent [contemporary] building materials, etc).</p>		<p>The second storey is a contemporary addition.</p>

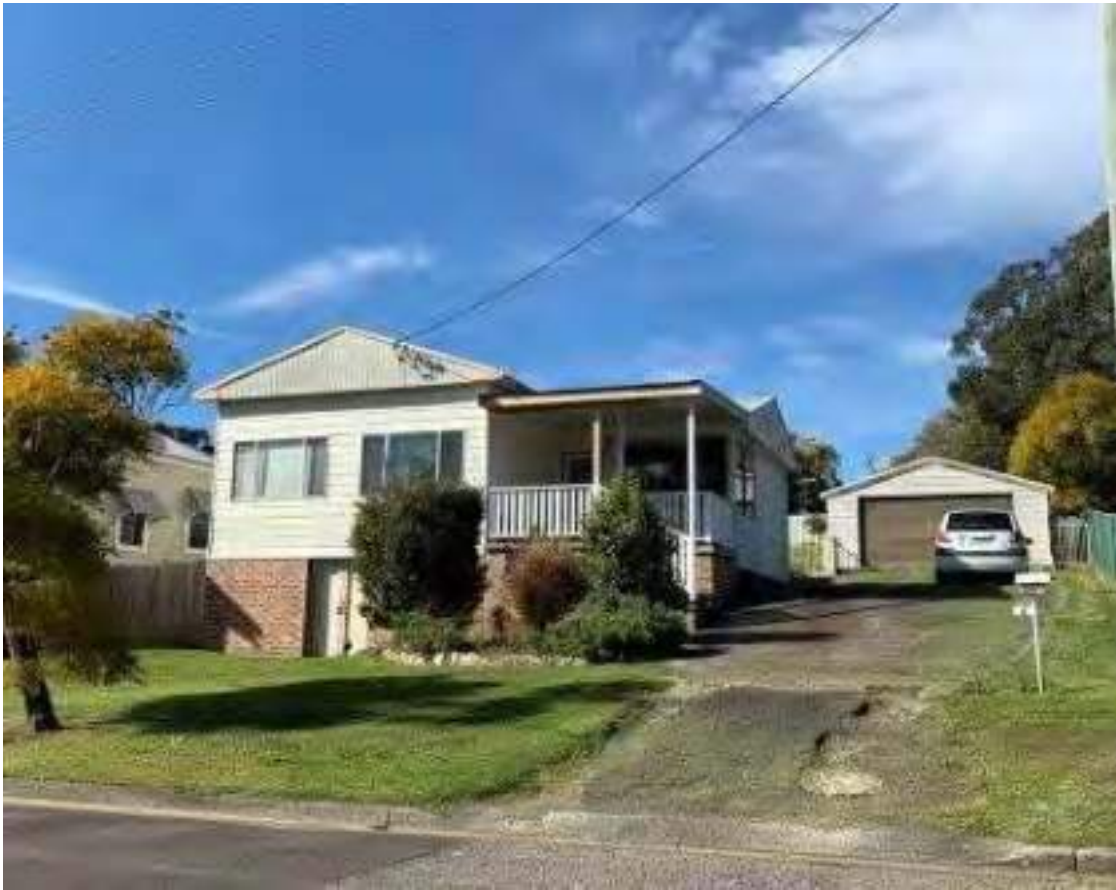
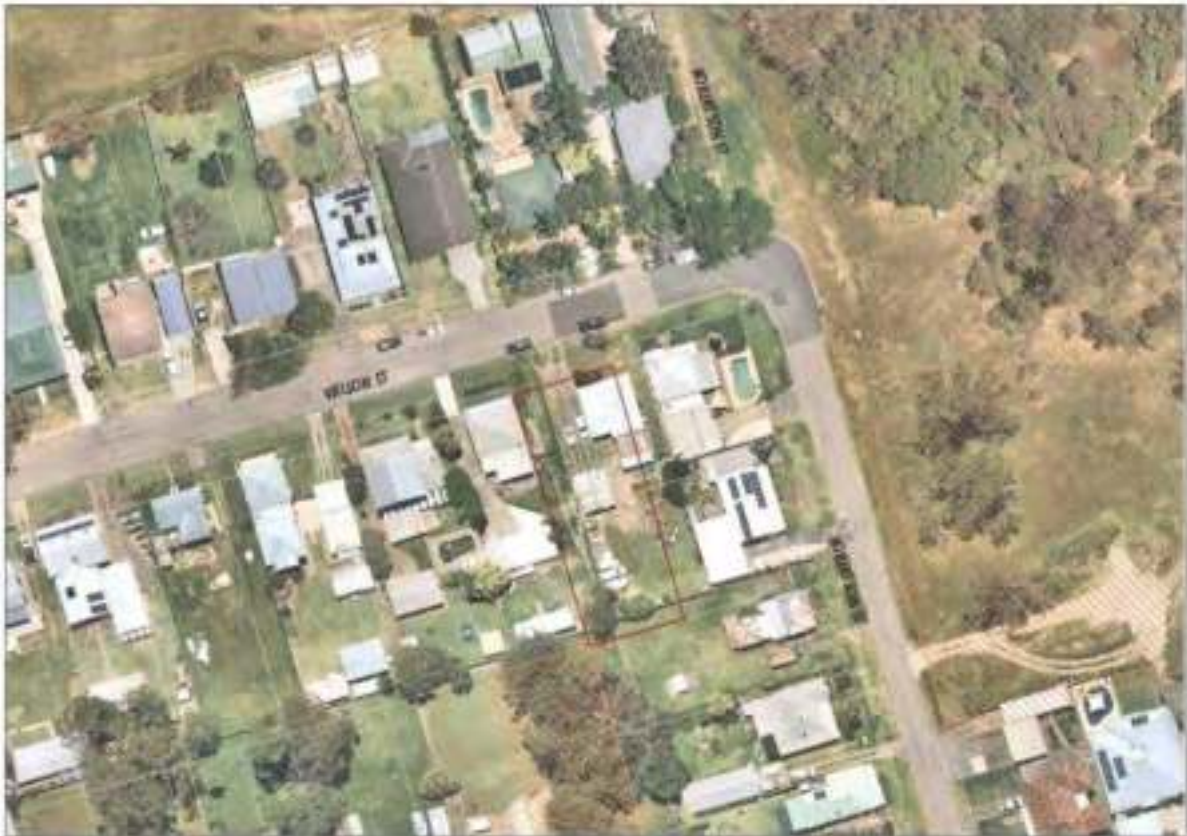
4 WILSON STREET, WEST WALLSEND 2286		
Conservation Area Contribution Level	Est. Construction Date	Previous studies and/or community input
Non-Contributory	Mid to late 20 th century onwards	No prior heritage assessments or research undertaken.
Assessment Text		Observed Modifications
<p>The scale (e.g. double-storey or greater) and general style of the dwelling is inconsistent with that of the streetscape and wider HCA.</p> <p>The dwelling does not contribute positively to the streetscape and wider HCA, particularly in comparison to Contributory 1 and 2 buildings. The presence of the building has an adverse impact on the streetscape and/or wider HCA.</p> <p>The dwelling features inappropriately proportioned and positioned fenestrations, an inappropriate roof form (gabled or hipped) and/or other features that are inconsistent with the architectural character of the area (e.g. unsympathetic additions, inconsistent [contemporary] building materials, etc).</p>		<p>It is possible that the western portion of the dwelling is a contemporary extension, however this has been constructed in a similar manner to the remaining dwelling.</p>

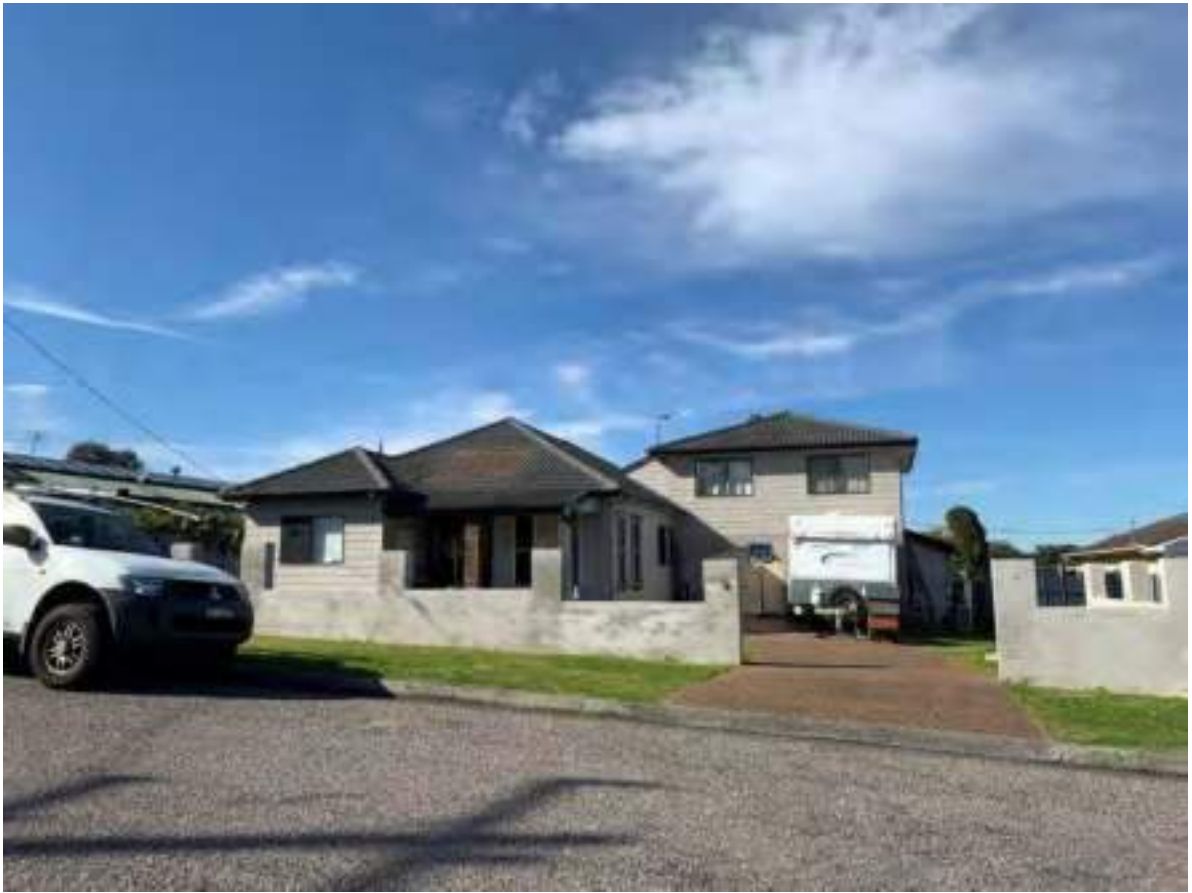
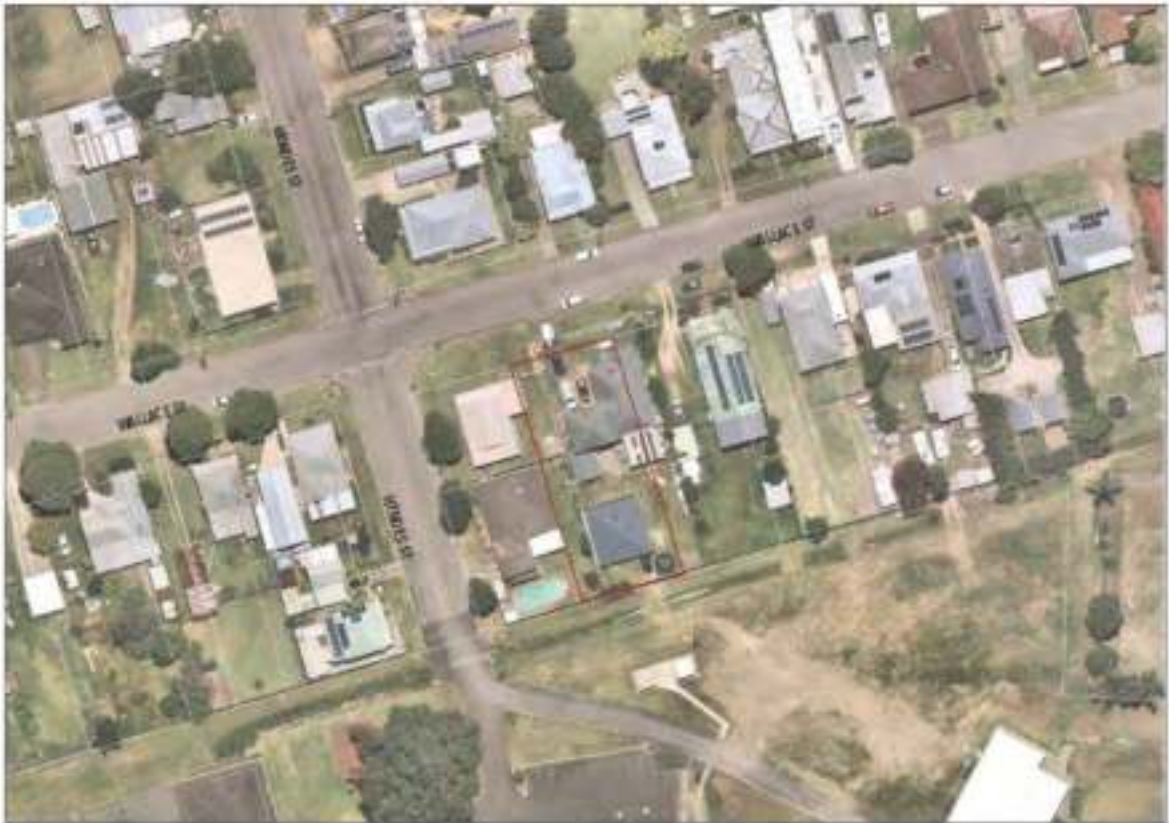
34 WALLACE STREET, WEST WALLSEND 2286		
Conservation Area Contribution Level	Est. Construction Date	Previous studies and/or community input
Non-Contributory	Mid to late 20 th century onwards	No prior heritage assessments or research undertaken.
Assessment Text		Observed Modifications
<p>The scale (e.g. double-storey or greater) and general style of the dwelling is inconsistent with that of the streetscape and wider HCA.</p> <p>The dwelling does not contribute positively to the streetscape and wider HCA, particularly in comparison to Contributory 1 and 2 buildings. The presence of the building has an adverse impact on the streetscape and/or wider HCA.</p> <p>The dwelling features inappropriately proportioned and positioned fenestrations, an inappropriate roof form (gabled or hipped) and/or other features that are inconsistent with the architectural character of the area (e.g. unsympathetic additions, inconsistent [contemporary] building materials, etc).</p>		<p>The western portion of the dwelling is a contemporary extension, with a second storey built and double garage underneath. This contemporary addition is unsympathetic to the heritage streetscape and contrasts the neighbouring properties.</p>

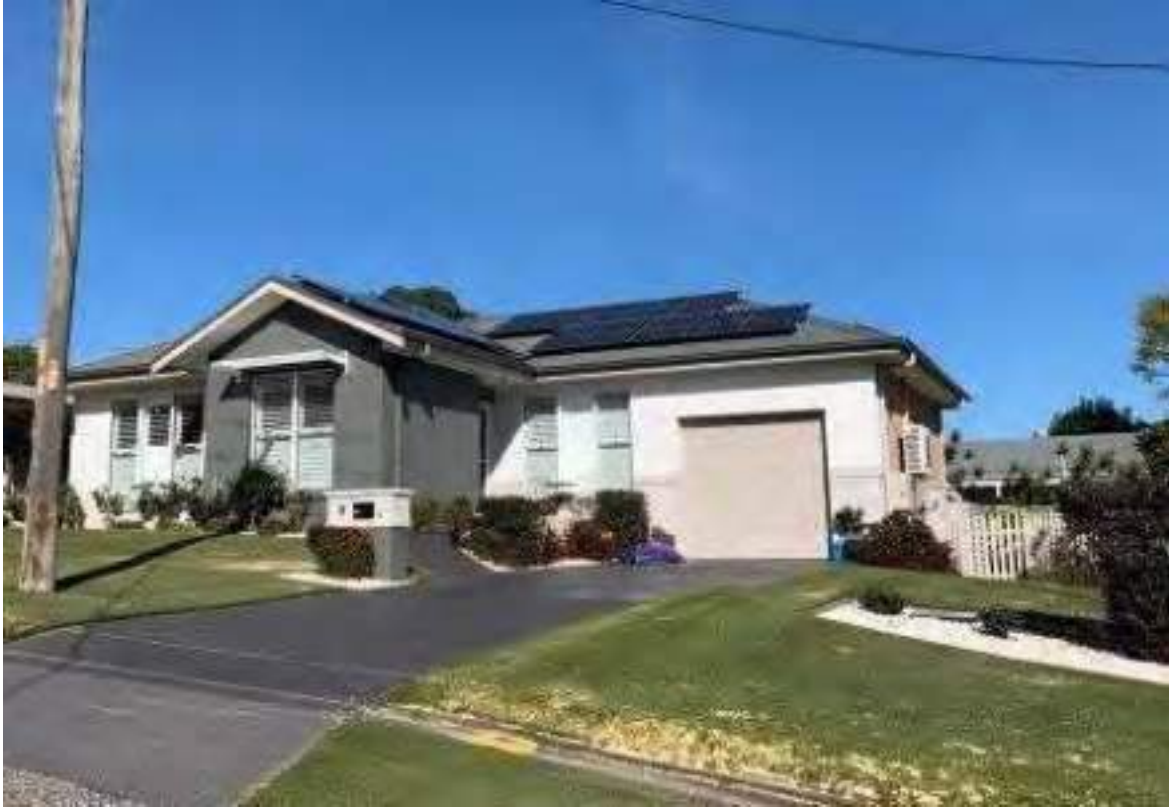
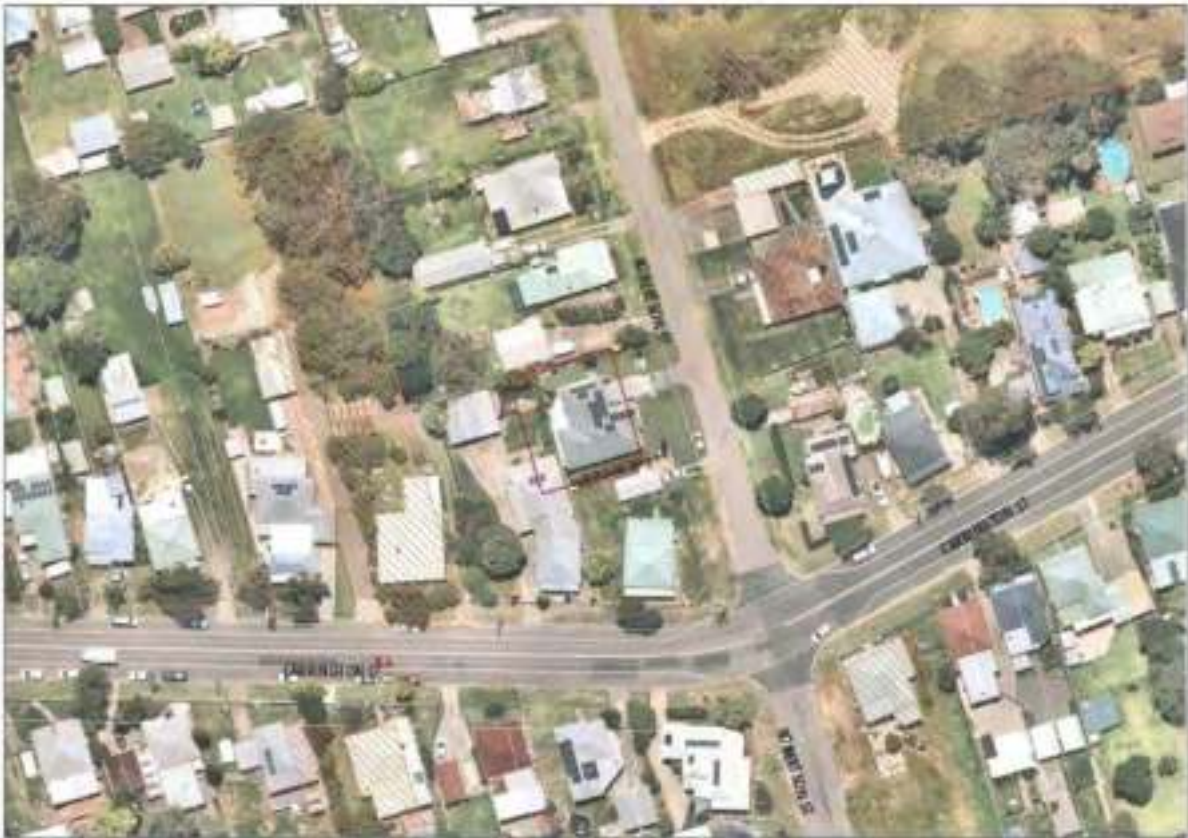
8 ROBERTSON STREET, WEST WALLSEND 2286		
Conservation Area Contribution Level	Est. Construction Date	Previous studies and/or community input
Non-Contributory	Mid to late 20 th century onwards	No prior heritage assessments or research undertaken.
Assessment Text		Observed Modifications
<p>The scale (e.g. double-storey or greater) and general style of the dwelling is inconsistent with that of the streetscape and wider HCA.</p> <p>The dwelling does not contribute positively to the streetscape and wider HCA, particularly in comparison to Contributory 1 and 2 buildings. The presence of the building has an adverse impact on the streetscape and/or wider HCA.</p> <p>The dwelling features inappropriately proportioned and positioned fenestrations, an inappropriate roof form (gabled or hipped) and/or other features that are inconsistent with the architectural character of the area (e.g. unsympathetic additions, inconsistent [contemporary] building materials, etc).</p>		No modifications observed.

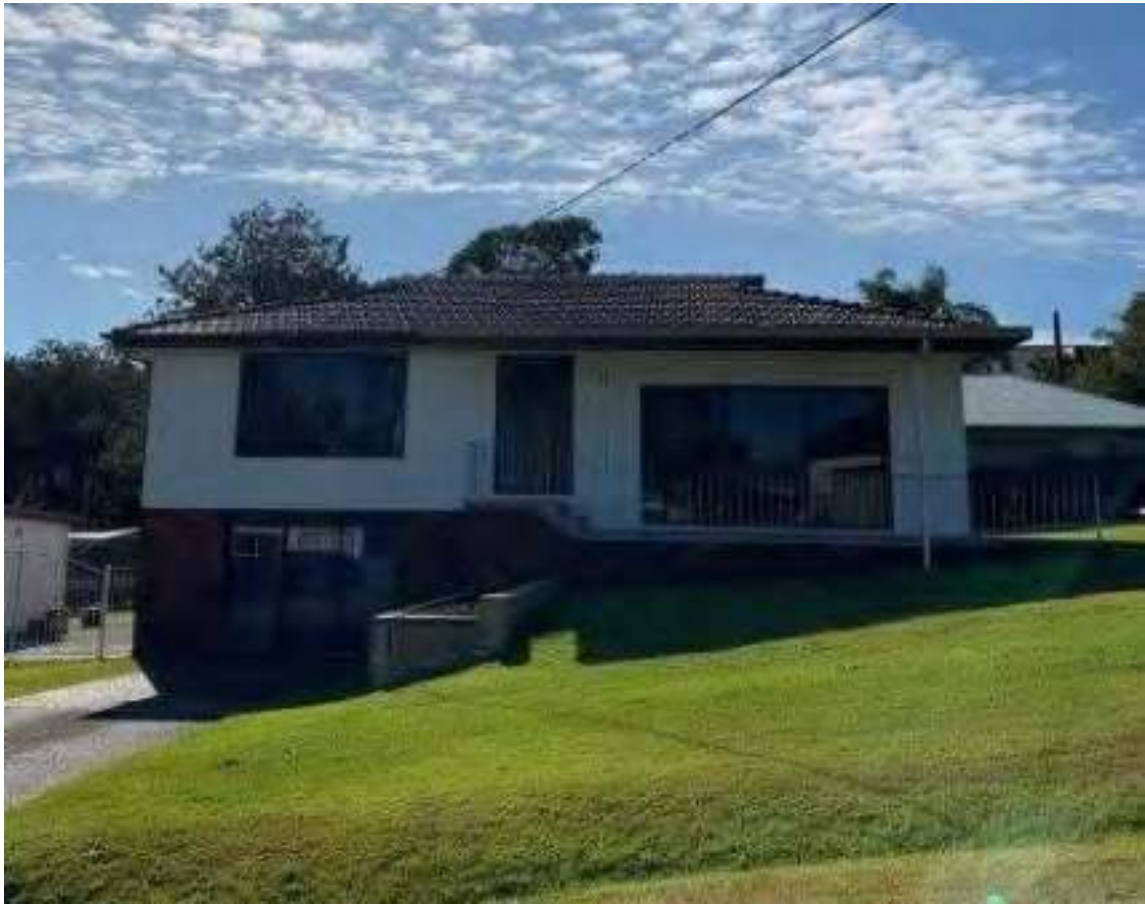
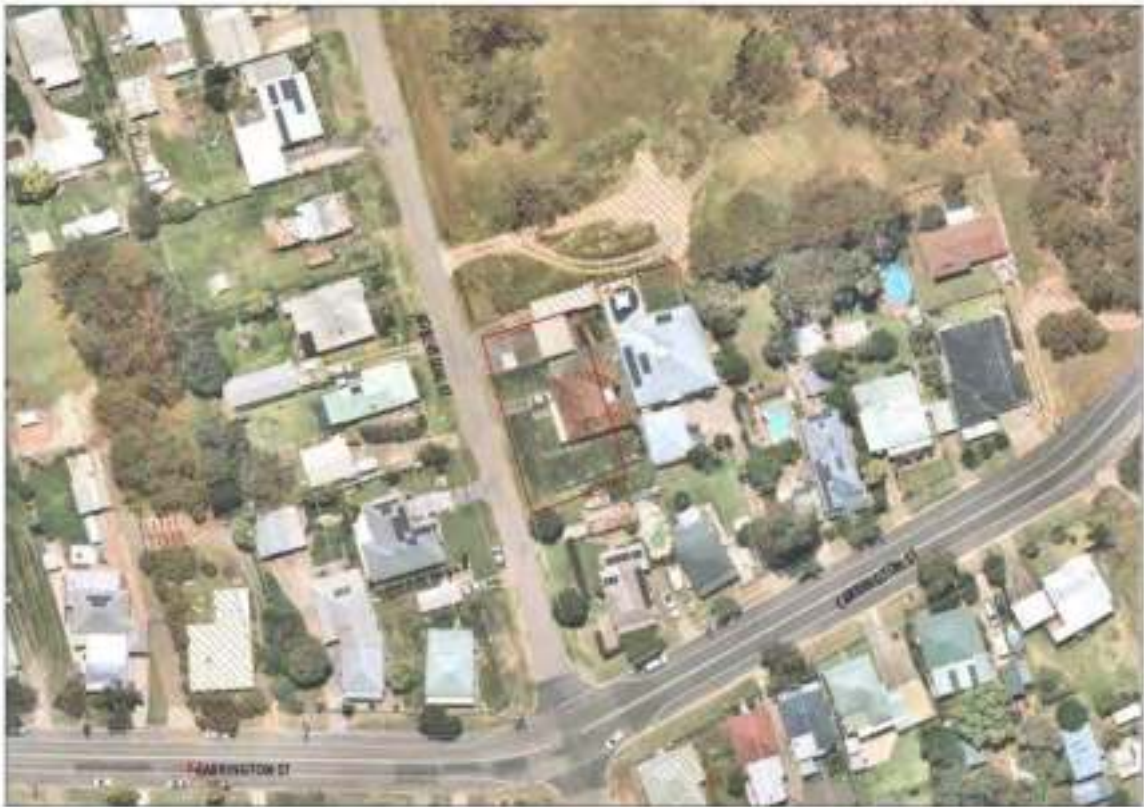
1 ROBERTSON STREET, WEST WALLSEND 2286

Conservation Area Contribution Level	Est. Construction Date	Previous studies and/or community input
Non-Contributory	Mid to late 20 th century onwards	No prior heritage assessments or research undertaken.
Assessment Text		Observed Modifications
<p>The scale (e.g. double-storey or greater) and general style of the dwelling is inconsistent with that of the streetscape and wider HCA.</p> <p>The dwelling does not contribute positively to the streetscape and wider HCA, particularly in comparison to Contributory 1 and 2 buildings. The presence of the building has an adverse impact on the streetscape and/or wider HCA.</p> <p>The dwelling features inappropriately proportioned and positioned fenestrations, an inappropriate roof form (gabled or hipped) and/or other features that are inconsistent with the architectural character of the area (e.g. unsympathetic additions, inconsistent [contemporary] building materials, etc).</p>		No modifications observed.

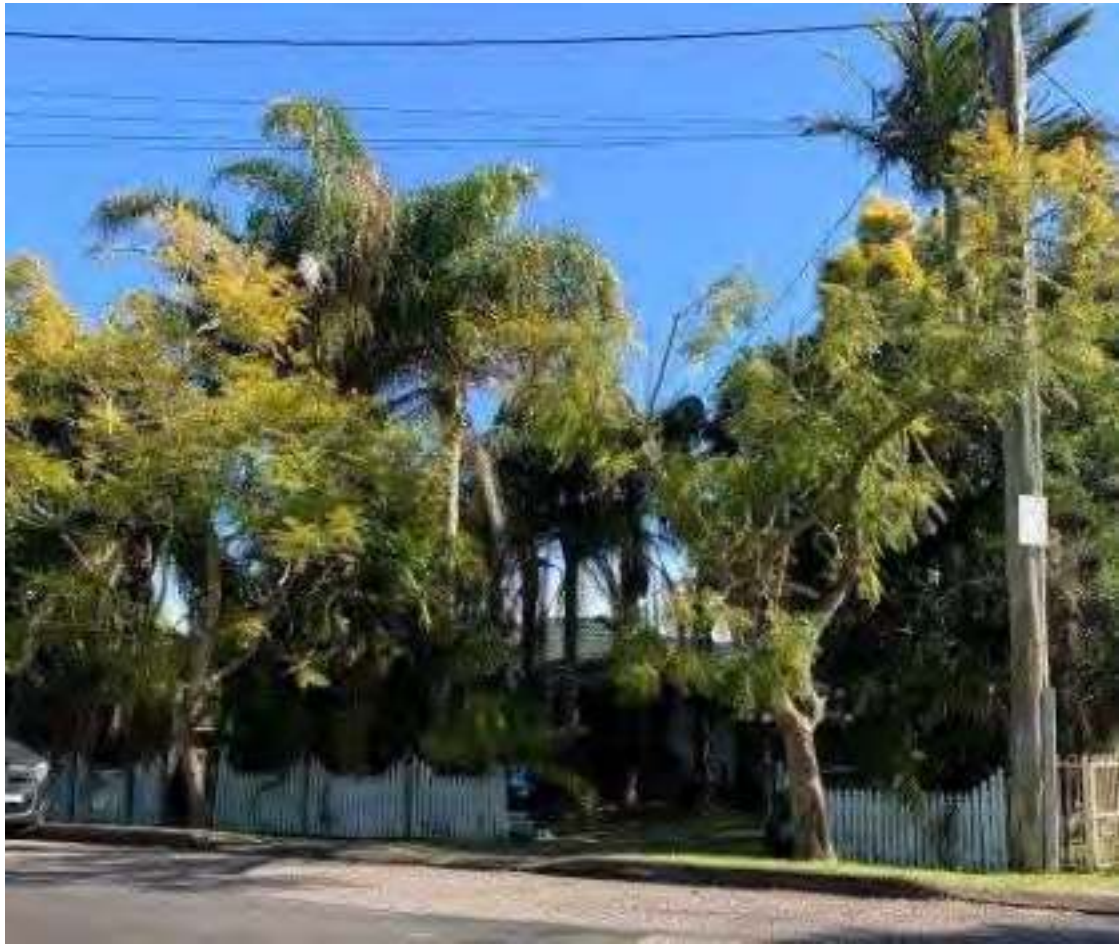
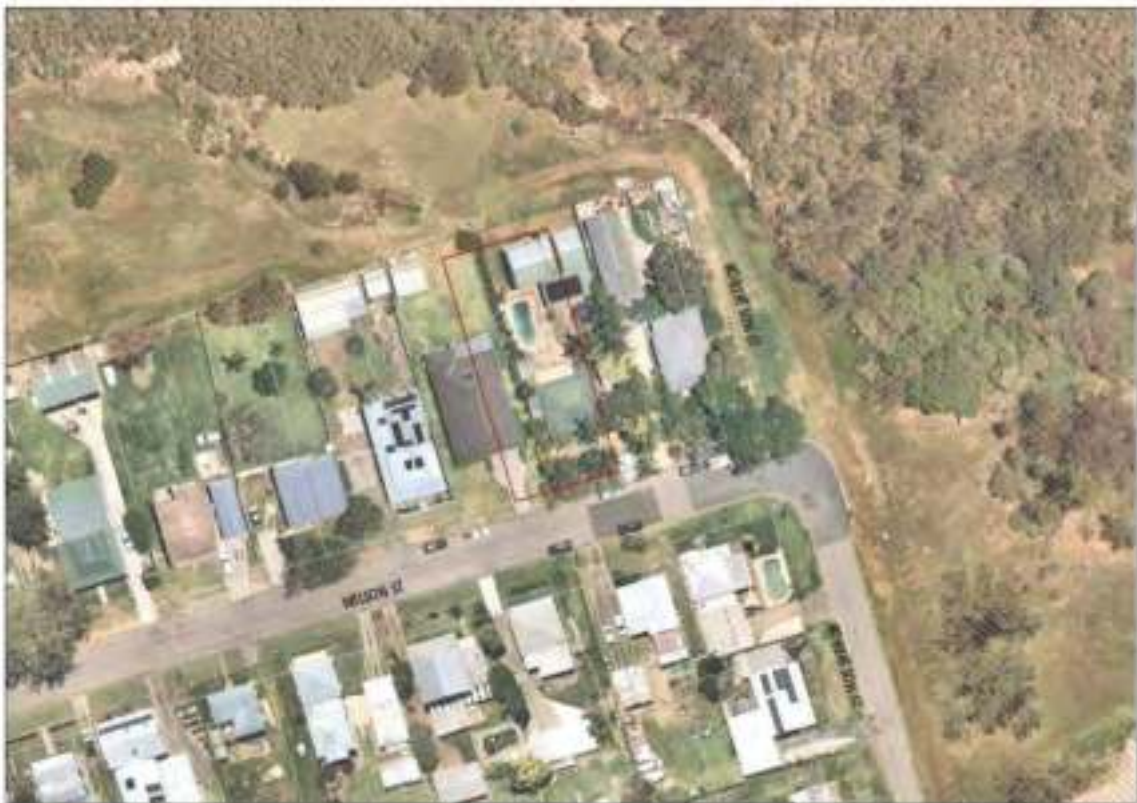
3 WILSON STREET, WEST WALLSEND 2286		
Conservation Area Contribution Level	Est. Construction Date	Previous studies and/or community input
Non-Contributory	Mid to late 20 th century onwards	No prior heritage assessments or research undertaken.
Assessment Text		Observed Modifications
<p>The scale (e.g. double-storey or greater) and general style of the dwelling is inconsistent with that of the streetscape and wider HCA.</p> <p>The dwelling does not contribute positively to the streetscape and wider HCA, particularly in comparison to Contributory 1 and 2 buildings. The presence of the building has an adverse impact on the streetscape and/or wider HCA.</p> <p>The dwelling features inappropriately proportioned and positioned fenestrations, an inappropriate roof form (gabled or hipped) and/or other features that are inconsistent with the architectural character of the area (e.g. unsympathetic additions, inconsistent [contemporary] building materials, etc).</p>		No modifications observed.

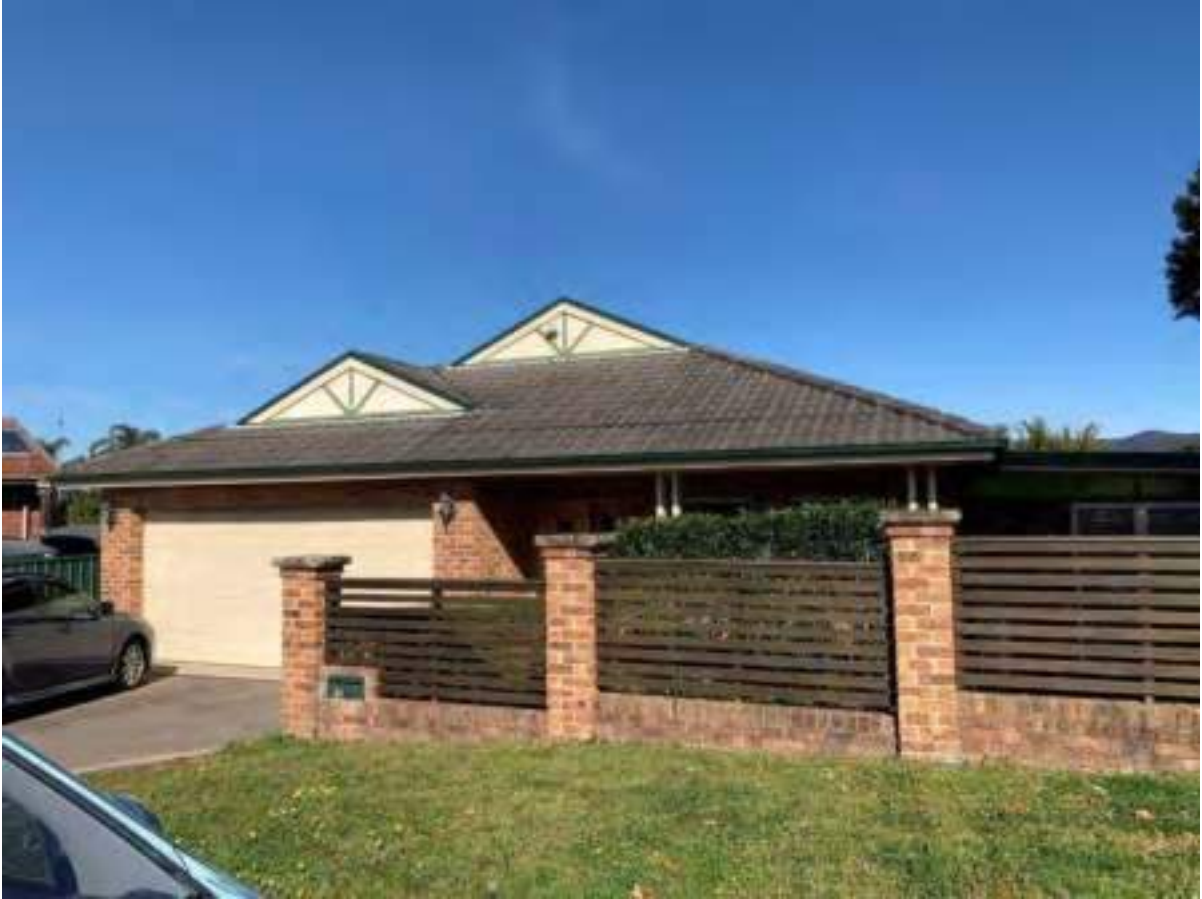
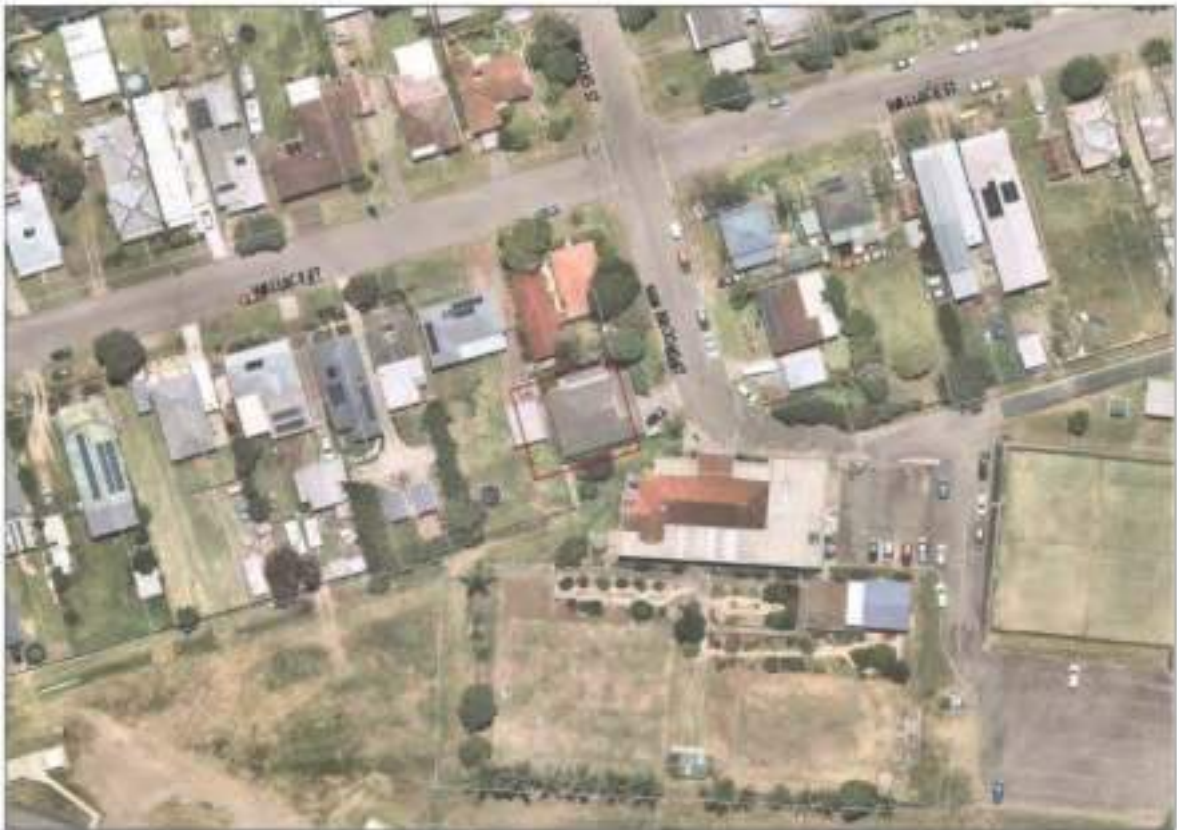
20 BROOKS STREET, WEST WALLSEND 2286		
Conservation Area Contribution Level	Est. Construction Date	Previous studies and/or community input
Non-Contributory	Mid to late 20th century onwards	No prior heritage assessments or research undertaken.
Assessment Text		Observed Modifications
<p>The scale (e.g. double-storey or greater) and general style of the dwelling is inconsistent with that of the streetscape and wider HCA.</p> <p>The dwelling does not contribute positively to the streetscape and wider HCA, particularly in comparison to Contributory 1 and 2 buildings. The presence of the building has an adverse impact on the streetscape and/or wider HCA.</p> <p>The dwelling features inappropriately proportioned and positioned fenestrations, an inappropriate roof form (gabled or hipped) and/or other features that are inconsistent with the architectural character of the area (e.g. unsympathetic additions, inconsistent [contemporary] building materials, etc).</p>		No modifications observed.
