APPENDIX 2

Building Assessment Sheets (Inventory Sheets)

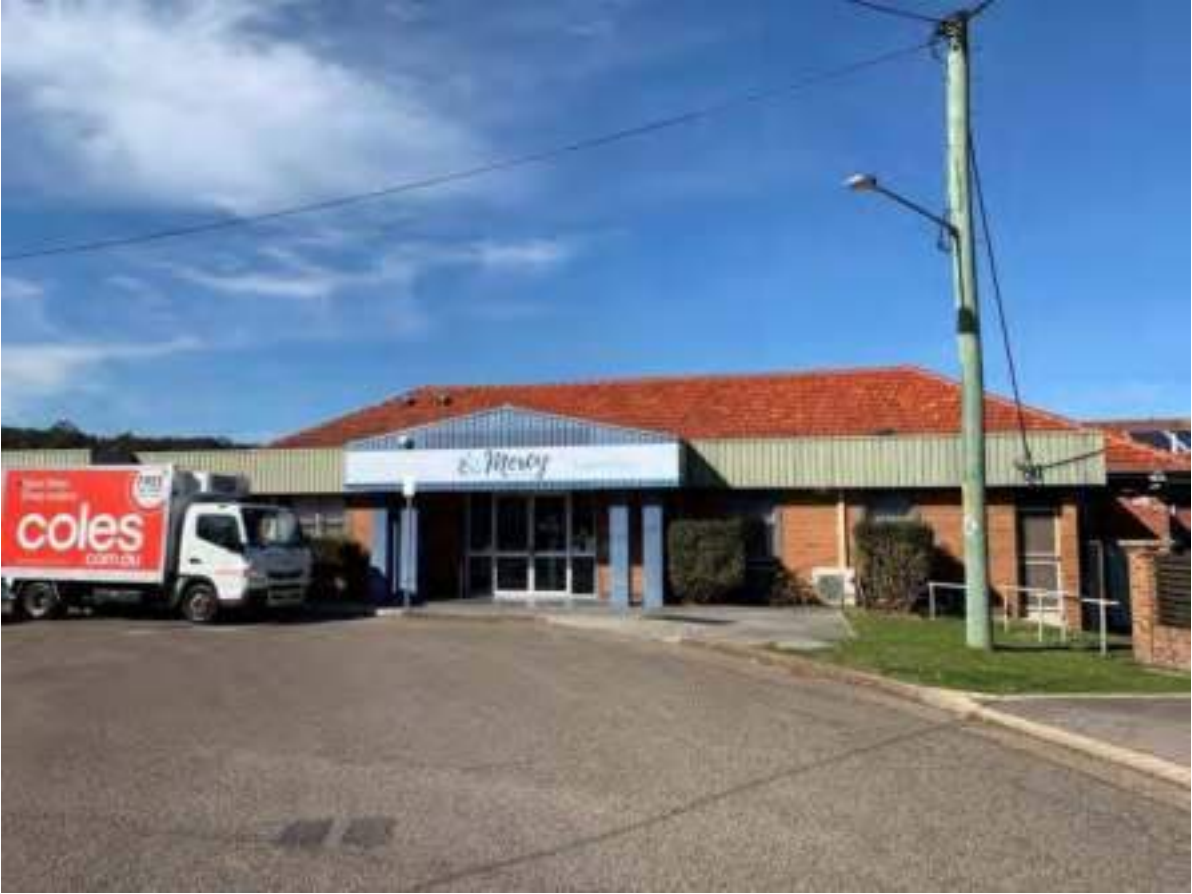
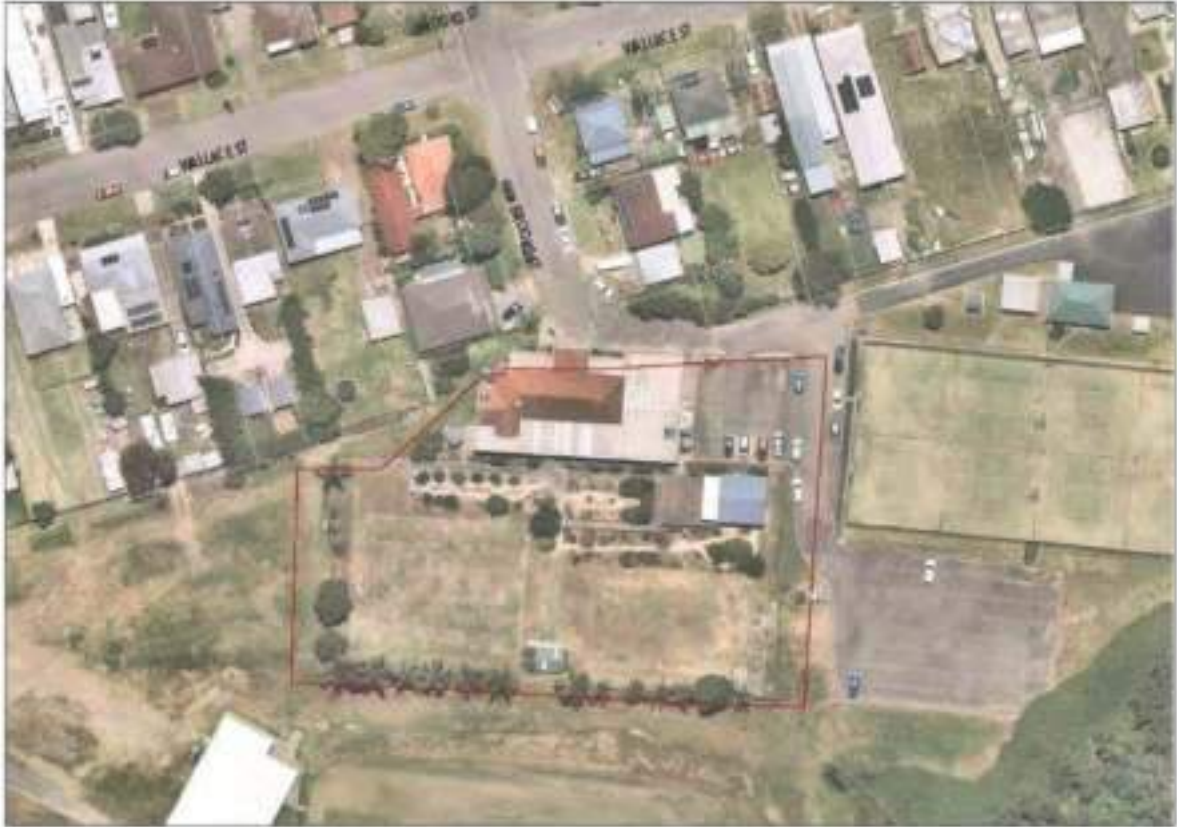
13 BROOKS STREET, WEST WALLSEND 2286

Conservation Area Contribution Level	Est. Construction Date	Previous studies and/or community input
Non-Contributory	Mid to late 20 th century onwards	No prior heritage assessments or research undertaken.
Assessment Text		Observed Modifications
<p>The scale (e.g. double-storey or greater) and general style of the dwelling is inconsistent with that of the streetscape and wider HCA.</p> <p>The dwelling does not contribute positively to the streetscape and wider HCA, particularly in comparison to Contributory 1 and 2 buildings. The presence of the building has an adverse impact on the streetscape and/or wider HCA.</p> <p>The dwelling features inappropriately proportioned and positioned fenestrations, an inappropriate roof form (gabled or hipped) and/or other features that are inconsistent with the architectural character of the area (e.g. unsympathetic additions, inconsistent [contemporary] building materials, etc).</p>		<p>The timber parapet with 'Mercy' stated above is a contemporary modification associated with the buildings change in occupation.</p>

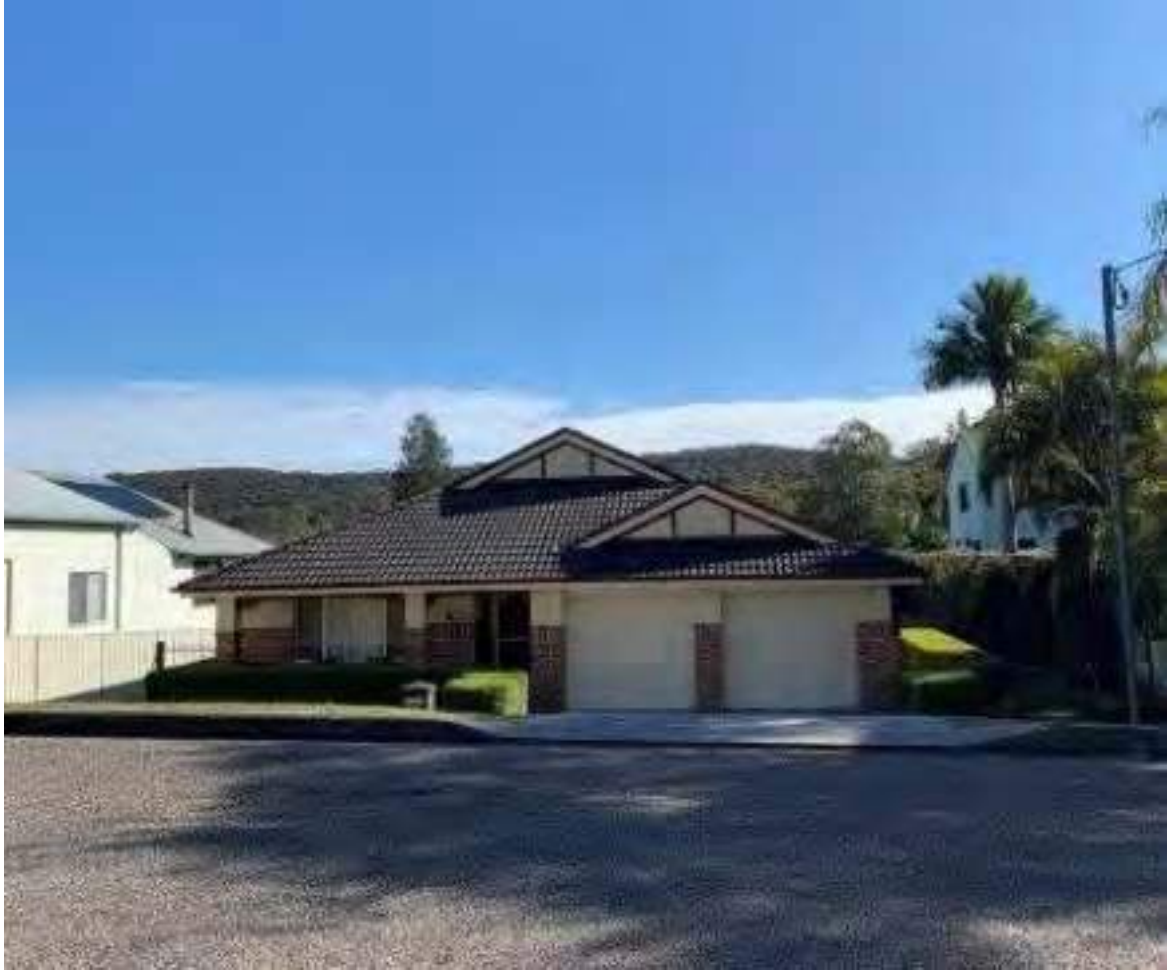
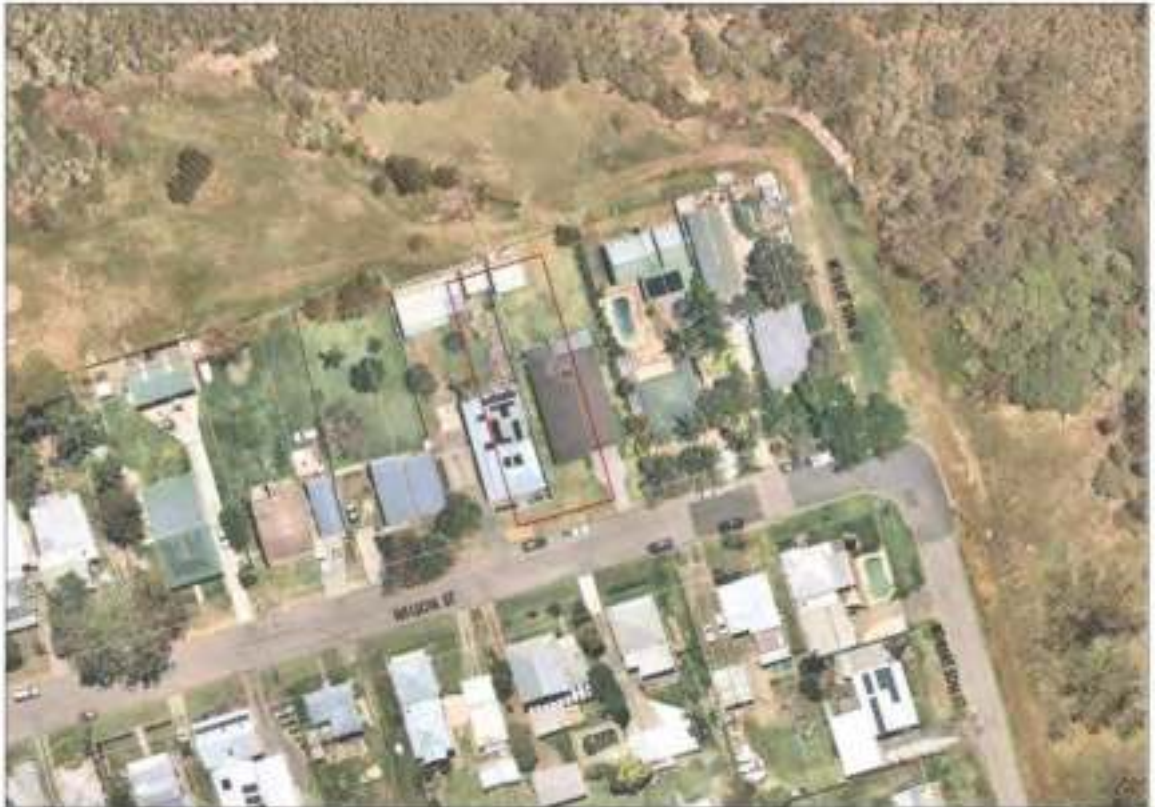
5 WILSON STREET, WEST WALLSEND 2286

Conservation Area Contribution Level	Est. Construction Date	Previous studies and/or community input
Non-Contributory	Mid to late 20 th century onwards	No prior heritage assessments or research undertaken.
Assessment Text		Observed Modifications
<p>The scale (e.g. double-storey or greater) and general style of the dwelling is inconsistent with that of the streetscape and wider HCA.</p> <p>The dwelling does not contribute positively to the streetscape and wider HCA, particularly in comparison to Contributory 1 and 2 buildings. The presence of the building has an adverse impact on the streetscape and/or wider HCA.</p> <p>The dwelling features inappropriately proportioned and positioned fenestrations, an inappropriate roof form (gabled or hipped) and/or other features that are inconsistent with the architectural character of the area (e.g. unsympathetic additions, inconsistent [contemporary] building materials, etc).</p>		No modifications observed.

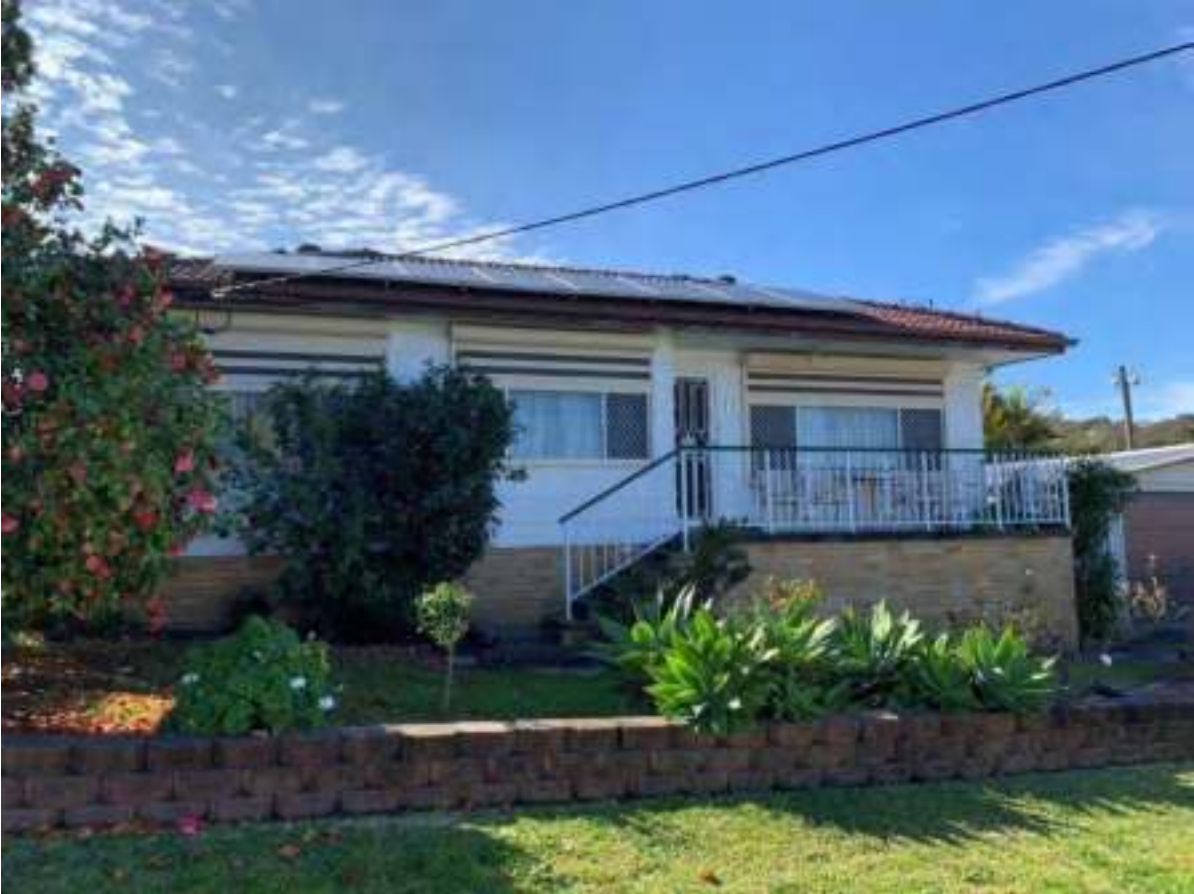
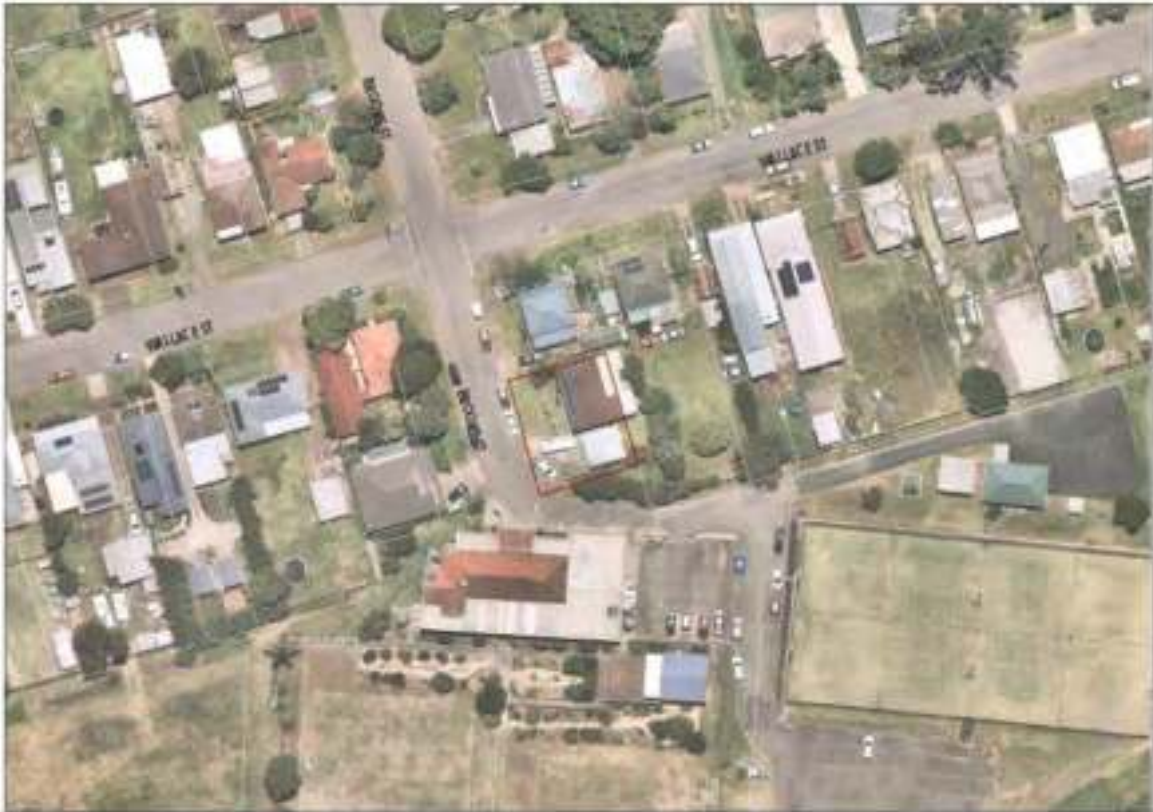
11 BROOKS STREET, WEST WALLSEND 2286

Conservation Area Contribution Level	Est. Construction Date	Previous studies and/or community input
Non-Contributory	Mid to late 20 th century onwards	No prior heritage assessments or research undertaken.
Assessment Text		Observed Modifications
<p>The scale (e.g. double-storey or greater) and general style of the dwelling is inconsistent with that of the streetscape and wider HCA.</p> <p>The dwelling does not contribute positively to the streetscape and wider HCA, particularly in comparison to Contributory 1 and 2 buildings. The presence of the building has an adverse impact on the streetscape and/or wider HCA.</p> <p>The dwelling features inappropriately proportioned and positioned fenestrations, an inappropriate roof form (gabled or hipped) and/or other features that are inconsistent with the architectural character of the area (e.g. unsympathetic additions, inconsistent [contemporary] building materials, etc).</p>		<p>Solar panels are highly visible along the western portion of the roof.</p>

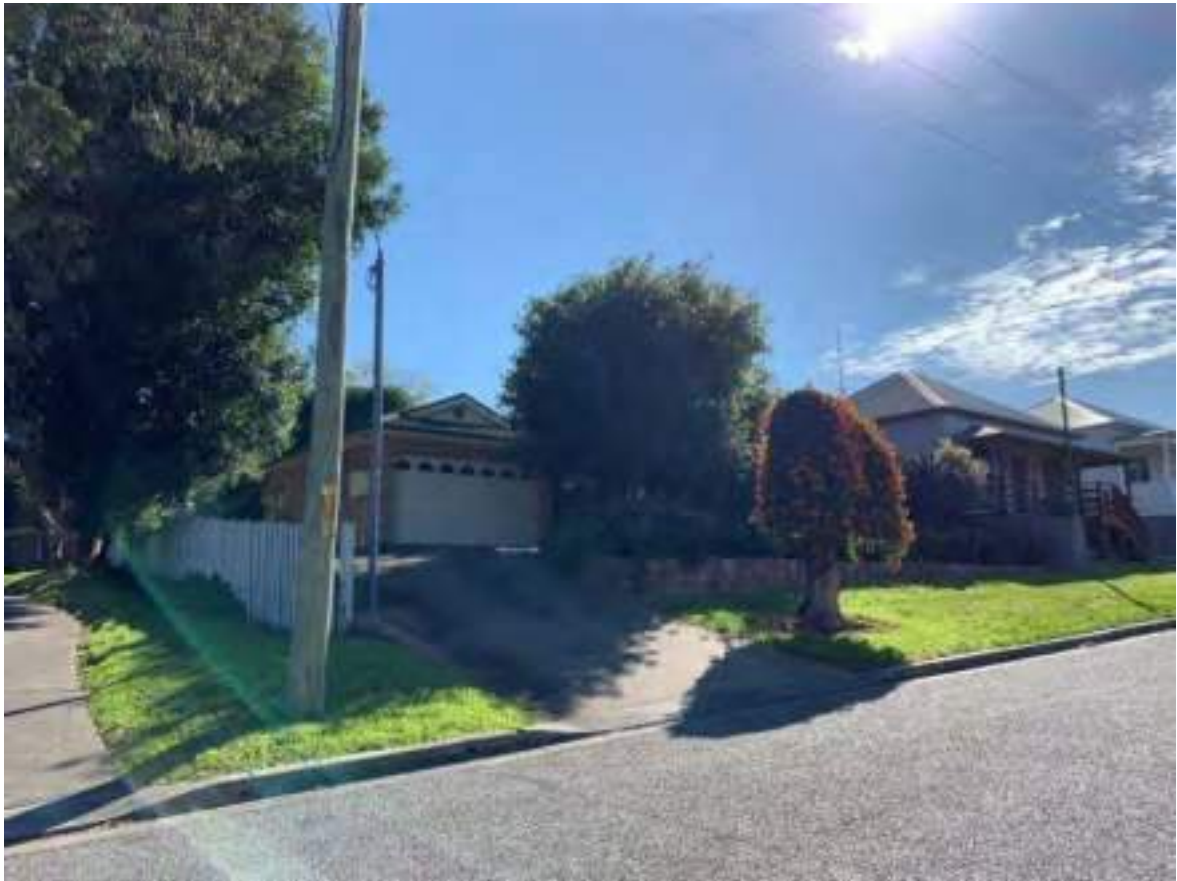
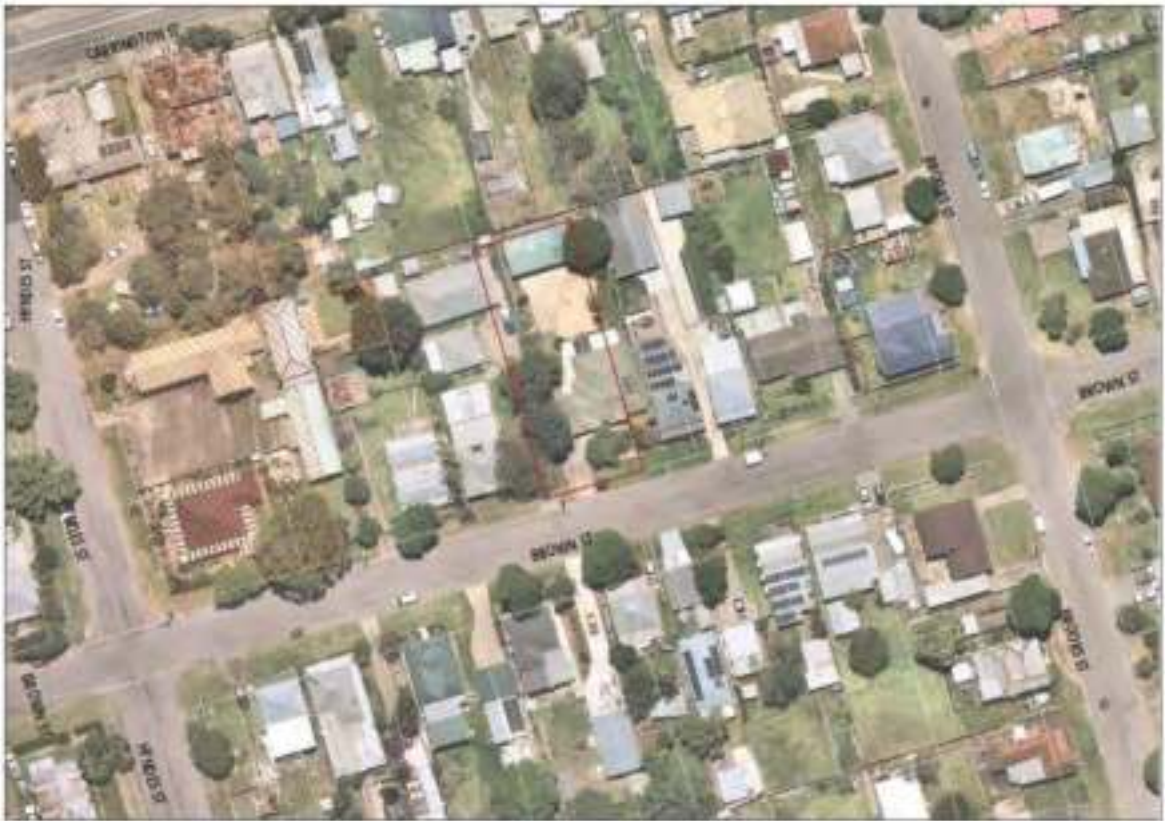
23 BROWN STREET, WEST WALLSEND 2286		
Conservation Area Contribution Level	Est. Construction Date	Previous studies and/or community input
Non-Contributory	Mid to late 20 th century onwards	No prior heritage assessments or research undertaken.
Assessment Text		Observed Modifications
<p>The scale (e.g. double-storey or greater) and general style of the dwelling is inconsistent with that of the streetscape and wider HCA.</p> <p>The dwelling does not contribute positively to the streetscape and wider HCA, particularly in comparison to Contributory 1 and 2 buildings. The presence of the building has an adverse impact on the streetscape and/or wider HCA.</p> <p>The dwelling features inappropriately proportioned and positioned fenestrations, an inappropriate roof form (gabled or hipped) and/or other features that are inconsistent with the architectural character of the area (e.g. unsympathetic additions, inconsistent [contemporary] building materials, etc).</p>		No modifications observed.

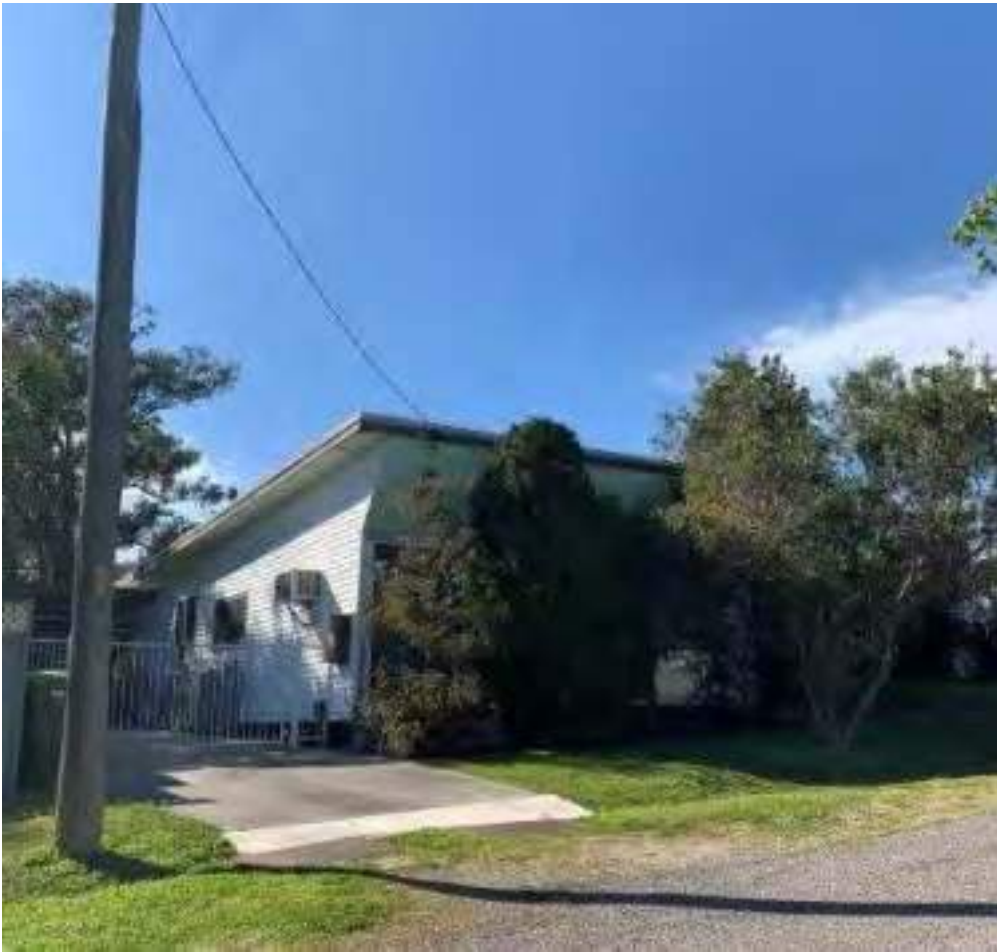
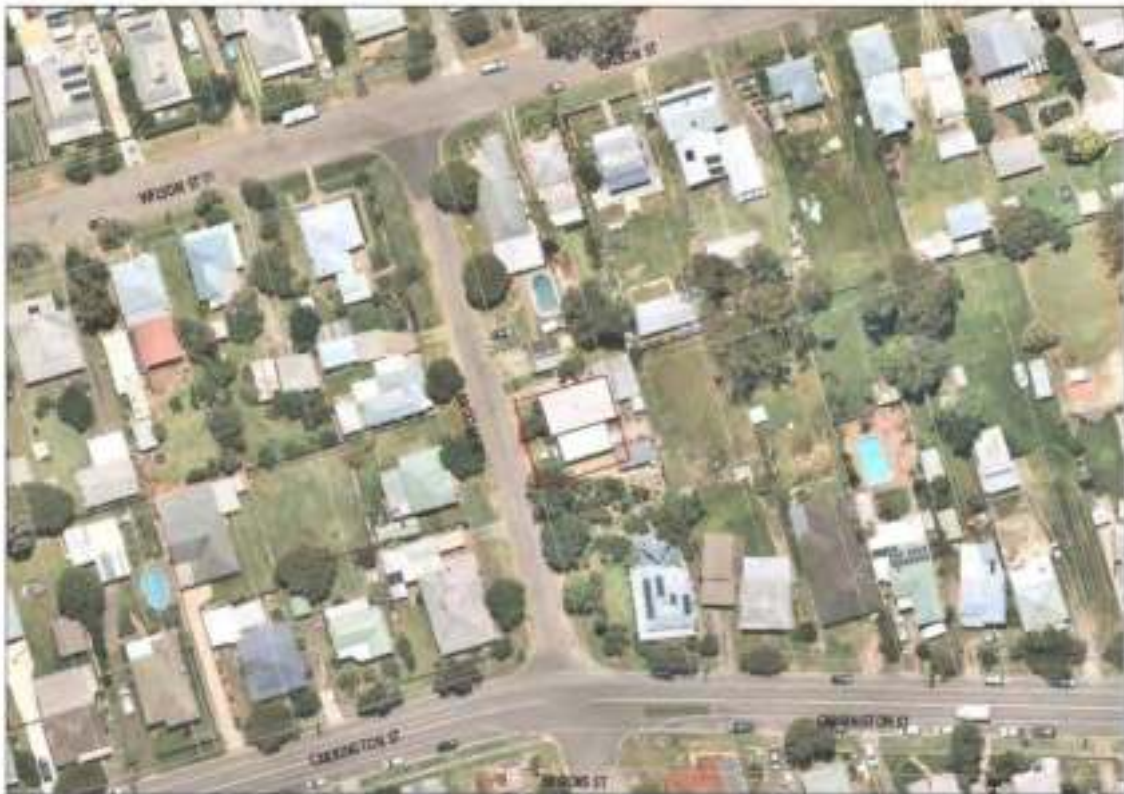
1 BROOKS STREET, WESTWALLEND 2286

1 BROOKS STREET, WEST WALLSEND 2286		
Conservation Area Contribution Level	Est. Construction Date	Previous studies and/or community input
Non-Contributory	Mid to late 20 th century onwards	No prior heritage assessments or research undertaken.
Assessment Text		Observed Modifications
<p>The scale (e.g. double-storey or greater) and general style of the dwelling is inconsistent with that of the streetscape and wider HCA.</p> <p>The dwelling does not contribute positively to the streetscape and wider HCA, particularly in comparison to Contributory 1 and 2 buildings. The presence of the building has an adverse impact on the streetscape and/or wider HCA.</p> <p>The dwelling features inappropriately proportioned and positioned fenestrations, an inappropriate roof form (gabled or hipped) and/or other features that are inconsistent with the architectural character of the area (e.g. unsympathetic additions, inconsistent [contemporary] building materials, etc).</p>		No modifications observed.

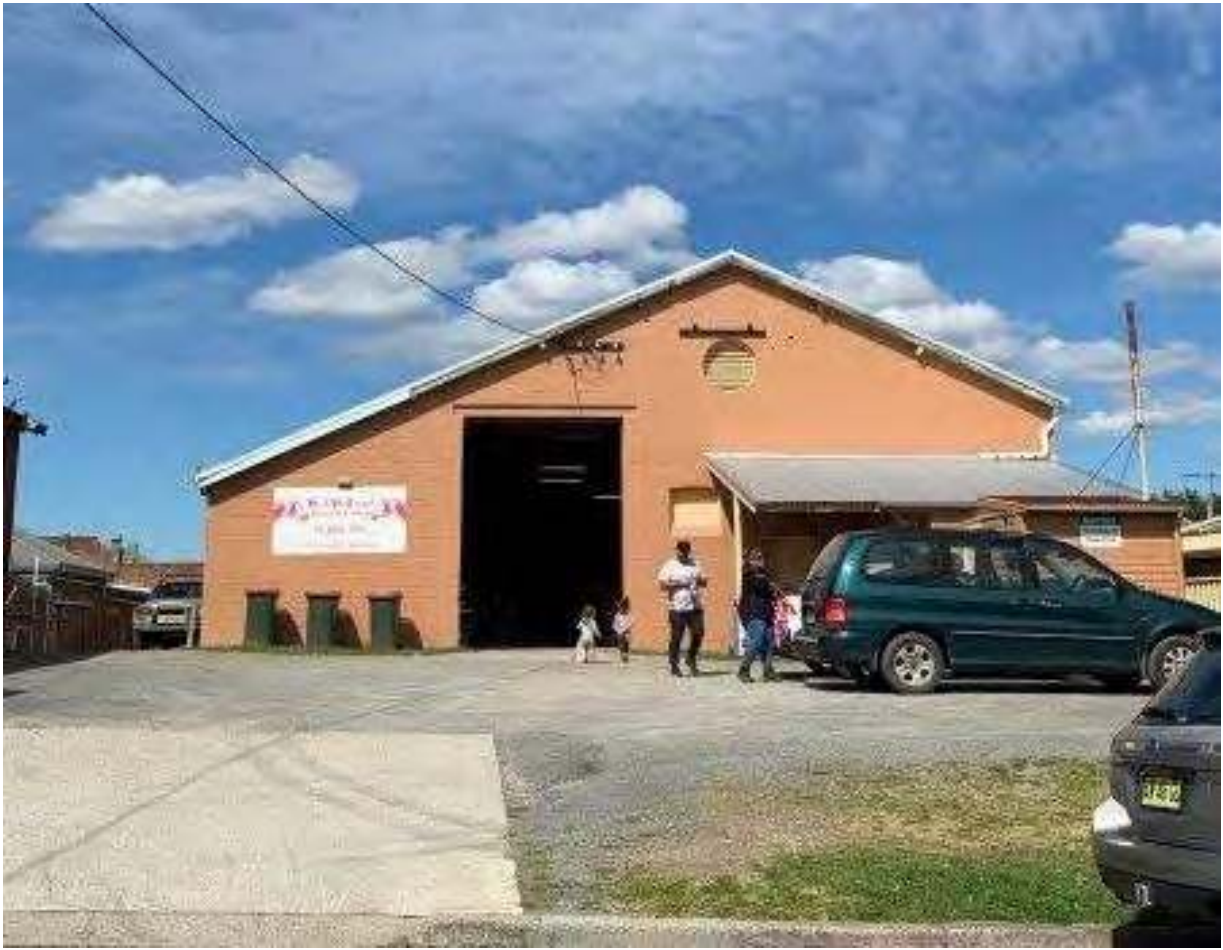
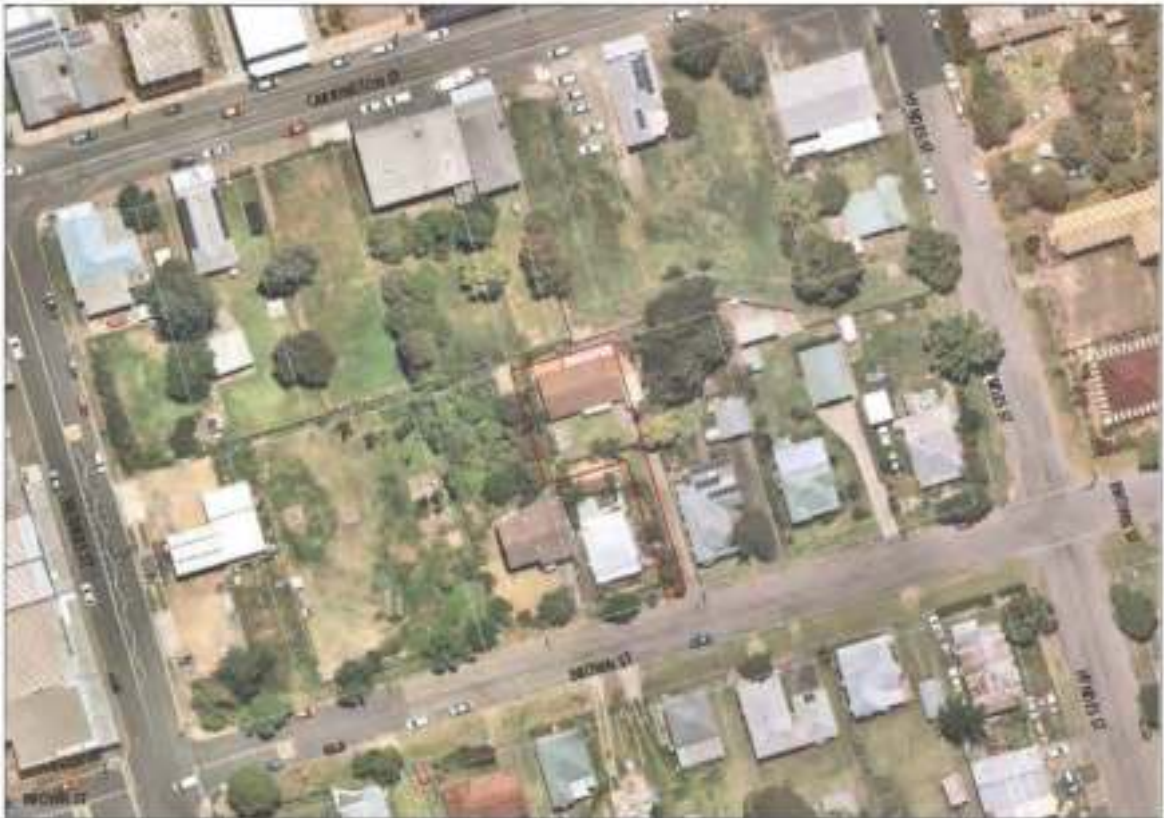
37A BROWN STREET, WEST WALLSEND 2286

Conservation Area Contribution Level	Est. Construction Date	Previous studies and/or community input
Non-Contributory	Mid to late 20 th century onwards	No prior heritage assessments or research undertaken.
Assessment Text		Observed Modifications
<p>The scale (e.g. double-storey or greater) and general style of the dwelling is inconsistent with that of the streetscape and wider HCA.</p> <p>The dwelling does not contribute positively to the streetscape and wider HCA, particularly in comparison to Contributory 1 and 2 buildings. The presence of the building has an adverse impact on the streetscape and/or wider HCA.</p> <p>The dwelling features inappropriately proportioned and positioned fenestrations, an inappropriate roof form (gabled or hipped) and/or other features that are inconsistent with the architectural character of the area (e.g. unsympathetic additions, inconsistent [contemporary] building materials, etc).</p>		No modifications observed.

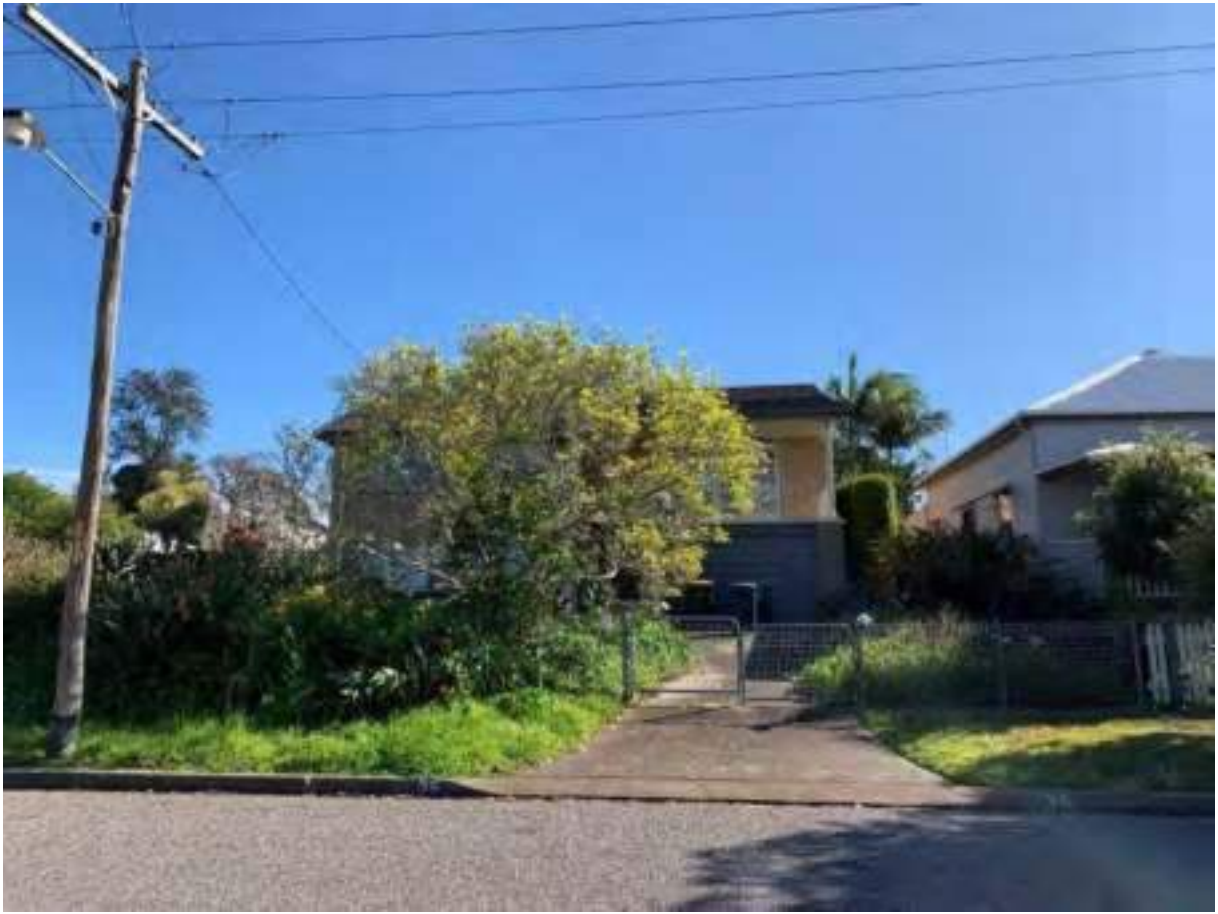
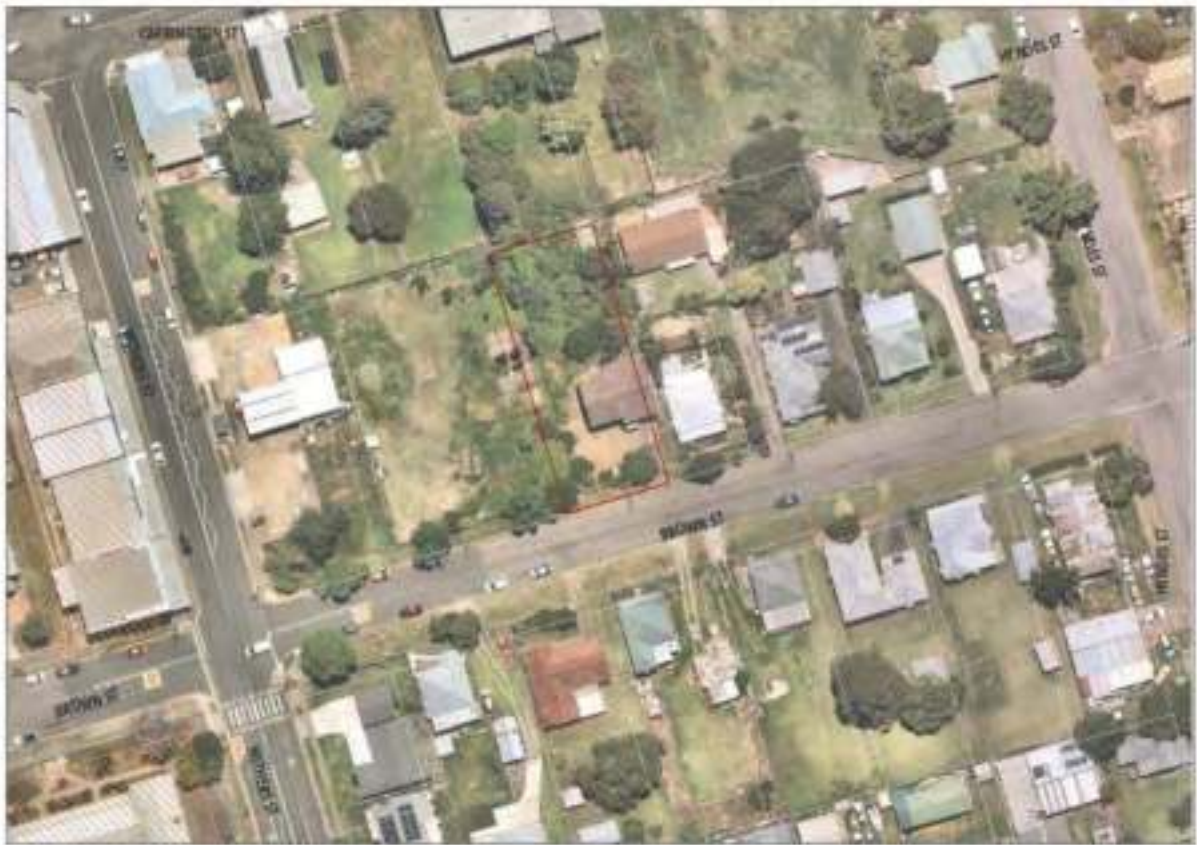
39 BROWN STREET, WEST WALLSEND 2286		
Conservation Area Contribution Level	Est. Construction Date	Previous studies and/or community input
Non-Contributory	Mid to late 20 th century onwards	No prior heritage assessments or research undertaken.
Assessment Text		Observed Modifications
<p>The scale (e.g. double-storey or greater) and general style of the dwelling is inconsistent with that of the streetscape and wider HCA.</p> <p>The dwelling does not contribute positively to the streetscape and wider HCA, particularly in comparison to Contributory 1 and 2 buildings. The presence of the building has an adverse impact on the streetscape and/or wider HCA.</p> <p>The dwelling features inappropriately proportioned and positioned fenestrations, an inappropriate roof form (gabled or hipped) and/or other features that are inconsistent with the architectural character of the area (e.g. unsympathetic additions, inconsistent [contemporary] building materials, etc).</p>		No modifications observed.

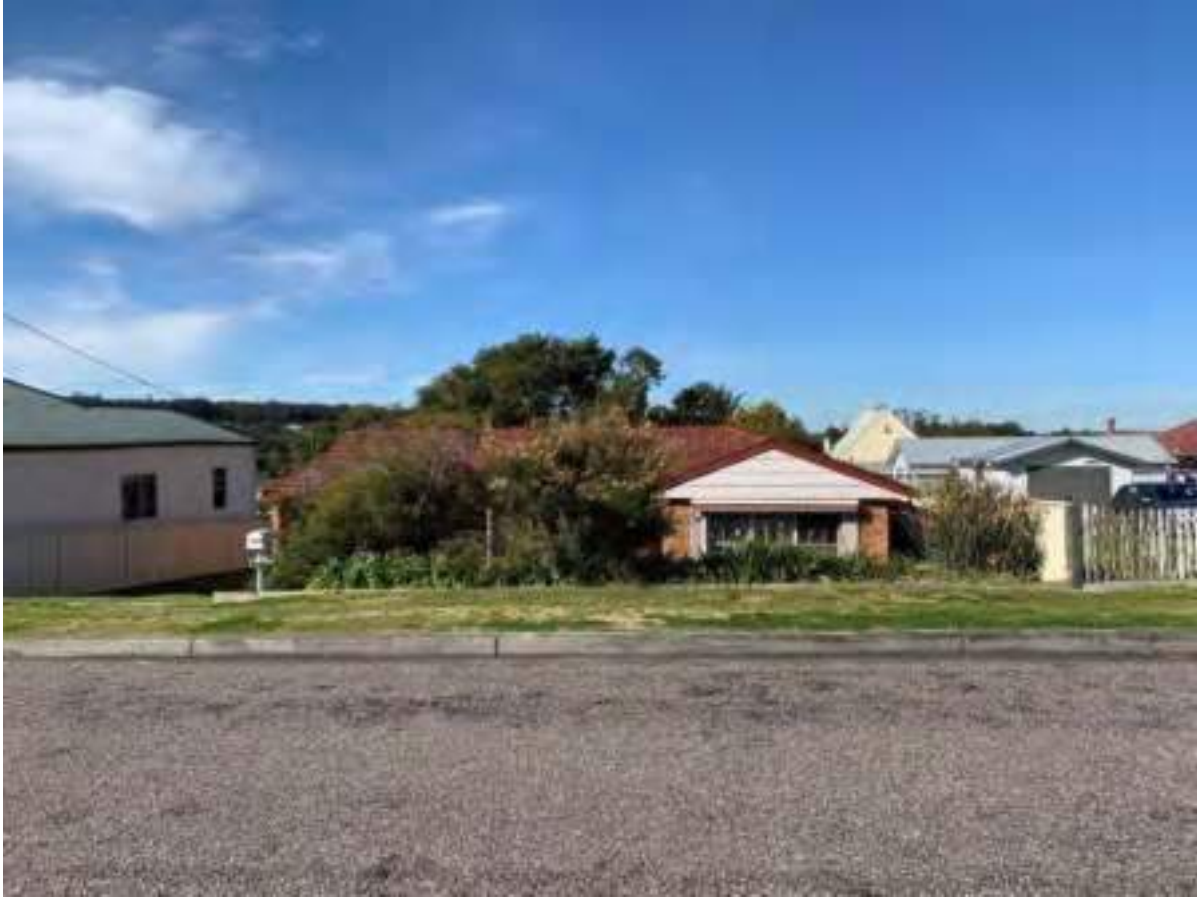
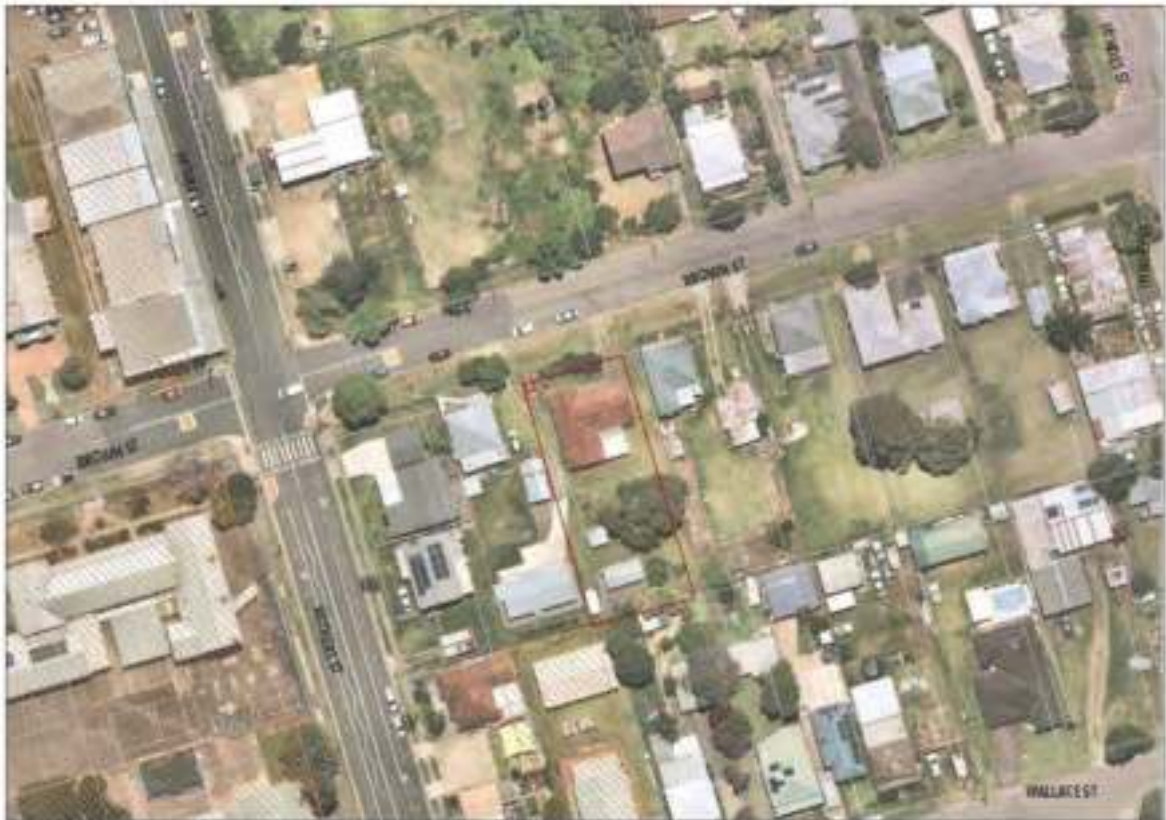
54 BROWN STREET, WEST WALLSEND 2286		
Conservation Area Contribution Level	Est. Construction Date	Previous studies and/or community input
Non-Contributory	Mid to late 20 th century onwards	No prior heritage assessments or research undertaken.
Assessment Text		Observed Modifications
<p>The scale (e.g. double-storey or greater) and general style of the dwelling is inconsistent with that of the streetscape and wider HCA.</p> <p>The dwelling does not contribute positively to the streetscape and wider HCA, particularly in comparison to Contributory 1 and 2 buildings. The presence of the building has an adverse impact on the streetscape and/or wider HCA.</p> <p>The dwelling features inappropriately proportioned and positioned fenestrations, an inappropriate roof form (gabled or hipped) and/or other features that are inconsistent with the architectural character of the area (e.g. unsympathetic additions, inconsistent [contemporary] building materials, etc).</p>		No modifications observed.

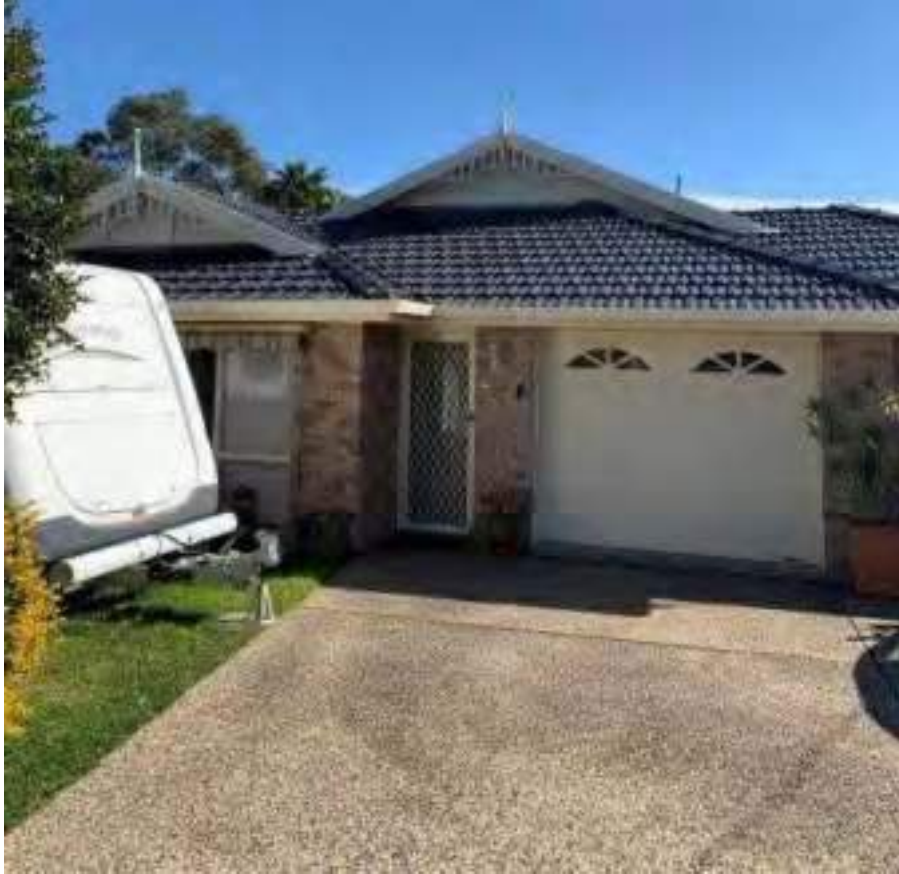
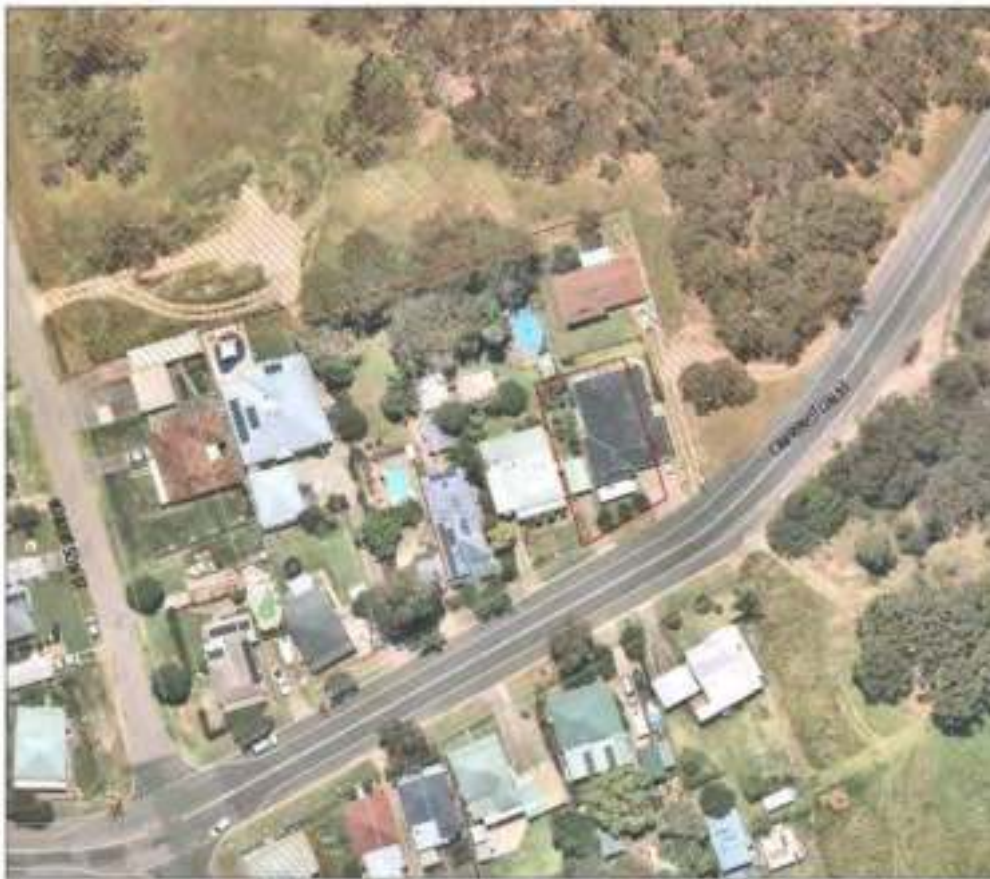
1 CARRINGTON STREET, WEST WALLSEND 2286		
Conservation Area Contribution Level	Est. Construction Date	Previous studies and/or community input
Non-Contributory	Mid to late 20th century onwards	No prior heritage assessments or research undertaken.
Assessment Text		Observed Modifications
<p>The scale (e.g. double-storey or greater) and general style of the dwelling is inconsistent with that of the streetscape and wider HCA.</p> <p>The dwelling does not contribute positively to the streetscape and wider HCA, particularly in comparison to Contributory 1 and 2 buildings. The presence of the building has an adverse impact on the streetscape and/or wider HCA.</p> <p>The dwelling features inappropriately proportioned and positioned fenestrations, an inappropriate roof form (gabled or hipped) and/or other features that are inconsistent with the architectural character of the area (e.g. unsympathetic additions, inconsistent [contemporary] building materials, etc).</p>		No modifications observed.

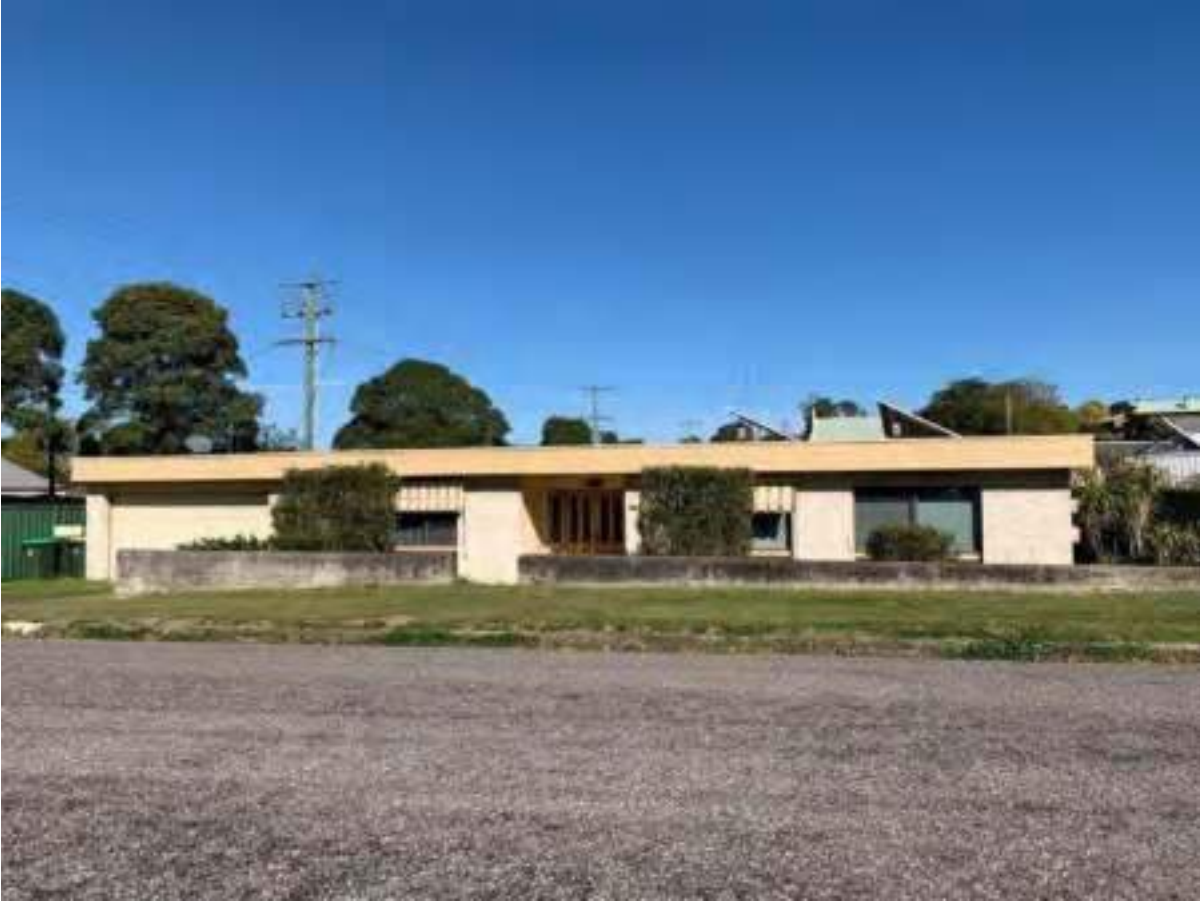
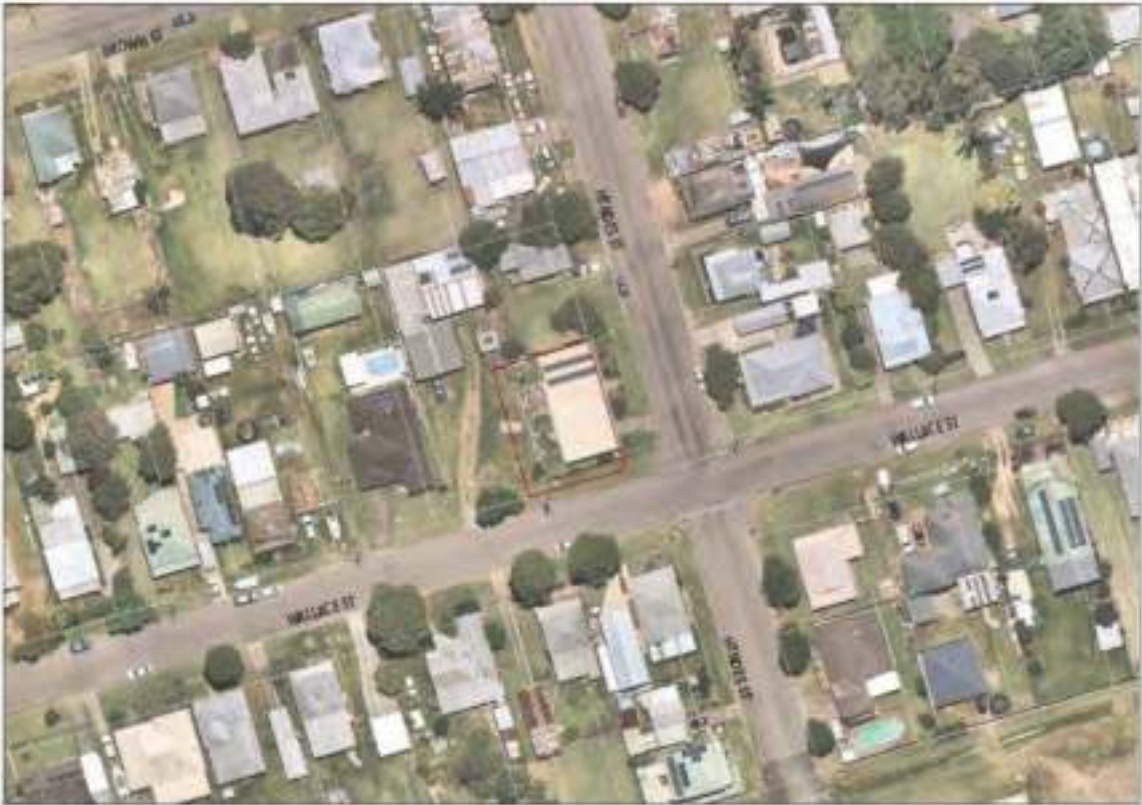
Conservation Area Contribution Level	Est. Construction Date	Previous studies and/or community input
Non-Contributory	Mid to late 20 th century onwards	No prior heritage assessments or research undertaken.
Assessment Text		Observed Modifications
<p>The scale (e.g. double-storey or greater) and general style of the dwelling is inconsistent with that of the streetscape and wider HCA.</p> <p>The dwelling does not contribute positively to the streetscape and wider HCA, particularly in comparison to Contributory 1 and 2 buildings. The presence of the building has an adverse impact on the streetscape and/or wider HCA.</p> <p>The dwelling features inappropriately proportioned and positioned fenestrations, an inappropriate roof form (gabled or hipped) and/or other features that are inconsistent with the architectural character of the area (e.g. unsympathetic additions, inconsistent [contemporary] building materials, etc).</p>		No modifications observed.
