APPENDIX 2

Building Assessment Sheets (Inventory Sheets)

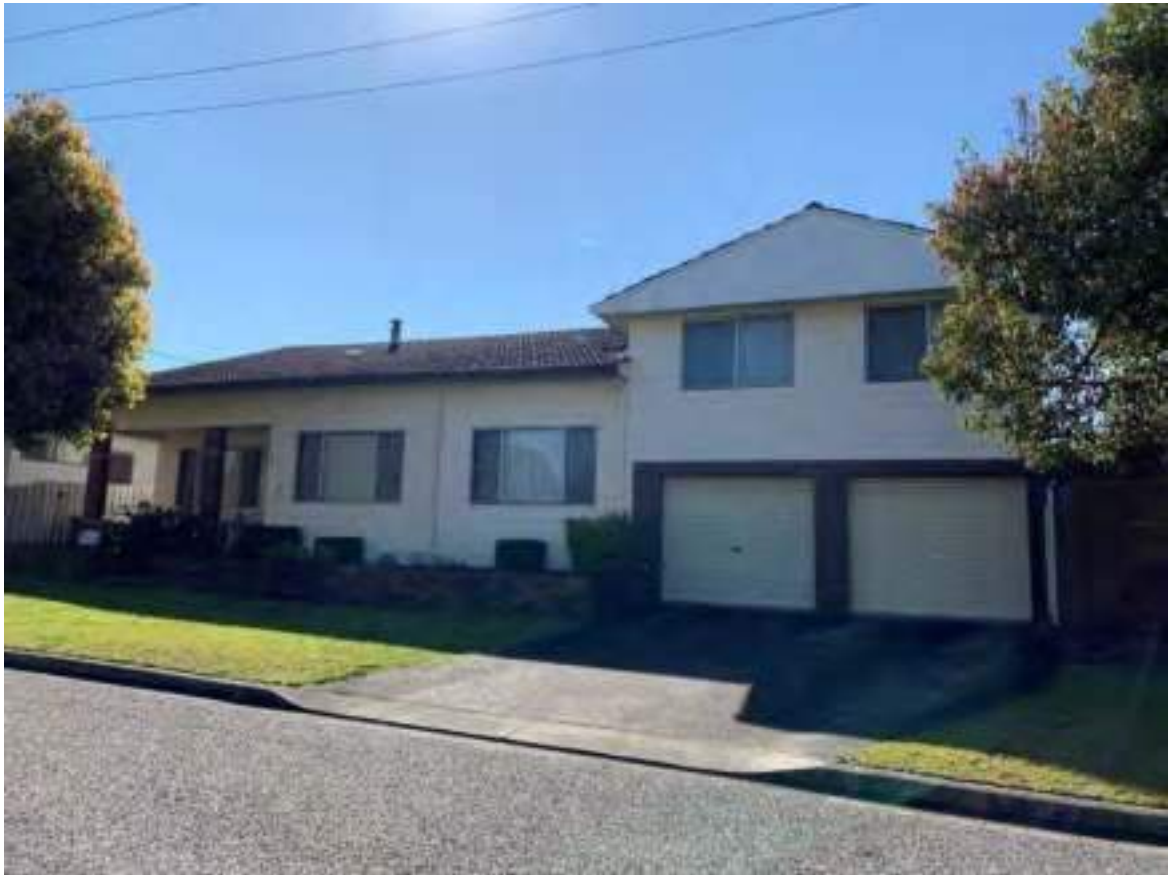
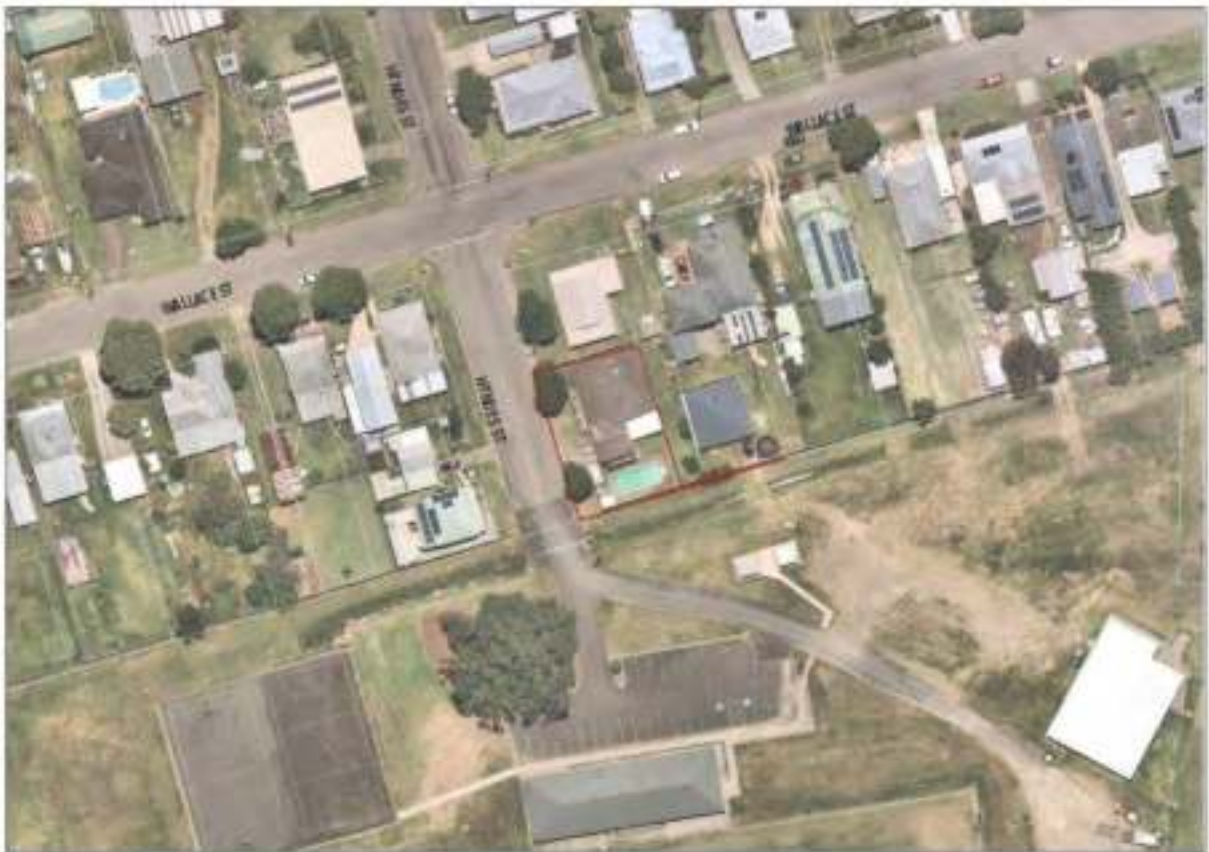
17 HYNDES STREET, WEST WALLSEND 2286

Conservation Area Contribution Level	Est. Construction Date	Previous studies and/or community input
Non-Contributory	Mid to late 20 th century onwards	No prior heritage assessments or research undertaken.
Assessment Text		Observed Modifications
<p>The scale (e.g. double-storey or greater) and general style of the dwelling is inconsistent with that of the streetscape and wider HCA.</p> <p>The dwelling does not contribute positively to the streetscape and wider HCA, particularly in comparison to Contributory 1 and 2 buildings. The presence of the building has an adverse impact on the streetscape and/or wider HCA.</p> <p>The dwelling features inappropriately proportioned and positioned fenestrations, an inappropriate roof form (gabled or hipped) and/or other features that are inconsistent with the architectural character of the area (e.g. unsympathetic additions, inconsistent [contemporary] building materials, etc).</p>		No modifications observed.

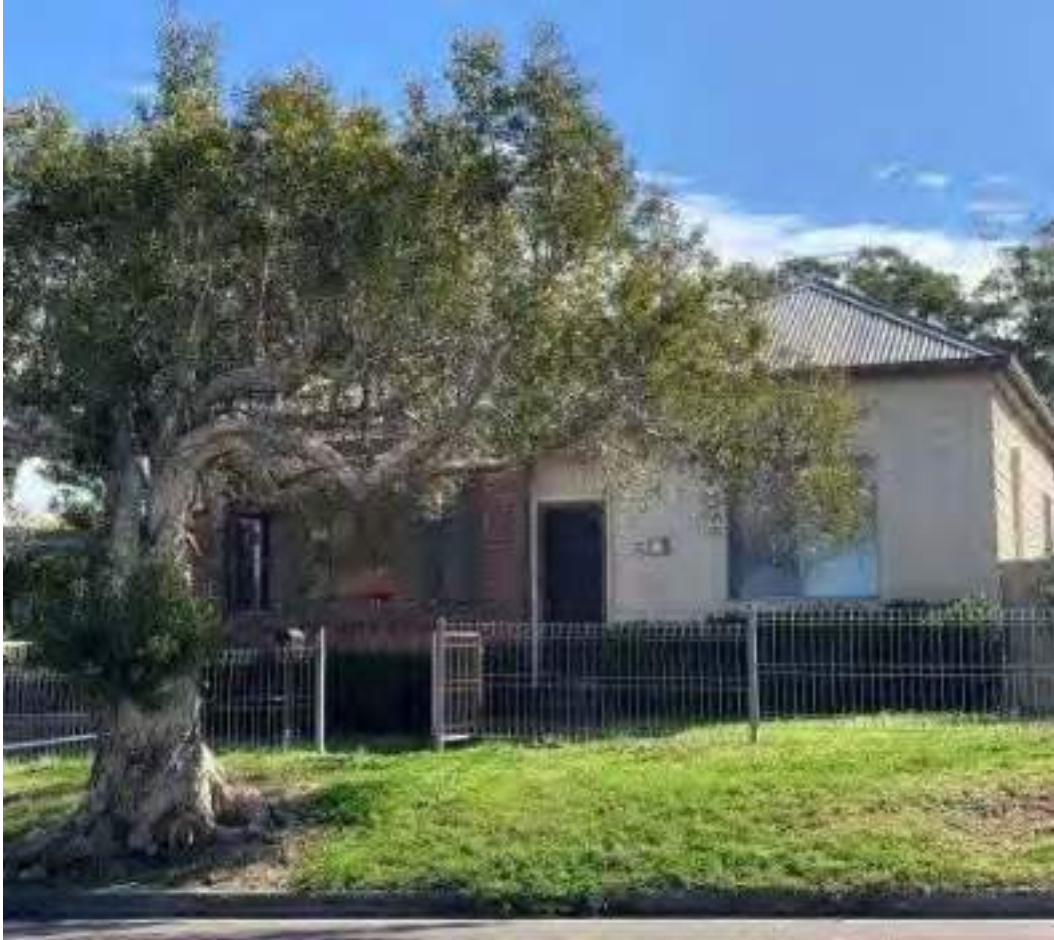
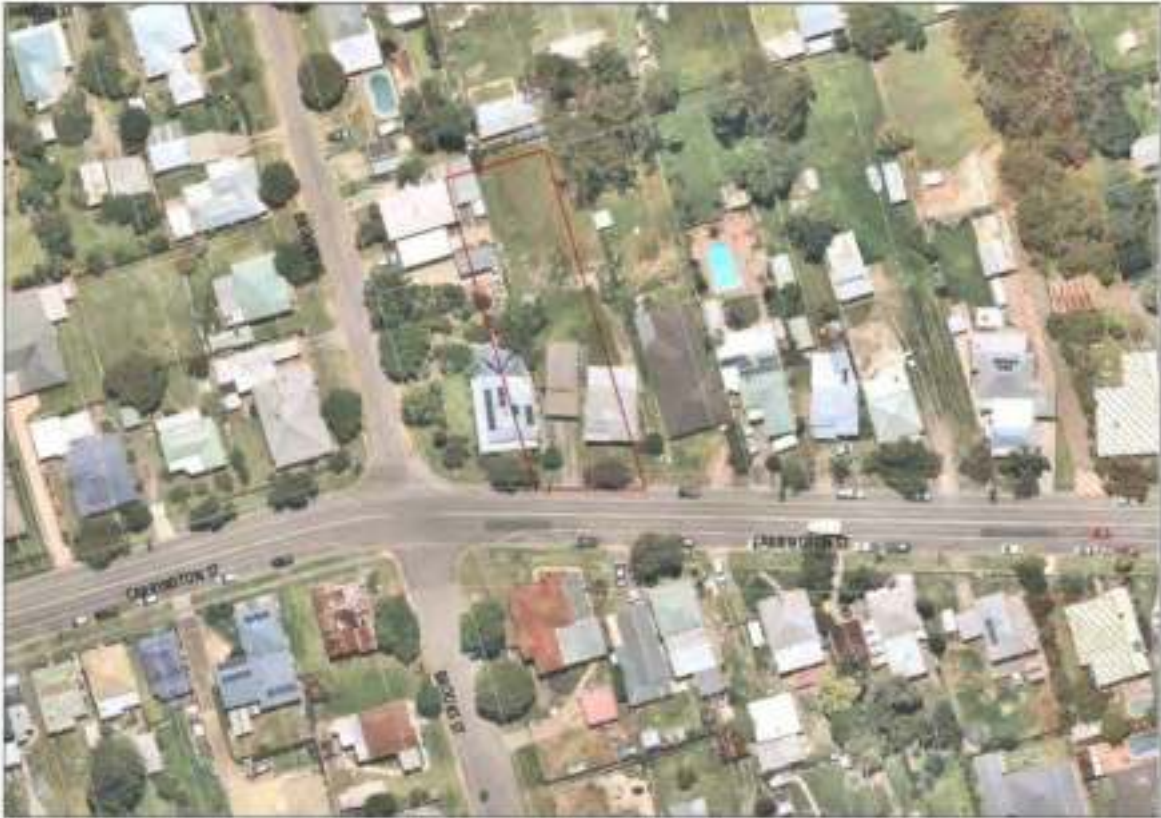
27 CARRINGTON STREET, WEST WALLSEND 2286

Conservation Area Contribution Level	Est. Construction Date	Previous studies and/or community input
Non-Contributory	Mid to late 20 th century onwards	No prior heritage assessments or research undertaken.
Assessment Text		Observed Modifications
<p>The scale (e.g. double-storey or greater) and general style of the dwelling is inconsistent with that of the streetscape and wider HCA.</p> <p>The dwelling does not contribute positively to the streetscape and wider HCA, particularly in comparison to Contributory 1 and 2 buildings. The presence of the building has an adverse impact on the streetscape and/or wider HCA.</p> <p>The dwelling features inappropriately proportioned and positioned fenestrations, an inappropriate roof form (gabled or hipped) and/or other features that are inconsistent with the architectural character of the area (e.g. unsympathetic additions, inconsistent [contemporary] building materials, etc).</p>		<p>The visible windows are contemporary in style.</p> <p>The brickwork veranda wall and support pillars are potentially an addition.</p>

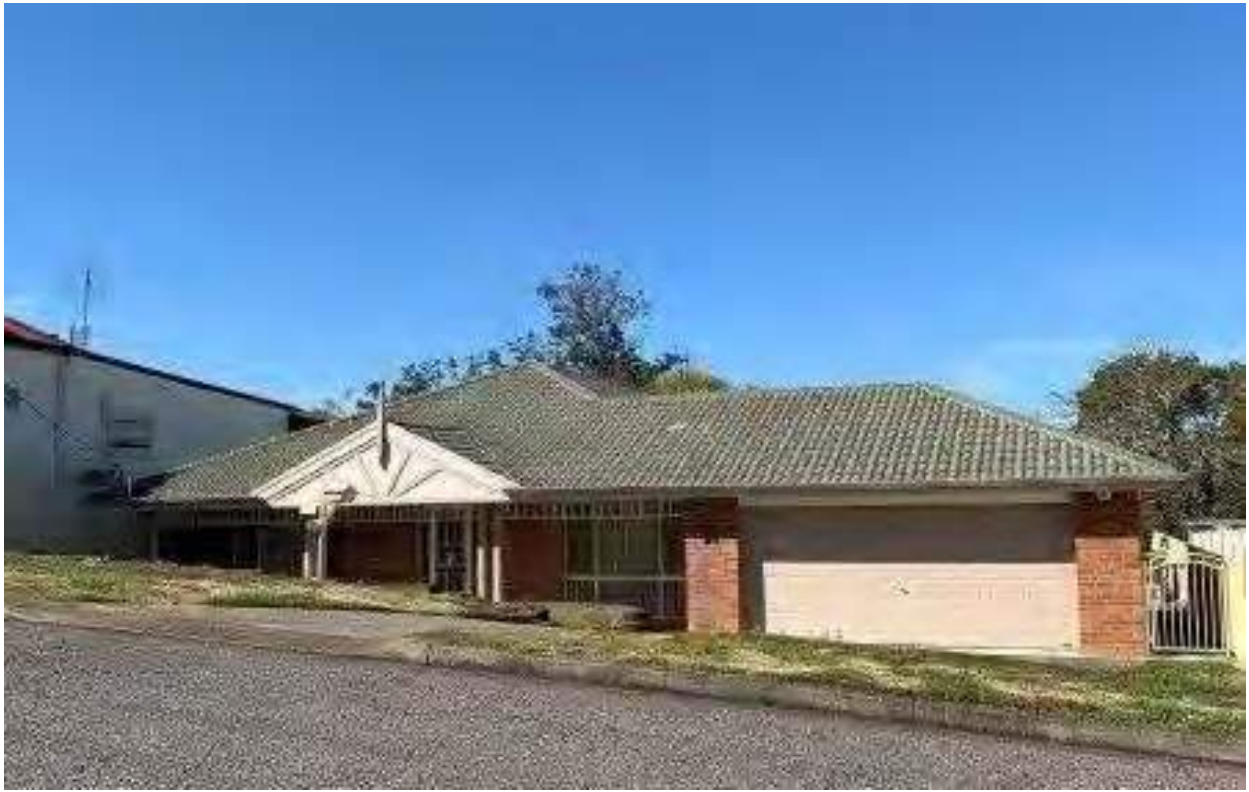
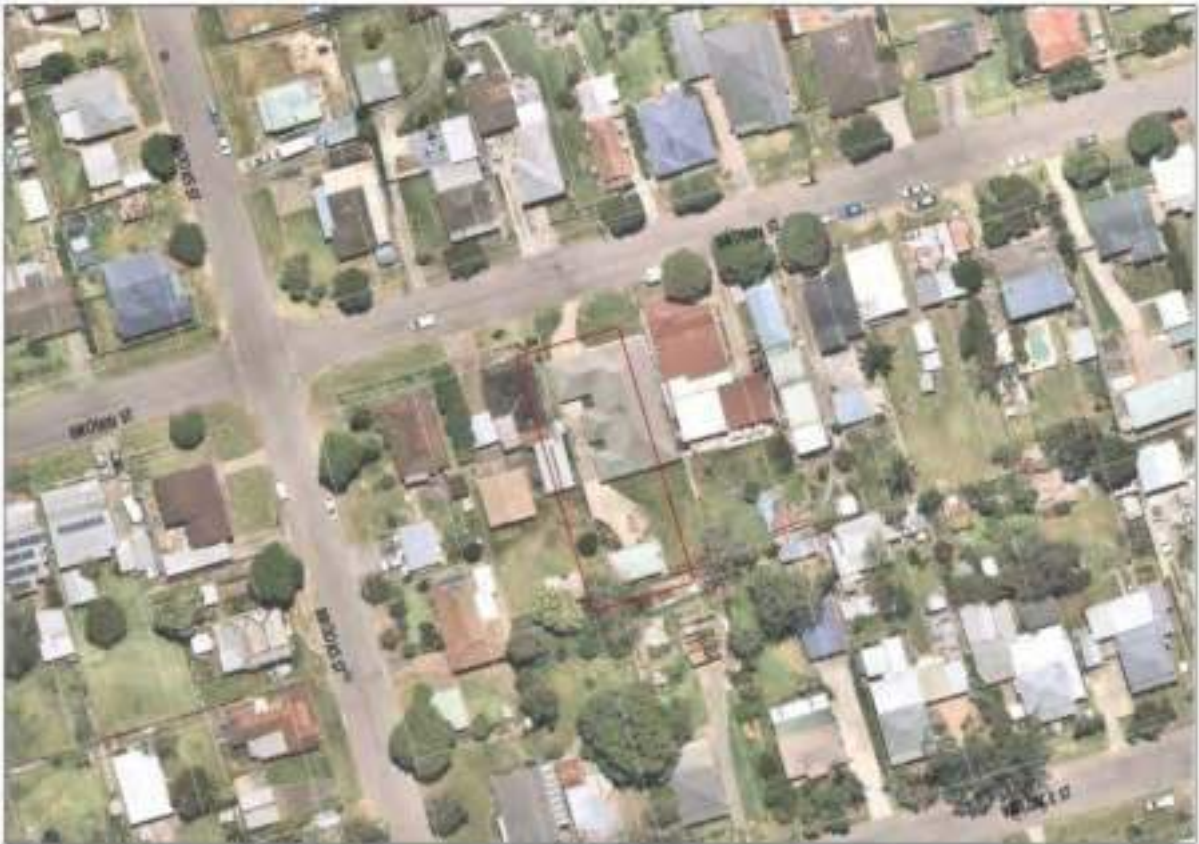
20 BROWN STREET, WEST WALLSEND 2286		
Conservation Area Contribution Level	Est. Construction Date	Previous studies and/or community input
Non-Contributory	Mid to late 20 th century onwards	No prior heritage assessments or research undertaken.
Assessment Text		Observed Modifications
<p>The scale (e.g. double-storey or greater) and general style of the dwelling is inconsistent with that of the streetscape and wider HCA.</p> <p>The dwelling does not contribute positively to the streetscape and wider HCA, particularly in comparison to Contributory 1 and 2 buildings. The presence of the building has an adverse impact on the streetscape and/or wider HCA.</p> <p>The dwelling features inappropriately proportioned and positioned fenestrations, an inappropriate roof form (gabled or hipped) and/or other features that are inconsistent with the architectural character of the area (e.g. unsympathetic additions, inconsistent [contemporary] building materials, etc).</p>		No modifications observed.

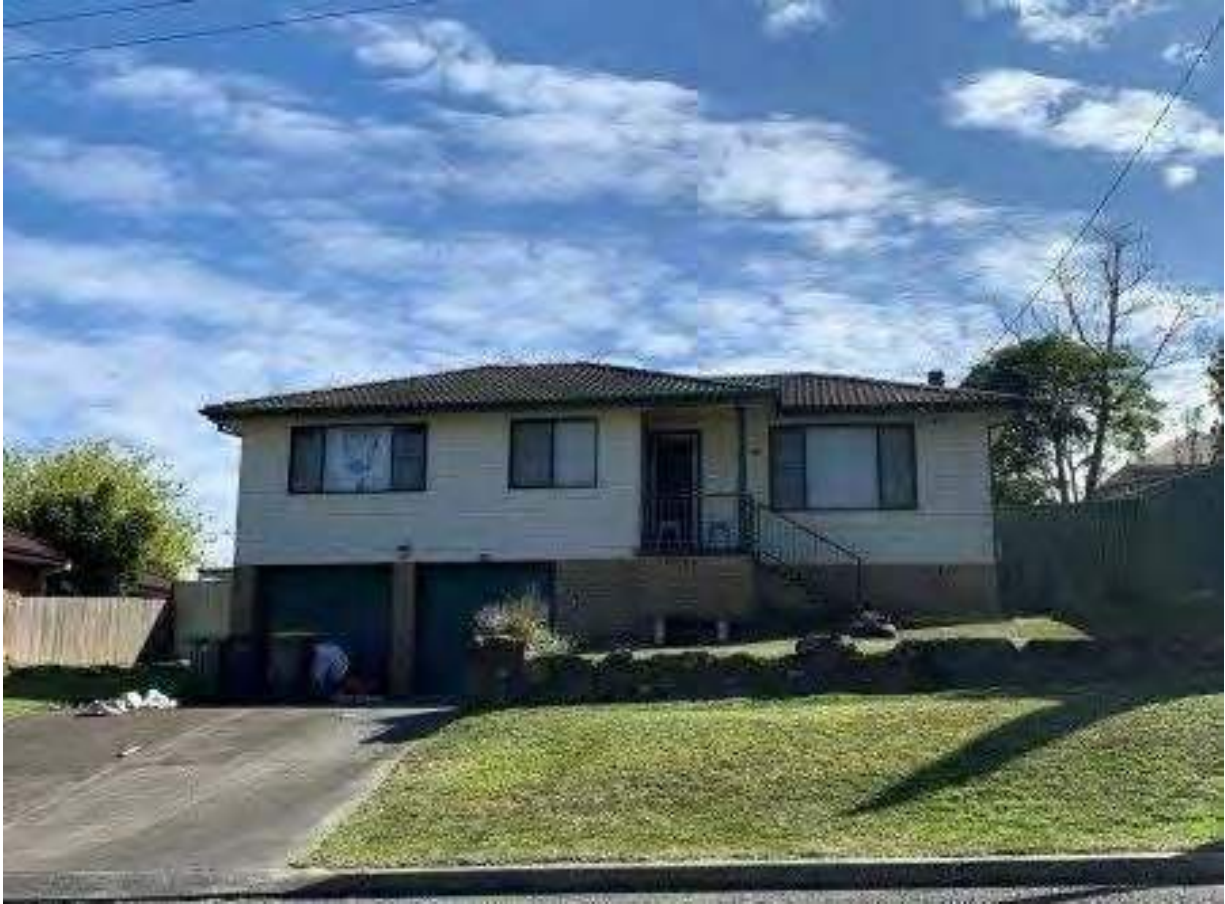
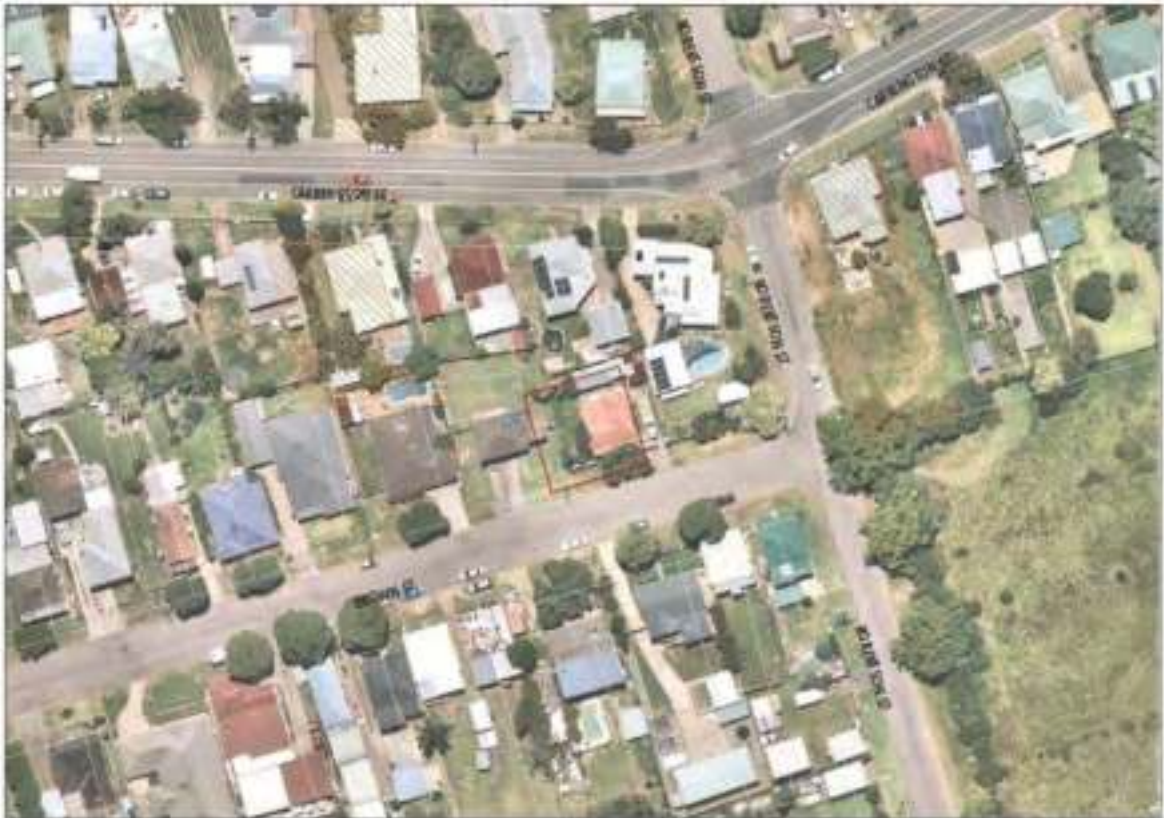
3 BROWN STREET, WEST WALLSEND 2286		
Conservation Area Contribution Level	Est. Construction Date	Previous studies and/or community input
Non-Contributory	Mid to late 20 th century onwards	No prior heritage assessments or research undertaken.
Assessment Text		Observed Modifications
<p>The scale (e.g. double-storey or greater) and general style of the dwelling is inconsistent with that of the streetscape and wider HCA.</p> <p>The dwelling does not contribute positively to the streetscape and wider HCA, particularly in comparison to Contributory 1 and 2 buildings. The presence of the building has an adverse impact on the streetscape and/or wider HCA.</p> <p>The dwelling features inappropriately proportioned and positioned fenestrations, an inappropriate roof form (gabled or hipped) and/or other features that are inconsistent with the architectural character of the area (e.g. unsympathetic additions, inconsistent [contemporary] building materials, etc).</p>		No modifications observed.

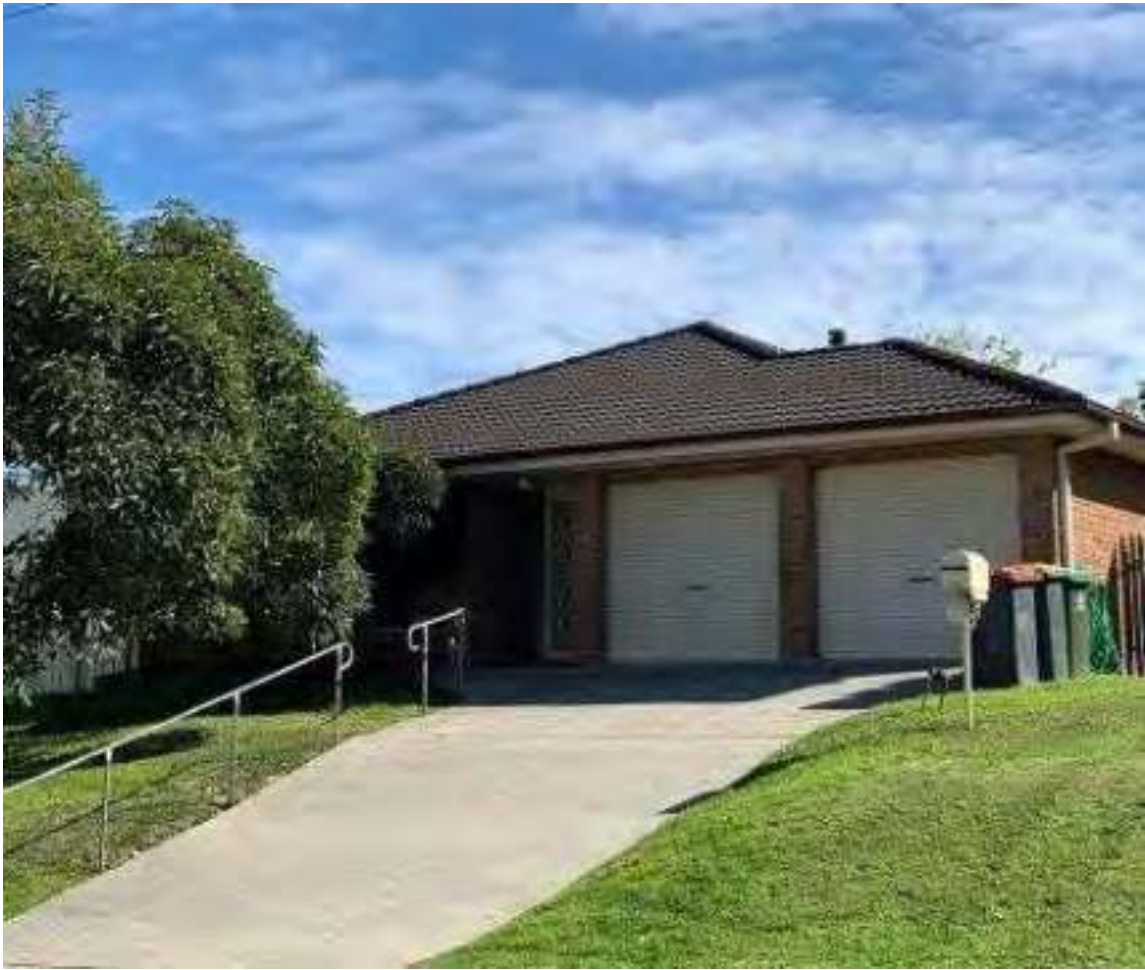
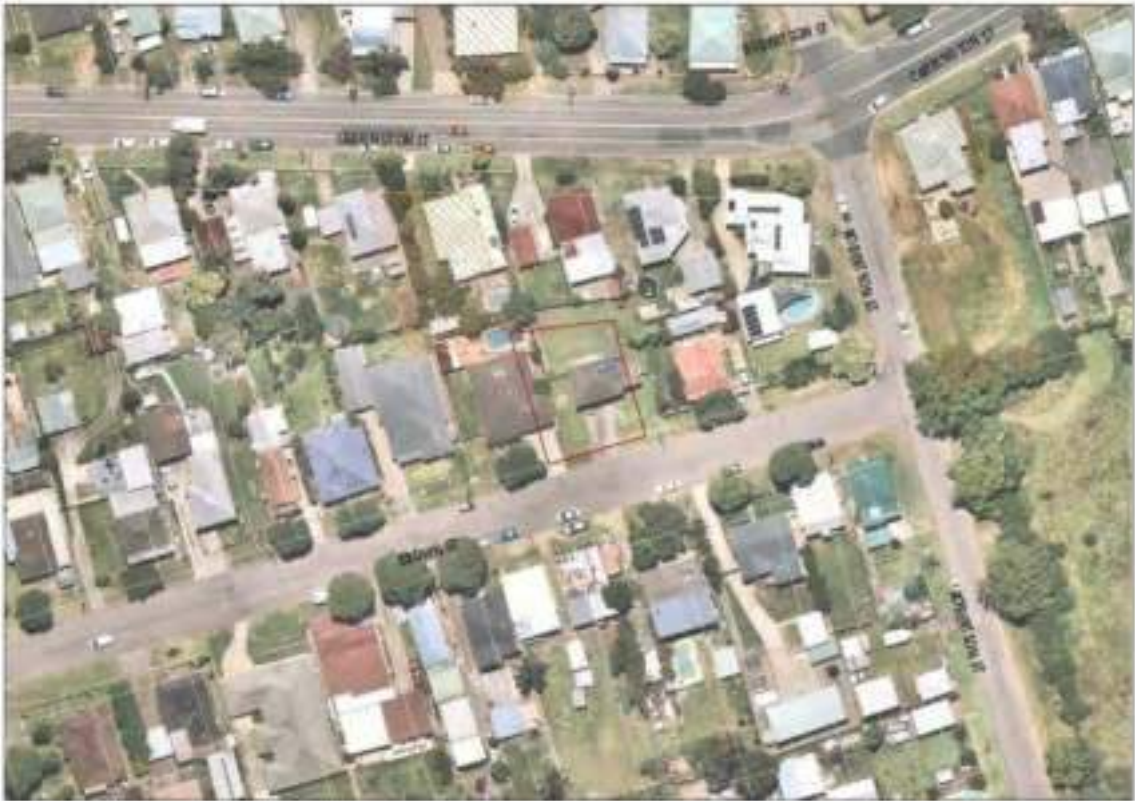
5 BROWN STREET, WEST WALLSEND 2286

Conservation Area Contribution Level	Est. Construction Date	Previous studies and/or community input
Non-Contributory	Mid to late 20 th century onwards	No prior heritage assessments or research undertaken.
Assessment Text		Observed Modifications
<p>The scale (e.g. double-storey or greater) and general style of the dwelling is inconsistent with that of the streetscape and wider HCA.</p> <p>The dwelling does not contribute positively to the streetscape and wider HCA, particularly in comparison to Contributory 1 and 2 buildings. The presence of the building has an adverse impact on the streetscape and/or wider HCA.</p> <p>The dwelling features inappropriately proportioned and positioned fenestrations, an inappropriate roof form (gabled or hipped) and/or other features that are inconsistent with the architectural character of the area (e.g. unsympathetic additions, inconsistent [contemporary] building materials, etc).</p>		No modifications observed.

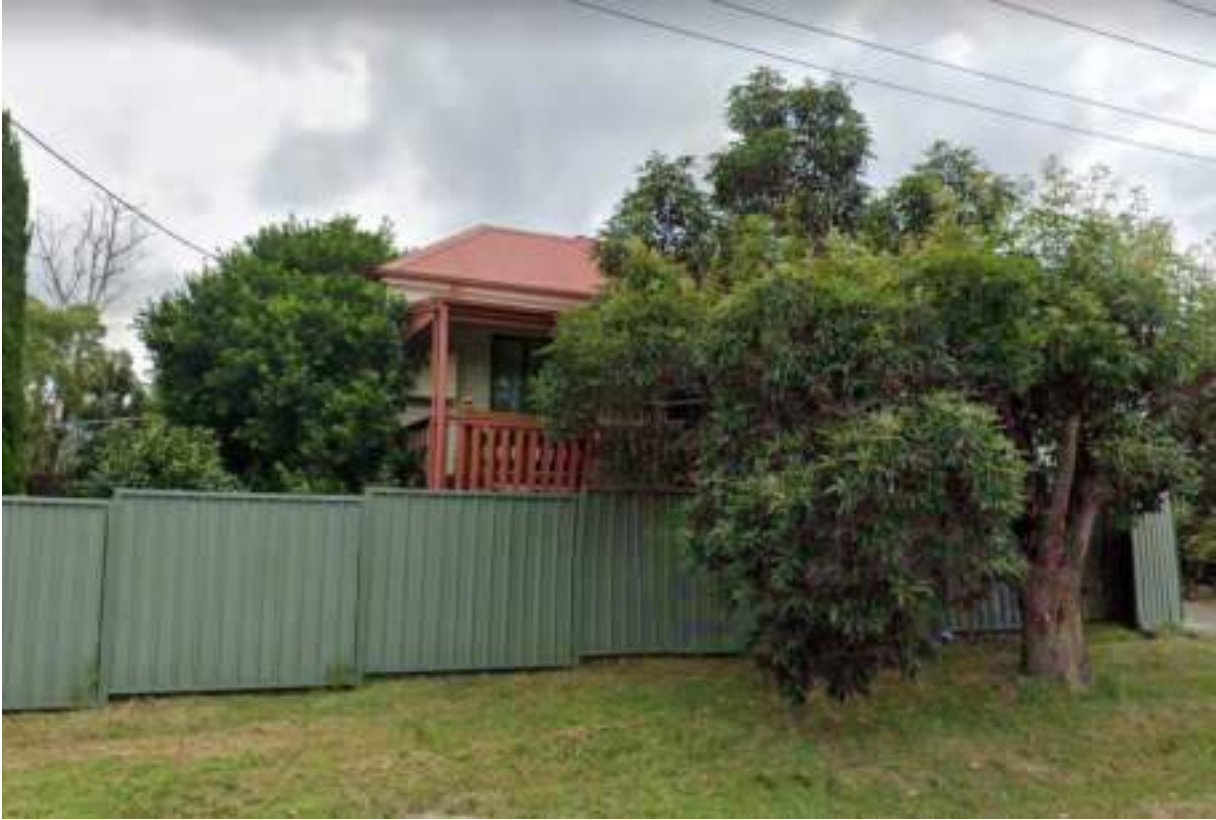
1 BROWN STREET, WEST WALLSEND 2286

Conservation Area Contribution Level	Est. Construction Date	Previous studies and/or community input
Non-Contributory	Mid to late 20 th century onwards	No prior heritage assessments or research undertaken.
Assessment Text		Observed Modifications
<p>The scale (e.g. double-storey or greater) and general style of the dwelling is inconsistent with that of the streetscape and wider HCA.</p> <p>The dwelling does not contribute positively to the streetscape and wider HCA, particularly in comparison to Contributory 1 and 2 buildings. The presence of the building has an adverse impact on the streetscape and/or wider HCA.</p> <p>The dwelling features inappropriately proportioned and positioned fenestrations, an inappropriate roof form (gabled or hipped) and/or other features that are inconsistent with the architectural character of the area (e.g. unsympathetic additions, inconsistent [contemporary] building materials, etc).</p>		No modifications observed.

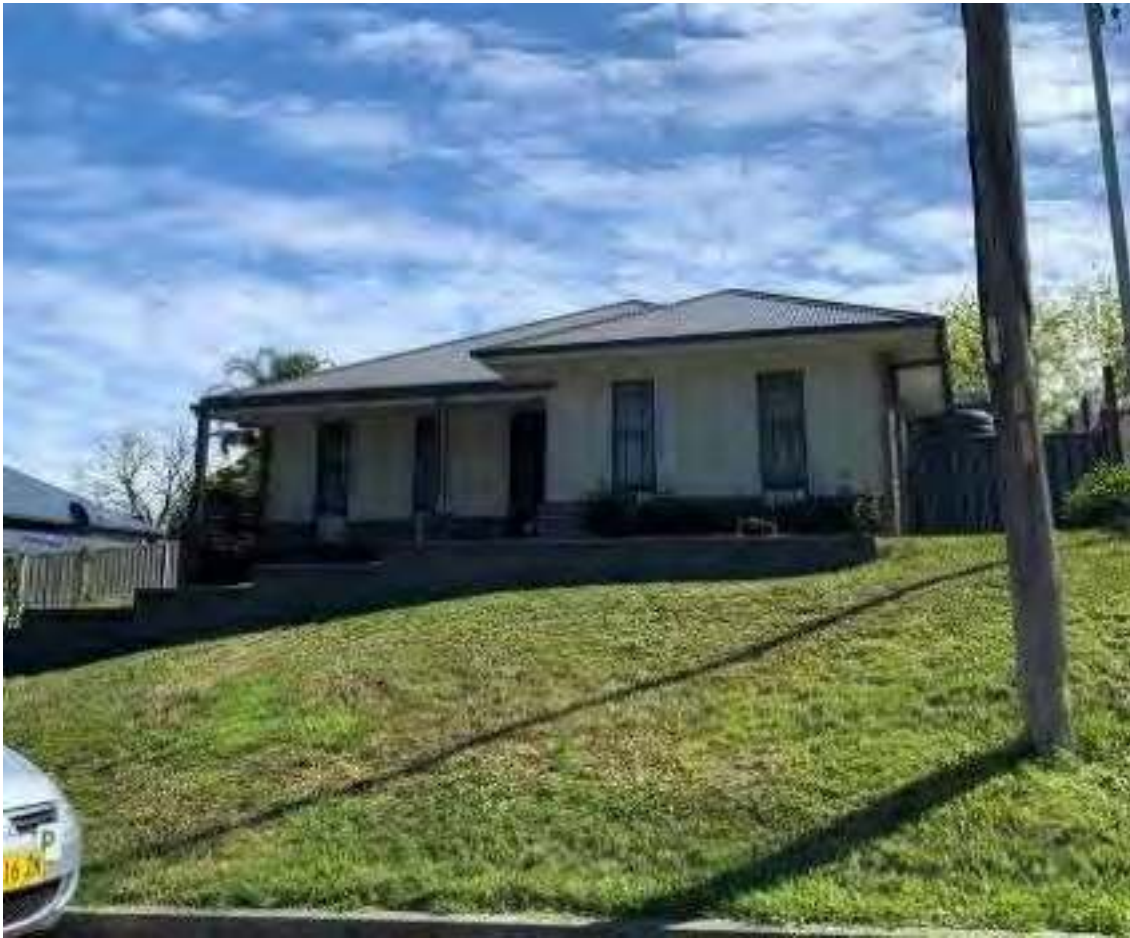
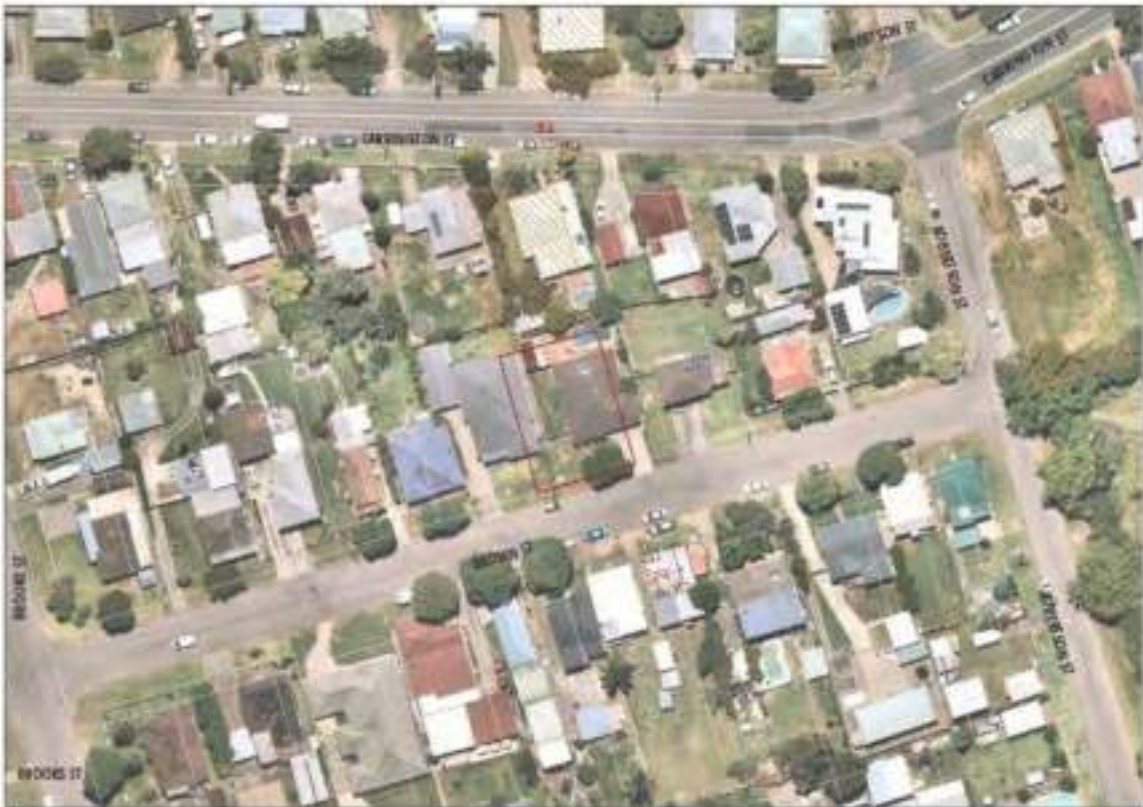
7 BROWN STREET, WEST WALLSEND 2286

Conservation Area Contribution Level	Est. Construction Date	Previous studies and/or community input
Non-Contributory	Mid to late 20 th century onwards	No prior heritage assessments or research undertaken.
Assessment Text		Observed Modifications
<p>The scale (e.g. double-storey or greater) and general style of the dwelling is inconsistent with that of the streetscape and wider HCA.</p> <p>The dwelling does not contribute positively to the streetscape and wider HCA, particularly in comparison to Contributory 1 and 2 buildings. The presence of the building has an adverse impact on the streetscape and/or wider HCA.</p> <p>The dwelling features inappropriately proportioned and positioned fenestrations, an inappropriate roof form (gabled or hipped) and/or other features that are inconsistent with the architectural character of the area (e.g. unsympathetic additions, inconsistent [contemporary] building materials, etc).</p>		No modifications observed.

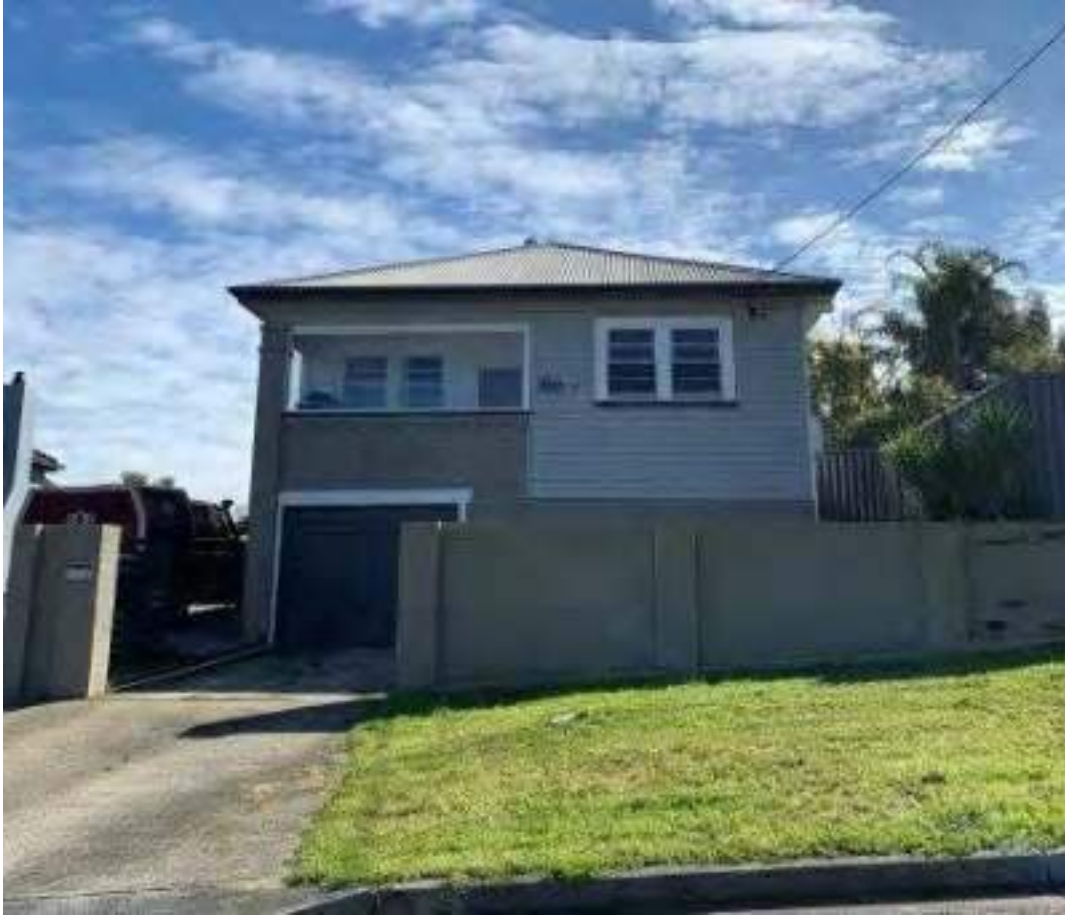
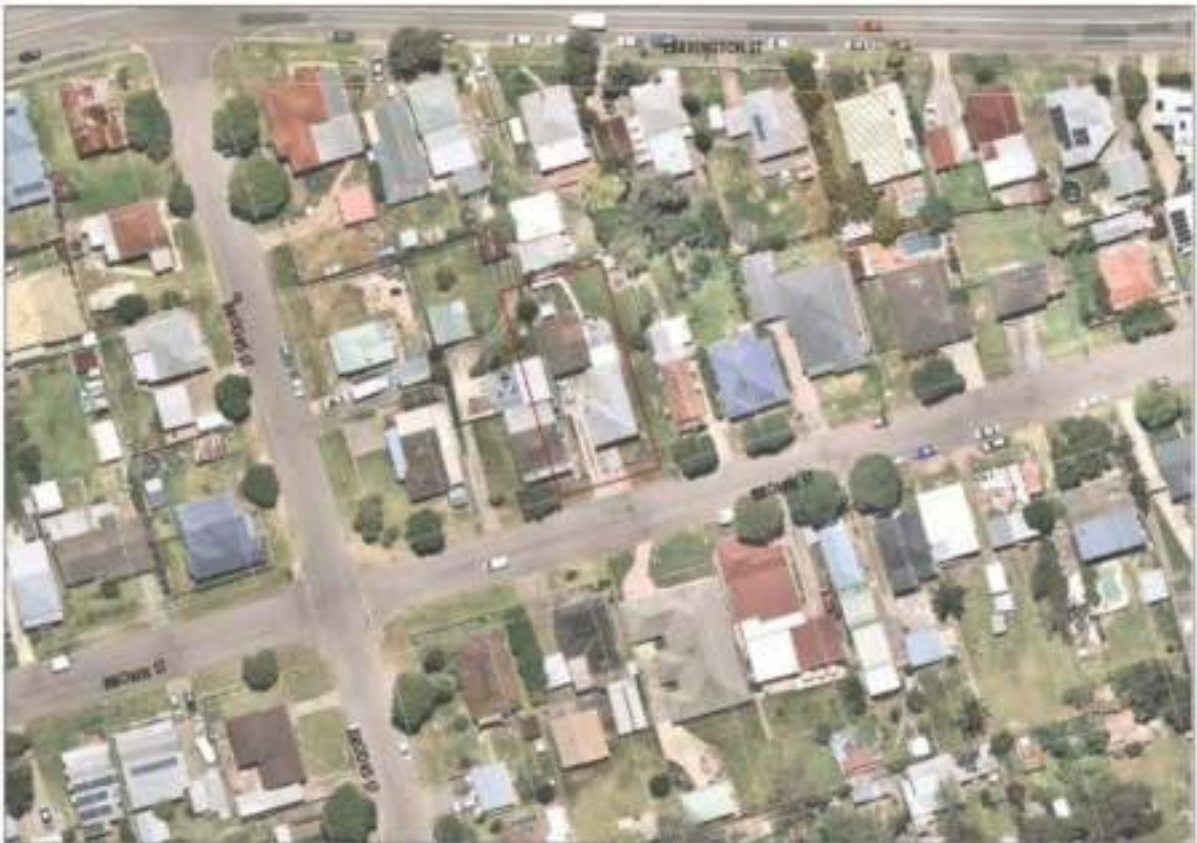
13 BROWN STREET, WEST WALLSEND 2286

Conservation Area Contribution Level	Est. Construction Date	Previous studies and/or community input
Non-Contributory	Mid to late 20 th century onwards	No prior heritage assessments or research undertaken.
Assessment Text		Observed Modifications
<p>The scale (e.g. double-storey or greater) and general style of the dwelling is inconsistent with that of the streetscape and wider HCA.</p> <p>The dwelling does not contribute positively to the streetscape and wider HCA, particularly in comparison to Contributory 1 and 2 buildings. The presence of the building has an adverse impact on the streetscape and/or wider HCA.</p> <p>The dwelling features inappropriately proportioned and positioned fenestrations, an inappropriate roof form (gabled or hipped) and/or other features that are inconsistent with the architectural character of the area (e.g. unsympathetic additions, inconsistent [contemporary] building materials, etc).</p>		<p>The veranda has been fully enclosed with the addition of a large window, previously an open space, allowing for the space to be converted into an additional living area.</p>

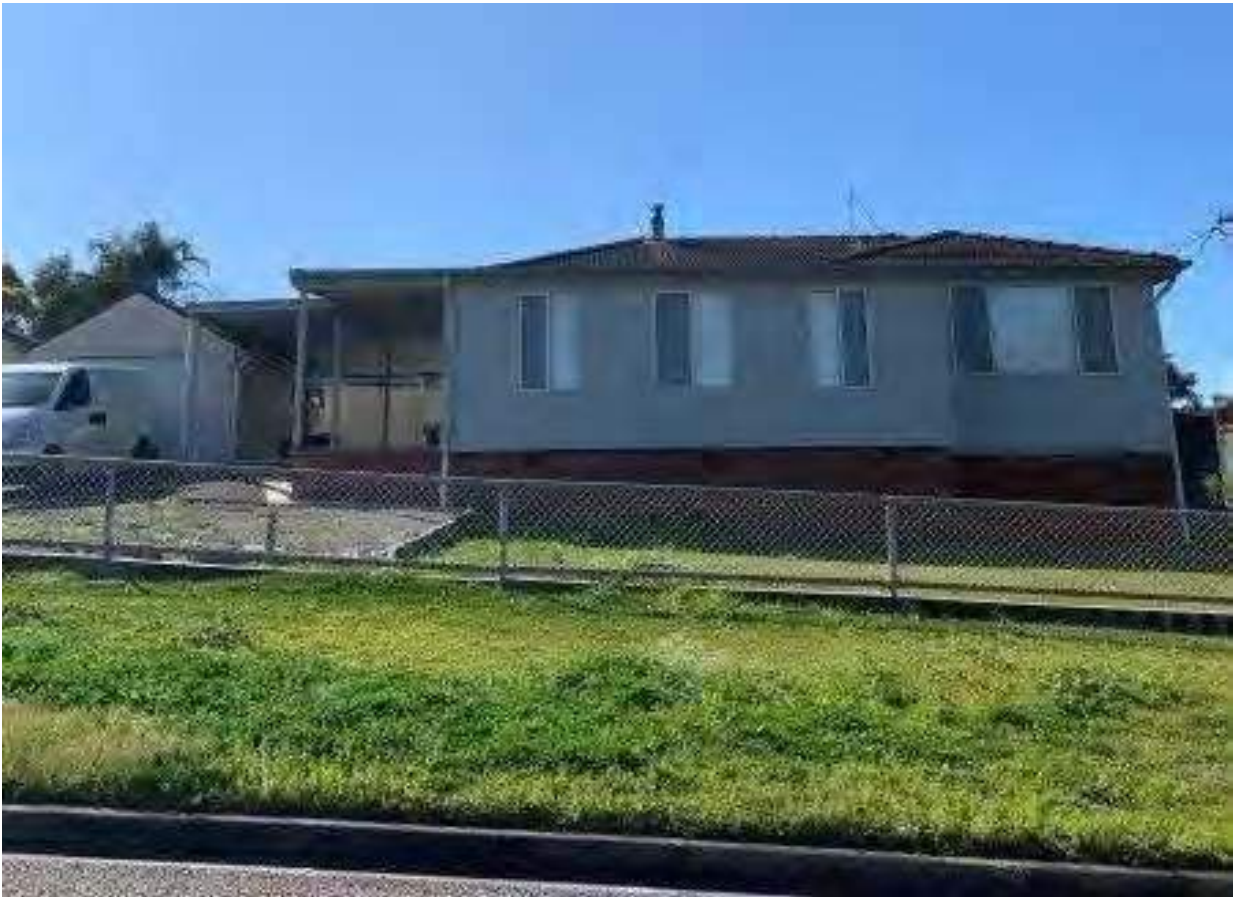
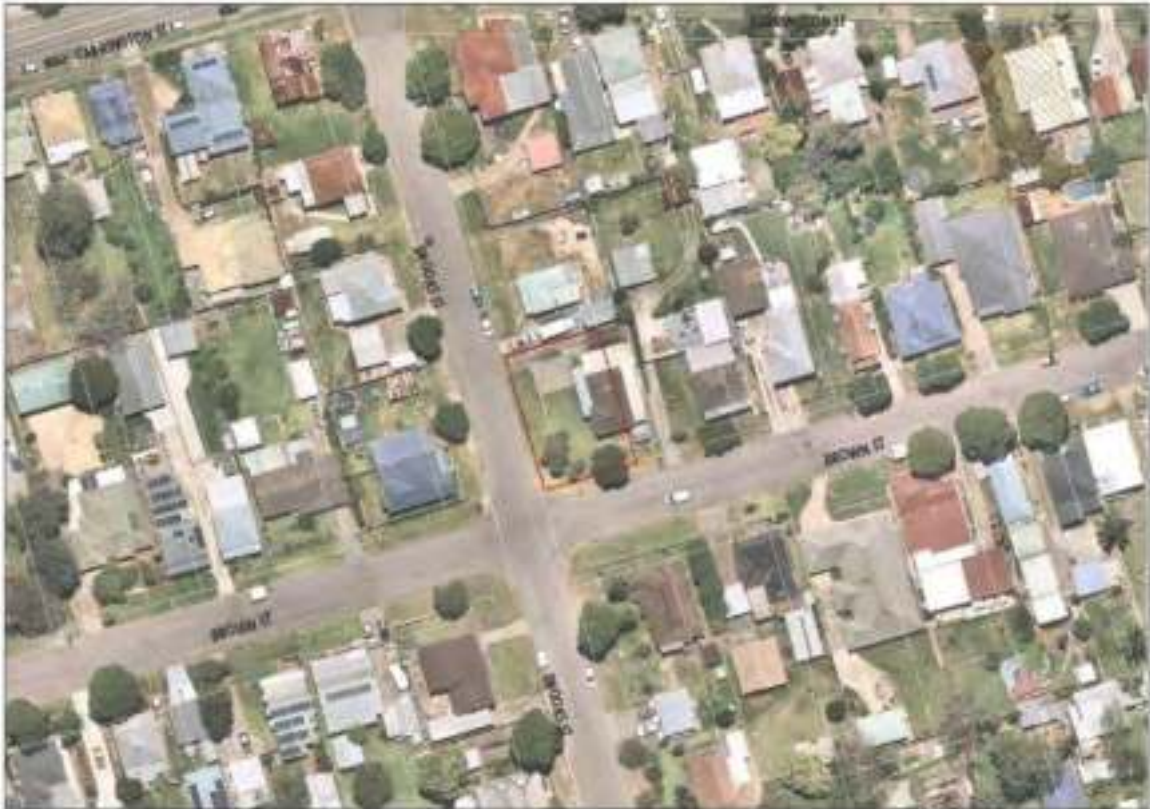
5 BROOKS STREET, WEST WALLSEND 2286

Conservation Area Contribution Level	Est. Construction Date	Previous studies and/or community input
Non-Contributory	Mid to late 20 th century onwards	No prior heritage assessments or research undertaken.
Assessment Text		Observed Modifications
<p>The scale (e.g. double-storey or greater) and general style of the dwelling is inconsistent with that of the streetscape and wider HCA.</p> <p>The dwelling does not contribute positively to the streetscape and wider HCA, particularly in comparison to Contributory 1 and 2 buildings. The presence of the building has an adverse impact on the streetscape and/or wider HCA.</p> <p>The dwelling features inappropriately proportioned and positioned fenestrations, an inappropriate roof form (gabled or hipped) and/or other features that are inconsistent with the architectural character of the area (e.g. unsympathetic additions, inconsistent [contemporary] building materials, etc).</p>		<p>The veranda located on the north western side of the dwelling has been extended, with a flat roof and metal support posts.</p>

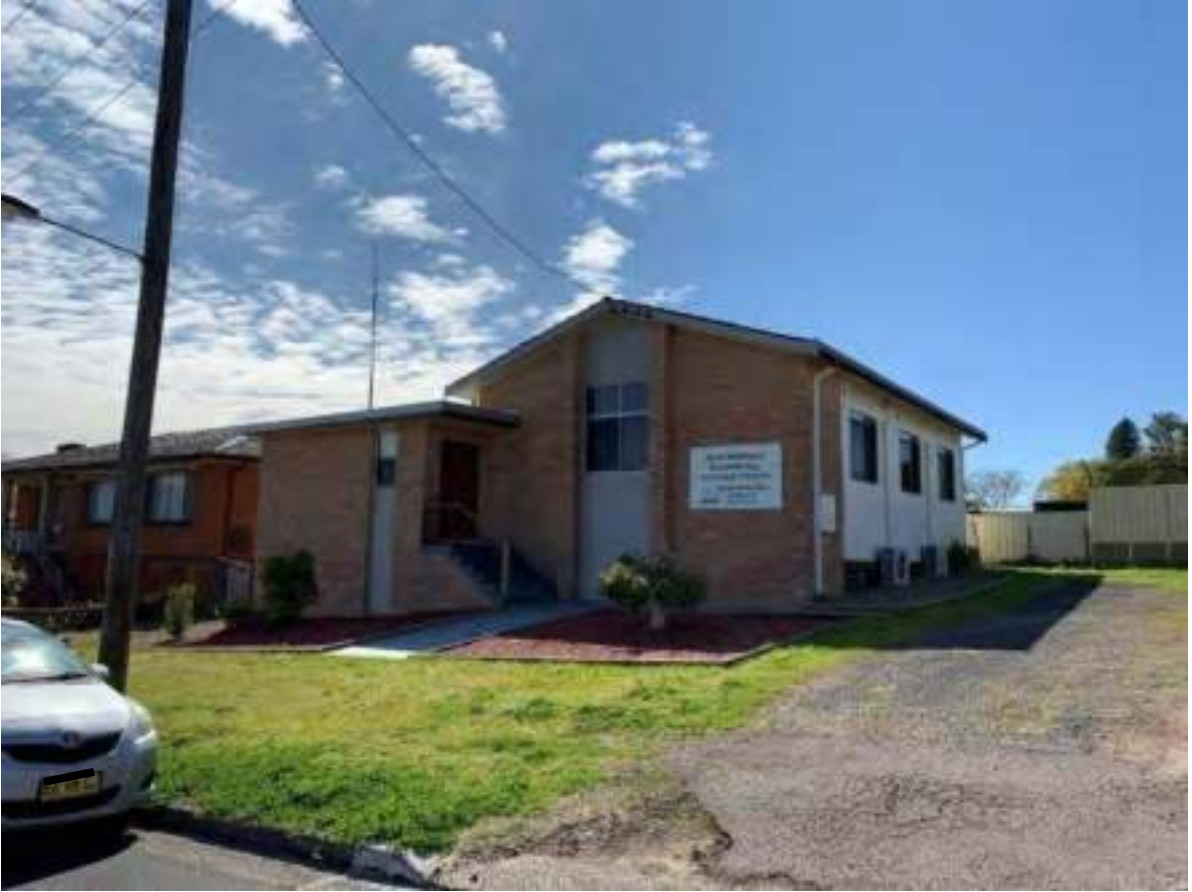
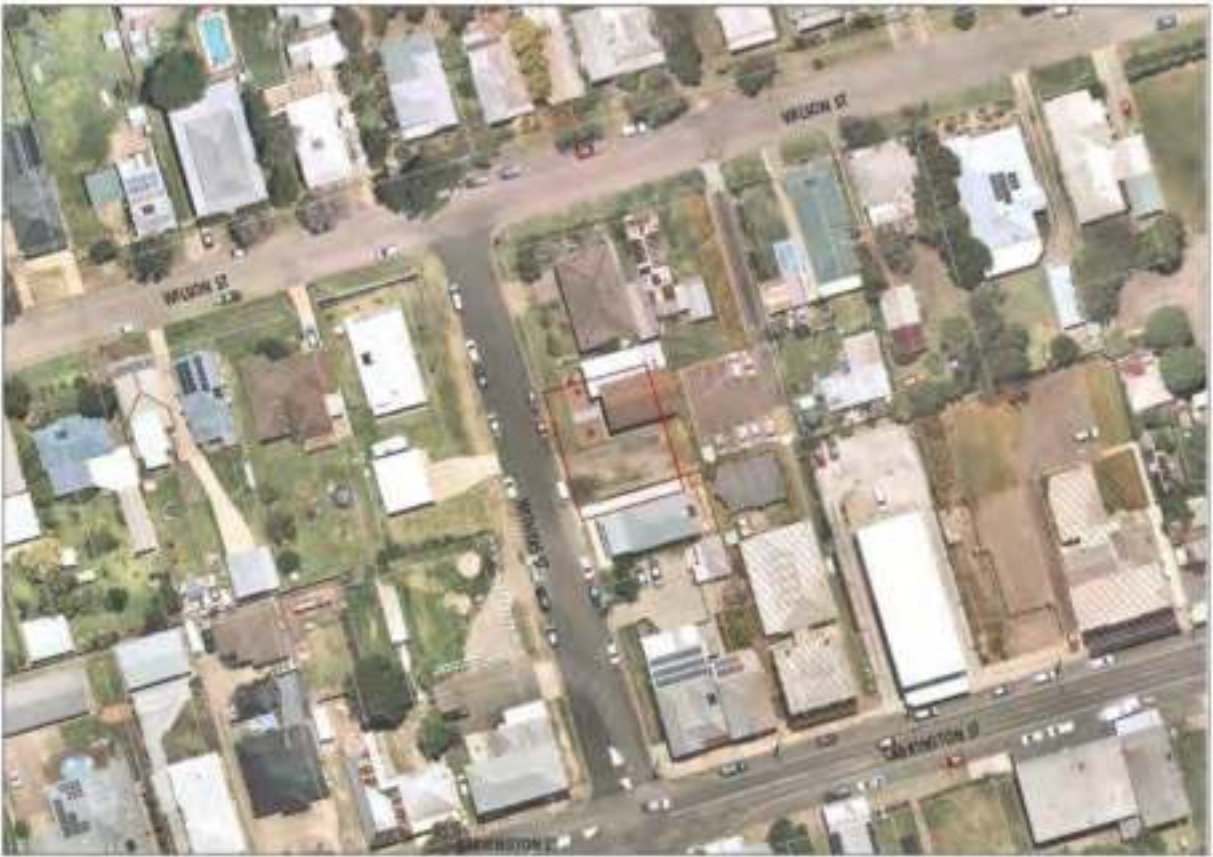
3 WITHERS STREET, WEST WALLSEND 2286		
Conservation Area Contribution Level	Est. Construction Date	Previous studies and/or community input
Non-Contributory	Mid to late 20 th century onwards	No prior heritage assessments or research undertaken.
Assessment Text		Observed Modifications
<p>The scale (e.g. double-storey or greater) and general style of the dwelling is inconsistent with that of the streetscape and wider HCA.</p> <p>The dwelling does not contribute positively to the streetscape and wider HCA, particularly in comparison to Contributory 1 and 2 buildings. The presence of the building has an adverse impact on the streetscape and/or wider HCA.</p> <p>The dwelling features inappropriately proportioned and positioned fenestrations, an inappropriate roof form (gabled or hipped) and/or other features that are inconsistent with the architectural character of the area (e.g. unsympathetic additions, inconsistent [contemporary] building materials, etc).</p>		No modifications observed.
