APPENDIX 2

Building Assessment Sheets (Inventory Sheets)

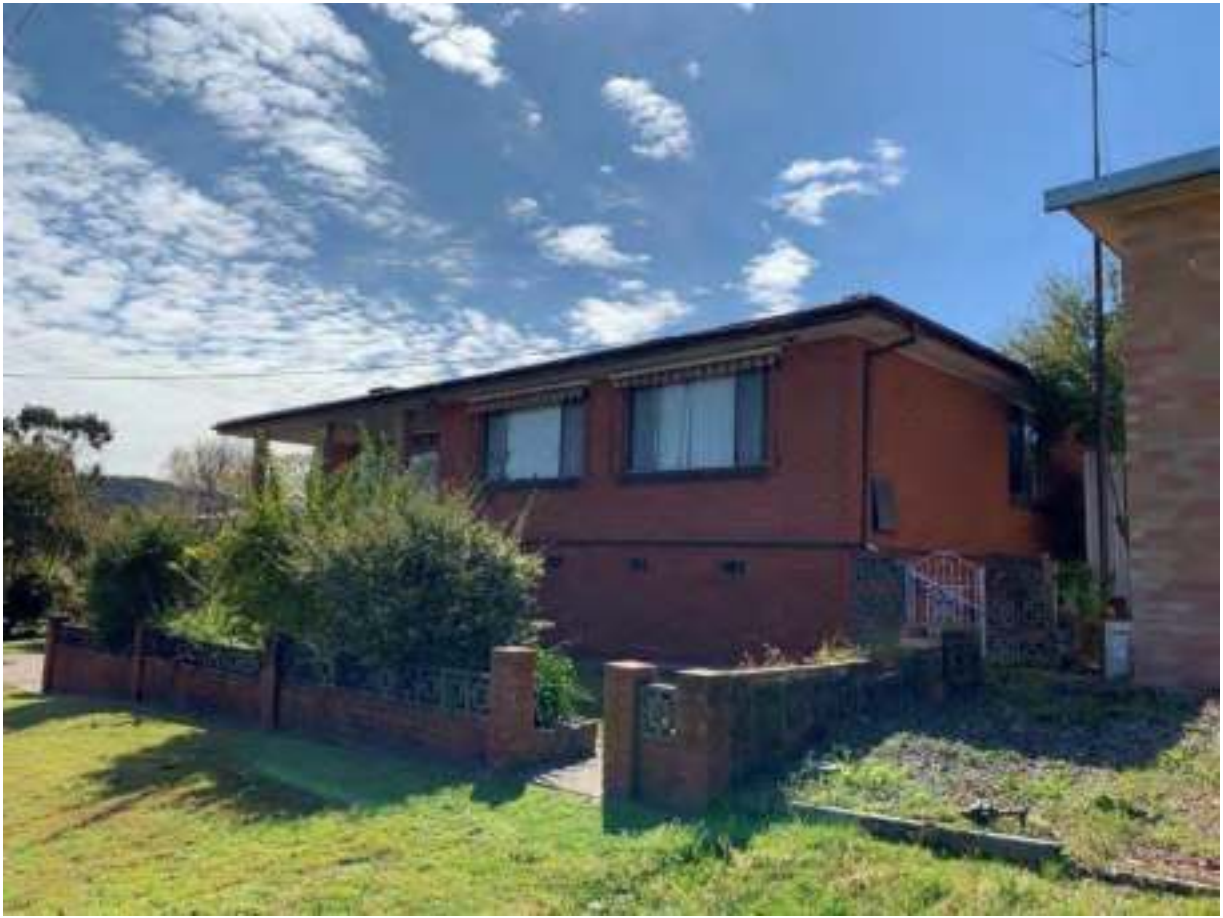
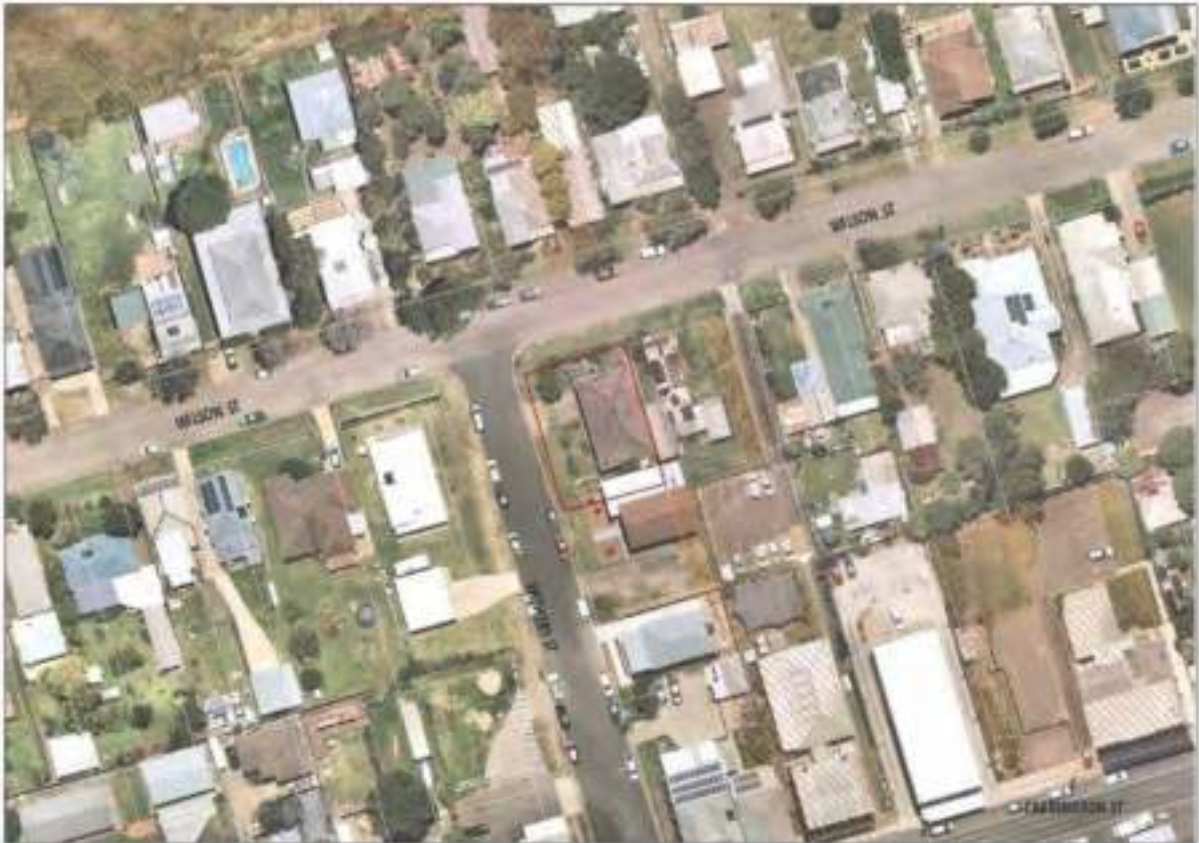
1 WITHERS STREET, WEST WALLSEND 2286		
Conservation Area Contribution Level	Est. Construction Date	Previous studies and/or community input
Non-Contributory	Mid to late 20 th century onwards	No prior heritage assessments or research undertaken.
Assessment Text		Observed Modifications
<p>The scale (e.g. double-storey or greater) and general style of the dwelling is inconsistent with that of the streetscape and wider HCA.</p> <p>The dwelling does not contribute positively to the streetscape and wider HCA, particularly in comparison to Contributory 1 and 2 buildings. The presence of the building has an adverse impact on the streetscape and/or wider HCA.</p> <p>The dwelling features inappropriately proportioned and positioned fenestrations, an inappropriate roof form (gabled or hipped) and/or other features that are inconsistent with the architectural character of the area (e.g. unsympathetic additions, inconsistent [contemporary] building materials, etc).</p>		No modifications observed.

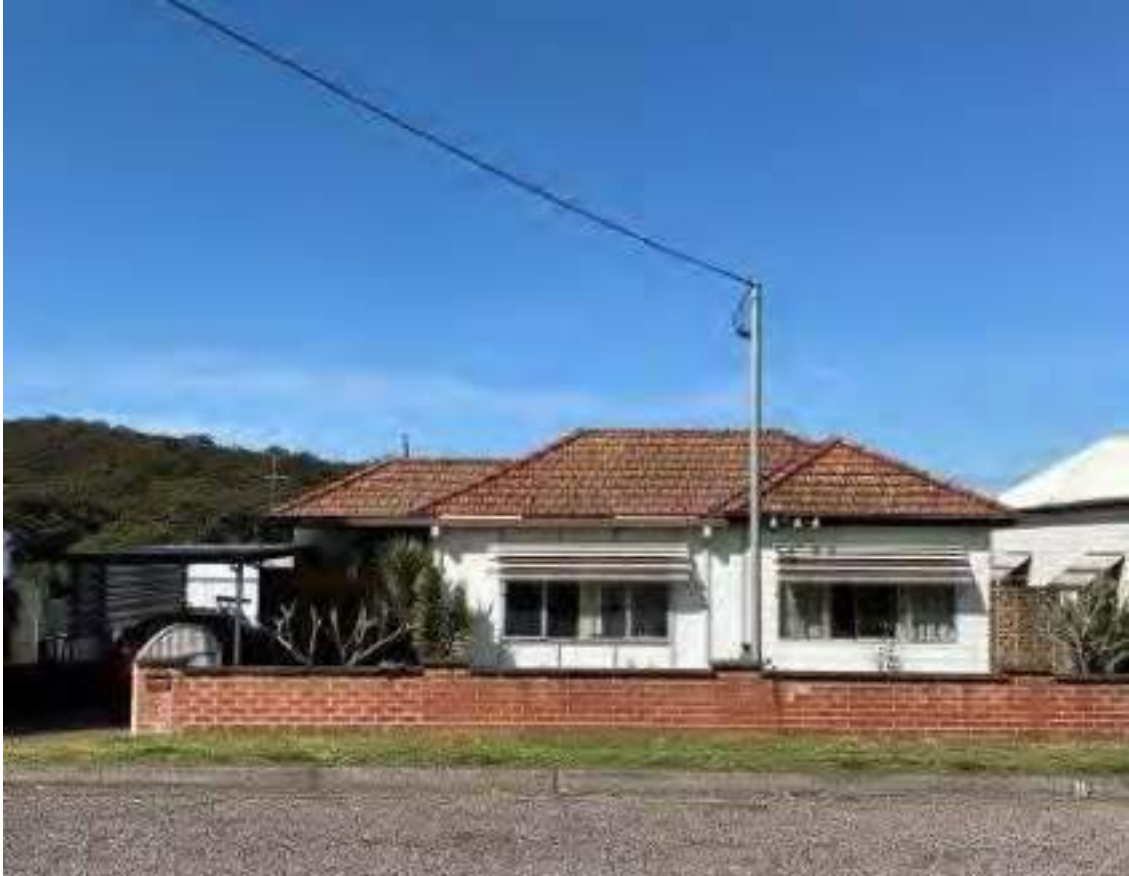
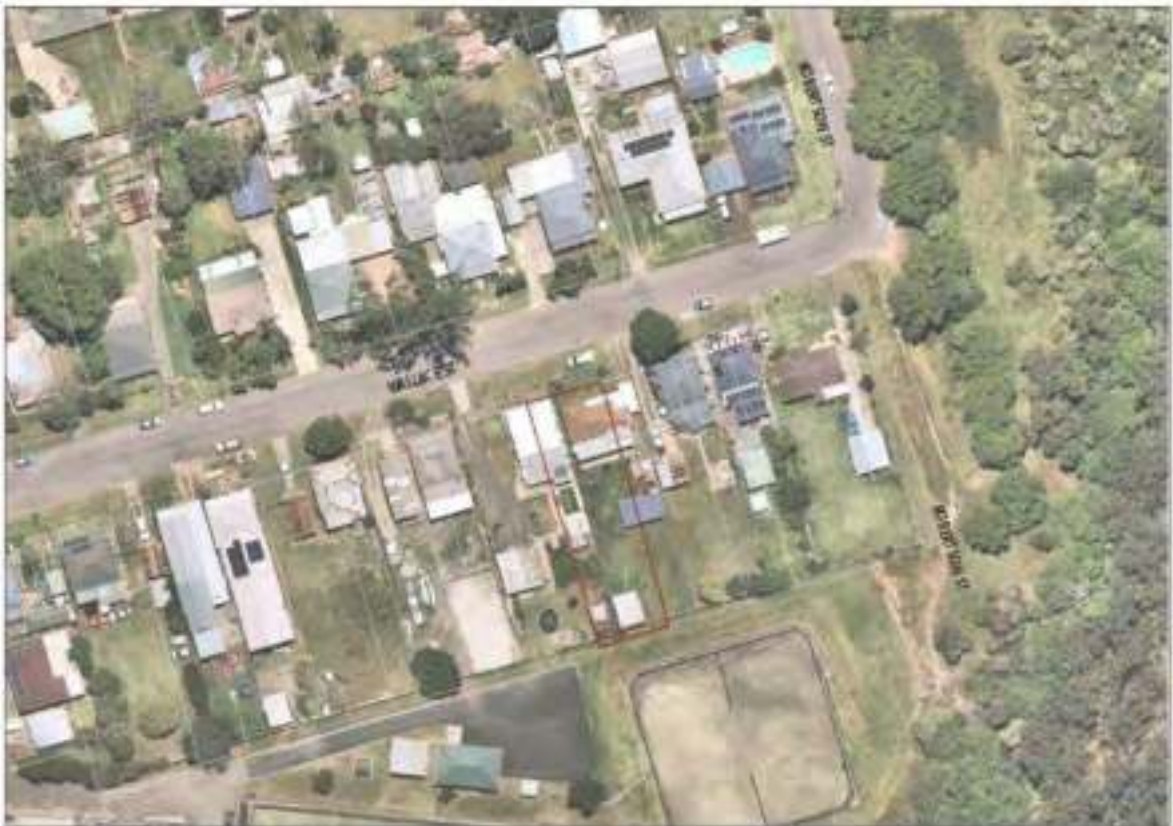
8 WALLACE STREET, WEST WALLSEND 2286		
Conservation Area Contribution Level	Est. Construction Date	Previous studies and/or community input
Non-Contributory	Mid to late 20 th century onwards	No prior heritage assessments or research undertaken.
Assessment Text		Observed Modifications
<p>The scale (e.g. double-storey or greater) and general style of the dwelling is inconsistent with that of the streetscape and wider HCA.</p> <p>The dwelling does not contribute positively to the streetscape and wider HCA, particularly in comparison to Contributory 1 and 2 buildings. The presence of the building has an adverse impact on the streetscape and/or wider HCA.</p> <p>The dwelling features inappropriately proportioned and positioned fenestrations, an inappropriate roof form (gabled or hipped) and/or other features that are inconsistent with the architectural character of the area (e.g. unsympathetic additions, inconsistent [contemporary] building materials, etc).</p>		<p>A carport has been built onto the eastern side of the dwelling.</p>

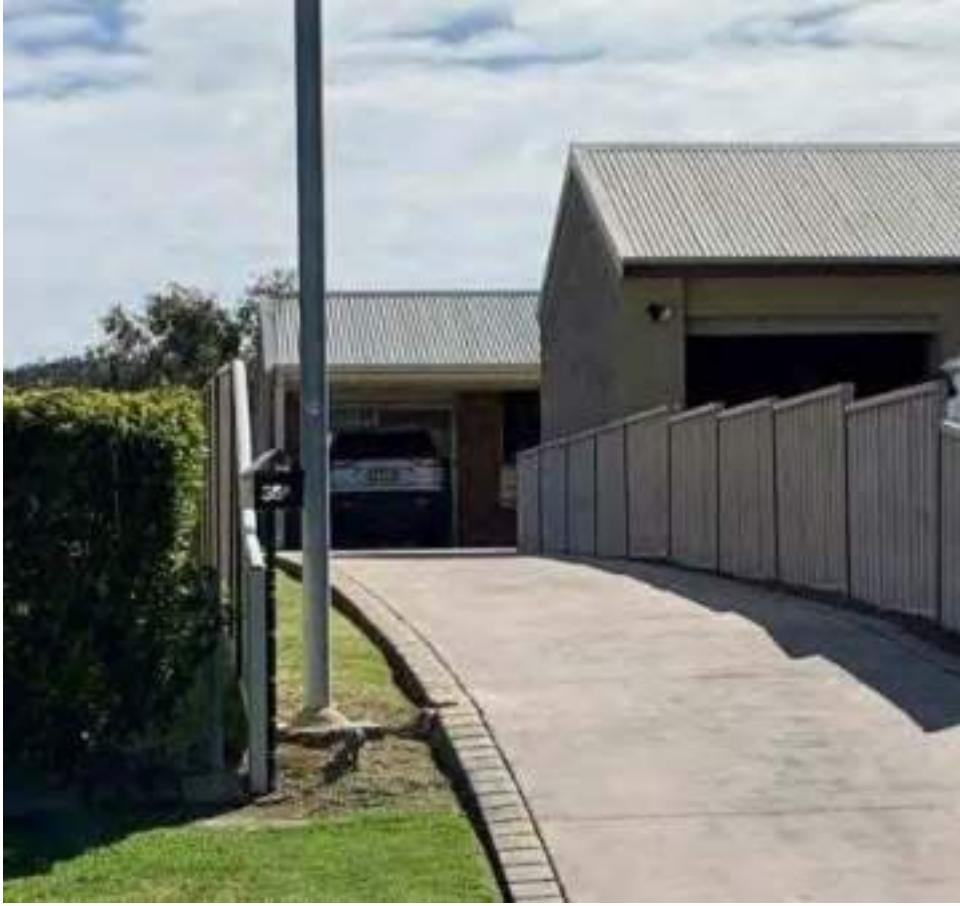
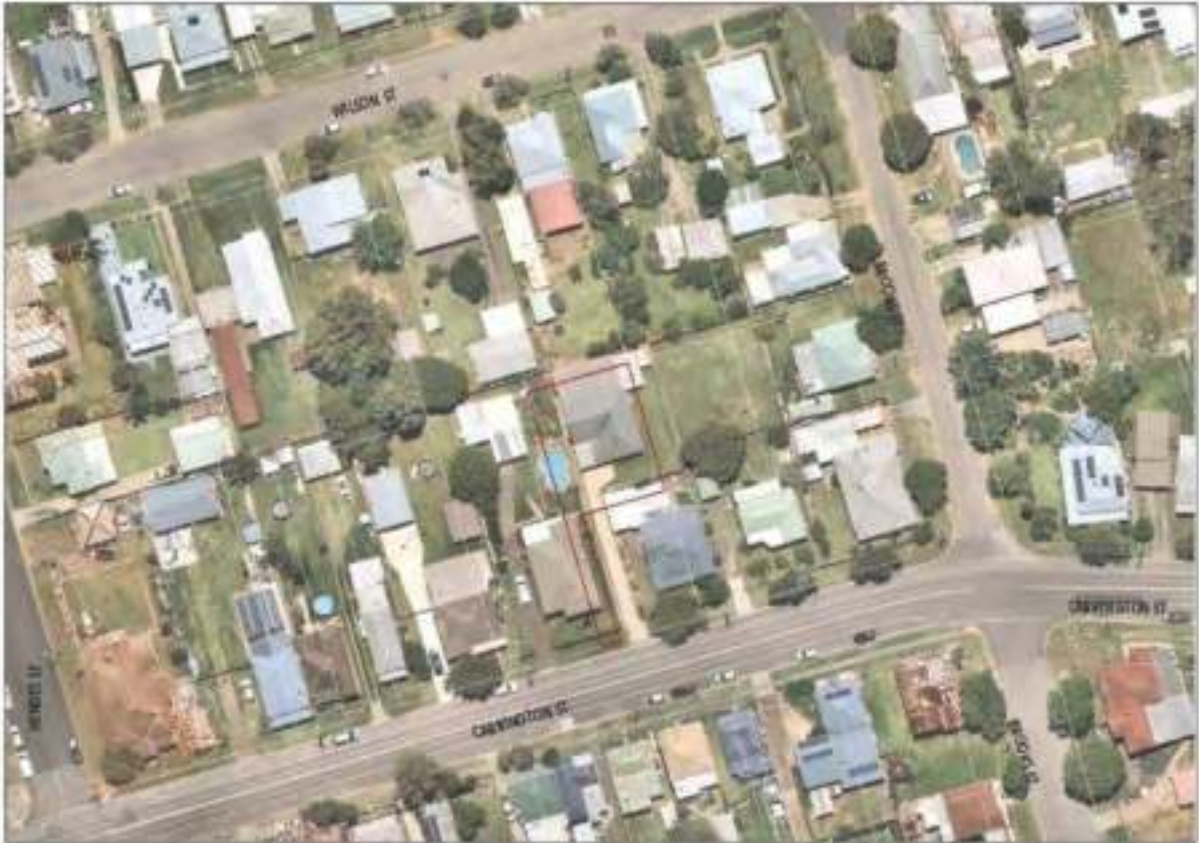
35A CARRINGTON STREET, WEST WALLSEND 2286

Conservation Area Contribution Level	Est. Construction Date	Previous studies and/or community input
Non-Contributory	Mid to late 20 th century onwards	No prior heritage assessments or research undertaken.
Assessment Text		Observed Modifications
<p>The scale (e.g. double-storey or greater) and general style of the dwelling is inconsistent with that of the streetscape and wider HCA.</p> <p>The dwelling does not contribute positively to the streetscape and wider HCA, particularly in comparison to Contributory 1 and 2 buildings. The presence of the building has an adverse impact on the streetscape and/or wider HCA.</p> <p>The dwelling features inappropriately proportioned and positioned fenestrations, an inappropriate roof form (gabled or hipped) and/or other features that are inconsistent with the architectural character of the area (e.g. unsympathetic additions, inconsistent [contemporary] building materials, etc).</p>		No modifications observed.

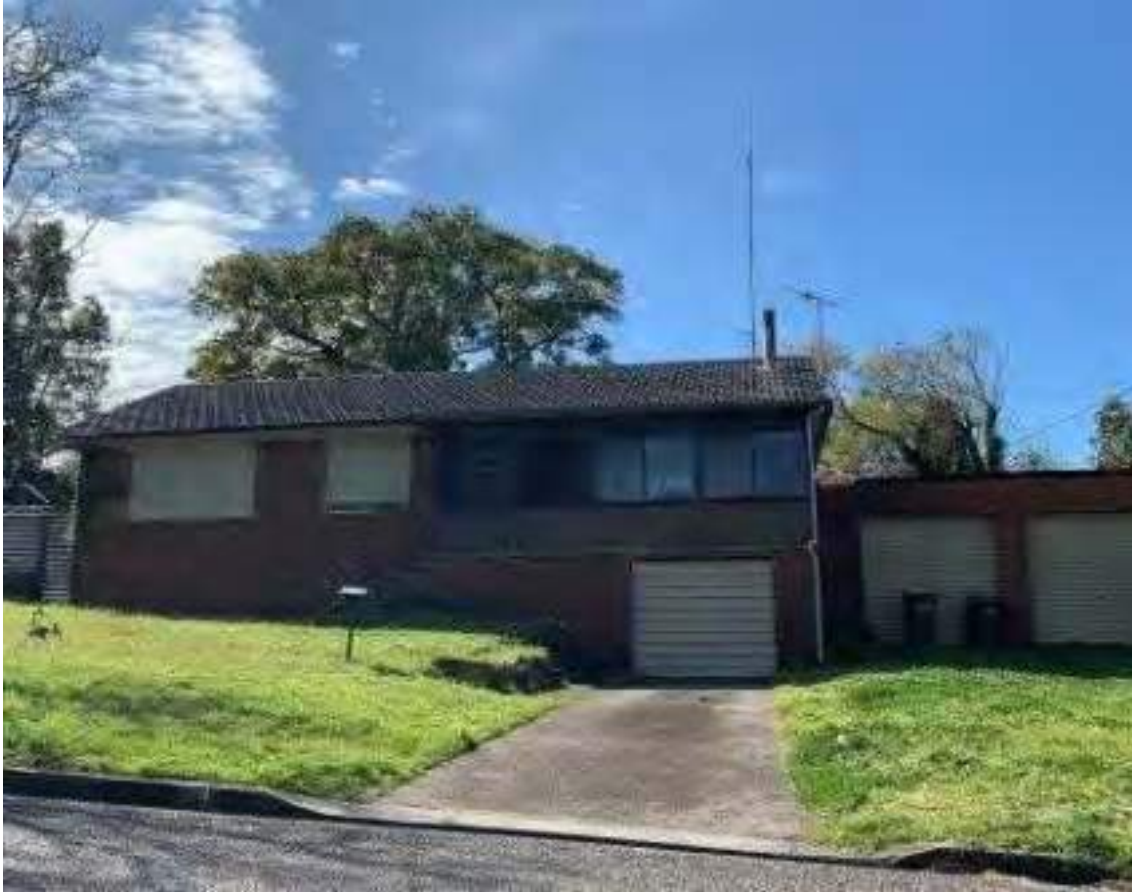
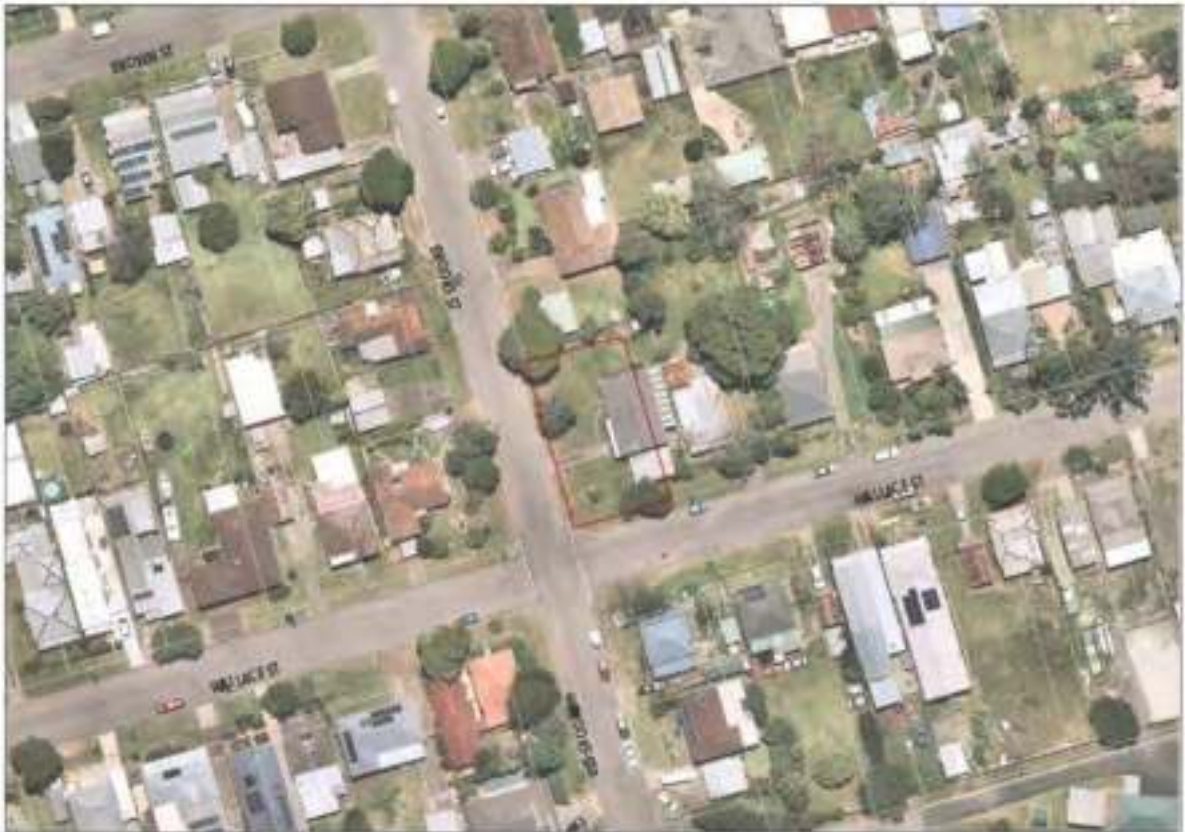
9 BROOKS STREET, WEST WALLSEND 2286		
Conservation Area Contribution Level	Est. Construction Date	Previous studies and/or community input
Non-Contributory	Mid to late 20 th century onwards	No prior heritage assessments or research undertaken.
Assessment Text		Observed Modifications
<p>The scale (e.g. double-storey or greater) and general style of the dwelling is inconsistent with that of the streetscape and wider HCA.</p> <p>The dwelling does not contribute positively to the streetscape and wider HCA, particularly in comparison to Contributory 1 and 2 buildings. The presence of the building has an adverse impact on the streetscape and/or wider HCA.</p> <p>The dwelling features inappropriately proportioned and positioned fenestrations, an inappropriate roof form (gabled or hipped) and/or other features that are inconsistent with the architectural character of the area (e.g. unsympathetic additions, inconsistent [contemporary] building materials, etc).</p>		No modifications observed.

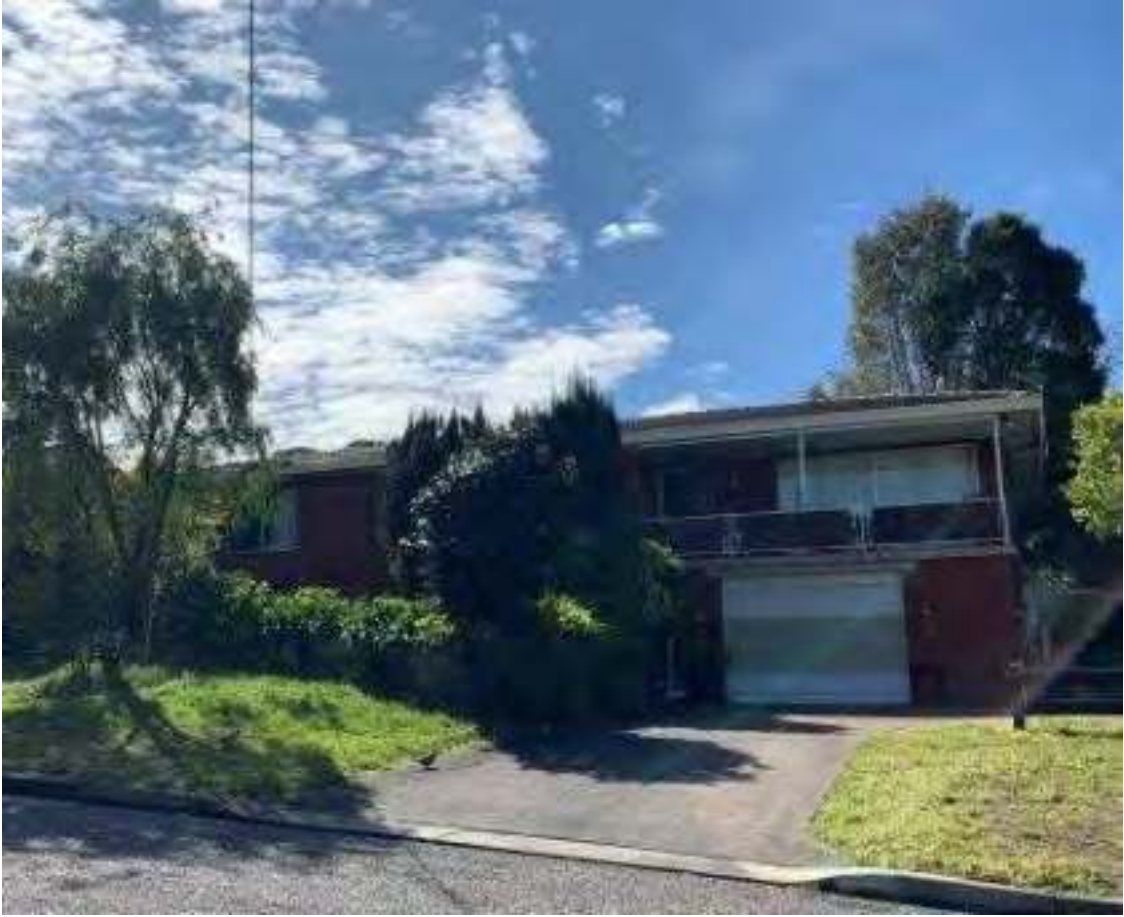
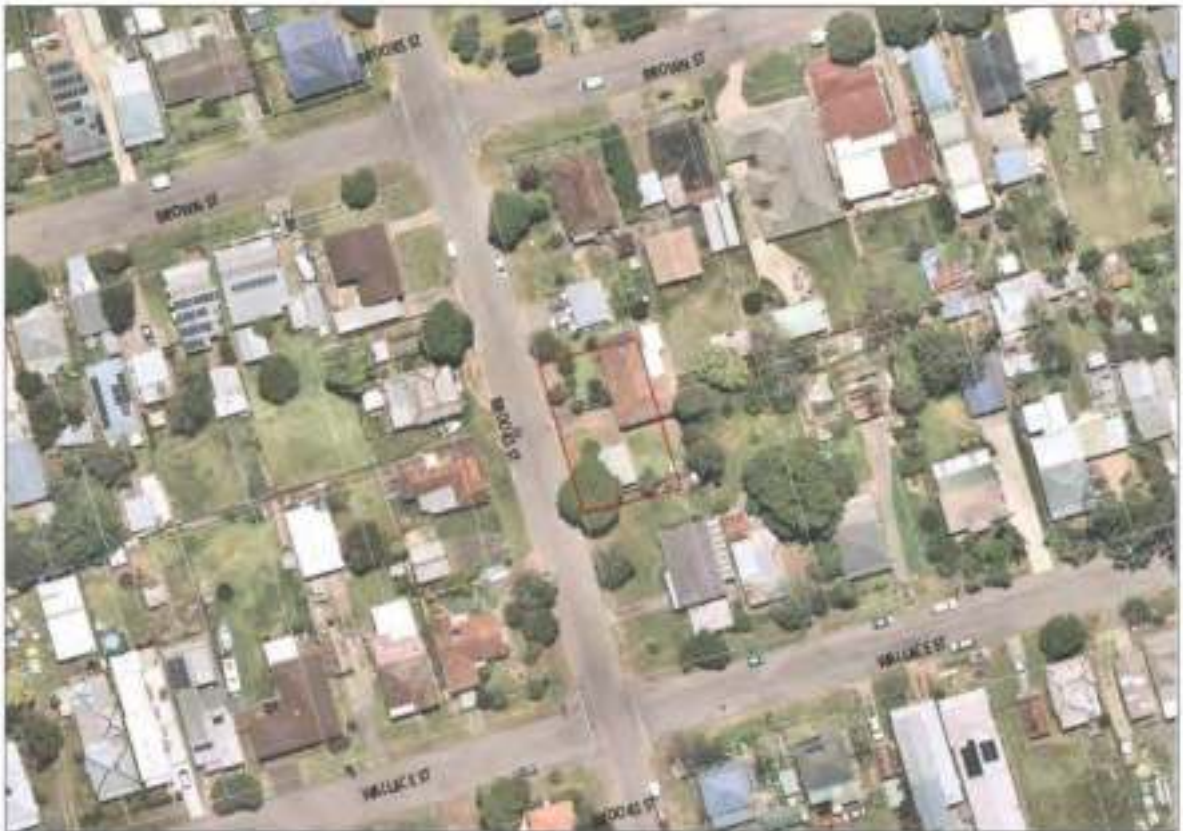
7 BROOKS STREET, WEST WALLSEND 2286		
Conservation Area Contribution Level	Est. Construction Date	Previous studies and/or community input
Non-Contributory	Mid to late 20 th century onwards	No prior heritage assessments or research undertaken.
Assessment Text		Observed Modifications
<p>The scale (e.g. double-storey or greater) and general style of the dwelling is inconsistent with that of the streetscape and wider HCA.</p> <p>The dwelling does not contribute positively to the streetscape and wider HCA, particularly in comparison to Contributory 1 and 2 buildings. The presence of the building has an adverse impact on the streetscape and/or wider HCA.</p> <p>The dwelling features inappropriately proportioned and positioned fenestrations, an inappropriate roof form (gabled or hipped) and/or other features that are inconsistent with the architectural character of the area (e.g. unsympathetic additions, inconsistent [contemporary] building materials, etc).</p>		No modifications observed.

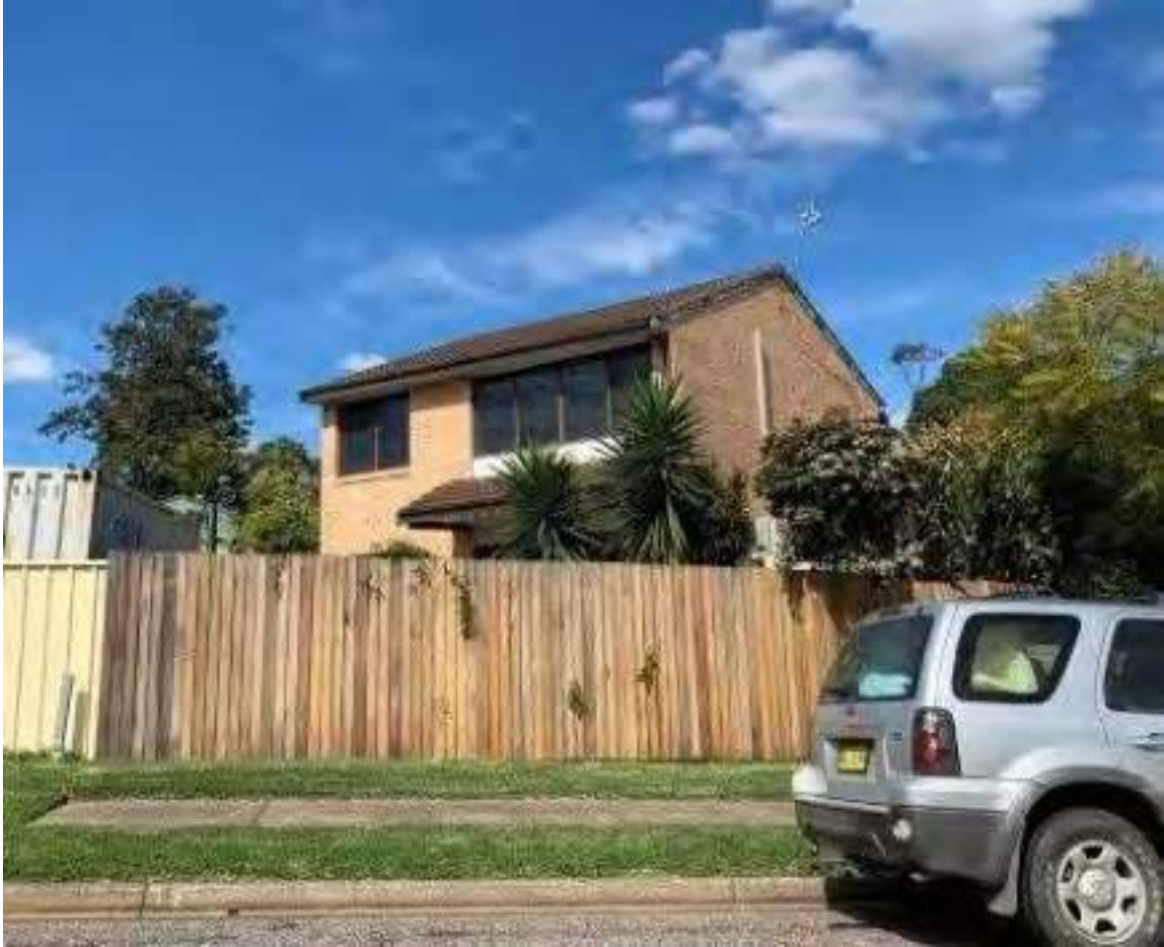
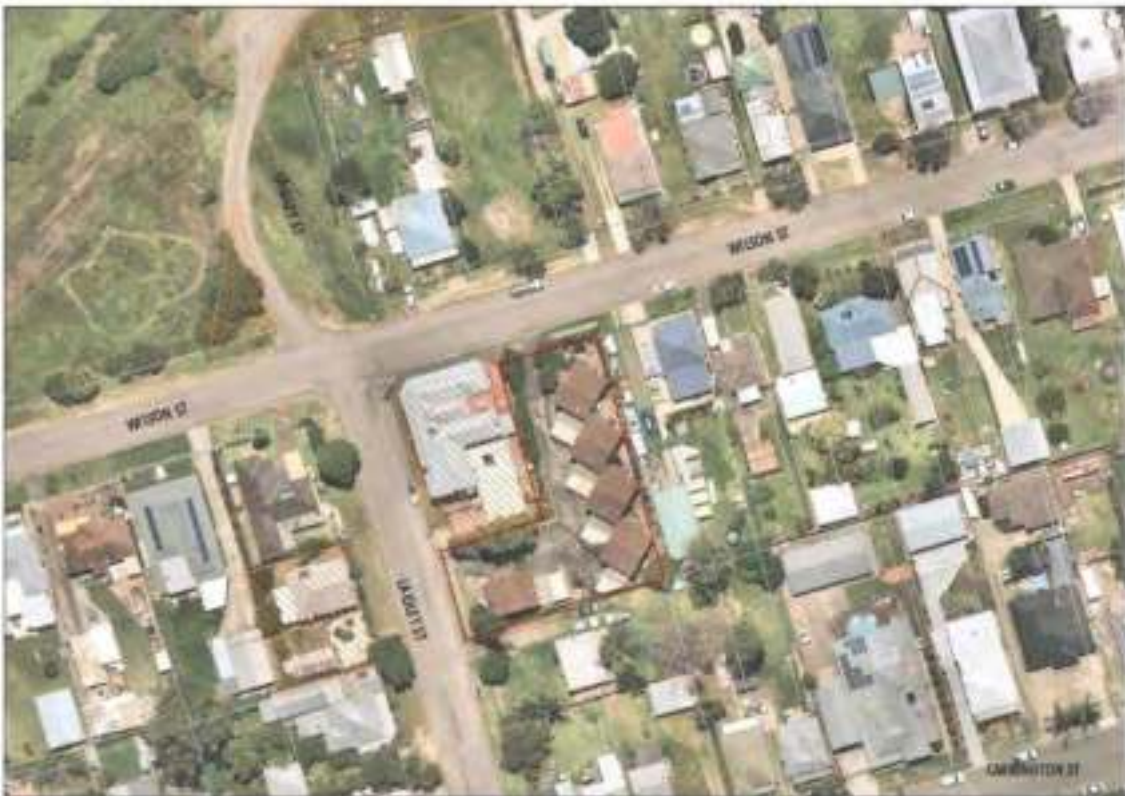
68 WILSON STREET, WEST WALLSEND 2286		
Conservation Area Contribution Level	Est. Construction Date	Previous studies and/or community input
Non-Contributory	Mid to late 20 th century onwards	No prior heritage assessments or research undertaken.
Assessment Text		Observed Modifications
<p>The scale (e.g. double-storey or greater) and general style of the dwelling is inconsistent with that of the streetscape and wider HCA.</p> <p>The dwelling does not contribute positively to the streetscape and wider HCA, particularly in comparison to Contributory 1 and 2 buildings. The presence of the building has an adverse impact on the streetscape and/or wider HCA.</p> <p>The dwelling features inappropriately proportioned and positioned fenestrations, an inappropriate roof form (gabled or hipped) and/or other features that are inconsistent with the architectural character of the area (e.g. unsympathetic additions, inconsistent [contemporary] building materials, etc).</p>		No modifications observed.

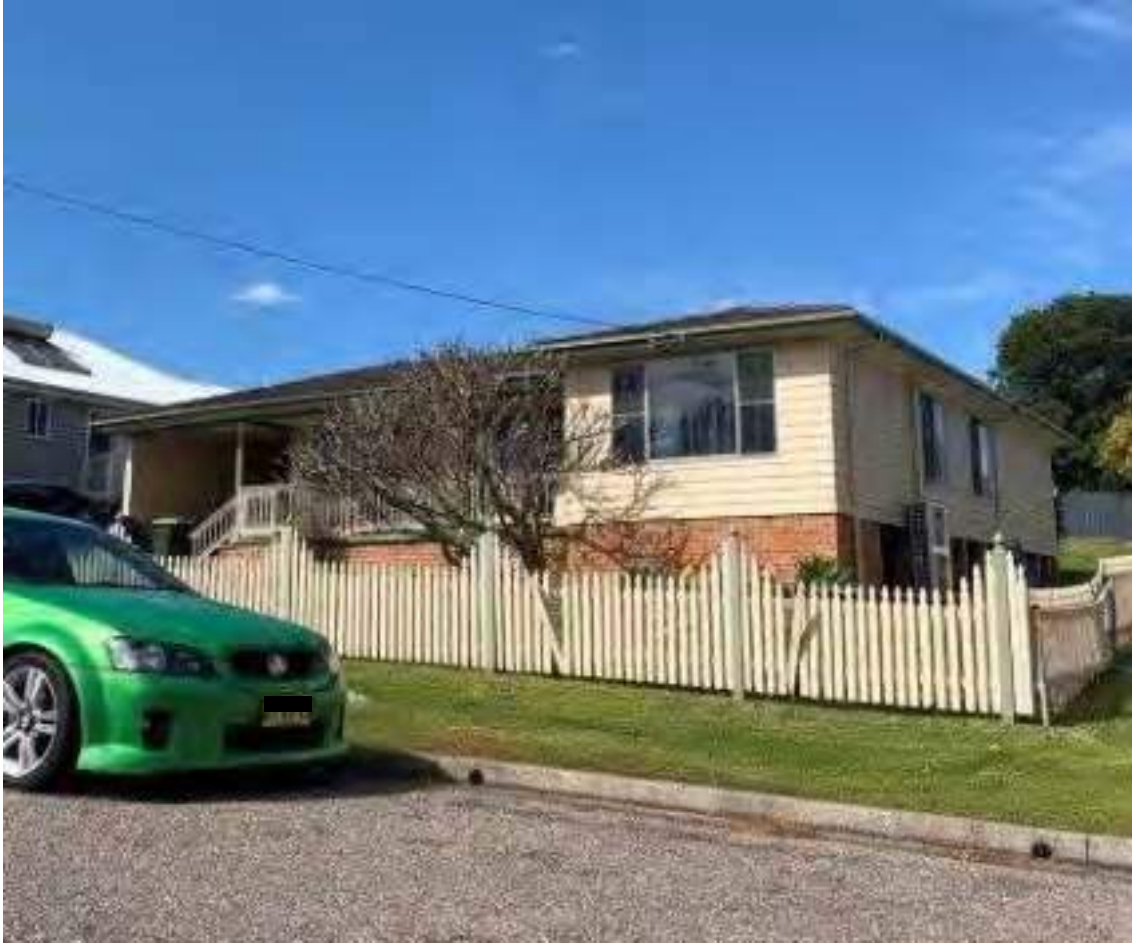
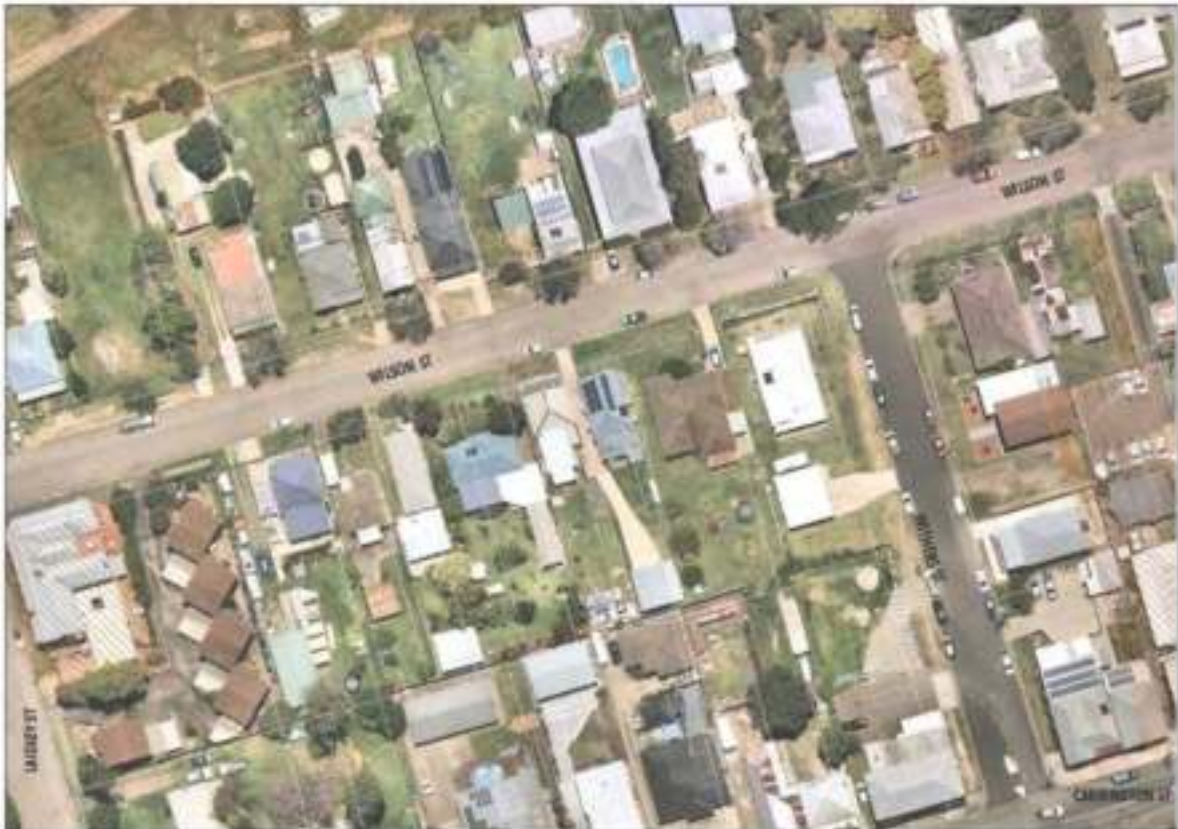
54 WILSON STREET, WEST WALLSEND 2286		
Conservation Area Contribution Level	Est. Construction Date	Previous studies and/or community input
Non-Contributory	Mid to late 20 th century onwards	No prior heritage assessments or research undertaken.
Assessment Text		Observed Modifications
<p>The scale (e.g. double-storey or greater) and general style of the dwelling is inconsistent with that of the streetscape and wider HCA.</p> <p>The dwelling does not contribute positively to the streetscape and wider HCA, particularly in comparison to Contributory 1 and 2 buildings. The presence of the building has an adverse impact on the streetscape and/or wider HCA.</p> <p>The dwelling features inappropriately proportioned and positioned fenestrations, an inappropriate roof form (gabled or hipped) and/or other features that are inconsistent with the architectural character of the area (e.g. unsympathetic additions, inconsistent [contemporary] building materials, etc).</p>		No modifications observed.

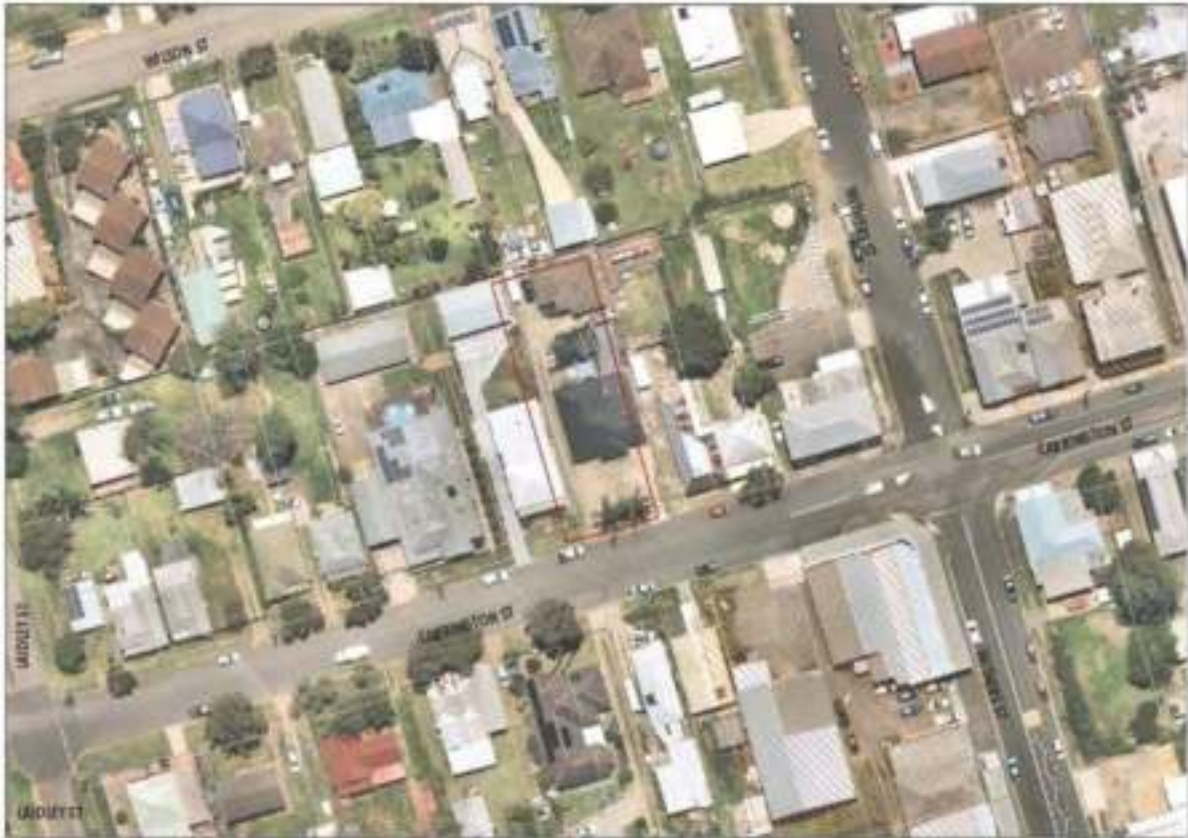
Conservation Area Contribution Level	Est. Construction Date	Previous studies and/or community input
Non-Contributory	Mid to late 20 th century onwards	No prior heritage assessments or research undertaken.
Assessment Text		Observed Modifications
<p>The scale (e.g. double-storey or greater) and general style of the dwelling is inconsistent with that of the streetscape and wider HCA.</p> <p>The dwelling does not contribute positively to the streetscape and wider HCA, particularly in comparison to Contributory 1 and 2 buildings. The presence of the building has an adverse impact on the streetscape and/or wider HCA.</p> <p>The dwelling features inappropriately proportioned and positioned fenestrations, an inappropriate roof form (gabled or hipped) and/or other features that are inconsistent with the architectural character of the area (e.g. unsympathetic additions, inconsistent [contemporary] building materials, etc).</p>		No modifications observed.

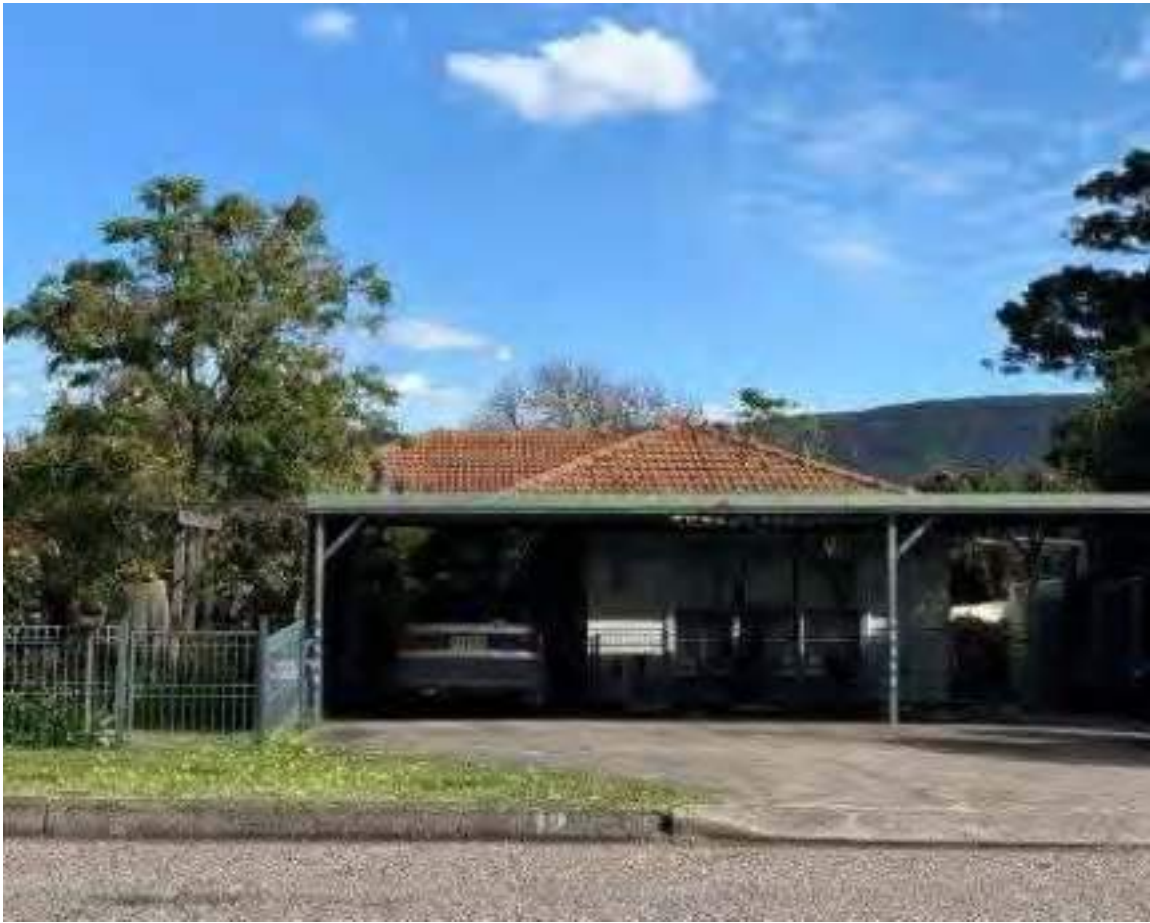
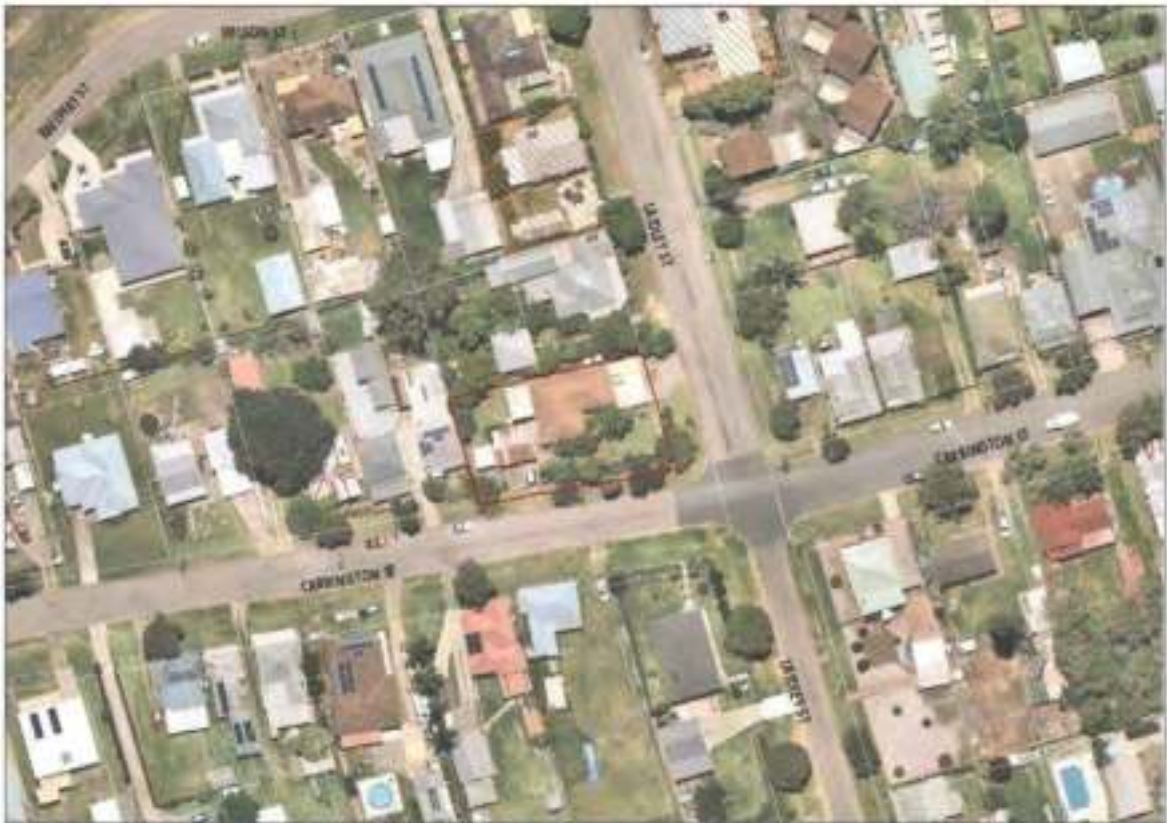
12 LAIDLEY STREET, WEST WALLSEND 2286		
Conservation Area Contribution Level	Est. Construction Date	Previous studies and/or community input
Non-Contributory	Mid to late 20 th century onwards	No prior heritage assessments or research undertaken.
Assessment Text		Observed Modifications
<p>The scale (e.g. double-storey or greater) and general style of the dwelling is inconsistent with that of the streetscape and wider HCA.</p> <p>The dwelling does not contribute positively to the streetscape and wider HCA, particularly in comparison to Contributory 1 and 2 buildings. The presence of the building has an adverse impact on the streetscape and/or wider HCA.</p> <p>The dwelling features inappropriately proportioned and positioned fenestrations, an inappropriate roof form (gabled or hipped) and/or other features that are inconsistent with the architectural character of the area (e.g. unsympathetic additions, inconsistent [contemporary] building materials, etc).</p>		<p>A large carport has been constructed at the front eastern side of the dwelling, obscuring the dwelling.</p>

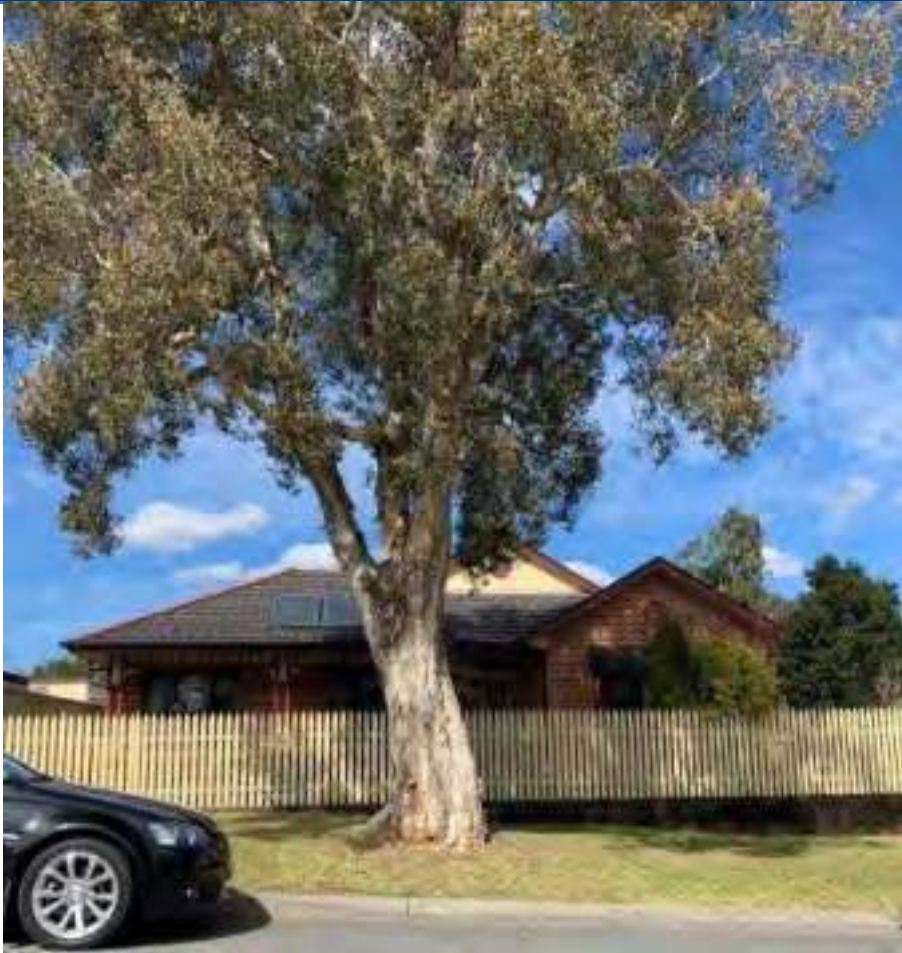
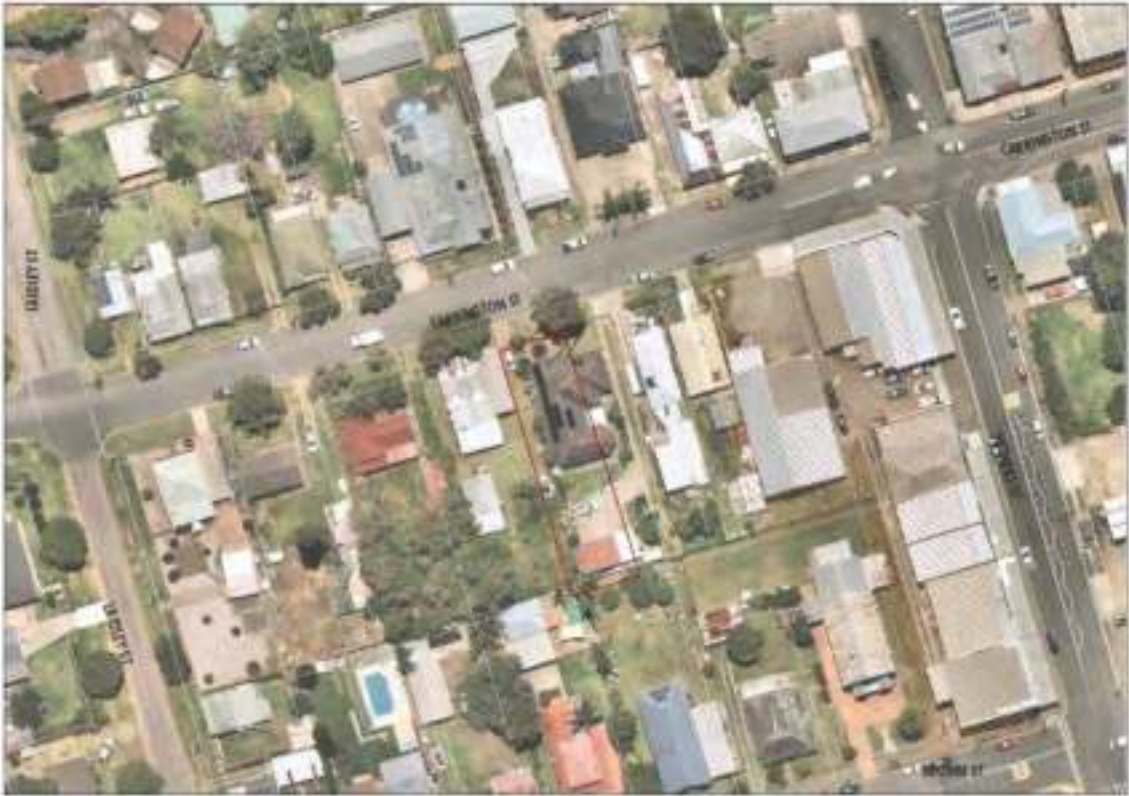
80 CARRINGTON STREET, WEST WALLSEND 2286

Conservation Area Contribution Level	Est. Construction Date	Previous studies and/or community input
Non-Contributory	Mid to late 20 th century onwards	No prior heritage assessments or research undertaken.
Assessment Text		Observed Modifications
<p>The scale (e.g. double-storey or greater) and general style of the dwelling is inconsistent with that of the streetscape and wider HCA.</p> <p>The dwelling does not contribute positively to the streetscape and wider HCA, particularly in comparison to Contributory 1 and 2 buildings. The presence of the building has an adverse impact on the streetscape and/or wider HCA.</p> <p>The dwelling features inappropriately proportioned and positioned fenestrations, an inappropriate roof form (gabled or hipped) and/or other features that are inconsistent with the architectural character of the area (e.g. unsympathetic additions, inconsistent [contemporary] building materials, etc).</p>		<p>Solar panels/heating components are visible along the northern portion of the roof.</p>
