APPENDIX 2

Building Assessment Sheets (Inventory Sheets)

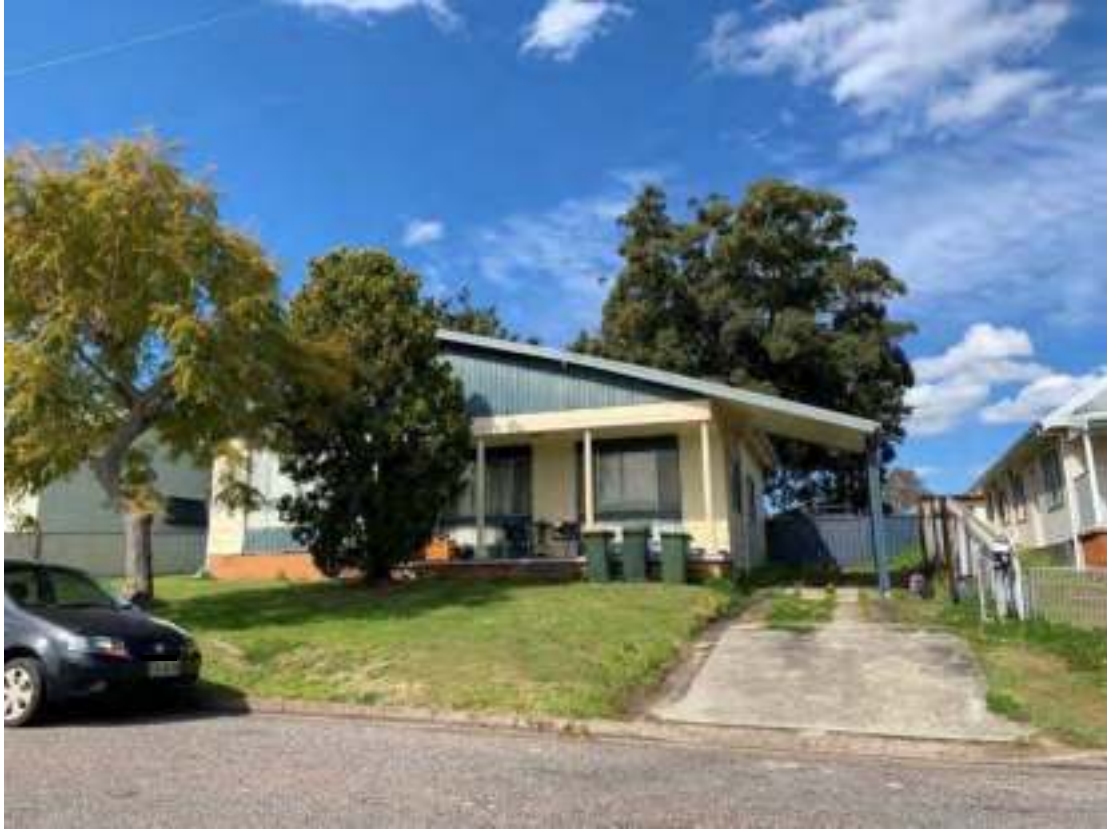
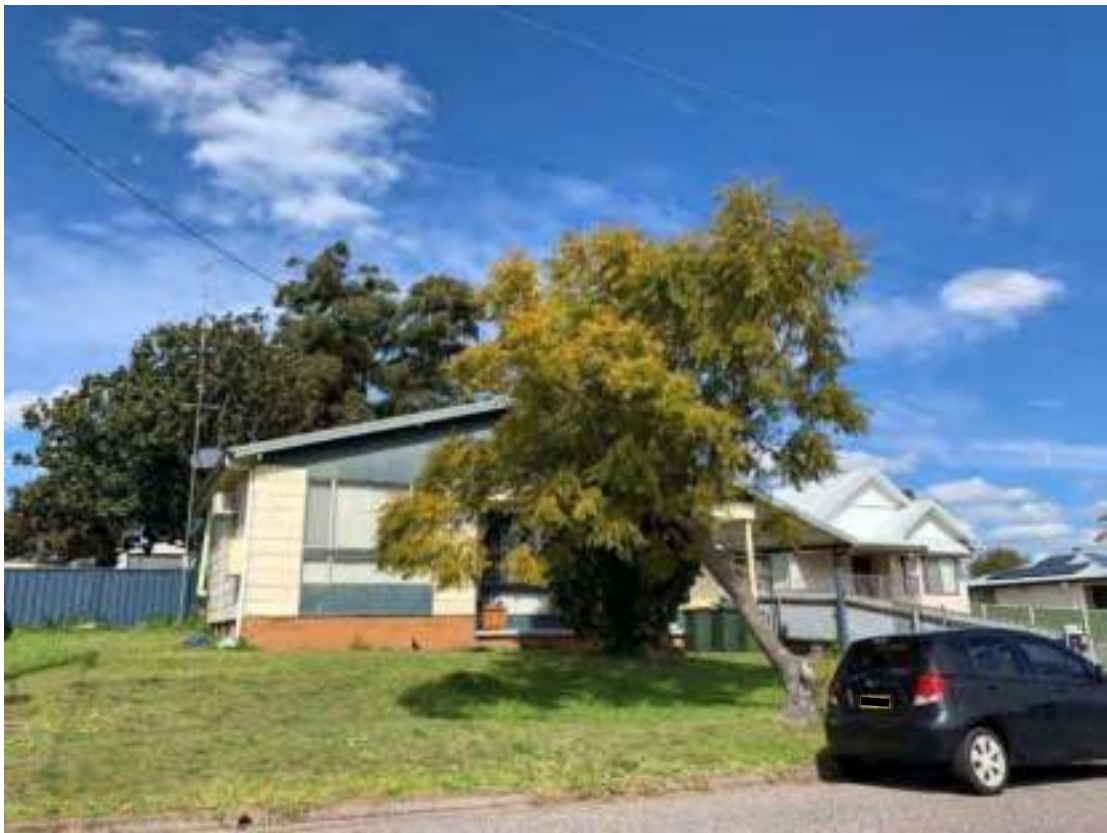
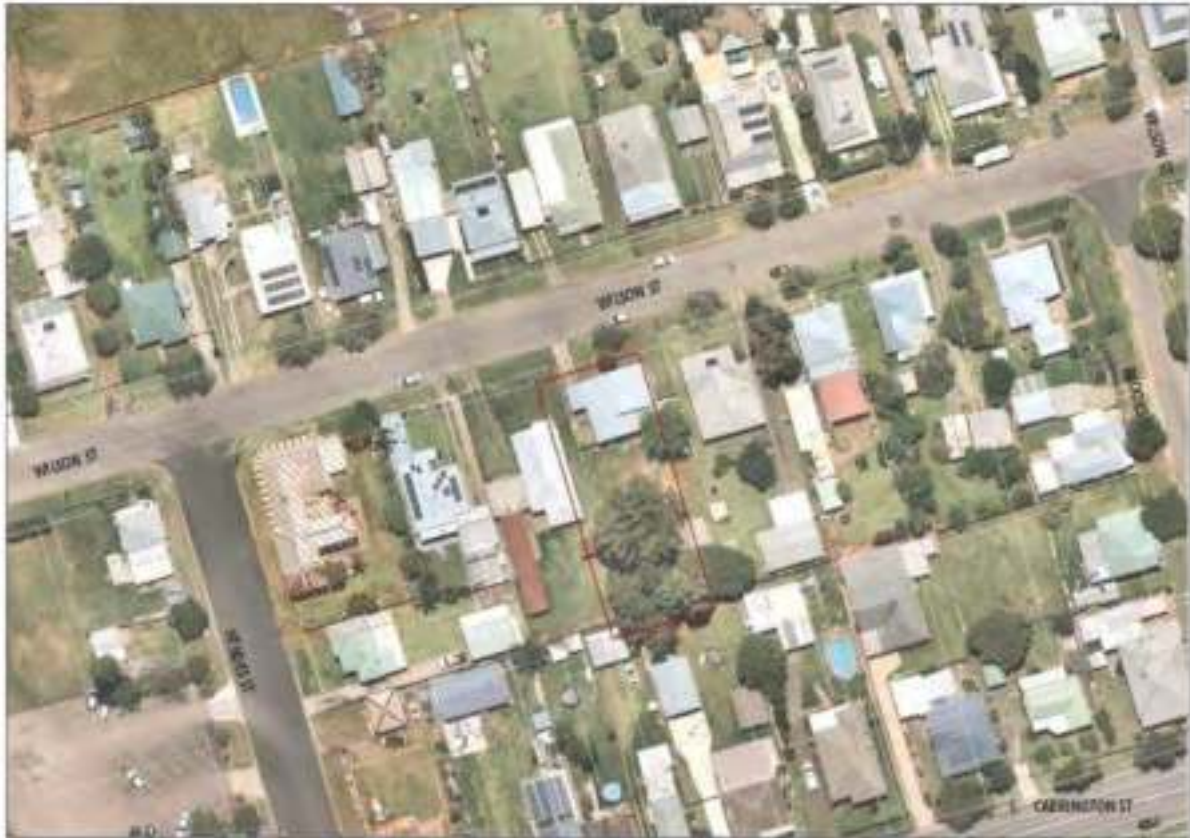
30 WILSON STREET, WEST WALLSEND 2286

Conservation Area Contribution Level	Est. Construction Date	Previous studies and/or community input
Non-Contributory	Mid to late 20 th century onwards	No prior heritage assessments or research undertaken.
Assessment Text		Observed Modifications
<p>The scale (e.g. double-storey or greater) and general style of the dwelling is inconsistent with that of the streetscape and wider HCA.</p> <p>The dwelling does not contribute positively to the streetscape and wider HCA, particularly in comparison to Contributory 1 and 2 buildings. The presence of the building has an adverse impact on the streetscape and/or wider HCA.</p> <p>The dwelling features inappropriately proportioned and positioned fenestrations, an inappropriate roof form (gabled or hipped) and/or other features that are inconsistent with the architectural character of the area (e.g. unsympathetic additions, inconsistent [contemporary] building materials, etc).</p>		<p>All visible windows are contemporary in style.</p>

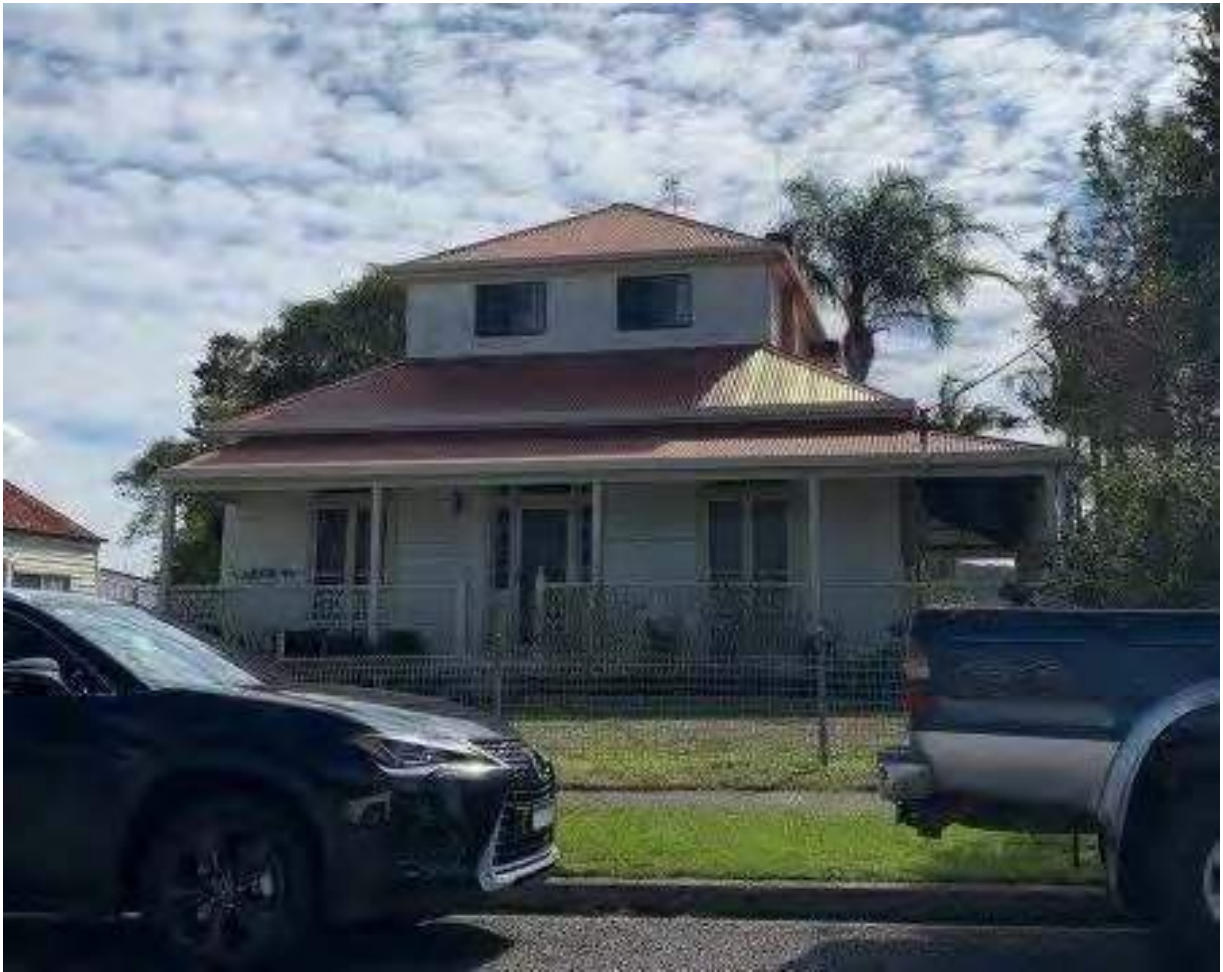
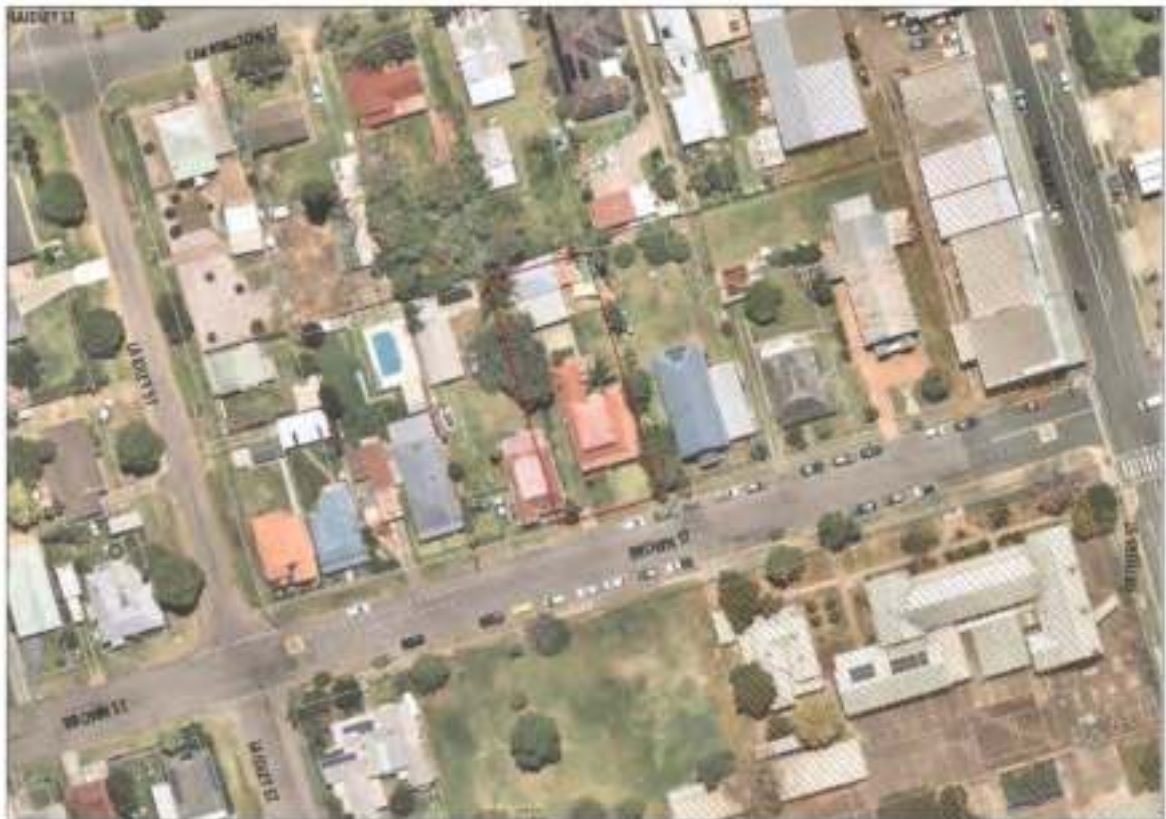
47 BROWN STREET, WEST WALLSEND 2286

Conservation Area Contribution Level	Est. Construction Date	Previous studies and/or community input
Non-Contributory	Mid to late 20 th century onwards	No prior heritage assessments or research undertaken.
Assessment Text		Observed Modifications
<p>The scale (e.g. double-storey or greater) and general style of the dwelling is inconsistent with that of the streetscape and wider HCA.</p> <p>The dwelling does not contribute positively to the streetscape and wider HCA, particularly in comparison to Contributory 1 and 2 buildings. The presence of the building has an adverse impact on the streetscape and/or wider HCA.</p> <p>The dwelling features inappropriately proportioned and positioned fenestrations, an inappropriate roof form (gabled or hipped) and/or other features that are inconsistent with the architectural character of the area (e.g. unsympathetic additions, inconsistent [contemporary] building materials, etc).</p>		<p>The second storey extension is a contemporary addition, and uncommon for the area. This modification is unsympathetic in style and detracts from the heritage streetscape.</p>

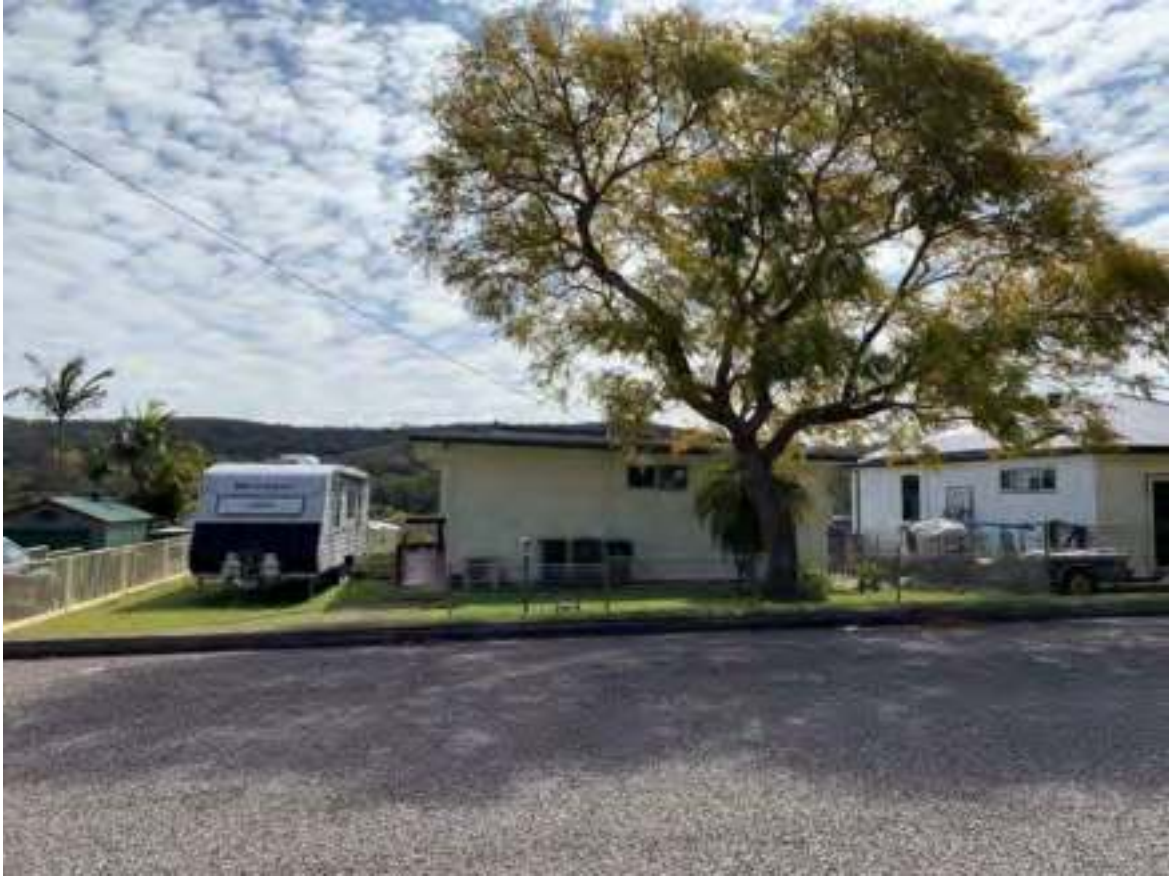
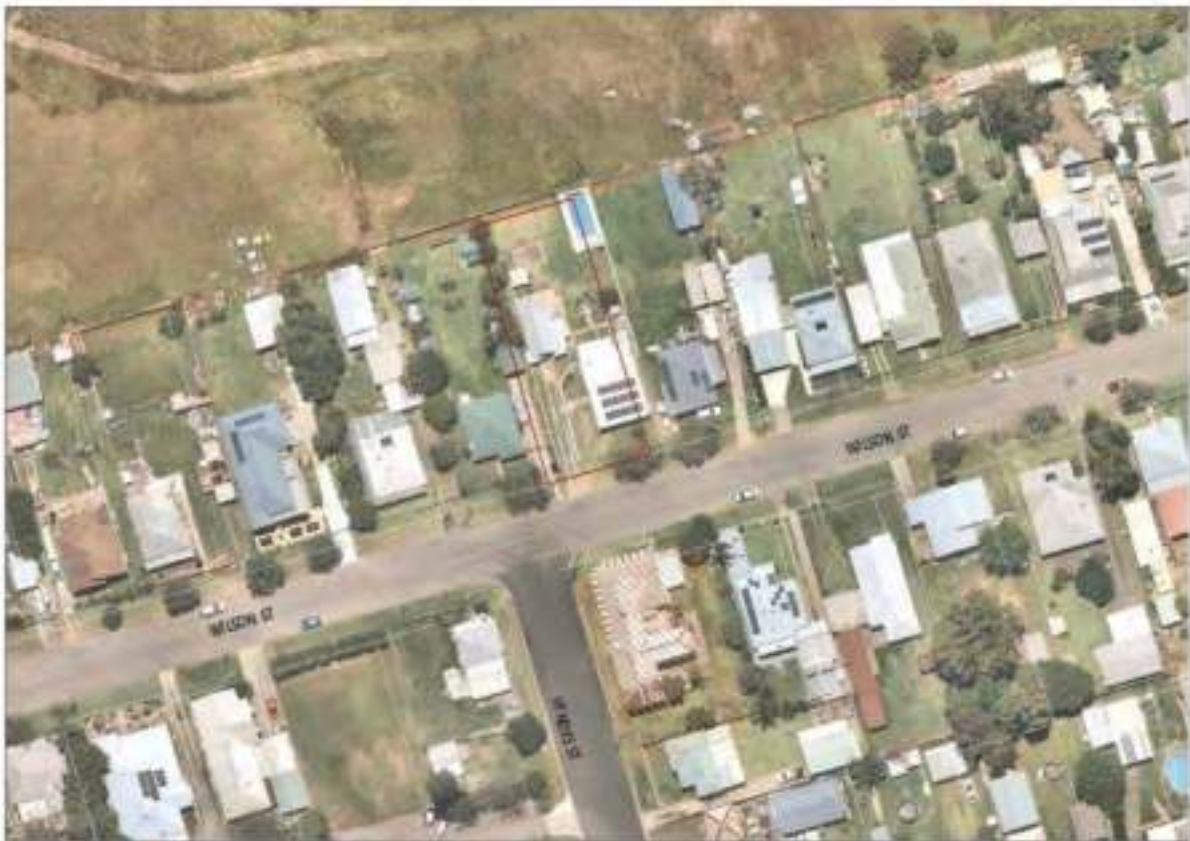
35 WILSON STREET, WEST WALLSEND 2286		
Conservation Area Contribution Level	Est. Construction Date	Previous studies and/or community input
Non-Contributory	Mid to late 20 th century onwards	No prior heritage assessments or research undertaken.
Assessment Text		Observed Modifications
<p>The scale (e.g. double-storey or greater) and general style of the dwelling is inconsistent with that of the streetscape and wider HCA.</p> <p>The dwelling does not contribute positively to the streetscape and wider HCA, particularly in comparison to Contributory 1 and 2 buildings. The presence of the building has an adverse impact on the streetscape and/or wider HCA.</p> <p>The dwelling features inappropriately proportioned and positioned fenestrations, an inappropriate roof form (gabled or hipped) and/or other features that are inconsistent with the architectural character of the area (e.g. unsympathetic additions, inconsistent [contemporary] building materials, etc).</p>		No modifications observed.

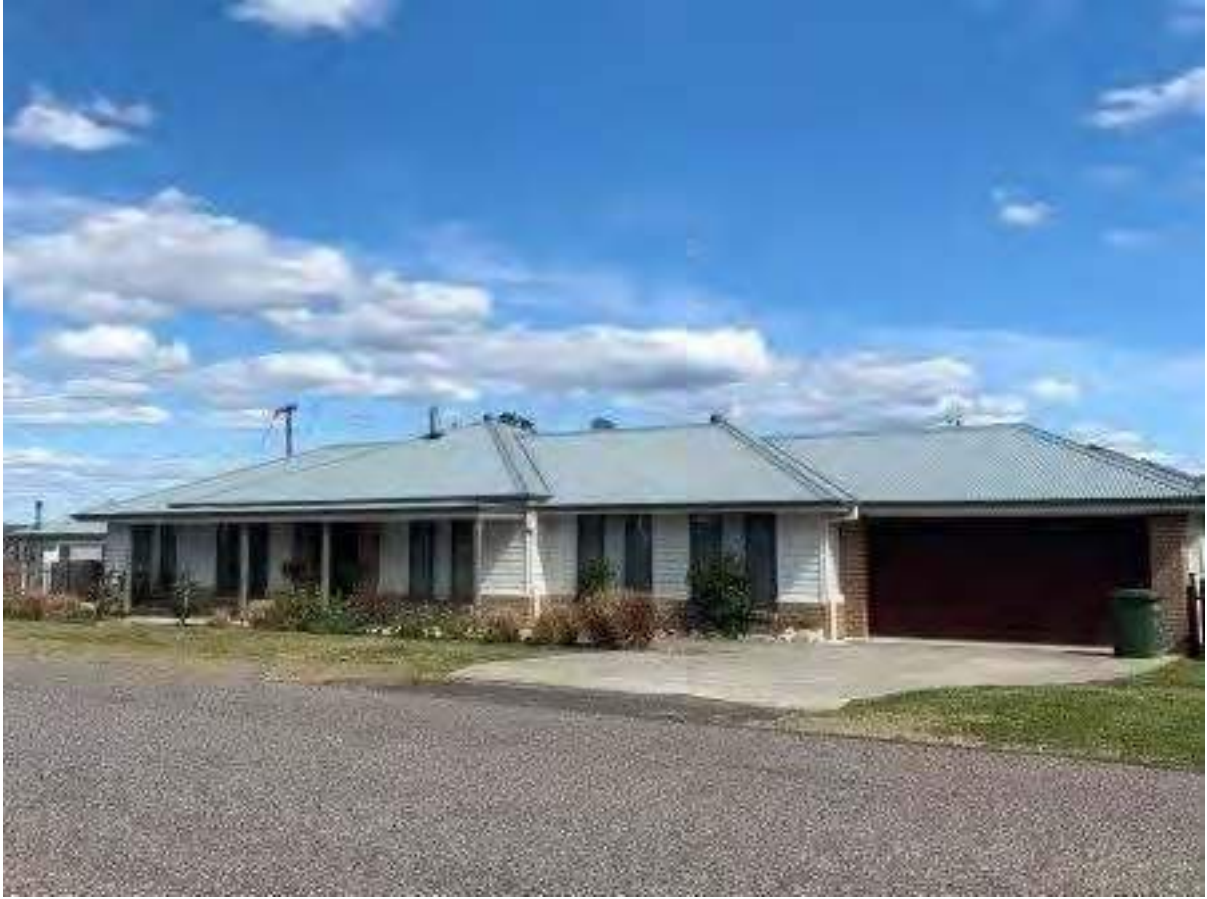
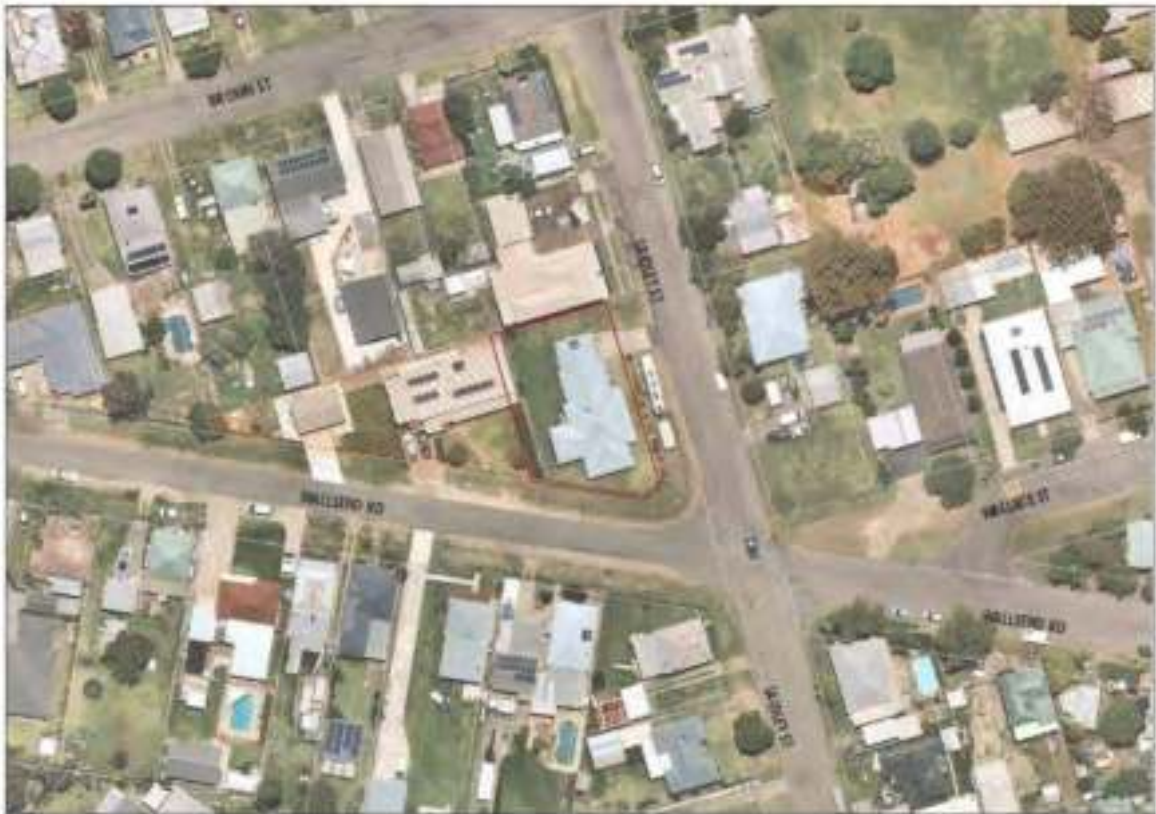
24 LAIDLEY STREET, WEST WALLSEND 2286		
Conservation Area Contribution Level	Est. Construction Date	Previous studies and/or community input
Non-Contributory	Mid to late 20 th century onwards	No prior heritage assessments or research undertaken.
Assessment Text		Observed Modifications
<p>The scale (e.g. double-storey or greater) and general style of the dwelling is inconsistent with that of the streetscape and wider HCA.</p> <p>The dwelling does not contribute positively to the streetscape and wider HCA, particularly in comparison to Contributory 1 and 2 buildings. The presence of the building has an adverse impact on the streetscape and/or wider HCA.</p> <p>The dwelling features inappropriately proportioned and positioned fenestrations, an inappropriate roof form (gabled or hipped) and/or other features that are inconsistent with the architectural character of the area (e.g. unsympathetic additions, inconsistent [contemporary] building materials, etc).</p>		No modifications observed.

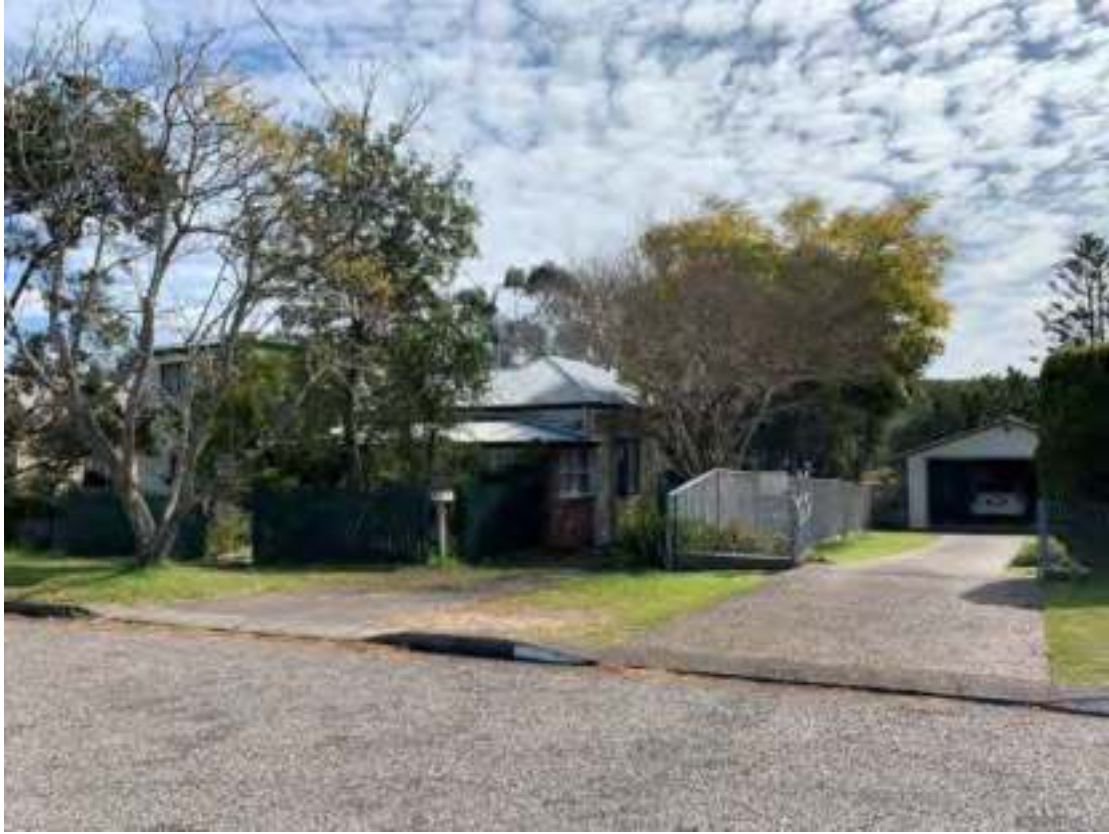
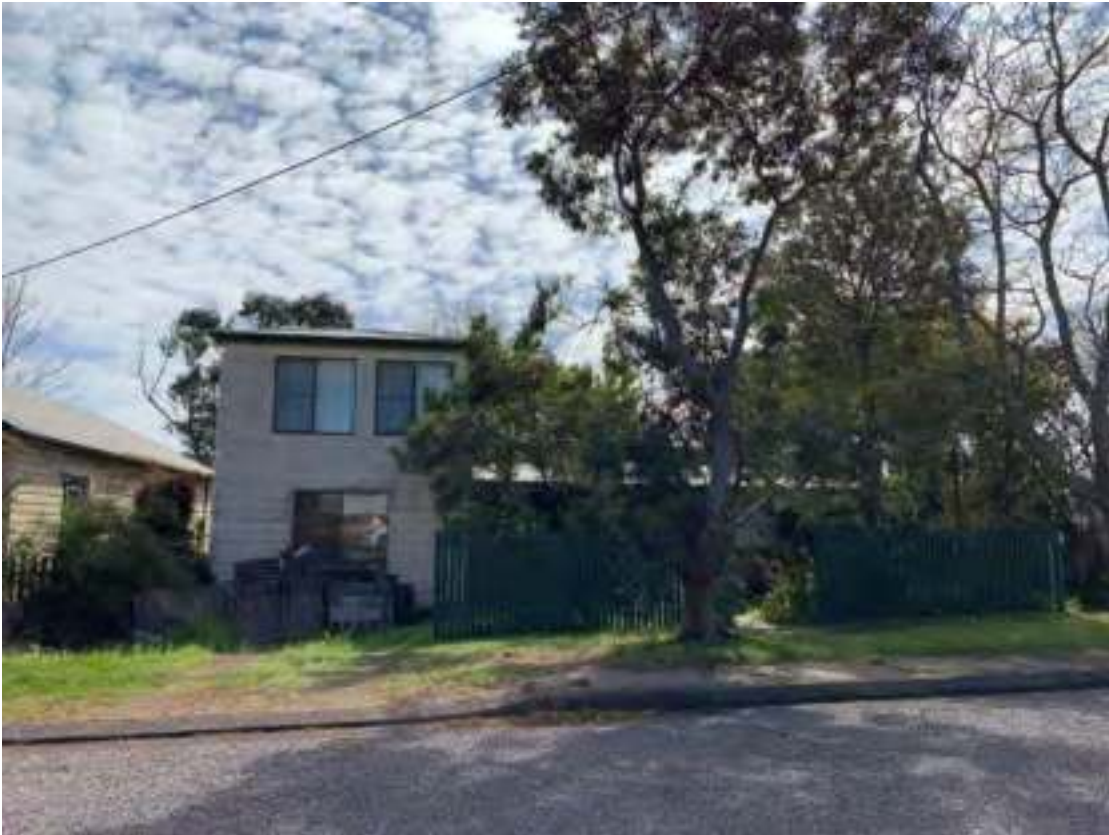
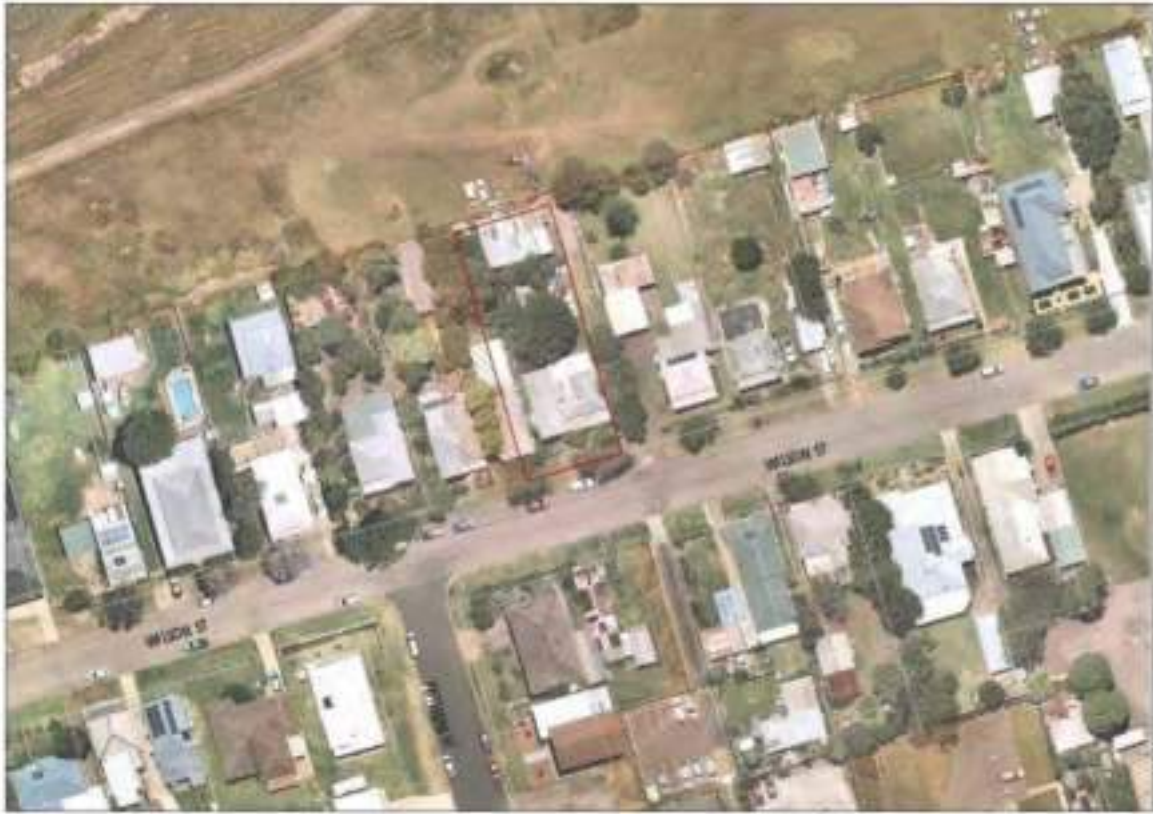
51 WILSON STREET, WEST WALLSEND 2286

Conservation Area Contribution Level	Est. Construction Date	Previous studies and/or community input
Non-Contributory	Mid to late 20 th century onwards	No prior heritage assessments or research undertaken.
Assessment Text		Observed Modifications
<p>The scale (e.g. double-storey or greater) and general style of the dwelling is inconsistent with that of the streetscape and wider HCA.</p> <p>The dwelling does not contribute positively to the streetscape and wider HCA, particularly in comparison to Contributory 1 and 2 buildings. The presence of the building has an adverse impact on the streetscape and/or wider HCA.</p> <p>The dwelling features inappropriately proportioned and positioned fenestrations, an inappropriate roof form (gabled or hipped) and/or other features that are inconsistent with the architectural character of the area (e.g. unsympathetic additions, inconsistent [contemporary] building materials, etc).</p>		<p>The veranda space has been built in to create an additional living area. Brickwork walls enclose the space, with contemporary windows also being installed.</p> <p>A double storey extension has been built onto the western portion of the dwelling. this is uncommon for the area and juxtaposes the surrounding single storey properties.</p> <p>All visible windows are contemporary in style.</p>

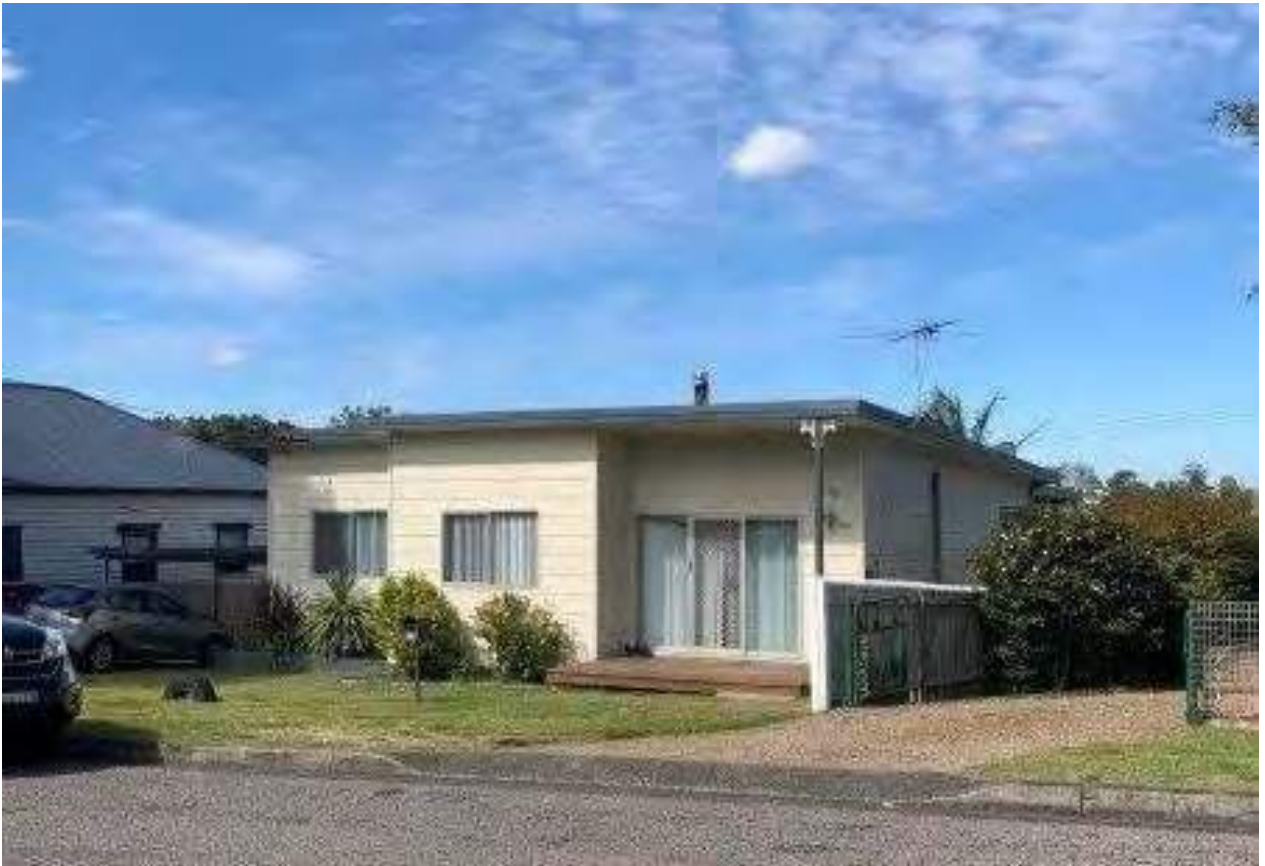
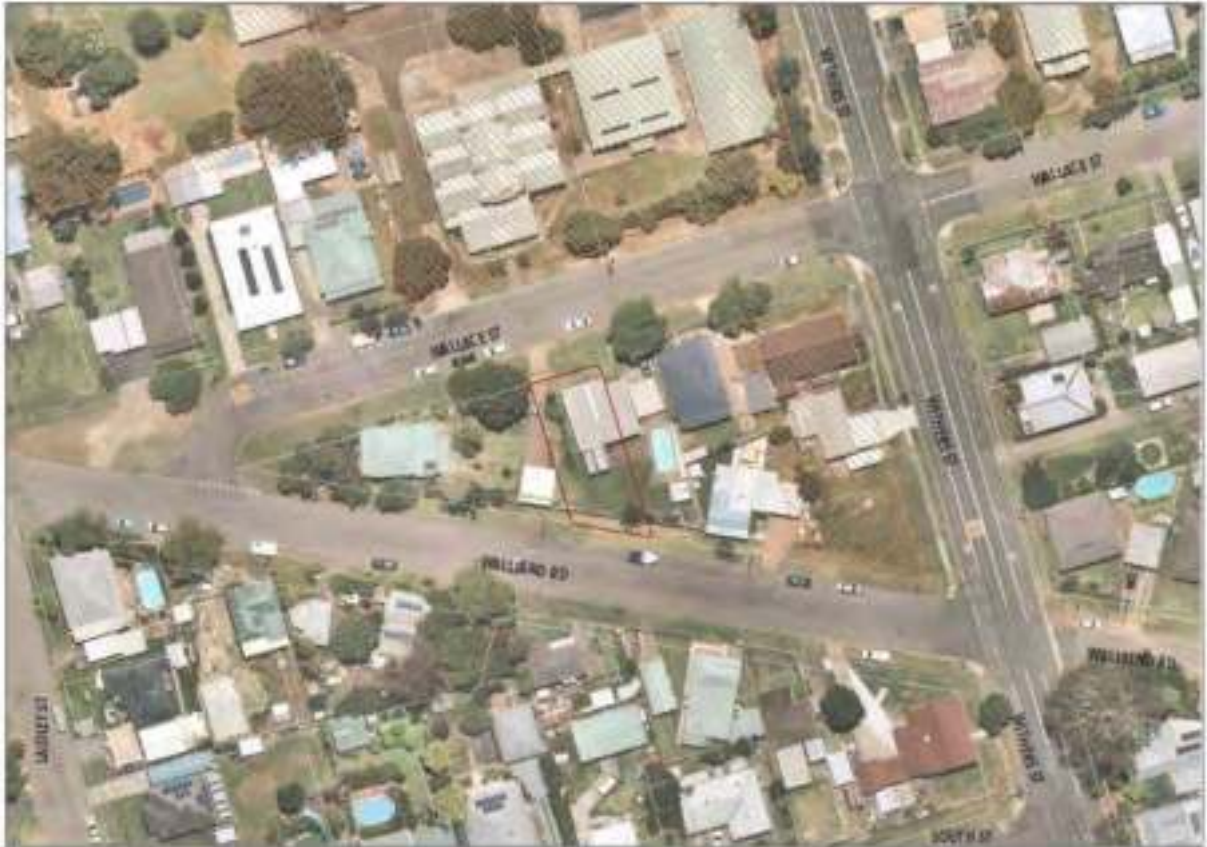
52 WALLACE STREET, WEST WALLSEND 2286

Conservation Area Contribution Level	Est. Construction Date	Previous studies and/or community input
Non-Contributory	Mid to late 20 th century onwards	No prior heritage assessments or research undertaken.
Assessment Text		Observed Modifications
<p>The scale (e.g. double-storey or greater) and general style of the dwelling is inconsistent with that of the streetscape and wider HCA.</p> <p>The dwelling does not contribute positively to the streetscape and wider HCA, particularly in comparison to Contributory 1 and 2 buildings. The presence of the building has an adverse impact on the streetscape and/or wider HCA.</p> <p>The dwelling features inappropriately proportioned and positioned fenestrations, an inappropriate roof form (gabled or hipped) and/or other features that are inconsistent with the architectural character of the area (e.g. unsympathetic additions, inconsistent [contemporary] building materials, etc).</p>		No modifications observed.

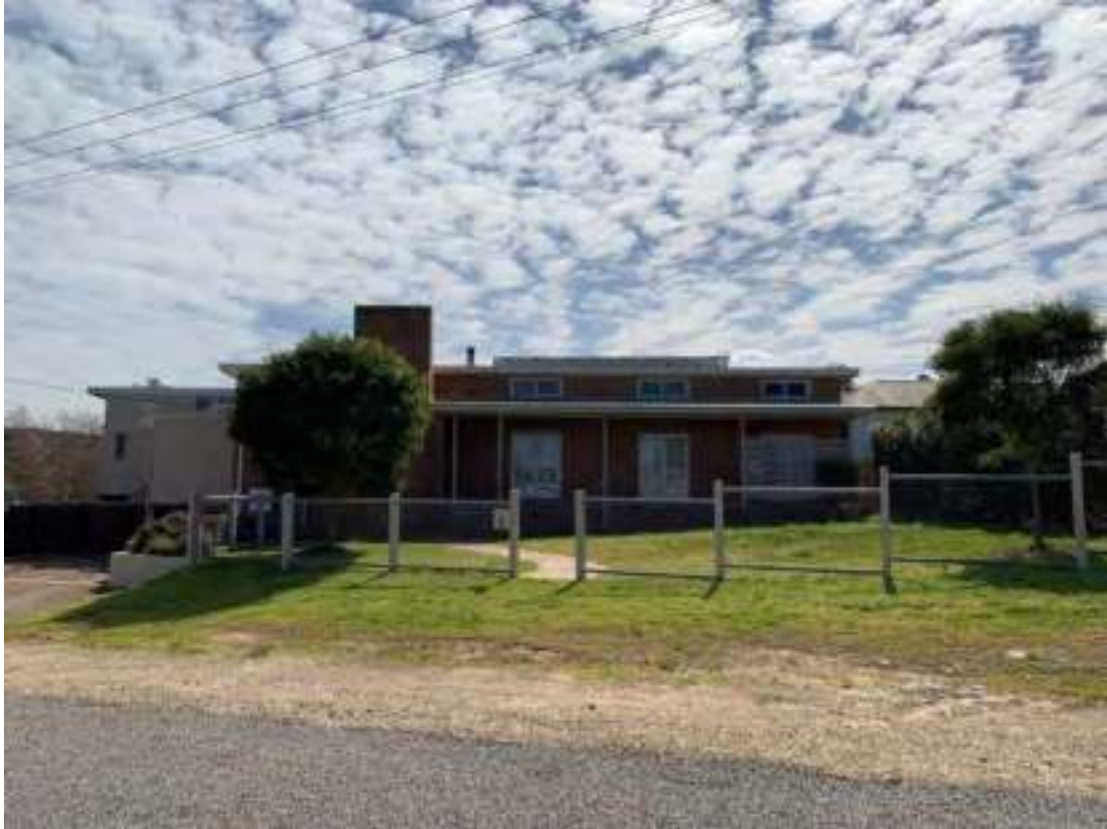
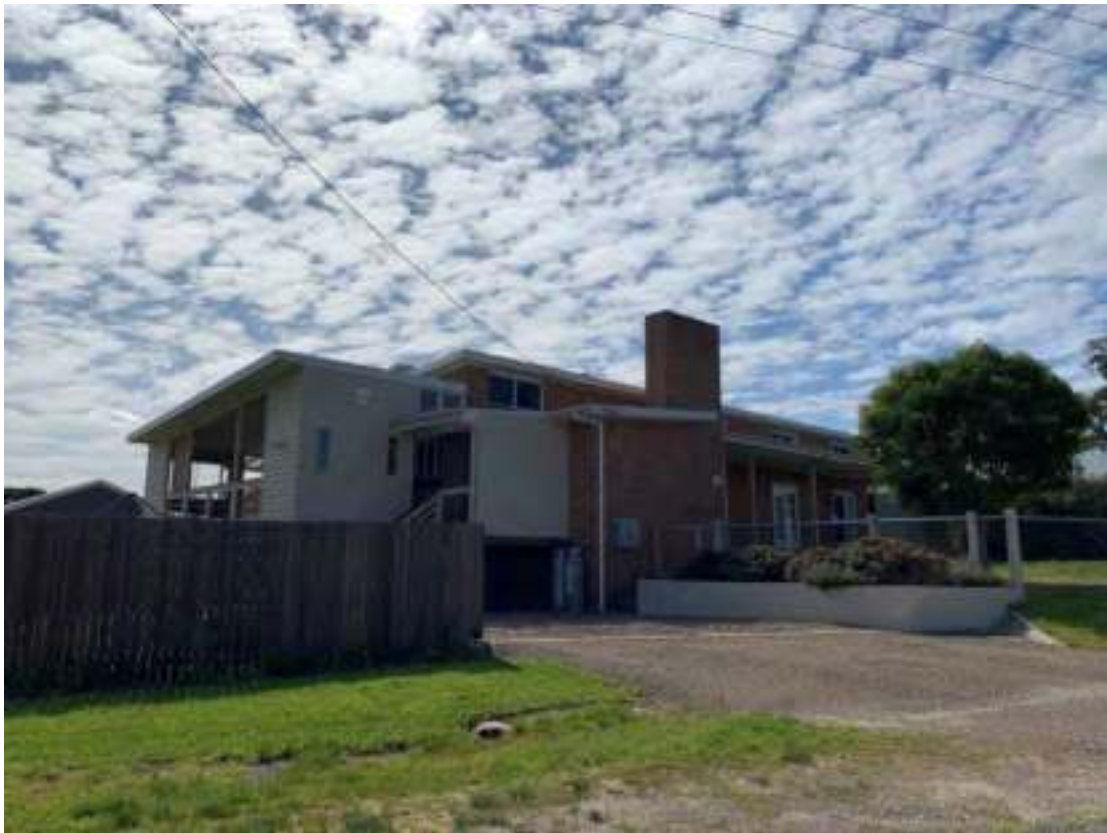
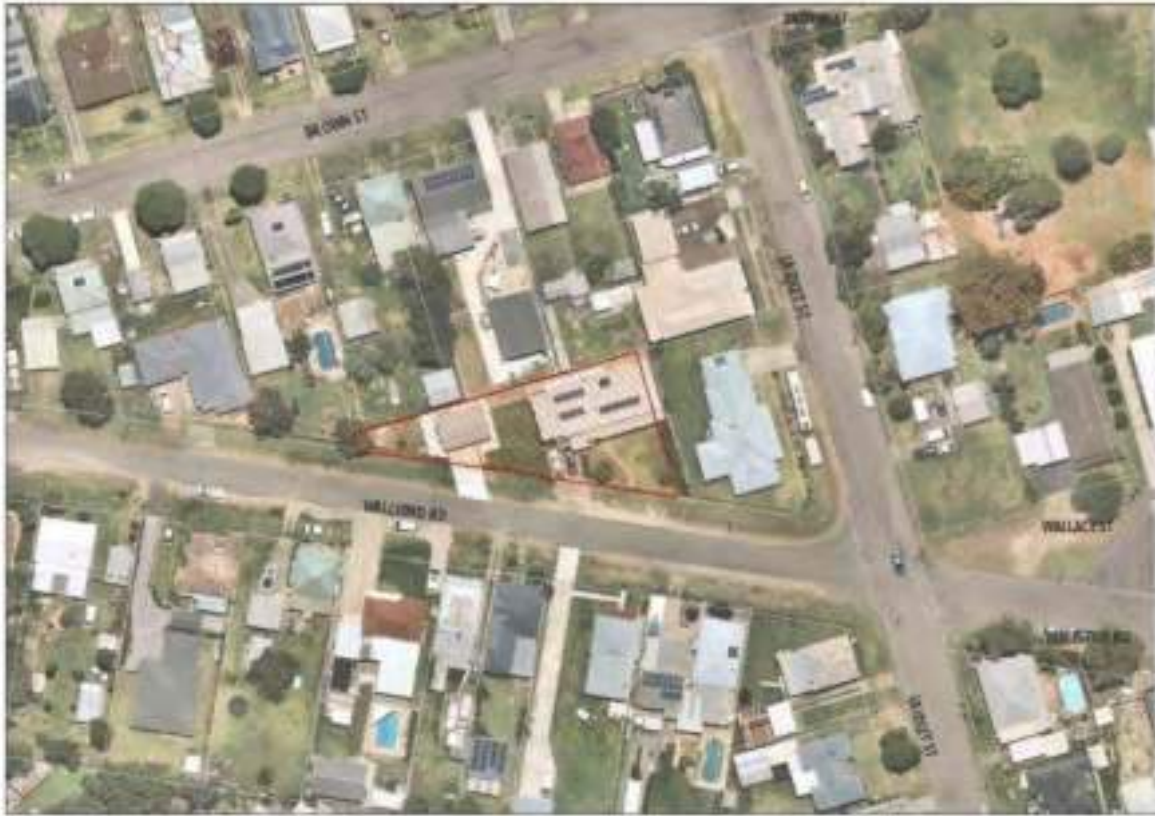
11 WALLSEND ROAD, WEST WALLSEND 2286

Conservation Area Contribution Level	Est. Construction Date	Previous studies and/or community input
Non-Contributory	Mid to late 20 th century onwards	No prior heritage assessments or research undertaken.
Assessment Text		Observed Modifications
<p>The scale (e.g. double-storey or greater) and general style of the dwelling is inconsistent with that of the streetscape and wider HCA.</p> <p>The dwelling does not contribute positively to the streetscape and wider HCA, particularly in comparison to Contributory 1 and 2 buildings. The presence of the building has an adverse impact on the streetscape and/or wider HCA.</p> <p>The dwelling features inappropriately proportioned and positioned fenestrations, an inappropriate roof form (gabled or hipped) and/or other features that are inconsistent with the architectural character of the area (e.g. unsympathetic additions, inconsistent [contemporary] building materials, etc).</p>		No modifications observed.

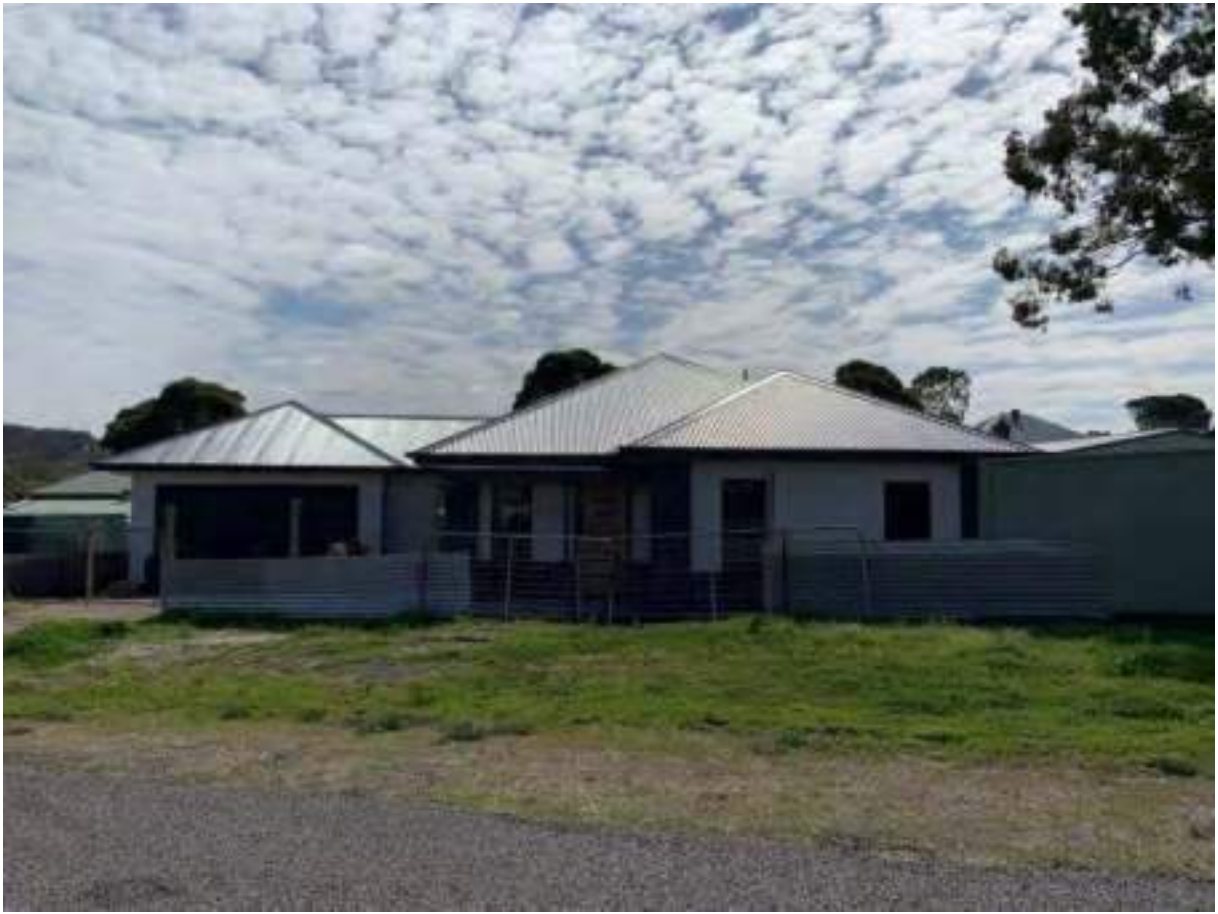
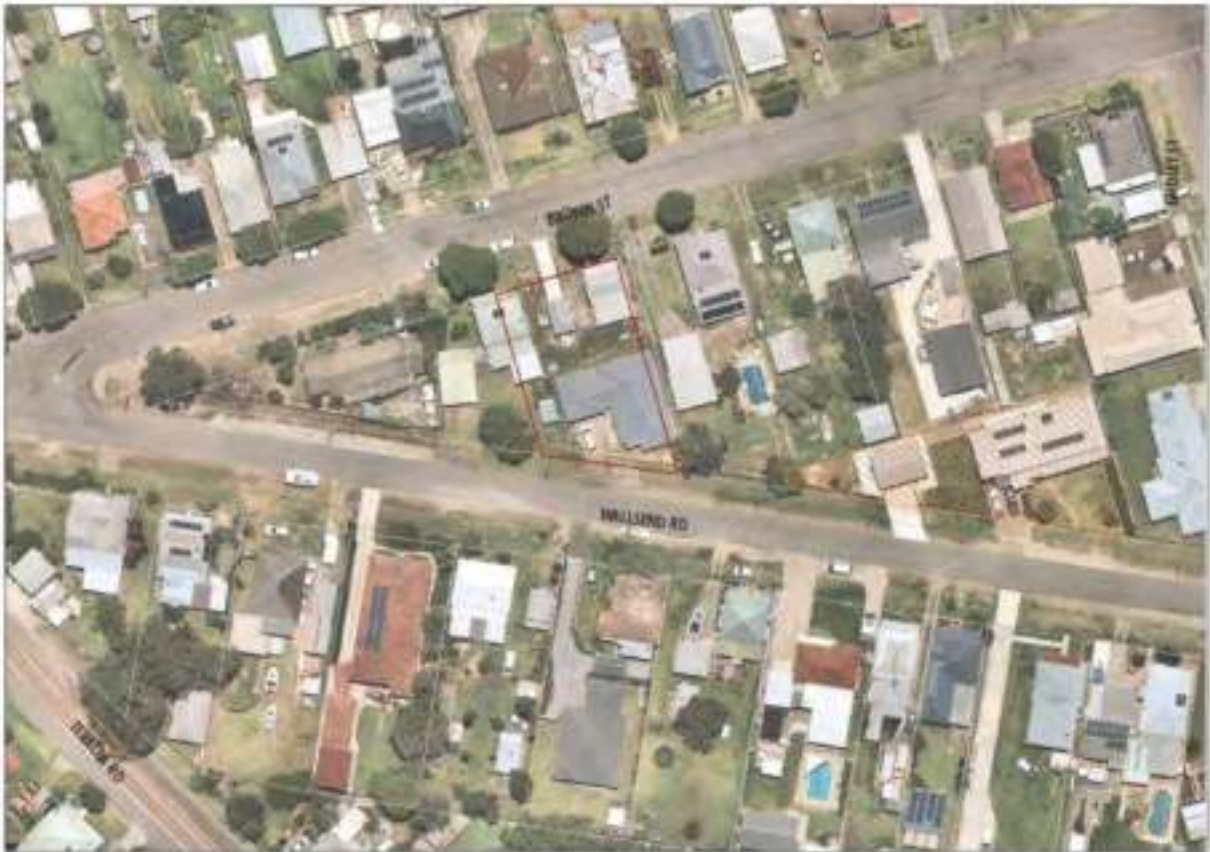
84 BROWN STREET, WEST WALLSEND 2286		
Conservation Area Contribution Level	Est. Construction Date	Previous studies and/or community input
Non-Contributory	Mid to late 20 th century onwards	No prior heritage assessments or research undertaken.
Assessment Text		Observed Modifications
<p>The scale (e.g. double-storey or greater) and general style of the dwelling is inconsistent with that of the streetscape and wider HCA.</p> <p>The dwelling does not contribute positively to the streetscape and wider HCA, particularly in comparison to Contributory 1 and 2 buildings. The presence of the building has an adverse impact on the streetscape and/or wider HCA.</p> <p>The dwelling features inappropriately proportioned and positioned fenestrations, an inappropriate roof form (gabled or hipped) and/or other features that are inconsistent with the architectural character of the area (e.g. unsympathetic additions, inconsistent [contemporary] building materials, etc).</p>		No modifications observed.
