APPENDIX 2

Building Assessment Sheets (Inventory Sheets)

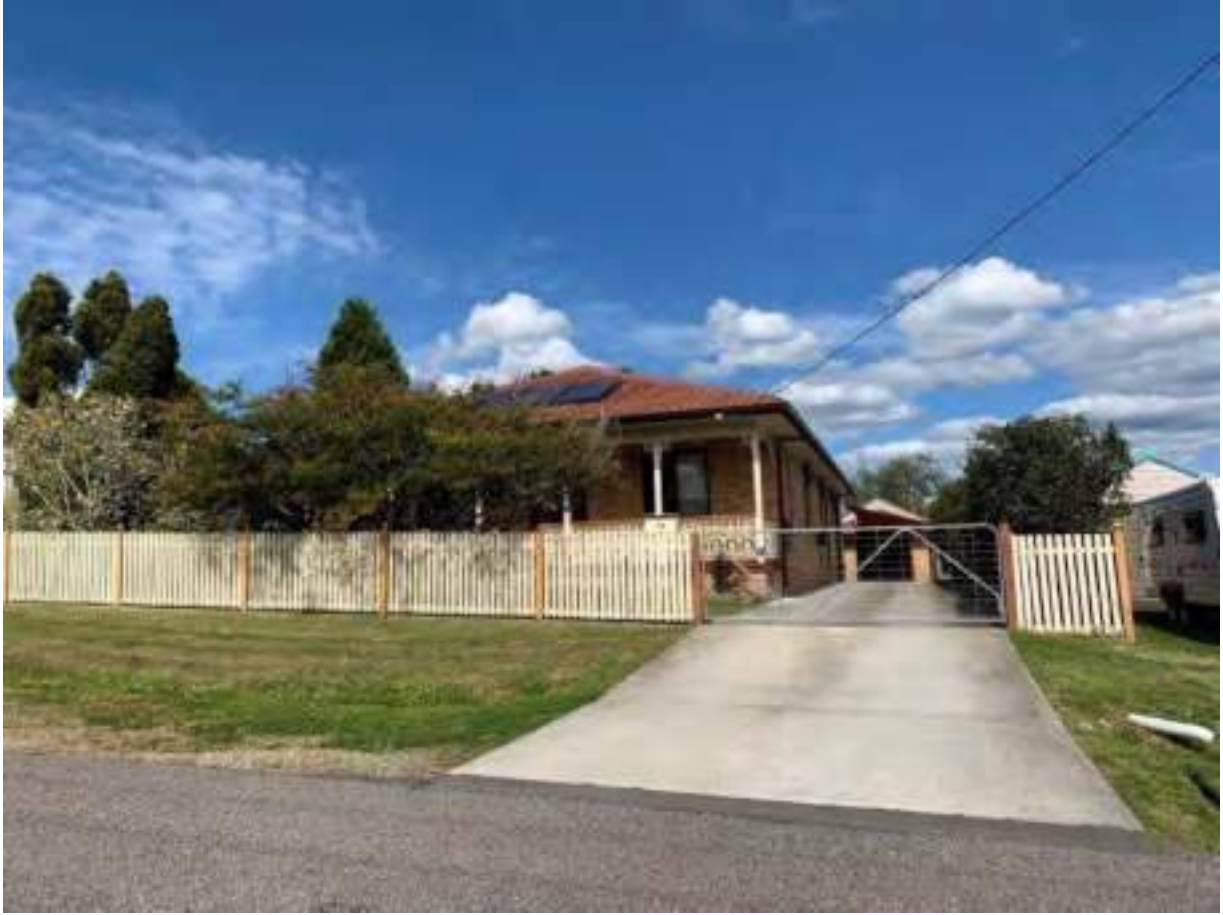
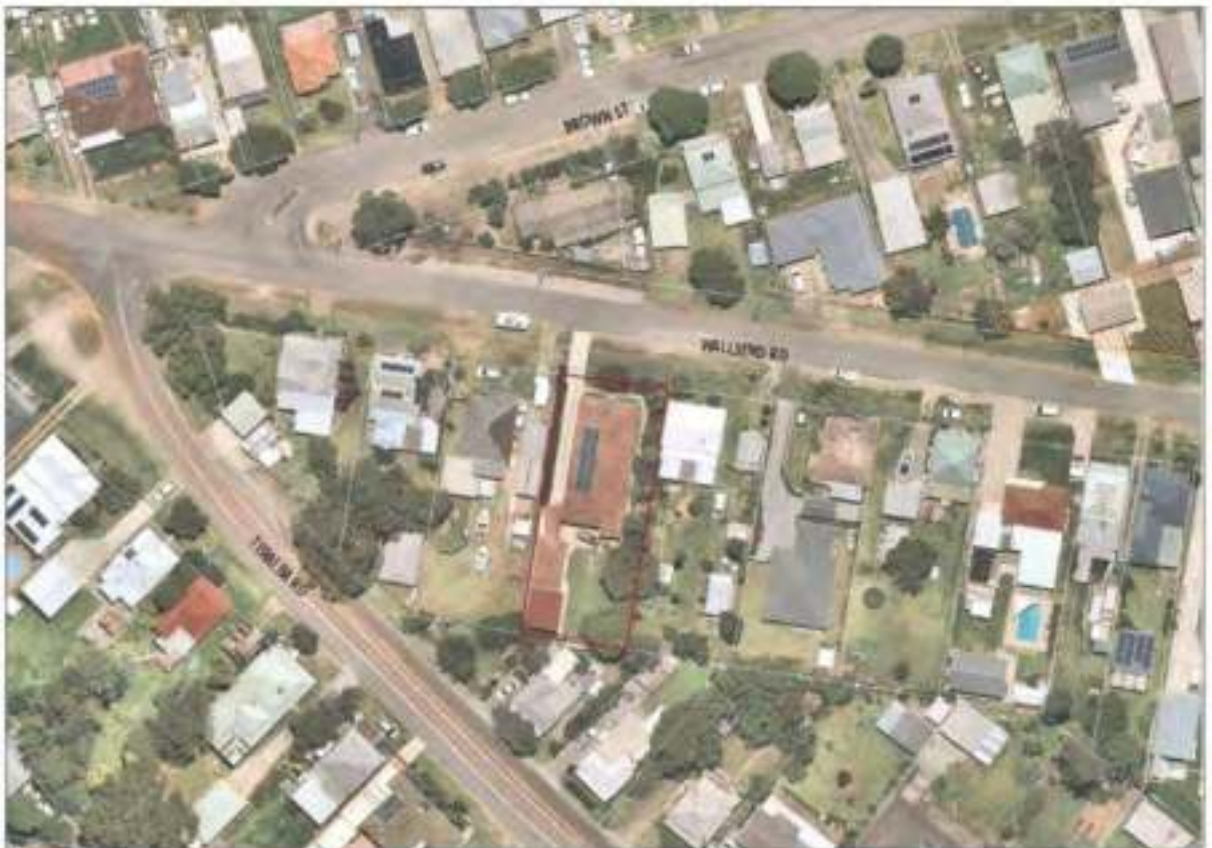
36 WALLSEND ROAD, WEST WALLSEND 2286		
Conservation Area Contribution Level	Est. Construction Date	Previous studies and/or community input
Non-Contributory	Mid to late 20 th century onwards	No prior heritage assessments or research undertaken.
Assessment Text		Observed Modifications
<p>The scale (e.g. double-storey or greater) and general style of the dwelling is inconsistent with that of the streetscape and wider HCA.</p> <p>The dwelling does not contribute positively to the streetscape and wider HCA, particularly in comparison to Contributory 1 and 2 buildings. The presence of the building has an adverse impact on the streetscape and/or wider HCA.</p> <p>The dwelling features inappropriately proportioned and positioned fenestrations, an inappropriate roof form (gabled or hipped) and/or other features that are inconsistent with the architectural character of the area (e.g. unsympathetic additions, inconsistent [contemporary] building materials, etc).</p>		No modifications observed.

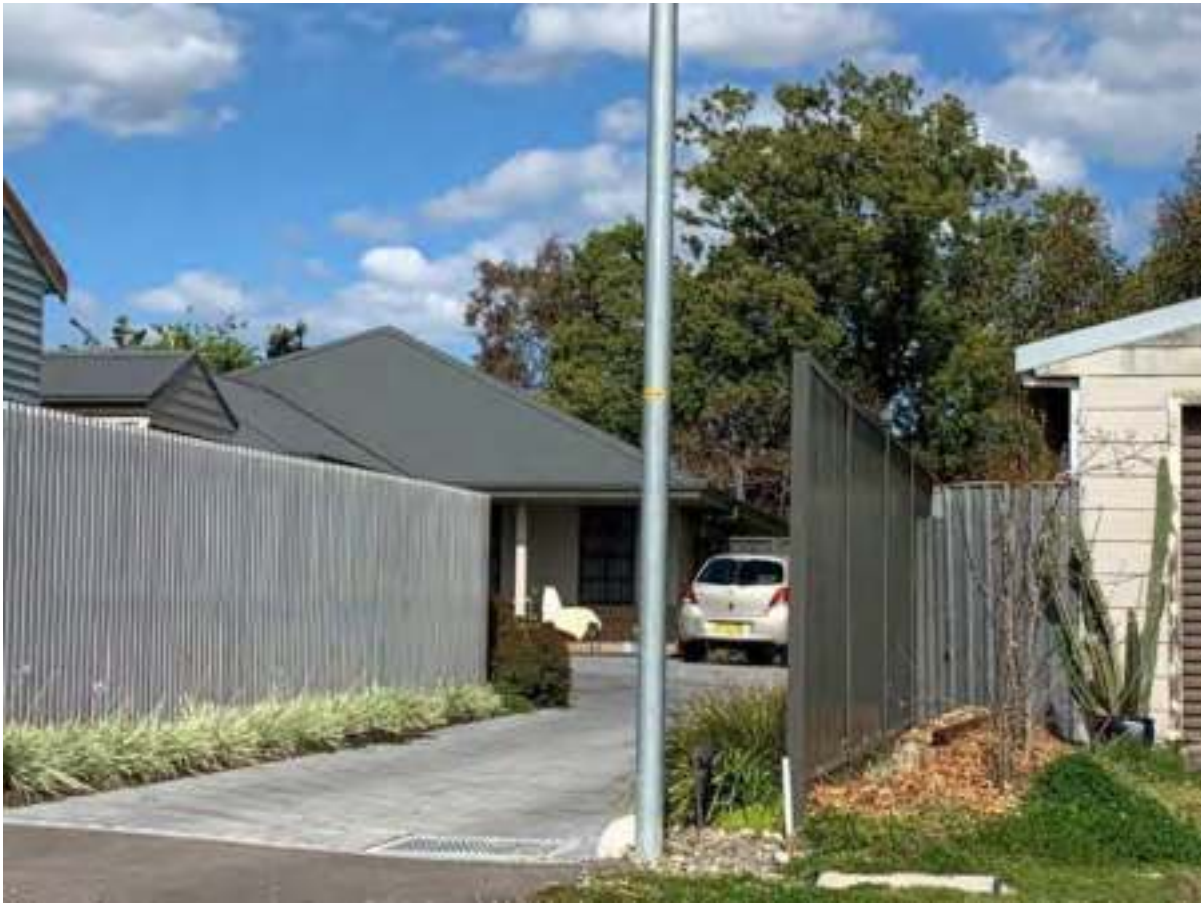
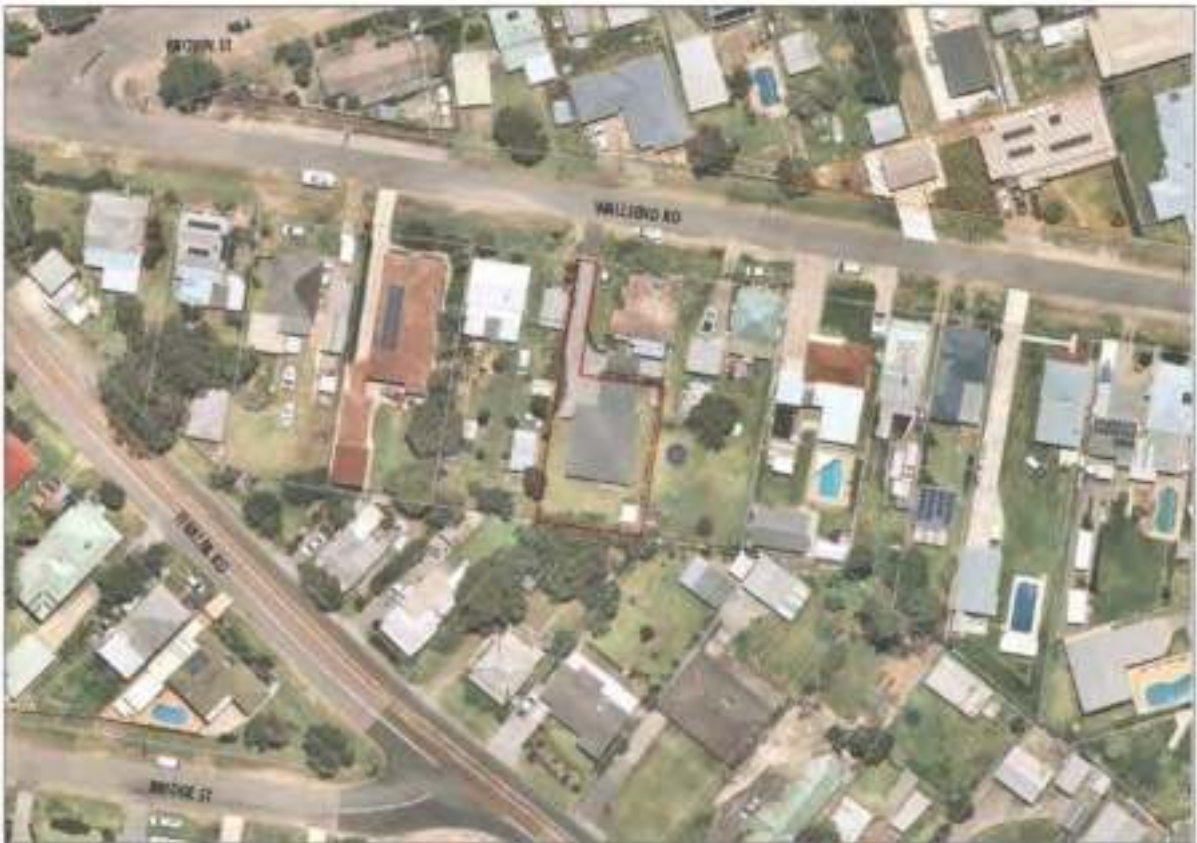
32 WALLSEND ROAD, WEST WALLSEND 2286

Conservation Area Contribution Level	Est. Construction Date	Previous studies and/or community input
Non-Contributory	Mid to late 20 th century onwards	No prior heritage assessments or research undertaken.
Assessment Text		Observed Modifications
<p>The scale (e.g. double-storey or greater) and general style of the dwelling is inconsistent with that of the streetscape and wider HCA.</p> <p>The dwelling does not contribute positively to the streetscape and wider HCA, particularly in comparison to Contributory 1 and 2 buildings. The presence of the building has an adverse impact on the streetscape and/or wider HCA.</p> <p>The dwelling features inappropriately proportioned and positioned fenestrations, an inappropriate roof form (gabled or hipped) and/or other features that are inconsistent with the architectural character of the area (e.g. unsympathetic additions, inconsistent [contemporary] building materials, etc).</p>		<p>The dwelling is located at the back of an allotment, and as such is obscured. No modifications observed.</p>

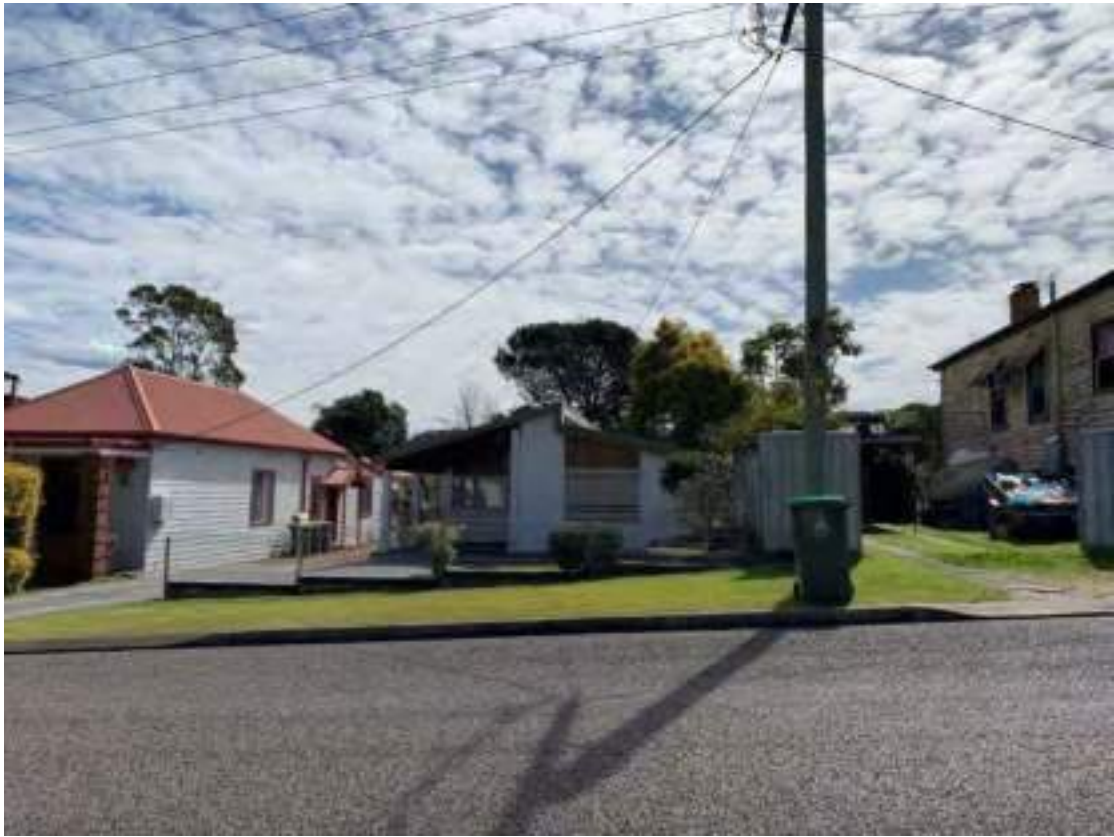
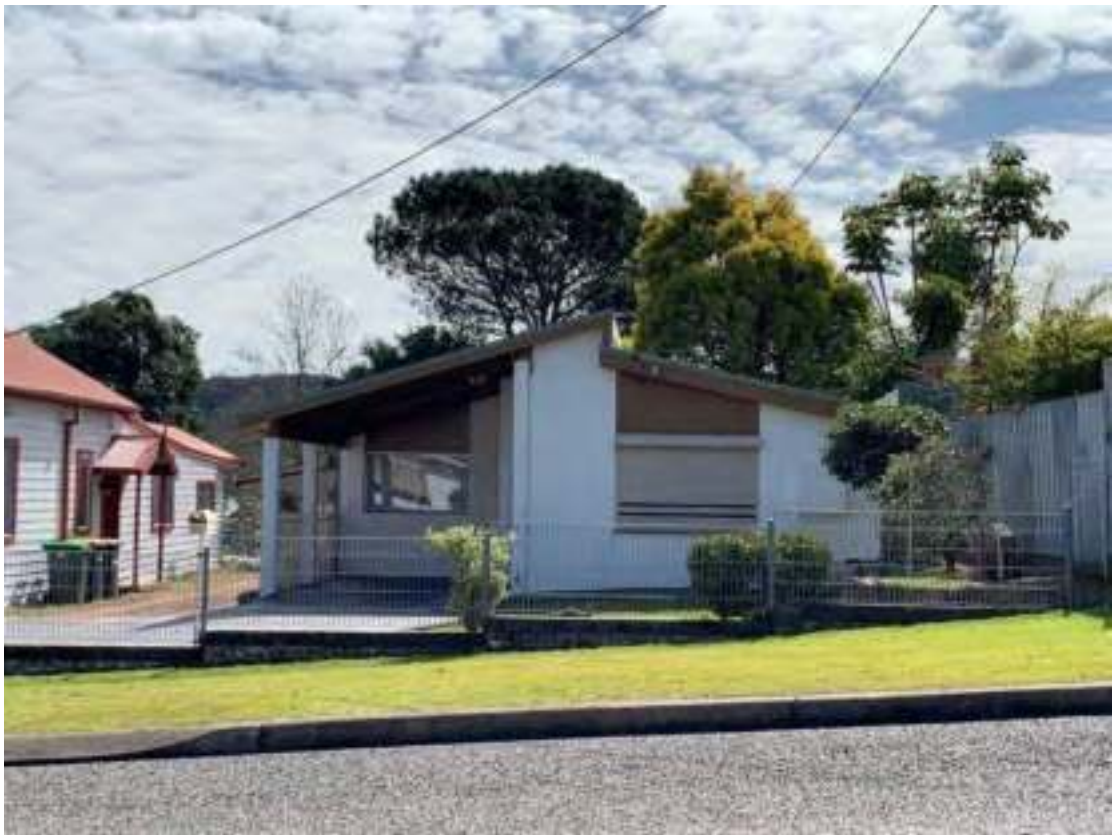
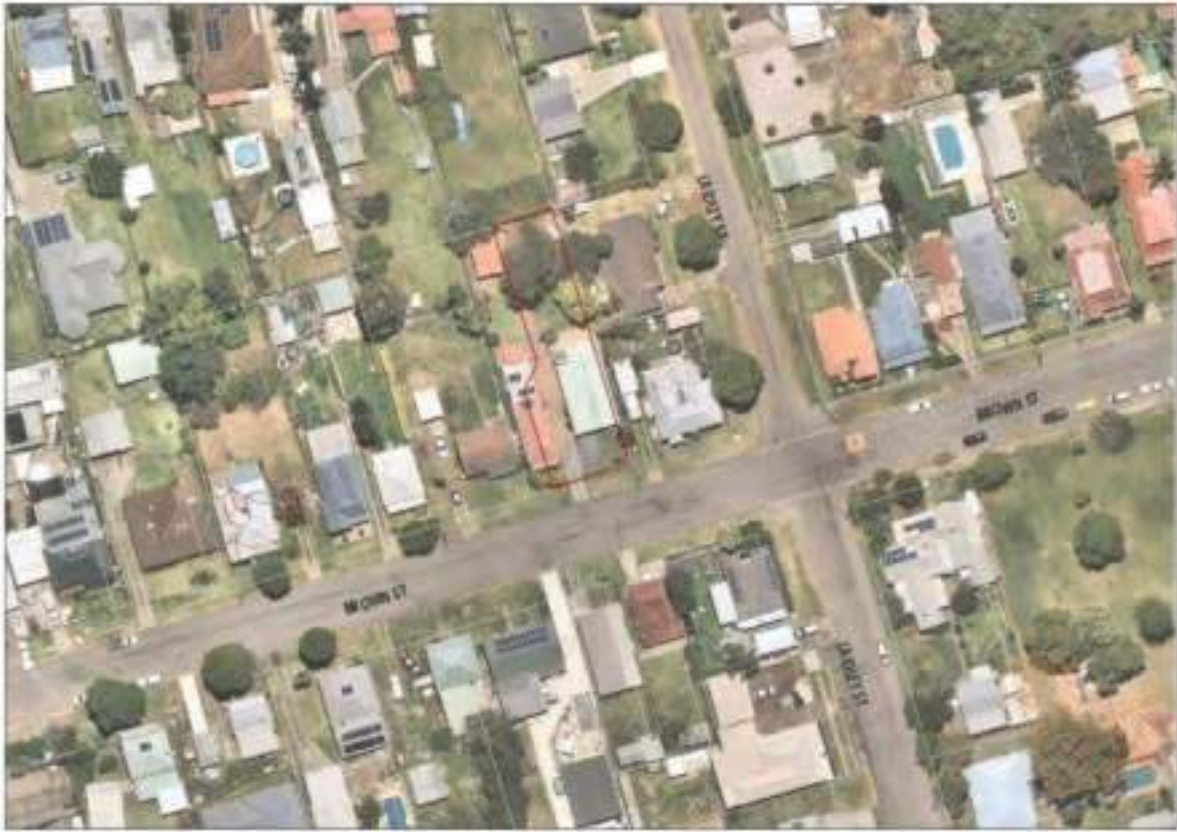
57 BROWN STREET, WEST WALLSEND 2286

Conservation Area Contribution Level	Est. Construction Date	Previous studies and/or community input
Non-Contributory	Mid to late 20 th century onwards	No prior heritage assessments or research undertaken.
Assessment Text		Observed Modifications
<p>The scale (e.g. double-storey or greater) and general style of the dwelling is inconsistent with that of the streetscape and wider HCA.</p> <p>The dwelling does not contribute positively to the streetscape and wider HCA, particularly in comparison to Contributory 1 and 2 buildings. The presence of the building has an adverse impact on the streetscape and/or wider HCA.</p> <p>The dwelling features inappropriately proportioned and positioned fenestrations, an inappropriate roof form (gabled or hipped) and/or other features that are inconsistent with the architectural character of the area (e.g. unsympathetic additions, inconsistent [contemporary] building materials, etc).</p>		No modifications observed.

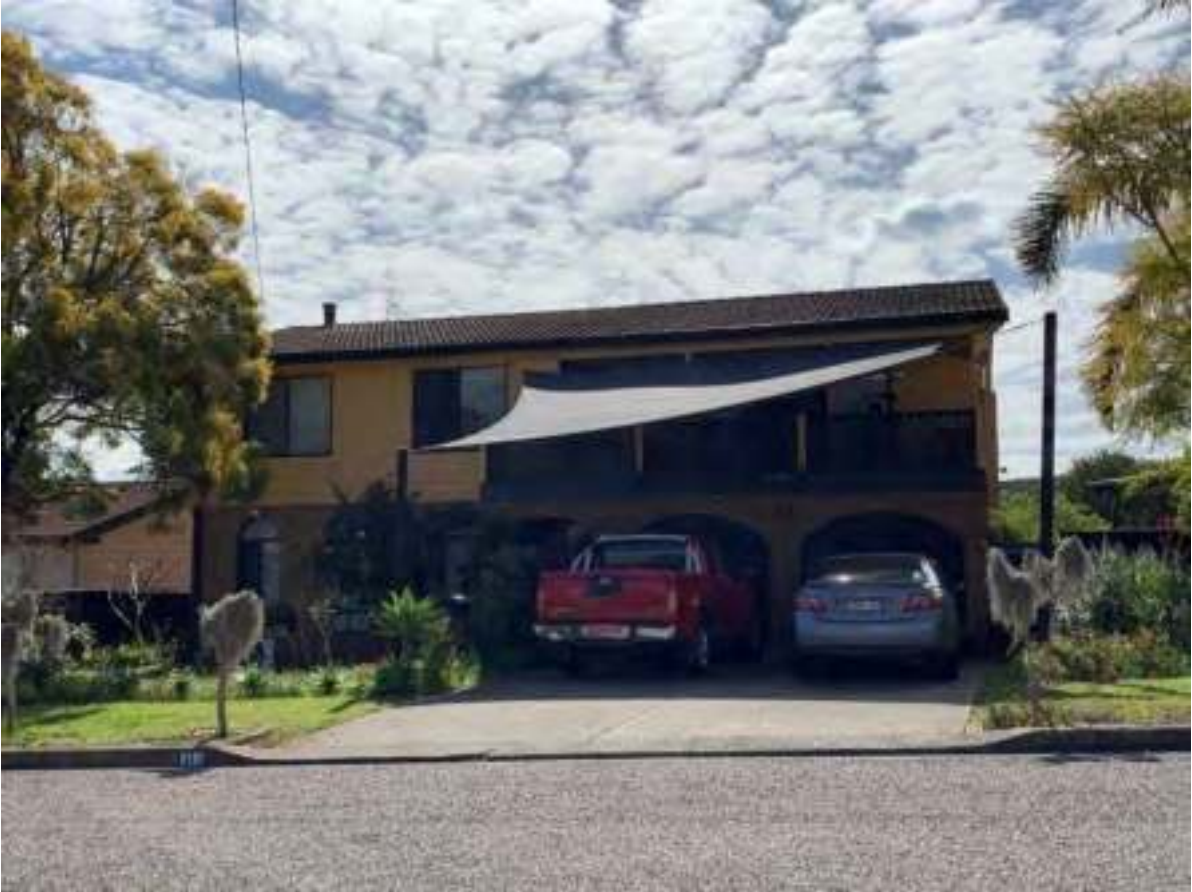
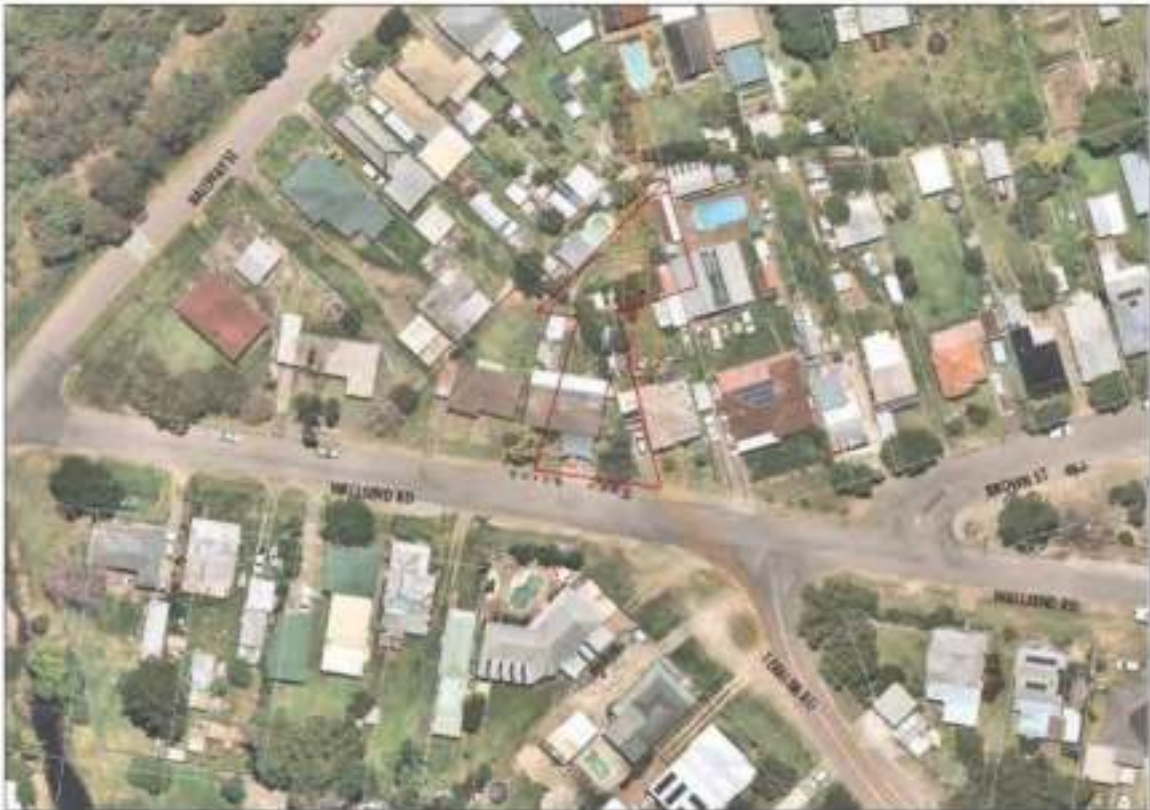
15 WALLSEND ROAD, WEST WALLSEND 2286

Conservation Area Contribution Level	Est. Construction Date	Previous studies and/or community input
Non-Contributory	Mid to late 20 th century onwards	No prior heritage assessments or research undertaken.
Assessment Text		Observed Modifications
<p>The scale (e.g. double-storey or greater) and general style of the dwelling is inconsistent with that of the streetscape and wider HCA.</p> <p>The dwelling does not contribute positively to the streetscape and wider HCA, particularly in comparison to Contributory 1 and 2 buildings. The presence of the building has an adverse impact on the streetscape and/or wider HCA.</p> <p>The dwelling features inappropriately proportioned and positioned fenestrations, an inappropriate roof form (gabled or hipped) and/or other features that are inconsistent with the architectural character of the area (e.g. unsympathetic additions, inconsistent [contemporary] building materials, etc).</p>		<p>A large canvas shade cloth has been installed.</p>

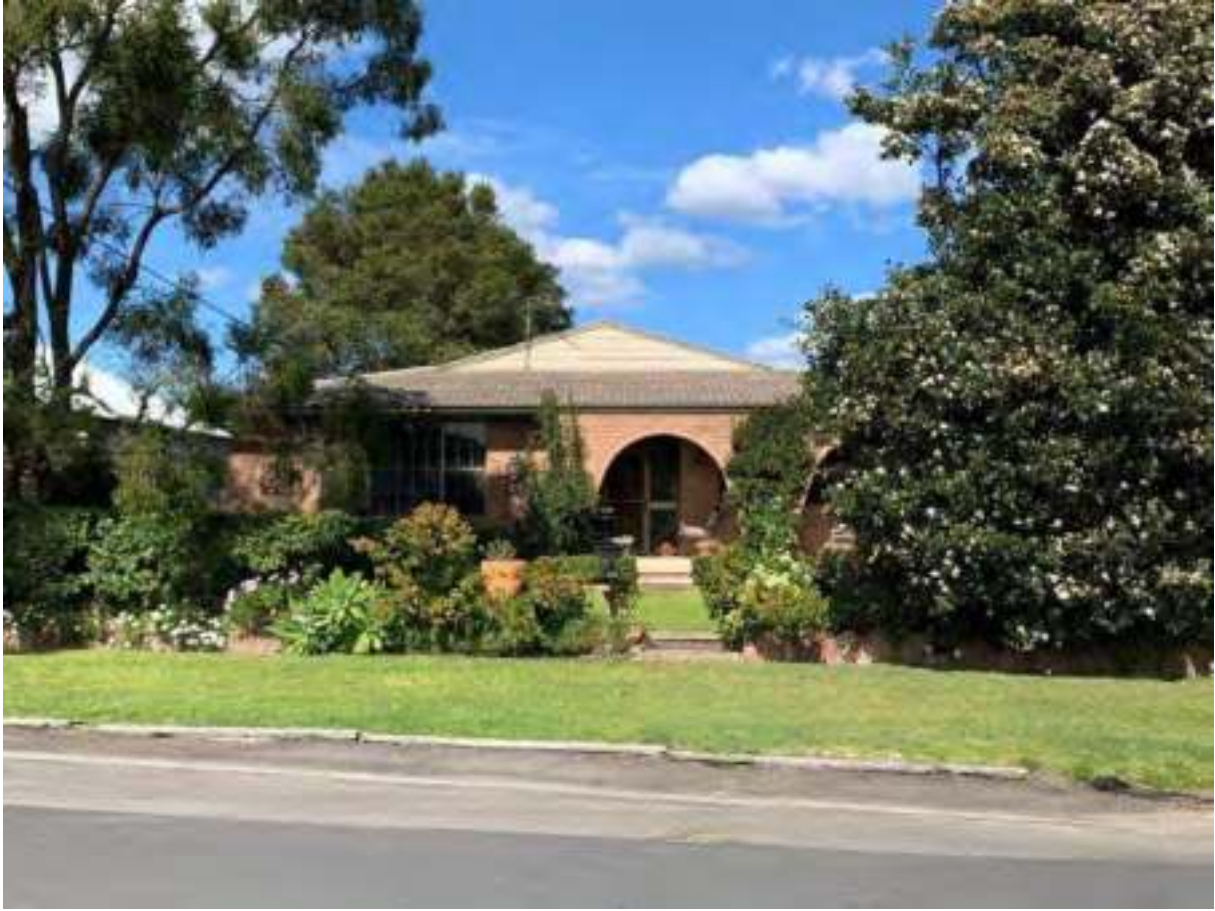
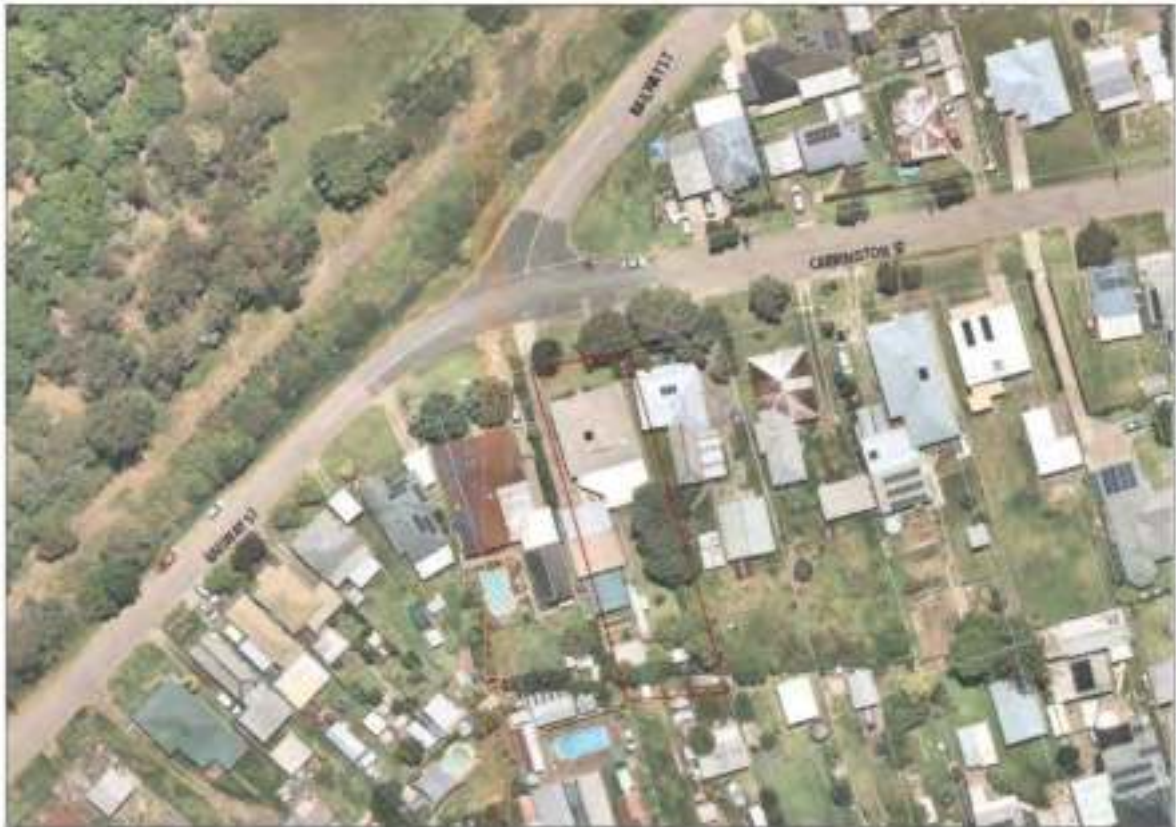
112 CARRINGTON STREET, WEST WALLSEND 2286

Conservation Area Contribution Level	Est. Construction Date	Previous studies and/or community input
Non-Contributory	Mid to late 20 th century onwards	No prior heritage assessments or research undertaken.
Assessment Text		Observed Modifications
<p>The scale (e.g. double-storey or greater) and general style of the dwelling is inconsistent with that of the streetscape and wider HCA.</p> <p>The dwelling does not contribute positively to the streetscape and wider HCA, particularly in comparison to Contributory 1 and 2 buildings. The presence of the building has an adverse impact on the streetscape and/or wider HCA.</p> <p>The dwelling features inappropriately proportioned and positioned fenestrations, an inappropriate roof form (gabled or hipped) and/or other features that are inconsistent with the architectural character of the area (e.g. unsympathetic additions, inconsistent [contemporary] building materials, etc).</p>		No modifications observed.

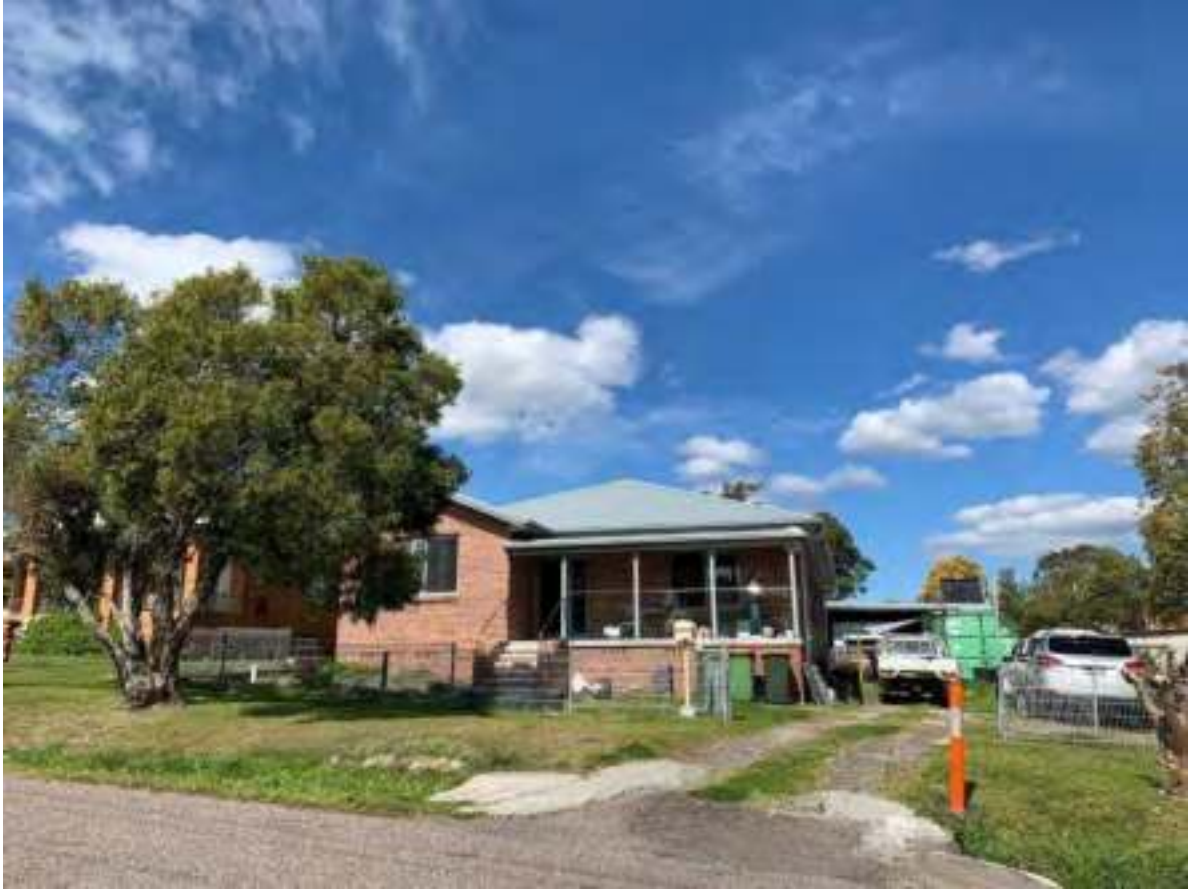
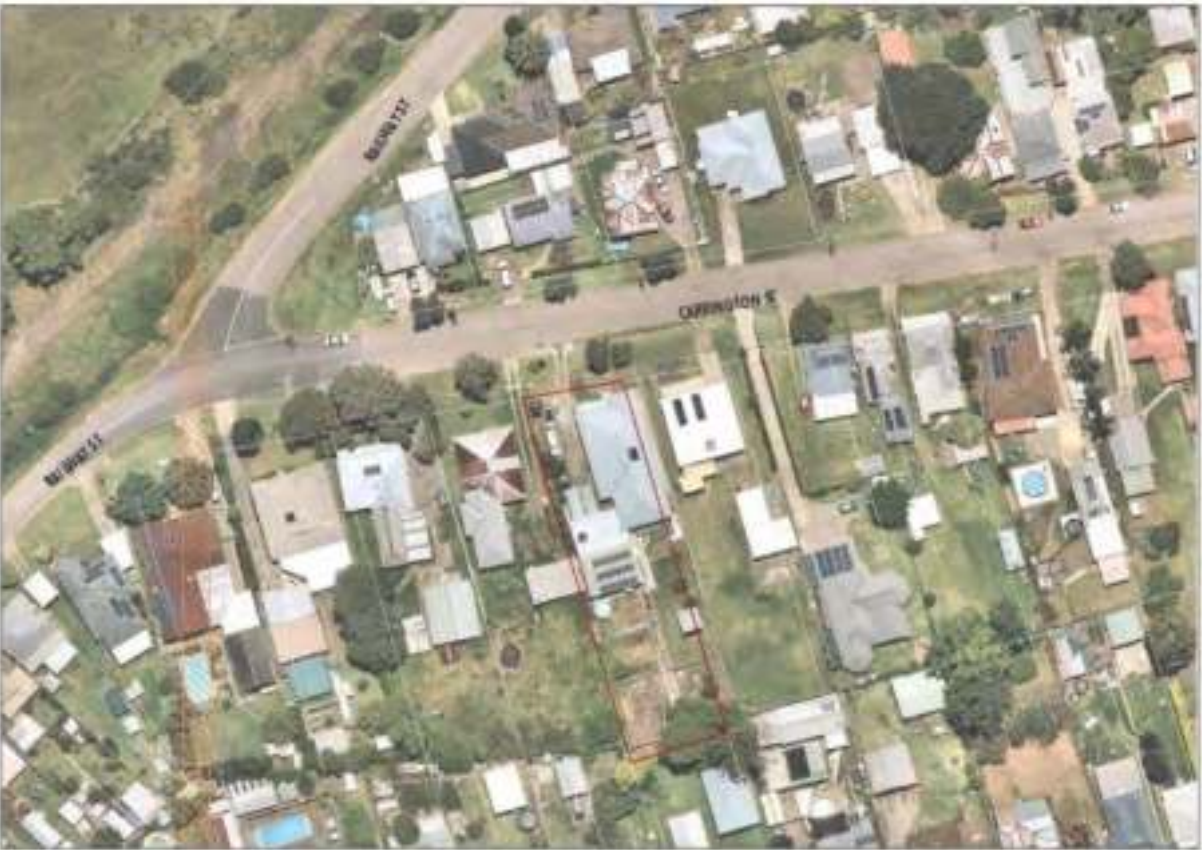
106 CARRINGTON STREET, WEST WALLSEND 2286

Conservation Area Contribution Level	Est. Construction Date	Previous studies and/or community input
Non-Contributory	Mid to late 20 th century onwards	No prior heritage assessments or research undertaken.
Assessment Text		Observed Modifications
<p>The scale (e.g. double-storey or greater) and general style of the dwelling is inconsistent with that of the streetscape and wider HCA.</p> <p>The dwelling does not contribute positively to the streetscape and wider HCA, particularly in comparison to Contributory 1 and 2 buildings. The presence of the building has an adverse impact on the streetscape and/or wider HCA.</p> <p>The dwelling features inappropriately proportioned and positioned fenestrations, an inappropriate roof form (gabled or hipped) and/or other features that are inconsistent with the architectural character of the area (e.g. unsympathetic additions, inconsistent [contemporary] building materials, etc).</p>		No modifications observed.

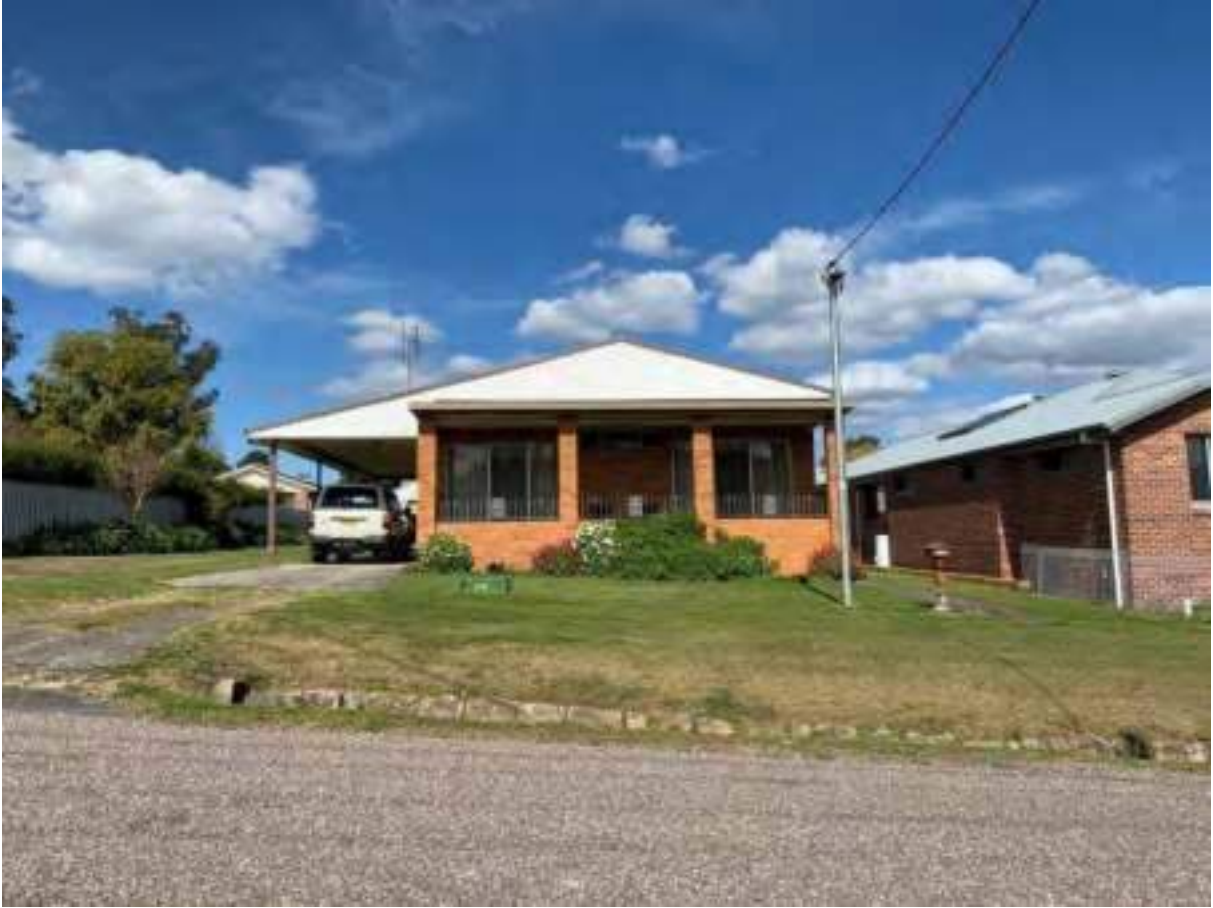
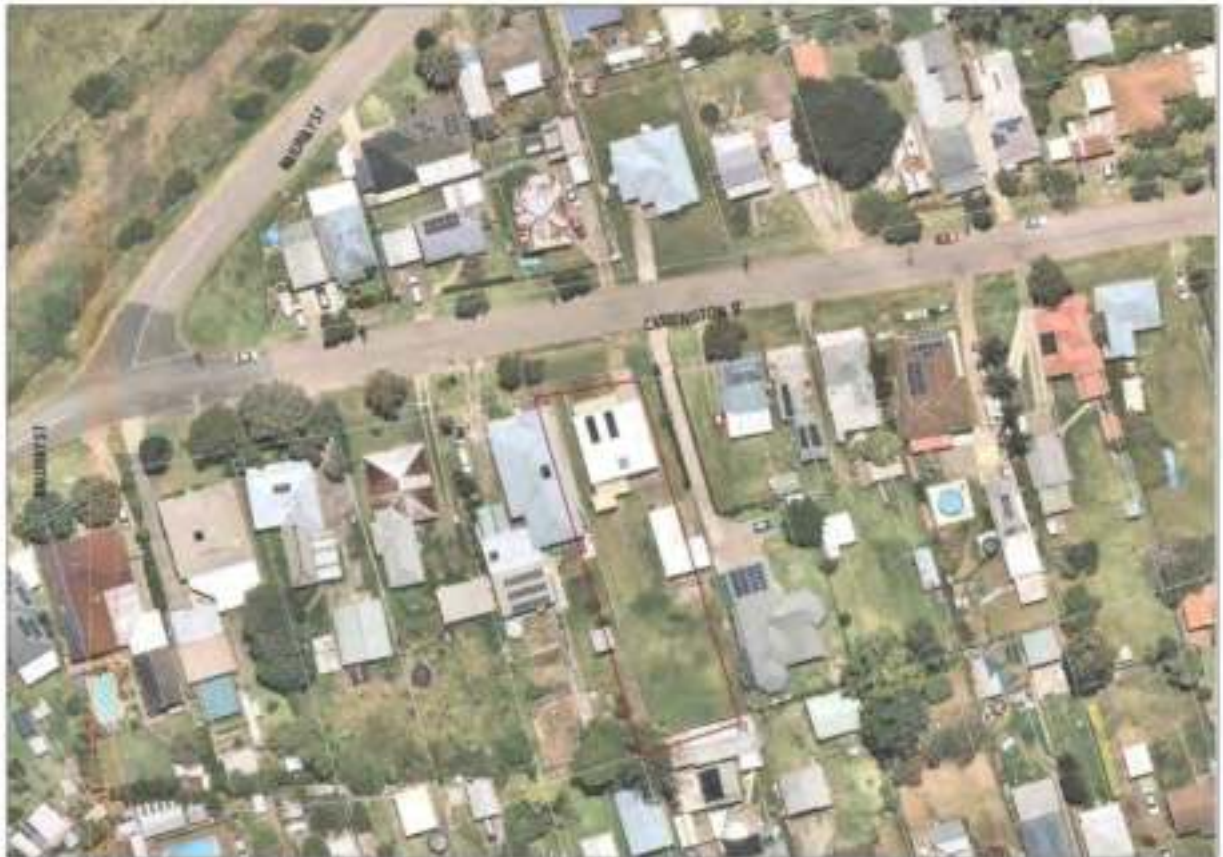
104 CARRINGTON STREET, WEST WALLSEND 2286

Conservation Area Contribution Level	Est. Construction Date	Previous studies and/or community input
Non-Contributory	Mid to late 20 th century onwards	No prior heritage assessments or research undertaken.
Assessment Text		Observed Modifications
<p>The scale (e.g. double-storey or greater) and general style of the dwelling is inconsistent with that of the streetscape and wider HCA.</p> <p>The dwelling does not contribute positively to the streetscape and wider HCA, particularly in comparison to Contributory 1 and 2 buildings. The presence of the building has an adverse impact on the streetscape and/or wider HCA.</p> <p>The dwelling features inappropriately proportioned and positioned fenestrations, an inappropriate roof form (gabled or hipped) and/or other features that are inconsistent with the architectural character of the area (e.g. unsympathetic additions, inconsistent [contemporary] building materials, etc).</p>		No modifications observed.

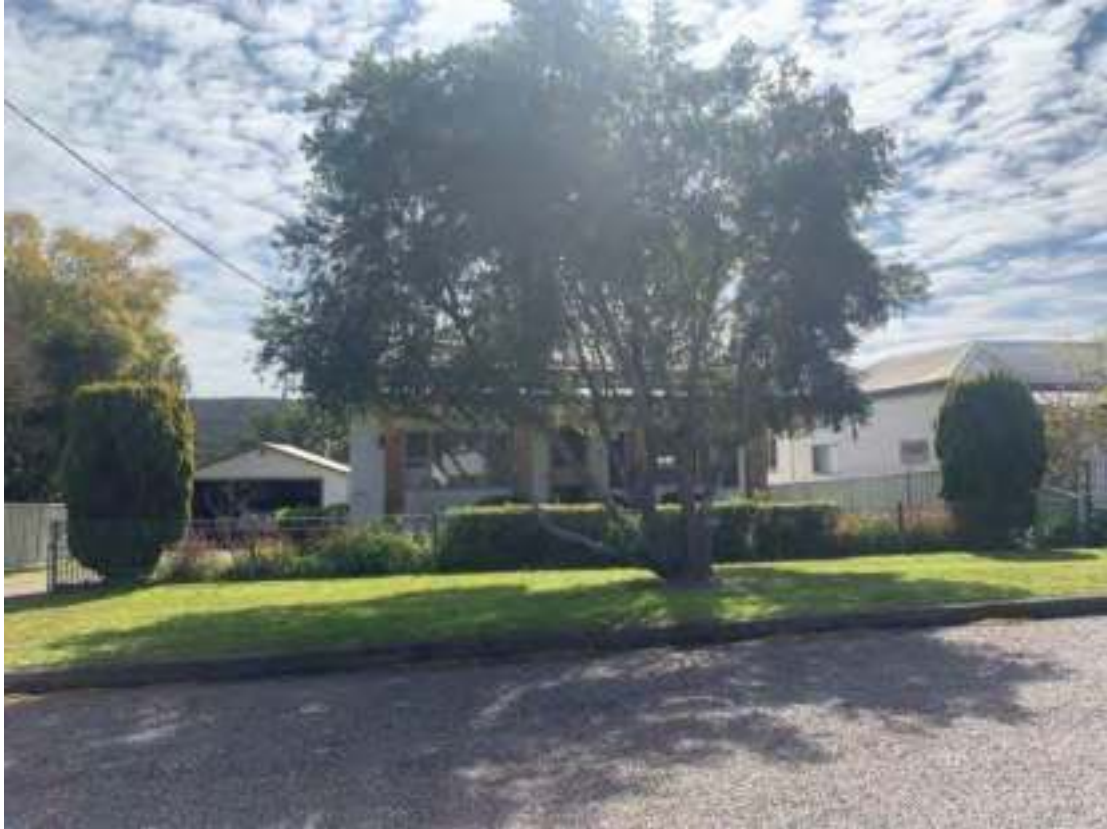
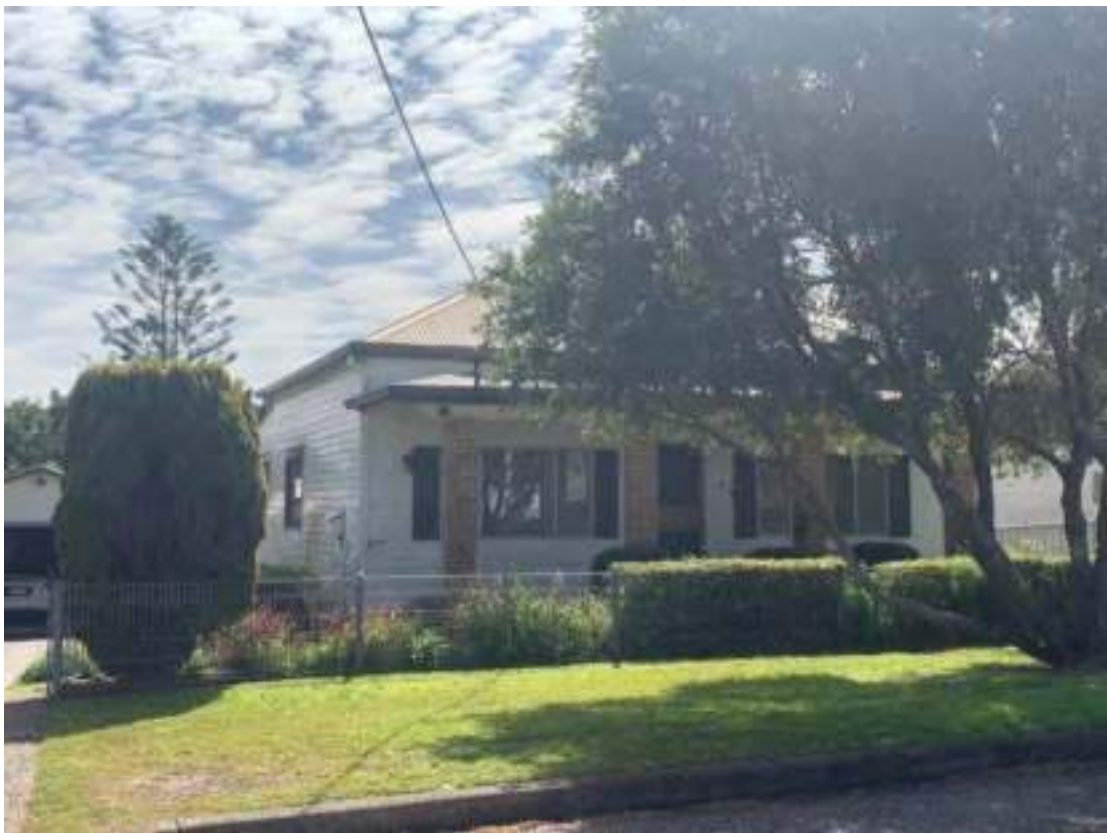
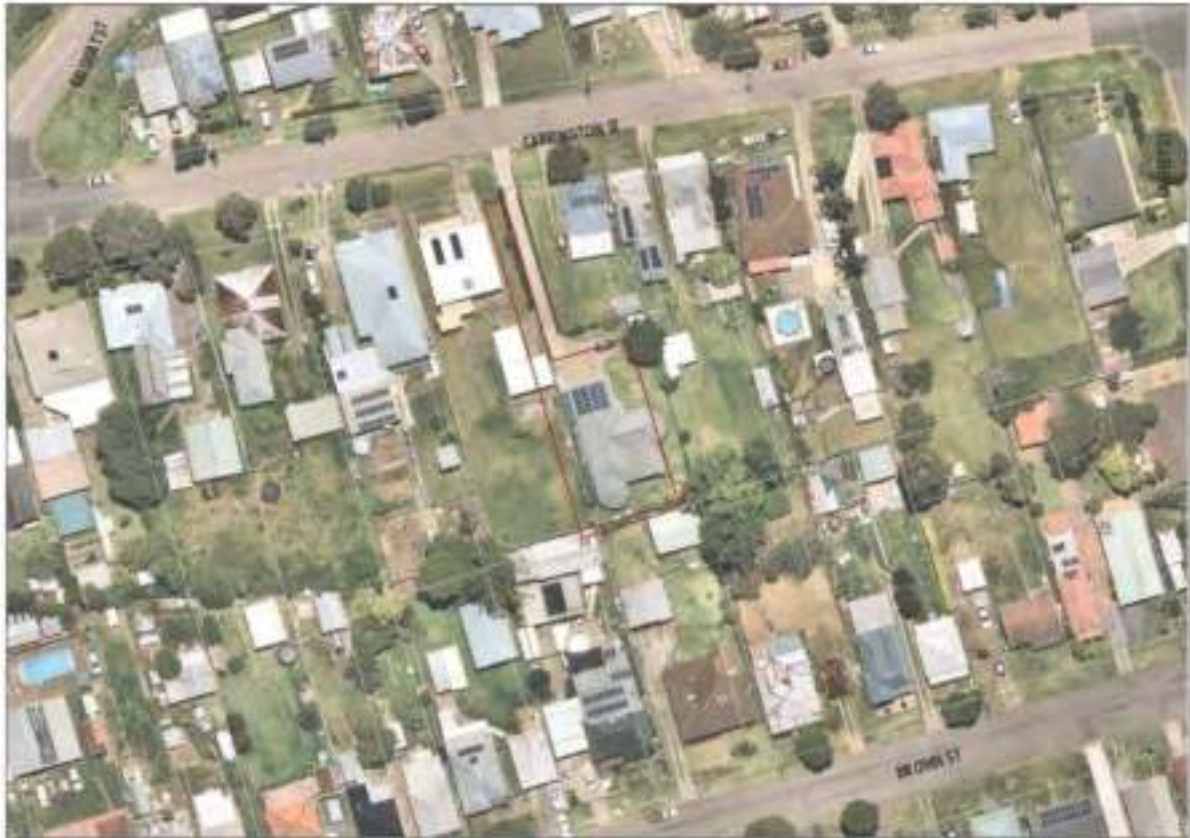
Conservation Area Contribution Level	Est. Construction Date	Previous studies and/or community input
Non-Contributory	Mid to late 20 th century onwards	No prior heritage assessments or research undertaken.
Assessment Text		Observed Modifications
<p>The scale (e.g. double-storey or greater) and general style of the dwelling is inconsistent with that of the streetscape and wider HCA.</p> <p>The dwelling does not contribute positively to the streetscape and wider HCA, particularly in comparison to Contributory 1 and 2 buildings. The presence of the building has an adverse impact on the streetscape and/or wider HCA.</p> <p>The dwelling features inappropriately proportioned and positioned fenestrations, an inappropriate roof form (gabled or hipped) and/or other features that are inconsistent with the architectural character of the area (e.g. unsympathetic additions, inconsistent [contemporary] building materials, etc).</p>		No modifications observed.

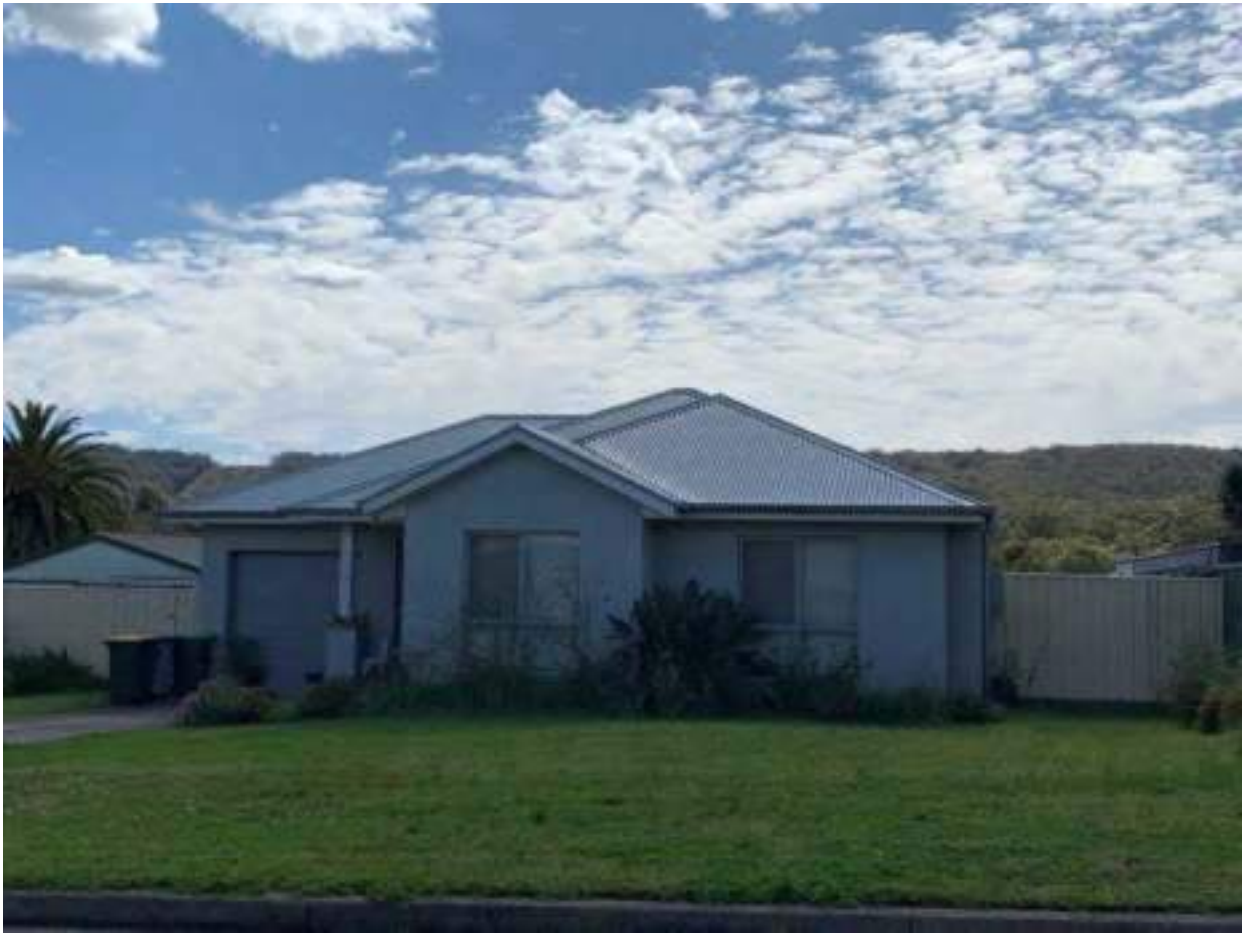
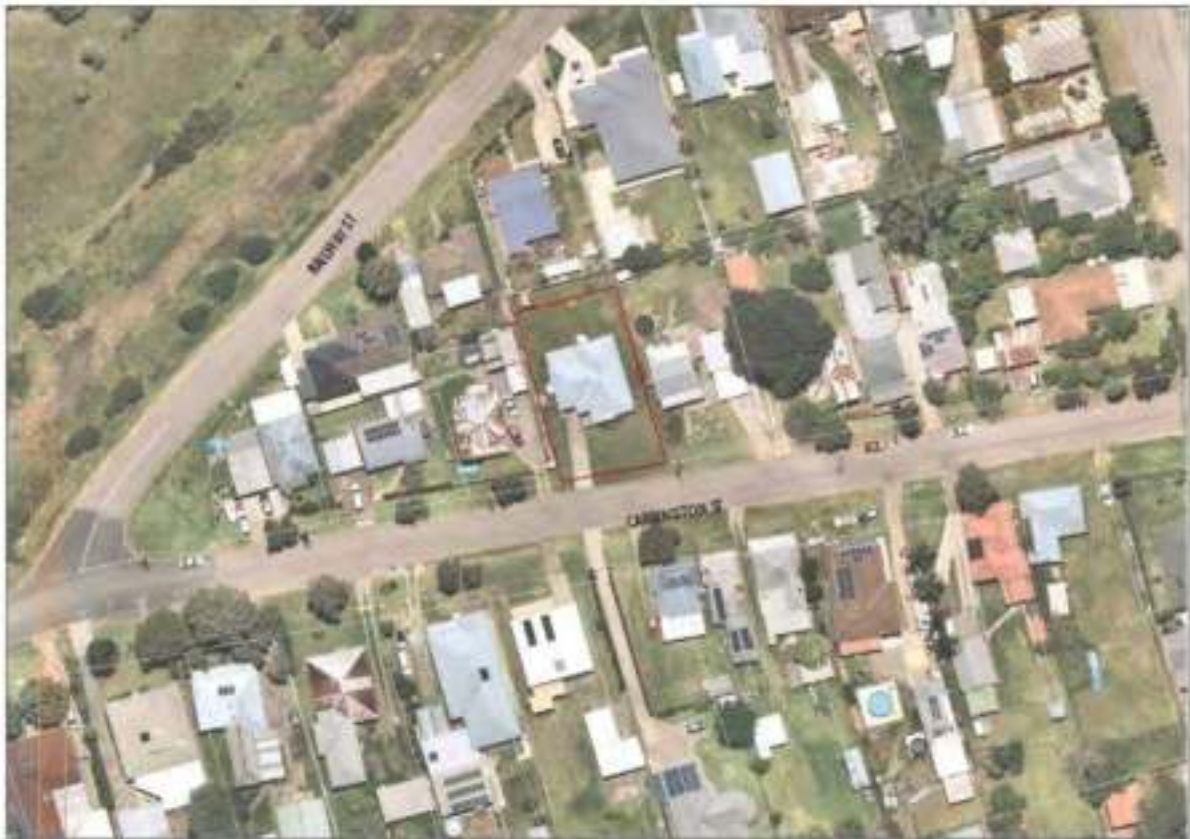
103 CARRINGTON STREET, WEST WALLSEND 2286

Conservation Area Contribution Level	Est. Construction Date	Previous studies and/or community input
Non-Contributory	Mid to late 20 th century onwards	No prior heritage assessments or research undertaken.
Assessment Text		Observed Modifications
<p>The scale (e.g. double-storey or greater) and general style of the dwelling is inconsistent with that of the streetscape and wider HCA.</p> <p>The dwelling does not contribute positively to the streetscape and wider HCA, particularly in comparison to Contributory 1 and 2 buildings. The presence of the building has an adverse impact on the streetscape and/or wider HCA.</p> <p>The dwelling features inappropriately proportioned and positioned fenestrations, an inappropriate roof form (gabled or hipped) and/or other features that are inconsistent with the architectural character of the area (e.g. unsympathetic additions, inconsistent [contemporary] building materials, etc).</p>		No modifications observed.
