APPENDIX 2

Building Assessment Sheets (Inventory Sheets)

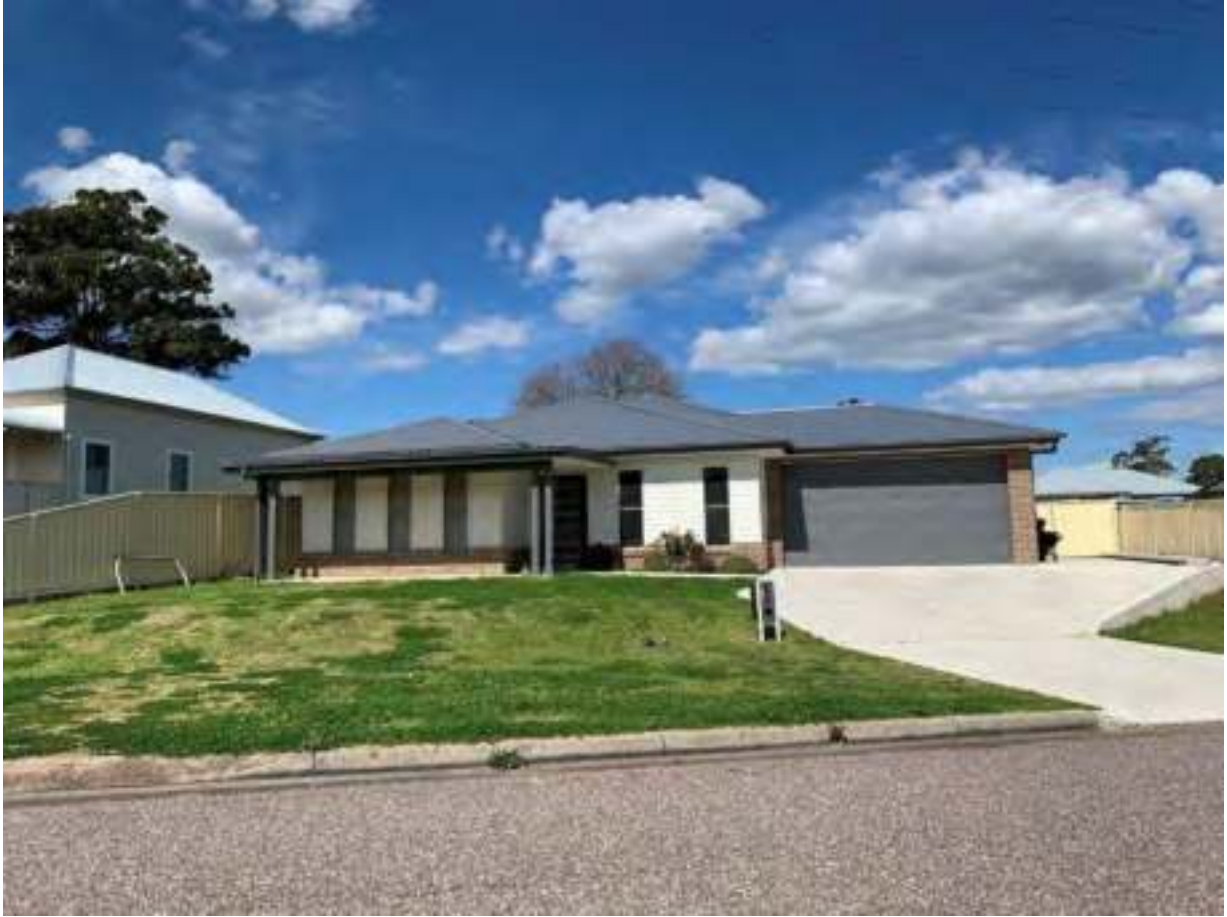
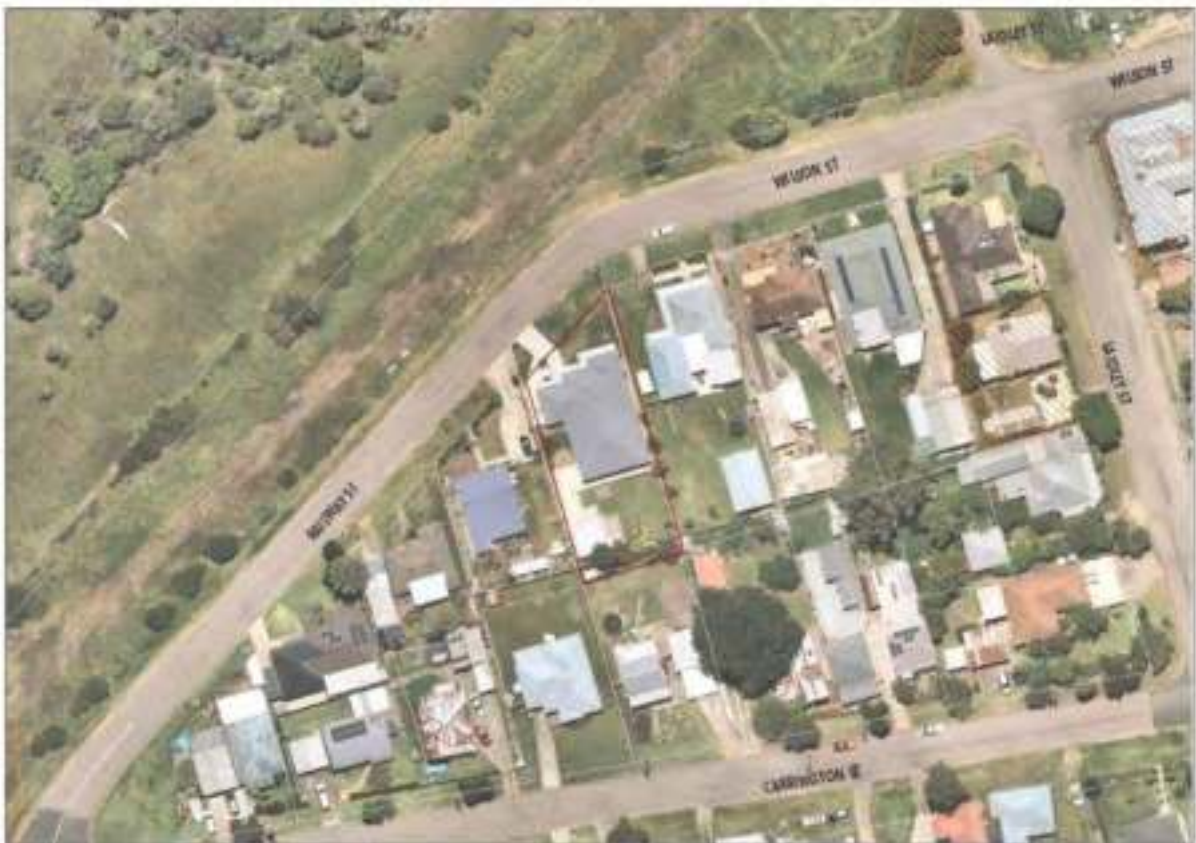
1 RAILWAY STREET, WEST WALLSEND 2286		
Conservation Area Contribution Level	Est. Construction Date	Previous studies and/or community input
Non-Contributory	Mid to late 20 th century onwards	No prior heritage assessments or research undertaken.
Assessment Text		Observed Modifications
<p>The scale (e.g. double-storey or greater) and general style of the dwelling is inconsistent with that of the streetscape and wider HCA.</p> <p>The dwelling does not contribute positively to the streetscape and wider HCA, particularly in comparison to Contributory 1 and 2 buildings. The presence of the building has an adverse impact on the streetscape and/or wider HCA.</p> <p>The dwelling features inappropriately proportioned and positioned fenestrations, an inappropriate roof form (gabled or hipped) and/or other features that are inconsistent with the architectural character of the area (e.g. unsympathetic additions, inconsistent [contemporary] building materials, etc).</p>		No modifications observed.

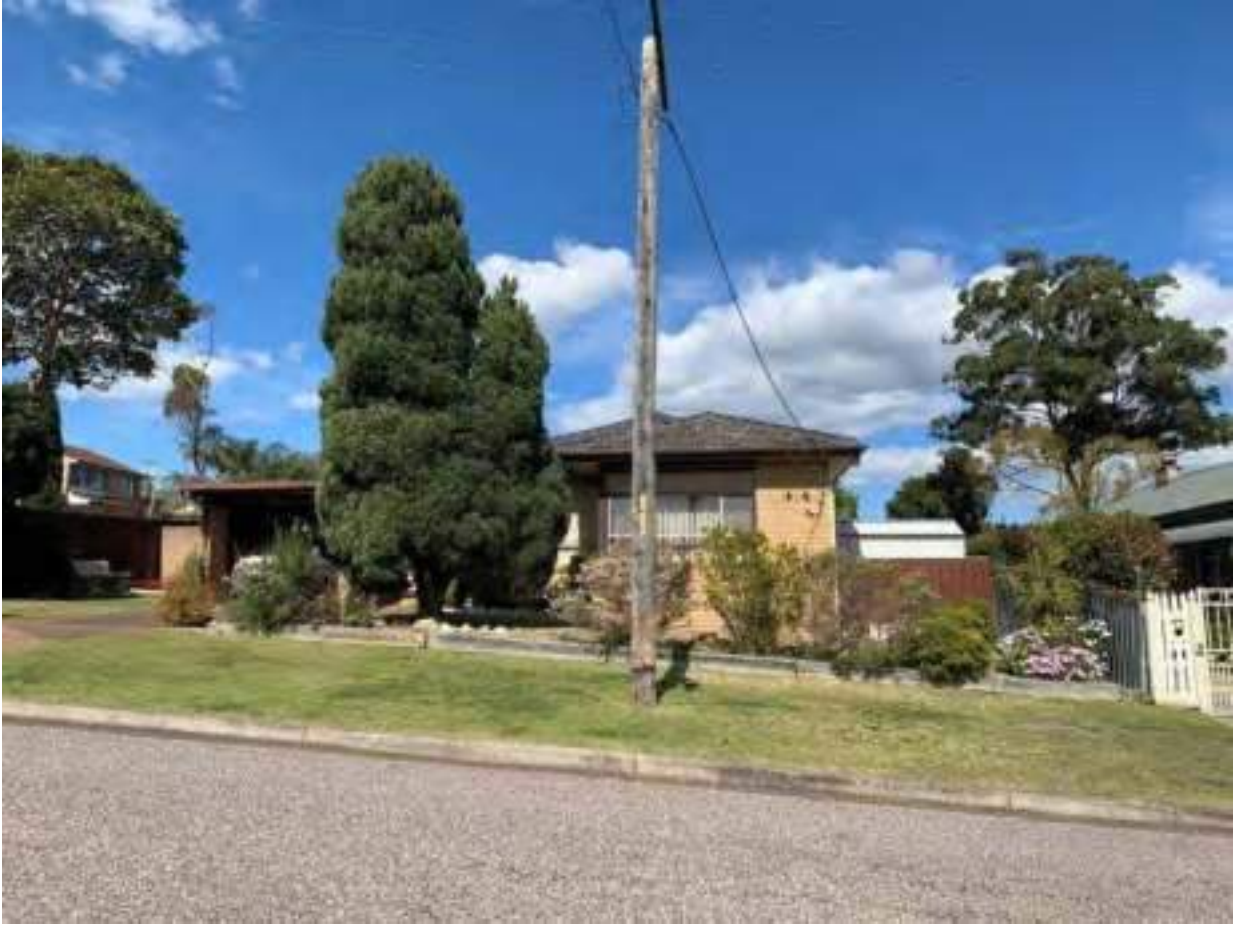
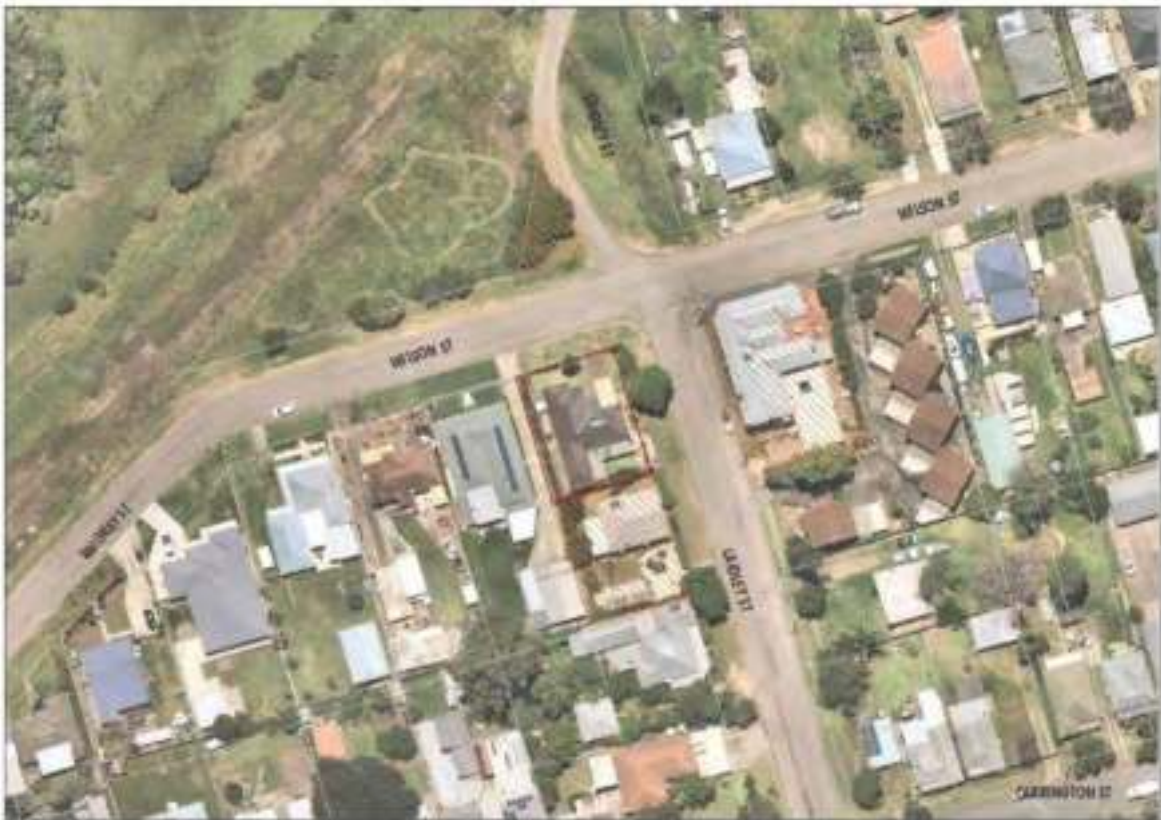
72 WILSON STREET, WEST WALLSEND 2286		
Conservation Area Contribution Level	Est. Construction Date	Previous studies and/or community input
Non-Contributory	Mid to late 20 th century onwards	No prior heritage assessments or research undertaken.
Assessment Text		Observed Modifications
<p>The scale (e.g. double-storey or greater) and general style of the dwelling is inconsistent with that of the streetscape and wider HCA.</p> <p>The dwelling does not contribute positively to the streetscape and wider HCA, particularly in comparison to Contributory 1 and 2 buildings. The presence of the building has an adverse impact on the streetscape and/or wider HCA.</p> <p>The dwelling features inappropriately proportioned and positioned fenestrations, an inappropriate roof form (gabled or hipped) and/or other features that are inconsistent with the architectural character of the area (e.g. unsympathetic additions, inconsistent [contemporary] building materials, etc).</p>		No modifications observed.

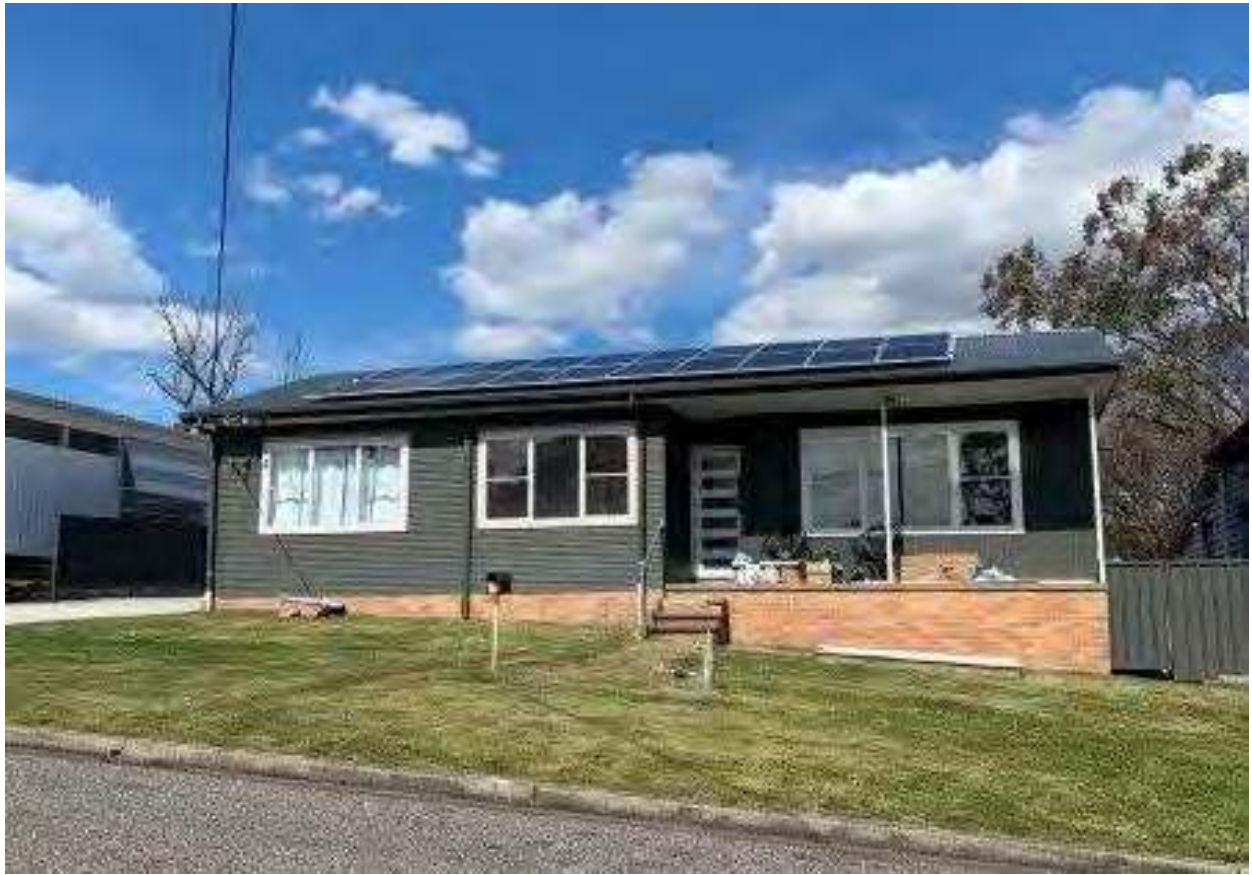
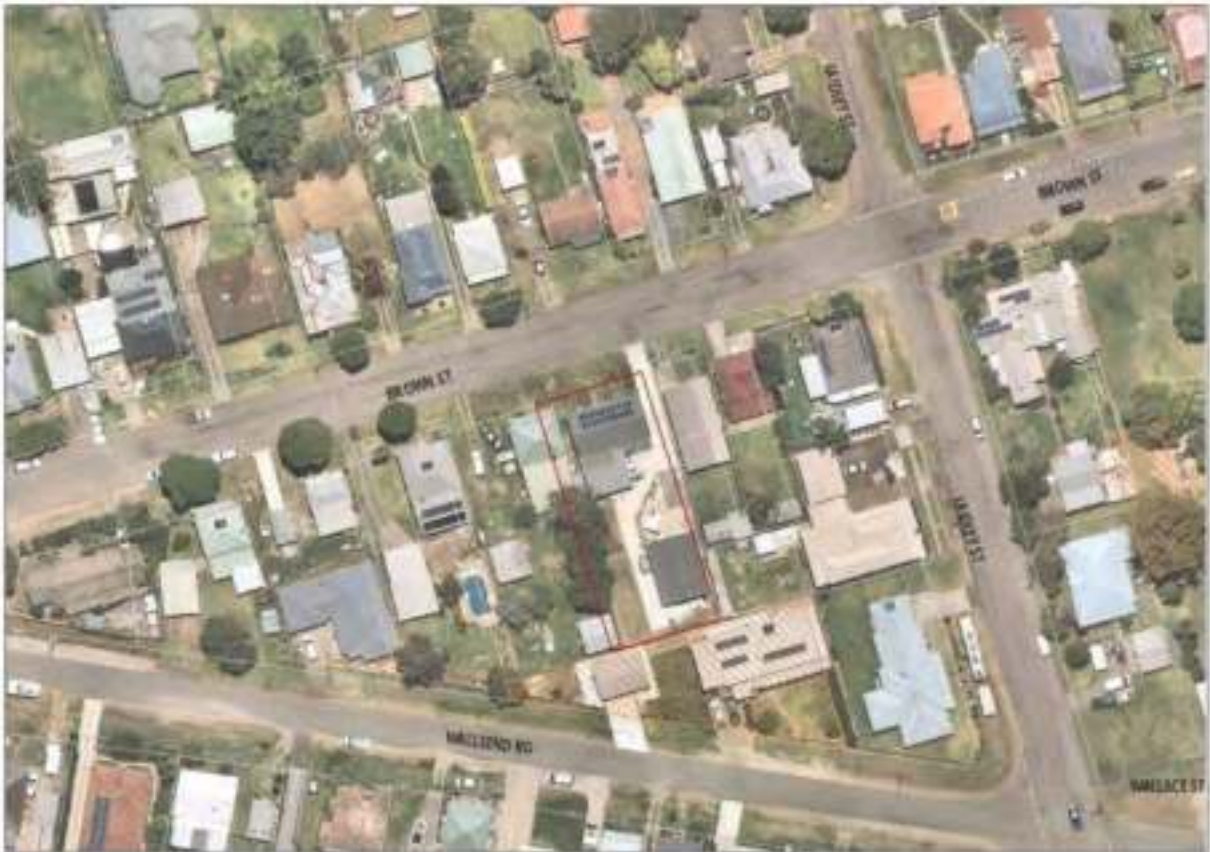
78 BROWN STREET, WEST WALLSEND 2286

Conservation Area Contribution Level	Est. Construction Date	Previous studies and/or community input
Non-Contributory	Mid to late 20 th century onwards	No prior heritage assessments or research undertaken.
Assessment Text		Observed Modifications
<p>The scale (e.g. double-storey or greater) and general style of the dwelling is inconsistent with that of the streetscape and wider HCA.</p> <p>The dwelling does not contribute positively to the streetscape and wider HCA, particularly in comparison to Contributory 1 and 2 buildings. The presence of the building has an adverse impact on the streetscape and/or wider HCA.</p> <p>The dwelling features inappropriately proportioned and positioned fenestrations, an inappropriate roof form (gabled or hipped) and/or other features that are inconsistent with the architectural character of the area (e.g. unsympathetic additions, inconsistent [contemporary] building materials, etc).</p>		<p>Solar panels are highly visible along the northern side of the roof.</p> <p>The visible windows and doors are contemporary in style.</p> <p>An extension has been built onto the southern side of the dwelling. This is not visible from the street and does not detract from the heritage streetscape.</p>

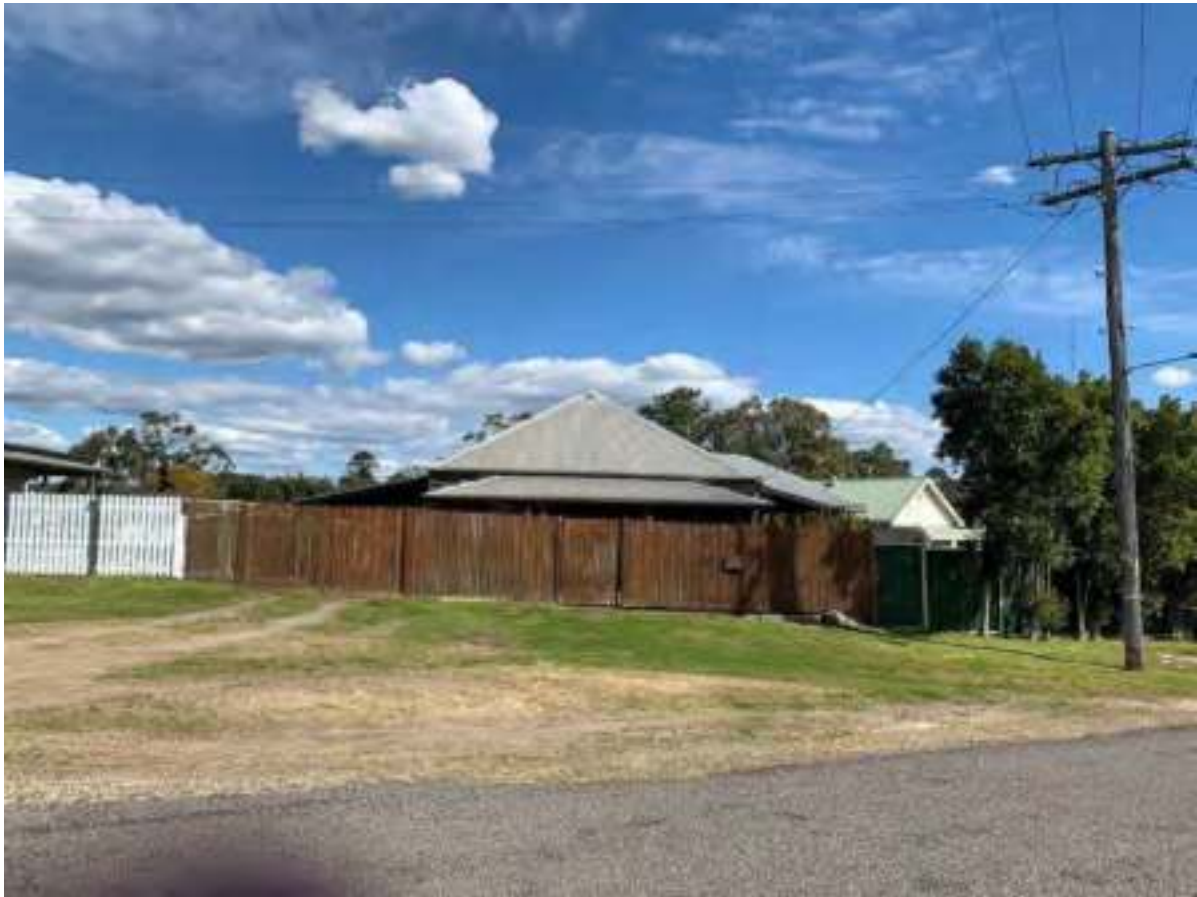
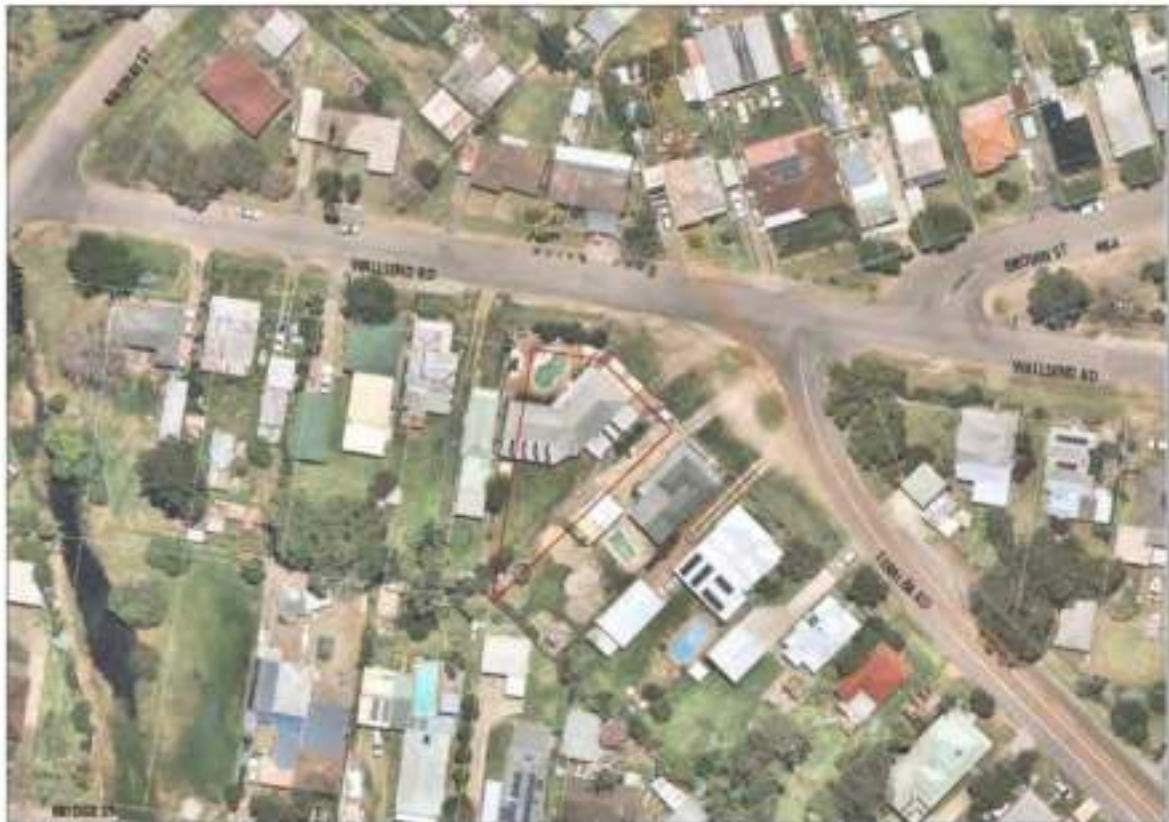
2 TERALBA ROAD, WEST WALLSEND 2286

Conservation Area Contribution Level	Est. Construction Date	Previous studies and/or community input
Non-Contributory	Mid to late 20 th century onwards	No prior heritage assessments or research undertaken.
Assessment Text		Observed Modifications
<p>The scale (e.g. double-storey or greater) and general style of the dwelling is inconsistent with that of the streetscape and wider HCA.</p> <p>The dwelling does not contribute positively to the streetscape and wider HCA, particularly in comparison to Contributory 1 and 2 buildings. The presence of the building has an adverse impact on the streetscape and/or wider HCA.</p> <p>The dwelling features inappropriately proportioned and positioned fenestrations, an inappropriate roof form (gabled or hipped) and/or other features that are inconsistent with the architectural character of the area (e.g. unsympathetic additions, inconsistent [contemporary] building materials, etc).</p>		<p>Due to the high north eastern front fence, the dwelling is obscured. No modifications observed.</p>

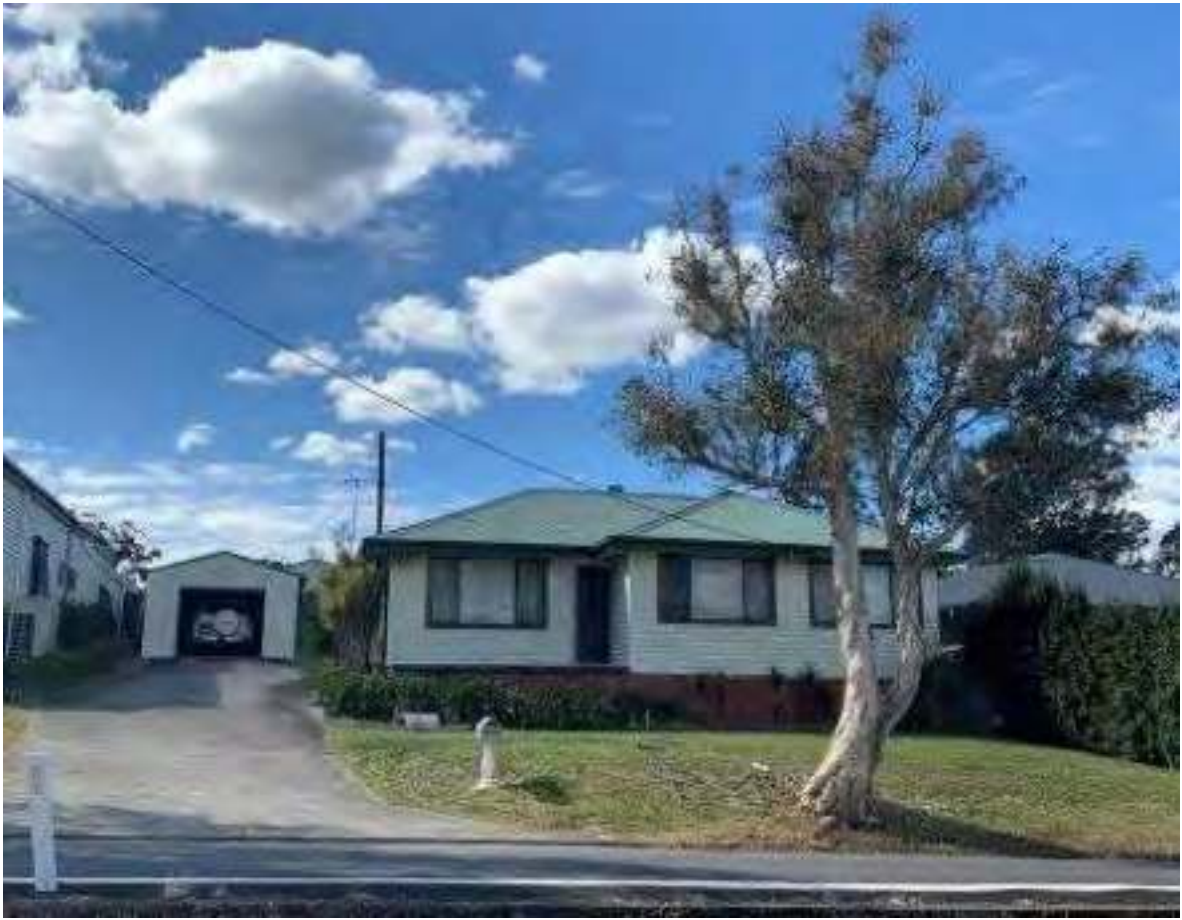
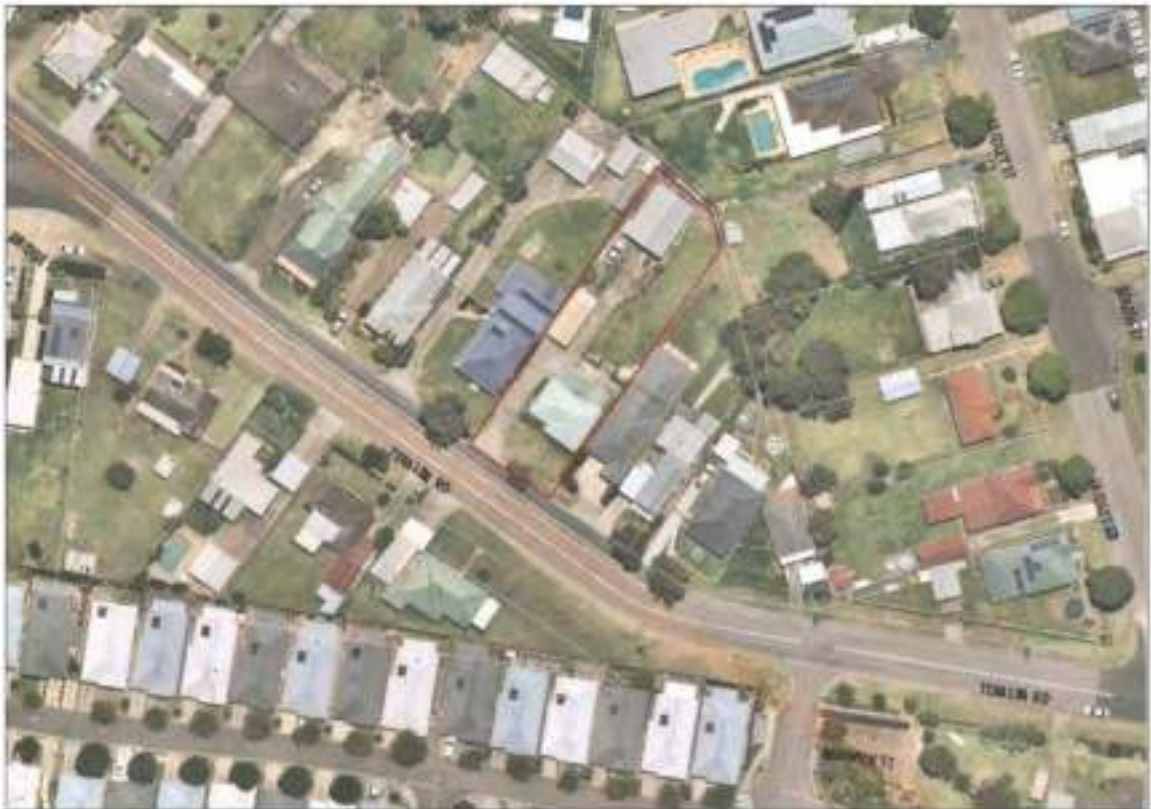
27 TERALBA ROAD, WEST WALLSEND 2286

Conservation Area Contribution Level	Est. Construction Date	Previous studies and/or community input
Non-Contributory	Mid to late 20 th century onwards	No prior heritage assessments or research undertaken.
Assessment Text		Observed Modifications
<p>The scale (e.g. double-storey or greater) and general style of the dwelling is inconsistent with that of the streetscape and wider HCA.</p> <p>The dwelling does not contribute positively to the streetscape and wider HCA, particularly in comparison to Contributory 1 and 2 buildings. The presence of the building has an adverse impact on the streetscape and/or wider HCA.</p> <p>The dwelling features inappropriately proportioned and positioned fenestrations, an inappropriate roof form (gabled or hipped) and/or other features that are inconsistent with the architectural character of the area (e.g. unsympathetic additions, inconsistent [contemporary] building materials, etc).</p>		No modifications observed.

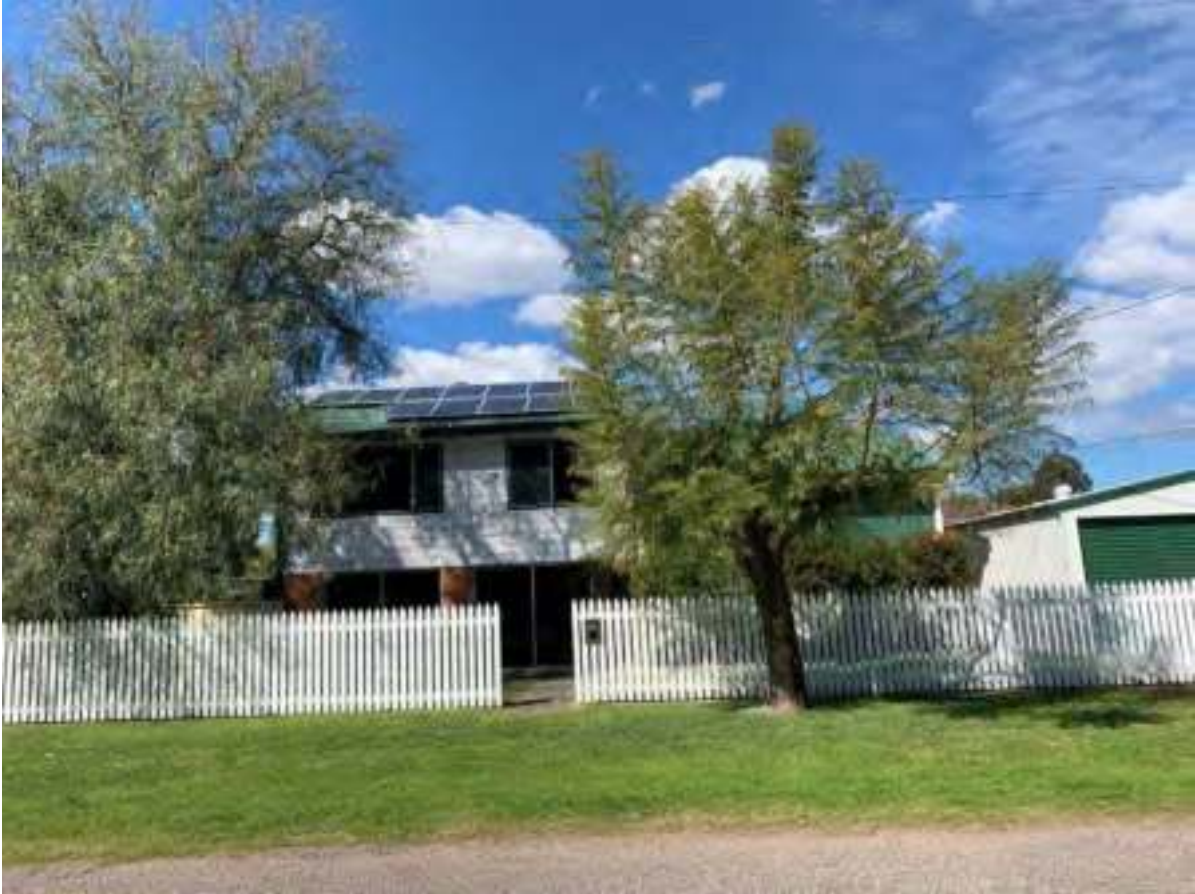
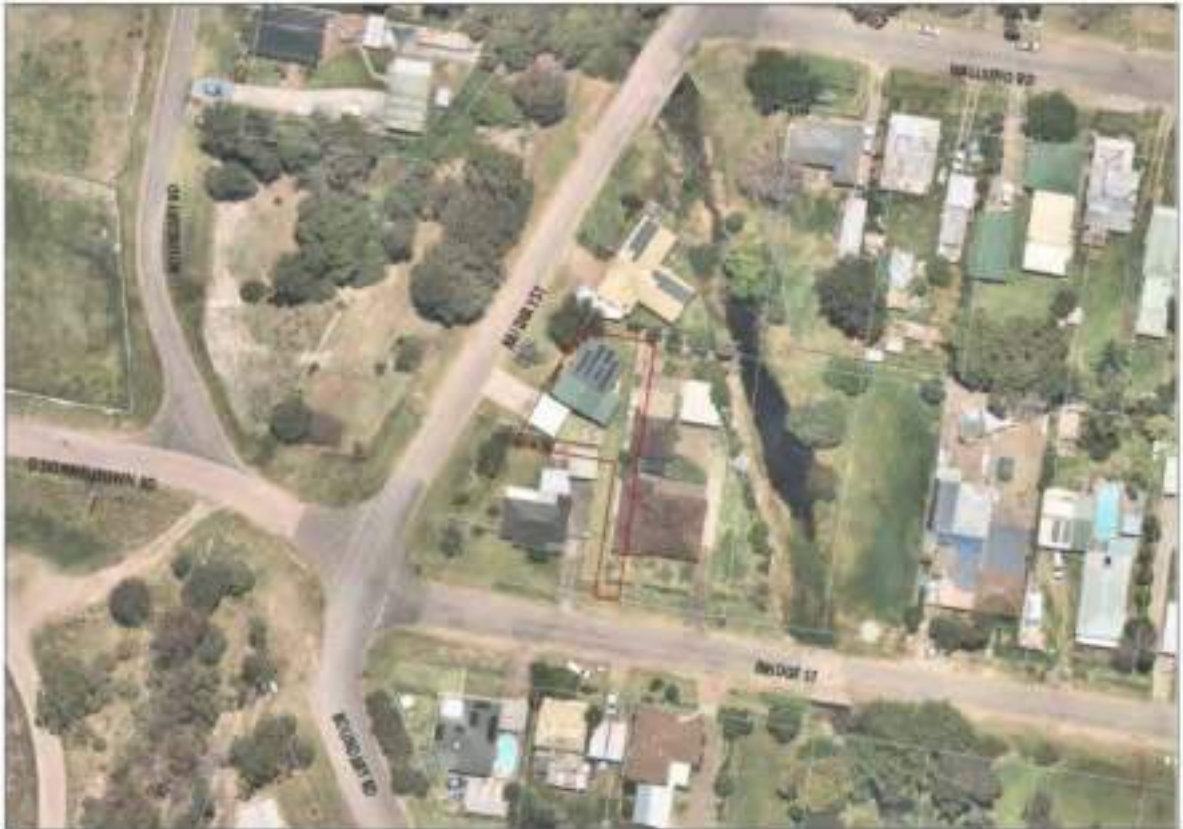
40 BOUNDARY ROAD, WEST WALLSEND 2286

Conservation Area Contribution Level	Est. Construction Date	Previous studies and/or community input
Non-Contributory	Mid to late 20 th century onwards	No prior heritage assessments or research undertaken.
Assessment Text		Observed Modifications
<p>The scale (e.g. double-storey or greater) and general style of the dwelling is inconsistent with that of the streetscape and wider HCA.</p> <p>The dwelling does not contribute positively to the streetscape and wider HCA, particularly in comparison to Contributory 1 and 2 buildings. The presence of the building has an adverse impact on the streetscape and/or wider HCA.</p> <p>The dwelling features inappropriately proportioned and positioned fenestrations, an inappropriate roof form (gabled or hipped) and/or other features that are inconsistent with the architectural character of the area (e.g. unsympathetic additions, inconsistent [contemporary] building materials, etc).</p>		<p>Solar panels are visible along the north western side of the roof.</p>

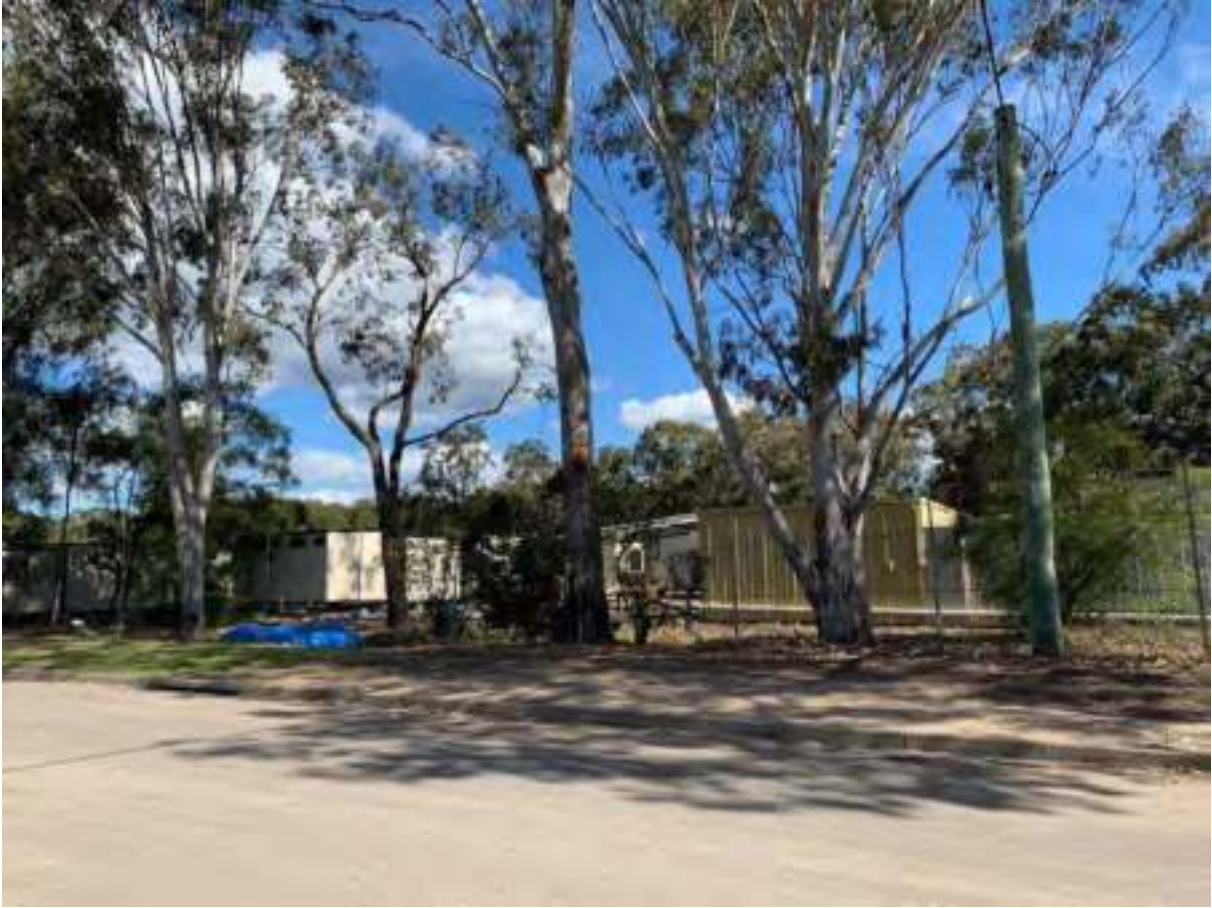
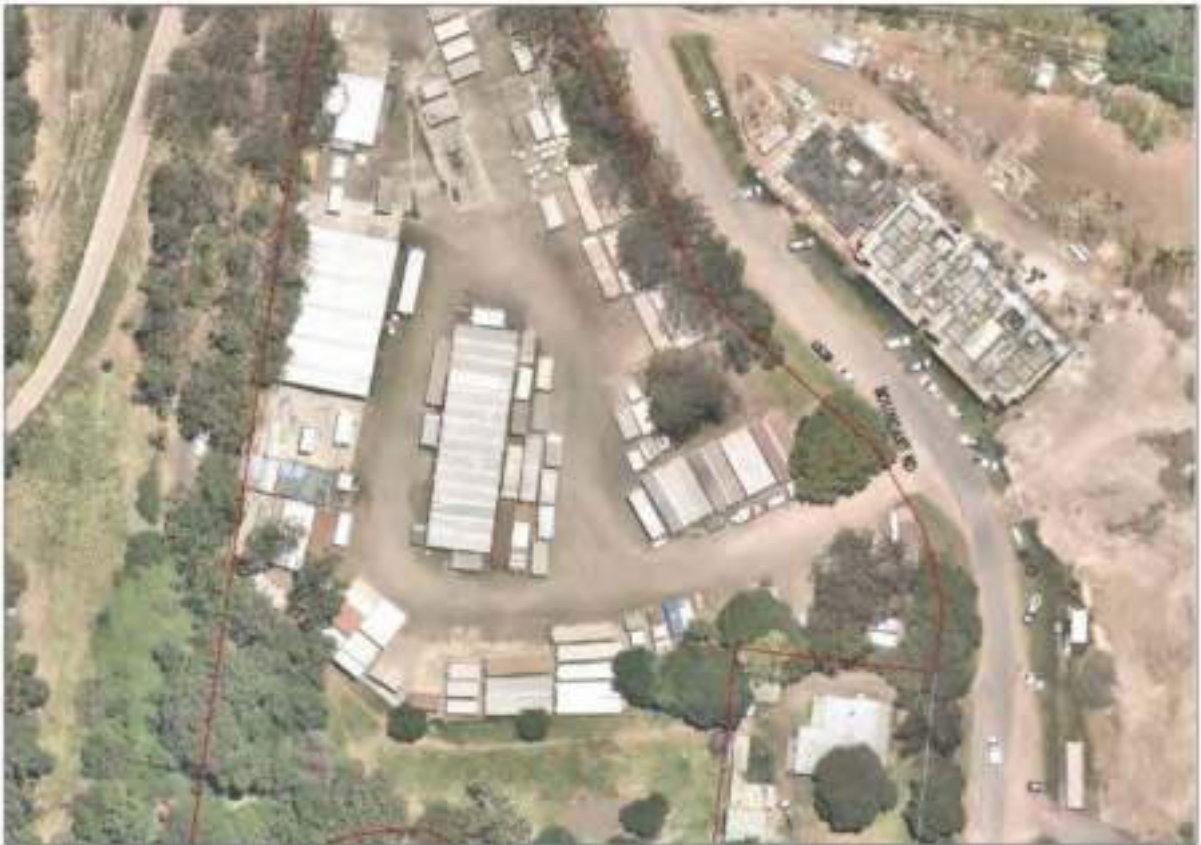
Conservation Area Contribution Level	Est. Construction Date	Previous studies and/or community input
Non-Contributory	Mid to late 20 th century onwards	No prior heritage assessments or research undertaken.
Assessment Text		Observed Modifications
<p>The scale (e.g. double-storey or greater) and general style of the dwelling is inconsistent with that of the streetscape and wider HCA.</p> <p>The dwelling does not contribute positively to the streetscape and wider HCA, particularly in comparison to Contributory 1 and 2 buildings. The presence of the building has an adverse impact on the streetscape and/or wider HCA.</p> <p>The dwelling features inappropriately proportioned and positioned fenestrations, an inappropriate roof form (gabled or hipped) and/or other features that are inconsistent with the architectural character of the area (e.g. unsympathetic additions, inconsistent [contemporary] building materials, etc).</p>		No modifications observed.

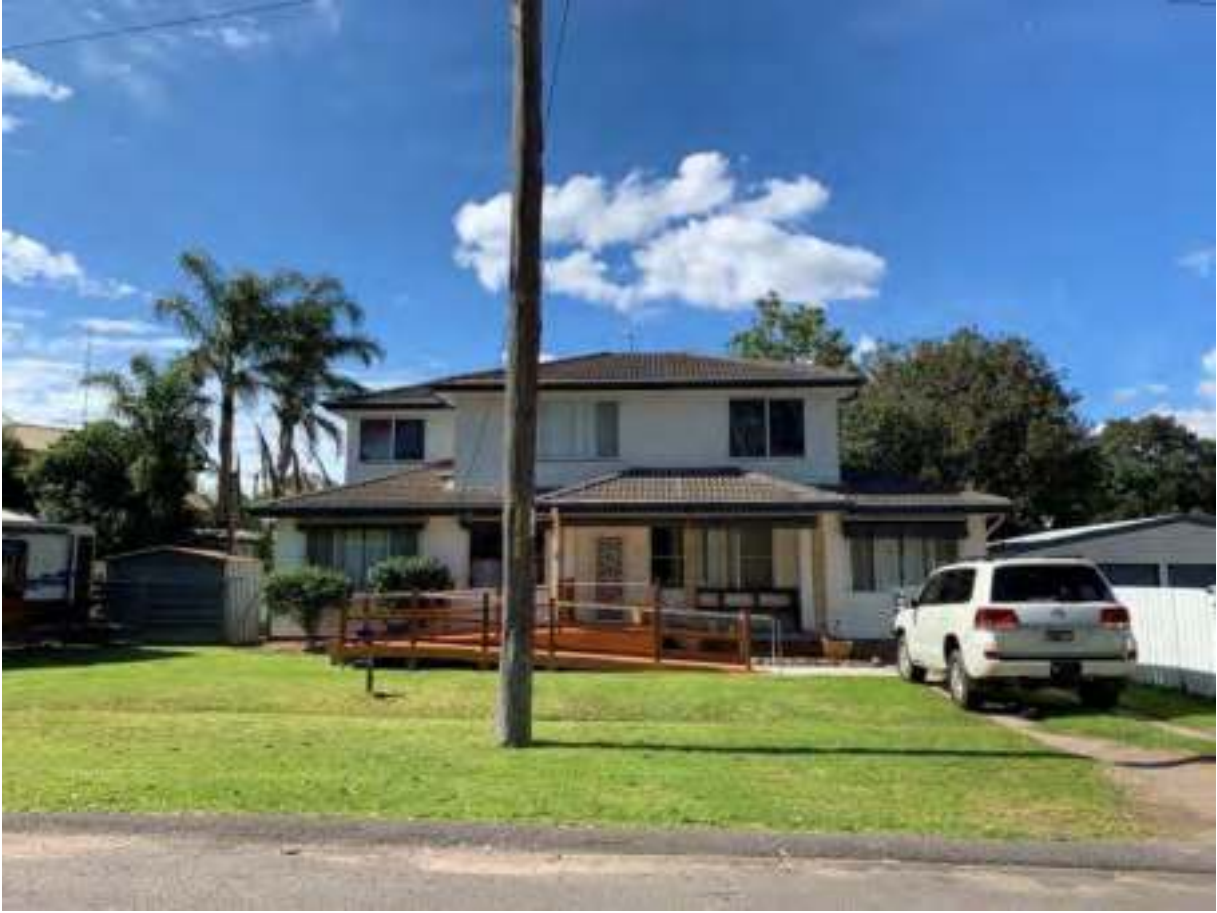
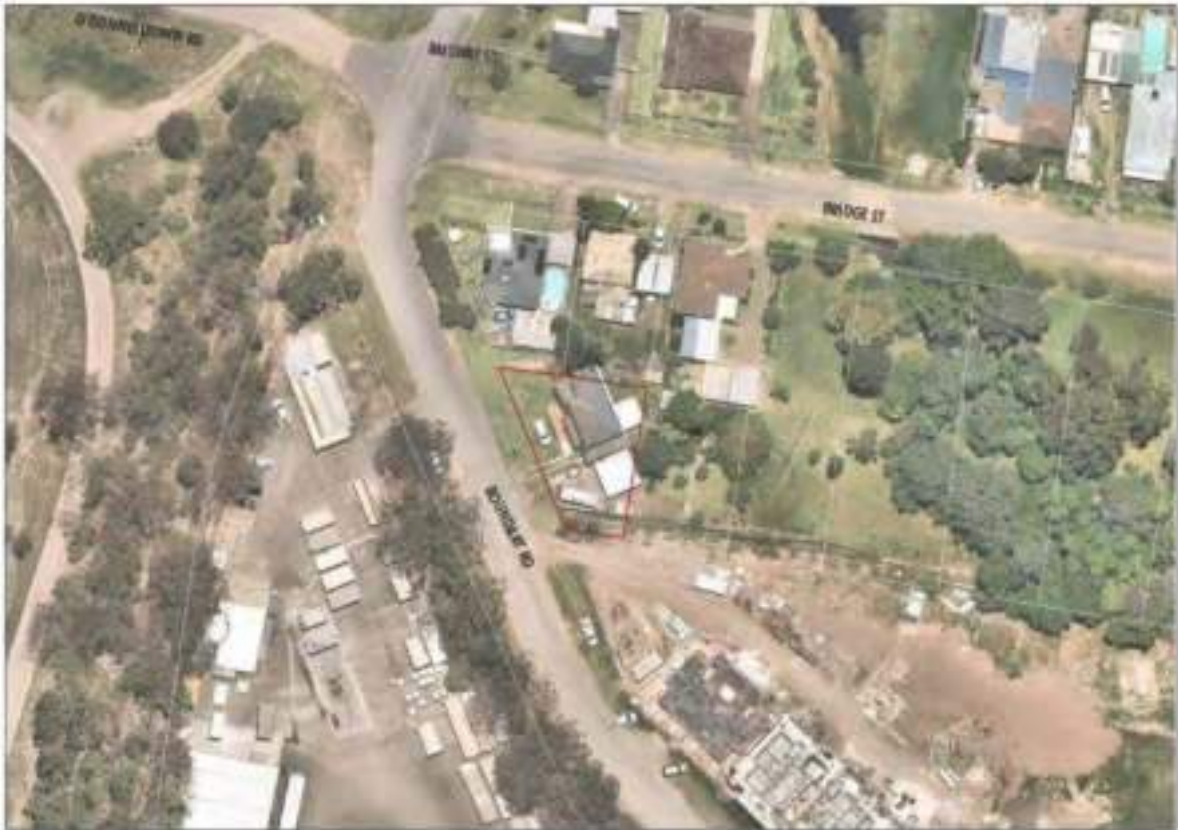
29 BOUNDARY ROAD, WEST WALLSEND 2286

Conservation Area Contribution Level	Est. Construction Date	Previous studies and/or community input
Non-Contributory	Mid to late 20 th century onwards	No prior heritage assessments or research undertaken.
Assessment Text		Observed Modifications
<p>The scale (e.g. double-storey or greater) and general style of the dwelling is inconsistent with that of the streetscape and wider HCA.</p> <p>The dwelling does not contribute positively to the streetscape and wider HCA, particularly in comparison to Contributory 1 and 2 buildings. The presence of the building has an adverse impact on the streetscape and/or wider HCA.</p> <p>The dwelling features inappropriately proportioned and positioned fenestrations, an inappropriate roof form (gabled or hipped) and/or other features that are inconsistent with the architectural character of the area (e.g. unsympathetic additions, inconsistent [contemporary] building materials, etc).</p>		No modifications observed.

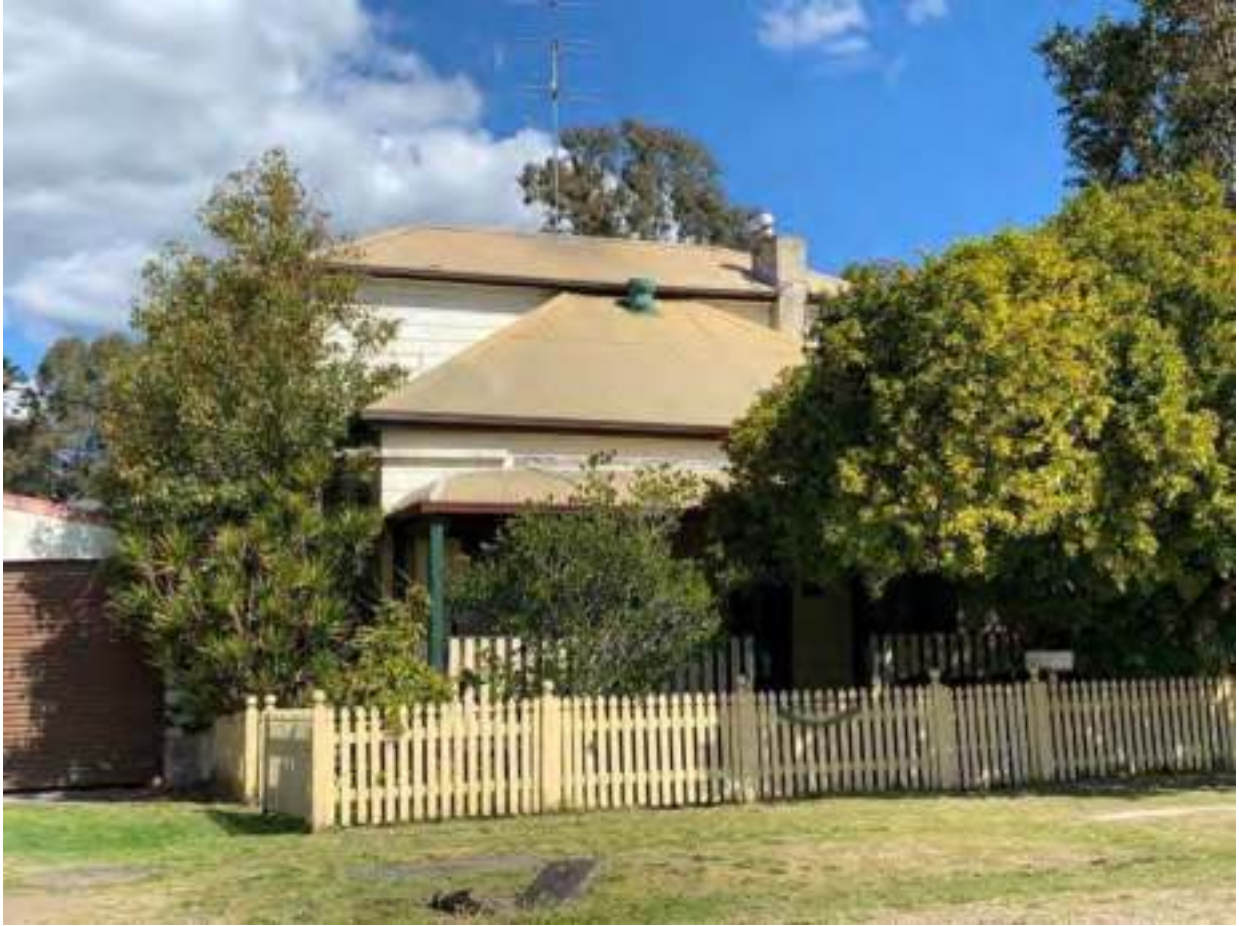
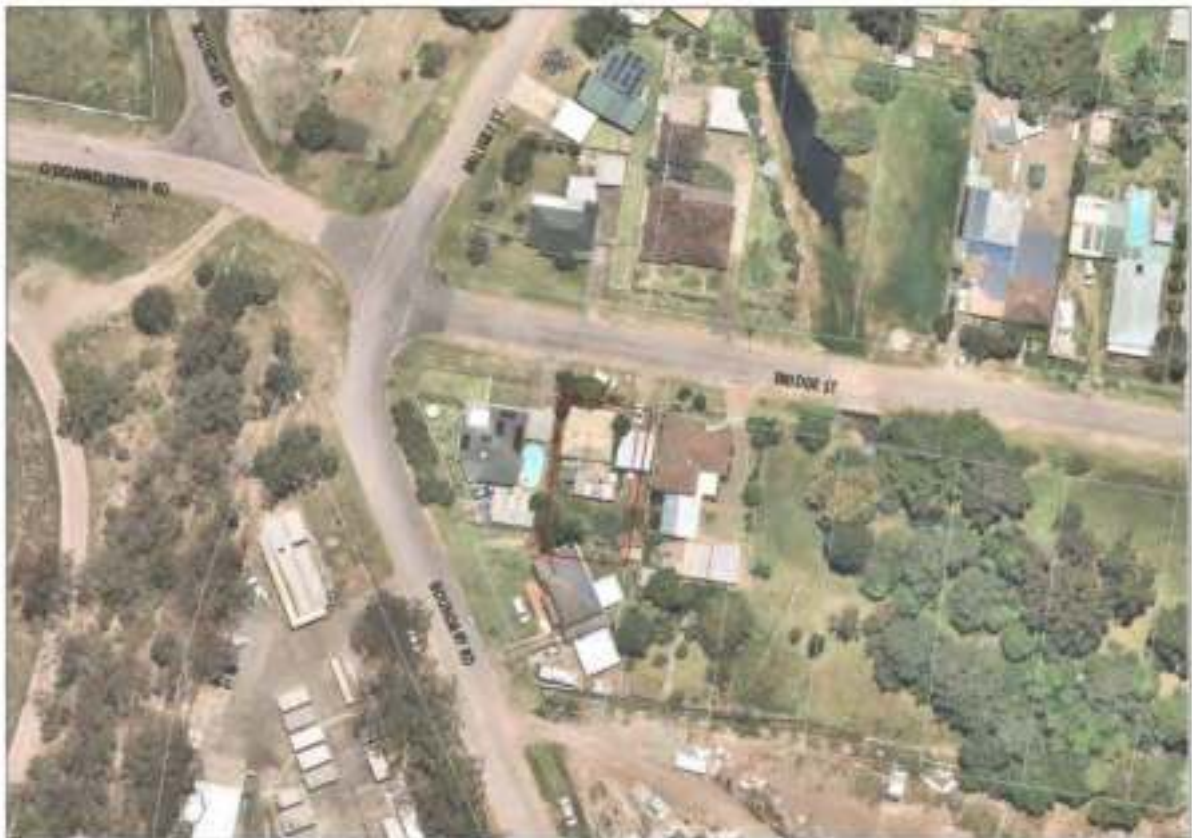
36 BRIDGE STREET, WEST WALLSEND 2286

Conservation Area Contribution Level	Est. Construction Date	Previous studies and/or community input
Non-Contributory	Mid to late 20 th century onwards	No prior heritage assessments or research undertaken.
Assessment Text		Observed Modifications
<p>The scale (e.g. double-storey or greater) and general style of the dwelling is inconsistent with that of the streetscape and wider HCA.</p> <p>The dwelling does not contribute positively to the streetscape and wider HCA, particularly in comparison to Contributory 1 and 2 buildings. The presence of the building has an adverse impact on the streetscape and/or wider HCA.</p> <p>The dwelling features inappropriately proportioned and positioned fenestrations, an inappropriate roof form (gabled or hipped) and/or other features that are inconsistent with the architectural character of the area (e.g. unsympathetic additions, inconsistent [contemporary] building materials, etc).</p>		<p>The second storey extension is a recent addition to the dwelling. a second storey is a uncommon feature in the area and juxtaposes the surrounding properties and heritage streetscape.</p>
