APPENDIX 2

Building Assessment Sheets (Inventory Sheets)

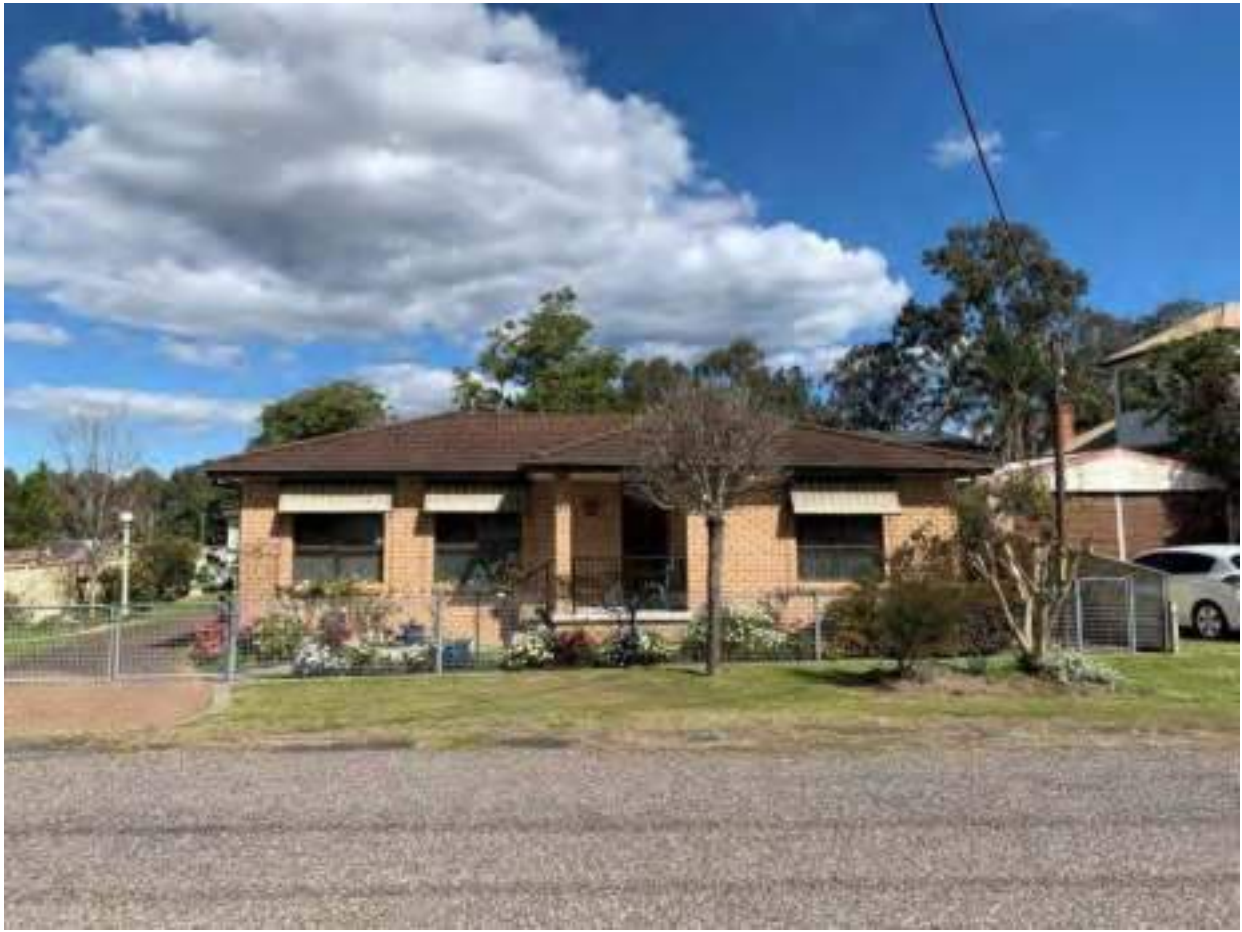
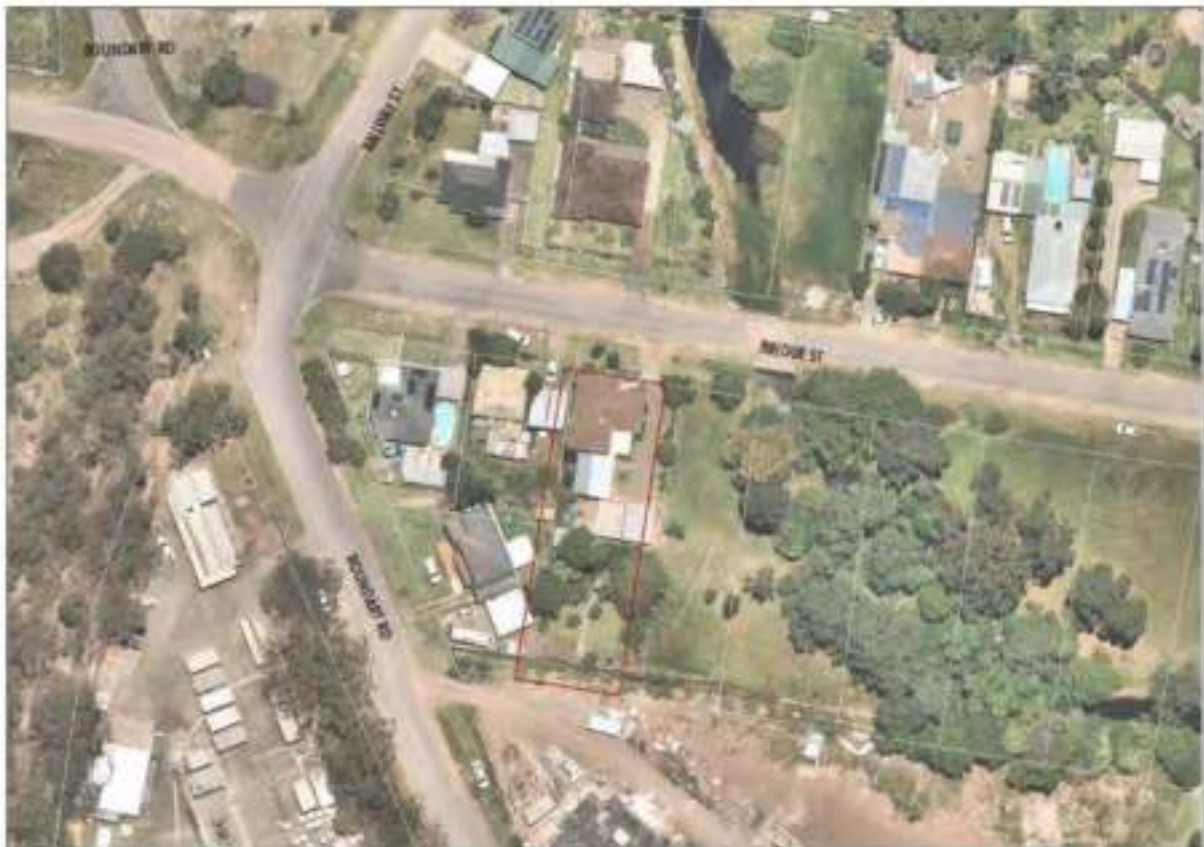
34 BRIDGE STREET, WEST WALLSEND 2286

Conservation Area Contribution Level	Est. Construction Date	Previous studies and/or community input
Non-Contributory	Mid to late 20 th century onwards	No prior heritage assessments or research undertaken.
Assessment Text		Observed Modifications
<p>The scale (e.g. double-storey or greater) and general style of the dwelling is inconsistent with that of the streetscape and wider HCA.</p> <p>The dwelling does not contribute positively to the streetscape and wider HCA, particularly in comparison to Contributory 1 and 2 buildings. The presence of the building has an adverse impact on the streetscape and/or wider HCA.</p> <p>The dwelling features inappropriately proportioned and positioned fenestrations, an inappropriate roof form (gabled or hipped) and/or other features that are inconsistent with the architectural character of the area (e.g. unsympathetic additions, inconsistent [contemporary] building materials, etc).</p>		No modifications observed.

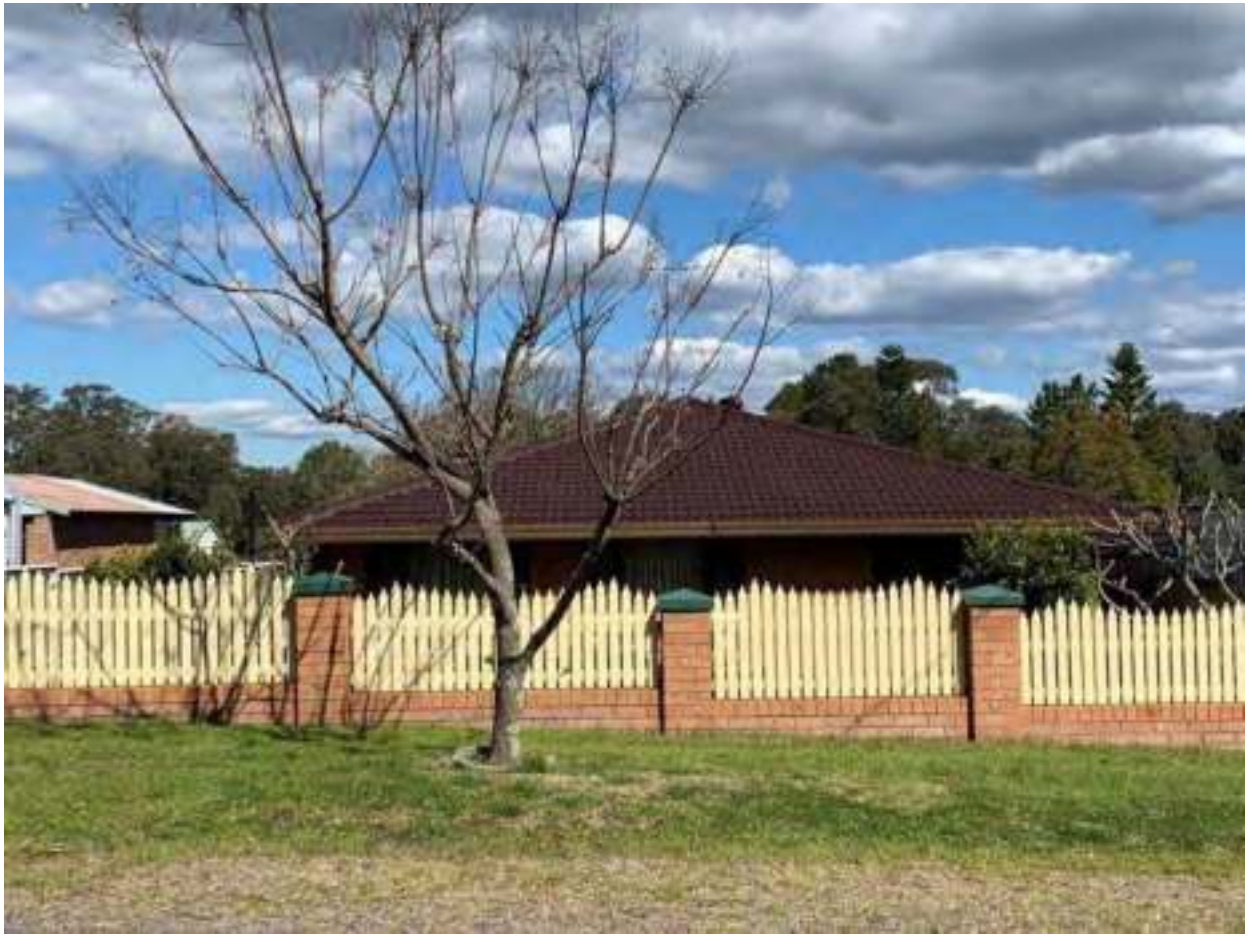
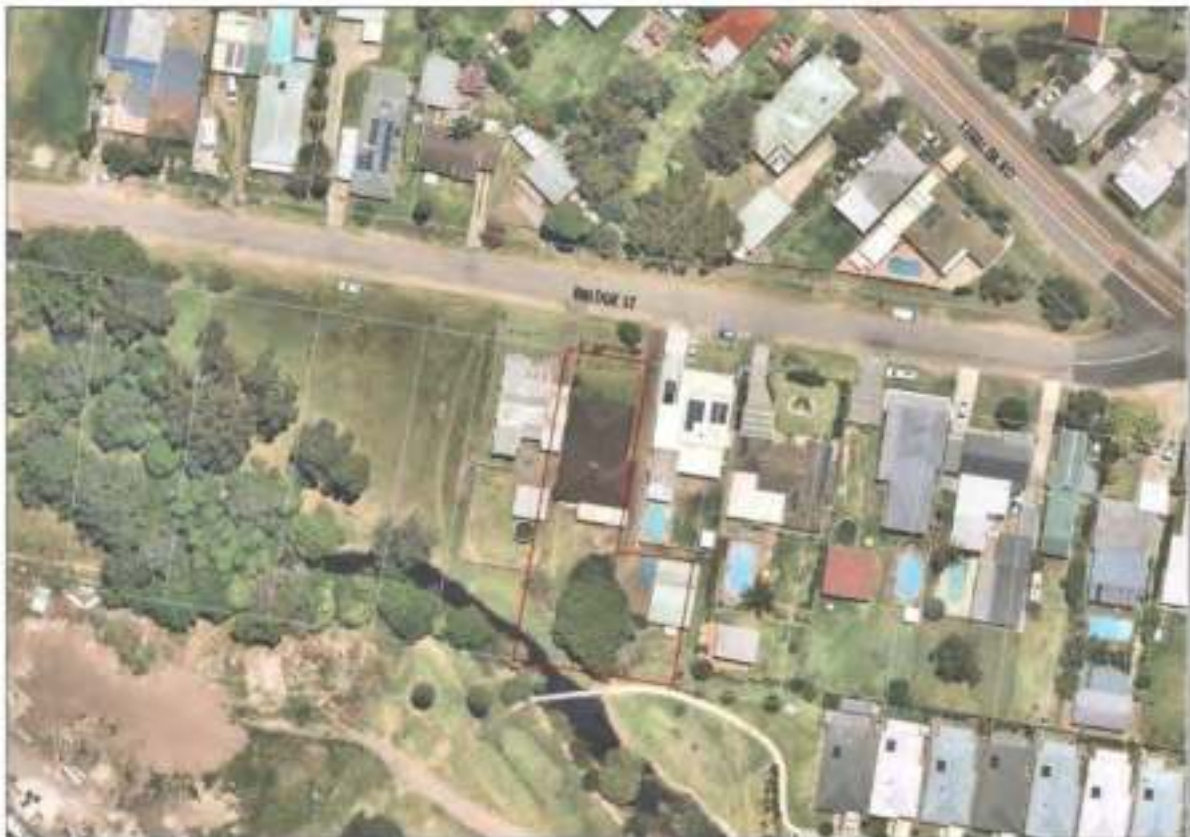
16 BRIDGE STREET, WEST WALLSEND 2286		
Conservation Area Contribution Level	Est. Construction Date	Previous studies and/or community input
Non-Contributory	Mid to late 20 th century onwards	No prior heritage assessments or research undertaken.
Assessment Text		Observed Modifications
<p>The scale (e.g. double-storey or greater) and general style of the dwelling is inconsistent with that of the streetscape and wider HCA.</p> <p>The dwelling does not contribute positively to the streetscape and wider HCA, particularly in comparison to Contributory 1 and 2 buildings. The presence of the building has an adverse impact on the streetscape and/or wider HCA.</p> <p>The dwelling features inappropriately proportioned and positioned fenestrations, an inappropriate roof form (gabled or hipped) and/or other features that are inconsistent with the architectural character of the area (e.g. unsympathetic additions, inconsistent [contemporary] building materials, etc).</p>		No modifications observed.

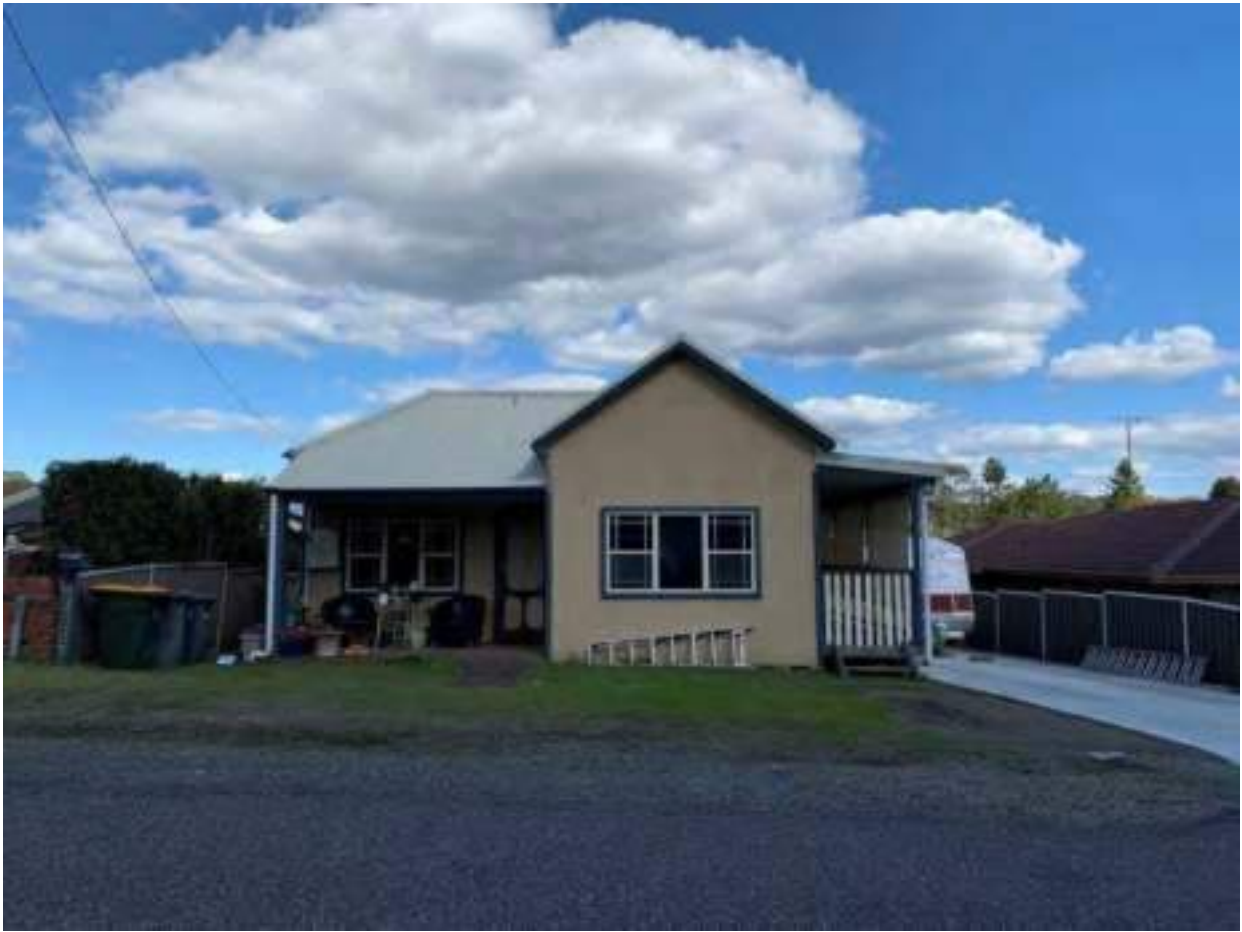
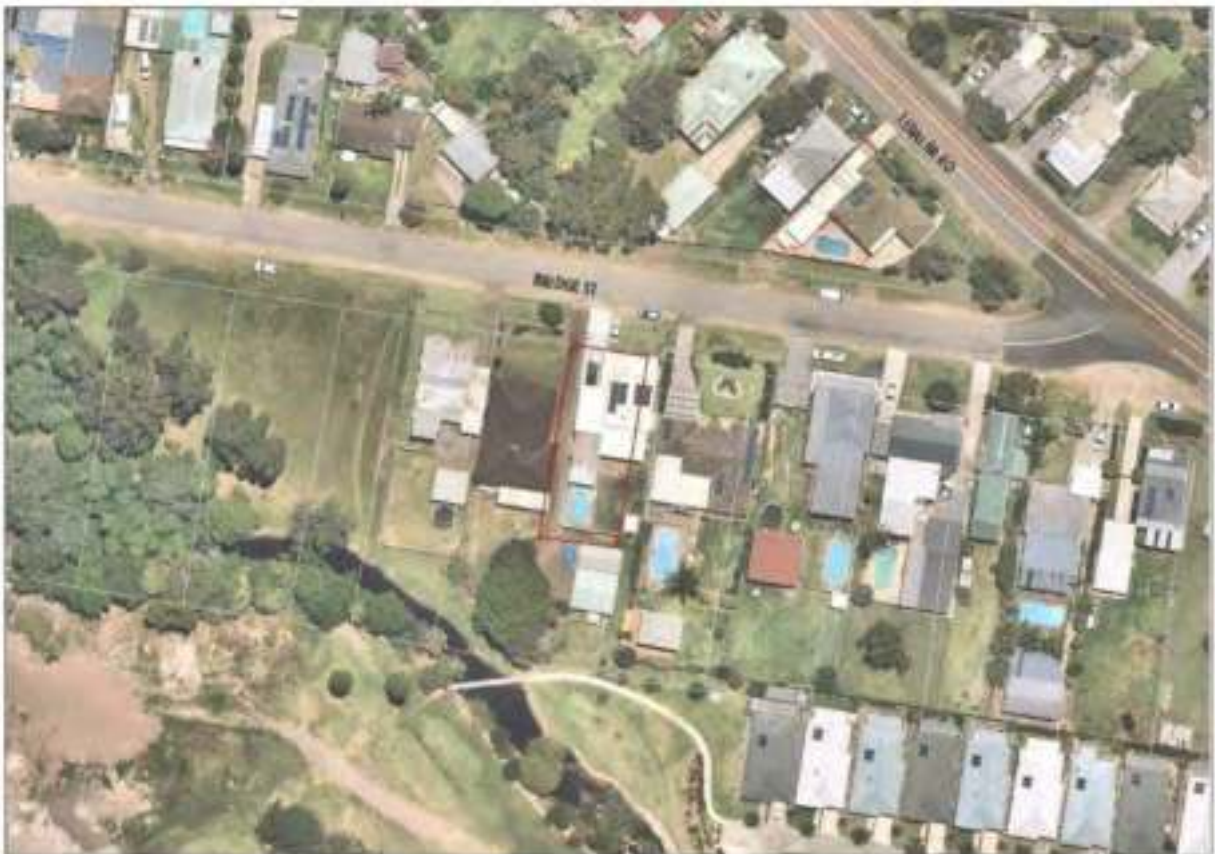
14 BRIDGE STREET, WEST WALLSEND 2286

Conservation Area Contribution Level	Est. Construction Date	Previous studies and/or community input
Non-Contributory	Mid to late 20 th century onwards	No prior heritage assessments or research undertaken.
Assessment Text		Observed Modifications
<p>The scale (e.g. double-storey or greater) and general style of the dwelling is inconsistent with that of the streetscape and wider HCA.</p> <p>The dwelling does not contribute positively to the streetscape and wider HCA, particularly in comparison to Contributory 1 and 2 buildings. The presence of the building has an adverse impact on the streetscape and/or wider HCA.</p> <p>The dwelling features inappropriately proportioned and positioned fenestrations, an inappropriate roof form (gabled or hipped) and/or other features that are inconsistent with the architectural character of the area (e.g. unsympathetic additions, inconsistent [contemporary] building materials, etc).</p>		<p>The western veranda is a contemporary addition, with the skillion roof, timber posts and balustrade being recently constructed.</p>

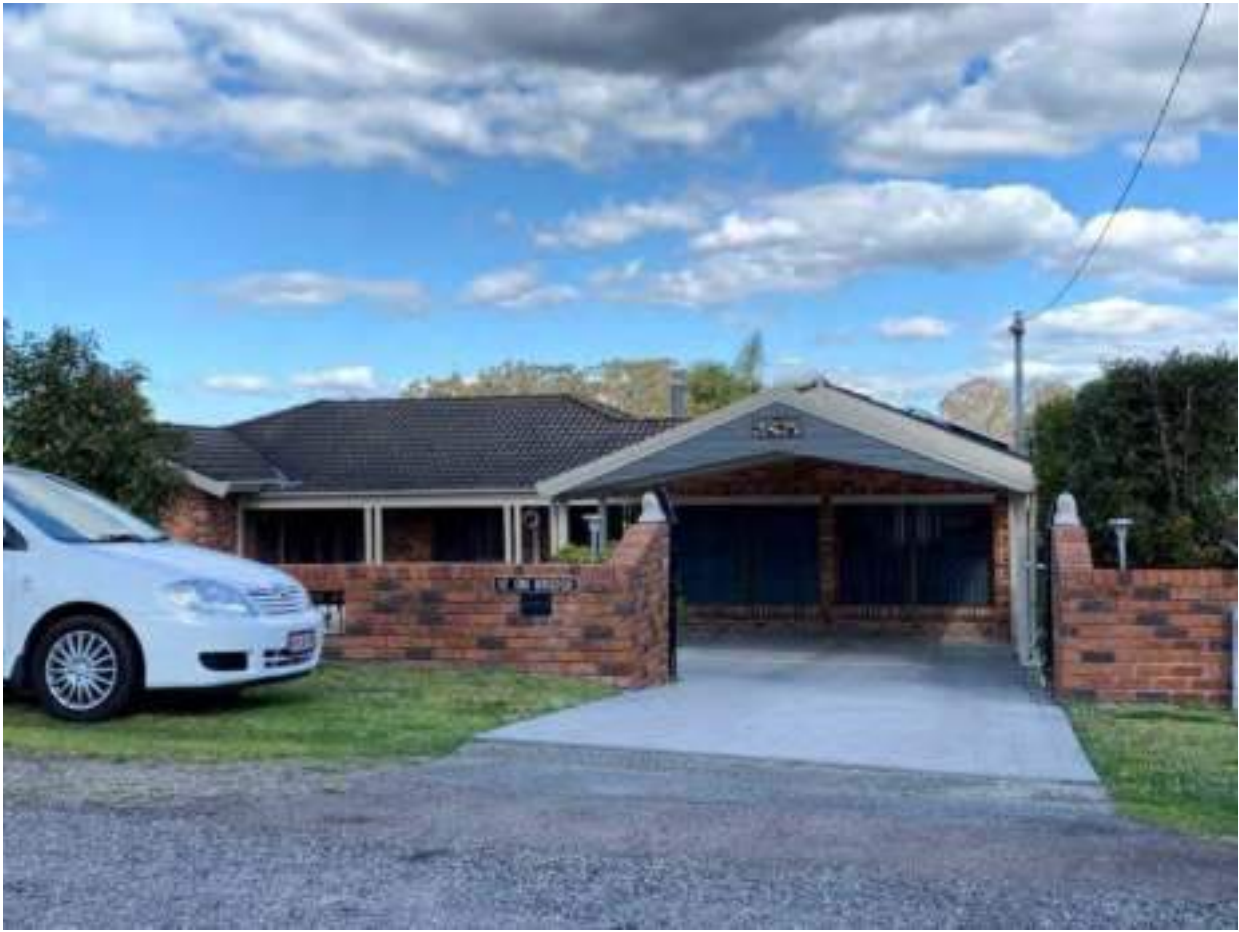
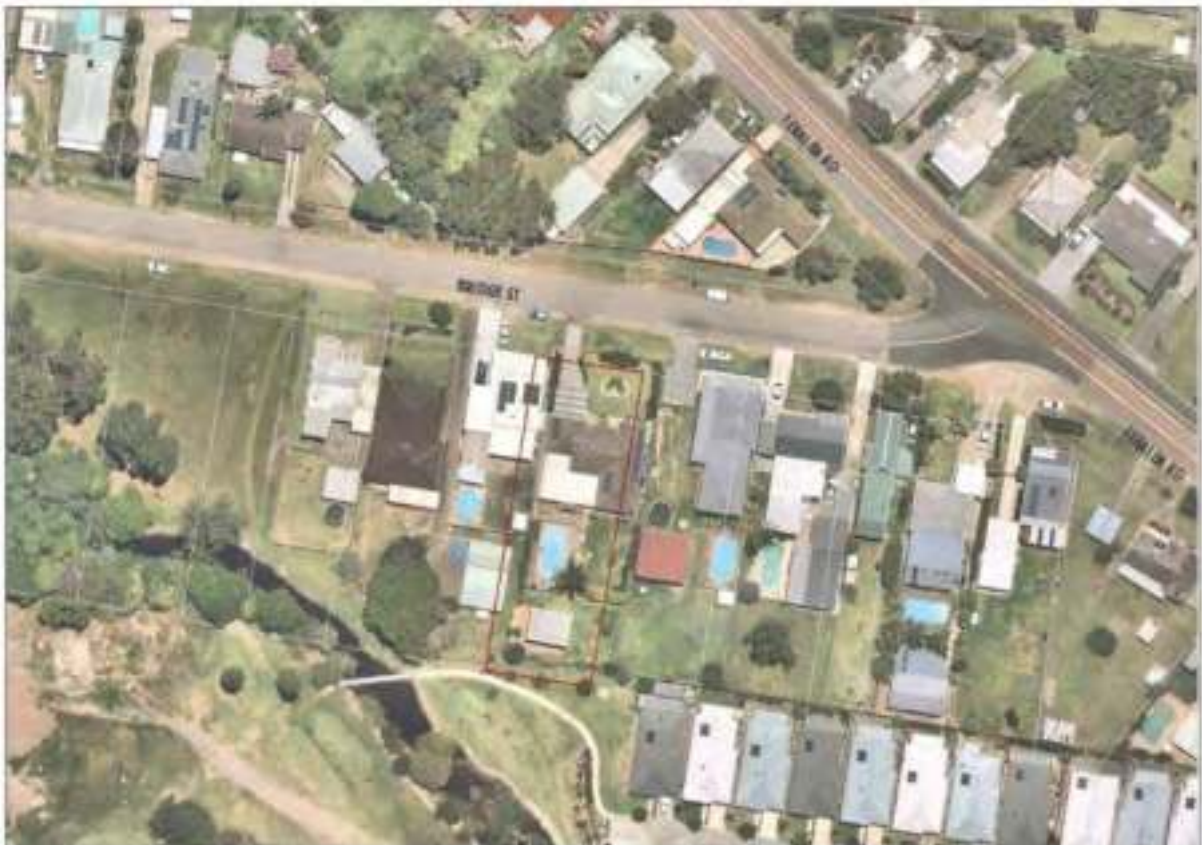
12 BRIDGE STREET, WEST WALLSEND 2286

Conservation Area Contribution Level	Est. Construction Date	Previous studies and/or community input
Non-Contributory	Mid to late 20 th century onwards	No prior heritage assessments or research undertaken.
Assessment Text		Observed Modifications
<p>The scale (e.g. double-storey or greater) and general style of the dwelling is inconsistent with that of the streetscape and wider HCA.</p> <p>The dwelling does not contribute positively to the streetscape and wider HCA, particularly in comparison to Contributory 1 and 2 buildings. The presence of the building has an adverse impact on the streetscape and/or wider HCA.</p> <p>The dwelling features inappropriately proportioned and positioned fenestrations, an inappropriate roof form (gabled or hipped) and/or other features that are inconsistent with the architectural character of the area (e.g. unsympathetic additions, inconsistent [contemporary] building materials, etc).</p>		No modifications observed.

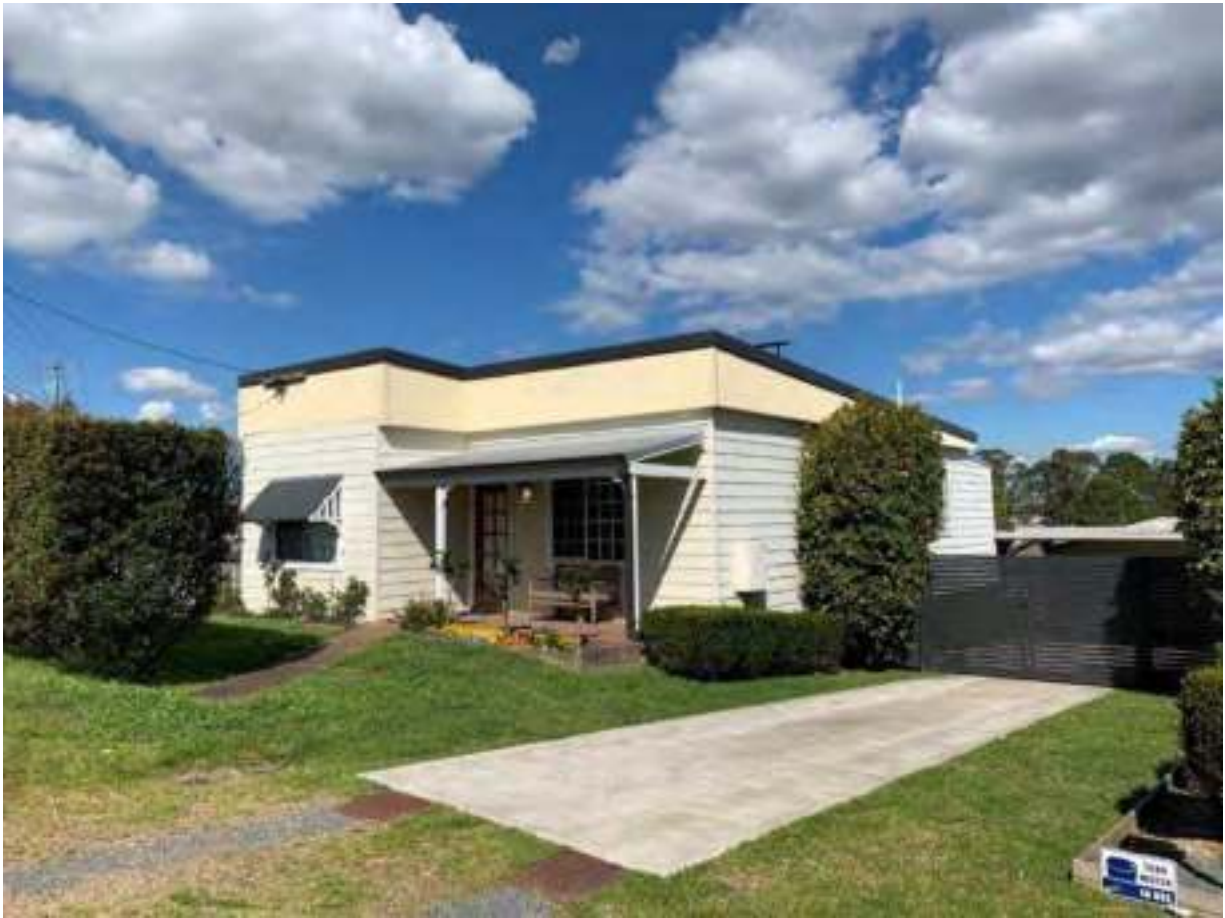
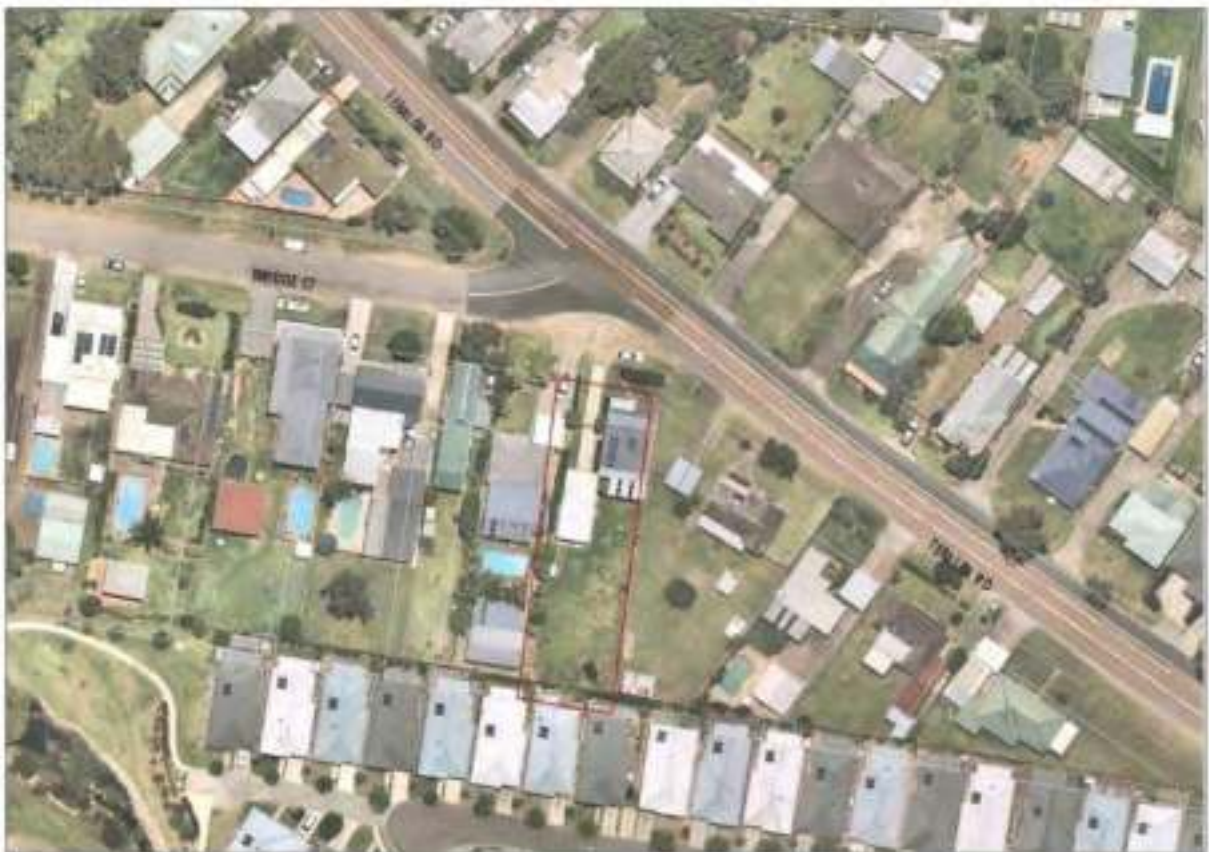
2 BRIDGE STREET, WEST WALLSEND 2286

Conservation Area Contribution Level	Est. Construction Date	Previous studies and/or community input
Non-Contributory	Mid to late 20 th century onwards	No prior heritage assessments or research undertaken.
Assessment Text		Observed Modifications
<p>The scale (e.g. double-storey or greater) and general style of the dwelling is inconsistent with that of the streetscape and wider HCA.</p> <p>The dwelling does not contribute positively to the streetscape and wider HCA, particularly in comparison to Contributory 1 and 2 buildings. The presence of the building has an adverse impact on the streetscape and/or wider HCA.</p> <p>The dwelling features inappropriately proportioned and positioned fenestrations, an inappropriate roof form (gabled or hipped) and/or other features that are inconsistent with the architectural character of the area (e.g. unsympathetic additions, inconsistent [contemporary] building materials, etc).</p>		<p>The skillion veranda roof is likely a prior modification, with no roof being there previously.</p>

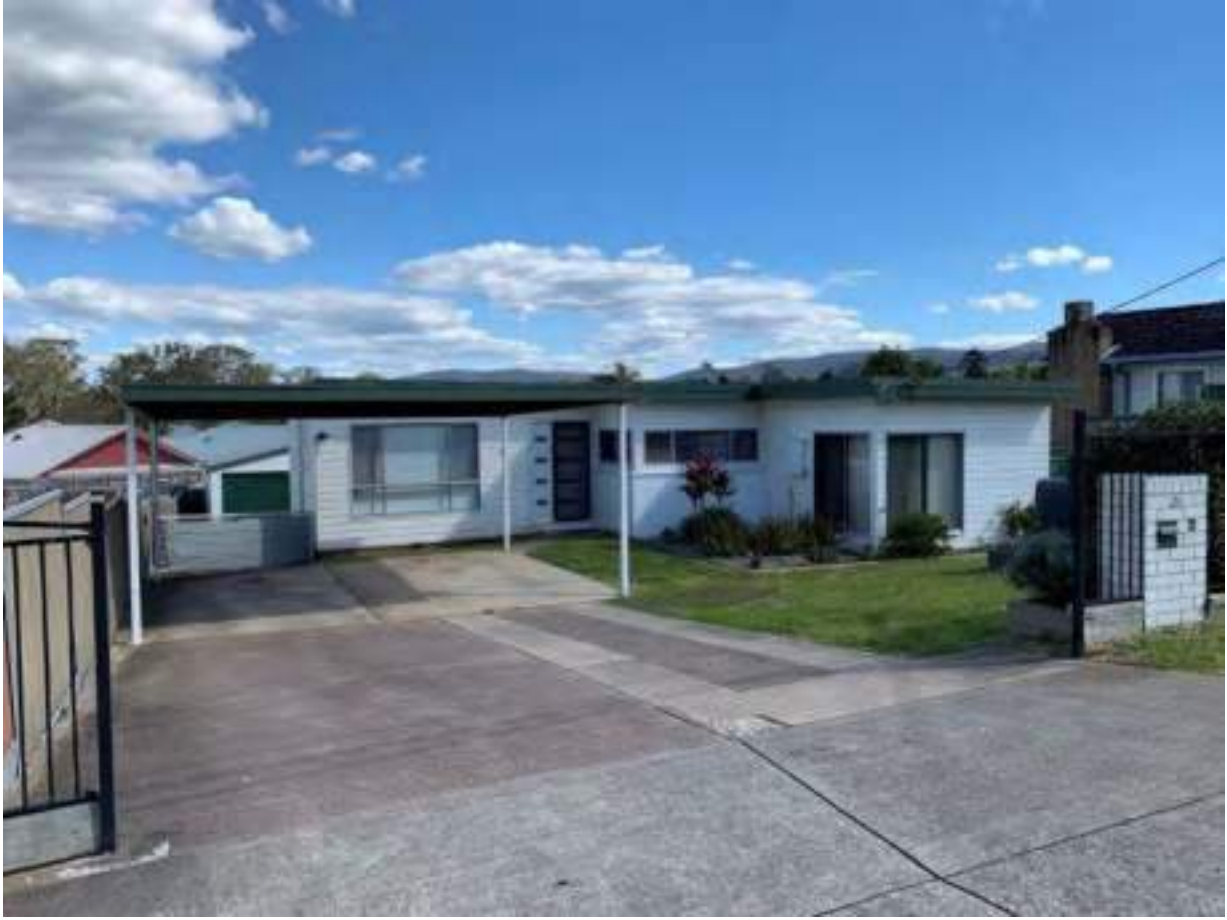
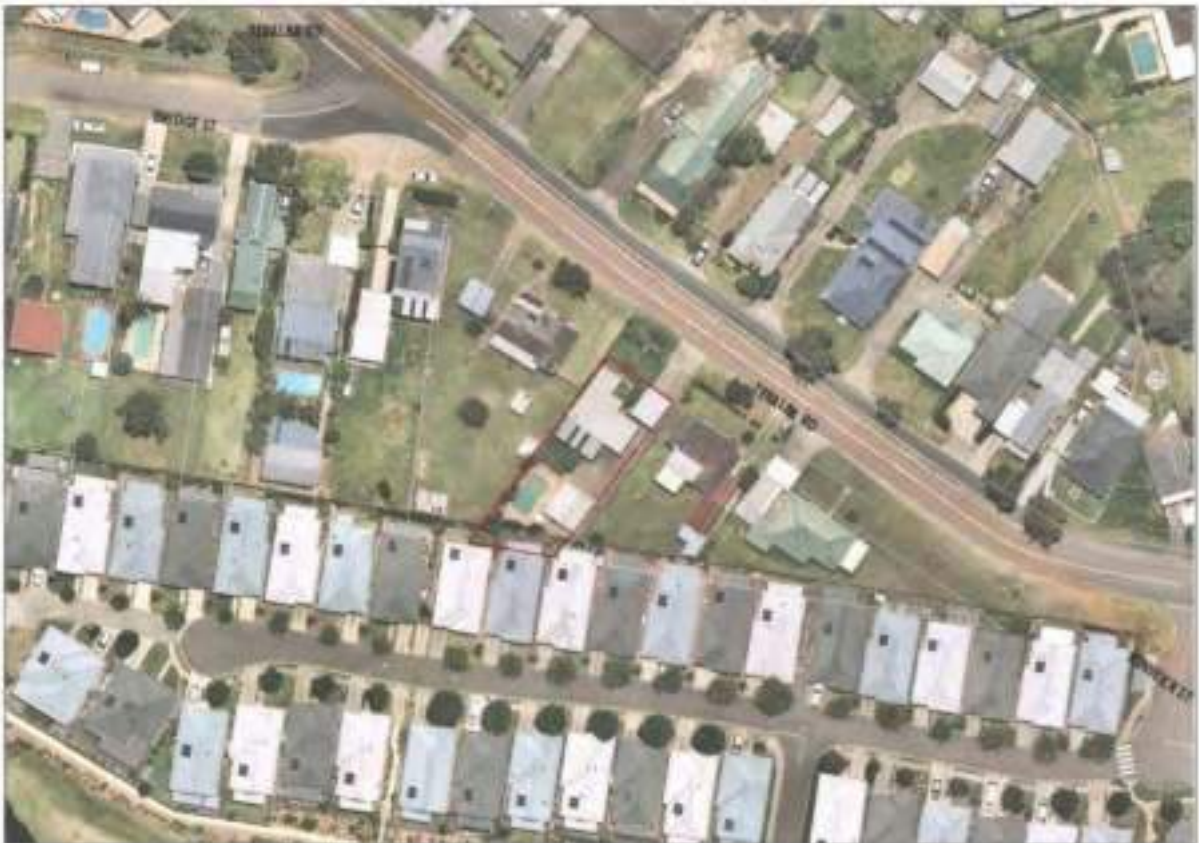
20 TERALBA ROAD, WEST WALLSEND 2286

Conservation Area Contribution Level	Est. Construction Date	Previous studies and/or community input
Non-Contributory	Mid to late 20 th century onwards	No prior heritage assessments or research undertaken.
Assessment Text		Observed Modifications
<p>The scale (e.g. double-storey or greater) and general style of the dwelling is inconsistent with that of the streetscape and wider HCA.</p> <p>The dwelling does not contribute positively to the streetscape and wider HCA, particularly in comparison to Contributory 1 and 2 buildings. The presence of the building has an adverse impact on the streetscape and/or wider HCA.</p> <p>The dwelling features inappropriately proportioned and positioned fenestrations, an inappropriate roof form (gabled or hipped) and/or other features that are inconsistent with the architectural character of the area (e.g. unsympathetic additions, inconsistent [contemporary] building materials, etc).</p>		<p>A car port has been constructed at the front north eastern side of the dwelling, being highly visible and partially obscuring the dwelling.</p>

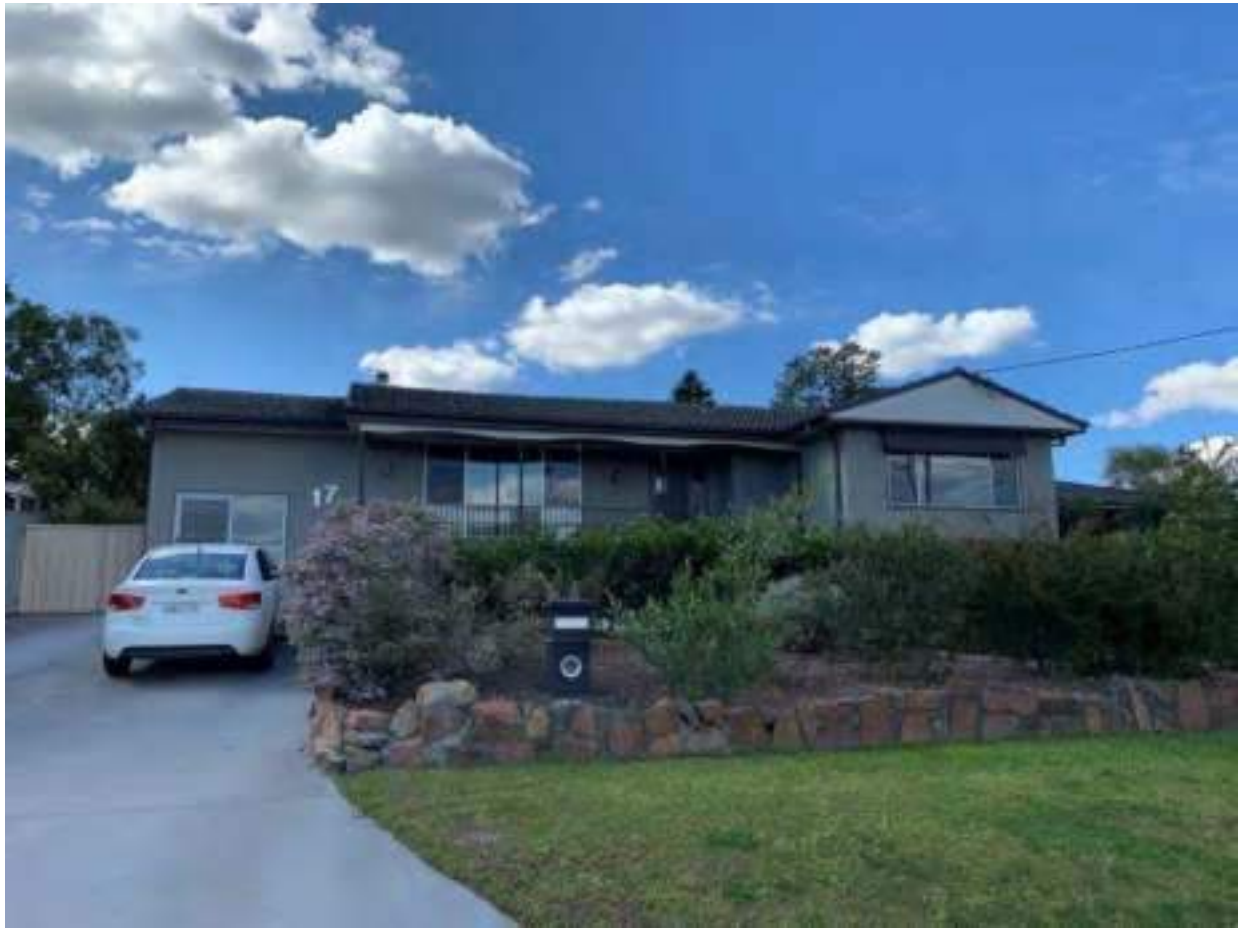
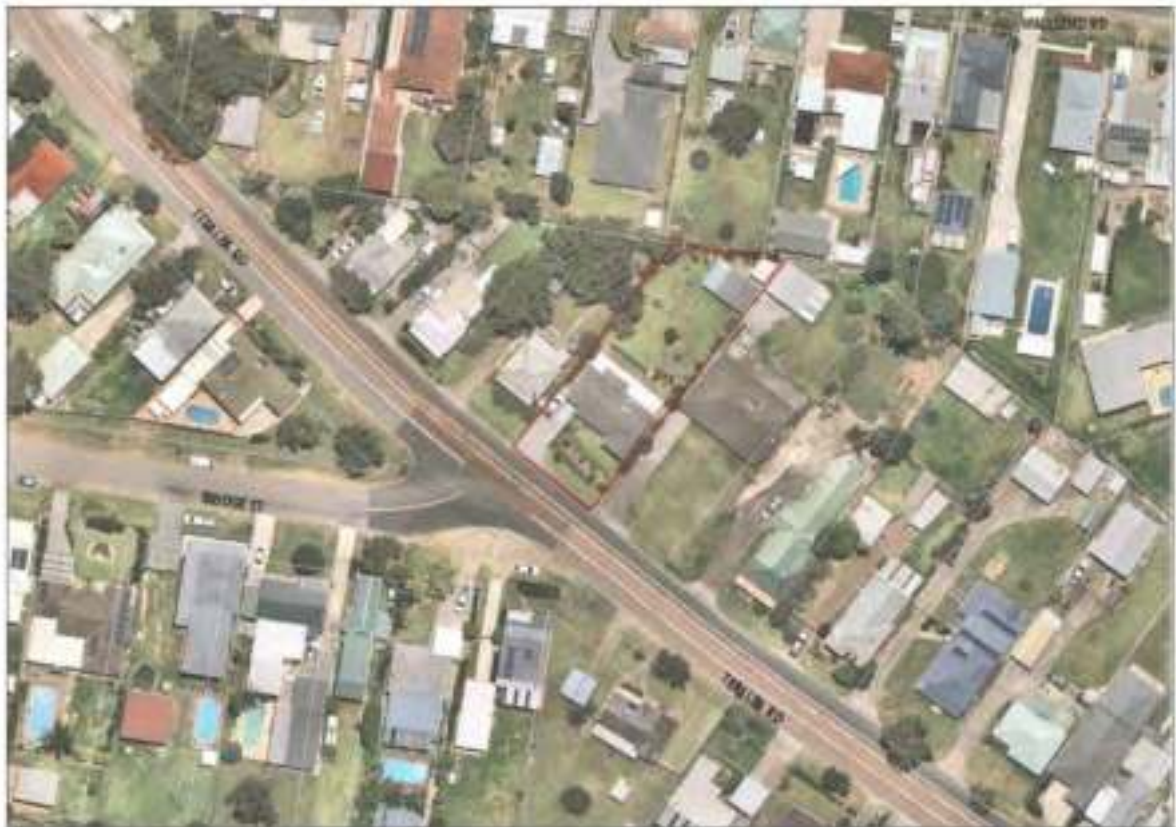
17 TERALBA ROAD, WEST WALLSEND 2286

Conservation Area Contribution Level	Est. Construction Date	Previous studies and/or community input
Non-Contributory	Mid to late 20 th century onwards	No prior heritage assessments or research undertaken.
Assessment Text		Observed Modifications
<p>The scale (e.g. double-storey or greater) and general style of the dwelling is inconsistent with that of the streetscape and wider HCA.</p> <p>The dwelling does not contribute positively to the streetscape and wider HCA, particularly in comparison to Contributory 1 and 2 buildings. The presence of the building has an adverse impact on the streetscape and/or wider HCA.</p> <p>The dwelling features inappropriately proportioned and positioned fenestrations, an inappropriate roof form (gabled or hipped) and/or other features that are inconsistent with the architectural character of the area (e.g. unsympathetic additions, inconsistent [contemporary] building materials, etc).</p>		<p>An extension has been built onto the north western side of the dwelling. this has been undertaken in a sympathetic style, replicating the existing materials and style.</p>

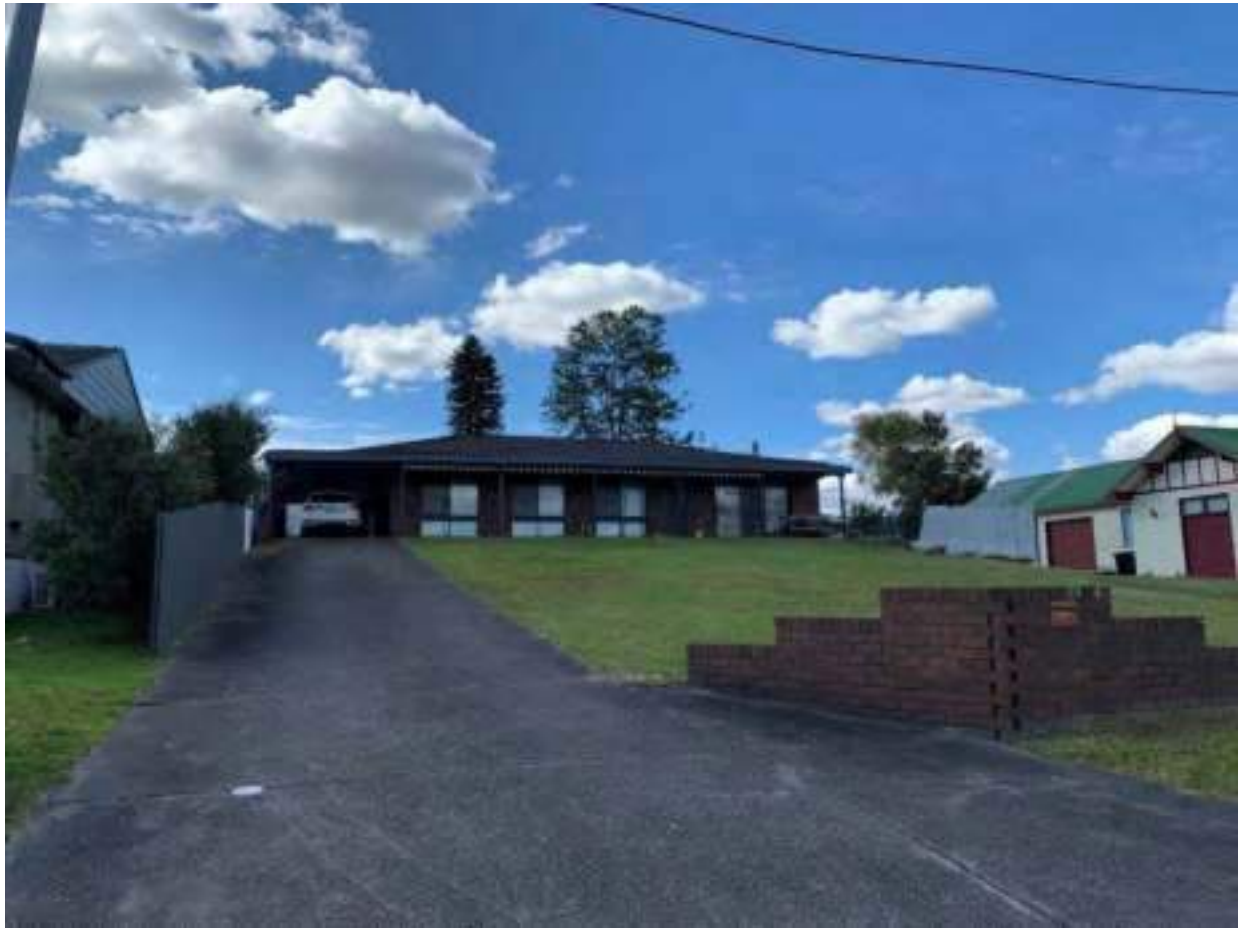
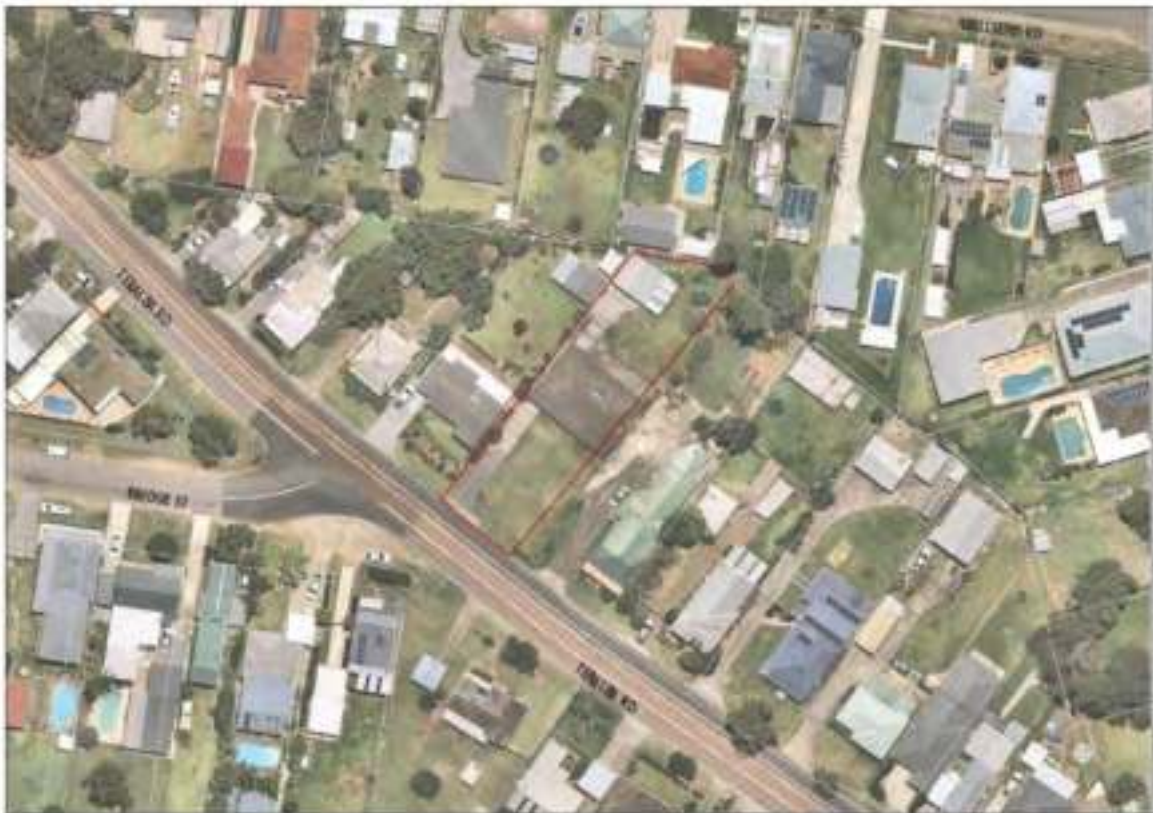
19 TERALBA ROAD, WEST WALLSEND 2286

Conservation Area Contribution Level	Est. Construction Date	Previous studies and/or community input
Non-Contributory	Mid to late 20 th century onwards	No prior heritage assessments or research undertaken.
Assessment Text		Observed Modifications
<p>The scale (e.g. double-storey or greater) and general style of the dwelling is inconsistent with that of the streetscape and wider HCA.</p> <p>The dwelling does not contribute positively to the streetscape and wider HCA, particularly in comparison to Contributory 1 and 2 buildings. The presence of the building has an adverse impact on the streetscape and/or wider HCA.</p> <p>The dwelling features inappropriately proportioned and positioned fenestrations, an inappropriate roof form (gabled or hipped) and/or other features that are inconsistent with the architectural character of the area (e.g. unsympathetic additions, inconsistent [contemporary] building materials, etc).</p>		No modifications observed.

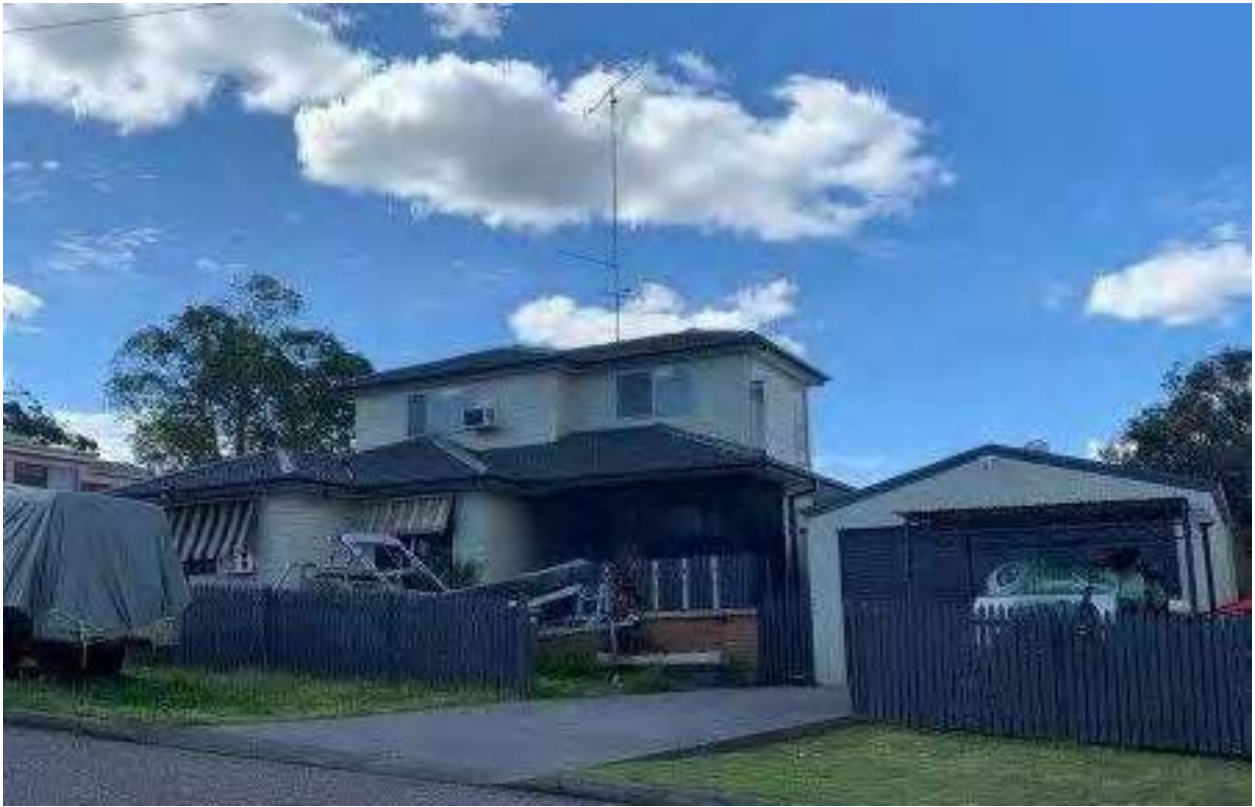
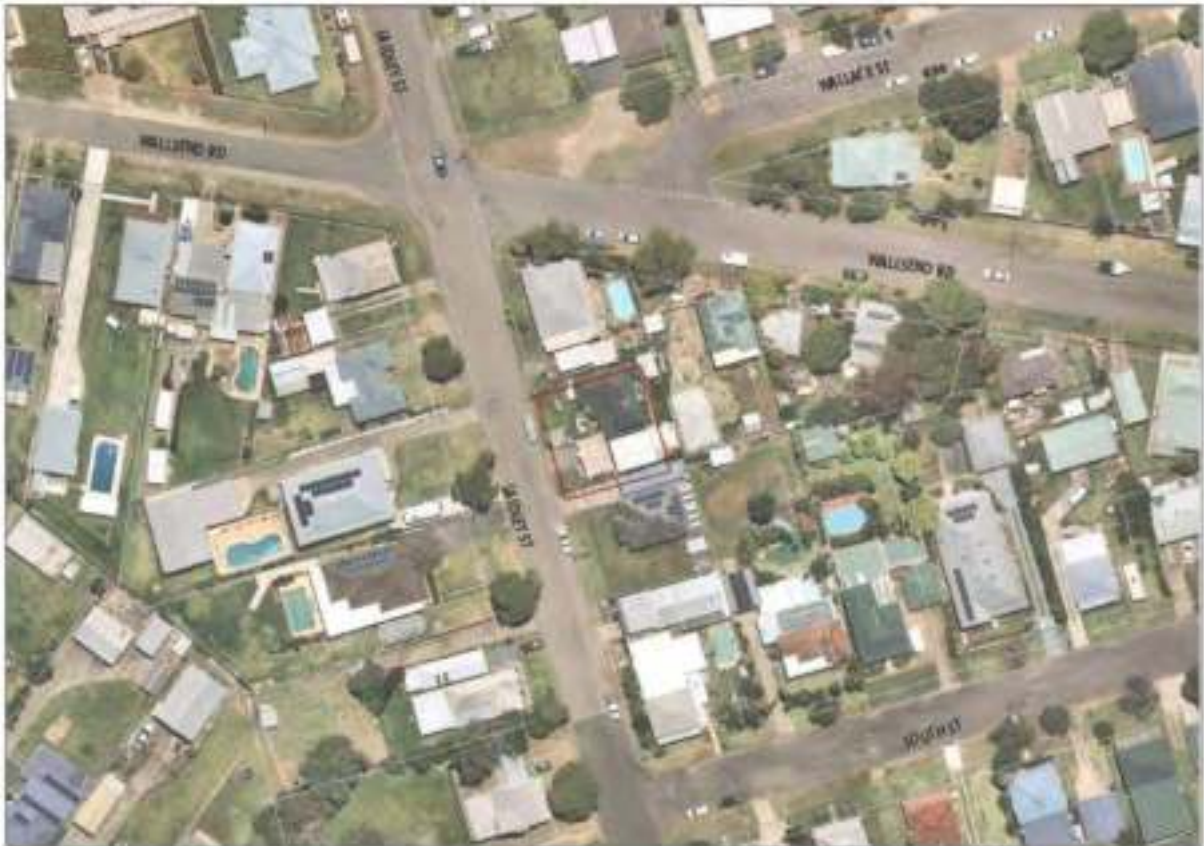
31 LAIDLEY STREET, WEST WALLSEND 2286		
Conservation Area Contribution Level	Est. Construction Date	Previous studies and/or community input
Non-Contributory	Mid to late 20 th century onwards	No prior heritage assessments or research undertaken.
Assessment Text		Observed Modifications
<p>The scale (e.g. double-storey or greater) and general style of the dwelling is inconsistent with that of the streetscape and wider HCA.</p> <p>The dwelling does not contribute positively to the streetscape and wider HCA, particularly in comparison to Contributory 1 and 2 buildings. The presence of the building has an adverse impact on the streetscape and/or wider HCA.</p> <p>The dwelling features inappropriately proportioned and positioned fenestrations, an inappropriate roof form (gabled or hipped) and/or other features that are inconsistent with the architectural character of the area (e.g. unsympathetic additions, inconsistent [contemporary] building materials, etc).</p>		<p>A single door garage has been built to the southern side of the dwelling.</p>
