APPENDIX 2

Building Assessment Sheets (Inventory Sheets)

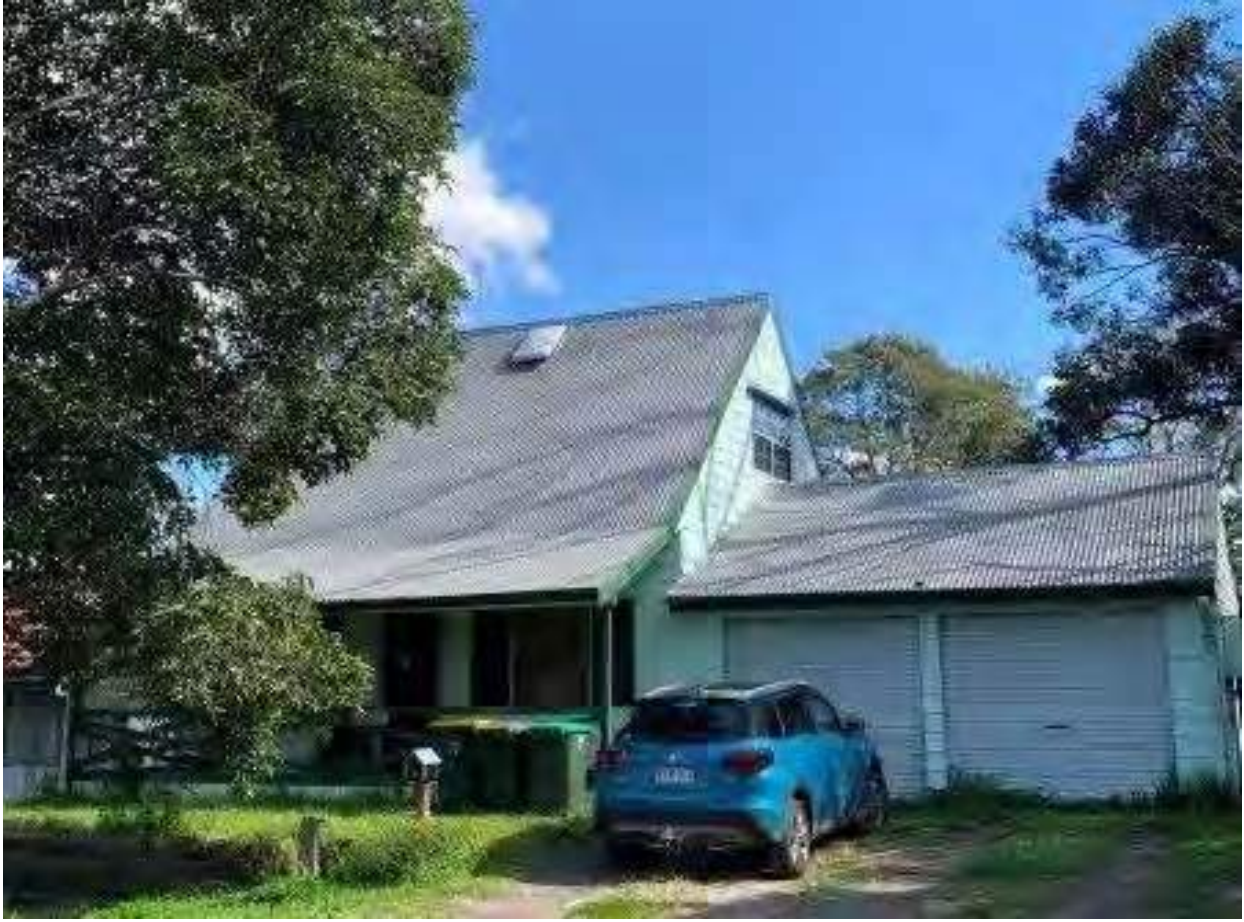
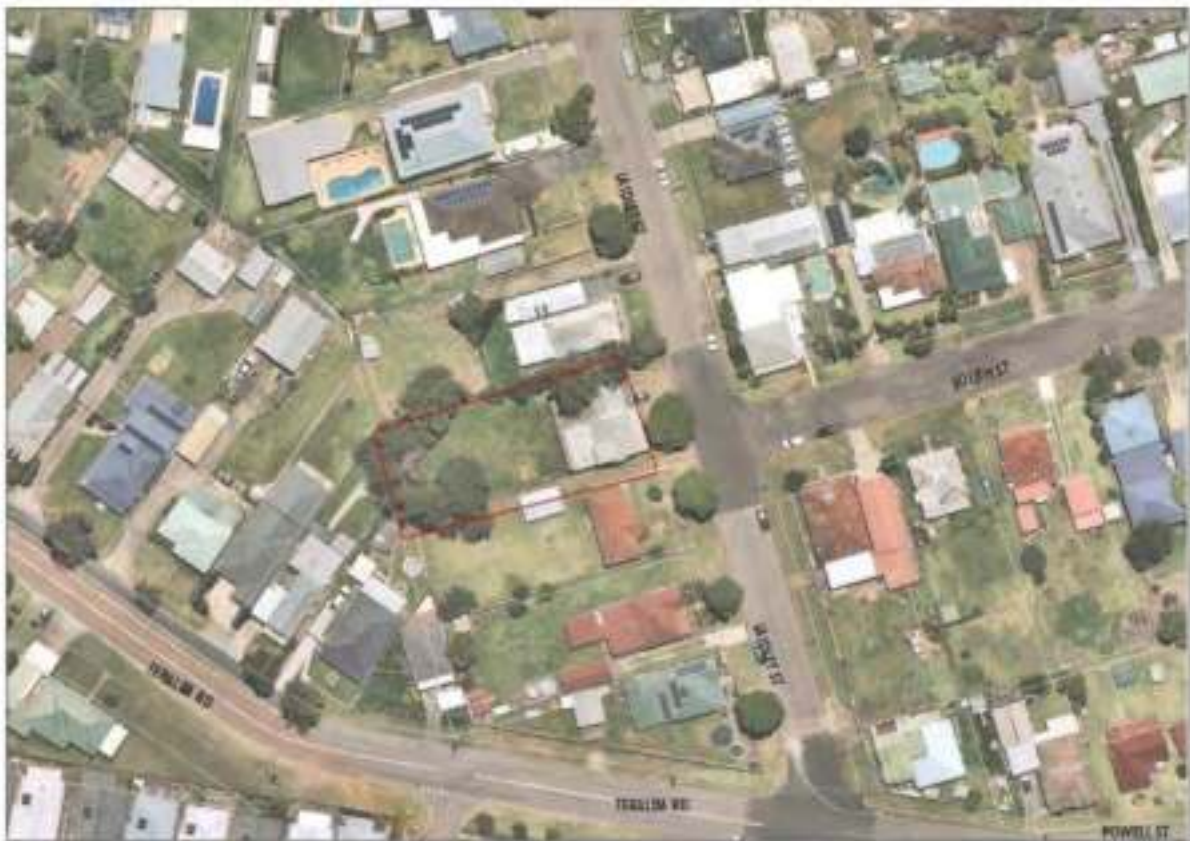
36 LAIDLEY STREET, WEST WALLSEND 2286		
Conservation Area Contribution Level	Est. Construction Date	Previous studies and/or community input
Non-Contributory	Mid to late 20 th century onwards	No prior heritage assessments or research undertaken.
Assessment Text		Observed Modifications
<p>The scale (e.g. double-storey or greater) and general style of the dwelling is inconsistent with that of the streetscape and wider HCA.</p> <p>The dwelling does not contribute positively to the streetscape and wider HCA, particularly in comparison to Contributory 1 and 2 buildings. The presence of the building has an adverse impact on the streetscape and/or wider HCA.</p> <p>The dwelling features inappropriately proportioned and positioned fenestrations, an inappropriate roof form (gabled or hipped) and/or other features that are inconsistent with the architectural character of the area (e.g. unsympathetic additions, inconsistent [contemporary] building materials, etc).</p>		No modifications observed.

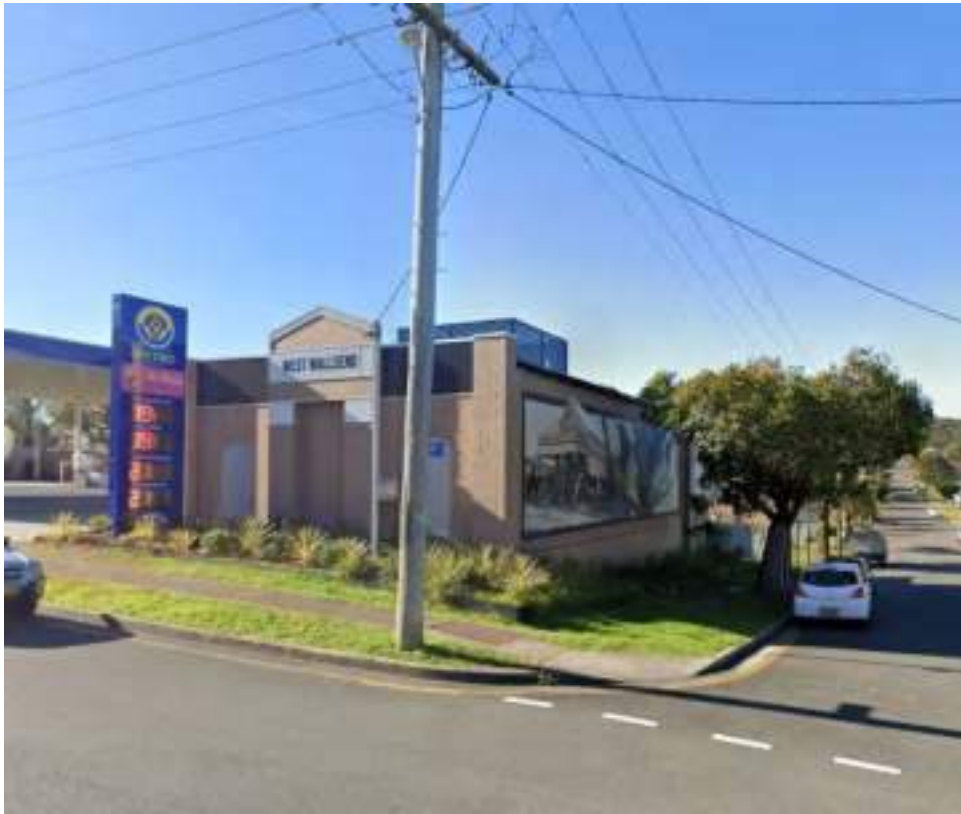
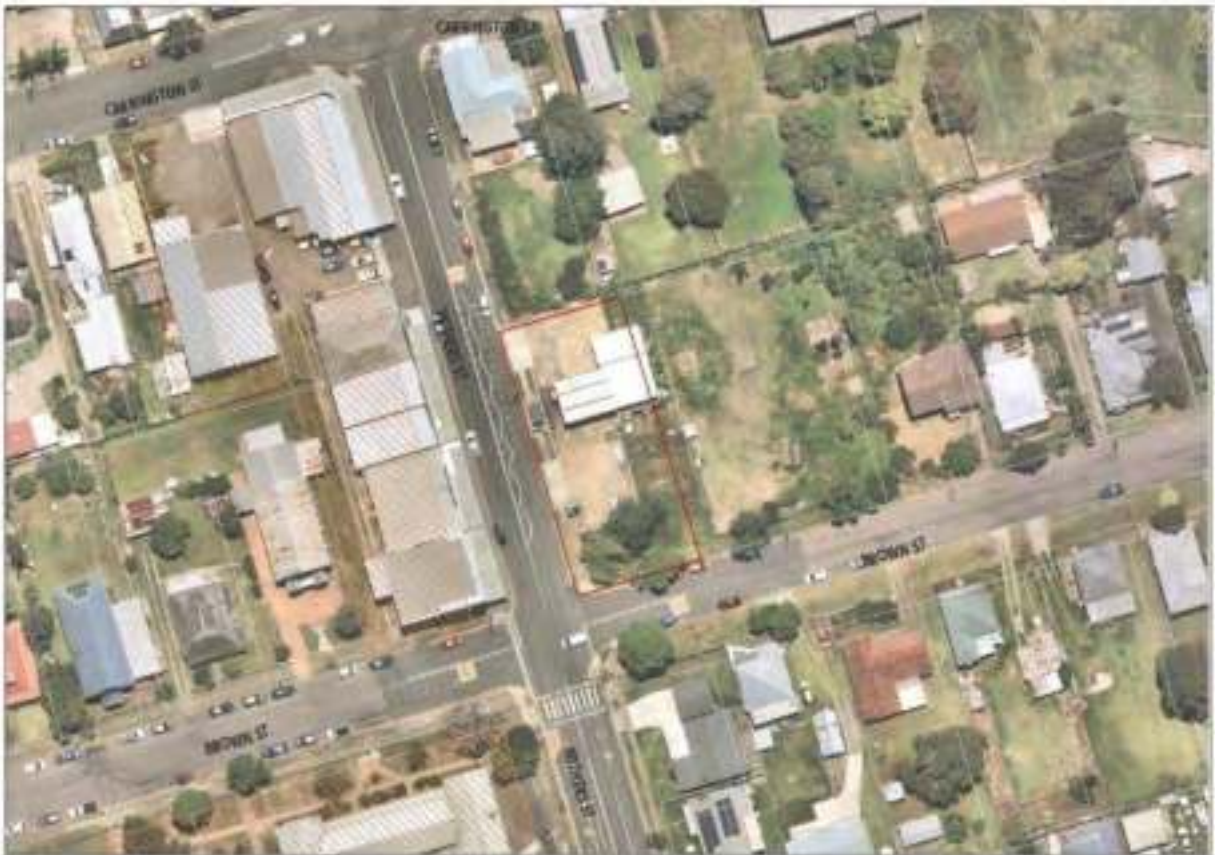
7 WITHERS STREET, WEST WALLSEND 2286

Conservation Area Contribution Level	Est. Construction Date	Previous studies and/or community input
Non-Contributory	2021-2022	No prior heritage assessments or research undertaken.
Assessment Text		Observed Modifications
<p>The scale (e.g. double-storey or greater) and general style of the dwelling is inconsistent with that of the streetscape and wider HCA.</p> <p>The dwelling does not contribute positively to the streetscape and wider HCA, particularly in comparison to Contributory 1 and 2 buildings. The presence of the building has an adverse impact on the streetscape and/or wider HCA.</p> <p>The dwelling features inappropriately proportioned and positioned fenestrations, an inappropriate roof form (gabled or hipped) and/or other features that are inconsistent with the architectural character of the area (e.g. unsympathetic additions, inconsistent [contemporary] building materials, etc).</p>		<p>Building currently serves as a Metro Petroleum, constructed in a sympathetic manner.</p>

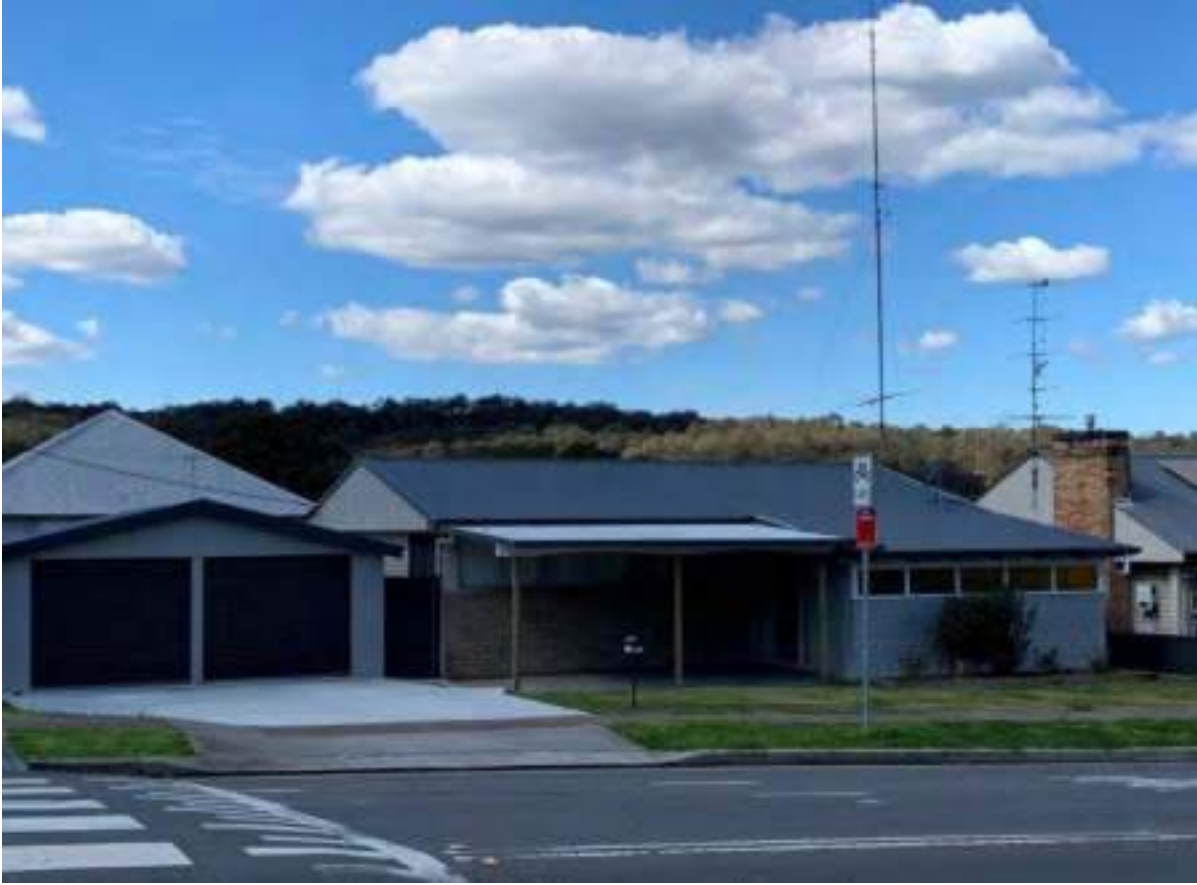
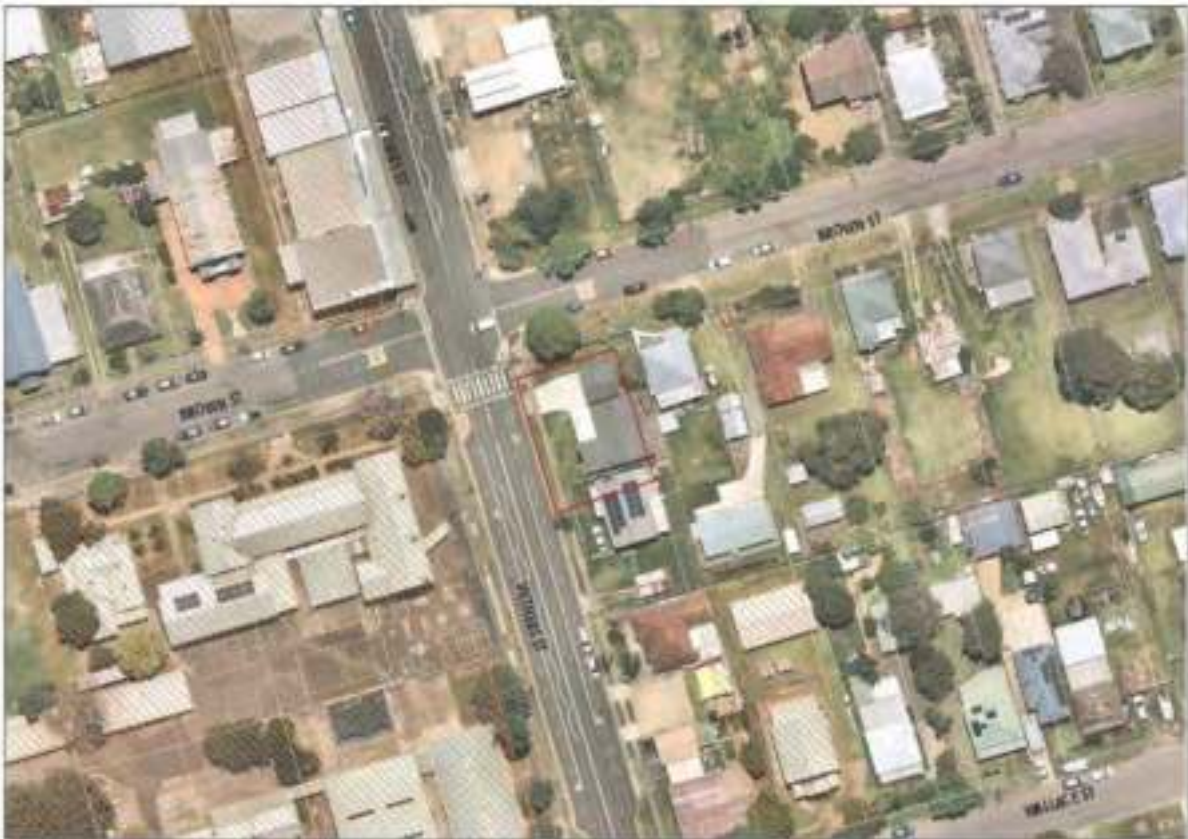
7A WITHERS STREET, WEST WALLSEND 2286

Conservation Area Contribution Level	Est. Construction Date	Previous studies and/or community input
Non-Contributory	Mid to late 20 th century onwards	No prior heritage assessments or research undertaken.
Assessment Text		Observed Modifications
<p>The scale (e.g. double-storey or greater) and general style of the dwelling is inconsistent with that of the streetscape and wider HCA.</p> <p>The dwelling does not contribute positively to the streetscape and wider HCA, particularly in comparison to Contributory 1 and 2 buildings. The presence of the building has an adverse impact on the streetscape and/or wider HCA.</p> <p>The dwelling features inappropriately proportioned and positioned fenestrations, an inappropriate roof form (gabled or hipped) and/or other features that are inconsistent with the architectural character of the area (e.g. unsympathetic additions, inconsistent [contemporary] building materials, etc).</p>		<p>The flat veranda roof is a contemporary addition, with the space likely having been vacant previously.</p> <p>A double garage has been built on the northern side of the dwelling.</p>

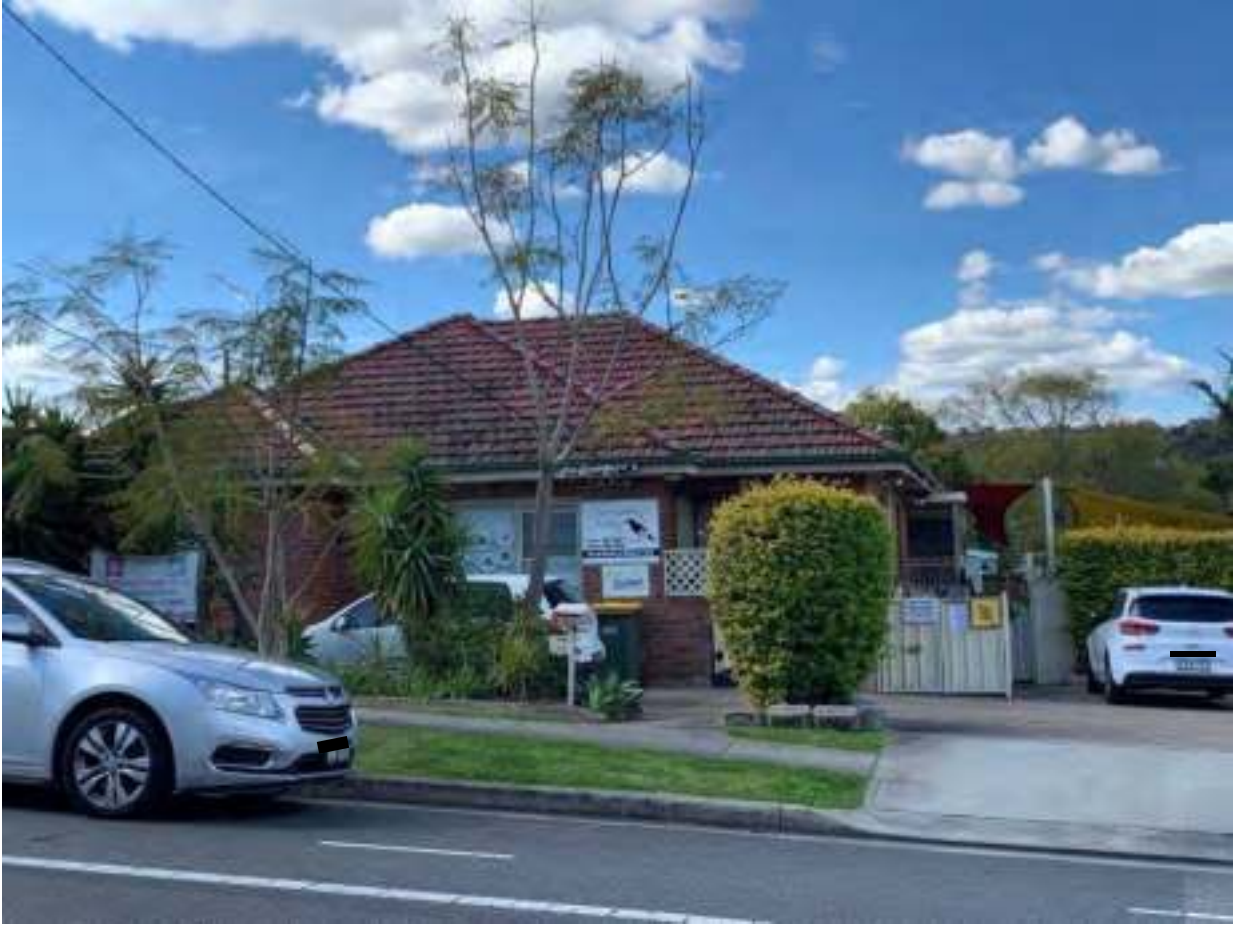
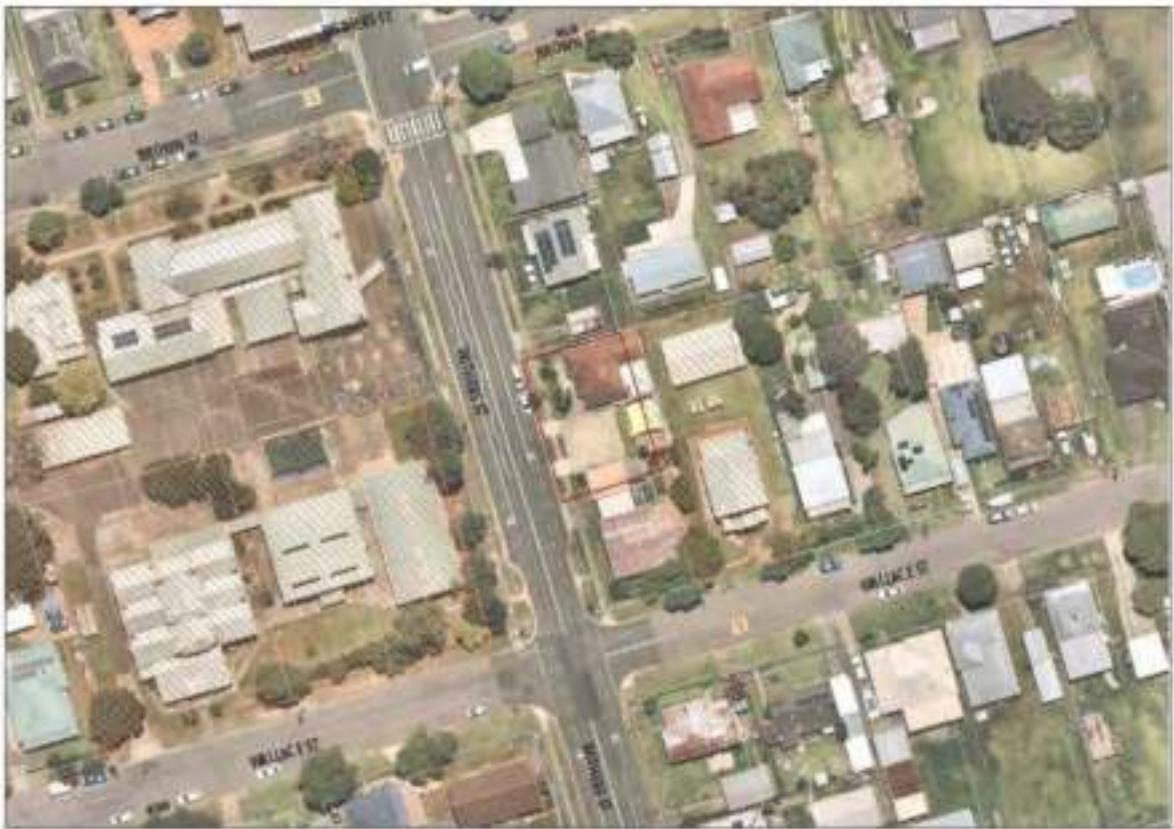
11 WITHERS STREET, WEST WALLSEND 2286

Conservation Area Contribution Level	Est. Construction Date	Previous studies and/or community input
Non-Contributory	Mid to late 20 th century onwards	No prior heritage assessments or research undertaken.
Assessment Text		Observed Modifications
<p>The scale (e.g. double-storey or greater) and general style of the dwelling is inconsistent with that of the streetscape and wider HCA.</p> <p>The dwelling does not contribute positively to the streetscape and wider HCA, particularly in comparison to Contributory 1 and 2 buildings. The presence of the building has an adverse impact on the streetscape and/or wider HCA.</p> <p>The dwelling features inappropriately proportioned and positioned fenestrations, an inappropriate roof form (gabled or hipped) and/or other features that are inconsistent with the architectural character of the area (e.g. unsympathetic additions, inconsistent [contemporary] building materials, etc).</p>		No modifications observed.

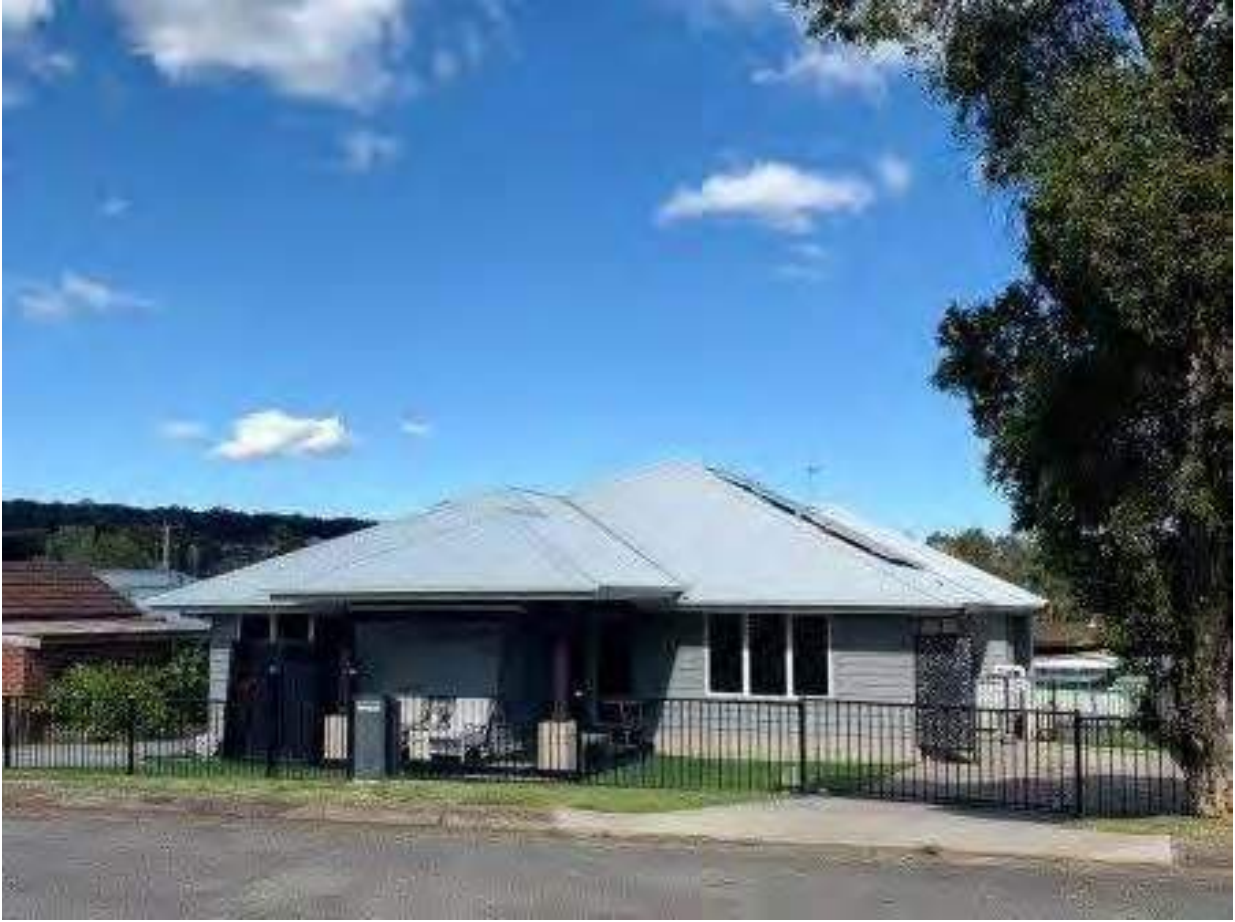
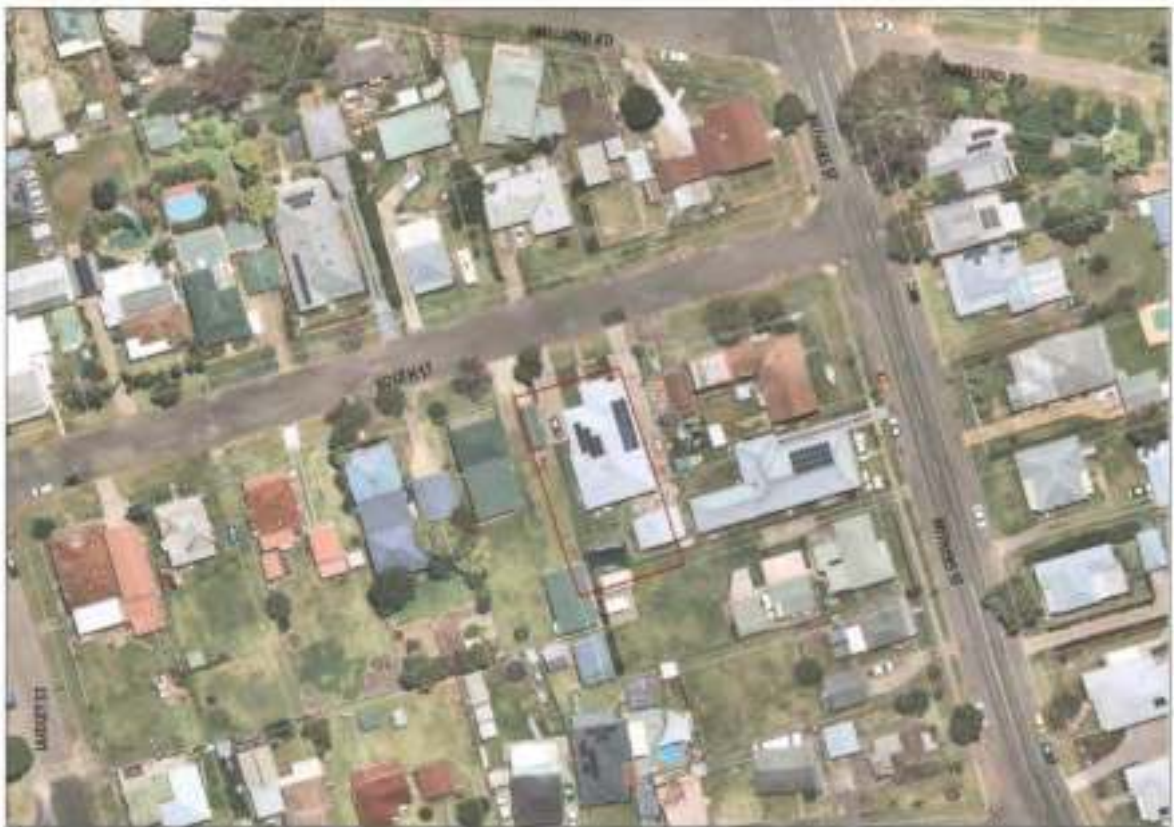
2A SOUTH STREET, WEST WALLSEND 2286

Conservation Area Contribution Level	Est. Construction Date	Previous studies and/or community input
Non-Contributory	Mid to late 20 th century onwards	No prior heritage assessments or research undertaken.
Assessment Text		Observed Modifications
<p>The scale (e.g. double-storey or greater) and general style of the dwelling is inconsistent with that of the streetscape and wider HCA.</p> <p>The dwelling does not contribute positively to the streetscape and wider HCA, particularly in comparison to Contributory 1 and 2 buildings. The presence of the building has an adverse impact on the streetscape and/or wider HCA.</p> <p>The dwelling features inappropriately proportioned and positioned fenestrations, an inappropriate roof form (gabled or hipped) and/or other features that are inconsistent with the architectural character of the area (e.g. unsympathetic additions, inconsistent [contemporary] building materials, etc).</p>		No modifications observed.

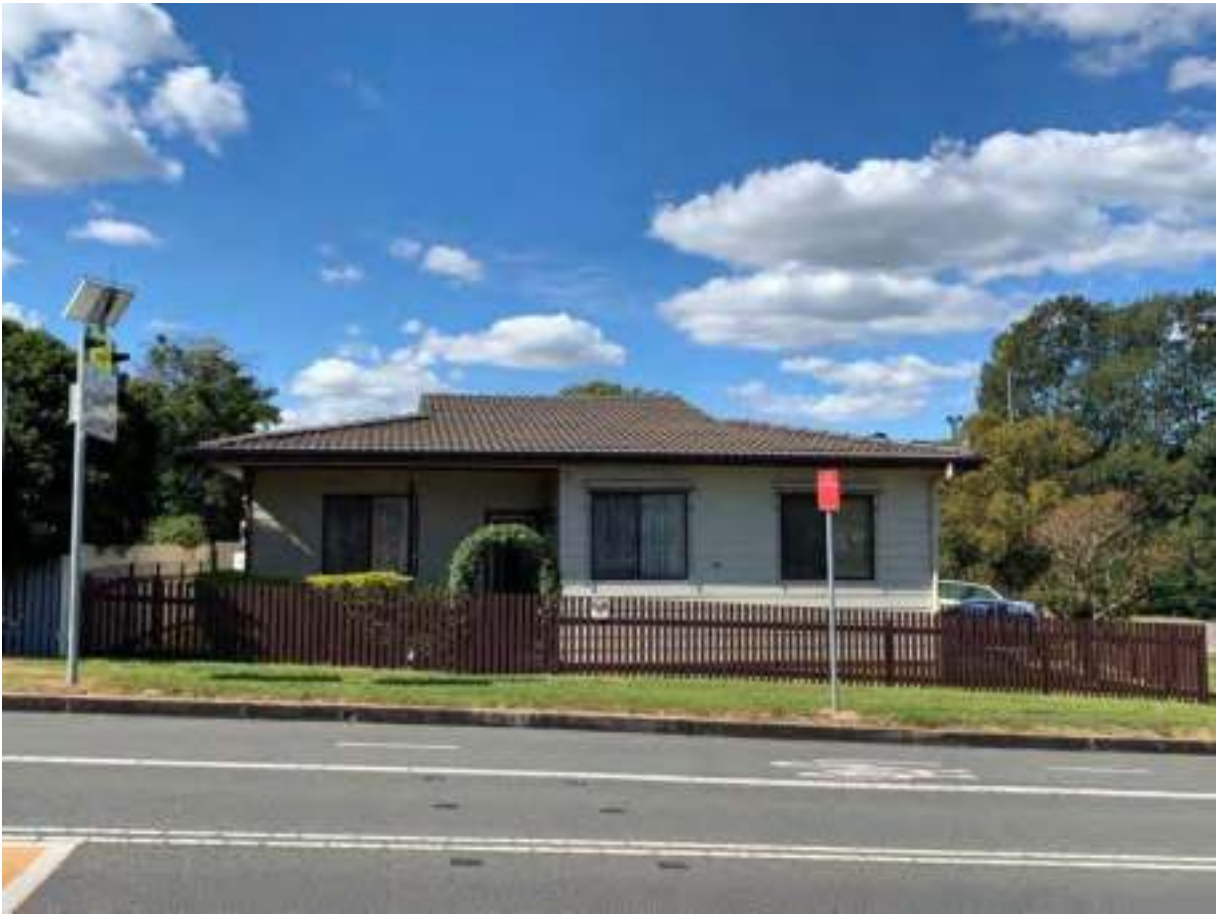
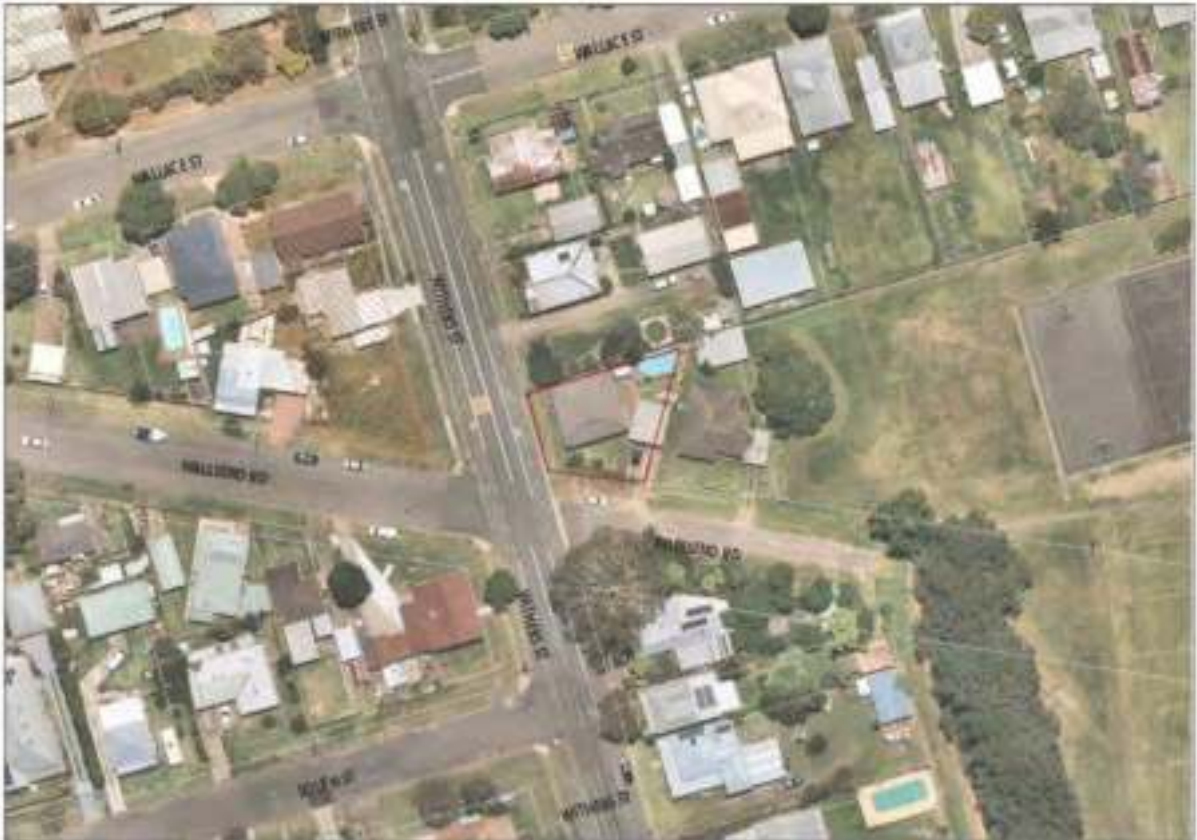
19 WITHERS STREET, WEST WALLSEND 2286		
Conservation Area Contribution Level	Est. Construction Date	Previous studies and/or community input
Non-Contributory	Mid to late 20th century onwards	No prior heritage assessments or research undertaken.
Assessment Text		Observed Modifications
<p>The scale (e.g. double-storey or greater) and general style of the dwelling is inconsistent with that of the streetscape and wider HCA.</p> <p>The dwelling does not contribute positively to the streetscape and wider HCA, particularly in comparison to Contributory 1 and 2 buildings. The presence of the building has an adverse impact on the streetscape and/or wider HCA.</p> <p>The dwelling features inappropriately proportioned and positioned fenestrations, an inappropriate roof form (gabled or hipped) and/or other features that are inconsistent with the architectural character of the area (e.g. unsympathetic additions, inconsistent [contemporary] building materials, etc).</p>		No modifications observed.

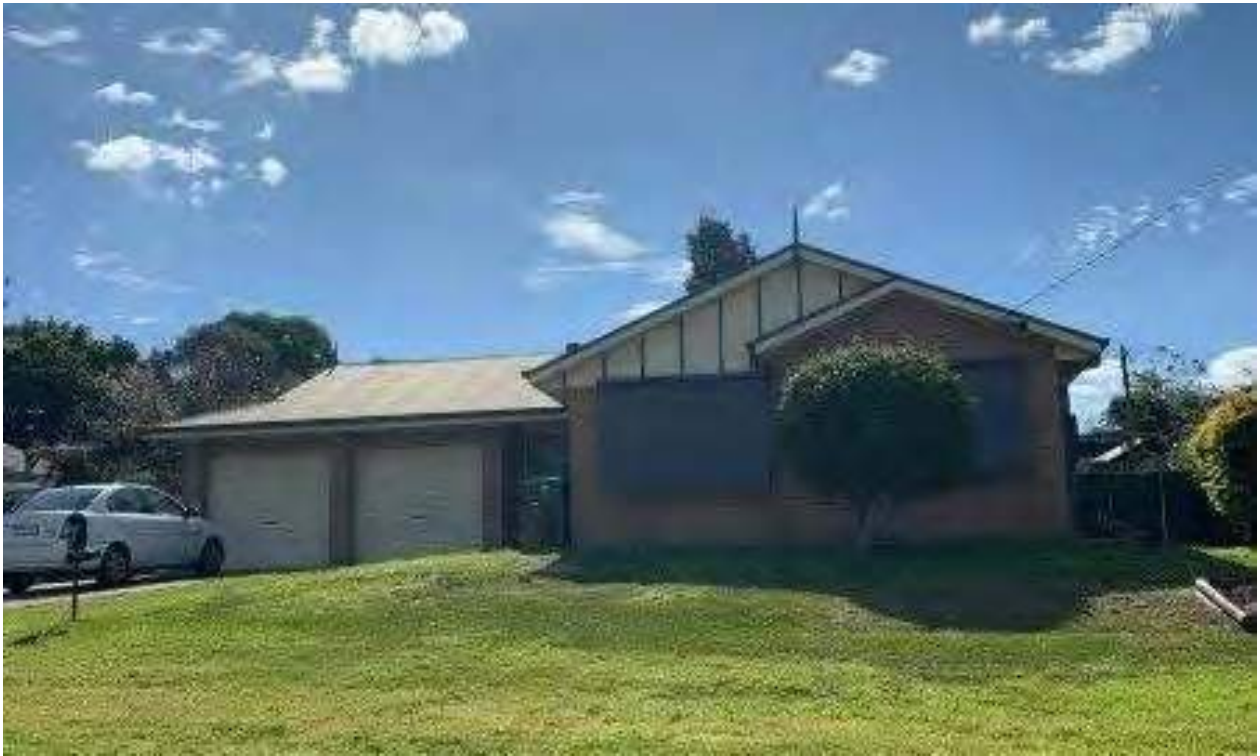
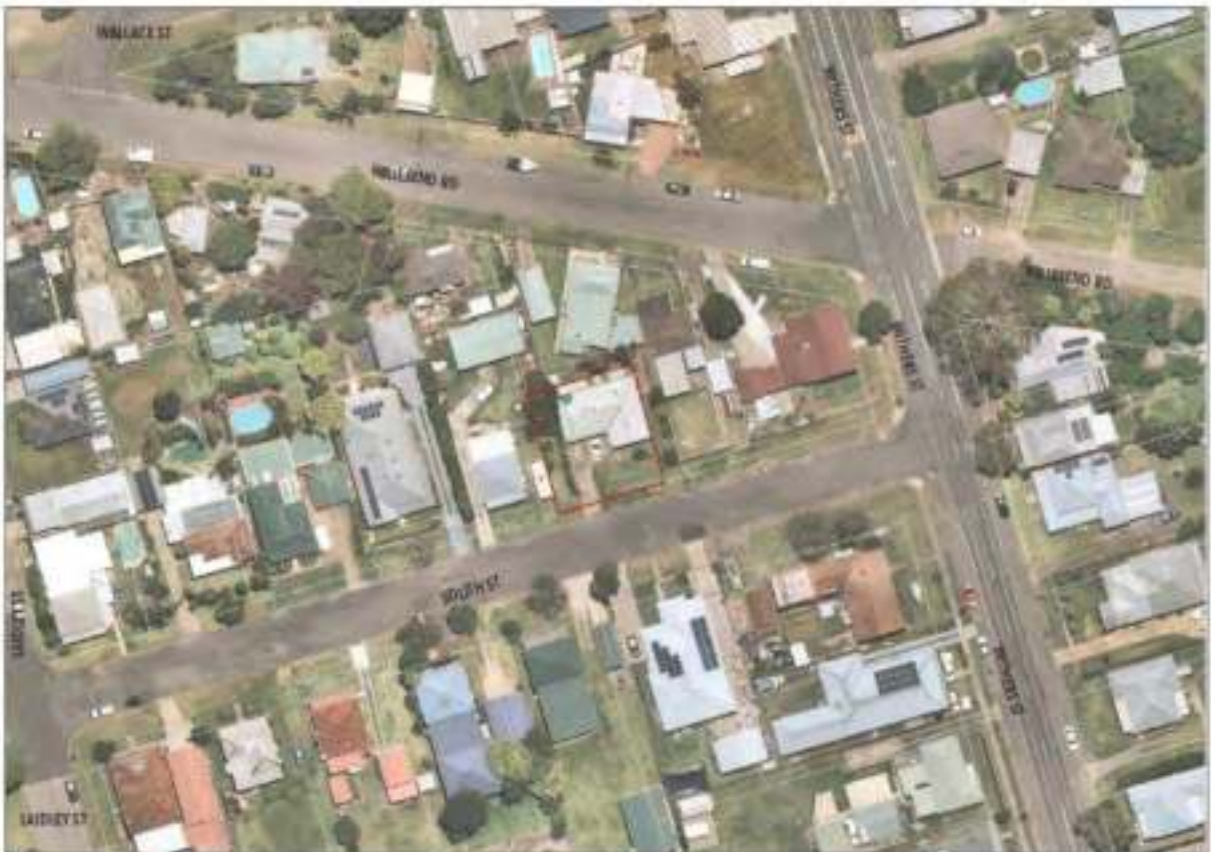
1A SOUTH STREET, WEST WALLSEND 2286

Conservation Area Contribution Level	Est. Construction Date	Previous studies and/or community input
Non-Contributory	Mid to late 20 th century onwards	No prior heritage assessments or research undertaken.
Assessment Text		Observed Modifications
<p>The scale (e.g. double-storey or greater) and general style of the dwelling is inconsistent with that of the streetscape and wider HCA.</p> <p>The dwelling does not contribute positively to the streetscape and wider HCA, particularly in comparison to Contributory 1 and 2 buildings. The presence of the building has an adverse impact on the streetscape and/or wider HCA.</p> <p>The dwelling features inappropriately proportioned and positioned fenestrations, an inappropriate roof form (gabled or hipped) and/or other features that are inconsistent with the architectural character of the area (e.g. unsympathetic additions, inconsistent [contemporary] building materials, etc).</p>		No modifications observed.

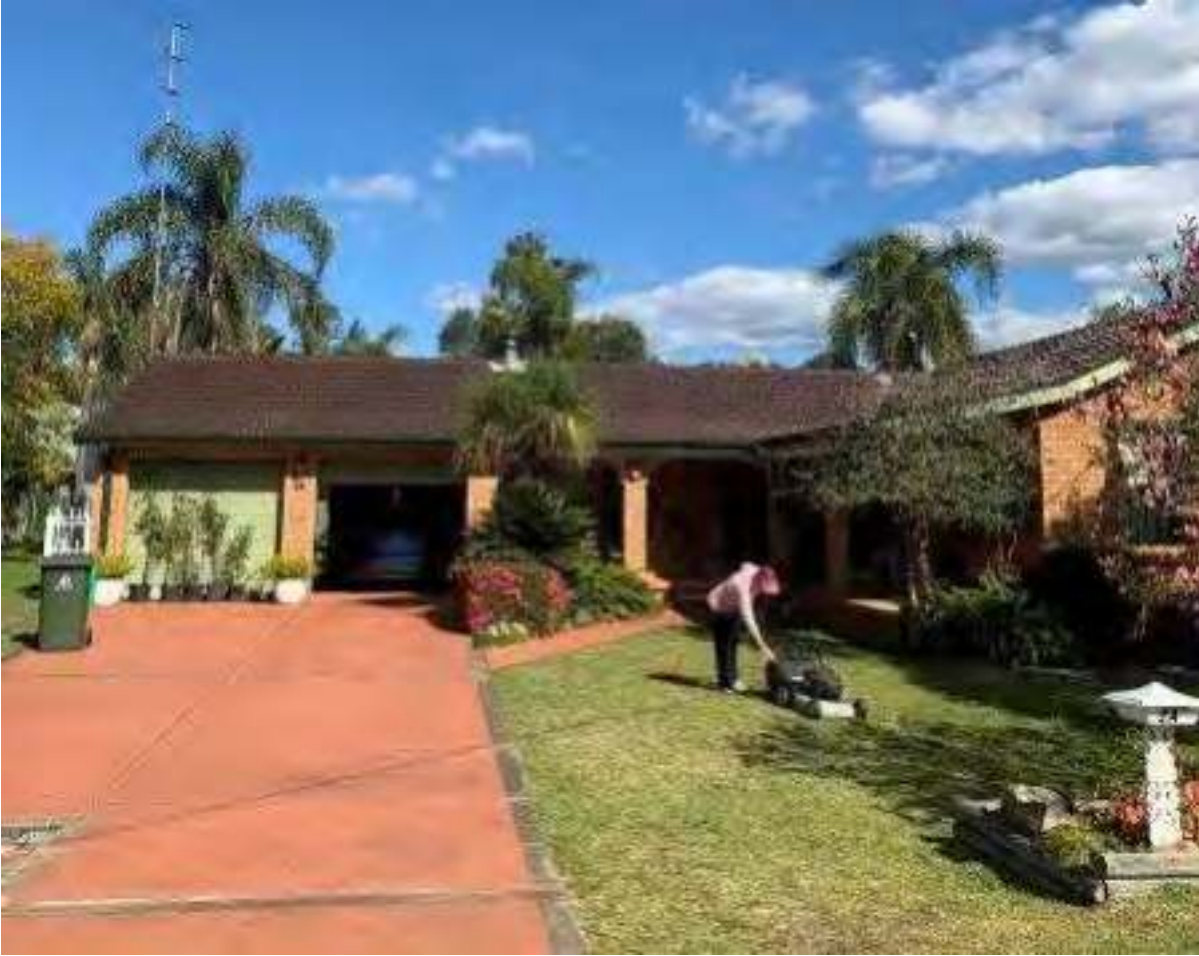
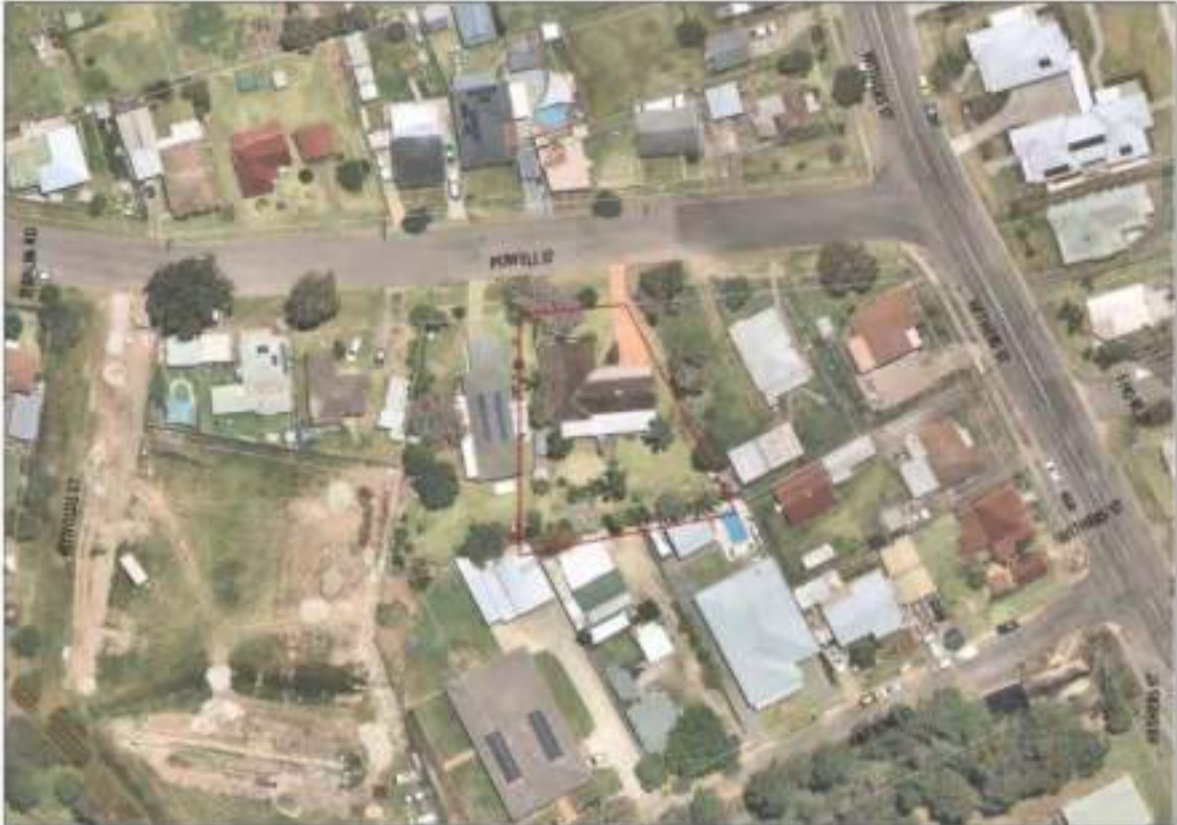
Conservation Area Contribution Level	Est. Construction Date	Previous studies and/or community input
Non-Contributory	Mid to late 20 th century onwards	No prior heritage assessments or research undertaken.
Assessment Text		Observed Modifications
<p>The scale (e.g. double-storey or greater) and general style of the dwelling is inconsistent with that of the streetscape and wider HCA.</p> <p>The dwelling does not contribute positively to the streetscape and wider HCA, particularly in comparison to Contributory 1 and 2 buildings. The presence of the building has an adverse impact on the streetscape and/or wider HCA.</p> <p>The dwelling features inappropriately proportioned and positioned fenestrations, an inappropriate roof form (gabled or hipped) and/or other features that are inconsistent with the architectural character of the area (e.g. unsympathetic additions, inconsistent [contemporary] building materials, etc).</p>		No modifications observed.

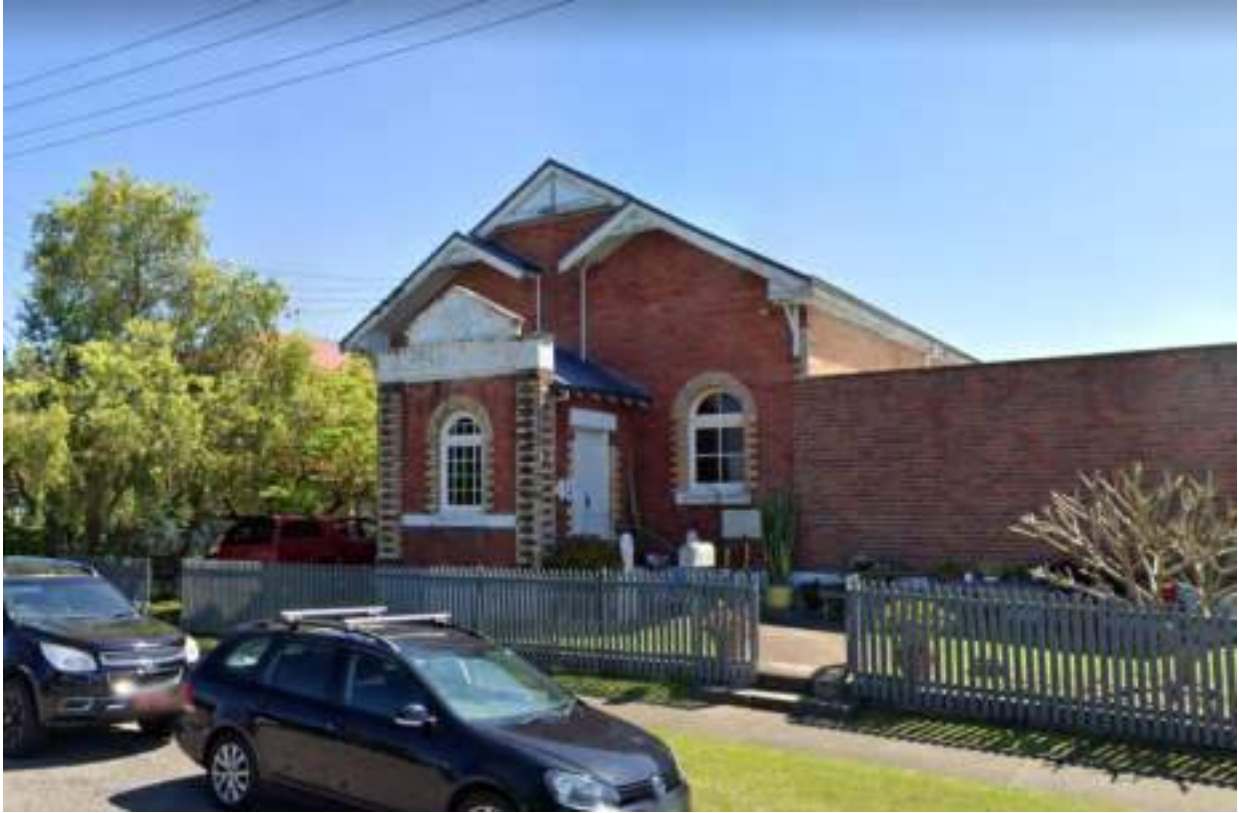
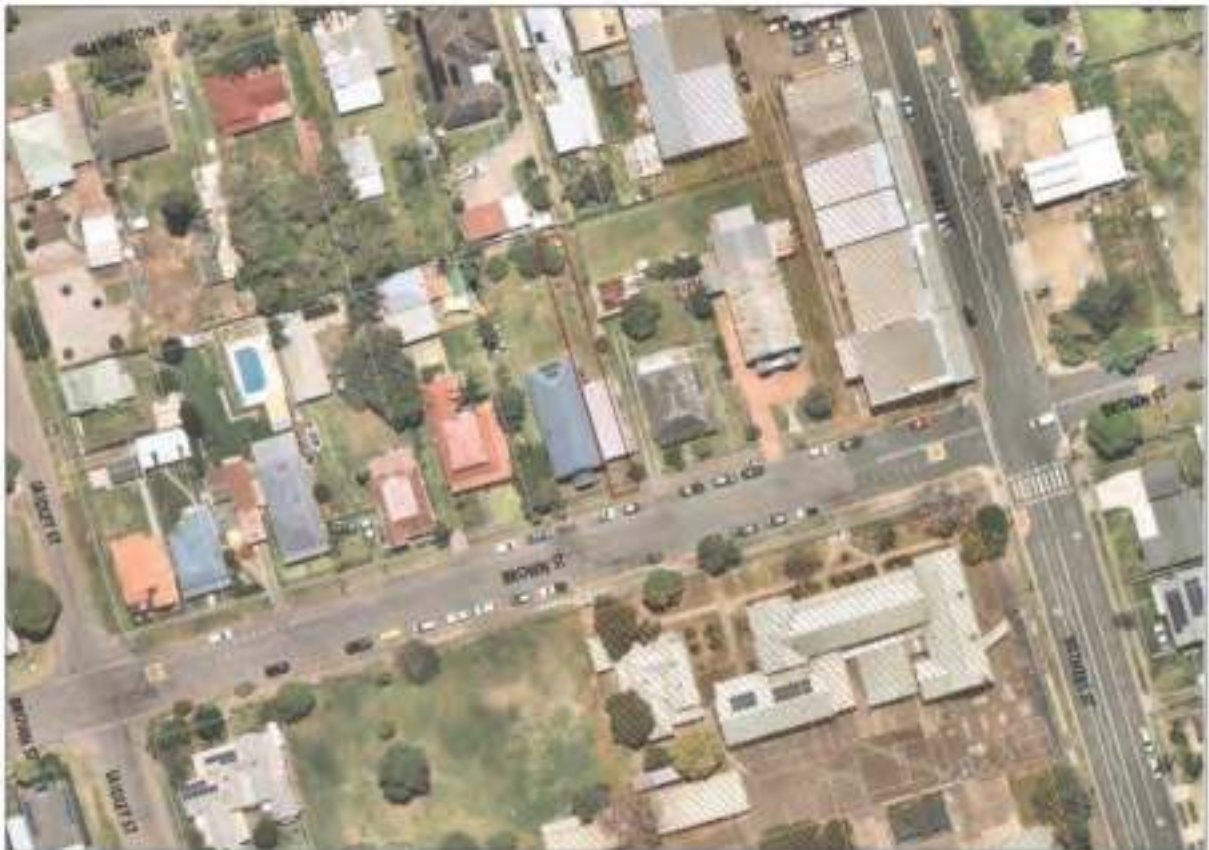
45 BROWN STREET, WEST WALLSEND 2286		
Conservation Area Contribution Level	Est. Construction Date	Previous studies and/or community input
Non-Contributory	Mid to late 20 th century onwards	No prior heritage assessments or research undertaken.
Assessment Text		Observed Modifications
<p>The scale (e.g. double-storey or greater) and general style of the dwelling is inconsistent with that of the streetscape and wider HCA.</p> <p>The dwelling does not contribute positively to the streetscape and wider HCA, particularly in comparison to Contributory 1 and 2 buildings. The presence of the building has an adverse impact on the streetscape and/or wider HCA.</p> <p>The dwelling features inappropriately proportioned and positioned fenestrations, an inappropriate roof form (gabled or hipped) and/or other features that are inconsistent with the architectural character of the area (e.g. unsympathetic additions, inconsistent [contemporary] building materials, etc).</p>		No modifications observed.

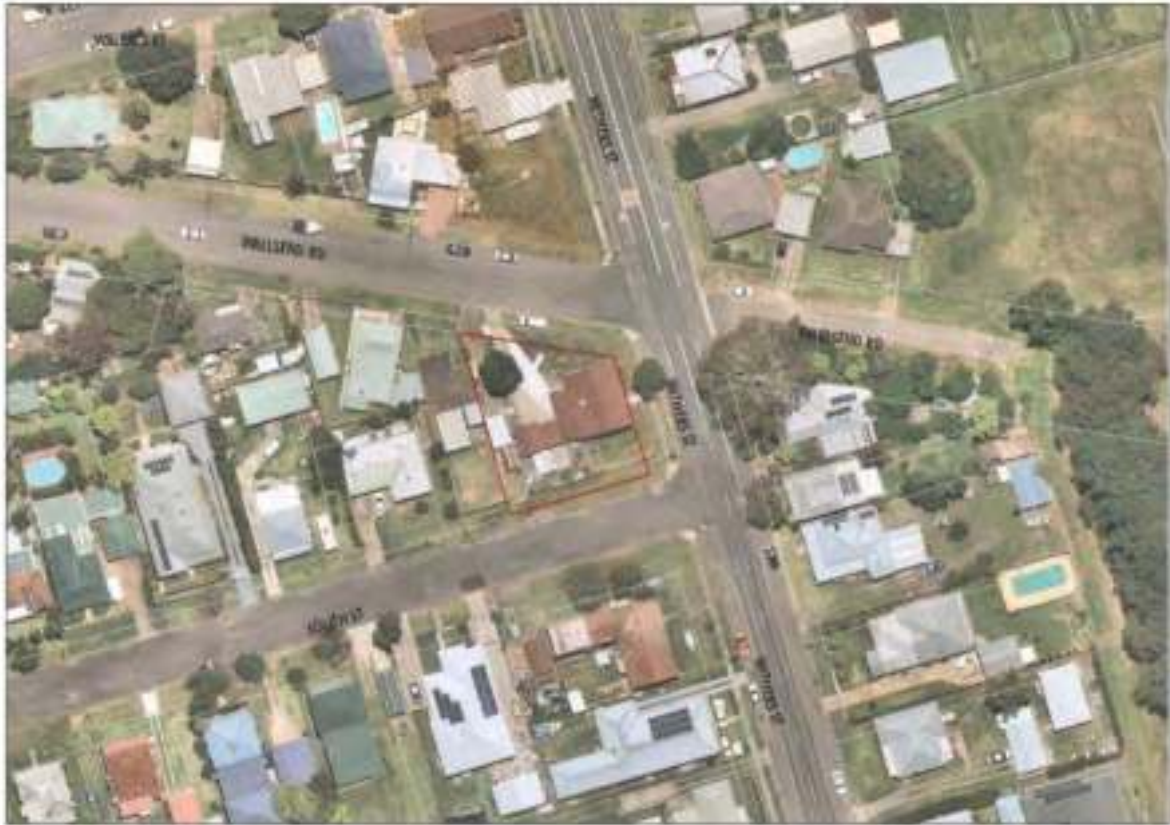
10 WITHERS STREET, WEST WALLSEND 2286

Conservation Area Contribution Level	Est. Construction Date	Previous studies and/or community input
Non-Contributory	Mid to late 20 th century onwards	No prior heritage assessments or research undertaken.
Assessment Text		Observed Modifications
<p>The scale (e.g. double-storey or greater) and general style of the dwelling is inconsistent with that of the streetscape and wider HCA.</p> <p>The dwelling does not contribute positively to the streetscape and wider HCA, particularly in comparison to Contributory 1 and 2 buildings. The presence of the building has an adverse impact on the streetscape and/or wider HCA.</p> <p>The dwelling features inappropriately proportioned and positioned fenestrations, an inappropriate roof form (gabled or hipped) and/or other features that are inconsistent with the architectural character of the area (e.g. unsympathetic additions, inconsistent [contemporary] building materials, etc).</p>		<p>All visible windows are contemporary in style.</p>
