APPENDIX 2

Building Assessment Sheets (Inventory Sheets)

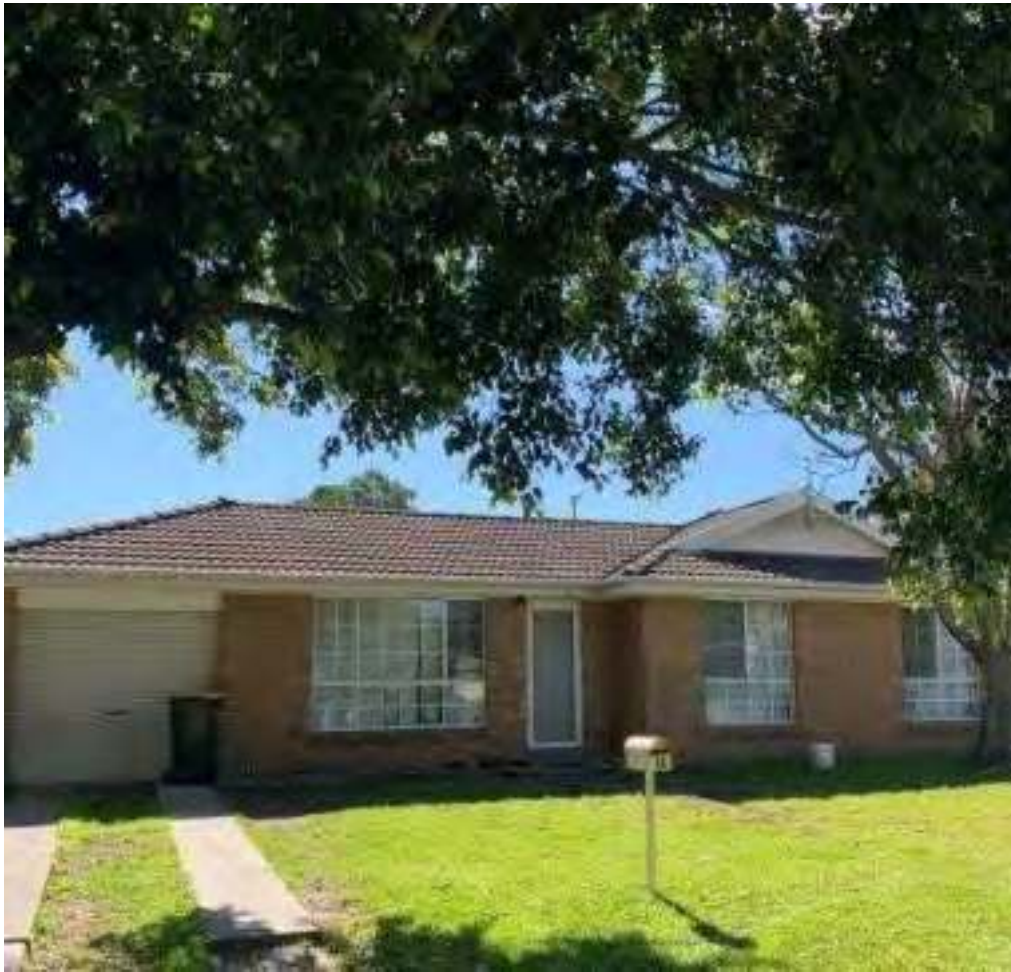
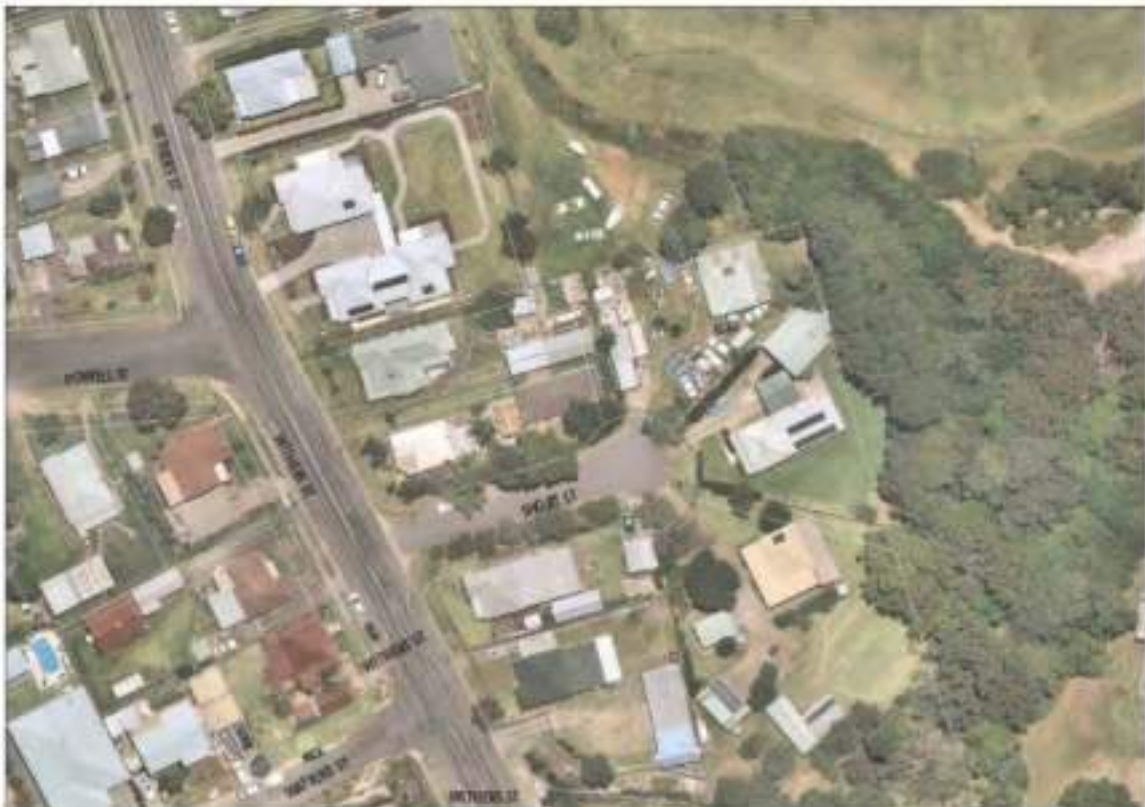
1A SHORT STREET, WEST WALLSEND 2286

Conservation Area Contribution Level	Est. Construction Date	Previous studies and/or community input
Non-Contributory	Mid to late 20 th century onwards	No prior heritage assessments or research undertaken.
Assessment Text		Observed Modifications
<p>The scale (e.g. double-storey or greater) and general style of the dwelling is inconsistent with that of the streetscape and wider HCA.</p> <p>The dwelling does not contribute positively to the streetscape and wider HCA, particularly in comparison to Contributory 1 and 2 buildings. The presence of the building has an adverse impact on the streetscape and/or wider HCA.</p> <p>The dwelling features inappropriately proportioned and positioned fenestrations, an inappropriate roof form (gabled or hipped) and/or other features that are inconsistent with the architectural character of the area (e.g. unsympathetic additions, inconsistent [contemporary] building materials, etc).</p>		No modifications observed.

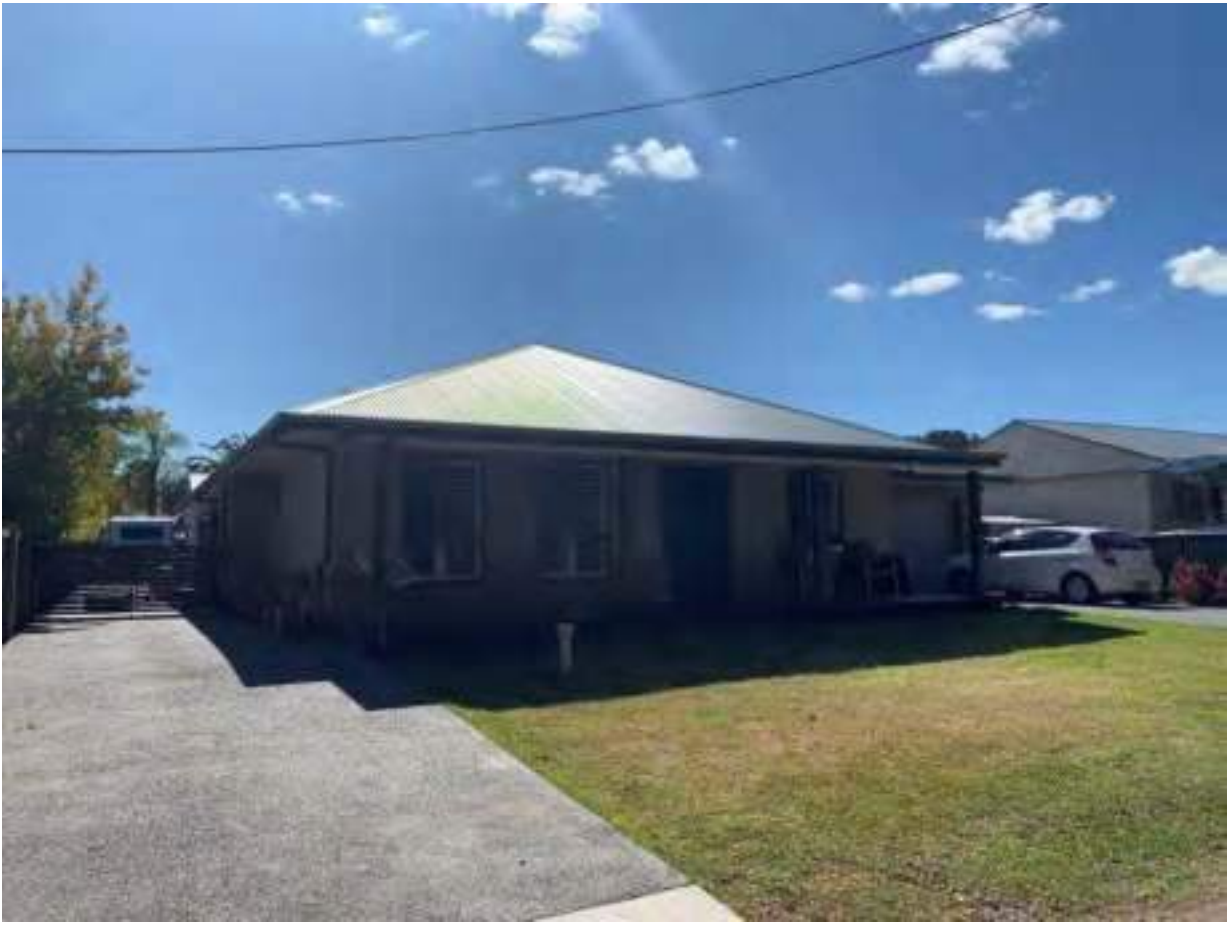
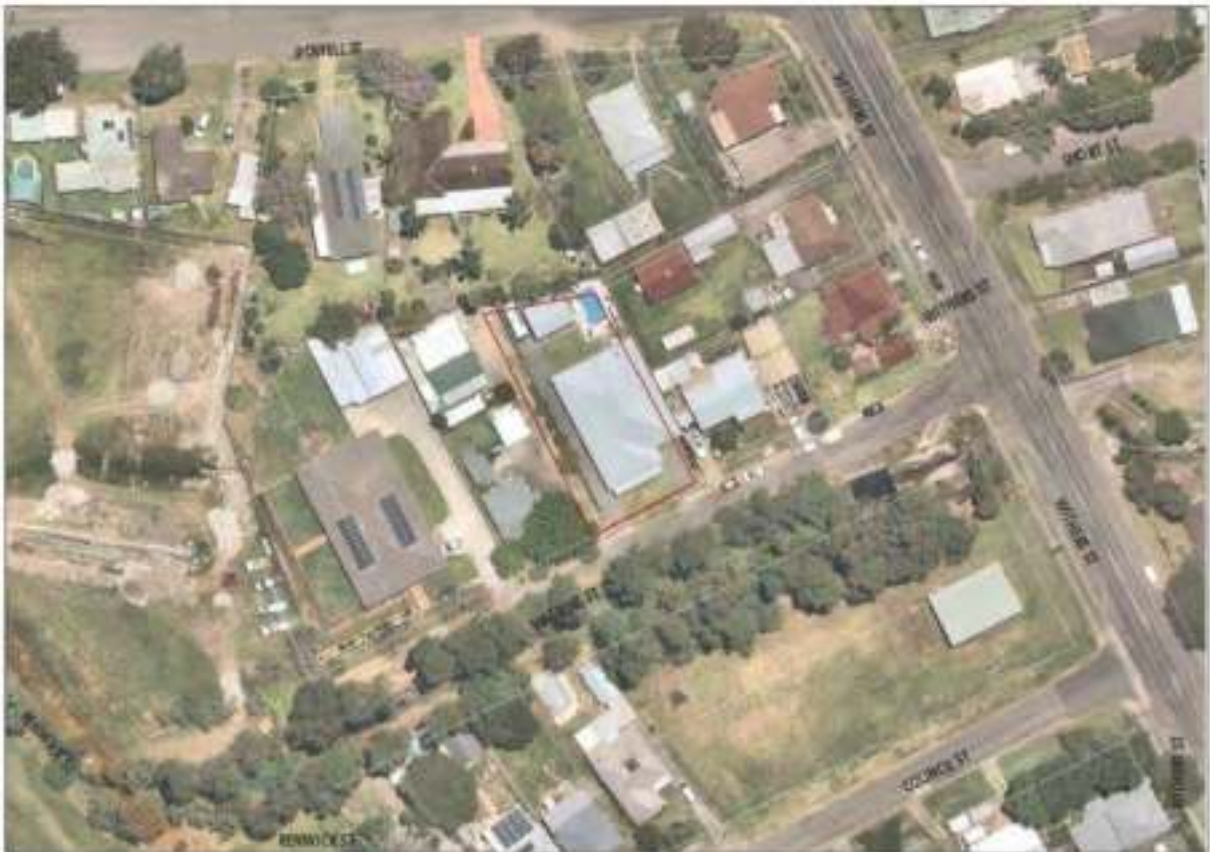
1 WATKINS STREET, WEST WALLSEND 2286		
Conservation Area Contribution Level	Est. Construction Date	Previous studies and/or community input
Non-Contributory	Mid to late 20 th century onwards	No prior heritage assessments or research undertaken.
Assessment Text		Observed Modifications
<p>The scale (e.g. double-storey or greater) and general style of the dwelling is inconsistent with that of the streetscape and wider HCA.</p> <p>The dwelling does not contribute positively to the streetscape and wider HCA, particularly in comparison to Contributory 1 and 2 buildings. The presence of the building has an adverse impact on the streetscape and/or wider HCA.</p> <p>The dwelling features inappropriately proportioned and positioned fenestrations, an inappropriate roof form (gabled or hipped) and/or other features that are inconsistent with the architectural character of the area (e.g. unsympathetic additions, inconsistent [contemporary] building materials, etc).</p>		No modifications observed.

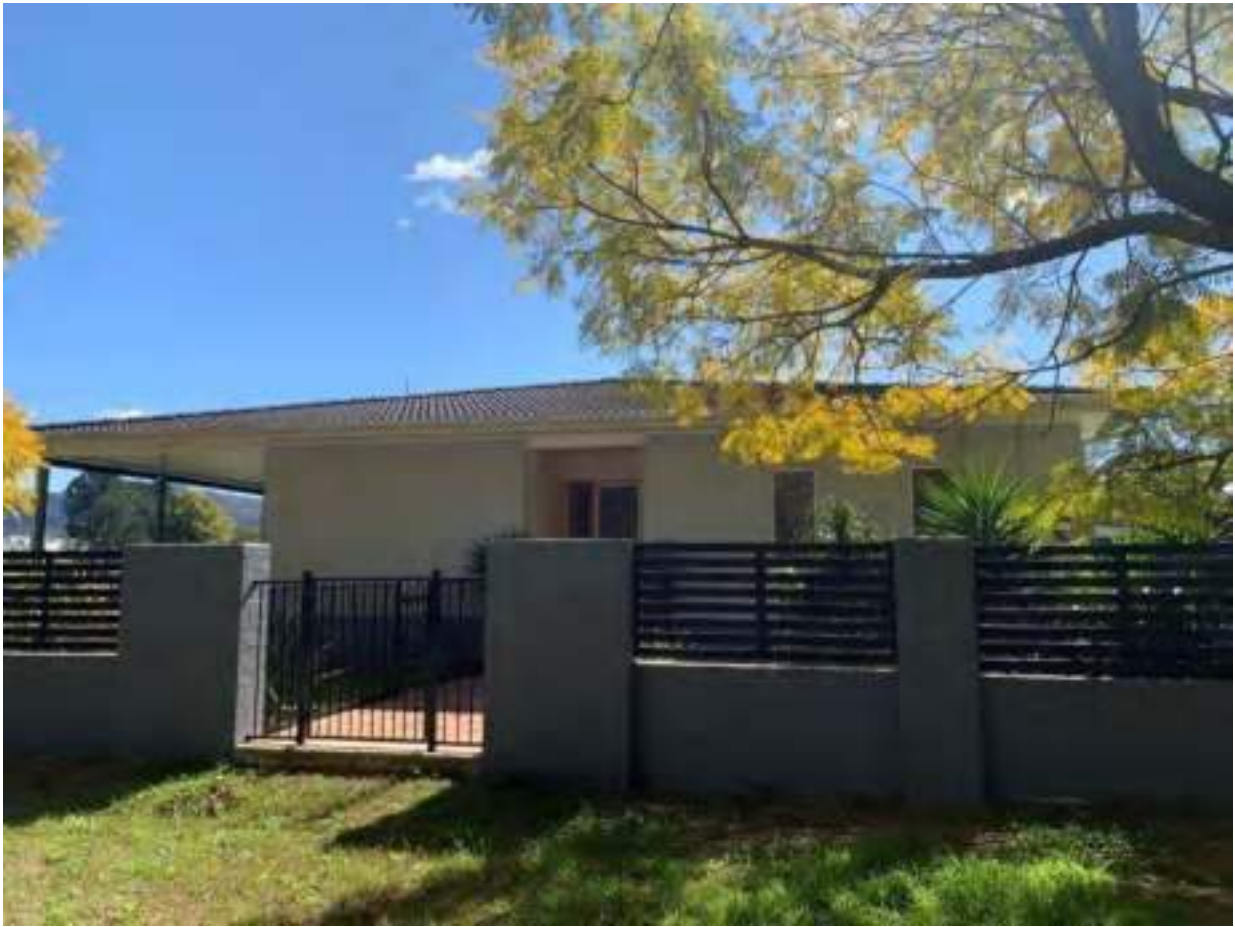
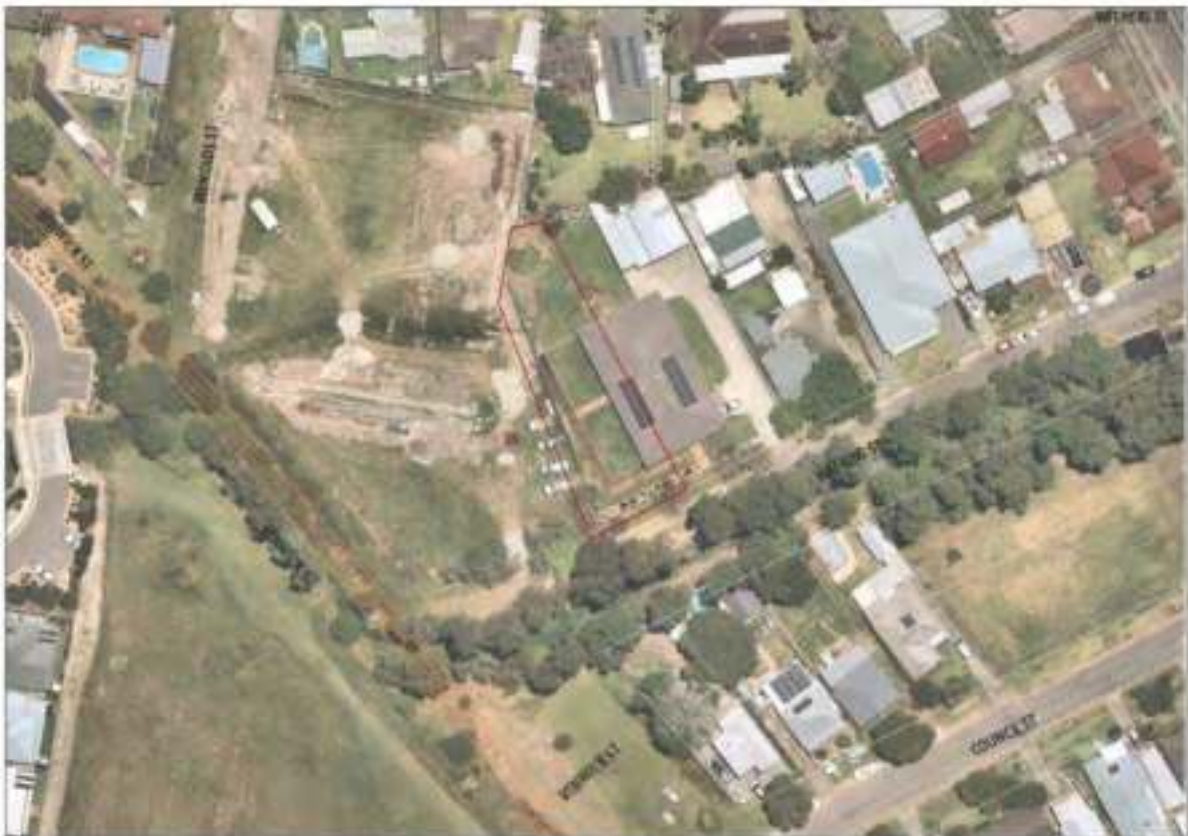
5 WATKINS STREET, WEST WALLSEND 2286

Conservation Area Contribution Level	Est. Construction Date	Previous studies and/or community input
Non-Contributory	Mid to late 20 th century onwards	No prior heritage assessments or research undertaken.
Assessment Text		Observed Modifications
<p>The scale (e.g. double-storey or greater) and general style of the dwelling is inconsistent with that of the streetscape and wider HCA.</p> <p>The dwelling does not contribute positively to the streetscape and wider HCA, particularly in comparison to Contributory 1 and 2 buildings. The presence of the building has an adverse impact on the streetscape and/or wider HCA.</p> <p>The dwelling features inappropriately proportioned and positioned fenestrations, an inappropriate roof form (gabled or hipped) and/or other features that are inconsistent with the architectural character of the area (e.g. unsympathetic additions, inconsistent [contemporary] building materials, etc).</p>		No modifications observed.

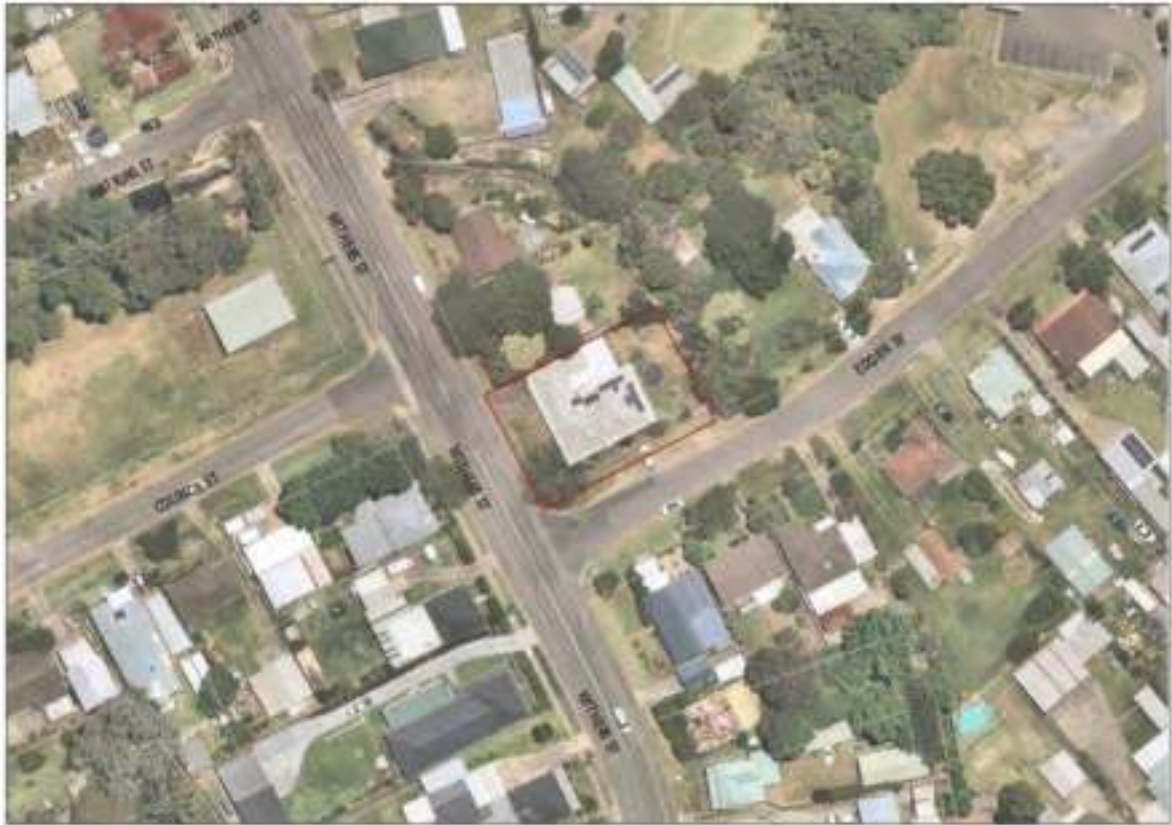
39 EDDEN STREET, WEST WALLSEND 2286

Conservation Area Contribution Level	Est. Construction Date	Previous studies and/or community input
Non-Contributory	Mid to late 20 th century onwards	No prior heritage assessments or research undertaken.
Assessment Text		Observed Modifications
<p>The scale (e.g. double-storey or greater) and general style of the dwelling is inconsistent with that of the streetscape and wider HCA.</p> <p>The dwelling does not contribute positively to the streetscape and wider HCA, particularly in comparison to Contributory 1 and 2 buildings. The presence of the building has an adverse impact on the streetscape and/or wider HCA.</p> <p>The dwelling features inappropriately proportioned and positioned fenestrations, an inappropriate roof form (gabled or hipped) and/or other features that are inconsistent with the architectural character of the area (e.g. unsympathetic additions, inconsistent [contemporary] building materials, etc).</p>		No modifications observed.

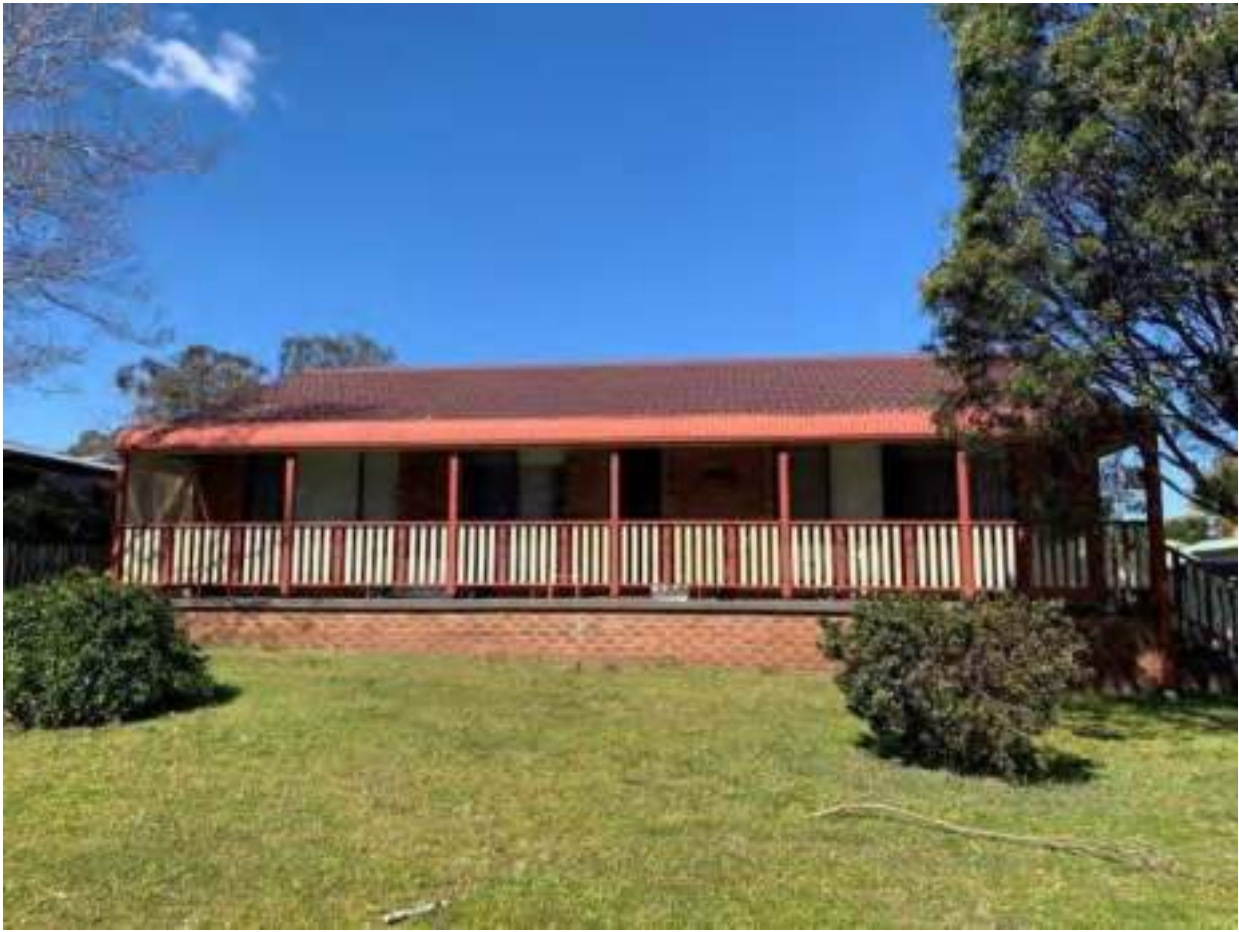
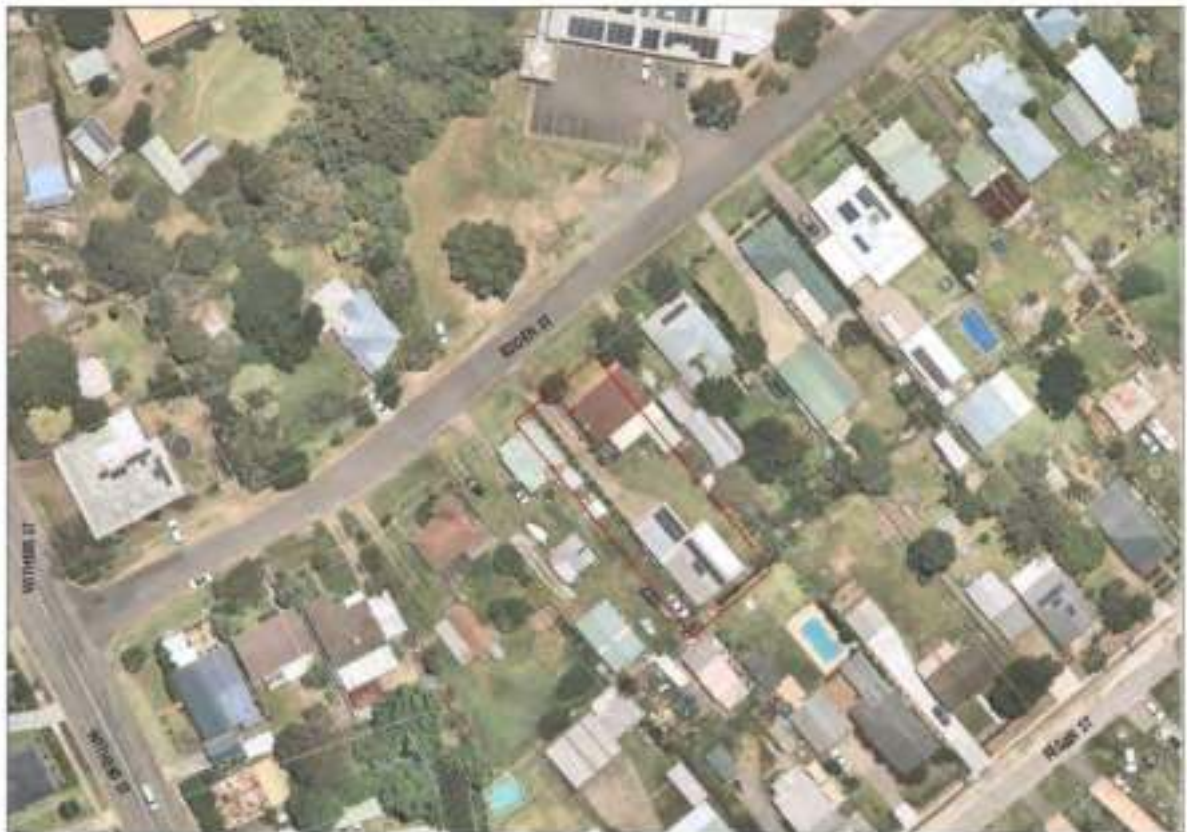
32 EDDEN STREET, WEST WALLSEND 2286		
Conservation Area Contribution Level	Est. Construction Date	Previous studies and/or community input
Non-Contributory	Mid to late 20 th century onwards	No prior heritage assessments or research undertaken.
Assessment Text		Observed Modifications
<p>The scale (e.g. double-storey or greater) and general style of the dwelling is inconsistent with that of the streetscape and wider HCA.</p> <p>The dwelling does not contribute positively to the streetscape and wider HCA, particularly in comparison to Contributory 1 and 2 buildings. The presence of the building has an adverse impact on the streetscape and/or wider HCA.</p> <p>The dwelling features inappropriately proportioned and positioned fenestrations, an inappropriate roof form (gabled or hipped) and/or other features that are inconsistent with the architectural character of the area (e.g. unsympathetic additions, inconsistent [contemporary] building materials, etc).</p>		<p>The timber balustrade and bull nosed veranda roof are both contemporary additions to the dwelling.</p>

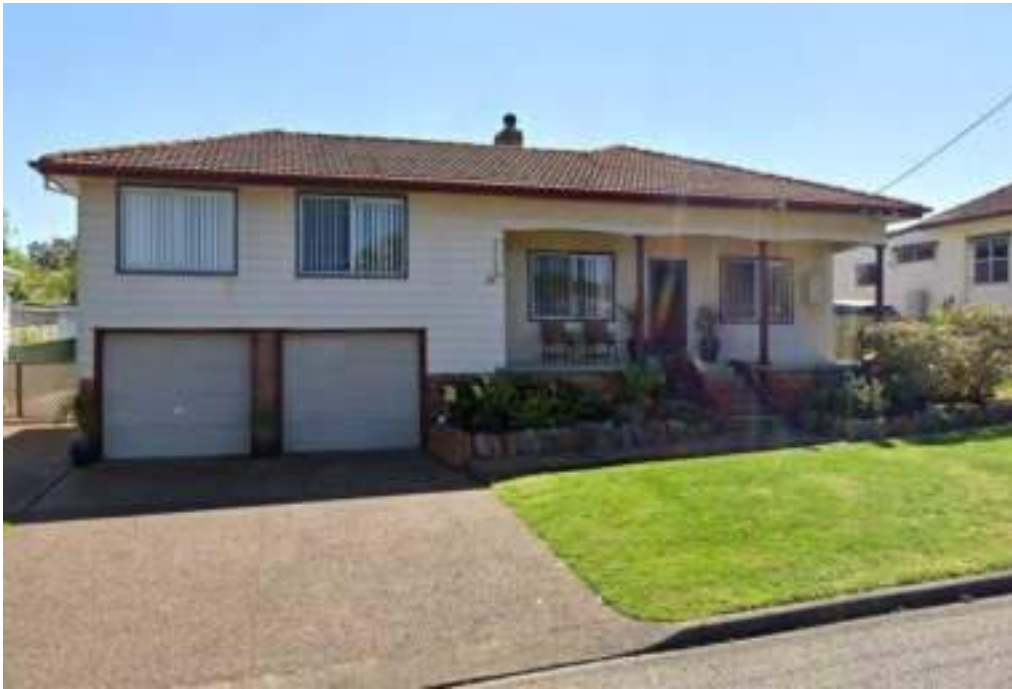
23 WALLACE STREET, WEST WALLSEND 2286

Conservation Area Contribution Level	Est. Construction Date	Previous studies and/or community input
Non-Contributory	Mid to late 20 th century onwards	No prior heritage assessments or research undertaken.
Assessment Text		Observed Modifications
<p>The scale (e.g. double-storey or greater) and general style of the dwelling is inconsistent with that of the streetscape and wider HCA.</p> <p>The dwelling does not contribute positively to the streetscape and wider HCA, particularly in comparison to Contributory 1 and 2 buildings. The presence of the building has an adverse impact on the streetscape and/or wider HCA.</p> <p>The dwelling features inappropriately proportioned and positioned fenestrations, an inappropriate roof form (gabled or hipped) and/or other features that are inconsistent with the architectural character of the area (e.g. unsympathetic additions, inconsistent [contemporary] building materials, etc).</p>		<p>No modifications observed. Split level with double garage incorporated to principal façade.</p>

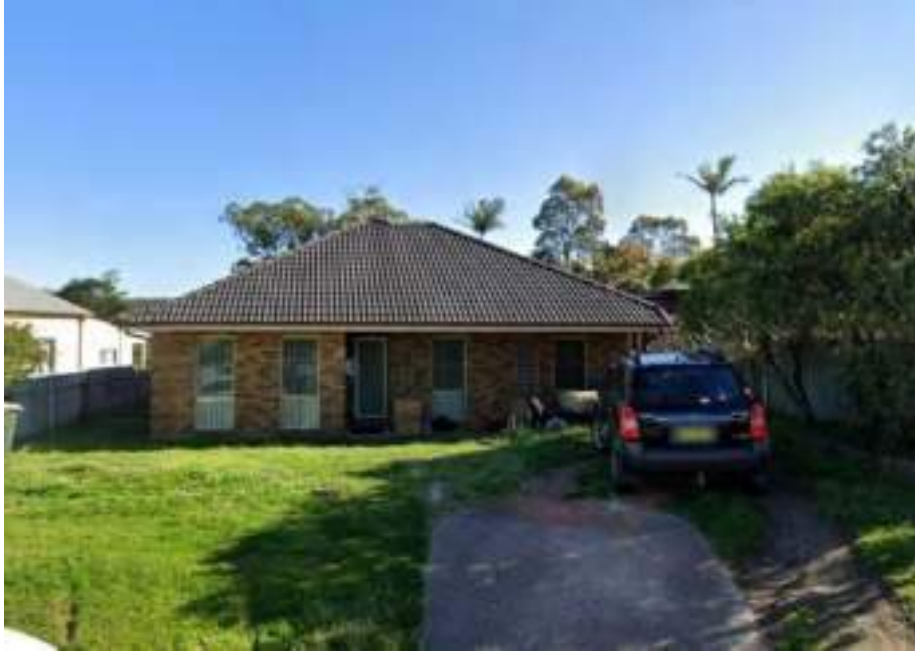
25 CARRINGTON STREET, WEST WALLSEND 2286

Conservation Area Contribution Level	Est. Construction Date	Previous studies and/or community input
Non-Contributory	Mid to late 20 th century onwards	No prior heritage assessments or research undertaken.
Assessment Text		Observed Modifications
<p>The scale (e.g. double-storey or greater) and general style of the dwelling is inconsistent with that of the streetscape and wider HCA.</p> <p>The dwelling does not contribute positively to the streetscape and wider HCA, particularly in comparison to Contributory 1 and 2 buildings. The presence of the building has an adverse impact on the streetscape and/or wider HCA.</p> <p>The dwelling features inappropriately proportioned and positioned fenestrations, an inappropriate roof form (gabled or hipped) and/or other features that are inconsistent with the architectural character of the area (e.g. unsympathetic additions, inconsistent [contemporary] building materials, etc).</p>		<p>No modifications observed. Contemporary single storey brick dwelling.</p>

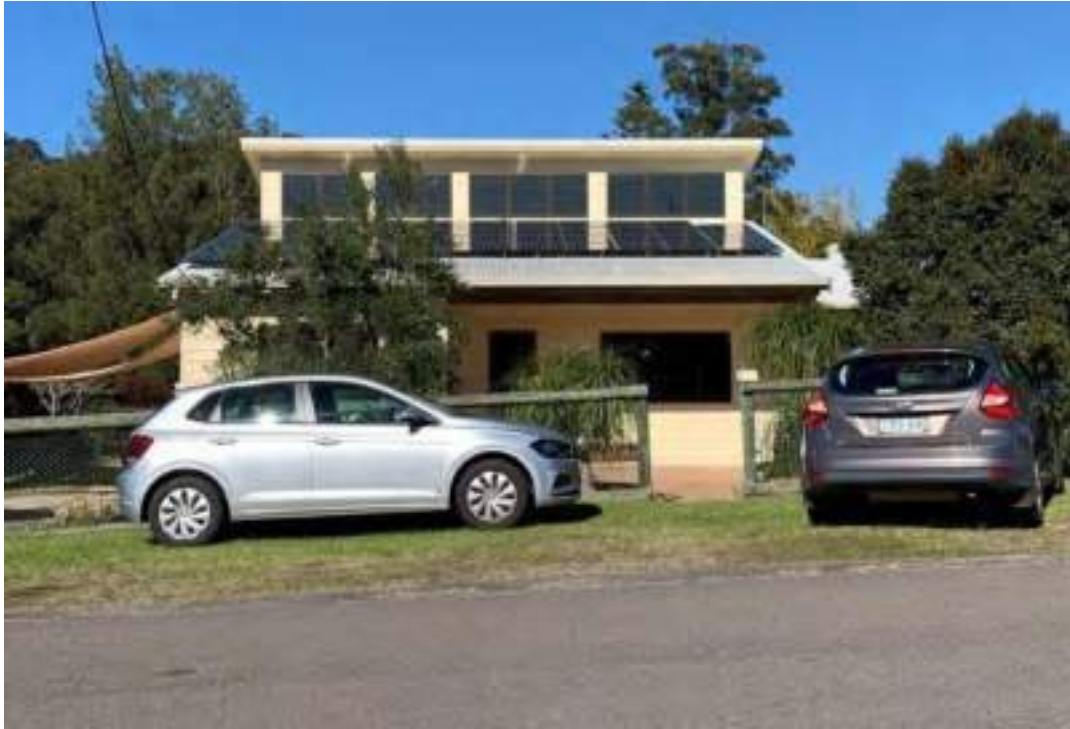
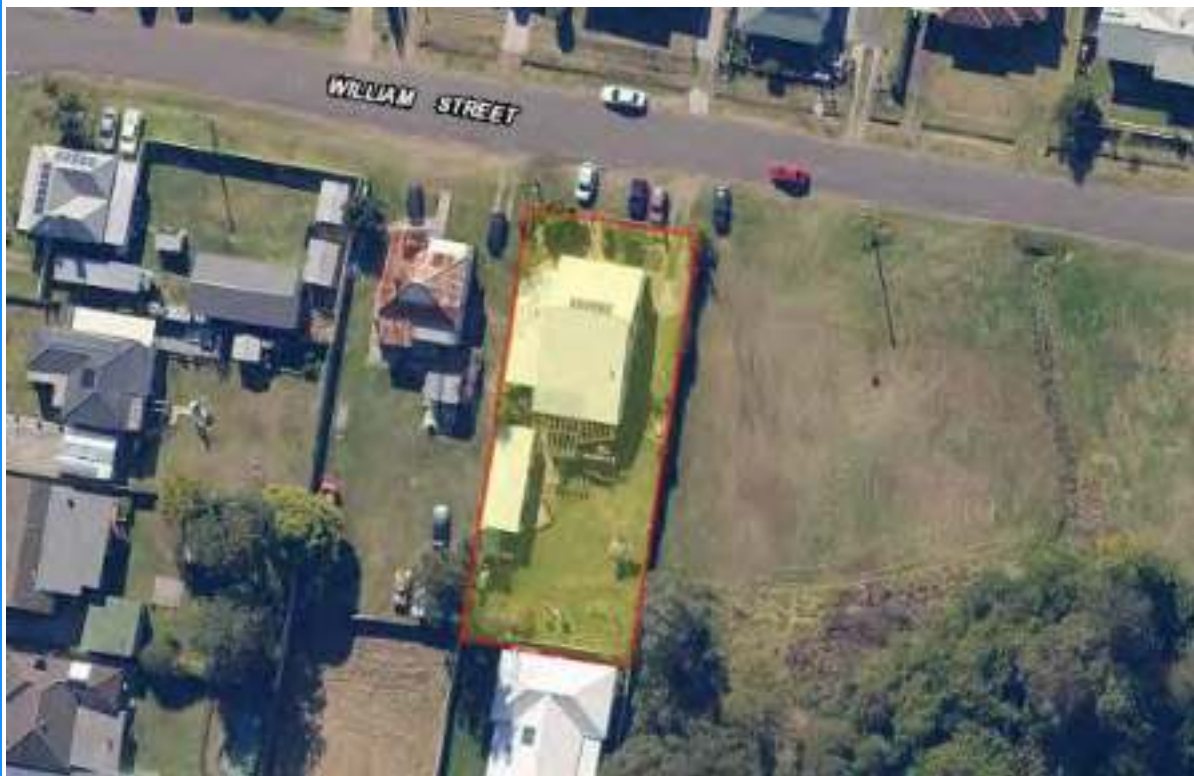
18 WILLIAM STREET, HOLMESVILLE 2286

Conservation Area Contribution Level	Est. Construction Date	Previous studies and/or community input
Non-Contributory	Mid to late 20 th century onwards	No prior heritage assessments or additional research undertaken.
Assessment Text		Observed Modifications
<p>The scale (e.g. double-storey or greater) and general style of the dwelling is inconsistent with that of the streetscape and wider HCA.</p> <p>The dwelling does not contribute positively to the streetscape and wider HCA, particularly in comparison to Contributory 1 and 2 buildings. The presence of the building has an adverse impact on the streetscape and/or wider HCA.</p> <p>The dwelling features inappropriately proportioned and positioned fenestrations, an inappropriate roof form (gabled or hipped) and/or other features that are inconsistent with the architectural character of the area (e.g. unsympathetic additions, inconsistent [contemporary] building materials, etc).</p>		Solar panels have been installed along the northern portion of the roof.
