Combined Preliminary & Detailed Site Investigation Report

1 Progress Road, Mount Hutton, NSW 2290

Report No. 65042

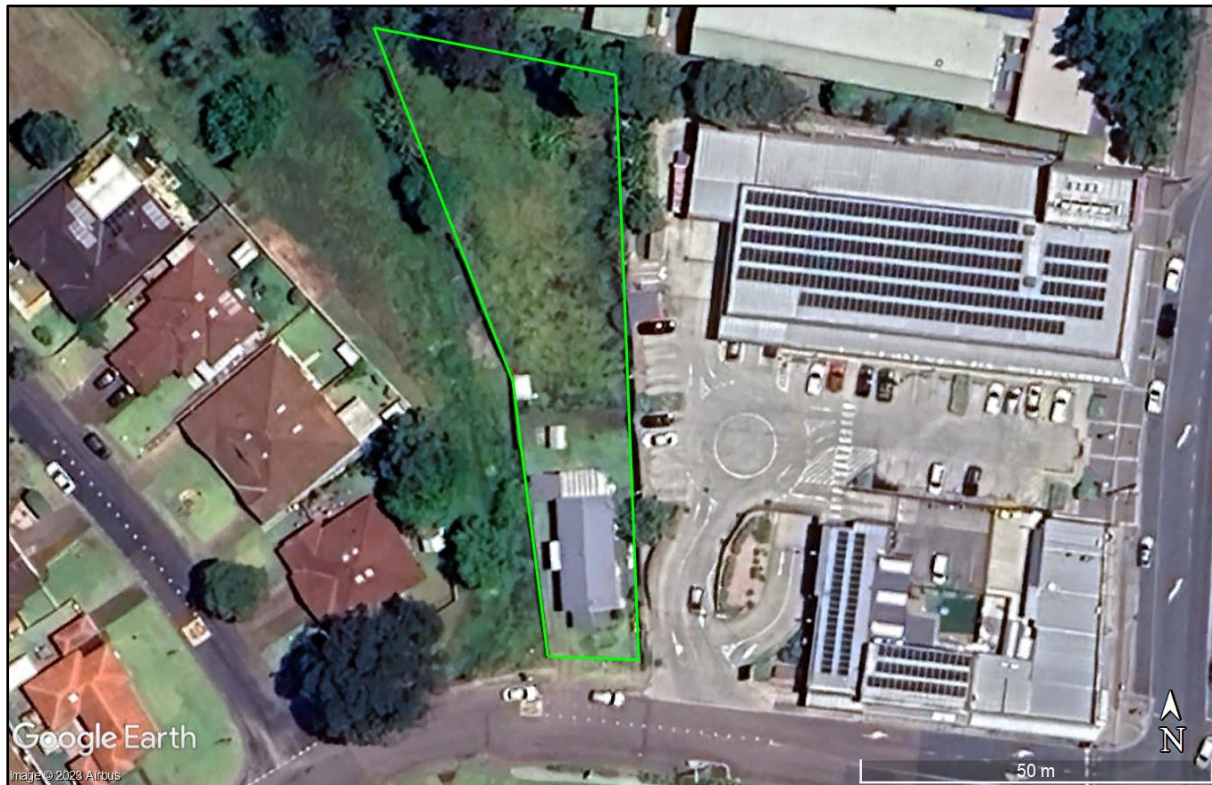
Figure 1. Site boundary highlighted green. [Google Earth](#) dated 12/2022.

- i. The Site is located in Mount Hutton, a suburb approximately 12 geodesic kilometers south-east of Newcastle ([Appendix C](#), Figure 1c).
- ii. The Site perimeter is rectangularly shaped and about 92 m long. The south end is ~ 13 m wide and starts to widen near the middle and ends at its widest (~ 32 m) at the north (Figure 1; [Appendix C](#), Figures 1.1c).

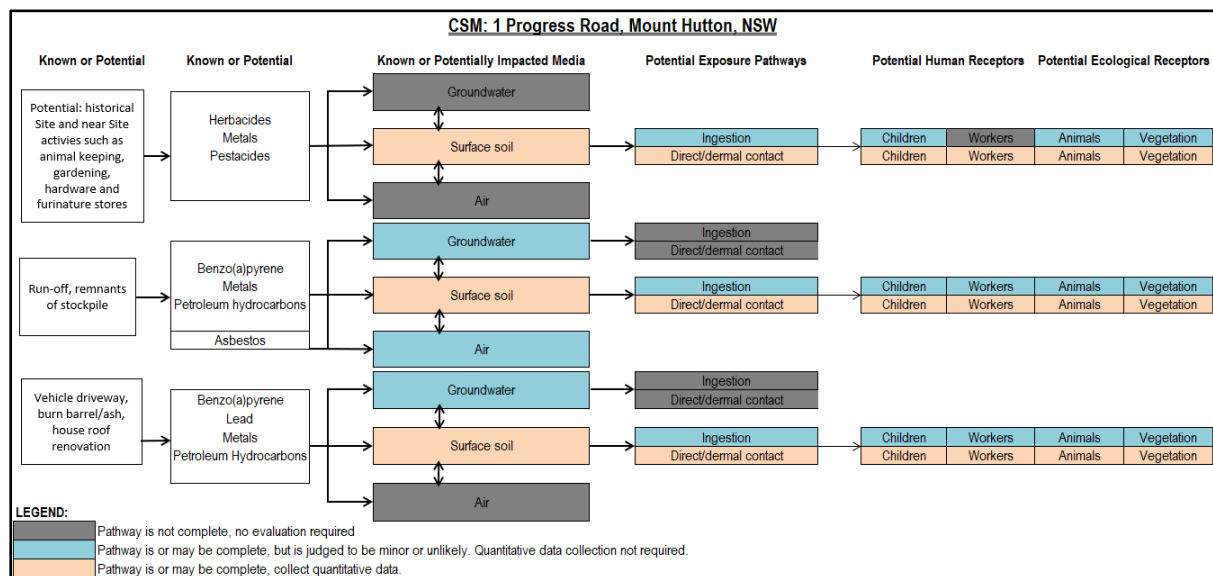
Figure 3. A visual representation of the Site Conceptual Site Model (CSM).

CSM	Description
Potential Primary Sources of Contamination	1. Rusted metal burn barrel with charcoal/charred material 2. Historic commercial and agricultural activities on and around the Site 3. Unsealed driveway 4. Eastern boundary wall drainage system 5. Possible remnants of asbestos-containing stockpile 6. Roof renovation
Potential Secondary Sources of Contamination	7. Adjacent Local Centre carpark 8. Ashes in soil around the garden area's top soil 9. Driveway
Potential Media Affected	10. Soil (charcoal layer, potential asbestos remnants, contaminants from driveway) 11. Groundwater (due to proximity to Scrubby Creek and drainage system)
Potential Transport Mechanisms	12. Surface runoff 13. Wind (especially for asbestos)
Potential Exposure Routes	14. Inhalation of airborne contaminants (especially asbestos) 15. Direct contact with soil 16. Ingestion from soil/plants
Potential Receptors	17. Humans (residents, visitors, workers) 18. Local fauna and flora

Potential Exposure Pathways	19. Soil to human (e.g., during construction work, gardening, etc.) 20. Soil to plants to human 21. Airborne contaminants to human (especially asbestos inhalation).

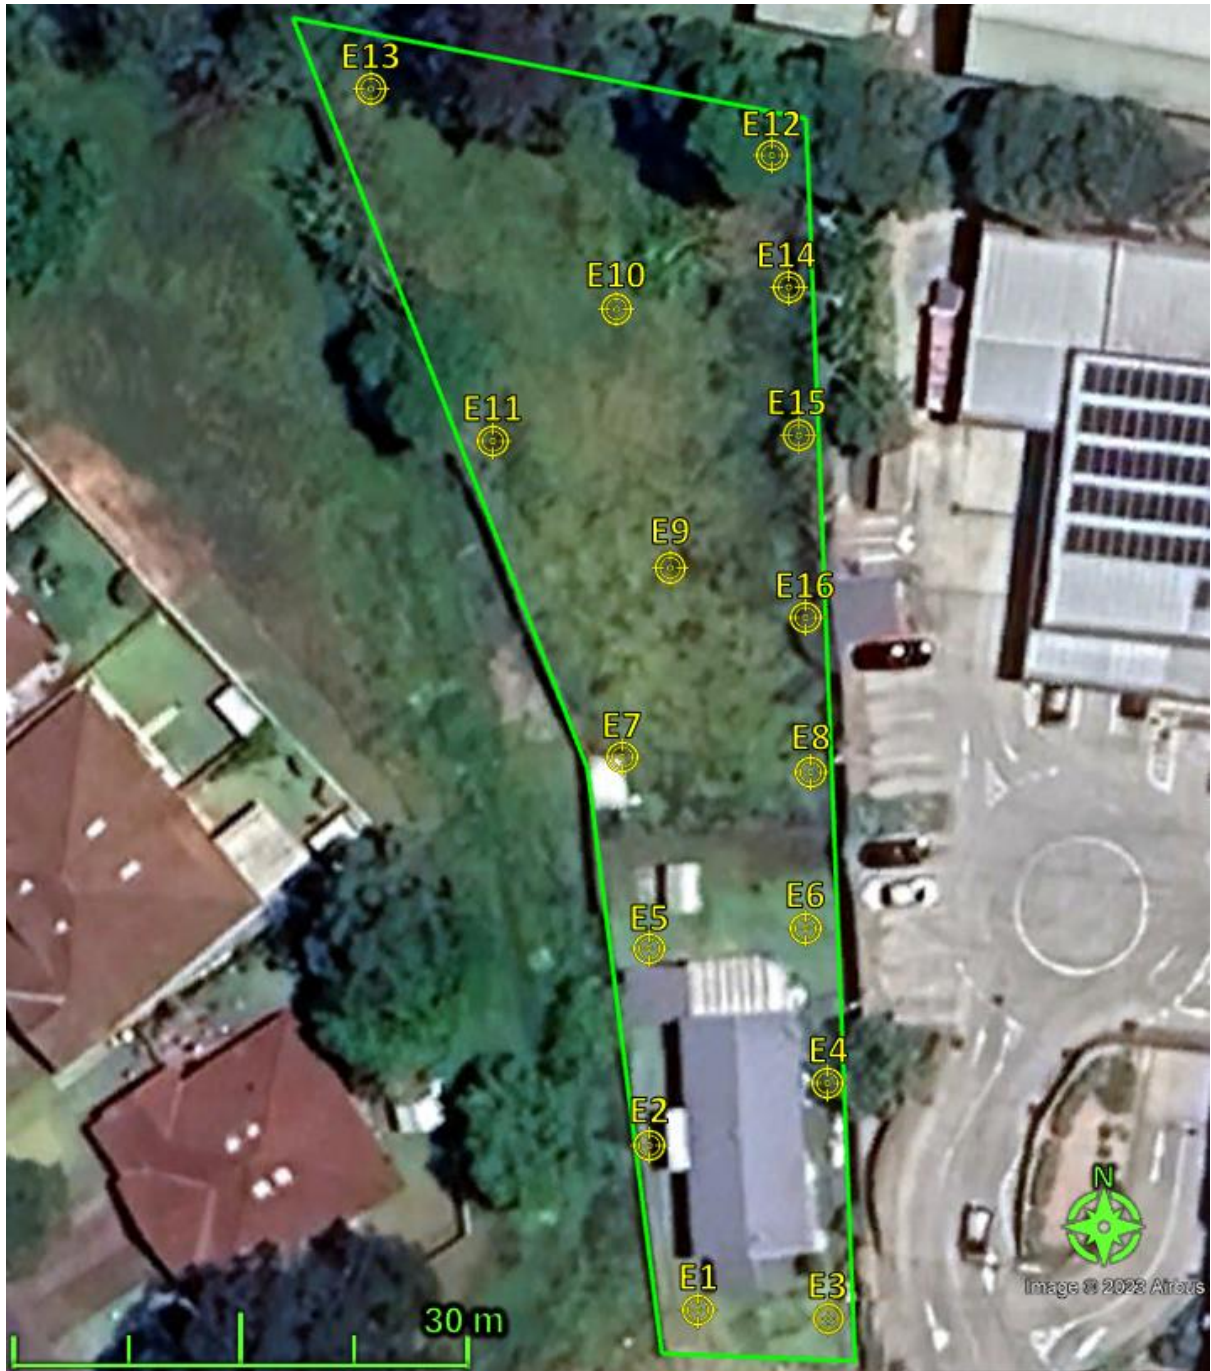
Figure 4. All 16 sampling locations. Each location is indicated by a yellow target under a yellow alphanumeric label. QA samples were from E9 and E10.

Table. Sample ID and depth. See Figure 4 for sampling locations.

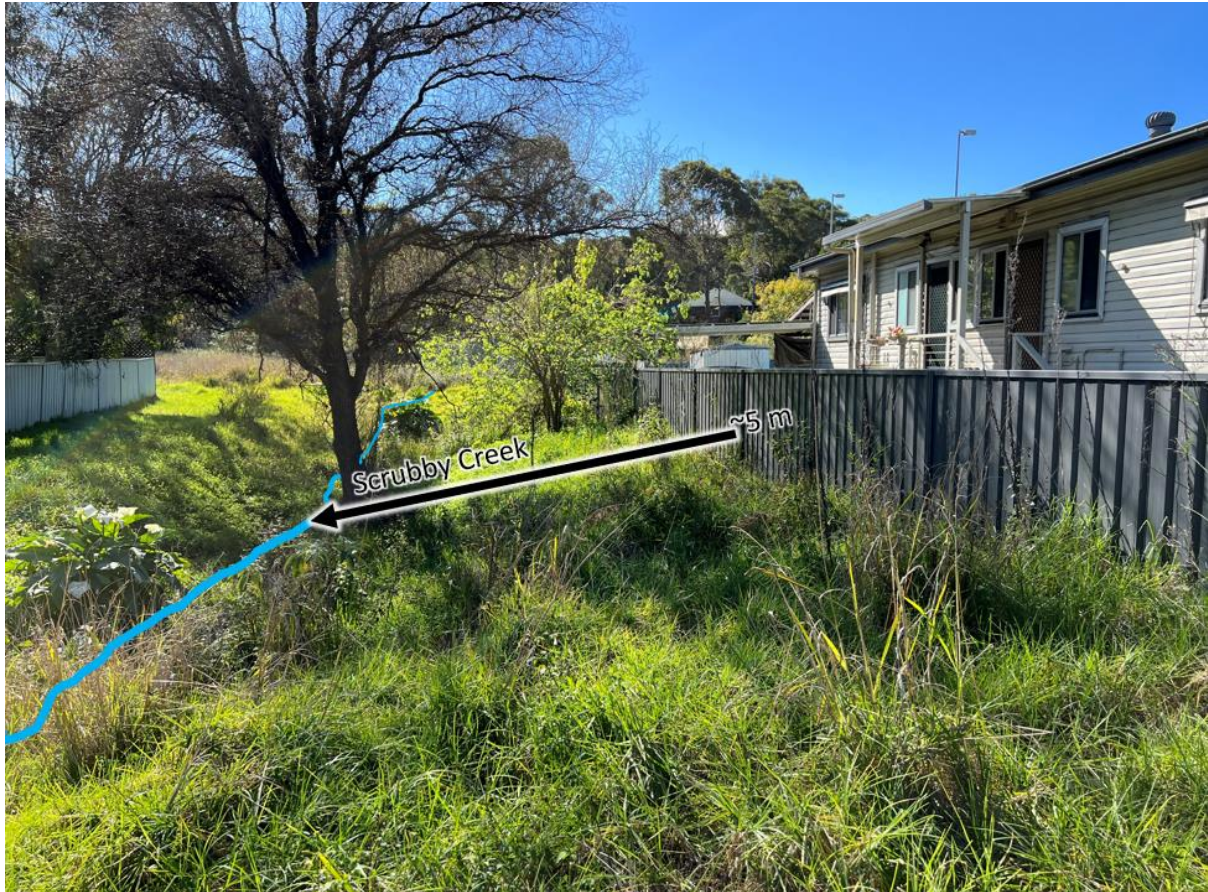
Figure 2c. Scrubby Creek. Photo edited to emphasise location of creek bed and average distance from the subject Site's boundary.

- vi. Scrubby Creek lies approximately just 3 to 5 m west of the Site's western boundary fence ([Appendix C](#), Figure 2c).
- vii. The eastern boundary is enclosed by a concrete wall (~2.5 m) that has an exposed plumbing/drainage system, presumably for routing run-off from the next-door Local Centre carpark ([Appendix C](#), Figure 3c).

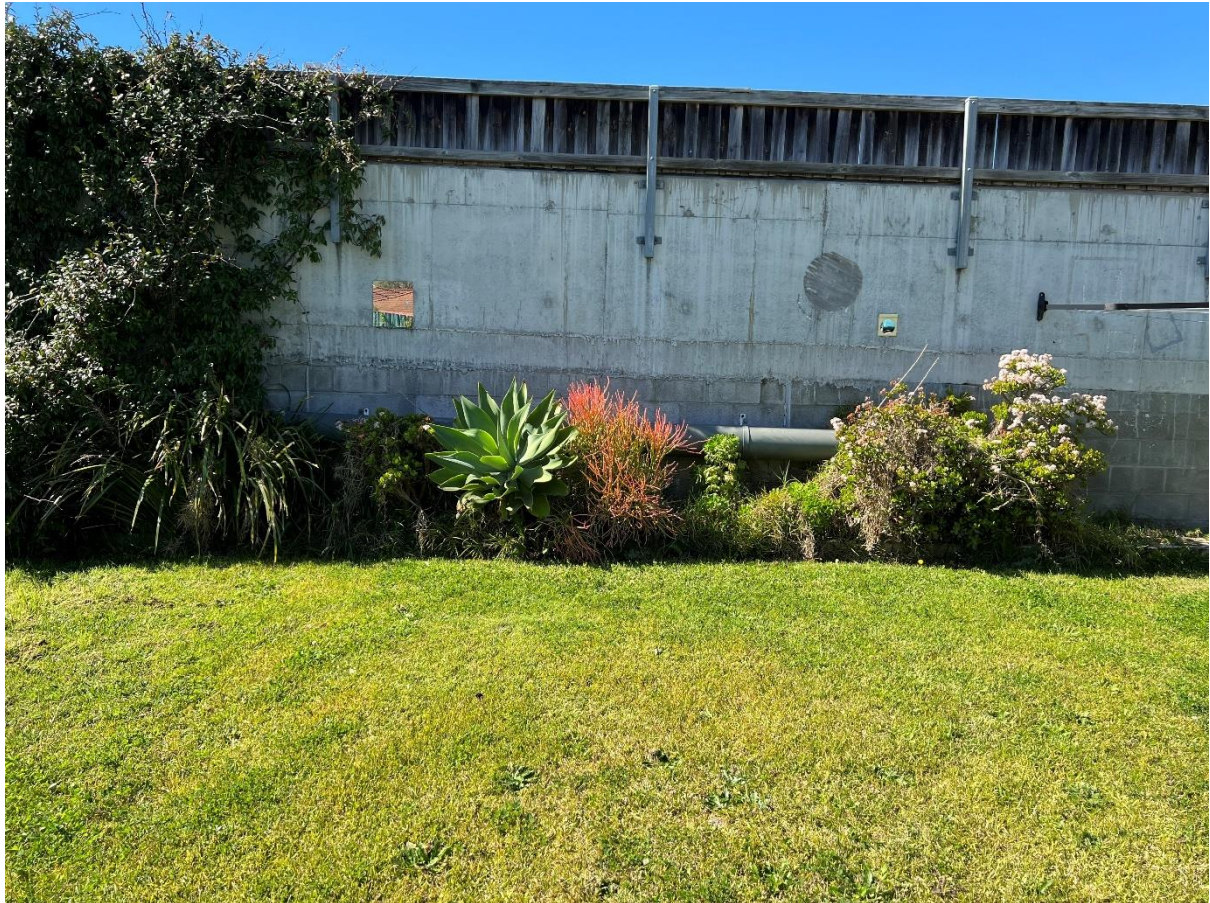
Figure 3c. Eastern boundary wall with a pipe, as seen from the southern portion of the Site. Photo taken 17 Aug 2023.

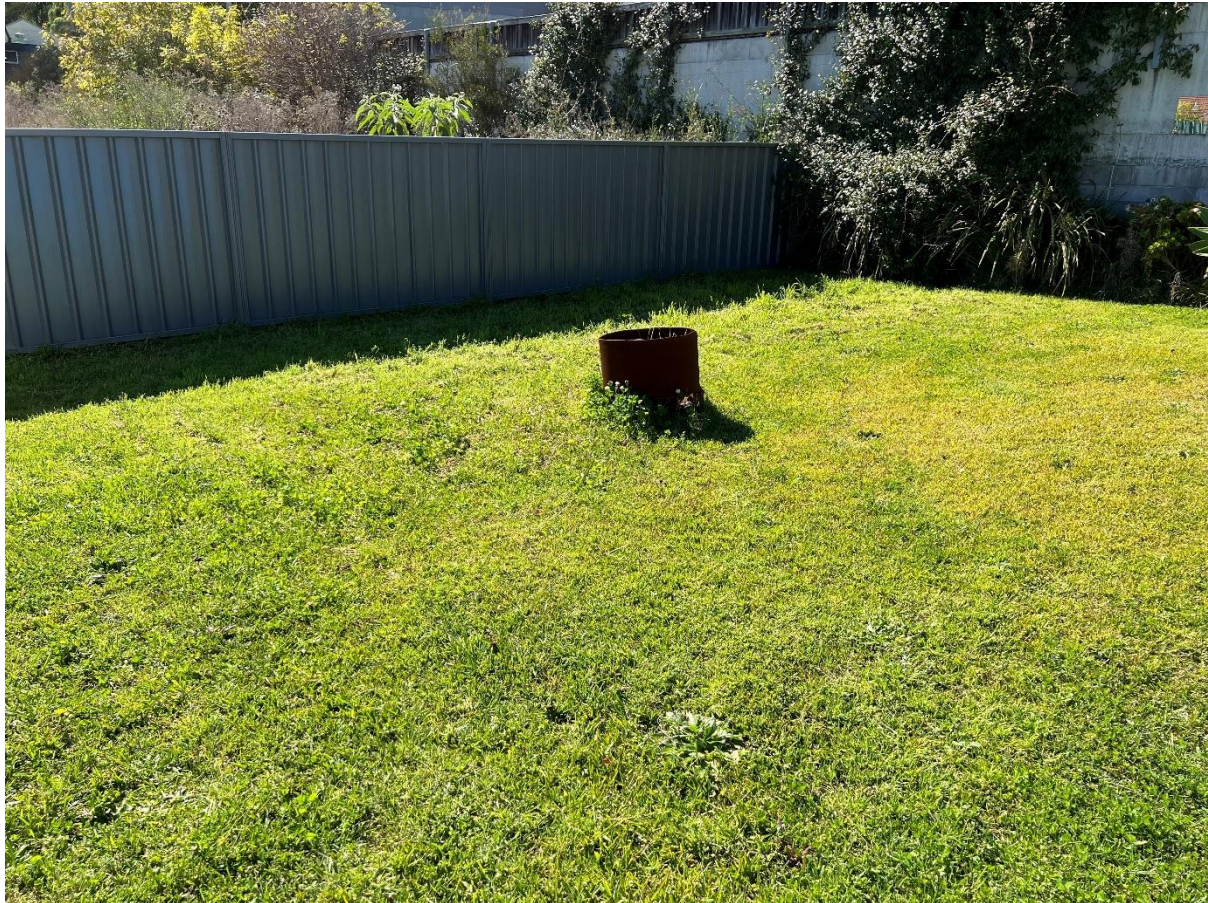
Figure 4c. A metal fence bisecting the Site and a burn barrel in south end of the Site. Photo taken 17 Aug 2023.

- viii. The southern portion of the Site is well maintained and in good aesthetic condition.
- ix. A metal fencing bisects the middle of the Site ([Appendix C](#), Figure 4c).

- xii. A rusted metal burn barrel was observed containing 300 – 400 mm of charcoal/charred material ([Appendix C](#), Figure 4c).
- xiii. A single residential 1-storey brick and wood house with an above-ground brick foundation is the only fixed structure on the Site. The house is approximately 8 meters back from Progress Road. It is estimated to have been built in the early 1960s.

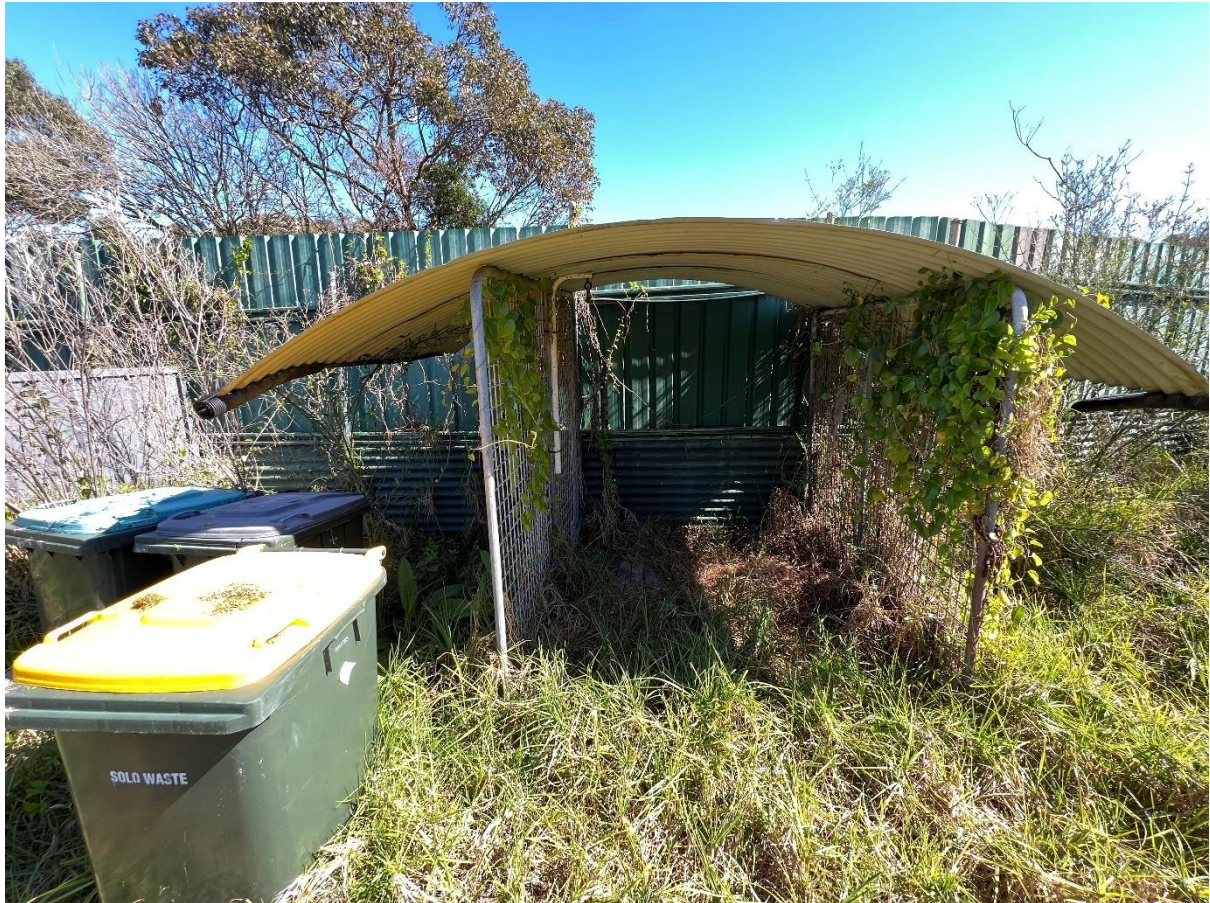
Figure 5c. A possible makeshift storage area near the bisecting fence on the north side. Photo taken 17 Aug 2023.

- xi. The north end is mostly empty, except for a few empty bins and some free-standing fence sections that appeared to be configured as a makeshift storage area (but storing nothing at the time of the visit ([Appendix C](#), Figure 5c).

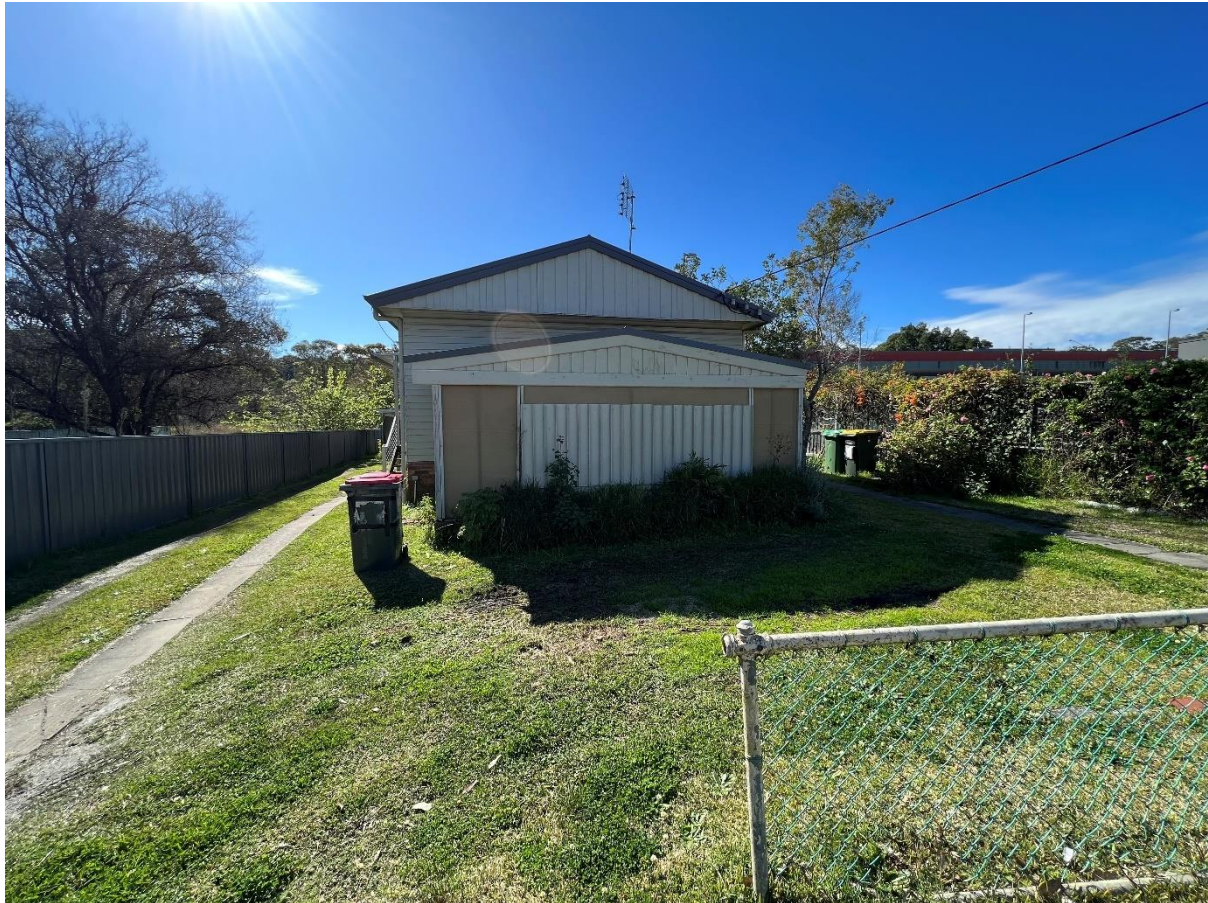
Figure 6c. Street side view, facing north, of the main structure currently on the Site. Two concrete paths on either side of the house and an old chain link fence can also be seen. Photo taken 17 Aug 2023.

- v. The Site's frontage (south) is adjacent to Progress Road and partially delineated with a small section of old chain-link fencing ([Appendix C](#), Figure 6c).

- xiv. The house appeared to use electricity for its HVAC system.
- xv. There was no paved-drive way on the Site, however, a narrow concrete walkway exists on either side of the house ([Appendix C](#), Figure 6c).

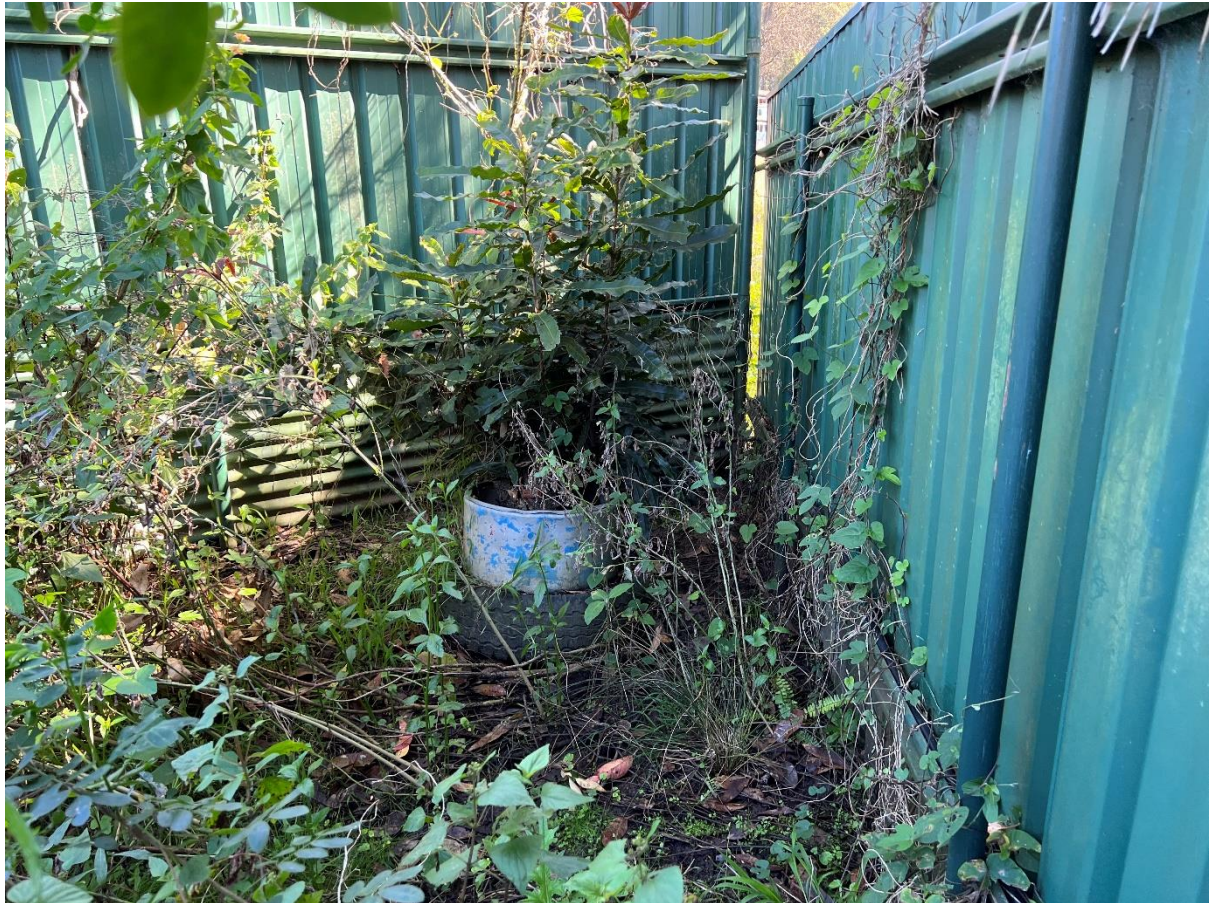
Figure 7c. NW corner featuring a tyre-drum-pot. Photo taken 17 Aug 2023.

- xvi. At the north-western corner there was a young banksia tree growing out of a makeshift plant pot constructed from a half barrel drum wedged into an old tyre ([Appendix C](#), Figure 7c)

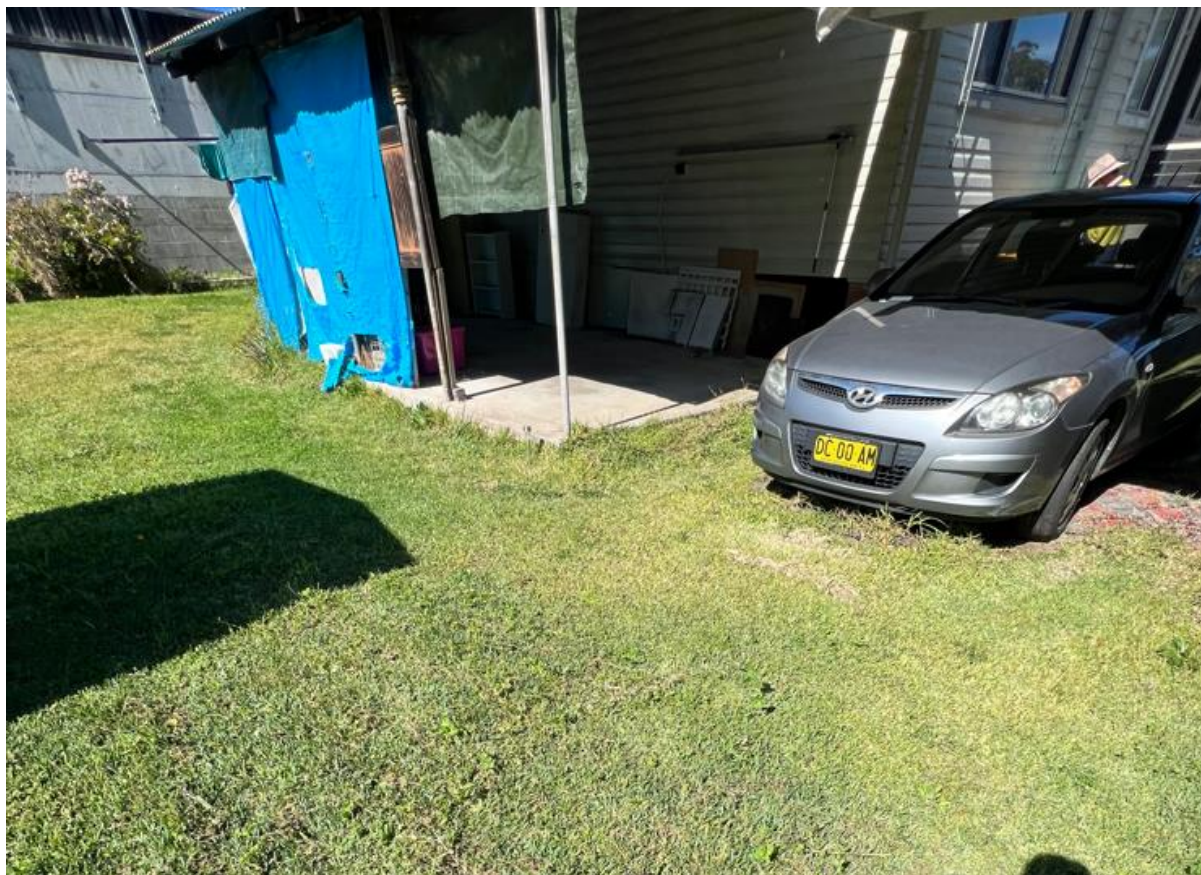
Figure 8c. A covered carport next to main structure. Photo taken 17 Aug 2023.

- xvii. A covered carport was actively being used for parking on the western side of the house ([Appendix C](#), Figure 8c).
- xviii. No significant bare patches of soil are present and around 90% of the ground is covered in grass and/or other vegetation.

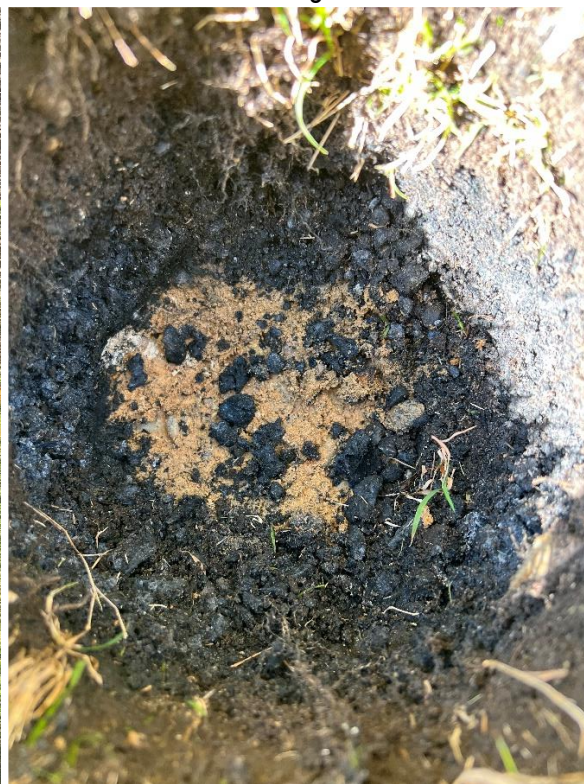
Figure 10c. Surface sample taken from eastern side of the house on the south end of the lot appeared to contain a layer of charcoal. A lighter coloured clayey sandstone material can be seen in the centre. Photo taken 17 Aug 2023.

- xx. Soil from the south, on the eastern side of the house, appeared to contain a layer of charcoal in the 100 mm soil, possibly from ashes spread onto the garden from the burn barrel ([Appendix C](#), Figure 9c).

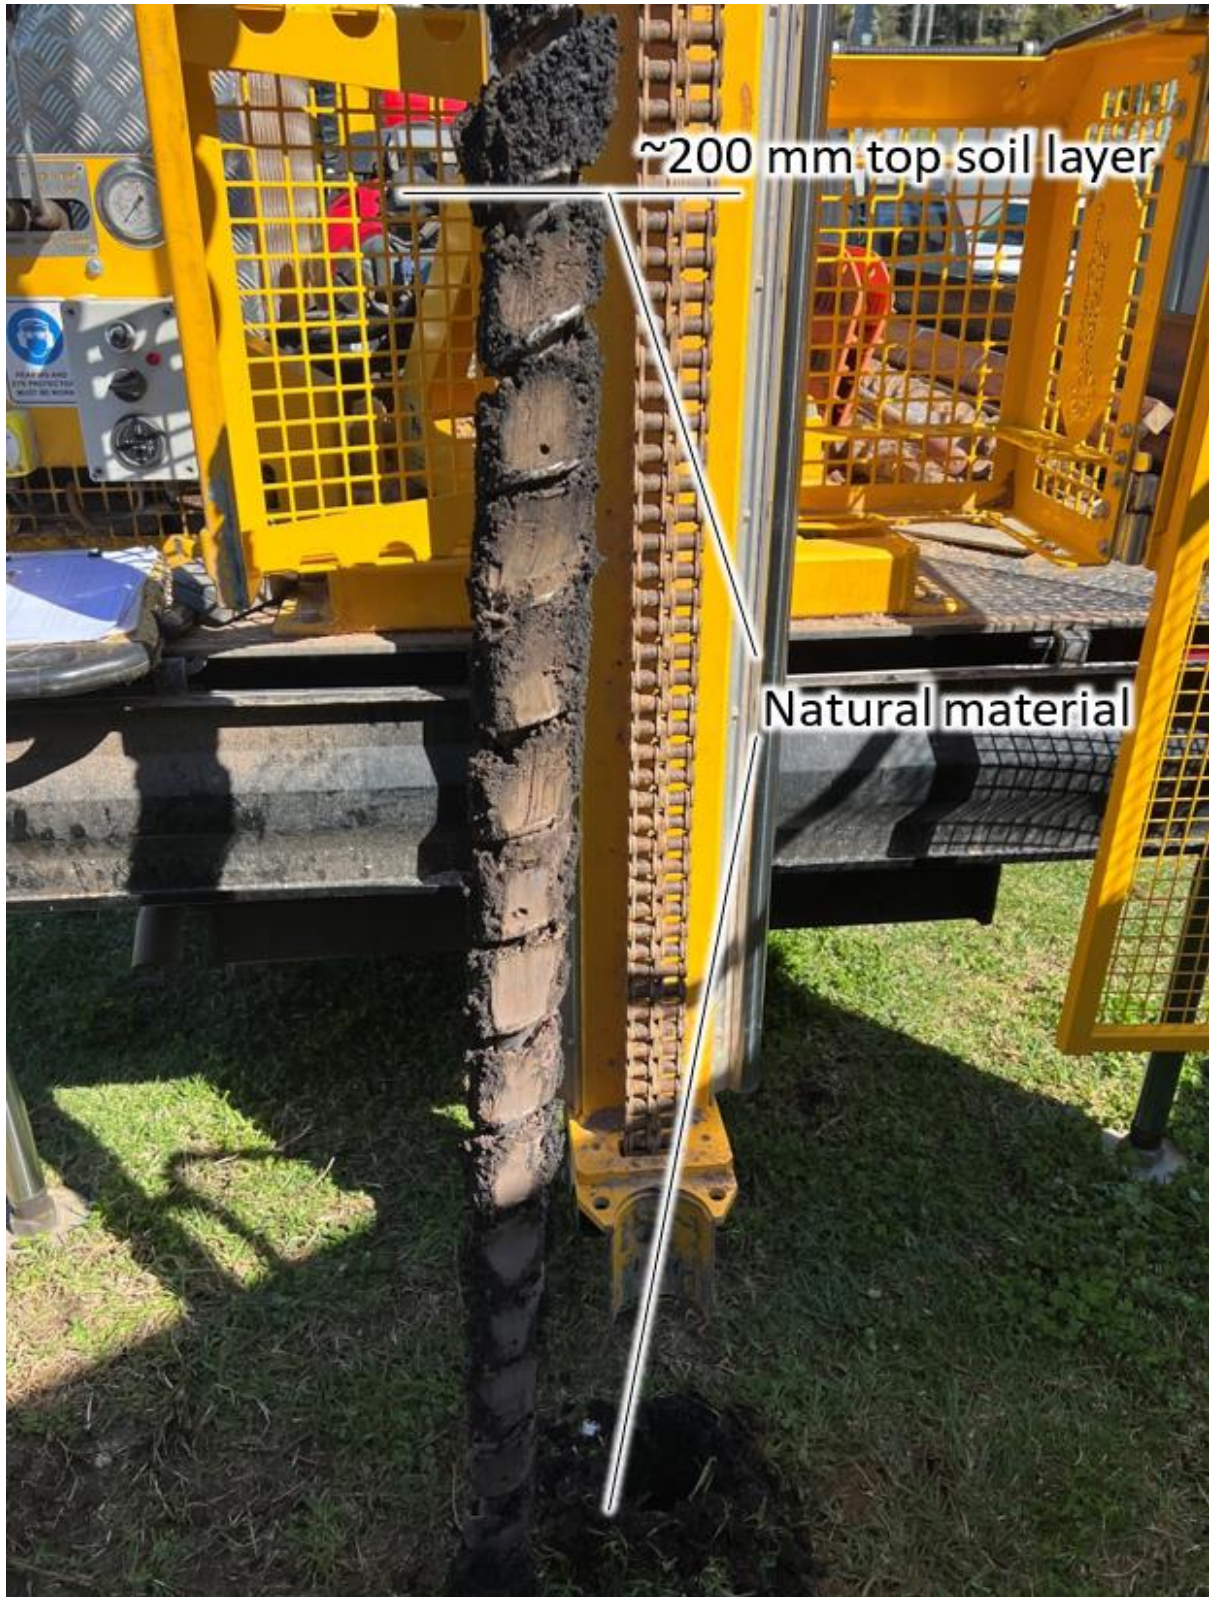
Figure 10c. A ~4 m bore sample, showing ~200 mm of top soil and natural silty clay below that. Sample obtained from the south west corner of the Site. Photo taken 17 Aug 2023.

Site Soil Characteristics: Surface soil samples taken from the Site at a surface depth of ranging from 50 to 150 mm found soil that appeared as brownish sandy loam with traces of gravel, overall consistent with natural material. A soil core indicated that clay was present at depths greater than 200 mm ([Appendix C](#), Figures 10c and 11c).

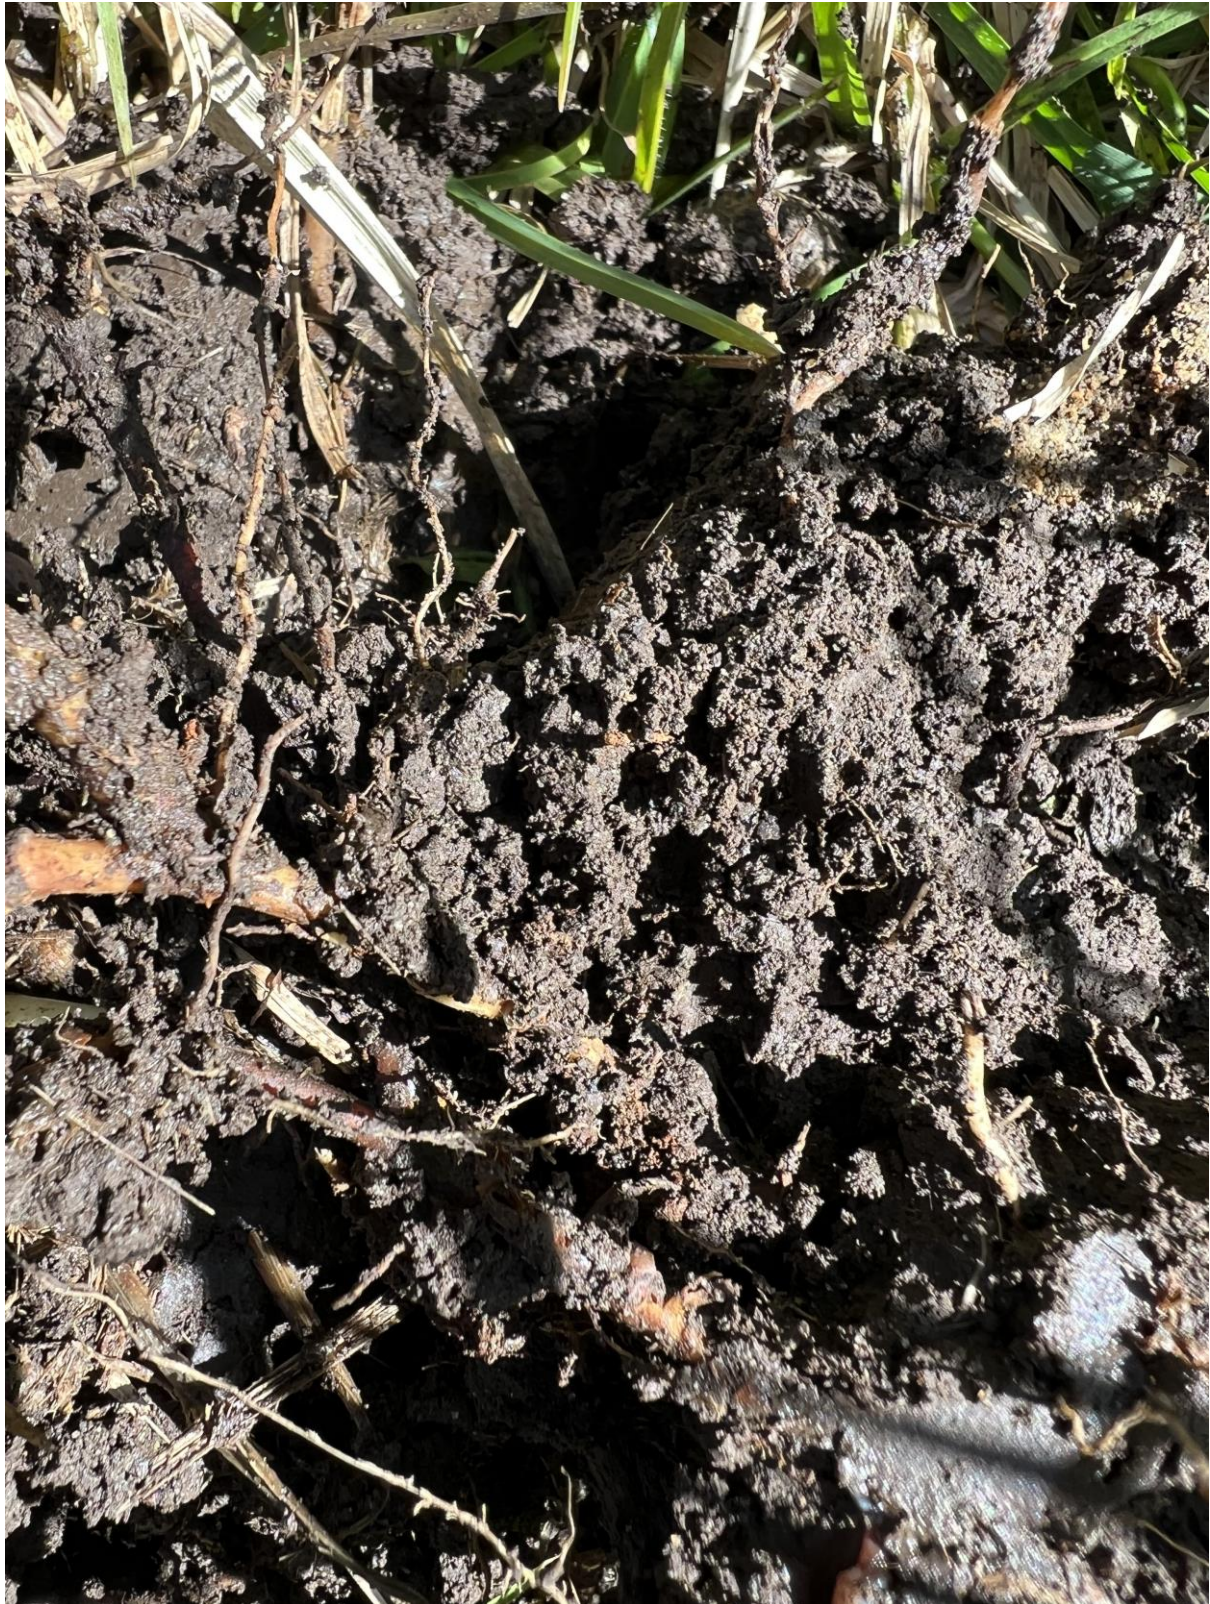
Figure 11c. An example of surface soil found across the Site. From sampling location E5. Photo taken 17 Aug 2023.
