# Redhead Beach vegetation and dune management technical advice

WRL TR 2025/17, September 2025

By V M Miller and J T Carley

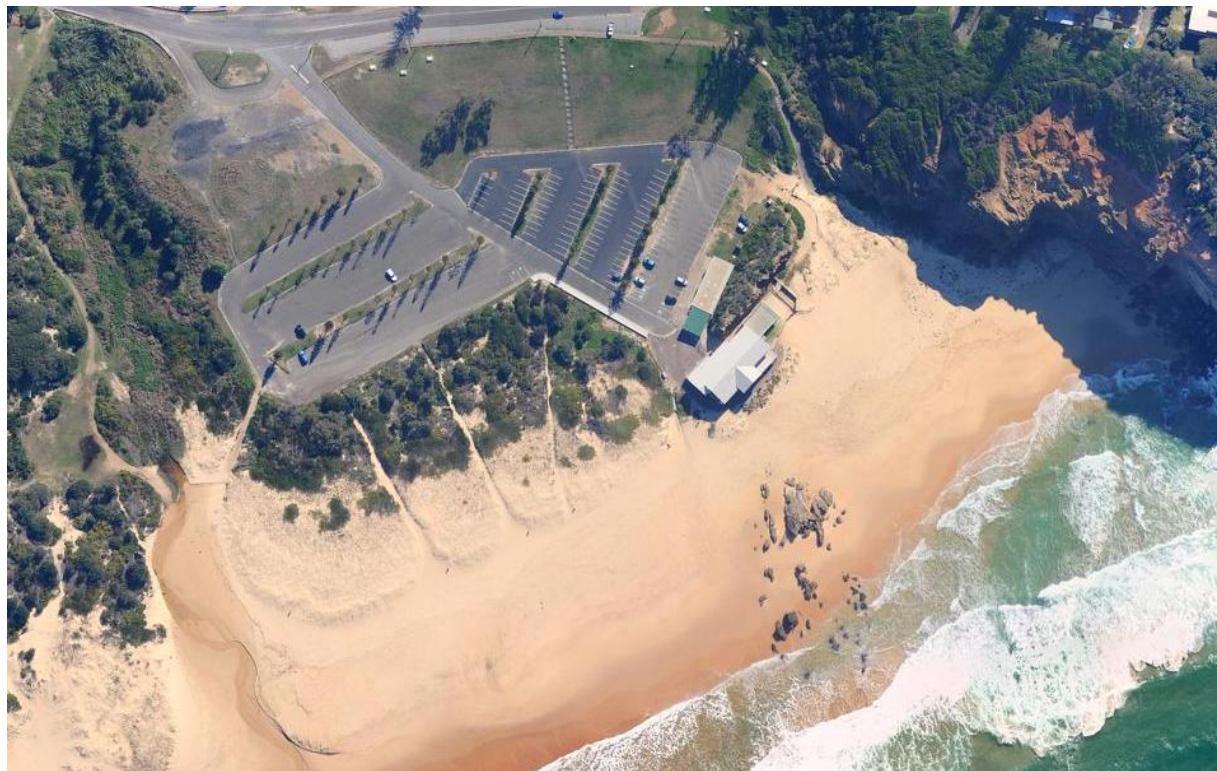
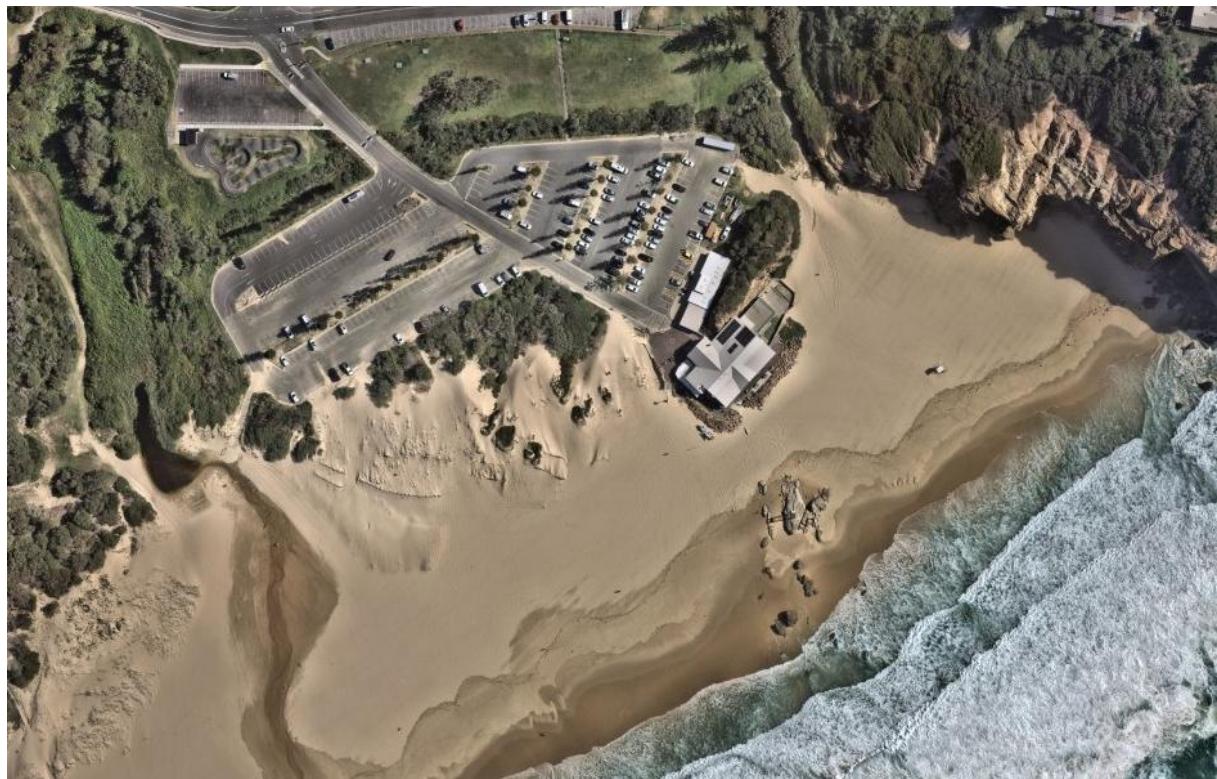
Over the past decade, the sand dune located immediately south-west of the SLSC has experienced a loss of vegetation, with a consequent increase in windblown sand reaching the carpark and loss of ecological habitat.

**Figure 1-2 Close up of Redhead Beach sand dune and SLSC, 2010 (Nearmap ©)**

**Figure 1-3 Close up of Redhead Beach sand dune and SLSC, 2025 (Nearmap ©)**

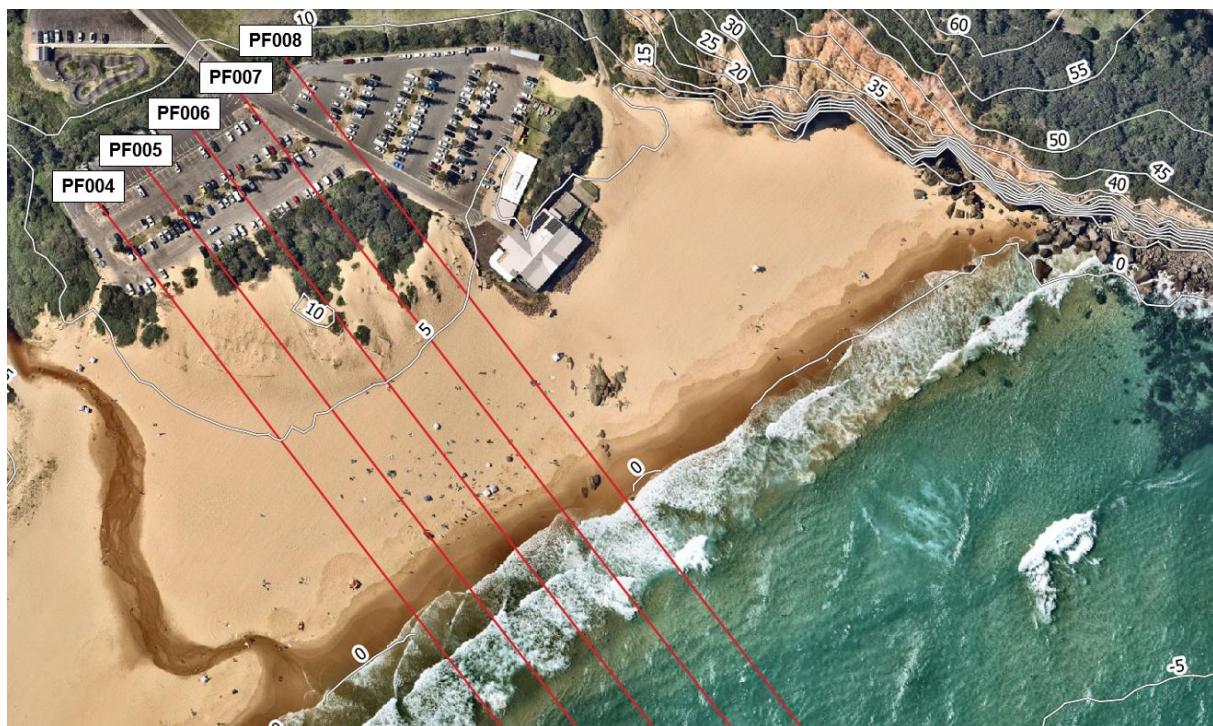
**Figure 3-1 Close up of cross shore beach profiles (PF4 to PF8)**

The cross-shore beach profile data of PF4 to PF8 for the DCCEEW and NSW marine LiDAR are shown in Figure 3-1 and Figure 3-3 respectively. Any remaining spikes from the classified DCCEEW drone survey, approximately between 60 to 100 m chainage, are assumed to be vegetation. The higher 0.1 m accuracy of the DCCEEW drone survey highlights the loss and movement of sand at the southern end of the dune.

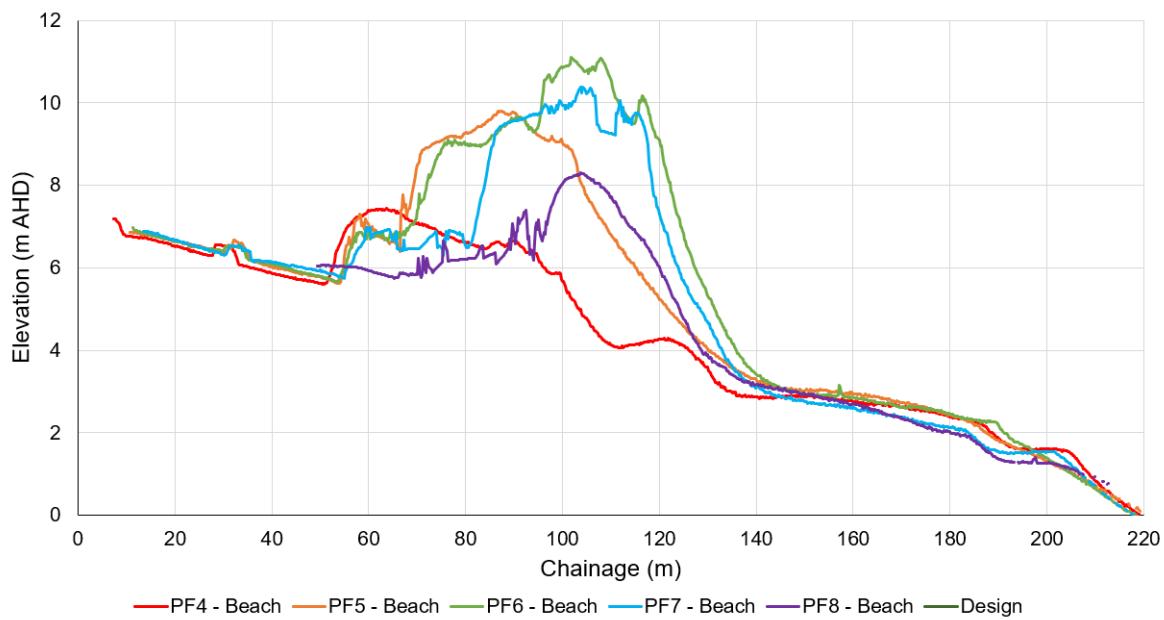
**Figure 3-2 DCCEEW drone survey (March 2025)**

- 1V:3H slope on the seaward face at PF6 to PF8 (see Figure 3-2)
- 1V:6H slope on the seaward face at PF4 and PF5 (see Figure 3-2)

Note: Some elevations landward of approximate chainage 120 m may be indicating the tree canopy and not the bare earth.

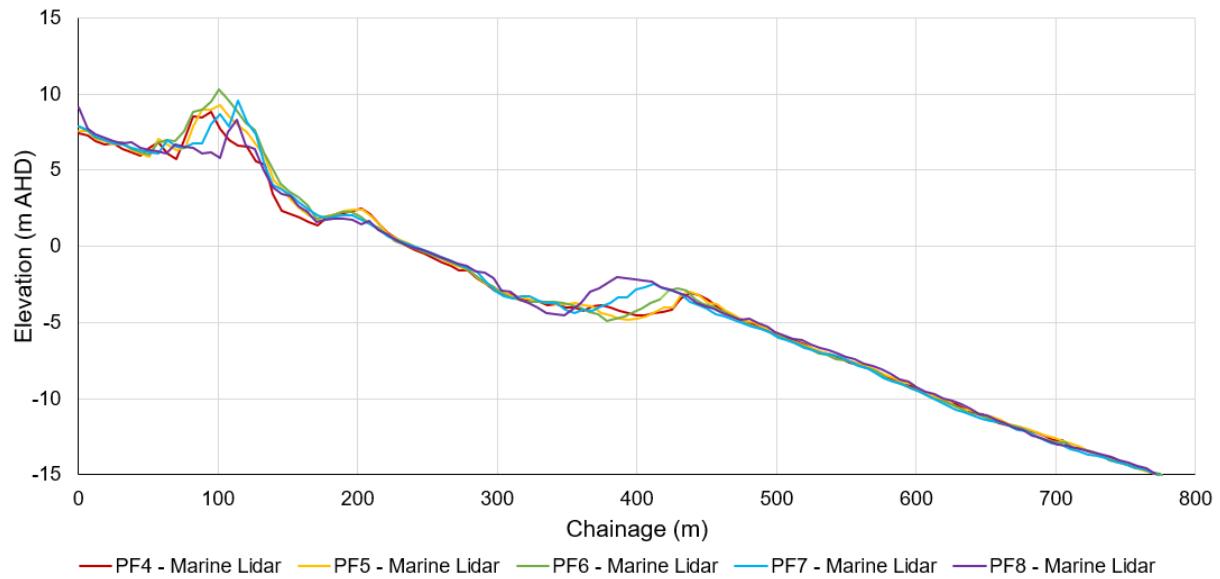
**Figure 3-4 NSW marine LiDAR data (2018)**

The NSW marine LiDAR data is shown in Figure 3-4. Based on an active profile from +5 m AHD to -15 m AHD, this indicates an approximate Bruun Factor slope of 1V:33H.

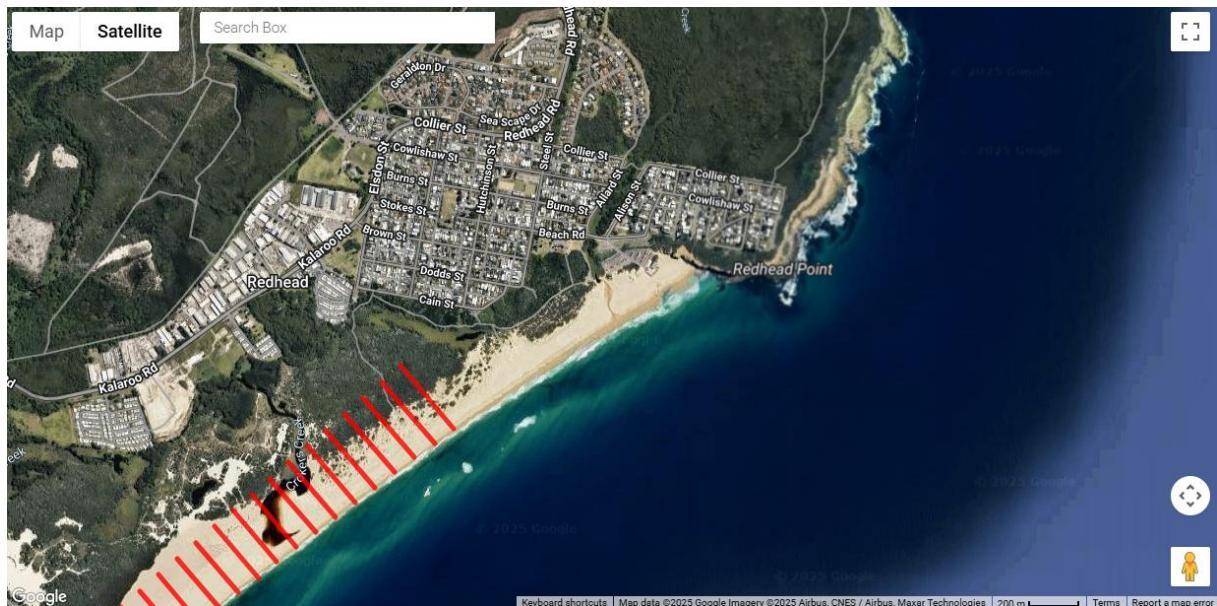
There is no historical beach profile data available along the northern end of Redhead Beach as shown in Figure 5-1.

**Figure 5-1 Historical beach profiles from the NSW Beach Profile Database (2025)**

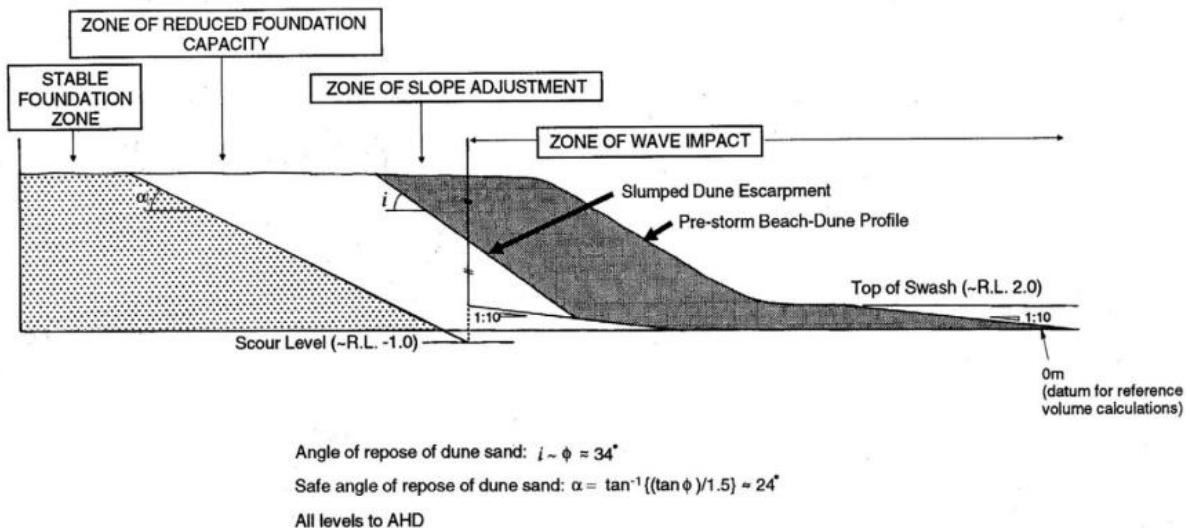
**Figure 5-2 Definition of dune stability scheme from Nielsen et al. (1992)**

The Zone of Slope Adjustment (ZSA) would be applicable to Redhead Beach as there is no planned construction on top of the sand dune. To determine the ZSA, the procedure of Nielsen et al. (1992) could be followed, as shown in Figure 5-2.

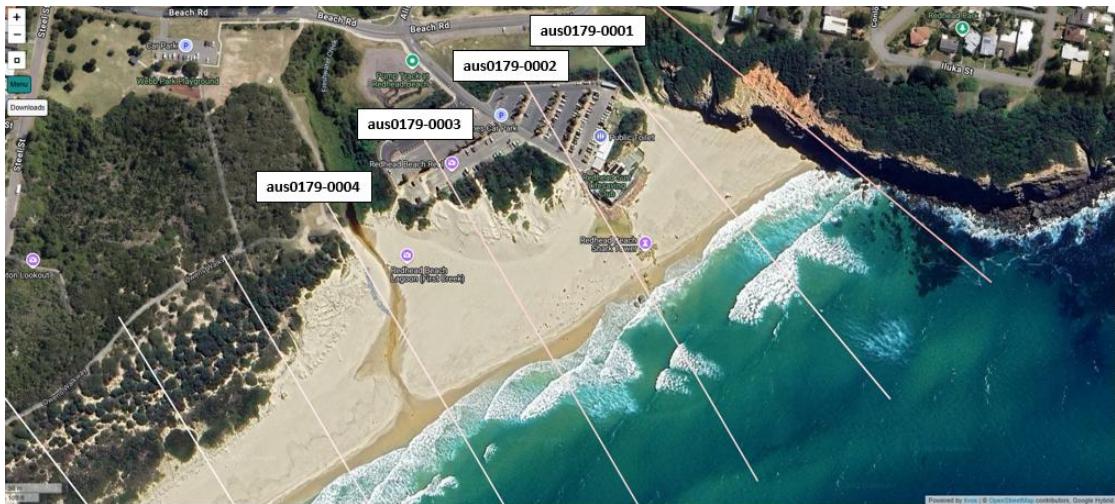
Beach width (distance from a baseline to the mean high water mark, 0.7 m AHD) was sourced from the CoastSat database hosted by WRL (<http://coastsat.wrl.unsw.edu.au>). The beach profiles located at Redhead Beach dune were profiles aus0179-0001 to aus0179-0004, shown in Figure 5-3. While there is apparent periods of erosion and accretion, and likely other cycles, Redhead Beach shows a mean beach recession trend of -0.03 m per year between 1987 to 2021. This is effectively zero and has occurred during a period where relative sea level rise has been approximately 2 mm per year (Watson, 2020). The time series of beach width from CoastSat is shown in Figure 5-4.

**Figure 5-3 CoastSat profiles**

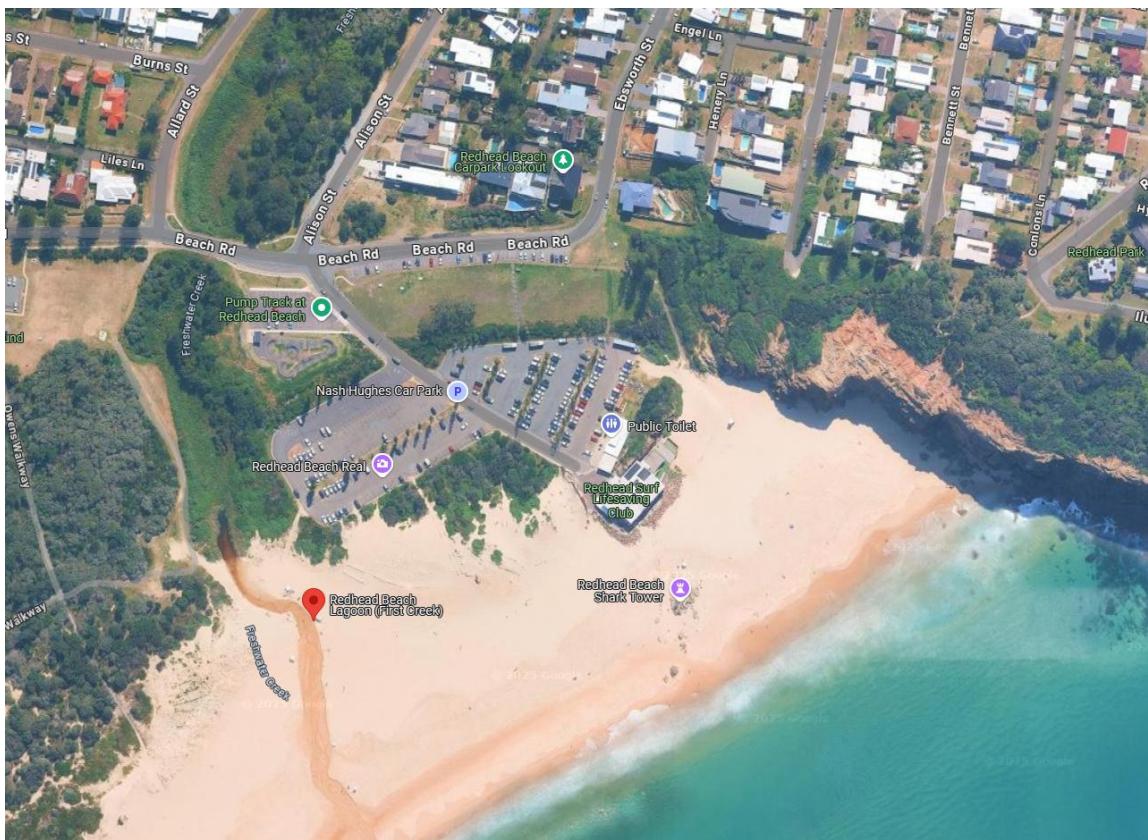
A small creek (Freshwater Creek) runs along the southern end of the subject dune (Figure 5-5). The northward meander of this creek can cause some erosion of the dune and loss of vegetation. More extensive meander is limited due to restrictions further upstream, such as passing under Beach Road.

**Figure 5-5 Freshwater Creek and Beach Road**

The meander of Freshwater Creek was quantified using the “InletTracker” software (Heimhuber, 2021) developed at WRL. This software estimates the historical location of the centreline/thalweg of a waterway (in this case Freshwater Creek) using satellite images between 1987 to 2024. The InletTracker analysis for Freshwater Creek is shown in Figure 5-6 and shows that Freshwater Creek did impact the dune on its northern bank on occasions. This would lead to some erosion of the dune and loss of vegetation.

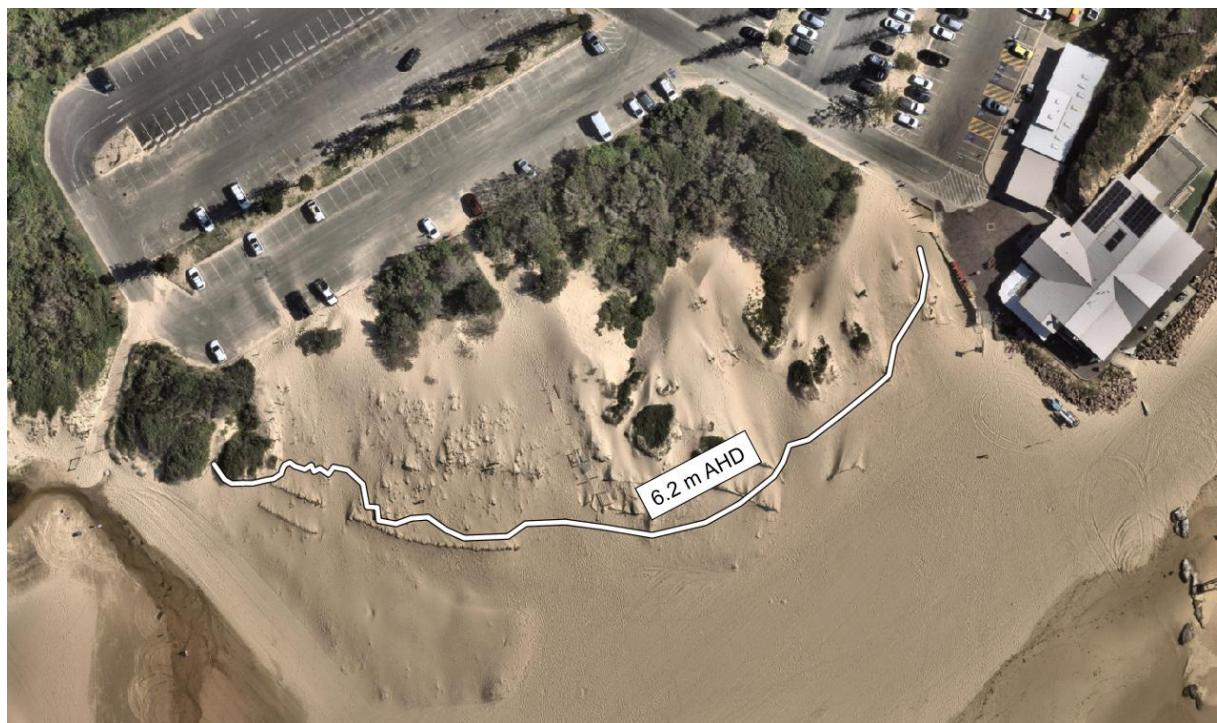
**Figure 5-7 2050 100 year ARI wave runup**

The highest R2% wave runup for all the considered scenarios was 6.2 m AHD as shown in Figure 5-7. The current sand dune crest height is between 8 m AHD to 9 m AHD, so there is no wave overtopping risk into the carpark. Dune reshaping works should retain a dune crest elevation above 6.2 m AHD to prevent wave overtopping into the carpark.

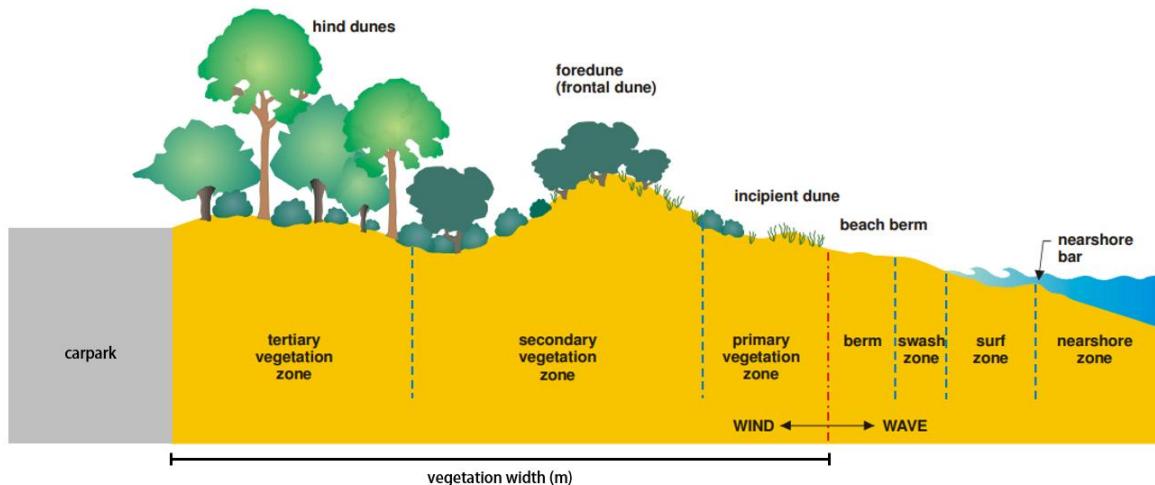
**Figure 6-1 Vegetation width measurement method (DLWC, 2001)**

Vegetation change was quantified by measuring the distance from the carpark to the seaward vegetation line along five transects. All data used for the analysis is outlined in Table 6-1 with a horizontal accuracy of approximately 1 m, using historical aerial photos provided to WRL for the period between 1975 to 2001 and Nearmap satellite imagery from 2010 to 2025. There was no clear vegetation line present prior to or in the 1975 aerial photo, hence this was chosen as a starting point. A visual representation of the primary vegetation zone from the NSW Coastal Dune Management Manual (DLWC, 2001) is shown in Figure 6-1. By measuring the vegetation width from historical photographs, a stable vegetation width and the date when it destabilised can be determined.

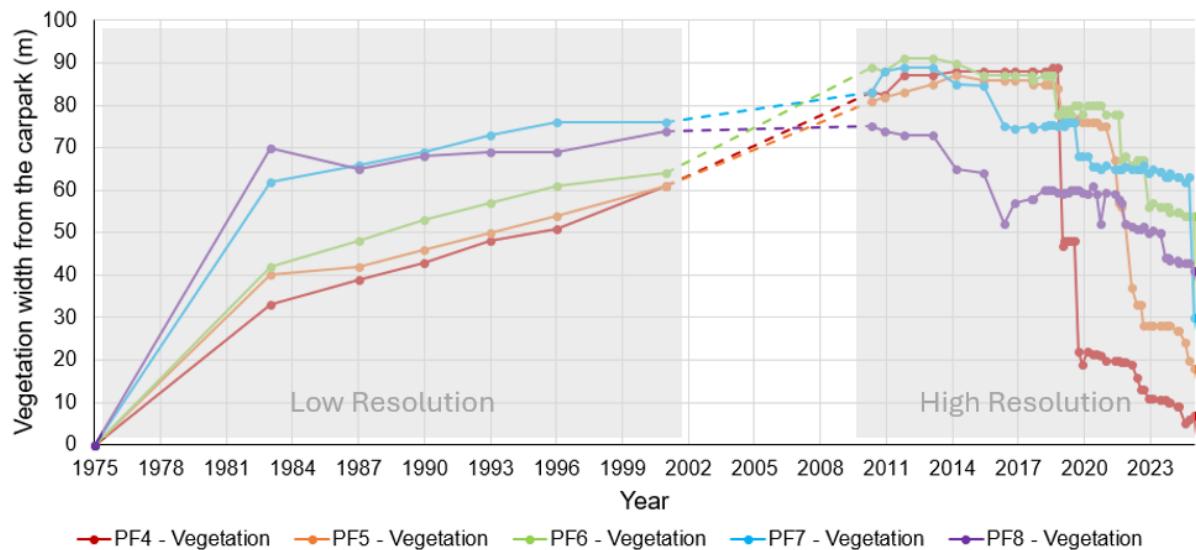
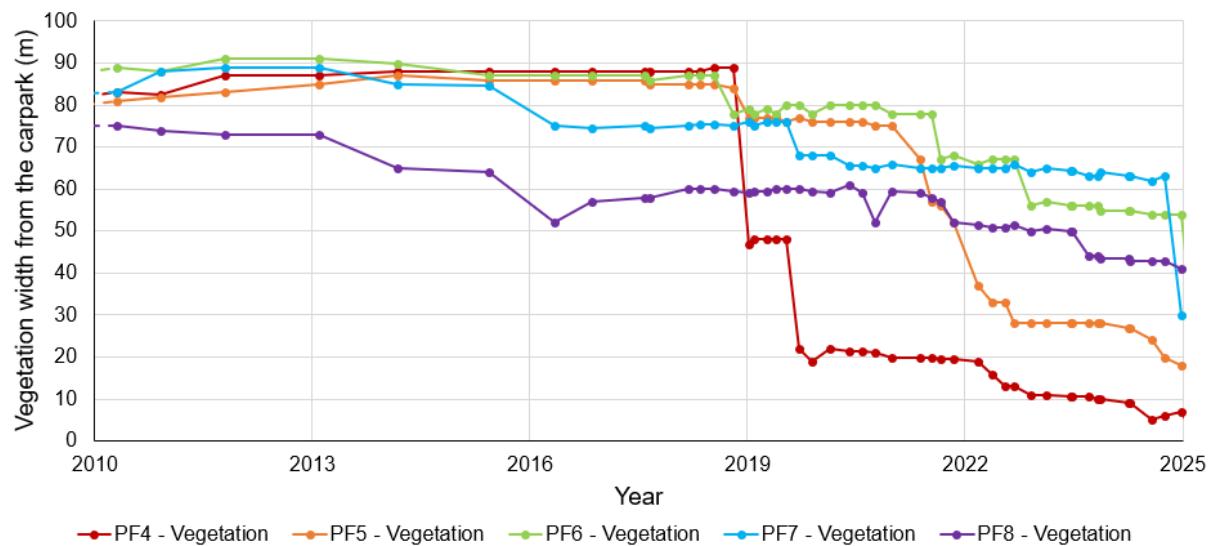
The vegetation width was measured for each historical aerial photo and results are shown in Figure 6-2 and Figure 6-3. The measurements show that from 1975 the vegetation width increased in the early 1980s, presumably due to managed planting under the NSW Beach Improvement Program. The vegetation continued to grow and reached a stable width of 85 to 90 m from the carpark in 2010 to 2018. Then in 2019 the vegetation width began to decrease across all five cross-sectional profiles. However, due to lower-quality images prior to 2010 and the gap of imagery from 2001 to 2010 the results prior to 2010 are less certain.

The results show that PF4, PF5, and PF6 had a vegetation width between 80 to 90 m from 2010 to 2019 whereupon the vegetation narrowed and was lost. The measurements have shown a narrowing trend with no sign of recovery at the southern three profiles (PF4 to PF6). The exception to this is the northern end of the sand dune (PF7 and PF8) where the vegetation width has been narrowing at a slower rate. Some uncertainty in measurements may be a result of windblown sand covering areas of the primary vegetation zone, image quality or alignment.

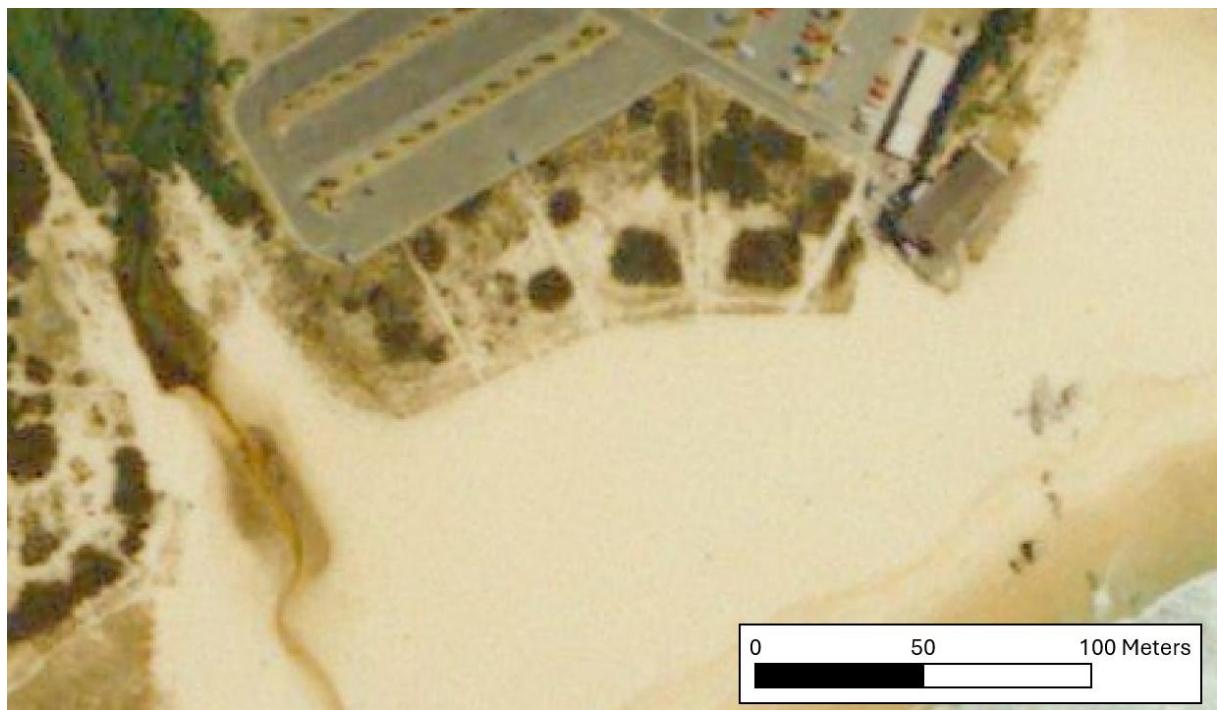
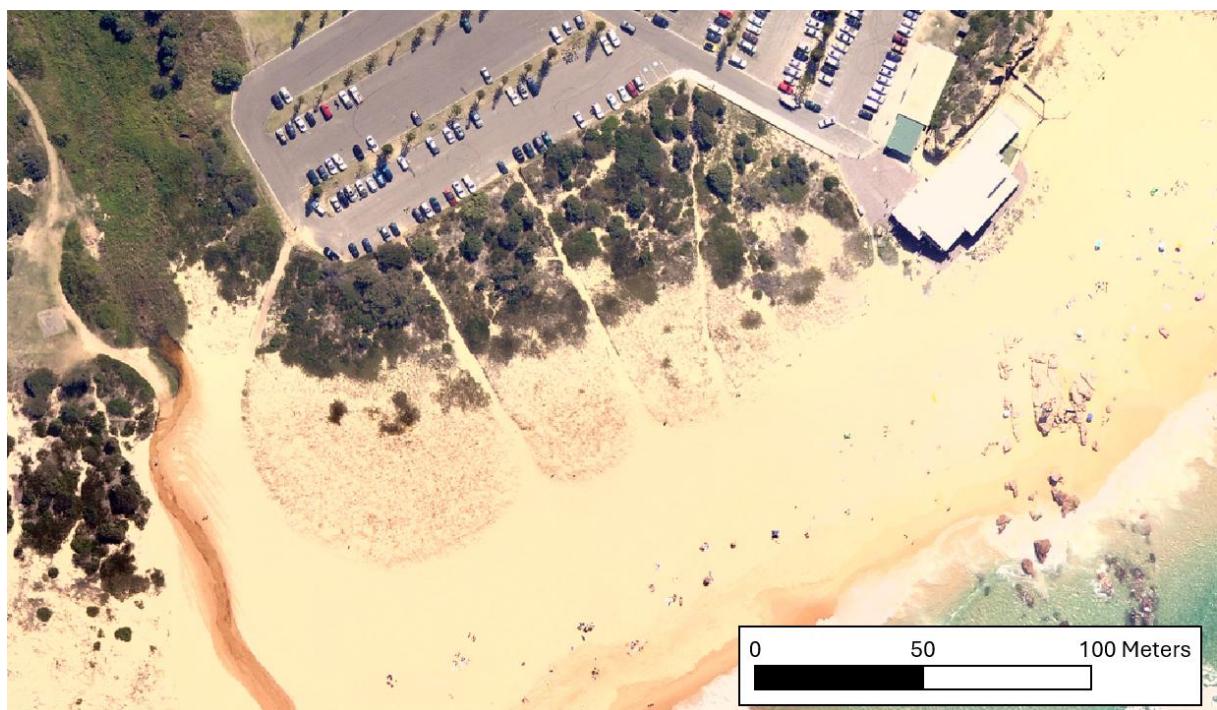
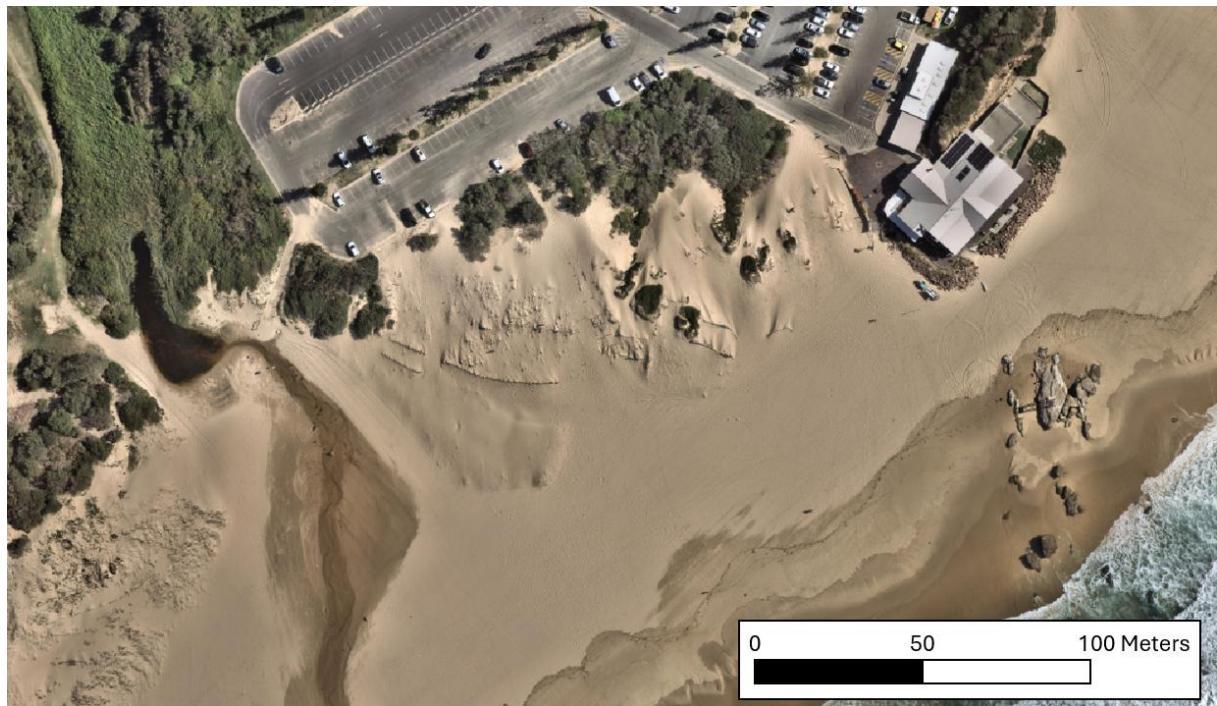
Aerial images taken in 1993, 2010, and 2025 are shown in Figure 6-4, Figure 6-5, and Figure 6-6 respectively to illustrate these changes.

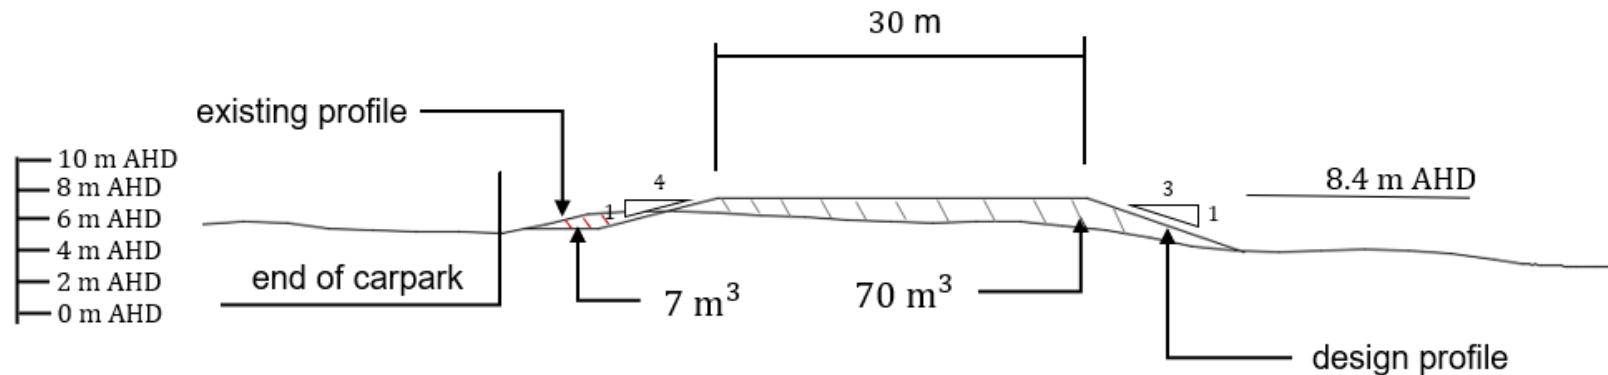
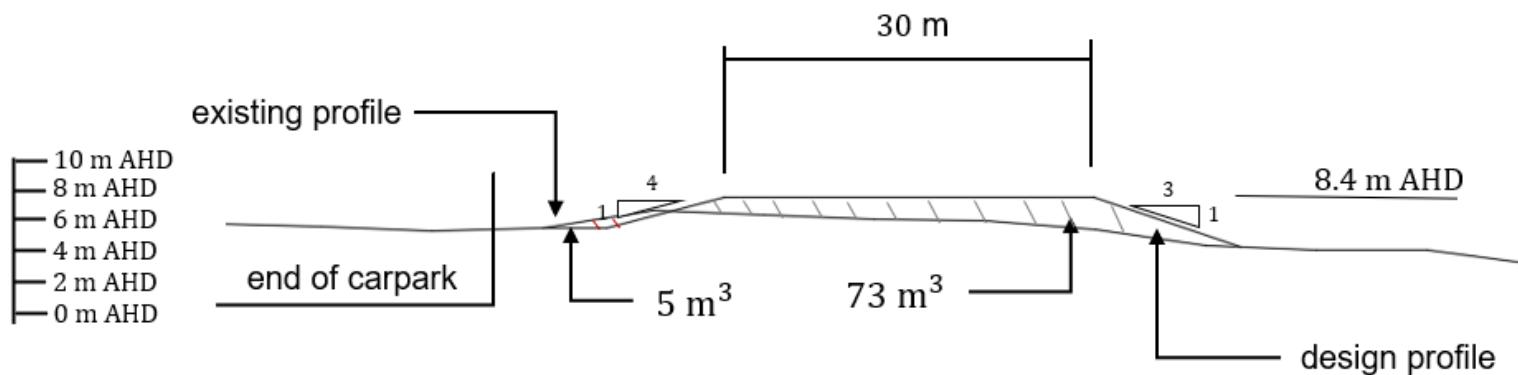
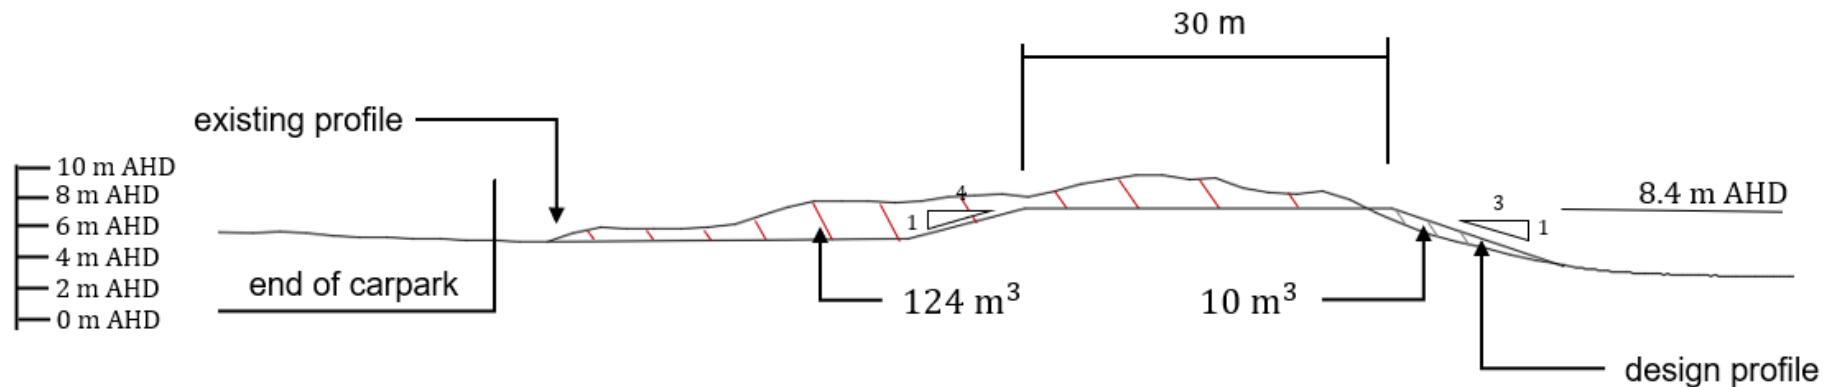
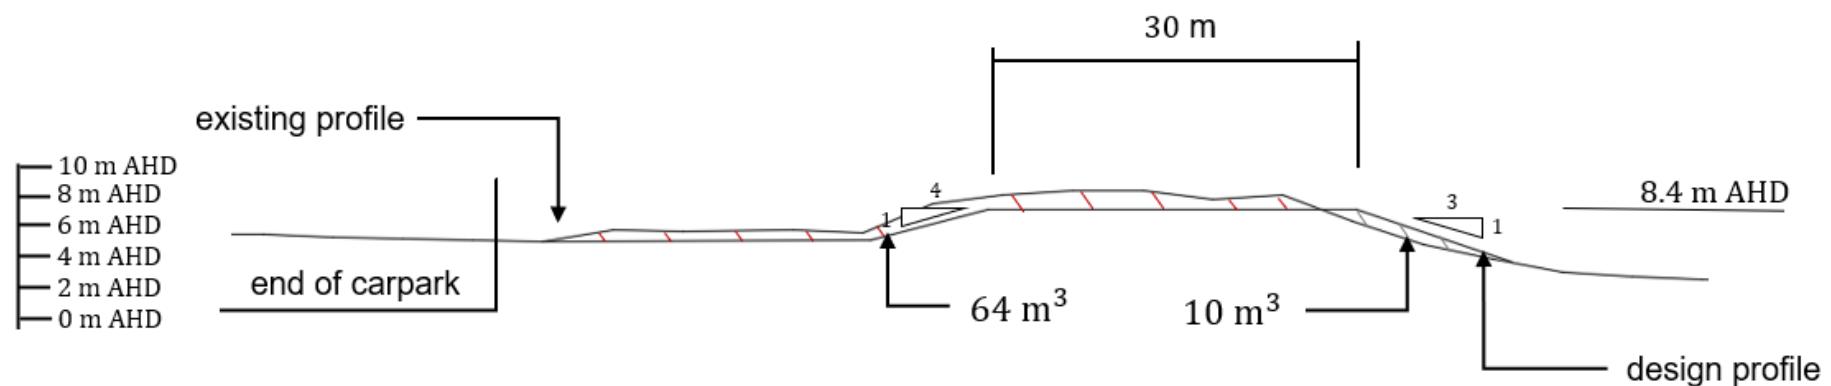
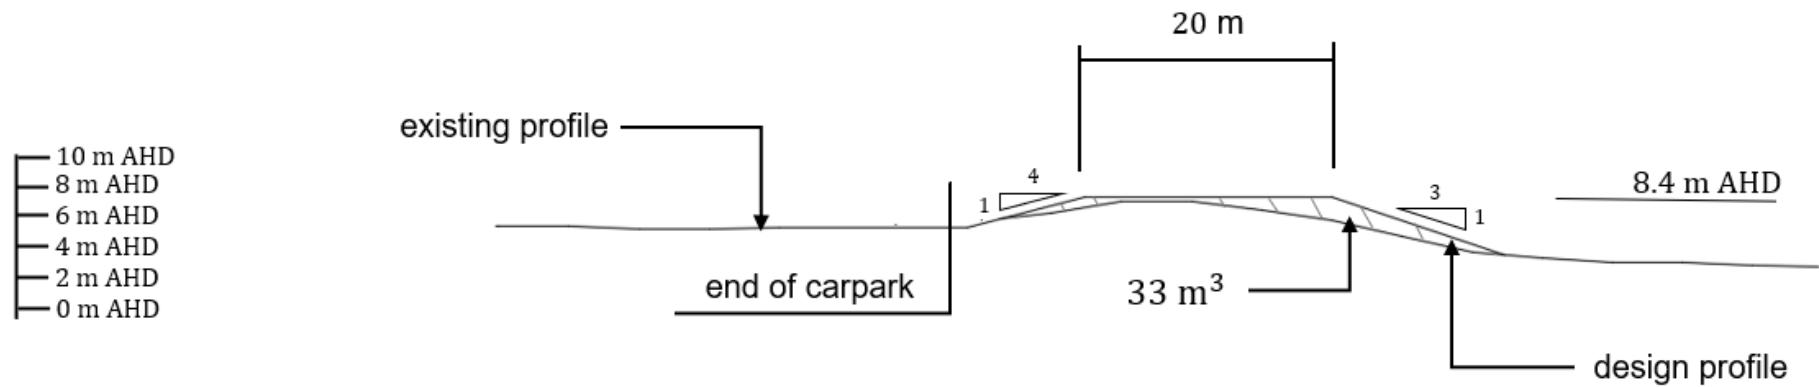
- 1V:4H hind dune slope
- Hind dune slope beginning approximately 30 m seaward from the carpark (tertiary vegetation)
- 30 m crest width at 8.4 m AHD crest height (secondary vegetation)
- 1V:3H seaward facing slope (primary vegetation)

The detailed designs for each profile (PF4 to PF8) are shown in Figure 7-1 to Figure 7-5. Red hatching represents cutting and grey hatching represents filling.

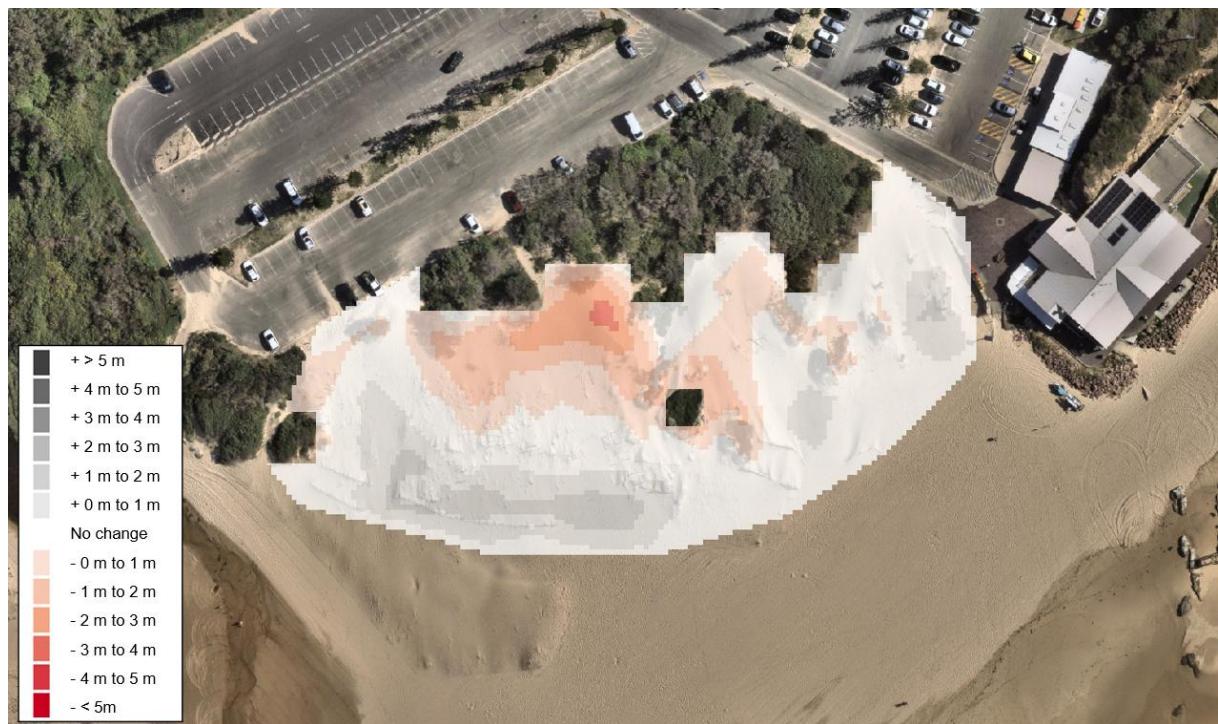
Figure 7-6 Cut and fill heatmap

A cut and fill analysis was conducted to visualise the major locations for sand change and is shown in Figure 7-6. The heatmap shows the proposed areas for removal of sand in red and addition of sand in grey. A more detailed representation using contour lines is shown in Figure 7-7. Sections of the cut and fill have been removed to account for areas of no data or areas where natural features impacted the results.

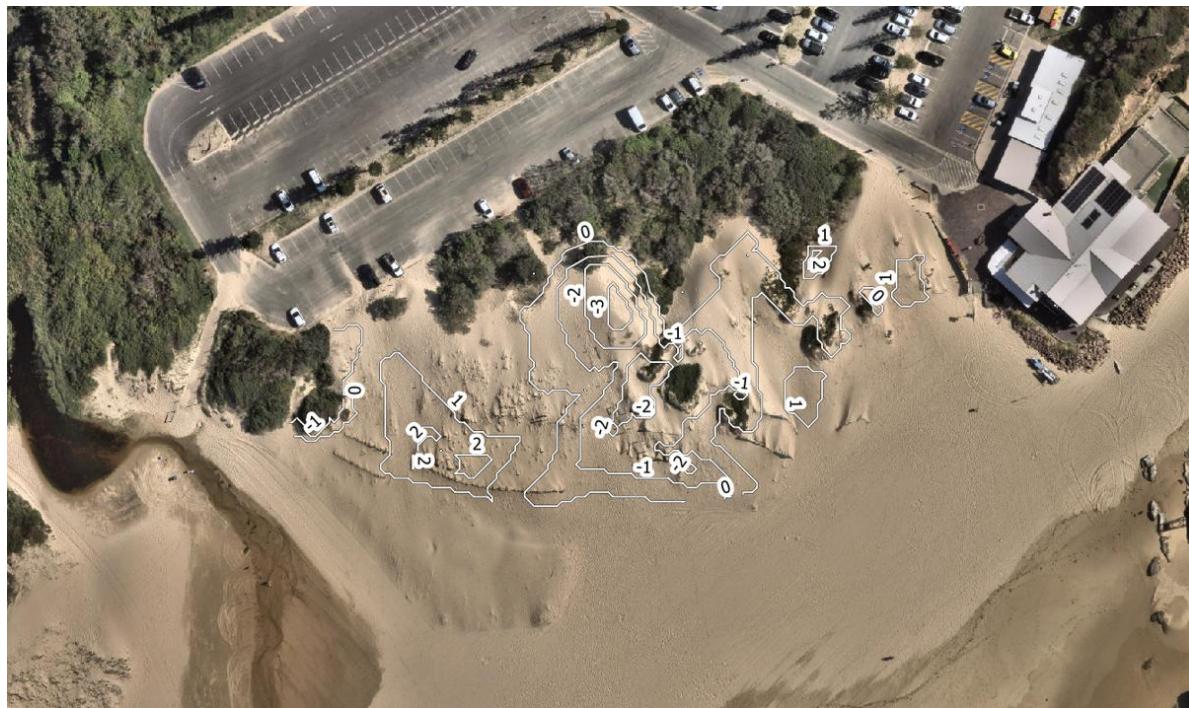
**Figure 7-7 Cut and fill contour lines**

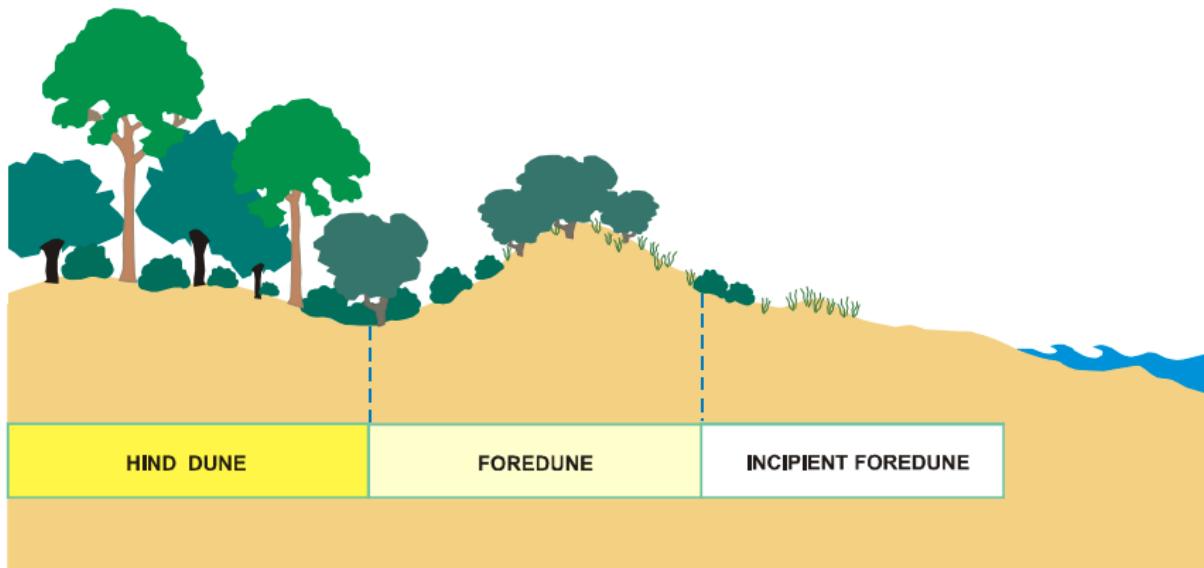
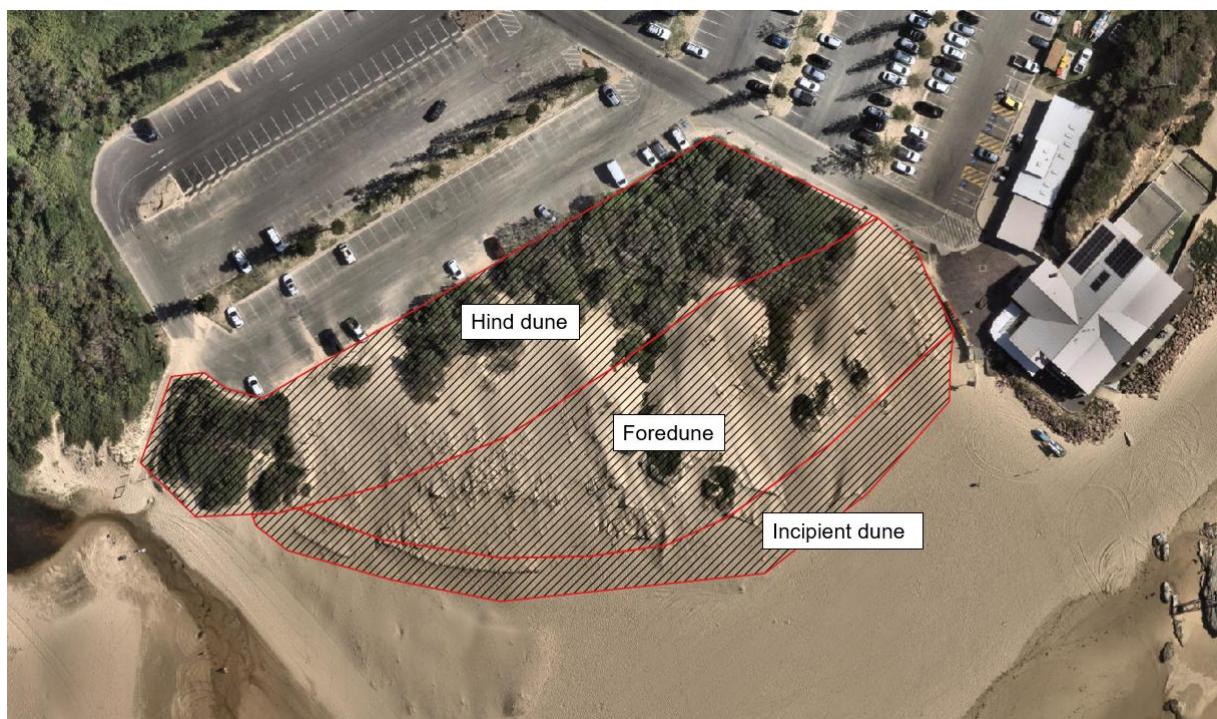
- Tertiary vegetation: between the carpark and the hind slope
  - *Ficus rubiginosa*
  - *Diospyros australis*
  - *Banksia integrifolia*
- Secondary vegetation: from the start of the hind slope to the end of the crest
  - *Lomandra longifoli*
  - *Leucopogon parviflorus*
  - *Acacia longifoli*
- Primary vegetation: along the seaward facing slope
  - *Spinifex sericeus*
  - *Carpobrotus glaucescens*
  - *Canavalia rosea*

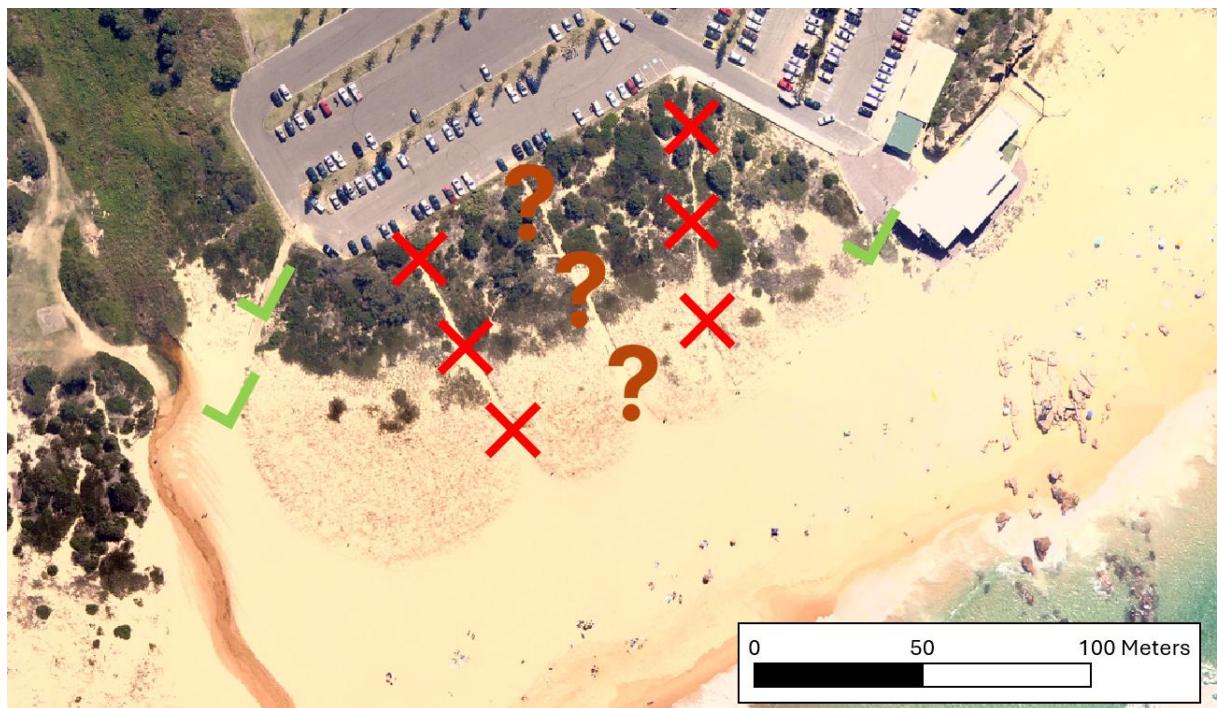
Figure 7-10 Suggested beach access ways from Redhead carpark

It may be feasible to rationalise/reduce the number of beach access ways from the carpark. By reducing the number of access paths, the foot traffic over the sand dune can be reduced to fewer sections. WRL suggests (Figure 7-10 using 2010 aerial imagery) that the south-western emergency access and north-eastern SLSC access are retained, the two intermediate paths be closed and the future of the central beach access path be further considered.
